HOFFMAN HOME INSPECTION

RESIDENTIAL REPORT

1234 Main St.
Wichita Kansas 67216

08/07/2017 9:00AM

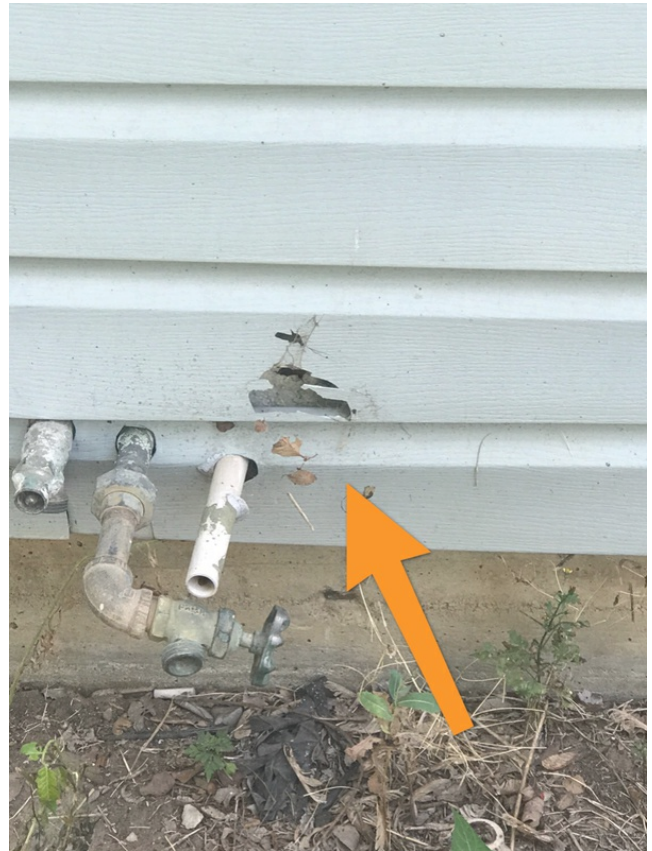
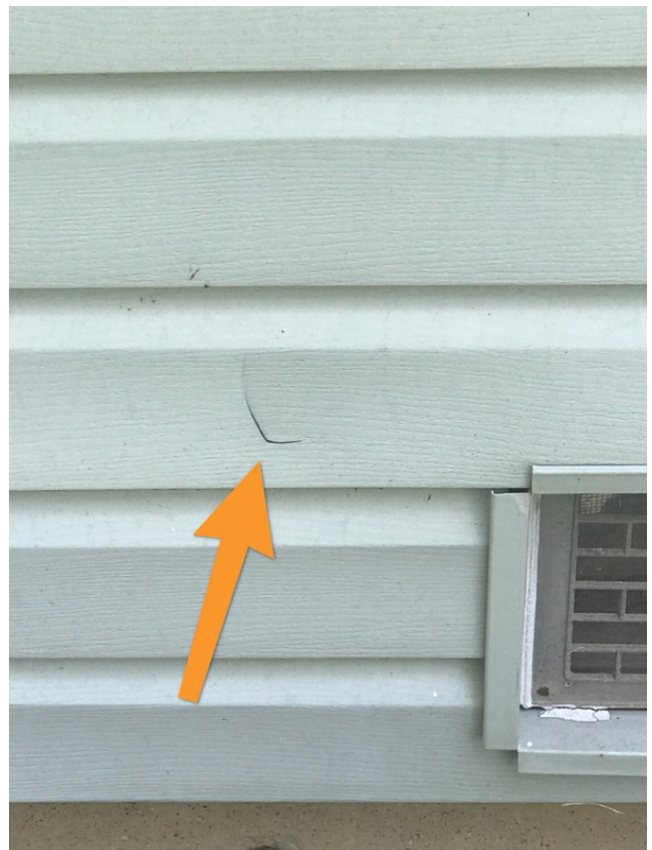
3.1.1 Siding, Flashing & Trim

DAMAGE - MAJOR

Moderate to major damage was observed at one or more points on the exterior. This can be the result of poor original compaction of soil at the time of construction or excess moisture in the underlying soil. Recommend consulting with a structural engineer and/or soil expert.

Contact a qualified siding specialist.

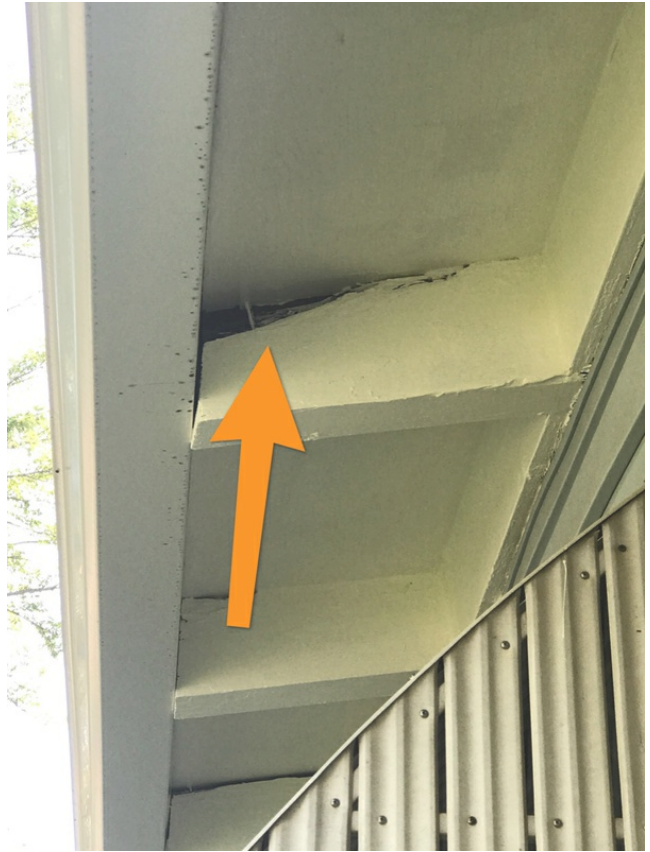
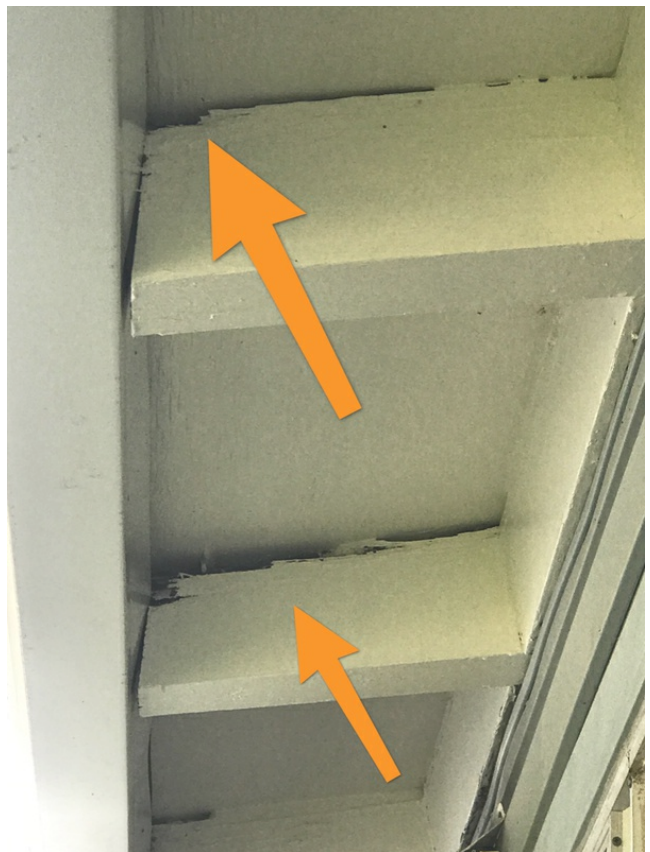
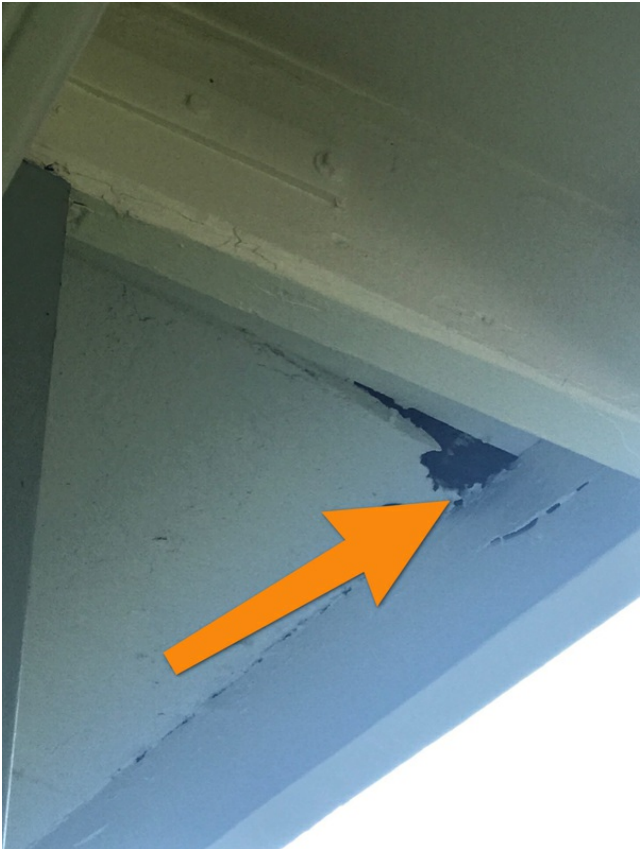
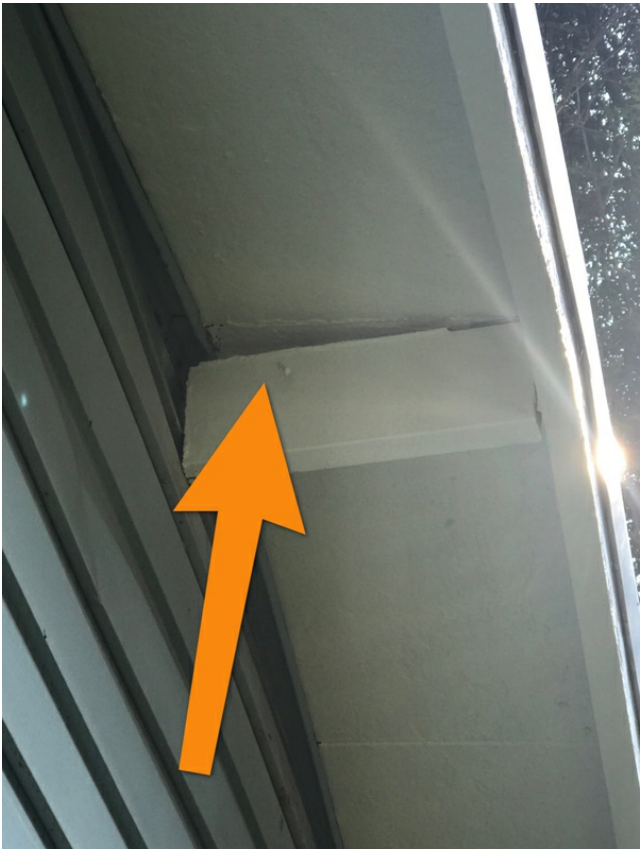
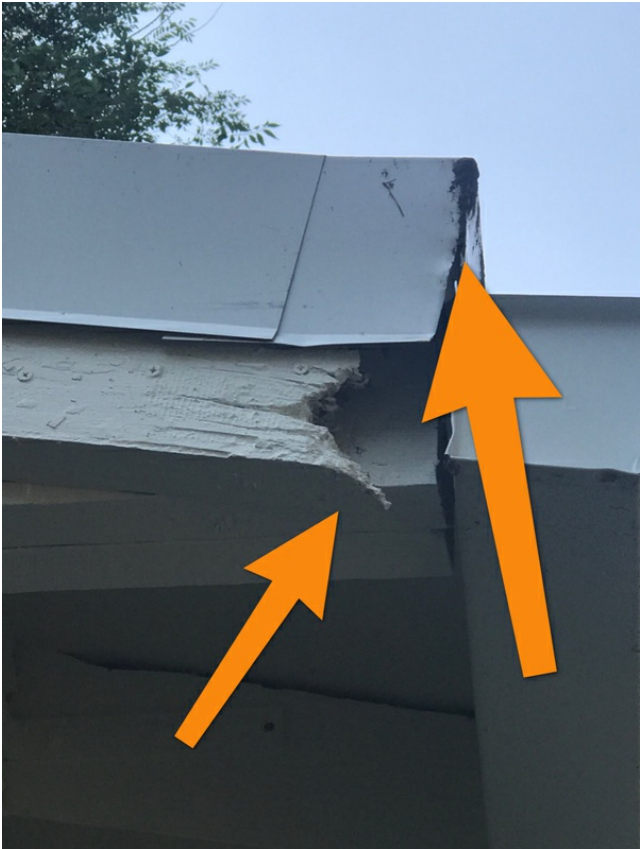
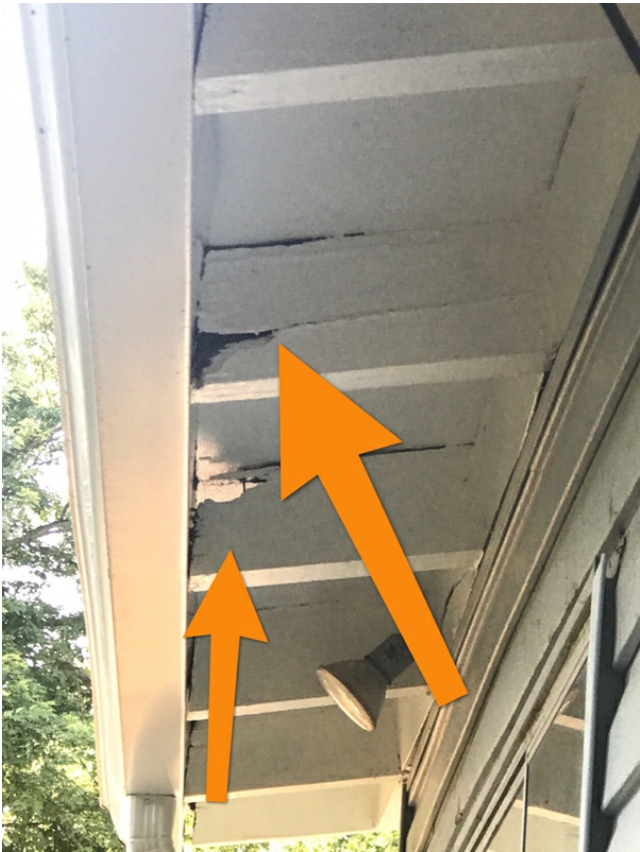
3.4.1 Eaves, Soffits & Fascia

EAVES - DAMAGED

One or more sections of the eaves are damaged. Recommend qualified roofer evaluate & repair.

Contact a qualified roofing professional.

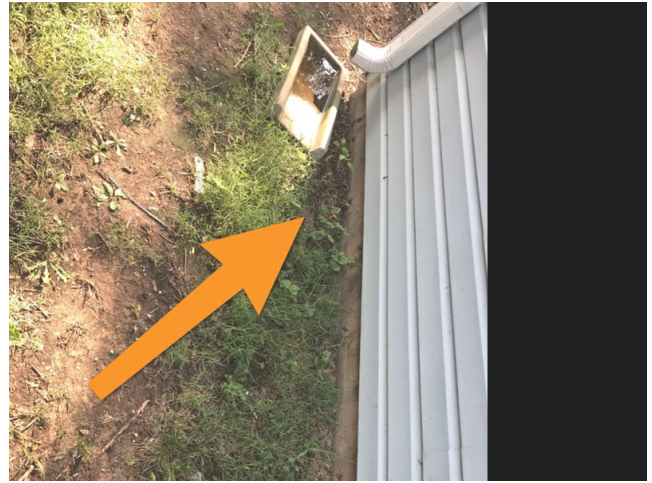
3.5.1 Vegetation, Grading, Drainage & Retaining Walls

NEGATIVE GRADING

Grading is sloping towards the home in some areas. This could lead to water intrusion and foundation issues.

Recommend qualified landscaper or foundation contractor regrade so water flows away from home.

Contact a qualified landscaper or gardener.

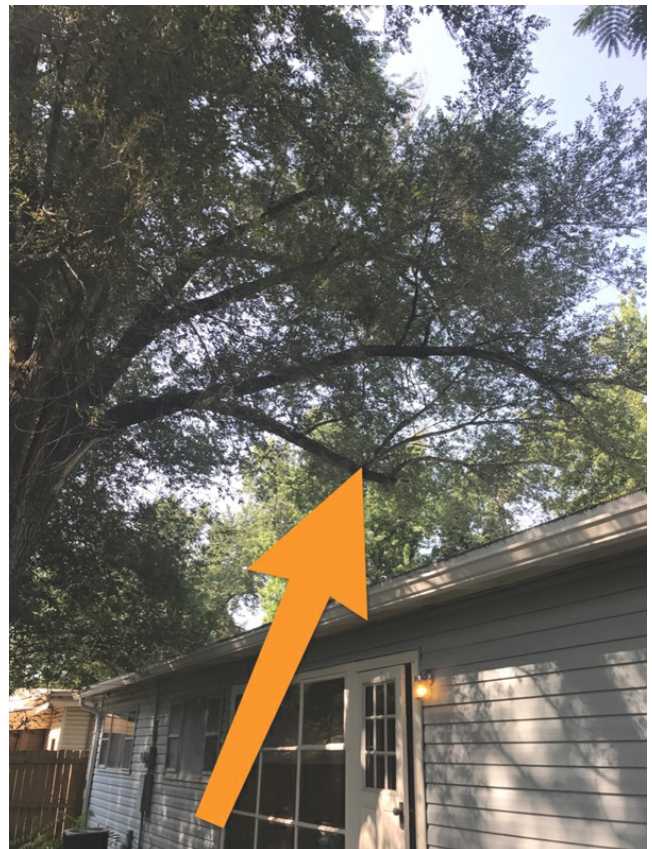
3.5.2 Vegetation, Grading, Drainage & Retaining Walls

TREE OVERHANG

Trees observed overhanging the roof. This can cause damage to the roof and prevent proper drainage. Recommend a qualified tree service trim to allow for proper drainage.

Contact a qualified tree service company.

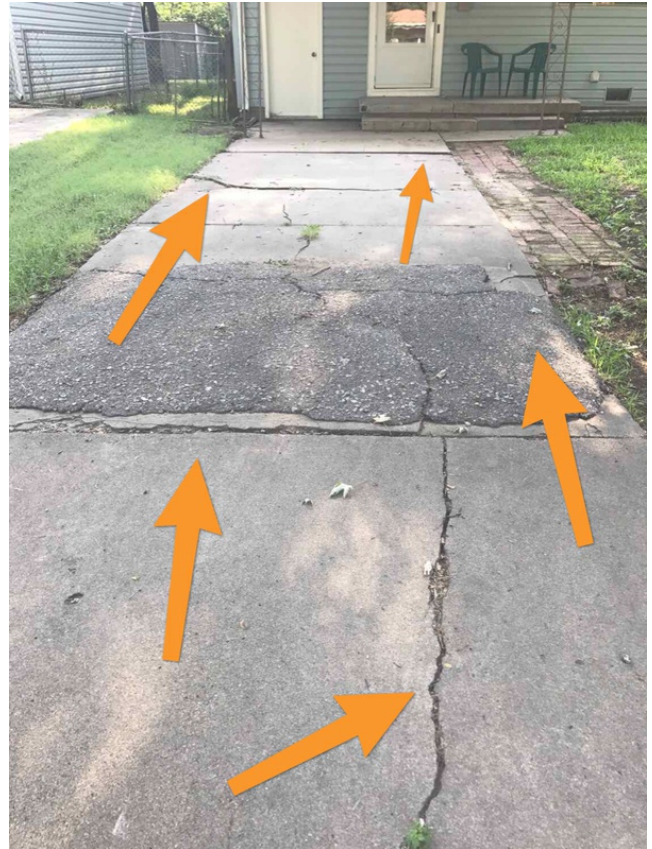
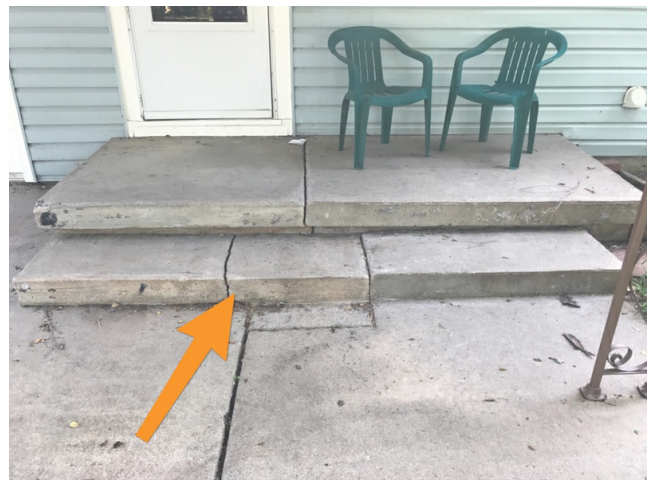
3.6.1 Walkways, Patios & Driveways

DRIVEWAY CRACKING - MAJOR

Major cracks observed. Recommend driveway contractor evaluate and replace.

Contact a qualified driveway contractor.

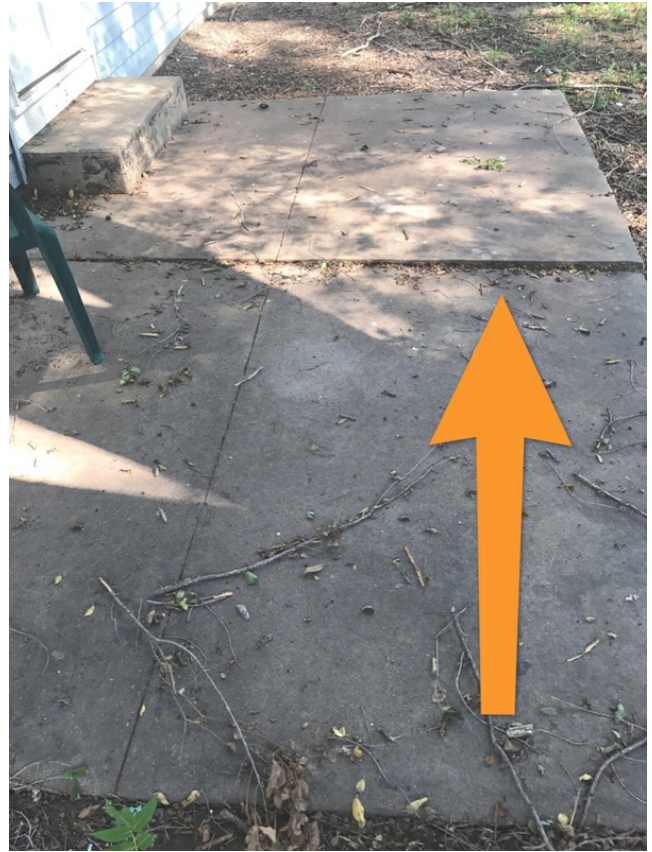
3.6.2 Walkways, Patios & Driveways

PATIO SETTLING - MAJOR

EAST

Significant settling observed. Further deterioration could result. Recommend concrete contractor evaluate & repair.

Contact a qualified concrete contractor.

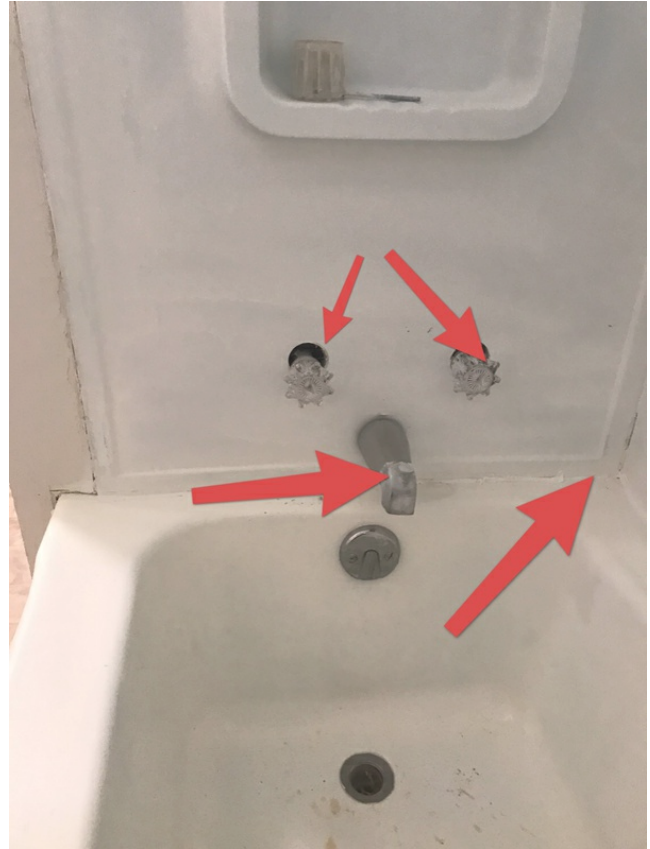
5.1.1 Fixtures / Faucets

IMPROPER INSTALLATION

1ST FLOOR HALL BATHROOM

Fixtures were installed improperly.
Recommend a qualified handyman or
plumber evaluate and repair.

Contact a quality handyman.

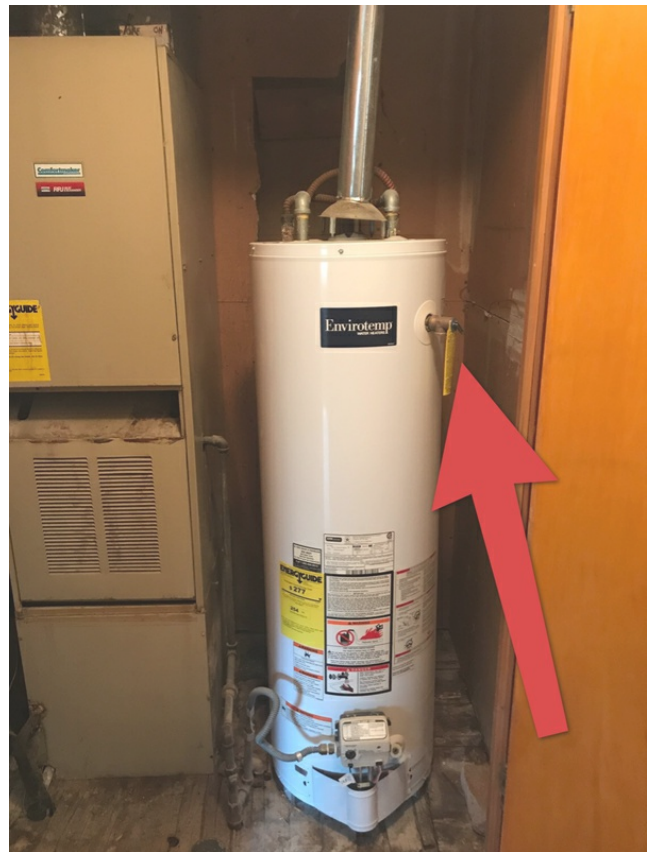
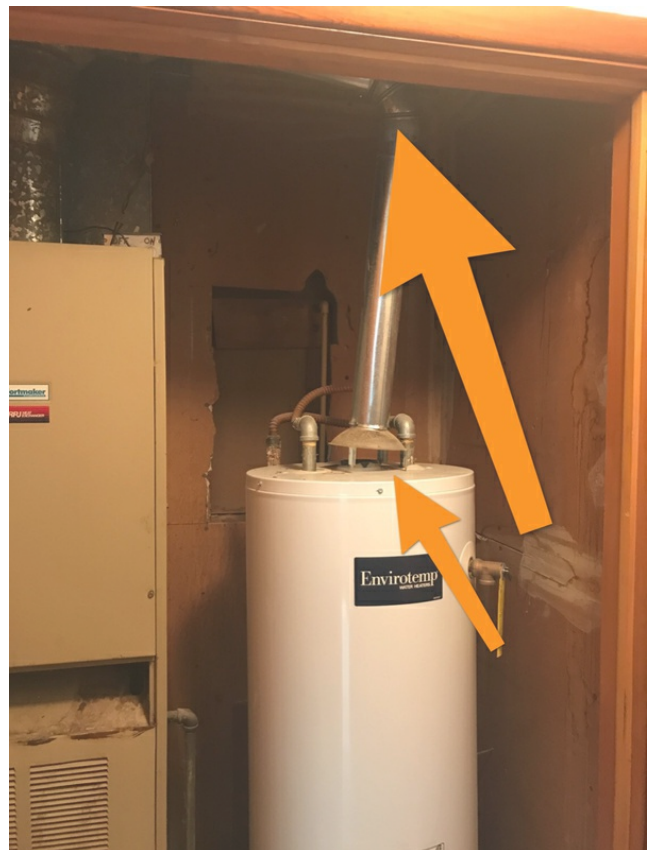
5.3.2 Water Heater

IMPROPER INSTALLATION

⚠ Safety Hazard and/or Requires Immediate Attention

Water heater is improperly installed.
Recommend qualified plumber evaluate & repair.

Contact a qualified plumber.

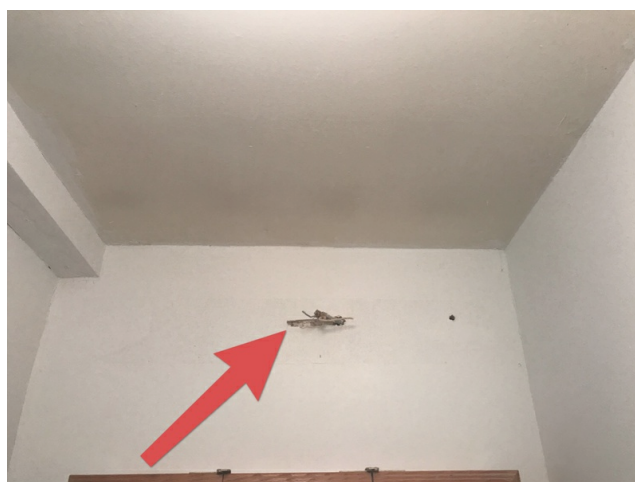
6.4.1 Connected Devices and Fixtures

OPEN JUNCTION BOX

⚠ Safety Hazard and/or Requires Immediate Attention

Open junction box observed. Recommend concealing or replacing.

Recommended DIY Project

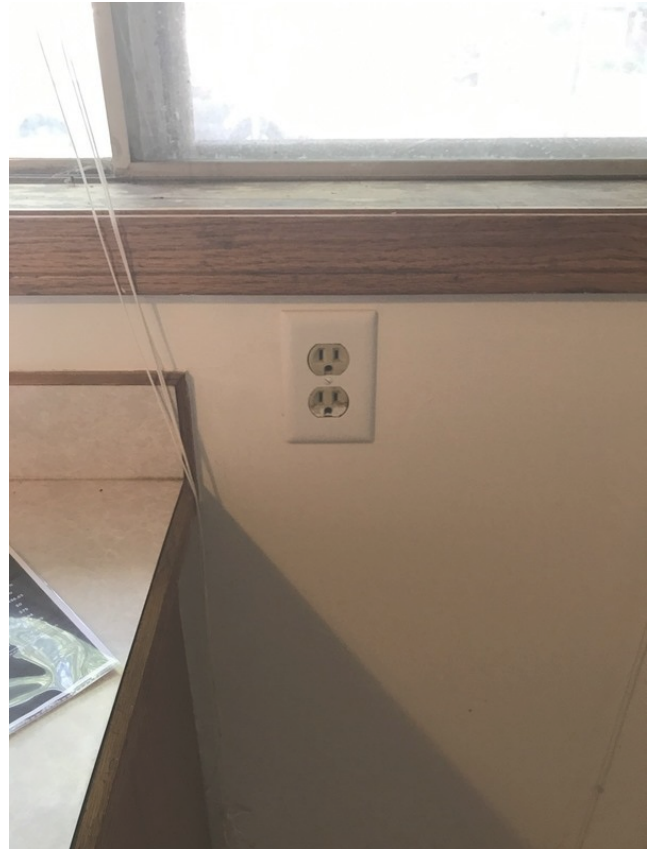
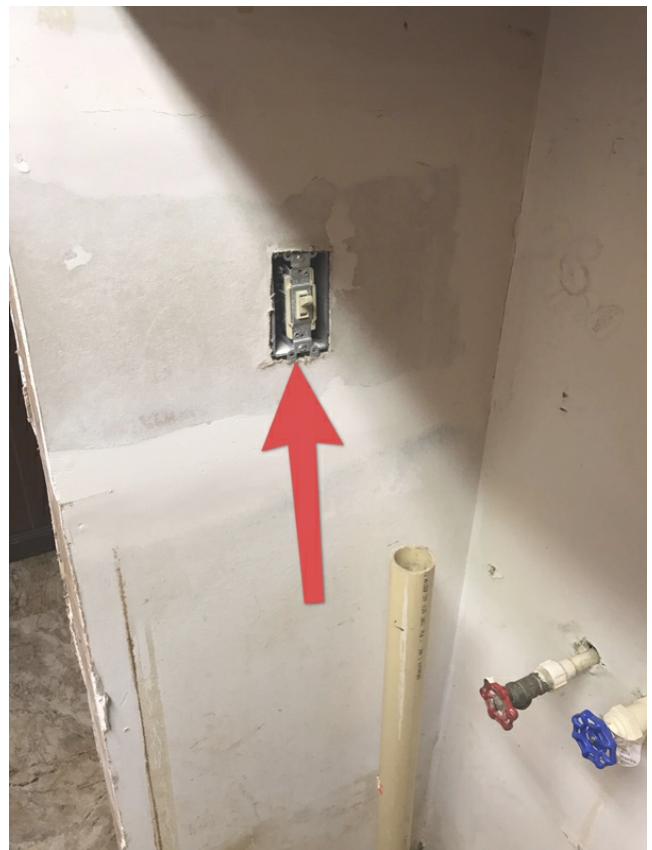
6.5.1 Polarity and Grounding of Receptacles

**OUTLET(S) NOT
GROUNDED**

KITCHEN

**⚠ Safety Hazard and/or Requires Immediate
Attention**

One or more outlets are not grounded.
Recommend a qualified electrician replace
non-grounded outlets with grounded ones.

Contact a qualified electrician.

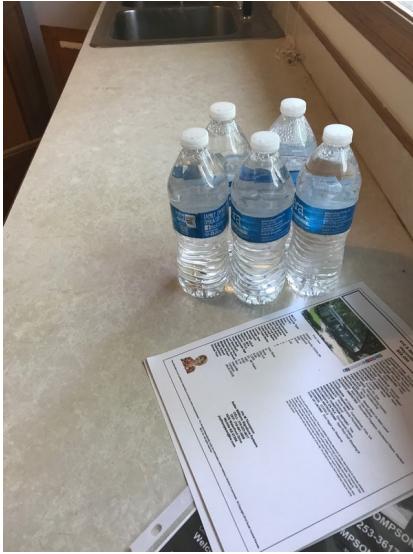
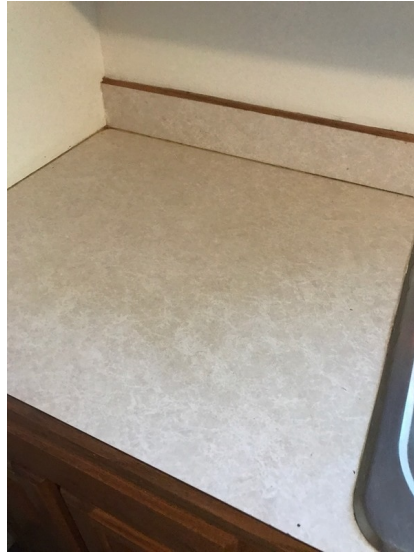
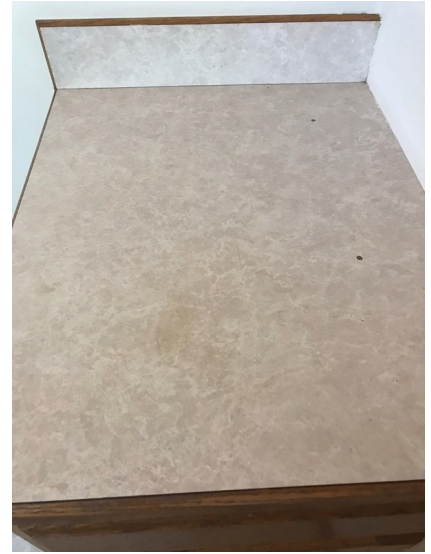
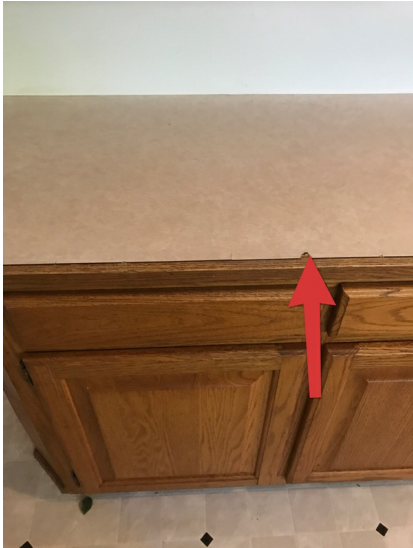
Kitchen 1st Floor

Laminate

Countertop is chipped

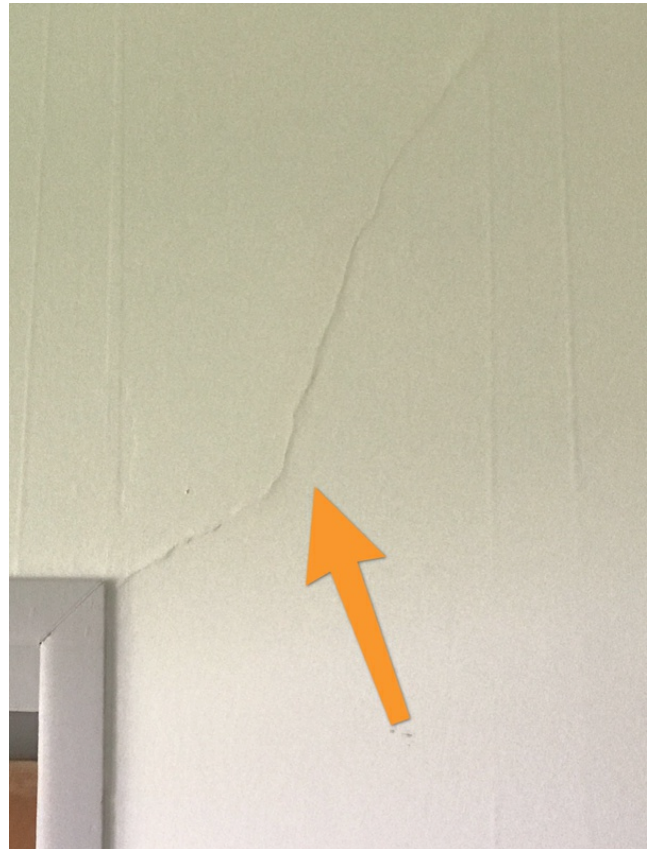
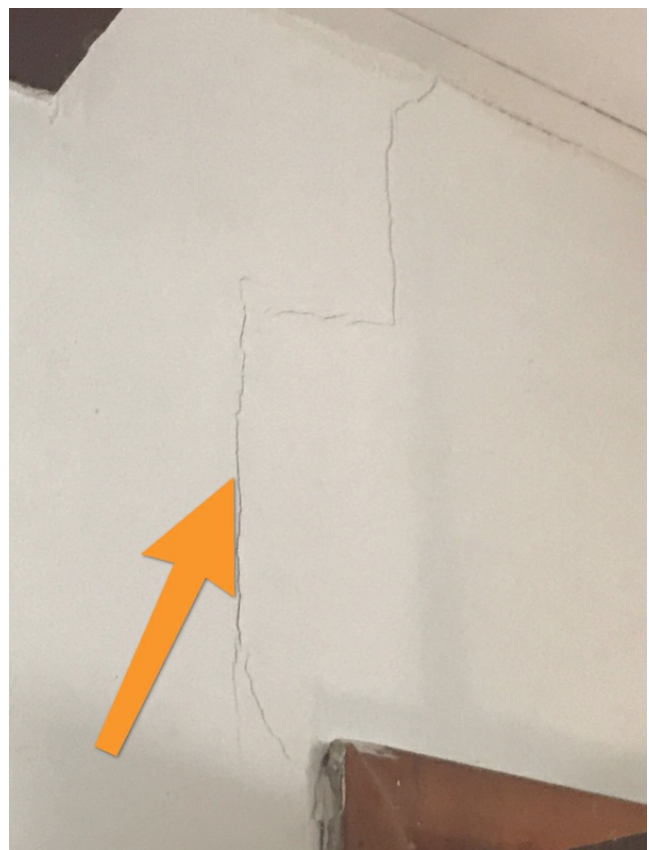
9.1.1 Walls

MINOR CORNER CRACKS

Minor cracks at the corners of doors and windows in walls. Appeared to be the result of long-term settling. Some settling is not unusual in a home of this age and these cracks are not a structural concern.

Contact a qualified structural engineer.

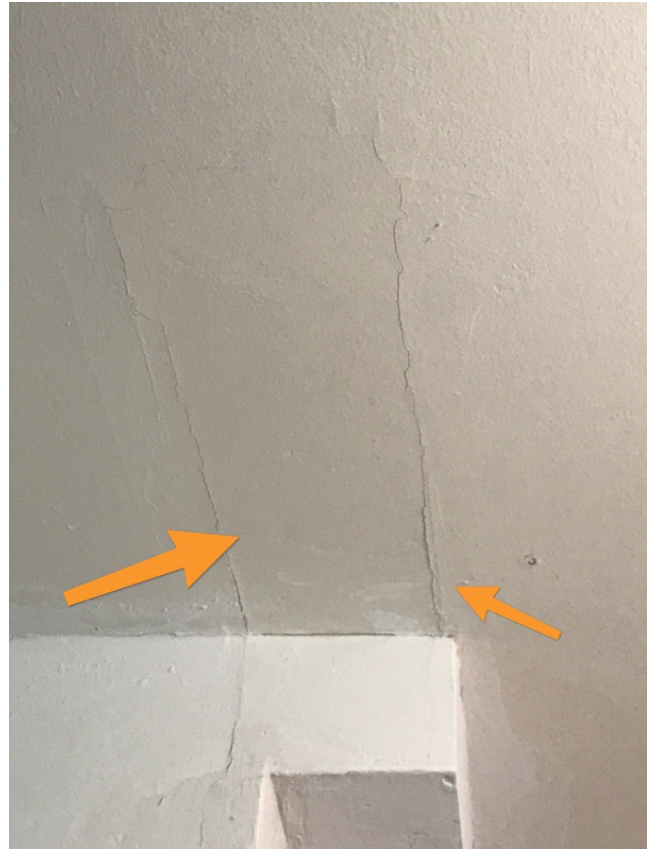
9.2.1 Ceilings

MINOR DAMAGE

Minor damage or deterioration to the ceiling was visible at the time of the inspection.

Contact a qualified professional.

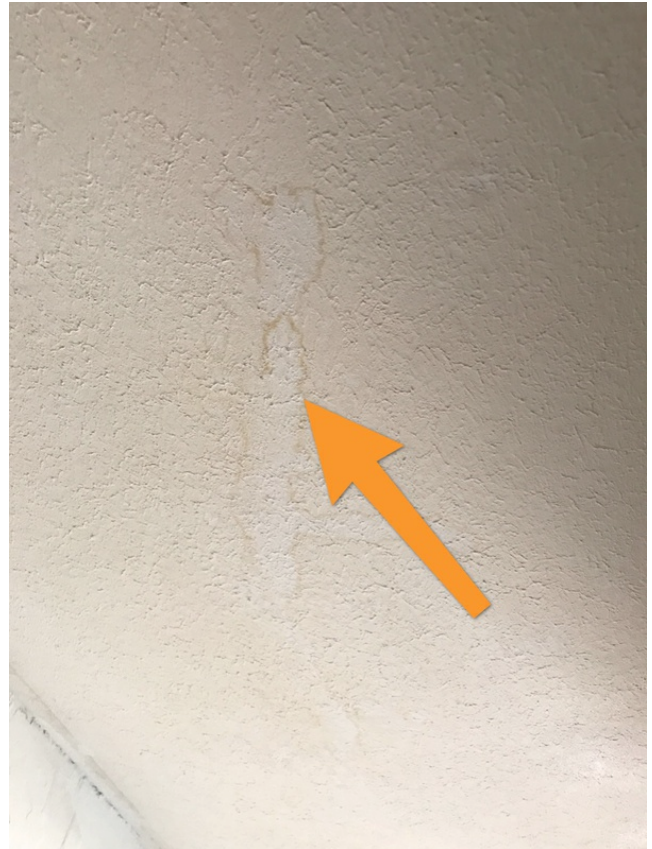
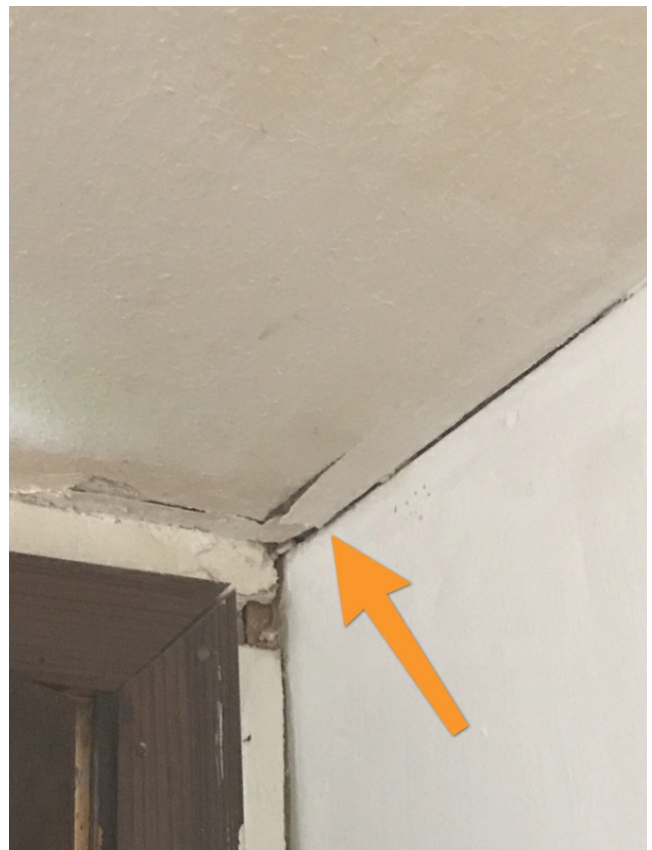
9.2.2 Ceilings

POSSIBLE ROOF LEAK DAMAGE

ABOVE FRONT DOOR

Stains on the ceiling appear to be the result of roof leaks. The source of leakage should be identified and corrected, and the ceiling re-painted.

Contact a qualified professional.

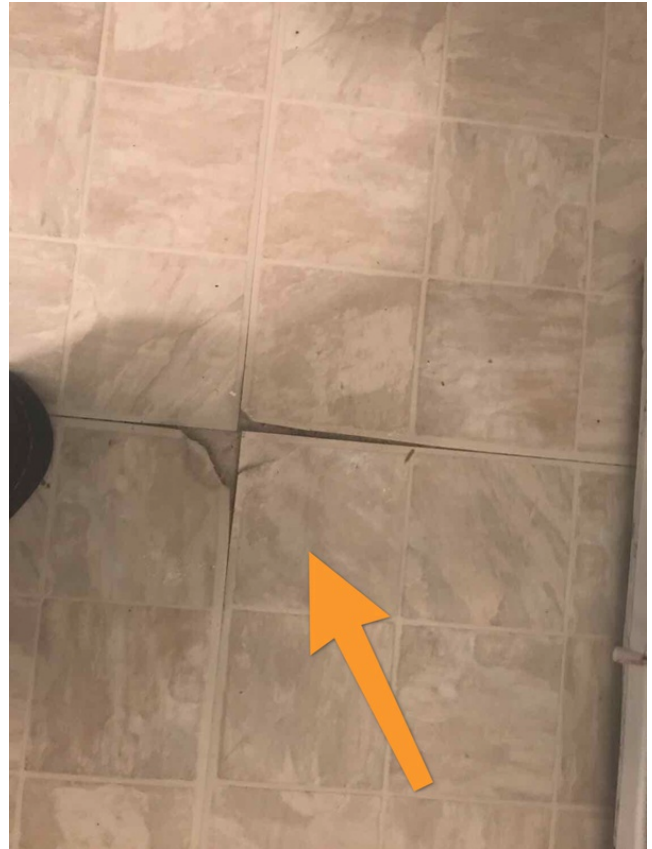
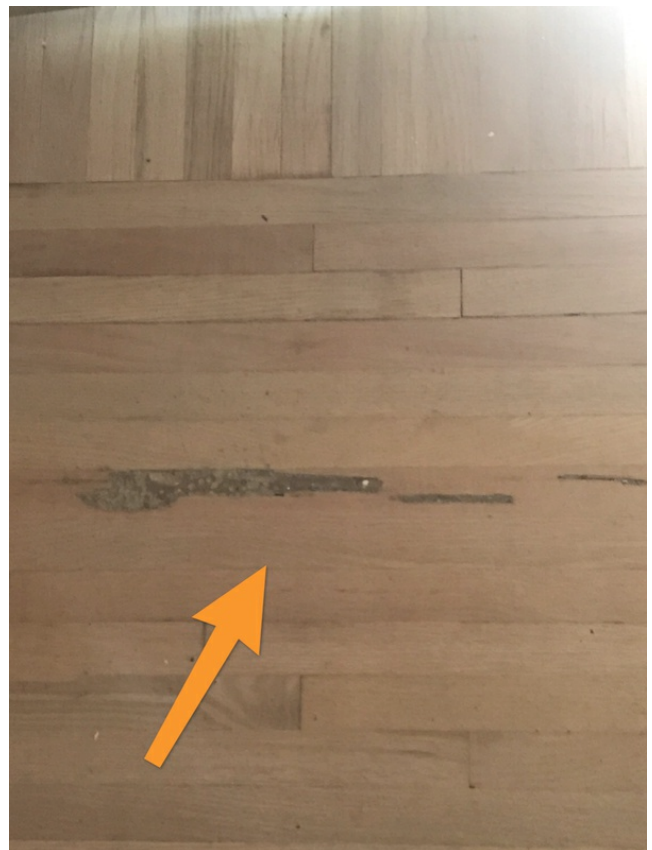
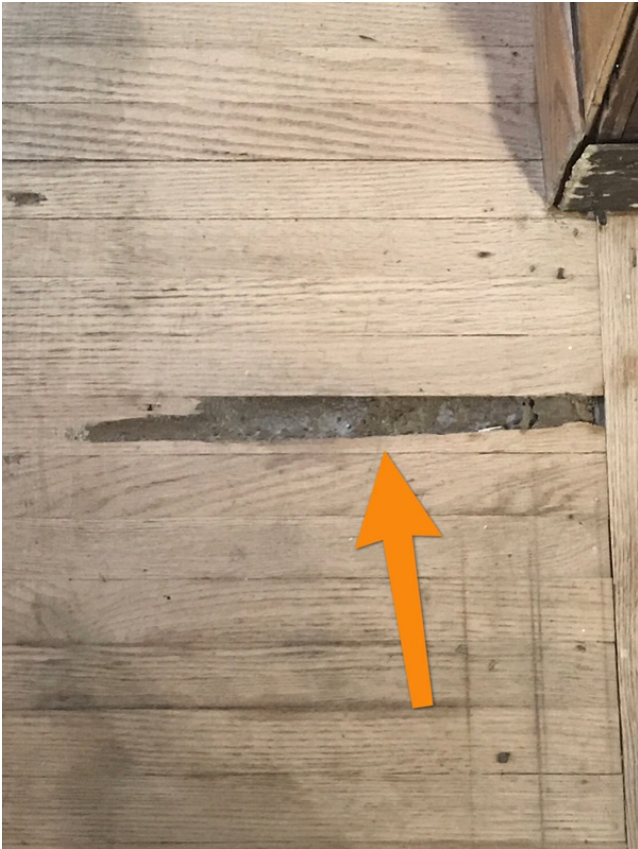
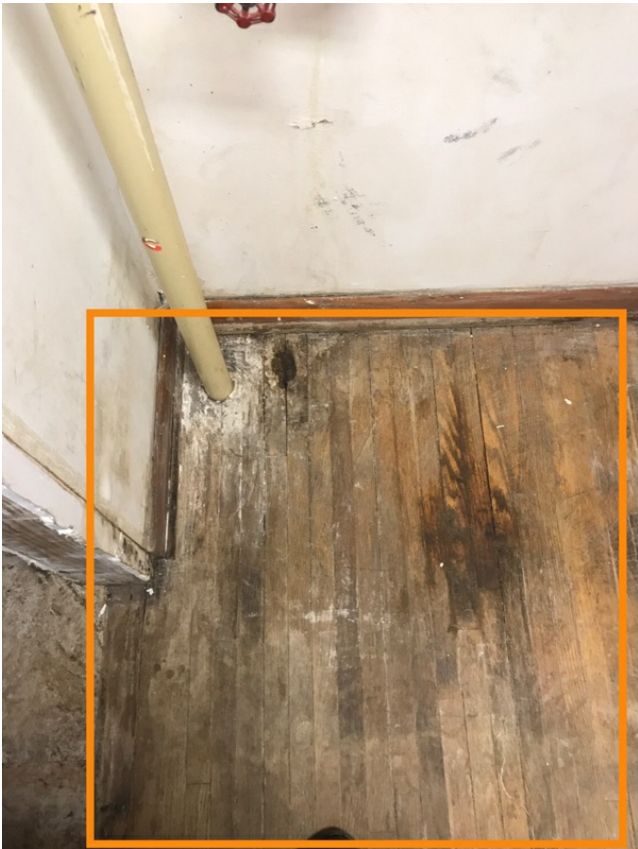
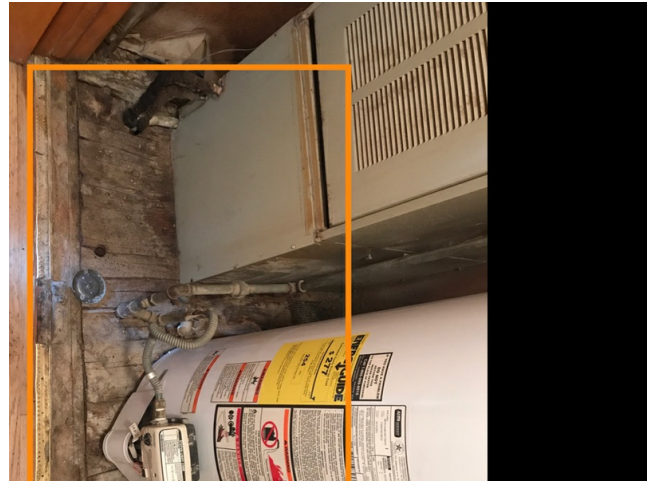
9.3.1 Floors

DAMAGED (GENERAL)

The home flooring had general moderate damage visible at the time of the

inspection. Recommend evaluation by a qualified flooring contractor.

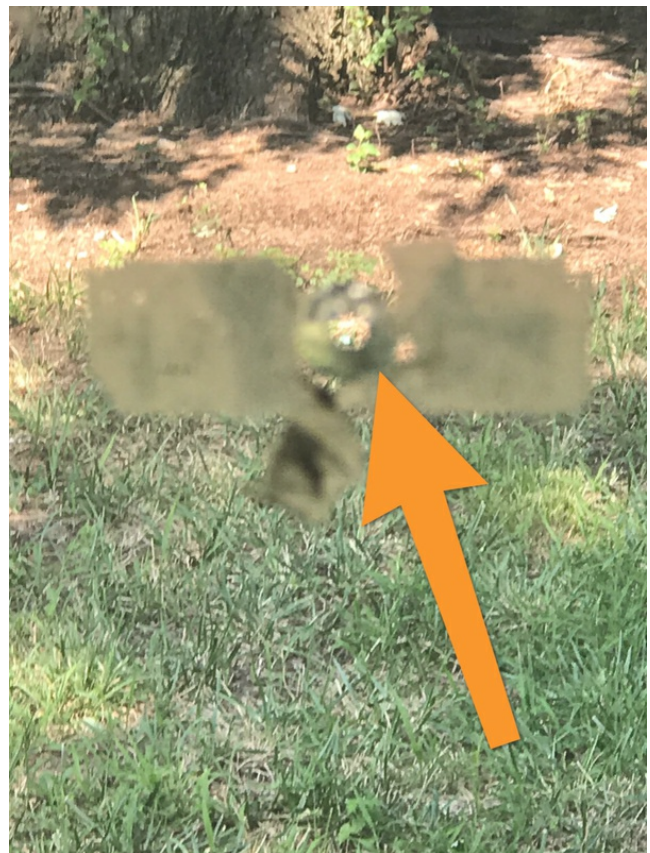
9.7.1 Windows

DAMAGED

One or more windows appears to have general damage, but are operational. Recommend a window professional clean, lubricate, seal & adjust as necessary.

Contact a qualified window repair/installation contractor.

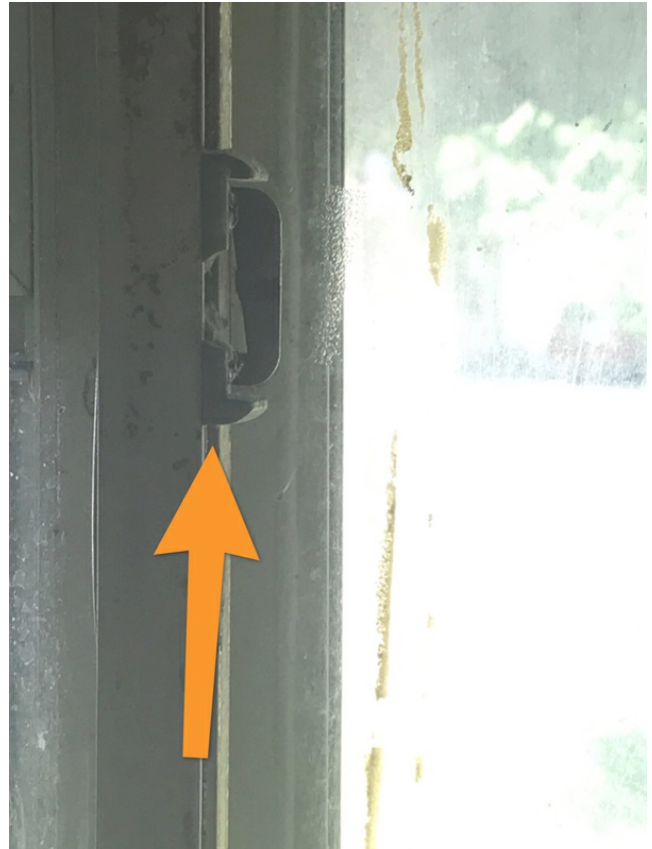
9.7.2 Windows

MISSING HARDWARE

Window missing hardware. Recommend replacement.

Contact a qualified window repair/installation contractor.

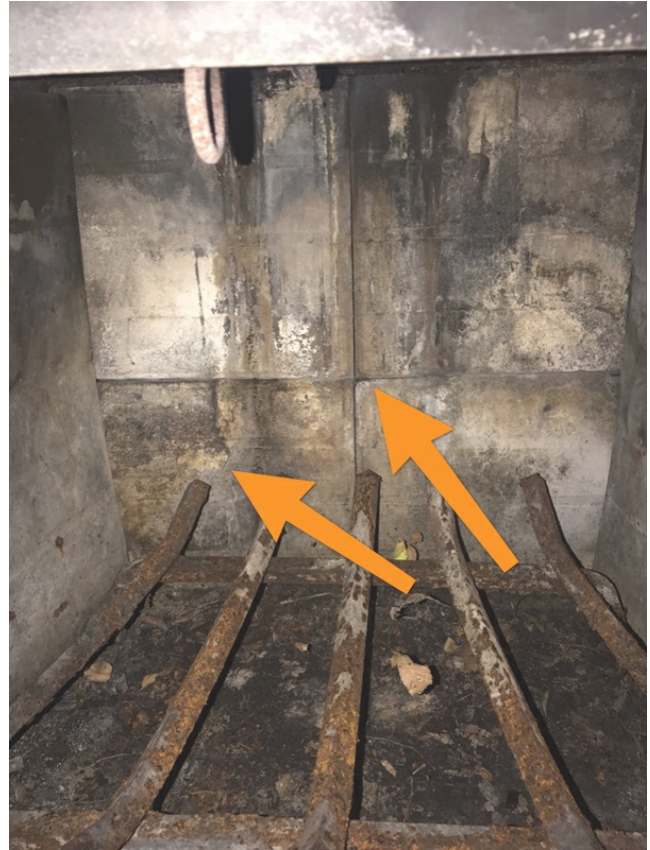
12.1.1 Fireplaces, Stoves & Inserts

FIREWALL CRACKED

! Safety Hazard and/or Requires Immediate Attention

The brick lining of the fireplace was cracked in one or more places, which could lead to chimney damage or toxic fumes entering the home. Recommend a qualified fireplace contractor evaluate and repair.

Contact a qualified fireplace contractor.
