# MUSSELMAN HOME INSPECTION LLC

## HOME HEALTH CHECK

1234 Main St.  
Harleysville PA 19438

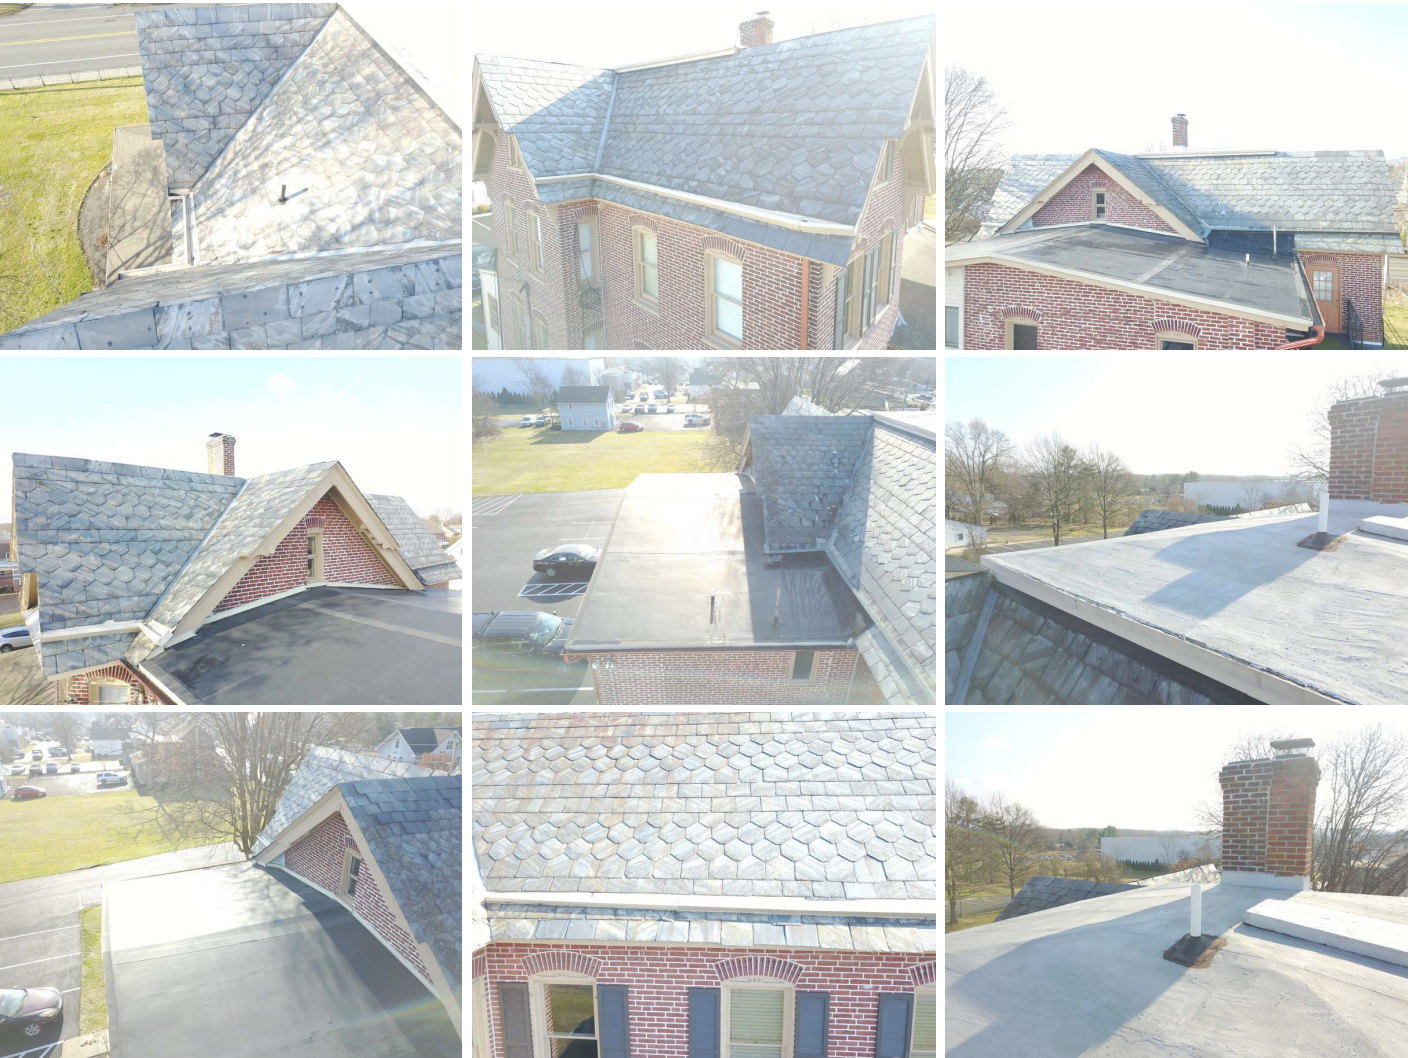
### Flashings: Vent Collar flashing

Vent Collars typically last 7-10 depending on the condition they are in. Consider replacing them proactively to help prevent roof leaks.

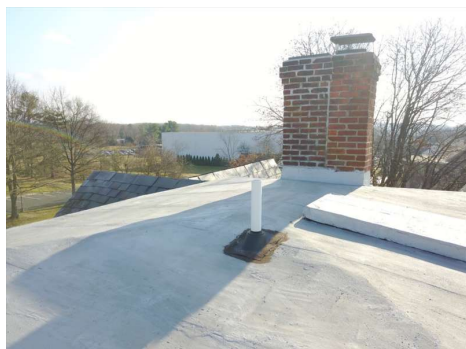
service/coat flat roofs on a regular basis.

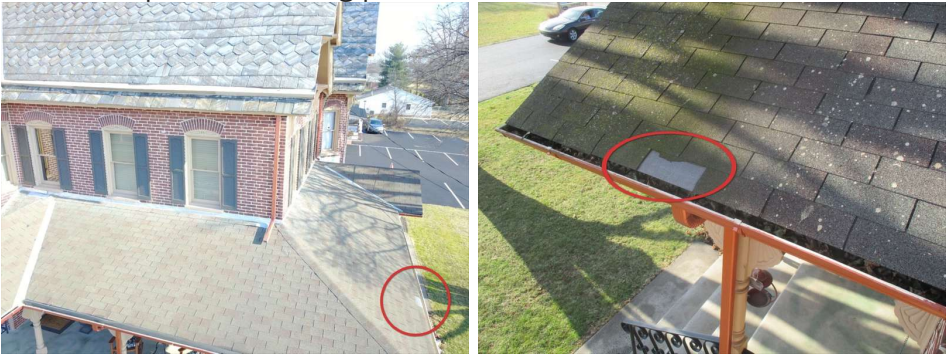
2.1.1 Coverings

SHINGLES MISSING

Observed areas that appeared to be missing sufficient coverings. Recommend qualified roofing contractor evaluate & repair.

Contact a qualified roofing professional.

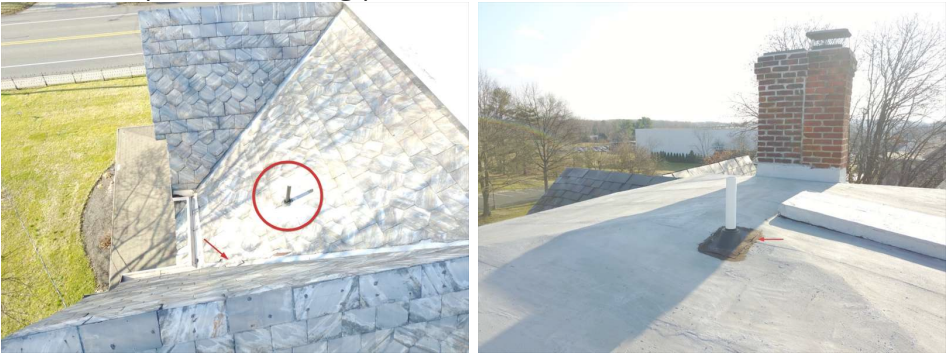
2.2.1 Flashings

VENT COLLAR - CRACKED OR COMPROMISED

Vent collar flashing is comprised and could be leaking. Consult roofer to add new rubber seal.

The rubber on vent collar is missing. There are a couple small pieces of broken slate

caulking /tar around vent collar looks cracked

Contact a qualified roofing professional.

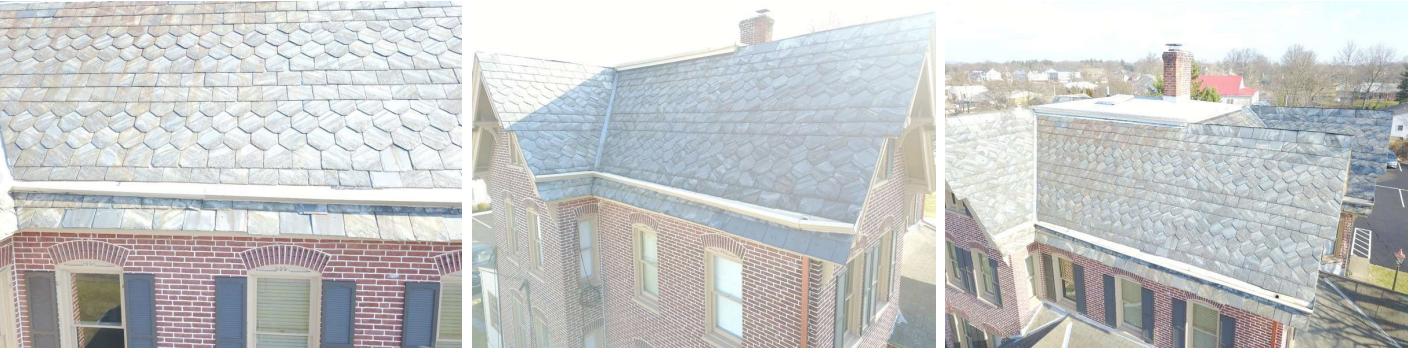
Roof Drainage Systems: "Yankee Gutters"

Can have challenges around the downspout connection. Monitor gutter and downspout connection areas for leaks.

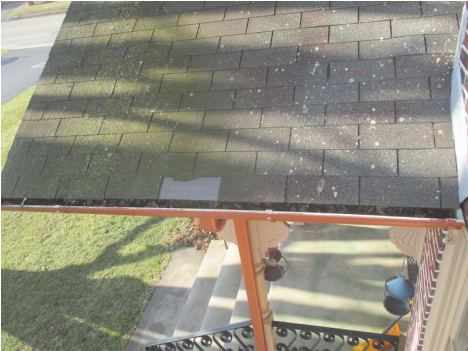
3.2.1 Gutter Debris

SIGNS OF CLOGGED GUTTERS

Keep gutters clean and functional. Clogged gutters and poor grade are the number one cause of water in the basement and structural damage.

Contact a qualified professional.

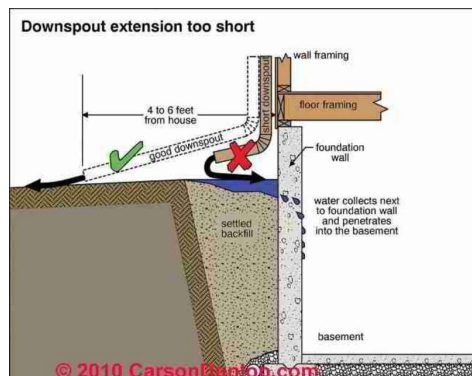
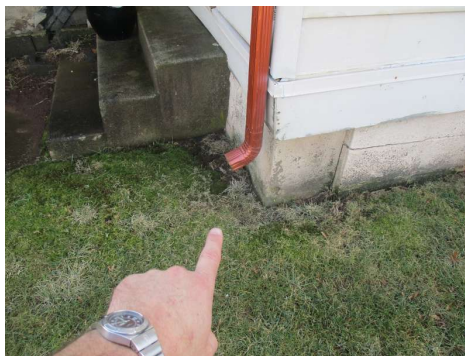
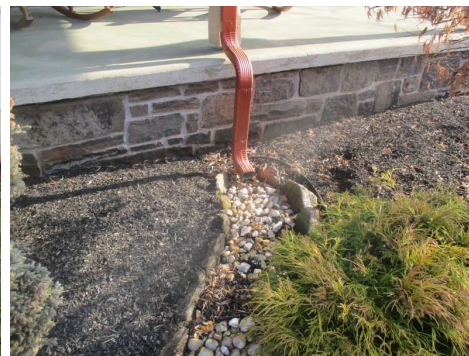
## 3.3.1 Gutter Downspout Location

**DOWNSPOUTS END TOO CLOSE TO THE FOUNDATION**

Downspouts ideally direct water 6' away from the foundation.

Consider adding plastic under the river rock to divert water.

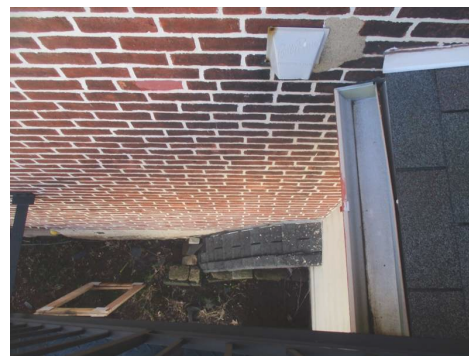
## 3.4.1 Gutter Pitch

**GUTTER POSITION IS IN QUESTION**

When it's raining monitor gutter for collection. The gutter should be collecting all the water coming off the roof and directing it into the downspout and away from the foundation. If the gutter is not collecting water consult gutter profession to evaluate and correct. There are three basic options 1. Reposition or adjust gutter to collect water. 2. Add a [diverter](#) to direct water into the gutter. 3. Install larger size gutter to handle the volume.

Contact a handyman or DIY project

a little tweak to the gutter could help keep your basement dry.

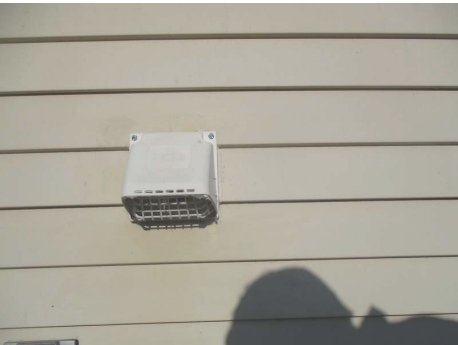
**Clean dryer vents on a regular basis to help prevent fires. :**  
**Consider cleaning dryer vent.**

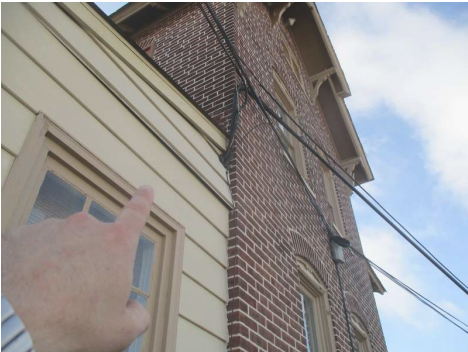
4.1.1 Siding, Flashing & Trim

EVIDENCE OF WATER INTRUSION

Siding showed signs of water intrusion. This could lead to further siding deterioration and/or mold. Recommend a qualified siding contractor evaluate and repair. Make sure where the utility line goes in that it is properly sealed.

Contact a qualified siding specialist.

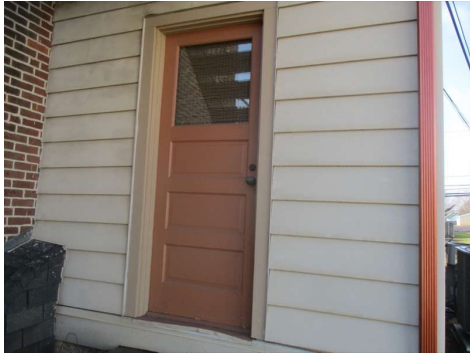
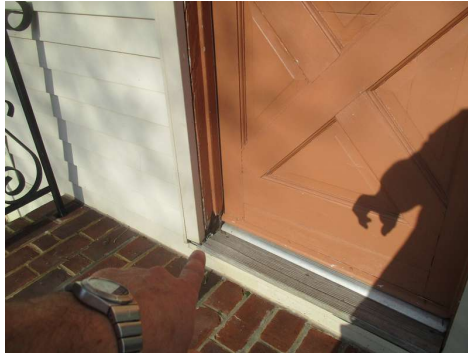
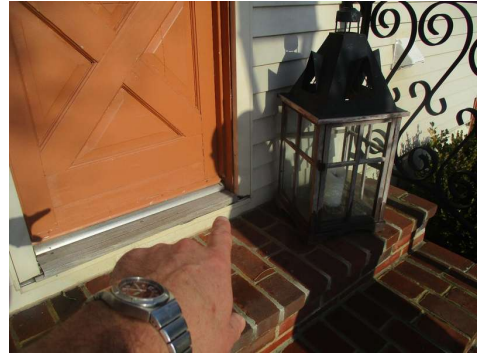
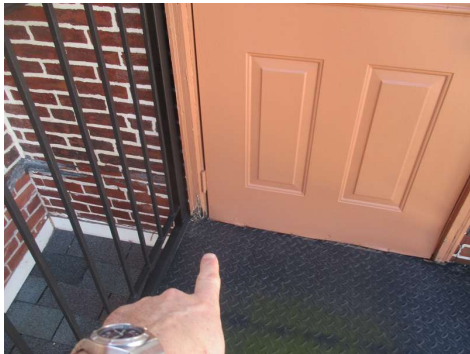
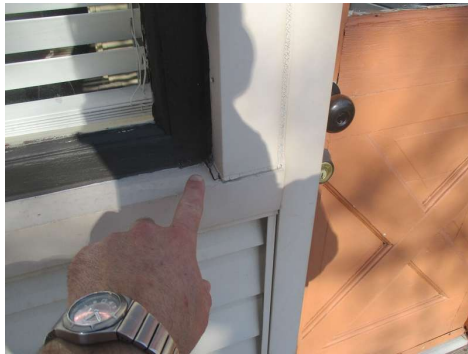
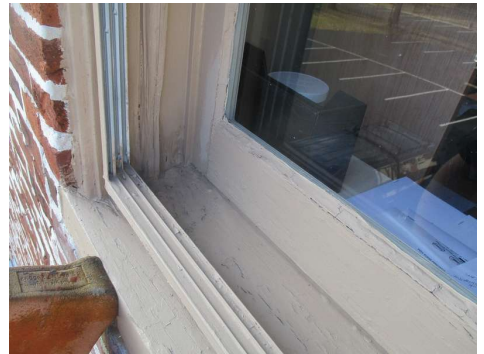
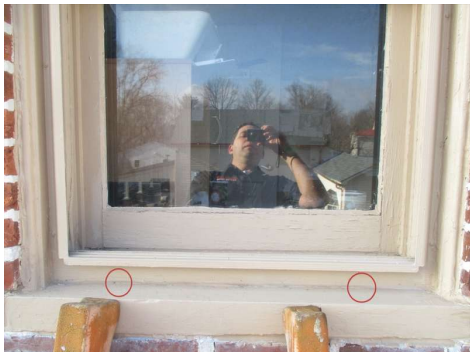
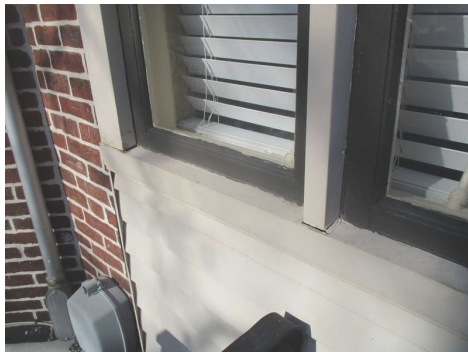
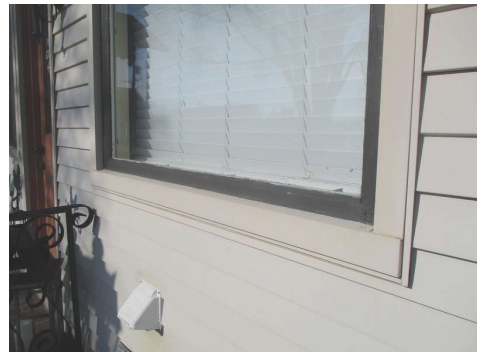
## 4.1.2 Siding, Flashing &amp; Trim

**GAPS AROUND TRIM**

There are various openings in the trim around the property and wood rot. Consult contractor to seal gaps to keep water out. When replacing wood consider composite alternatives to keep the look but increase longevity.

Storm window frame should come off or weep holes at the bottom should be drilled in to allow water out.

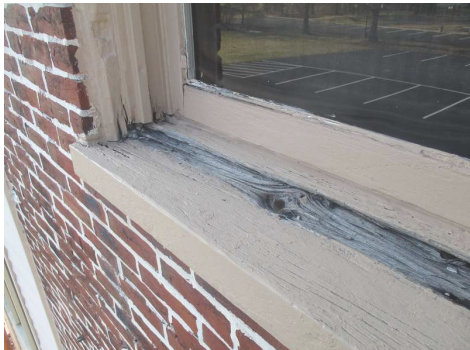
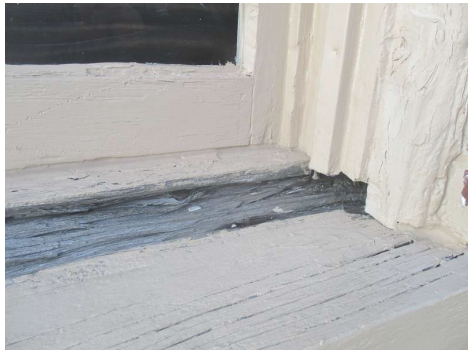
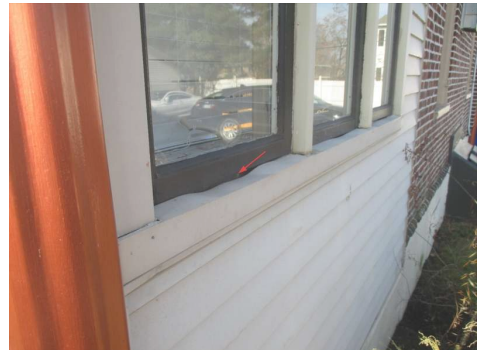
look inside for signs of water...Seal between window and aluminum. Ace hardware sells "Big Stretch" caulk great for this application

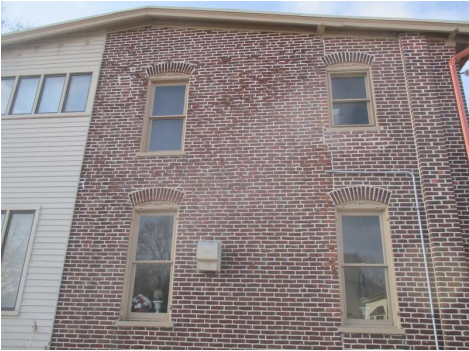
4.1.3 Siding, Flashing & Trim

MORTAR DETERIORATION

Consult masonry professional to evaluate and repoint where necessary.

Contact a qualified masonry professional.

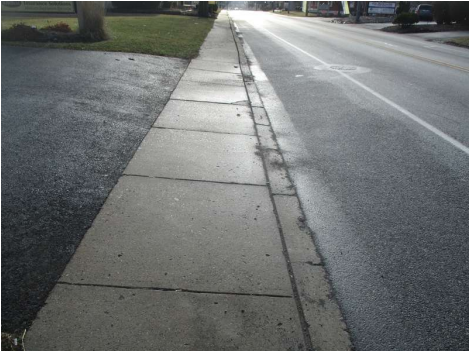
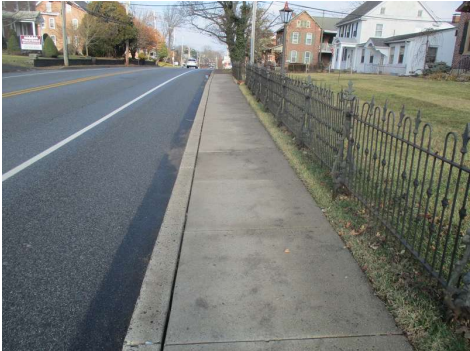
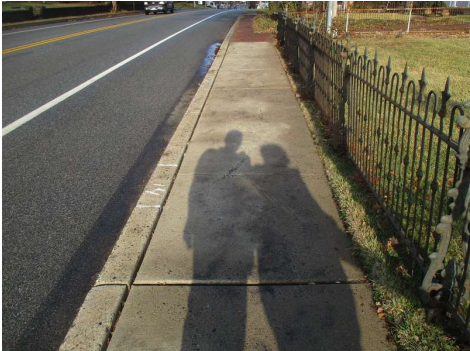
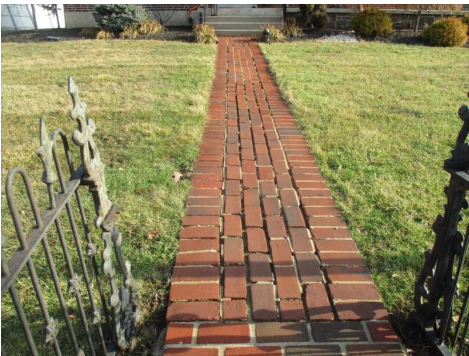
4.5.1 Walkways, Patios & Driveways

ALWAYS MONITOR SIDEWALKS FOR SAFETY.

Remember you are responsible for keeping people safe on your property so inspect walkways and sidewalks regularly. In the winter months keep walkways and sidewalks clear and slip resistant in compliance with local laws and regulations.

Consider pointing brick, the mortar will secure bricks together reducing the likelihood of movement and trip hazards.

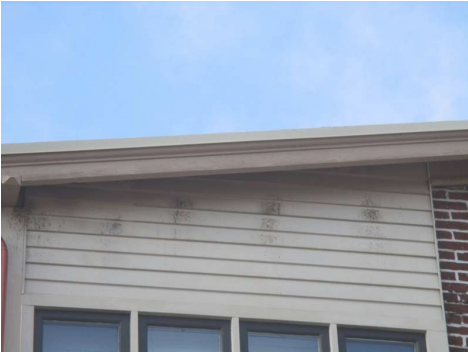
6.1.1 Fascia

OPENINGS IN FASCIA SHOULD BE SEALED

There some openings in the fascia that should be sealed and monitored. Signs of carpenter bees, question pest control about treatment.

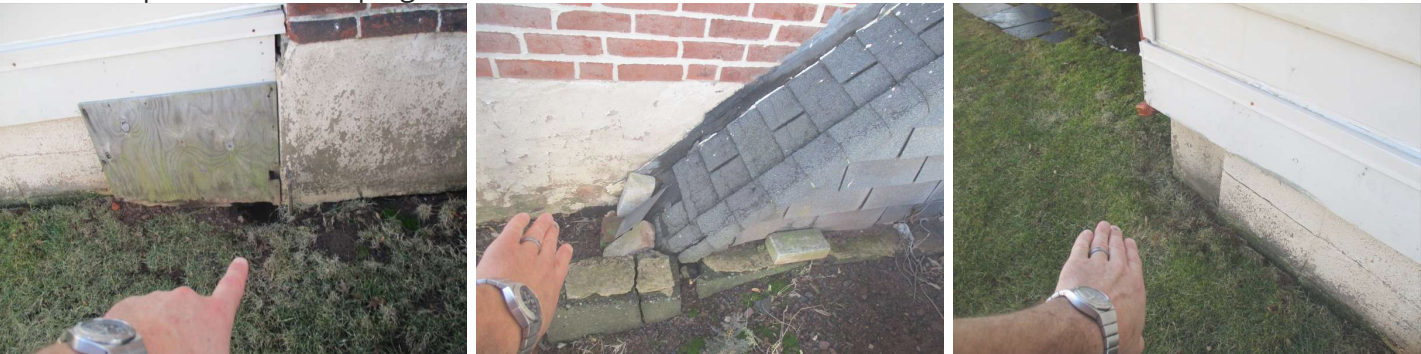
7.1.1 Ensure exterior grade is directing water away from the foundation.

NEGATIVE GRADING

Grading is sloping towards the home in some areas. This could lead to water intrusion and foundation issues. Recommend qualified landscaper contractor regrade so water flows away from home. Mulch is not used for grading, the soil under the mulch is the transporter of water. Also, mulch should not be thicker than 1.5" to help prevent fungal growth. [Here is a helpful article](#) discussing negative grading.

Looks like a friend maybe living in here.

Recommendation  
Contact a qualified landscaping contractor

Add downspout extension and improve the grade.

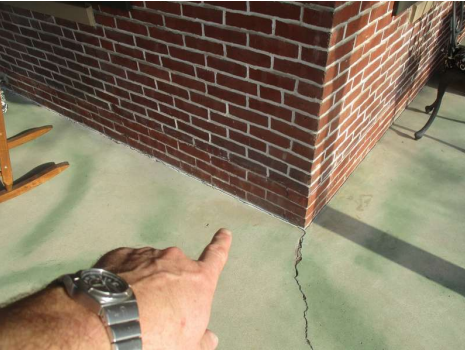
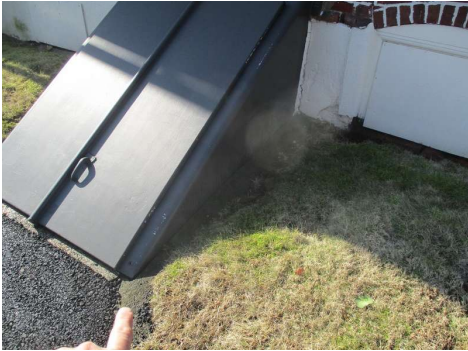
7.2.1 Sealing hard surfaces around foundation.

IT IS BEST TO SEAL WHERE HARD SURFACES MEET THE FOUNDATION.

It is best to seal where hard surfaces meet the foundation to prevent movement and water infiltration.

Recommendation  
Contact a handyman or DIY project

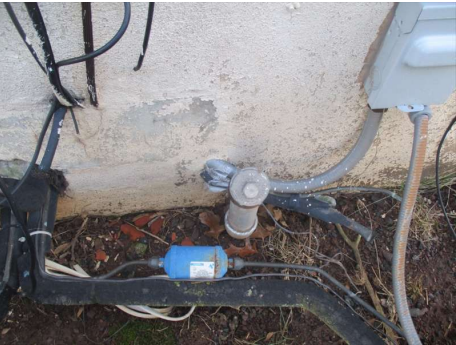
Refrigerant line insulation condition : Refrigerant line insulation is in good condition

Refrigerant line insulation helps maximize the efficiency of the system.

Air Conditioning compressors are the engine of the air conditioning system.

3.5-ton unit manufactured 7/98  
Budget for replacement

It's very important to have the A/C system serviced on annual basis to ensure proper operation. A/C compressors typically are designed to last 15-20 years.

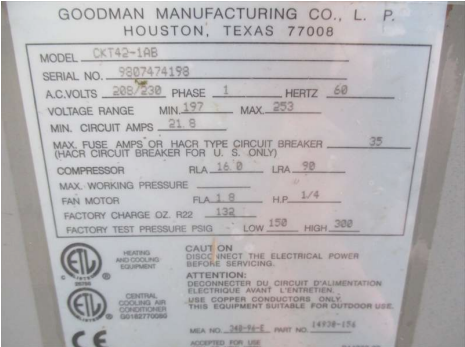
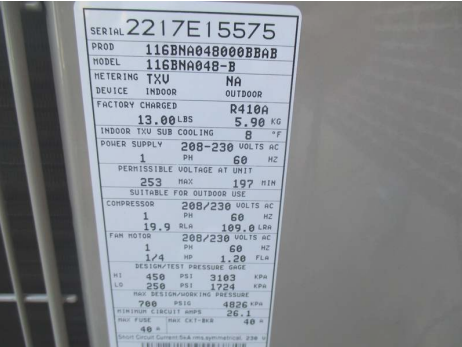
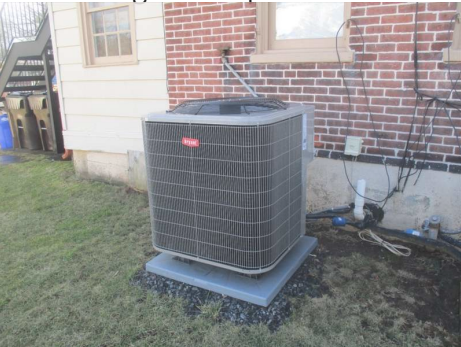
4-ton unit manufactured 2017

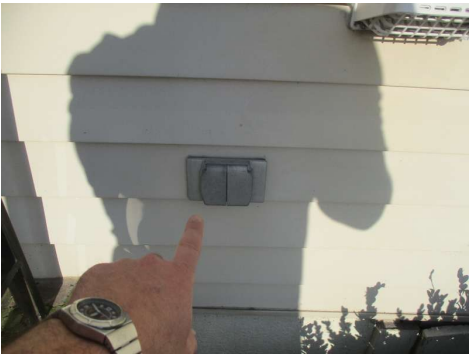
EXTERIOR GFCI OUTLETS ARE OFTEN CONNECTED TO THE OUTLET UNDER THE ELECTRIC PANEL.

Exterior GFCI outlets are often connected to the outlet under the electric panel. For this reason, we don't check them since we are unable to turn them back on. However, manufacturers recommend testing GFCI outlets monthly. [This a video on how to test a GFCI outlet.](#)
