HOMEFRONT INSPECTIONS, LLC

RESIDENTIAL REPORT

1234 Main St.

04/11/2018 9:00AM

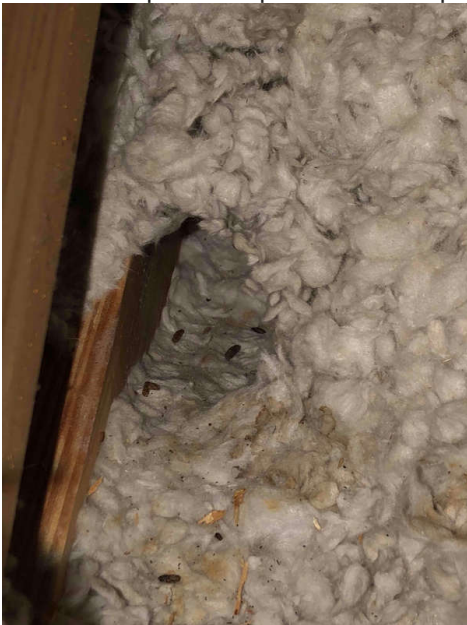
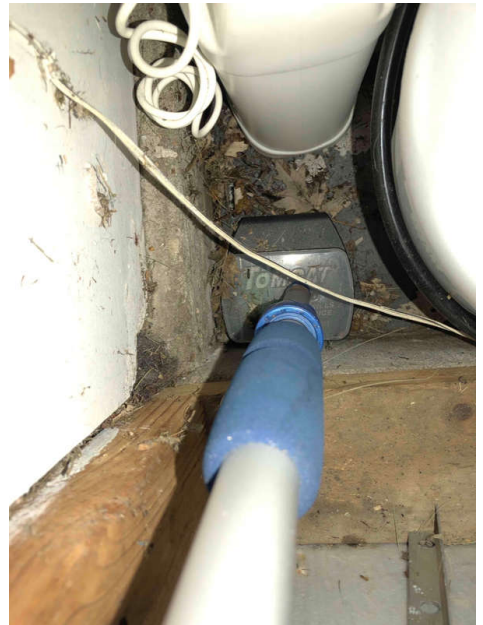
1.1.1 General Concerns

Evidence of rodent activity was observed in and/or around the property. Consult with the property owner about this. A qualified person should make repairs to seal openings in structure, set traps, and clean rodent waste as necessary.

Trap observed in garage.

Contact a qualified pest control specialist.

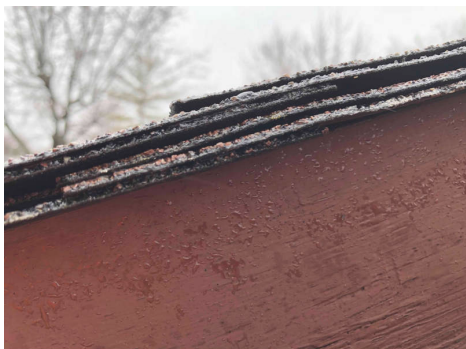
Coverings: Multiple Layers (Composition)

The roof appeared to have two or more layers of shingles. Additional layers of composition shingles typically last only 80% of their rated life, and the shingle manufacturer's warranty may be voided. The client should be aware that all layers of shingles will need to be removed when this roof surface needs replacing.

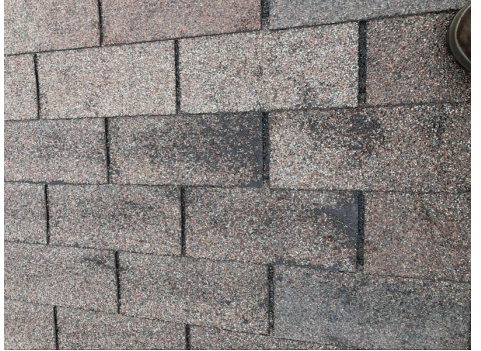
GRANULAR DETERIORATION

There was visible erosion of the granular surface of some asphalt shingles. This can accelerate deterioration of the shingles.

Contact a qualified roofing professional.

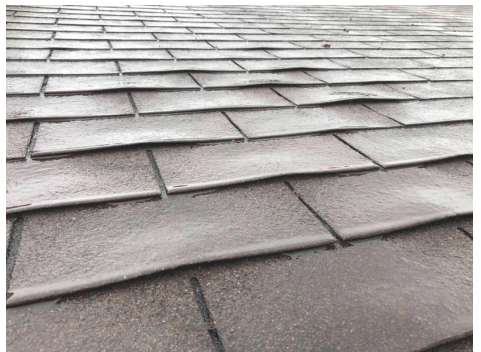
2.1.2 Coverings

LOOSE OR LIFTING

Some shingles were loose or lifting. Leaks can occur as a result. This can be a conducive condition for wood-destroying organisms.

Contact a qualified roofing professional.

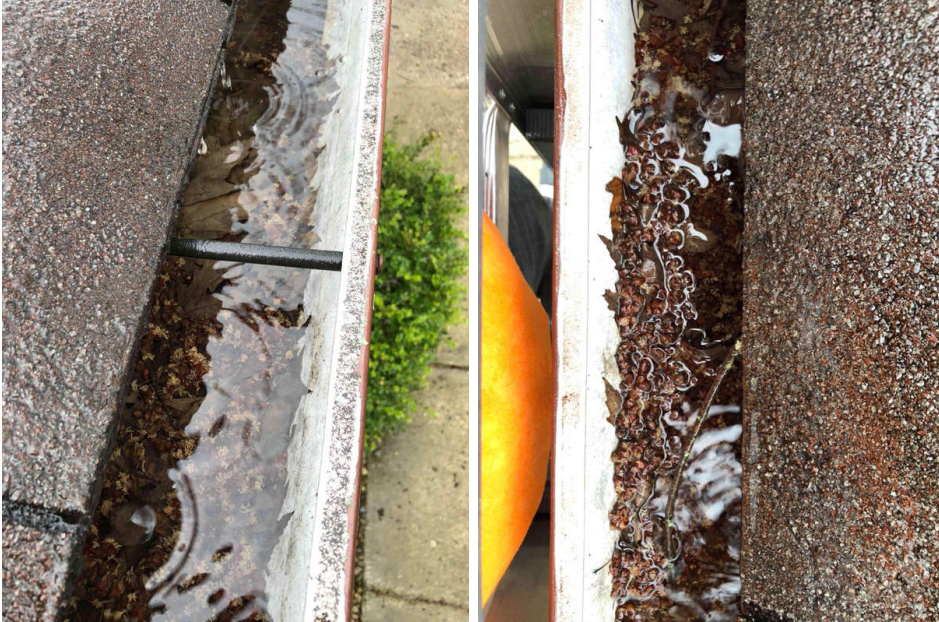
2.2.1 Roof Drainage Systems

Debris has accumulated in the gutters. Recommend cleaning to facilitate water flow.

Recommended DIY Project

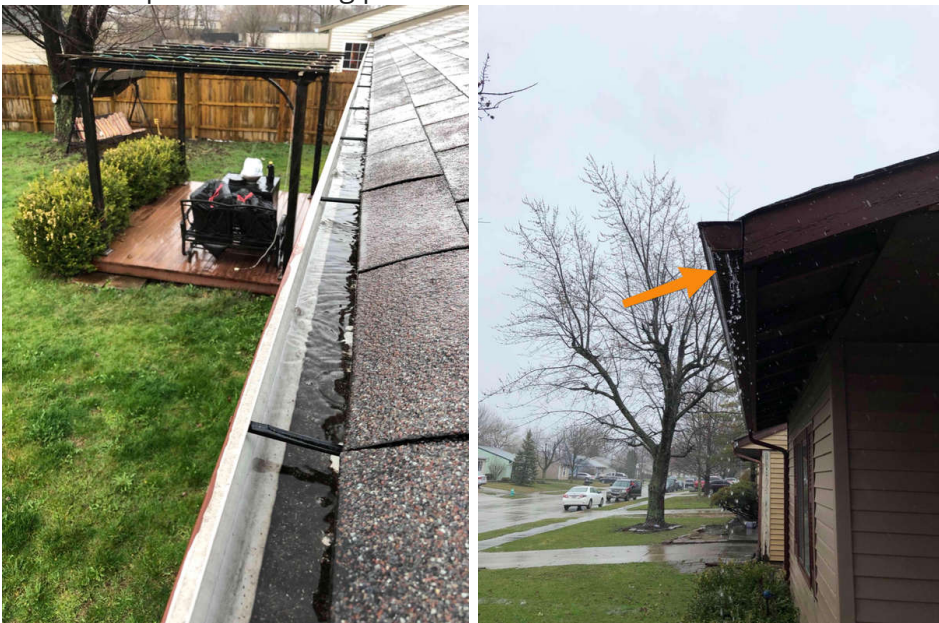
2.2.2 Roof Drainage Systems

GUTTER IMPROPERLY SLOPED

Gutter are improperly sloped in areas, which could result in runoff drainage around the foundation and possible structural shifting. Recommend qualified roofing or gutters contractor repair.

Contact a qualified roofing professional.

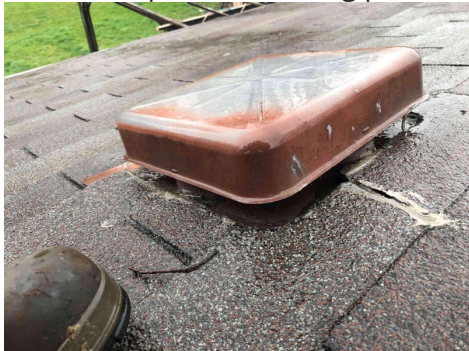
SUBSTANDARD INSTALLATION/REPAIRS

Observed substandard installation or repairs at one or more roof flashings. Leaks can occur as a result.

Lifting and exposed fasteners can promote leaking.

Contact a qualified roofing professional.

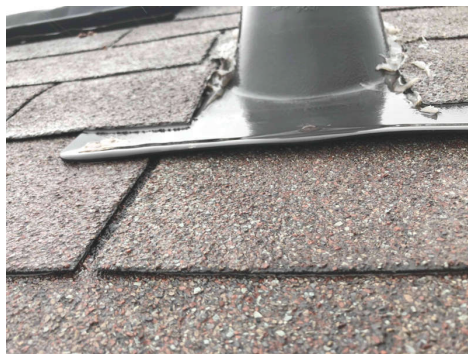
2.3.2 Flashings

LOOSE/SEPARATED

Flashings observed to be loose or separated, which can lead to water intrusion and/or mold. Recommend a qualified roofing contractor repair.

Contact a qualified roofing professional.

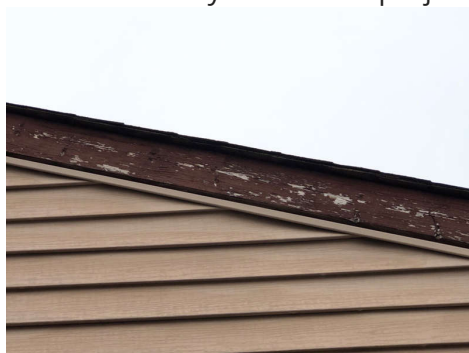
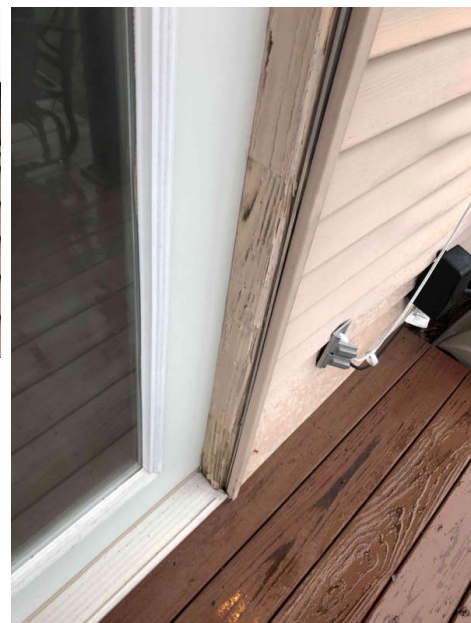
Paint or stain was worn or missing in some areas. Siding and trim with a failing finish can be damaged by moisture.

Contact a handyman or DIY project

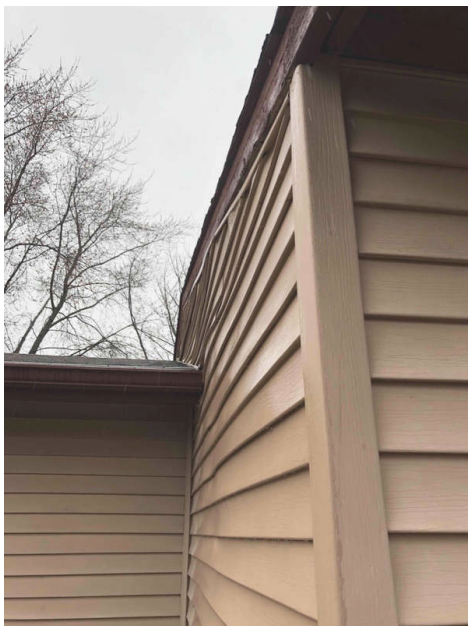
3.1.2 Siding, Flashing & Trim

Siding showed signs of water intrusion. This could lead to further siding deterioration and/or mold. Recommend a qualified siding contractor evaluate and repair.

See next photo.

Bowing siding may be due to water intrusion.

Contact a qualified general contractor.

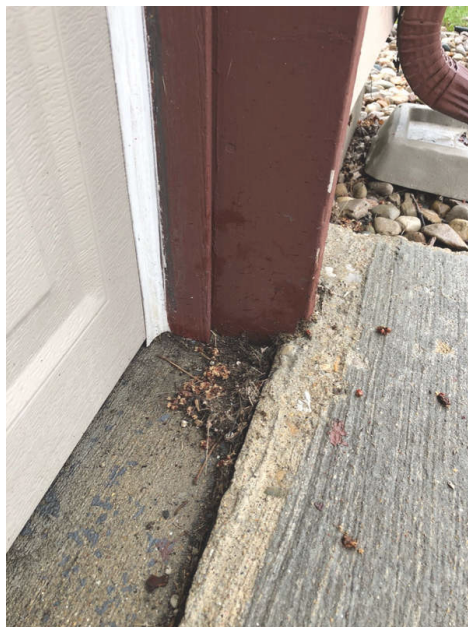
FLASHING/TRIM IMPROPERLY INSTALLED

Flashing & trim pieces were improperly installed, which could result in moisture intrusion and damaging leaks. Recommend a qualified siding contractor evaluate and repair.

Wood trim can pull moisture from contact with concrete.

Contact a qualified handyman.

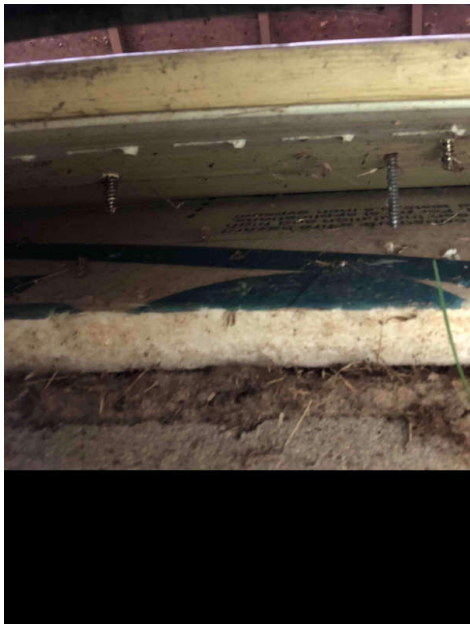
3.1.4 Siding, Flashing & Trim

LOOSE BOARDS

One or more siding boards were loose, which could result in moisture intrusion. Recommend a qualified siding contractor secure and fasten.

Contact a qualified general contractor.

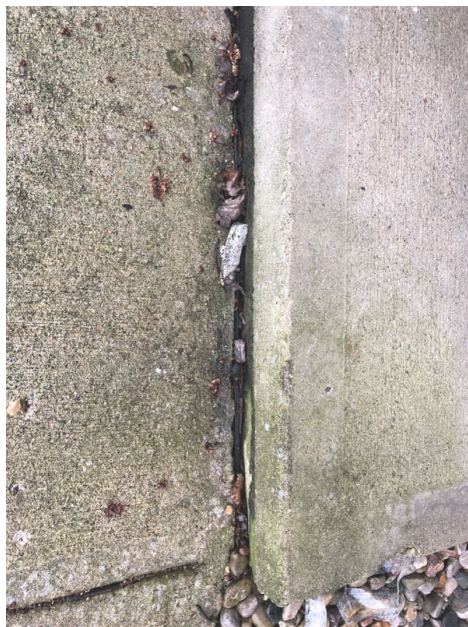
3.3.1 Walkways, Patios & Driveways

Minor cracking was observed at a joint in concrete. Recommend having a qualified person seal to prevent water intrusion.

Contact a handyman or DIY project

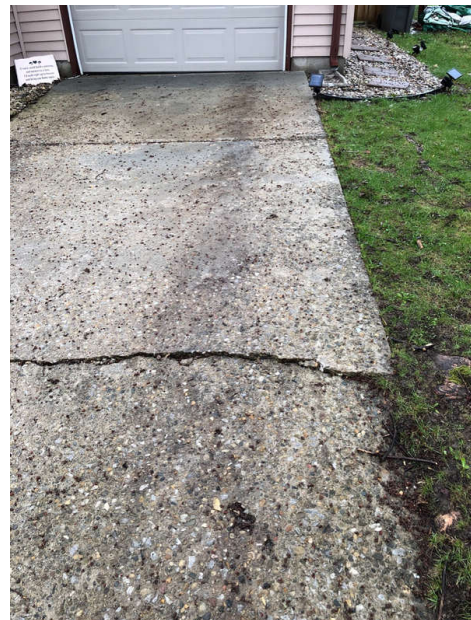
3.3.2 Walkways, Patios & Driveways

DRIVEWAY TRIP HAZARD

Trip hazards observed. Patch or repair recommended.

Contact a qualified professional.

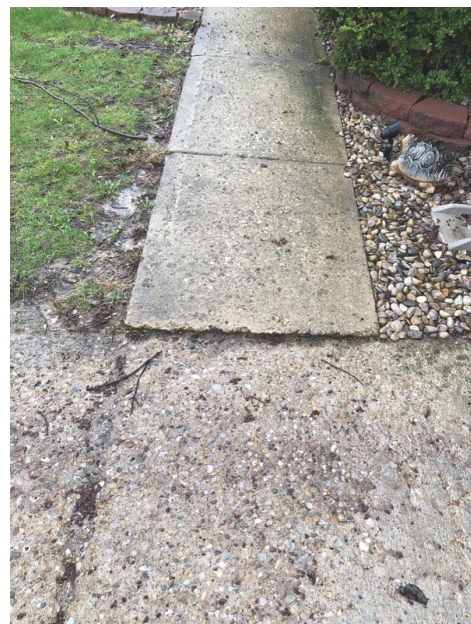
3.3.3 Walkways, Patios & Driveways

WALKWAY CRACKING - MAJOR

Major cracks observed. Recommend concrete contractor evaluate and correct to prevent trip hazard & preserve appearance.

Contact a qualified professional.

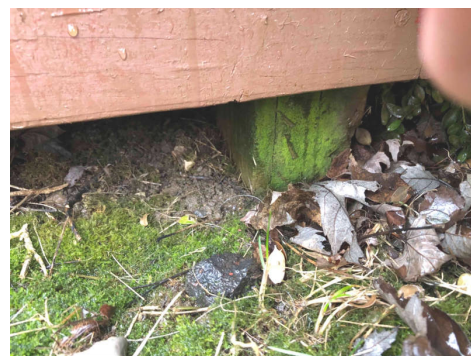
3.4.1 Decks, Balconies, Porches & Steps

Soil was in contact with one or more wooden deck, porch or balcony support posts. This is a conducive condition for wood destroying organisms. Recommend grading and/or removing soil to maintain clearance. Otherwise, recommend installing borate-based products (such as Impel rods) that may help prevent infestation and damage.

Contact a handyman or DIY project

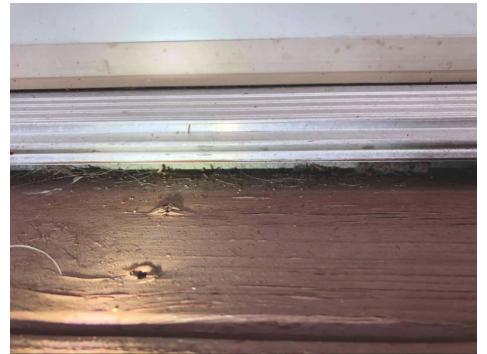
3.4.3 Decks, Balconies, Porches & Steps

Some decking boards were installed with little or no gap between them. Organic material such as leaves may accumulate in between boards and cause deterioration and/or rot. Ideally boards will have a 3/8 inch gap between them. At minimum, keep keep decking boards clean in future.

Contact a handyman or DIY project

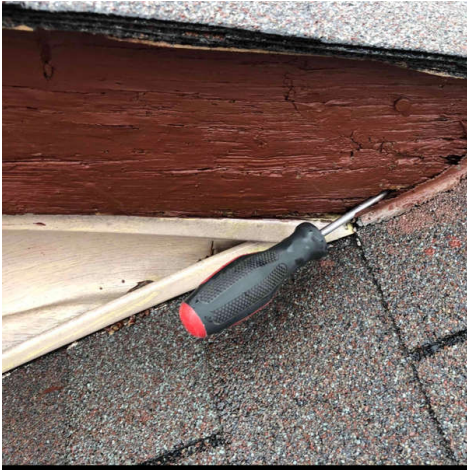
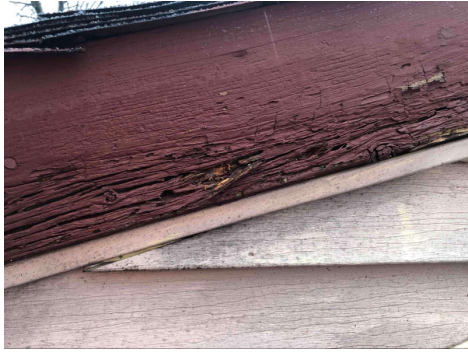
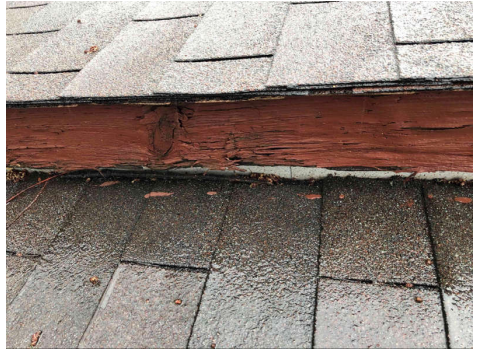
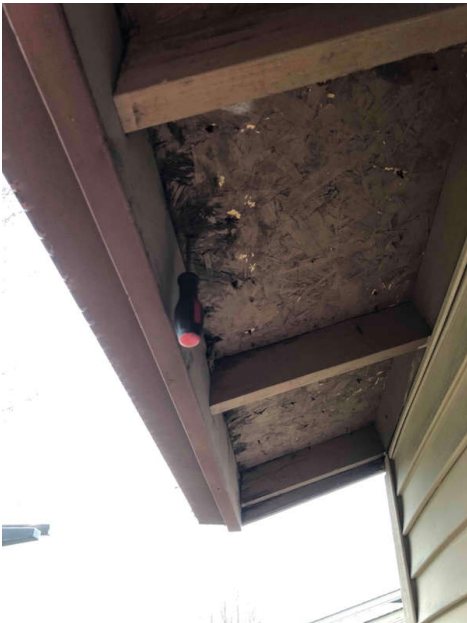
3.5.1 Eaves, Soffits & Fascia

WOOD ROT

Wood rot or significant water damage was observed at one or more sections of the eaves, soffits, fascia boards and/or rake boards. This may be due to a roof or gutter leak (see other comments in "Roof" sections). **All rotten wood should be replaced.**

Contact a qualified general contractor.

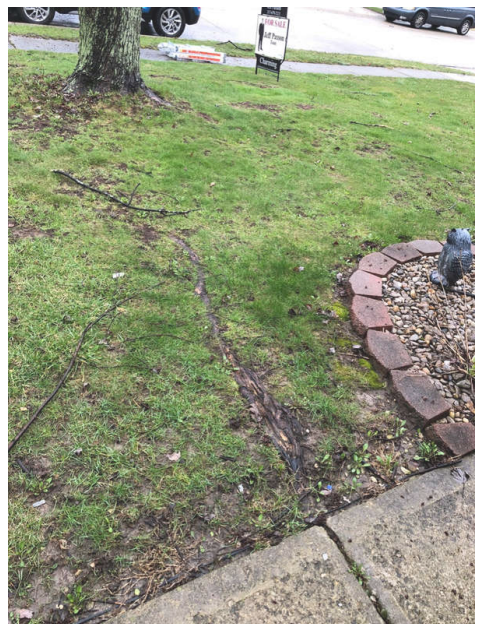
3.6.1 Vegetation, Grading, Drainage & Retaining Walls

TREE ROOTS

One or more large trees were observed close to the home. Tree roots can cause damage to foundations and plumbing. Recommend having a qualified tree service contractor or certified arborist evaluate further.

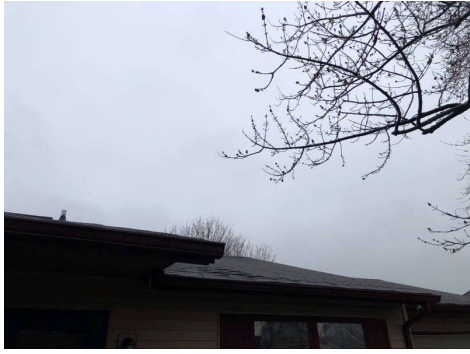
3.6.4 Vegetation, Grading, Drainage & Retaining Walls

Trees observed overhanging the roof. This can cause damage to the roof and prevent proper drainage. Recommend a qualified tree service trim to allow for proper drainage.

Contact a qualified tree service company.

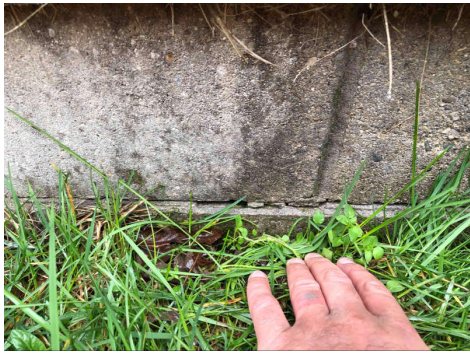
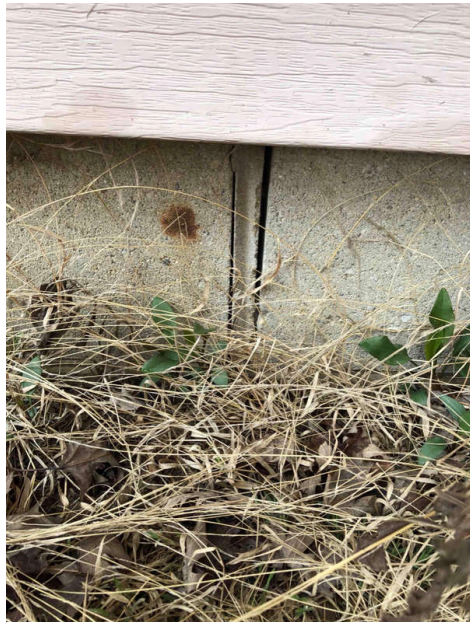
4.1.1 Foundation

FOUNDATION CRACKS - MINOR

Minor cracking was observed at the foundation. This did not appear to be a structural concern. Recommend sealing to prevent water intrusion. Numerous products exist to seal such cracks including hydraulic cement, non-shrinking grout, and epoxy sealants. [Here is an informational article on foundation cracks.](#)

Contact a handyman or DIY project

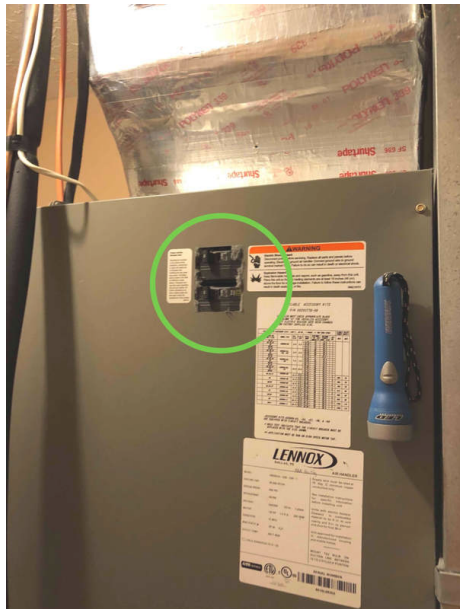
Equipment: Safety Devices

Electrical kill switch (breakers) for furnace.

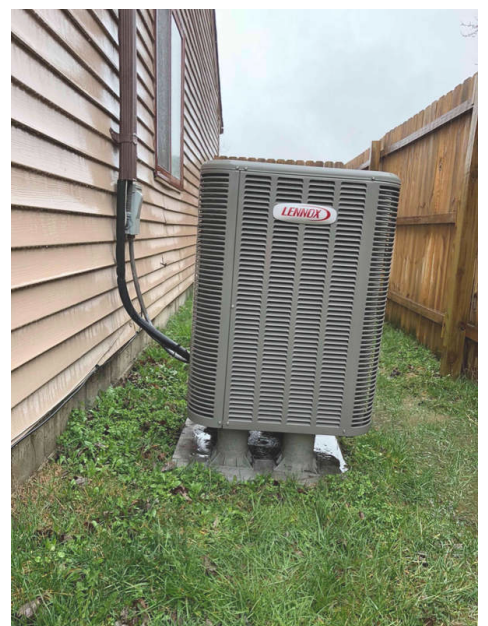
Pad supporting the outdoor condensing unit is not level. This can cause accelerated deterioration of components. Recommend licensed HVAC contractor level the unit.

Contact a qualified HVAC professional.

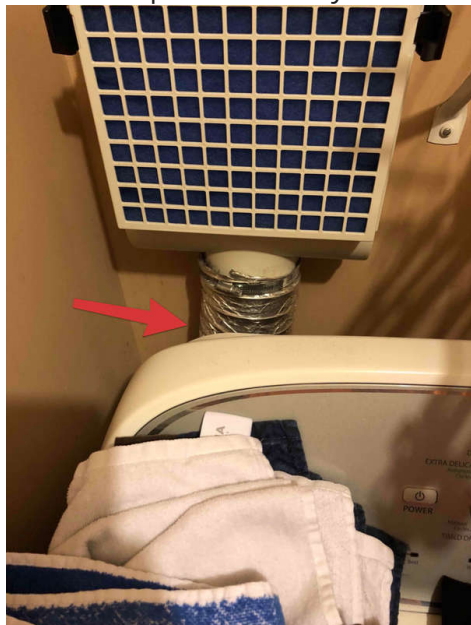
7.8.1 Laundry

The clothes dryer was equipped with a mylar (material) duct. Flexible ducts are acceptable between the dryer and wall, however mylar is flammable. This is a potential fire hazard. Recommend replacing with a rigid or semi-rigid metal duct.

Mylar dryer duct also observed in attic.

Contact a qualified handyman.

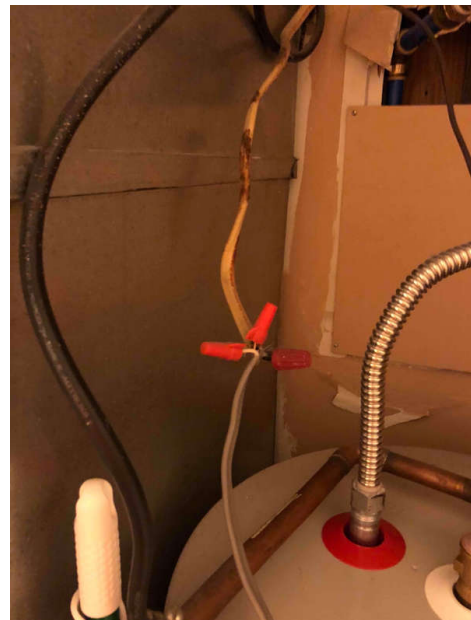
8.3.3 Wiring

SPLICES NOT IN BOX

Wire splices were exposed and were not contained in a covered junction box. This is a potential shock or fire hazard.

Contact a qualified electrical contractor.

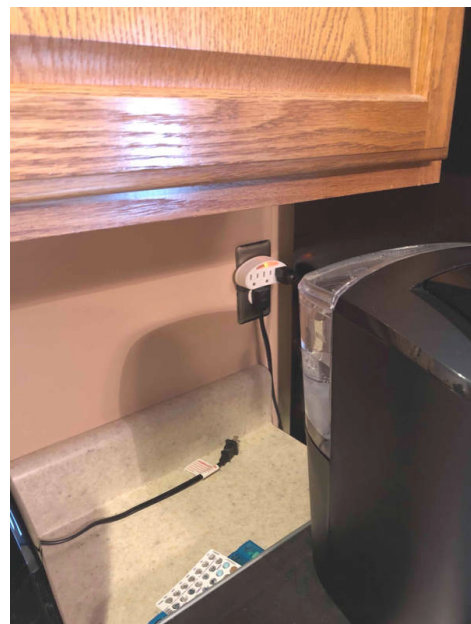
8.4.1 Receptacles

GFCI MISSING

One or more applicable receptacles was missing necessary GFCI protection, or inspector was unable to verify GFCI protection was present. This is a shock hazard.

Contact a qualified electrical contractor.

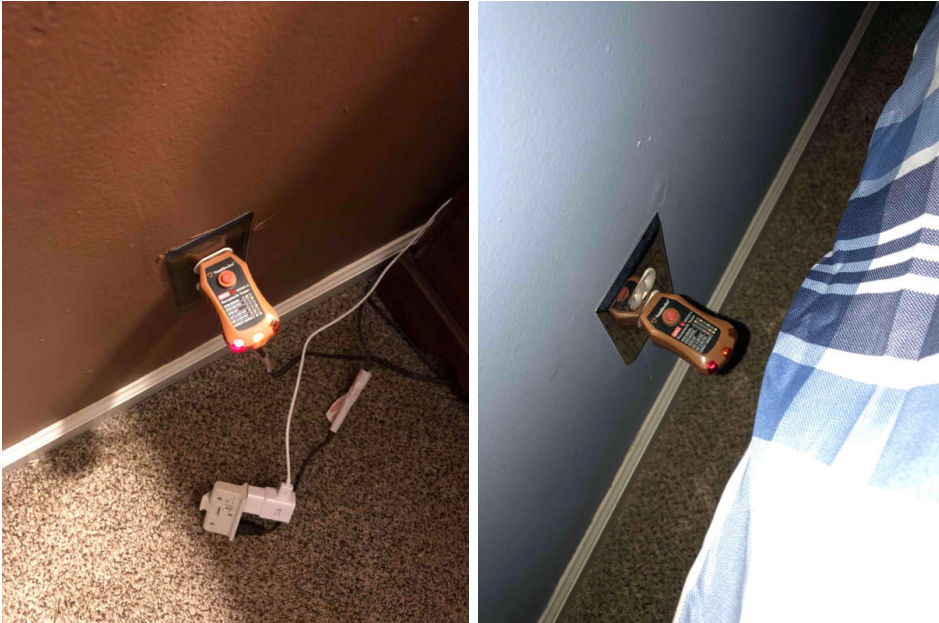
8.4.3 Receptacles

One or more receptacles have been wired with reverse polarity. This can create a shock hazard. Recommend licensed electrician evaluate & repair.

Contact a qualified electrical contractor.

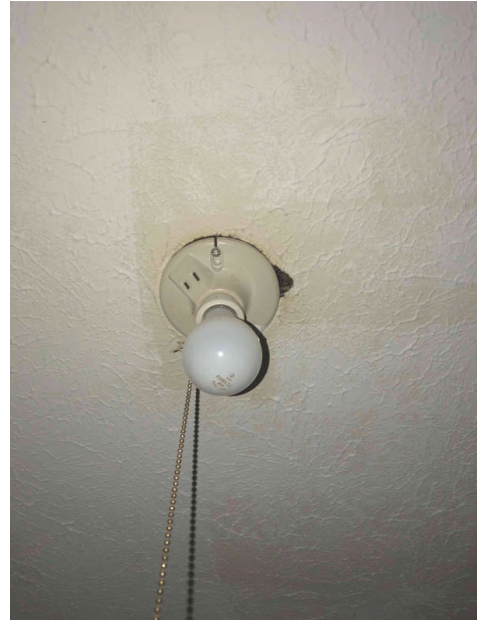
8.8.2 Lighting

A gap and discoloration was observed at a light fixture in the master bedroom closet. Recommend further evaluation by a qualified electrical contractor.

Contact a qualified electrical contractor.

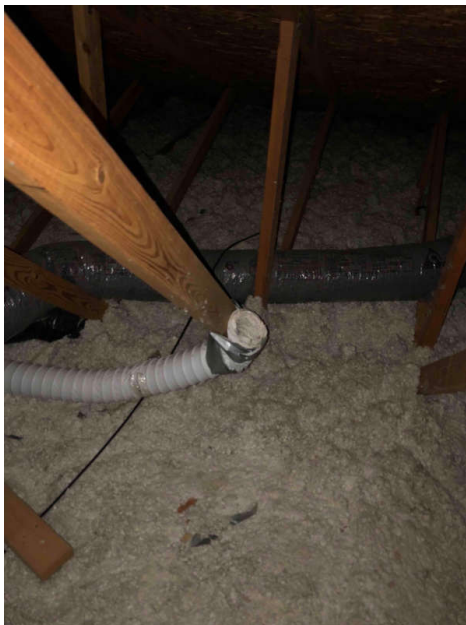
Bathroom fan vents into the attic. Also observed gaps at dryer exhaust duct in attic. These can cause moisture to accumulate in attic space and result in mold.

Contact a qualified handyman.

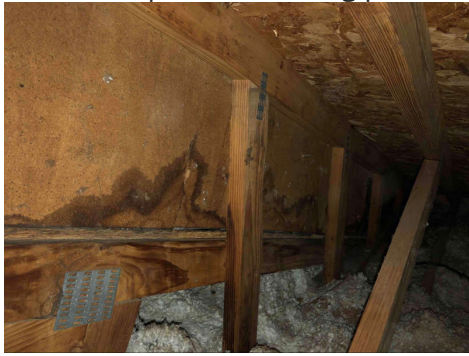
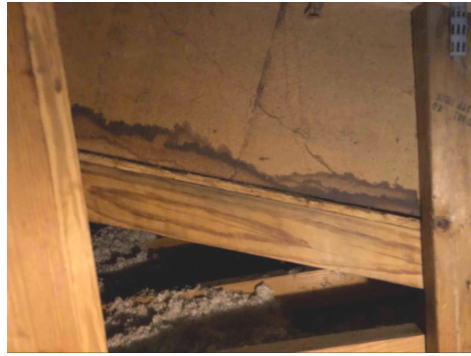
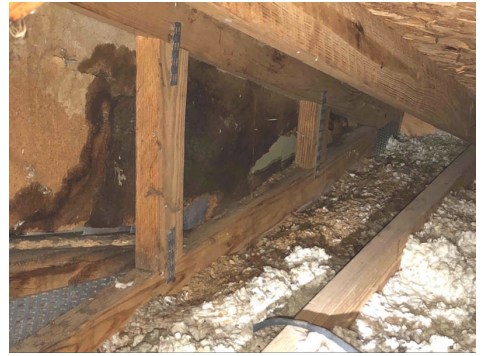
9.5.1 Roof Structure

ROOF LEAK

Inspector observed evidence of active past roof leaking in the attic space. This can cause water damage and/or wood rot, and is a conducive condition for wood-destroying organisms.

At raised living room ceiling.

Contact a qualified roofing professional.

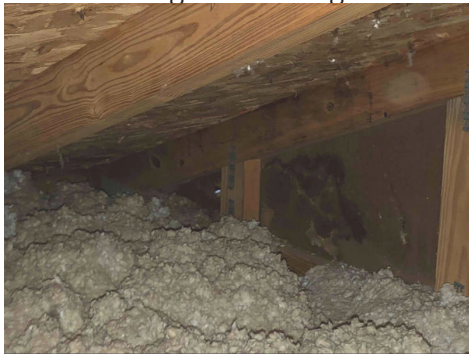
NE corner of attic.

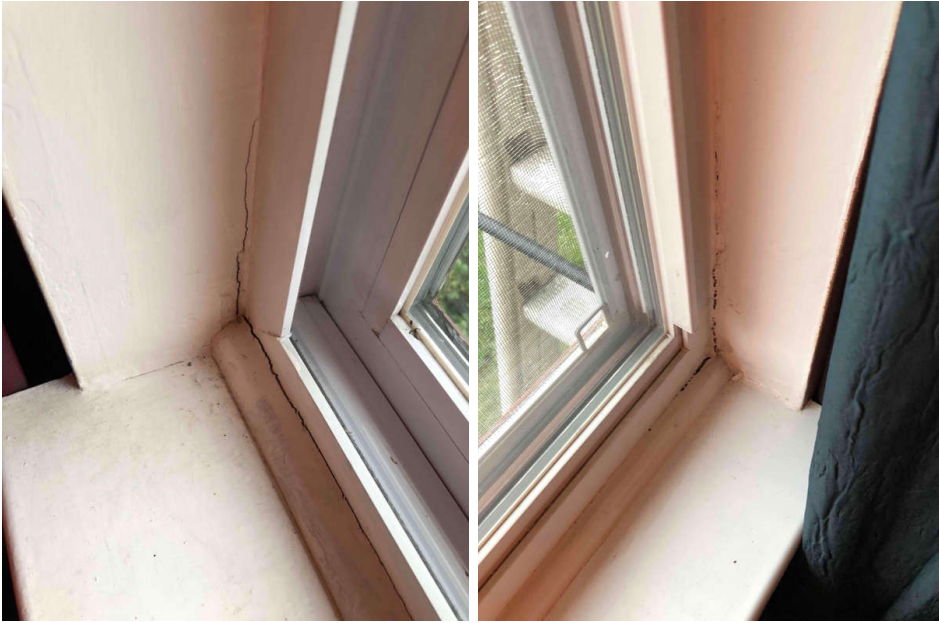
10.2.1 Windows

Minor cracks were observed at some windows. Recommend sealing (caulking) to preserve energy efficiency of home.

Recommended DIY Project

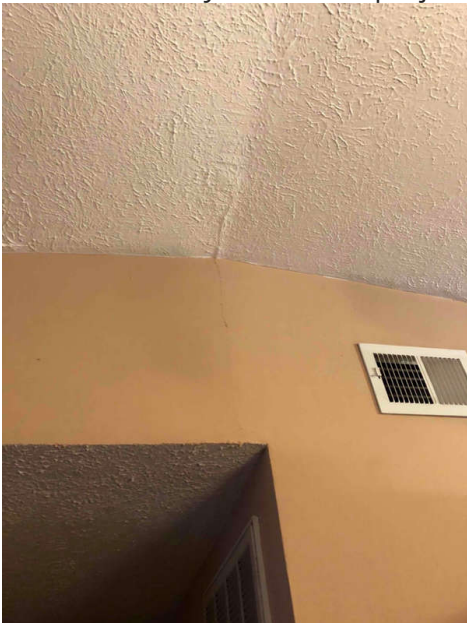
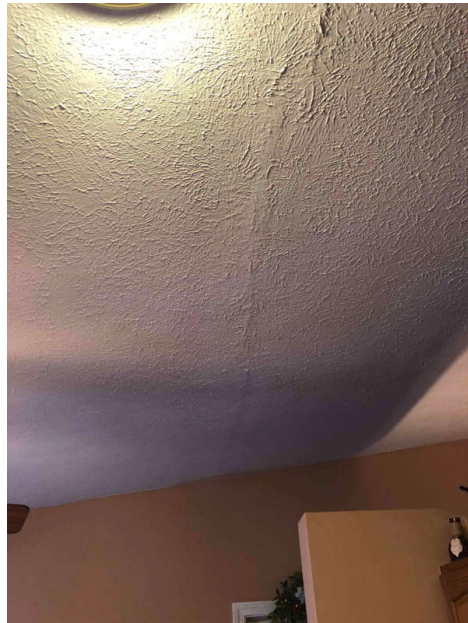
10.5.1 Ceilings

MINOR CRACKS

Minor cracks and/or nail pops were found in ceilings at one or more areas. Cracks and nail pops are common, are often caused by lumber shrinkage or minor settlement, and can be more or less noticeable depending on humidity. They did not appear to be a structural concern, but client may wish to repair for aesthetic reasons.

Contact a handyman or DIY project
