# INTEGRITY INSPECTION SERVICES LLC

## HOME INSPECTION REPORT

1234 Main St.  
Naches WA 98937

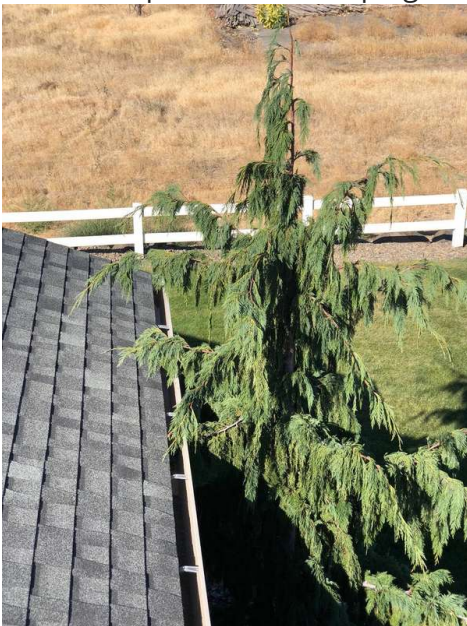
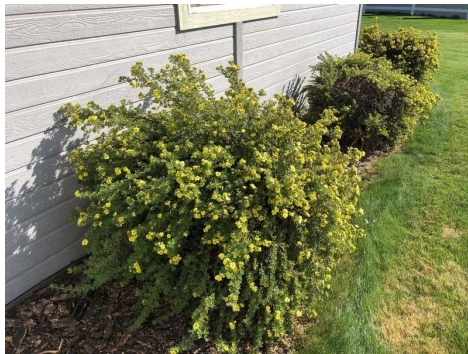
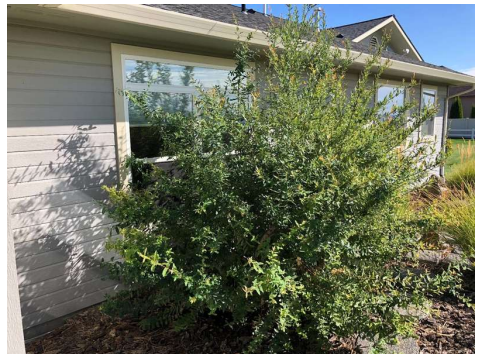
### 2.1.1 Vegetation & Grading

### VEGETATION AGAINST HOME

Trees, shrubs and/or vegetation in contact with home may cause undue wear and trap moisture against home leading to eventual compromise. Recommend all vegetation be maintained with a minimum of 8" clearance from home/exterior siding.

Contact a qualified landscaping contractor

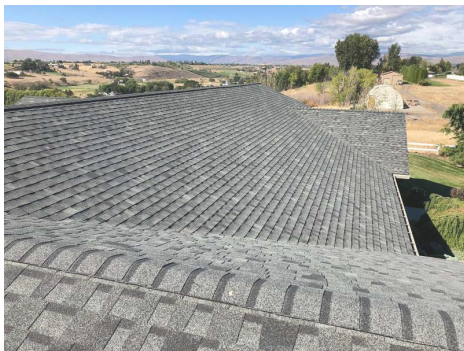
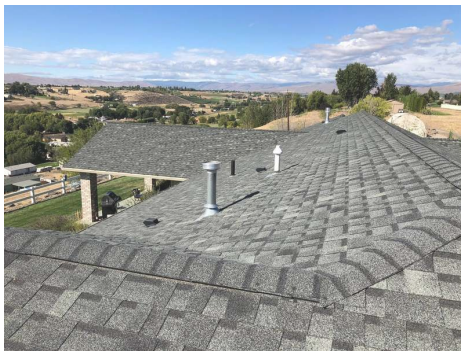
### Coverings: Servicable

Roof covering appears to be in good serviceable condition.

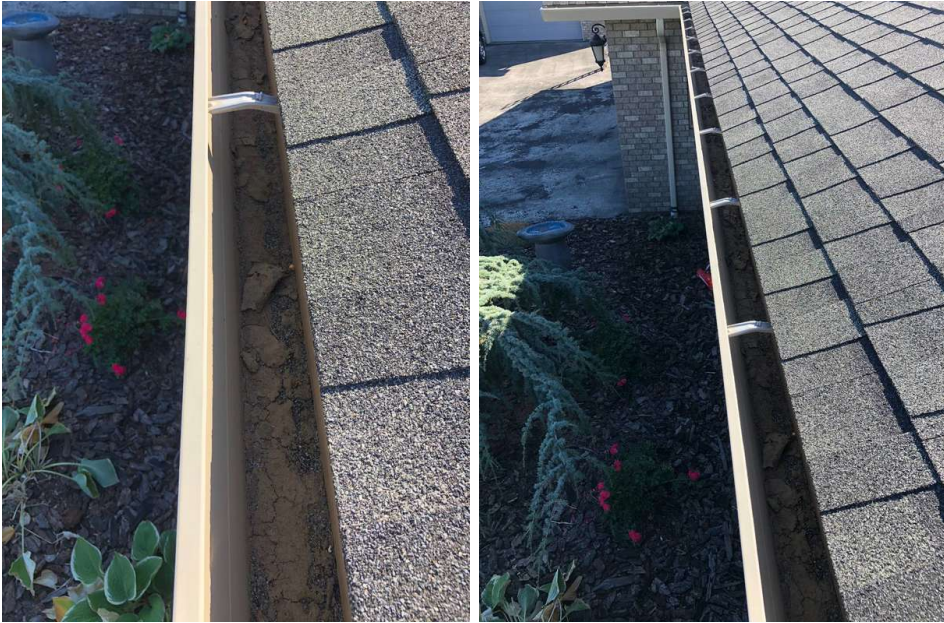
### 4.2.1 Gutter Systems

#### CLEAN GUTTERS

Gutters contain dirt or debris that may restricting proper drainage. Full gutters may also add unneeded weight to gutter system leading to potential failure. [Here is a DIY resource](#) for cleaning your gutters.

Contact a handyman or DIY project

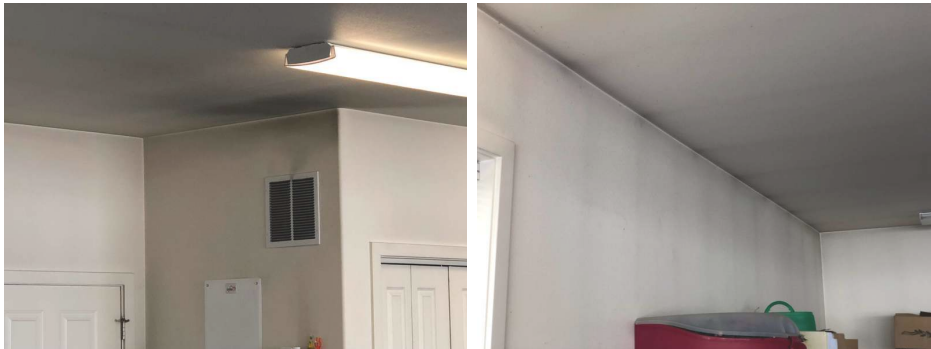
#### Ceilings: Soot Staining / Streaking

Garage

Soot streaking at interior walls and/or ceilings is typically evidence of inefficient burning of a fossil fuel appliance and/or open flame such as a candle or incense.

\*See HWT notes.

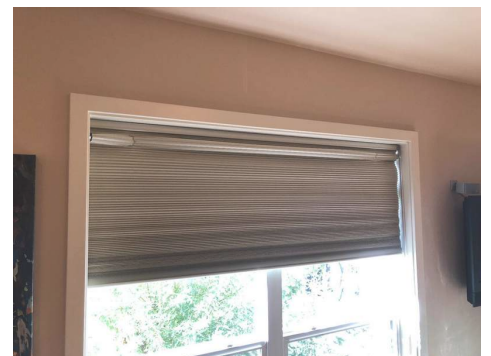
#### 5.5.1 Windows

#### WINDOW BLINDS DAMAGED

MASTER BEDROOM

Some window blinds were damaged or did not operate properly and may be in need of adjustment or repair.

Contact a qualified handyman.

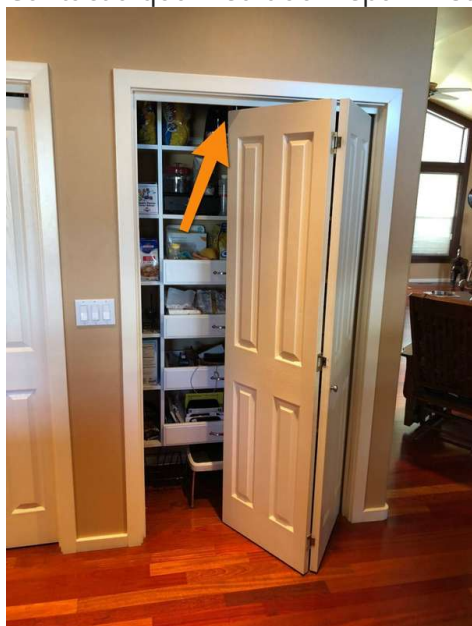
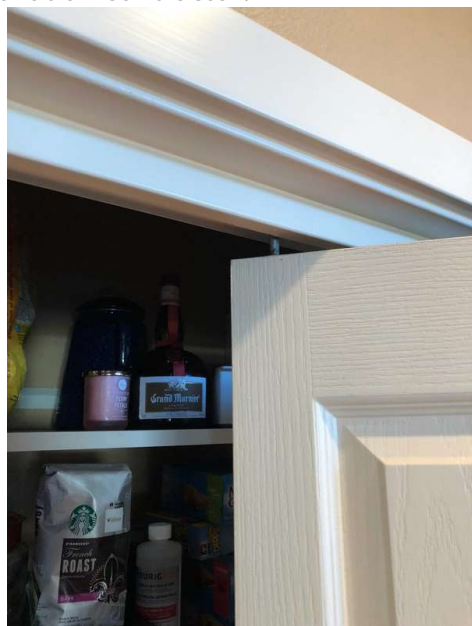
#### 5.6.1 Doors

#### HARDWARE MISSING

KITCHEN

Some interior closet door hardware was missing or not installed and was not operating smoothly/properly.

Contact a qualified door repair/installation contractor.

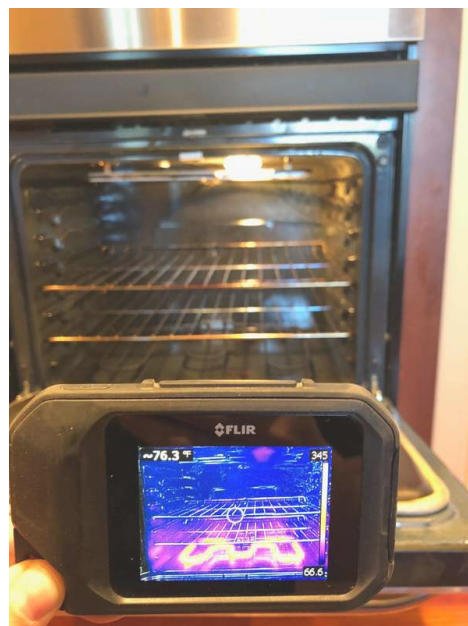
6.11.1 Wall Oven

#### **BURNER NOT OPERATING**

Inspector was unable to confirm operation of Broil function at lower oven.

Contact a qualified appliance repair professional.

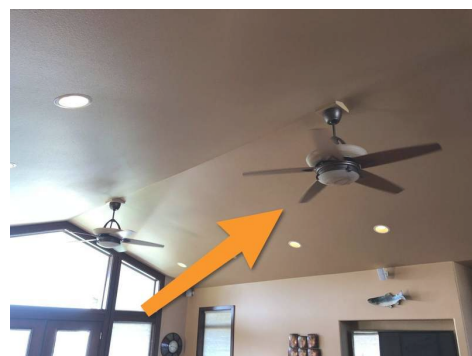
### 8.4.1 Connected Devices & Fixtures

#### LIGHT INOPERABLE

#### LIVING ROOM

Inspector was unable to confirm operation of one or more lights at time of inspection. New light bulb possibly needed. Recommend further evaluation and repair as needed.

Contact a qualified electrical contractor.

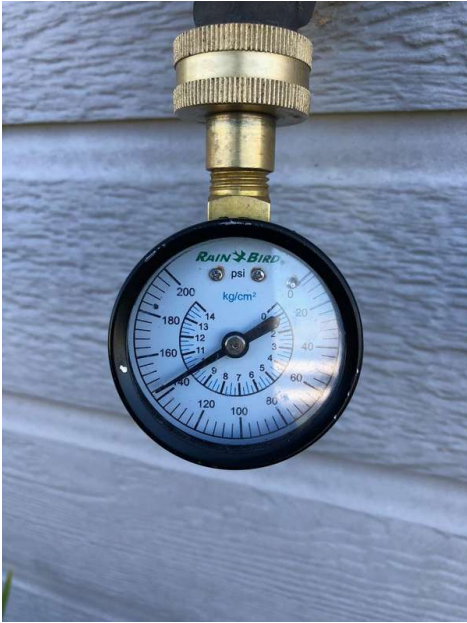
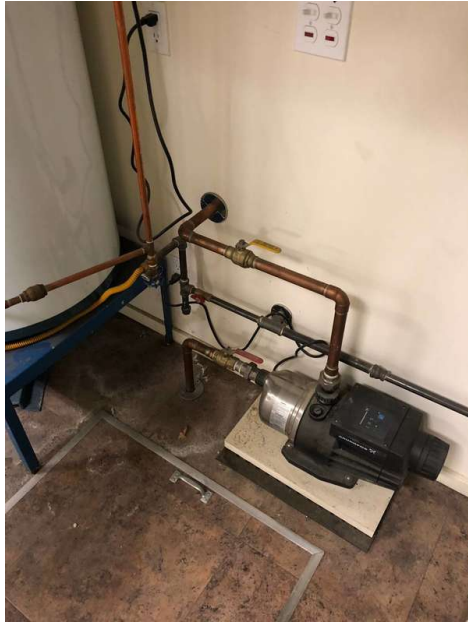
### 9.1.1 Supply Plumbing

#### HIGH WATER PRESSURE

High water pressure may put unneeded stress/strain on your plumbing system (pipes and fixtures). The generally recommended safe water pressure for residential application is 60-80 P.S.I. Recommend adjusting water pressure at Booster Pump. Here is a helpful [article](#) on Water Reducing Valves.

Contact a qualified plumbing contractor.

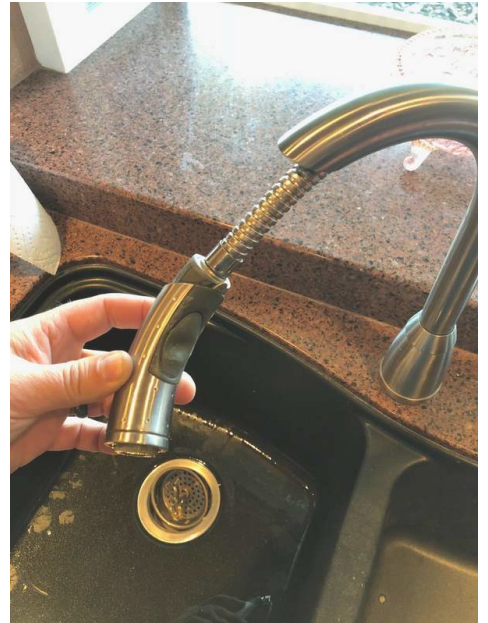
9.2.1 Fixtures & Faucets

**FIXTURE DAMAGED**

KITCHEN

Fixture damaged or not operating properly and may be in need of repair.

Contact a qualified handyman.

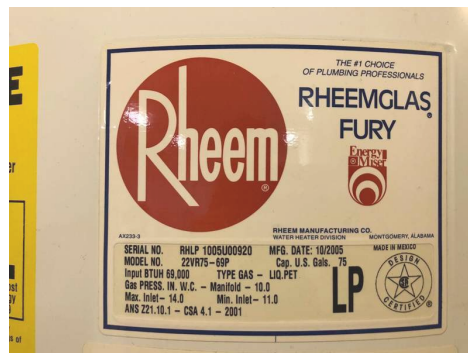
### 10.1.1 Equipment

#### DEFERRED COST ITEM

Hot Water Tank appears to be 12 years old or more and may be within 5 years of its estimated useful life. This comment is based off an estimated useful life of 12-15 years. Recommend Monitor. Anticipate maintenance and/or future replacement.

Recommendation  
Recommend monitoring.

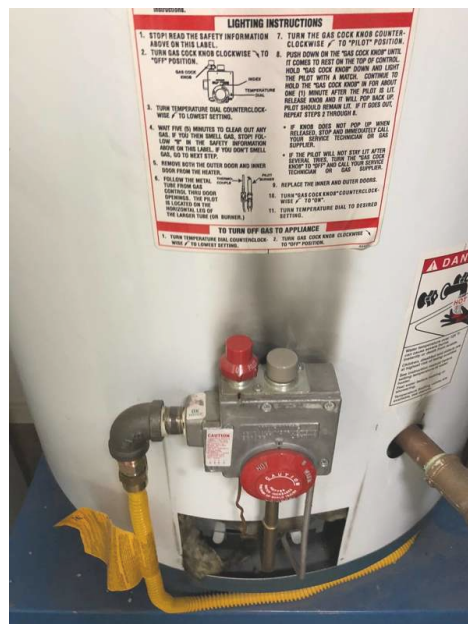
### 10.1.2 Equipment

#### FLAME ROLL-OUT

Scorching or evidence of flame roll-out noted at Hot Water Tank. Flame roll-out may be an indication of poor operation or other defects. Recommend further evaluation by a qualified professional and repair or replace as needed.

Recommendation  
Contact a qualified plumbing contractor.

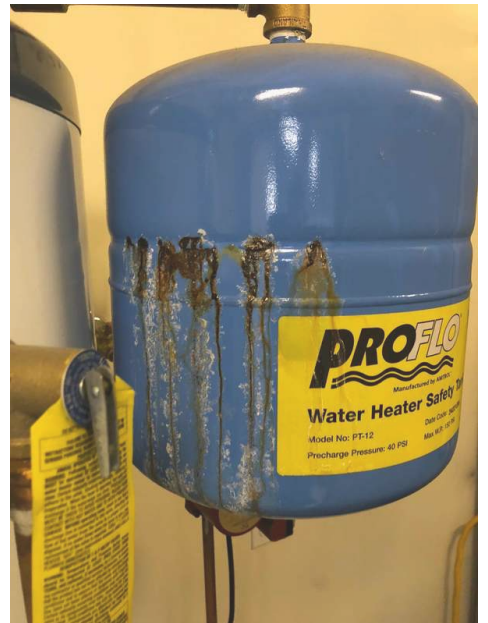
## 10.1.4 Equipment

**EXPANSION TANK LEAKING**

Rust or evidence of leaking noted at expansion tank. Recommend repair or replace as needed.

Contact a qualified plumbing contractor.

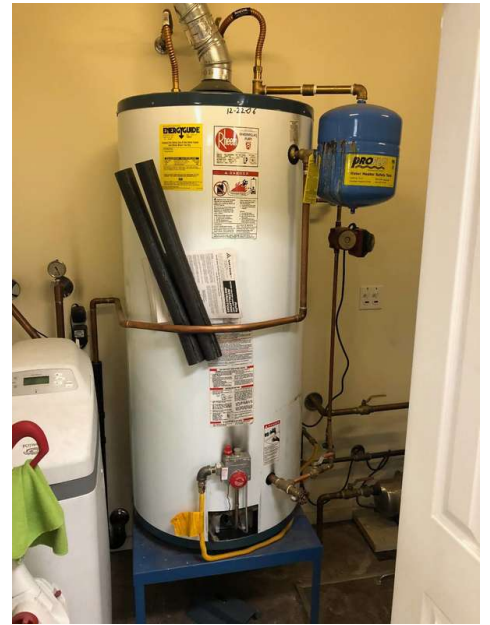
## 10.3.1 Safety Features

**SEISMIC STRAPPING NOT INSTALLED OR IMPROPER**

Modern safety standards requires seismic strapping at top and bottom thirds of installed Hot Water Tanks. See this helpful [link](#) for approved strapping and anchoring techniques. Recommend repair.

Contact a qualified appliance repair professional.

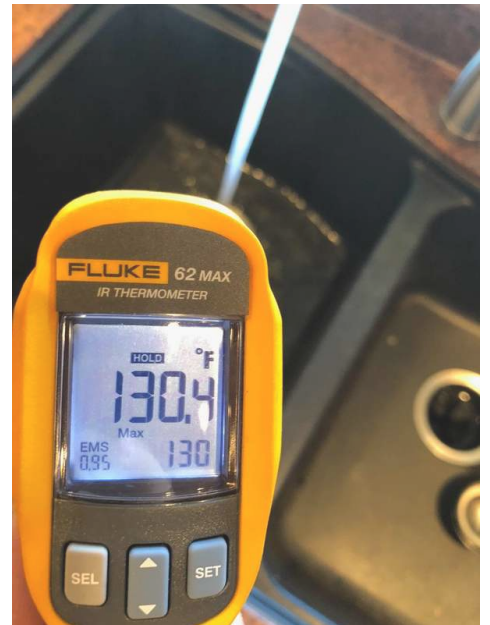
10.3.2 Safety Features

**WATER TEMPERATURE HIGH**

Water temperature was measured above maximum recommended safe water temperature of 120°F. Recommend adjusting water temperature to no more than 120°F to prevent potential scaling.

Contact a qualified appliance repair professional.

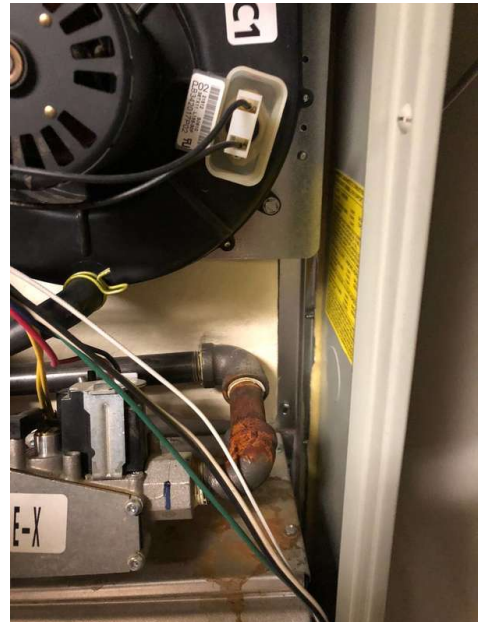
11.1.1 Heating Equipment

### CONDENSATE LEAK

Evidence of a condensate leak noted at furnace. Condition conducive to rust/deterioration and potential compromise. Recommend a qualified professional further evaluate and repair.

Contact a qualified HVAC professional.

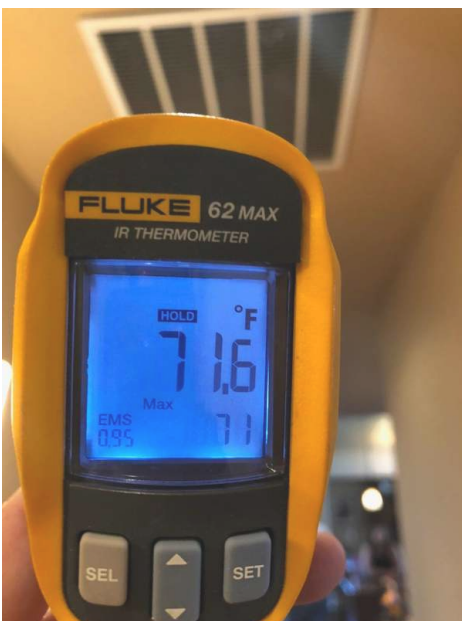
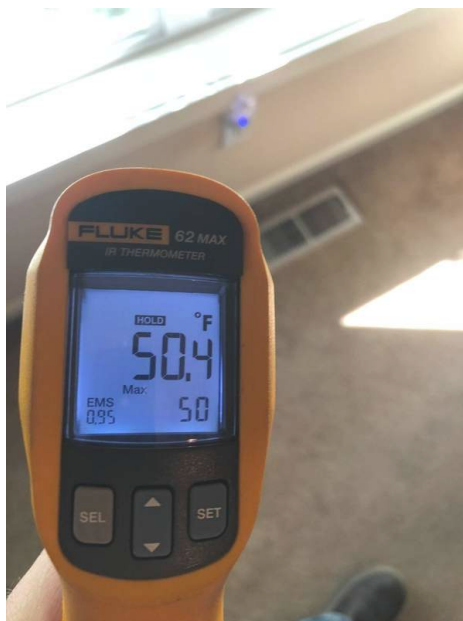
### Temperature Split / Differential

14-21°F

The AC or Heat Pump Temperature Split is the comparison of the Return Air (air going into the system) as compared to the Supply Air (air coming out of the system). A healthy AC/Heat Pump should be operating with a 14-21°F Temperature Split.

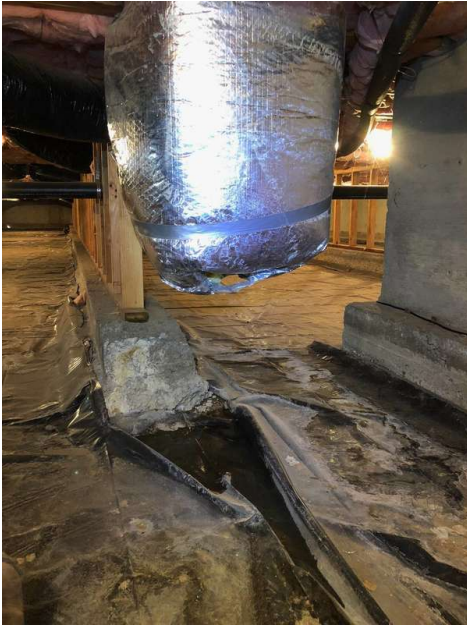
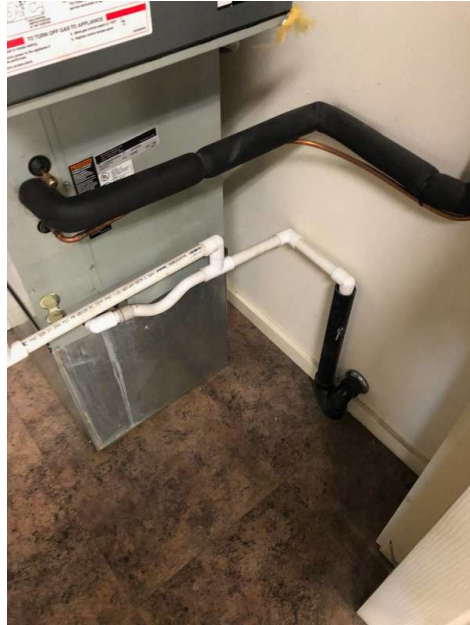
### 12.2.1 Distribution Systems

#### CONDENSATE LEAK

##### CRAWLSPACE

Leaking observed at Furnace Plenum and/or ducting. Probable condensate leak. Condition conducive to eventual deterioration and loss of system efficiency. Recommend a qualified professional further evaluate and repair/remedy as needed.

Contact a qualified HVAC professional.

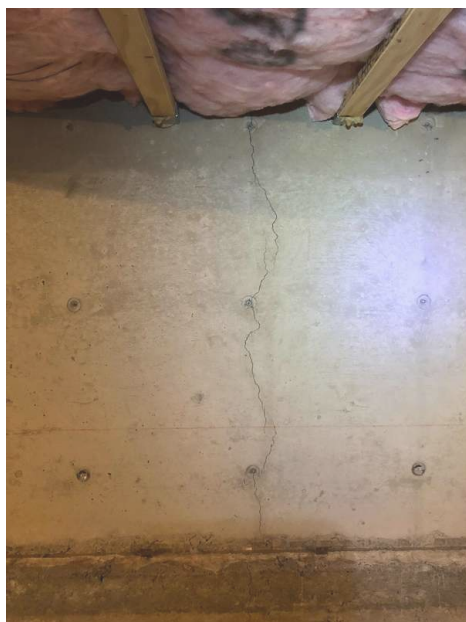
**Foundation: Typical Cracks**

Small vertical cracks known as shrinkage cracks or typical cracks were noted. These small vertical cracks are not considered to be related to structural compromise. If any vertical cracks begin to grow then further evaluation would be required. Recommend monitor. Cracks may be sealed from exterior to prevent moisture intrusion.

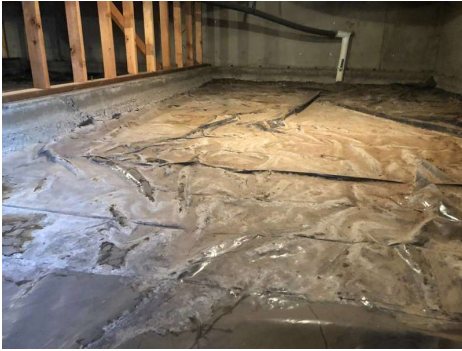
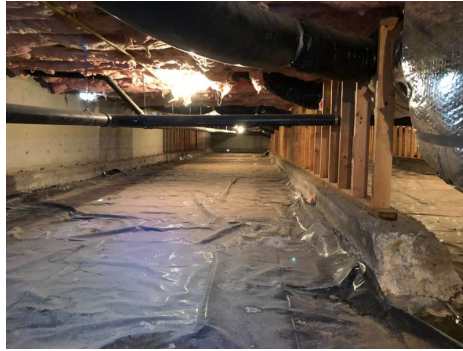
**Floor Structure & Crawlspace: Evidence of Past Moisture**

Evidence of past moisture noted in crawlspace at plastic vapor barrier. Possible past plumbing leak or moisture intrusion through foundation vents. No standing moisture observed at time of inspection. No evidence of compromise resulting from moisture noted. Recommend further inquiry and monitor.

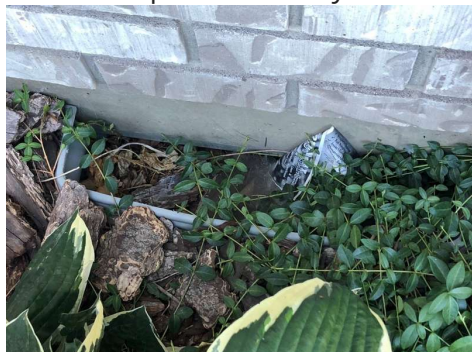
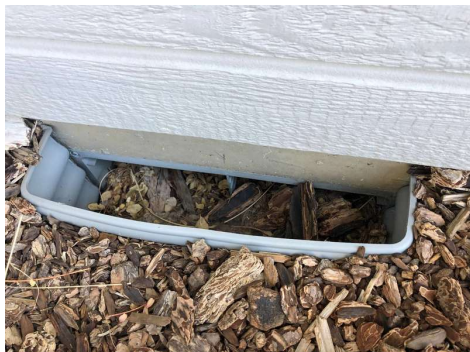
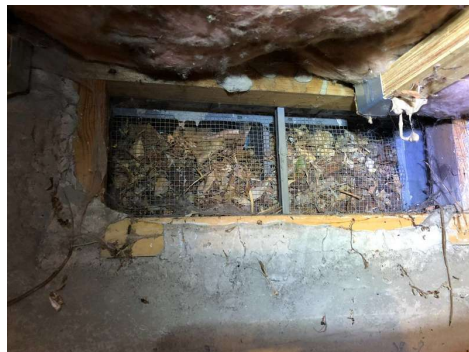
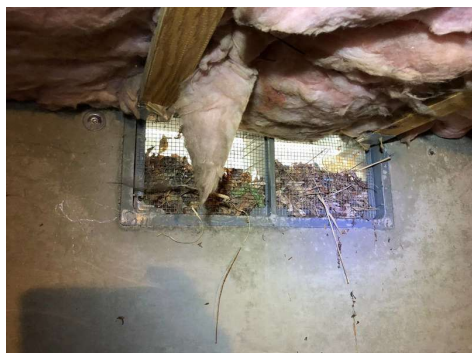
### 14.3.1 Crawlspace

#### FOUNDATION VENT/S RESTRICTED

THROUGHOUT EXTERIOR

Some foundation vents throughout are blocked or restricted with landscaping, leaves/debris and/or insulation. Recommend opening/clearing all foundation vents to ensure adequate crawlspace ventilation.

Contact a qualified handyman.

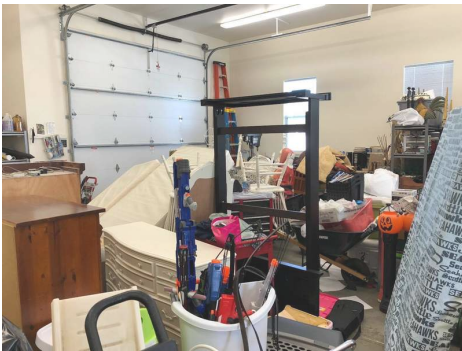
### Excessive Contents

Garage/Shop interior inspection was limited/restricted by excessive contents and stored items. Inspector was unable to access some outlets, windows, etc. at time of inspection.

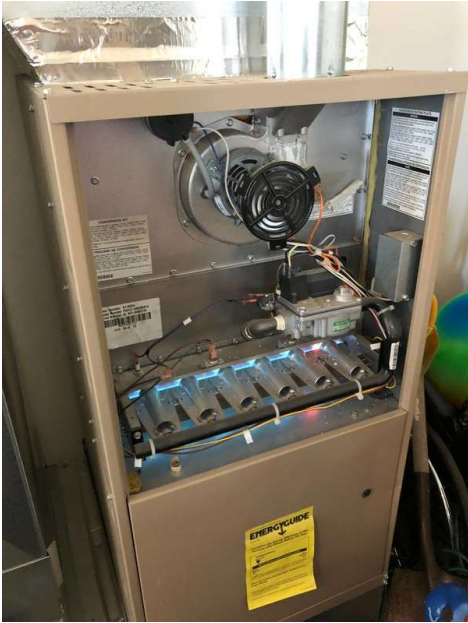
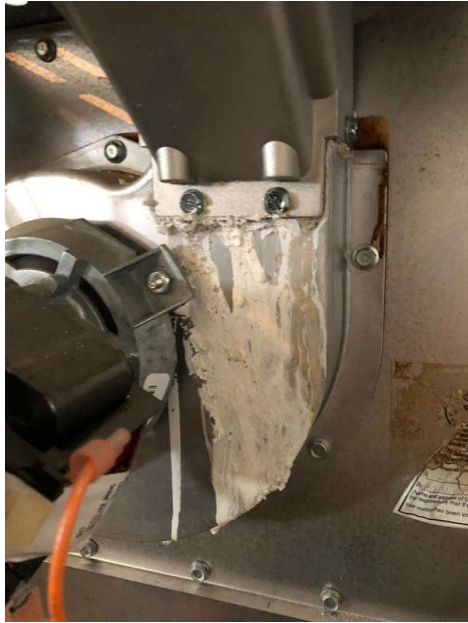
### 16.1.1 Heat Source

#### CONDENSATE LEAK

Evidence of condensate leak noted at furnace cabinet. Recommend further evaluation/inquiry and repair as needed.

Contact a qualified HVAC professional.

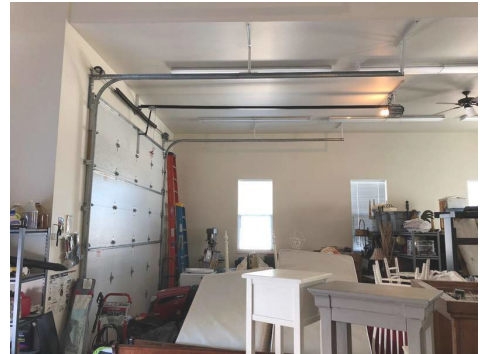
16.4.1 Garage Doors

**OPENER NOISY**

Garage door opener was noisy when operating and may be at or nearing the end of its useful life. Recommend further evaluation and maintenance or repair.

Contact a qualified garage door contractor.
