ROGUE INSPECTION SERVICES LLC

RESIDENTIAL REPORT

1234 Main St.
Jacksonville OR 97530

11/14/2018 9:00AM

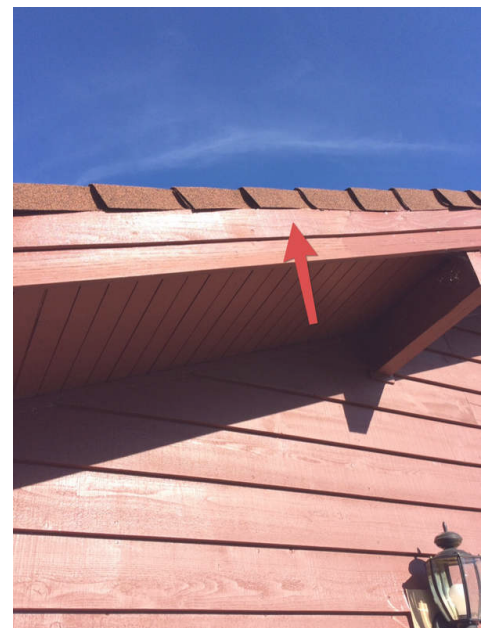
FLASHING/TRIM IMPROPERLY INSTALLED

Flashing & trim pieces were improperly installed, which could result in moisture intrusion and damaging leaks. Recommend a qualified siding contractor evaluate and install flashing over all horizontal trim.

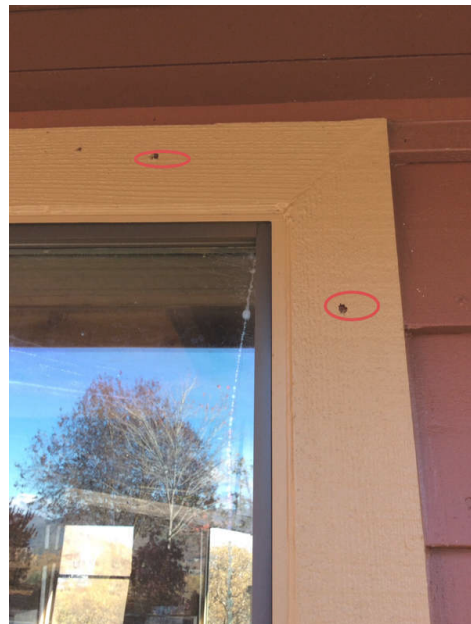
2.1.2 Siding, Flashing & Trim

There are holes that are exposed on the exterior siding. Recommend sealing to prevent water damage to the siding.

Contact a qualified professional.

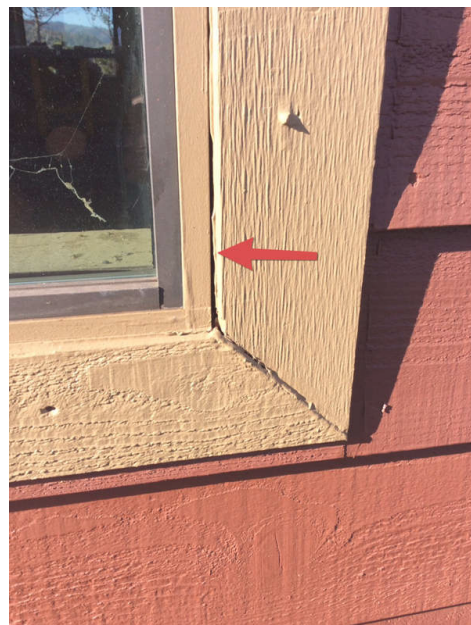
2.1.3 Siding, Flashing & Trim

CRACKED SEALANT AT TRIM JOINTS

The sealant at the trim joints and window trim has deteriorated and cracked. Recommend re-sealing to prevent moisture damage.

Recommended DIY Project

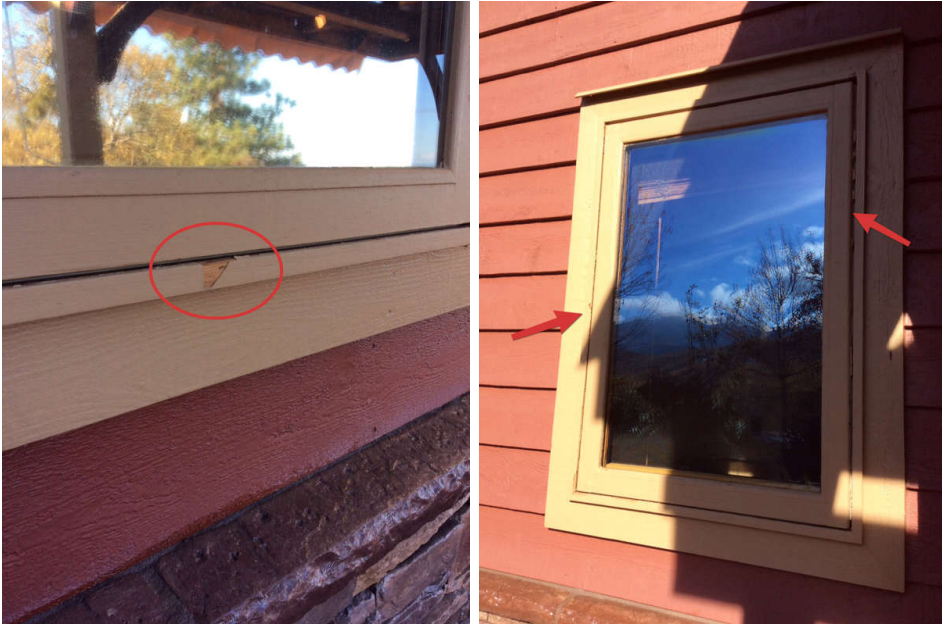
2.1.4 Siding, Flashing & Trim

FAILING PAINT

The paint is failing on various locations around the house and the wood is exposed. Recommend painting to provide a waterproof barrier and to prevent dry Rot.

Contact a qualified painter.

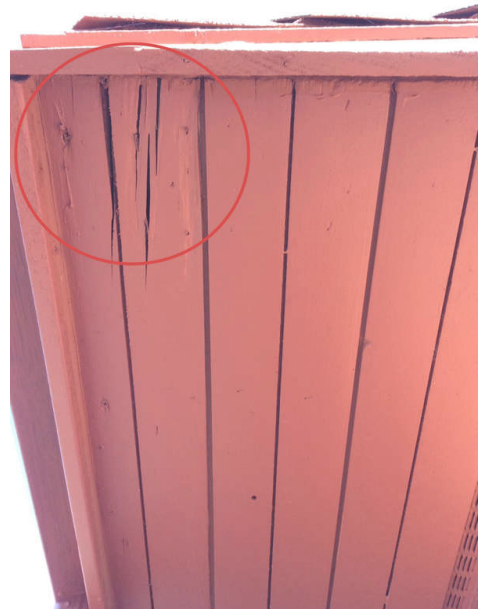
2.1.5 Siding, Flashing & Trim

DRY ROT

There is dry rot present on the exterior trim in some areas. Recommend repair as needed.

Contact a qualified siding specialist.

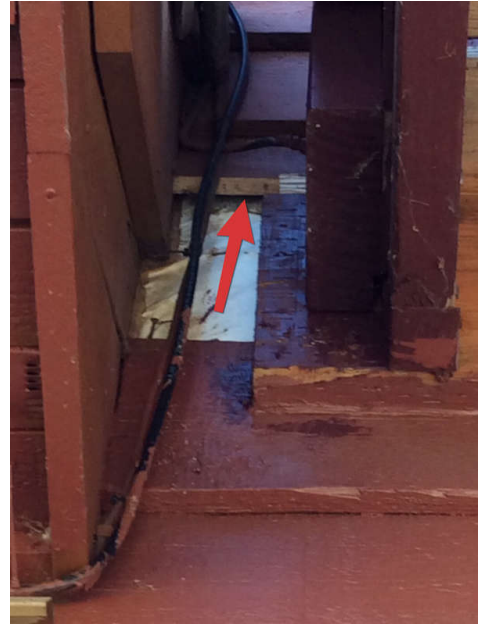
2.1.6 Siding, Flashing & Trim

HOLES IN SIDING

Recommend replacement of sections that are damaged to prevent damage to structure from water and pests.

Contact a qualified professional.

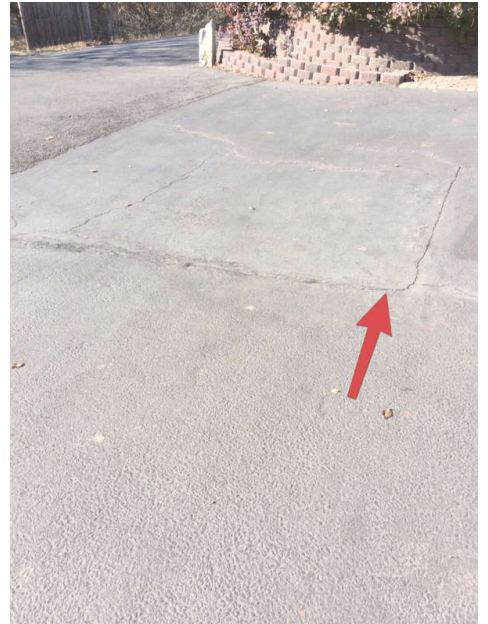
2.3.1 Walkways, Patios & Driveways

DRIVEWAY CRACKING - MINOR

Minor cosmetic cracks observed, which may indicate movement in the soil. Recommend monitor and/or have concrete contractor patch/seal.

Recommend monitoring.

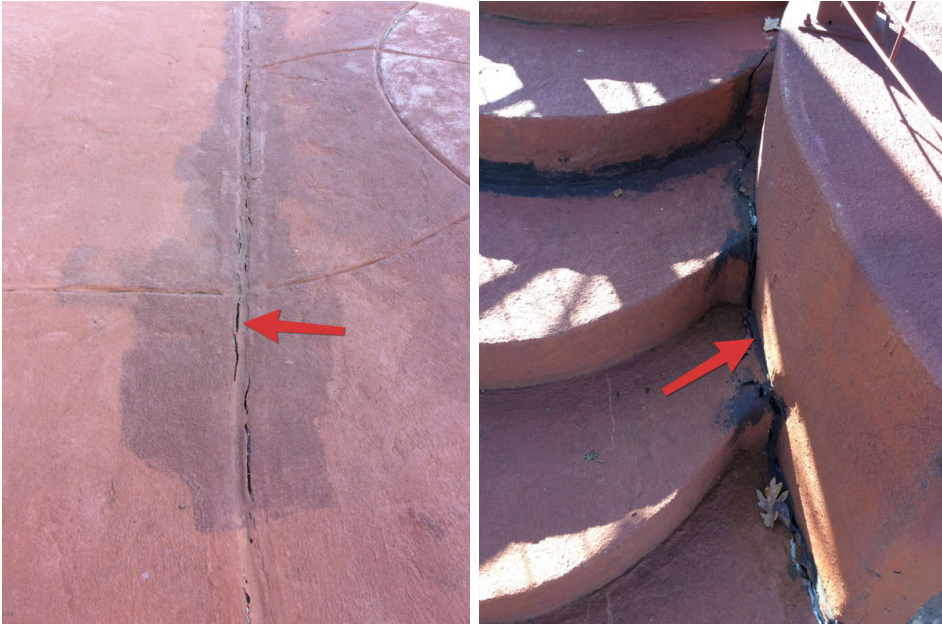
2.3.2 Walkways, Patios & Driveways

PATIO CRACKING - MINOR

Normal settling & cracking observed. Recommend monitor and/or patch/seal.

Recommend monitoring.

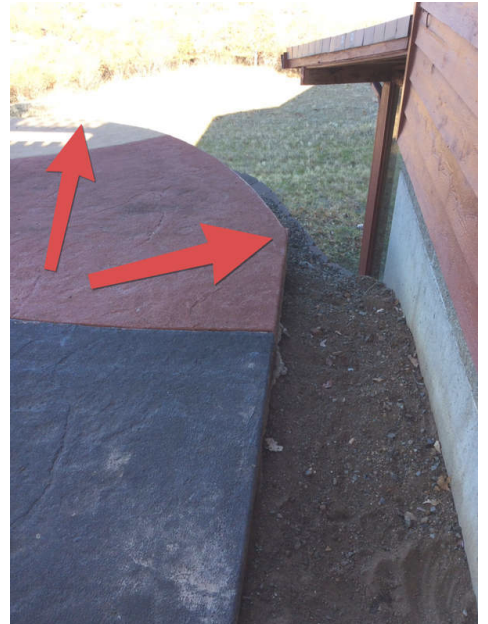
2.4.1 Decks, Balconies, Porches & Steps

MISSING HANDRAIL

Handrail is missing around the patio on the west side of the house. A handrail should be installed for safety.

Contact a qualified professional.

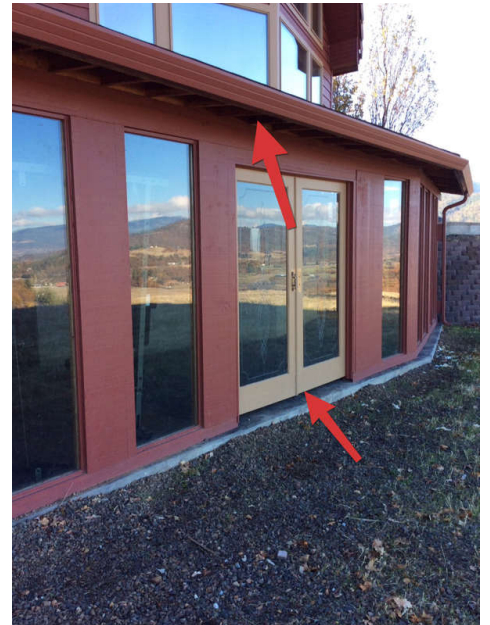
2.4.2 Decks, Balconies, Porches & Steps

UNFINISHED PORCH

Interior of basement porch is exposed to elements and/or pests due to it being unfinished. Recommend repair/finishing as desired.

Contact a qualified professional.

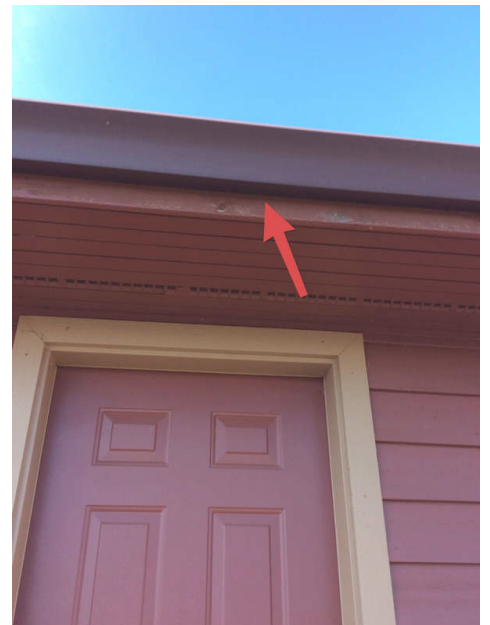
2.5.1 Eaves, Soffits & Fascia
PAINT/FINISH FAILING

The paint or finish is failing on the fascia in one or more locations. I recommend repainting to prevent water damage to the wood.

Contact a qualified painter.

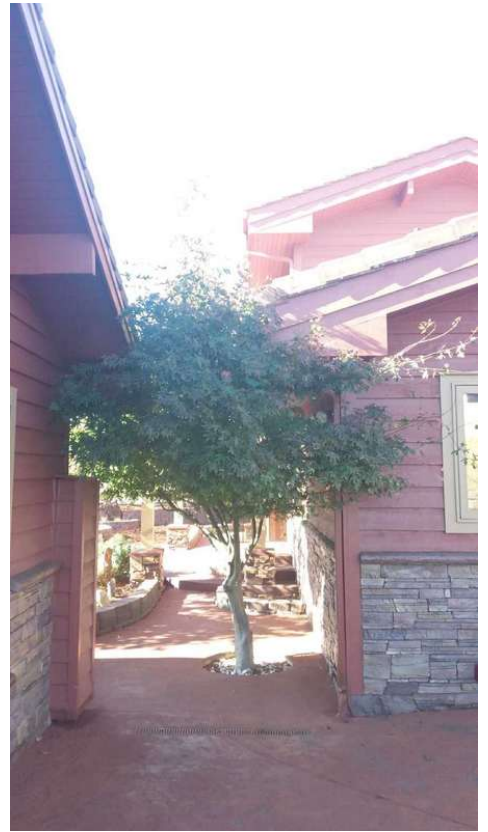
2.6.1 Vegetation, Grading, Drainage & Retaining Walls

Keep vegetation trimmed and away from the house. It creates a pathway for insects and rodents and can create prolonged moisture contact with the siding and trim.

Recommended DIY Project

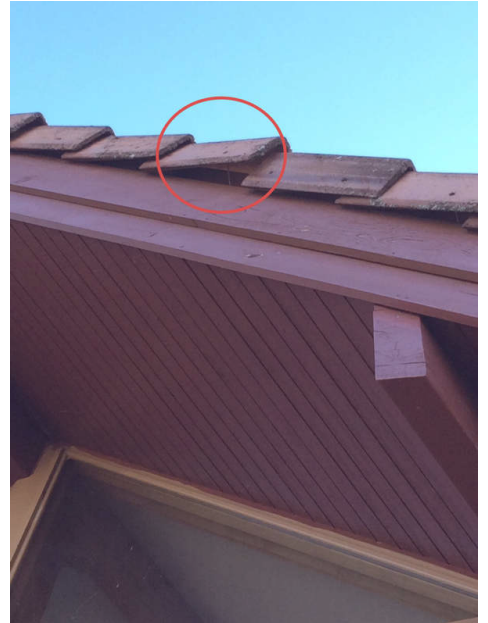
Observed one or more under-driven nails/fasteners. Recommend a qualified roofing contractor evaluate and repair. In at least one observed area, the under-driven nail has penetrated the upper layer of shingles.

Contact a qualified roofing professional.

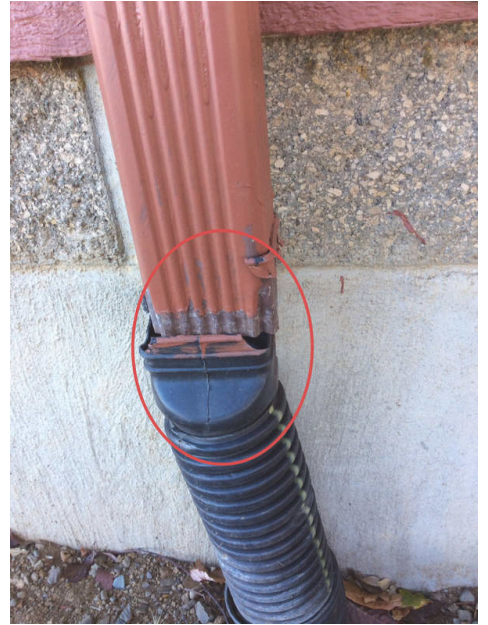
3.2.1 Roof Drainage Systems

One or more downspouts drain too close to the home's foundation. This can result in excessive moisture in the soil at the foundation, which can lead to foundation/structural movement. Recommend a qualified contractor adjust downspout extensions to drain at least 6 feet from the foundation.

Recommended DIY Project

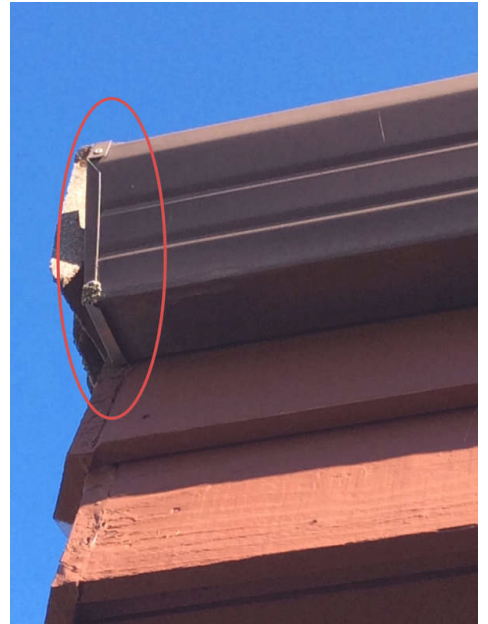
3.2.2 Roof Drainage Systems

The sealant at the seams and gutter joints has deteriorated and is in need of repair. Recommend repair by a licensed gutter professional to ensure that all seams are properly sealed to prevent leaks.

Contact a qualified gutter contractor

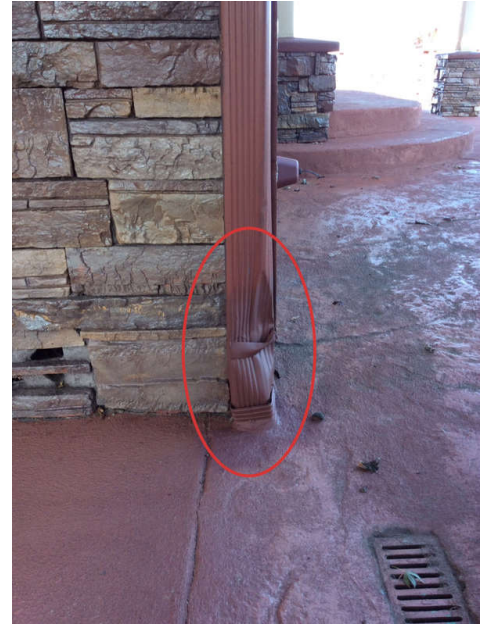
3.2.3 Roof Drainage Systems

DAMAGED DOWNSPOUT

The underground downspout connection is damaged. Recommend repair to prevent water from draining near the foundation.

Contact a qualified professional.

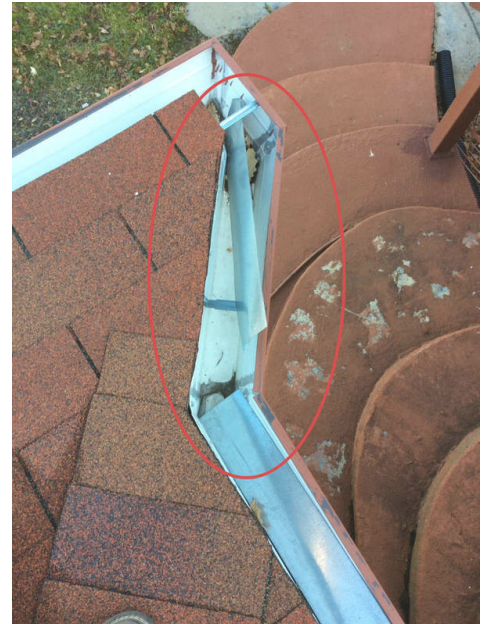
3.2.4 Roof Drainage Systems

GUTTER SCREEN DAMAGED

Screen is loose or damaged, recommend replacing with proper gutter screen.

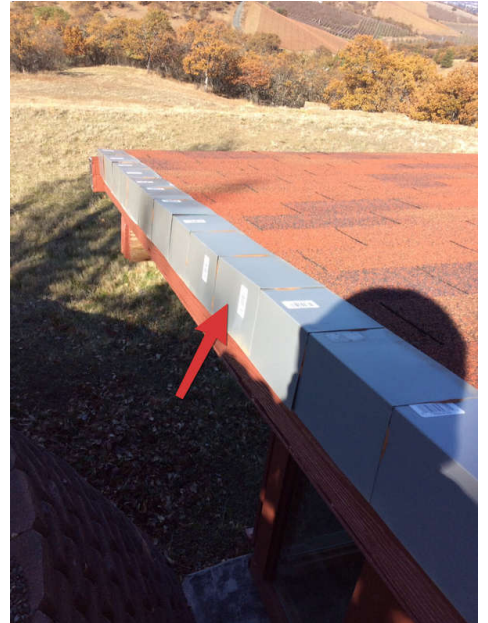
3.3.1 Flashings

STEP FLASHING IMPROPERLY INSTALLED

The step flashing on the dormer is improperly installed. Recommend repair and proper installation by a licensed roofing contractor.

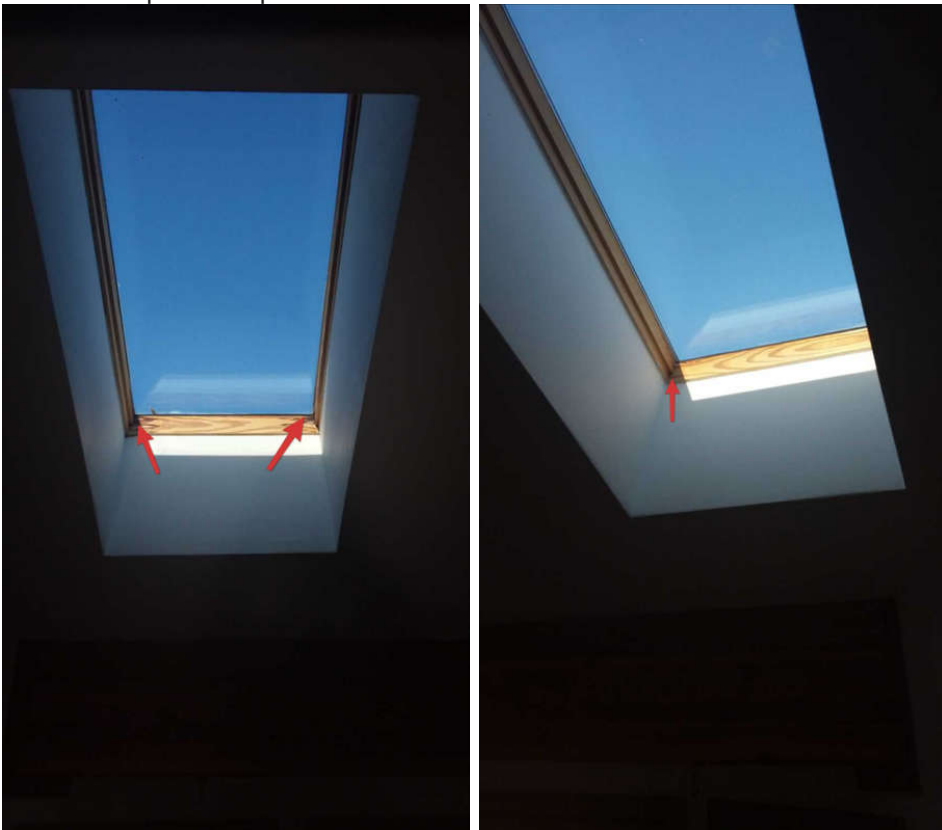
3.4.1 Skylights, Chimneys & Other Roof Penetrations

There are signs of possible water penetration at or near the skylight. Skylights, if not properly installed, are prone to leaking. Monitor the condition and if there is sign of leak then have the skylight repaired or replaced.

Contact a qualified professional.

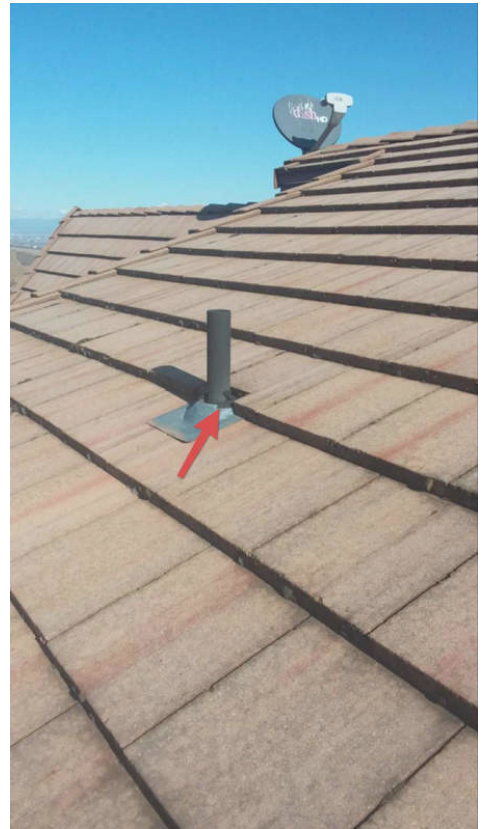
3.4.2 Skylights, Chimneys & Other Roof Penetrations

VENT BOOT CRACKED

The vent boot is cracked and in need of replacement. Recommend replacing to prevent water from entering the attic.

Contact a qualified roofing professional.

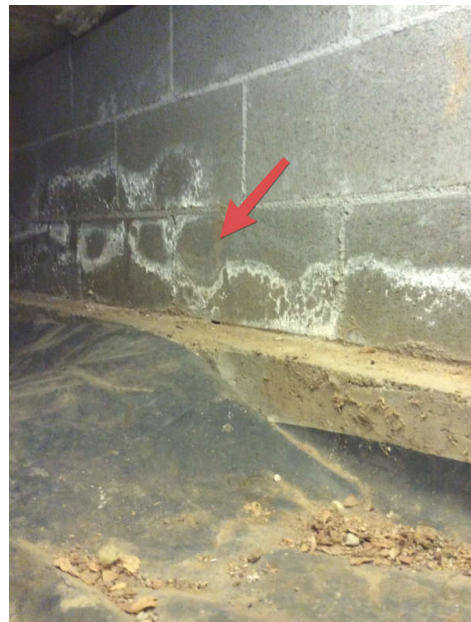
4.1.2 Foundation

EFFLORESCENCE

Water staining on foundation indicates that gutters may be clogged and causing moisture to be absorbed into foundation. Recommend maintenance on gutters drainage system to direct water away from home. Also, ensure that the sprinkler system is not hitting the siding/foundation.

Recommend monitoring.

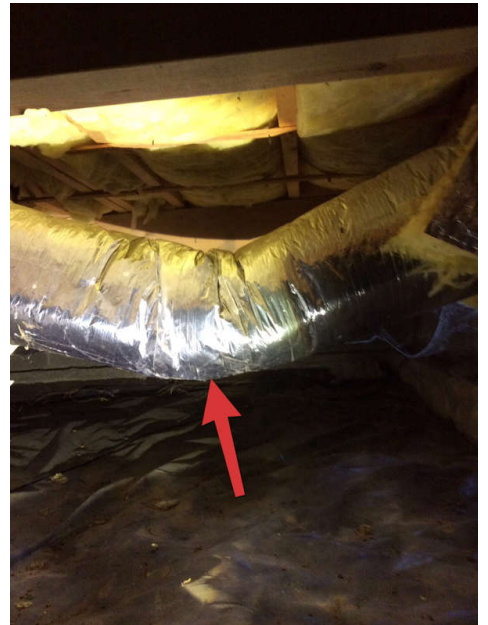
DUCT DAMAGED

Air supply duct has water inside. Recommend a qualified HVAC contractor repair.

Contact a qualified HVAC professional.

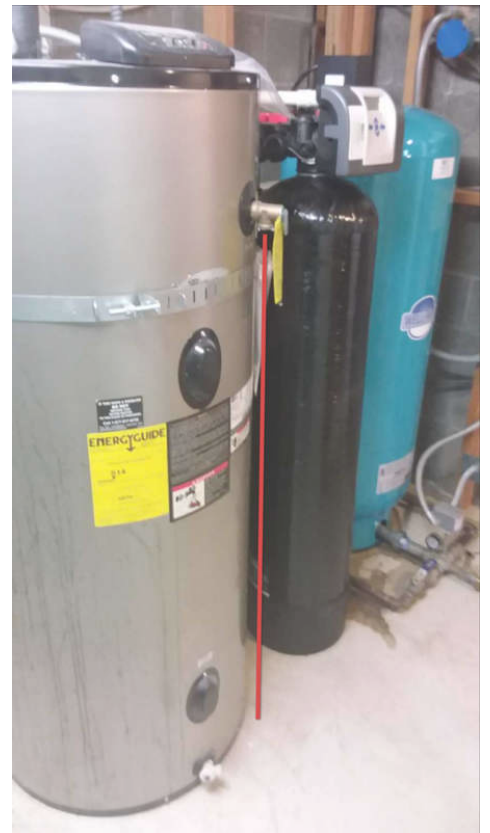
7.4.2 Hot Water Systems, Controls, Flues & Vents

An extension should be placed on the T&P valve that extends within 6 inches of the floor. Recommend repair by a licensed plumber.

Contact a qualified plumbing contractor.

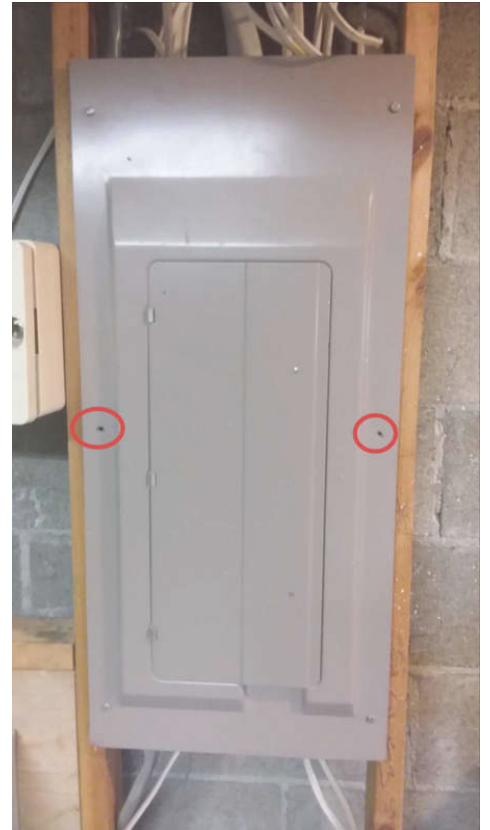
MISSING PANEL SCREWS

The main panel is missing screws that hold the cover in place.
Recommend replacing with flat head compressed thread screws.

Contact a handyman or DIY project

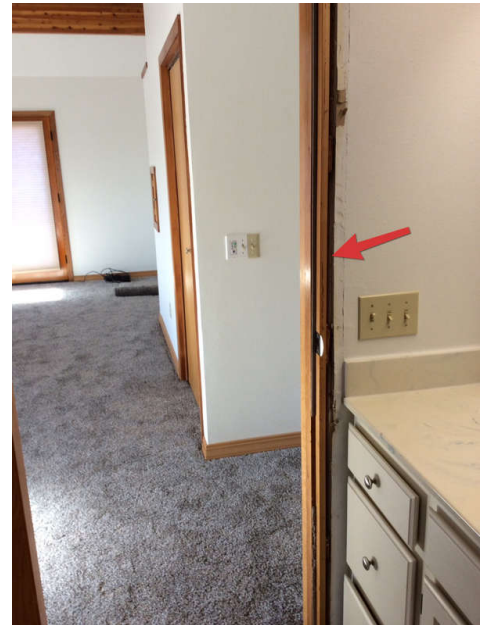
DOOR TRIM MISSING

Recommend installing wood trim on door for finished appearance.

Contact a qualified professional.

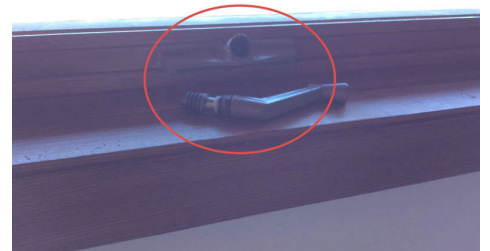
10.2.1 Windows

WINDOW HARDWARE DAMAGED

The window on the east side of the house does not lock. Recommend replacement.

Contact a qualified handyman.

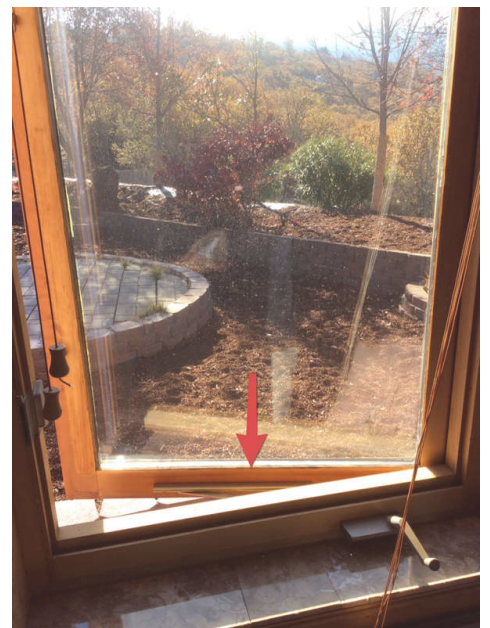
10.2.2 Windows

WATER DAMAGE

There is water damage at one or more windows. Recommend resealing to prevent further damage.

Contact a qualified handyman.

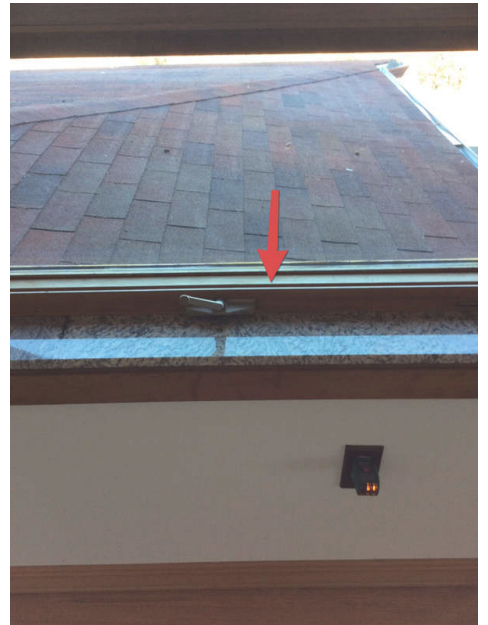
10.2.3 Windows

PAINT FAILING

Recommend resealing to prevent further damage to window

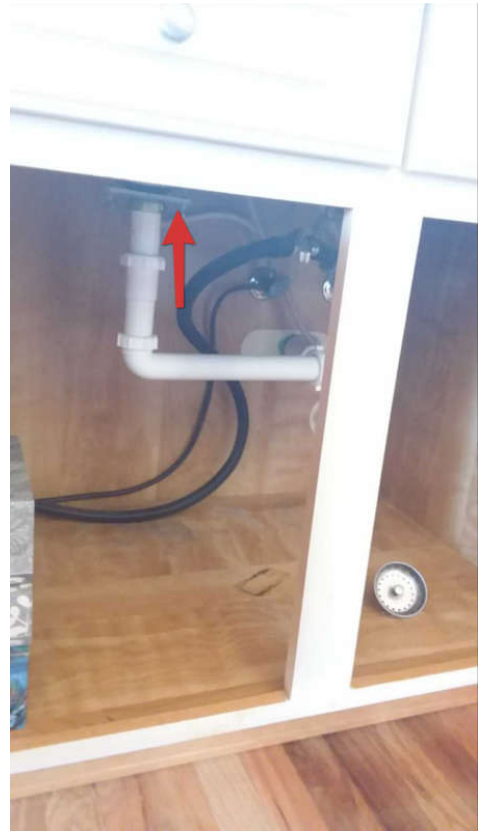
Recommend creating a high loop with the dishwasher drain line to prevent backflow from the kitchen sink.

Recommended DIY Project

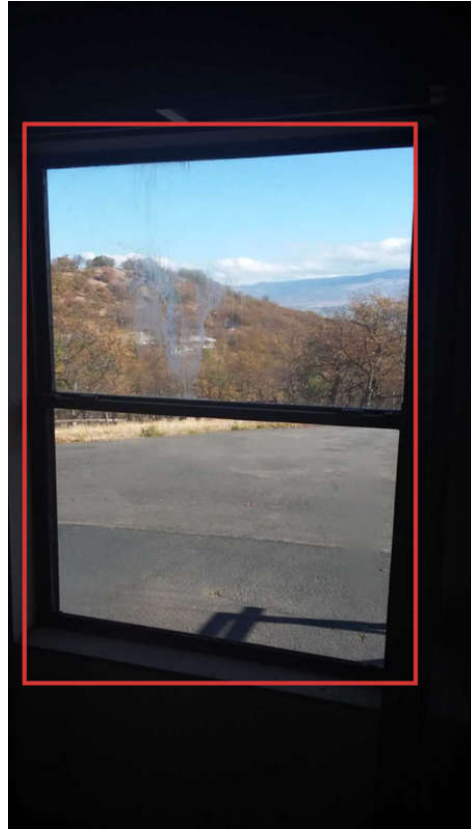
12.7.1 Windows

BROKEN SEAL

Contact a qualified window repair/installation contractor.

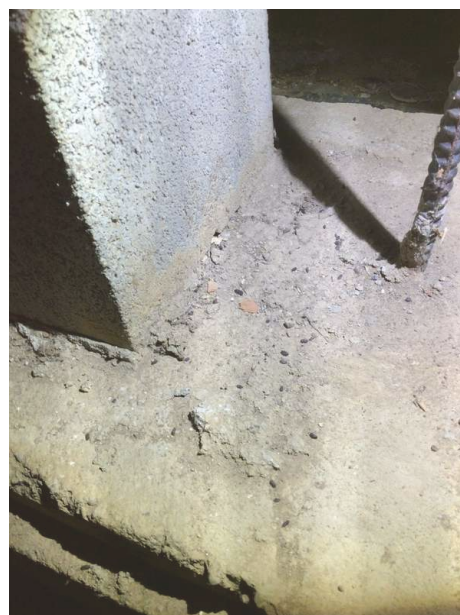
Crawlspace floor

Recommend baiting as needed.
