SMART INSPECTIONS LLC

RESIDENTIAL COPY

1234 Main St.  
Waterford Works New Jersey 08089

11/02/2018 9:00AM

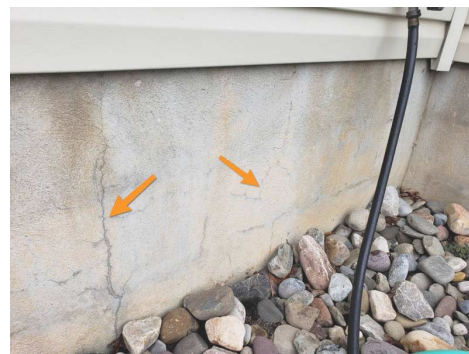
#### 2.1.1 Foundation Walls

#### EXTERIOR FOUNDATION - SHRINKAGE CRACKS

The foundation wall exhibited signs of shrinkage cracking. Shrinkage cracks appear as part of the natural concrete curing process and are not a structural concern. The inspector recommends monitoring the cracks for future displacement or shifting by a qualified professional.

Contact a foundation contractor.

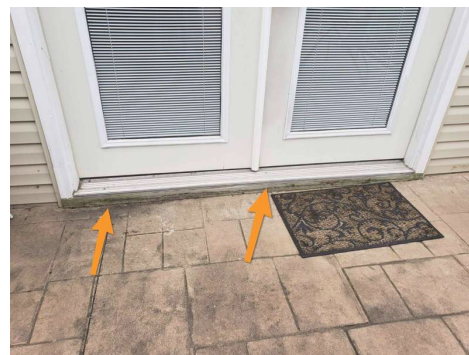
#### 2.6.1 Doors

#### DOOR - KICK PLATE DAMAGE

The front door kick plate exhibited signs of wood rot and water damage. This condition, if not repaired, will only cause more moisture intrusion, which may damage surrounding components. The wood rot is likely caused by the excess moisture that the roof drainage system is depositing on the patio. The inspector recommends further evaluation of the entire door and repair of the kick plate by a qualified professional.

Contact a qualified door repair/installation contractor.

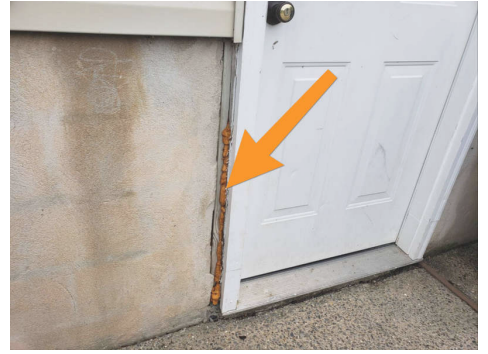
## 2.6.2 Doors

**DOOR MISSING TRIM**

One or more sections of the door trim were missing. This condition may allow moisture intrusion, which may damage surrounding components. The inspector recommends further evaluation and repair by a qualified professional.

Contact a qualified professional.

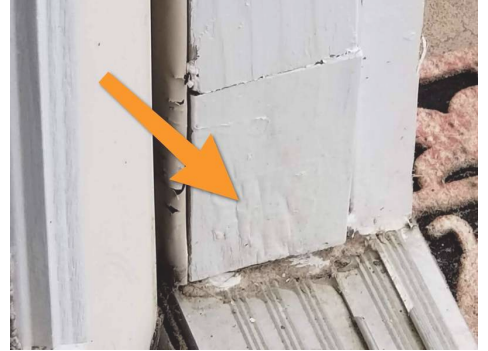
## 2.6.3 Doors

**DOOR TRIM - WOOD ROT**

One or more door trims exhibited signs of wood rot. This condition will only worsen over time if not repaired. The inspector recommends repair of the door trim by a qualified professional.

Contact a qualified door repair/installation contractor.

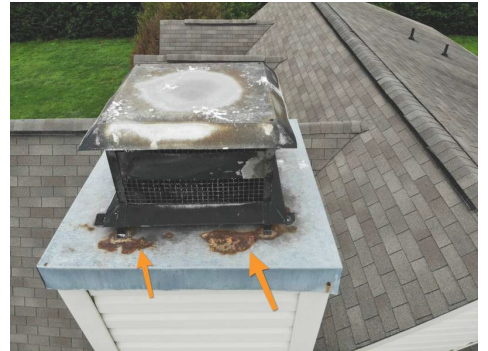
## 2.8.1 Chimney Exterior

**CHIMNEY CROWN - MINOR CORROSION**

The chimney crown exhibited signs of corrosion. This condition may allow moisture intrusion, which may cause damage to surrounding components. The inspector recommends further evaluation and repair of the chimney crown by a qualified professional.

Contact a qualified chimney contractor.

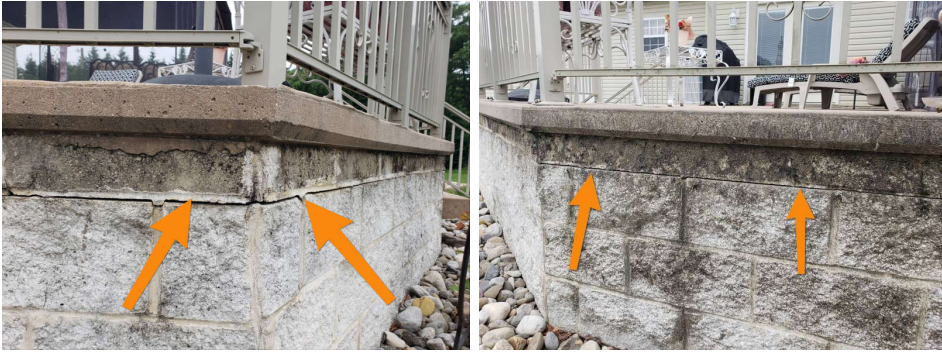
## 2.9.1 Decks, Patios and Porches

**PATIO - HORIZONTAL CRACK**

One or more portions of the patio exhibited signs of a horizontal crack. This condition is generally caused by lateral pressure on the wall. The inspector recommends further evaluation and repair by a qualified professional.

Contact a qualified professional.

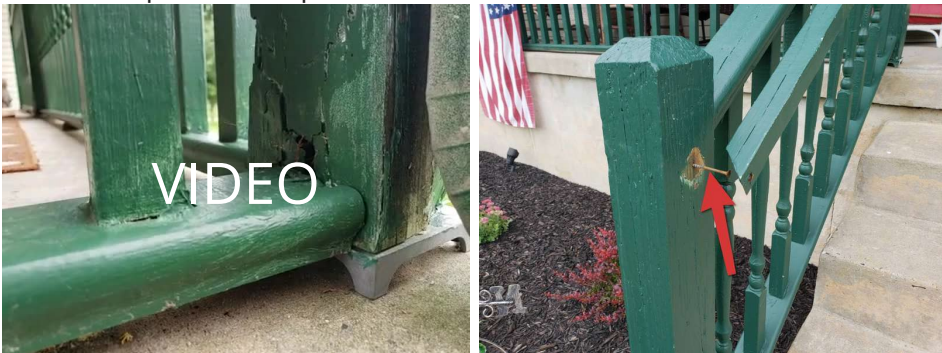
2.10.1 Walkways, Steps and Railings

**RAILING - NOT ATTACHED**

The front stairway railing was not attached to its support post. This condition may cause a safety hazard for anyone who may use the railing for support. The inspector recommends further evaluation and repair by a qualified professional.

Contact a qualified carpenter.

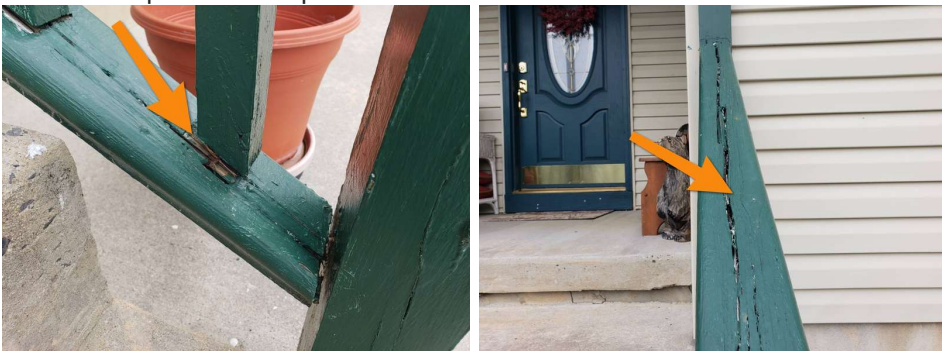
2.10.2 Walkways, Steps and Railings

**RAILING - WOOD ROT**

The front railing exhibited signs of wood rot in one or more locations. This condition may cause structural failure of the railings. The inspector recommends further evaluation and repair by a qualified professional.

Contact a qualified carpenter.

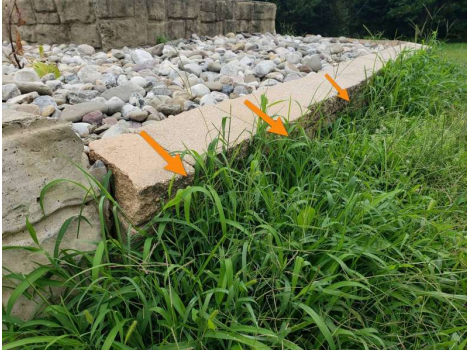
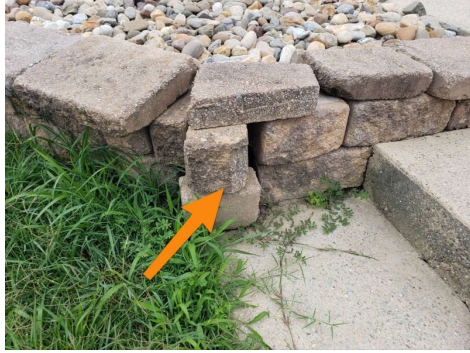
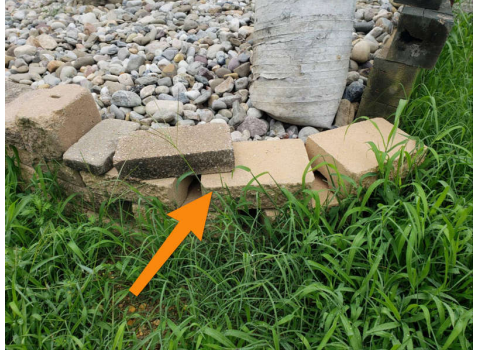
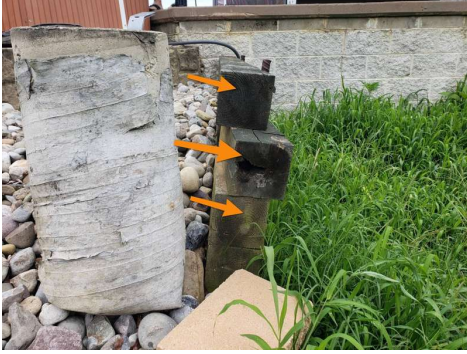
2.12.1 Landscaping and Retaining Walls

**RETAINING WALL - DETERIORATION**

One or more retaining walls are exhibiting signs of deterioration. This condition may cause the retaining walls to fail when under additional loads. The inspector recommends further evaluation and repair of the retaining walls by a qualified professional.

Contact a qualified professional.

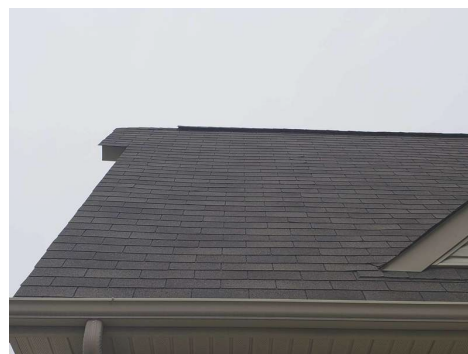
Although functional, standard three tab roof shingles had widening gaps between tabs and missing granules, which indicate they are near the end of their functional life expectancy. The shingles are likely original to the structure, approx. 17 years old. The life expectancy of three tab shingles is about 20 years. Continued use of the shingles without replacement may lead to moisture penetration into the interior space. The inspector recommends further evaluation of the asphalt shingles by a qualified professional.

Contact a qualified roofing professional.

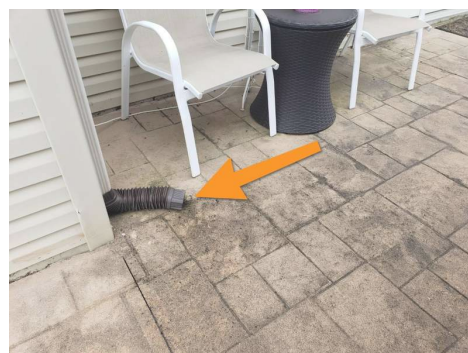
## 3.2.1 Roof Drainage Systems

One or more downspouts drain too close to the home's foundation. This can result in excessive moisture in the soil at the foundation, which can lead to foundation/structural movement. The inspector recommends a qualified contractor adjust downspout extensions to drain at least 6 feet from the foundation.

Contact a qualified gutter contractor

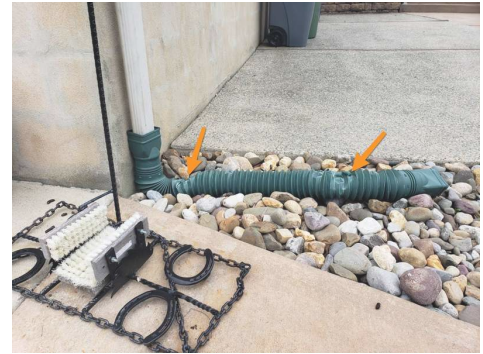
3.2.2 Roof Drainage Systems

**DOWNSPOUT EXTENSION - CRUSHED**

One or more downspout extension pipes were crushed. This condition may cause water to back up, causing the roof drainage system to fail. The inspector recommends further evaluation and repair of the entire roof drainage system by a qualified professional.

Contact a qualified gutter contractor

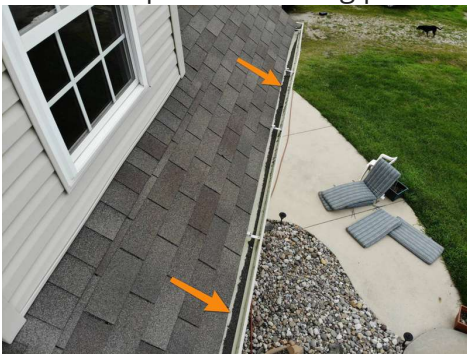
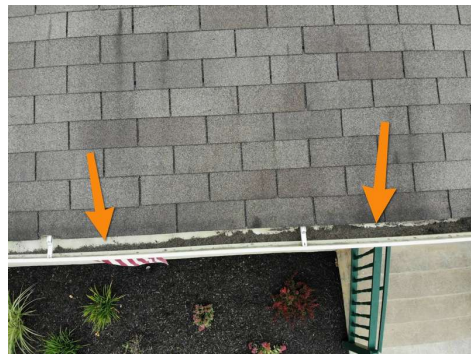
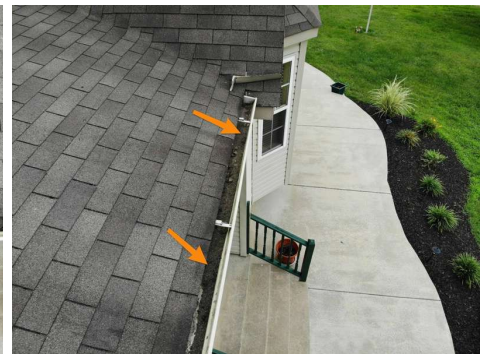
3.2.3 Roof Drainage Systems

**GUTTER - LOOSE GRANULES**

One or more gutters exhibited signs of containing loose shingle granules. This condition is characteristic of an aging roof. The granules should be cleaned from the gutters so they don't impede the flow of water runoff. The inspector recommends further evaluation and repair by a qualified professional.

Contact a qualified roofing professional.

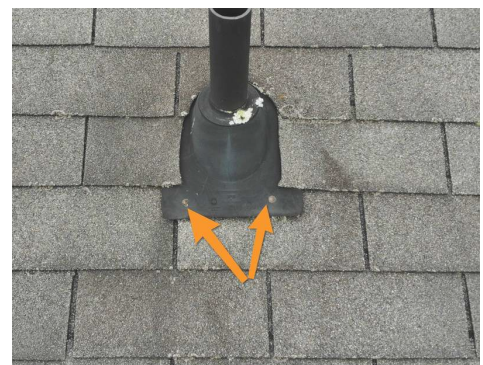
3.3.1 Roof Flashings

**ROOF PENETRATION - EXPOSED FLASHING FASTENERS**

One or more vent flashing fasteners were exposed to environmental elements. This condition may cause fastener corrosion, which could cause moisture intrusion. The inspector recommends evaluation and repair of all of the roof penetration flashings by a qualified professional.

Contact a qualified roofing professional.

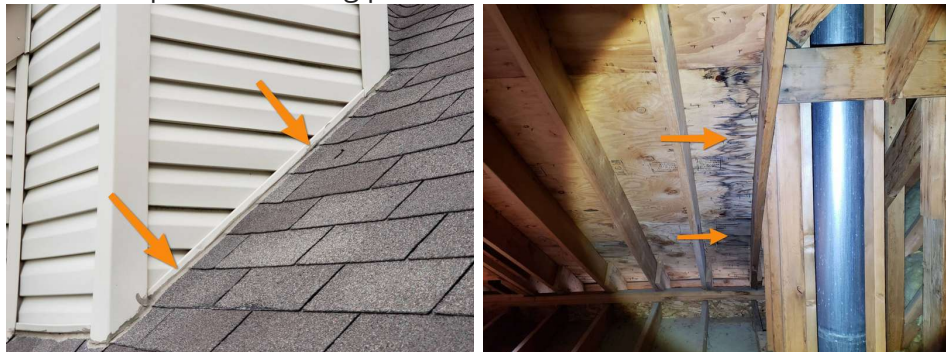
## 3.3.2 Roof Flashings

The joint around the chimney is sealed with silicon. Silicon is not the preferred method for sealing the connection between the siding and chimney. This condition is likely an attempt to stop moisture intrusion that has caused damage to the roof structure over the garage. The inspector recommends further evaluation and repair of the affected areas by a qualified professional.

Contact a qualified roofing professional.

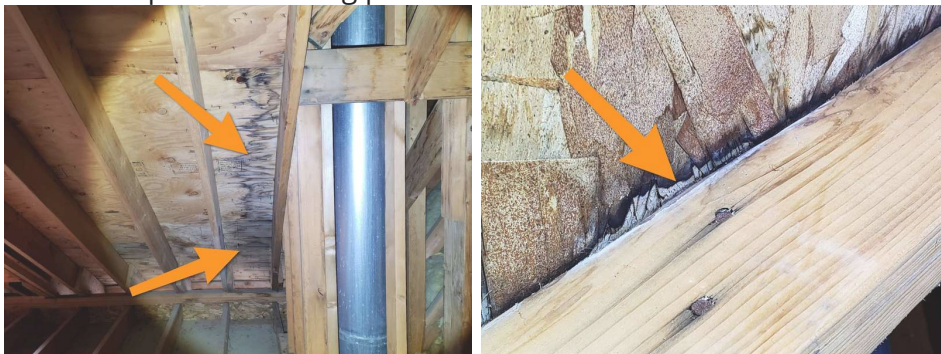
#### ROOF SHEATHING - MOISTURE INTRUSION

At the time of the inspection, one or more sections of the roof sheathing exhibited signs of moisture intrusion. This condition, if it has not already been repaired, may lead to the growth of mold and/or water damage to surrounding components. The inspector recommends further evaluation of the roof sheathing by a qualified professional.

Contact a qualified roofing professional.

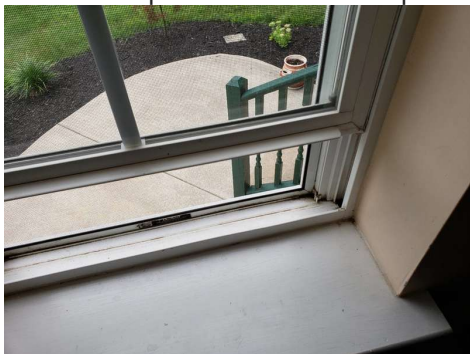
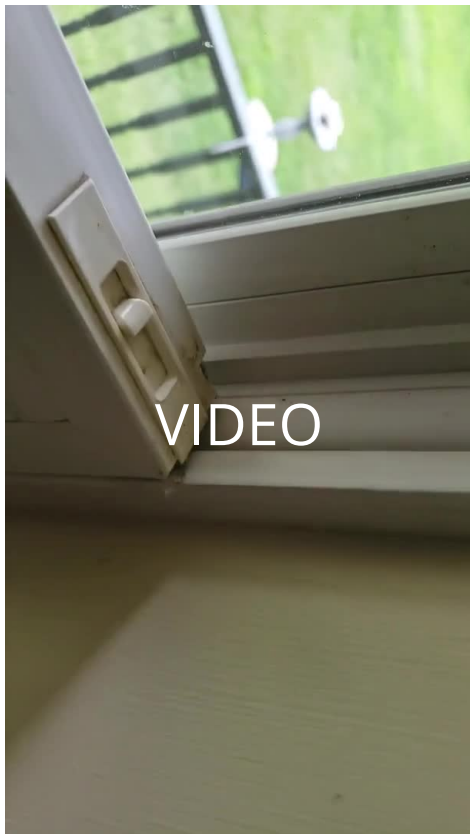
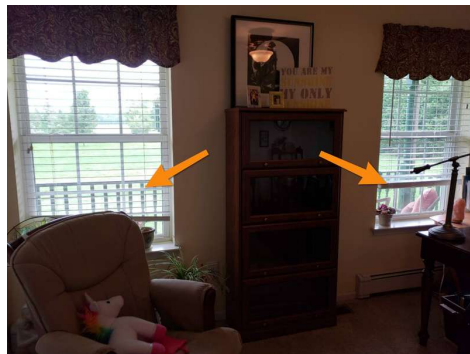
5.1.1 Windows

**WINDOW - DAMAGED**

One or more windows appear to have general damage, but are functional. This condition may prevent the windows from operating as intended. The inspector recommends further evaluation and repair by a qualified professional.

Contact a qualified window repair/installation contractor.

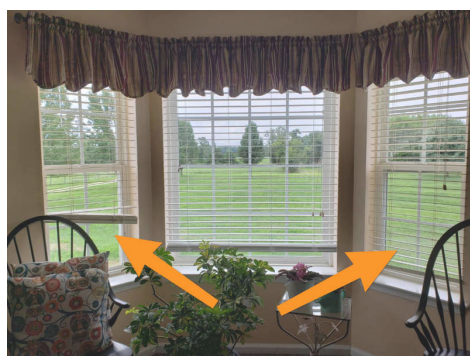
5.1.2 Windows

One or more of the windows at the time of the inspection were not operational. Inoperable windows may prevent egress during emergency situations. The inspector recommends that all of the windows be evaluated and repaired by a qualified professional.

Contact a qualified window repair/installation contractor.

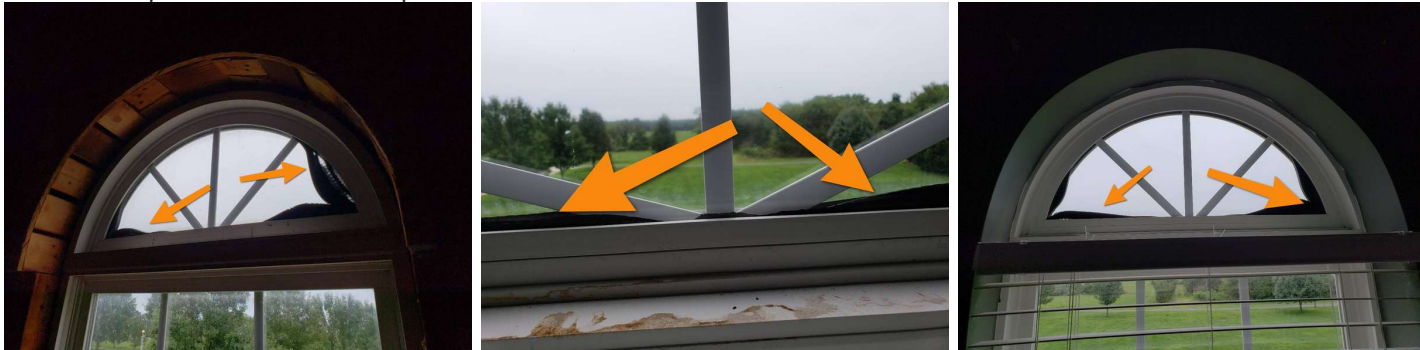
5.1.3 Windows

**WINDOW - DAMAGED SEALANT**

One or more windows exhibited signs of damaged sealant. This condition may compromise the thermal efficiency of the windows. The inspector recommends further evaluation and repair by a qualified professional.

Contact a qualified window repair/installation contractor.

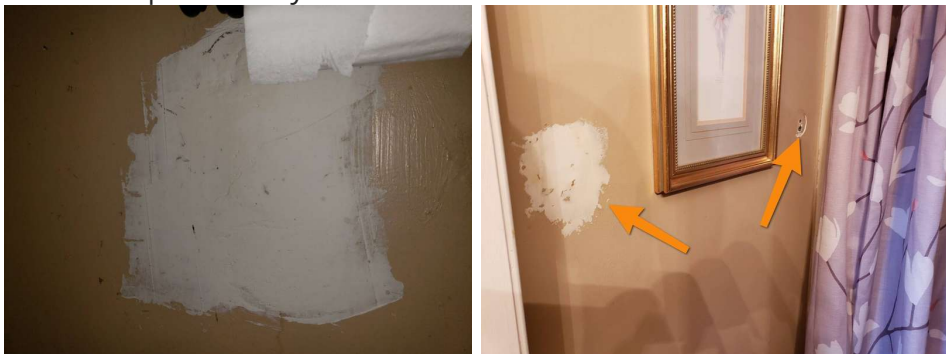
5.5.1 Walls

One or more sections of dry patching was sub-standard. This condition is an indication of poor workmanship, likely not done by a qualified professional. The inspector recommends the drywall be re-patched using proper techniques by a qualified professional.

Contact a qualified drywall contractor.

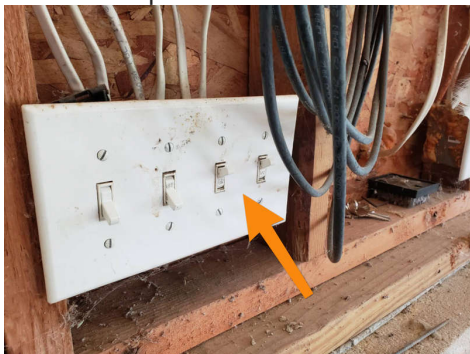
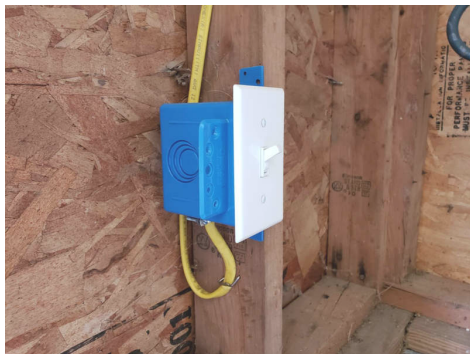
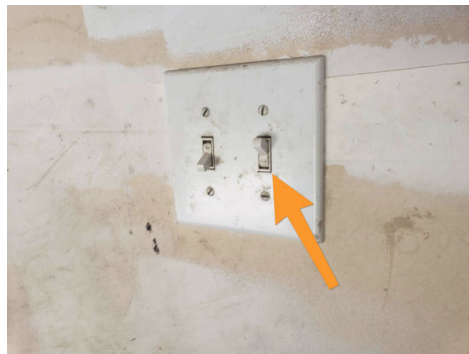
At the time of the inspection, there were several switches that were inoperable. The cause of this condition is unknown. The inspector recommends consultation with the owner to determine which switches work which receptacles and fixtures. If the condition still exists after consultation with the owner, then all the switches should be further evaluated and repaired by a qualified professional.

Contact a qualified electrical contractor.

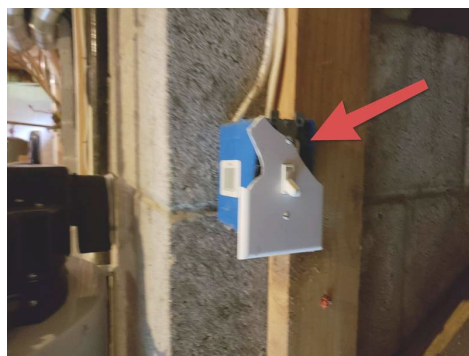
6.6.2 Lighting Fixtures, Switches & Receptacles

### RECEPTACLE - COVER PLATES DAMAGED

One or more switch plate covers are damaged. This condition may cause a shock hazard. The inspector recommends further evaluation and repair by a qualified professional.

Contact a qualified electrical contractor.

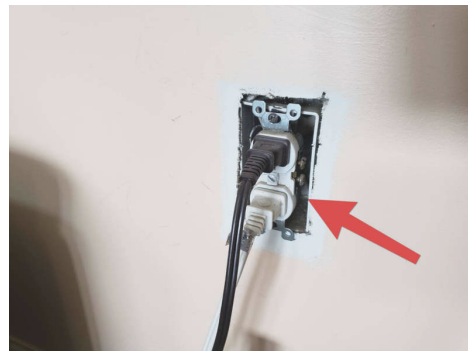
## 6.6.3 Lighting Fixtures, Switches &amp; Receptacles

**RECEPTACLE - MISSING COVER PLATE**

One or more receptacle cover plates were missing. This condition may cause an electrical short or shock hazard. The inspector recommends evaluation and repair of all cover plates by a qualified professional.

Contact a qualified electrical contractor.

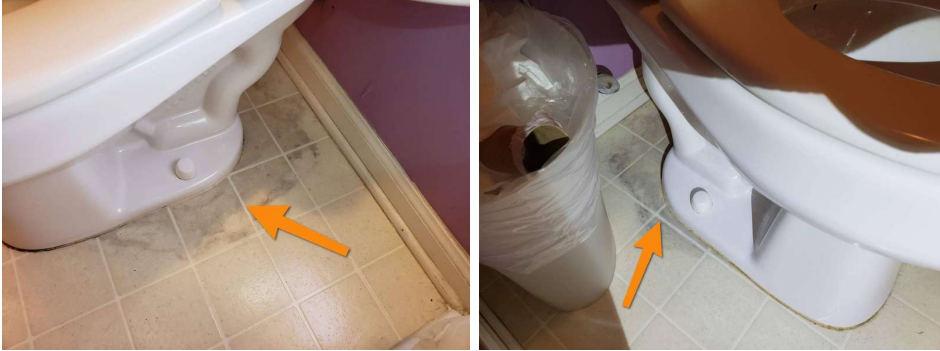
#### TOILET - FAILING WAX SEAL

The wax seal on one or more toilets is failing. This condition may allow moisture intrusion which may cause damage to surrounding components. The inspector recommends further evaluation and repair by a qualified professional.

Contact a qualified plumbing contractor.

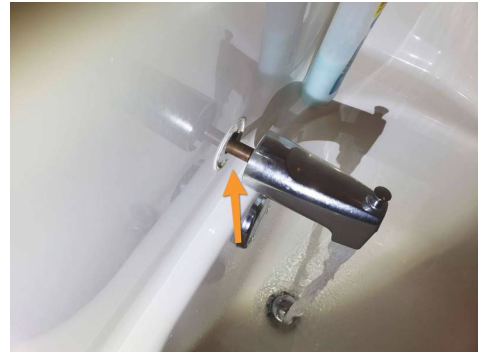
### 7.4.2 Fixtures and Faucets

#### TUB - IMPROPER SPOUT INSTALLATION

The tub spout is not properly installed. This condition may allow moisture intrusion at the wall penetration which may cause damage to surrounding components. The inspector recommends further evaluation and repair by a qualified professional.

Contact a qualified plumbing contractor.

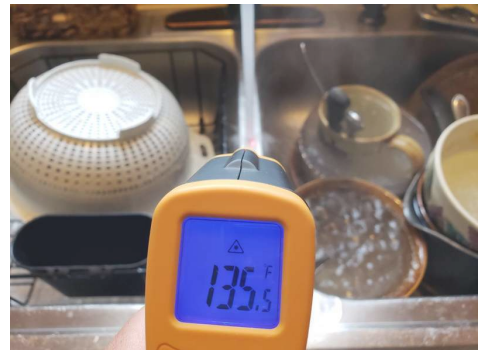
### 7.5.1 Water Heater

#### WATER HEATER - EXCESSIVE TEMPERATURE

At the time of the inspection the temperature of the water in the kitchen was 135 Degrees F. This condition may be a scalding hazard. The inspector recommends further evaluation and repair by a qualified professional.

Contact a qualified plumbing contractor.

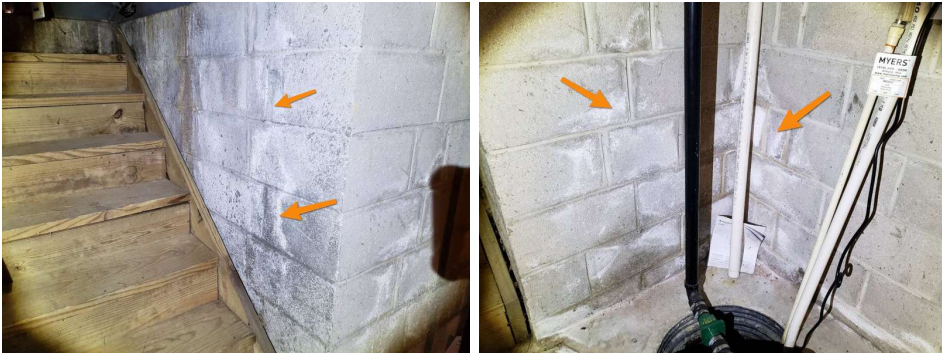
### 8.1.1 Foundation Walls

One or more foundation walls showed signs of efflorescence. Efflorescence is a white, powdery deposit that is consistent with moisture intrusion. This can compromise the soil's ability to support the home structure and/or lead to mold growth. The inspector recommends the affected walls be evaluated by a qualified contractor to identify the source of moisture and repair.

Contact a foundation contractor.

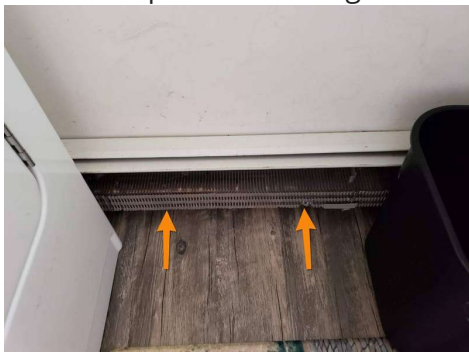
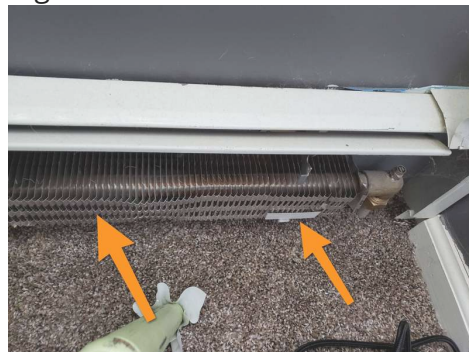
One or more sections of baseboard heating elements were not covered. This condition is a burn hazard especially to small children. The elements are also susceptible to damage if not covered. The inspector recommends further evaluation and repair of all of the baseboard heating elements by a qualified professional.

Contact a qualified heating and cooling contractor

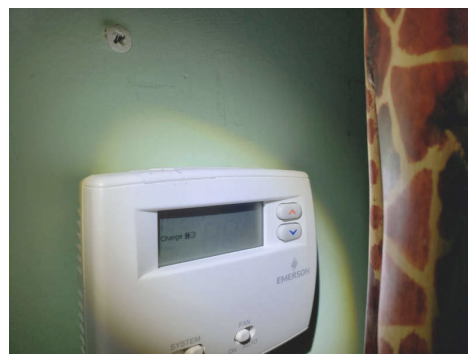
## 9.5.1 Normal Operating Controls

One or more thermostats were not functional at the time of the inspection. If the thermostats fail then the corresponding heating element will not turn one. The inspector recommends further evaluation by a qualified professional.

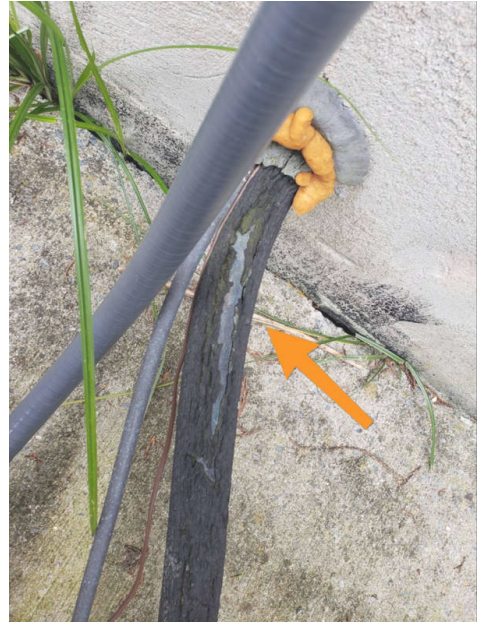
## 10.3.1 Refrigerant Lines

**MISSING SUCTION LINE INSULATION**

Contact a handyman or DIY project
