VISUAL PROPERTY INSPECTION

1234 Main St.
El Paso TX 79928

PROPERTY INSPECTION REPORT

Concerning: 1234 Main St. El Paso TX 79928
(Address or Other Identification of Inspected Property)

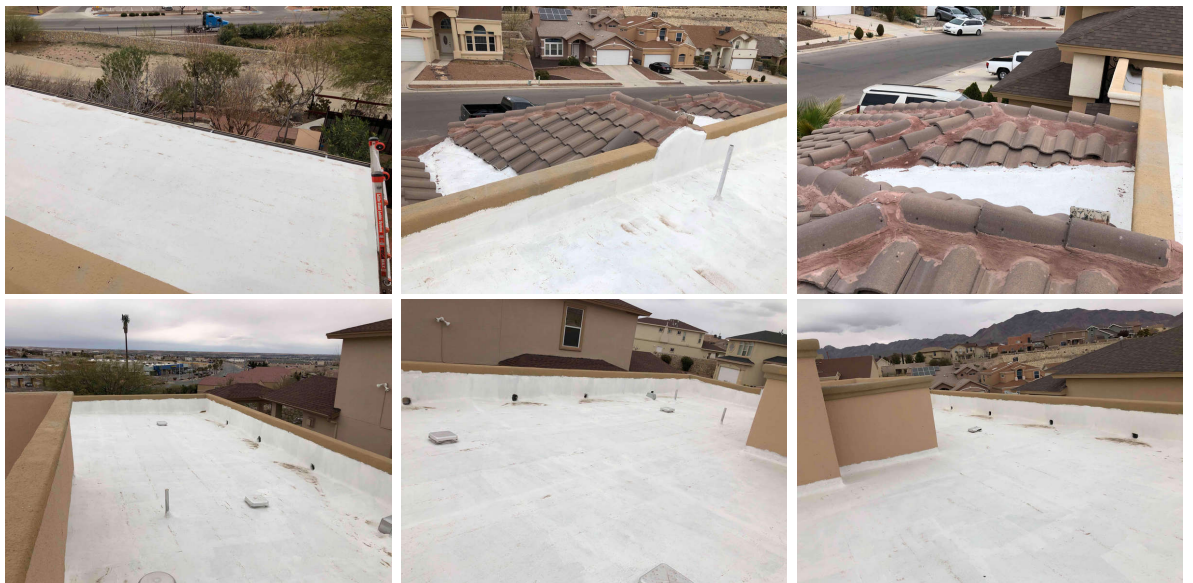
Images of Roof:

Roof is in good condition and appears to have been recently sealed.

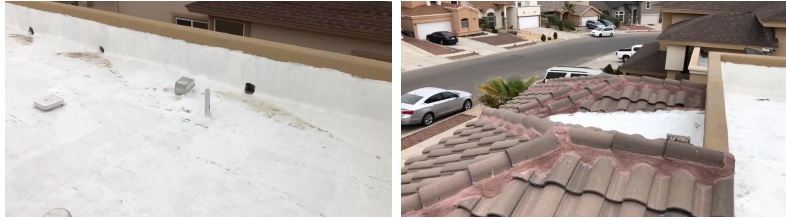
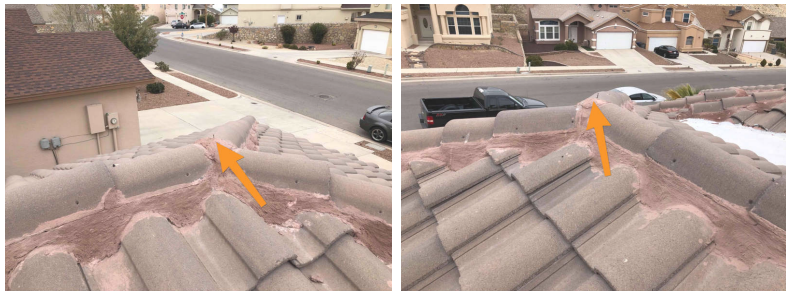
1: Fasteners/Nails Underdriven

A few fasteners/nails were under driven or protruding through the overlying shingles. This should be corrected to help prevent moisture intrusion into the roof structure.

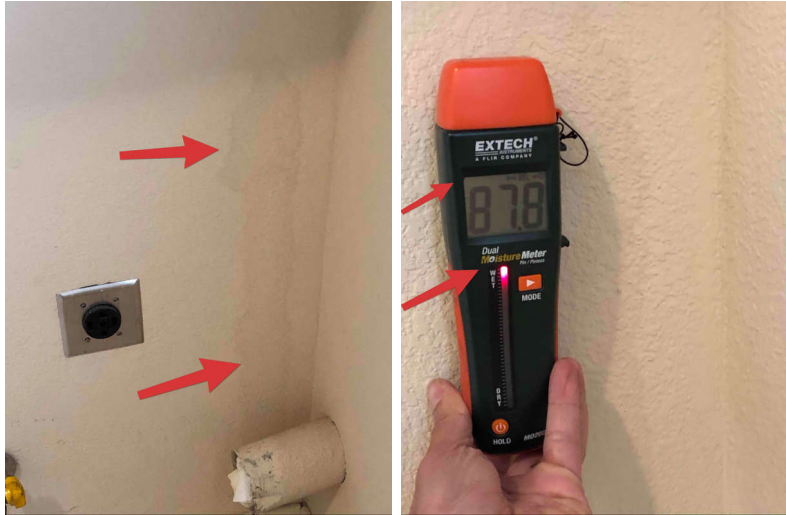
1: Moisture Detected on Interior Wall

Location: Laundry Room

Thermal imaging and/or a moisture meter indicated the possibility of moisture in interior wall, this may be an indication of a leak. Recommend further evaluation by a qualified professional to determine cause and if any corrective measure needs to be taken.

Moisture meter reading

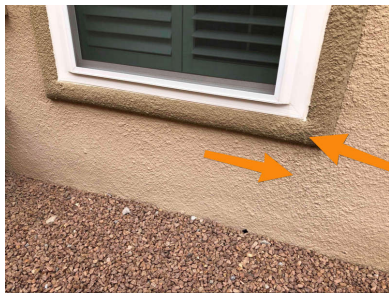
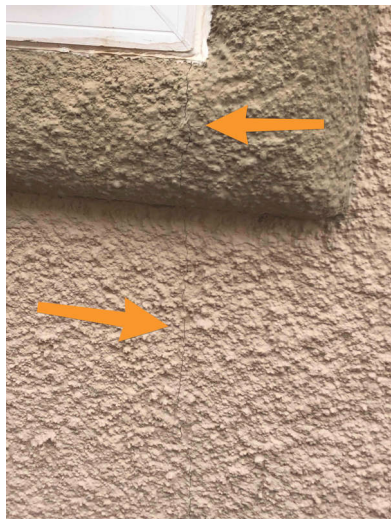
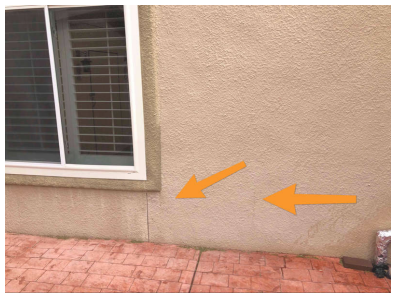
2: Minor Stucco Cracks

Location: Westside Wall By Window & Back Wall

Minor cracks were observed in the stucco around the home. These cracks should be sealed with a stucco crack flex sealant to prevent further expansion and moisture penetration into the home structure by a qualified professional.

West side of home

Back wall of home

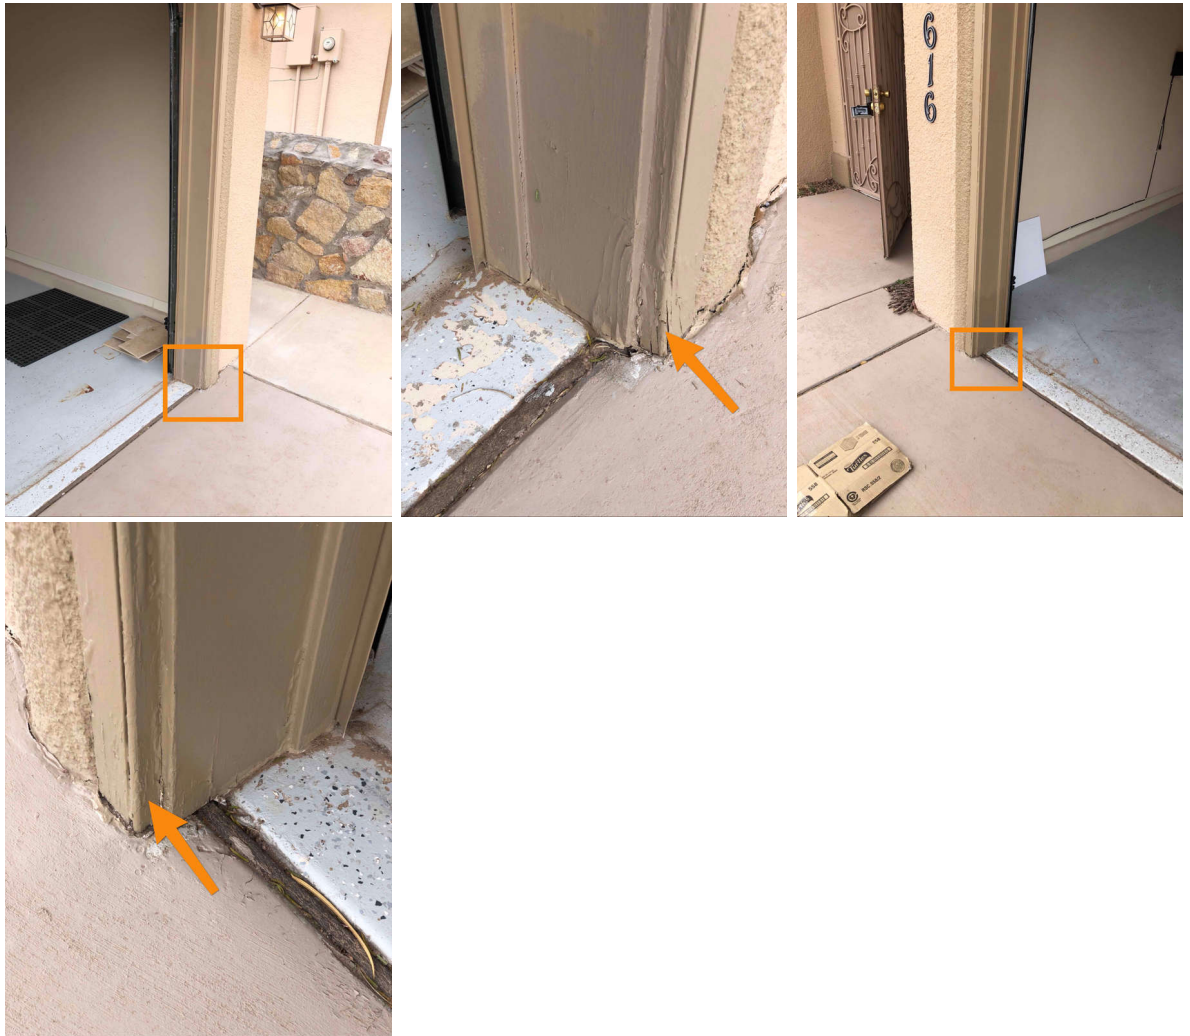
3: Wood Trim - Damaged/Deteriorated

Location: Garage Door Trim

Exterior wood trim was found to be damaged and or deteriorated. This should be repaired to help prevent further damage to trim.

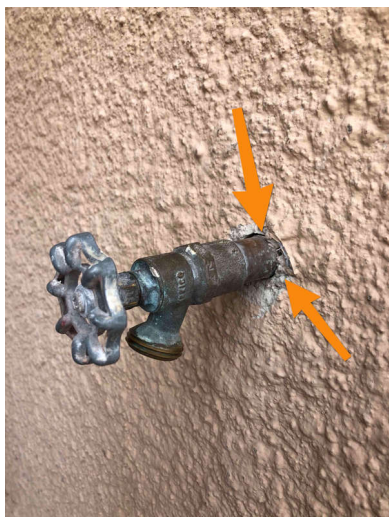
4: Exterior Wall - Penetrations Not Sealed

Exterior water lines at the exterior wall intersection had gaps and were not properly sealed. These lines should be sealed with an approved sealant at the wall penetrations to prevent moisture from getting into the structure of the home.

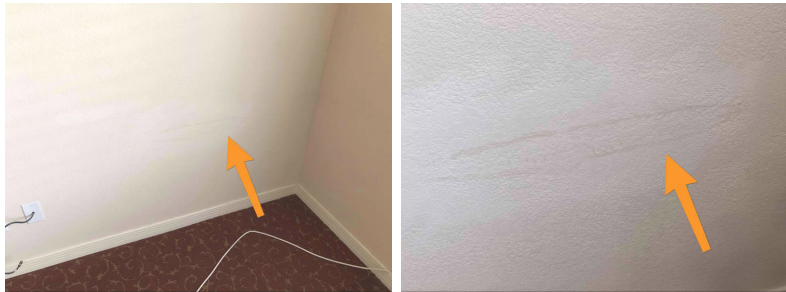
5: Water Stains On Wall

Location: Bedroom Facing Street

Water Stains visible on the interior wall at the time of inspection which may be from a previous leakage. The moisture meter and/or thermal imaging was negative for moisture at time of inspection, which may suggest the leak has been repaired.

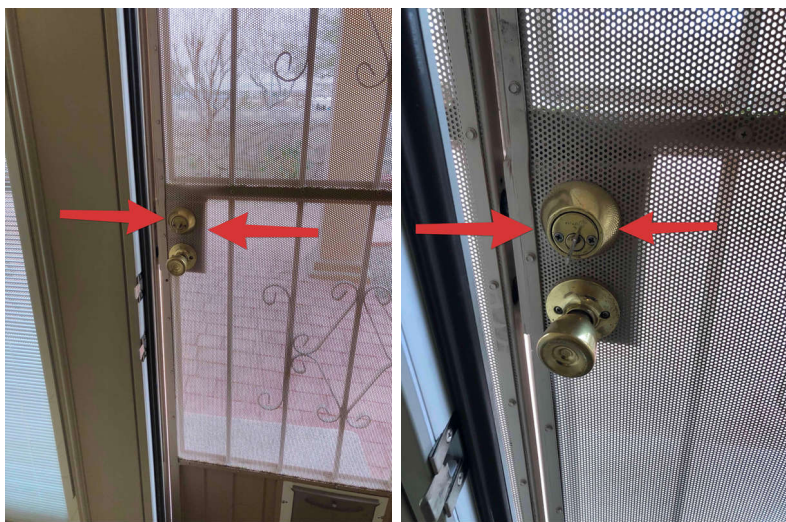
1: Double Keyed Deadbolt

Location: Exterior Screen Doors

A door to the exterior had a deadbolt which required a key for operation from the inside. This condition is unsafe as it may slow or prevent exit during an emergency. Installation of these types of deadbolts is no longer a standard practice in new construction. The Inspector recommends that all deadbolts in the home that require a key for exit from the home interior be replaced with a deadbolt that operates from the inside with a lever.

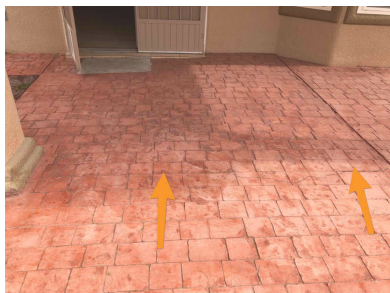
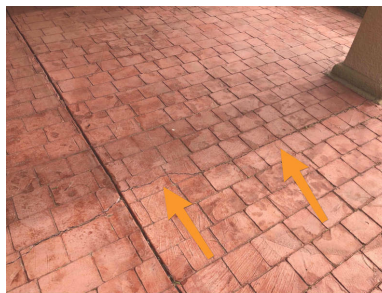
1: Common Cracks

Location: Back Porch

Common cracks were visible in the sidewalk/porch cement at the time of the inspection. Monitor and repair as necessary

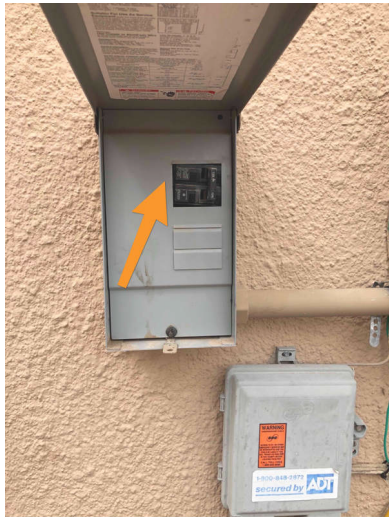
1: Main Panel Breakers Not Labeled

Location: Main Panel On Side Of Home

A Circuit Directory identifying individual electrical circuits was missing, illegible or inaccurate at this panel. The panel should contain a clearly-marked label identifying individual circuits so that in an emergency, individual circuits can be quickly shut off.

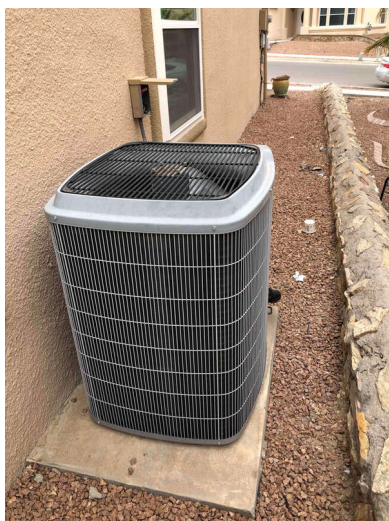
A/C unit functional test has a return temp of 61 F and the supply has a temp of 40 F for a differential of 21 F.

A differential between 15 to 22 F is considered normal.

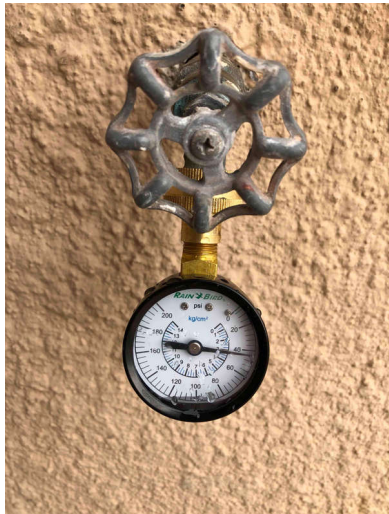
Static water pressure reading: 45 psi -

Normal is between 40 - 80 psi

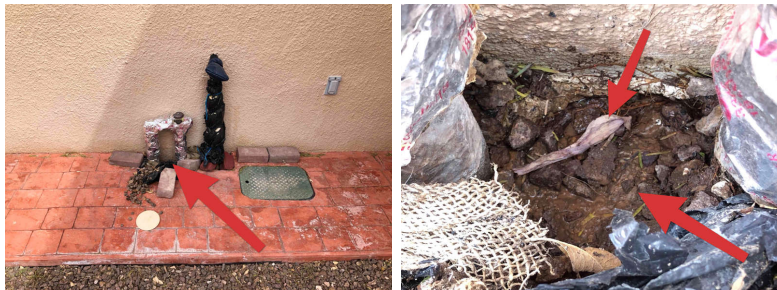
1: Possible Water Line Leak

At the time of inspection I checked the water meter after all the water in the home had been turned off and the meter was still turning, indicating water was still flowing to the house due to a possible leak in a water supply line. I did observe a wet area around irrigation water line in the back of the home. I recommend further evaluation for a possible leak in the home by a licensed plumber .

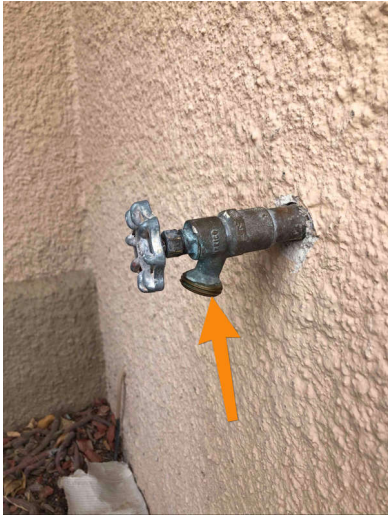
2: Hose Bib Backflow Preventer - Missing

Exterior hose bibs were found to be missing backflow preventer devices (vacuum breakers). Vacuum breakers are easy to install, inexpensive and should be in place on all exterior bibs (water hose faucets) to help prevent exterior water from getting siphoned into the homes water supply. [Click here for more information](#)

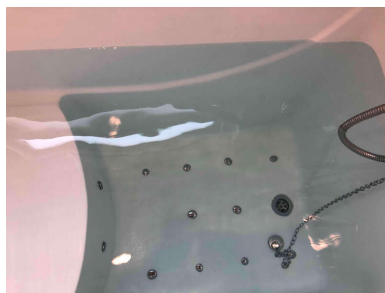
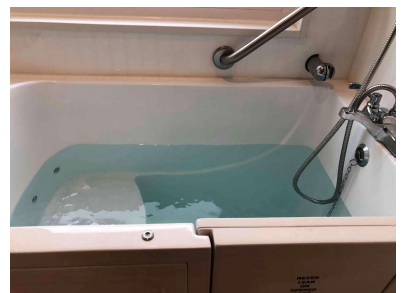
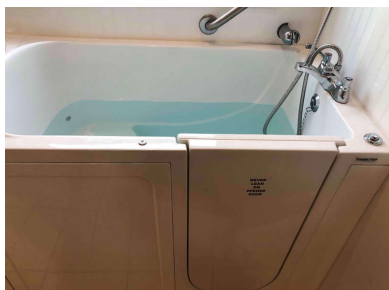
D. Hydro-Massage Therapy Equipment

Unit was tested and worked properly at the time of the inspection. Unit is GFCI protected.

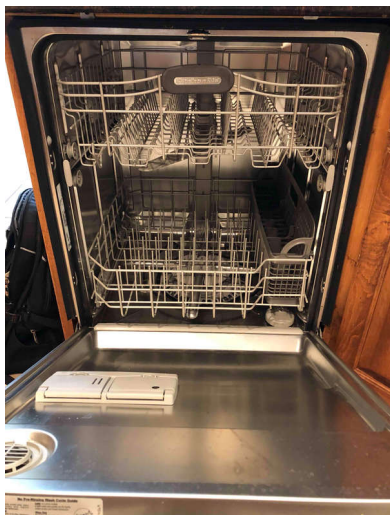
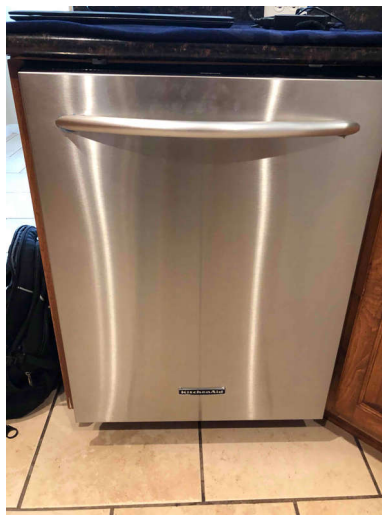
A. Dishwasher

Dishwasher was tested for a full cycle, in normal mode, and appears to be functioning normally at time of inspection.

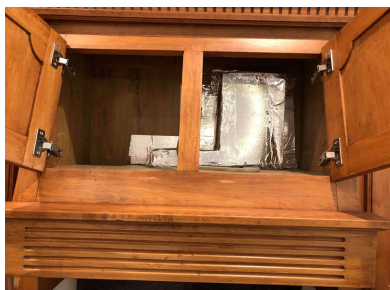
Exhaust / Range Hood:

Range hood was tested and appears to be functioning normally at the time of the inspection. Vented to the outside.

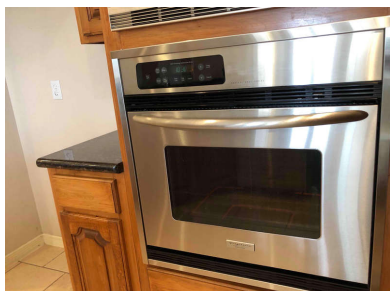
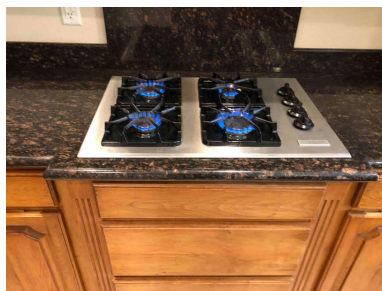
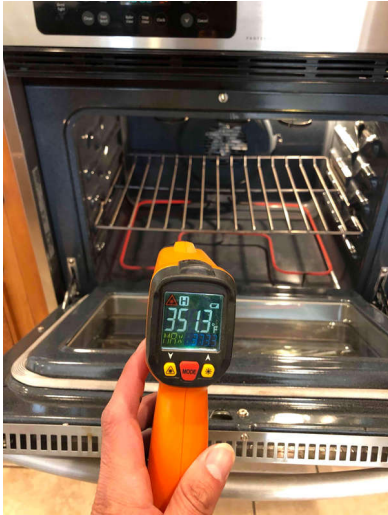
D. Ranges, Cooktops and Ovens

Oven tested at 350 degrees F. Actual Temp measured: 351 degrees F. (+/- 25 F allowed difference) is acceptable.

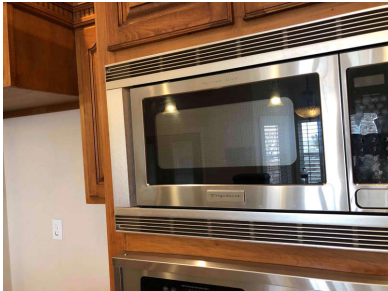
- E. Microwave Ovens**
Built in Microwave Manufacturer: FRIGIDAIRE

Comments:
Microwave was tested for one minute and appears to be functioning correctly at time of inspection.
