RELIANCE HOME INSPECTIONS RESIDENTIAL REPORT

1234 Main St.
STANWOOD Washington 98292

Buyer Name
02/02/2019 9:00AM

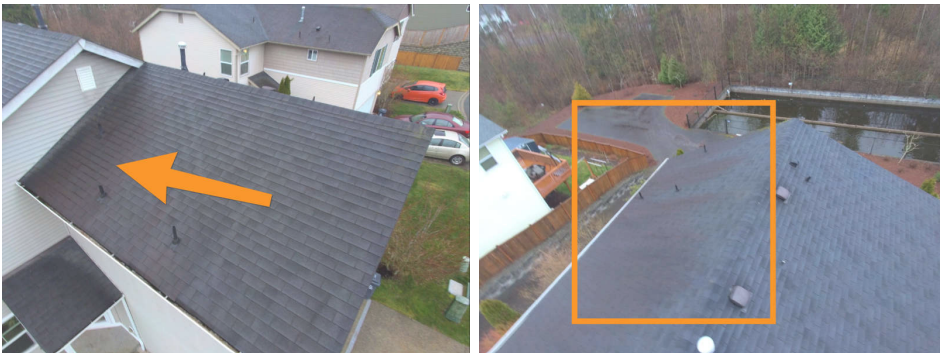
Roof shingles were discolored, which can be caused by moisture, rust or soot. Recommend a qualified roofing contractor evaluate and remedy with a roof cleaning or repair.

Contact a qualified professional.

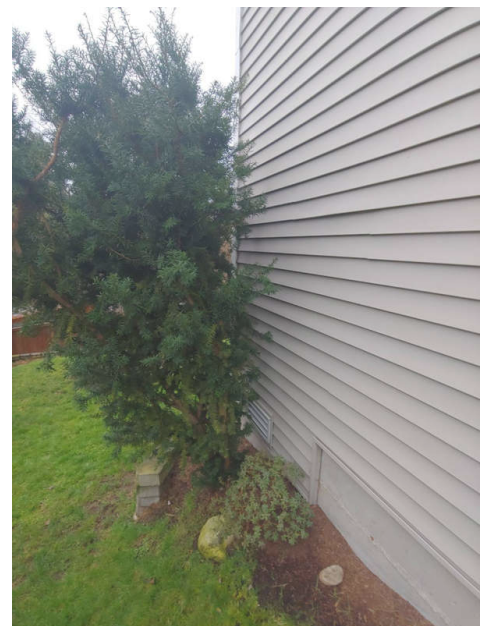
Vegetation such as trees, shrubs and/or vines was in contact with or close to the building exterior and/or other structures. Vegetation can serve as a pathway for wood-destroying insects and can retain moisture against the exterior after it rains. This is a conducive condition for wood-destroying organisms. Recommend pruning, moving or removing vegetation as necessary to maintain at least 6 inches of space between it and the building exterior. A 1-foot clearance is better.

Contact a qualified lawn care professional.

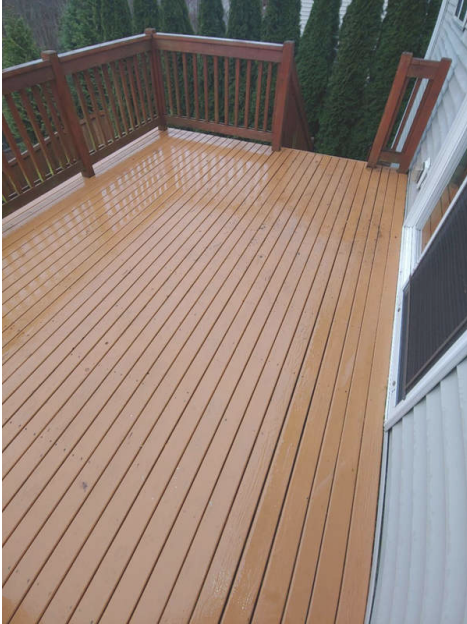
3.6.1 Decks/Stairs

DECK IN NEED OF PAINTING / SEALING / MAINTENANCE

Wooden deck or porch surfaces were overdue for normal maintenance. Recommend that a qualified person clean and preserve as necessary. Restaining the decking and railing will help preserve the lifespan of the deck.

Recommended DIY Project

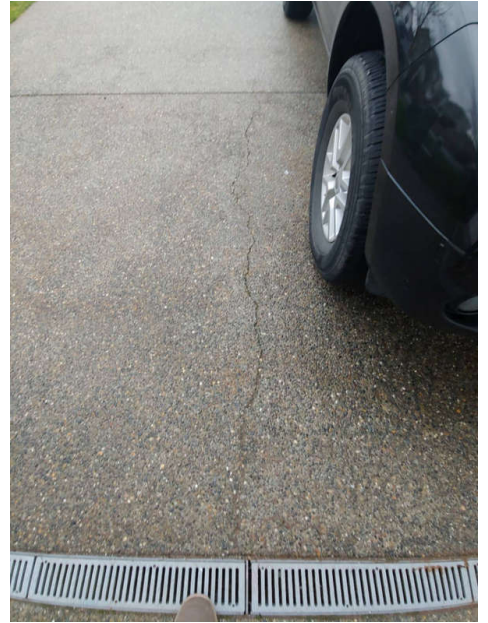
MINOR DRIVEWAY DAMAGE

Minor deterioration (e.g. cracks, holes, settlement, heaving) was found in the driveway, but no trip hazards were found. The client may wish to have repairs made for cosmetic reasons.

Contact a qualified professional.

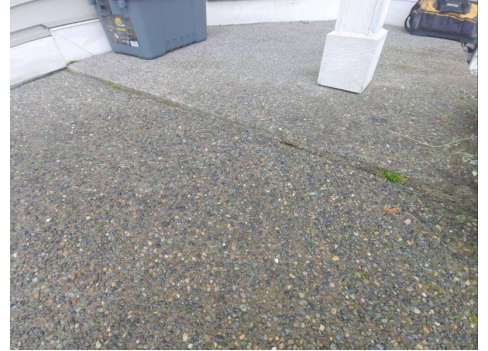
4.2.2 Driveway, Walkway, Patio

MINOR DAMAGE- SIDEWALK/PATIO

To the left of the front door, the concrete patio has had a small amount of settling happen. It has settled down about 1/4" or so. Leaving a little lip that could cause a potential trip hazard. Be aware when using this area to prevent any potential tripping hazards.

Contact a qualified professional.

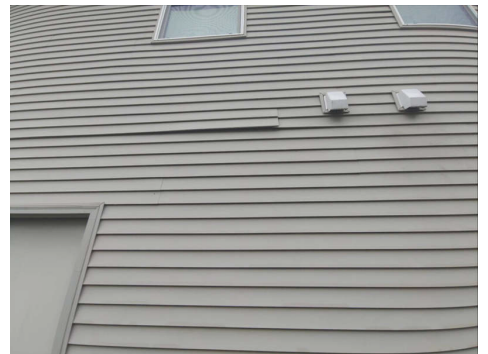
4.3.1 Exterior issues

The vinyl siding on the right-hand side of the house has come loose in one or more areas. I recommend resealing the siding so further damage from wind and rain does not occur.

Contact a qualified professional.

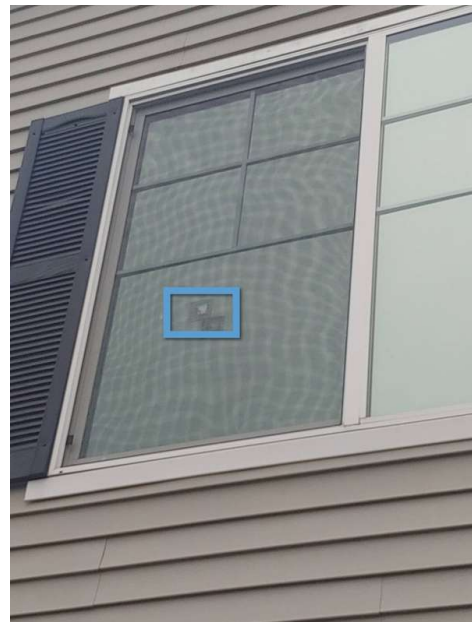
4.5.1 Windows and Door

SCREEN DAMAGED

The screen on one or more windows has been damaged and patched. I recommend rescreening the window.

Contact a qualified professional.

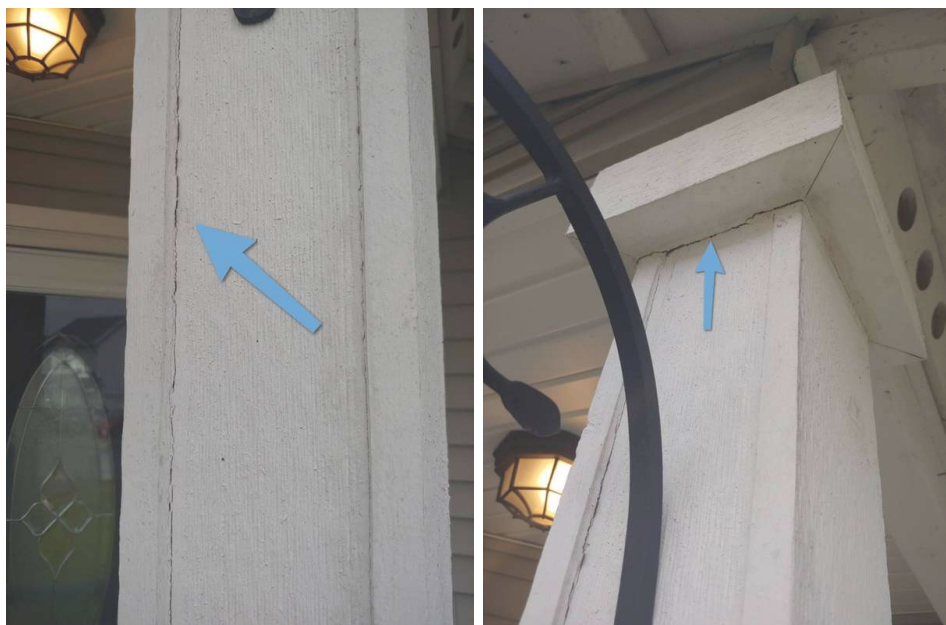
4.8.1 Wood Siding And Trim

Caulk was *missing / deteriorated / substandard* in some areas. For example, *around windows / around doors / at siding butt joints / at siding-trim junctions / at wall penetrations*. Recommend that a qualified person renew or install caulk as necessary. Where gaps are wider than 1/4 inch, an appropriate material other than caulk should be used.

Photos only represent a couple of spots around the house where caulking was notated. I recommend that all caulking is further evaluated and replaced where needed around the house.

Contact a qualified handyman.

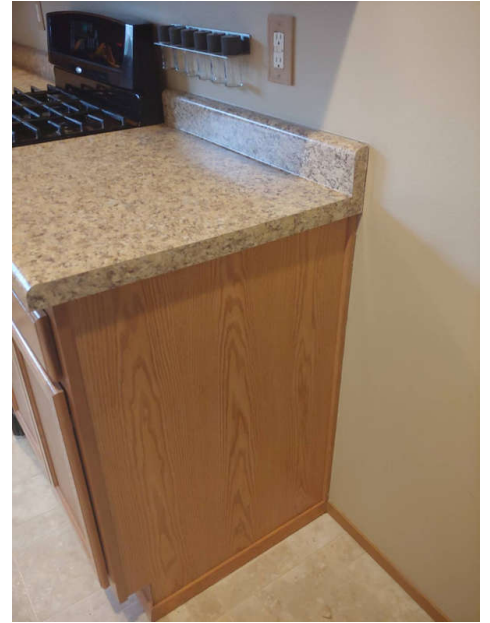
6.1.1 Cabinets

CABINETS LOOSE

One or more cabinets were loose, or were secured with too few or substandard fasteners. An adequate number of appropriate fasteners should be used. For wall-hung cabinets, inadequate fasteners can pose a safety hazard if cabinets fall. Recommend that a qualified person repair as necessary.

Contact a qualified cabinet contractor.

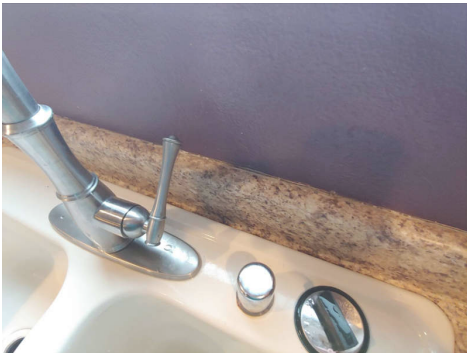
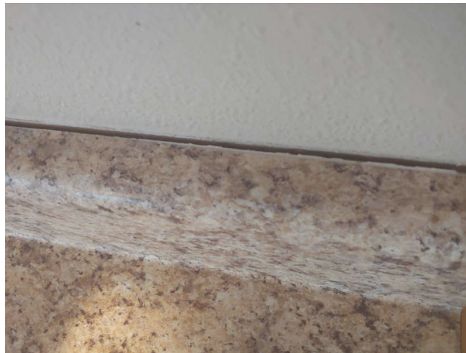
6.2.1 Countertops-Backsplash

CAULKING

One or more areas of the kitchen counter top(s) are recommended to be re-sealed (caulked) to keep any moisture and or water out and prevent future damage.

Recommended DIY Project

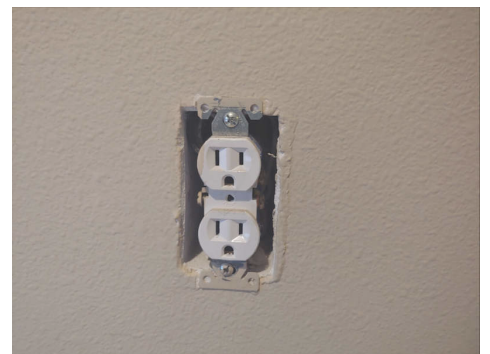
6.3.1 Electrical

COVER PLATE MISSING

Cover plate(s) are missing from one or more electric boxes, such as for receptacles, switches and/or junction boxes. They are intended to contain fire and prevent electric shock from exposed wires. This is a safety hazard due to the risk of fire and shock. Cover plates should be installed where missing.

Contact a qualified electrical contractor.

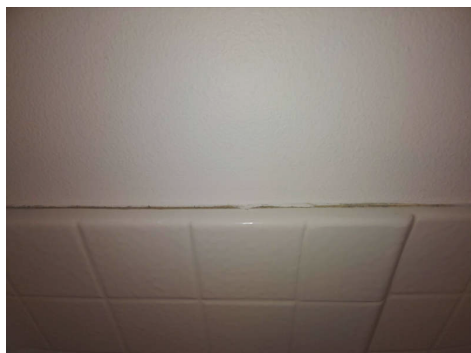
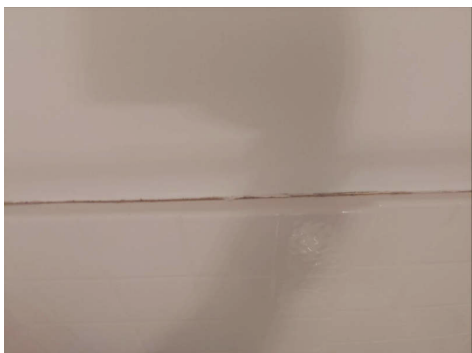
7.1.1 Bathub

Caulk is missing or deteriorated above one or more bathtubs, where the tub surround meets the tub. It should be replaced where deteriorated and/or applied where missing to prevent water intrusion and damage to the wall structure.

Recommended DIY Project

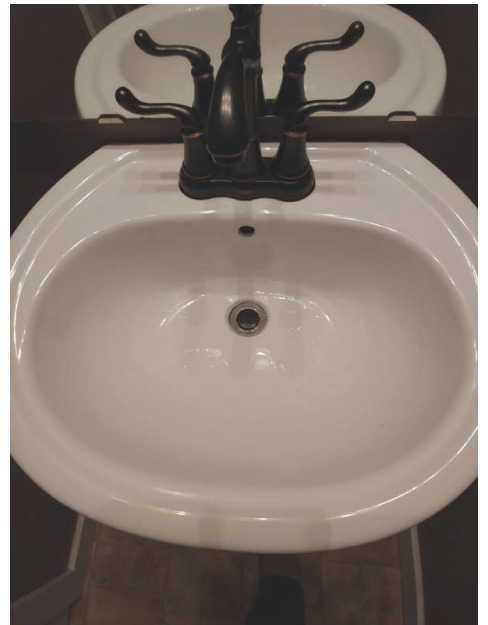
7.7.1 Sink/countertop

One or more sink stopper(s) mechanisms are missing, or need adjustment or repair. Stopper mechanisms should be installed where missing and/or repairs should be made so sink stoppers open and close easily.

Contact a qualified plumbing contractor.

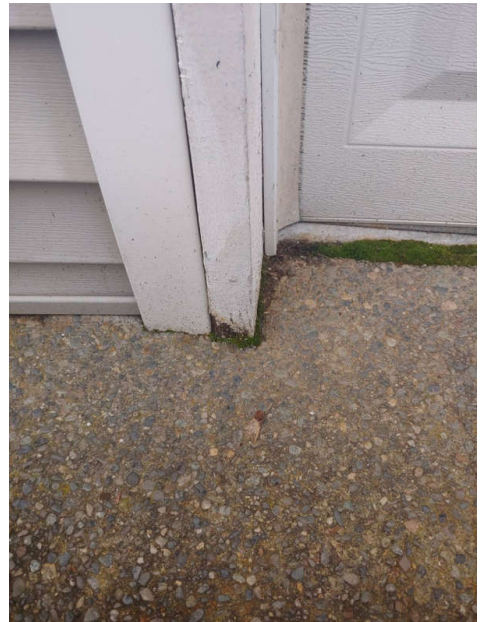
11.1.1 Interior-Exterior doors-Windows

The trim on the outside of the garage door is in contact with the concrete. This allows water to wick up on an unfinished end. I recommend touch up painting and keeping these sealed so the trim pieces do not rot.

Contact a qualified professional.

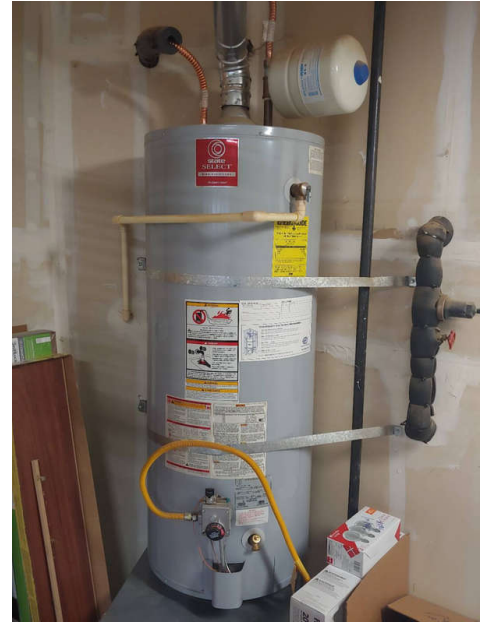
12.1.1 Water Heater

The estimated useful life for most water heaters is 8 to 12 years. This water heater appears to be approaching this age and may need replacing at any time. Recommend budgeting for a replacement in the near future.

Contact a qualified plumbing contractor.

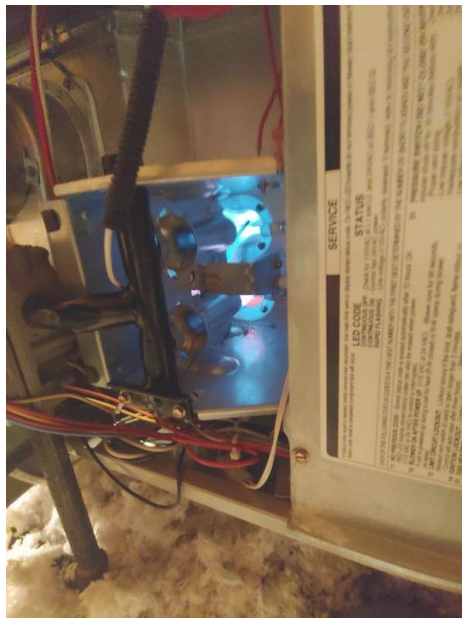
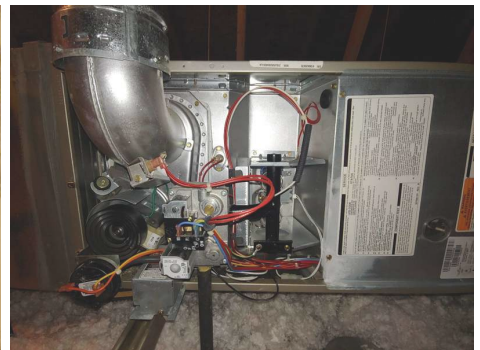
Heat system appears to be in working order. Supply air from the heating system should be 100 degrees Fahrenheit or higher.

The photo(s) below is/are a thermal image of the supply air temperature at register(s) at the time of this inspection.

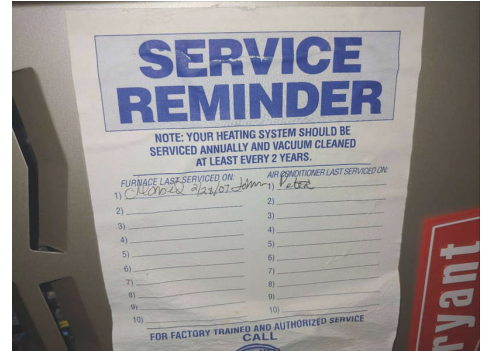
SERVICE HEATING / COOLING SYSTEM

The last service date of the forced air heating / cooling system appeared to be more than 1 year ago, or the inspector was unable to determine the last service date. Ask the property owner when it was last serviced. If unable to determine the last service date, or if this system was serviced more than 1 year ago, recommend that a qualified HVAC contractor service this system and make repairs if necessary. Because this system has a compressor and refrigerant system, this servicing should be performed annually in the future. Any needed repairs noted in this report should be brought to the attention of the contractor when it's serviced.

Contact a qualified HVAC professional.
