22 HOME INSPECT LLC

RESIDENTIAL HOME INSPECTION

1234 Main St.
Tempe AZ 85284

03/11/2019 9:00AM

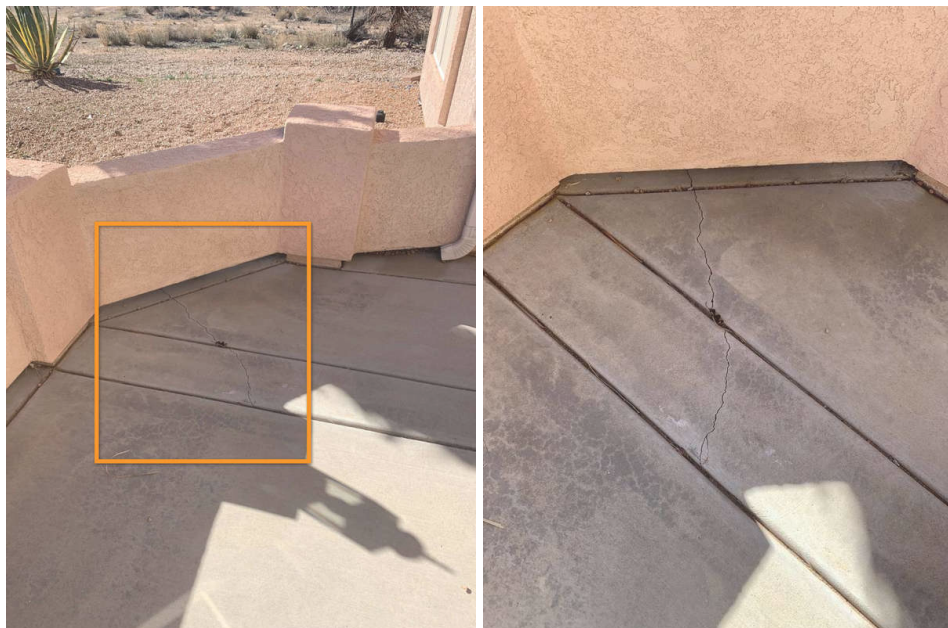
**WALKWAY - COMMON CRACKING**

Common cracks (1/4-inch or less) were visible in the Walkway. Cracks exceeding 1/4 inch should be filled with an appropriate material to avoid continued damage to the Walkway surface from water intrusion.

Contact a handyman or DIY project

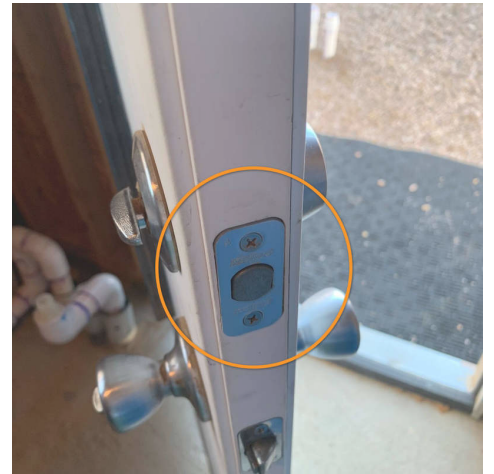
One or more deadbolts were inoperable or difficult to operate. Recommend that a qualified person repair as necessary.

Contact a qualified handyman.

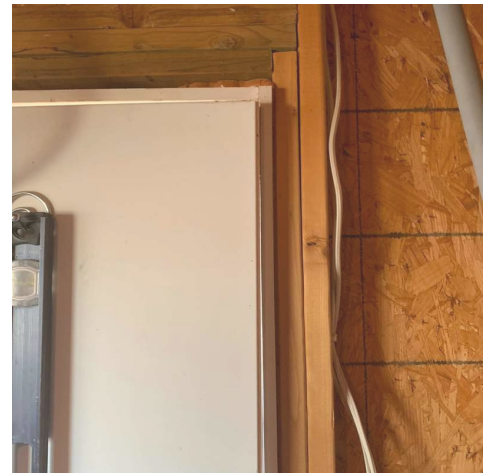
5.1.2 Doors (Exterior / Entry)

One or more doorways were visibly out of square and doors did not close. Recommend making repairs by a Qualified Contractor to ensure proper function. (Detached Structure)

Contact a qualified professional.

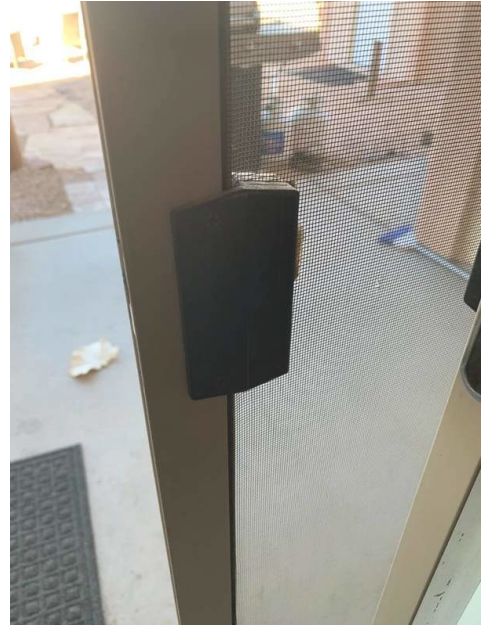
SCREEN DOOR - LOCK DAMAGED

Rear screen door latch was damaged or missing. Recommend that a qualified person repair or replace as necessary.

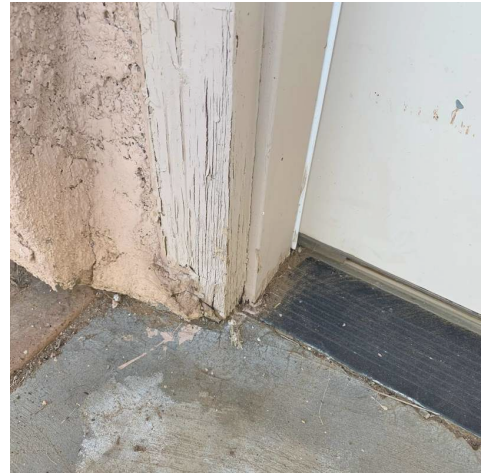
DOOR - FRAME MOISTURE DAMAGE (MINOR)

Minor moisture damaged observed on the exterior door trim. Recommend repainting in order to prevent further damage. (Garage side access)

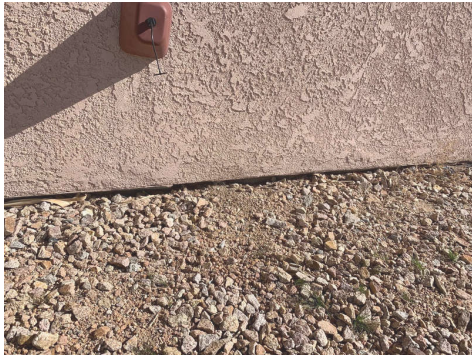
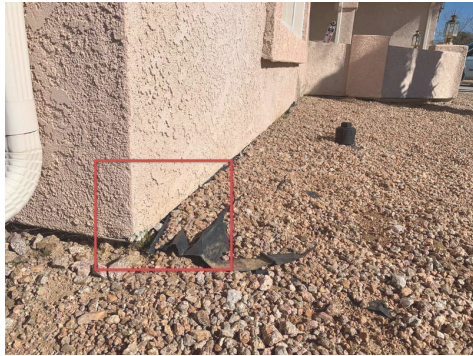
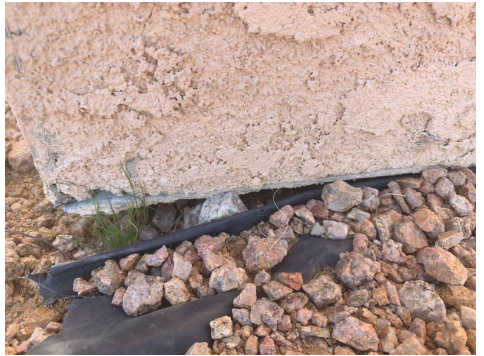
5.2.1 Walls (Exterior)

STUCCO SIDING - GROUND CLEARANCE

Stucco covering exterior walls of the home had inadequate clearance from grade. Stucco should terminate a minimum of 4 inches above grade and 2 inches from hardscape. Condensed water behind the veneer may not be able to escape, and moisture can accumulate in the wood structure behind. This also presents a pathway for wood destroying organisms to enter the dwelling undetected. Recommend grading and/or removing soil as necessary to maintain a 4-6 inches clearance and continue to monitor. Hardscape corrections should be further evaluated and discussed with a licensed contractor for repair options.

Contact a qualified professional.

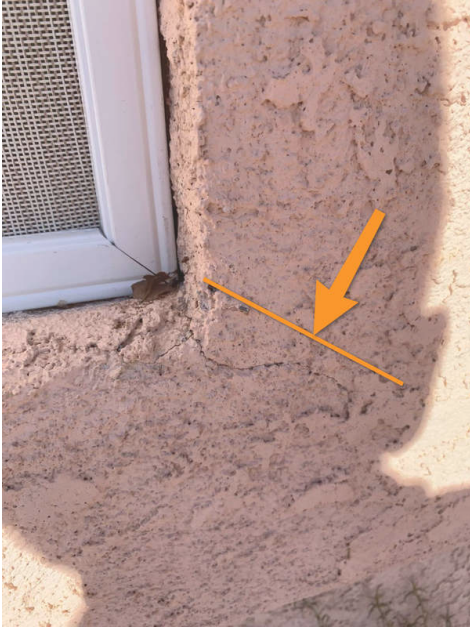
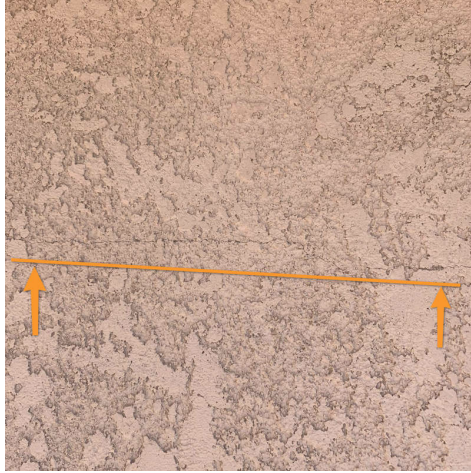
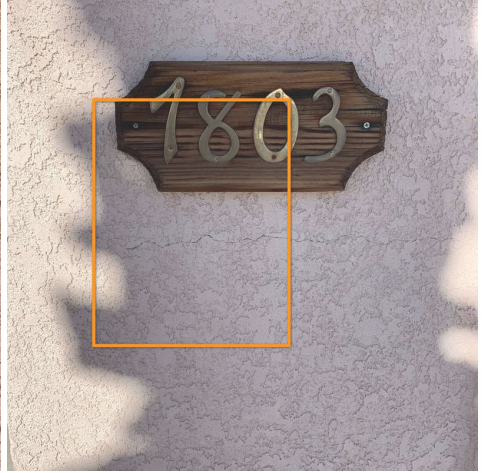
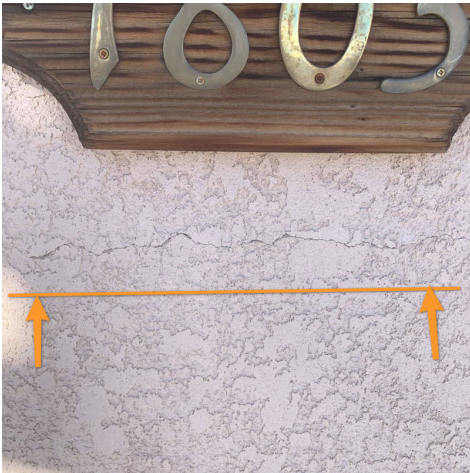
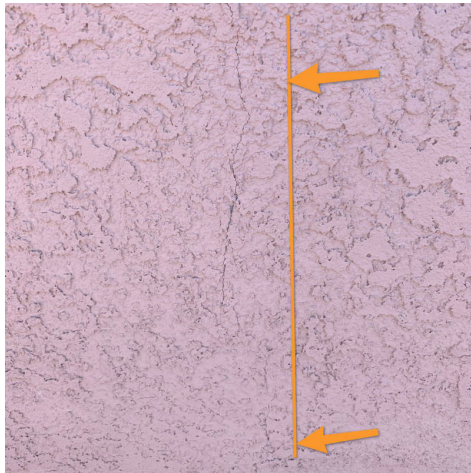
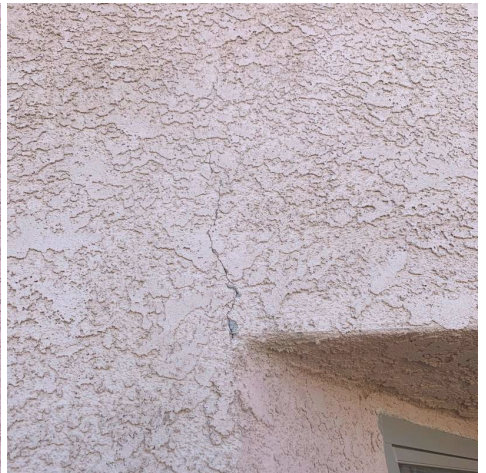
5.2.2 Walls (Exterior)

STUCCO SIDING - MINOR THERMAL CRACKING

OBSERVED AROUND ENTIRE HOME

The stucco covering exterior walls showed widespread minor cracking. This type of cracking, called "thermal cracking" is typically due to internal stresses created by temperature changes. It is common as stucco ages and is currently a cosmetic concern, not a structural problem. However, recommend continuing monitoring and cracks exceeding 1/16-inch in width should be filled with an appropriate material to minimize future damages.

Contact a qualified professional.

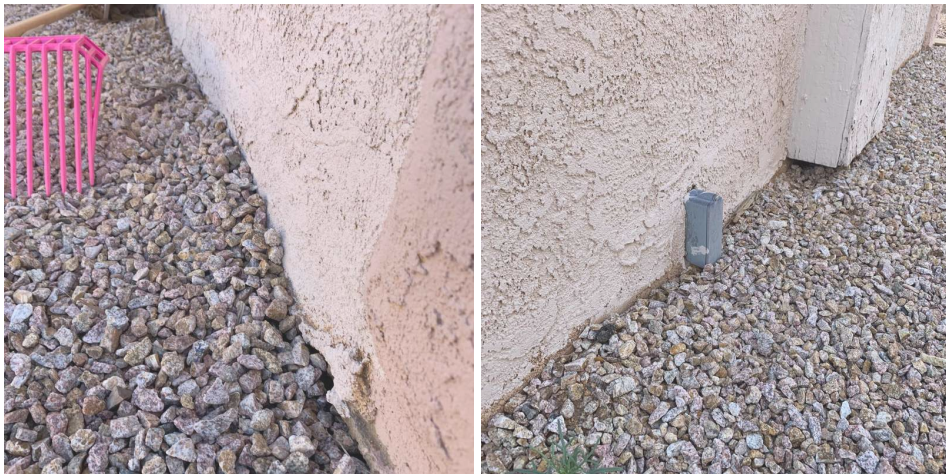
5.2.3 Walls (Exterior)

DETACHED STRUCTURE

Stucco covering exterior walls of the home showed evidence of poor installation practices. Stucco was in complete contact with ground to prevent potential damage from moisture intrusion to the (Detached Structure) materials, potential structural damage from wood decay, and possible development of microbial growth such as mold. Recommend consulting with a Licenced contractor for repair options.

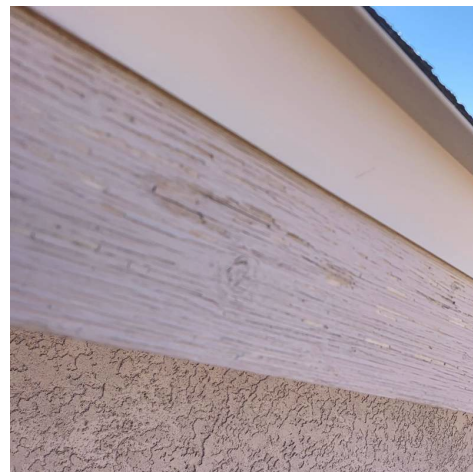
PAINT FINISH - FADING/FAILING

The paint finish is fading, chipping, and/or failing. Failure to maintain the finish coating can lead to ultraviolet and/or moisture damage, reducing the lifespan of the siding. Recommend monitoring or have areas be properly prepared and painted by a Qualified Painter.

Recommend monitoring.

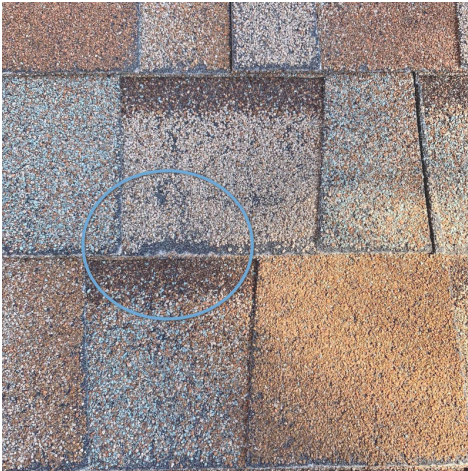
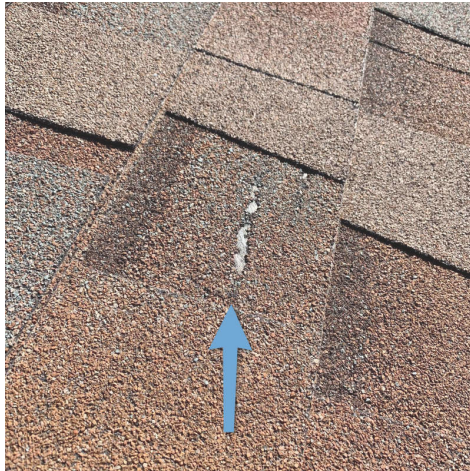
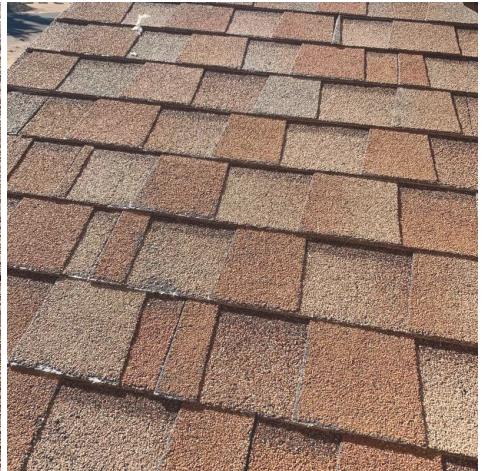
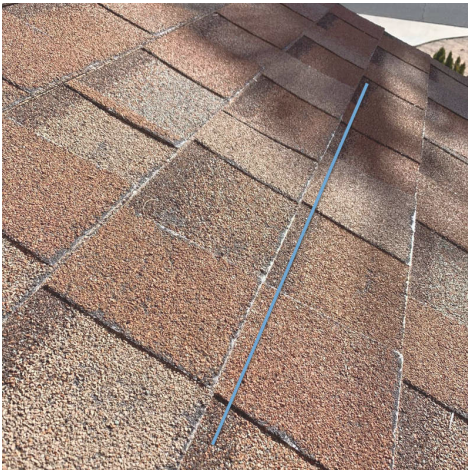
The general condition of the roof appears to be in serviceable condition with signs of weathering and aging. Recommend regular maintenance and inspection.

Recommend monitoring.

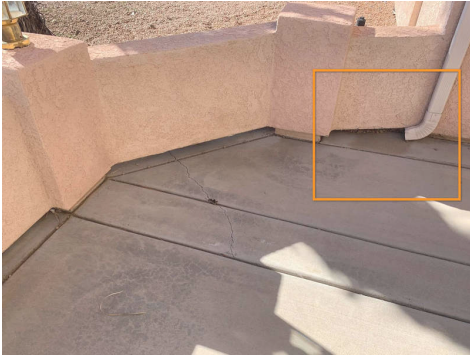
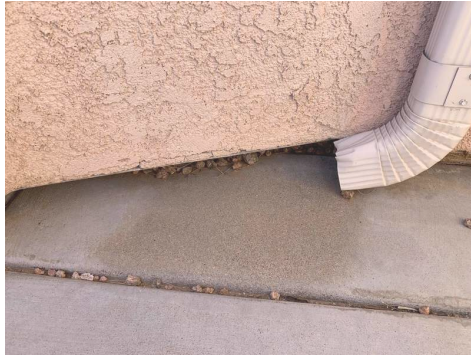
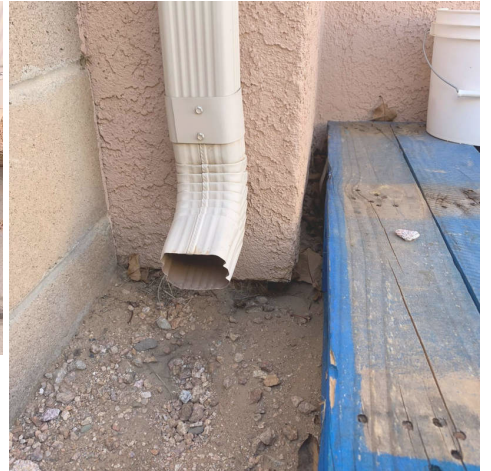
6.2.1 Roof Drainage System

Concern/Moderate**DOWNSPOUT - IMPROPER TERMINATION**

One or more downspouts discharged roof drainage next to the foundation or sloped back into the foundation. This condition can result in excessively high moisture levels in soil at the foundation and can cause damage related to soil/foundation movement. Recommend installation of downspout extensions to discharge roof drainage a minimum of 6 feet from the foundation.

Contact a qualified professional.

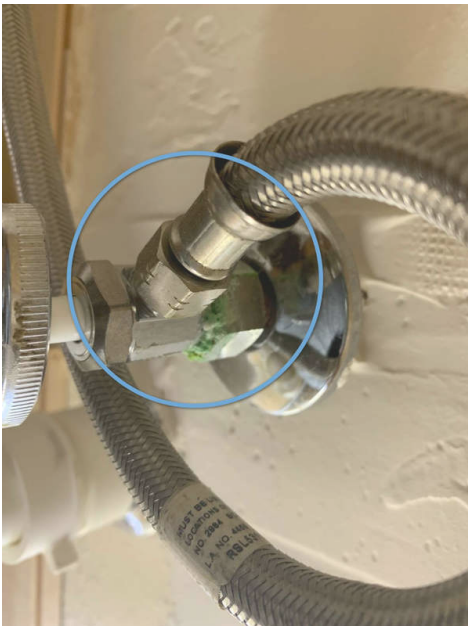
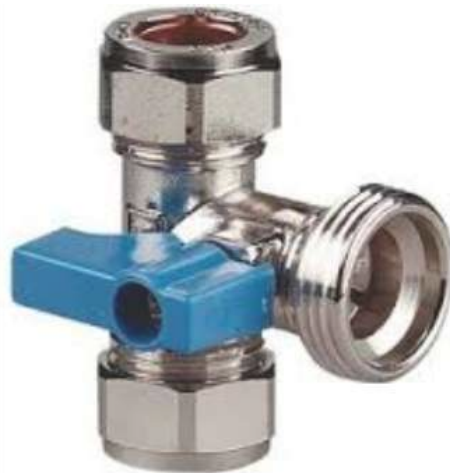
VALVES - MINOR CORROSION / UPGRADE

Minor corrosion observed on valves in one or more locations. No test performed on gate valves at the time of the inspection. Recommend upgrading to ball valve design for better reliability and ensuring proper operation of all shut-off valves.

Contact a qualified professional.

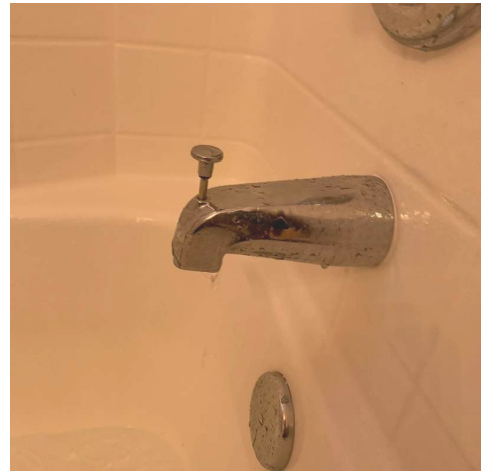
7.5.1 Bathtub / Shower

DIVERTER PULL DAMAGED

The diverter pull was not functioning properly. Recommend repair.

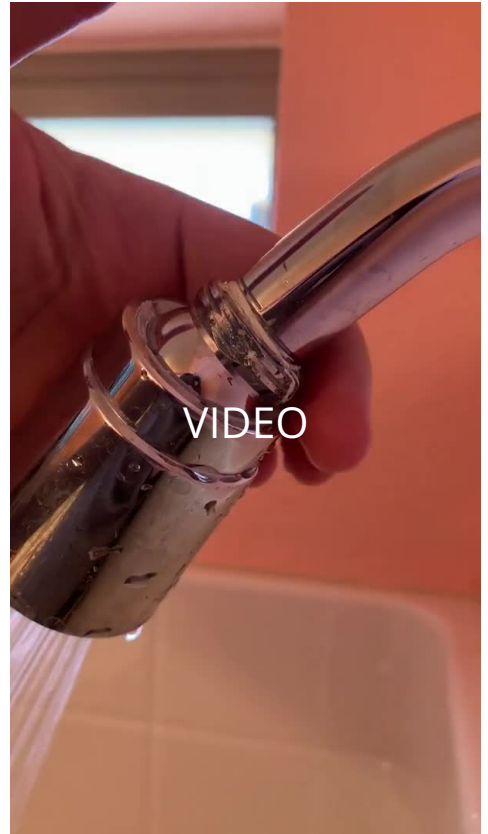
7.5.2 Bathtub / Shower

SHOWER/BATHTUB - FAUCET LEAK

Faucet handles leaked when testing operation, which is causing wasted water and is not performing as intended. Recommend making repairs or replacing the faucet.

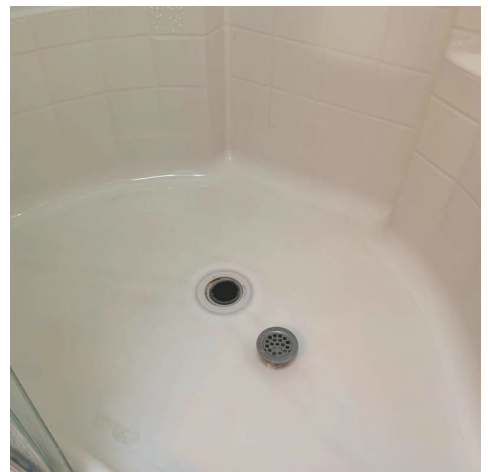
7.5.3 Bathtub / Shower

SHOWER DRAIN - DAMAGED OR MISSING

The shower drain guard was missing or damaged during the time of inspection. Recommend reairing or replacing as needed.

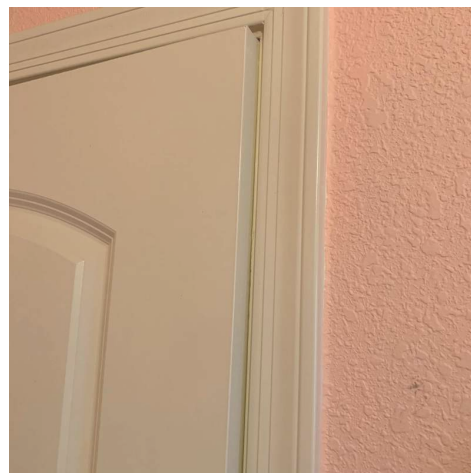
Potential safety hazards and cosmetic implications. One or more door(s)stick and/or rub when opening. Recommend making adjustments or repairs if necessary, preventing possible emergency egress concerns.

Contact a handyman or DIY project

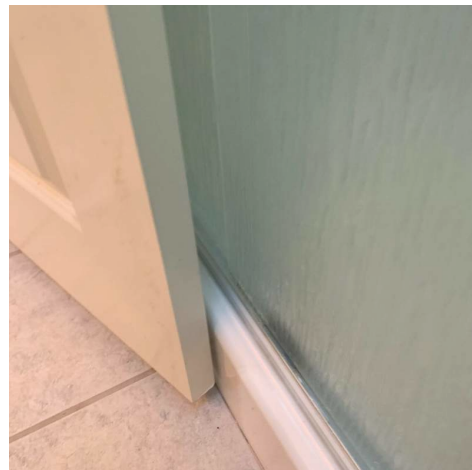
8.1.2 Doors (Interior & Closets)

DOOR STOPPER(S)

Door stoppers were damaged or missing. Recommend installing or replacing as needed.
