RESIDENTIAL REPORT

1234 Main St.  
Weaverville NC 28787

Buyer Name  
07/09/2018 9:00AM

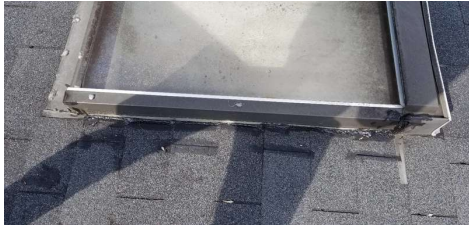
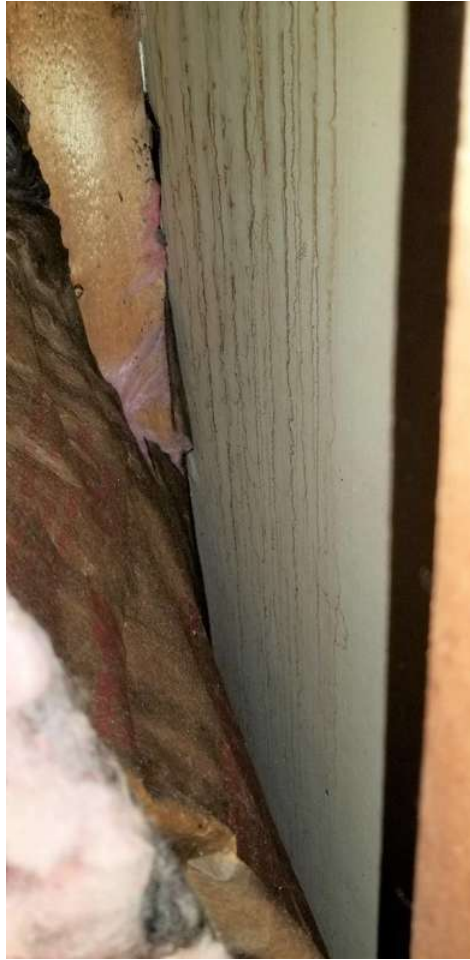
There are signs of past moisture penetration at or near one or more skylights as evidenced by skylight caulking on the roof and water stains running down the boxed out sheetrock enclosure in the attic behind the insulation. Moisture penetration into the building envelope can cause structural damage and undesirable environmental conditions. Monitoring is recommended. If signs of moisture penetration appear in the future, a Licensed Roofing Contractor should be consulted for evaluation and repair.

Contact a qualified roofing professional.

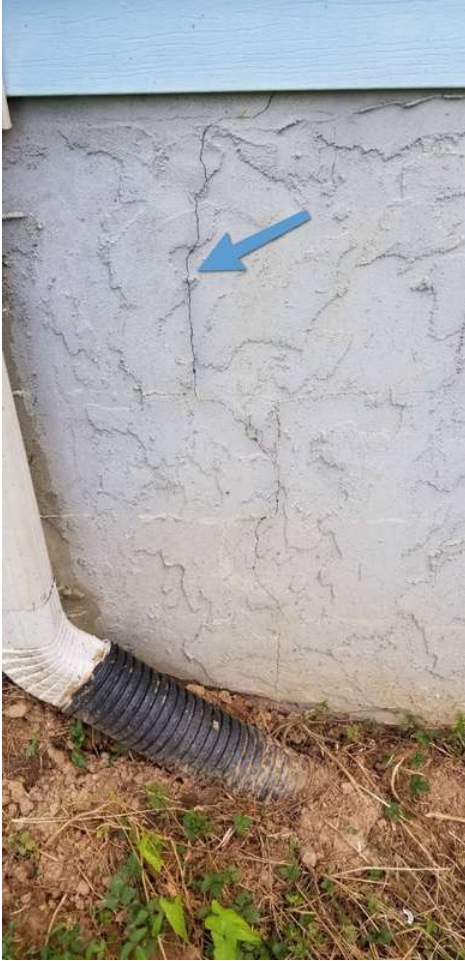
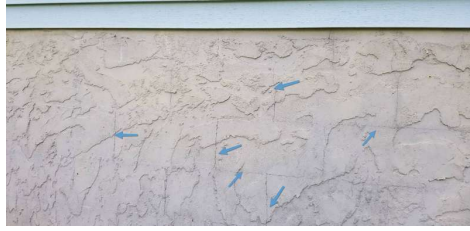
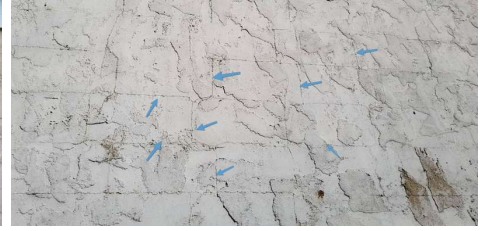
The Stucco has cracking of less than measurable width in one or more places. If the cracks were to widen over time, they could allow moisture penetration into the building envelope, structural damage and undesirable environmental conditions. A Licensed Stucco Contractor should be consulted for further evaluation and repair if deemed necessary.

Under screened in patio

Contact a stucco repair contractor

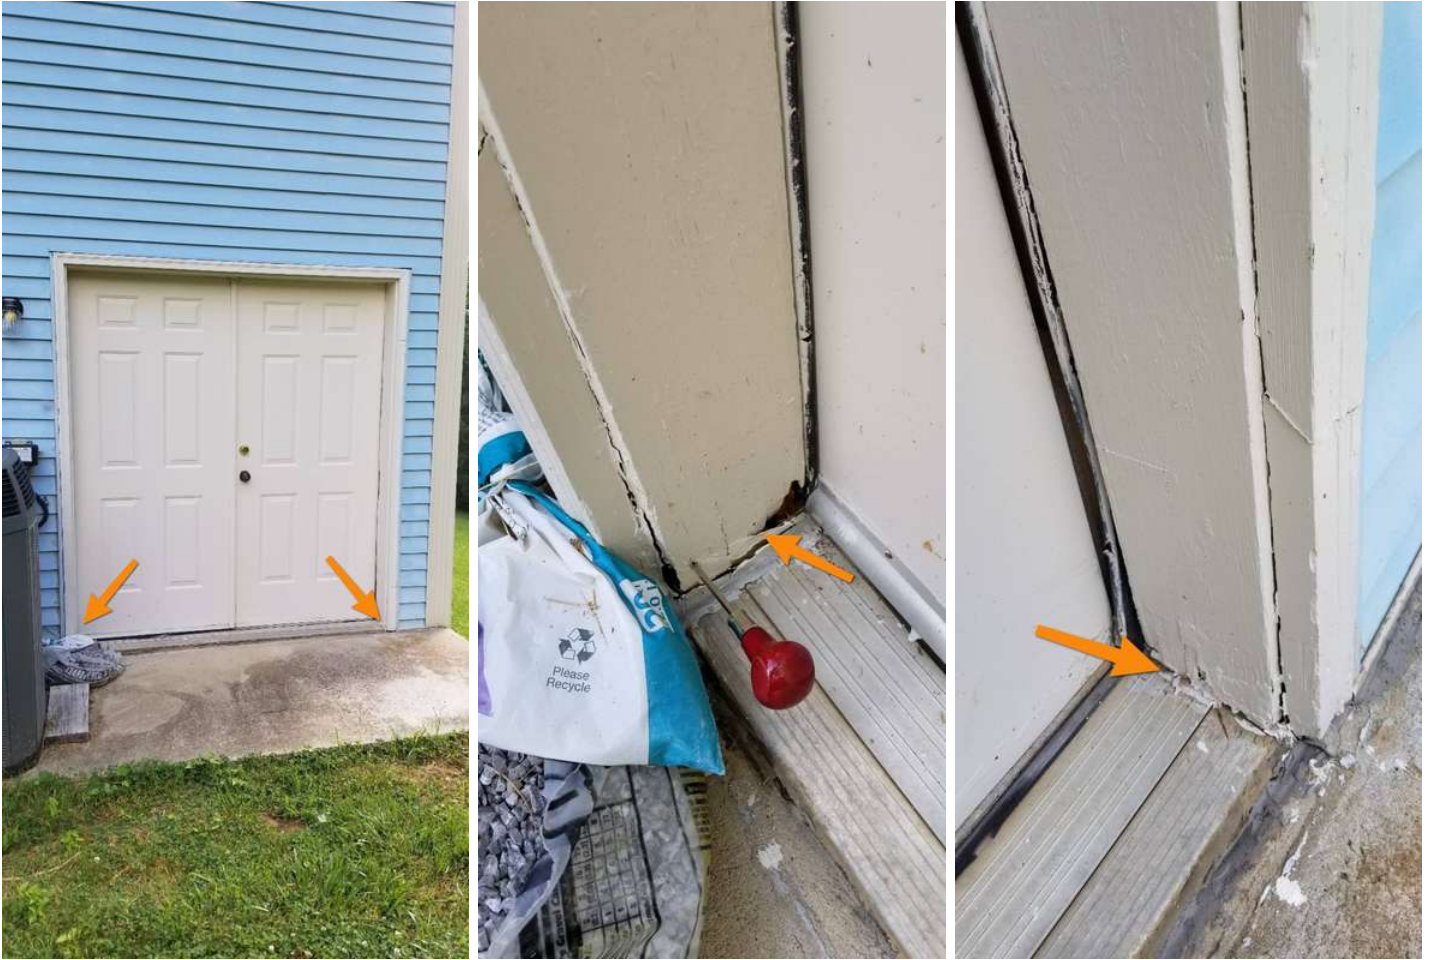
3.1.2 Wall Cladding, Flashing & Trim

**DETERIORATING TRIM**

One or more areas of exterior trim are deteriorating. Deteriorated wood trim can lead to moisture penetration into the building envelope, structural damage, and undesirable environmental conditions. A Licensed General Contractor should be consulted for evaluation and repair.

Contact a qualified general contractor.

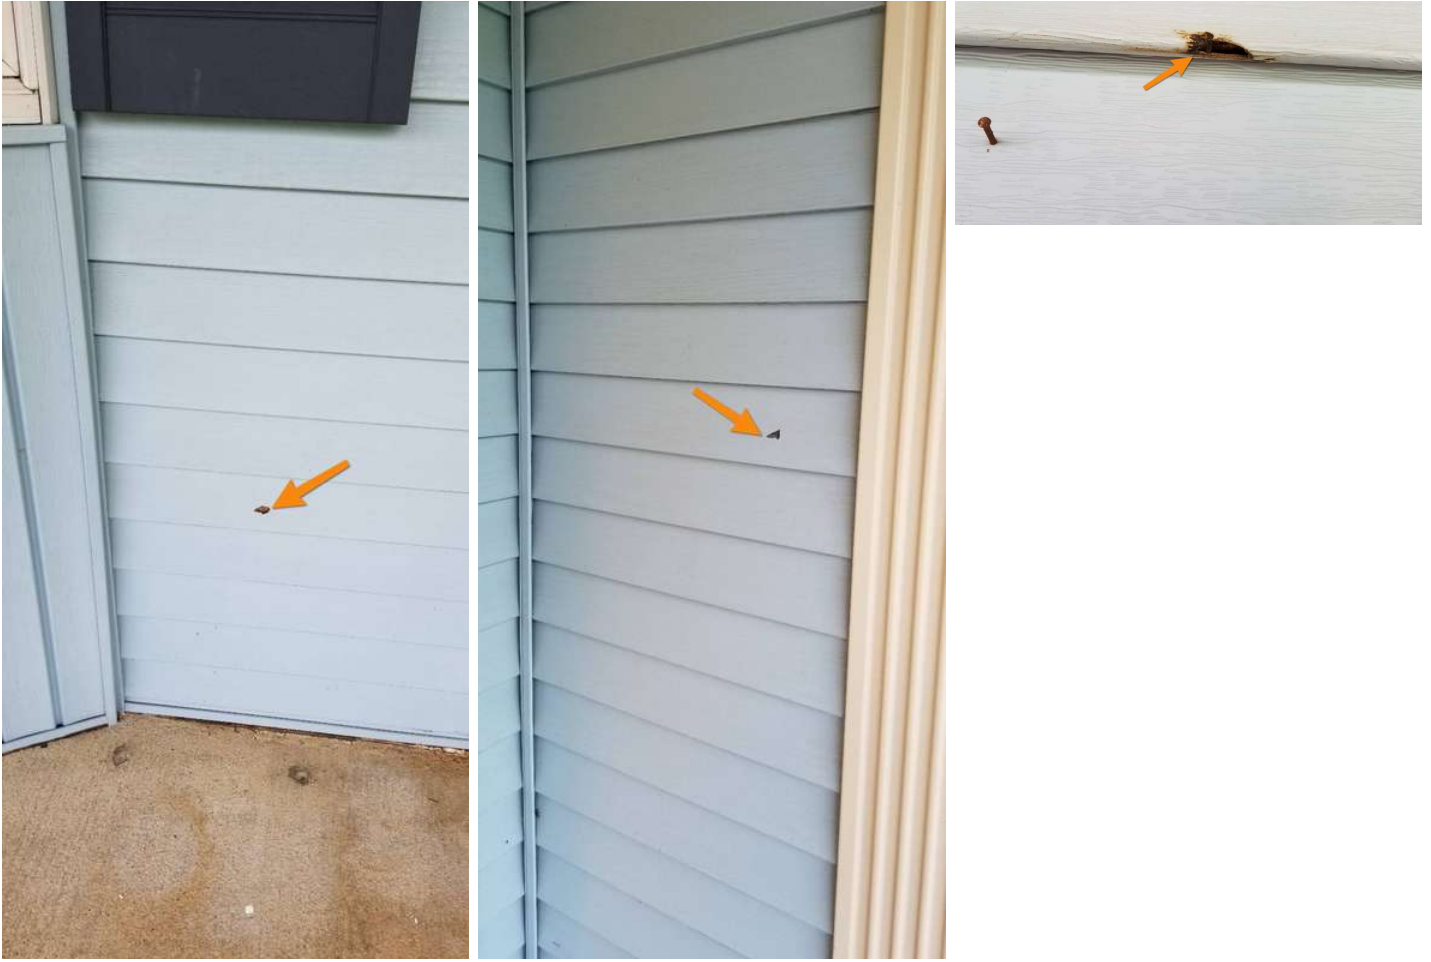
### 3.1.3 Wall Cladding, Flashing & Trim

#### **SIDING DAMAGED**

One or more areas of siding appeared to have been damaged/cut. Damaged siding can allow moisture penetration into the building envelope from wind driven rain, structural damage and undesirable environmental conditions. A Licensed Siding Contractor should be consulted for evaluation and repair.

Contact a qualified siding specialist.

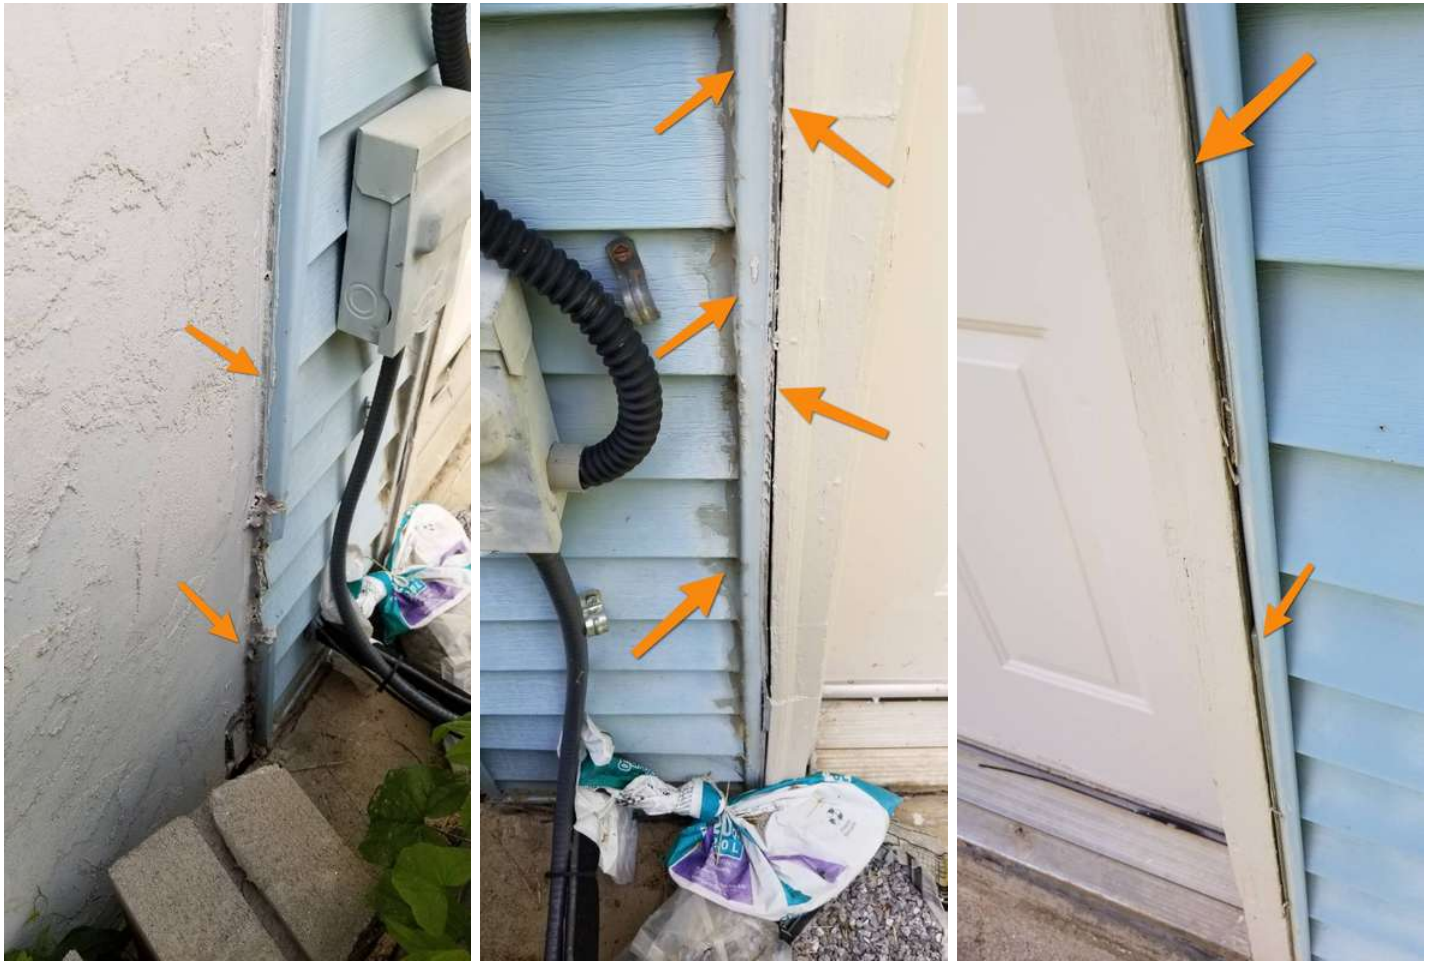
### 3.1.4 Wall Cladding, Flashing & Trim

#### **HEAVY CAULKING**

There is heavy caulking in one or more places evidencing past moisture penetration. Heavy caulking is not a permanent fix. Moisture penetration into the building envelope can cause structural damage over time and undesirable environmental conditions. A Licensed General Contractor should be consulted for evaluation and repair.

Contact a qualified general contractor.

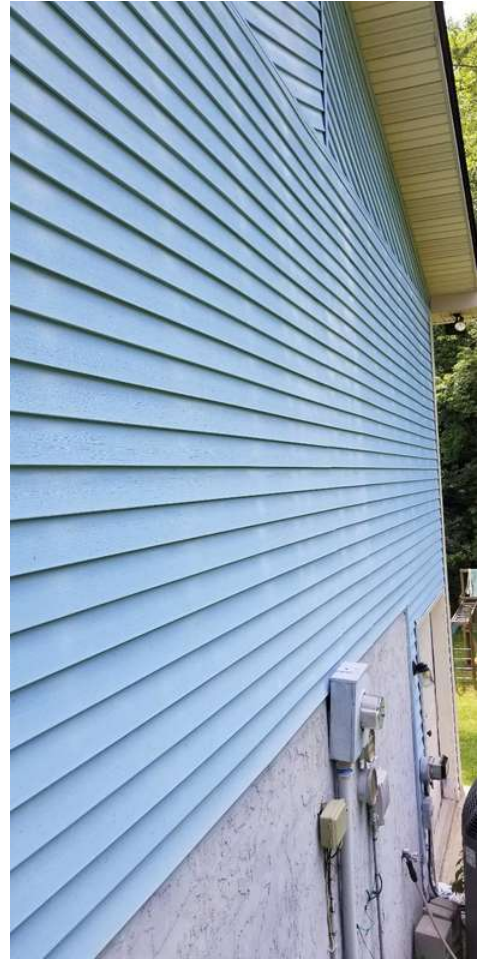
3.1.5 Wall Cladding, Flashing & Trim

The siding in one or more places shows signs of discoloration. Discoloration of vinyl siding can occur from many causes. A Licensed Siding Contractor should be consulted for evaluation and repair if deemed necessary.

Contact a qualified siding specialist.

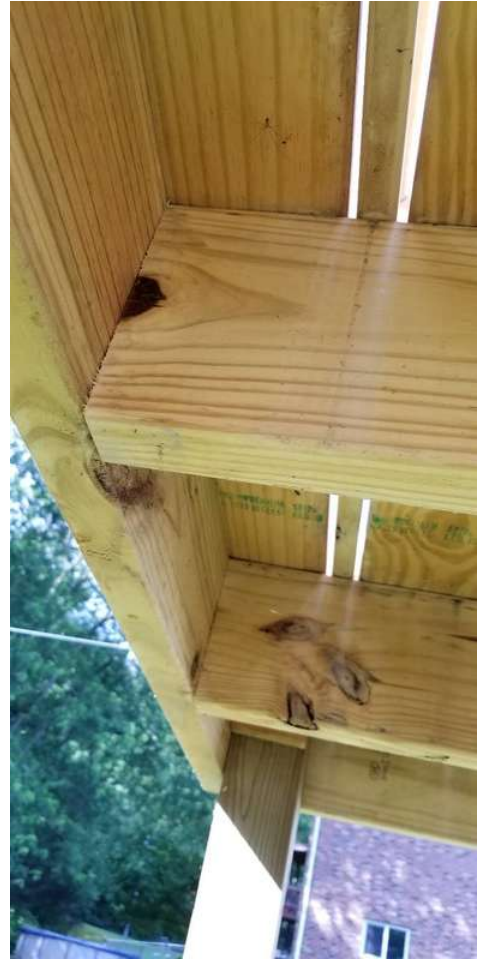
3.5.1 Decks, Balconies, Stoops, Steps, Areaways,  
Porches, & Railings

### **JOIST HANGERS MISSING OR IMPROPERLY INSTALLED**

One or more areas of the deck have missing or improperly installed joist hangers, or lack of ledger boards, relying on nail connections only. This could cause the deck to collapse under load. A Licensed Deck Contractor should be consulted for evaluation and repair.

Contact a qualified deck contractor.

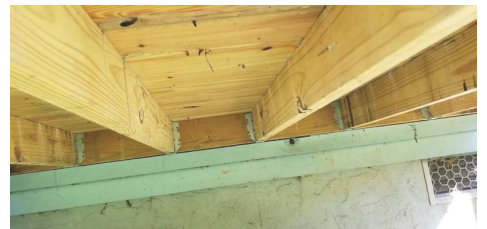
3.5.2 Decks, Balconies, Stoops, Steps, Areaways, Porches, & Railings

The deck appears to be nailed to the home with no other visible means of attachment. Nails can corrode and fail behind the deck band causing the deck to collapse. Concealed damage to framing and/or siding behind the deck can also result in deck collapse. Unless it can otherwise be demonstrated that the deck attachment to the house is secure, the deck should be directly supported from below or bolted to the house. A Licensed General Contractor or Licensed Structural Engineer should be consulted for a full evaluation of the deck attachment and modify or repair as deemed necessary.

Contact a qualified general contractor.

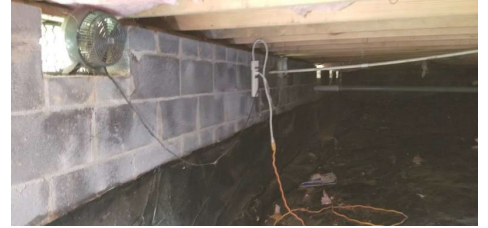
4.6.1 Foundation, Basement & Crawlspace

### **INTERMITTENT EXCESSIVE MOISTURE CONDITIONS**

There is evidence of intermittent excessive moisture conditions in the crawlspace. Excessive moisture in the crawlspace can lead to undesirable environmental conditions, wood destroying organism growth, structural damage and rusting of metal components of the HVAC systems. A License General Contractor should be consulted for evaluation and repair.

Contact a qualified general contractor.

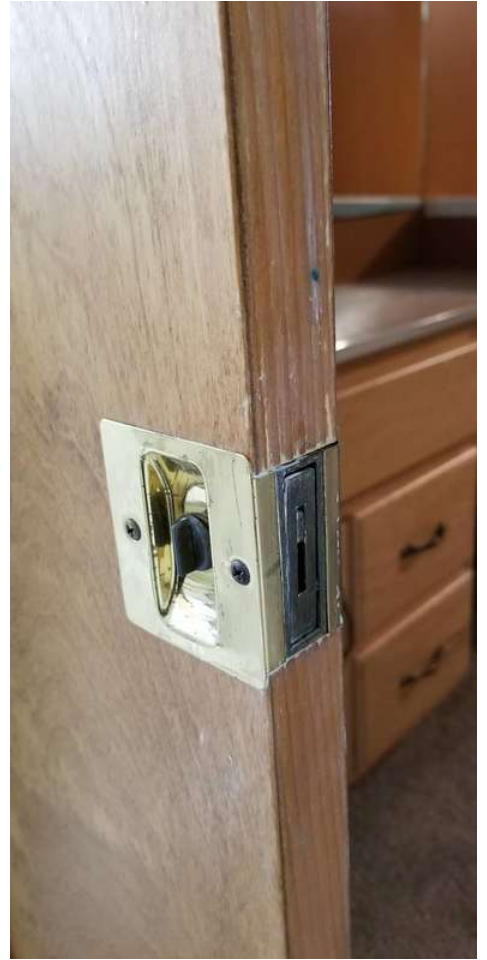
One or more interior doors do not latch properly. A Door Repair and Installation Contractor should be consulted for evaluation and repair.

Contact a qualified door repair/installation contractor.

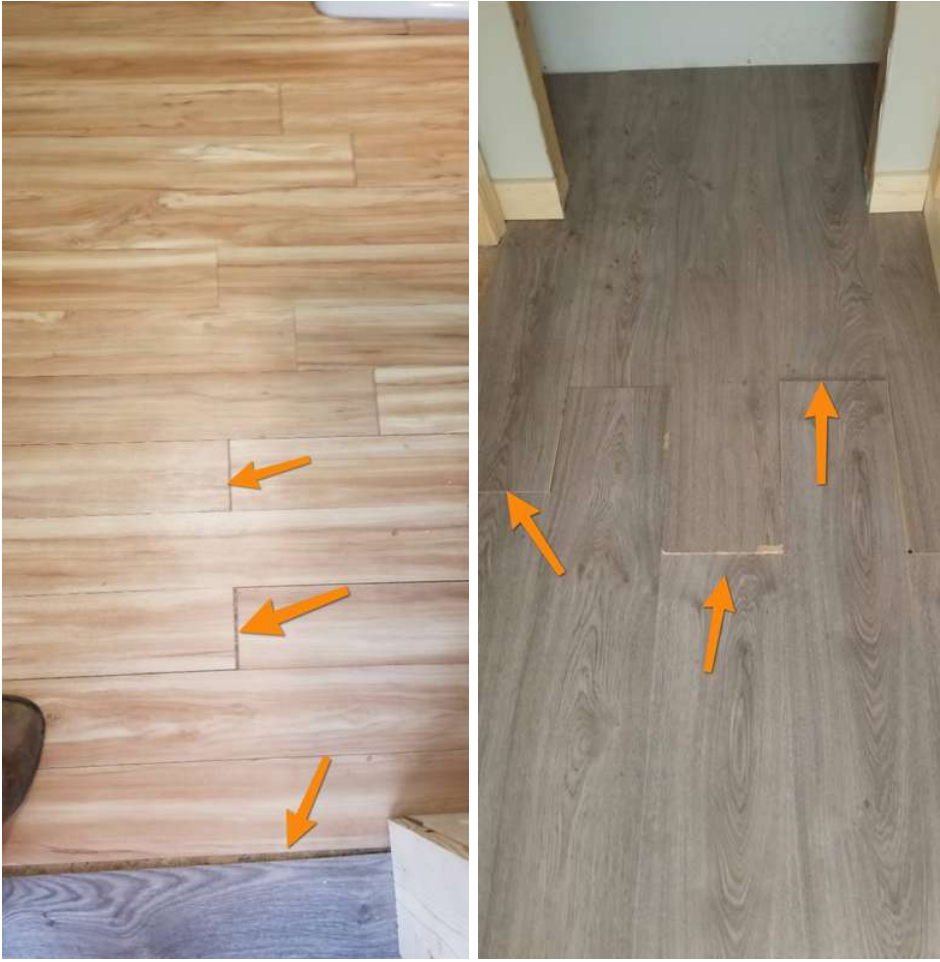
### 5.2.1 Floors

## **FLOOR NOT INSTALLED TO INDUSTRY STANDARDS**

One or more areas of the flooring are not installed to industry standards with gaps between pieces and overlapping of pieces. A Licensed Flooring Contractor should be consulted for evaluation and repair.

Contact a qualified flooring contractor

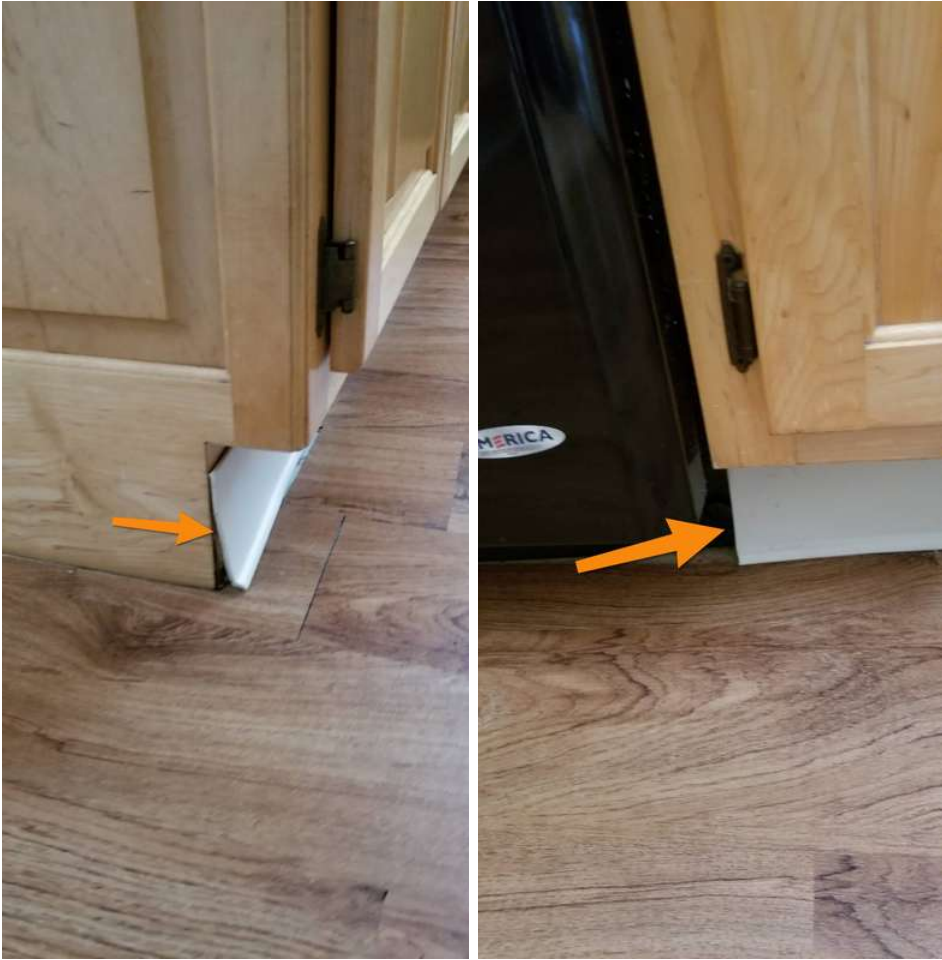
### 5.2.2 Floors

#### **LOOSE VINYL TRIM**

The vinyl trim is loose in one or more places. A Licensed Flooring Contractor should be consulted for evaluation and repair.

Contact a qualified flooring contractor

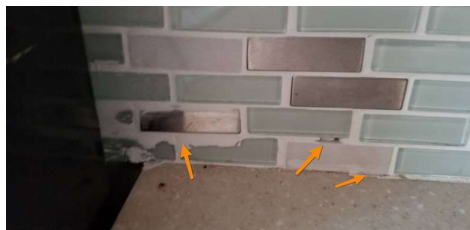
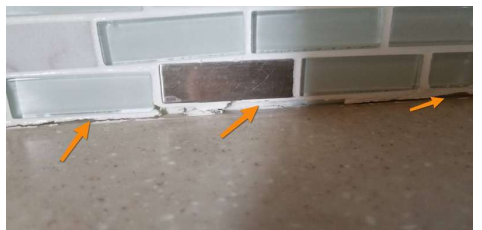
5.2.3 Floors

**TILE NOT INSTALLED TO INDUSTRY STANDARDS**

The tile has not been grouted to industry standards. A Licensed Tile Contractor should be consulted for evaluation and repair.

Contact a qualified tile contractor

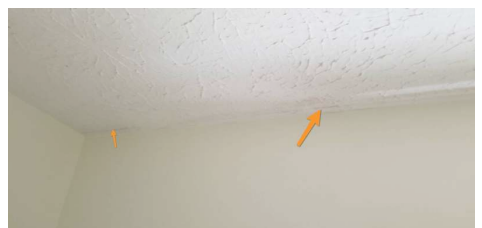
5.4.1 Ceilings

**LOOSE TAPE**

One or more areas of the sheet rock taping are coming loose. A Drywall Contractor should be consulted for evaluation and repair.

Contact a qualified drywall contractor.

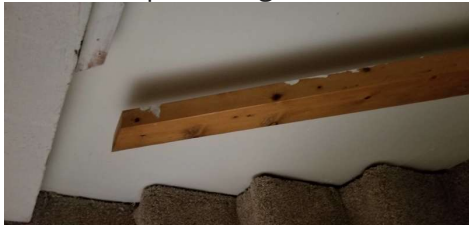
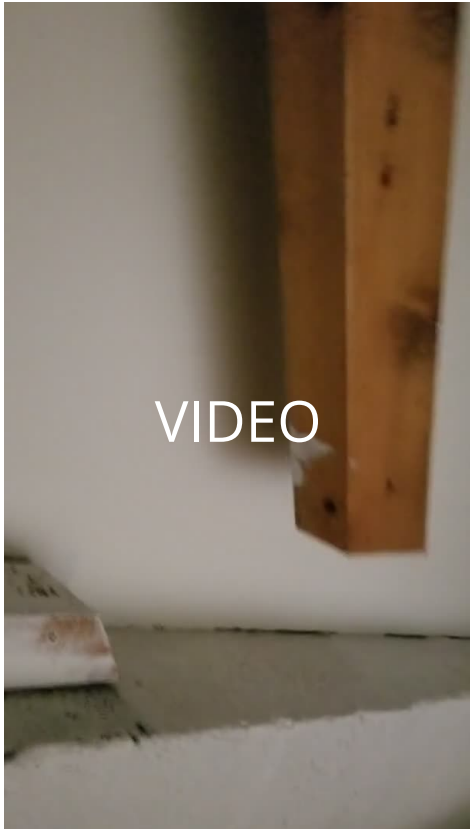
5.5.1 Steps, Stairways, Balconies, & Railings

**LOOSE HANDRAIL**

The stair handrail is loose in one or more places. Loose handrails are a safety hazard and should be repaired as soon as possible. A Licensed General Contractor should be consulted for evaluation and repair.

Contact a qualified general contractor.

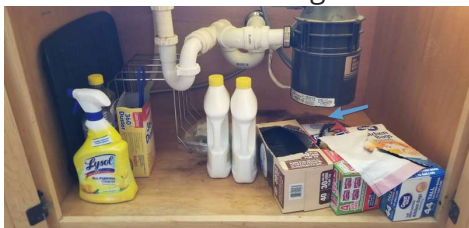
5.6.1 Countertops & Cabinets

**EVIDENCE OF PAST LEAKING**

There is evidence of past leaking in one or more cabinet sink bases. This may be from a plumbing leak or from leaking bottles that have been stored under the sink. Recommend continued monitoring.

Recommend monitoring.

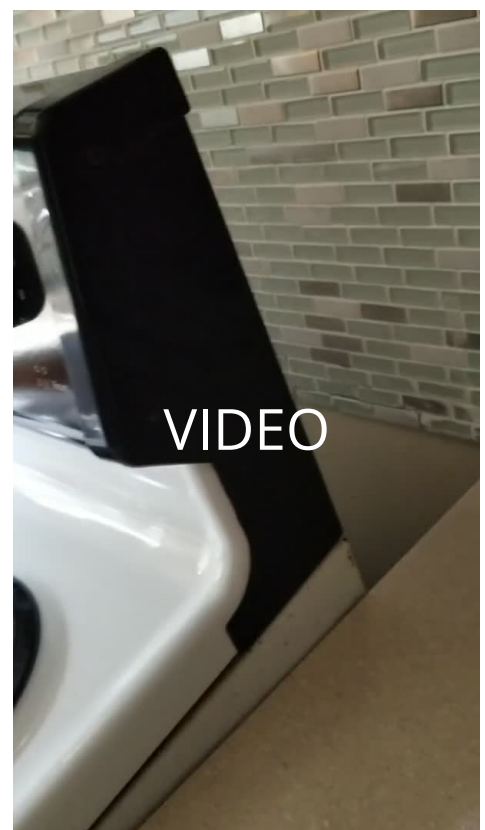
The range was not securely fastened to an anti tilt device. This poses a safety hazard, especially to children. A Qualified Professional should be consulted for evaluation and repair or installation of an approved anti tilt device.

Contact a qualified professional.

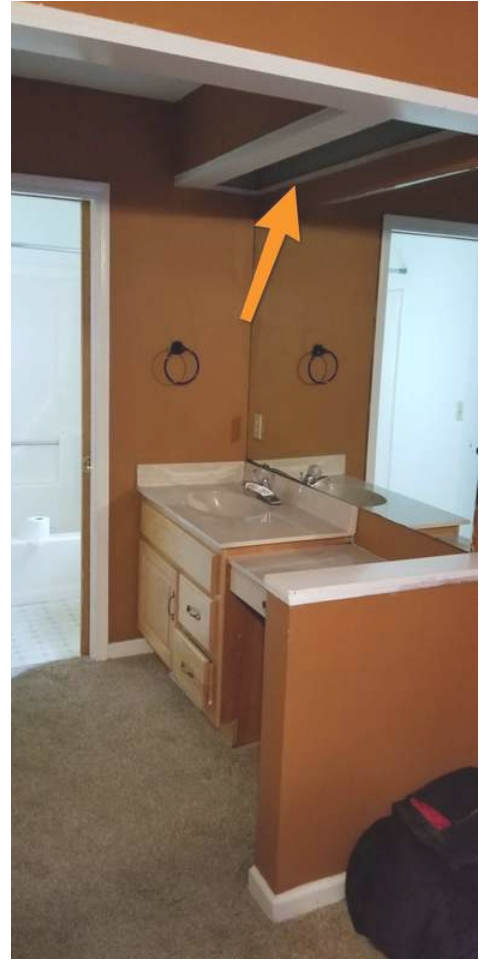
General Recommendations**LIGHT INOPERABLE**

One or more lights were not operational at the time of inspection. The light bulb(s) should be replaced and the light fixtures retested. If the light still does not operate, a Licensed Electrical Contractor should be consulted for evaluation and repair.

Contact a qualified electrical contractor.

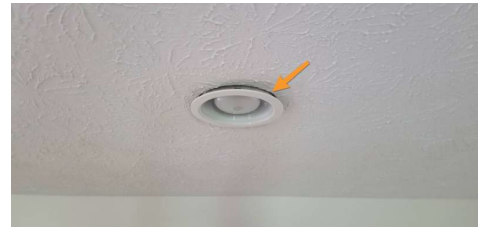
## 7.4.2 Lighting Fixtures, Switches &amp; Receptacles

General Recommendations**LOOSE LIGHT FIXTURE**

One or more can light fixtures are loose in the ceiling. A Licensed Electrical Contractor should be consulted for evaluation and repair.

Contact a qualified electrical contractor.

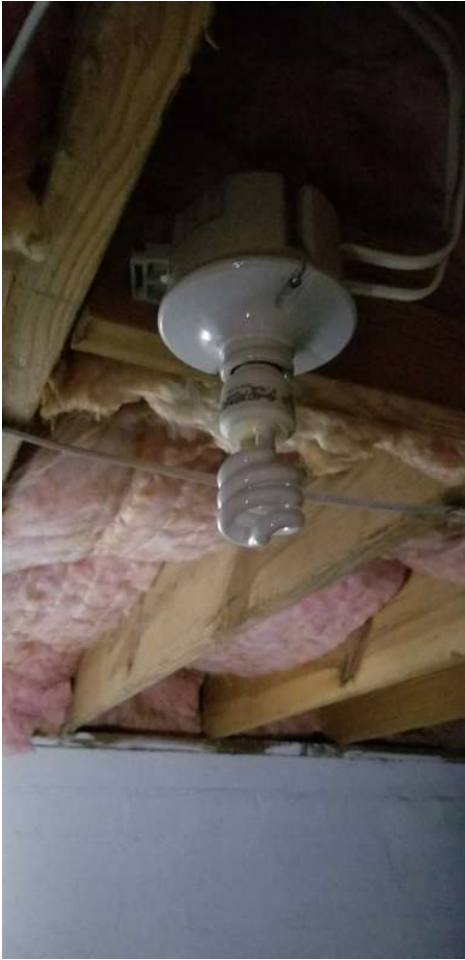
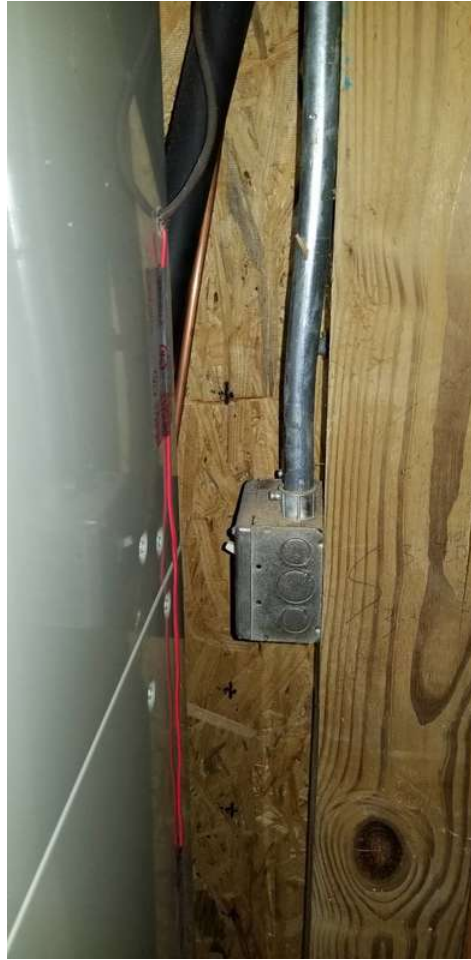
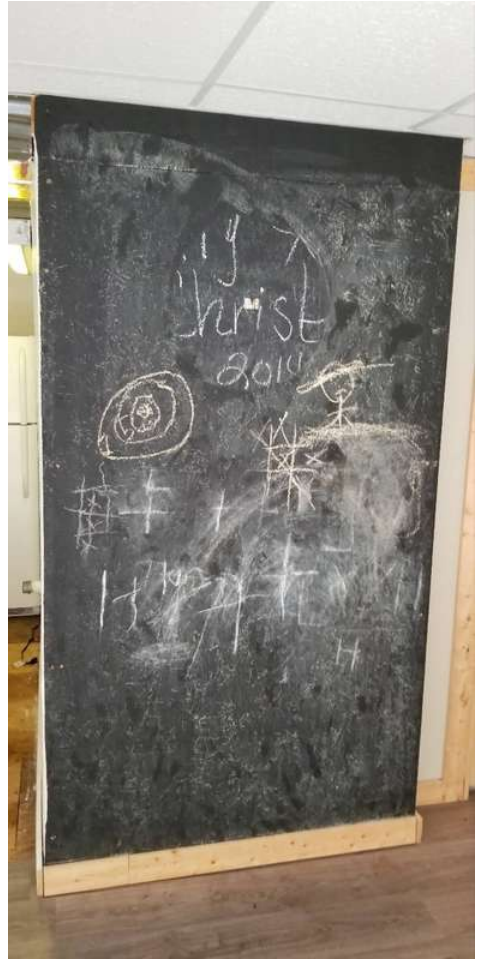
## 7.4.3 Lighting Fixtures, Switches &amp; Receptacles

General Recommendations**INACCESSIBLE LIGHT SWITCH**

Chalkboard panel must be removed to access light switch as well as the HVAC air handler and water heater.

Contact a qualified electrical contractor.

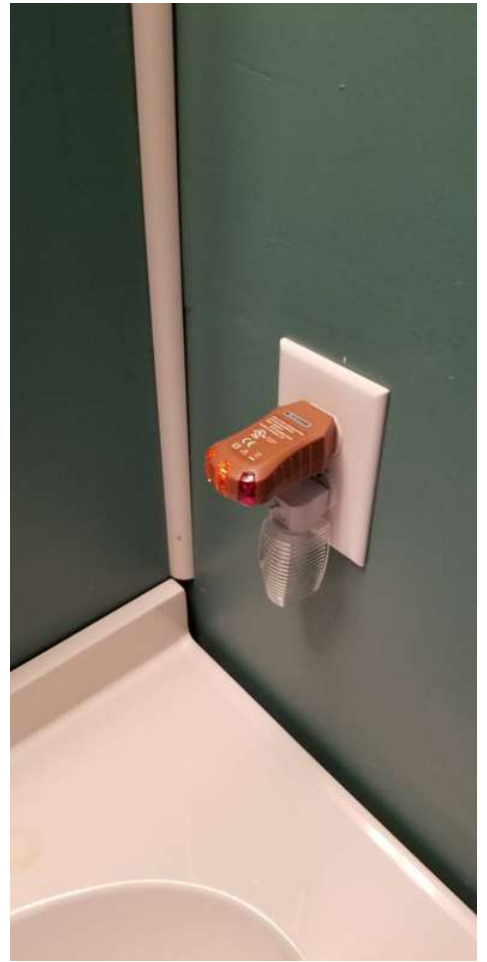
7.5.1 GFCI Receptacles

The outlet in the lower bathroom does not appear to be GFCI protected. This is a shock hazard. A Licensed Electrical Contractor should be consulted for evaluation and repair.

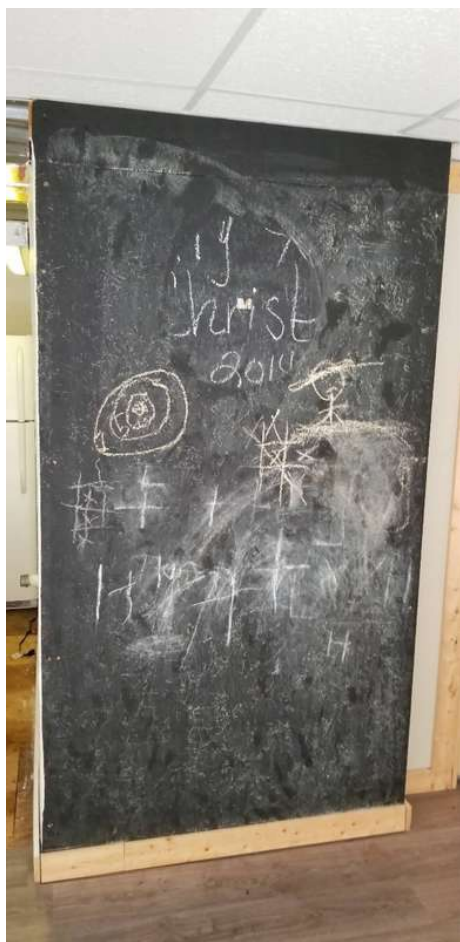
The water heater as well as the HVAC air handler are located behind this chalkboard panel

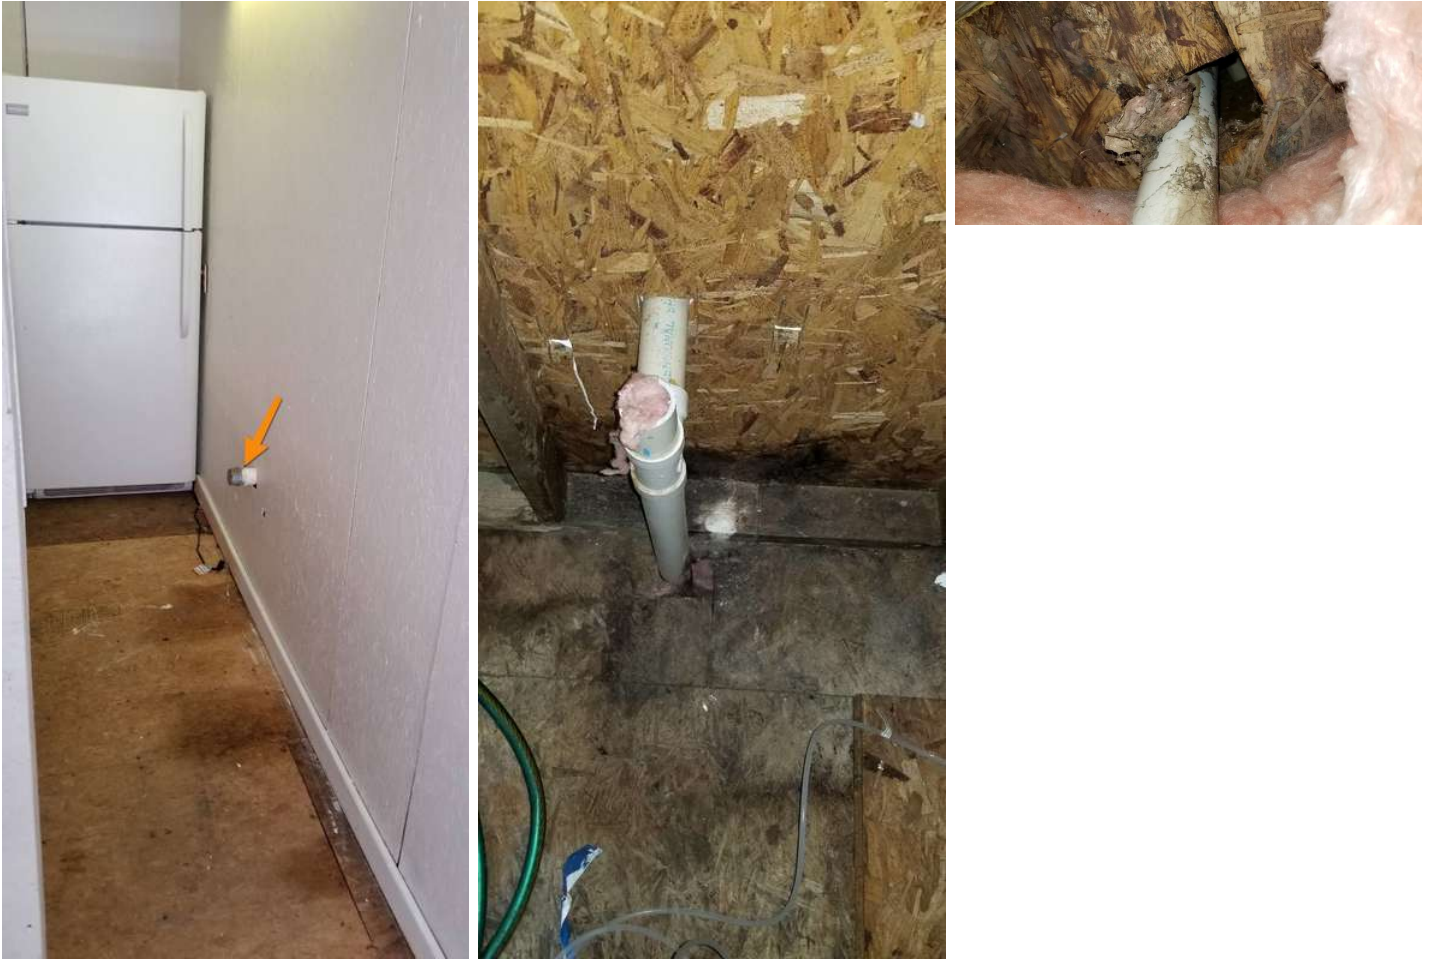
## 8.2.1 Drain, Waste, &amp; Vent Systems

**LEAKING PIPE**

Contact a qualified plumbing contractor.

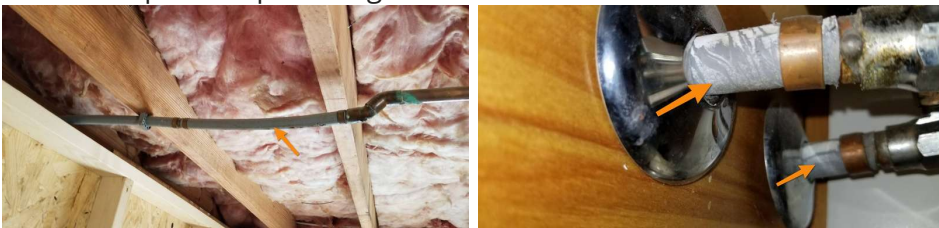
### 8.3.1 Water Supply, Distribution Systems & Fixtures

#### **POLYBUTYLENE DISTRIBUTION LINES**

Contact a qualified plumbing contractor.

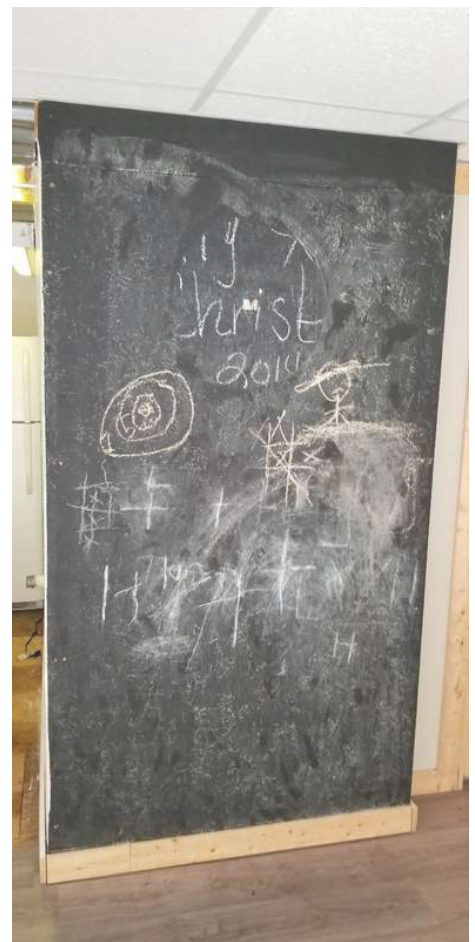
HVAC air handler and water heater located behind chalkboard panel
