TRUE MEASURE HOME INSPECTIONS

PROPERTY INSPECTION REPORT

1234 Main St.
Port Orange Florida 32127

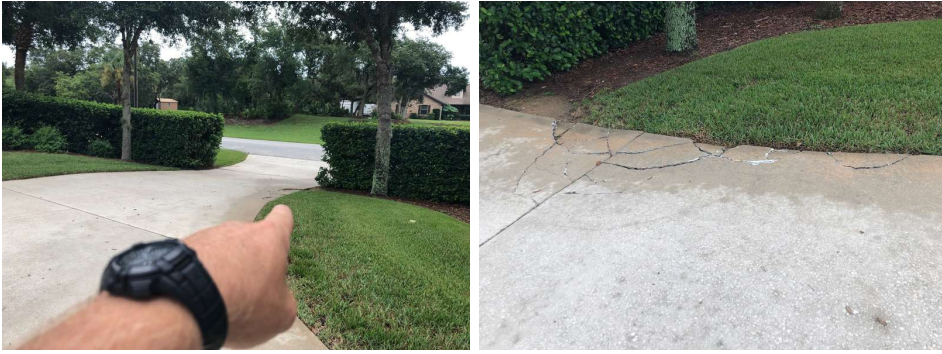
DRIVEWAY CRACKING - MAJOR

Major cracks observed. Recommend concrete contractor evaluate and replace.

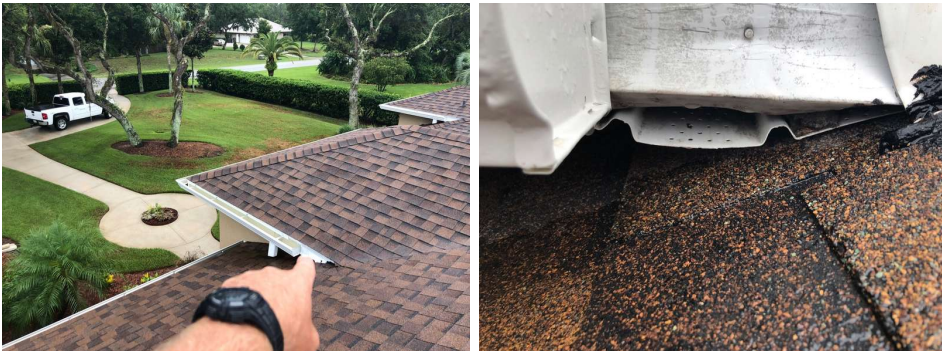
There are soffit vent screens that are open to the attic. This may allow pests to enter the attic space. Repair to prevent this from happening.

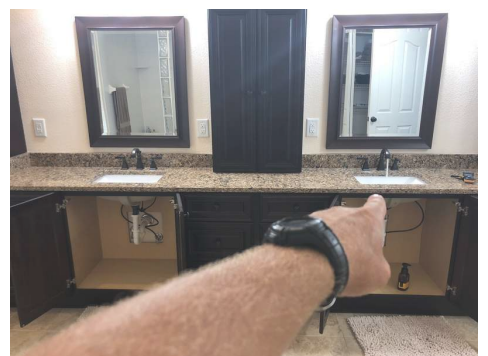
There were sink/tub stoppers that do not operate as they should. Repair as needed.

Contact a qualified plumbing contractor.

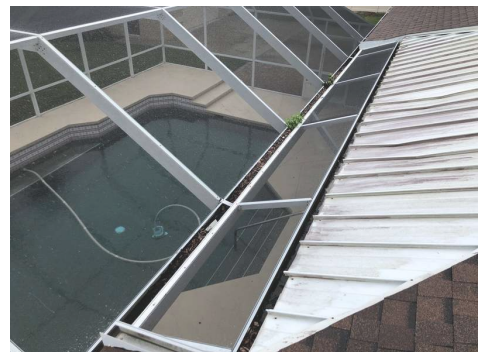
Debris has accumulated in the gutters. I recommend cleaning to facilitate water flow.

Contact a qualified roofing professional.

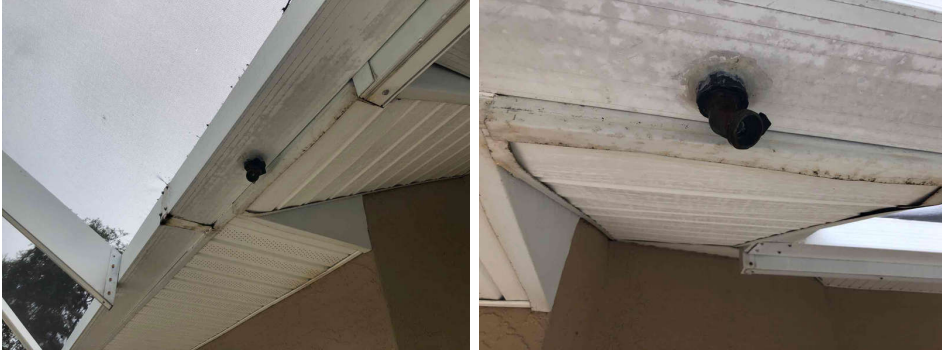
Gutters were leaking in one or more areas. Repair to allow water to direct where it is supposed to go. There was also an odd hose attachment at this location. The reason for this is unknown, but this should also be removed and replaced with clean gutter to prevent further leaks in this area.

Contact a qualified roofing professional.

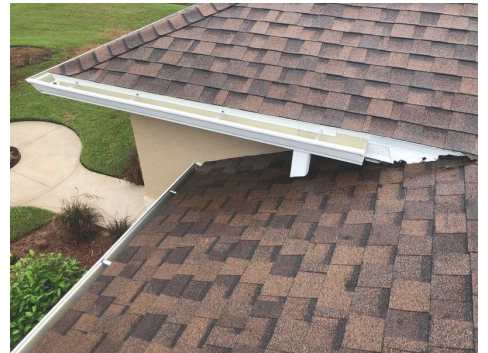
There are second-story downspouts that drain directly onto the roof. This can cause the shingles to wear out faster than expected. A better solution is to run these downspouts into the gutters below.

Contact a qualified gutter contractor

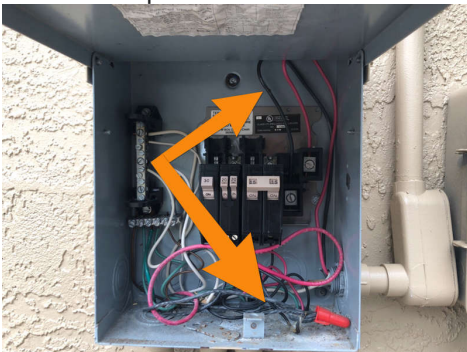
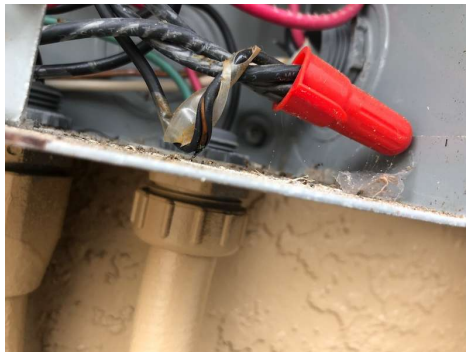
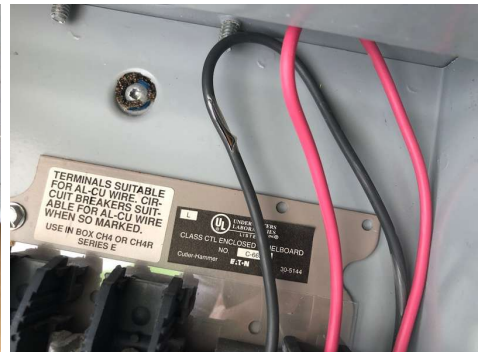
There are wires that have insulation that is stripped past where they should be. This can allow these wires to short out easier and therefore should be repaired by a licensed electrician.

Contact a qualified electrical contractor.

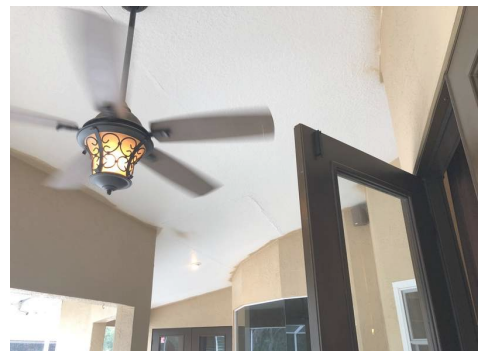
And there is a ceiling fan that is very close to her door when the door is opened. Consider raising this fan to prevent damage.

Contact a qualified electrical contractor.

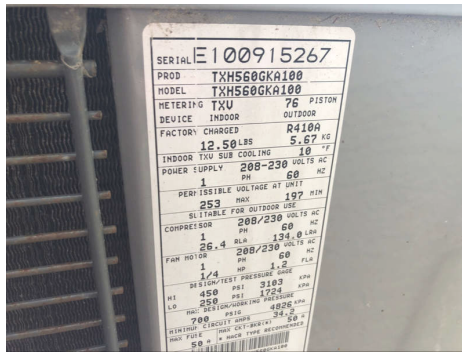
Condensing unit label. Manufactured in 2010

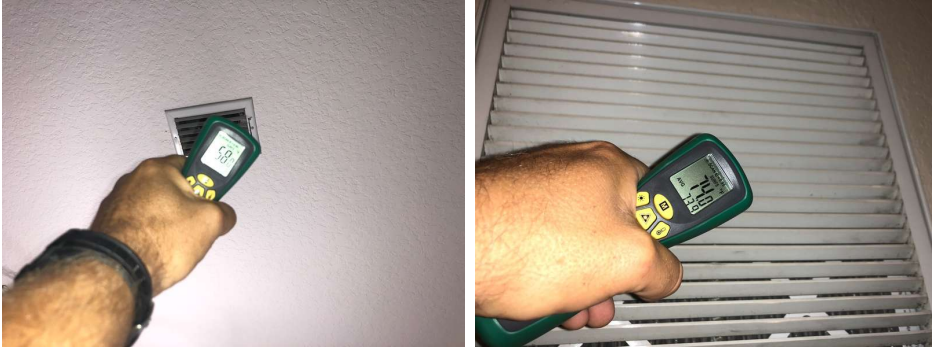
16 degrees

It is normal for the difference between supply and return air to be between 14 & 22 degrees. Differentials that are lower or higher than this should be further investigated by a HVAC contractor as the causes for this is beyond the scope of a general home inspection.

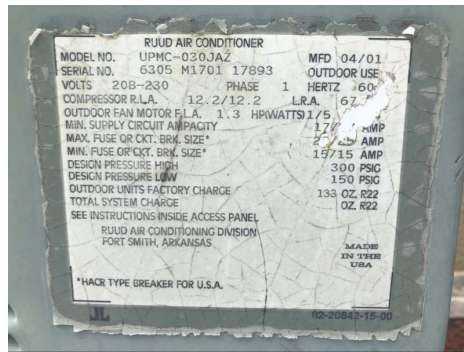
Condensing unit label. Manufactured in 2001.

The air conditioning system is older and at or past the end of its expected life span. I recommend a licensed HVAC contractor service and re-evaluate the system prior to the end of your inspection contingency to be sure there are no hidden surprises after closing.

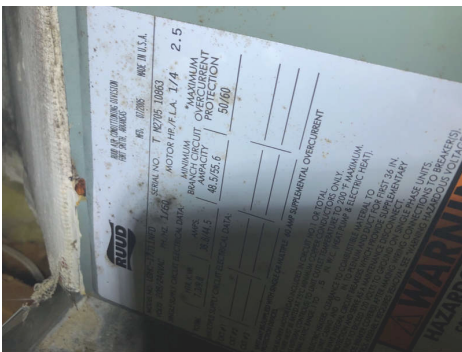
Air handler unit label. Manufactured in 2005.

The air handler unit and condensing unit or manufactured in different years. This may make replacement for the newer component sooner than expected.

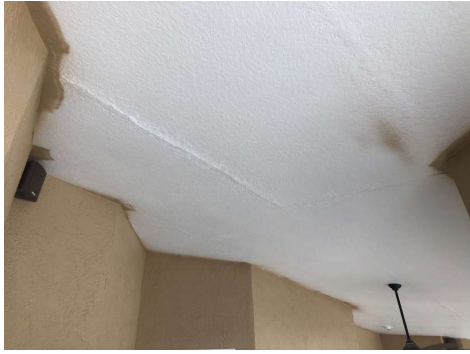
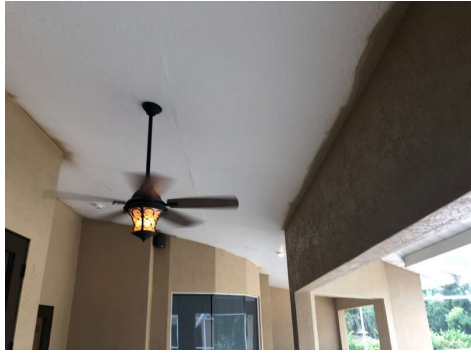
Ceiling drywall sagged visibly at the time of the inspection. This appears to be due to leakage from above. The source of moisture intrusion should be identified and corrected, and the damaged section of drywall replaced.

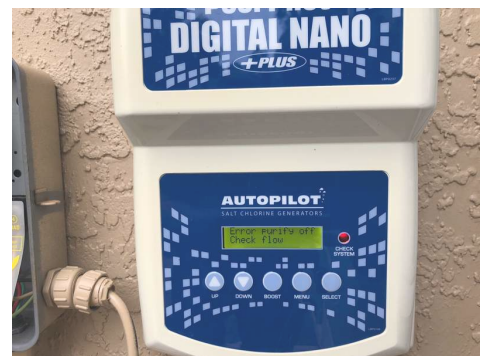
This is a saltwater pool. This uses salt and a chlorine generator to convert that salt into chlorine. There is a control box associated with this chlorine generator, and it has an error message on it. This should be reevaluated by a pool repair person and repaired as needed. There was a report from a company that services this pool that said that this was working properly. I suggest having a different company look at this so that you get an unbiased opinion of this.

Contact a qualified Swimming Pool Contractor

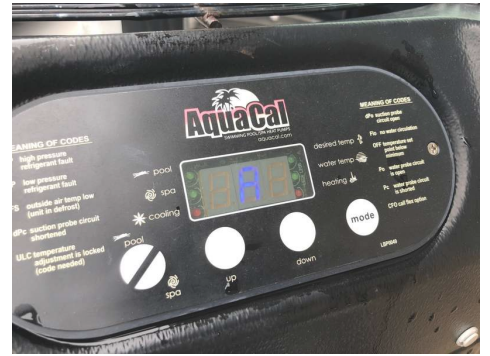
CONTROLS DAMAGED/DETERIORATED

The controls on the front of the heater are difficult to read. I recommend repair in order to be able to read this and know what the controls are reading.
