RELIANCE HOME INSPECTIONS RESIDENTIAL REPORT

1234 Main St.
STANWOOD, Washington 98292

Buyer Name
07/05/2019 9:00AM

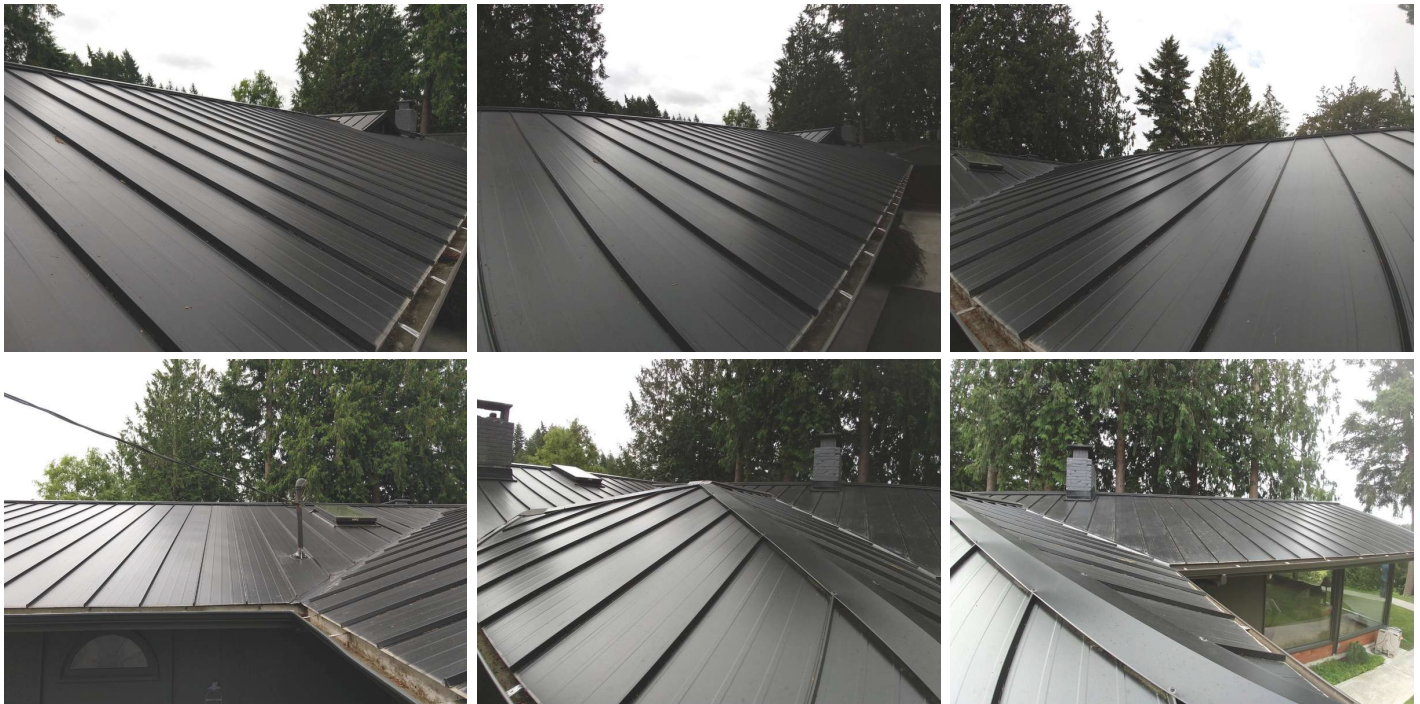
General: Roof Pictures

The overall condition of the roof was found to be in good shape at the time of the inspection. Metal roofs are traditionally very durable and are a excellent choice for the NW weather we have.

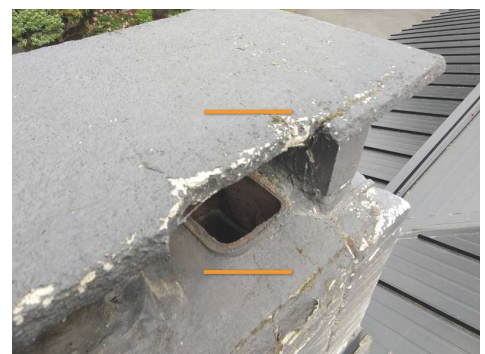
3.5.1 Chimney

DETERIORATED CONCRETE CAP

The top concrete chimney cap Has a chunk missing out of it and is showing early signs of deterioration. I recommend replacing this at some point in the near future before it becomes a bigger issue.

Contact a qualified chimney contractor.

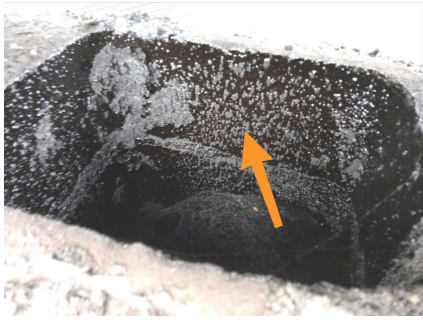
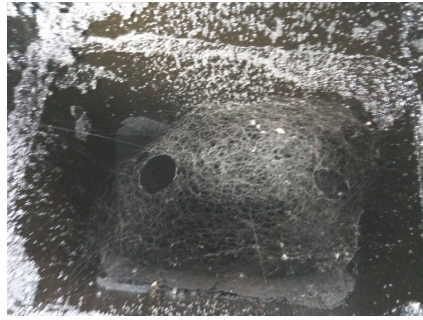
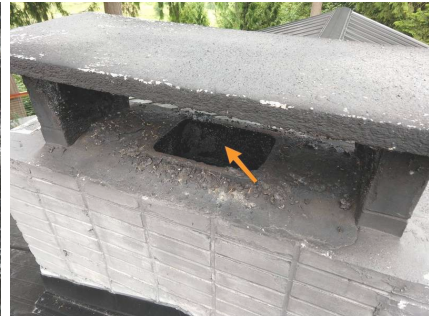
3.5.2 Chimney

The chimney flues are dirty and is in need of cleaning. I recommend the chimney is cleaned and certified before use by a chimney cleaning contractor.

Contact a qualified professional.

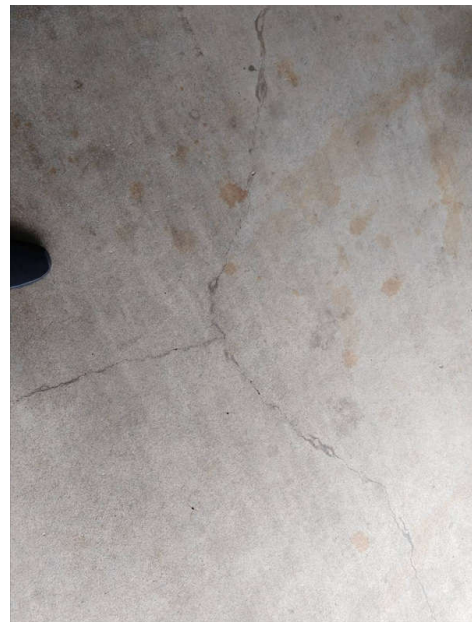
MINOR DRIVEWAY DAMAGE

Minor deterioration (e.g. cracks, holes, settlement, heaving) was found in the driveway, but no trip hazards were found. The client may wish to have repairs made for cosmetic reasons.

Contact a qualified professional.

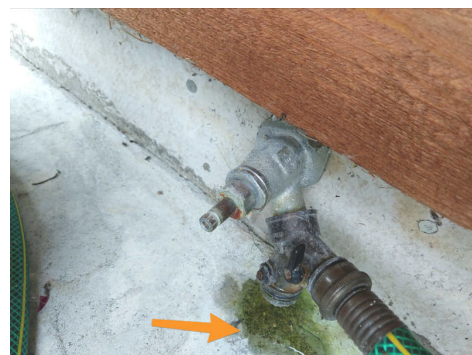
4.3.1 Exterior issues

HOSE BIBB LEAK

One or more hose bibs leaked *when tested / while off*. When hose bibs leak while turned off, it's often caused by a worn valve seat or a loose bonnet. When hose bibs leak while turned on, it may be due to worn "packing" around the stem or a defective backflow prevention device. Recommend that a qualified plumber repair as necessary.

Contact a qualified plumbing contractor.

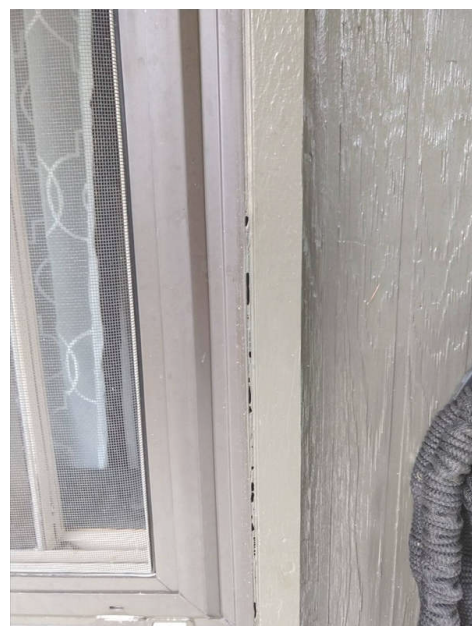
4.3.2 Exterior issues

Some of the caulking on the exterior trim boards, siding seams, windows, doors, fascia boards, was cracking. This can cause potential water intrusion areas, that will lead to accelerated deterioration. Caulking around trim boards, windows, fascia, and exterior fixtures should be inspected and repaired as needed on an annual basis.

Contact a qualified professional.

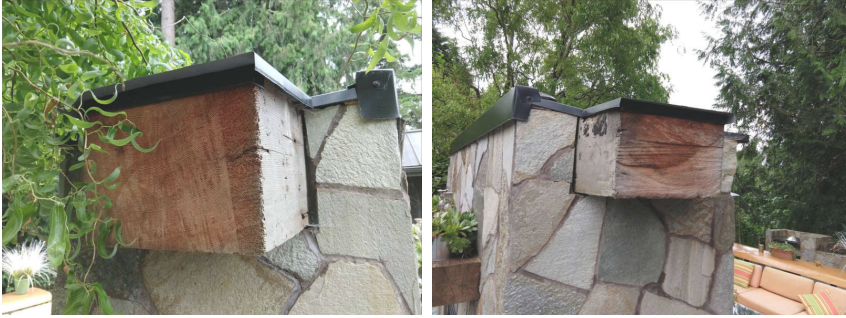
4.3.3 Exterior issues

The beam over the exterior fireplace is bare wood. I recommend sealing/staining this to prevent the beam from deterioration and water damage.

Contact a qualified professional.

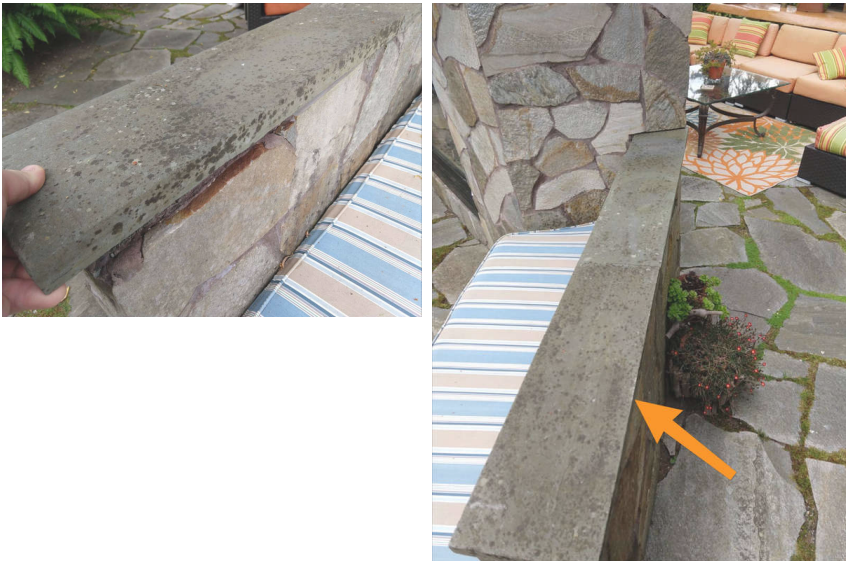
4.3.4 Exterior issues

CONCRETE BLOCKS LOOSE

The stone cap around the exterior fireplace is just sitting in place and is loose. I recommend mortaring these in place to prevent them from fall off and breaking or hurting someone. This would be a easy fix for A licensed masonry contractor.

Contact a qualified professional.

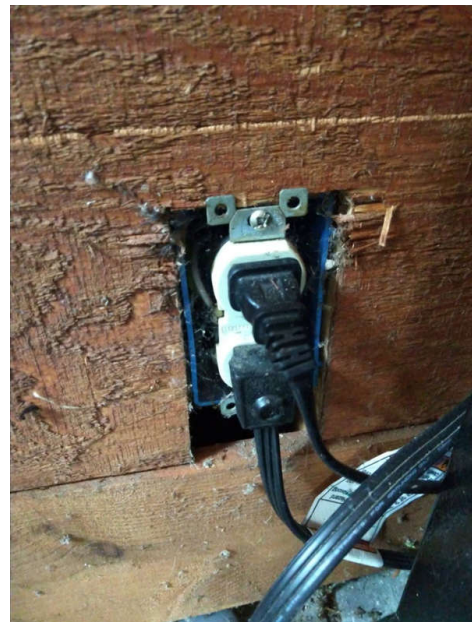
4.4.1 Electrical

COVER PLATE ISSUES

One or more *cover plates / light fixtures / electric boxes / conduits or conduit fittings / water proof covers* installed outside were *loose / damaged / deteriorated / corroded / substandard / missing components / missing*. This is a potential shock and/or fire hazard. Recommend that a qualified electrician repair as necessary.

Contact a qualified electrical contractor.

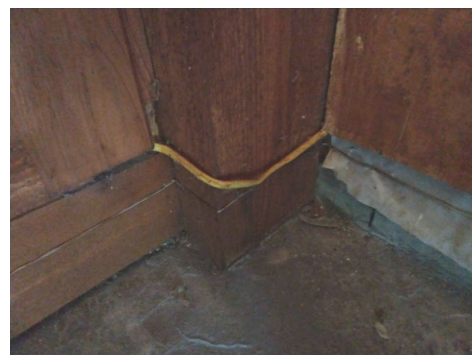
4.4.2 Electrical

One or more sections of outdoor wiring were exposed and *not rated for exterior use / subject to damage*. This is a potential shock hazard. Recommend that a qualified electrician repair per standard building practices. For example, by installing conduit, re-routing wires or replacing wiring.

Contact a qualified electrical contractor.

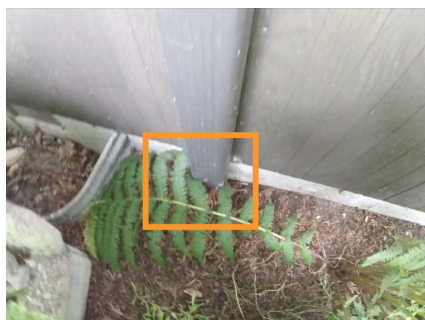
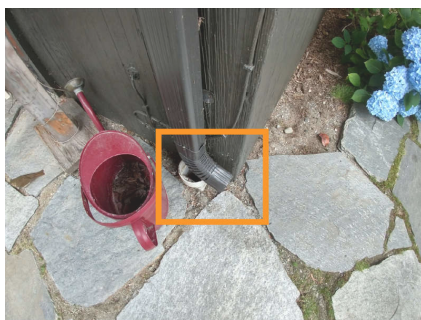
4.7.1 Gutters and Flashing

Extensions such as splash blocks or drain pipes for one or more downspouts were *missing / poorly sloped / misaligned / clogged / substandard / damaged*. Water can accumulate around the building foundation or inside crawl spaces or basements as a result. Recommend that a qualified person install, replace or repair extensions as necessary so rainwater drains away from the structure.

Contact a qualified professional.

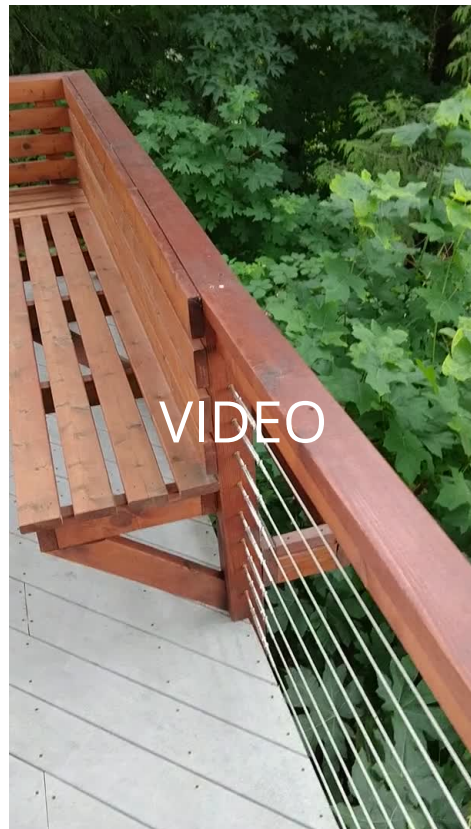
4.11.1 Deck

GUARDRAIL LOOSE

Guardrails at one or more locations with drop-offs higher than 30 inches were *loose / wobbly / damaged / deteriorated / missing components*, and pose a fall hazard. Recommend that a qualified person repair guardrails as necessary.

Contact a qualified professional.

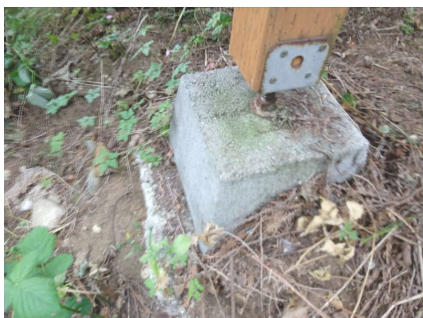
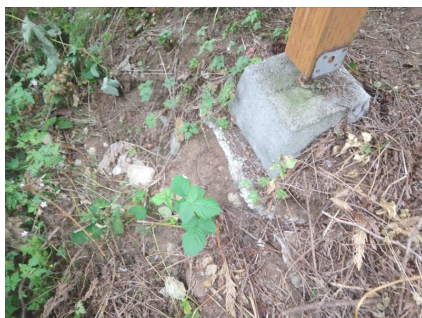
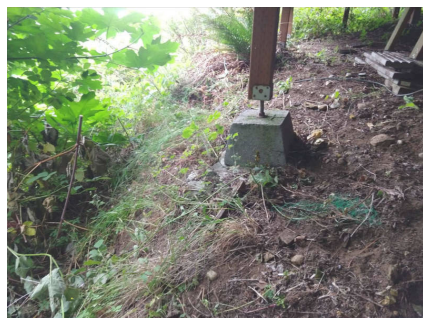
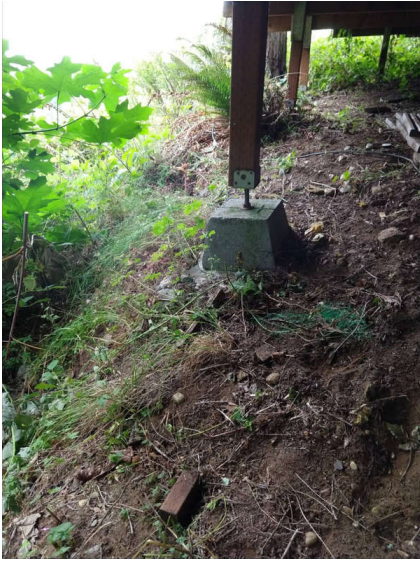
4.11.2 Deck

The ground around the deck support posts seems to be slowly eroding away. This could cause the deck to fail if the ground gave out. Maybe a retaining wall can be built out of landscape blocks. I recommend consulting with a landscape contractor about the best way to shore this up.

Contact a qualified professional.

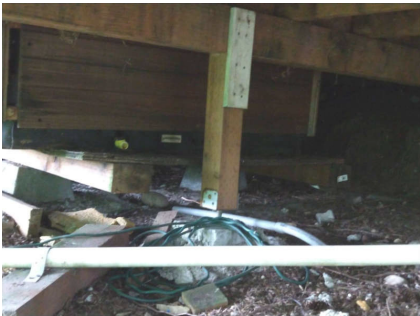
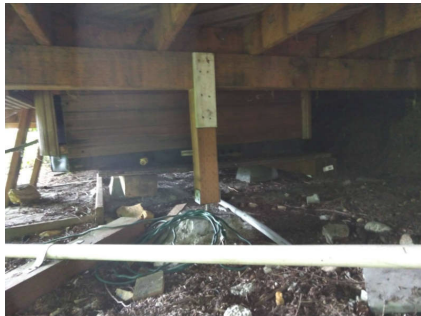
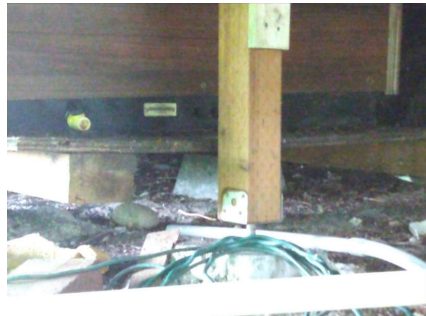
4.11.3 Deck

HOT TUB SUPPORTS

The support beams and plywood for the hot tub are beginning to deteriorate and warp under the weight of the hot tub. These supports should be shored up or replaced to ensure the hot tub does not fail. I recommend having this repaired by a licensed contractor.

Contact a qualified professional.

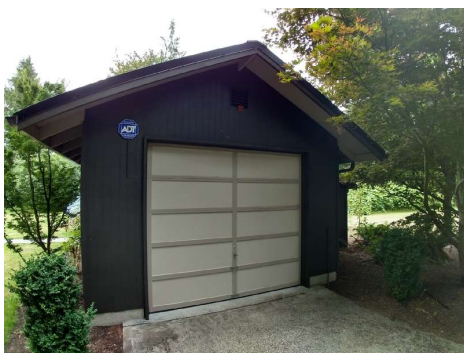
Vehicle door: Manual open

The garage door does not have an automatic vehicle door opener. It is manually operated. The client may want to have an automatic door opener installed for easy opening.

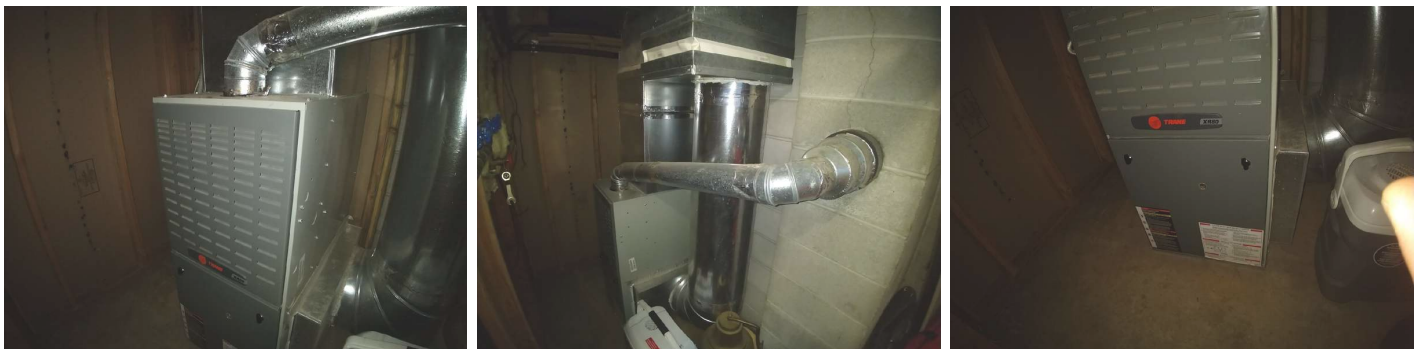
Heat system appears to be in working order. Supply air from the heating system should be 100 degrees Fahrenheit or higher.

The photo(s) below is/are a thermal image of the supply air temperature at register(s) at the time of this inspection.

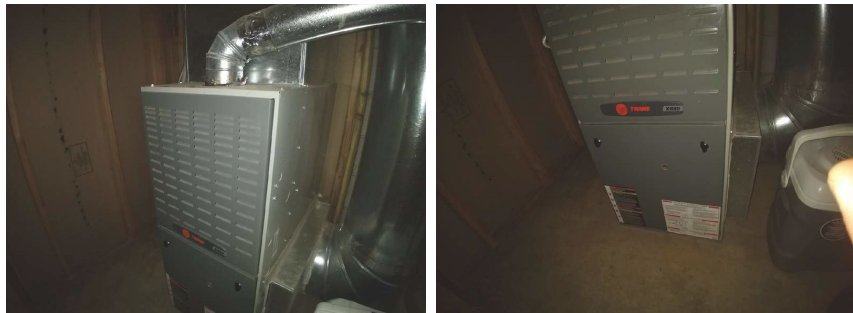
6.1.1 General comments

The last service date of the forced air heating system appeared to be more than 1 year ago, or the inspector was unable to determine the last service date. Ask the property owner when it was last serviced. If unable to determine the last service date, or if this system was serviced more than 1 year ago, recommend that a qualified HVAC contractor service this system and make repairs if necessary. This servicing should be performed annually in the future. Any needed repairs noted in this report should be brought to the attention of the contractor when it is serviced.

Contact a qualified HVAC professional.

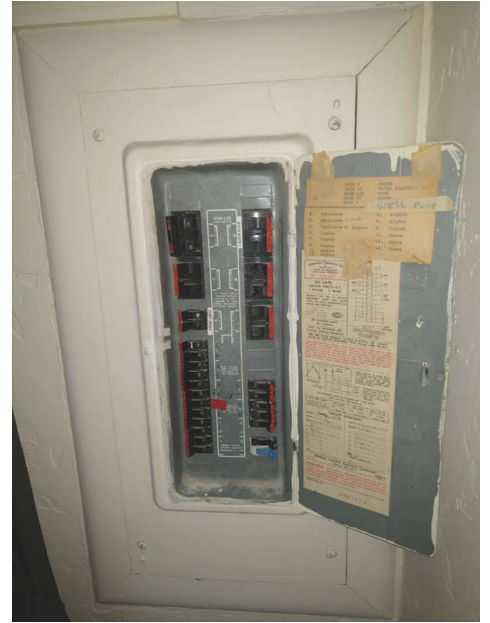
The dead front cover of the FPE Stab-LOK panel was not removed during the inspection for safety reasons. When we come across these panels we always recommend replacement of them. So the current wiring of the panel and branch wiring was not evaluated and is exempt from this report. See the comments below about the FPE Stab-LOK panel, but we recommend replacing the panel completely.

An electric panel was manufactured by the Federal Pacific Electric/Challenger company and used "Stab-Lok" circuit breakers. There is significant evidence that both double and single pole versions of these circuit breakers fail by not tripping when they are supposed to. I recommend that a qualified electrician carefully evaluate all Federal Pacific panels and upgrade them to a new panel. Federal Pacific/Stab-Loc Panels have been discontinued and are known fire hazards. Consider replacing Federal Pacific panels with modern panels that offer more flexibility for new, safer protective technologies like ground fault circuit interrupters (GFCIs) and arc fault circuit interrupters (AFCIs).

Contact a qualified electrical contractor.

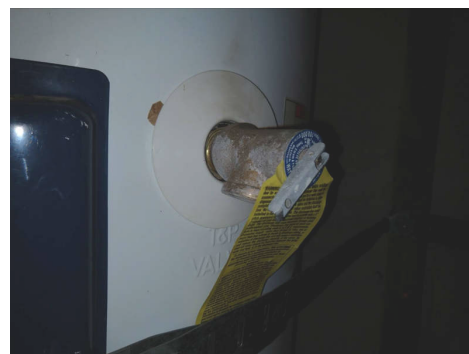
8.1.1 Water Heater

TPR DRAIN MISSING

Contact a qualified plumbing contractor.

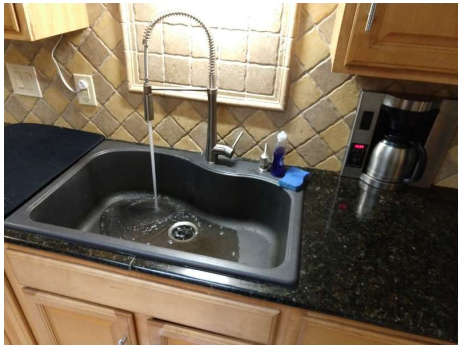
Kitchen Sink: Ran Water at Kitchen Sink

I ran water at the kitchen sink.

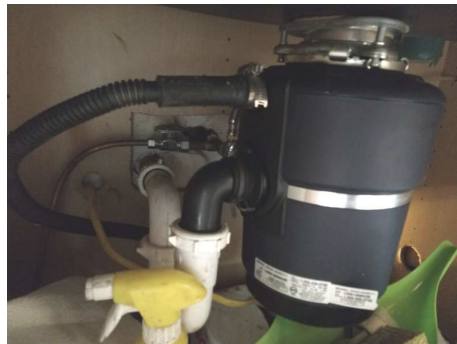
Garbage Disposal: Turned On Garbage Disposal

I turned on the garbage disposal.

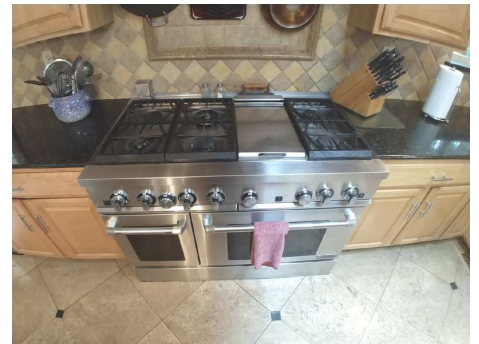
Range/Oven/Cooktop: Turned On Stove & Oven

I turned on the kitchen's stove and oven.

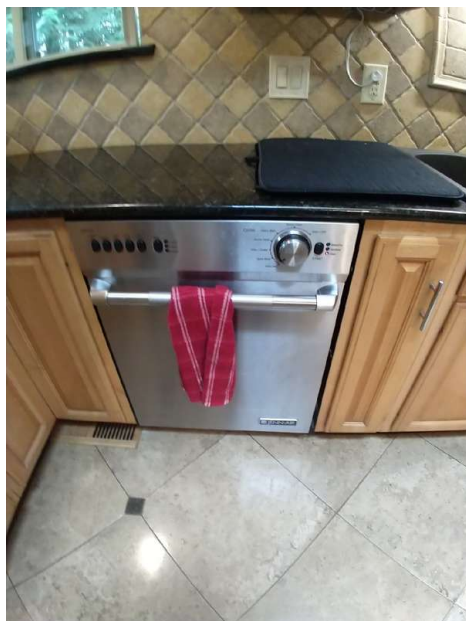
Dishwasher: Inspected Dishwasher

I inspected the dishwasher by turning it on and letting it run a short cycle.

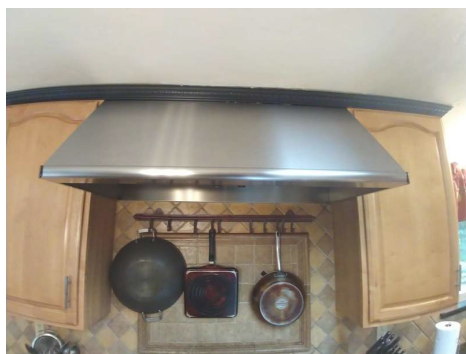
**Exhaust Fan: Inspected Exhaust Fan**

I inspected the exhaust fan in the kitchen. All mechanical exhaust fans should terminate outside. Confirming that the fan exhausts outside is beyond the scope of a home inspection.

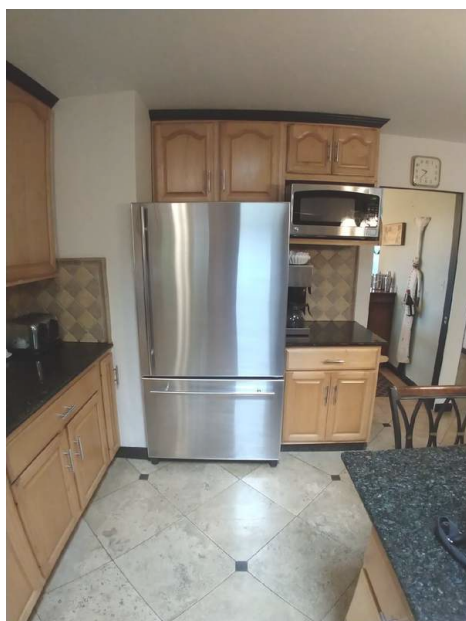
**Refrigerator: Refrigerator Was On**

I checked to see if the refrigerator was on. It was. That's all I inspected in relation to a refrigerator. Refrigerators are beyond the scope of a home inspection.

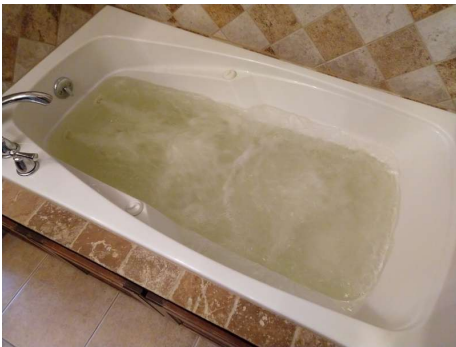
Bathub: Jetted Tub operation

The jetted tub operated as expected.

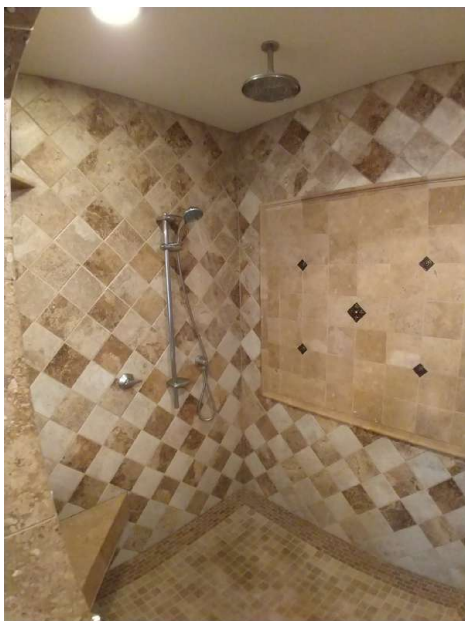
Shower: Running water

We tested and ran all of the showers in the house. At the time of the inspection there was no leaks the we could determine.

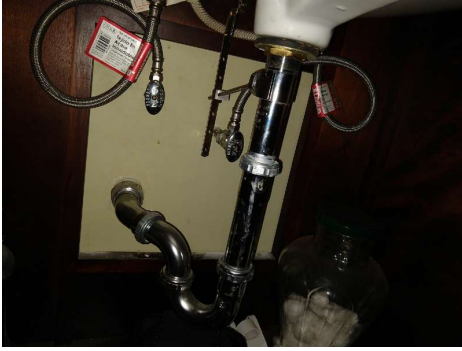
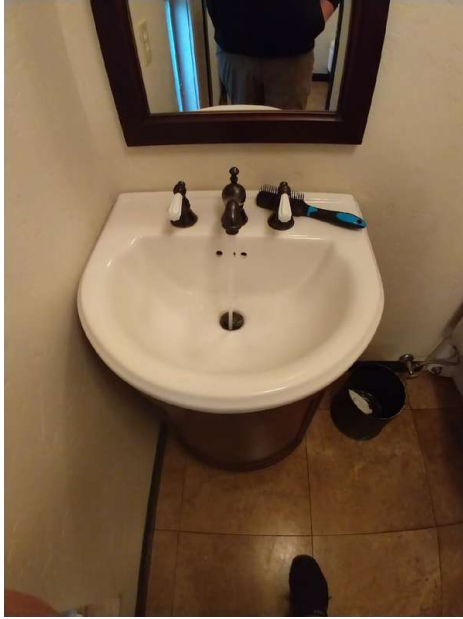
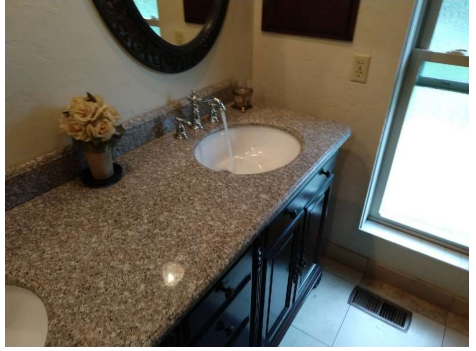
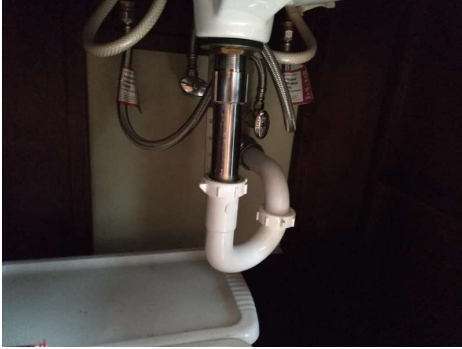
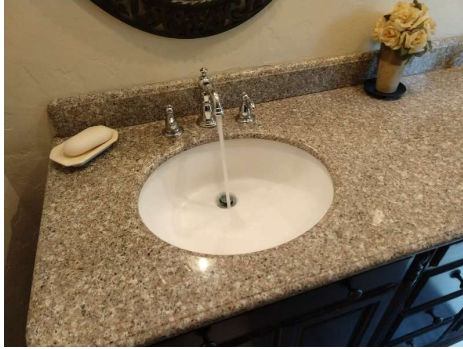
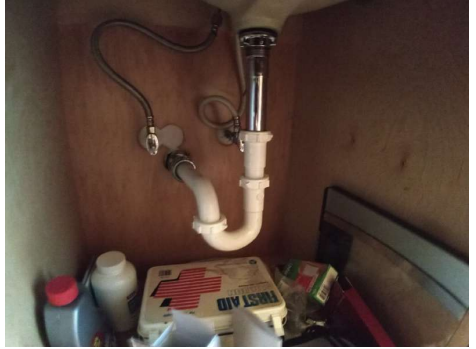
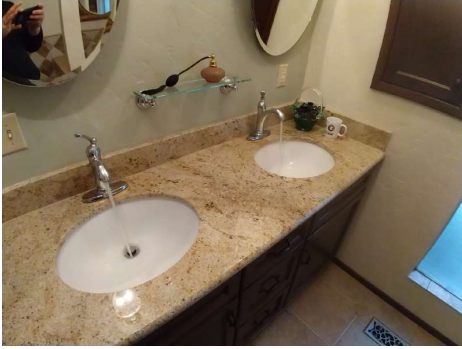
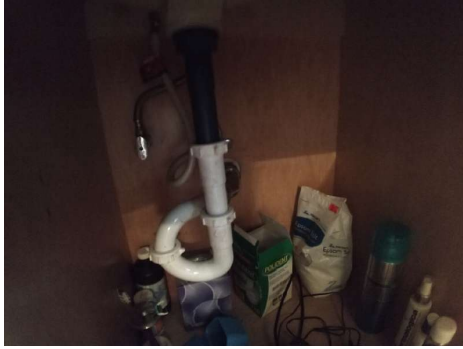
Sink/countertop: Running water and under sink area

We ran all of the water in all of the bathroom sinks. We inspected all of the plumbing underneath the sinks. At the time of the inspection there were no leaks present.

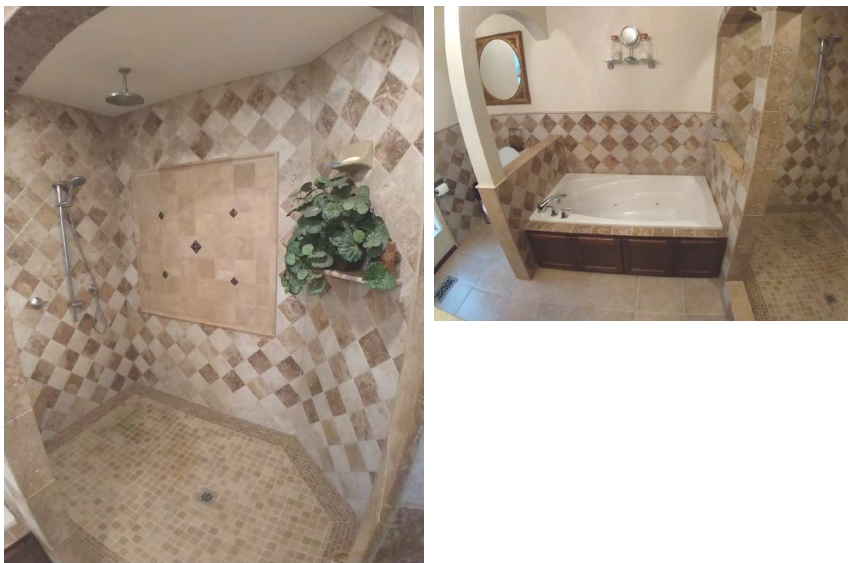
11.6.1 Shower

GROUT SEAL TILE SHOWER

Contact a qualified professional.

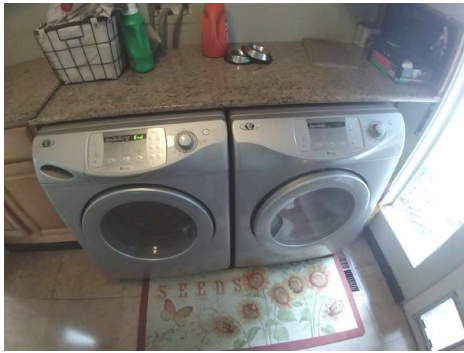
General: Dryer Operation

We normally operate clothes dryers without a wash load (i.e. we run the unit through its full cycle empty). This gives us an idea of the unit's functionality, but we caution you, it does NOT replicate operating the unit fully loaded with a heavy wash load.

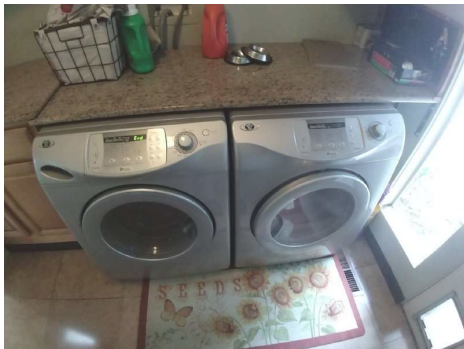
General: Washer Operation

We normally operate clothes washers without a wash load (i.e. we run the unit through its full cycle empty). This gives us an idea of the unit's functionality, but we caution you, it does not replicate the unit fully loaded with a heavy wash load.

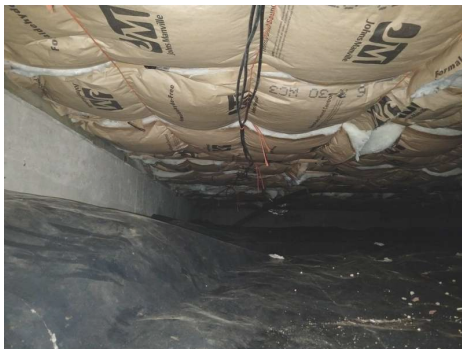
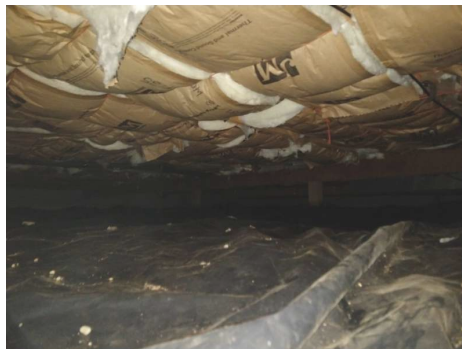
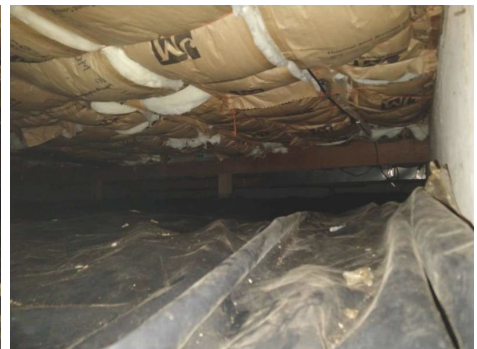
General: Crawl Space Photos

General crawl space photos.

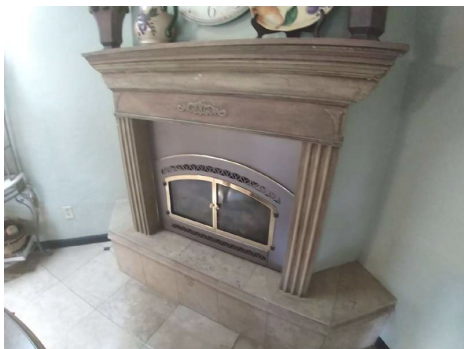
Flue and damper: Clean Annually

All solid fuel burning appliances (woodstoves and fireplaces, etc.) should be inspected annually by a qualified chimney service contractor, cleaned and repaired as necessary.
