**CHICAGOLAND HOME INSPECTORS, INC.**

## RESIDENTIAL REPORT

1234 Main St.  
Northbrook IL 60062

Buyer Name  
04/09/2018 9:00AM

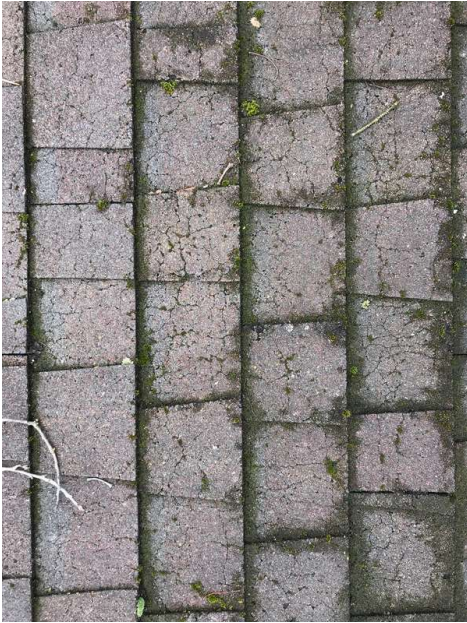
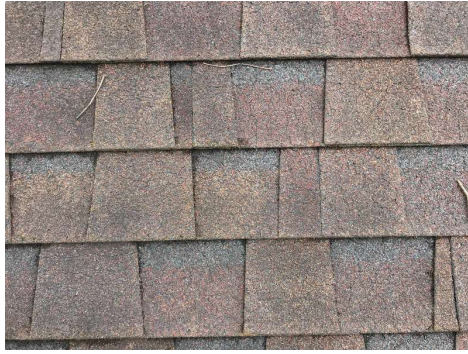
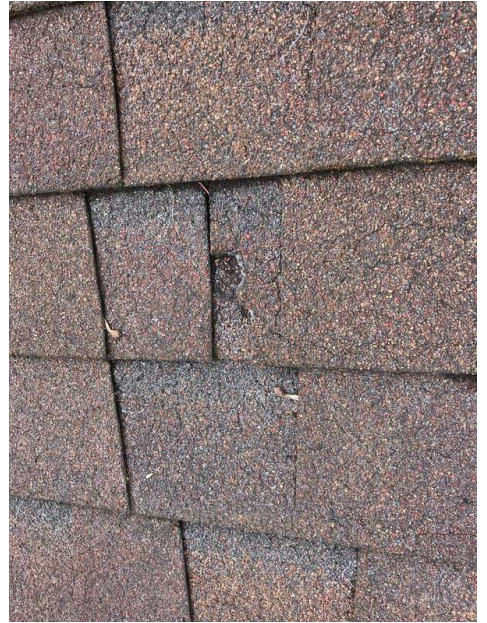
2.1.1 Main Roof Coverings

**DAMAGED COVERINGS**

Roof coverings exhibited general damage that could affect performance. Recommend a qualified roofer evaluate and repair.

Contact a qualified roofing professional.

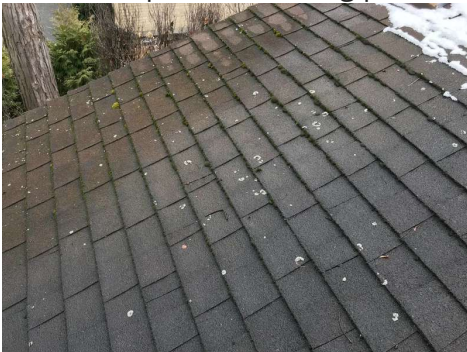
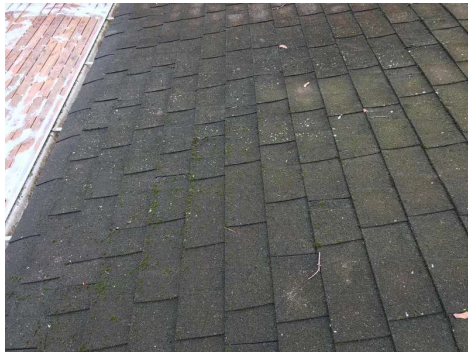
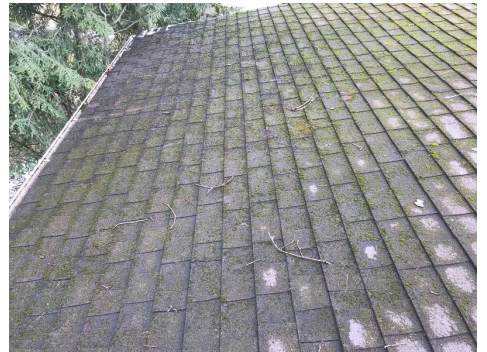
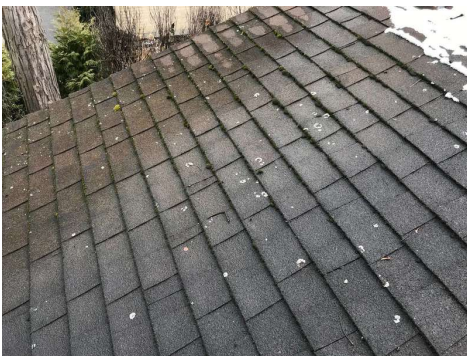
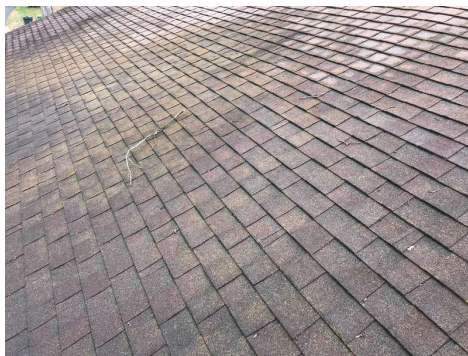
### 2.1.2 Main Roof Coverings

#### **DISCOLORATION**

**INFORMATION** - Roof shingles were discolored, which can be caused by moisture, rust or soot. Recommend a qualified roofing contractor evaluate and remedy with a roof cleaning or repair.

Contact a qualified roofing professional.

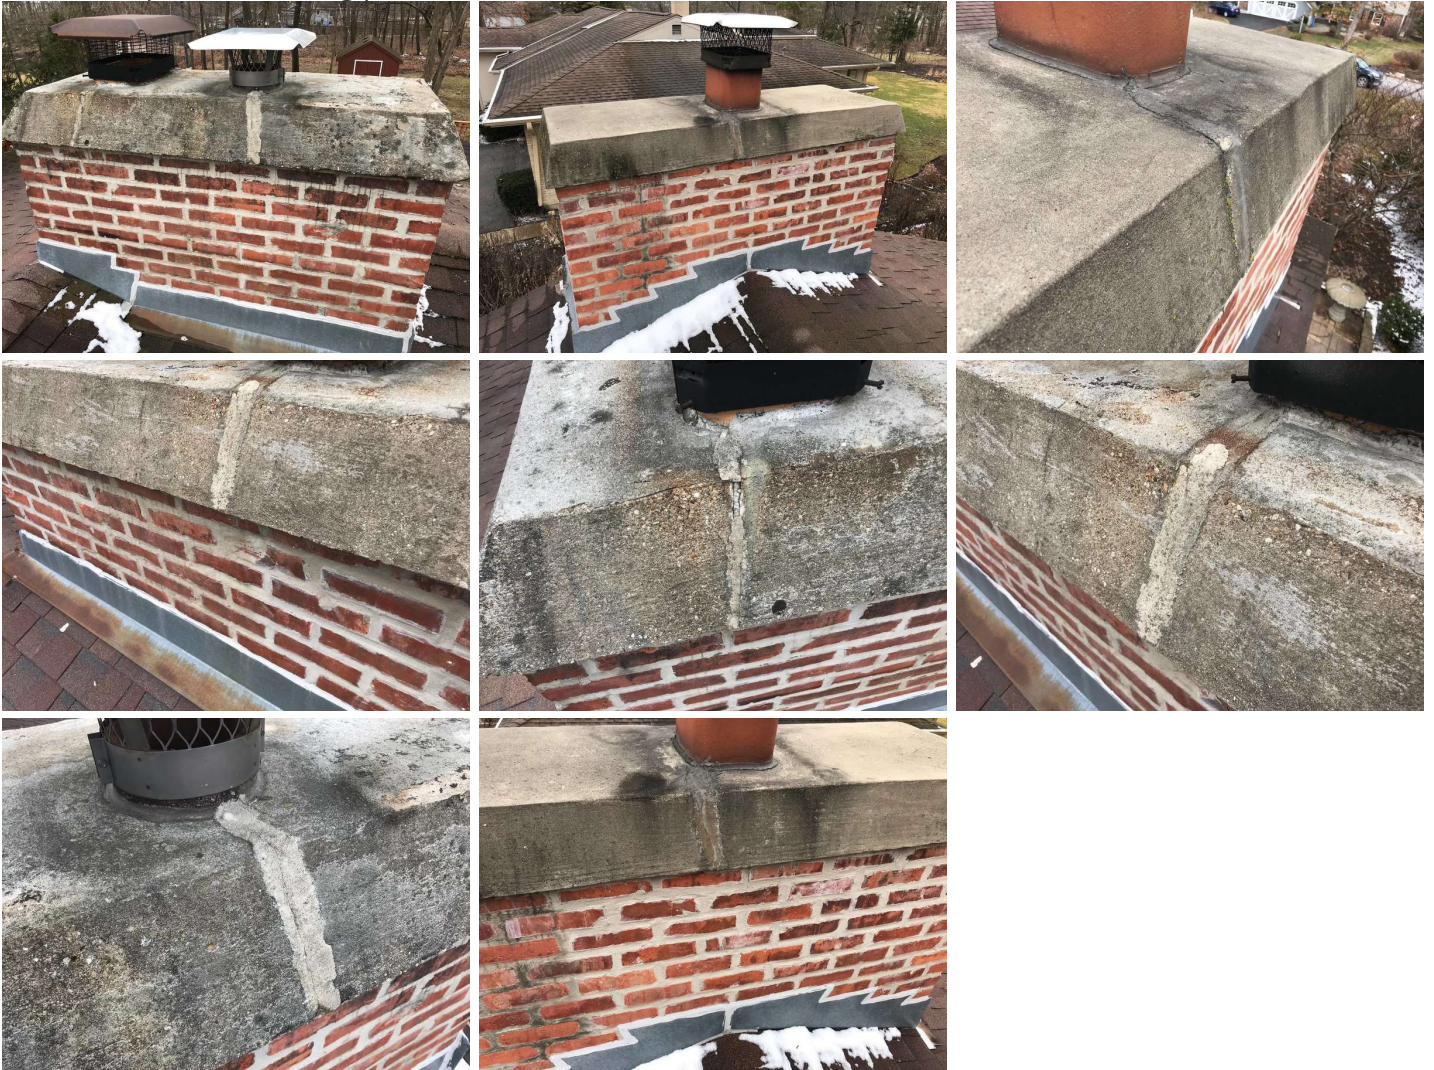
### 2.3.1 Skylights, Chimneys & Roof Penetrations

#### **CHIMNEY CROWN CRACKED**

The chimney crown had one or more cracks, which can lead to further damage to the chimney structure. Recommend a qualified contractor repair.

Contact a qualified roofing professional.

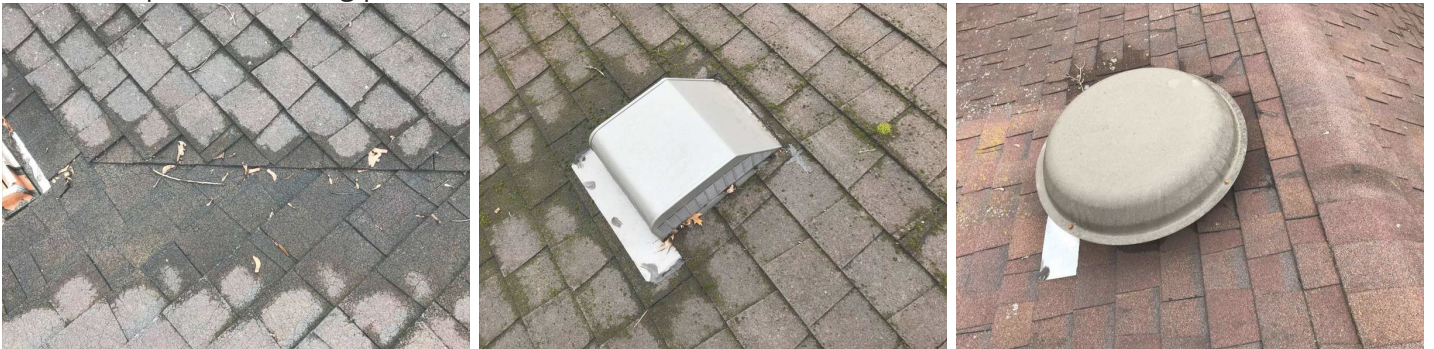
### 2.4.1 Flashings

#### **WORN**

Flashings showed signs of wear and tear. This is normal for a roof of this age. Recommend monitoring.

The valley flashing is cracked and worn.

Patching around the vent needs to be checked annually.

Patching on the attic fan needs to be inspected once a year.

Contact a qualified roofing professional.

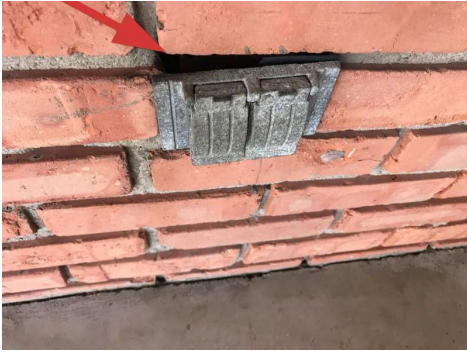
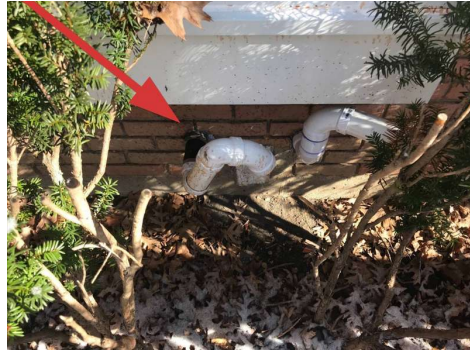
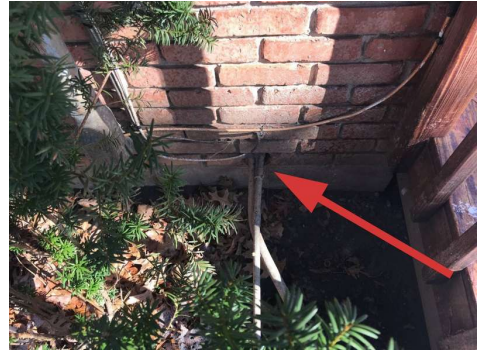
3.1.1 Siding, Flashing & Trim

#### IMPROPER CONSTRUCTION PRACTICES

Siding appears to be installed improperly and not up to standards. This could lead to moisture damage or deterioration of the home structure. These openings need to be sealed.

Contact a qualified professional.

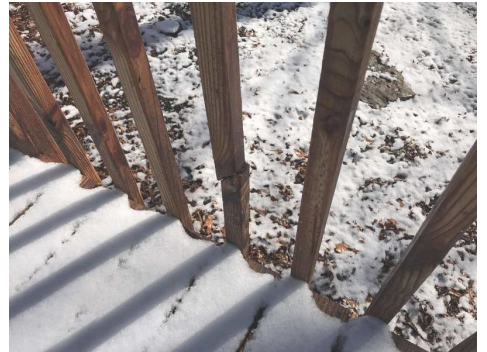
3.3.1 Decks, Balconies, Porches & Steps

**RAILINGS ARE DAMAGED**

Broken railings are present and should be repaired.

Contact a handyman or DIY project

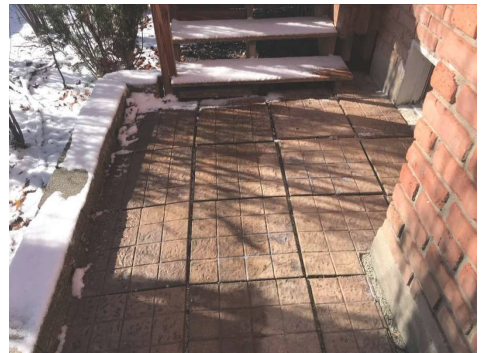
3.6.1 Walkways, Patios & Driveways

**PATIO CRACKING - MINOR**

Normal settling & cracking observed. Recommend monitor and/or patch/seal.

The patio settled on the left side.

Recommended DIY Project

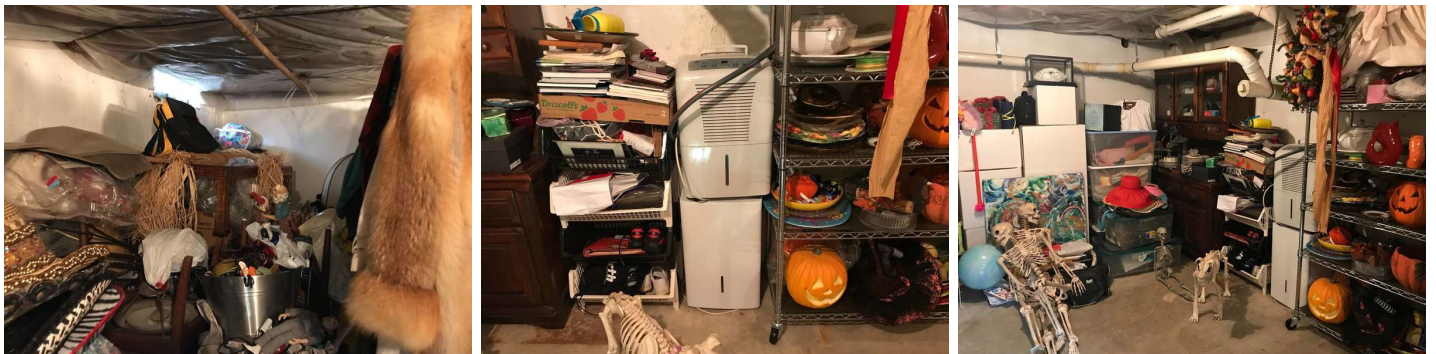
### STORAGE AND FINISHES

Storage blocked the foundation inspection. Please make a note to reserve the right for further inspection at final walk through.

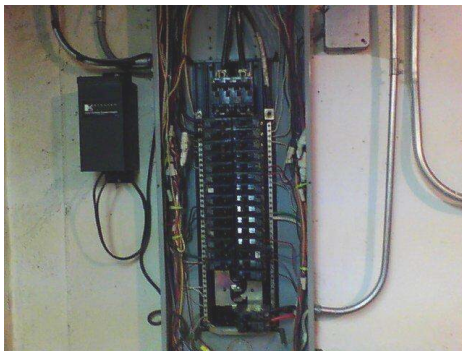
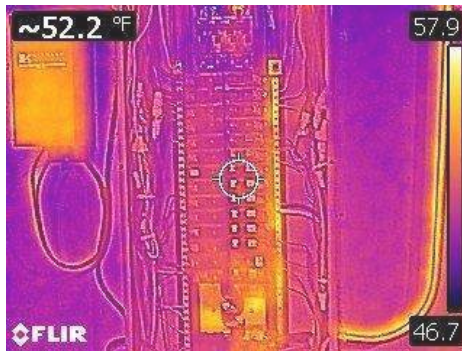
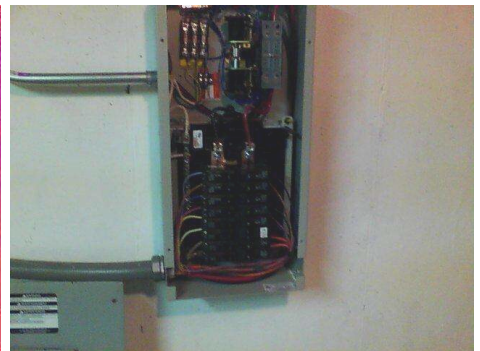
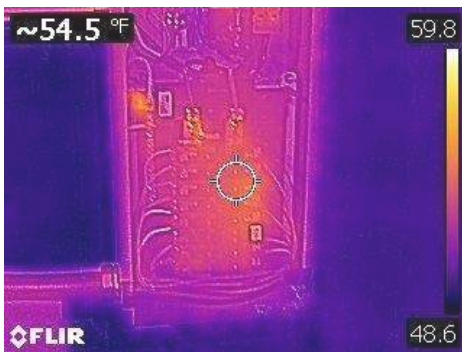
### Service and Grounding Equipment, Main Overcurrent Device, Main and Distribution Panels: Thermal Image of Panel

These photos are thermal images of the electrical panel.

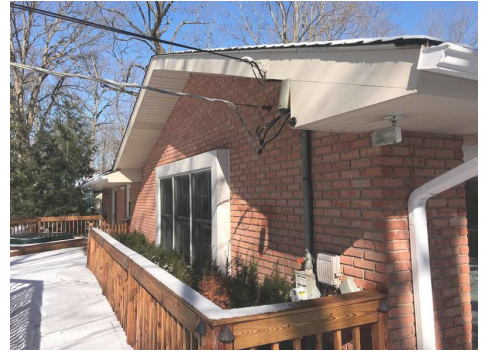
## 5.1.1 Service Entrance Conductors

**NOT ENOUGH CLEARANCE**

Service drop overhead wires are too low, not giving enough clearance above roof. Recommend contacting your local electric utility company or qualified electrician to see if they can correct.

Contact a qualified electrical contractor.

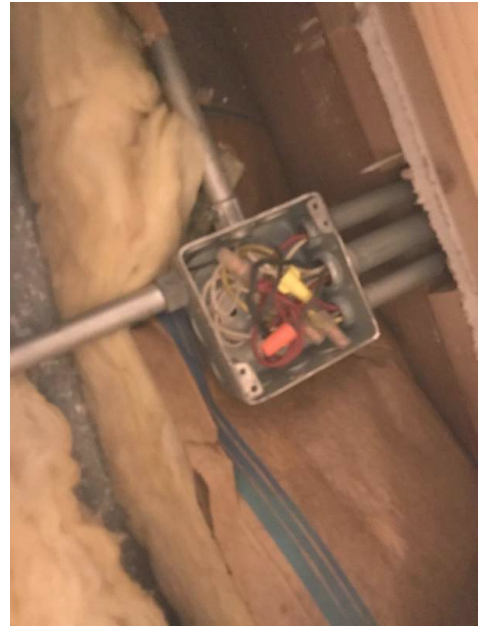
## 5.3.1 Branch Circuit Conductors, Overcurrent Devices and Compatibility of Their Amperage &amp; Voltage

**EXPOSED ENDS & SPLICES**

All wire connections & charged wires with exposed ends and splices should be covered in junction boxes for safety. Recommend a qualified electrician correct.

Contact a qualified electrical contractor.

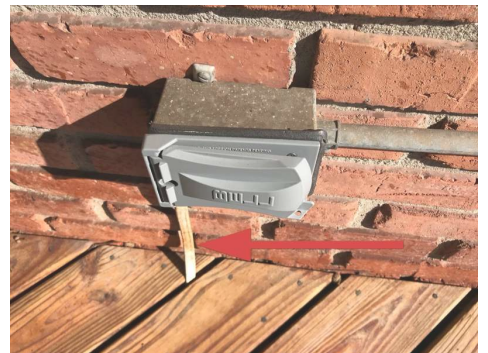
## 5.3.2 Branch Circuit Conductors, Overcurrent Devices and Compatibility of Their Amperage &amp; Voltage

**IMPROPER WIRING**

Improper wiring was observed at the time of inspection. Recommend a licensed electrician evaluate and repair.

NMC is not designed to be installed like this. This type of wiring is not accepted by the local authority.

Contact a qualified electrical contractor.

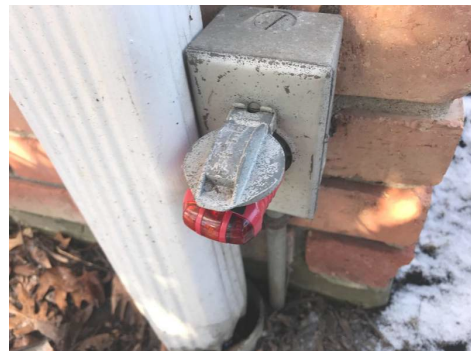
## 5.4.1 Outlets, Switches, Lights, and Ceiling Fans

**NO GFCI PROTECTION INSTALLED**

THE OUTDOOR AND BASEMENT OUTLETS

No GFCI protection present in all locations. Recommend licensed electrician upgrade by installing ground fault receptacles in all locations.

Contact a qualified electrical contractor.

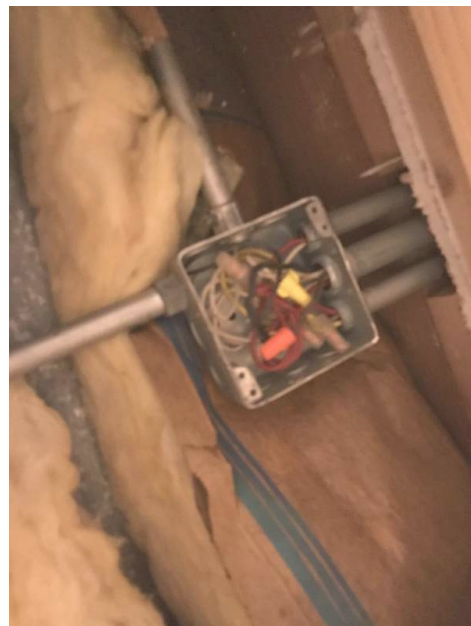
5.4.2 Outlets, Switches, Lights, and Ceiling Fans

**OPEN JUNCTION BOX**

Open junction box observed. Recommend concealing or replacing.

Recommended DIY Project

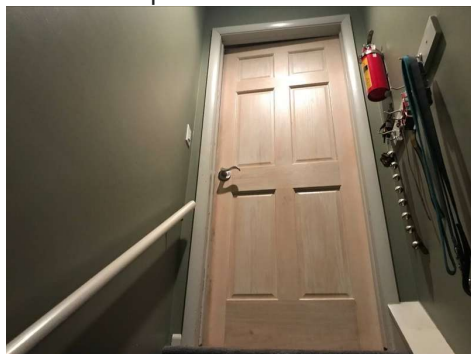
5.4.3 Outlets, Switches, Lights, and Ceiling Fans

**SWITCHES INSTALLED IMPROPERLY**

One or more switches are installed improperly. Recommend licensed electrician repair or replace.

There is no 3-way switch to the basement

Contact a qualified electrical contractor.

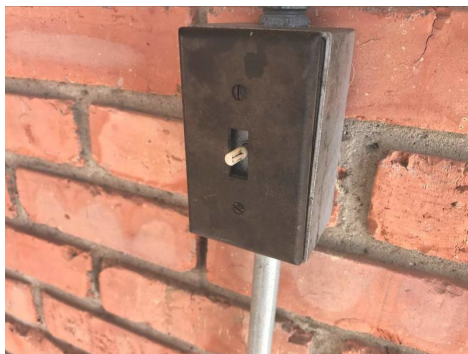
The outdoor dimmer switch is missing a knob

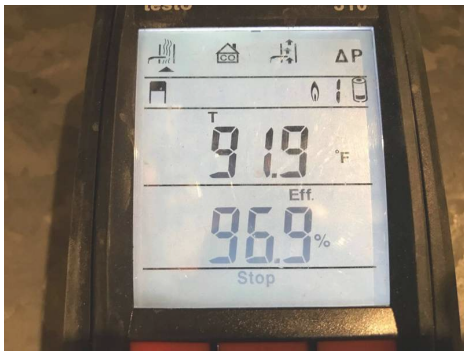
The pictures here are the reading from the combustion analysis. The system was operating normally and safely.

Efficiency reading. The furnace was operating at 96.9% efficiency.

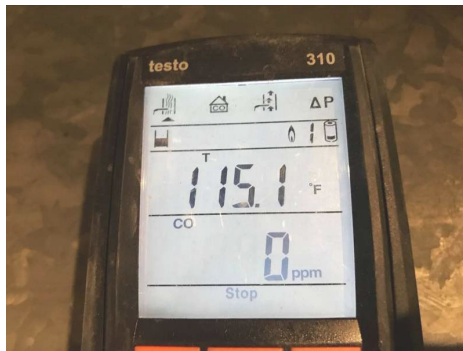
No carbon monoxide was detected in the circulation air.

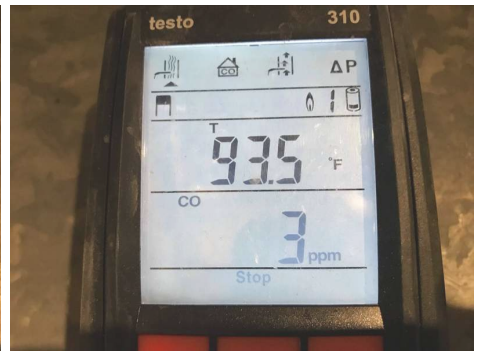
3 parts per million of carbon monoxide was detected in the exhaust. This is fantastic and shows the furnace is well tuned.

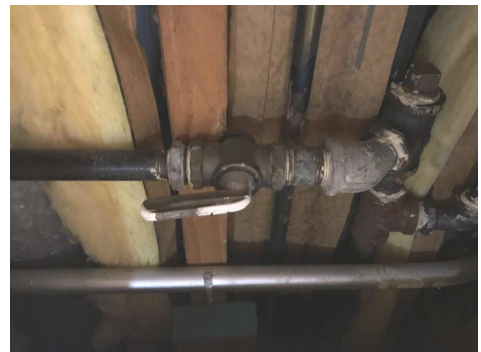
### 6.4.1 Fuel Storage & Distribution Systems

#### LEAKING GAS LINE

A gas line was observed to be leaking at time of inspection. Recommend a qualified plumber or local utility company evaluate and repair.

Contact a qualified plumbing contractor.

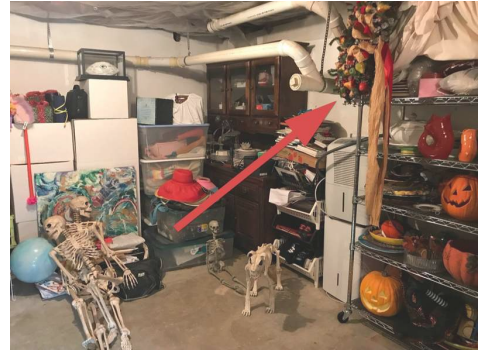
### 8.3.1 Drain, Waste, & Vent Systems

#### **IMPROPER CONNECTIONS OR IMPROPER REPAIR**

The waste lines have poor connections or the repair present is not trustworthy.

Duct tape is used on the connection where the pipe leaves the building.

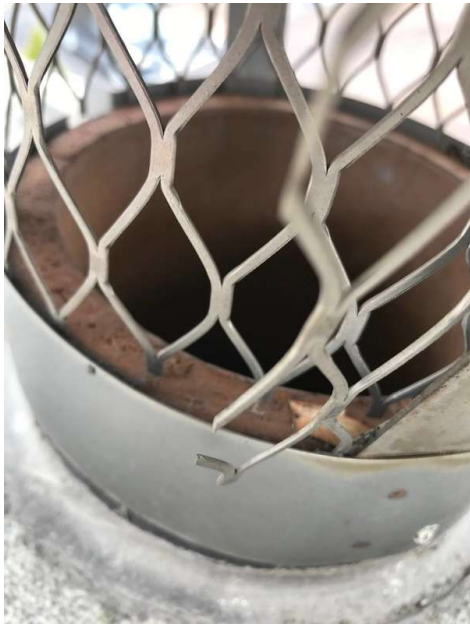
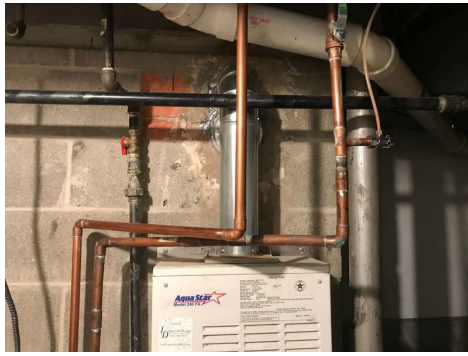
### 8.4.3 Water Heater

#### **THE WATER HEATER VENTS INTO THE CHIMNEY**

The water heater terminates into the chimney. This appliance needs to have a flue liner that carries the exhaust gasses all the way through, up, and out of the chimney. Lack of this liner causes deterioration of the chimney.

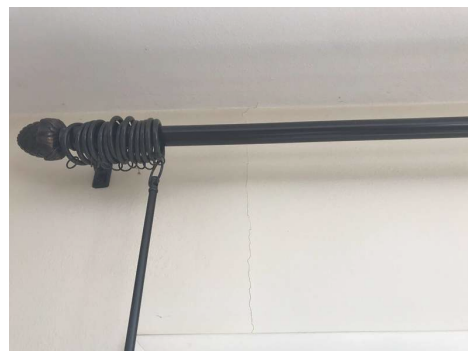
### 9.1.1 Walls

#### MINOR CRACKS

Minor cracks, nail pops, and other damage were noted on the walls. This is not unusual in a home of this age and these cracks are not a structural concern.

Contact a qualified structural engineer.

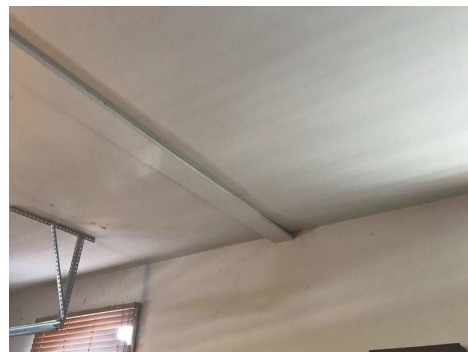
### 9.2.1 Ceilings

#### MINOR DAMAGE

Minor damage or deterioration to the ceiling was visible at the time of the inspection.

Contact a qualified professional.

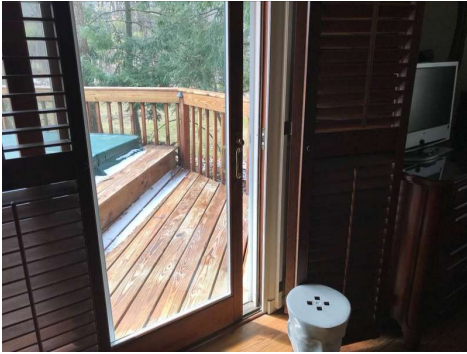
9.4.1 Doors

**DOOR DOESN'T LATCH**

Door doesn't latch properly. Recommend handyman repair latch and/or strike plate.

Bedroom door does not lock

Contact a qualified handyman.

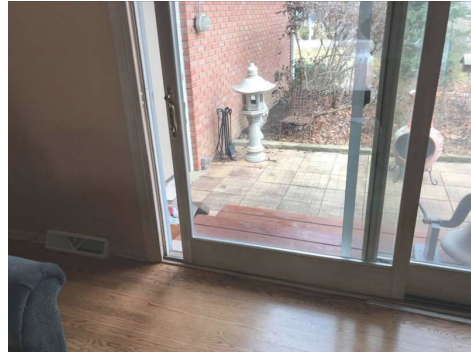
Family room door does not lock

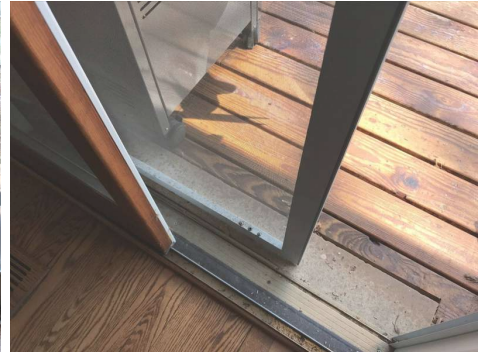
The screen is off the track

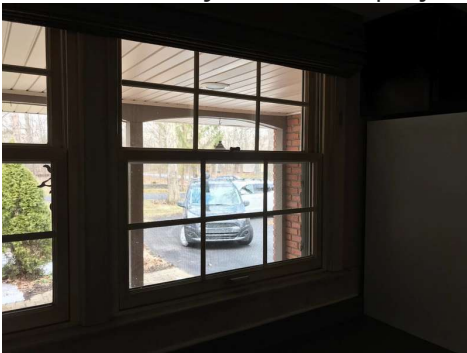
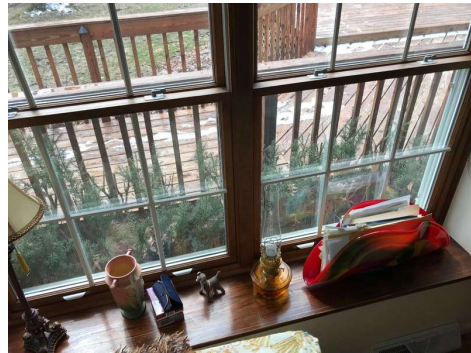
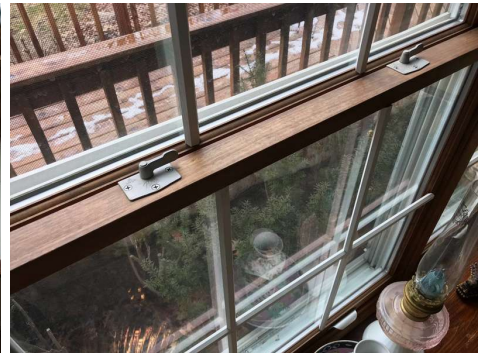
9.5.1 Windows

**DIFFICULT TO OPERATE**

Some of the windows were difficult to open, close, or tilt inwards for cleaning. The windows were also drafty and seperated when the locks were engaged.

Contact a handyman or DIY project

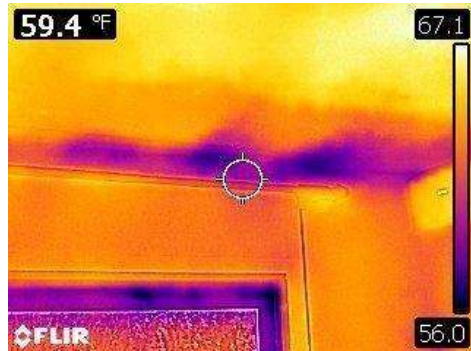
### 10.1.1 Attic Insulation

#### INSUFFICIENT INSULATION

Insulation depth was inadequate. Recommend a qualified attic insulation contractor install additional insulation.

Contact a qualified insulation contractor.

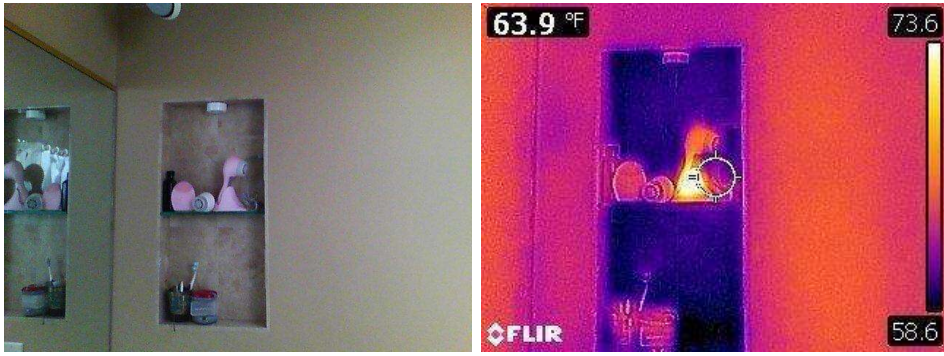
### 10.2.1 Wall Insulation

#### INSUFFICIENT INSULATION

Insulation depth was inadequate. Recommend a qualified attic insulation contractor install additional insulation.

Contact a qualified insulation contractor.

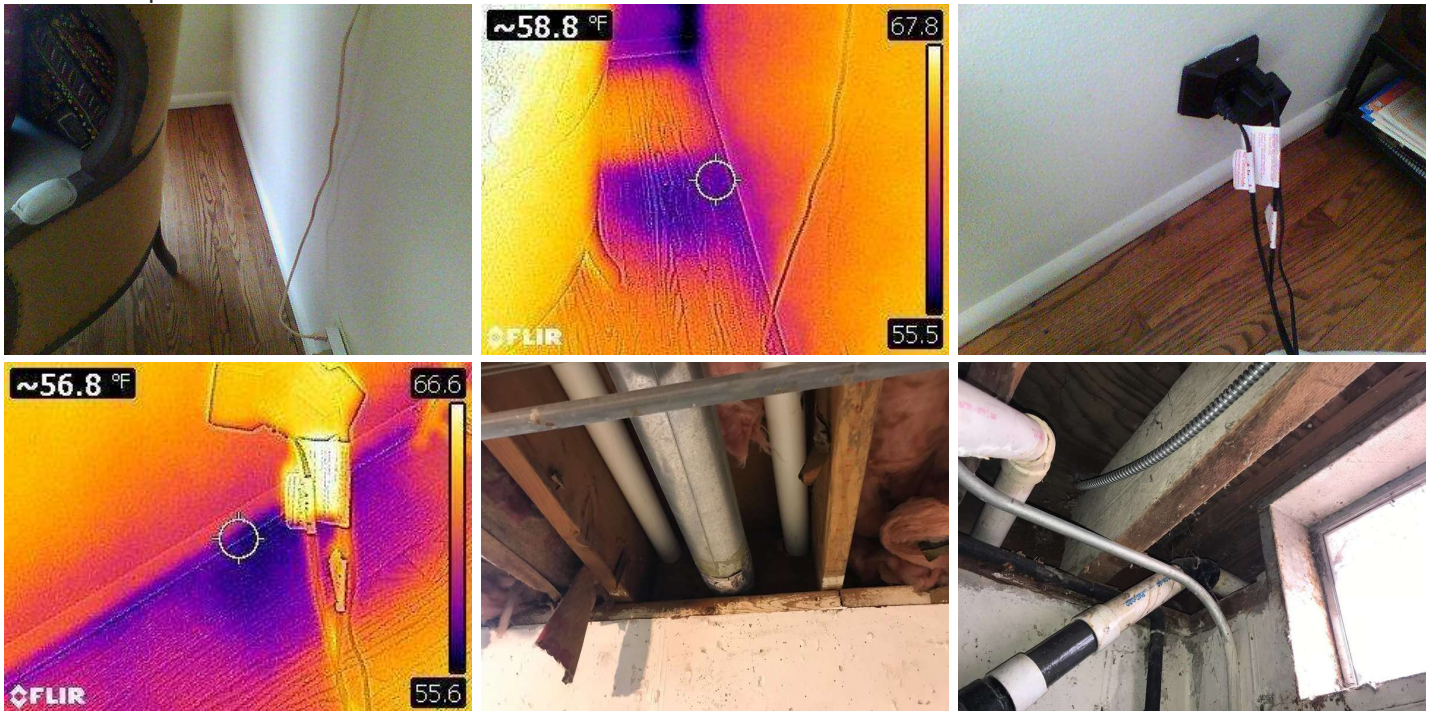
### 10.3.1 Under Floor and Rim Joist Insulation

#### **INSUFFICIENT INSULATION**

Insulation depth was inadequate. Recommend a qualified attic insulation contractor install additional insulation.

Contact a qualified insulation contractor.

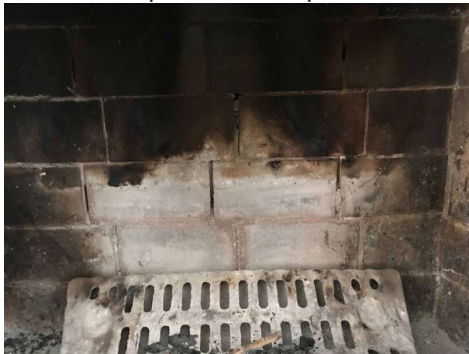
### 11.1.1 Fireplaces, Stoves & Inserts

#### **FIREWALL CRACKED**

The brick lining of the fireplace was cracked in one or more places, which could lead to chimney damage or toxic fumes entering the home. Recommend a qualified fireplace contractor evaluate and repair.

The fireplace in the family room has cracks in the firebox. This is unsafe to use until a level 2 inspection is performed by a chimney sweep.

Contact a qualified fireplace contractor.

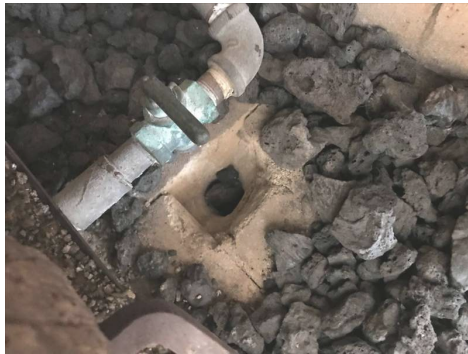
This is the fireplace in the piano room. There is a hole in the floor of the firebox. The isolation valve is inside the firebox.

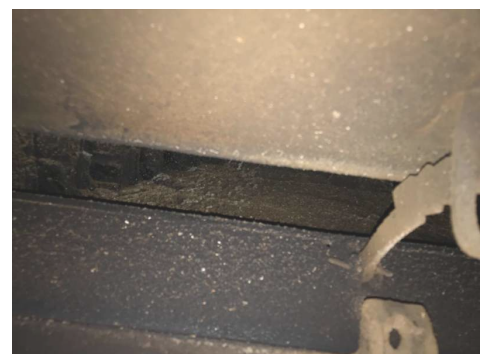
### 11.3.1 Chimney & Vent Systems

#### **CHIMNEY LINER DIRTY**

Chimney liner had layer of creosote dust, so underlying structure couldn't be inspected for cracks. Recommend qualified chimney sweep company inspect and/or clean.

Contact a qualified chimney contractor.

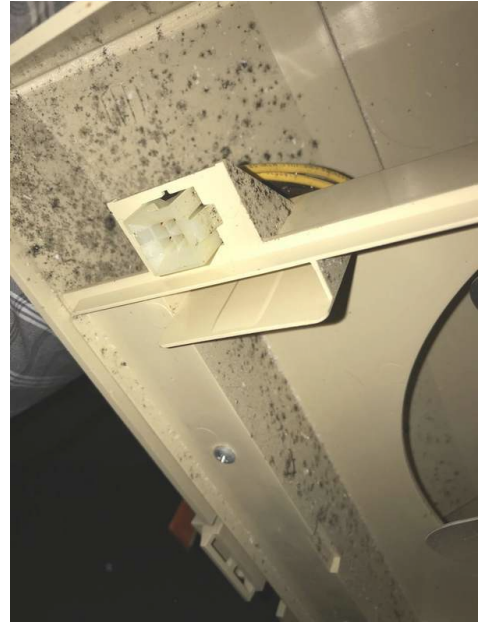
12.5.1 Humidifier

The humidifier has mold growing in it. I consider this unhealthy and it should be cleaned.

Contact a qualified HVAC professional.
