POTTS HOME INSPECTIONS, LLC

POTTS RESIDENTIAL REPORT

1234 Main St.
Chattanooga TN 37421

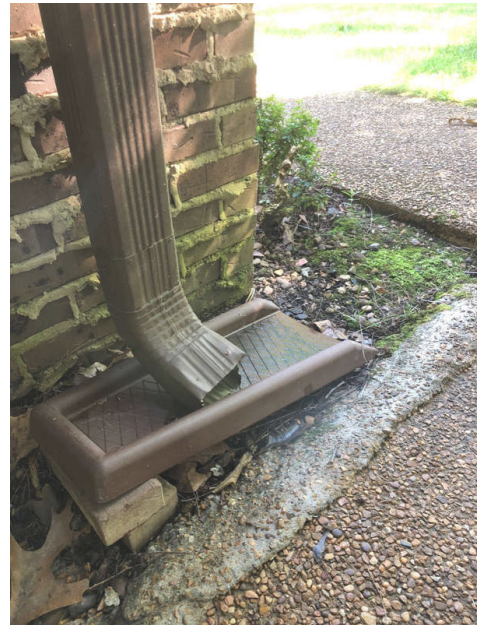
One or more downspouts drain too close to the home's foundation. This can result in excessive moisture in the soil at the foundation, which can lead to foundation/structural movement.

Recommend a qualified contractor adjust downspout extensions to drain at least 6 feet from the foundation.

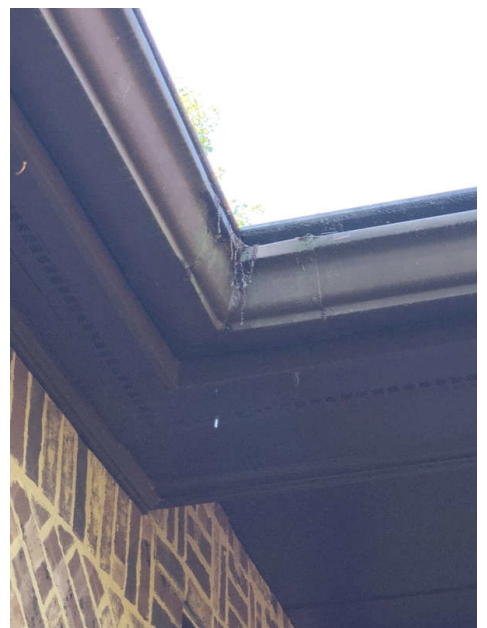
2.2.3 Roof Drainage Systems

GUTTER DAMAGED

Gutters were damaged. This can result in excessive moisture in the soil at the foundation, which can lead to foundation/structural movement. Recommend a qualified contractor evaluate and repair.

Contact a qualified roofing professional.

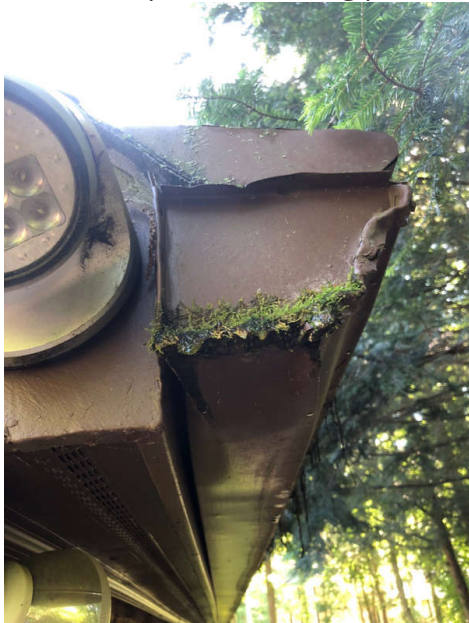
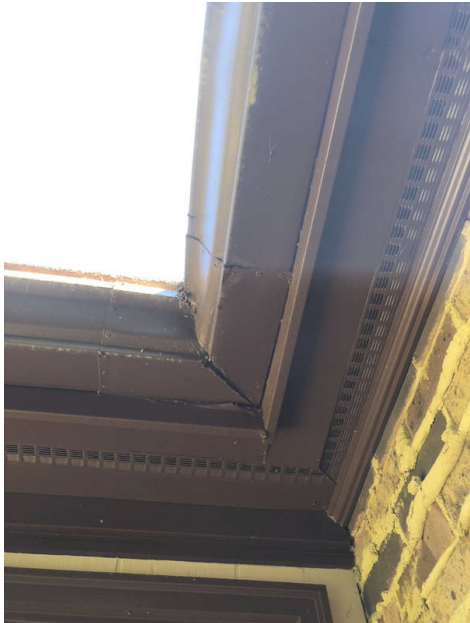
2.2.4 Roof Drainage Systems

Leaking Corner Gutters (Multiple)

GUTTER LEAKAGE

Gutters were observed to be leaking in one or more areas. This can result in excessive moisture in the soil at the foundation, which can lead to foundation/structural movement. Recommend a qualified contractor evaluate and repair gutters to proper functionality.

Moss Growing In Leak

Contact a qualified roofing professional.

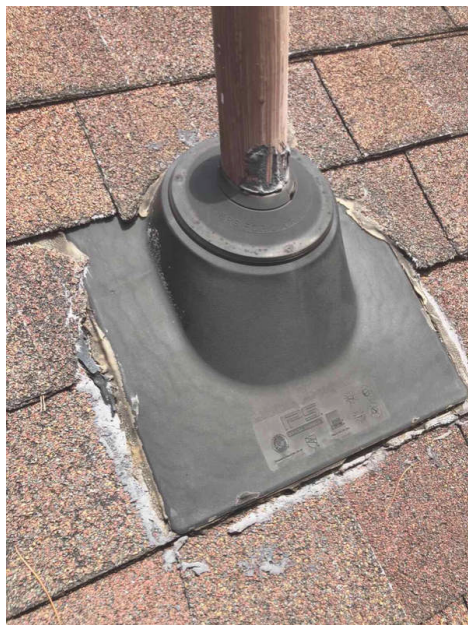
Plumbing boot shows signs of wear and age. Recommend that you monitor and be advised from roofing contractor on best way to waterproof and fix.

Contact a qualified professional.

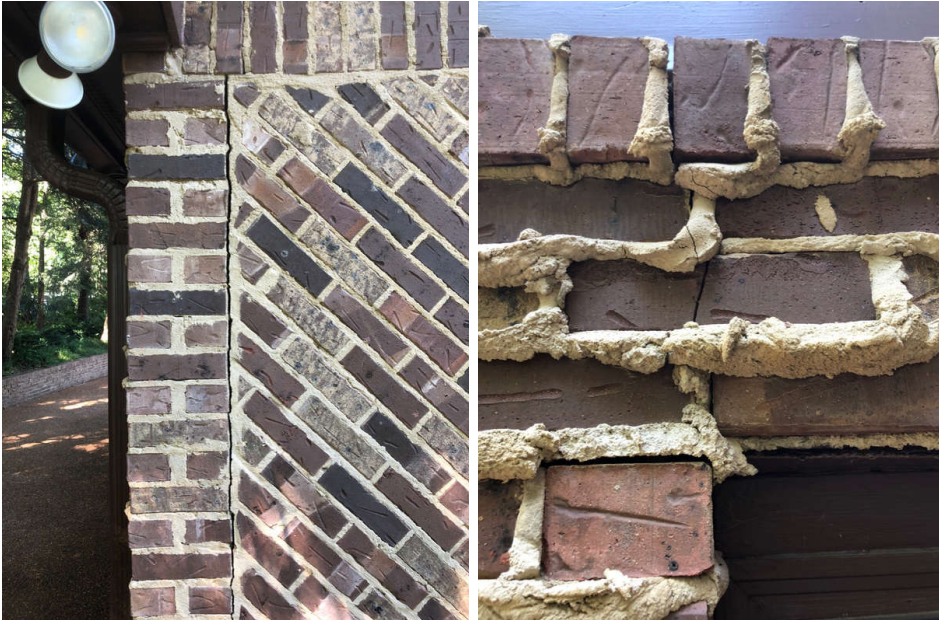
CRACKING - MINOR

Siding showed minor cracking in one or more places. Minor cracks / holes (14 or less) were present in siding. These should be sealed to prevent water infiltration. This is a result of soil changes, differential settlement and temperature changes, and are typical in homes of this age. Recommend periodic monitoring and evaluation.

Recommended DIY Project

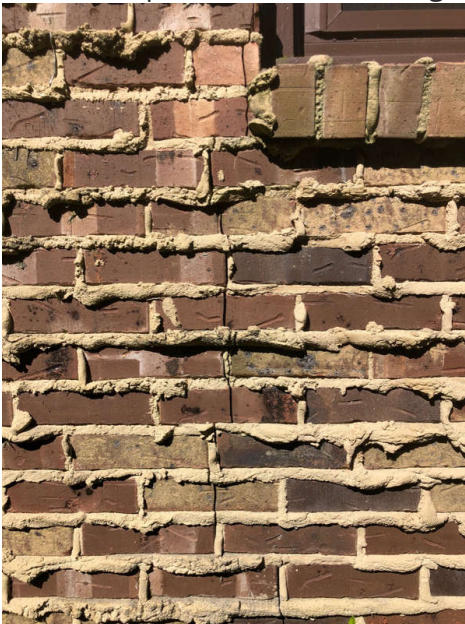
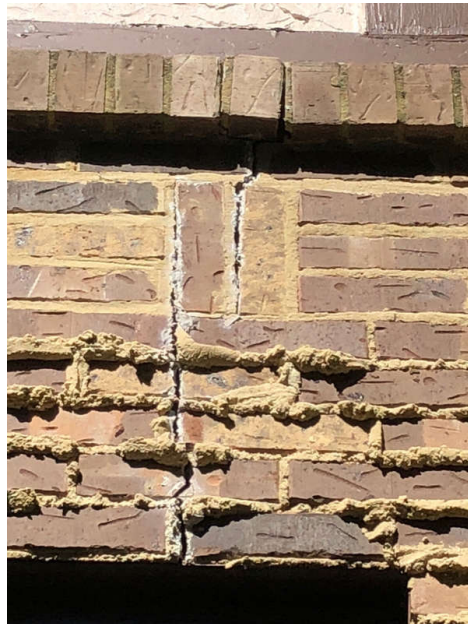
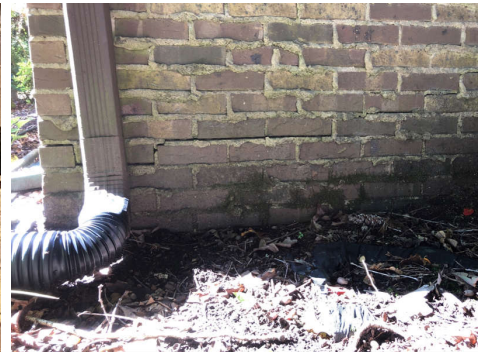
3.1.2 Siding, Flashing & Trim

CRACKING - MODERATE

Moderate to major cracking was observed at one or more points on the exterior. Moderate cracks (14" to 34") were present in exterior siding. These may be a structural concern and deem further inspection.

Recommend an evaluation by a qualified geotechnical and/or structural engineer to evaluate this property to determine the likelihood of future settlement and/or soil movement, and to determine the integrity of the structure.

Contact a qualified structural engineer.

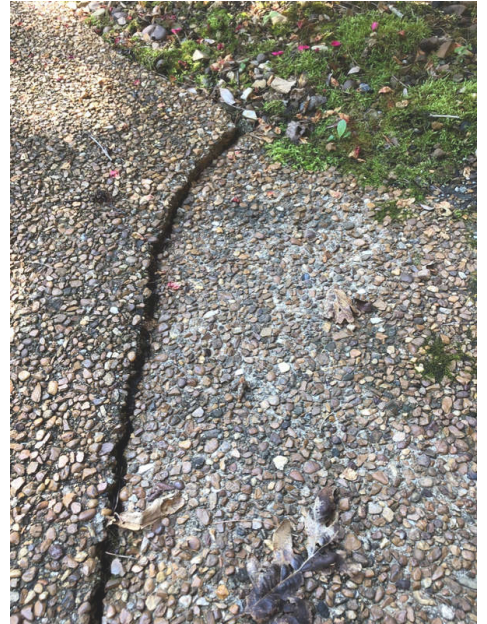
3.1.3 Siding, Flashing & Trim

CRACKING - MAJOR

Moderate to major cracking was observed at one or more points on the exterior. Measured at 3/4 or more Major cracks/holes (more than 1/4 wide) present in the siding. This can be the result of poor original compaction of soil at the time of construction or excess moisture in the underlying soil.

Recommend an evaluation by a qualified geotechnical and/or structural engineer to evaluate this property to determine the likelihood of future settlement and/or soil movement, and to determine the integrity of the structure.

Contact a qualified structural engineer.

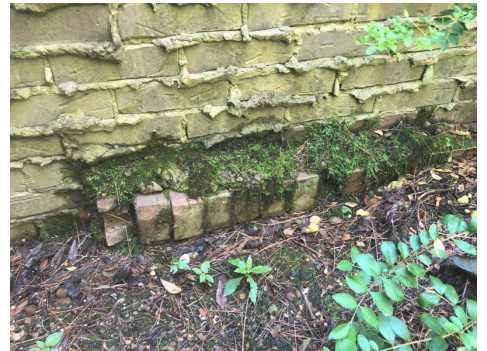
3.1.4 Siding, Flashing & Trim

There are signs of algae and/or mildew on the siding. This is a cosmetic issue and is not uncommon especially on shaded portions of the home. Recommend that said areas be washed or cleaned on a regular basis.

Contact a qualified professional.

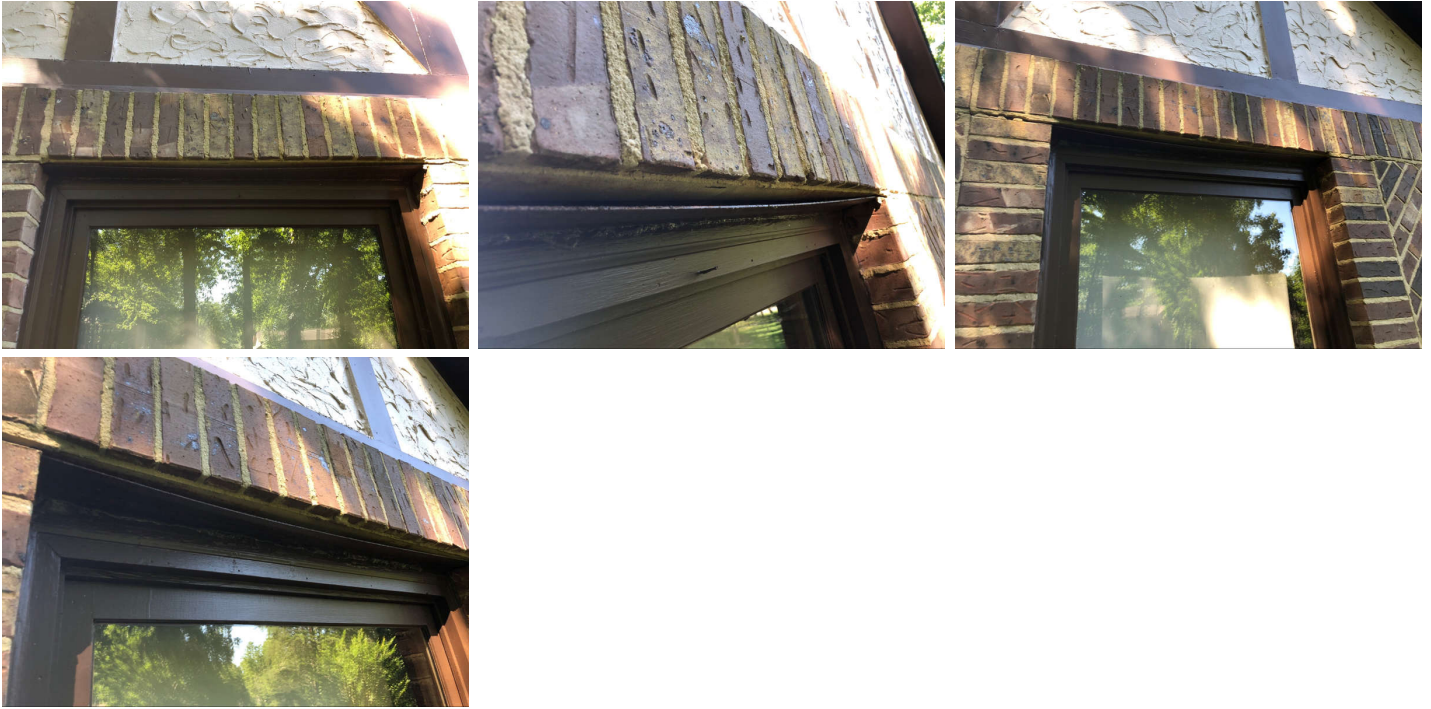
3.1.5 Siding, Flashing & Trim

Lintels above some of the front windows are undersized and have bowed. *Recommend contacting Masonry Contractor to evaluate and repair.*

Contact a qualified masonry professional.

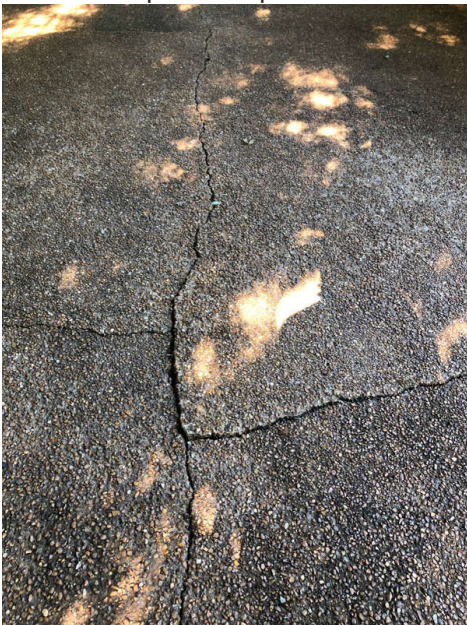
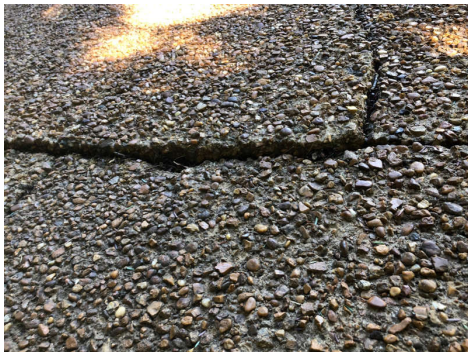
3.3.1 Walkways & Driveways

WALKWAY - TRIP HAZARD

Trip hazard was noted in the walkway. Rear brick walkway shows signs of settling with soil movement. Recommend contractor to level and grade properly so water dispersed away from the house.

Contact a qualified professional.

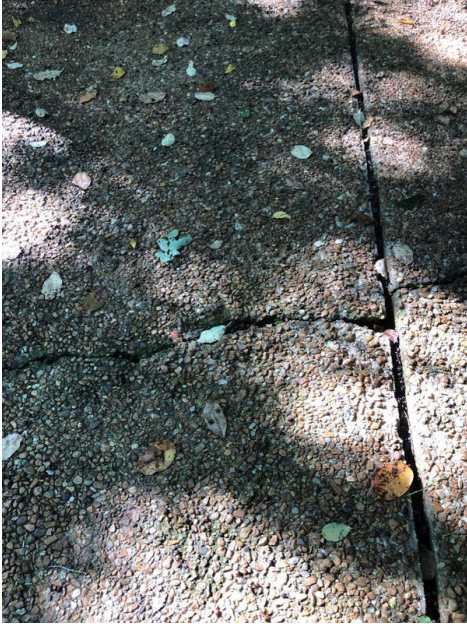
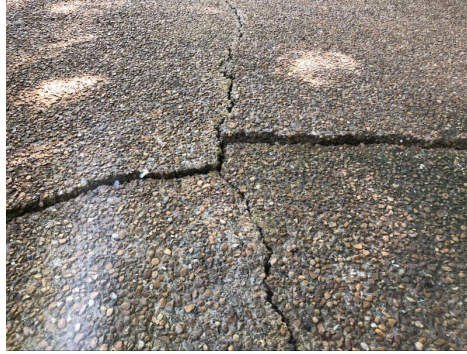
3.3.2 Walkways & Driveways

WALKWAY CRACKING - MINOR

Minor cosmetic cracks observed. Cracks of this type are typical of the area and can be a minor trip hazard. Recommend monitor and/or patch/seal.

Recommended DIY Project

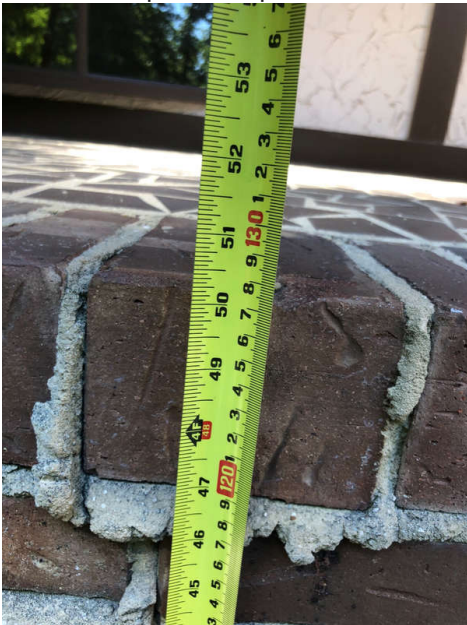
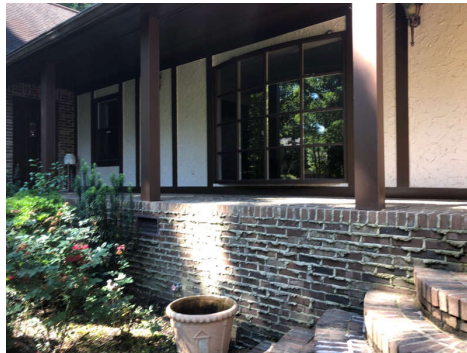
3.4.1 Decks, Balconies, & Porches

DECK/PORCH NO RAILING

Measure the height of the elevated floor level. All decks and porches, including those with insect screening, landings, balconies, mezzanines, galleries, ramps, or raised floor surfaces located more than 30 inches (US), above the floor or ground should have guards. *Recommend contacting Handyman/Contractor to discuss options.*

Contact a qualified professional.

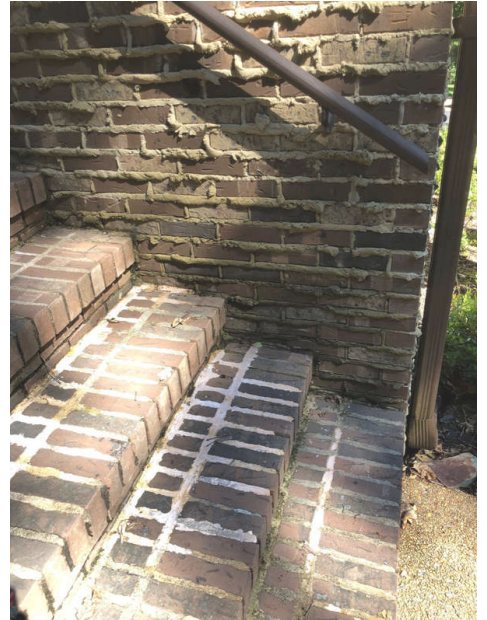
3.5.1 Steps

STAIRS - EXCESS WATER DAMAGE

Water damage was noted at the stairs. This may be due to incorrect gutter installation. *Recommend gutter contractor to evaluate and remedy.*

Contact a qualified gutter contractor

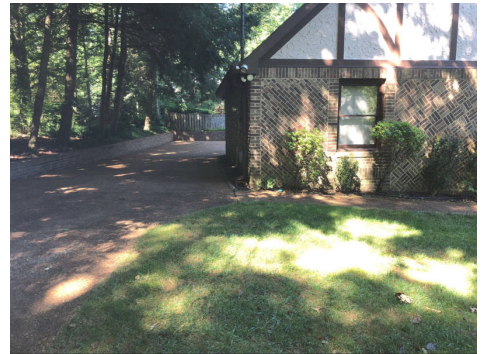
3.7.1 Grading & Drainage

NEGATIVE GRADING

Grading is sloping towards the home in some areas. This could lead to water intrusion and foundation issues. Recommend qualified landscaper or foundation contractor regrade so water flows away from home.

Contact a qualified landscaping contractor

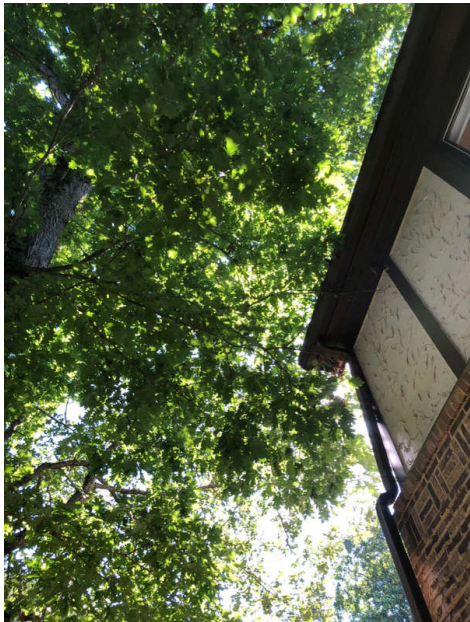
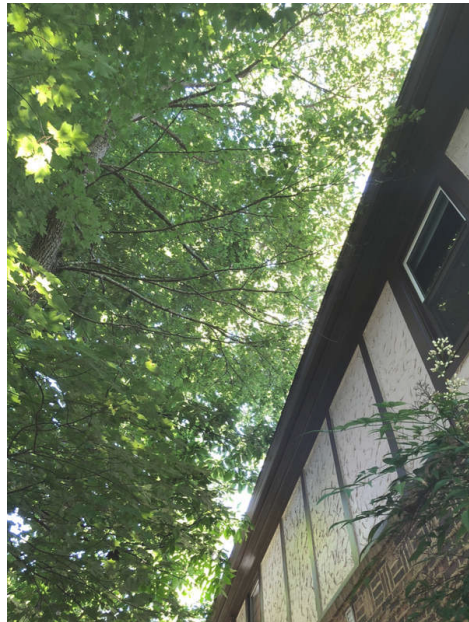
3.8.1 Vegetation

OVERHANGING TREES

Multiple trees were noted overhanging the property. Recommend contacting a tree service or arborist to evaluate and remove potential hazards.

Contact a qualified tree service company.

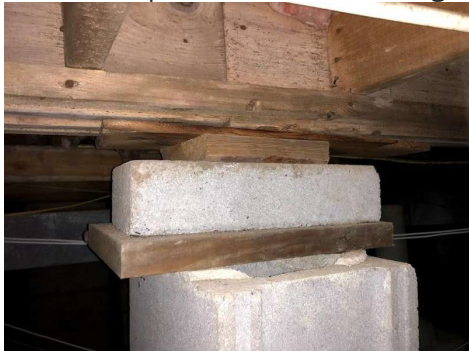
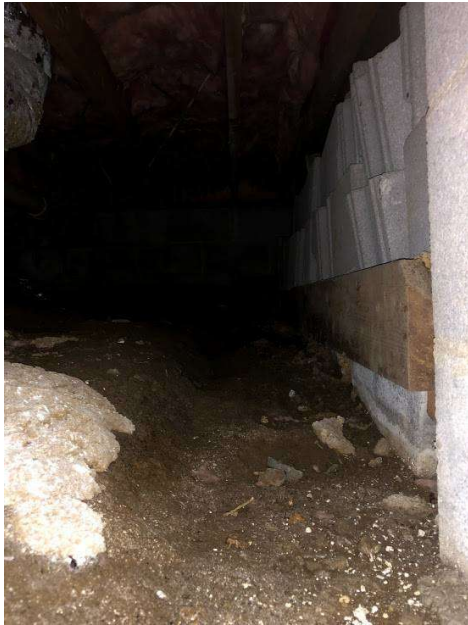
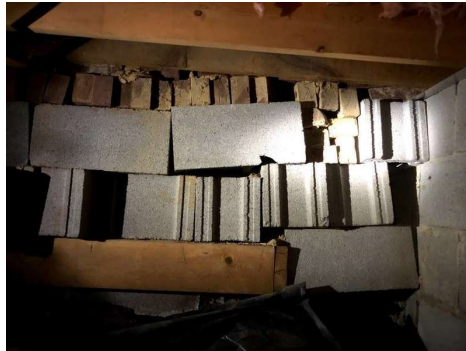
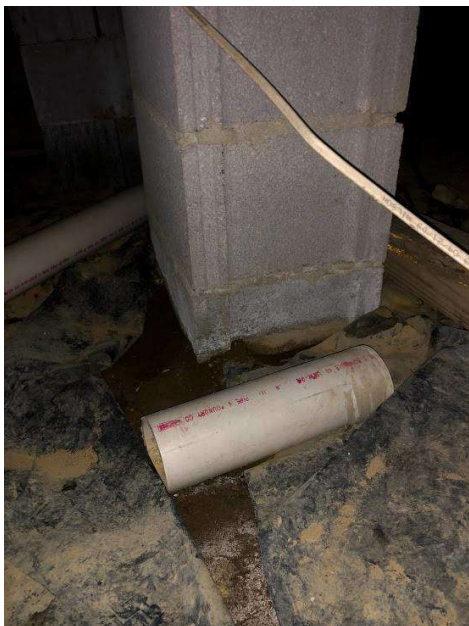
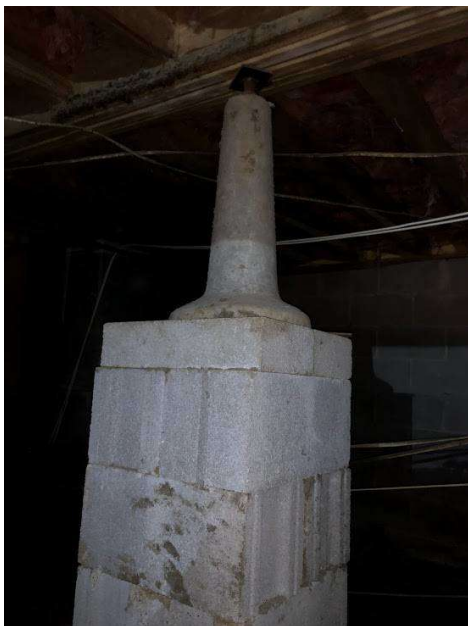
4.1.1 Foundation

IMPROPER CONSTRUCTION PRACTICES

Improper or sub-standard construction practices were noted at the foundation wall or slabs/piers. Multiple places had revealed in-field support and repair jobs to the foundation. The mix of long-term replacements with short-term fixes can reveal a large issue and should be looked into by an expert in that field. Due to the overwhelming number of post construction supports - not all of the photos show all of the *new* footings/piers.

Recommend a structural engineer evaluate and advise on how to bring the construction up to standards.

Contact a qualified structural engineer.

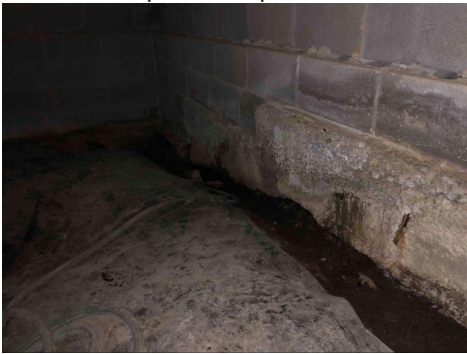
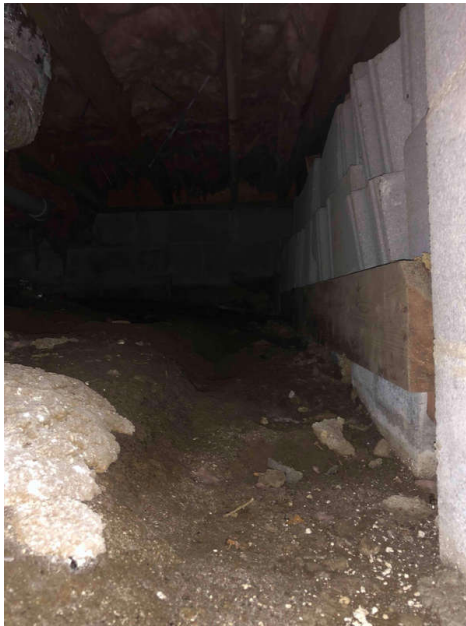
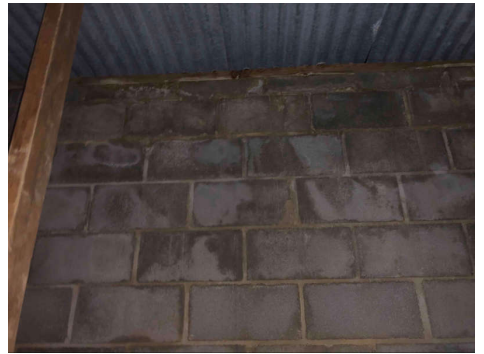
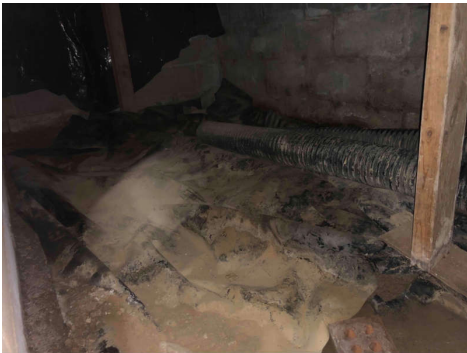
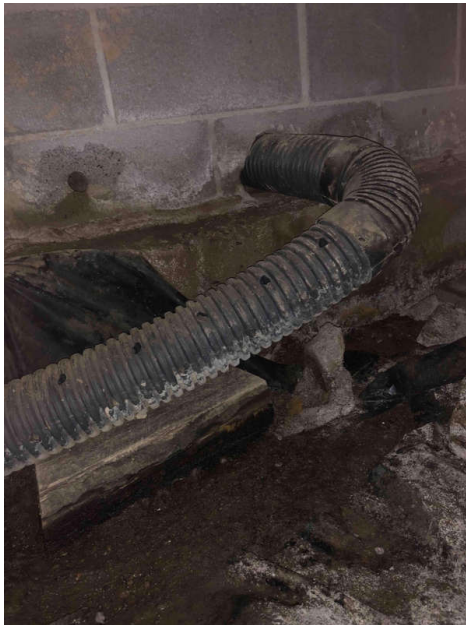
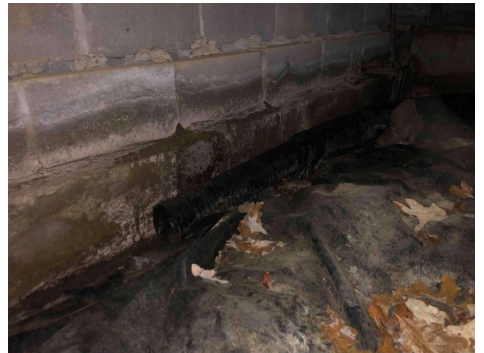
Soil in the crawlspace was damp or wet. This condition may be the result of rising ground water or may result from surface runoff seeping under and/or through the foundation walls. *You should ask the seller for any information they can provide about this condition.*

Moisture intrusion can affect the ability of the soil beneath the foundation to carry the weight of the structure above and may cause structural damage from soil movement. Moisture intrusion can also damage home materials and encourage the growth of microbes such as mold.

Recommend taking action to identify the source of the moisture intrusion and correct the condition.

Contact a qualified professional.

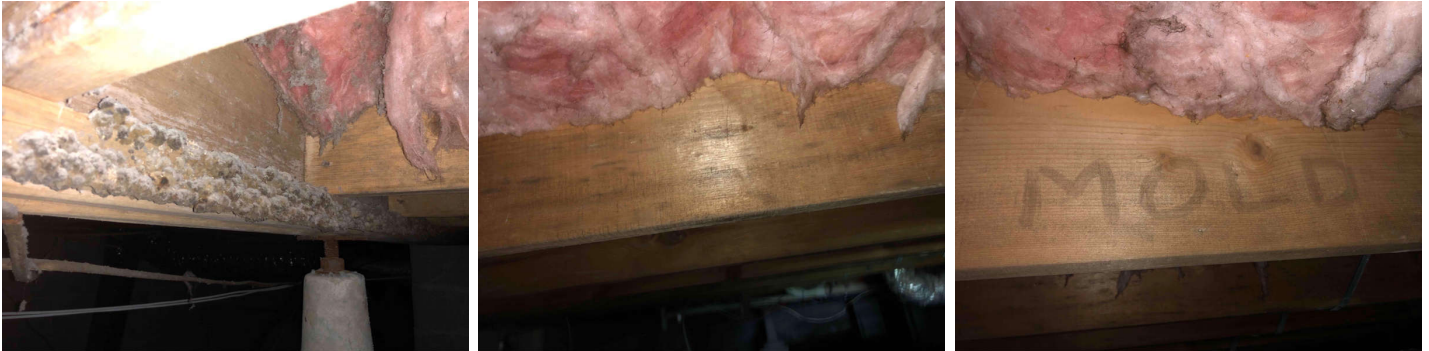
4.3.3 Crawlspace

Evidence of Mold and mold spores were noted during the inspection.

Mold cannot exist without moisture. Therefore, any moisture whatsoever, whether it be from inadequate grading and drainage, a leaking roof, window, or door, or moisture from a faulty exhaust vent, a condensate pipe, an evaporator coil, or a component of a plumbing system should be serviced immediately, or the potential for mold contamination will remain.

Recommend Mold Mitigation company assess the extent of the issue and provide remedy on removing active spores.

Contact a qualified mold inspection professional.

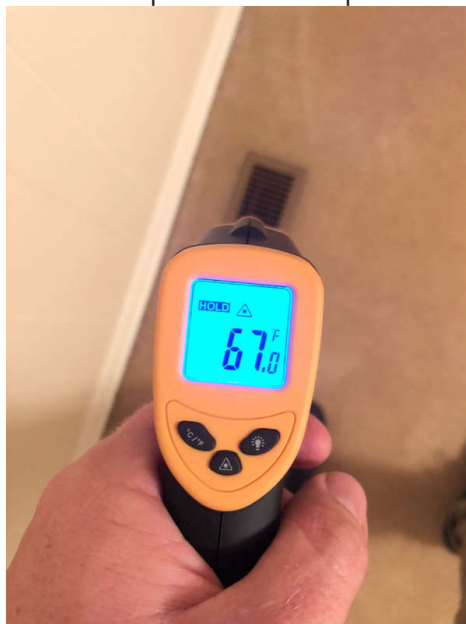
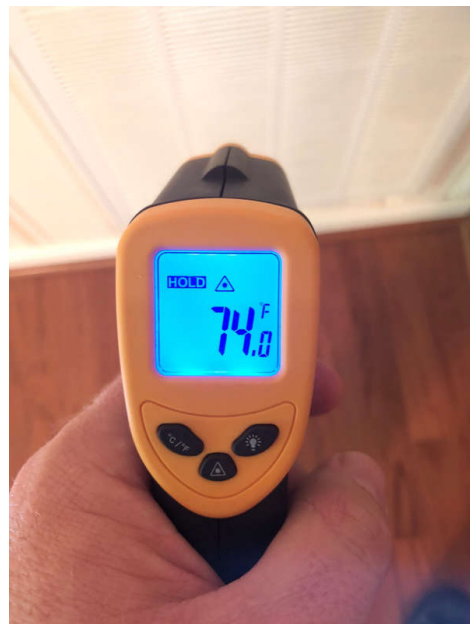
Inadequate temperature differential. Supply air from the air conditioning system was not cool enough. It should be 14 to 20 degrees Fahrenheit cooler than at the return duct(s), or current room temperature. This may be caused by refrigerant loss, dirty coils, a failing compressor, an oversized fan, or a deficient return air system.

A qualified heating and cooling contractor should evaluate and repair as necessary.

Contact a qualified HVAC professional.

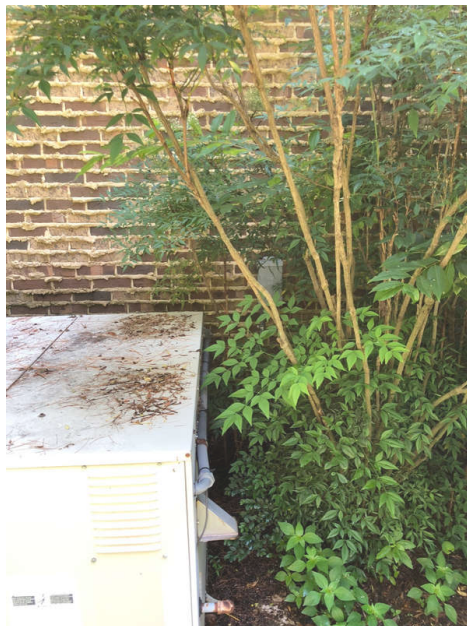
5.3.1 Condensing Unit

Vegetation such as trees, shrubs and/or vines are too close to the outdoor condensing unit. Standard building practices require that there be at least 12 inches of clearance on all sides and at least four to six feet above. Inadequate clearances around the condensing unit can result in reduced efficiency, increased energy costs and/or damage to equipment. Vegetation should be pruned and/or removed as necessary to maintain these clearances.

Contact a qualified landscaping contractor

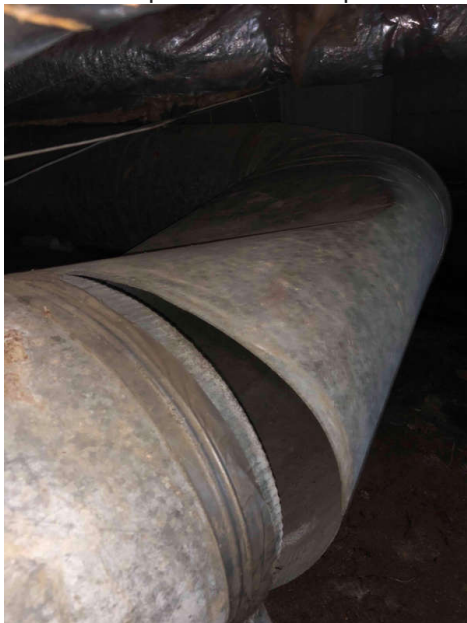
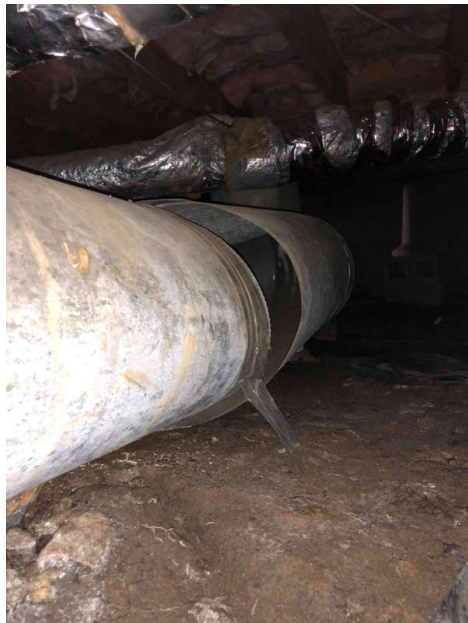
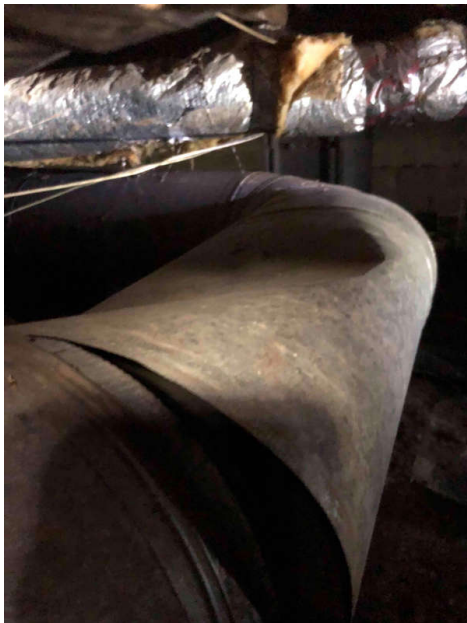
5.5.1 Duct Work

BROKEN/DISCONNECTED

One or more air supply ducts are broken or disconnected. Increased moisture levels in unconditioned spaces and higher energy costs may result. A qualified contractor should evaluate and make permanent repairs as necessary.

Contact a qualified HVAC professional.

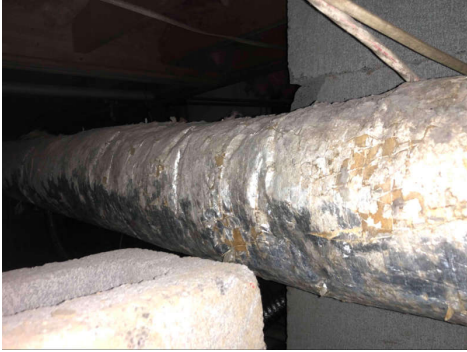
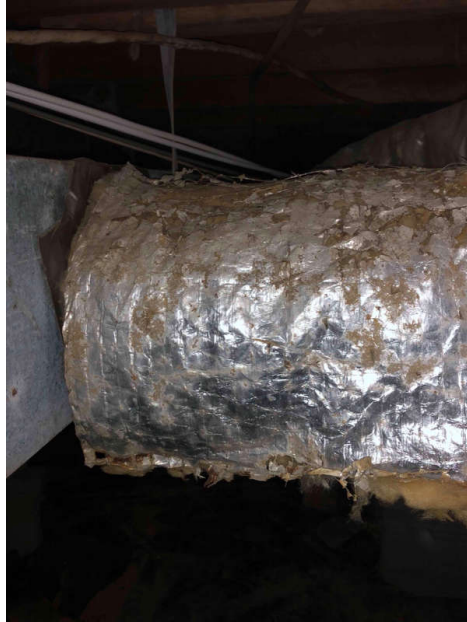
5.5.2 Duct Work

INSULATION DETERIORATED

Insulation on one or more heating/cooling ducts in unconditioned spaces is damaged and/or deteriorated. A qualified contractor should evaluate and replace insulation and/or ducts as necessary and as per standard building practices.

Contact a qualified HVAC professional.

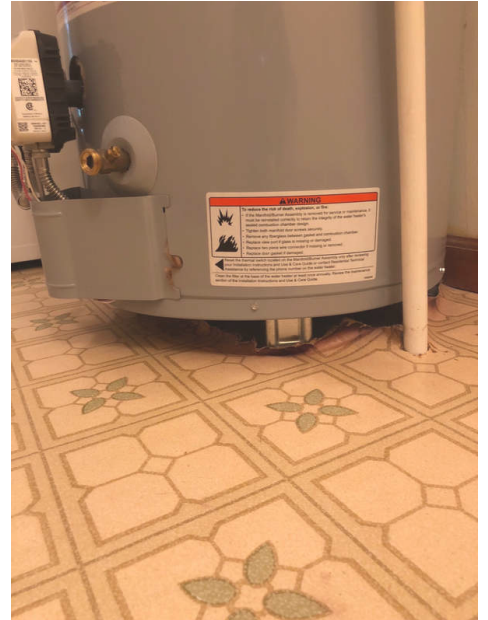
No drip pan was present. Where a leak from a water heater tank would cause damage, a pan is required. The pan should be galvanized steel, aluminum, or plastic. A plastic pan must not be installed under a gas-fired water heater tank. The pan must be drained by an indirect waste pipe and should terminate over an indirect waste receptor, or should extend to the exterior and terminate between 6 and 24 inches of the ground surface.

Recommend installation by a qualified plumber.

Contact a qualified plumbing contractor.

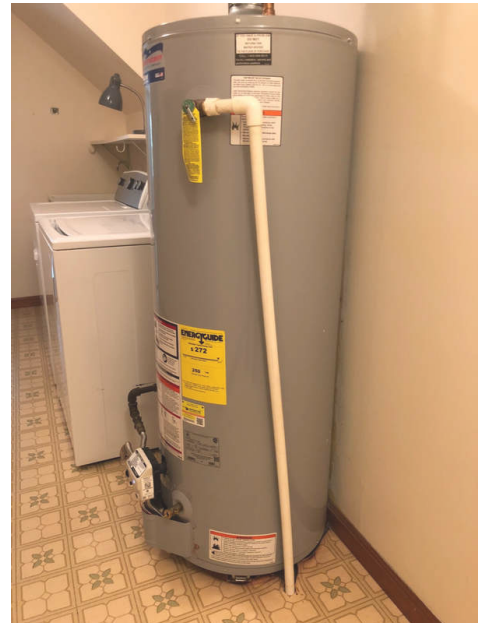
6.4.2 Hot Water Systems, Controls, Flues & Vents

Incorrect TPR Valve

Recommend a licensed plumber, qualified professional or handyman to add the correct drainpipe.

Contact a qualified plumbing contractor.

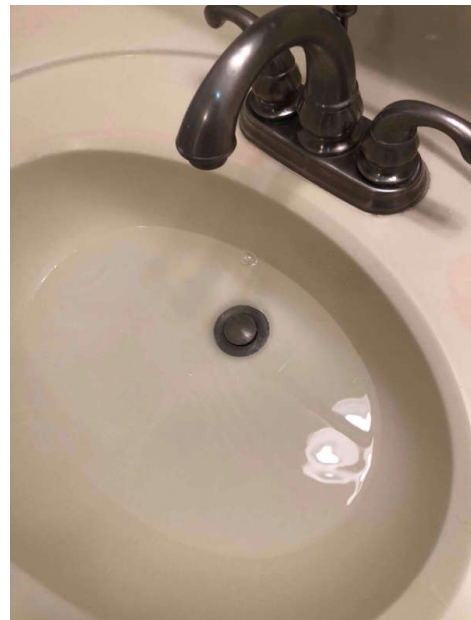
6.5.1 Drain, Waste, & Vent Systems

Sink had slow/poor drainage. Recommend a qualified plumber repair.

Contact a qualified plumbing contractor.

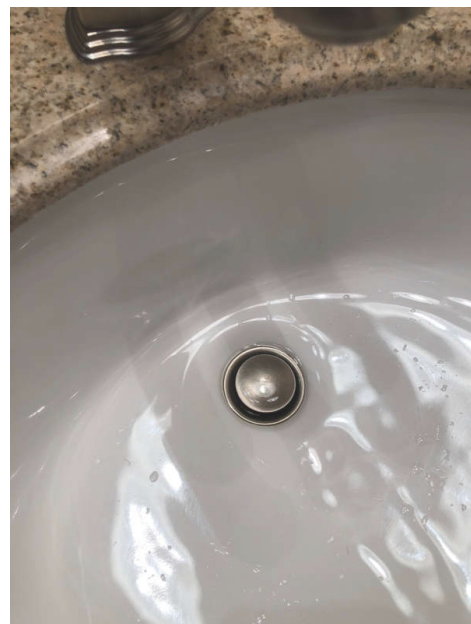
6.8.1 Bathroom

SINK PLUG - NOT WORKING

The automatic plug in the vanity is not working as it should. Recommend a DIY or contractor to update and remedy.

Contact a handyman or DIY project

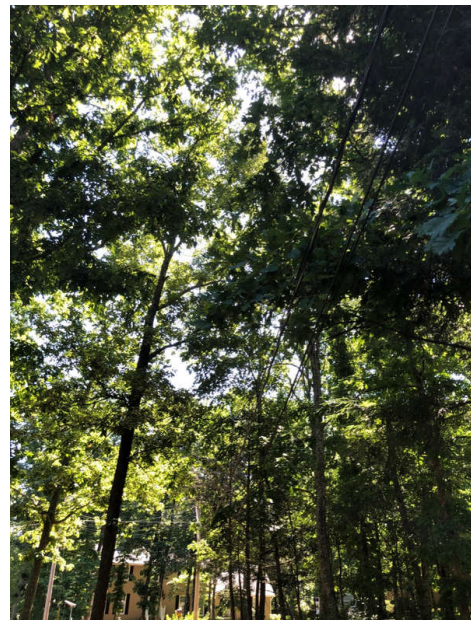
Vegetation is close to the electrical supply lines. Your electrical service provider is responsible for any cables and vegetation removal to your drip loop service connection. Recommend contacting EPB and requesting vegetation trim trees/branches back to prevent power outages.

Contact a qualified professional.

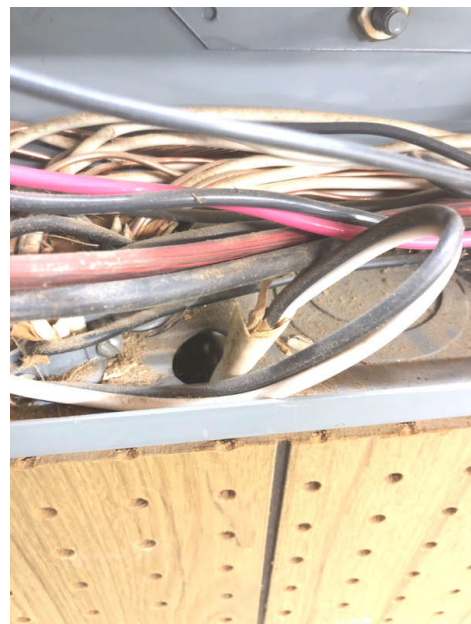
7.2.1 Main & Subpanels, Service & Grounding,
Main Overcurrent Device

BUSHING MISSING / LOST

One or more bushings were missing or loose from where wires enter holes in panel. This is a potential safety hazard because the wiring insulation can be cut or abraded on the metal edge of the hole(s). Recommend that a qualified electrician install or repair bushings where necessary.

Contact a qualified electrical contractor.

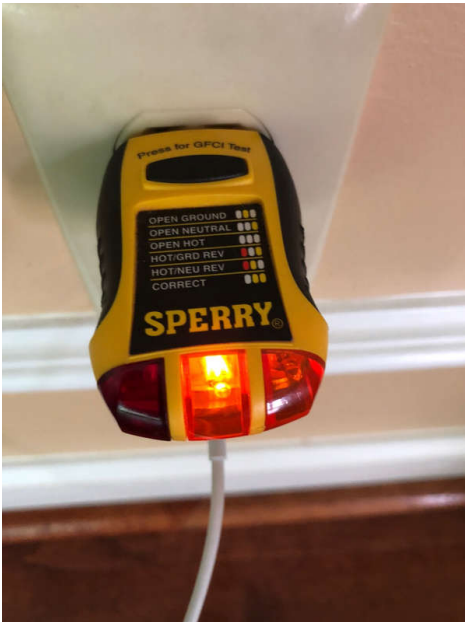
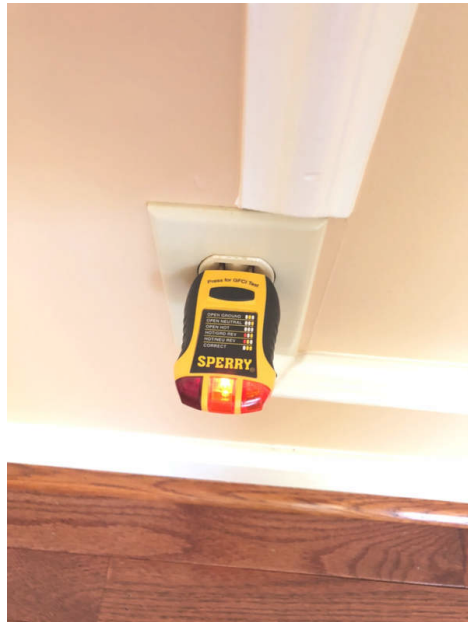
7.3.1 Branch Wiring Circuits, Breakers & Fuses

Testing revealed ungrounded 3 prong outlets; change to 2, or establish ground. *Recommend a certified electrician evaluate.*

Contact a qualified electrical contractor.

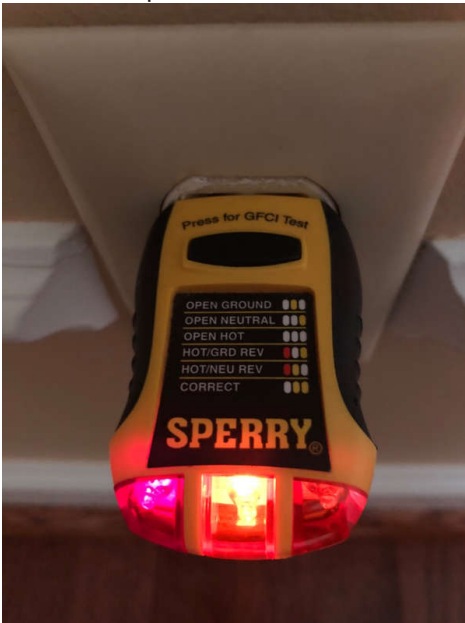
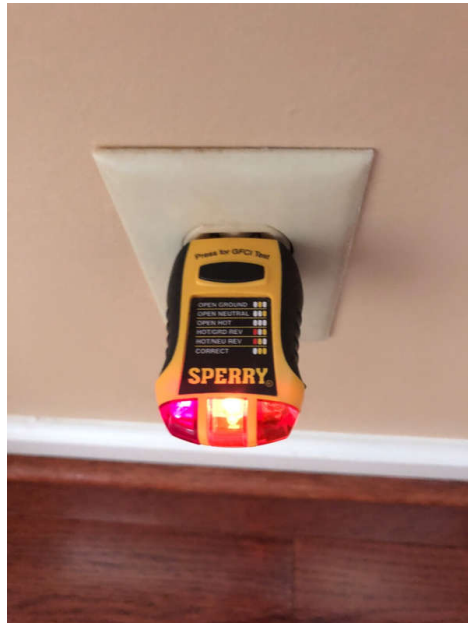
7.3.2 Branch Wiring Circuits, Breakers & Fuses

One or more outlets had their wiring reverse so that hot and neutral wires were reversed. Recommend a qualified electrician to evaluate and fix.

Contact a qualified electrical contractor.

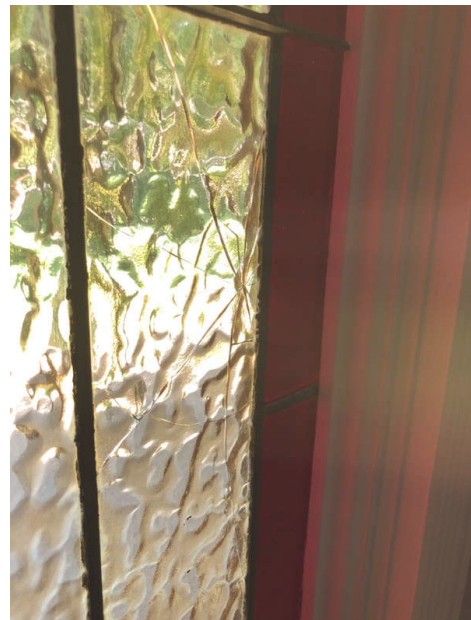
WINDOW - CRACKED

One or more windows had cracks in the glass. *Recommend replace or repair.*

Contact a qualified professional.

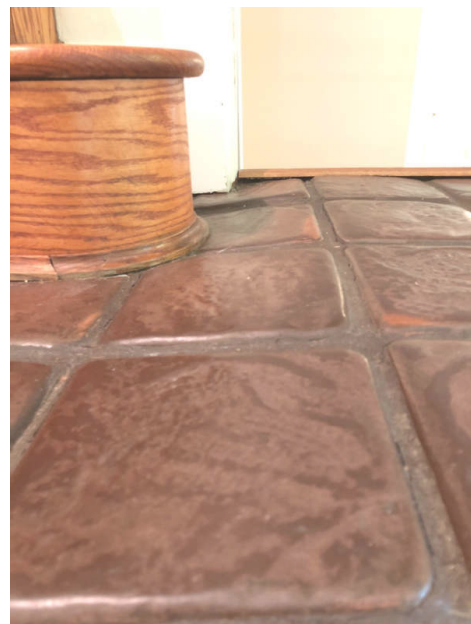
9.3.1 Floors

FLOOR SAGGING

Some noticeable sagging was noted at the floor. *Recommend having licensed contractor or structural engineer out to investigate and evaluate if structural concern.*

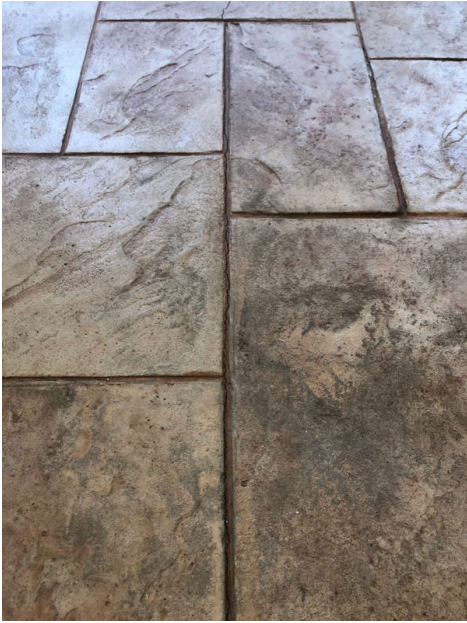
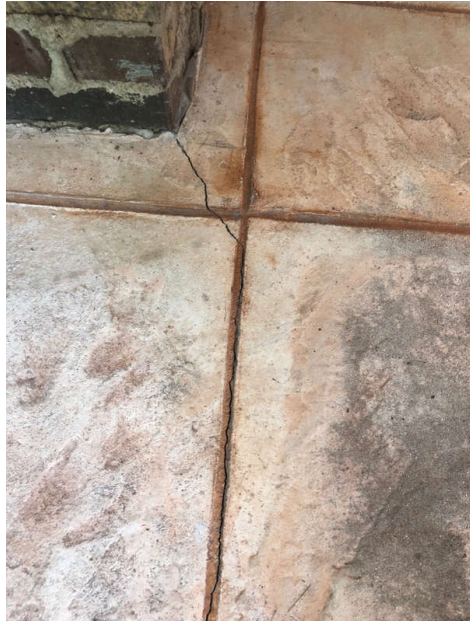
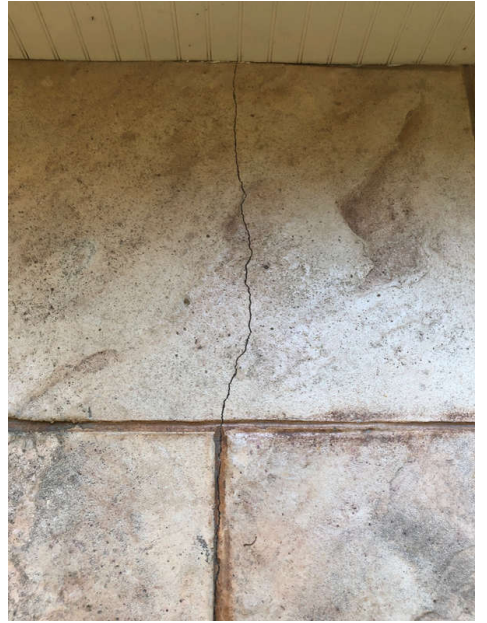
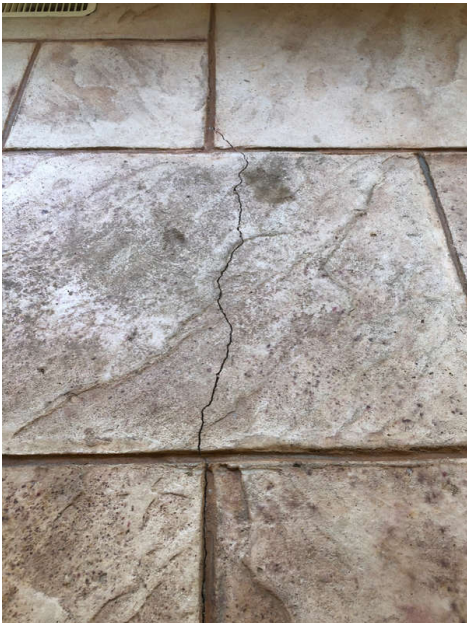
9.3.2 Floors

TILES CRACKED

Several tiles were cracked at the back covered patio. Recommend monitoring to determine if movement will continue.

Recommend monitoring.

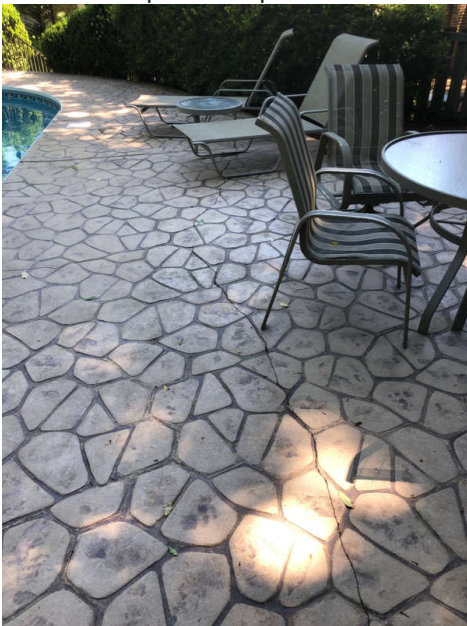
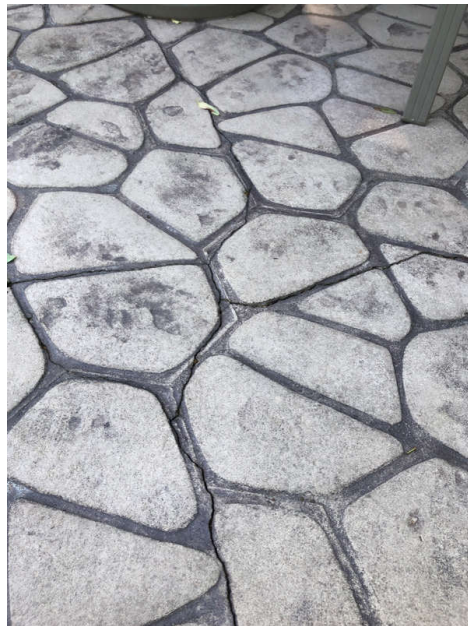
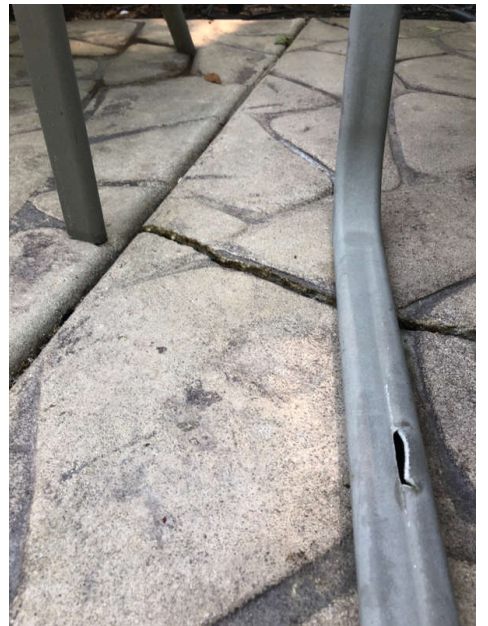
13.2.2 Walkway

WALKWAY - MODERATE CRACKING

Contact a qualified professional.
