NORTHBANK HOME INSPECTION

RESIDENTIAL REPORT

1234 Main St.
Vancouver, WA 98663

07/12/2019 9:00AM

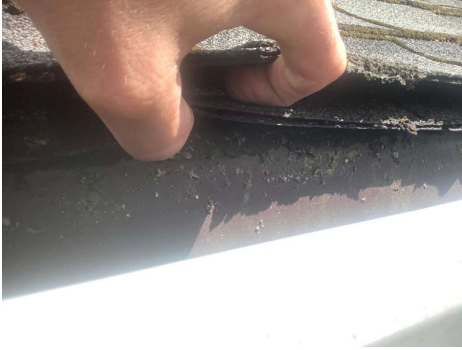
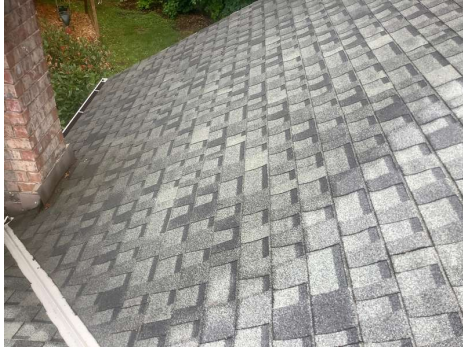
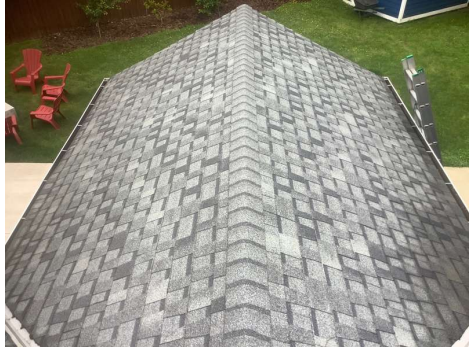
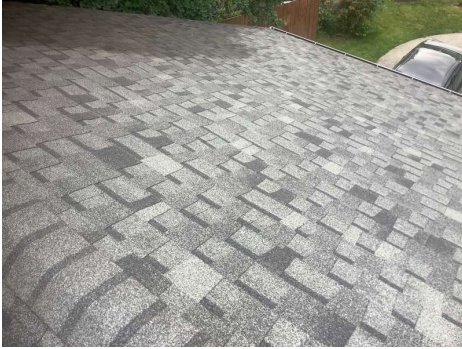
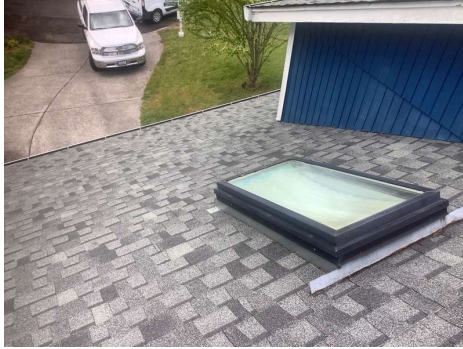
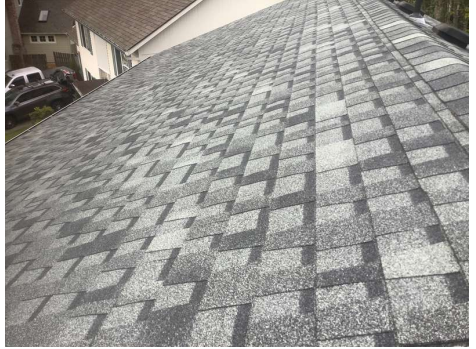
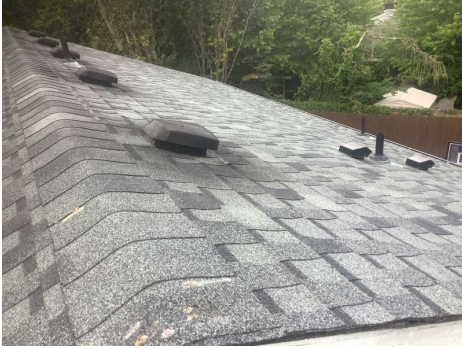
Coverings: Roof coverings

Roof coverings were observed by ladder and walking portions of the roof.

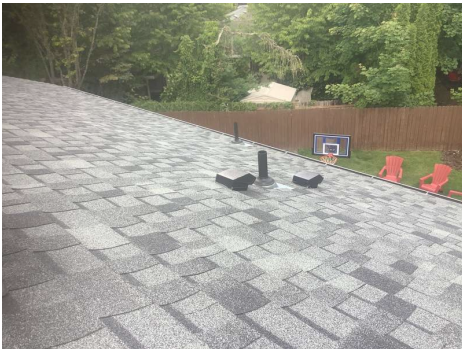
Chimneys, Skylights, & Other Roof Penetrations: Plumbing vents

Plumbing vent boots typically need to be replaced every 10-15 years. Recommend monitoring for deterioration, cracks in the vent boot, and leaks.

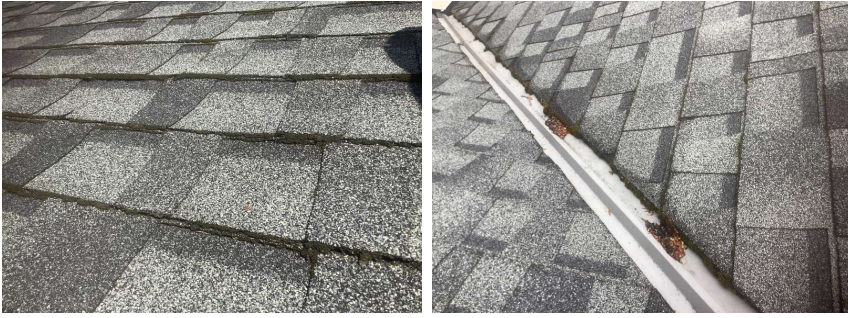
2.1.2 Coverings

MOSS

Maintenance/Monitor Item

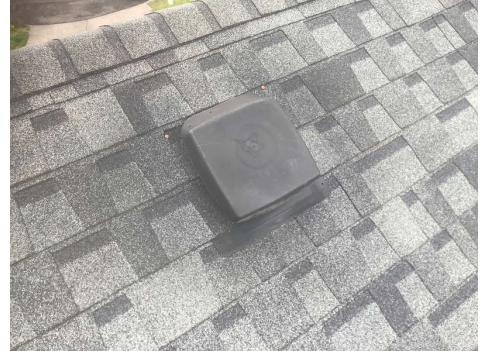
2.1.3 Coverings

COVERINGS DARKENED

Maintenance/Monitor Item

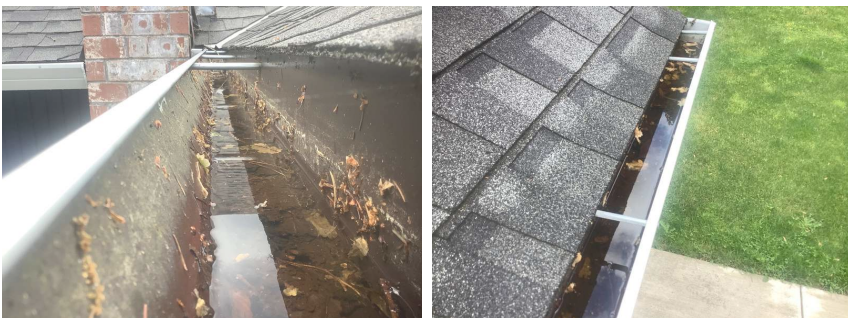
2.2.1 Roof Drainage Systems

DEBRIS

Maintenance/Monitor Item

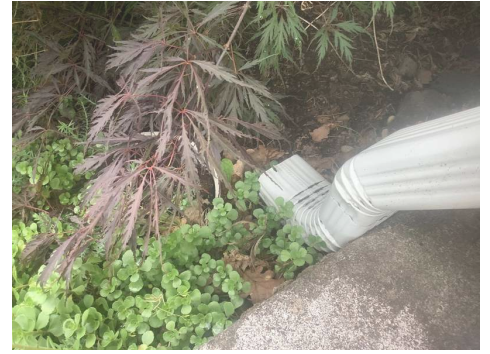
One or more downspouts drain too close to the home's foundation. This can result in excessive moisture in the soil at the foundation, which can lead to foundation/structural damage from soil movement. Recommend a qualified professional adjust downspout extensions to drain at least 6 feet from the foundation.

Contact a qualified roofing professional.

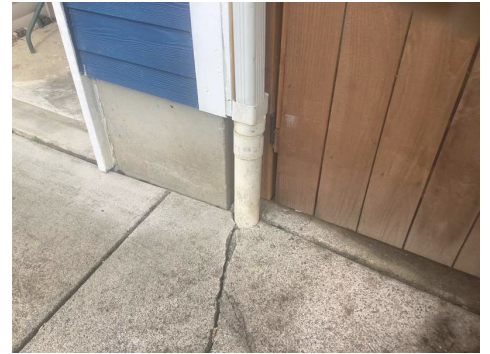
2.2.3 Roof Drainage Systems

The roof drainage systems are connected to drains underground and I cannot verify if the discharge is an appropriate distance away from the foundation or if the drain lines are compromised. The minimum distance water should be diverted away from the foundation is 6 feet. Recommend monitoring.

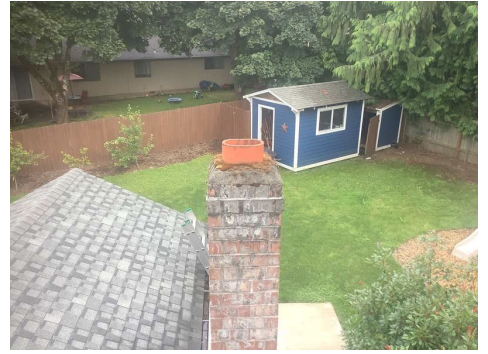
CHIMNEY CAP MISSING

No chimney cap was observed. This is important to protect from moisture intrusion, pests, and protect the chimney. Additionally, the chimney should be equipped with a spark arrestor, which protects against errant fireplace embers that may start fires after drifting out of the chimney. Recommend a qualified roofer or chimney expert install.

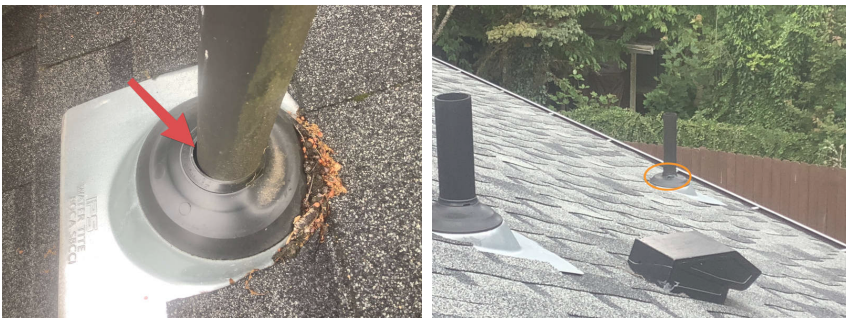
Plumbing vent and boot is installed in a substandard manner -- the gasket is compressed. This could create gaps that can allow moisture to enter or lead to gasket damage. Recommend a qualified contractor repair.

Contact a qualified roofing professional.

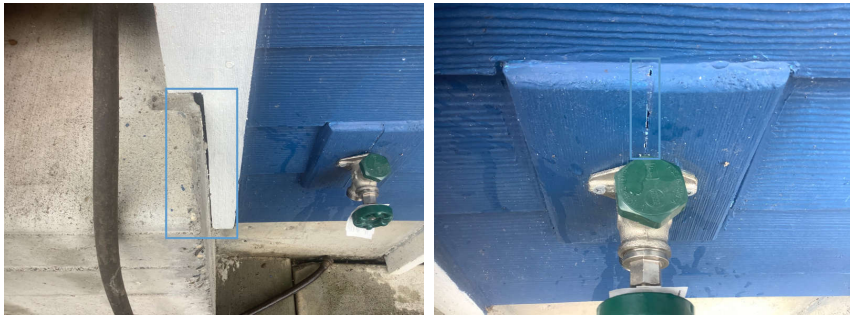
The siding sealant is deteriorated in one or more areas. This can allow water intrusion, which could lead to underlying wall component damage. Recommend a qualified contractor repair sealant or install flashing in these areas.

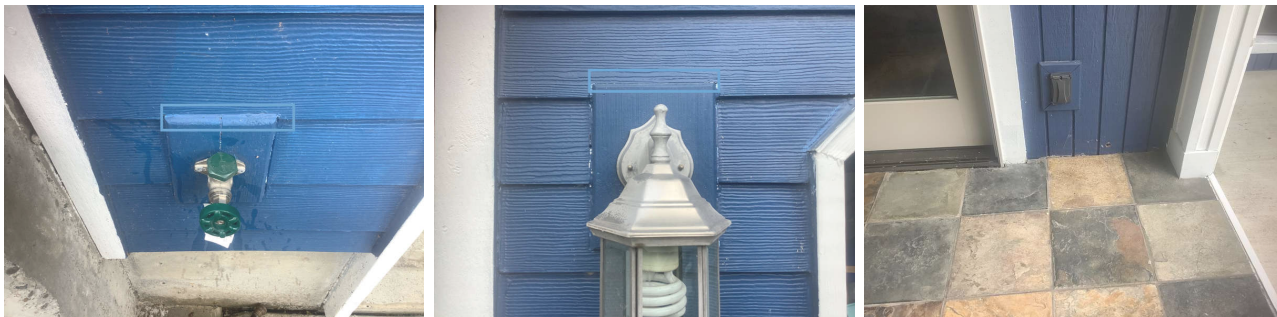
3.1.2 Siding, Flashing & Trim

Flashing is not installed where its needed. This can allow water to damage the siding, windows, fixtures, or other components, and lead to multiple issues, including rot of wooden components. Appropriate flashings can help extend the life of building components. Recommend a qualified contractor install flashing where needed.

Contact a qualified siding specialist.

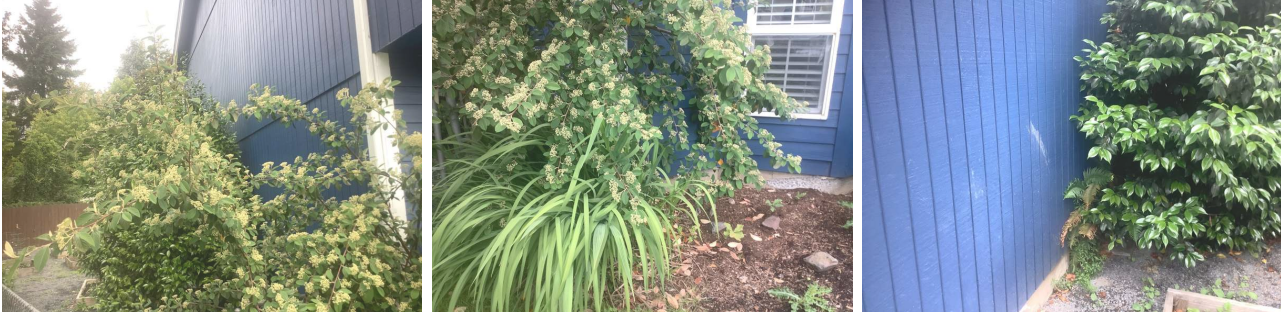
3.1.4 Siding, Flashing & Trim

VEGETATION

Contact a qualified landscaping contractor

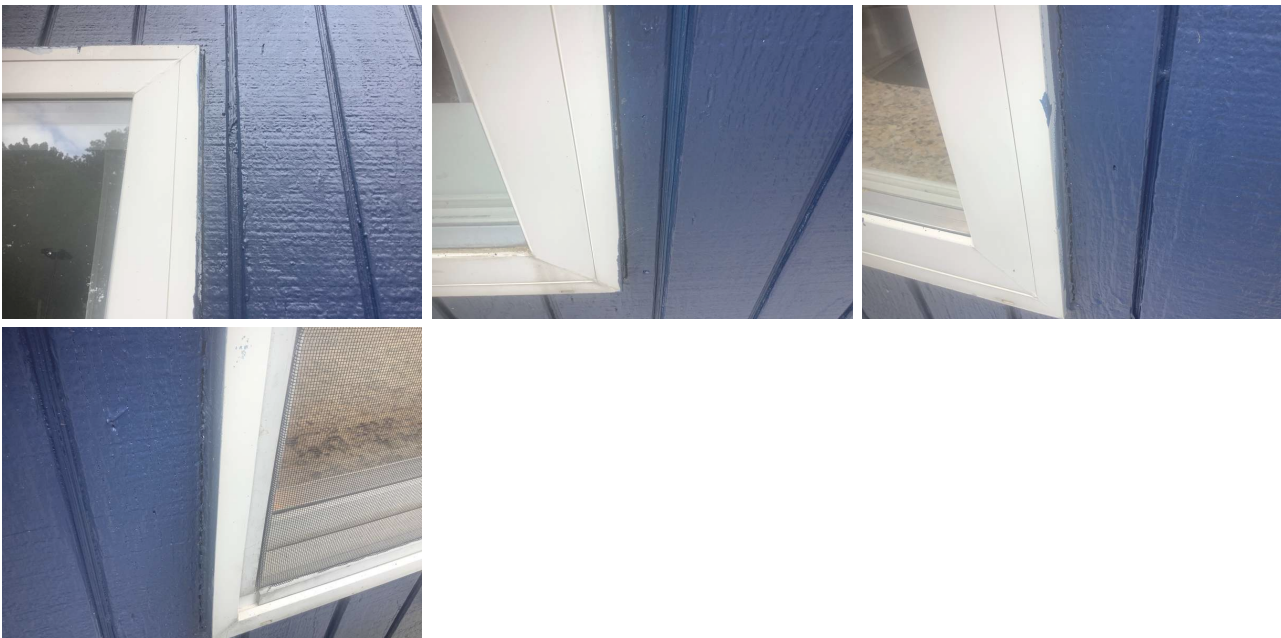
3.1.5 Siding, Flashing & Trim

WINDOW EXTERIOR SEAL CRACK

Contact a qualified handyman.

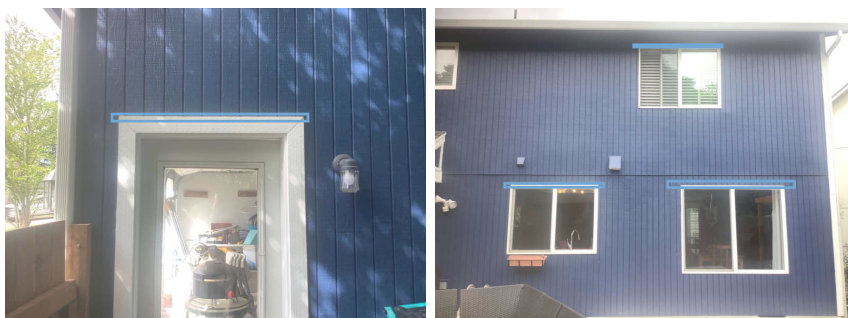
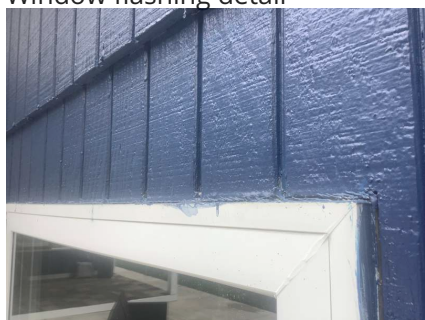
3.1.7 Siding, Flashing & Trim

SIDING ROOF CLEARANCE

Siding is near or touching roof coverings. Without a larger clearance, rain water can wick up into siding and cause damage. This may lead to siding deterioration and rot. Recommend a qualified contractor repair.

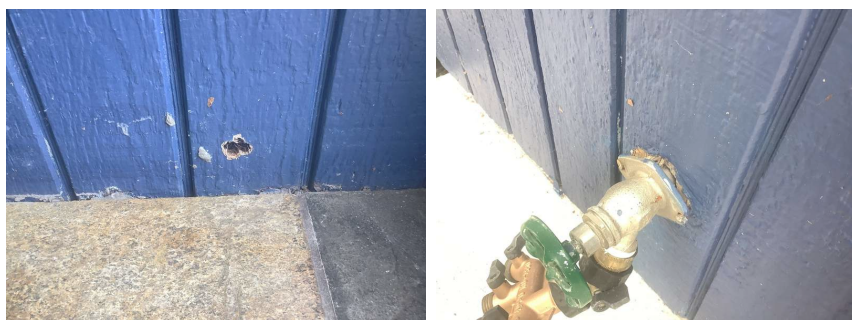
3.1.10 Siding, Flashing & Trim

Trim in one or more areas does not have enough clearance from the ground. Trim should be a minimum of 1-2 inches above hardscape, ie concrete, or 6-8 inches above soil to prevent water wicking up into the trim and causing damaged. Recommend a qualified contractor repair.

Contact a qualified handyman.

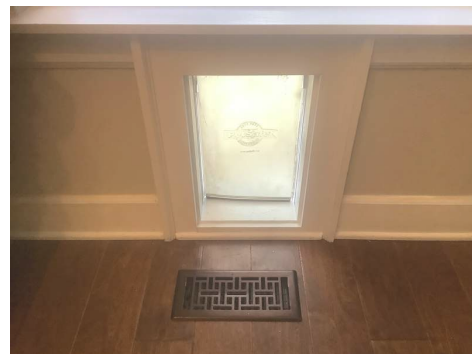
3.2.2 Exterior Doors

DOOR NEEDS ADJUSTMENT

An exterior door and trim are not properly aligned and need adjustment - the door does not close and gaps near the trim are present. Recommend a qualified millworks contractor repair.

Contact a qualified door repair/installation contractor.

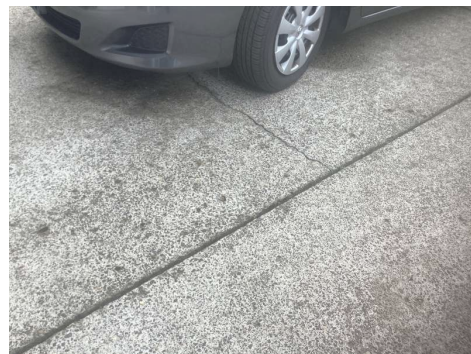
3.3.2 Walkways, Patios & Driveways

WALKWAY CRACKING - LARGE

Large cracks and damage were observed on portions of the exterior walkways. These cracks could be related to inadequate site drainage in this area, which can lead to settling and damage. Recommend concrete contractor evaluate and correct to prevent trip hazard and preserve appearance.

Contact a qualified concrete contractor.

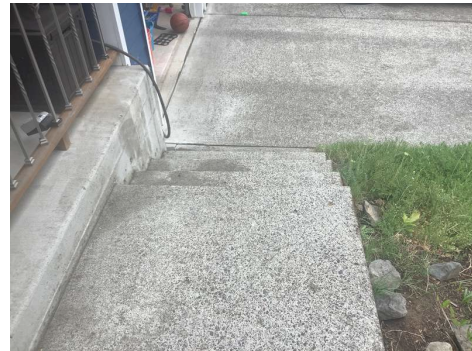
3.4.1 Decks, Balconies, Porches & Steps

FRONT EXTERIOR STAIRS

One or more exterior stairways do not have a graspable handrail. Stairways having four or more risers or rising more than 30 inches (76 cm), whichever is less, should be equipped with a graspable handrail, according to Washington state guidelines. Recommend installation of appropriate railing by a qualified contractor. Consider your own needs and safety requirements when deciding whether upgrading to these modern standards is necessary for your family.

Contact a qualified general contractor.

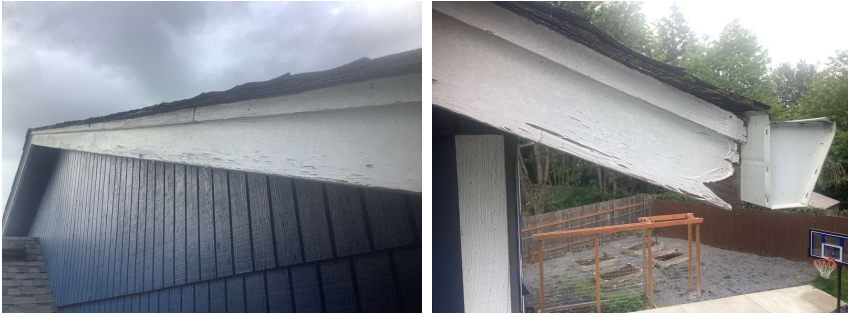
FASCIA PAINT DETERIORATED

Fascia paint is deteriorated. Deteriorated paint can allow fascia to become damaged and susceptible to rot. Recommend a qualified contractor repair.

Contact a qualified painting contractor.

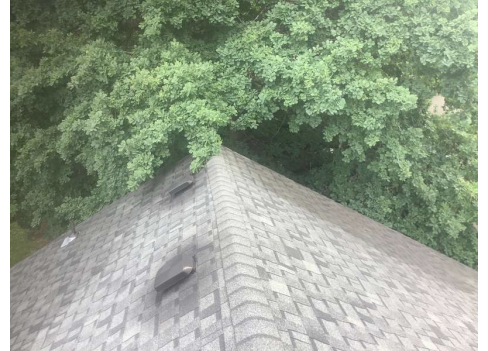
3.6.1 Vegetation, Grading, Drainage & Retaining Walls

Trees observed overhanging the roof. This can cause damage to the roof and prevent proper drainage from clogged gutters. Additionally, tree overhang can allow access to the roof for pests. Recommend a qualified tree service trim as needed.

Contact a qualified tree service company.

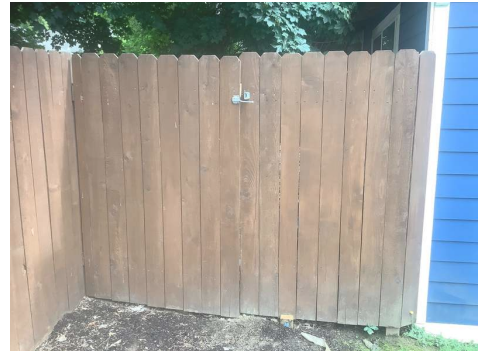
3.8.1 Fence

Gate is sagging. This can affect its function. Recommend a qualified contractor install tension device to repair.

Contact a handyman or DIY project

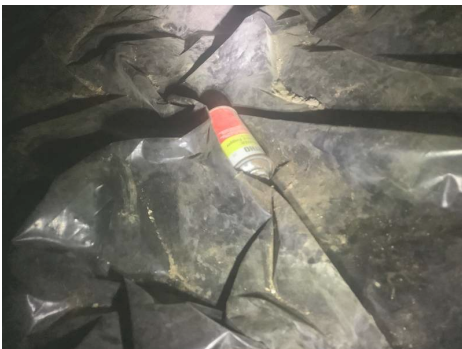
Basements & Crawspaces: Crawlspace fumigation

Fumigation products were observed in the crawlspace. These are designed to kill bugs. No active infestation of insects were observed at the time of inspection.

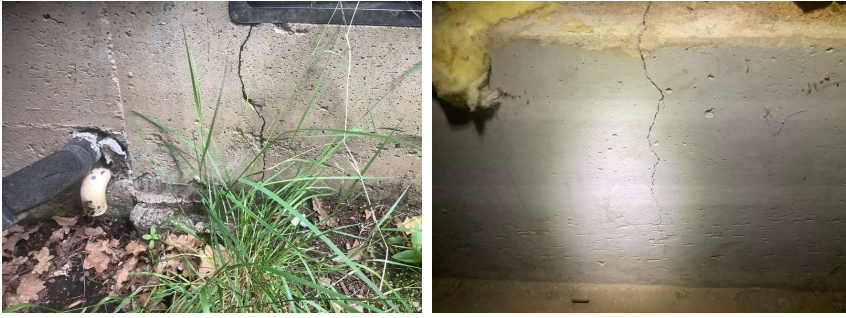
4.1.1 Foundation

FOUNDATION CRACKS - MINOR

Minor cracking was noted at the foundation. This is common as concrete ages -- shrinkage surface cracks are normal. Cracks should not exceed more than 1/4 inch in width, which may indicate more significant settling. Recommend monitoring for more serious shifting/displacement and having a qualified contractor seal cracks to prevent moisture intrusion.

Recommend monitoring.

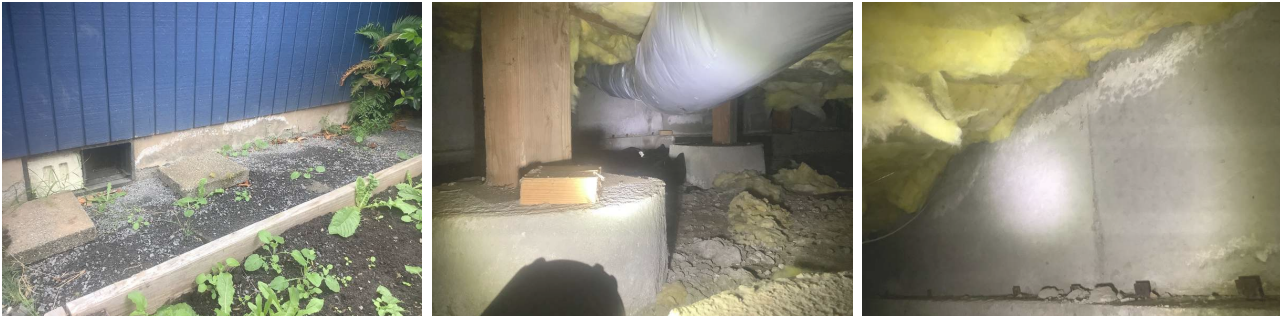
4.1.2 Foundation

EFFLORESCENCE

Efflorescence (white salt staining) on concrete wall indicates moisture is in contact with the foundation, which is typically caused by poor site drainage. Recommend ensuring the gutters and the downspout drain lines are functioning properly and the grading slopes away from the home appropriately. Efflorescence should alert you to the possibility that future steps may be needed. Recommend monitoring and having a qualified contractor repair drainage or grading issues.

Contact a qualified general contractor.

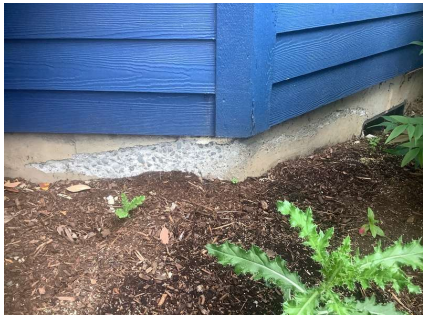
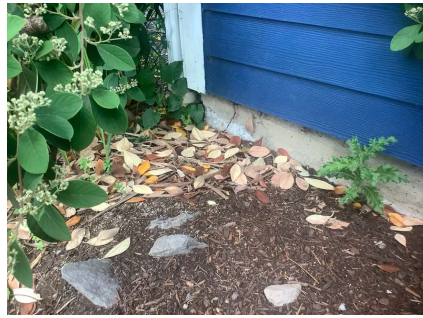
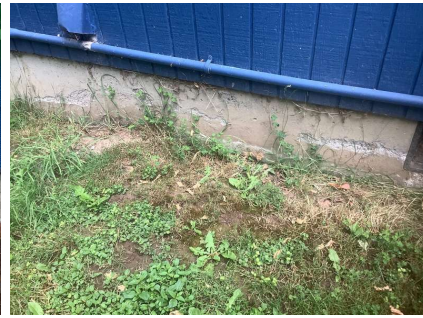
4.1.3 Foundation

CHIPPING (SPALLING)

Chipping, or spalling, of the foundation was observed in areas around the home. Spalling can be caused by multiple effects, but water near the foundation is typically the most common source. This can be caused by inadequate site drainage that may allow water saturate the soil around the foundation, wick up the foundation, and freeze, leading to spalling. This underscores the importance of directing water away from the foundation. This can also be related to the concrete mixture when it was poured. Recommend monitoring and correcting drainage issues if needed.

Contact a qualified general contractor.

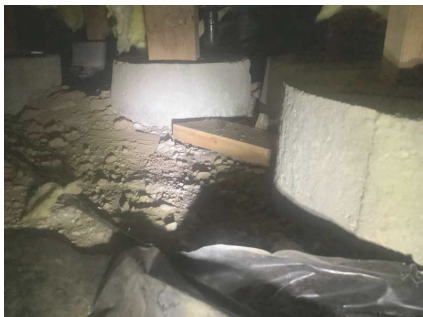
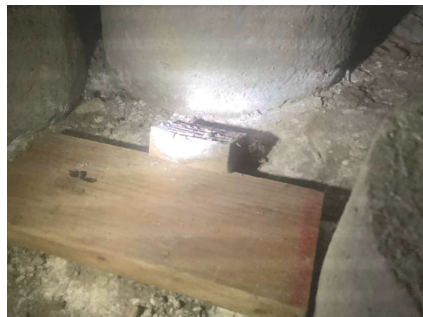
Various debris was observed on the floor of the crawlspace, some of which could be a source of nutrients for wood-destroying organisms. Recommend removal of debris from crawlspace by a qualified professional.

Contact a qualified handyman.

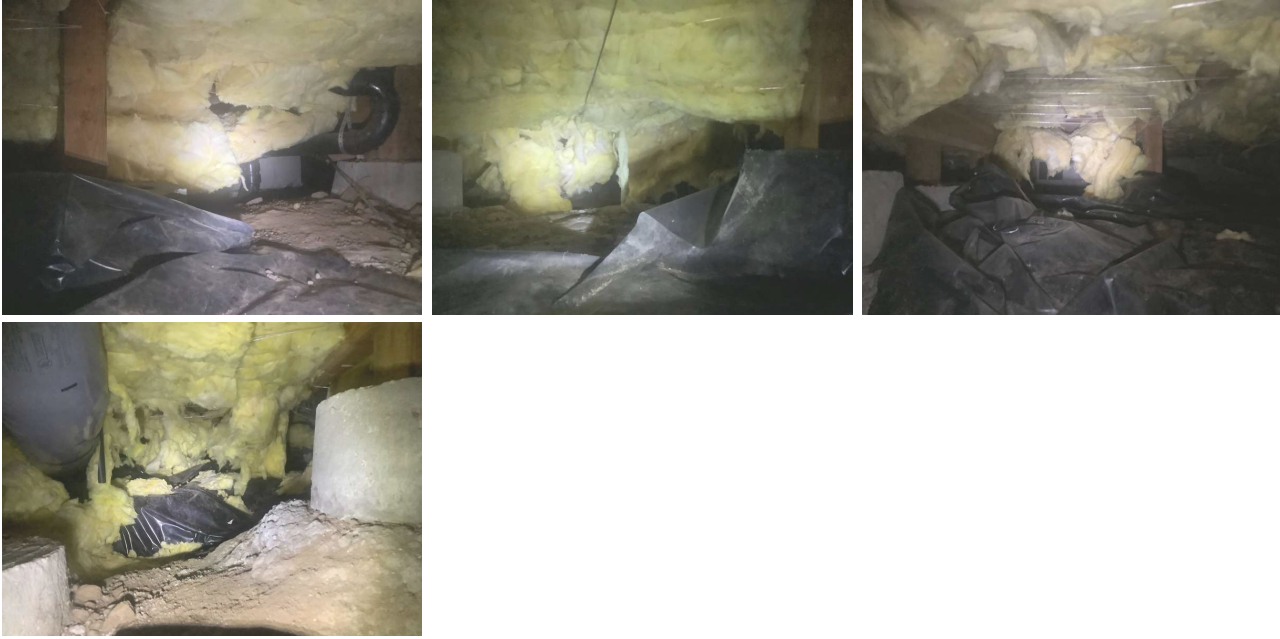
4.2.3 Basements & Crawlspaces

DAMAGED INSULATION

Insulation is damaged in the crawlspace. This can lead to energy loss. Recommend a qualified insulation contractor repair.

Contact a qualified insulation contractor.

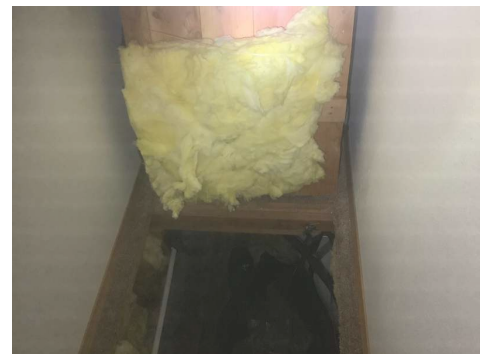
4.2.4 Basements & Crawlspaces

WEATHERSTRIPPING - CRAWLSPACE HATCH INADEQUATE

Contact a handyman or DIY project

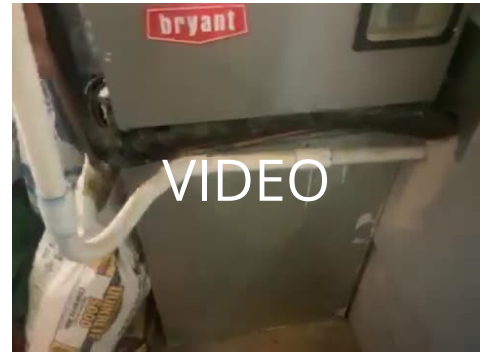
5.1.1 Heating Equipment

The furnace condensation line is not secure. This could lead to improper drainage of condensate and potentially make the pipe prone to damage. Recommend a qualified contractor repair.

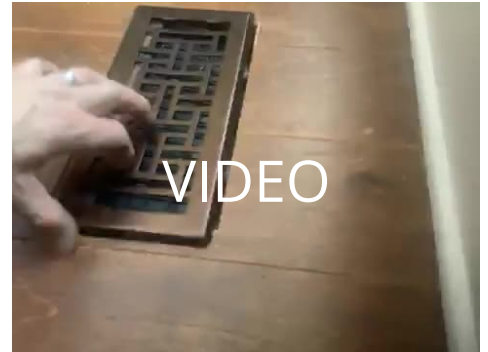
5.4.1 Distribution Systems

REGISTER LOOSE

Register is loose. Recommend a qualified contractor secure.

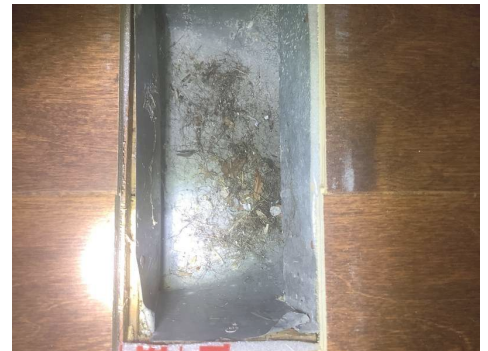
5.4.2 Distribution Systems

DUCTS NEED CLEANING

Debris was observed in ducts around the home. This can impact air quality and the efficiency of the HVAC system. Recommend a qualified professional clean duct system at least annually.

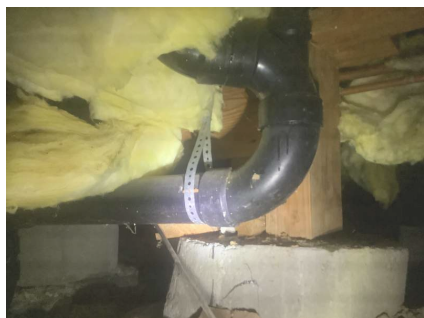
The ABS (plastic) drain lines are hung with metal straps. Metal straps can damage the ABS piping over long periods of time. Recommend a qualified maintenance person re-hang pipes with plastic material.

Contact a qualified handyman.

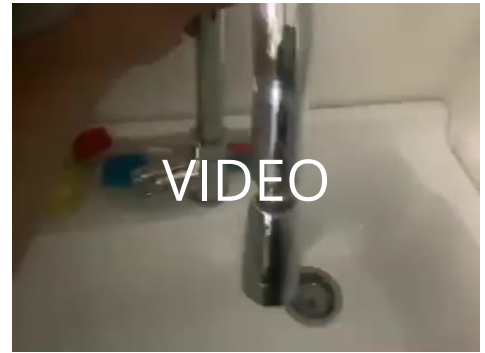
6.3.1 Water Supply, Distribution Systems & Fixtures

LOOSE FAUCET

One or more faucets are loose. This can cause damage to the fixture. Recommend a qualified contractor repair.

Contact a qualified professional.

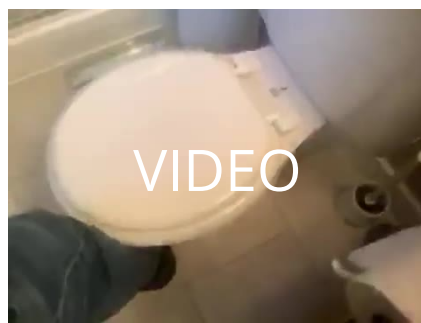
6.3.2 Water Supply, Distribution Systems & Fixtures

LOOSE TOILET

One or more toilets are loose. Loose toilets can leak and cause significant water damage to the subfloor if not repaired. Recommend a qualified contractor evaluate wax ring -- replace if necessary -- and tighten toilet.

Contact a handyman or DIY project

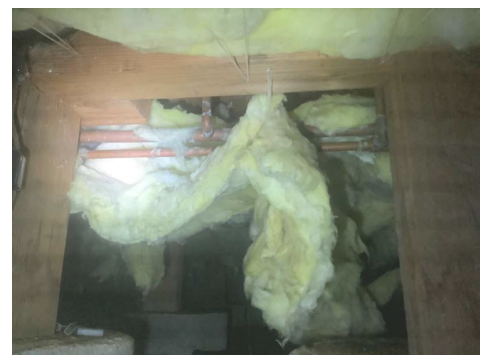
6.3.3 Water Supply, Distribution Systems & Fixtures

The water distribution pipes are not insulated in portions of the home. This can be a significant source of energy loss. Additionally, cold temperatures can freeze the water in pipes in unconditioned spaces, expand, and cause the pipes to burst, typically at joints. Recommend a qualified contractor insulate all water supply plumbing.

Contact a qualified plumbing contractor.

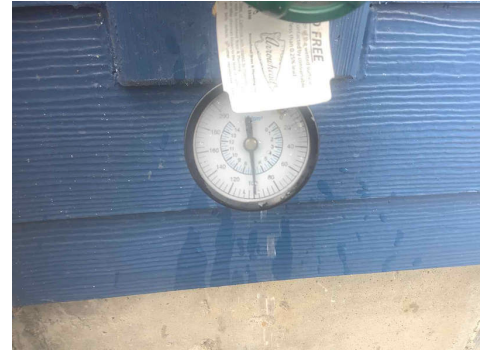
6.3.4 Water Supply, Distribution Systems & Fixtures

The water pressure was measured at about 100 psi; the recommended water pressure is between 40-80 psi. High water pressure can cause fixtures such as water heaters, faucets, shut-off valves, and toilet components to fail prematurely. Recommend a qualified contractor evaluate and recommend remedy, typically with a pressure-reducing valve.

Contact a qualified plumbing contractor.

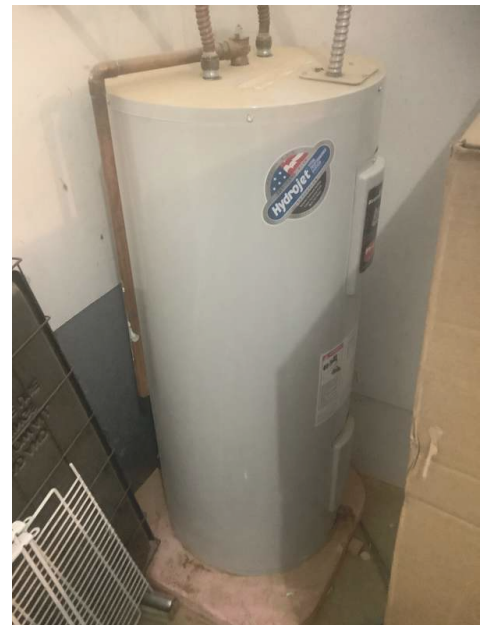
INADEQUATE SEISMIC STRAPS

The water heater is not equipped with adequate seismic straps. Seismic straps, which help prevent tipping of the water heater in the event of an earthquake, should be installed on the upper and lower thirds of the tank. Recommend a qualified professional install seismic straps.

Contact a qualified handyman.

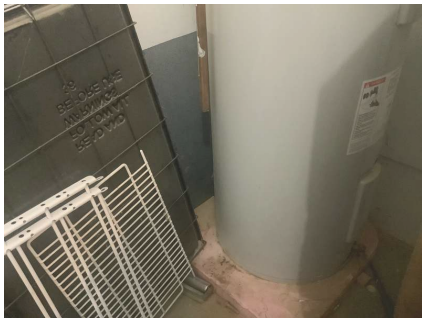
6.4.3 Hot Water Systems, Controls, Flues & Vents

TPR DISCHARGE INADEQUATE

The temperature pressure relief (TPR) valve pipe does not extend within six inches of the ground. If tripped due to high pressure or temperature, the steam released could scald someone nearby. Recommend a qualified professional extend the TPR valve pipe to prevent injury.

Contact a qualified plumbing contractor.

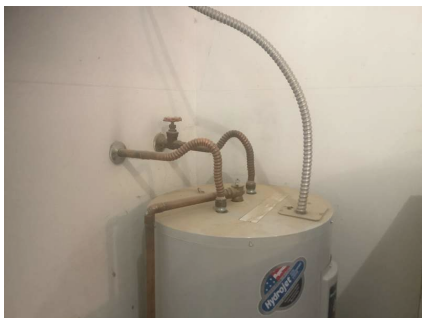
6.4.4 Hot Water Systems, Controls, Flues & Vents

An expansion tank is not installed on the water heater. Expansion tanks allow for the thermal expansion of water in the plumbing system -- basically water expands when heated. Without an expansion tank, thermal expansion can put stress on plumbing connections and fixtures and eventually lead to premature failure. These tanks are standard in new installations. Recommend a qualified plumber evaluate and install.

Contact a qualified plumbing contractor.

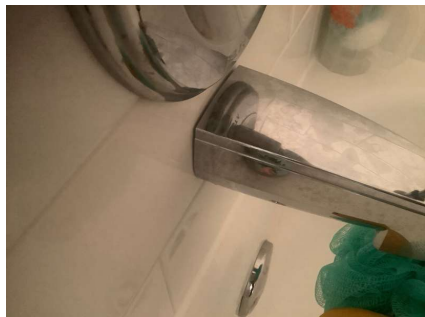
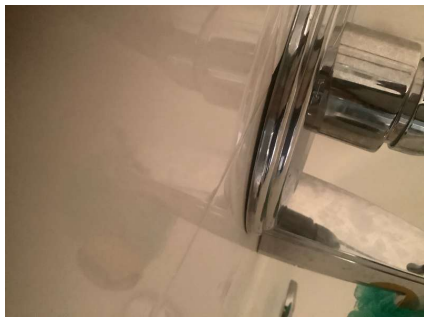
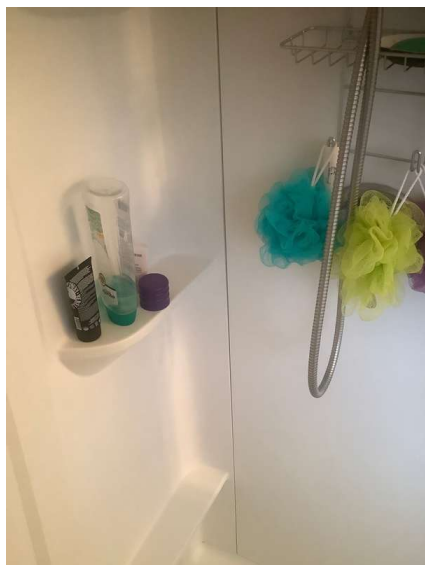
6.5.1 Bathtubs & Showers

CAULK IN NEED OF REPAIR

Shower/tub has missing or deteriorated caulk. This can lead to water damage behind the surround. Recommend a qualified contractor repair.

Contact a handyman or DIY project

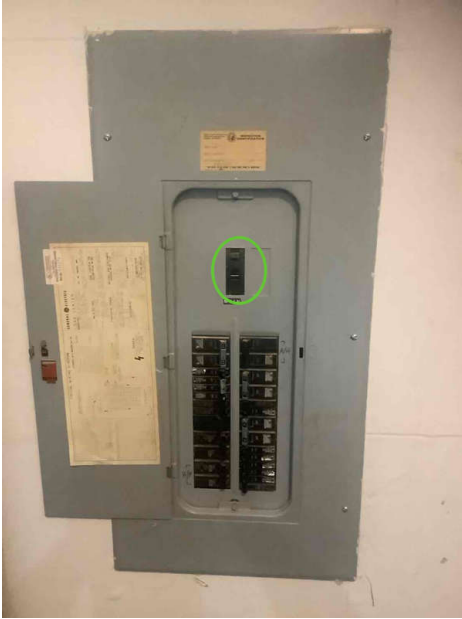
Branch Wiring Circuits, Breakers & Fuses: Main disconnect

The switch (or switches) circled in green is the main electrical disconnect.

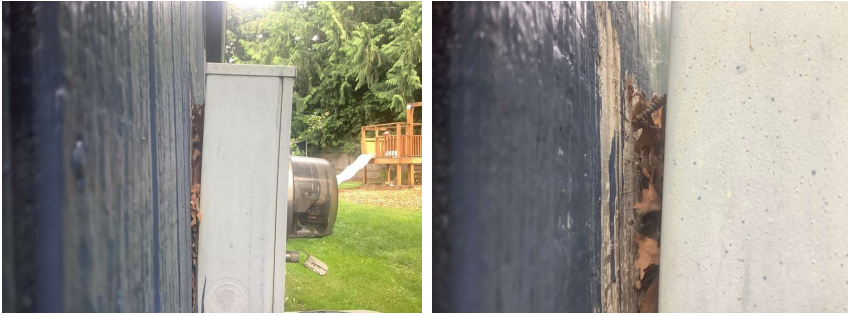
7.1.1 Service Entrance Conductors

The electrical service meter box is not secure. This can lead to damage to the meter box and moisture intrusion in the box, panel, and underlying siding components. Recommend a qualified electrical contractor repair.

Contact a qualified electrical contractor.

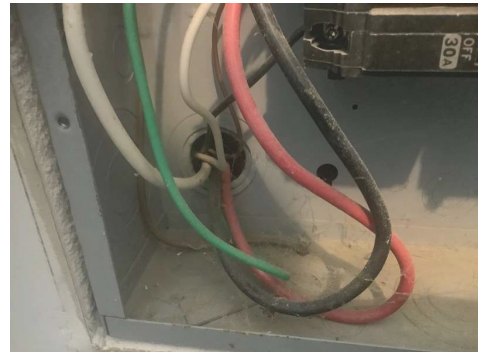
7.2.1 Main & Subpanels, Service & Grounding, Main Overcurrent Device

MISSING, LOOSE BUSHING(S)

One or more bushings are missing, loose, or open in an electrical panel box. Bushings help protect wires from becoming damaged by the sharp edges of knockouts. Additionally, bushings help prevent rodents from entering the panel box. Recommend a qualified contractor repair.

Contact a qualified electrical contractor.

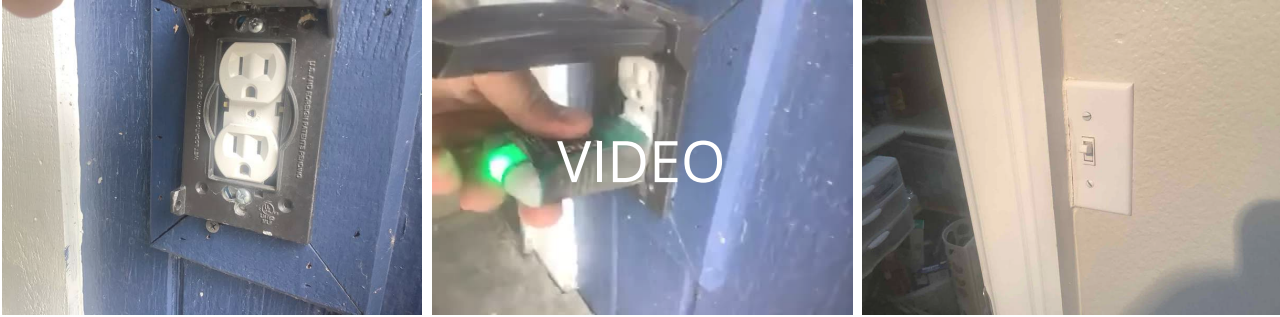
IMPROPER INSTALLATION

Electrical receptacles, lights, or switches in one or more areas are installed improperly. This can be a short or shock hazard. Recommend a qualified contractor repair.

Contact a qualified electrical contractor.

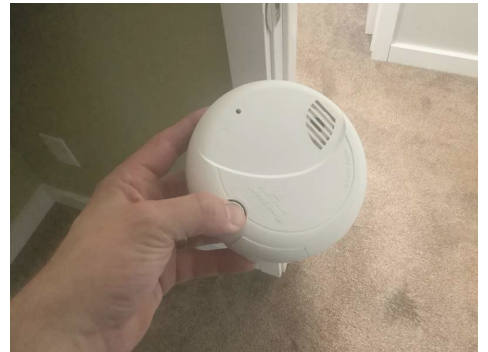
DEFECTIVE

One or more smoke detectors are not functioning properly - this could be caused by dead batteries. Smoke alarms throughout the home should ideally be interconnected -- if one is triggered, all alarms should sound. Recommend replacing smoke alarm and evaluation by a qualified electrical contractor.

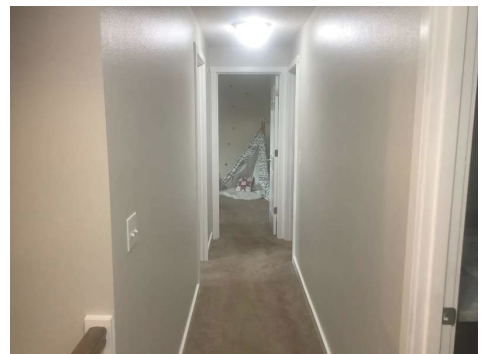
7.7.1 Carbon Monoxide Detectors

INAPPROPRIATE LOCATION

Carbon monoxide detector effectiveness may be compromised due to location -- detector should be 5 feet from the ground -- where CO floats -- to properly function. CO detectors are required in common areas outside of each sleeping room on every floor and living space. If this unit is a dual smoke/CO detector, consider installing a stand-alone CO detector in an appropriate location. Recommend relocating according to manufacturer's instructions.

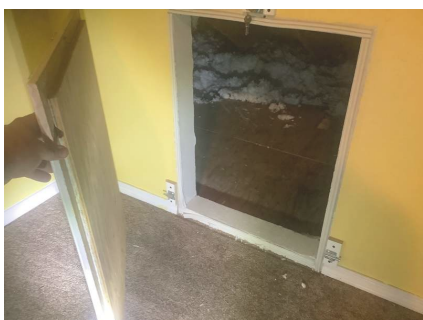
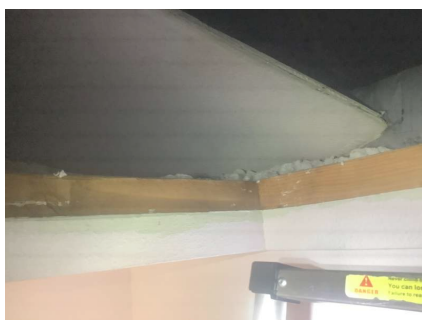
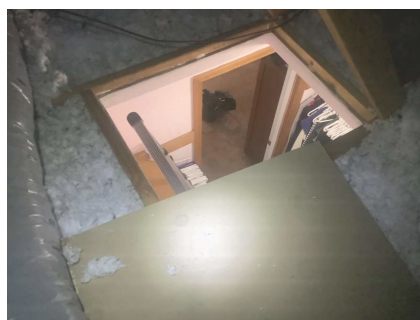
ATTIC HATCH -- INADEQUATE INSULATION

The attic hatch has inadequate insulation. This area can be a significant source of energy loss. Additionally, improperly sealed attic hatches can allow energy (hot/cold air) to leak into the attic. Recommend a qualified contractor properly secure insulation to the hatch and repair weatherstripping, if needed.

Contact a qualified insulation contractor.

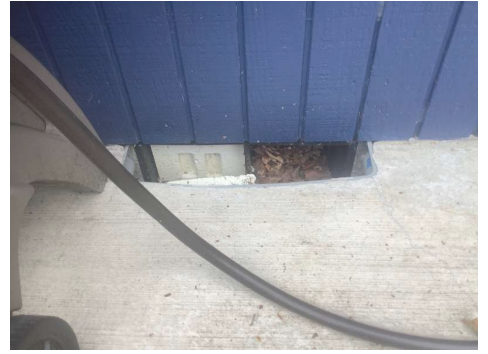
8.2.1 Ventilation

CRAWLSPACE VENTS BLOCKED

One or more of the crawlspace vents are blocked. This can create air "dead zones" which can promote increased moisture levels and conditions conducive to wood-destroying organisms. Additionally, this can direct radon gas -- a radioactive gas that can cause lung cancer found in elevated levels in about 25 percent of homes in this area -- inside the home. Recommend removing blocking material to allow proper ventilation of the crawlspace.

Contact a qualified concrete contractor.

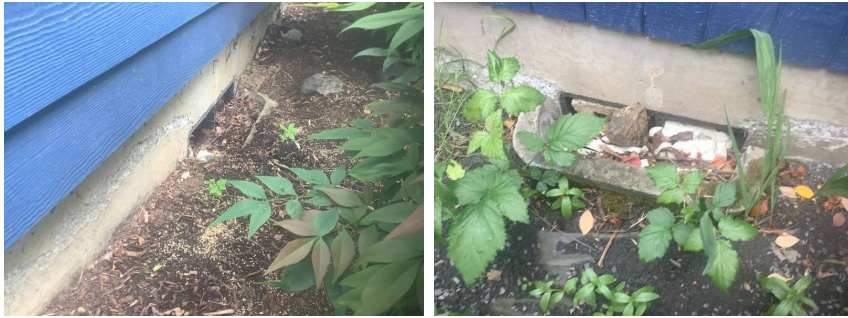
8.2.2 Ventilation

FOUNDATION VENT BELOW GRADE

One or more foundation vents are below grade. This can allow water to enter the crawlspace. Recommend installation of foundation vent wells by a qualified professional.

Contact a qualified handyman.

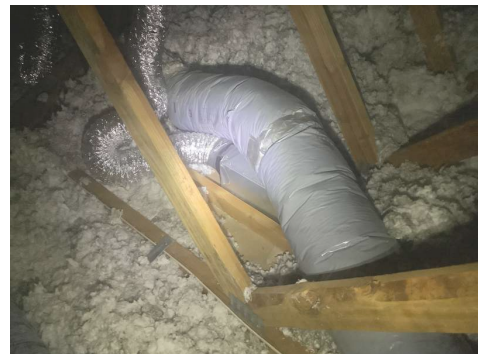
8.3.1 Exhaust Systems

DUCT-TAPED DUCTS

Exhaust ducts in the home are connected or sealed with duct tape. Counter-intuitively, duct tape as a duct sealer fails quickly, and often, quite catastrophically. This can promote moisture in the areas through which the ducting runs and create an environment conducive to mold, wood-destroying insects, and fungi. I recommend a qualified contractor properly seal or connect ducts with a product like mastic.

Contact a qualified handyman.

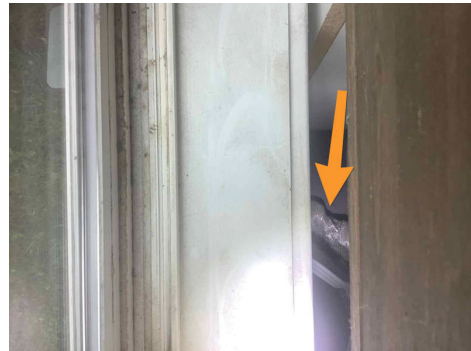
8.3.2 Exhaust Systems

DRYER DUCT DAMAGED

The dryer duct is damaged. This could allow lint to become trapped and start a fire. Recommend a qualified professional repair or replace.

Contact a handyman or DIY project

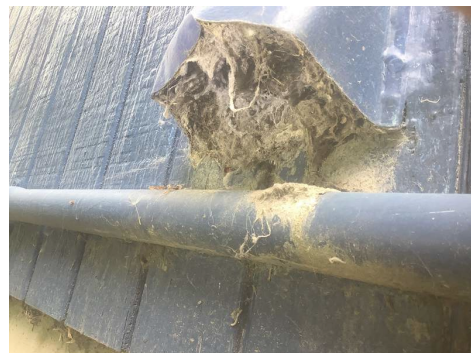
8.3.3 Exhaust Systems

The dryer vent is obstructed with lint and does not close. Excessive lint can be a fire hazard and allow pest access. Recommend a qualified person clean.

Contact a handyman or DIY project

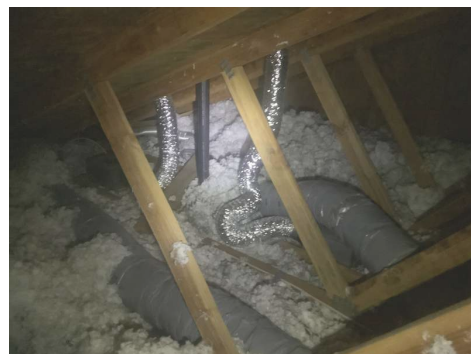
8.3.4 Exhaust Systems

Exhaust ducts are not insulated. Insulation around these ducts helps minimize the condensation that will otherwise occur as typically warm, moist exhaust air passes through the ductwork. Recommend a qualified contractor insulate ducts.

Contact a qualified HVAC professional.

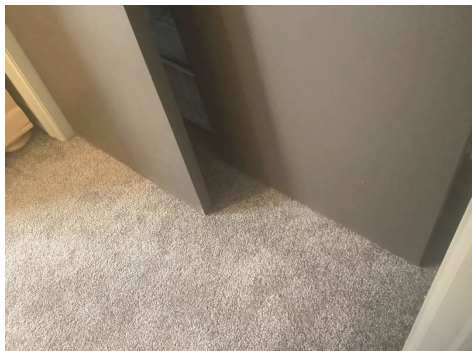
CLOSET DOOR GUIDE DAMAGED/MISSING

Closet door guide is damaged or missing. This can lead to damage to the door from improper movement. Recommend installation of a guide by a qualified person.

Contact a handyman or DIY project

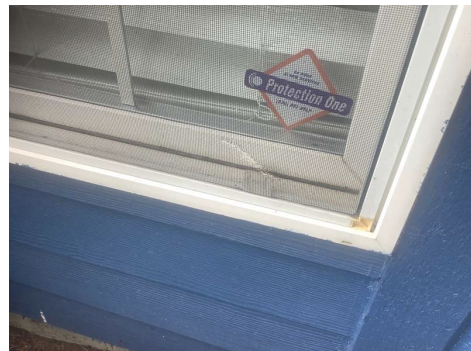
9.2.1 Windows

DAMAGED SCREEN

Screen(s) in one or more windows are torn or have damaged frames. Screens should be replaced where necessary.

Contact a qualified window repair/installation contractor.

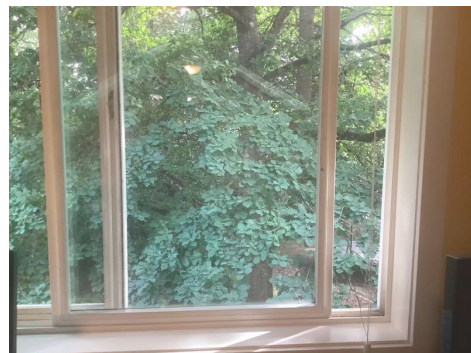
9.2.2 Windows

MISSING SCREEN(S)

One or more windows are missing screens. Recommend replacement.

Contact a qualified window repair/installation contractor.

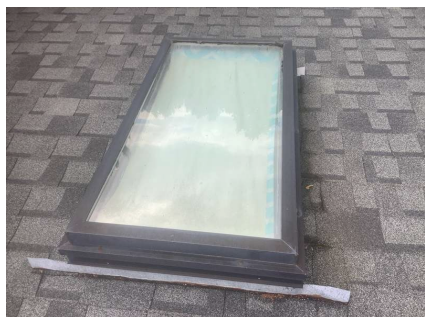
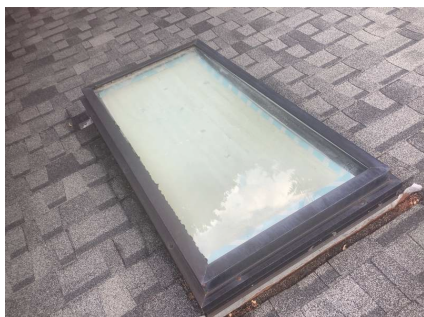
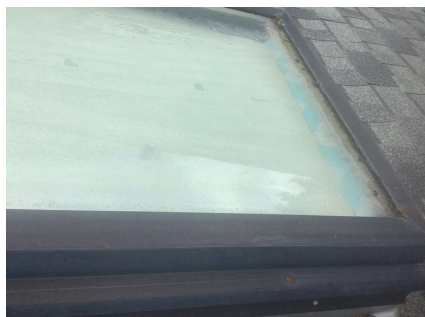
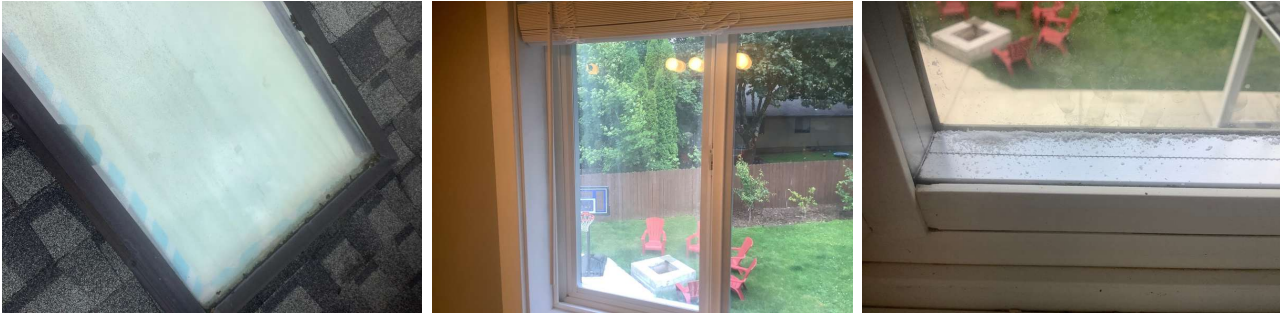
9.2.3 Windows

POSSIBLE FAILED SEAL

Observed evidence condensation is or has been between the window panes, which indicates a failed seal. Failed seals can promote mold growth and decrease energy efficiency. Recommend qualified window contractor evaluate & replace.

Be aware that evidence of broken seals may be more or less visible from one day to the next depending on the temperature, humidity, sunlight, etc. Windows or glass doors other than those that I identified may also have failed seals and need glass replaced, too.

Contact a qualified window repair/installation contractor.

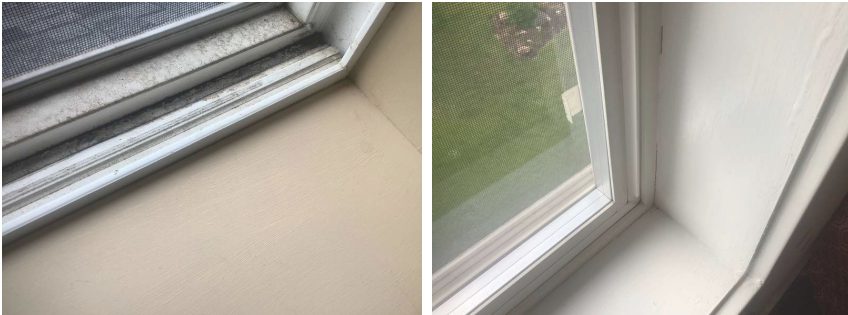
9.2.4 Windows

SEAL DETERIORATED

The window/door corner seals are deteriorated and in need of repair. This can lead to energy loss. Recommend a qualified contractor repair.

Contact a qualified handyman.

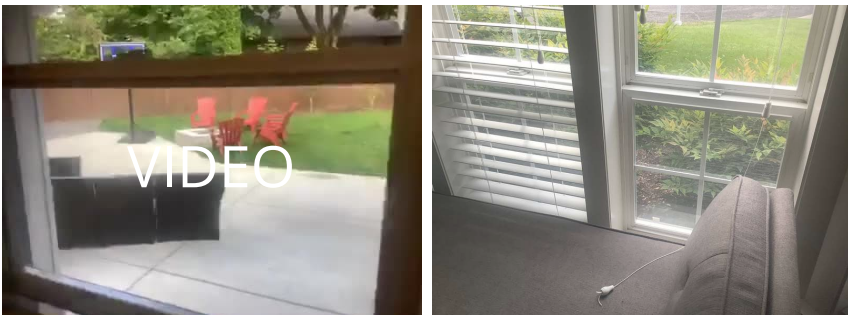
9.2.5 Windows

WINDOW NEEDS ADJUSTMENT

One or more windows are difficult to use and need adjustment and/or lubrication. Recommend a qualified contractor repair.

Contact a qualified window repair/installation contractor.

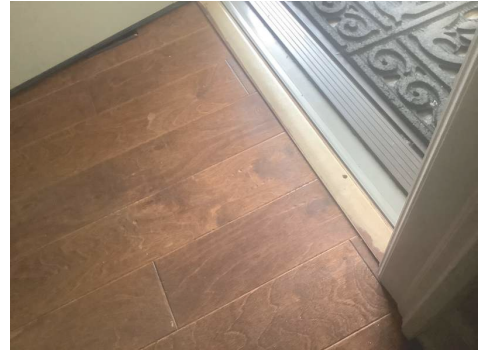
9.3.1 Floors

INTERIOR TRIM DAMAGED

Interior trim is damaged in one or more areas. Recommend a qualified contractor repair or replace.

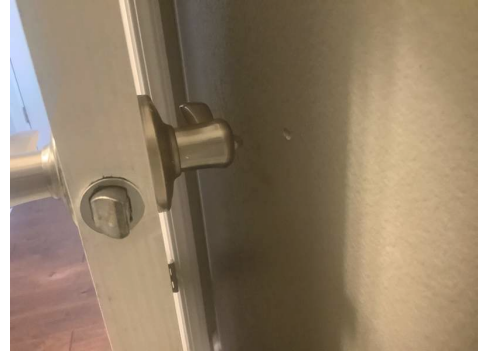
9.4.1 Walls

DOORKNOB DAMAGE

Wall appears to be damaged from doorknob. Recommend a qualified handyman or drywall contractor repair.

Contact a qualified drywall contractor.

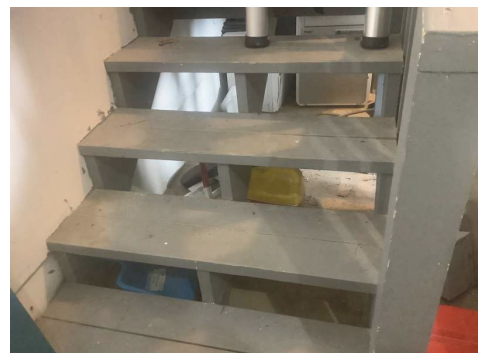
Stairs have open risers. Open risers can be a trip hazard. Recommend a qualified contractor closes the risers.

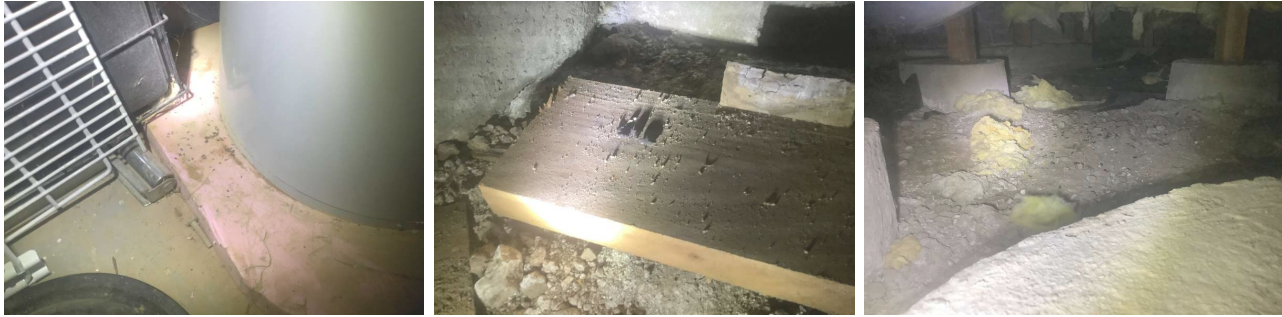
Evidence of rodents was observed. Rodents can be a nuisance and also cause damage to the home. Recommend monitoring and evaluation by a qualified pest professional, if needed.

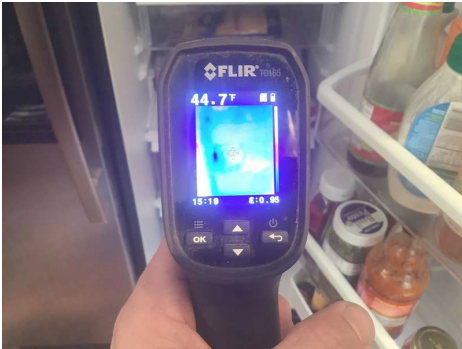
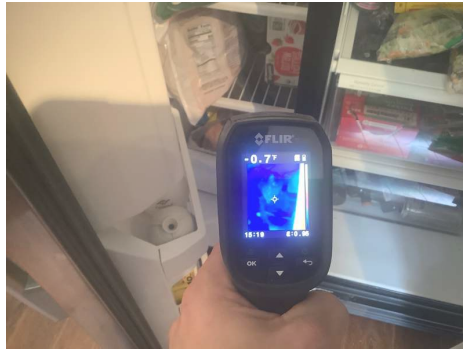
Refrigerator: Refrigerator/freezer operational

The refrigerator and freezer were operational at the time of inspection.

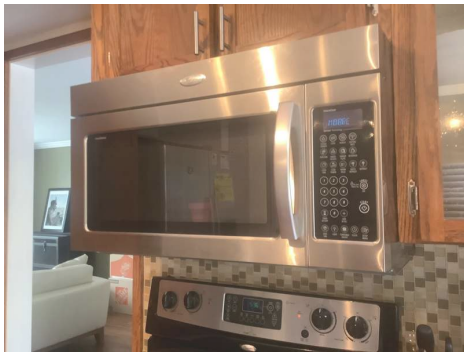
Built-in Microwave: Microwave operational

The built-in microwave was operational at time of inspection.

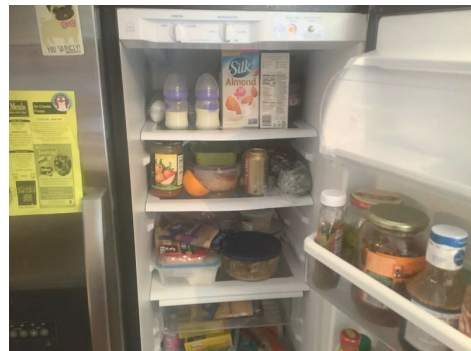
10.1.2 Refrigerator

NEEDS FILTER CHANGE

The refrigerator water filter should be replaced. Recommend replacement.
