NORTHBANK HOME INSPECTION

RESIDENTIAL REPORT

1234 Main St.
Vancouver, WA 98663

07/12/2019 9:00AM

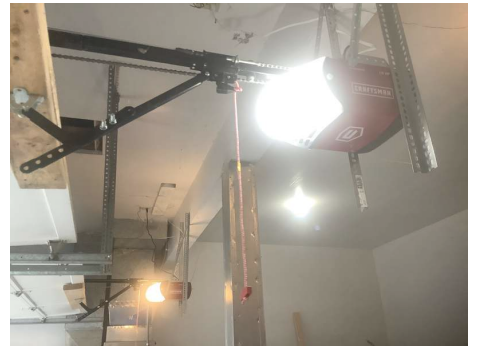
Garage Door Opener: Opener

The garage door opener was operational at the time of inspection.

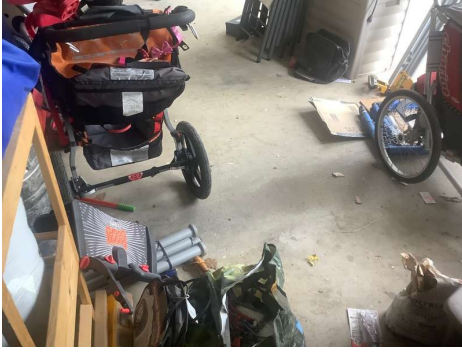
The garage floor showed signs of normal expansion/contraction concrete cracking in the visible areas.
