EMPIRE INSPECTORS, LLC

EMPIRE RESIDENTIAL INSPECTION

1234 Main St.
Yorktown Heights NY 10598

Buyer Name
05/10/2018 9:00AM

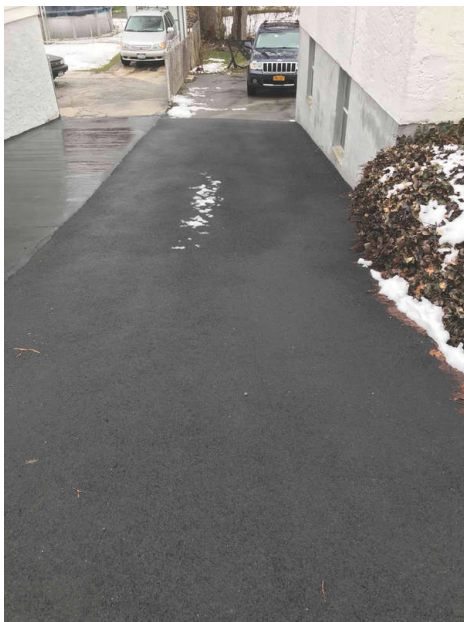
Driveways: Driveway OK

The asphalt driveway was in good condition with minor cracks. Recommend regular seal coating every 2-3 years to preserve the driveway and keep it from cracking and deteriorating. Underground tree roots, salt, snow melting products and lack of maintenance are the biggest contributors to asphalt deterioration.

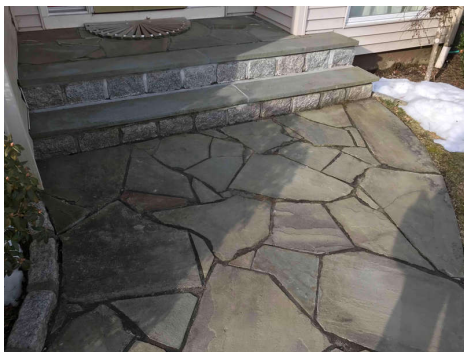
Steps: Steps OK

The steps were in good condition with no major defects noted. Salt and snow melting materials are the largest contributor to surface deterioration.

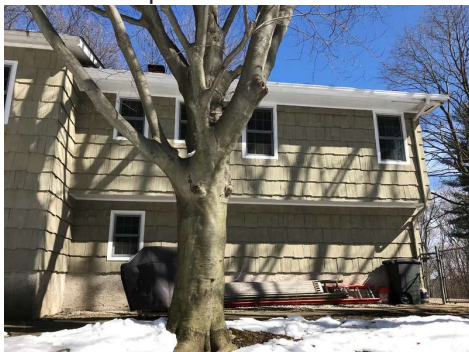
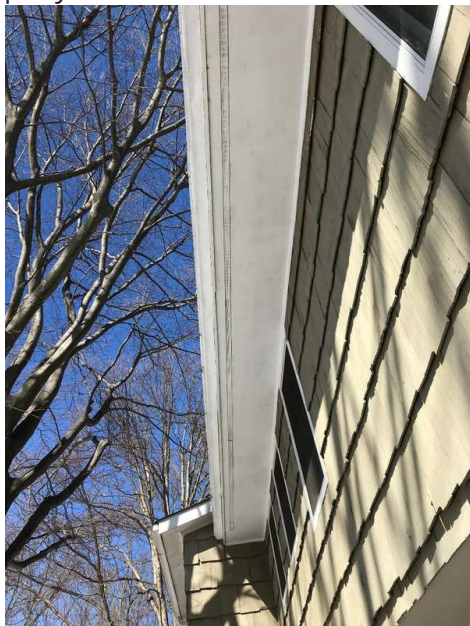
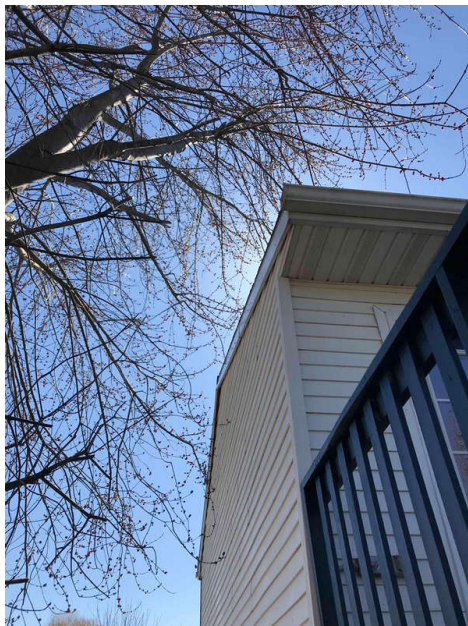
2.1.1 Vegetation, Grading, Drainage & Retaining Walls

Trees observed overhanging the roof. This can cause damage to the roof and prevent proper drainage. Recommend a qualified tree service trim to allow for proper drainage.

Contact a qualified tree service company.

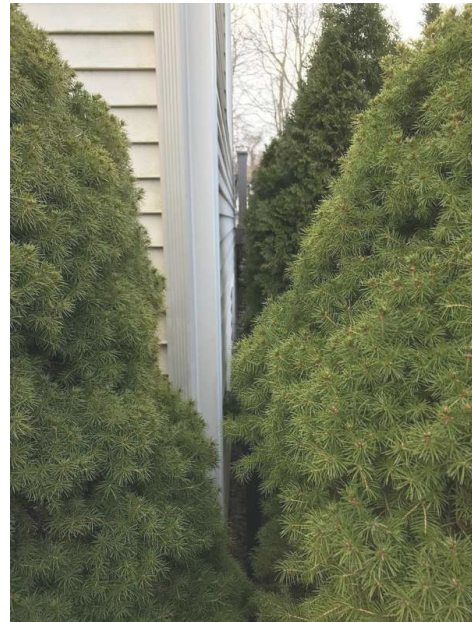
2.1.2 Vegetation, Grading, Drainage & Retaining Walls

Shrub and tree growth were not far enough away from the siding of the house. Regular maintenance and pruning should be done on an ongoing basis to prevent contact with the house or roof which could lead to unwanted moisture contacting the siding of the house. Recommend trimming back shrubs so they are not touching the siding.

Contact a qualified landscaping contractor

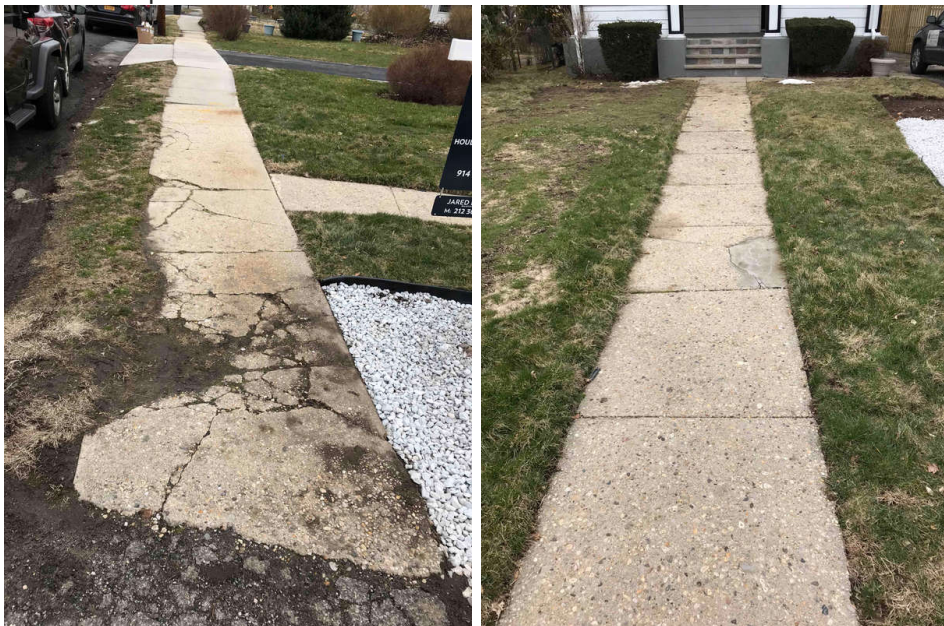
2.3.1 Walkways

WALKWAY CRACKING - MAJOR

The walkway was cracked and deteriorated. Recommend having a qualified contractor repair.

Contact a qualified concrete contractor.

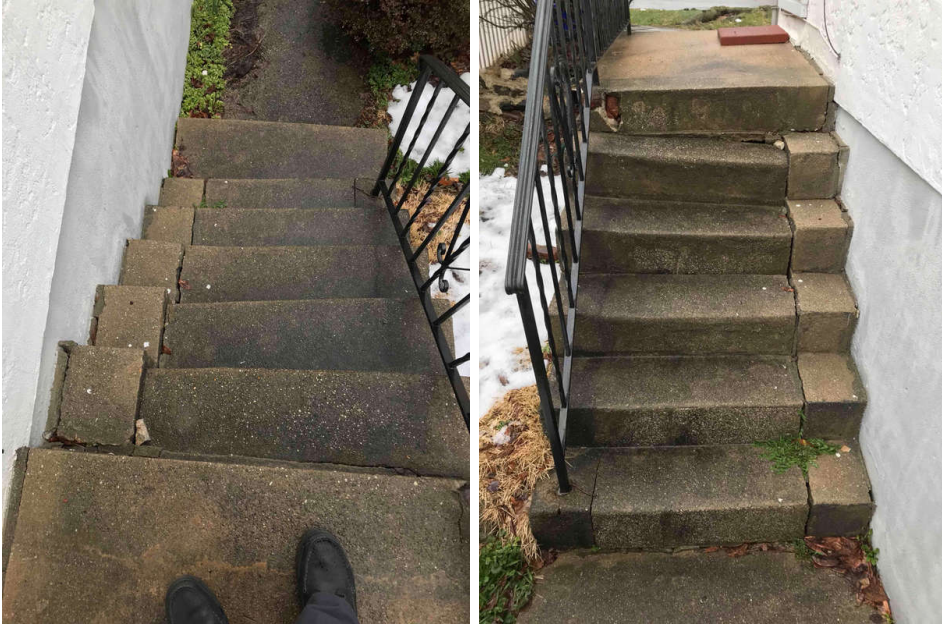
2.4.1 Steps

STEPS POOR CONDITION

The side steps were in poor condition with cracks, surface deterioration, settling/heaving and loose railings. Recommend hiring a qualified masonry contractor to evaluate and repair or replace as necessary.

Contact a qualified masonry professional.

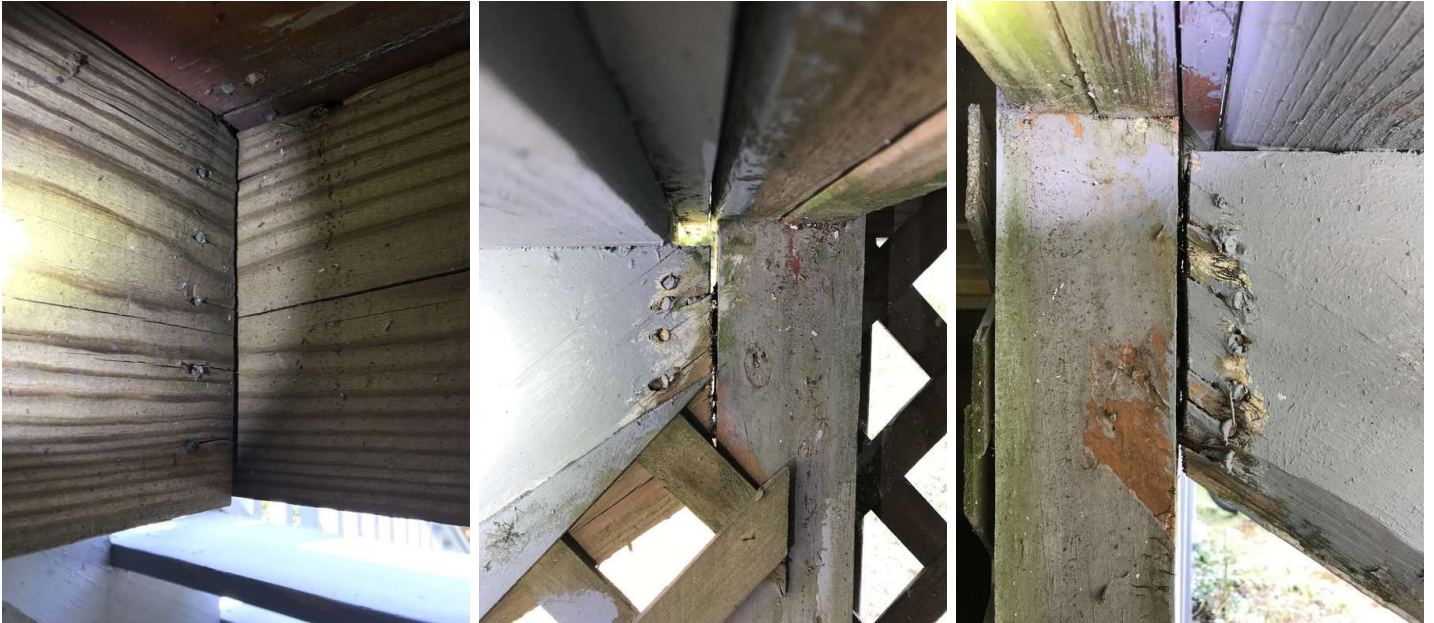
2.5.1 Decks, Balconies, Porches

IMPROPER DECK CONSTRUCTION PRACTICES

Deck was observed to have general poor construction. Improper fasteners, lack of lag bolts and joist hangers, improper post to beam connections were noted. Recommend having a qualified deck contractor evaluate and repair all defects as necessary

Contact a qualified deck contractor.

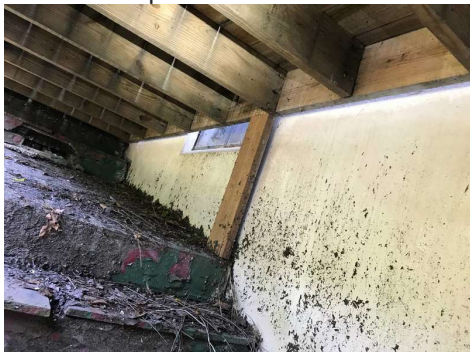
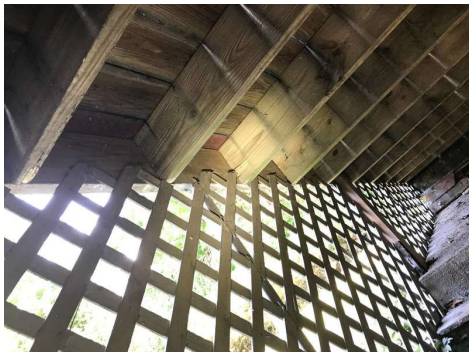
2.5.2 Decks, Balconies, Porches

Joist hanger(s) are missing or improperly installed. This could cause the deck structure to fail. Recommend that joist hangers be properly installed by qualified contractor.

Contact a qualified deck contractor.

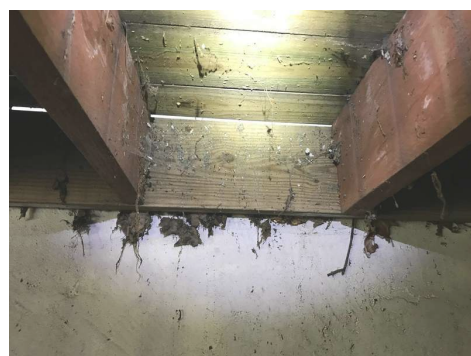
2.5.3 Decks, Balconies, Porches

LEDGER BOARD IMPROPERLY INSTALLED

The ledger board is not properly attached to the building. This can cause the deck to pull away from the building and possibly collapse. Recommend that the deck and/or ledger board be properly attached by qualified contractor.

Contact a qualified deck contractor.

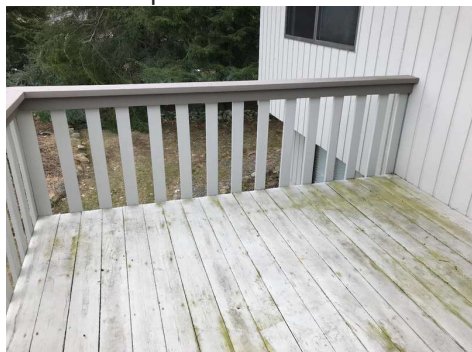
2.5.4 Decks, Balconies, Porches

RAILING UNSAFE

There is an unsafe opening in the railing. The spacing on the rail should not exceed 4". An opening greater than 4" is a serious safety hazard especially for children as their head or other body part can become trapped.

Contact a qualified deck contractor.

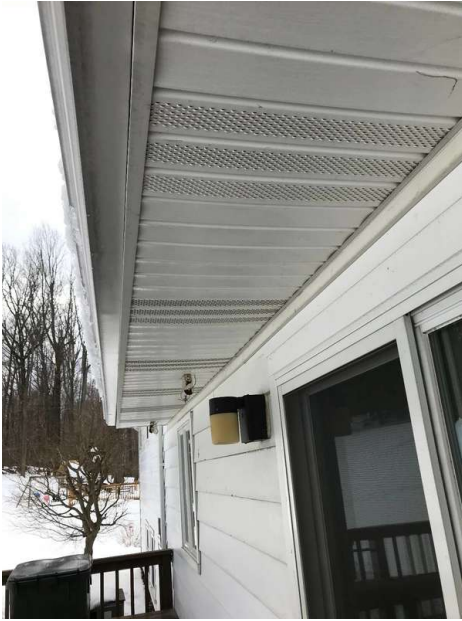
Eaves, Soffits & Fascia: Vinyl Fascias and Soffits OK

The fascias and soffits were comprised of maintenance-free vinyl and aluminum and in good condition. It is important to immediately repair any soffit or fascia materials that may become loose or dislodged to prevent water and ice from getting behind these surfaces and causing damage to any wood products.

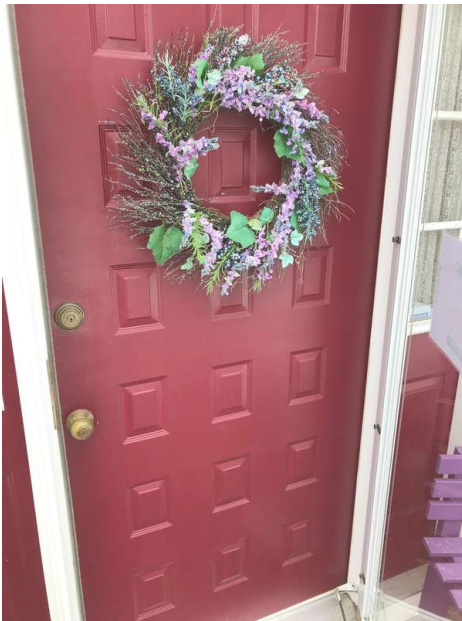
**Exterior Doors: Door OK**

The front entry door was in good condition with no defects noted. The screen/storm door was operational and in working condition on the day of inspection.

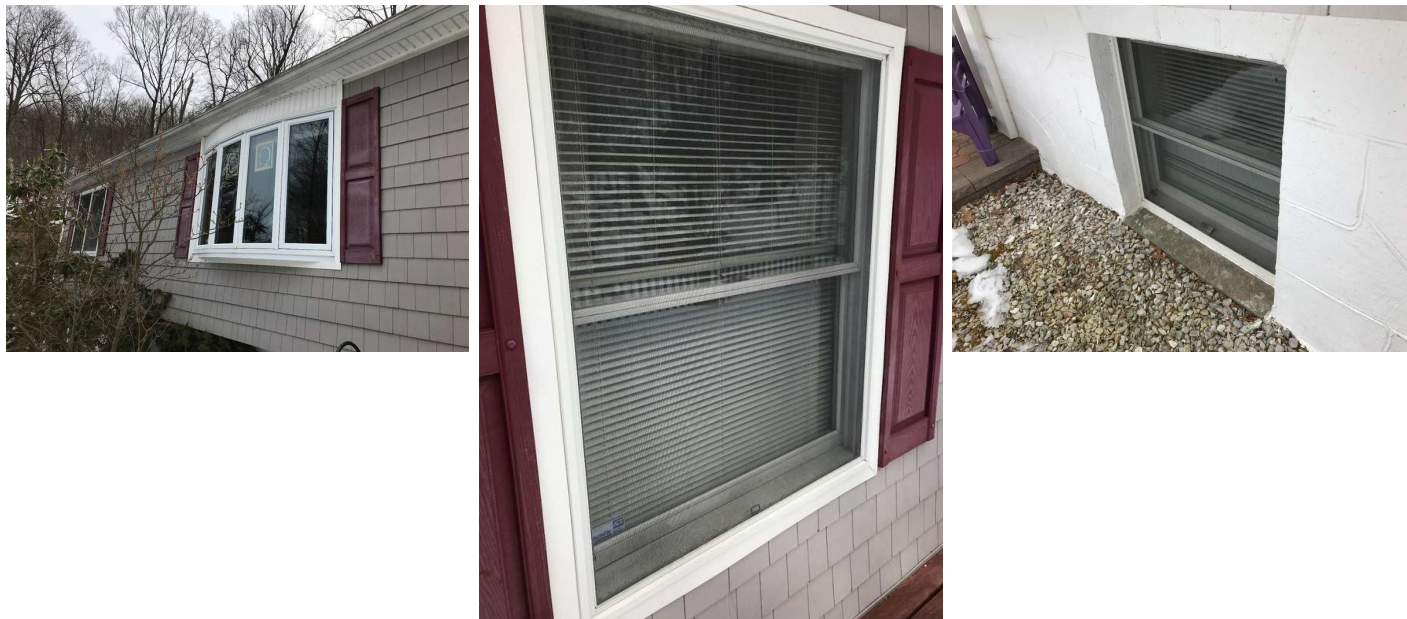
Window Exteriors: Vinyl Windows OK

The windows were all maintenance-free vinyl windows. No major defects were noted on the exterior on the day of inspection.

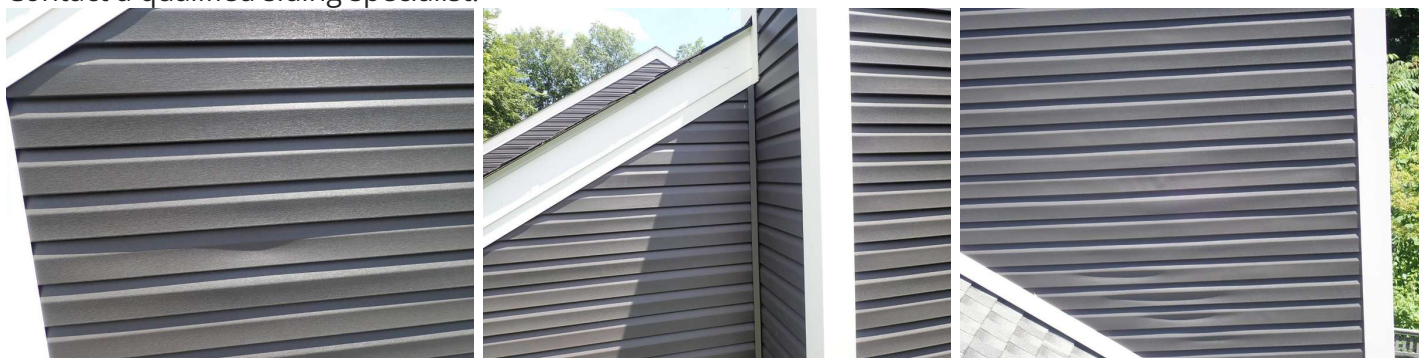
3.1.1 Siding, Flashing & Trim

Vinyl siding was warping or buckling in areas. This is often as a result of nailing siding boards too tight to the home, preventing expansion/contraction. This can also be caused by excessive heat from sunlight reflecting off LowE windows/skylights. Recommend a qualified siding contractor evaluate and repair.

Contact a qualified siding specialist.

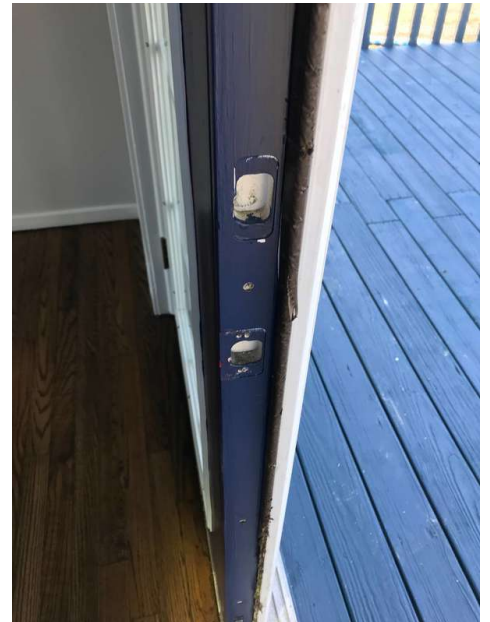
3.3.1 Exterior Doors

HARDWARE MISSING

Rear entry door is missing one or more pieces of hardware. Recommend replacing or upgrading.

Contact a qualified door repair/installation contractor.

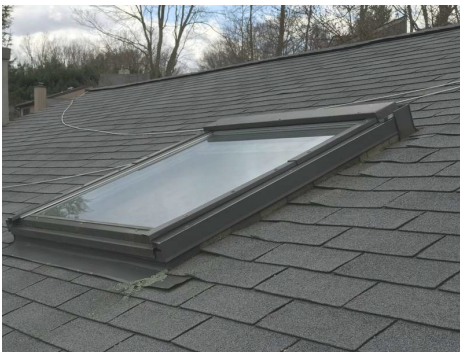
Skylights, Chimneys & Other Roof Penetrations: Skylights - OK

The skylights all appeared to be fixed in nature and no defects were noted. There were no watermarks or stains in the inside of the house or around the skylight areas.

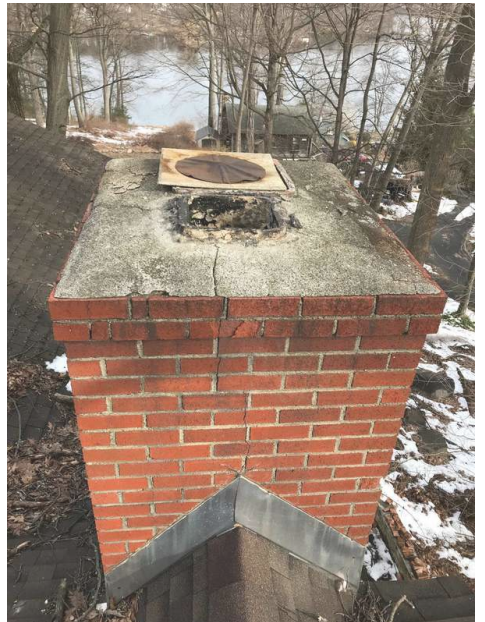
CHIMNEY POOR CONDITION

The chimney(s) had no spark arrestor or cap. The Inspector recommends that all chimneys have an approved spark arrestor installed by a qualified contractor to prevent pest entry and to help protect the roof-covering materials from potential chimney-source ignition. There was cracking in the brick and mortar and the flue pipe did not extend far enough out of the chimney. Recommend having a qualified contractor evaluate and repair.

Contact a qualified chimney contractor.

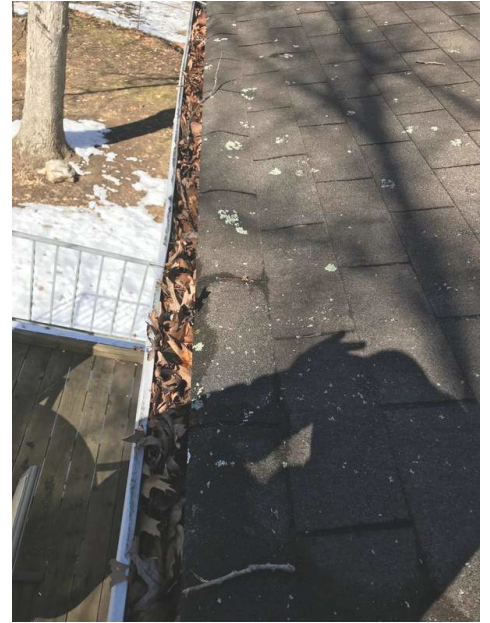
4.4.1 Roof Drainage Systems

Debris has accumulated in the gutters. Recommend cleaning to facilitate water flow.

Contact a handyman or DIY project

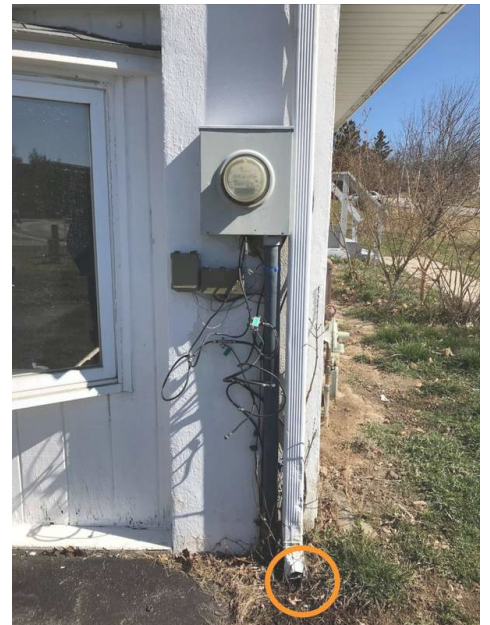
4.4.2 Roof Drainage Systems

One or more downspouts drain too close to the home's foundation. This can result in excessive moisture in the soil at the foundation, which can lead to foundation/structural movement. Recommend a qualified contractor adjust downspout extensions to drain at least 4-6 feet from the foundation.

Contact a handyman or DIY project

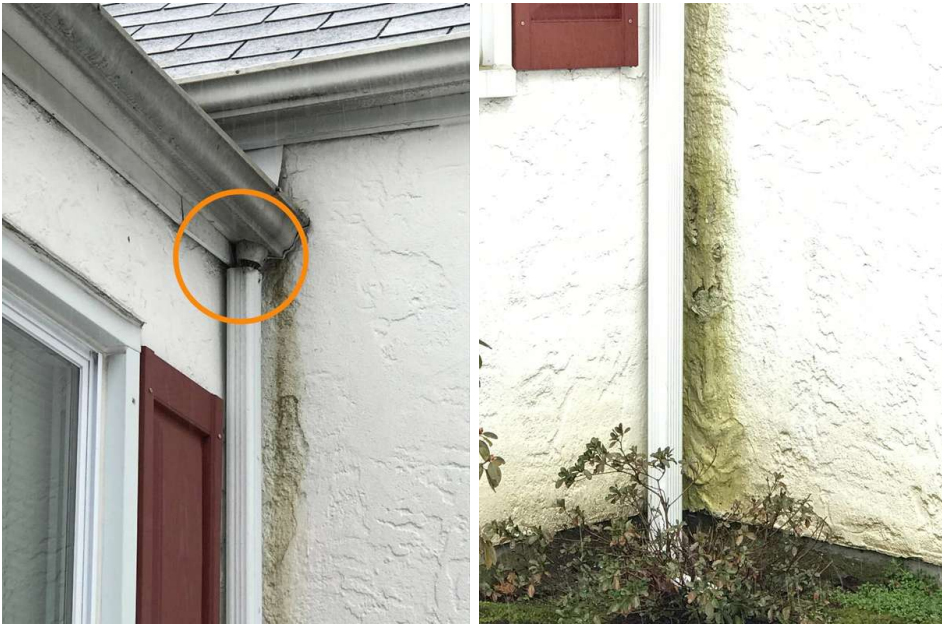
4.4.3 Roof Drainage Systems

One or more downspouts designed to discharge roof drainage needed to be re-connected in order to properly control roof run-off. This condition can result in excessively high moisture levels in soil at the foundation and can cause damage related to soil/foundation movement. Excessive moisture levels in soil near the foundation can effect the ability of the soil to support the weight of the structure above and can cause damage related to soil/foundation movement. The Inspector recommends re-connection of any disconnected downspouts to help protect the home structure. All work should be performed by a qualified contractor..

Contact a qualified roofing professional.

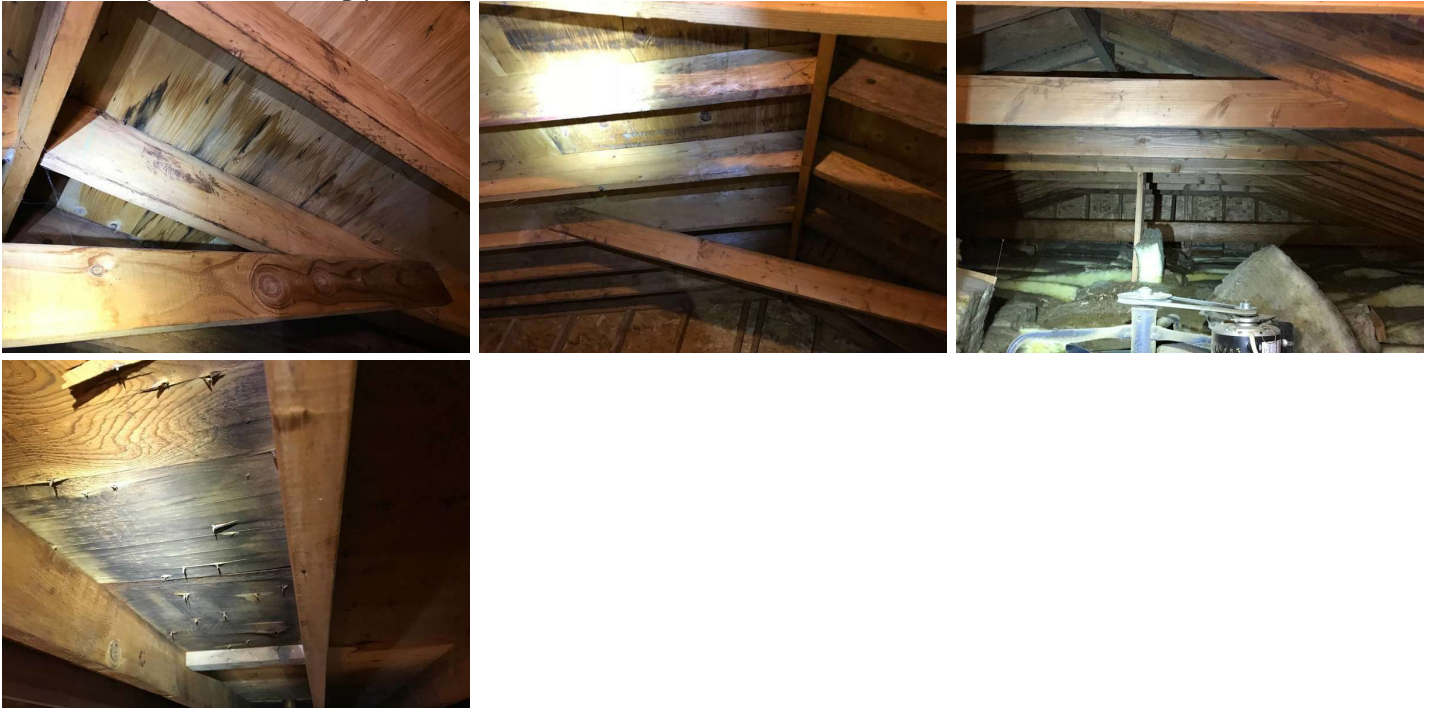
4.5.1 Roof Structure & Attic

ATTIC MOISTURE

There were signs of moisture staining and previous roof leaks in the attic. The plumbing stack was noted and through the roof. Recommend having a qualified roofing contractor evaluate and repair all defects as necessary.

Contact a qualified roofing professional.

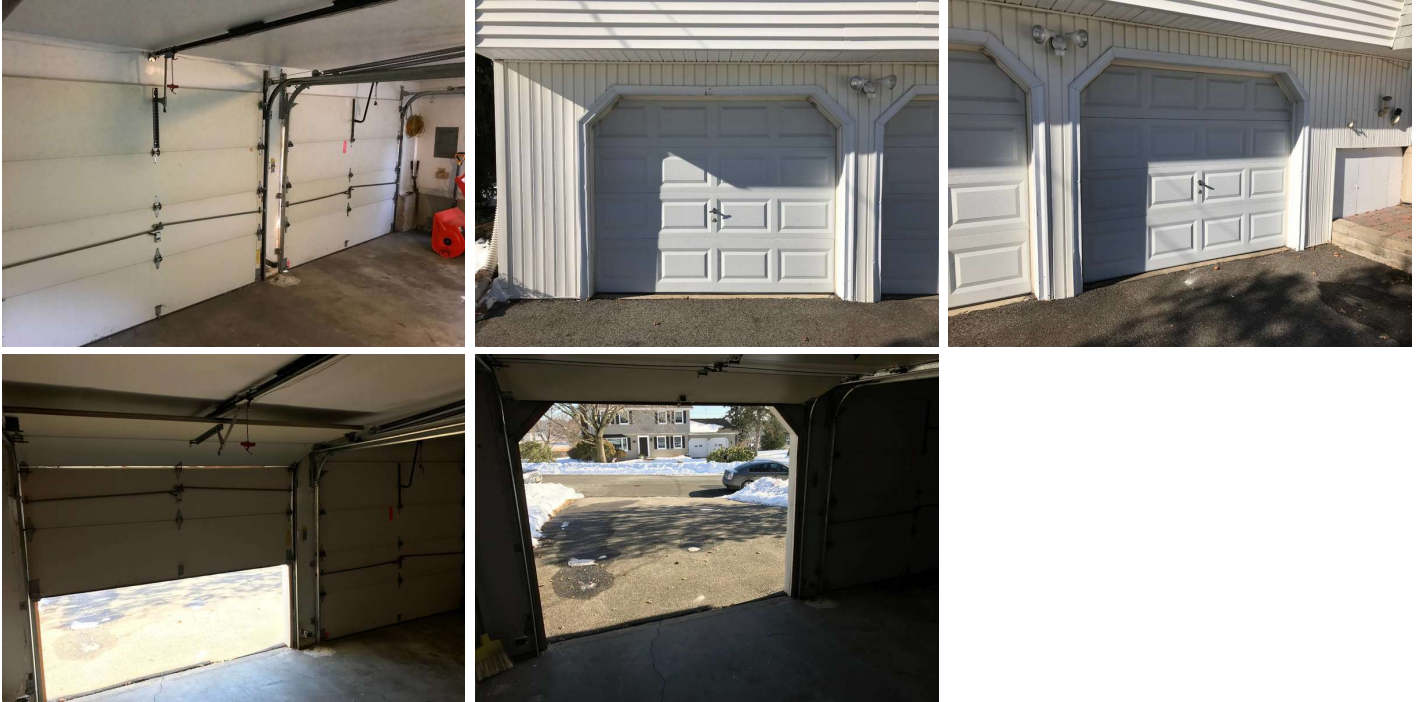
Garage Door: Garage Doors OK

At the time of the inspection, no deficiencies were observed in the condition of the garage doors.

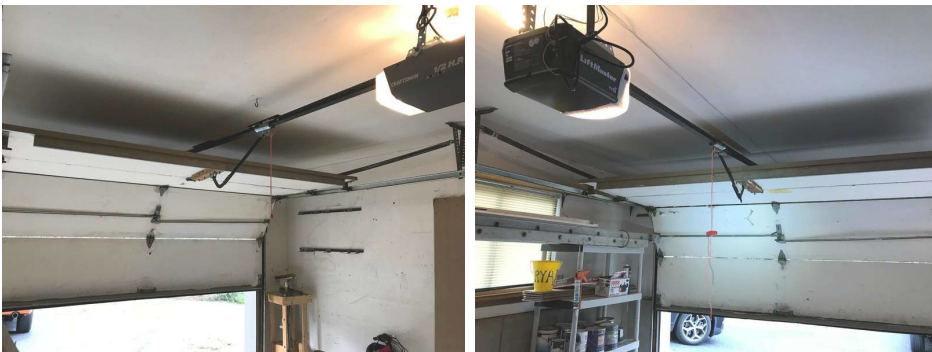
Garage Door Opener: Opener OK

The Garage door opener(s) were operational at the time of inspection. They were tested for functionality and the auto reverse feature worked when the sensors were obstructed. Recommend regular maintenance to ensure proper operation of track and roller hardware.

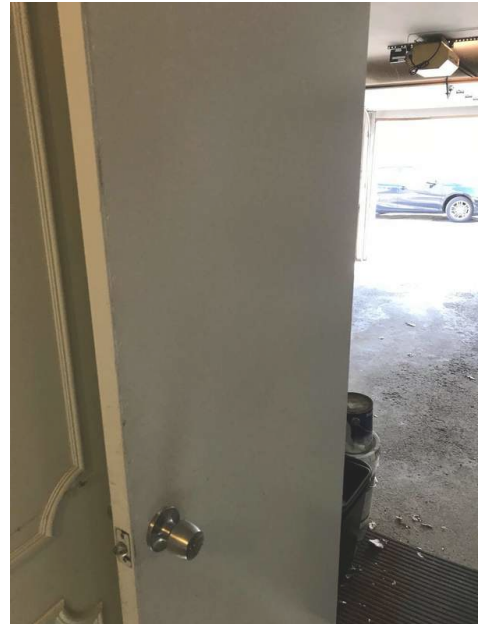
Door separating garage and home does not meet safety standards. Doors must be at least 1 3/8-inch thick, solid wood/metal/steel, or a 20-minute fire-rated door with self-closing hinges. Recommend having a qualified contractor replace the door as necessary.

Contact a qualified door repair/installation contractor.

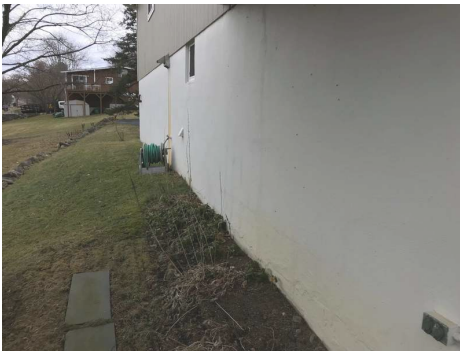
Foundation: Foundation Exterior OK

The foundation walls appeared to be in good condition. No major defects or cracks were noted on the exterior on the day of inspection. Regular maintenance is required to make sure any cracks are sealed to prevent water intrusion.

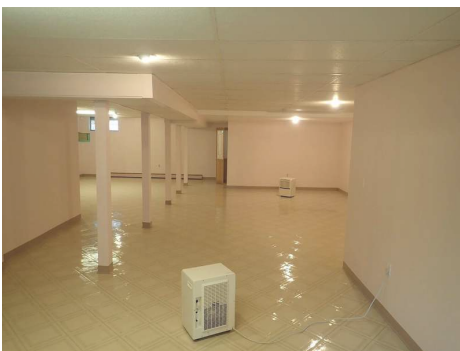
Basements & Crawlspaces: Basement OK

The interior of the basement appeared to be in good condition. The framing and support of the house as seen from the basement were in good condition and to traditional building methods.

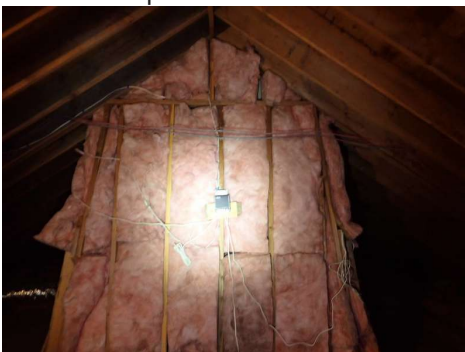
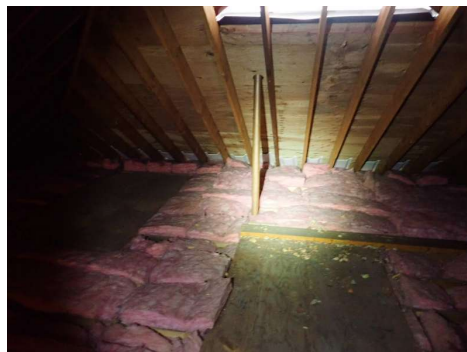
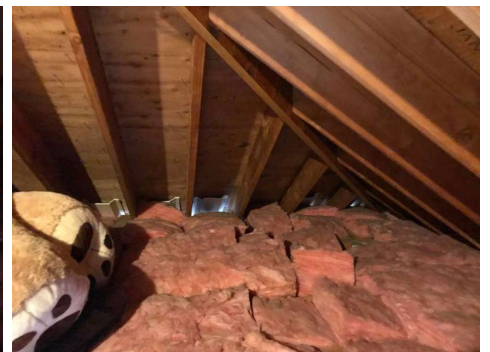
IMPROPER INSTALLATION

Thermal insulation in the attic was poorly-installed and had significant gaps which will result in unwanted heat gain or loss. This condition will increase heating and cooling costs and reduce comfort levels and may contribute to ice damming of the roof during the winter. The Inspector recommends that insulation be properly distributed to cover all portions of the attic located above the home living space.

Contact a qualified insulation contractor.

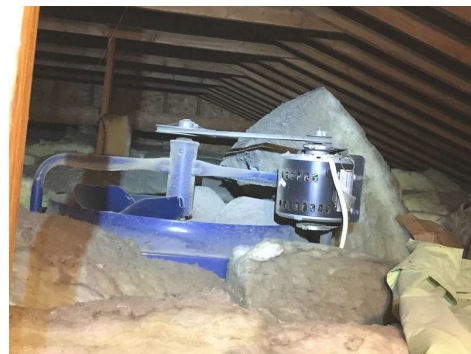
7.2.1 Ventilation

No cover was provided for sealing and insulating the whole-house fan penetration during the heating season. This condition will result in the loss of home heat and increased heating costs. The fan was also rubbing on the displaced fiberglass insulation.

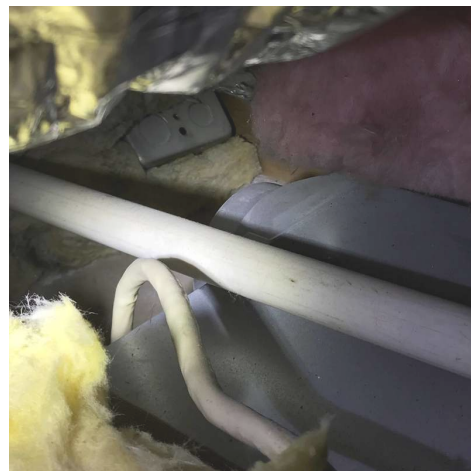
7.3.1 Exhaust Systems

BATHROOM VENTS INTO ATTIC

Bathroom fan vents into the attic, which can cause moisture and mold. Recommend having a qualified contractor properly install ductwork to terminate exhaust to the exterior.

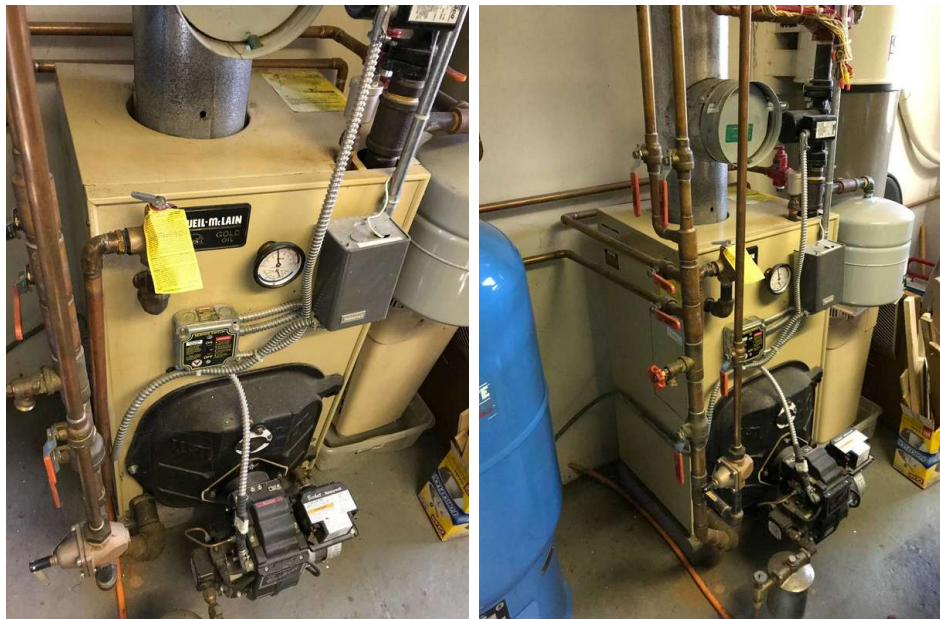
The boiler was a Weil McLain oil fired unit and approximately 14 years old and in working condition. The unit appeared to have been serviced properly as evidenced by the service tags. The system was tested on the day of inspection and fired properly as heat was delivered to all areas in the house. It is recommended to get annual servicing of the unit to keep it at peak operating efficiency.

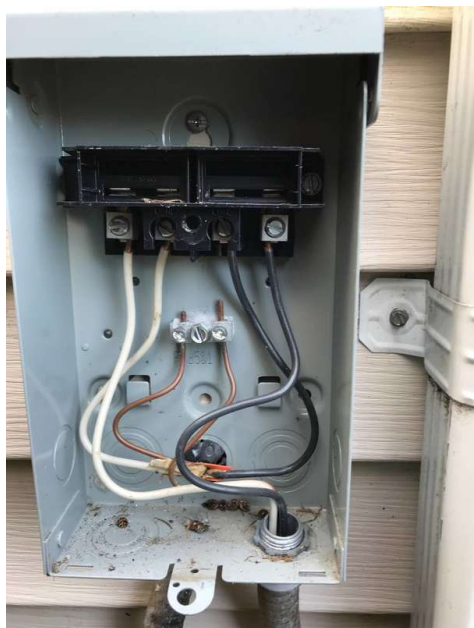
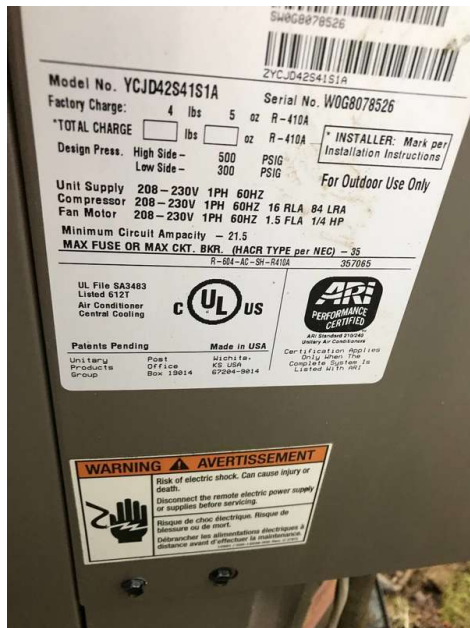
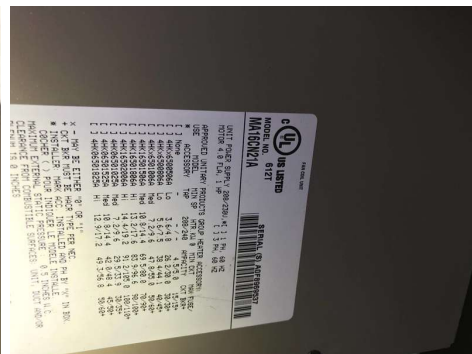
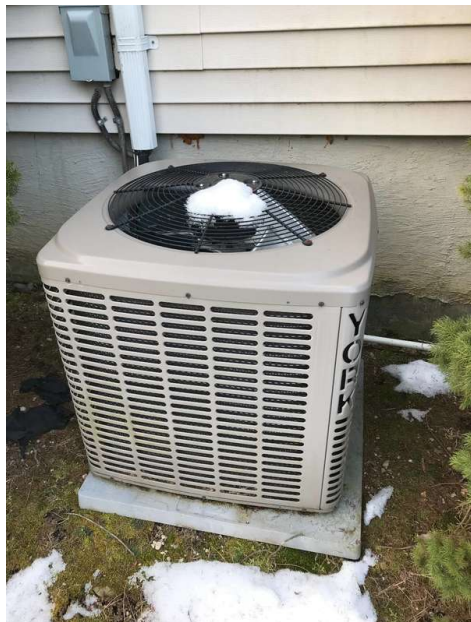
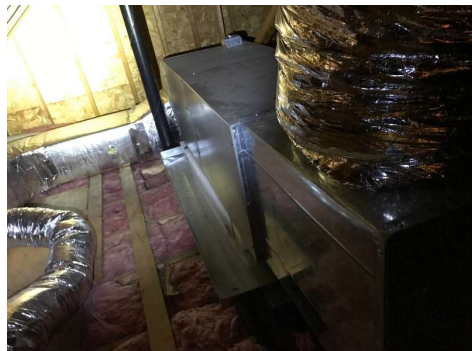
The air conditioning could not be tested on the day of inspection due to the outside temperature being below 65 degrees for the past 12 hours. The electrical disconnects were noted and in good condition and it is important to get annual servicing of the units so they operate at peak efficiency. It is recommended that you speak to your Realtor and Attorney about holding money back in escrow until the system can be fully tested if this hasn't occurred by the day of closing.

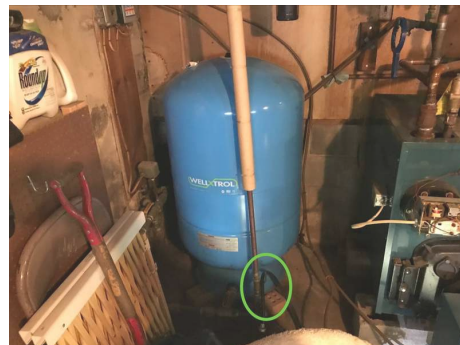
Main Water Shut-off Device: Location
Basement, At Well Tank

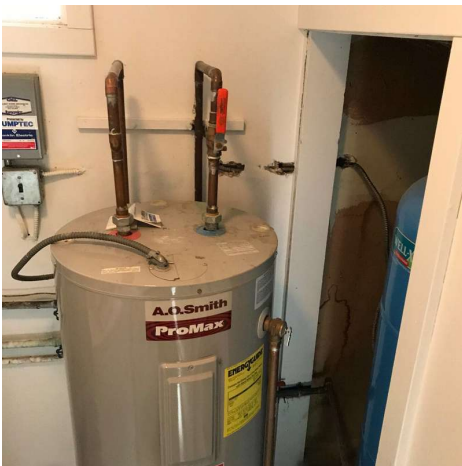
Hot Water Systems, Controls, Flues & Vents: Water Heater OK

The water heater was operational on the day of inspection. The TPRV and extension were present and in good condition. There was no rust present on the day of inspection and hot water was received at all test points in the home.

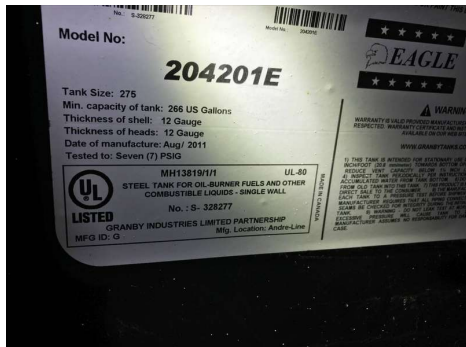
Fuel Storage & Distribution Systems: Oil Tank OK

The oil tank was an above ground tank located in the garage. It was a top tap tank with steel fill and vent pipes. It was approximately 7 years old and no rust, pitting or defects were noted. Oil tanks have an average lifespan of 20+ years depending on climate and environment they are in. Any signs of rust should immediately be looked at by a qualified oil tank company.

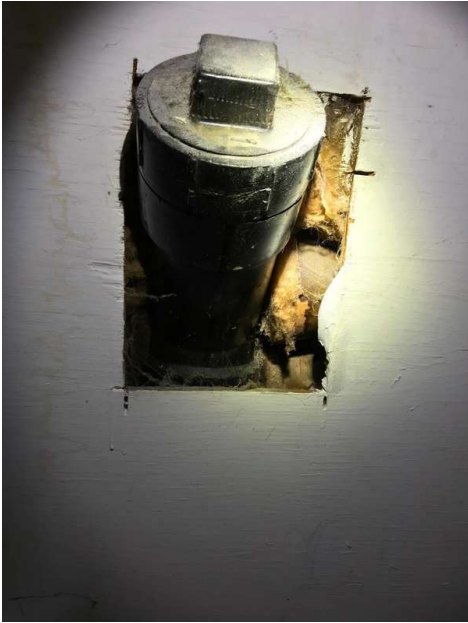
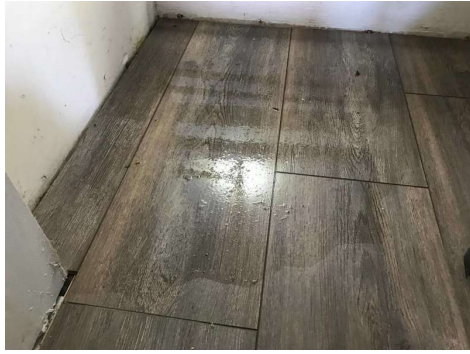
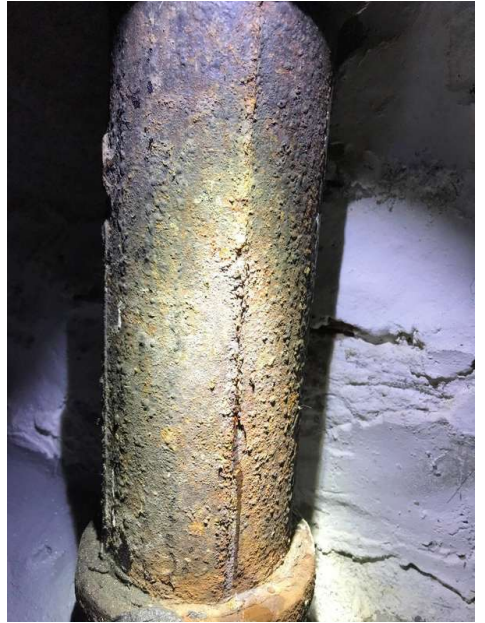
10.3.1 Sewage & Drain, Waste, & Vent (DWV) Systems

LEAKING PIPE

Contact a qualified plumbing contractor.

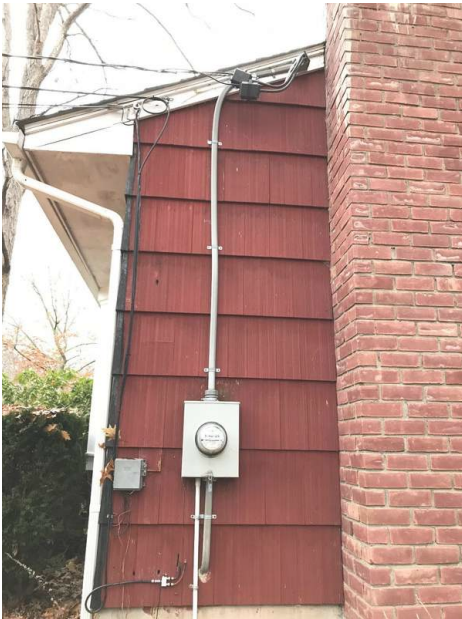
Service Entrance Conductors: Overhead Service OK

At the time of the inspection, the Inspector observed no deficiencies in the condition of the service drop. Components inspected included the service conductors, splice, drip loop, and point of attachment to the home.

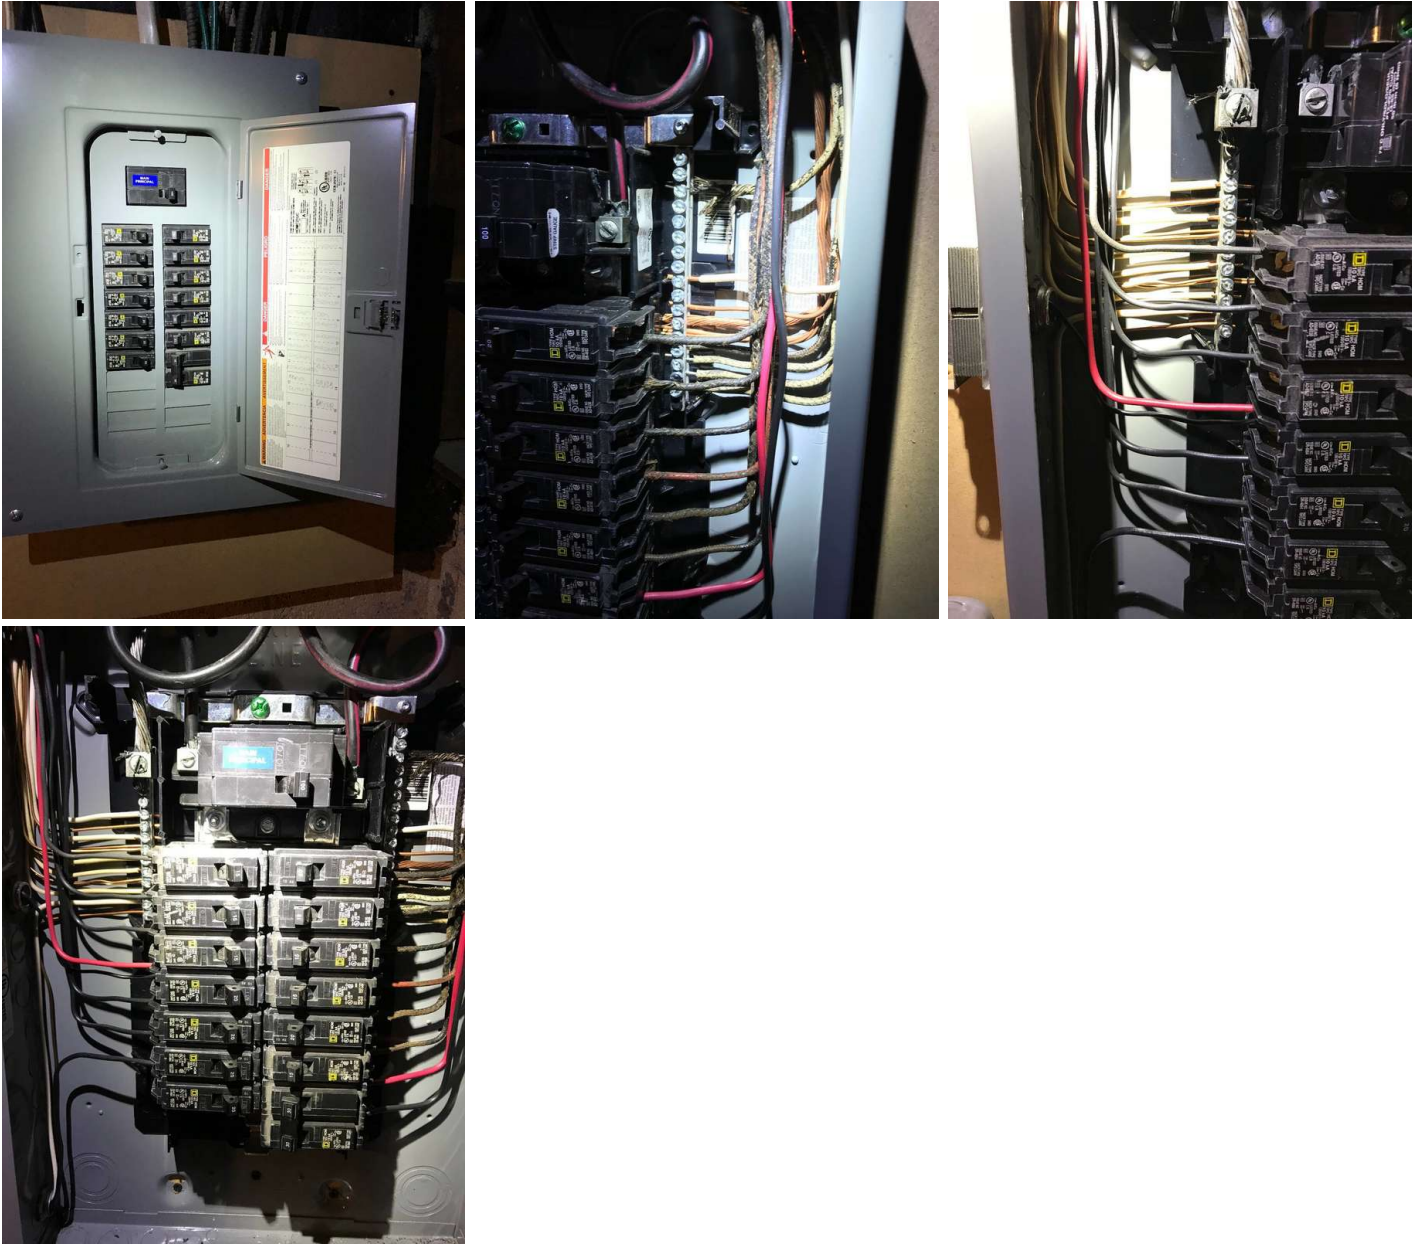
Main & Subpanels, Service & Grounding, Main Overcurrent Device: Service Panel OK

The electric panel was located in the basement and was 100 amp main service. The panel was in good condition with no defects noted and grounding was proper. There were no double taps or missing covers and there was additional room for expansion.

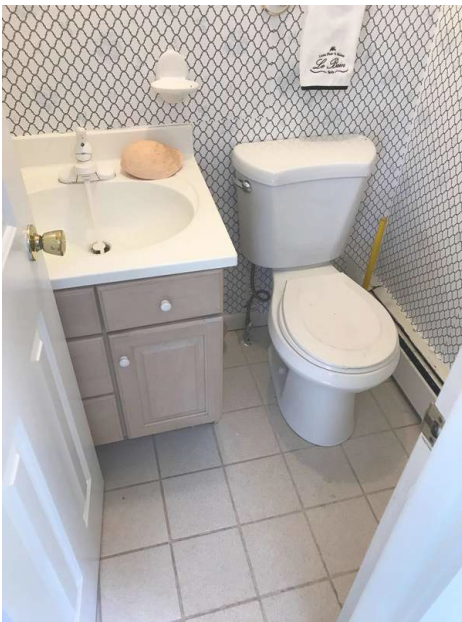
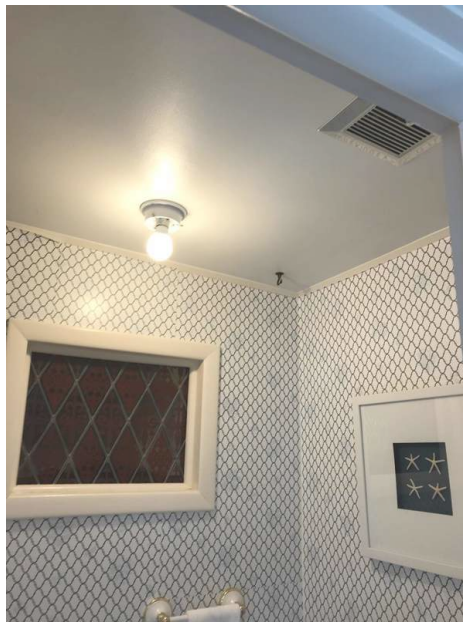
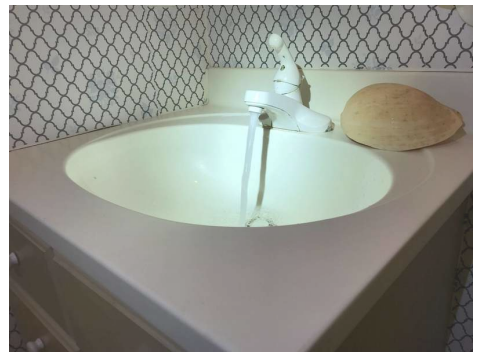
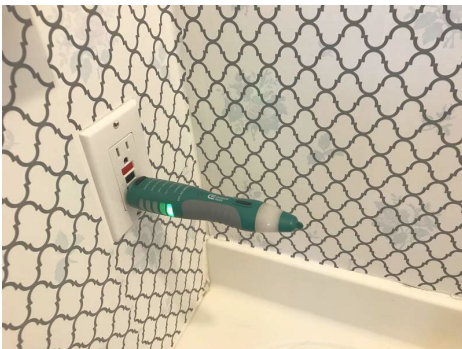
1/2 Bathroom
1st Floor

The half bathroom was in working condition with no leaks noted at the sink or toilet. The exhaust fan and GFCI outlets and were tested and operated properly on the date of inspection.

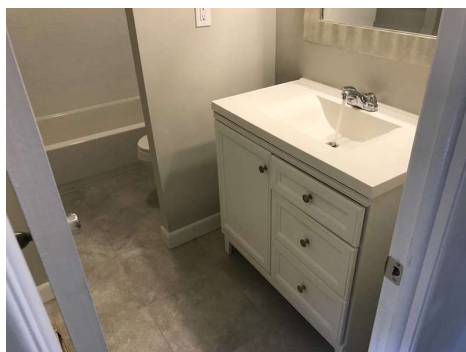
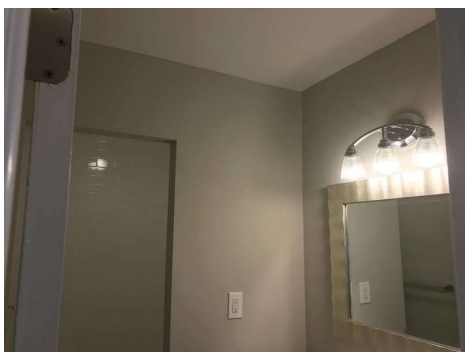
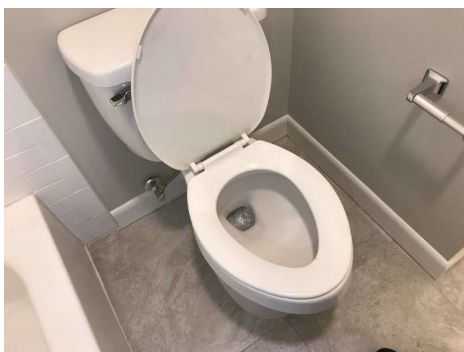
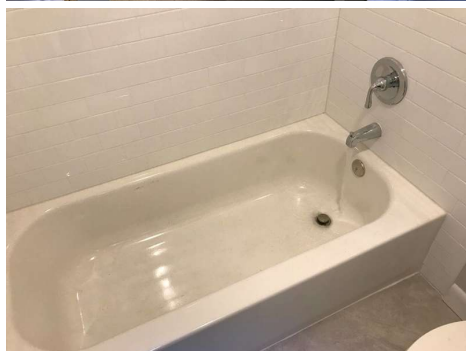
Bathroom #1

The bathroom was in working condition with no leaks noted at the sink, tub/shower or toilet. The exhaust fan and GFCI outlets were tested and operated properly on the date of inspection.

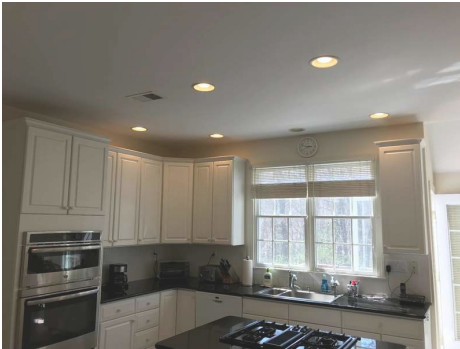
The kitchen was in working condition with no major defects noted. There were no leaks at the sink or dishwasher. All the cabinets and countertops were operational and secure. The exhaust fan for the cooktop(downdraft exhaust) and GFCI outlets were tested and operated properly on the date of inspection. The bottom of the sinkbase cabinet appeared to have been damaged by a prior leak.

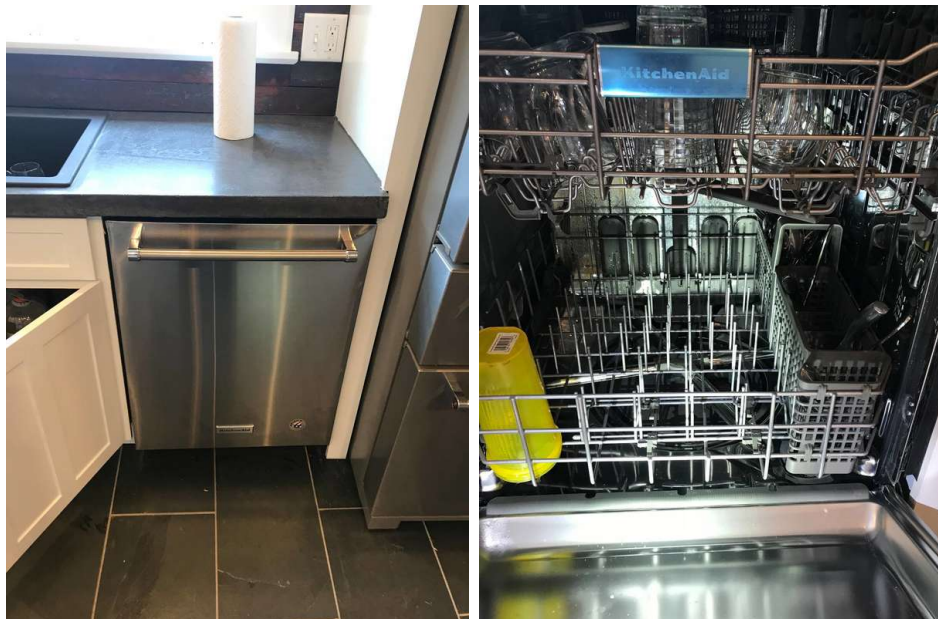
Dishwasher: Dishwasher OK

At the time of the inspection, the Inspector observed no deficiencies in the condition and operation of the dishwasher. It was operated through a cycle.

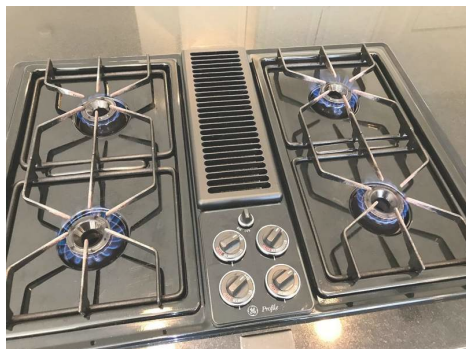
**Cooktop: Cooktop OK**

At the time of the inspection, the Inspector observed no deficiencies in the condition and operation of the cooktop.
