EMPIRE INSPECTORS, LLC

EMPIRE RESIDENTIAL INSPECTION

1234 Main St.
Yorktown Heights NY 10598

Buyer Name
05/10/2018 9:00AM

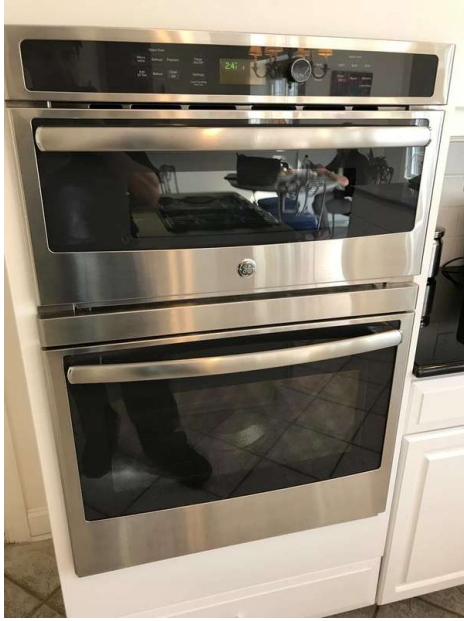
Oven/Range: Oven OK

At the time of the inspection, the Inspector observed no deficiencies in the condition and operation of the oven.

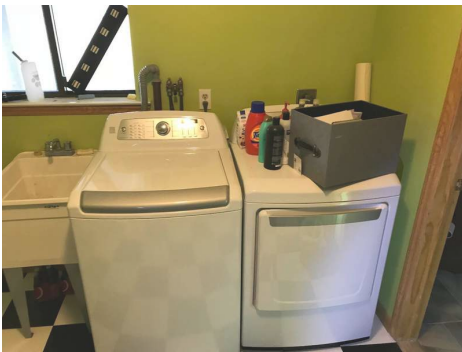
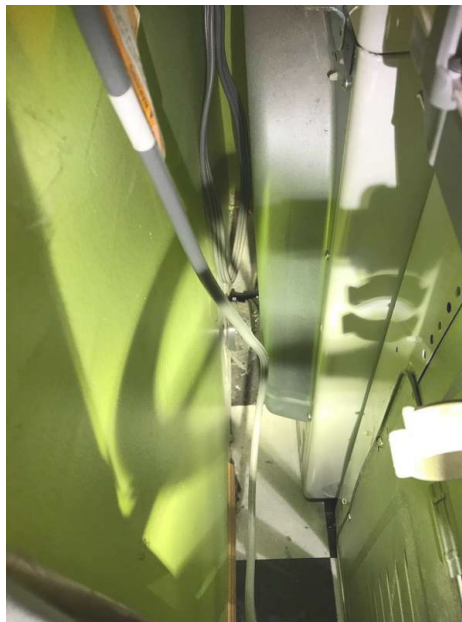
Laundry - OK

The laundry area was in acceptable condition with no major defects noted. There were no leaks at the washing machine connections and there was an exhaust hose present to vent the dryer properly to the exterior.
