DUNN RIGHT RESIDENTIAL INSPECTION

1234 Main St.
Summerside PE C1N 4J9

Buyer Name
01/19/2019 9:00AM

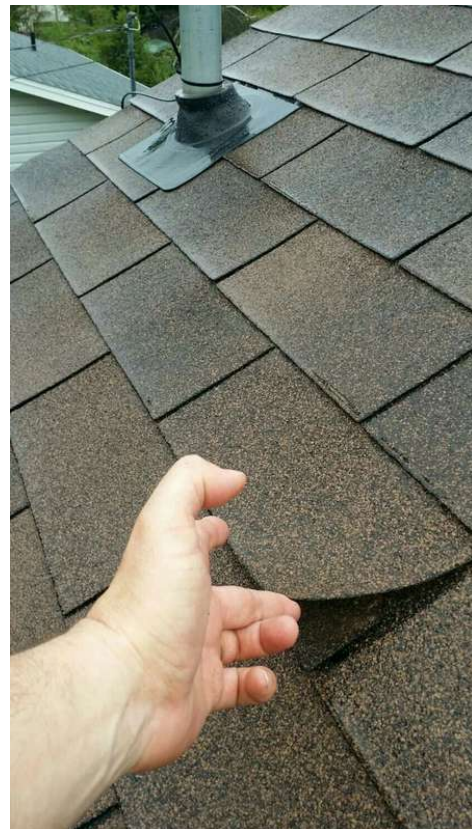
2.1.1 Coverings

**LOOSE SHINGLES, RECOMMEND RESEALING TO AVOID LOSS OF SHINGLES**

Contact a qualified professional.

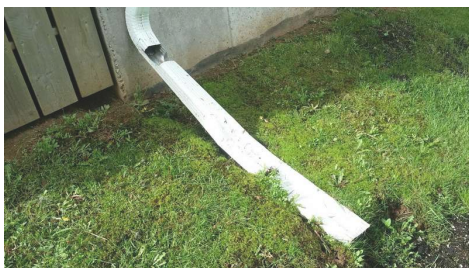
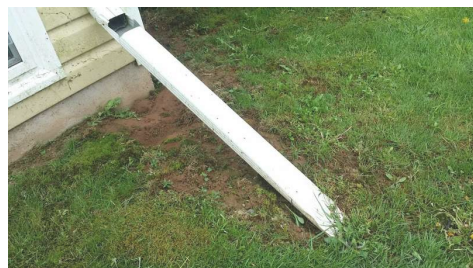
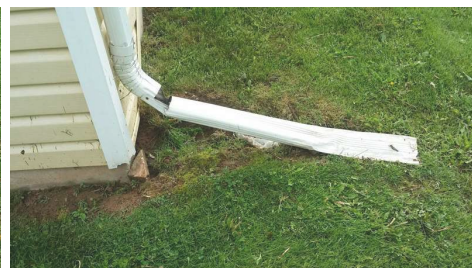
2.2.1 Roof Drainage Systems

DOWNSPOUTS DRAIN NEAR FOUNDATION

One or more downspouts are damaged and drain too close to the foundation which may cause water to enter into the home. Recommend adjusting downspout extensions to drain at least 6 feet from the foundation.

Contact a handyman or DIY project

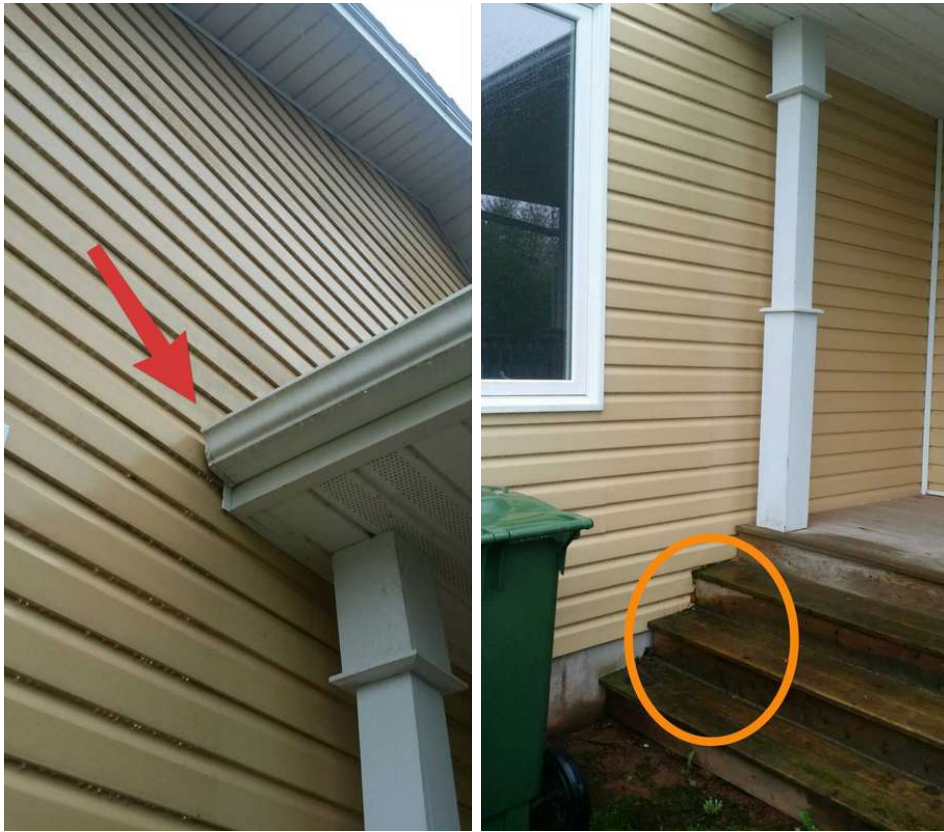
2.3.1 Flashings

MISSING

Kickout Flashings is missing at time of inspection. Flashings provide protection against moisture intrusion. Recommend a qualified roofing contractor evaluate and remedy.

Water over flowing gutter landing on porch steps due to missing Kickout Flaxhing

Contact a qualified roofing professional.

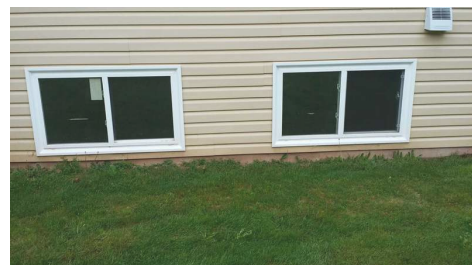
3.7.1 Windows

EGRESS WINDOW - EXIT

Recommend installing ladder or means to escape from the egress area.

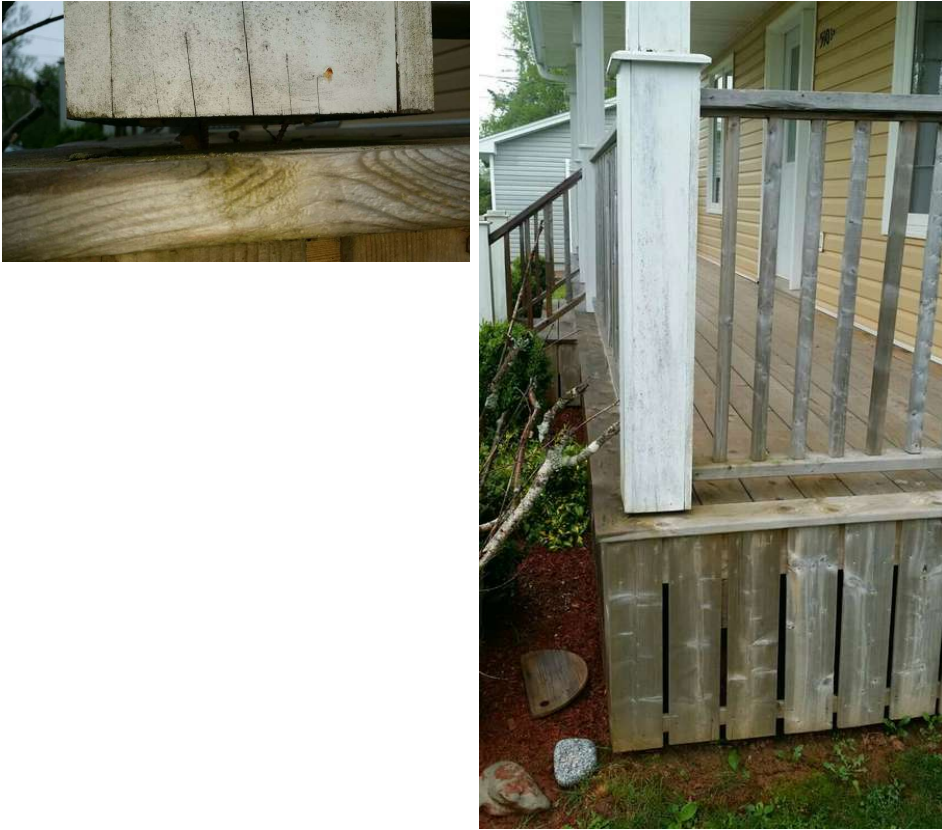
3.8.1 Decks, Balconies, Porches & Steps

COLUMN SUPPORT NOT ATTACHED TO PORCH

Recommend column be mechanically attached to porch floor as a means to better secure them.

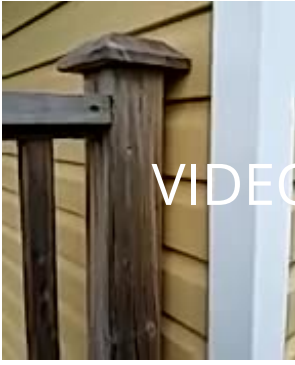
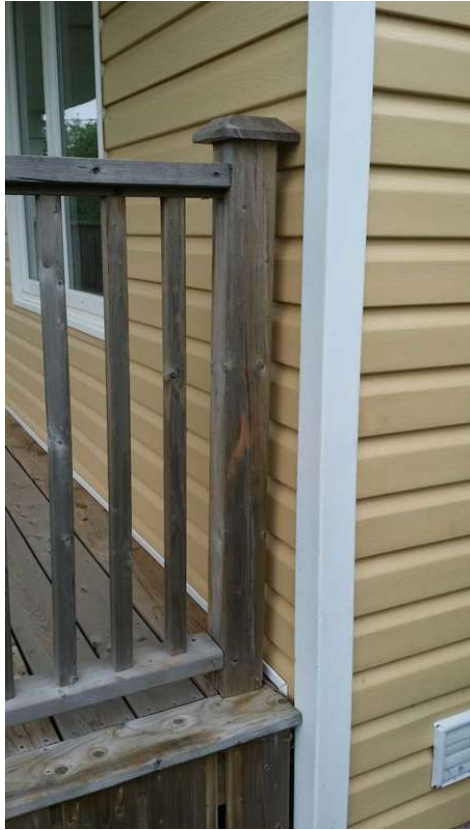
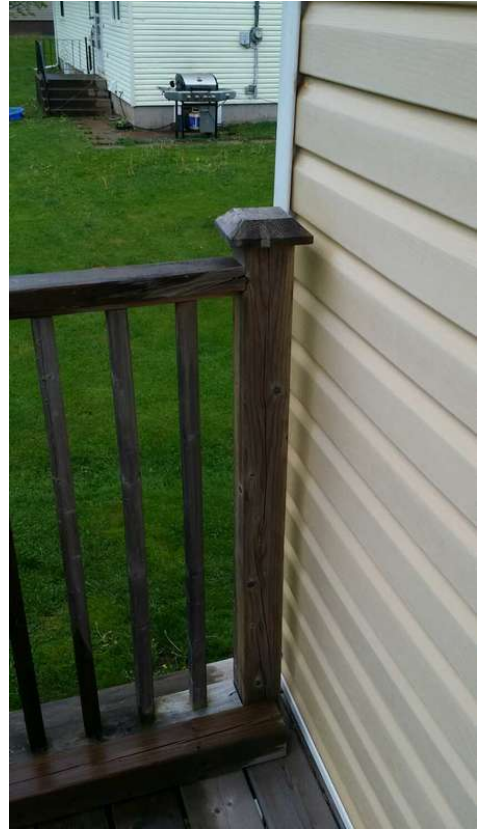
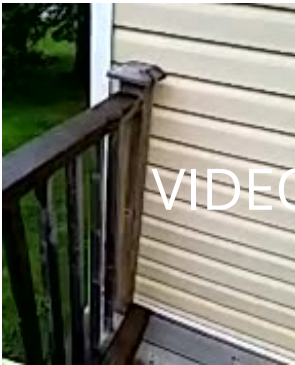
3.8.2 Decks, Balconies, Porches & Steps

LOOSE RAILING

PORCH AND BACK DECK

Loose Railing can create a possible fall hazard, recommend repair

Contact a qualified professional.

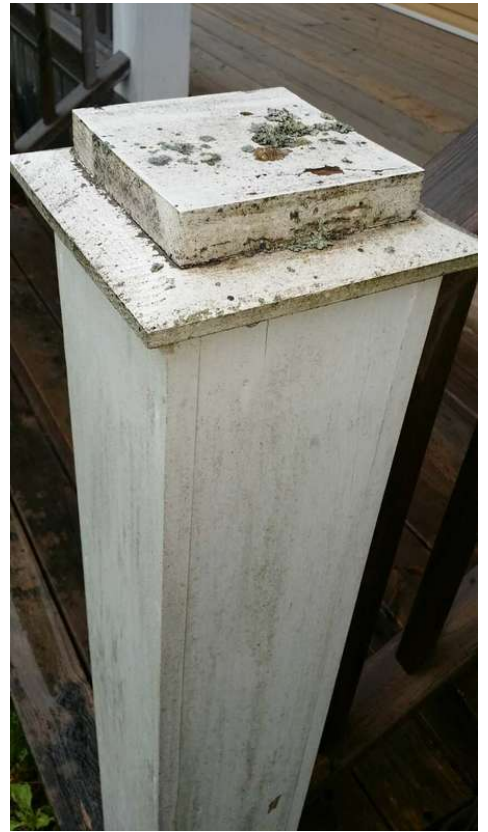
3.8.3 Decks, Balconies, Porches & Steps

PAINTING MAINTENANCE

The paint or finish is failing. This can lead to deterioration and rot of the material. Recommend that the areas be properly prepared and painted / finished.

Contact a qualified professional.

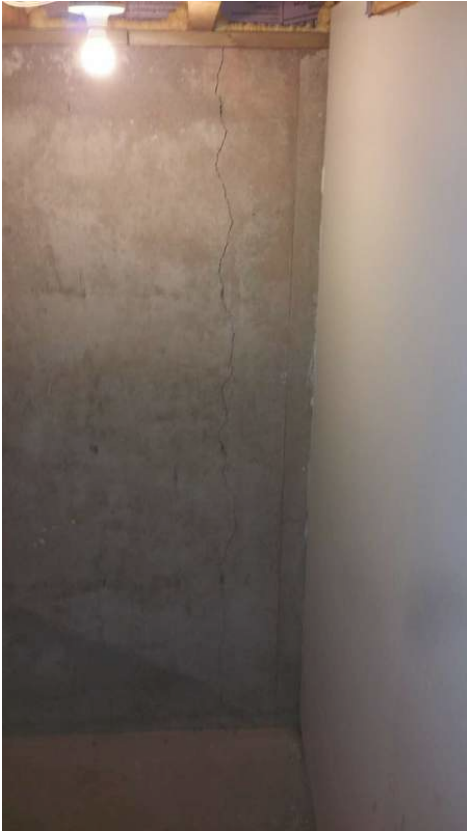
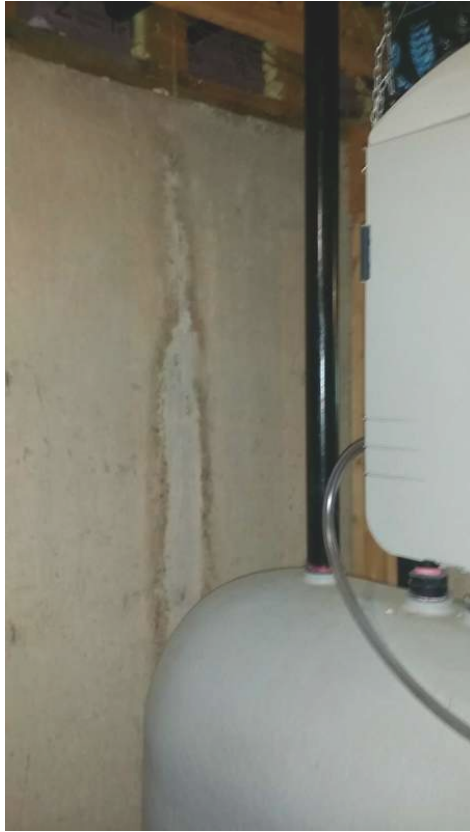
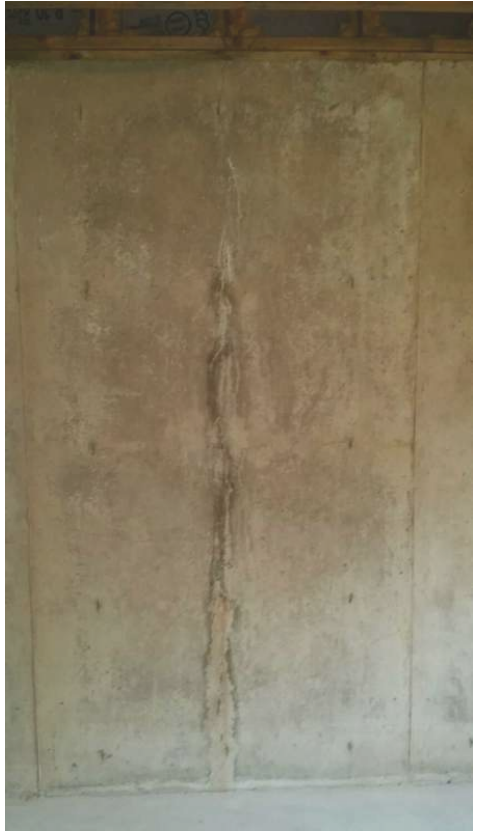
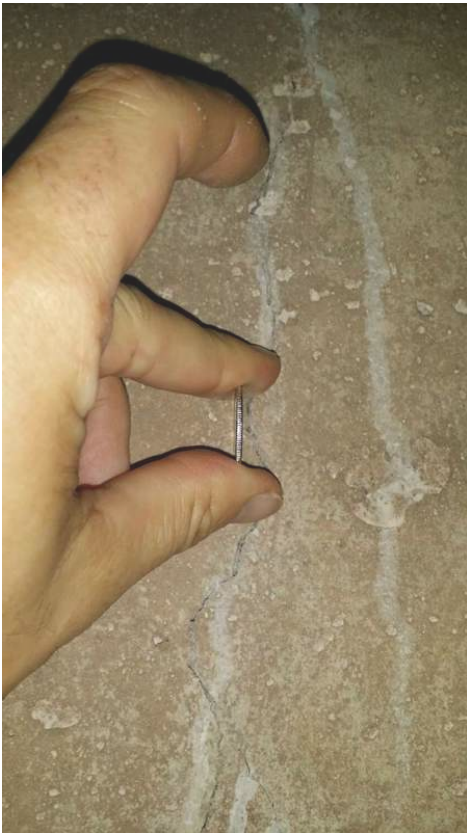
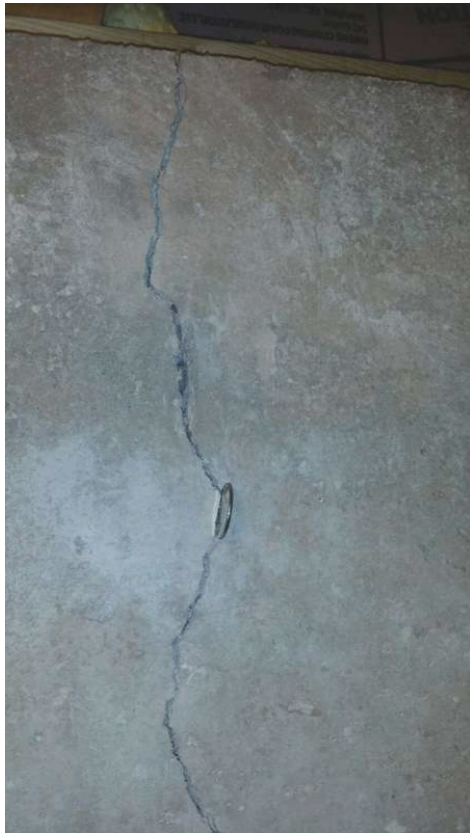
Foundation

FOUNDATION CRACKS - MINOR

Minor cracking was noted at the foundation. This is common as concrete ages and shrinkage surface cracks are normal. Recommend monitoring for more serious shifting/displacement.

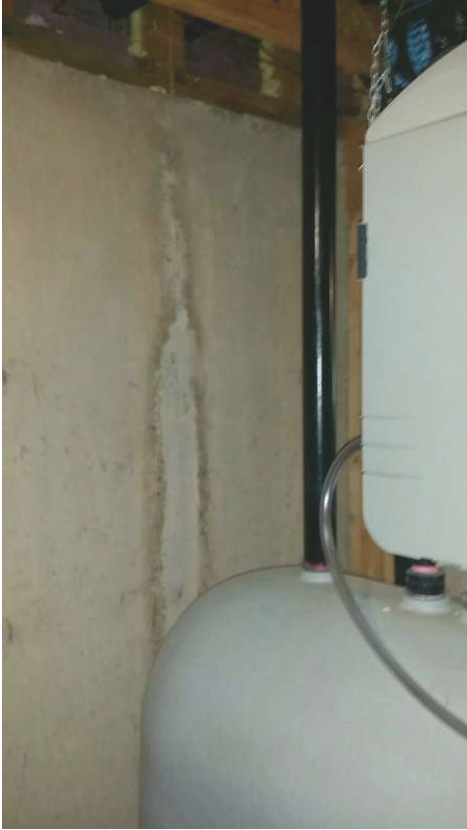
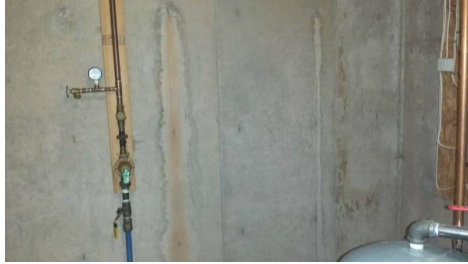
4.2.1 Foundation

EFFLORESCENCE OBSERVED

This is a mineral deposit left behind from exterior water infiltration.

Contact a qualified professional.

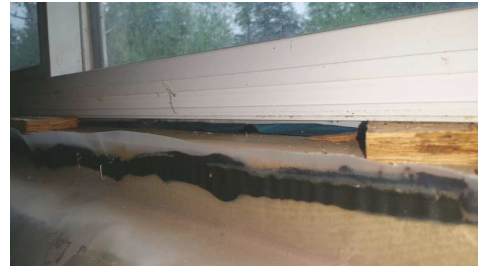
4.4.1 Vapor Retarders
(Crawlspace or Basement)

GAPS OBSERVED

BASEMENT

Contact a qualified professional.

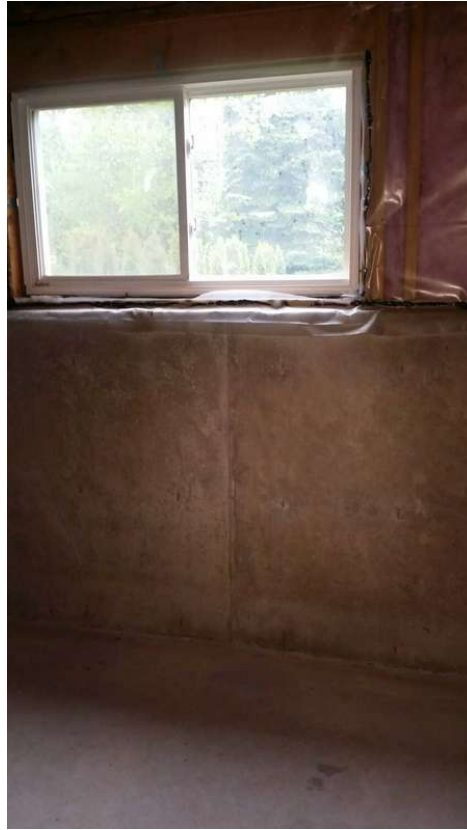
4.5.1 Emergency Basement Egress

EGRESS MAY NOT MEET CODE

Windows are 54 inches off the floor

Contact a qualified general contractor.

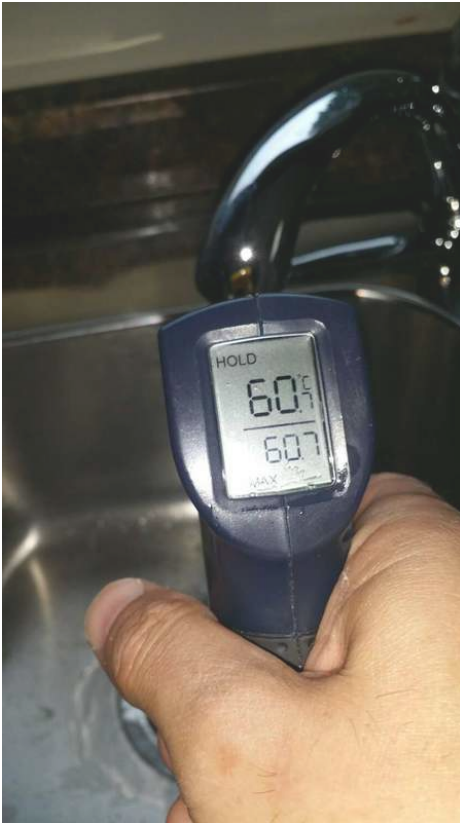
Hot Water Systems, Controls, Flues & Vents: Hot Water Temperature At Tap

60 Celsius

Recommend 45 to 50 degrees Celsius/ 118 to 122 Fahrenheit. Implications Scalding

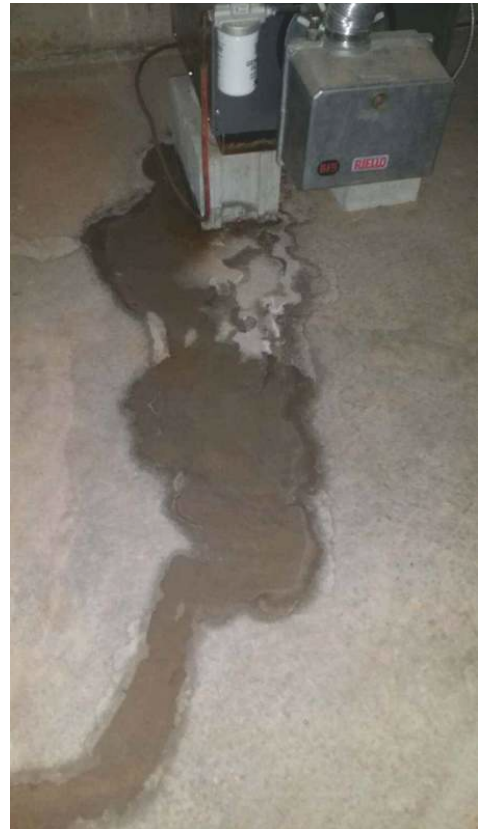
6.4.1 Hot Water Systems,
Controls, Flues & Vents

WATER STAINS - LEAKAGE

BASEMENT

Water stains were observed beneath water heater, indicating a past or present leak. Leak was gone when I returned one week later.

Recommend further evaluation and repair by a qualified plumber.

Contact a qualified plumbing contractor.

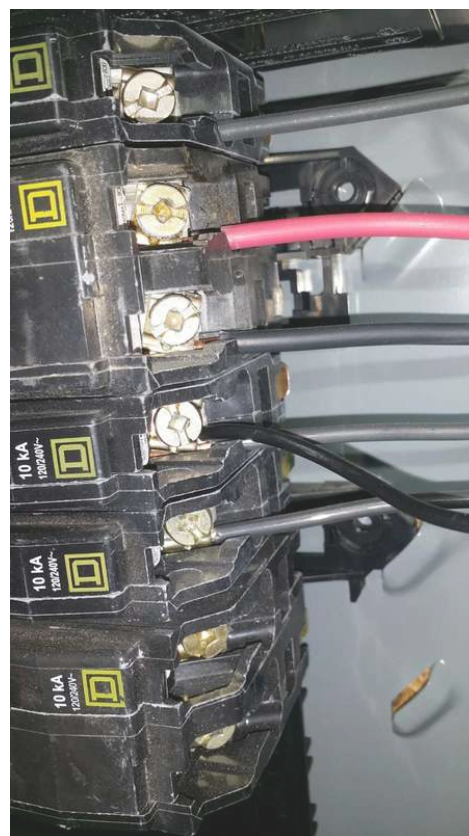
7.2.1 Branch Wiring Circuits,
Breakers & Fuses

DOUBLE TAPPED HOT CONDUCTORS

One or more electrical circuits were double tapped. This means that two or more wires are connected to a circuit breaker that is only designed to accept one wire. This looks like is a low Voltage wire for security system. Recommend that further inspection and repair by electrical contractor.

Contact a qualified electrical contractor.

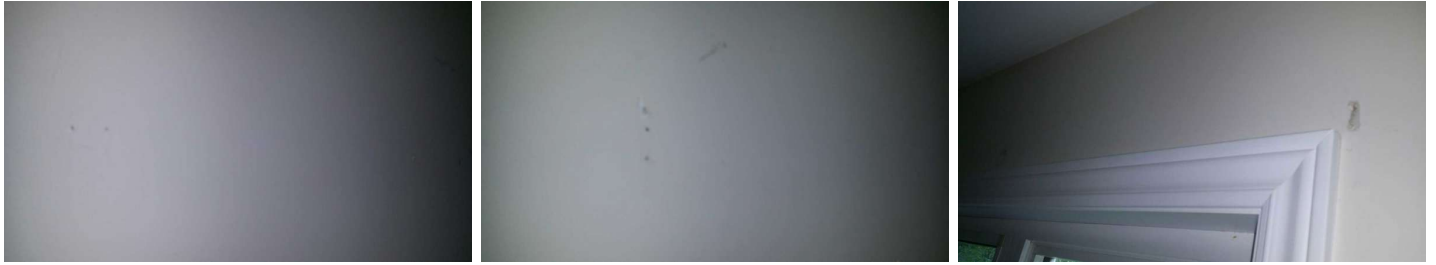
8.5.1 Walls

POOR PATCHING

Sub-standard drywall patching observed at time of inspection. Recommend re-patching.

Contact a qualified drywall contractor.

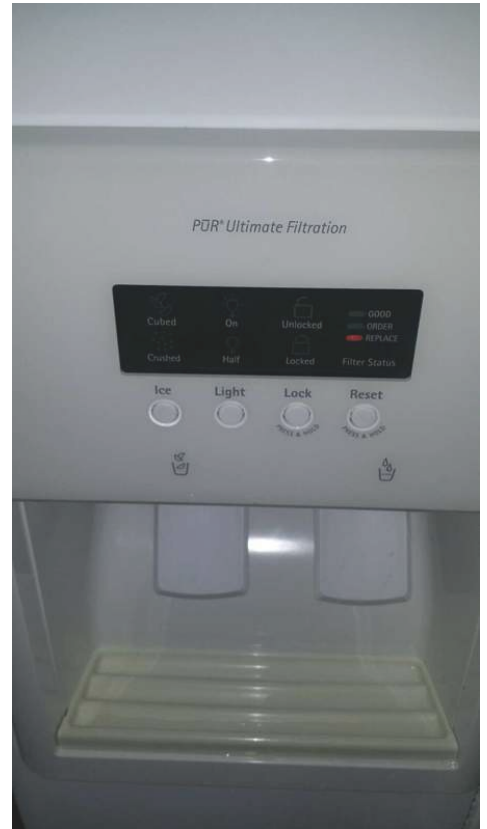
11.5.1 Refrigerator

ICE MAKER WATER DISPENSER

Ice maker was not operable and not tested. Recommend confirming operation of units prior to closing.

Contact a qualified professional.

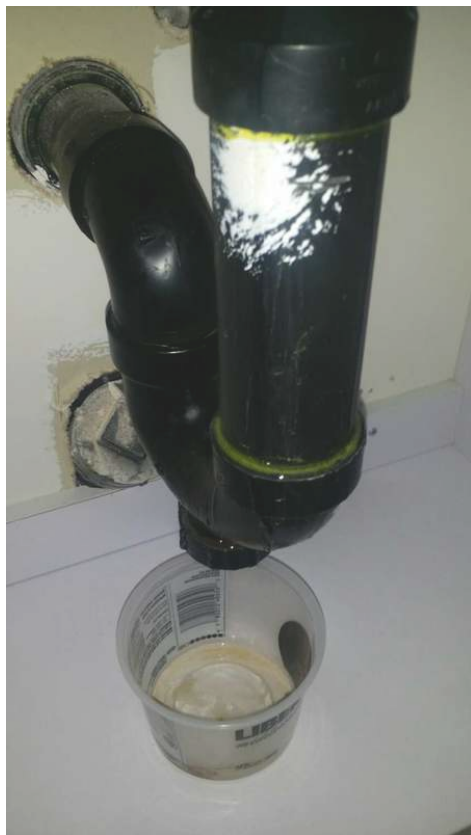
16.2.1 Plumbing & Fixtures

LEAKING DRAIN PIPE

A drain, pipe showed signs of a leak. Recommend a qualified plumber evaluate and repair.

Contact a qualified plumbing contractor.

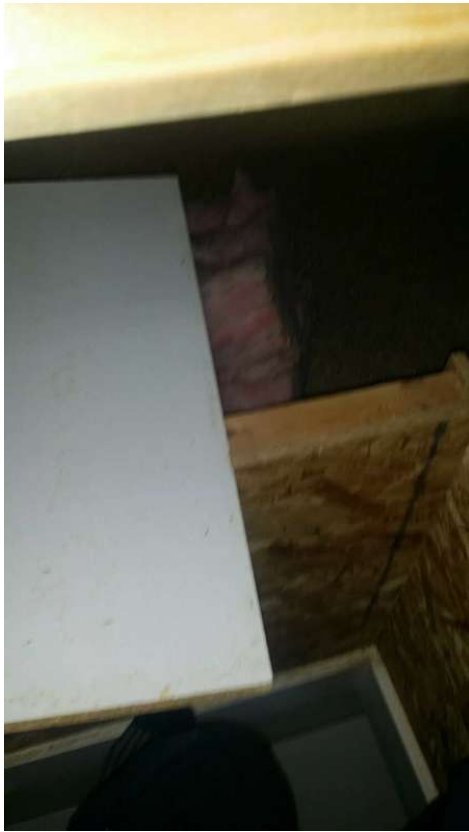
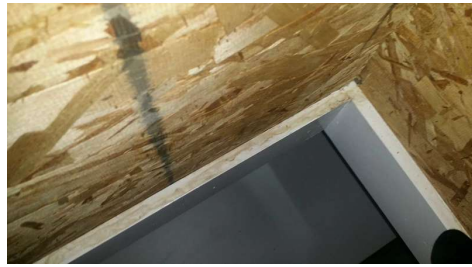
17.1.1 Attic Insulation

SEAL AROUND ATTIC ACCESS PANEL NEED TO BE REPLACED

Moist air escaping into the attic space can cause mold and wood decay.
