HIGHLANDER INSPECTIONS

RESIDENTIAL INSPECTION

1234 Main St.
Big Bear Lake CA 92315

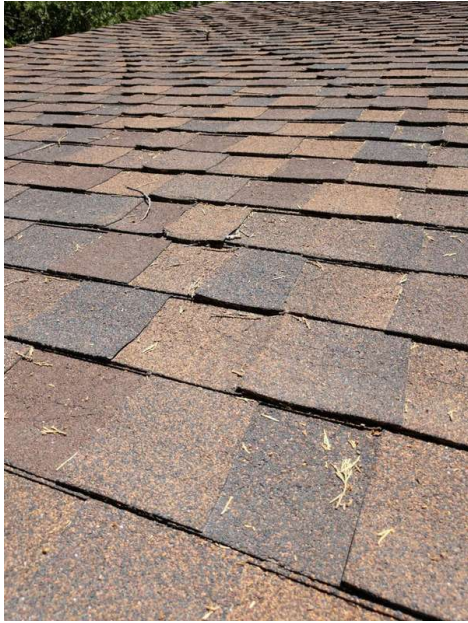
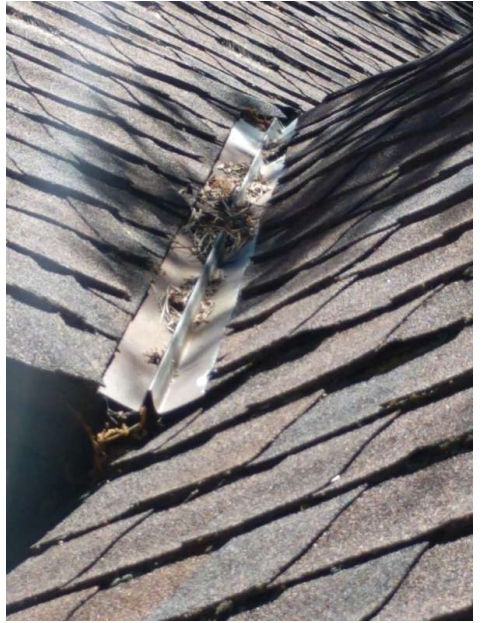
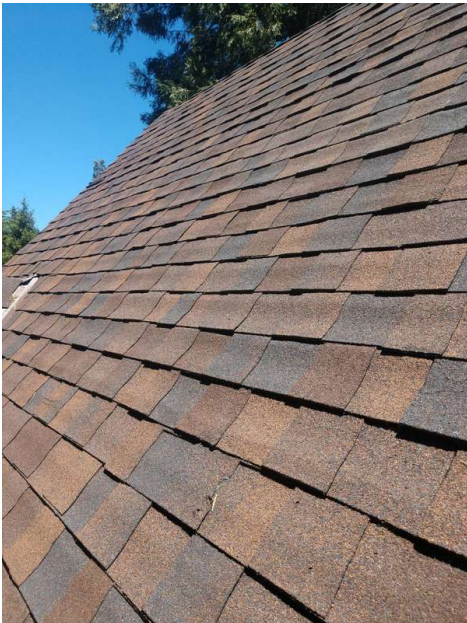
Observed the roof covering to be curling at the corners and edges. This is a sign of age and also the effects of moisture beneath.

Recommend further evaluation by a licensed roofing contractor.

Contact a qualified roofing professional.

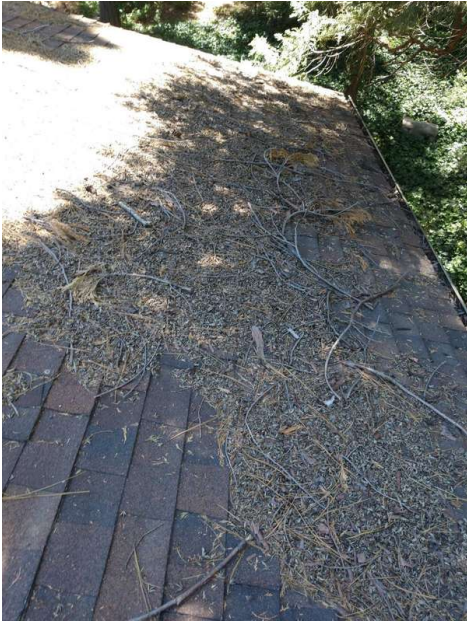
2.1.2 Coverings

Debris observed on roof surface. Recommend removal.

Contact a qualified roofing professional.

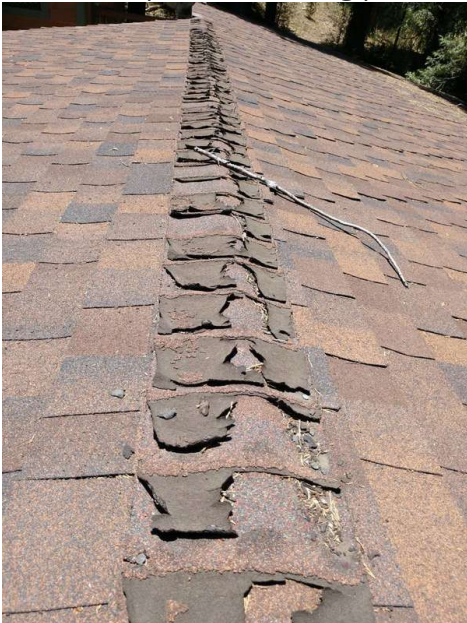
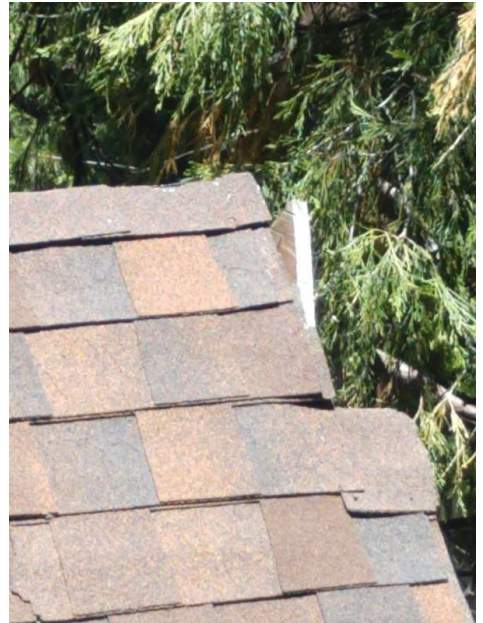
2.1.3 Coverings

Roof coverings showed moderate damage. Recommend a qualified roofing professional evaluate and repair.

Contact a qualified roofing professional.

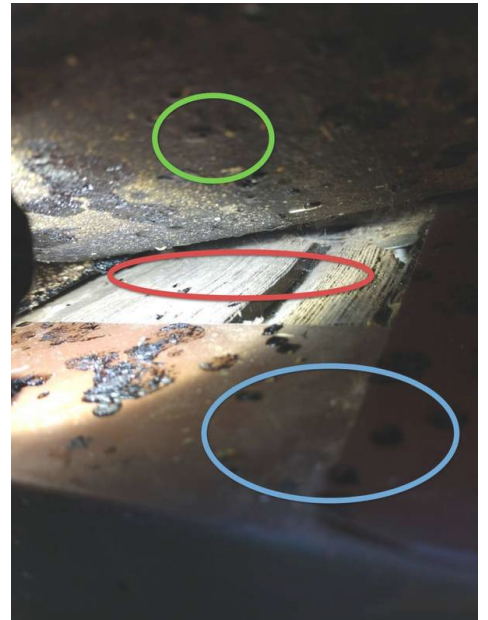
2.1.4 Coverings

Observed at least 2 layers of roofing on the Garage and carport, and what appears to be a layer of roofing underneath the top layer covering the House. Roofing over an existing layer significantly reduces the lifespan of the material being installed.

Green circle - bottom of fiberglass shingle
Red circle - previous roofing material, wood shingle or shake
Blue circle - metal drip edge

Recommend monitoring and consulting a licensed roofing contractor for evaluation and repairs as needed.

Contact a qualified roofing professional.

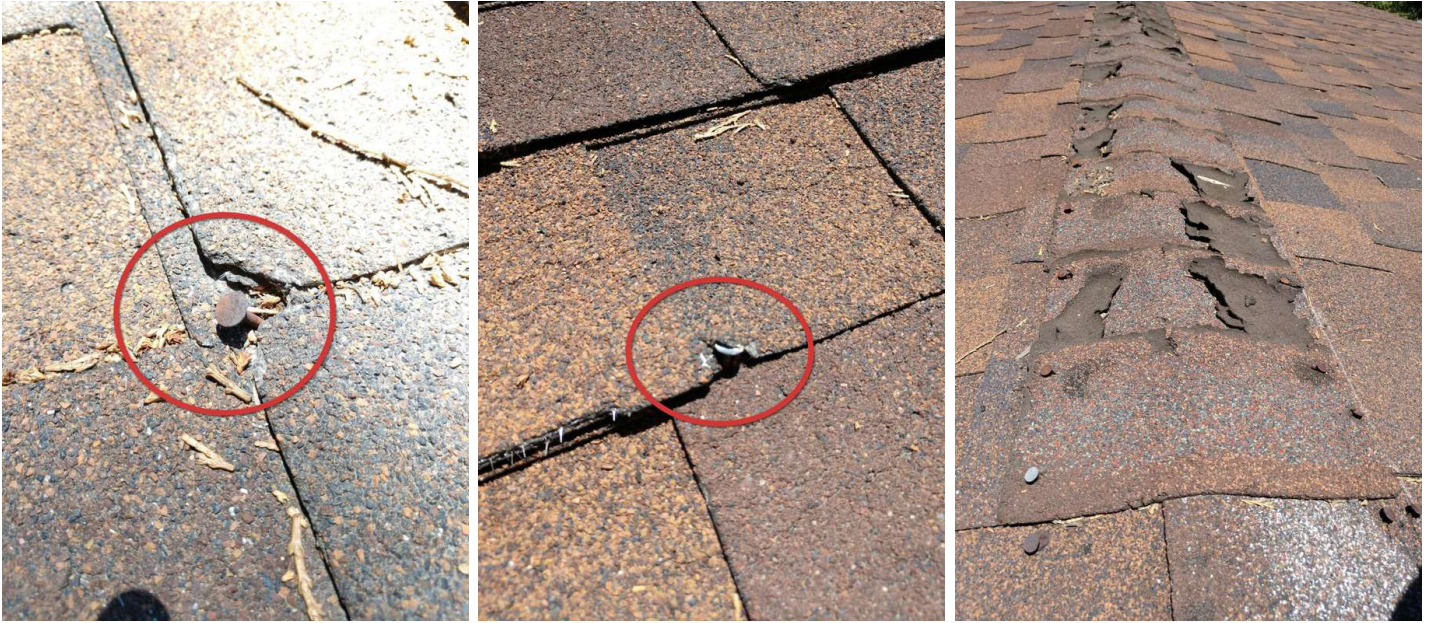
2.1.5 Coverings

Observed missing or unsealed fasteners at ridge caps and roof to wall intersection. This could allow unwanted water entry below roof covering and underlayment, damage to these components, shortened life span of roof covering and sheathing, water intrusion into attic damaging insulation and interior ceilings.

Recommend licensed roofing contractor evaluate and correct.

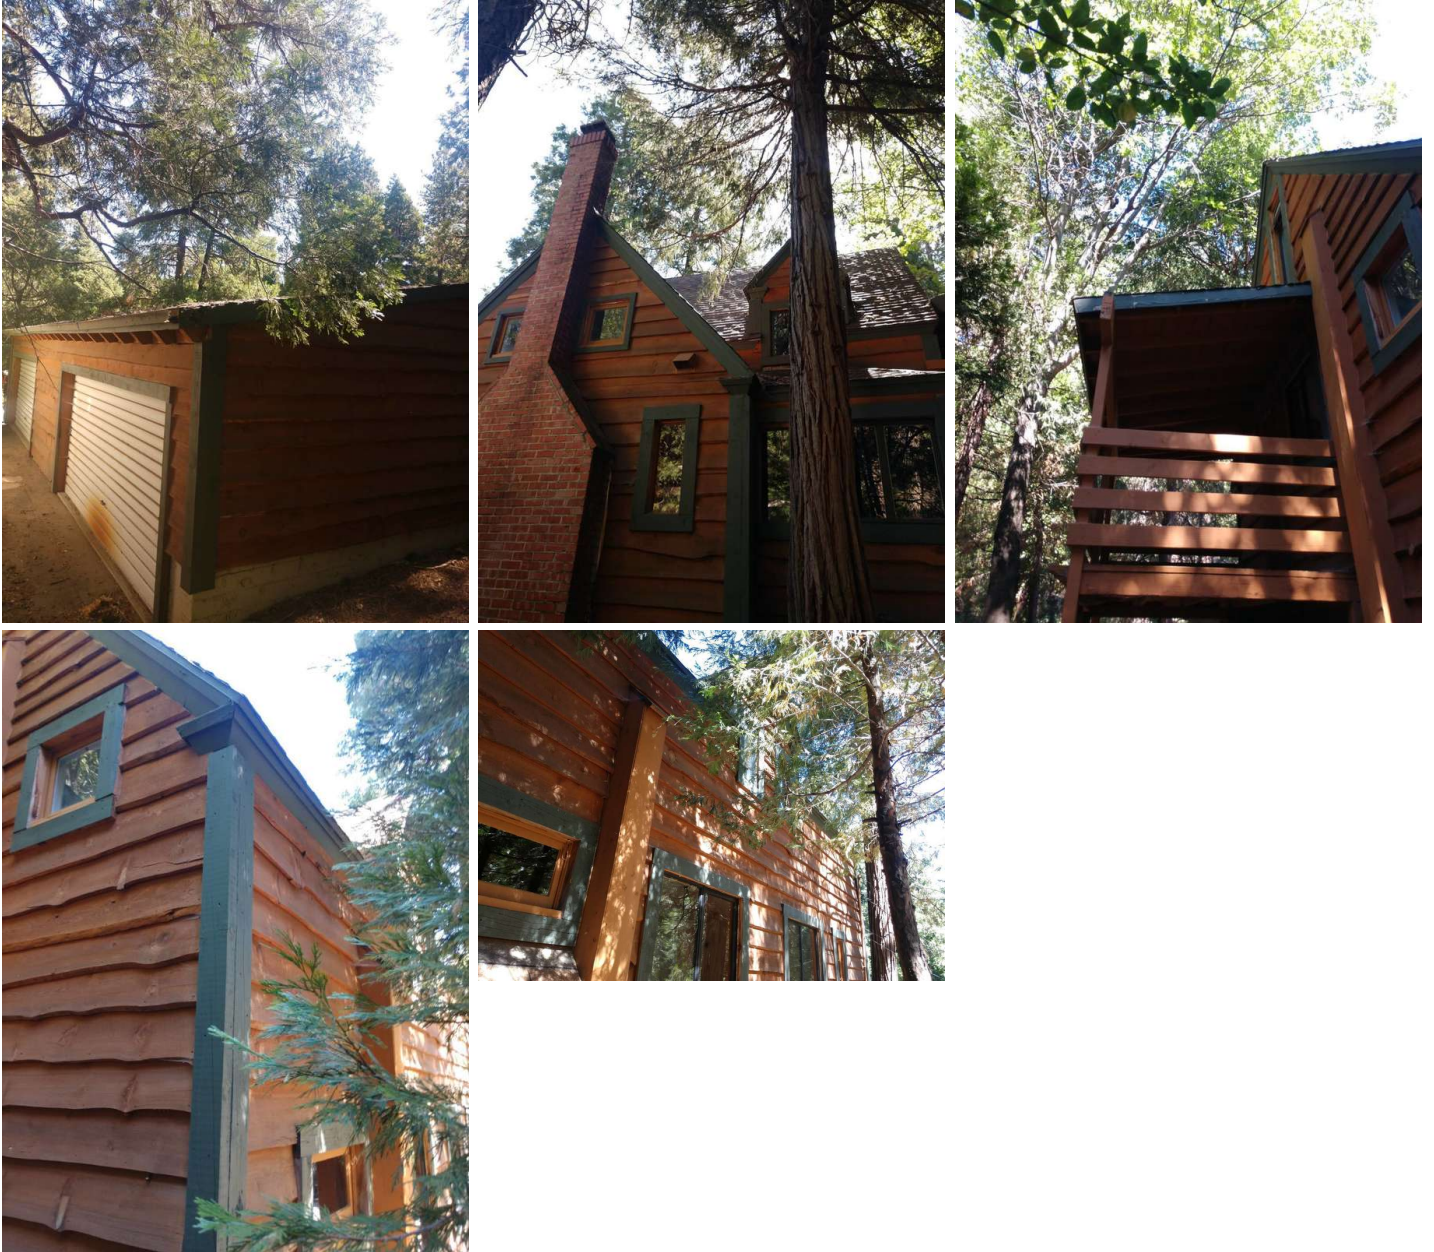
Tree branches are in contact with roof covering and structure. Tree limbs and branches can physically damage the wall coverings and roof coverings and can drop debris that can block valleys and gutters and hasten the deterioration of roof coverings. Tree limbs and entire trees can fall during high wind events.

Recommend evaluation and correction by licensed tree contractor.

Contact a qualified tree service company.

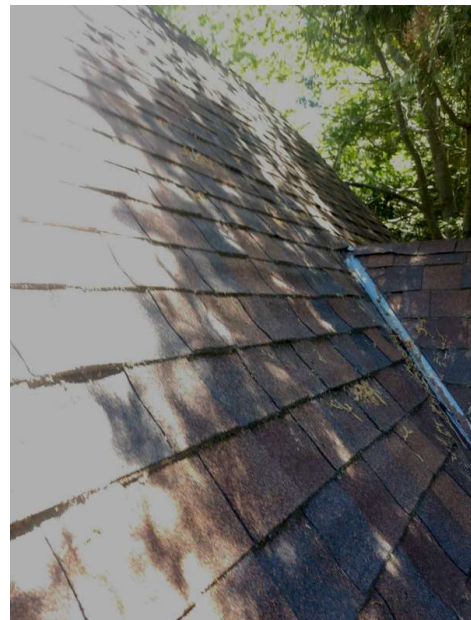
Observed bulges below the roof covering material. The ceiling covering inside is attached to the roof rafters, limiting access to view the inside of the roof sheathing.

Recommend evaluation by a licensed roofing contractor.

Contact a qualified roofing professional.

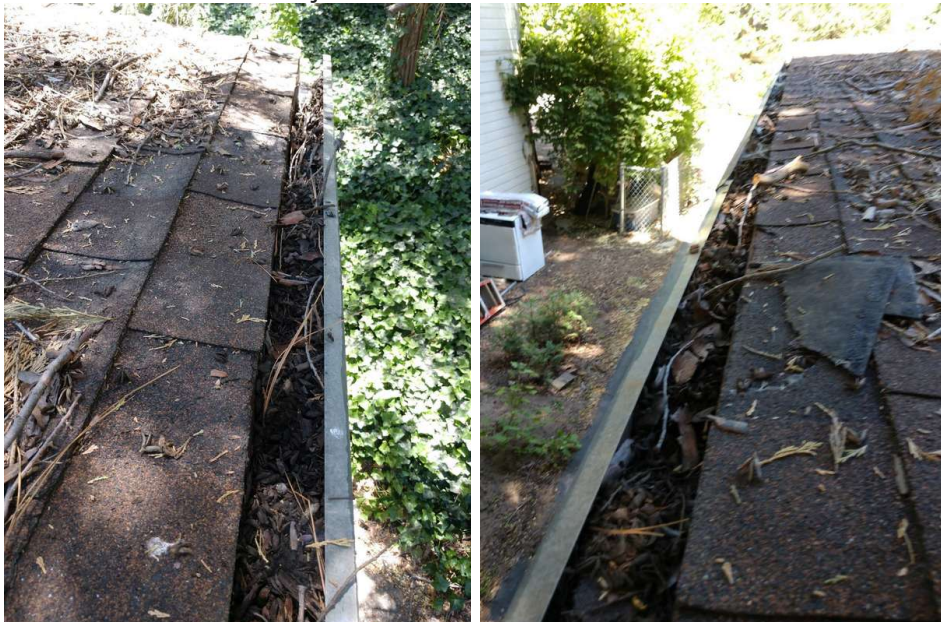
2.2.1 Roof Drainage Systems

Debris has accumulated in the gutters. Recommend cleaning to facilitate water flow.

Recommended DIY Project

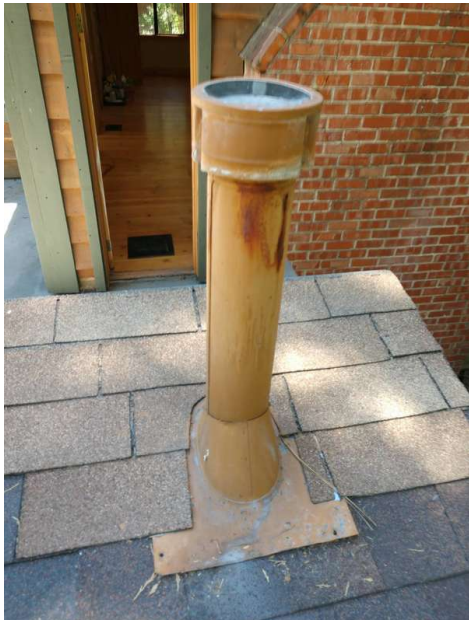
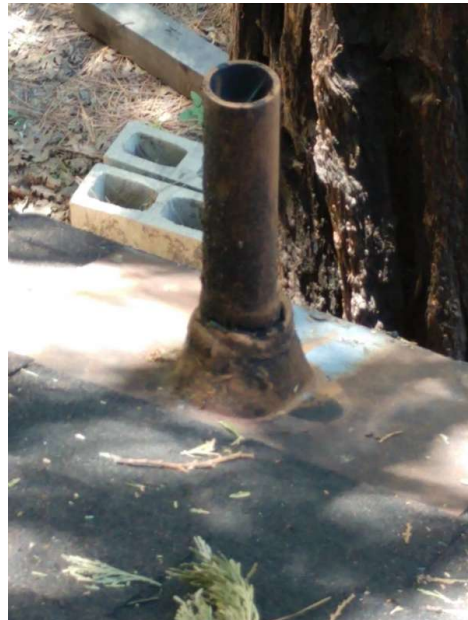
Roof flashings showed signs of minor corrosion and are still in working condition. Flashings should be cleaned and painted to prevent severe corrosion leading to moisture intrusion.

Recommend annual maintenance to all roof penetration flashings by a licensed roofing contractor.

Contact a qualified roofing professional.

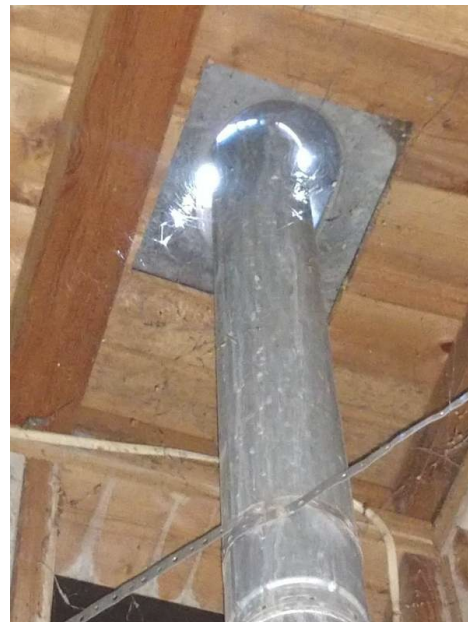
2.3.2 Flashings

Flashings observed to be loose or separated from the penetrating pipes, which can lead to water intrusion and/or mold.

Recommend a qualified roofing contractor patch and seal.

Contact a qualified roofing professional.

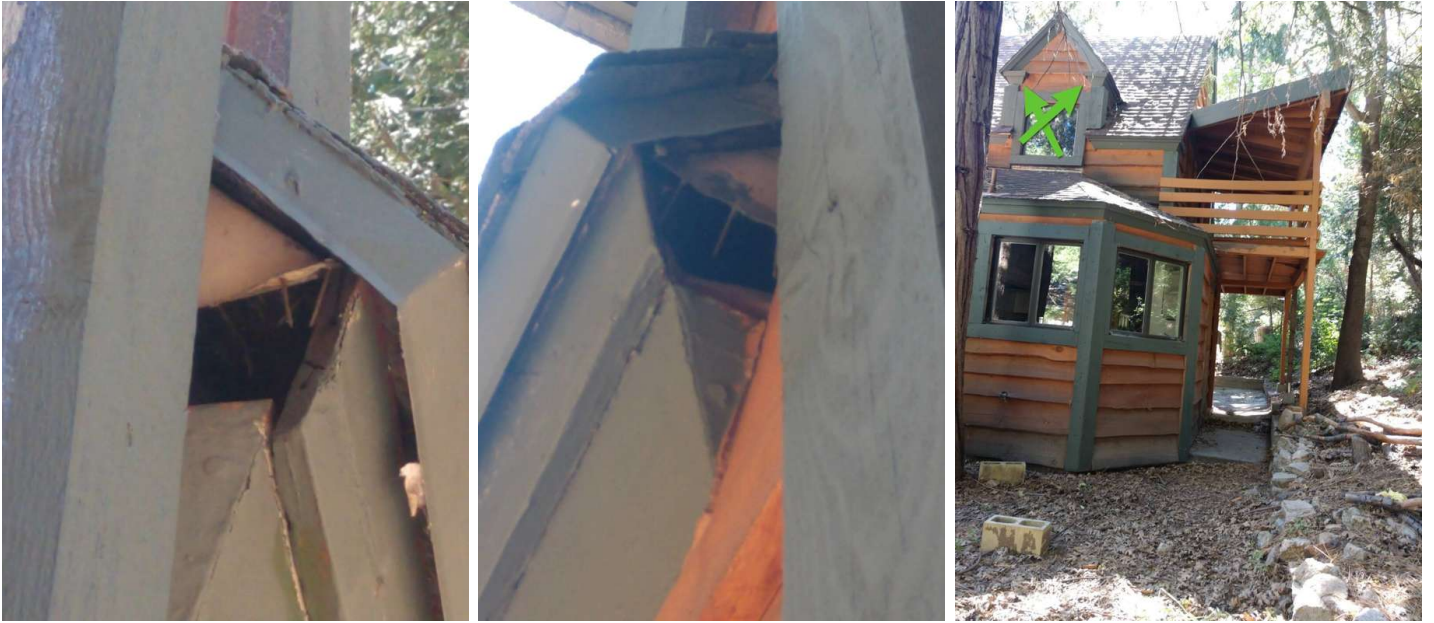
Observed a visible gap in the siding. This could allow excess moisture, as well as vermin into the structure. Recommend consulting a licensed siding contractor to evaluate and correct

Contact a qualified siding specialist.

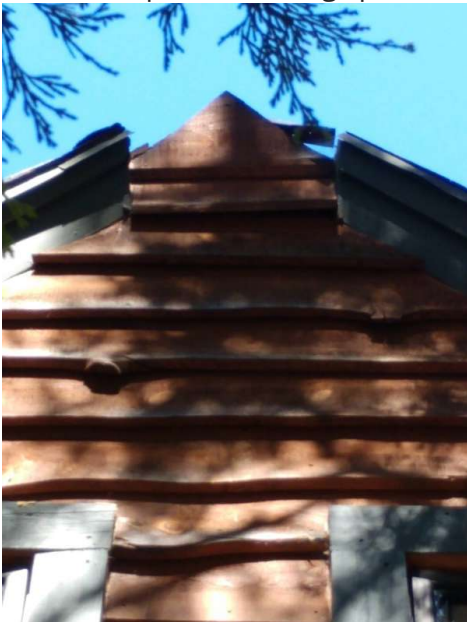
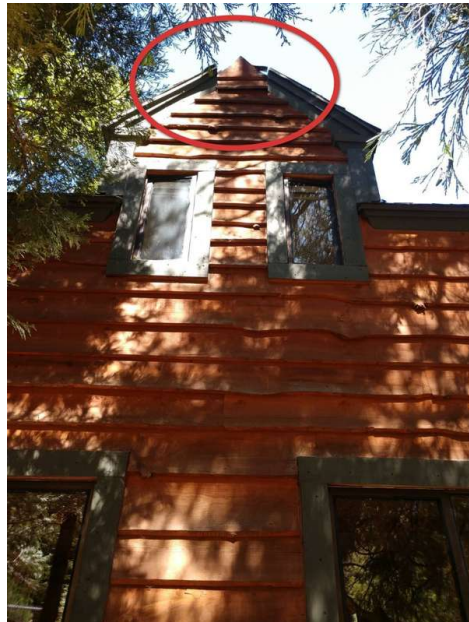
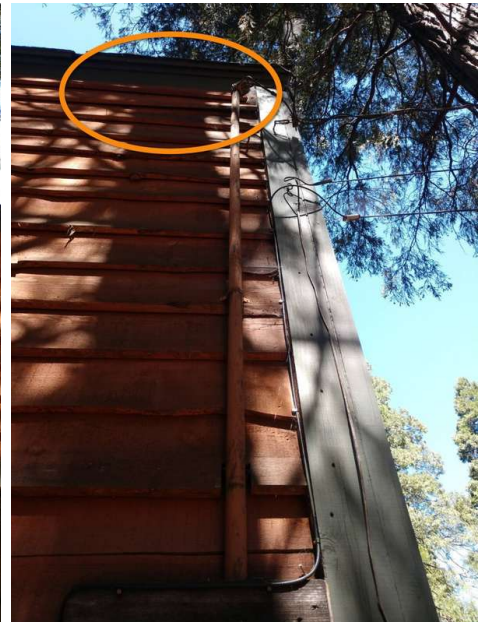
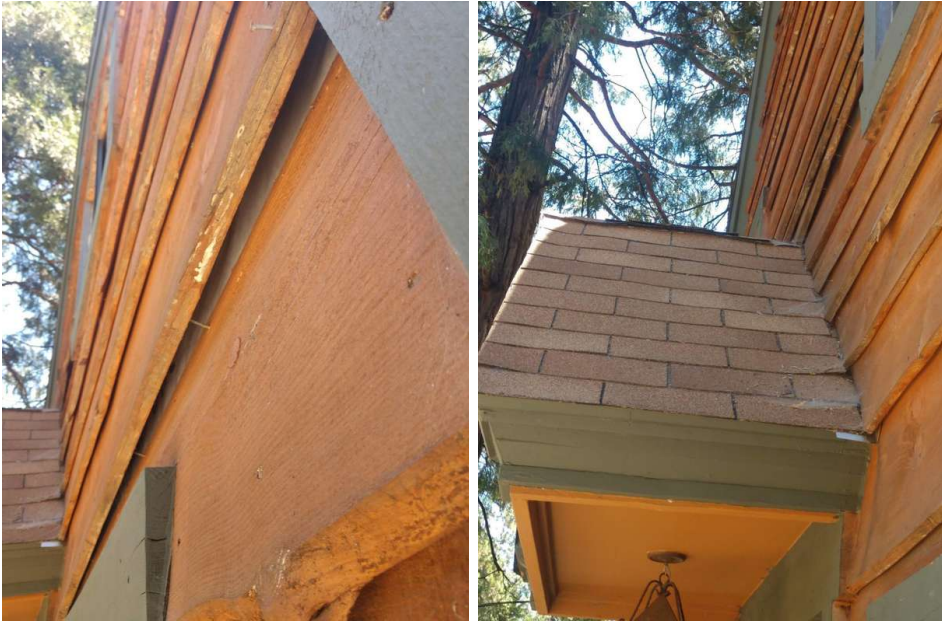
3.1.3 Siding, Flashing & Trim

One or more siding boards were loose, which could result in moisture intrusion. Slab siding continues to cure long after it is installed, this is a common occurrence.

Recommend consulting a licensed siding contractor with experience in slab wood siding to secure and fasten.

Contact a qualified siding specialist.

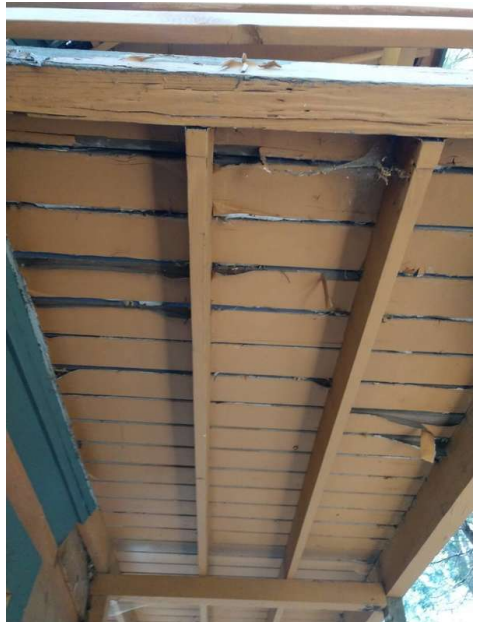
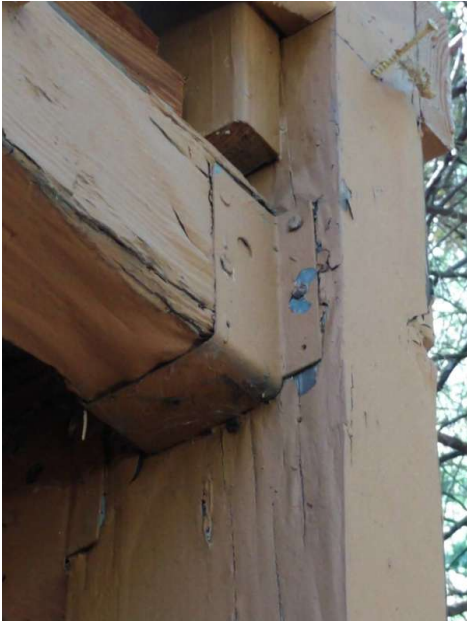
3.1.4 Siding, Flashing & Trim

Observed damaged/aged paint on deck, siding and trim. A sound finish will extend the life of the materials. Recommend evaluation and correction by a licensed painting contractor.

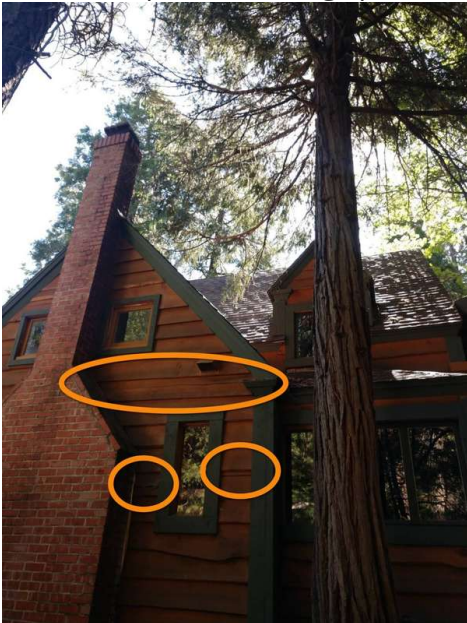
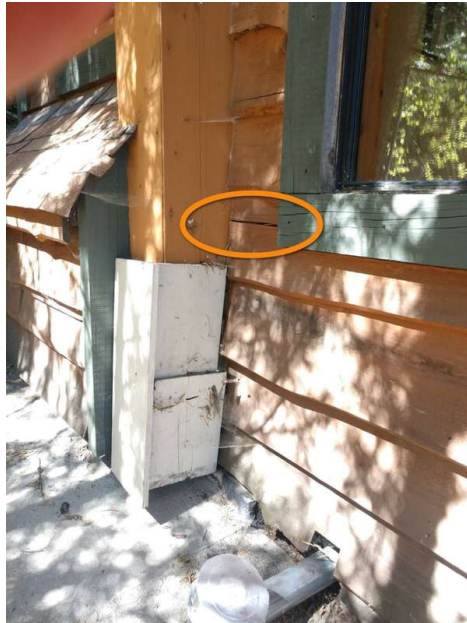
3.1.5 Siding, Flashing & Trim

Siding was splitting in one or more areas, which can lead to moisture intrusion and/or mold. Recommend sealing. For excessive splitting, consult a licensed siding contractor to evaluate and correct

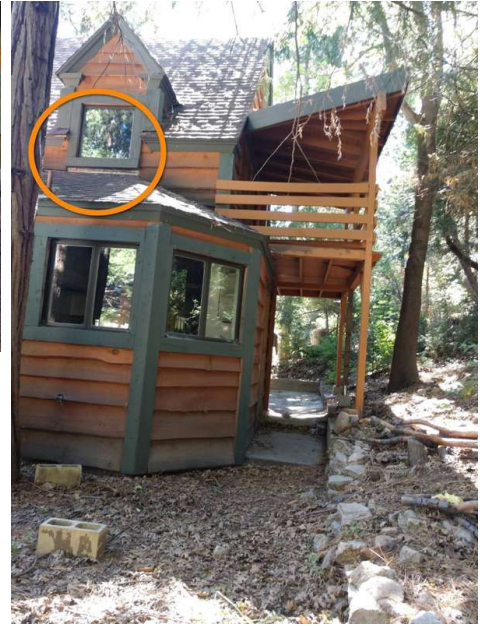
3.1.6 Siding, Flashing & Trim

Observed missing siding boards. Exposure of exterior wall surface allows entry of water, which can become the cause of many unwanted issues. Recommend consulting a licensed siding contractor to evaluate and correct.

Contact a qualified siding specialist.

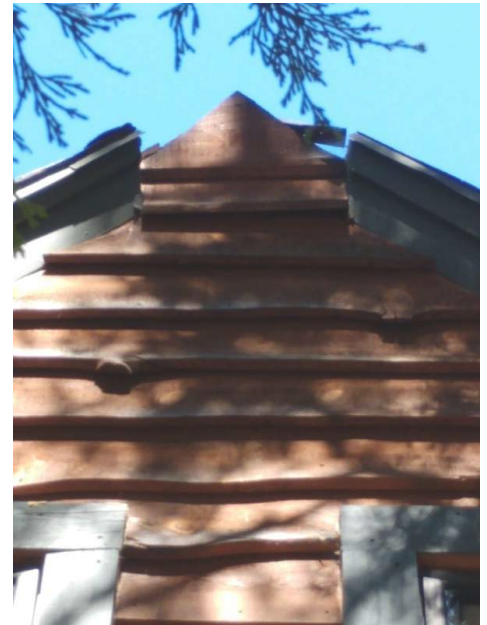
3.2.1 Eaves, Soffits & Fascia

A section of the fascia and roof have been damaged and are now missing. This presents potential water infiltration issues.

Recommend qualified roofer evaluate & repair.

Contact a qualified roofing professional.

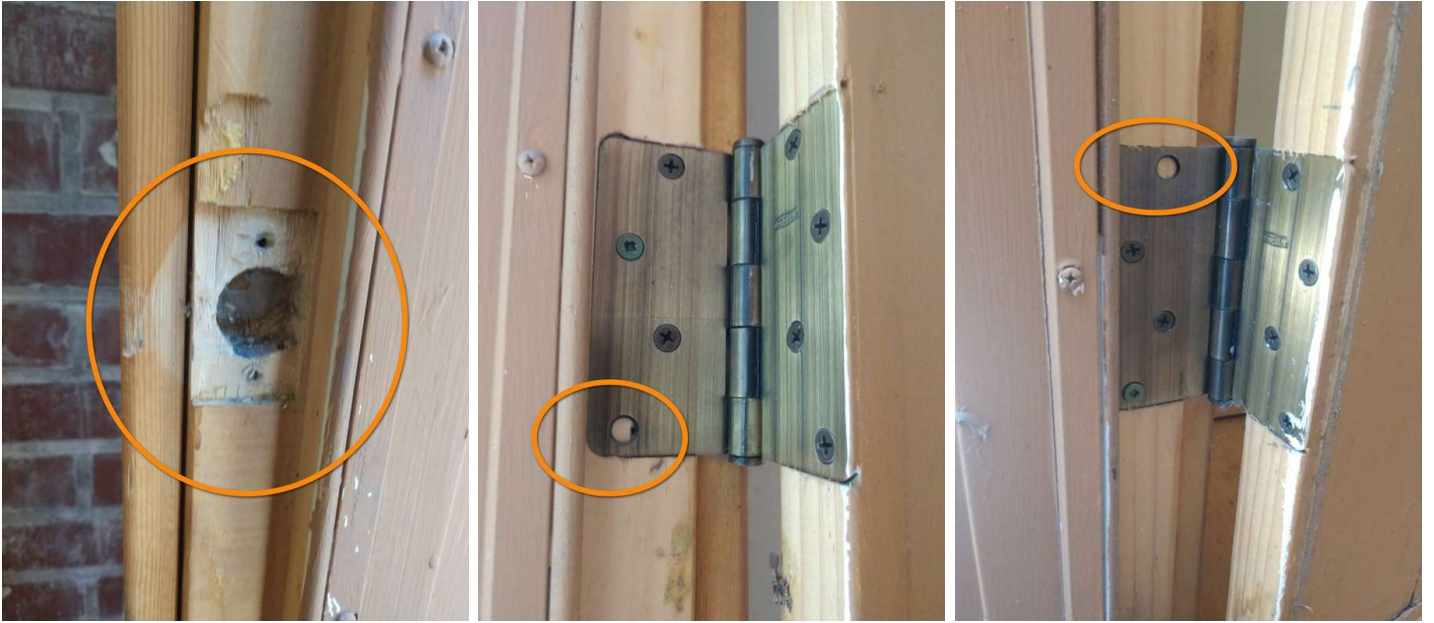
3.3.1 Exterior Doors

Door is missing one or more pieces of hardware. Recommend replacing or upgrading.

Recommended DIY Project

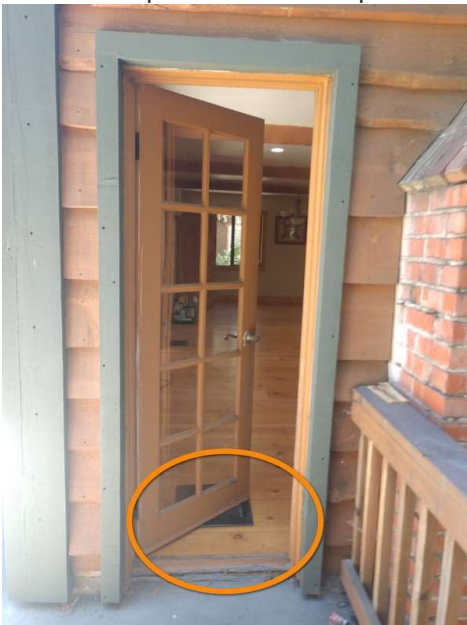
3.3.2 Exterior Doors

Weatherstripping on bottom of door drags on the floor register. Recommend evaluation and correction by licensed contractor.

Contact a qualified door repair/installation contractor.

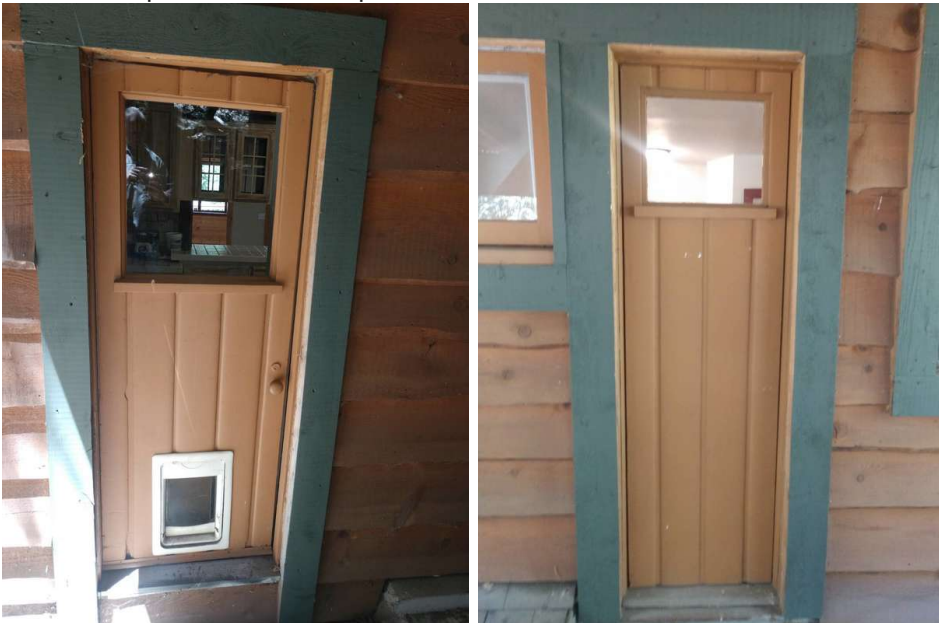
Door is missing any weatherstripping. This can result in significant energy loss and moisture intrusion. Recommend installation of standard weatherstripping as a DIY project or consult the services of a licensed contractor.

Contact a qualified door repair/installation contractor.

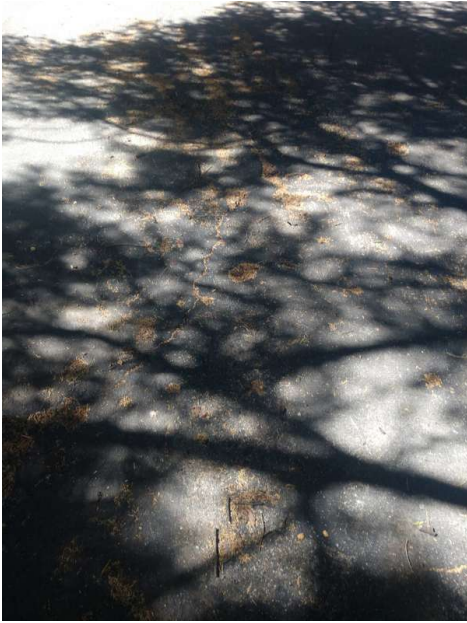
3.4.1 Walkways, Patios & Driveways

Minor cosmetic cracks observed, which may indicate movement in the soil. Recommend monitor and/or have licensed driveway contractor patch/seal.

Contact a qualified driveway contractor.

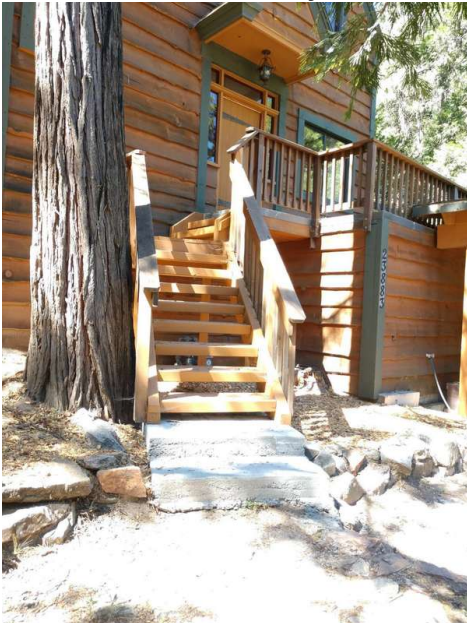
3.4.2 Walkways, Patios & Driveways

Observed erosion around concrete. Recommend installing erosion control measures to prevent future damage.

Recommended DIY Project

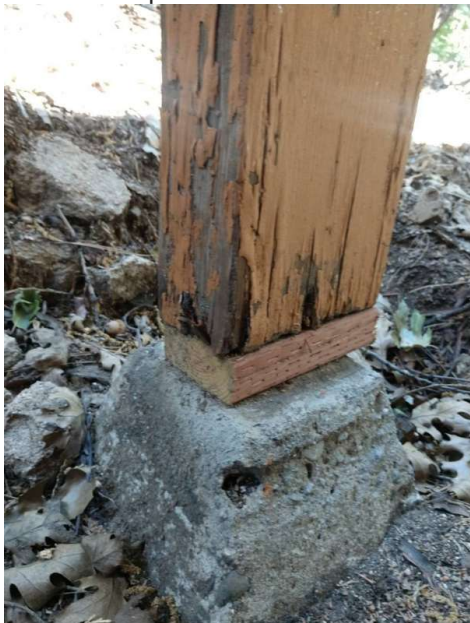
3.5.1 Decks, Balconies, Porches & Steps

Observed general substandard construction practices employed. Recommend licensed deck contractor evaluate and correct as necessary.

No mechanical fastener securing base to post.

Contact a qualified deck contractor.

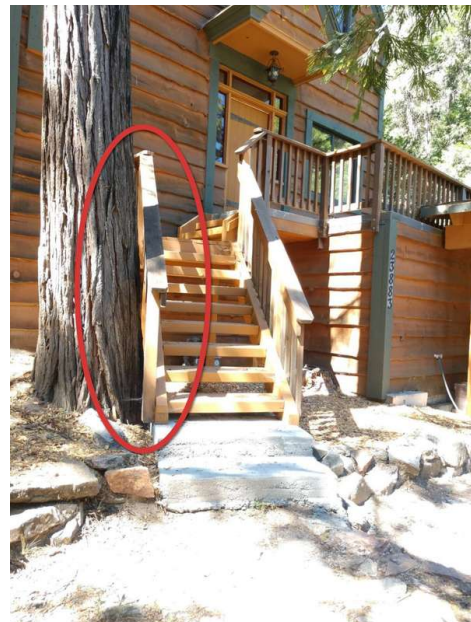
Observed stair railing to be loose. Recommend licensed contractor evaluate and correct.

Contact a qualified deck contractor.

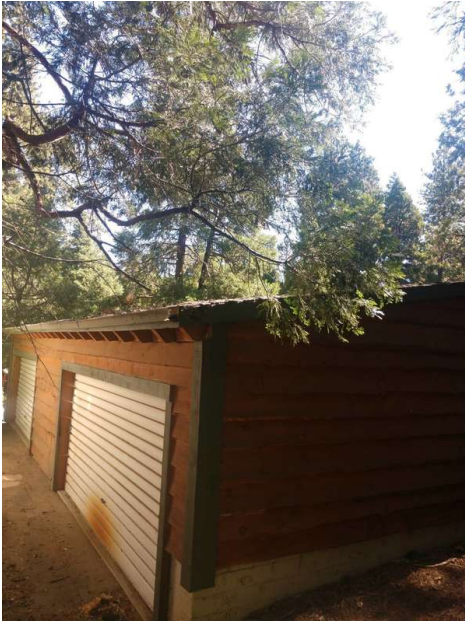
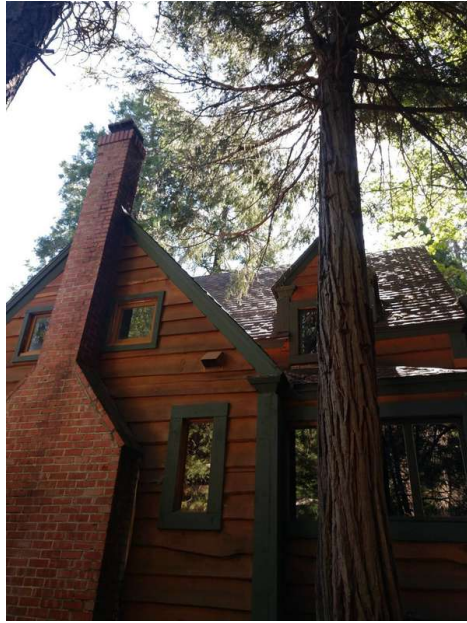
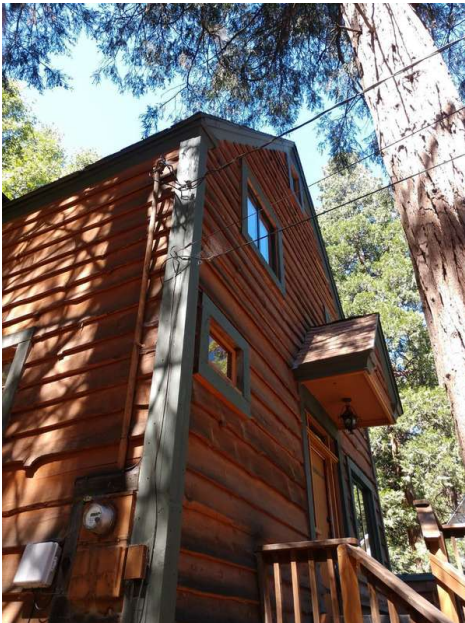
3.6.1 Vegetation, Grading, Drainage & Retaining Walls

Trees observed overhanging the roof. This can cause damage to the roof and prevent proper drainage. Recommend a licensed tree service trim to allow for proper drainage.

Contact a qualified tree service company.

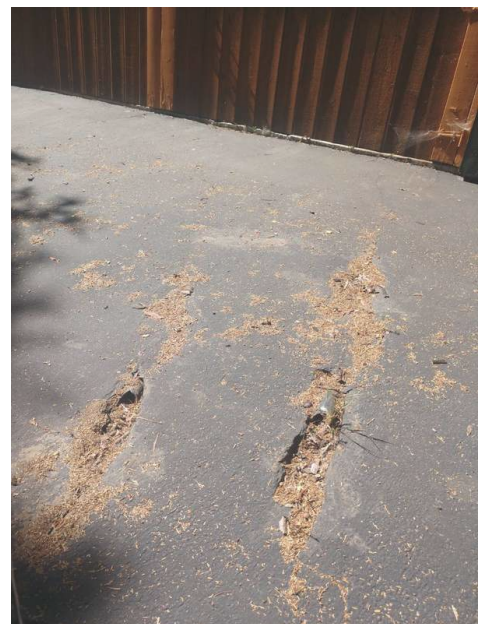
3.6.2 Vegetation, Grading, Drainage & Retaining Walls

Observed plastic drain line partially exposed at the end and nearly filled with material preventing the discharge of collected water. Recommend clearing away material to allow the emission of water, and directing the flow of water away from the building.

Recommended DIY Project

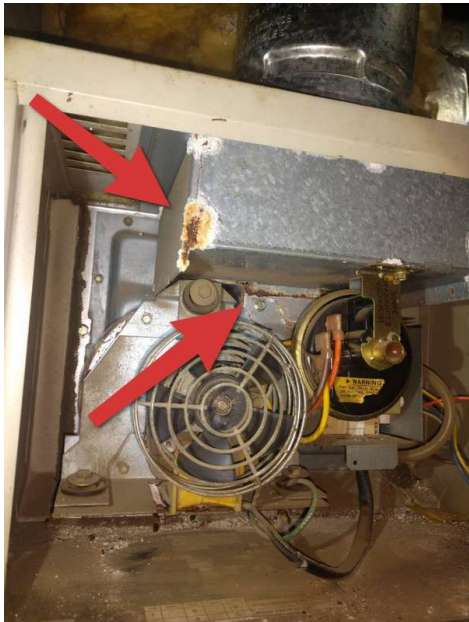
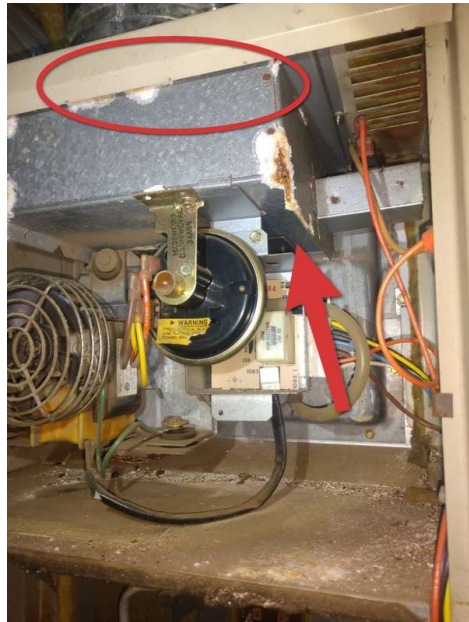
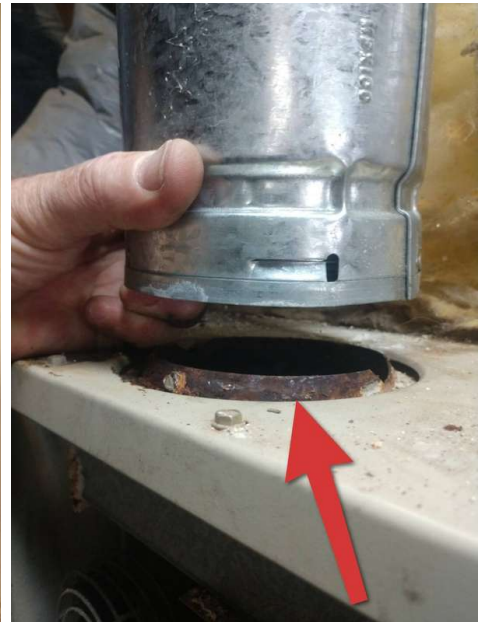
Furnace was corroded in one or more areas. This could be the result of improper venting, which the source would need to be identified. Recommend a HVAC contractor evaluate and repair.

Contact a qualified HVAC professional.

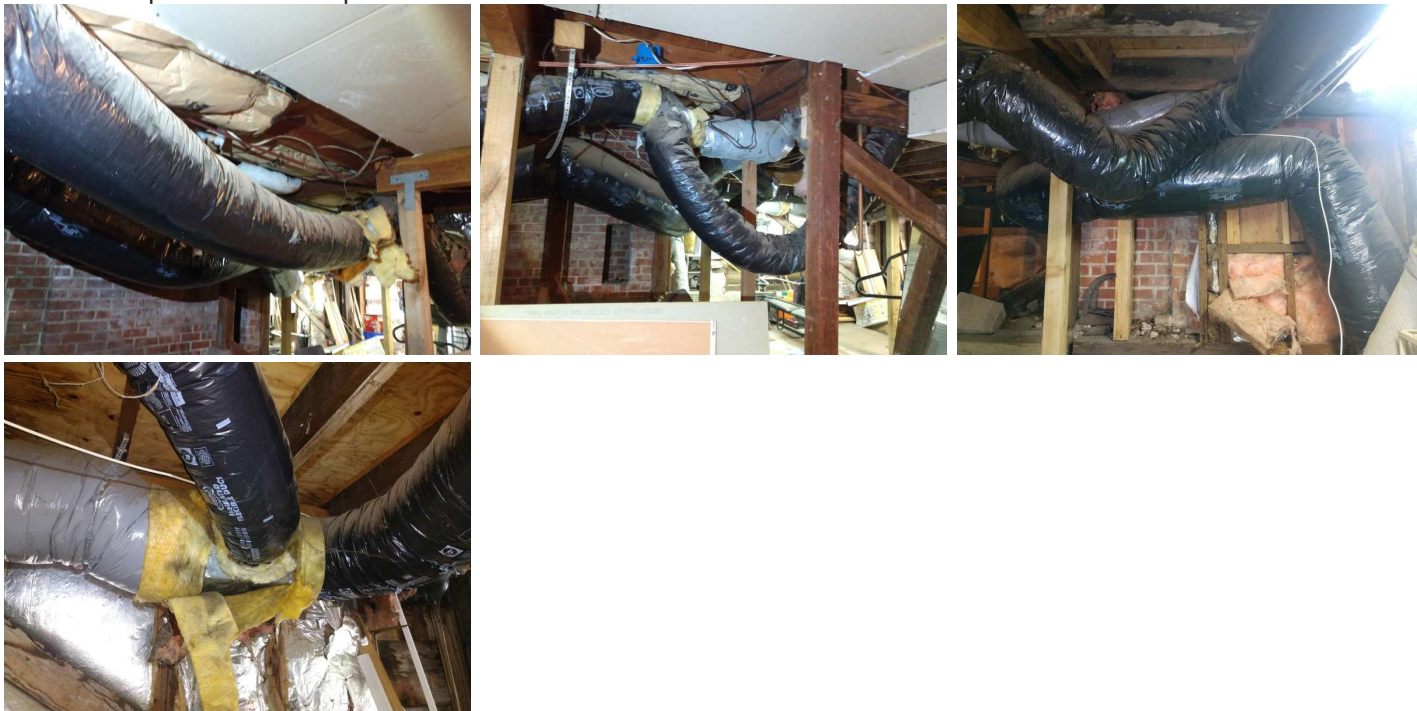
Observed ducting support is over spanned or not present in more than one location. Air flows best in a straight line, air ducts should be installed in a straight line with as few turns, dips and crimps as possible. Proper support is important for achieving straight ducts. Flex duct should be supported by at least 1 inch wide material at least every 4 feet horizontally and every 6 feet vertically and within one foot or one duct diameter on all sides of bends and fittings.

Recommend consulting a licensed HVAC contractor for evaluation and correction.

Contact a qualified HVAC professional.

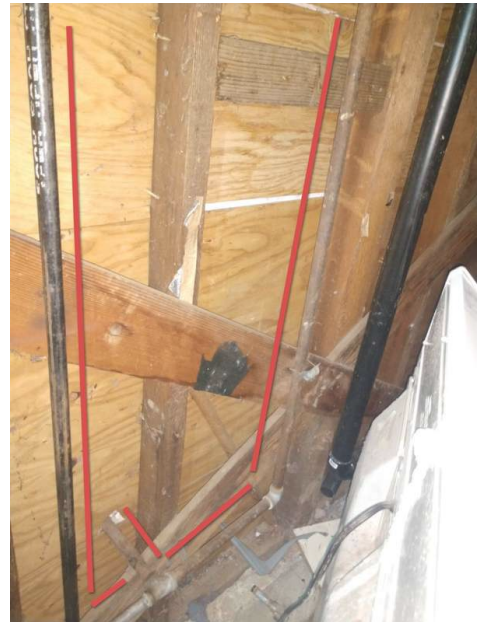
Red lines indicate location of natural gas line entering the building from the meter, branching in two, then rising. No electrical bonding present.

Contact a qualified electrical contractor.

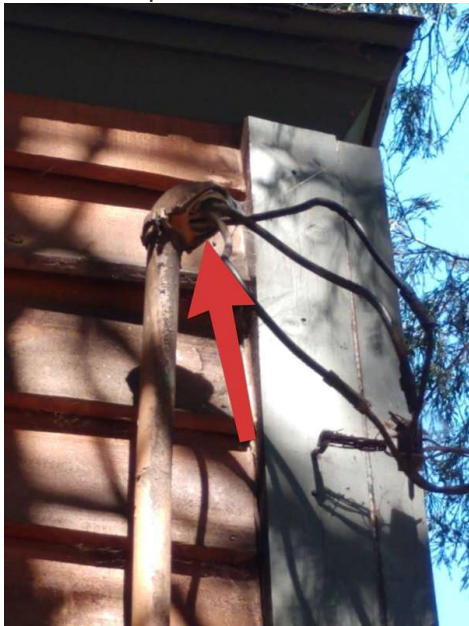
7.1.2 Service Entrance Conductors

Example of complete weather head.

Plastic protective insert is missing.

Contact a qualified electrical contractor.

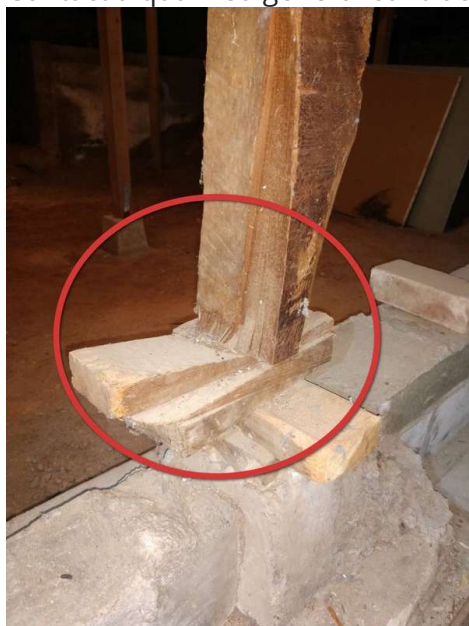
4x8 overspanned.

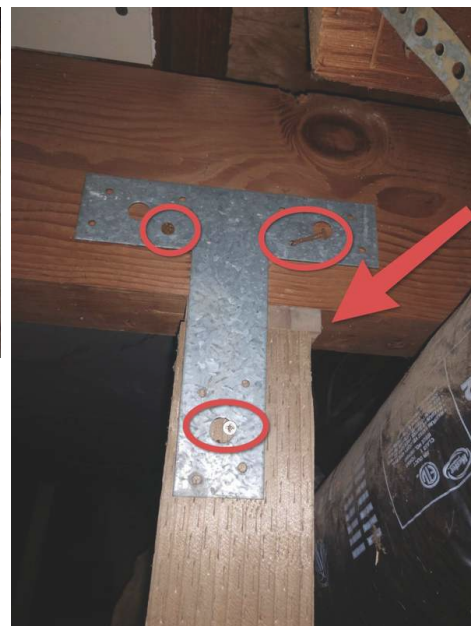
Inadequate number of and improper type of fasteners. Extension / shim inserted.

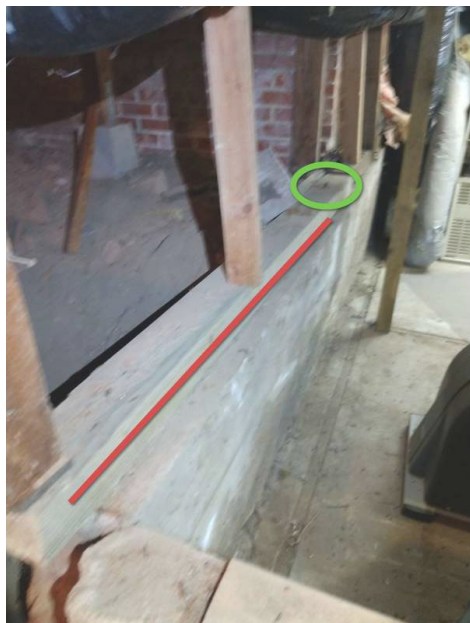
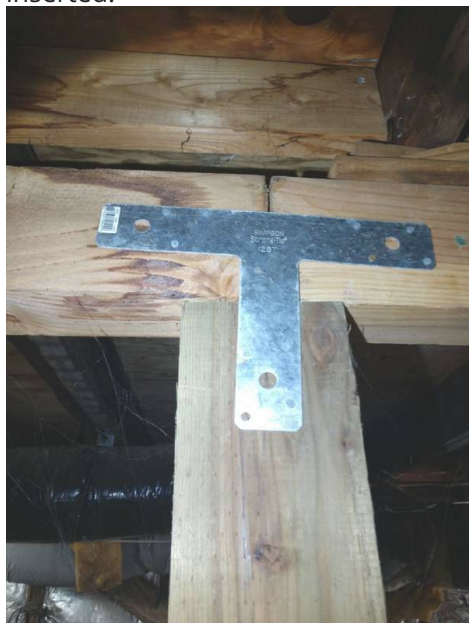
One bolt with no nut or fastener - green circle. No hold down bolts, posts not securely attached - red line

Undersized fasteners for this application.

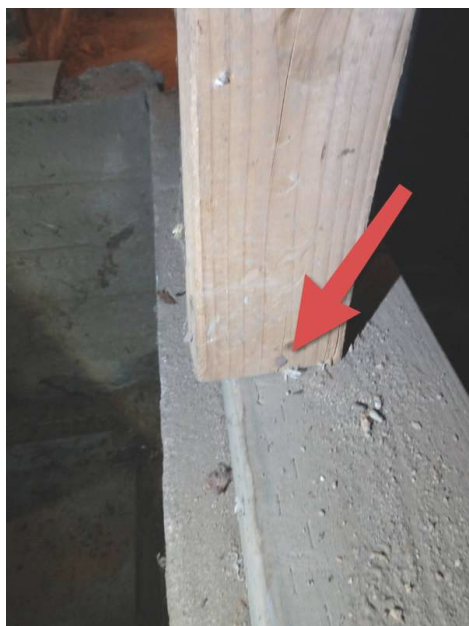
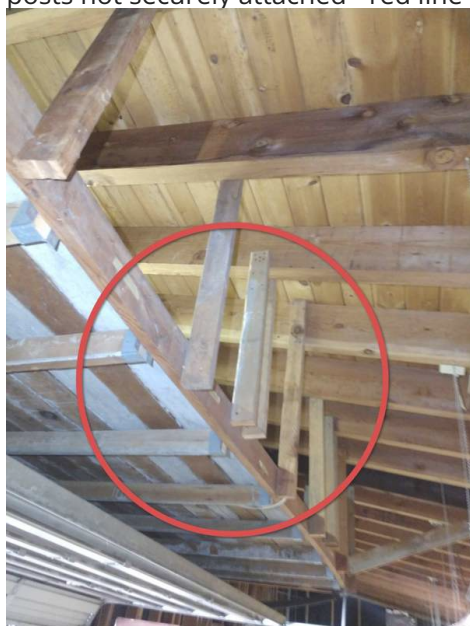
Improper support member, inadequate fastening, poor placement.

Substandard building practices above garage door.
