## RESIDENTIAL REPORT

1234 Main St.  
Fishers, IN 46037

Buyer Name  
07/17/2019 9:00AM

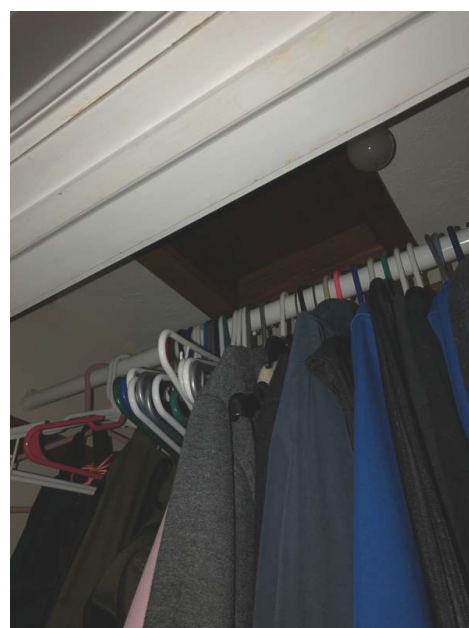
**ATTIC ACCESS-INACCESSABLE**

The attic access was not accessible due to residents personal items.

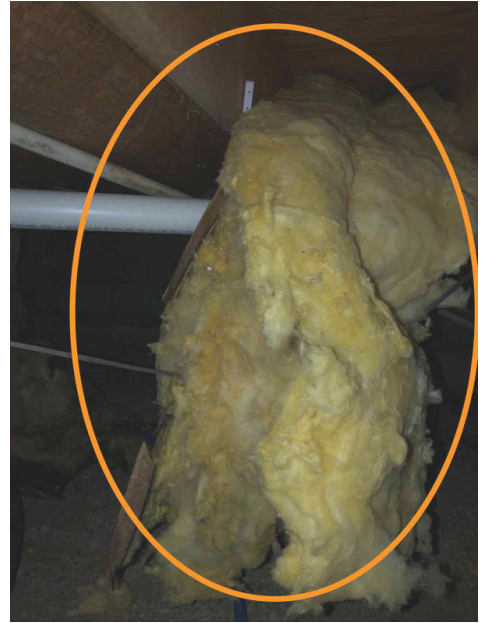
Crawlspace

**INSULATION-LOOSE**

The flooring insulation is displaced in several locations. This leads to poor efficiency and allows moisture to the sub-floor. Recommend qualified professional to return insulation to proper uniformity.

Contact a qualified professional.

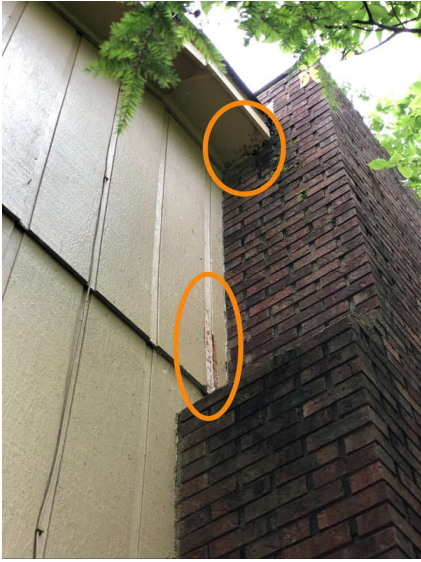
West

### DAMAGE

Damage to the siding was noted. This could lead to the siding falling off or allowing water to penetrate behind the material. Recommend qualified professional for repair.

Contact a qualified professional.

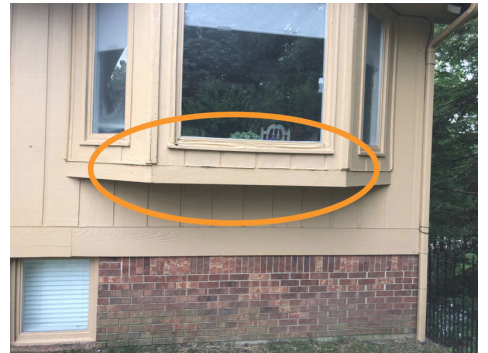
Bay window

**WOOD SIDING- DAMAGE/WOOD ROT**

The wood siding on the house showed signs of wood rot and damage. Recommend qualified siding professional to evaluate and repair or replace the siding where needed.

Contact a qualified siding specialist.

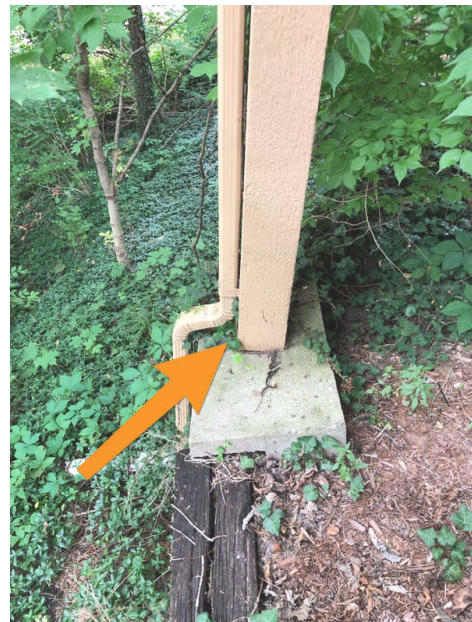
Southwest

**COLUMN-WOOD ROT**

One or more columns showed signs of wood rot. Recommend qualified professional to make necessary repairs.

Contact a qualified professional.

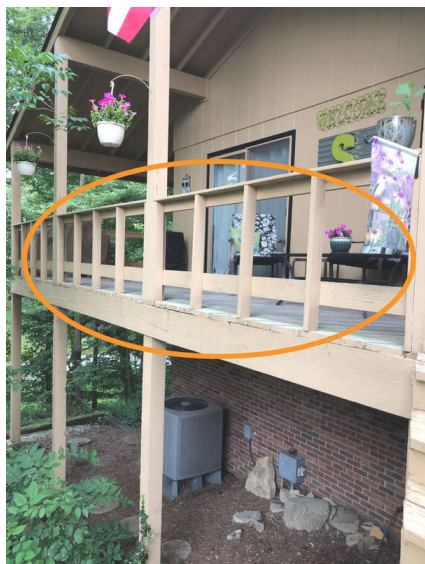
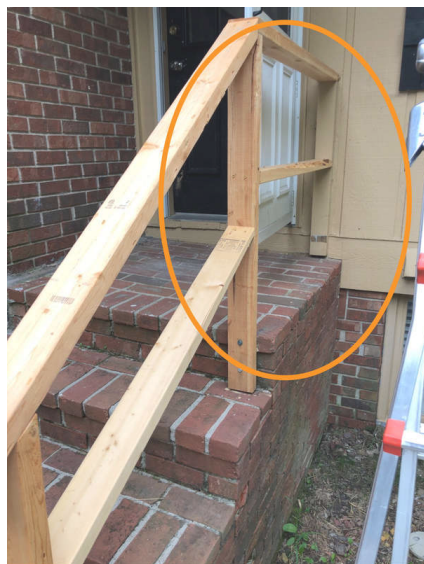
The spacing between the balusters is too wide and does not meet current safety standards. Recommend qualified handyman for repair.

Contact a qualified handyman.

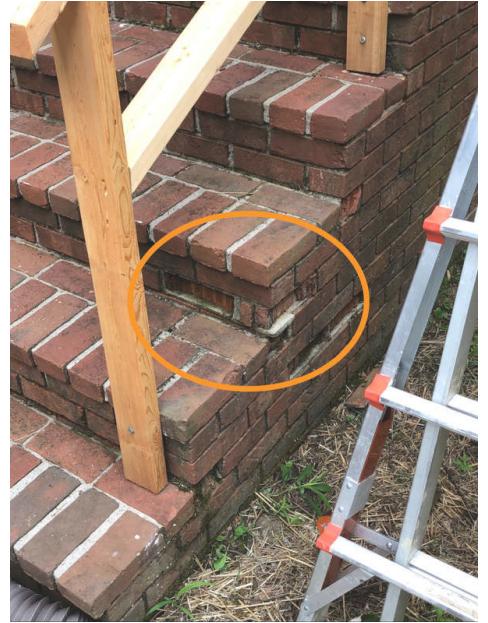
North

**BRICK-DAMAGED**

Some of the brick on the steps was damaged/deteriorated. This could lead to a trip or fall hazard. Recommend qualified masonry professional for repair.

Contact a qualified masonry professional.

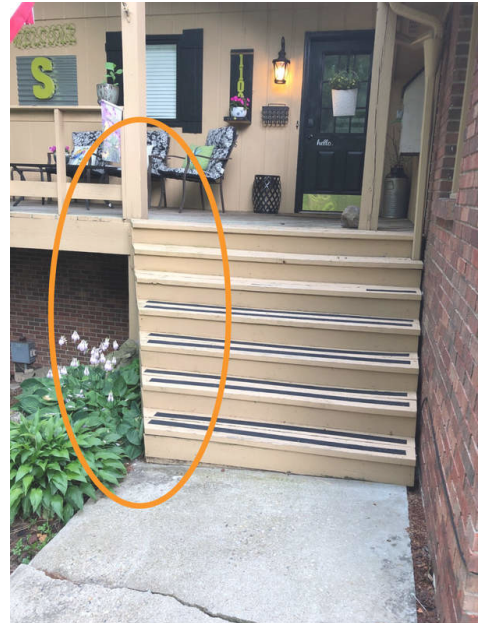
Main entry

A railing and handrail is needed for the steps. The height can be a safety hazard. Recommend qualified professional to install railing and handrail.

Contact a qualified professional.

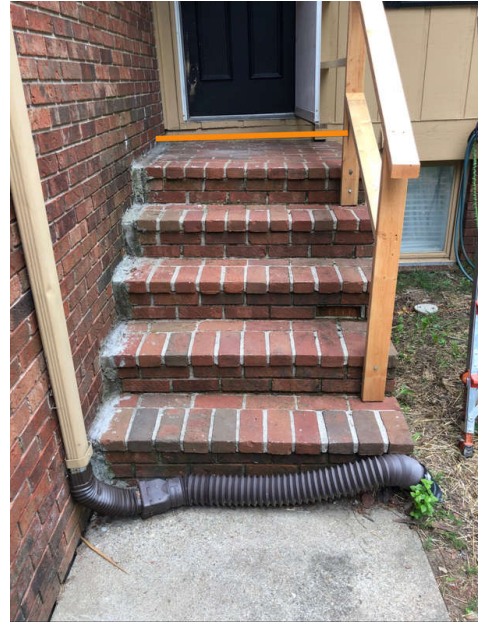
North

The porch has settled and is showing signs of deterioration. Recommend qualified professional for evaluation and repair.

Contact a qualified professional.

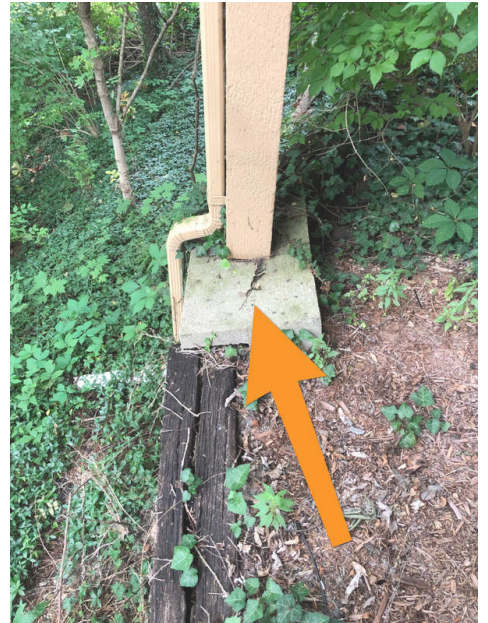
Southwest

The footer for the column has settled which could eventually effect the integrity of the column and the structure above. Recommend qualified professional for repair.

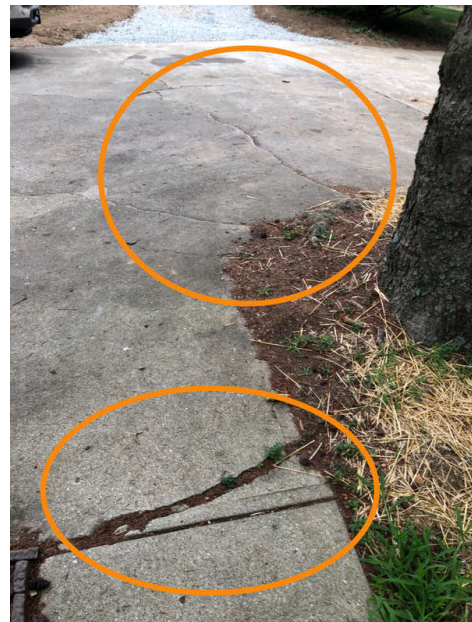
Driveway

**DRIVEWAY CRACKING - MAJOR**

Major cracks observed. Recommend driveway contractor evaluate and make necessary repairs.

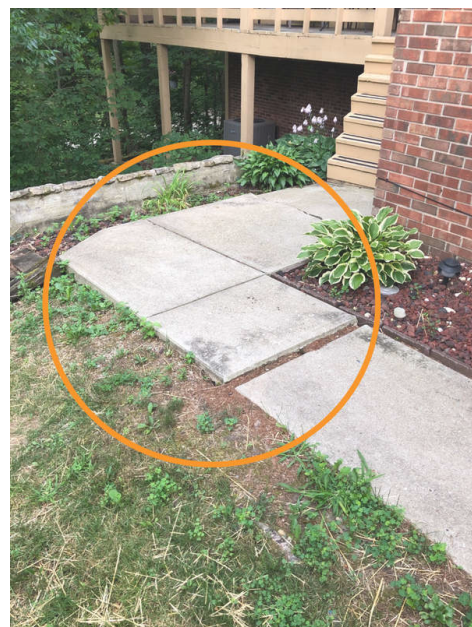
East

**WALKWAY TRIP HAZARD**

The walkway has settled which has caused a trip hazard. Recommend qualified professional for repair.

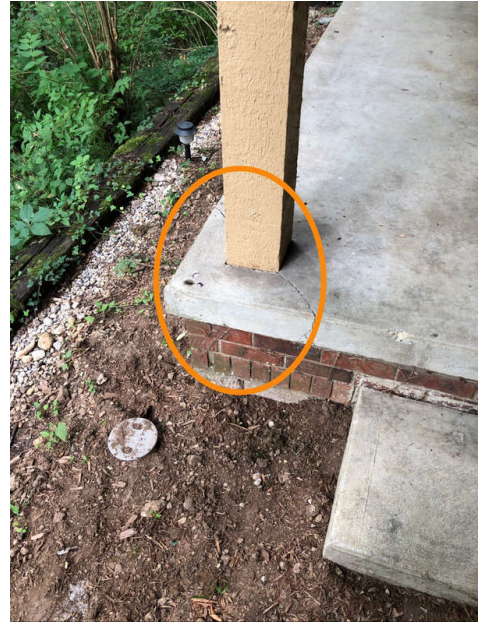
South-patio

**PATIO-LOOSE CONCRETE**

Concrete was observed to be loose at the time of inspection. This has the potential to be a trip and fall hazard. Recommend qualified professional for evaluation and possible repair.

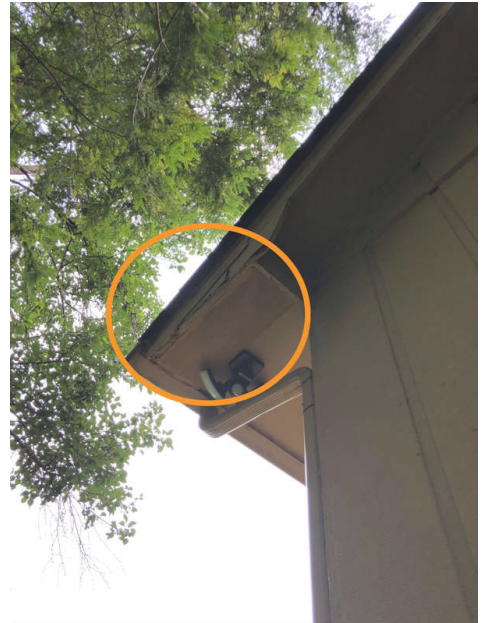
Northwest

**EAVES-WOOD ROT**

The eave was showing signs of wood rot. Recommend qualified professional for repair.

Contact a qualified professional.

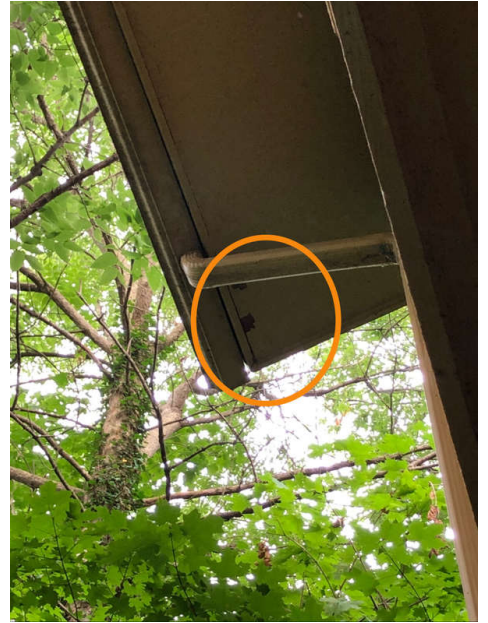
Southwest

**SOFFIT-DAMAGE**

The soffit was damaged. This will allow pests to enter. Recommend qualified professional for repair.

Contact a qualified professional.

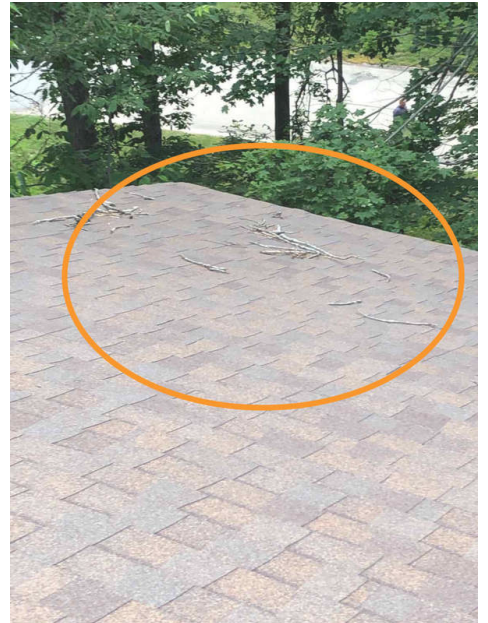
Southeast

**TREE DEBRIS ON ROOF**

Tree debris observed on roof. This can cause improper drainage to gutters and downspouts. Recommend clearing debris.

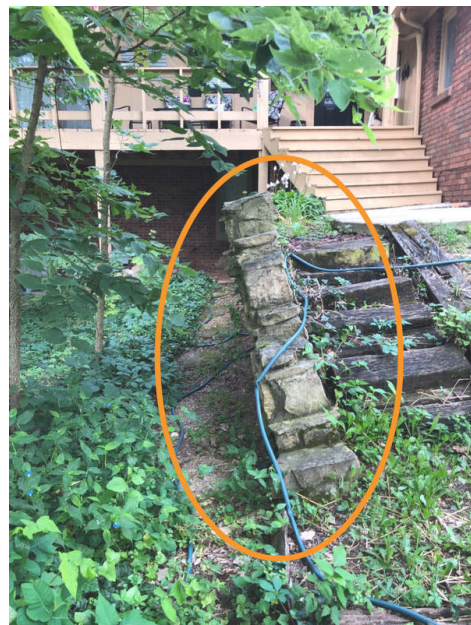
East

The retaining wall is leaning and May be in need of repair. Recommend qualified professional for further evaluation and possible repair.

Contact a qualified professional.

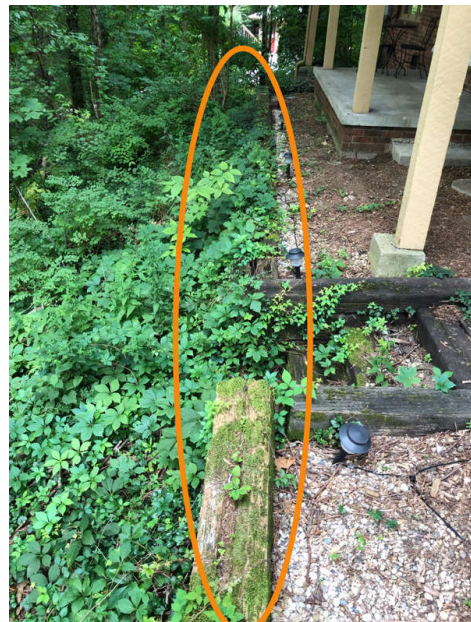
South

**RETAINING WALL-WOOD ROT**

Wood rot was present on the retaining wall. Recommend qualified professional to replace affected pieces.

Contact a qualified professional.

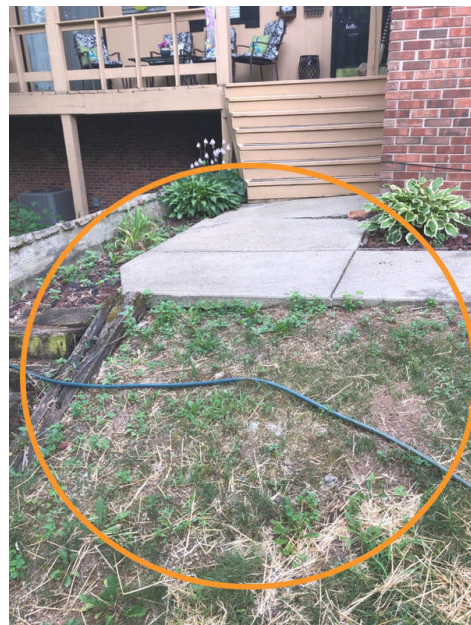
East

Significant settlement/movement was noted. This can lead to further damage and movement in this area. Recommend qualified professional for evaluation and repair.

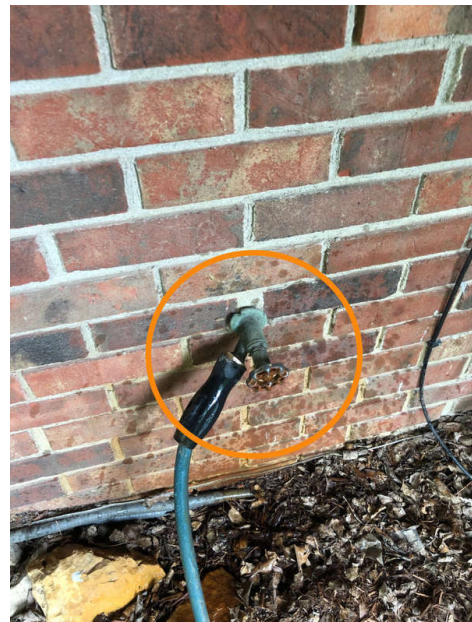
East

The exterior faucet is not secure on the wall. This can cause damage to the supply pipe. Recommend handyman to make the faucet secure.

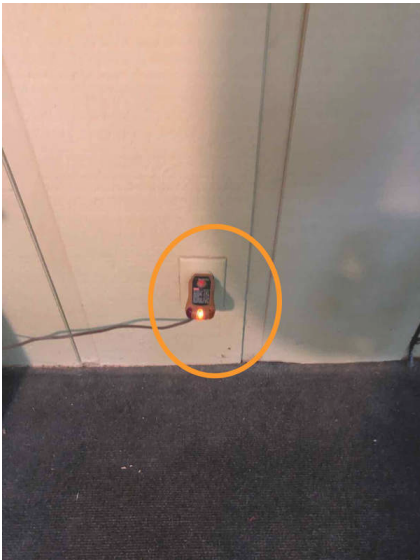
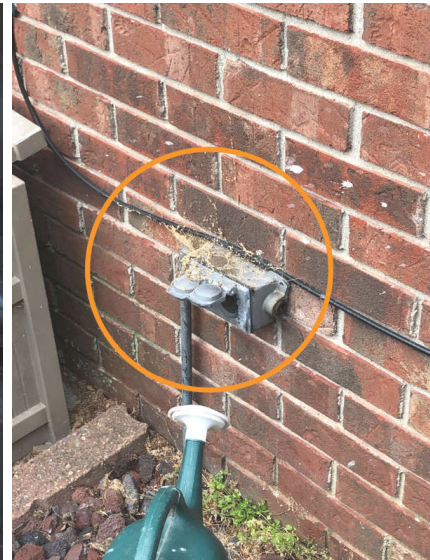
Exterior outlet(s) were not GFCI protected. All exterior outlets should be GFCI protected for safety. Recommend qualified electrician for repair.

Contact a qualified electrical contractor.

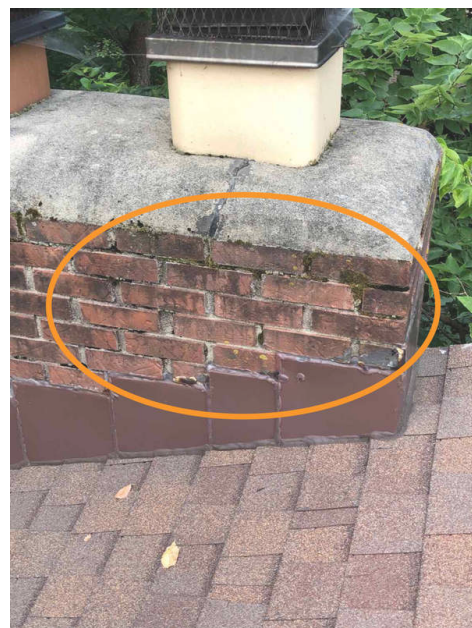
Vegetation growth was noted on the chimney. This growth can lead to deterioration of the mortar. Recommend qualified handyman to clean the chimney.

Contact a qualified professional.

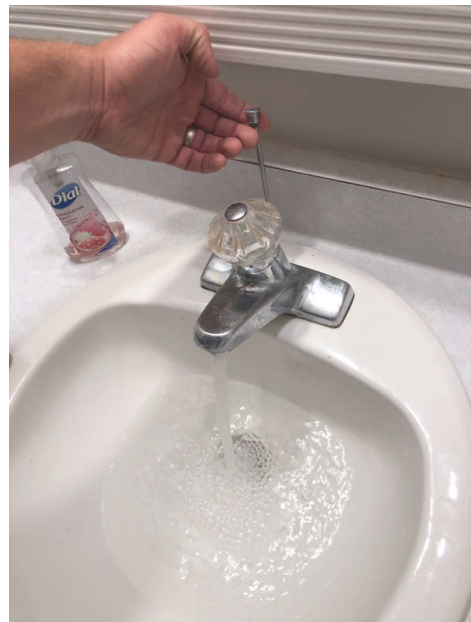
Master Bathroom

The sink drain stopper does not properly operate. Recommend qualified handyman for adjustments.

Contact a qualified handyman.

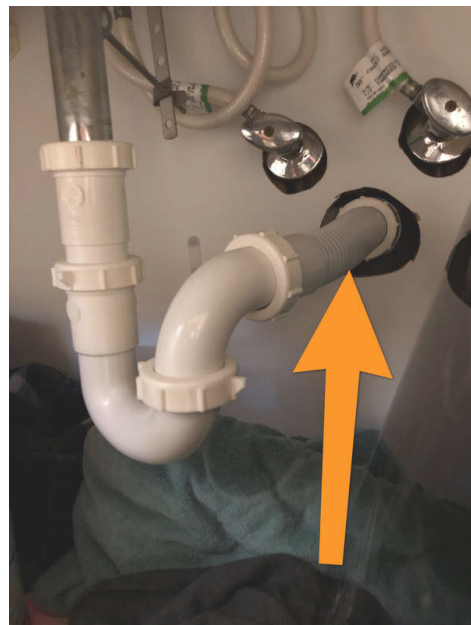
Hall Bathroom sink

A negative slope was noted on a drain pipe. This will cause slow drainage and a higher chance of a clog. Recommend qualified plumber to create the proper slope.

Contact a qualified professional.

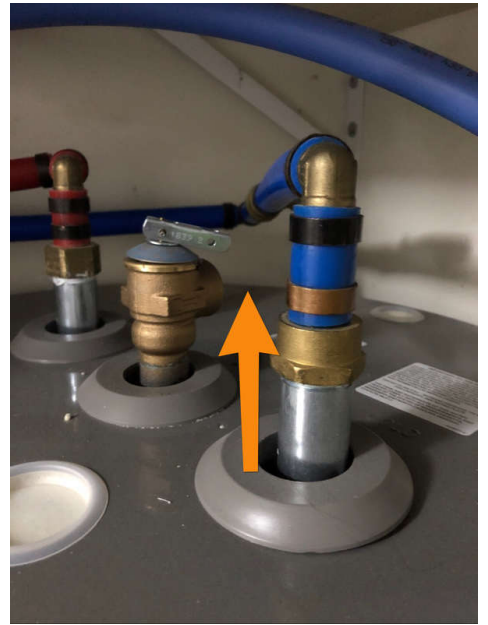
**MISSING T&P EXTENSION PIPE**

The t&p extension pipe has not been installed. Recommend qualified plumber for installation.

Contact a qualified professional.

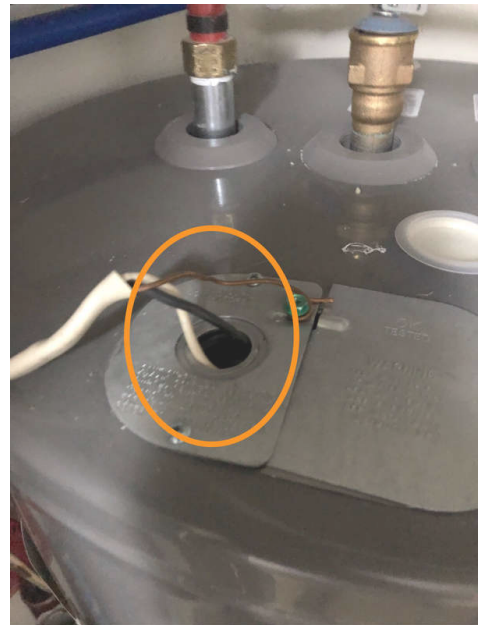
**GROMMET NEEDED**

A grommet is needed at the electrical entrance to protect the wire. Recommend qualified professional for installation.

Contact a qualified professional.

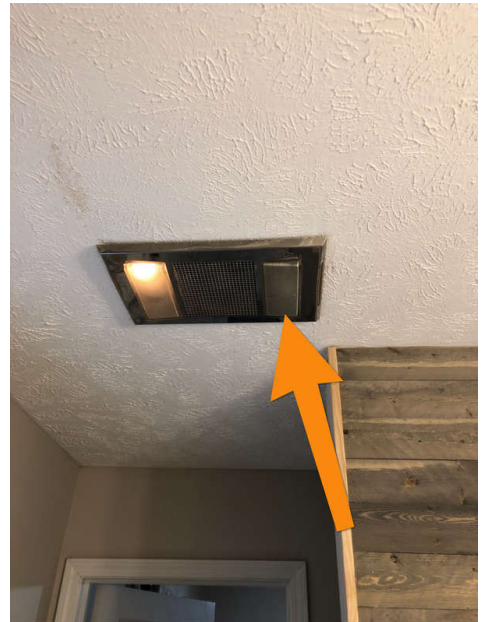
Hall Bathroom

#### **LIGHT INOPERABLE**

One or more lights are not operating. New light bulb possibly needed.

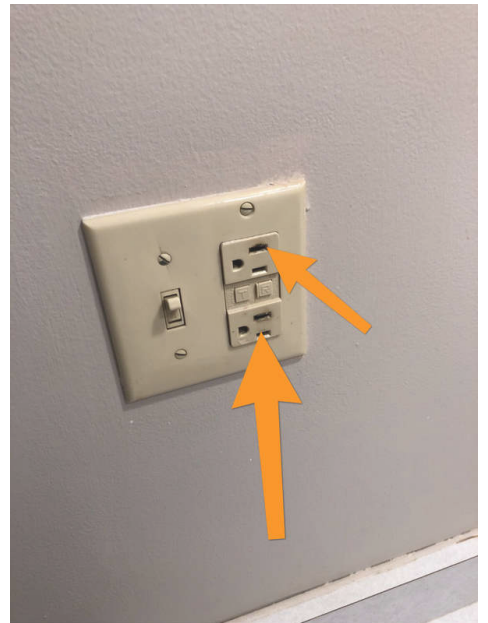
Master Bathroom

The outlet was melted. This is an indication that overheating occurred and could have caused damage to the outlet. Recommend qualified electrician for replacement.

Contact a qualified electrical contractor.

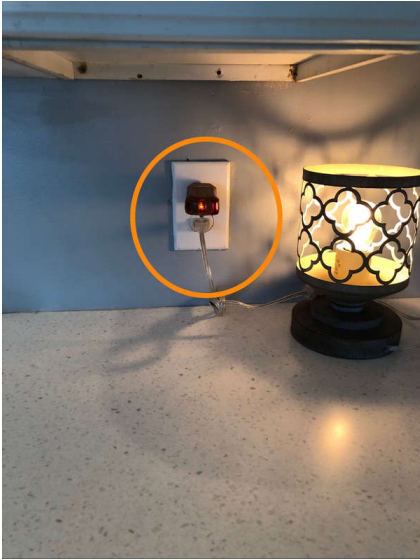
Southwest Dining Room

One or more outlets are not grounded. Grounding of outlets may not be a requirement depending on the age of the house. For the well being of electronics and people, grounding the outlets is an upgrade to consider.

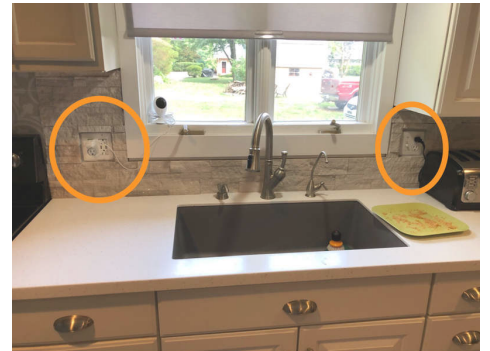
Kitchen

Outlets within 6 feet of a water source need to be GFCI protected. Recommend qualified electrician for repair.

Contact a qualified professional.

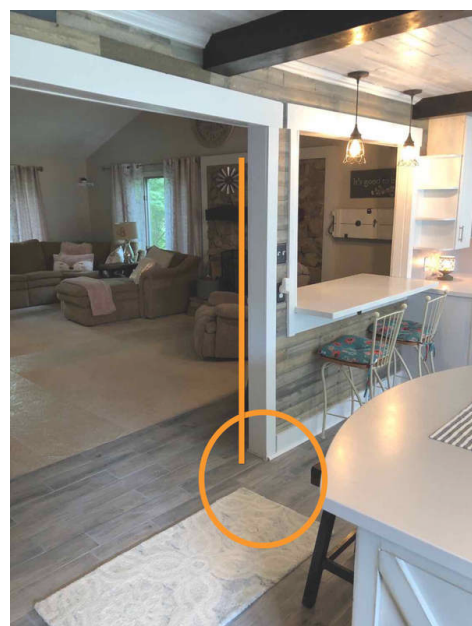
The floor was sloped and some settling has occurred. This can be an indication of foundation settling or other issues. Recommend qualified foundation professional for further evaluation.

Contact a foundation contractor.

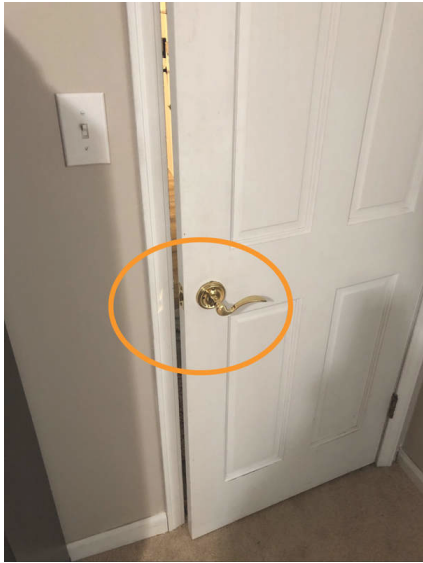
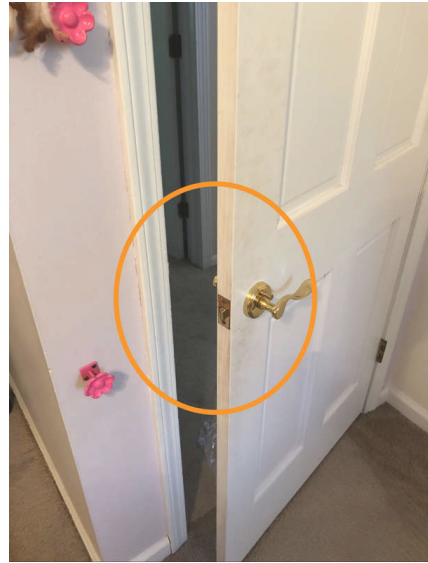
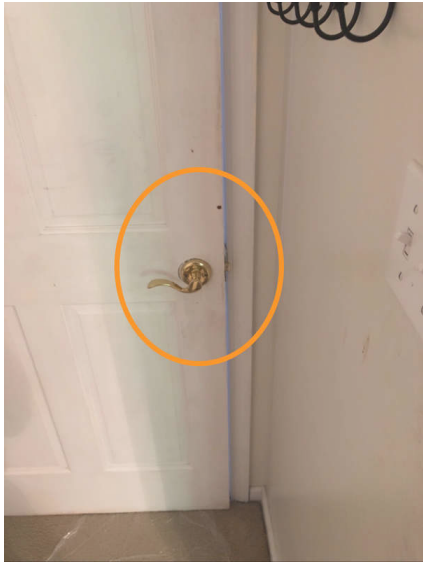
**DOOR DOESN'T LATCH**

Door doesn't latch properly. Recommend handyman repair latch and/or strike plate.

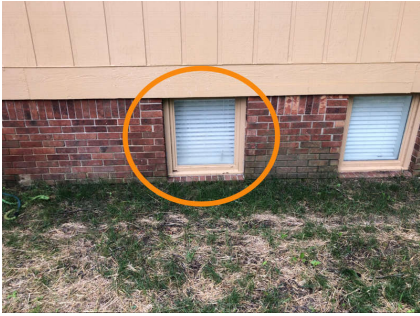
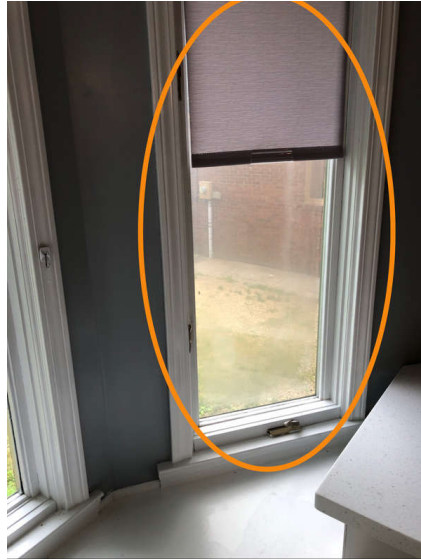
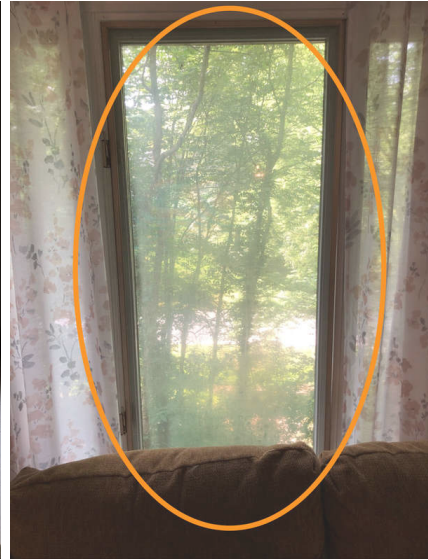
Bay window- Dining Room

**FAILED SEAL**

Observed condensation between the window panes, which indicates a failed seal. Recommend qualified window contractor evaluate & replace.

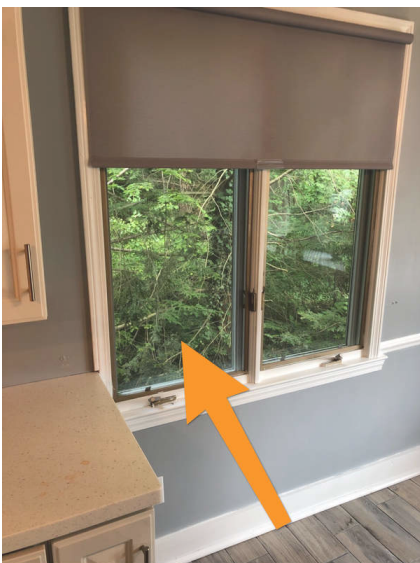
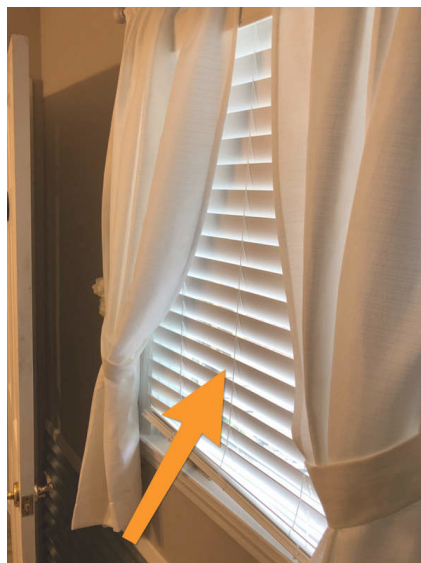
Some windows were difficult to operate. This could be because of their age and/or swelling. Recommend working them loose and maintaining workability or calling a window professional for further evaluation and make all necessary repairs.

Wouldn't completely close- Dining Room

Contact a qualified window repair/installation contractor.

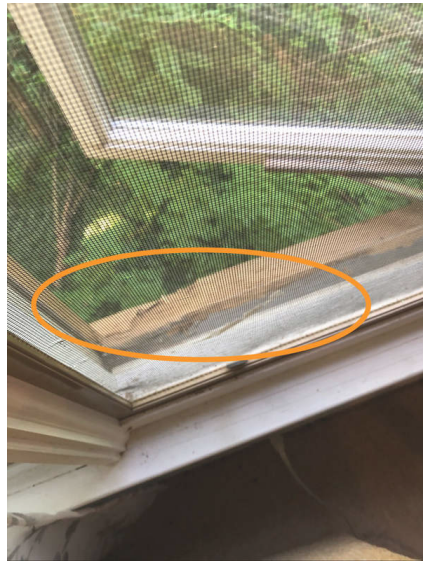
West Living Room

**WOOD ROT**

Wood rot was noted on the exterior trim. Recommend contacting window professional for repairing and replacing all affected materials.

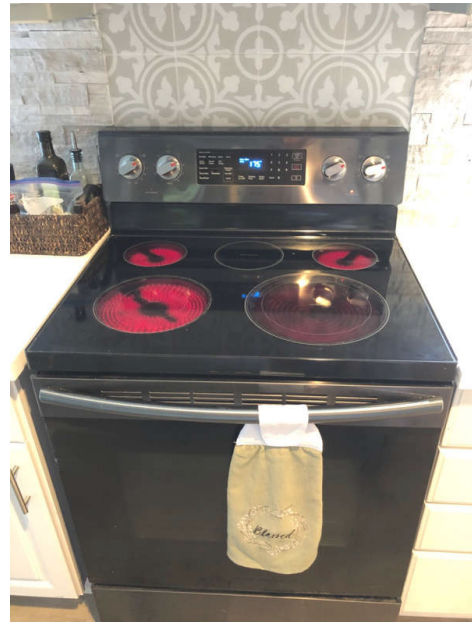
**RANGE NOT FASTENED**

Range was not fastened to the floor. This poses a safety hazard to children. Recommend a qualified contractor secure range so it can't tip.

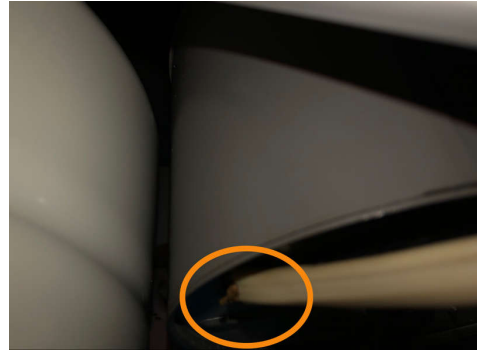
Disposal

A grommet is needed where the electrical wire enters the disposal. Recommend qualified professional for installation.

Contact a qualified professional.

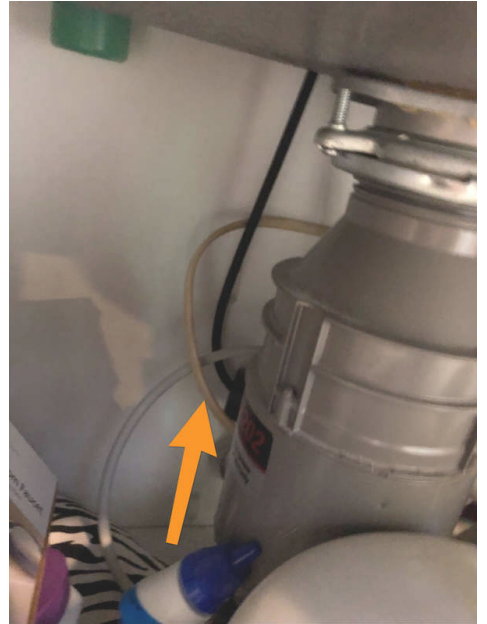
Disposal wire

Current standards state that the exposed wiring should be in electrical conduit for safety. However, depending on when disposal was installed, it may not have been required at that time. Recommend qualified electrician for installing conduit.

Contact a qualified electrical contractor.

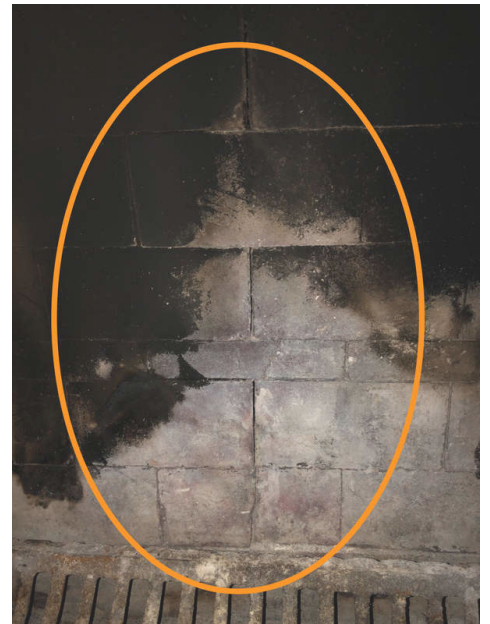
Fire brick

### DAMAGED FIREBRICK

The fire brick was damaged in places. Recommend qualified fire place professional for repair.

Contact a qualified professional.

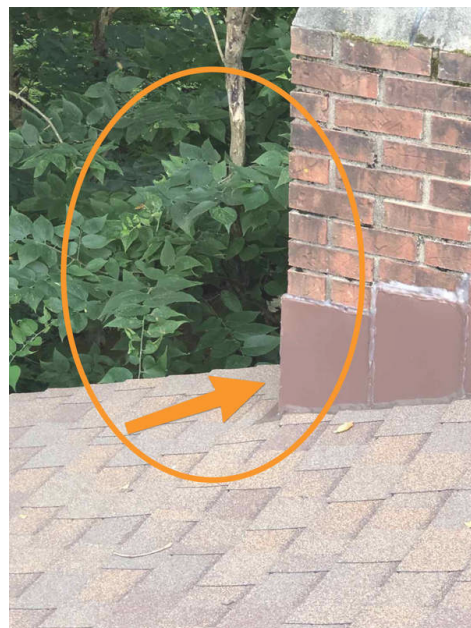
West

Bees were swarming at the time of inspection. Recommend qualified professional for treatment.

Contact a qualified professional.

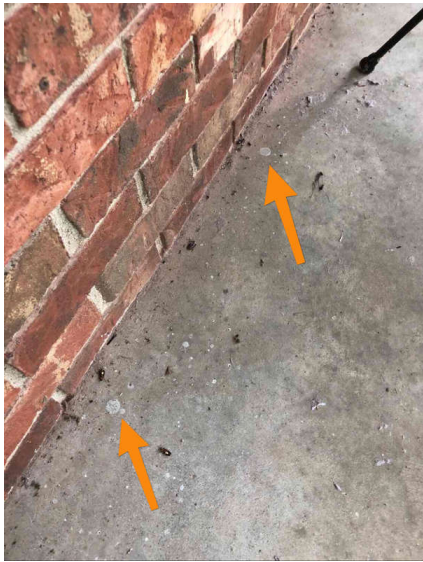
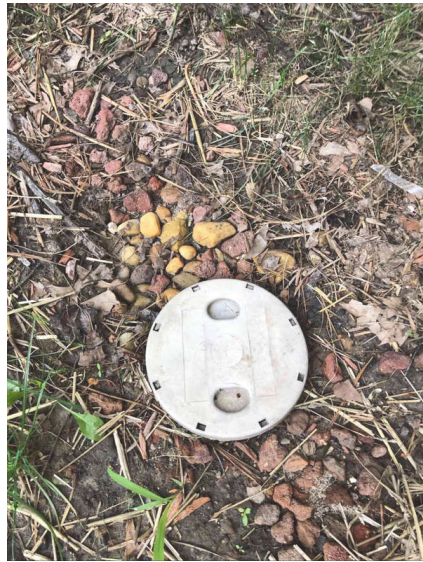
There was evidence of previous termite treatment. It is unknown if it is a recent treatment or not. Recommend asking current owner when treatment was done.

Drill holes- South patio

Bait station-around entire house
