EXPRESS INSPECTIONS LLC

ROOM-BY-ROOM RESIDENTIAL

1234 Main St.
Mifflinville PA 18631

Buyer Name
05/09/2019 9:00AM

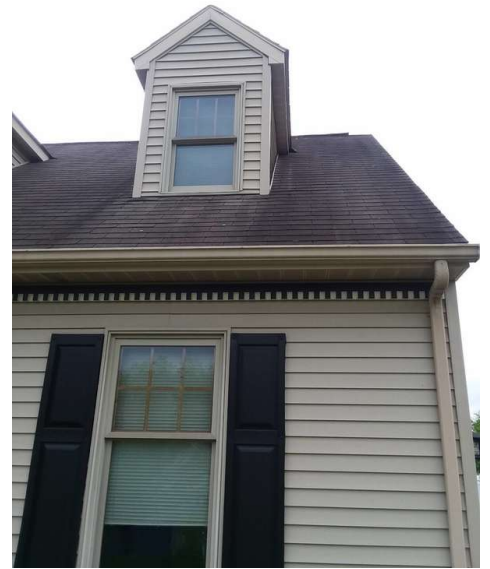
2.1.2 Coverings

DISCOLORATION

Roof shingles are somewhat discolored, probably caused by algae and is aesthetic in nature.

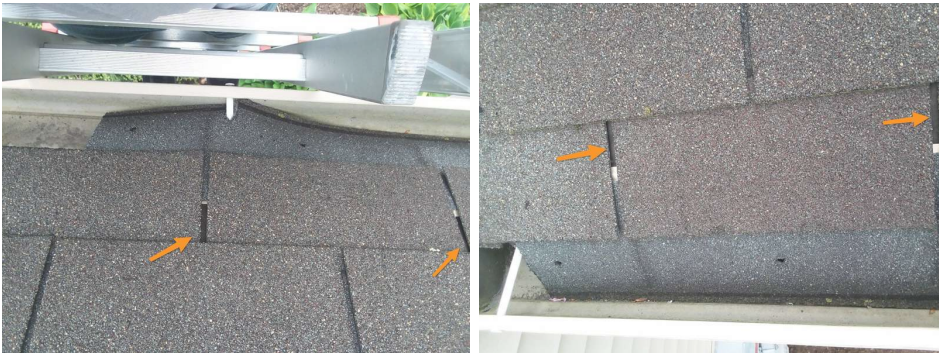
SHINGLE DISPLACED

GARAGE, FRONT LEFT NEAR GUTTER

Starter shingle pulled loose of nails and slid down into gutter. This shingle should be replaced to eliminate risk of leak into soffit area.

Underlayment exposed at water ways

Contact a qualified roofing professional.

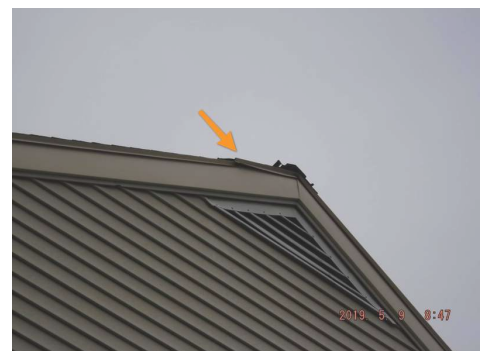
2.3.1 Flashings

DRIP EDGE LOOSE

LEFT REAR OF HOUSE

A short piece of drip edge is loose or out of place near peak. Recommend refastening to avoid water entry behind shingles, underlayment, or fascia.

Contact a qualified roofing professional.

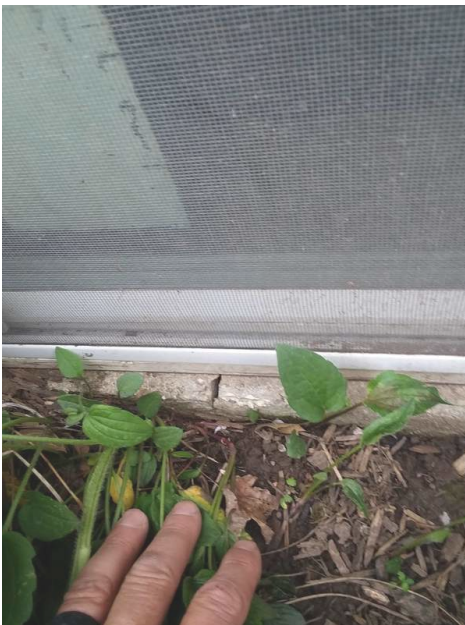
Left End of House

Inadequate clearance between siding and ground. Recommend 6" minimum ground clearance to bottom of siding to deter direct access to wood destroying insects to wood components of house. At basement windows on left end of house, window wells should be installed. Recommend altering conditions to allow minimum clearance.

Contact a handyman or DIY project

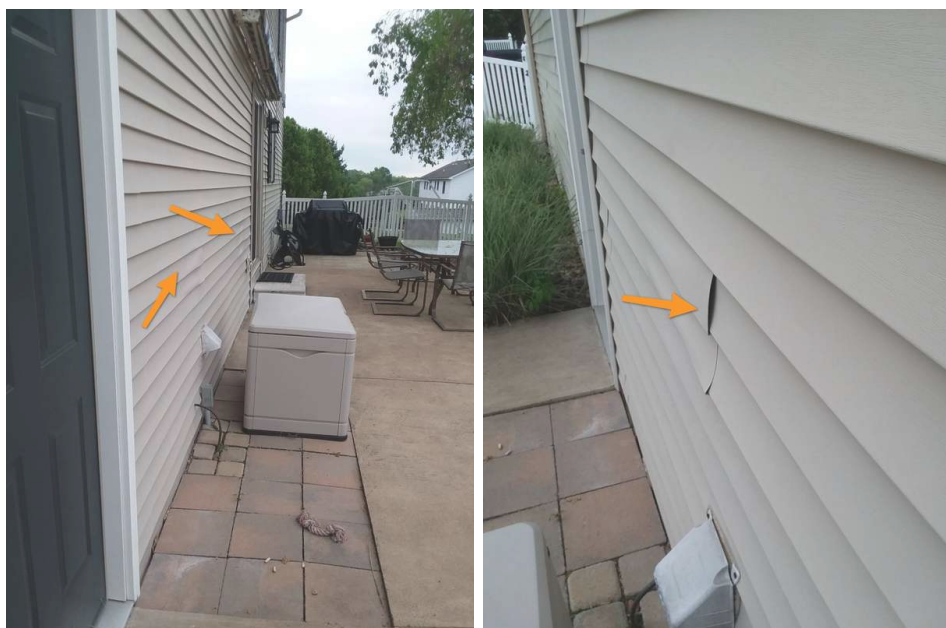
Vinyl siding was warping or buckling in areas. This is often as a result of nailing siding boards to tight to the home, but this doesn't seem to be the case here. This is mostly aesthetic, however insects could easily travel behind the siding at the gap. Recommend a qualified siding contractor evaluate and replace these pieces of siding.

Two areas

Gap could allow insect intrusion behind siding.

Contact a qualified professional.

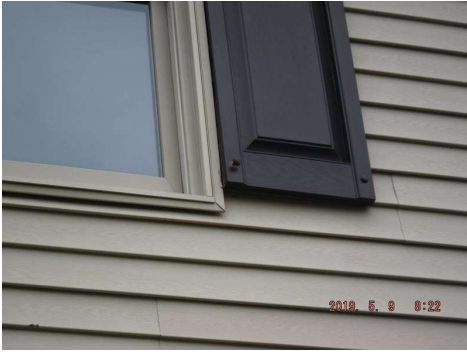
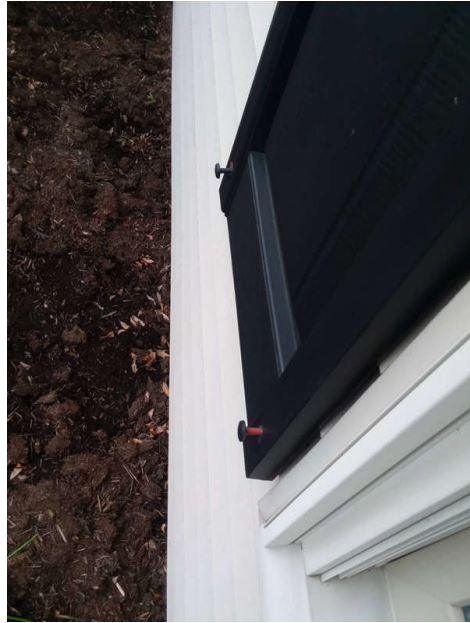
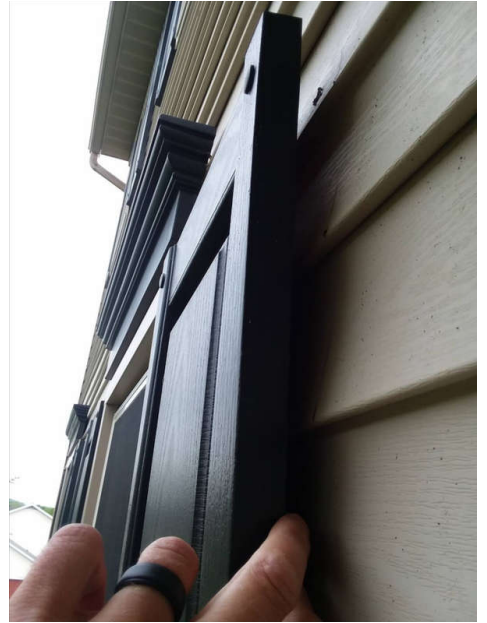
A number of shutter pins, which fasten the shutters to the wall, are broken. Shutters are in danger of falling or being blown off. Recommend replacing broken pins.

Contact a handyman or DIY project

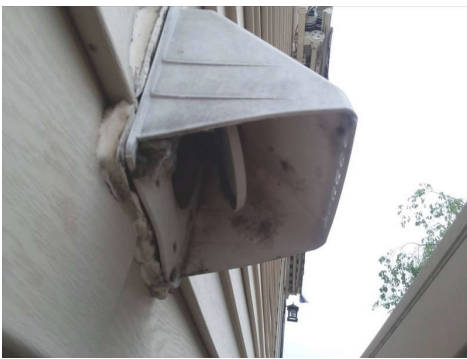
3.1.4 Siding, Flashing, Trim, Light Fixtures

DRYER VENT HOOD

Dryer vent hood is cracked and flapper does not close tightly. Recommend replacing with a new dryer vent hood.

Flapper does not close

Contact a handyman or DIY project

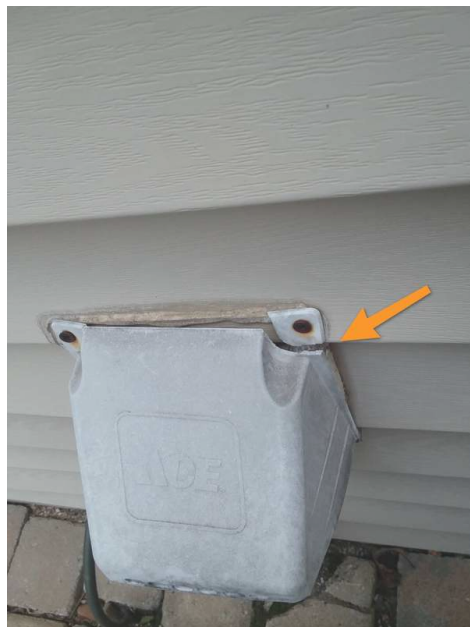
Cracked at top

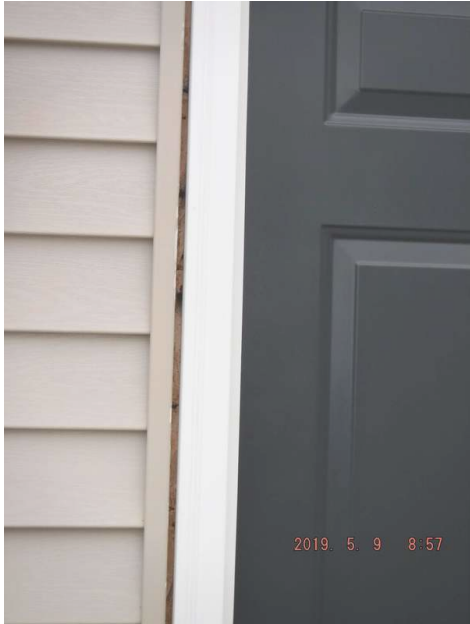
3.1.5 Siding, Flashing, Trim, Light Fixtures

A gap exists between the siding J-channel and the door molding and also rear garage wall at top. This could allow water entry, leading to damage to the wall sheathing and/or molding. Recommend applying a high grade exterior caulking to seal the gap at door molding. The siding may be able to be slid back together and overlapped, assuming the siding panels slid apart over the years.

Sheathing visible

Contact a handyman or DIY project

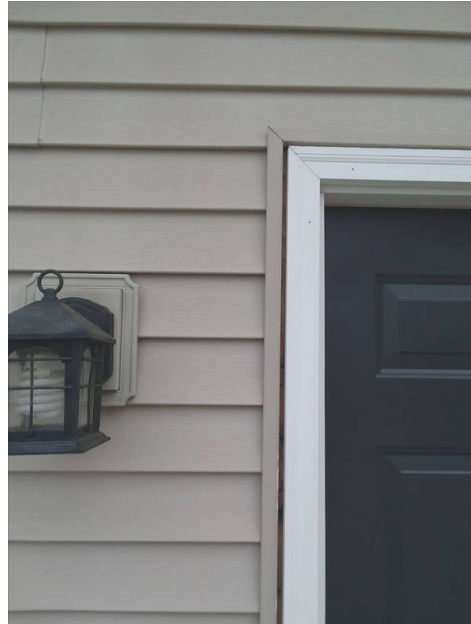
Caulk perimeter of door molding

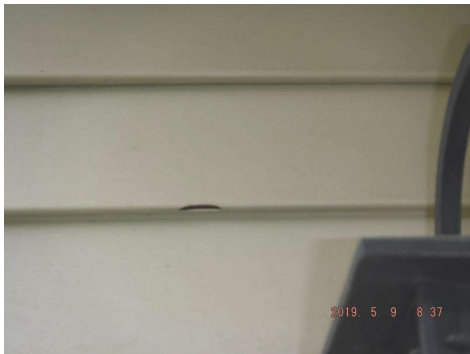
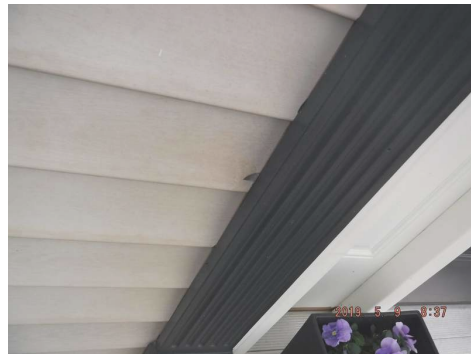
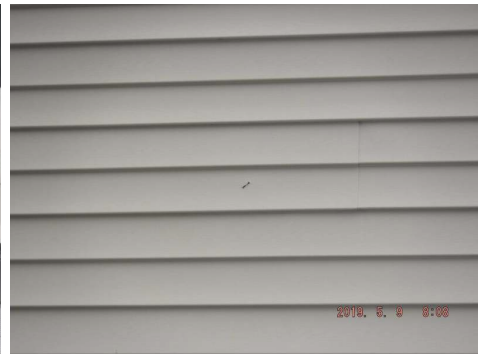
3.1.6 Siding, Flashing, Trim, Light Fixtures

SIDING MINOR DAMAGE

A few areas of minor siding damage are present. Recommend sealing, by a qualified handyman, with a color-matched caulking to avoid water/insect intrusion.

Contact a handyman or DIY project

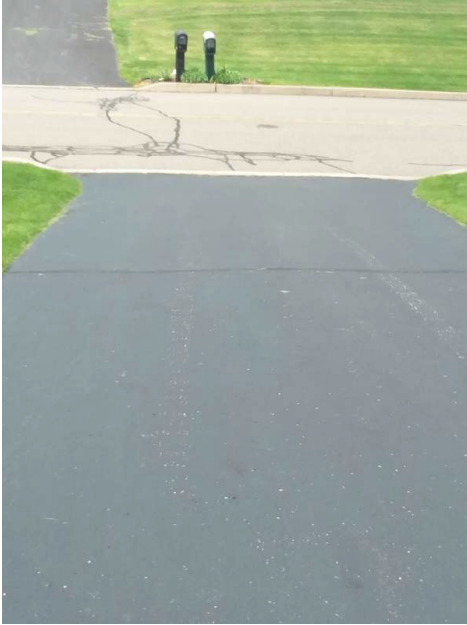
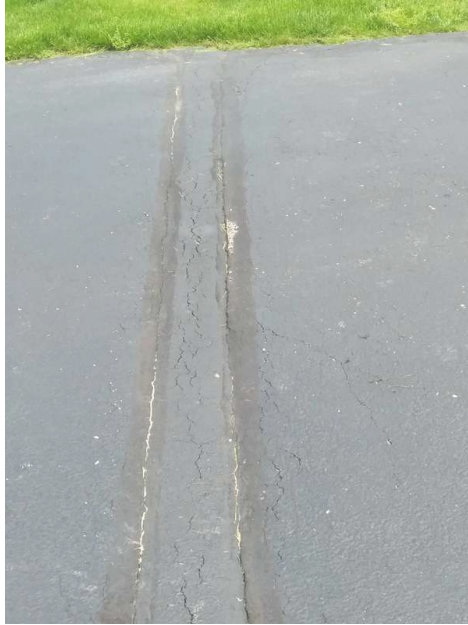
3.4.1 Walkways, Patios & Driveways

DRIVEWAY CRACKING - MINOR

Minor cosmetic cracks observed, which may indicate movement in the soil. Recommend monitor and/or have concrete contractor patch/seal.

Contact a handyman or DIY project

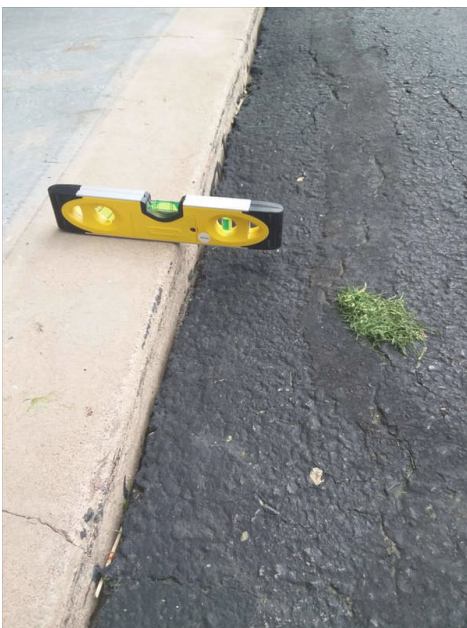
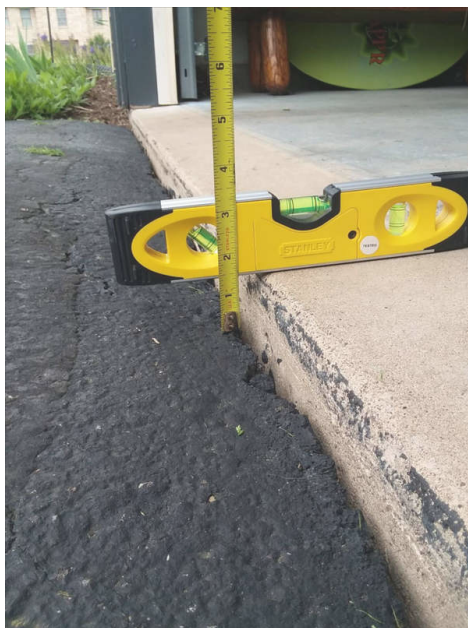
3.4.2 Walkways, Patios & Driveways

ASPHALT SETTLING AT GARAGE

Gap between driveway asphalt and garage concrete allows water to drain to ground, causing erosion and allowing asphalt to settle. The settling has resulted in a negative pitch of the asphalt towards the garage, and directing more water towards the gap. Recommend sealing the gap and monitoring the asphalt for further settling.

Driveway at garage

Contact a qualified professional.

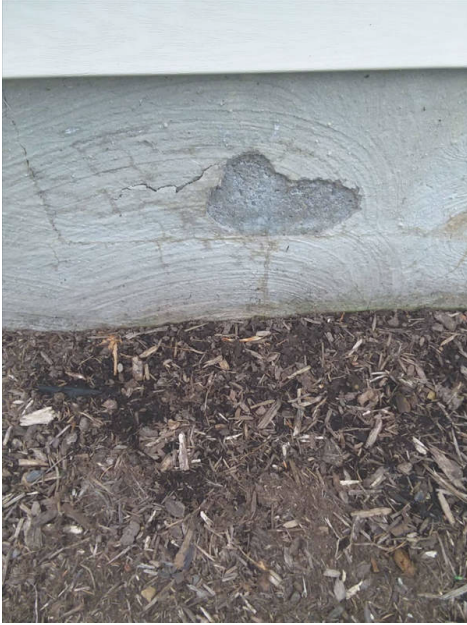
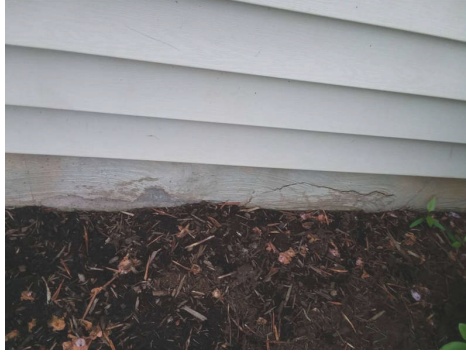
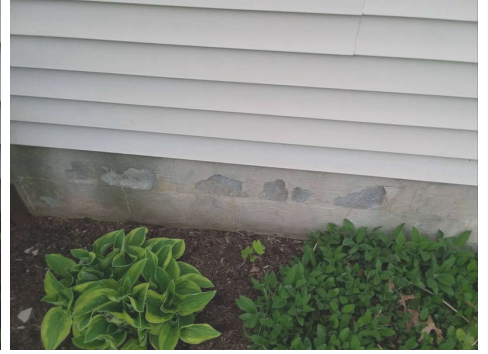
3.6.1 Exposed Foundation Walls, Window Wells

The parging at the foundation wall exhibits areas of flaking. Parging a CMU wall is mainly aesthetic but can offer a barrier to insect entry at minor cracks. Recommend monitoring the parging for further degradation and repair if desired.

Contact a qualified masonry professional.

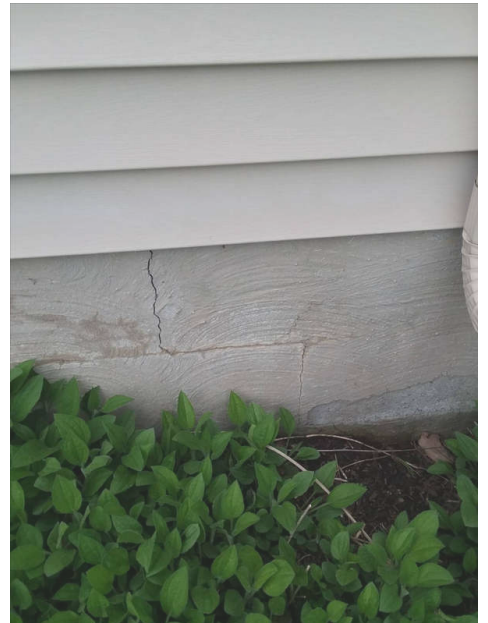
3.6.2 Exposed Foundation Walls, Window Wells

MINOR CRACKING

Some minor cracking is evident at the basement wall. This is a common occurrence with CMU walls and does not pose a structural issue. Recommend monitoring for worsening of or additional major basement wall cracks.

Contact a qualified professional.

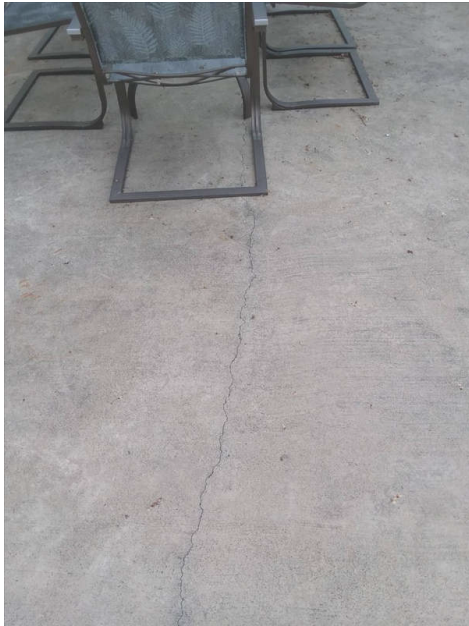
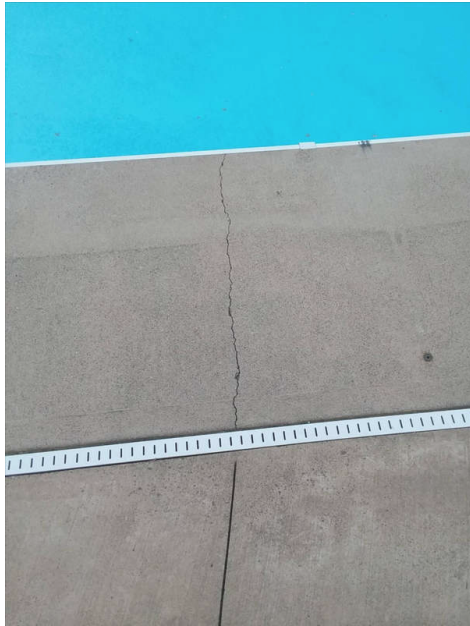
3.10.1 Swimming Pools, Hot Tubs

POOL PATIO MINOR CRACKING

Minor cracking is evident at various locations around pool area. Recommend monitoring for future cracking, widening of cracks or crack settling to different heights.

Contact a qualified professional.

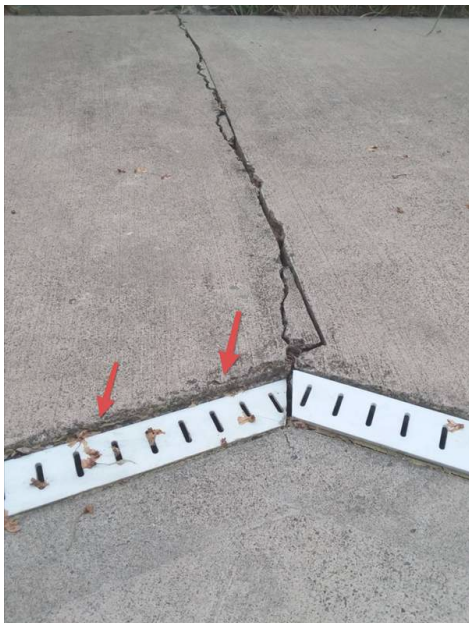
3.10.2 Swimming Pools, Hot Tubs

CONCRETE SLAB SETTLEMENT

Settling has occurred at two areas at the concrete slab closest to swimming pool and has created a trip hazard. Recommend a qualified concrete contractor evaluate and repair/replace.

Approx. 3/4" height difference between slabs

Contact a qualified concrete contractor.

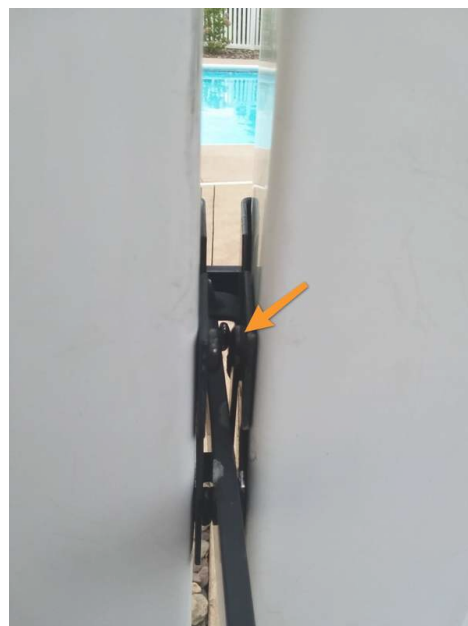
The Pool fence gate near the garage is difficult to open. The post leans towards the gate and causes the latch screws to catch on the bracket. Recommend reinstalling the post next to the gate.

Re-set the post to widen the gap between the post and gate.

Contact a handyman or DIY project

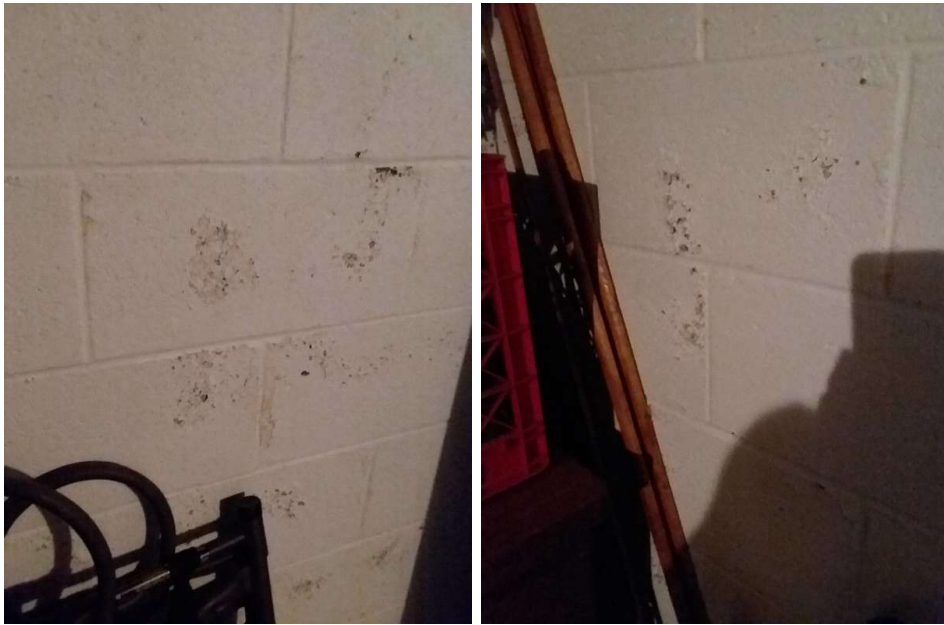
4.1.1 Basements & Crawlspaces

EFFLORESCENCE

Minor Efflorescence noted on the basement wall surface. This is a white, powdery deposit that is consistent with moisture. Recommend maintaining low humidity in basement area.

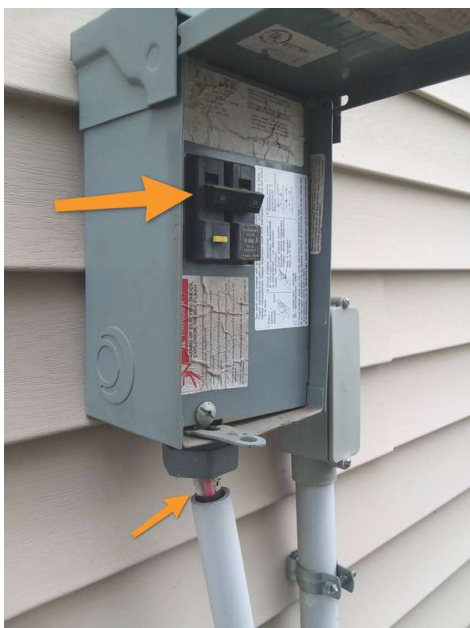
There is an unused electrical disconnect that may have powered a hot tub or other electrical equipment. The breaker is shut off at the main panel and the disconnect, the wire has been taped over, the conduit has been pulled partially out of the disconnect box and there is an opening into the box. Recommend a qualified electrician remove the wiring, conduit and disconnect box for safety purposes.

Breaker turned off, wiring exposed

Contact a qualified electrical contractor.

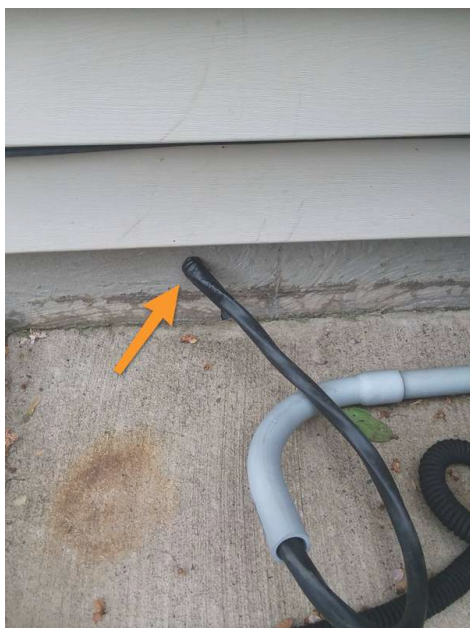
Wire taped but no adequate weather or human protection.

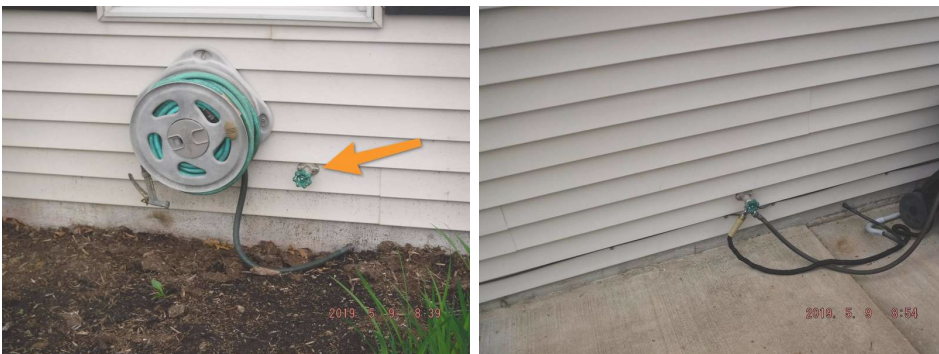
7.3.1 Water Supply Piping

The exterior faucets do not have an anti-siphon device to eliminate the possibility of siphoning contaminated water into the home's fresh water supply system. Recommend a qualified plumbing contractor replace existing exterior faucet with an anti-siphon exterior faucet or add a screw-on vacuum breaker.

Add anti-siphon device or change to hose bib with integral anti-siphon Rear

Contact a qualified plumbing contractor.

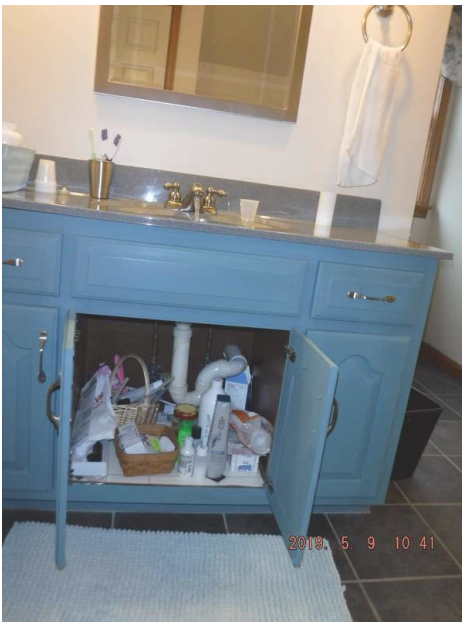
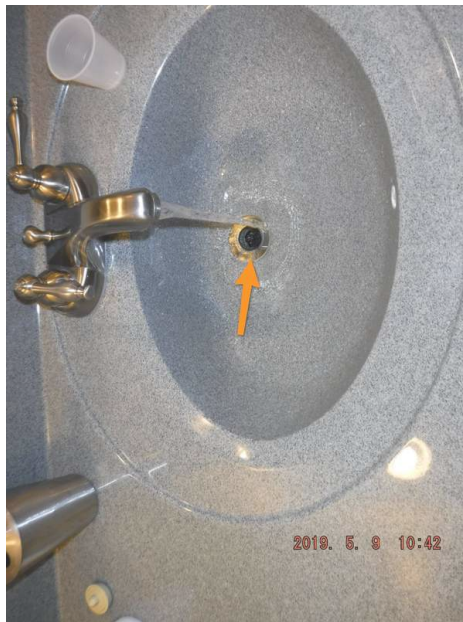
Master Bath

Master bath vanity missing drain stopper. Recommend replacement by qualified handyman.

Drain stopper missing

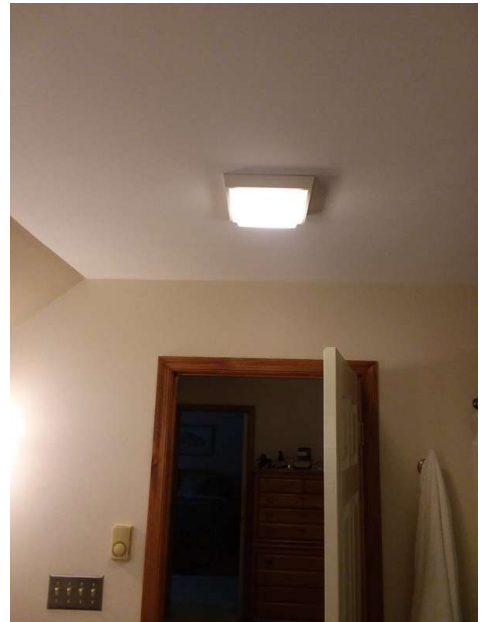
Bath fan is noisy and may need a new fan motor. Recommend evaluation by handyman and parts replacement if necessary.

Contact a qualified professional.

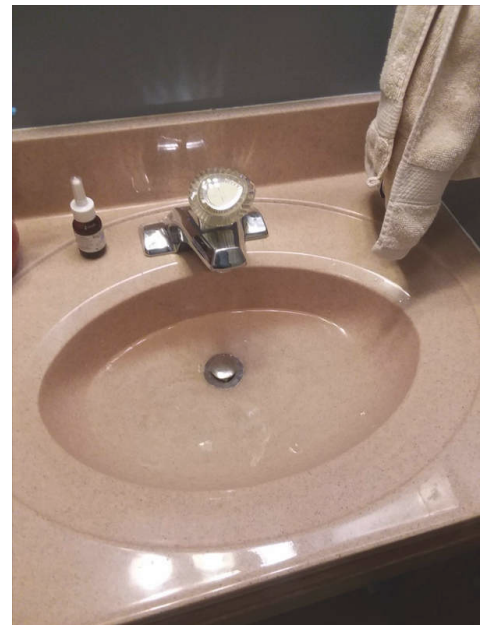
Vanity is draining very slowly. Recommend evaluating the clog and clearing the obstruction.

Slow Drain

Contact a handyman or DIY project

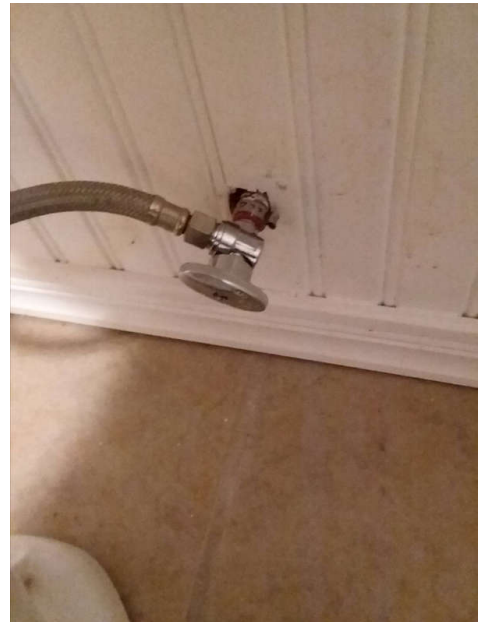
Toilet fills very slowly. Valve is on and hose is not kinked. Recommend qualified plumber evaluate and remedy.

Contact a qualified professional.

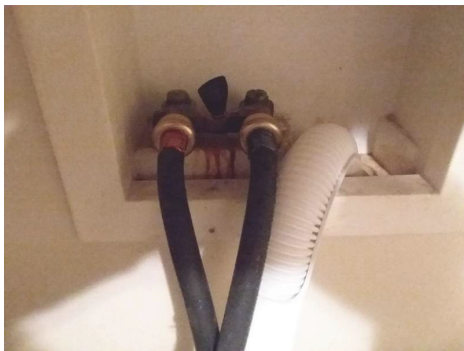
Above wash machine

Slight corrosion. Recommend handyman remove hoses, clean corrosion and reassemble.

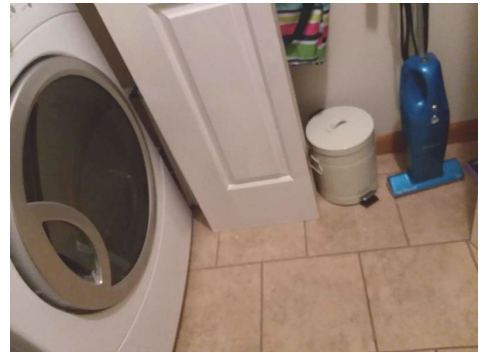
19.1.1 Bifold Doors

Bifold doors not properly installed. Recommend remove the doors, raise floor brackets up to top of floor surface, reinstall doors

Contact a handyman or DIY project

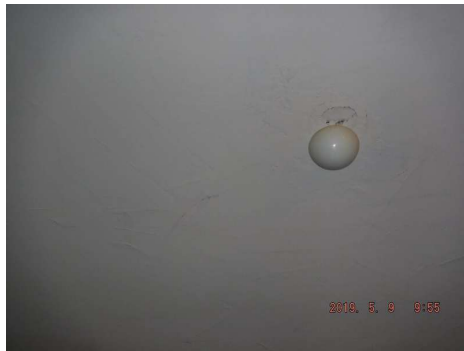
Damaged drywall is evident near garage-to-house entry at the door stop. Recommend a handyman remove stop bumper, repair and paint.

Wall Repair Needed

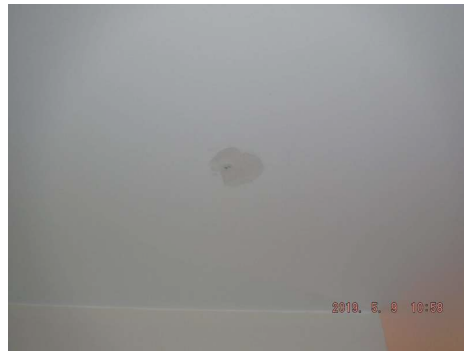
A ceiling blemish exists near the front door. It appears to be merely a poor repair drywall damaged from below. Recommend a handyman repair and paint.

Ceiling Repair Needed

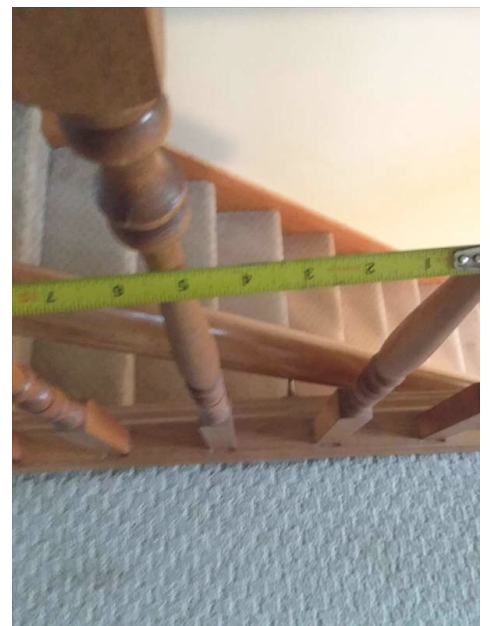
The baluster space is not up to modern building codes and safety standards. The space between balusters should not allow passage of a 4 inch sphere for child safety. Recommend a qualified handyman or original installer repair and bring up to code.

Contact a qualified handyman.

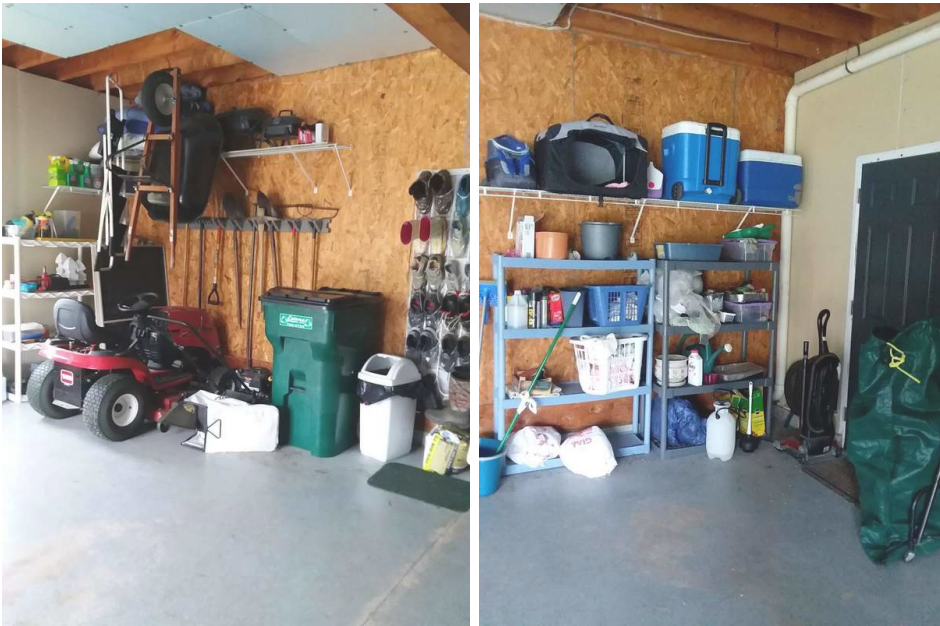
Firewall separating the home and garage is not compliant with modern building codes and standards. Firewalls should be built with materials to delay fire spreading into the living space. This is mainly fire-code drywall and a fire-resistant door. The drywall is not present. The door is acceptable with the addition of self-closing hinges or closer. Recommend a qualified contractor evaluate and bring firewall up to standards.

Contact a qualified professional.
