HOMEOLGY INSPECTIONS LLC

HOMEOLGY - INTERNACHI RESIDENTIAL

1234 Main St.
Kansas City MO 64151

Buyer Name
06/10/2018 9:00AM

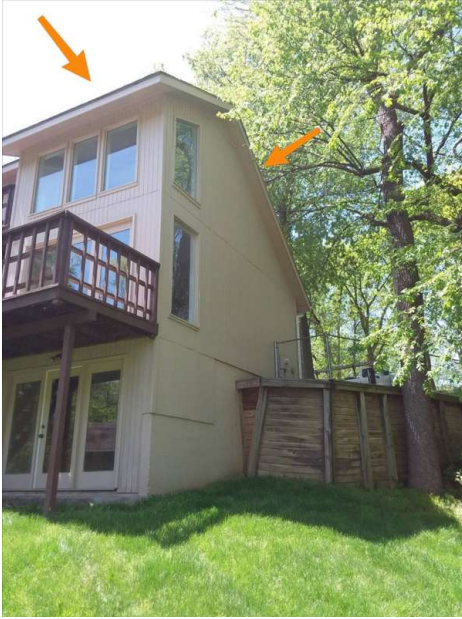
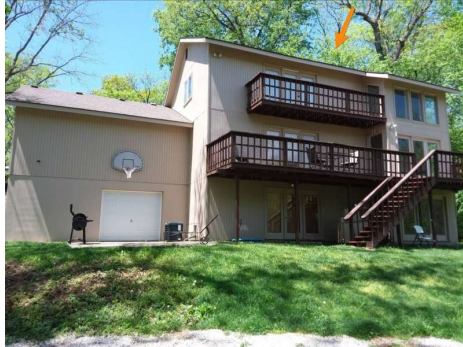
Limited Inspection- Safety

The Inspector was unable to safely walk the roof due to its steep slope and inspected the roof-covering materials and components from a ladder and from the ground. Not all portions of the roof were visible. A full roof inspection will require special equipment, the use of which exceeds the scope of the General Home Inspection. If you wish to have a more detailed roof inspection, the Inspector recommends that before the expiration of your Inspection Objection deadline, you hire a qualified roofing contractor with the equipment required to safely access the entire roof.

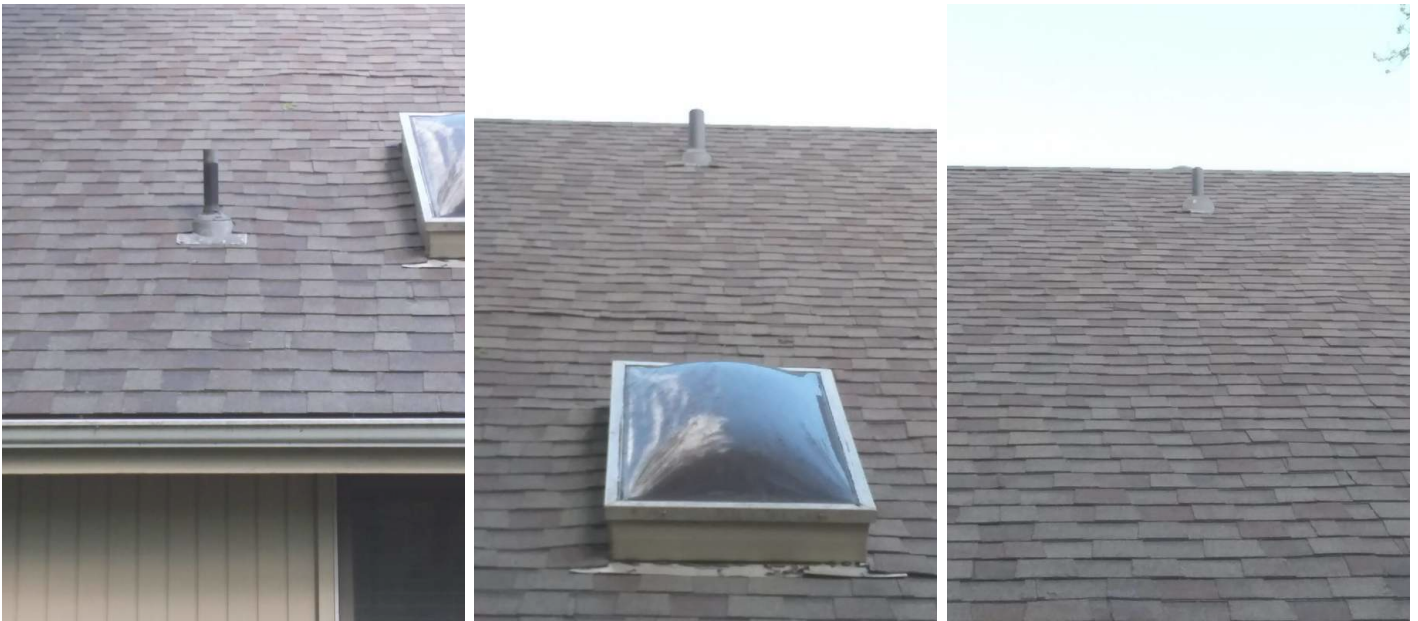
Other Roof Penetrations: Appear to be ok

Due to the limited accessibility The visible roof penetrations appeared to be in good functional condition. If you wish to have a more detailed roof inspection, the Inspector recommends that before the expiration of your Inspection Objection deadline, you hire a qualified roofing contractor with the equipment required to safely access the entire roof.

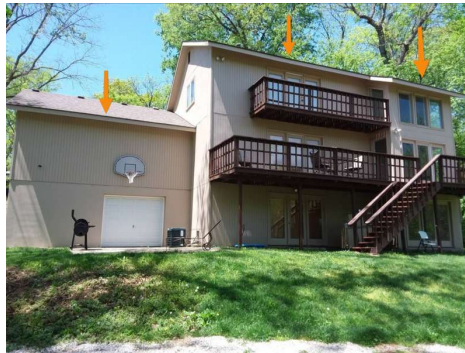
NO ROOF DRAINAGE SYSTEM

The home had no roof drainage system installed to channel roof drainage away from the foundation. This condition can result in excessively high moisture levels in soil at the foundation. Excessively high moisture levels in soil near the foundation can reduce the ability of the soil to support the weight of the home structure. The Inspector recommends installation of a roof drainage system to discharge roof drainage away from soil near the foundation.

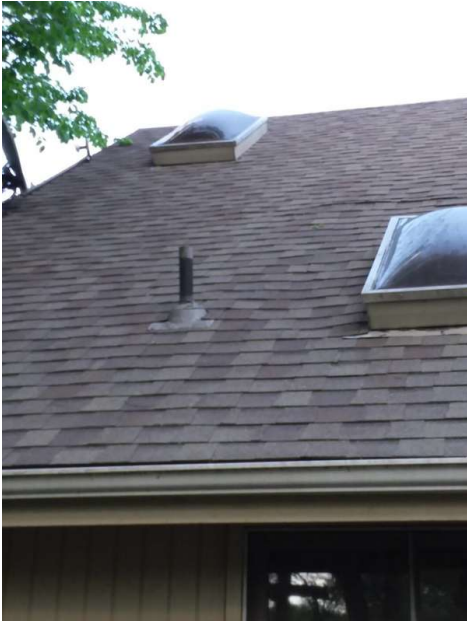
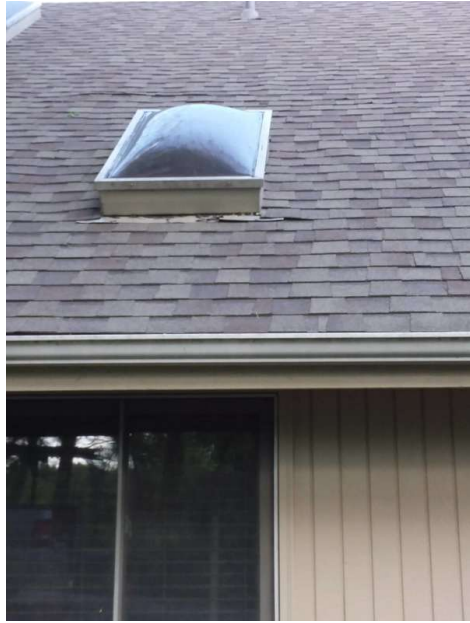
Skylights (exterior)

APPEARED TO BE OK

Due to the limited accessibility the visible skylights appeared to be in good functional condition. If you wish to have a more detailed roof inspection, the Inspector recommends that before the expiration of your Inspection Objection deadline, you hire a qualified roofing contractor with the equipment required to safely access the entire roof.

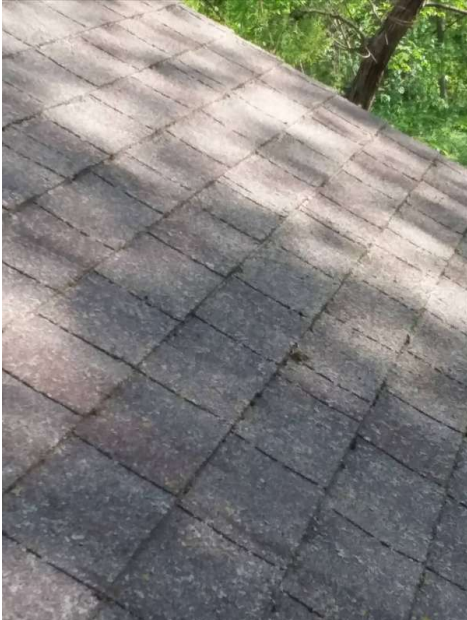
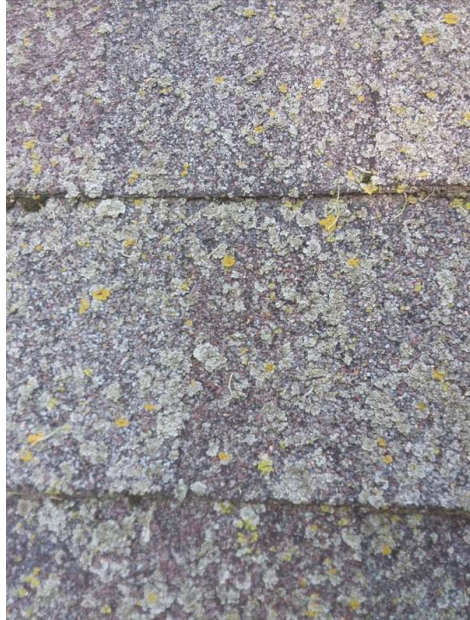
2.1.1 Coverings

Above garages front

Contact a qualified roofing professional.

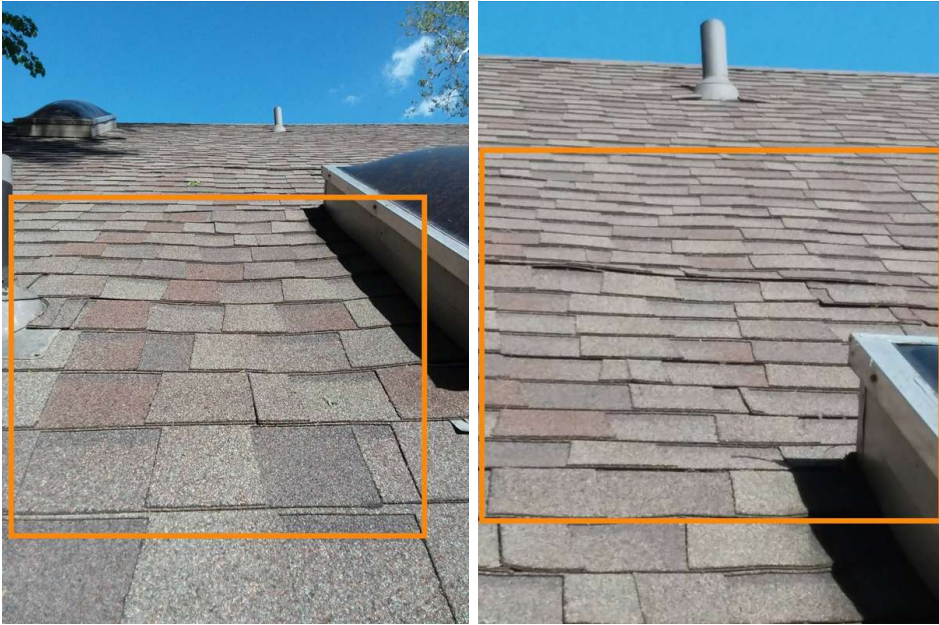
At the time of inspection one or more areas of the roof shingles appeared to be wavy. Recommend further evaluation by qualified roofing contractor.

Contact a qualified roofing professional.

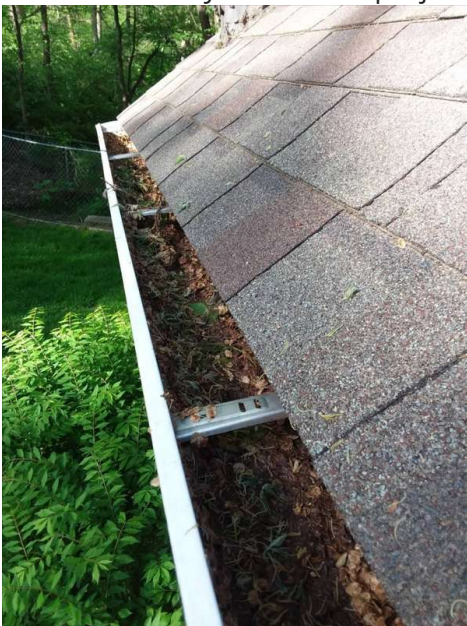
2.3.1 Roof Drainage Systems

Debris has accumulated in the gutters. Recommend cleaning to facilitate water flow.

front

Contact a handyman or DIY project

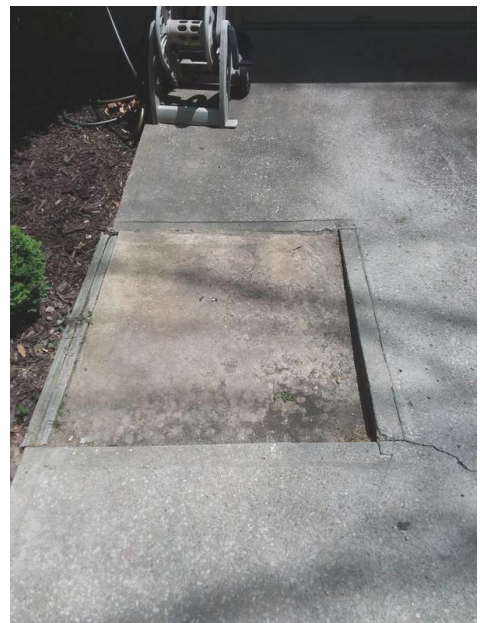
Drive has an area that was filled in at some point and has created a tripping hazard. Recommend leveling with the rest of the drive way to eliminate tripping hazard.

Contact a handyman or DIY project

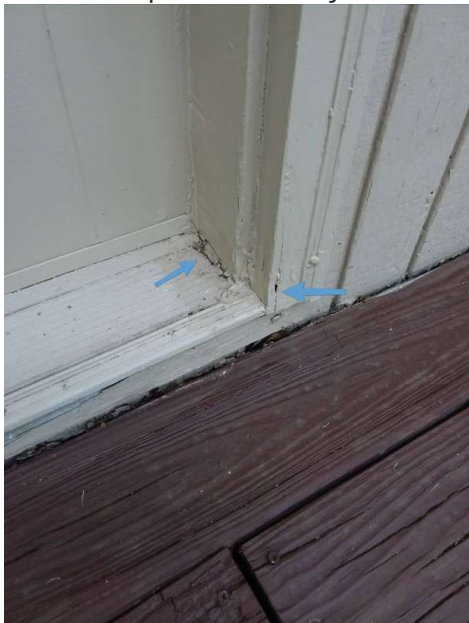
3.7.1 Exterior Doors

Sealant around doors was old, discolored, cracked or missing, and needed general maintenance to avoid potential moisture intrusion. Recommend maintenance be performed by a qualified contractor or possibly a handyman.

Exterior door at top deck

Contact a qualified handyman.

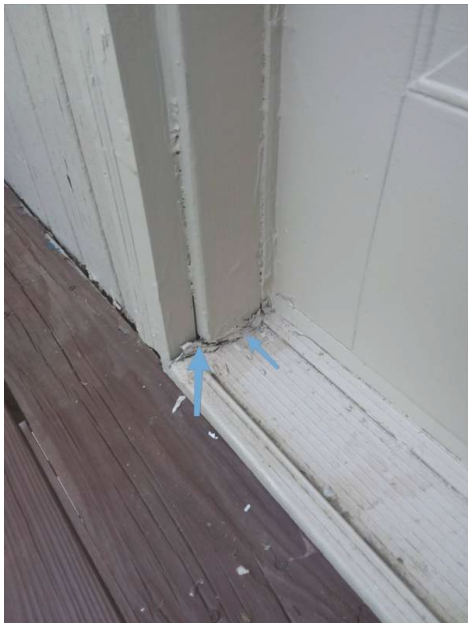
Exterior door at top deck

One or more exterior doors had thresholds that were not supported. This can lead to the deterioration and functionality of this part of the door. Recommend adding support to the entire threshold. This should be a DIY/Handyman issue.

Contact a handyman or DIY project

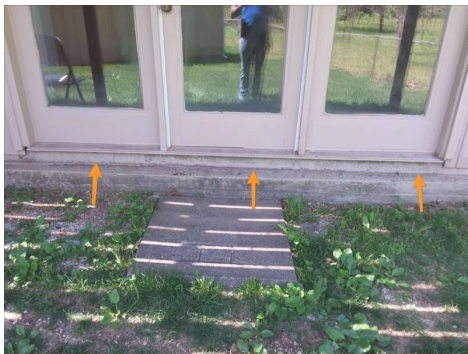
Lower level back door

One or more sections of exterior door trim appeared to have had previous water damage and had been repaired. Recommend monitoring and repair/replace when needed.

Recommend monitoring.

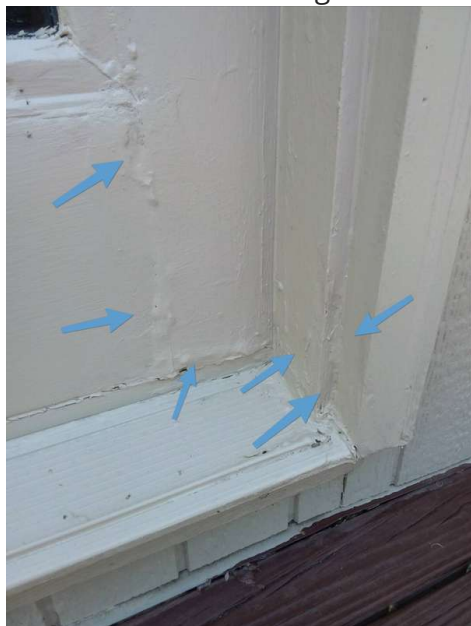
At main deck

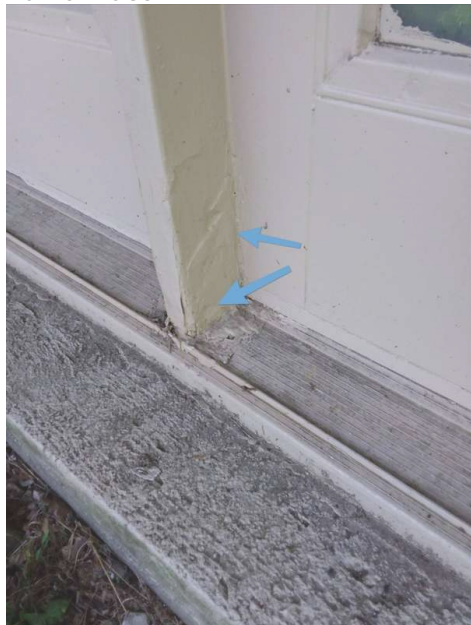
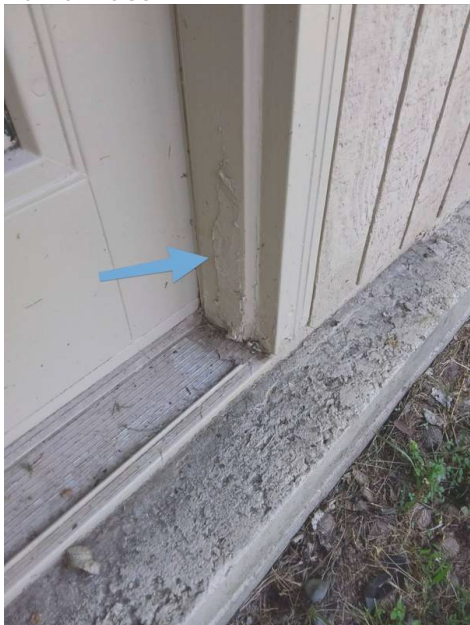
Sealant around windows was old, discolored, cracked or missing, and needed general maintenance to avoid potential moisture intrusion. Recommend maintenance be performed by a qualified contractor or possibly a handyman.

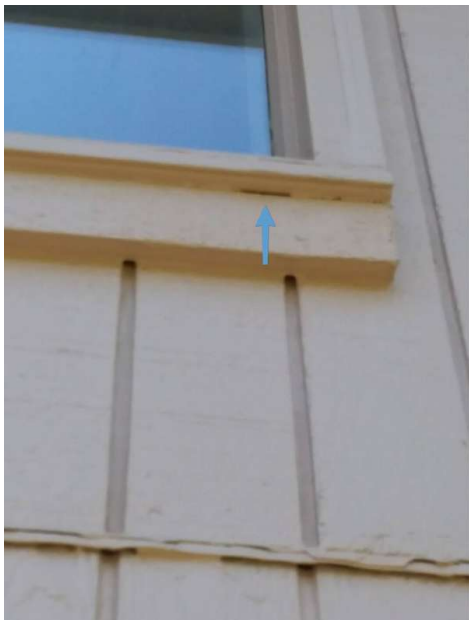
Main deck right side

Contact a handyman or DIY project

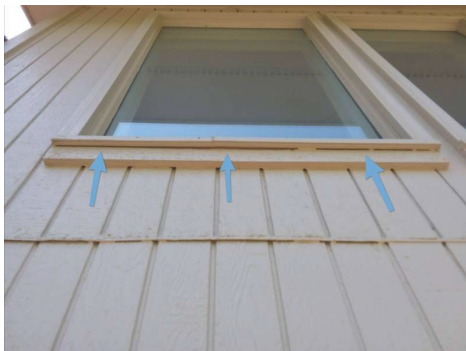
Main deck right side

One or more sections of exterior window trim appeared to have had previous water damage and had been repaired. Recommend monitoring and repair/replace when needed.

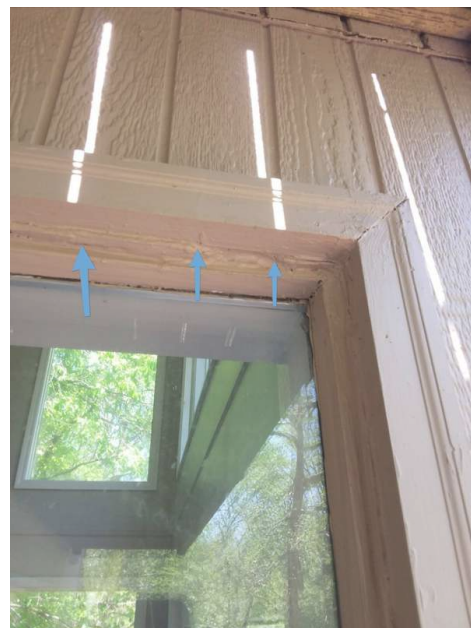
Middle deck area

Contact a handyman or DIY project

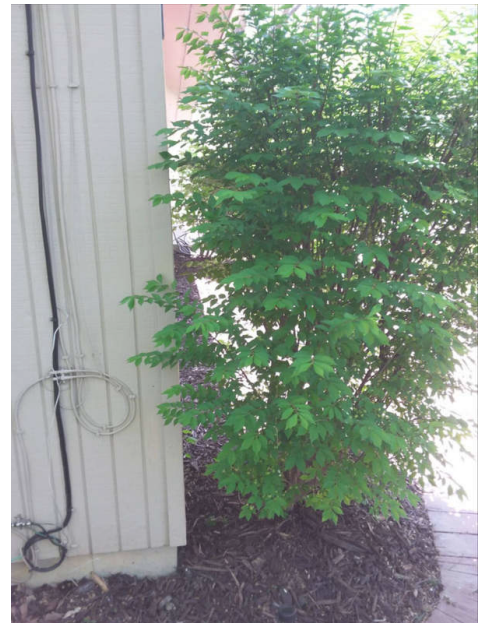
At the time of inspection, overgrown bushes/shrubs were in contact with one or more exterior areas of the home. Vegetation too close to the structure can potentially cause damage through moisture retention/intrusion which can lead to decay, rot, and or wood destroying insects. Recommend evaluation by a qualified Landscape contractor to remedy. Shrubs and bushes should be trimmed back 18 inches from structure.

By front door

Contact a handyman or DIY project

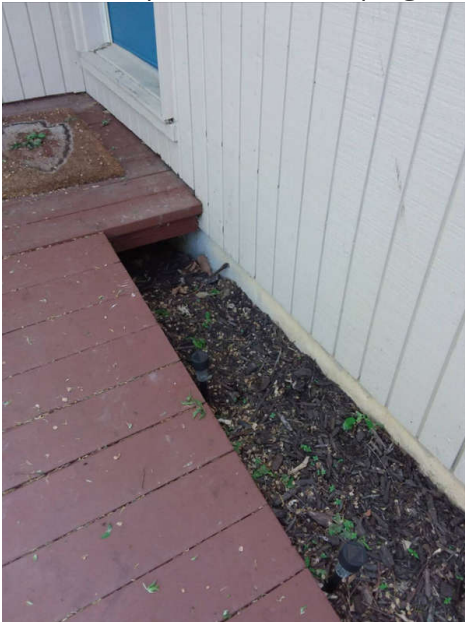
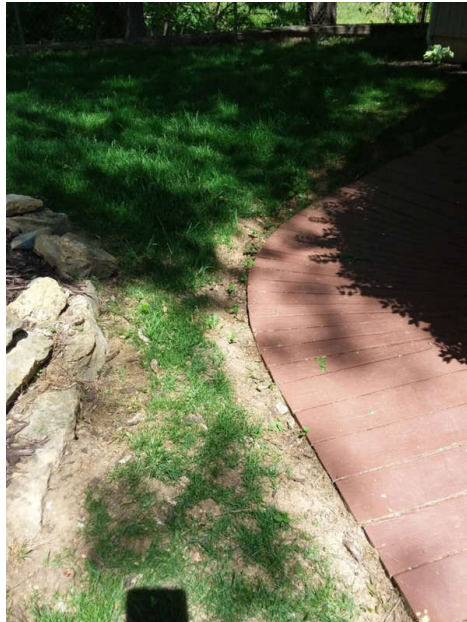
3.11.1 Grading and Drainage

Grading is sloping towards the home in some areas. This could lead to water intrusion and foundation issues. Recommend qualified landscaper or foundation contractor regrade so water flows away from home.

Left of front door

Contact a qualified landscaping contractor

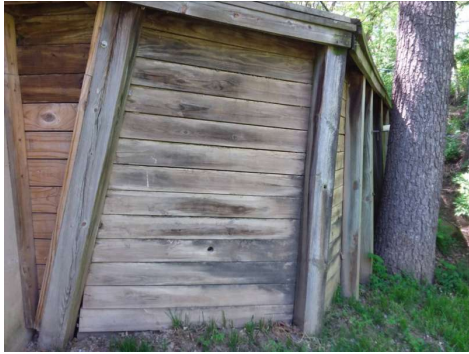
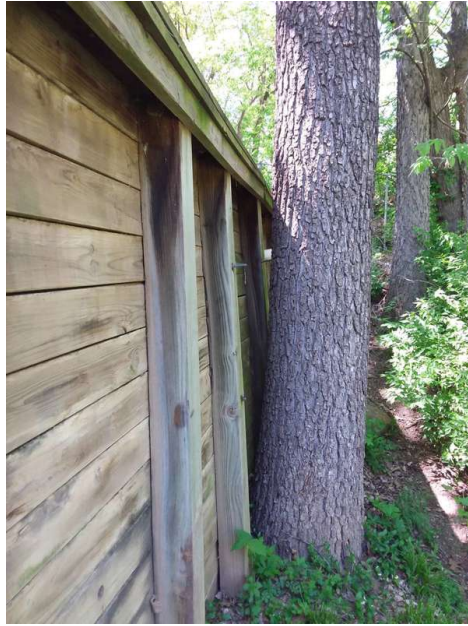
Treated wood was used to construct a significant retaining wall. Without the ability see both sides of the structure it is recommended that the structure be monitored for movement and deterioration. If these start to occur recommend further evaluation by structural engineer.

Recommend monitoring.

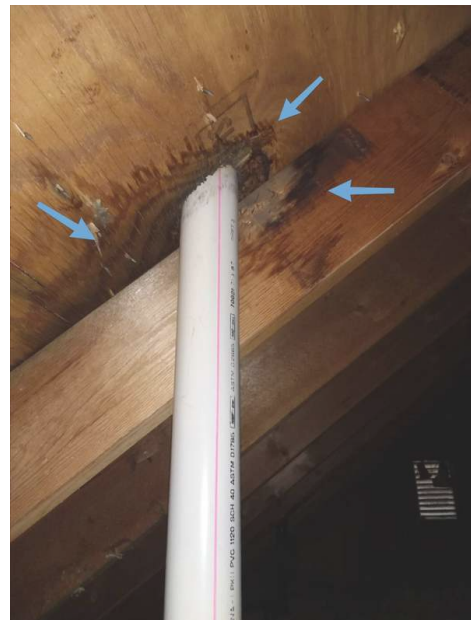
4.4.1 Roof & Ceiling Structure (attic)

Minor/Maintenance Item**EVIDENCE OF PREVIOUS MOISTURE INTRUSION**

Recommend monitoring.

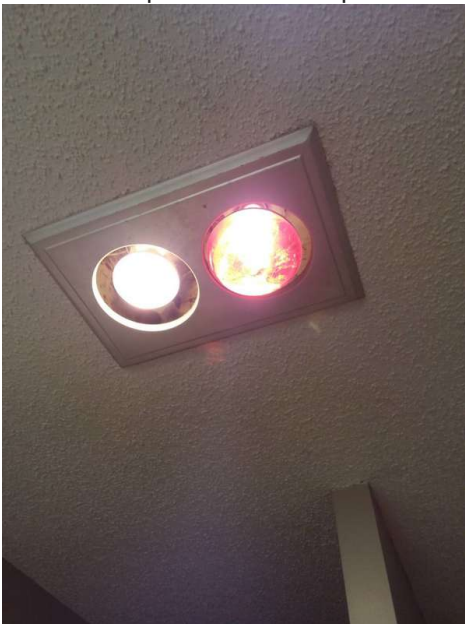
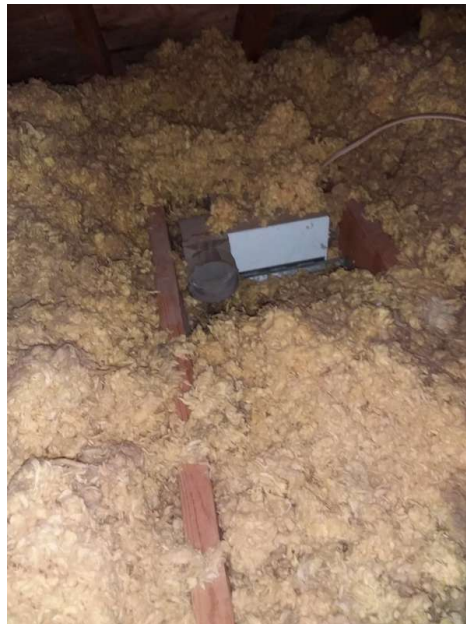
5.3.1 Exhaust Systems

BATHROOM VENTS INTO ATTIC

Contact a qualified HVAC professional.

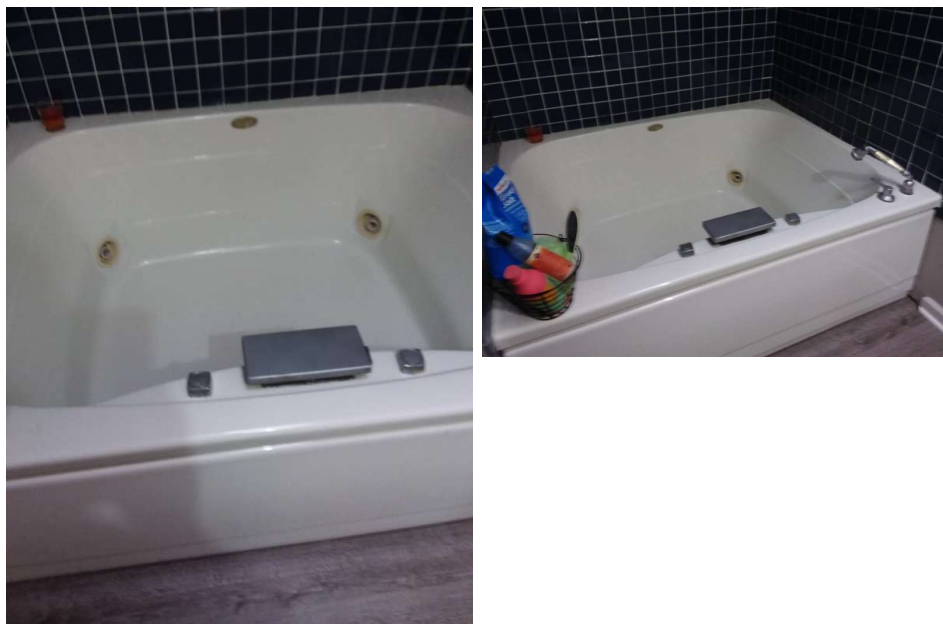
Due to the location, age, controls, the inability to see tub drain, was not filled and tested. However, the tub does activate the jets when turned on with the timer switch

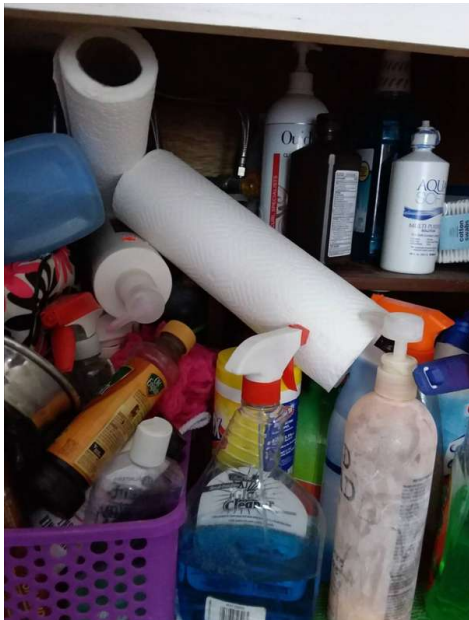
Third Floor

Vanity drains could not be inspected. Recommend having home owner remove belongings to inspect drains.

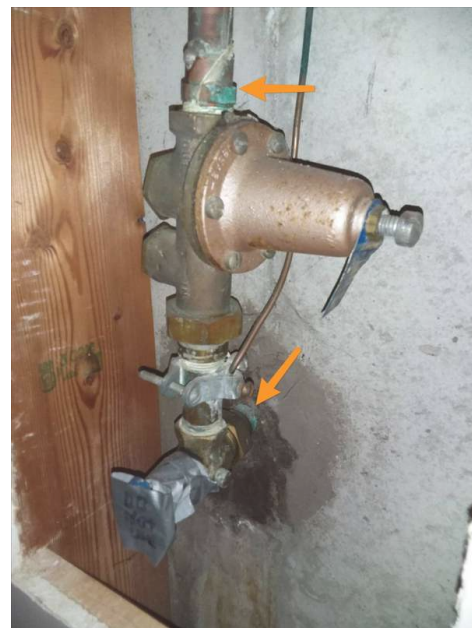
8.2.1 Water Supply, Distribution Systems & Fixtures

CORRODED DISTRIBUTION LINE- PAST LEAKAGE

Water distribution pipes were corroded and showed signs of past leakage. Monitor the pipes on a regular basis to prevent future damage from active leaking. To avoid problems in the future you may wish to have the corroded sections replaced by a qualified contractor.

Recommend monitoring.

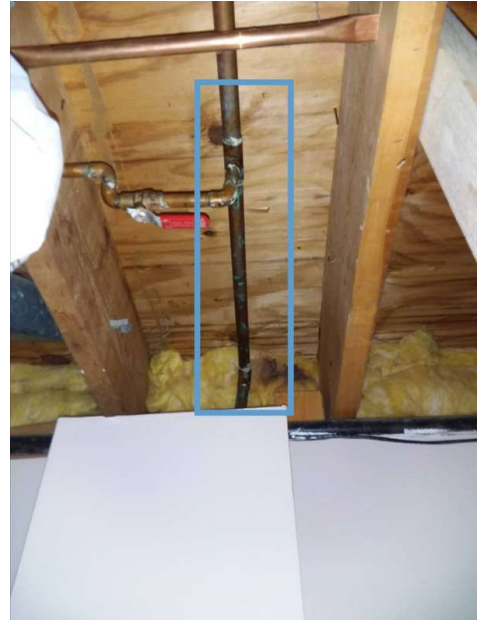
8.2.2 Water Supply, Distribution Systems & Fixtures

INADEQUATE FLOW

Plumbing fixture exhibited insufficient flow. The Inspector recommends that before the expiration of your Inspection Objection Deadline you consult with a qualified contractor to discuss options and costs for correction.

Contact a qualified plumbing contractor.

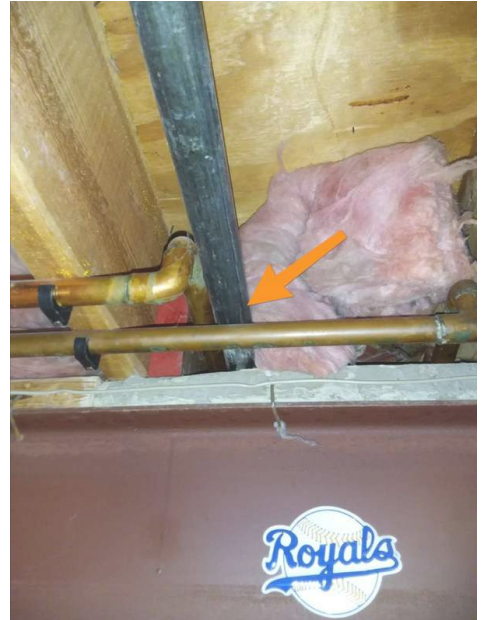
8.2.3 Water Supply, Distribution Systems & Fixtures

Above furnace room Basement

Contact a qualified plumbing contractor.

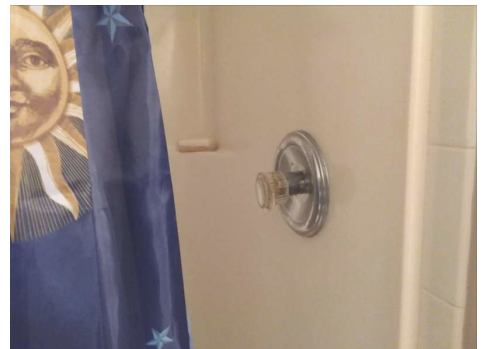
Basement shower

At the time of inspection, one or more plumbing fixtures were installed with the hot and cold backwards. This is not a problem but rather a condition to get used to due to not being a plumbing standard.

Contact a qualified professional.

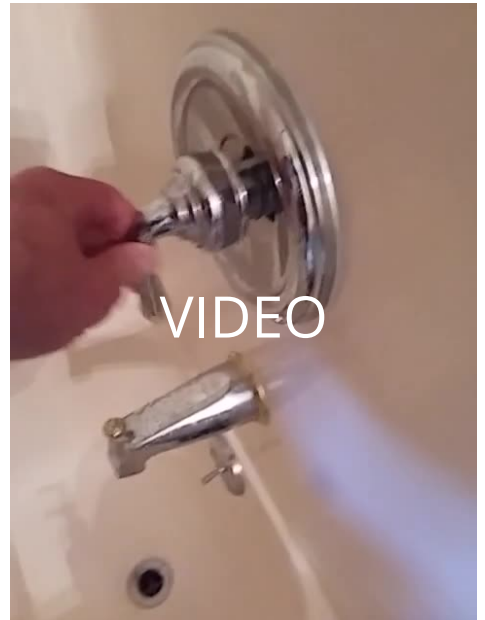
8.2.7 Water Supply, Distribution Systems &
Fixtures

LOOSE HANDLE

At the time of inspection one or more plumbing fixtures had loose handles. Recommend tightening the handle to keep it from falling off. If unable to tighten, recommend further evaluation by qualified plumbing contractor. This should be a handyman issue.

Contact a handyman or DIY project

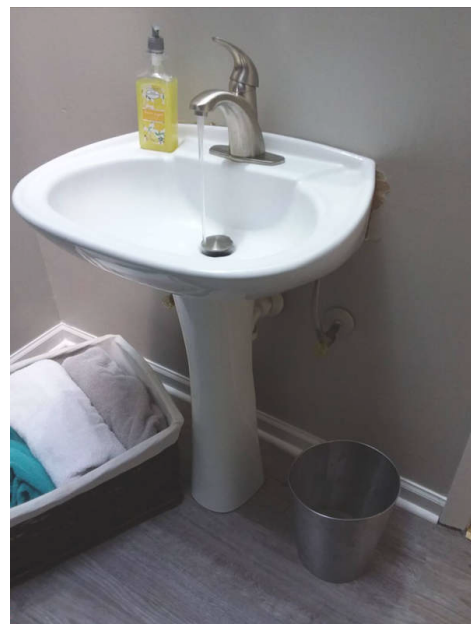
Third floor bath

At the time of inspection the hot water flow at one or more of the bathroom sinks appeared to be weak. Recommend further evaluation by qualified plumbing contractor.

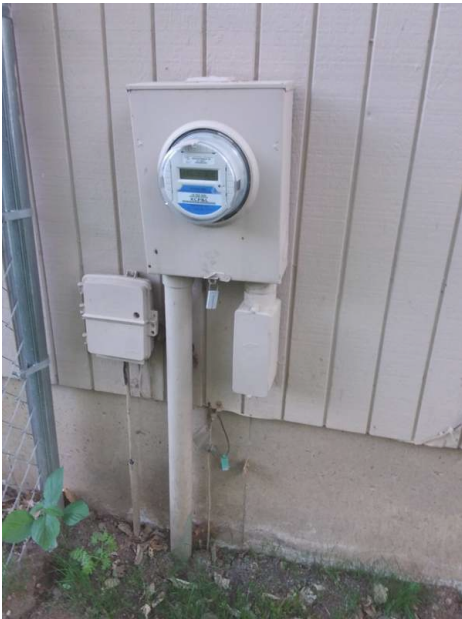
Service Entrance Conductors: Attached to Exterior- OK

The overhead service-drop conductors attached directly to the home exterior. Although this is an outdated practice, the Inspector observed no deficiencies in the condition of the attachment at the time of the inspection.

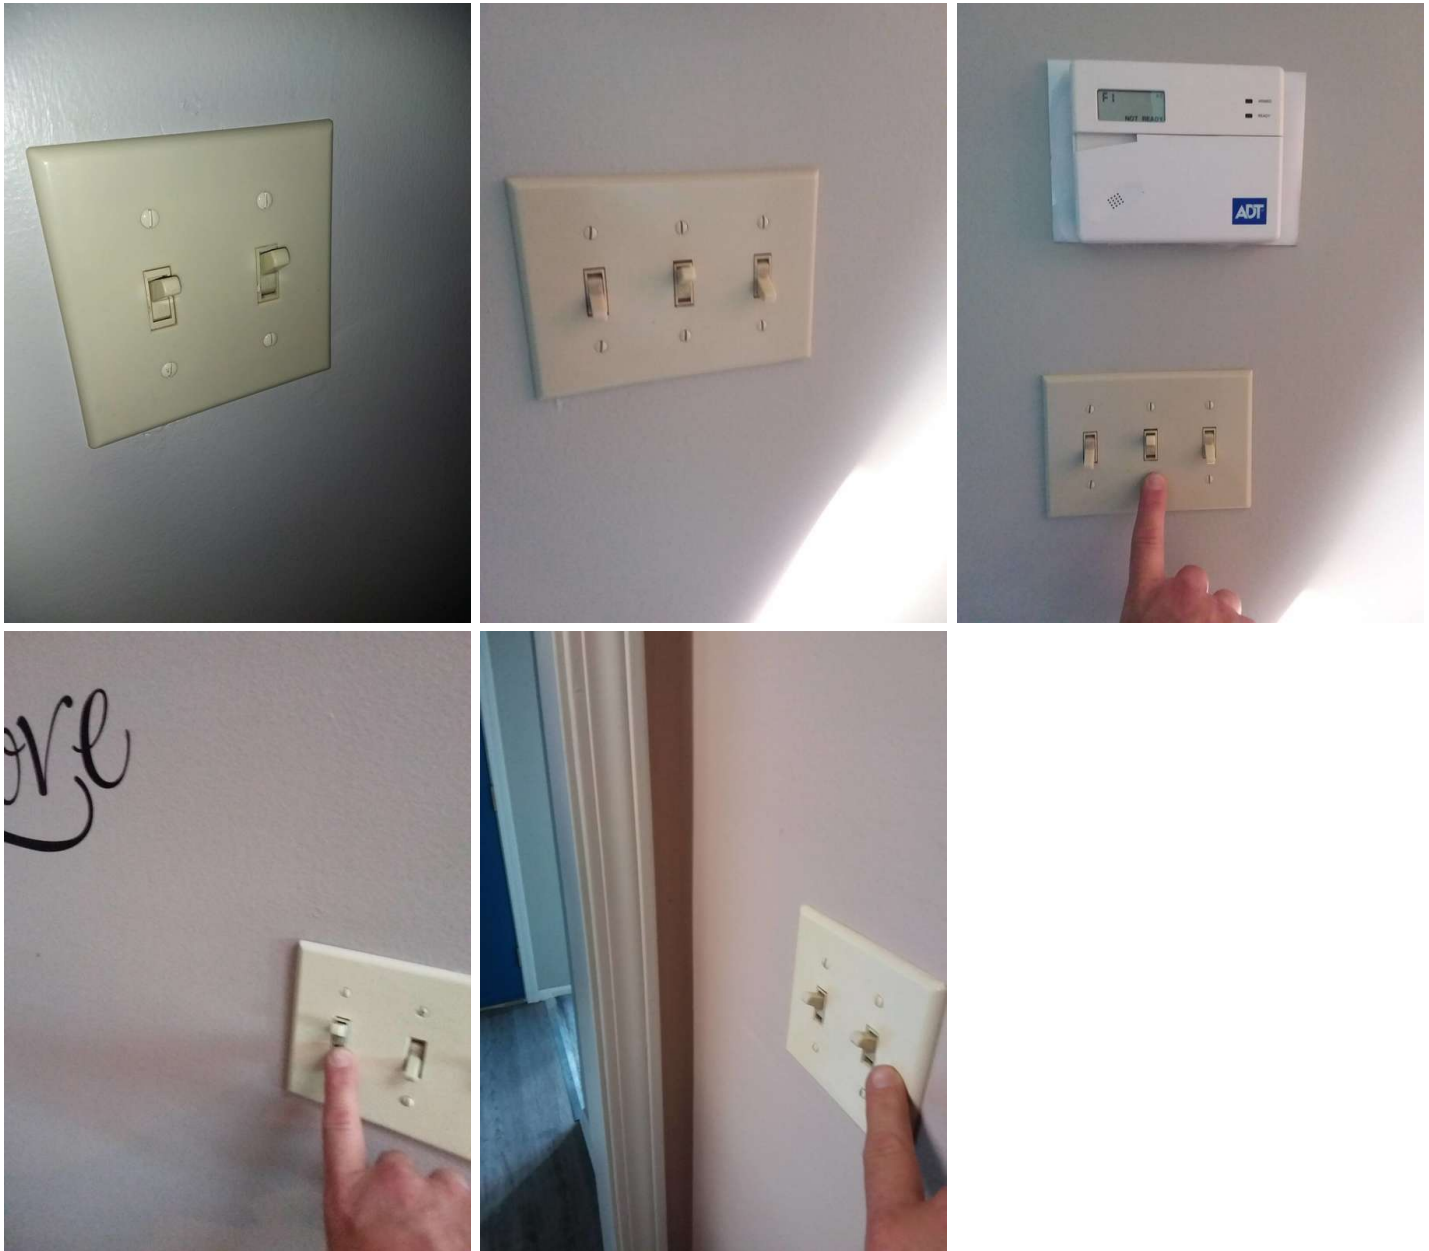
BASEMENT BEDROOM

The inspector was unable to determine what device is controlled by a switch. Recommend that you ask the seller about its function.

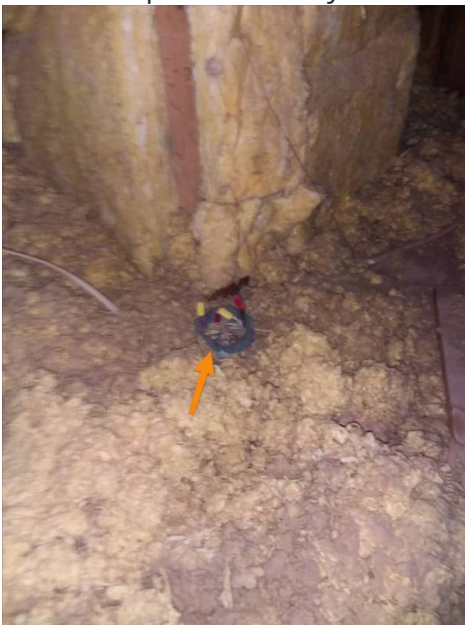
9.3.1 Branch Wiring, Circuits, Breakers & Fuses

⚠ Significant and/or Safety Concern

Attic

Contact a qualified handyman.

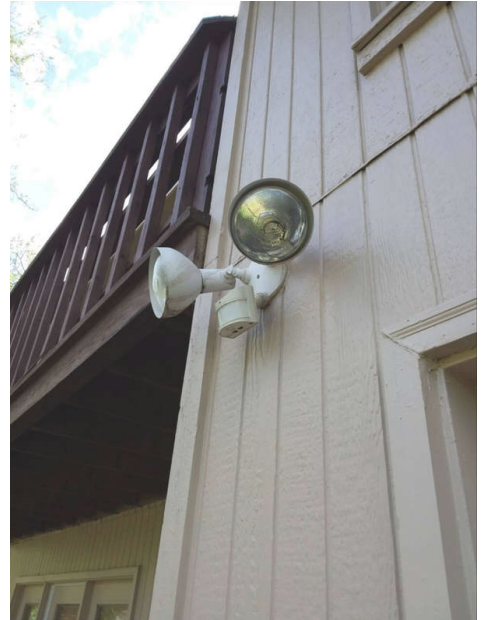
9.4.2 Lighting Fixtures, Switches & Receptacles

HOT-NEUTRAL REVERSED RECEPTACLE

An electrical receptacle had hot and neutral wires reversed. This condition should be corrected by a qualified electrical contractor

Contact a qualified electrical contractor.
