INSPEX HOME INSPECTIONS
Office: 725-605-5888 | Mobile: 725-222-1001
inspex@cox.net
<https://www.inspexgroup.com>

INSPECTION REPORT

1234 Main St.
Denver CO 80210

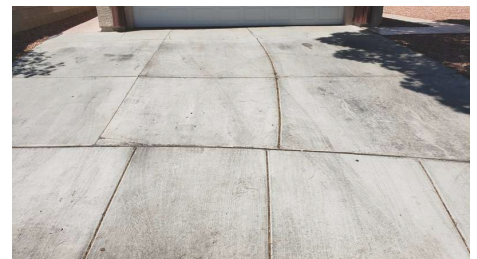
Walkway, Patios & Driveways: Driveway Photos

Walkway, Patios & Driveways: Driveway Surface
Concrete

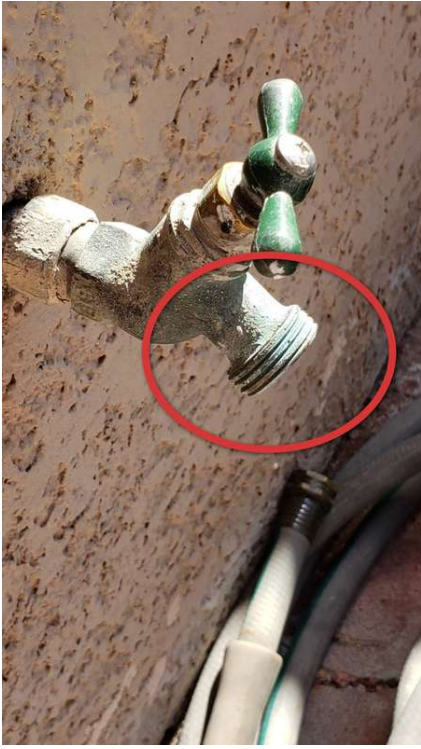
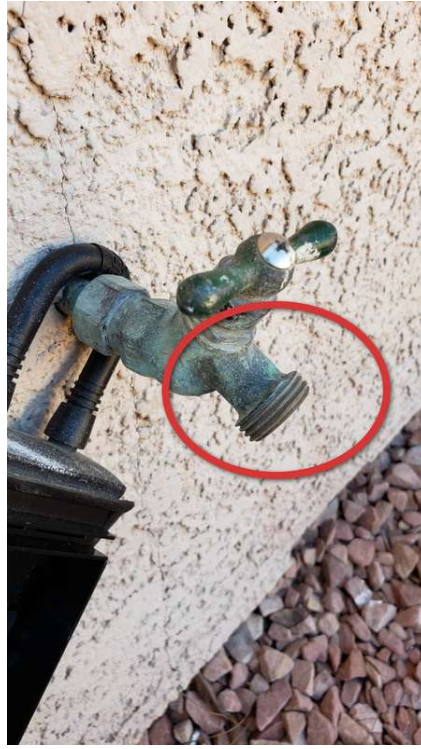
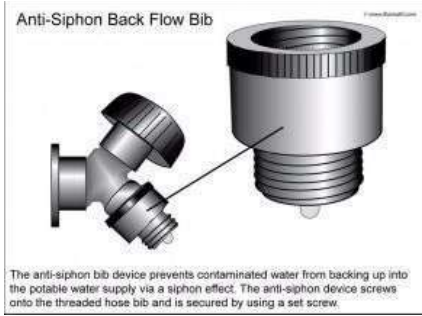
3.1.2 Exterior Issues

HOSE BIBB MISSING BACKFLOW PREVENTER

One or more hose bibs were missing backflow prevention devices. These devices reduce the likelihood of gray water entering the potable water supply. Recommend installing backflow prevention devices on all hose bibs where missing. They are available at most home improvement stores and are easily installed.

Contact a handyman or DIY project

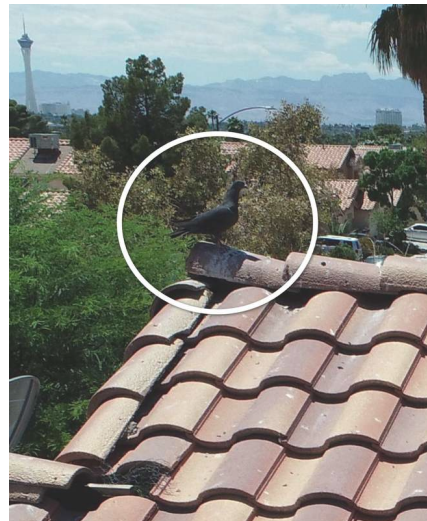
3.1.3 Exterior Issues

PIGEONS PRESENCE

There was evidence of pigeon gathering and droppings on the roof, windows trim and eaves. Recommend further review by a pest control person.

Contact a qualified pest control specialist.

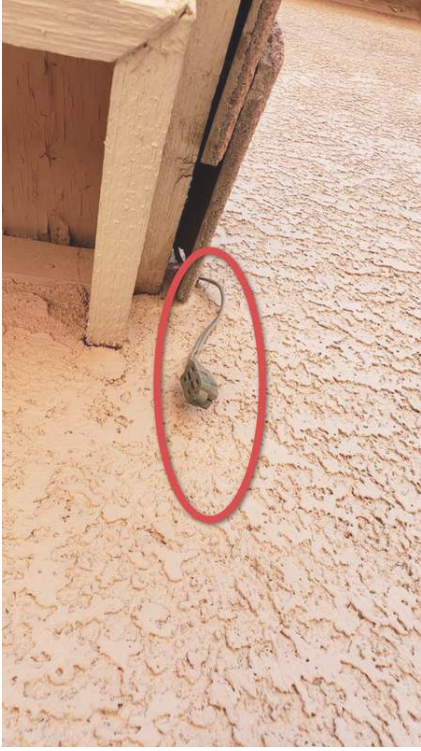
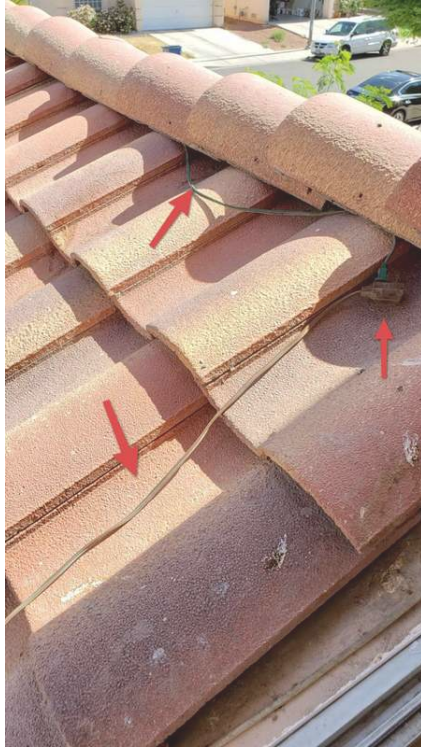
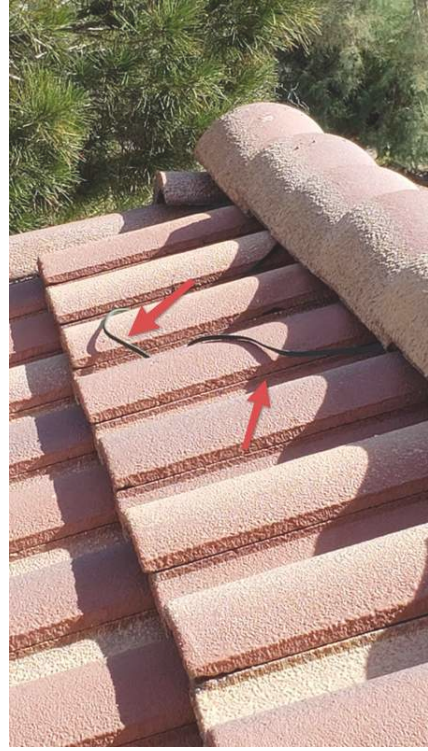
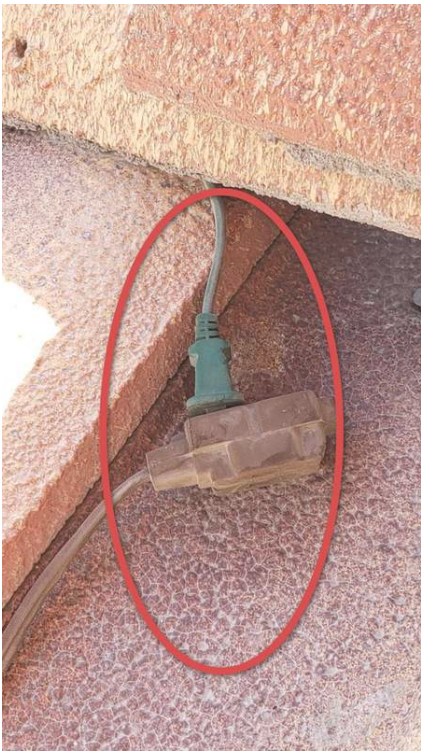
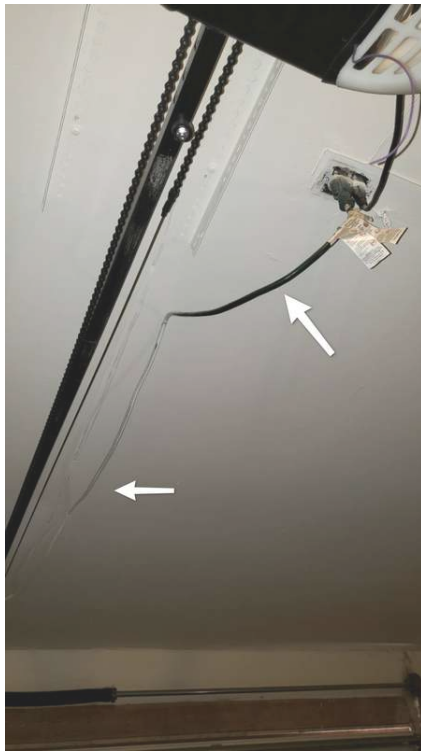
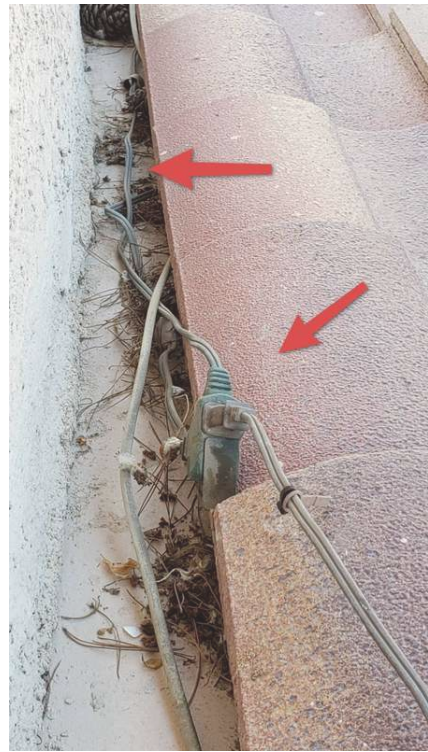
3.2.1 Electrical - Exterior

Extension cords seen used on the exterior of the home, this is not permitted by code standards. Recommend removing by a licensed electrician.

Contact a qualified electrical contractor.

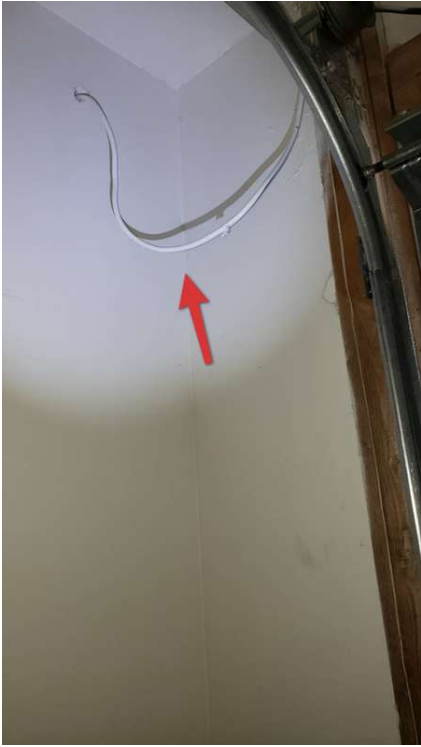
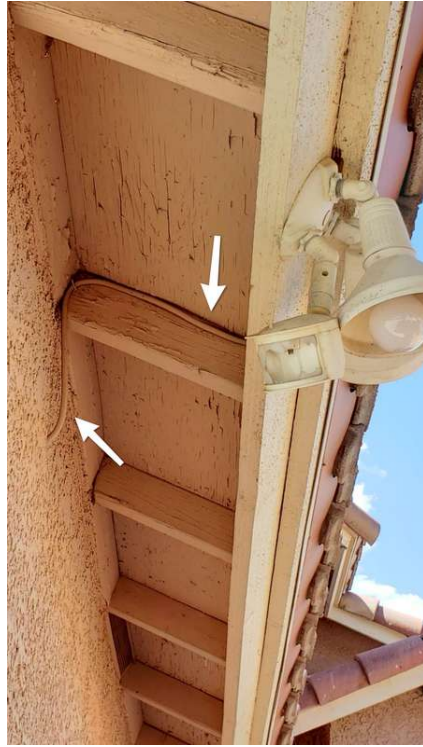
3.2.2 Electrical - Exterior

3.2.2 Exterior - Electrical - Exterior: Light Fixture Damaged / Deteriorated

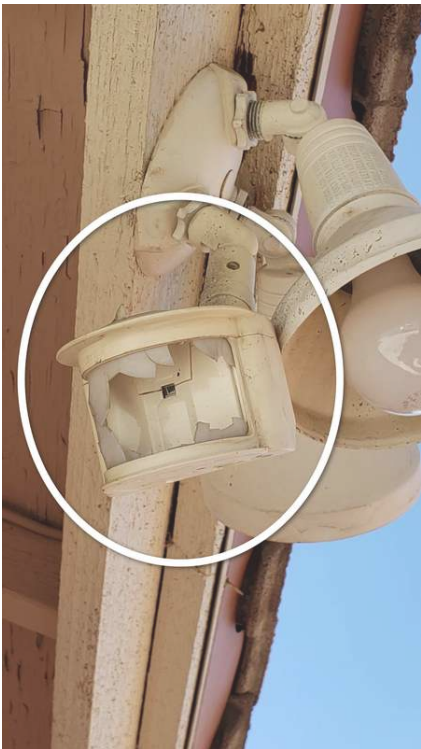
LIGHT FIXTURE DAMAGED / DETERIORATED

One or more light fixtures are damaged and/or deteriorated. A qualified electrician should evaluate and repair or replace where necessary.

Front - Right Side

Contact a qualified professional.

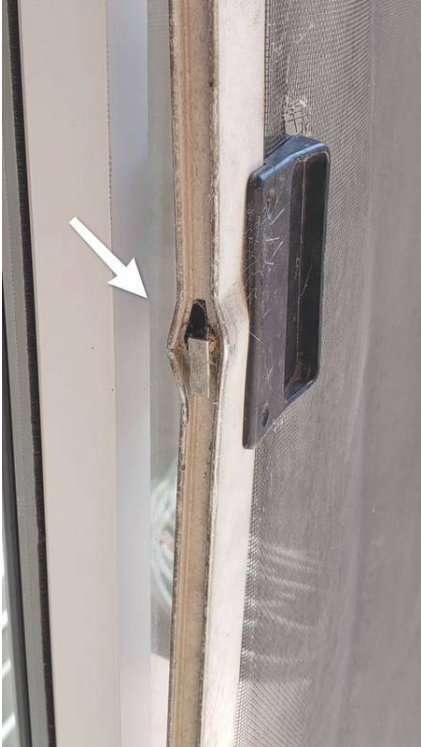
SCREENS MISSING OR DAMAGED

Screens were missing or damaged from one or more windows or doors. These windows may not provide ventilation during months when insects are active. On second story windows, these are also deterrents to keep small children from falling out of open windows during cooler temperatures. Recommend installing or repairing screens as necessary

Sliding Door to Patio

Contact a qualified window repair/installation contractor.

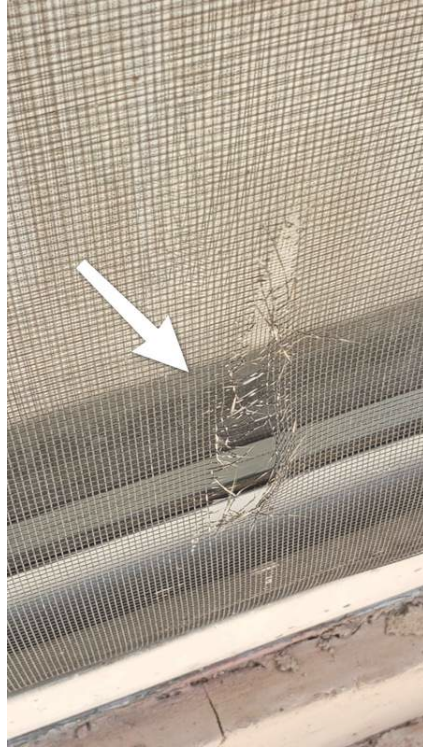
Sliding Door to Patio

3.6.1 Exterior - Exterior Windows: Screens Missing or Damaged
-

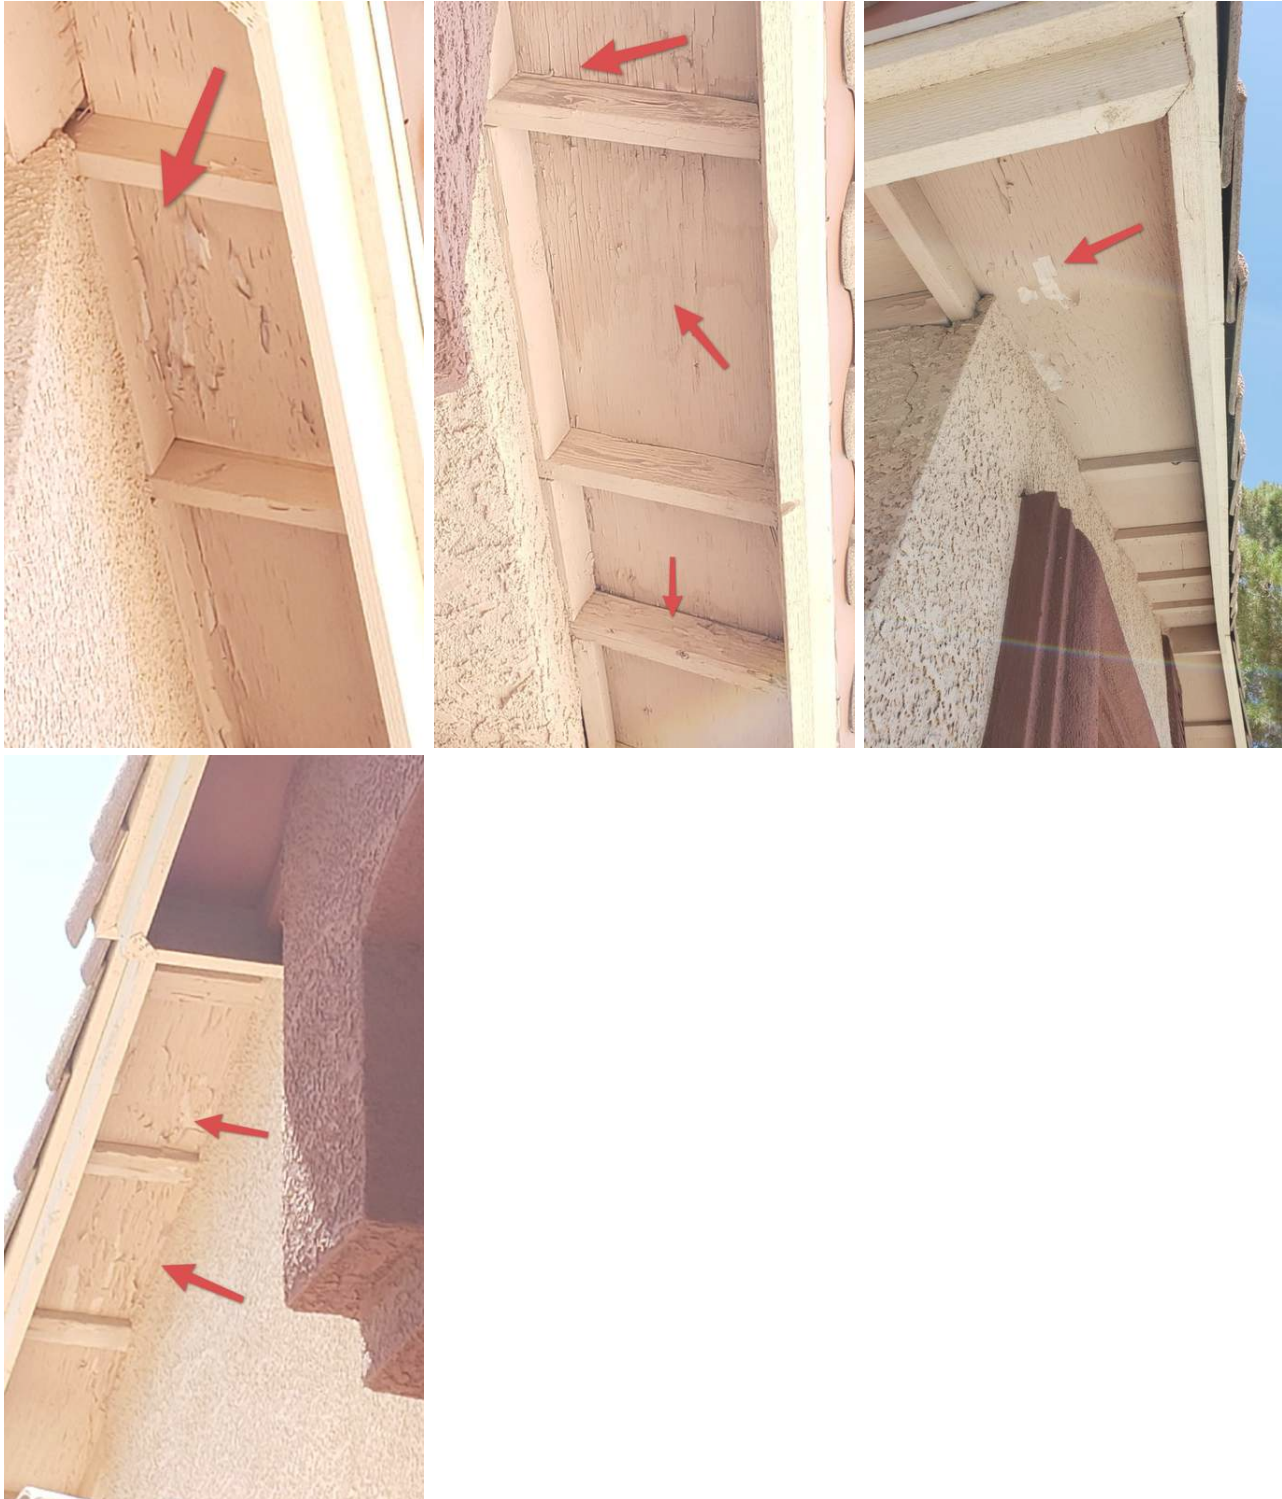
EAVE ROOF SHEATHING DETERIORATED

Eave roof sheathing at one or more areas was deteriorated and peeling paint was noted. Recommend repairs be made by a qualified contractor.

Contact a qualified general contractor.

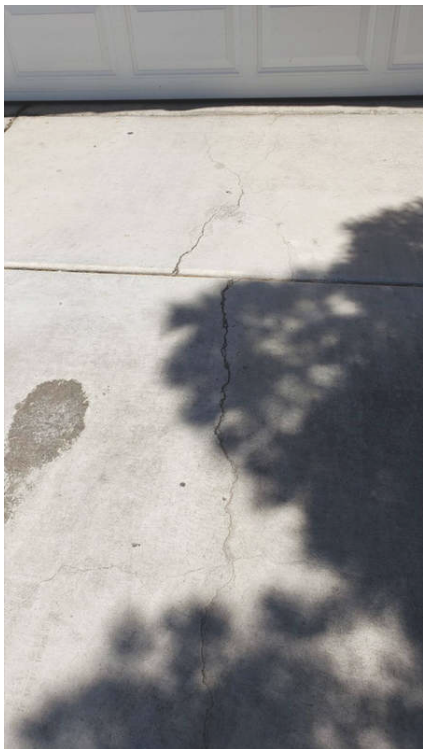
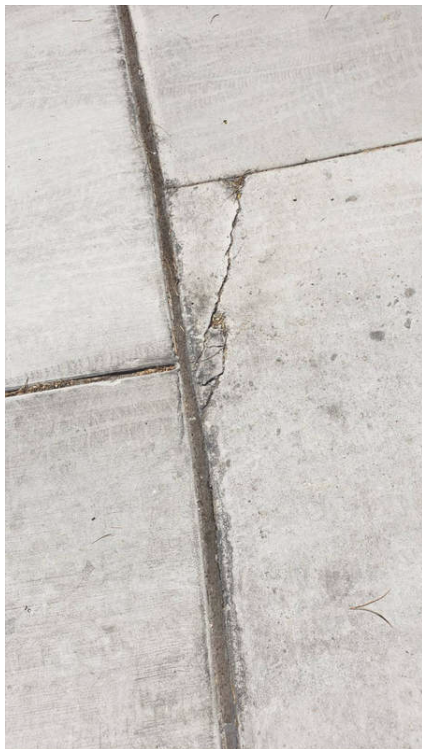
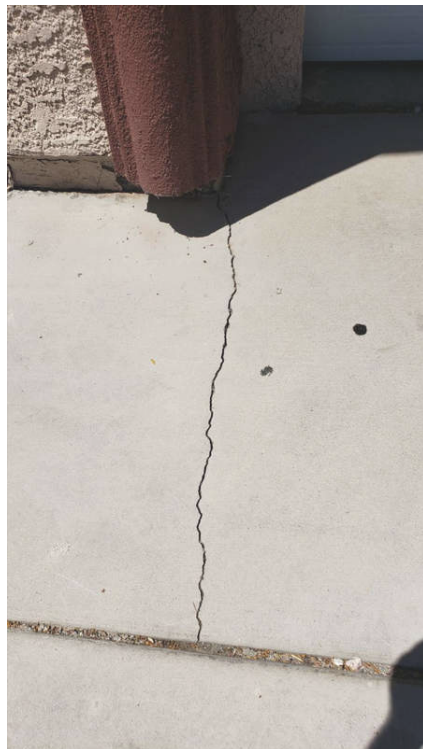
3.9.1 Walkway, Patios & Driveways

DRIVEWAY CRACKS / DETERIORATION - MONITOR

Minor deterioration (e.g. cracks, holes, settlement, heaving) was found in the driveway, but no trip hazards were found. The client may wish to have repairs made for cosmetic reasons.

Recommend monitoring.

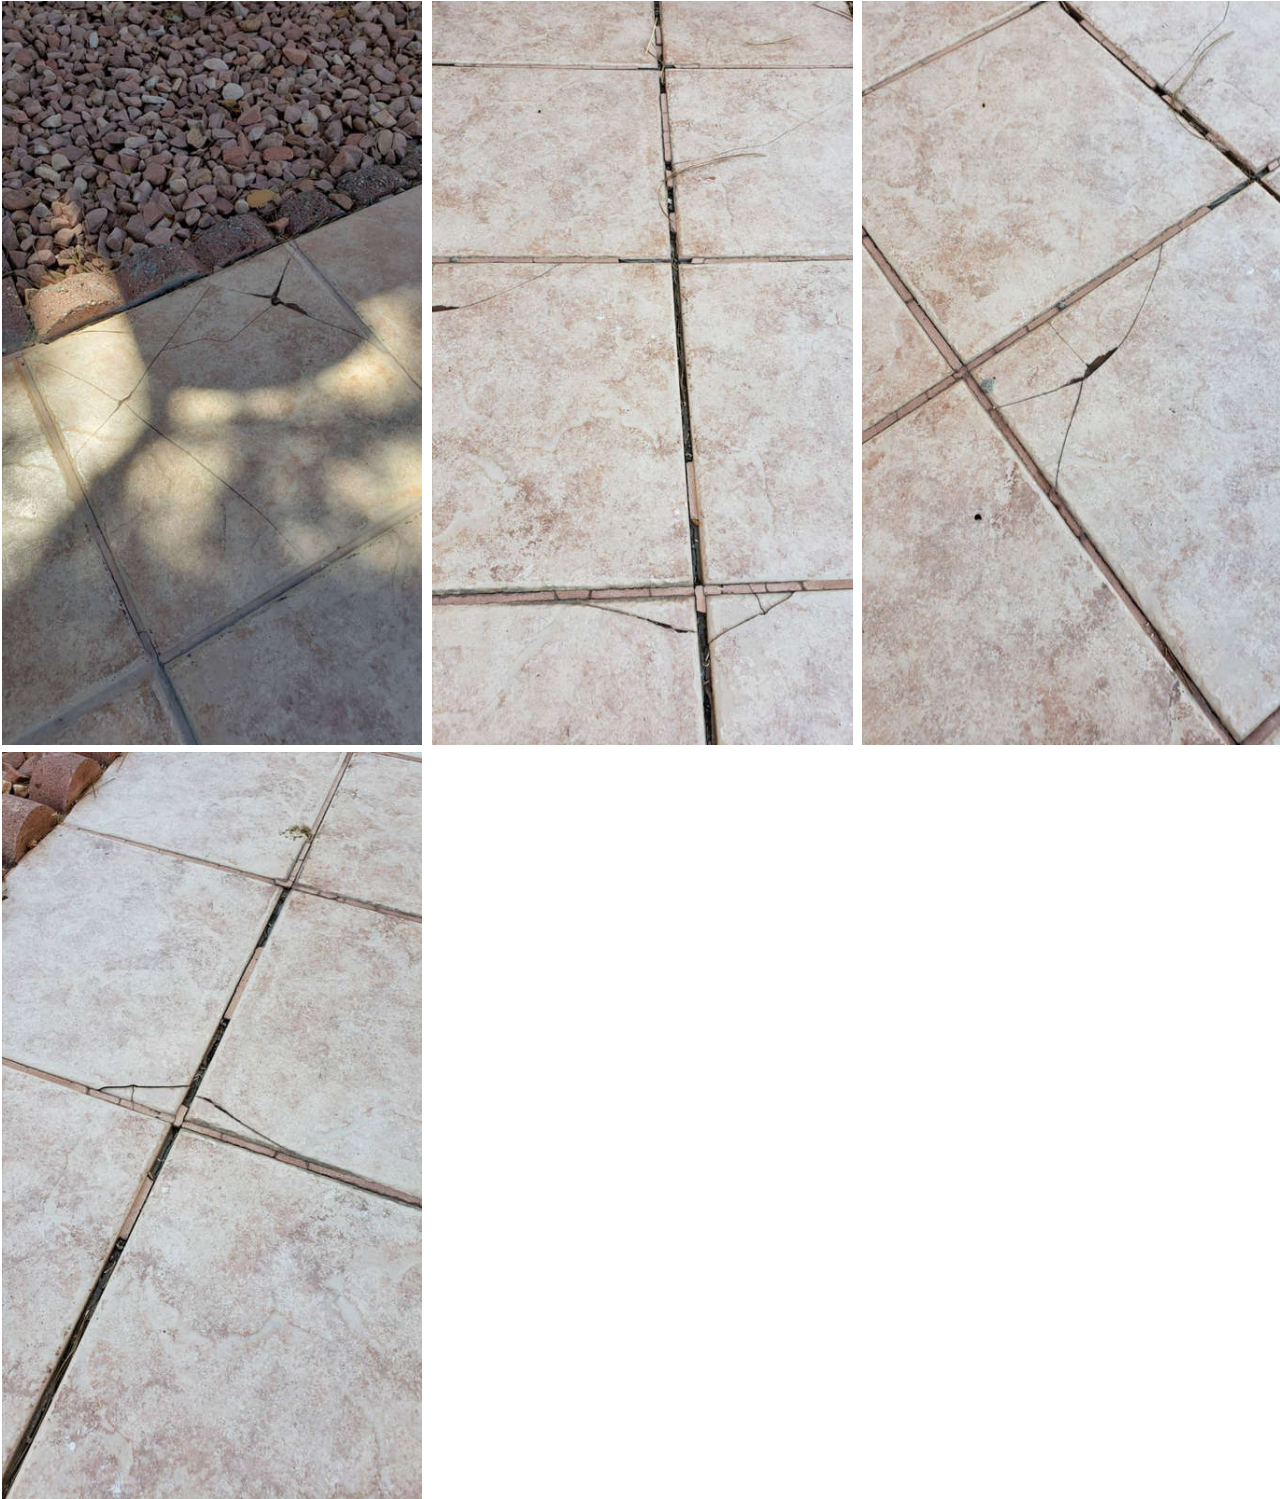
TILE CRACKS / GROUT DETERIORATION

Minor deterioration (e.g. tile cracks, holes, missing grout) was found in sidewalks, but no trip hazards were found. The client may wish to have repairs made for cosmetic reasons.

Recommend monitoring.

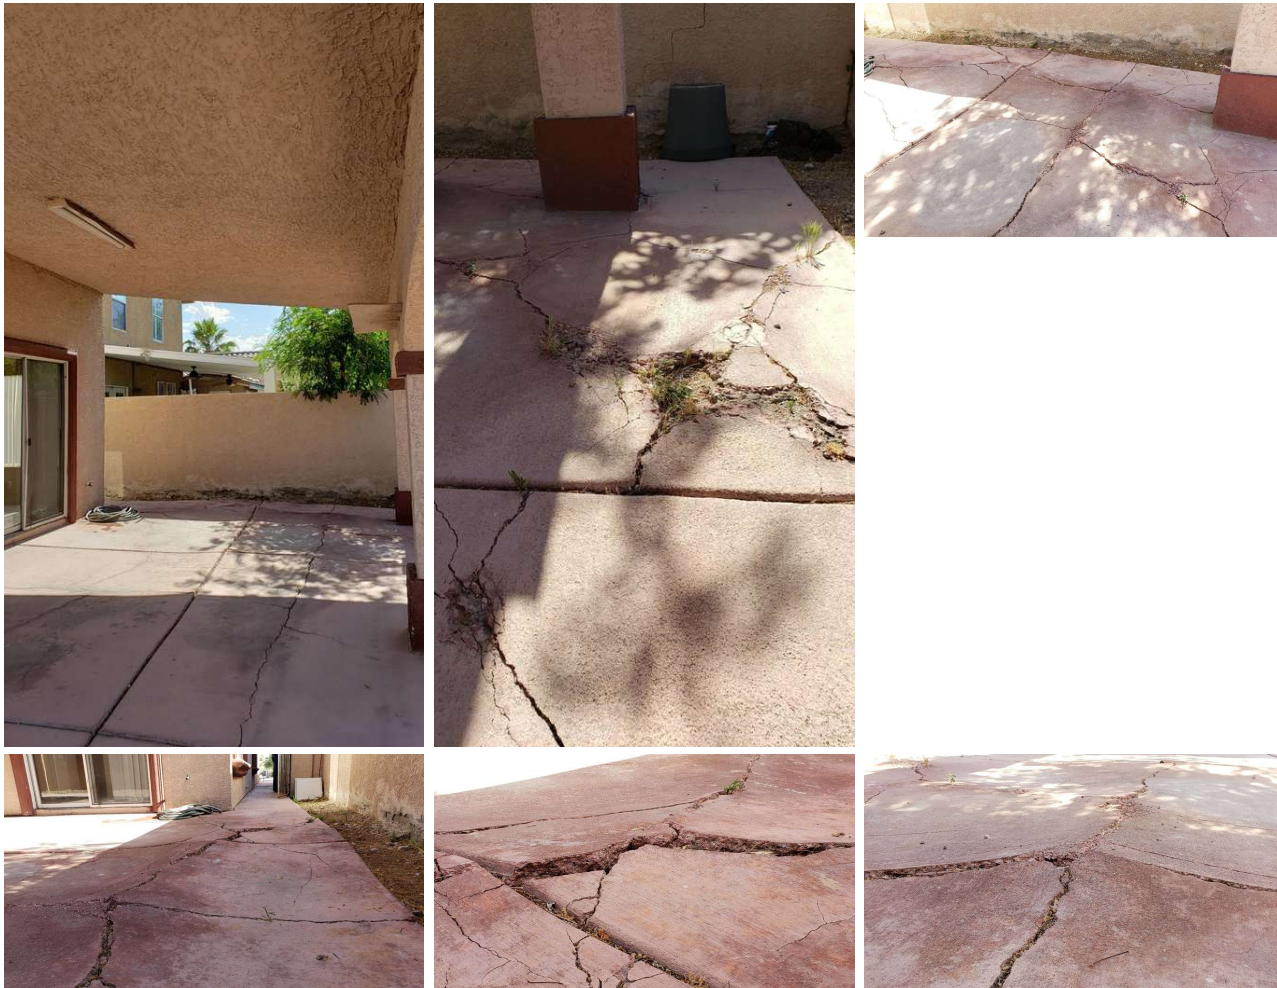
3.9.4 Walkway, Patios & Driveways

PATIO CONCRETE - DETERIORATED - REPLACE SLAB

The patio was undermined in one or more areas, where the soil has eroded out from beneath the patio. Significant cracks and/or damage has occurred, where one or more patio sections need replacing. Recommend that a qualified contractor replace all damaged sections as necessary.

Contact a qualified concrete contractor.

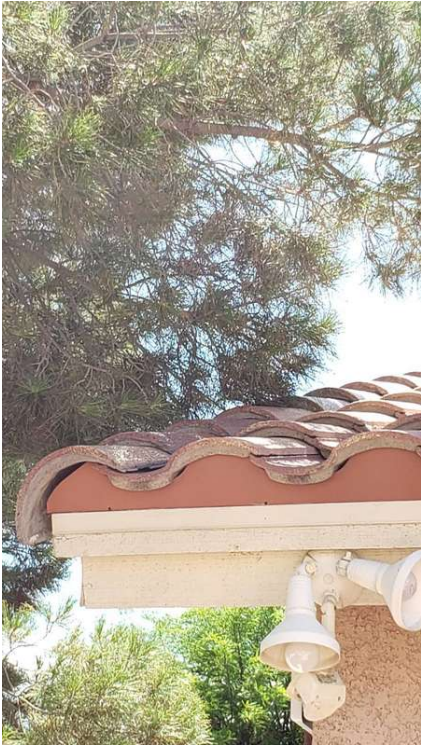
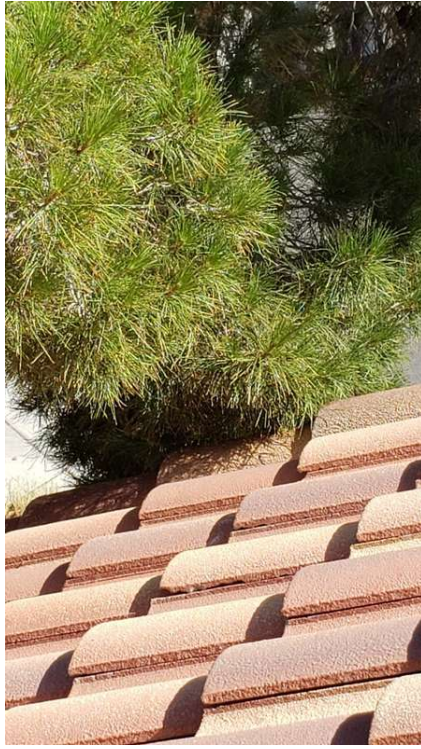
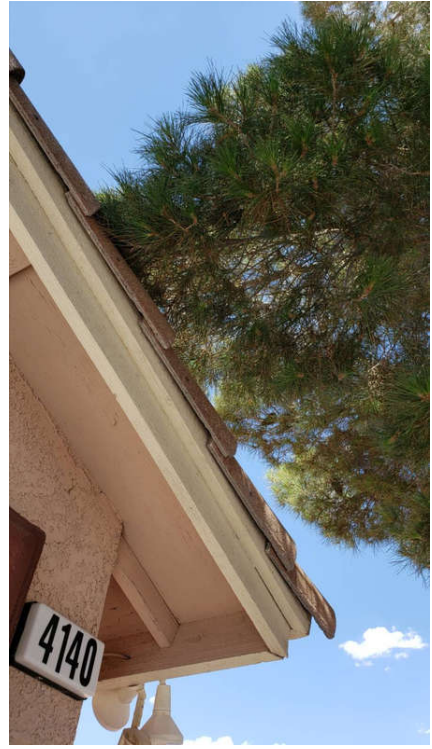
3.10.1 Vegetation, Grading, Soil & Drainage

TREE BRANCHES - OVERHANG THE ROOF

Tree branches were in contact with the roof or were touching the structure at one or more locations. Damage to the building or the roof can occur, especially during high winds, or may have already occurred (see other comments in this report if applicable). Recommend that a qualified tree service contractor or certified arborist prune back the tree as necessary to prevent damage to the roof and to the building exterior.

Contact a qualified tree service company.

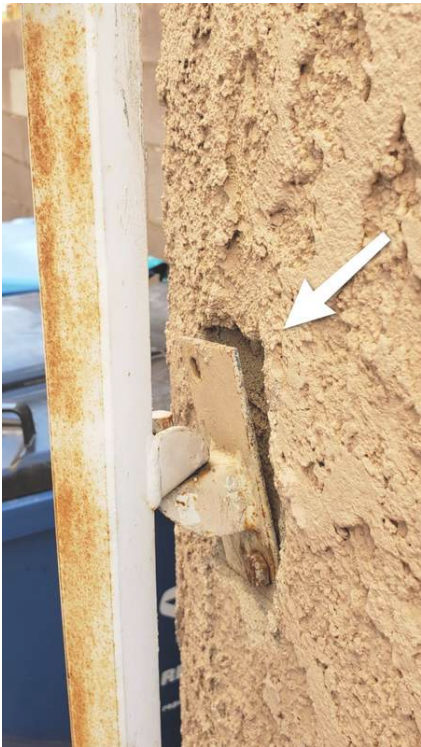
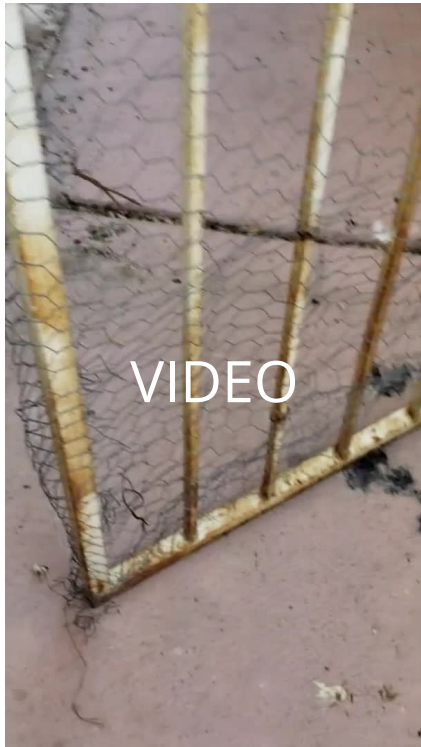
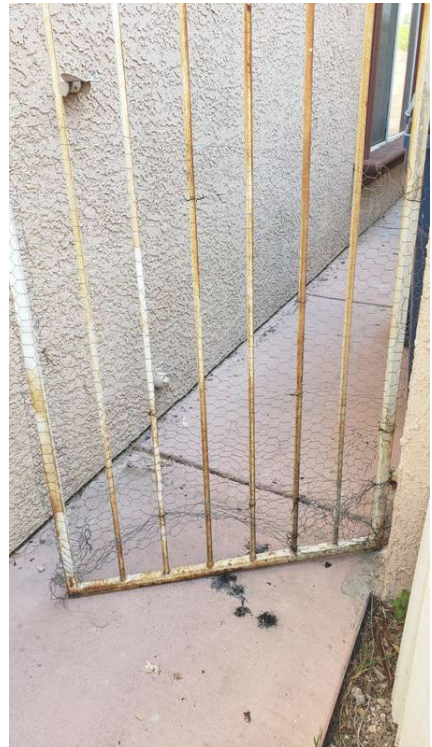
3.11.1 Fences, Gates & Walls

GATE REPAIR

One or more gates are damaged and/or deteriorated. A qualified contractor should evaluate and replace or make repairs as necessary.

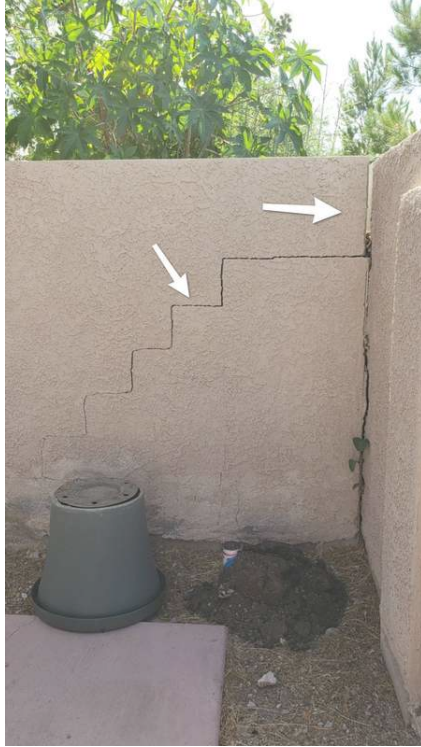
3.11.2 Fences, Gates & Walls

PERIMETER WALL CRACKS

Minor cracks, leaning or bowing were found in one or more perimeter walls. The perimeter walls appeared to be serviceable, but recommend monitoring them in the future. Further deterioration may occur and walls may need significant repairs or replacement at some point. Note that such repairs are often expensive.

Recommend monitoring.

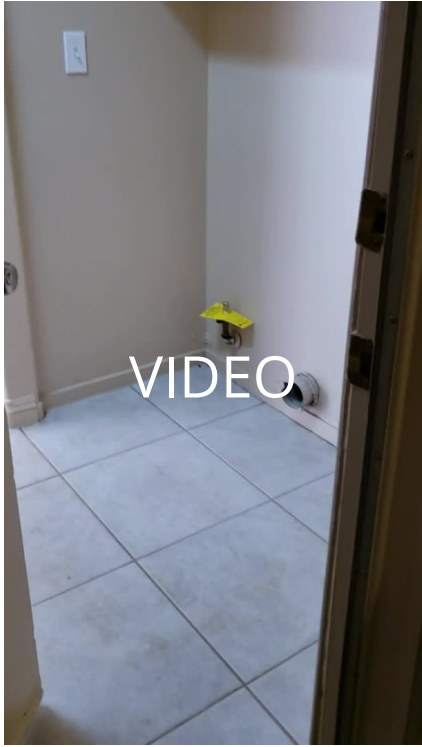
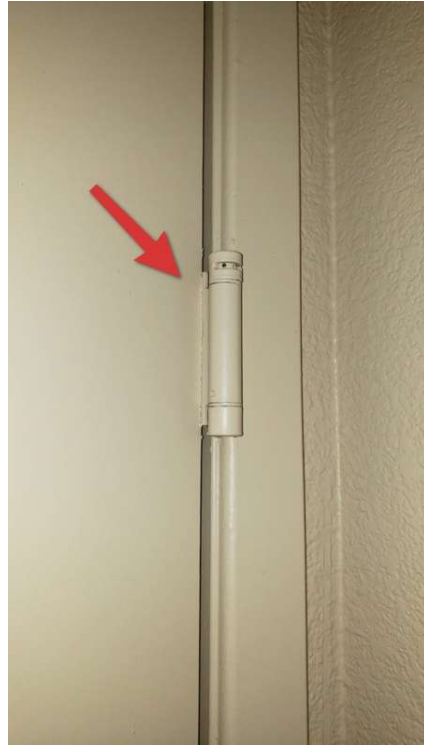
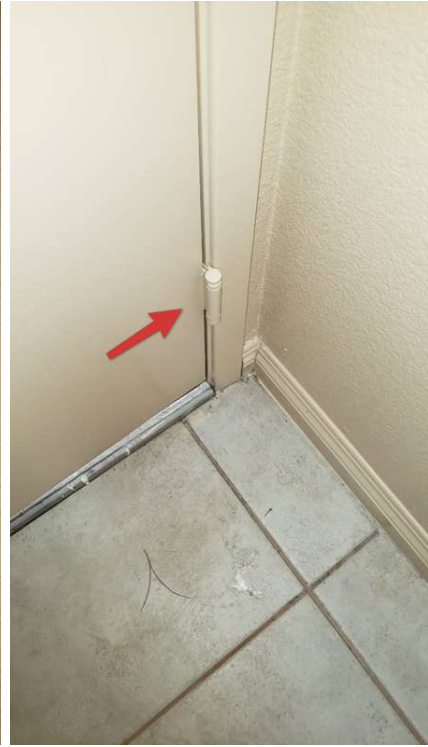
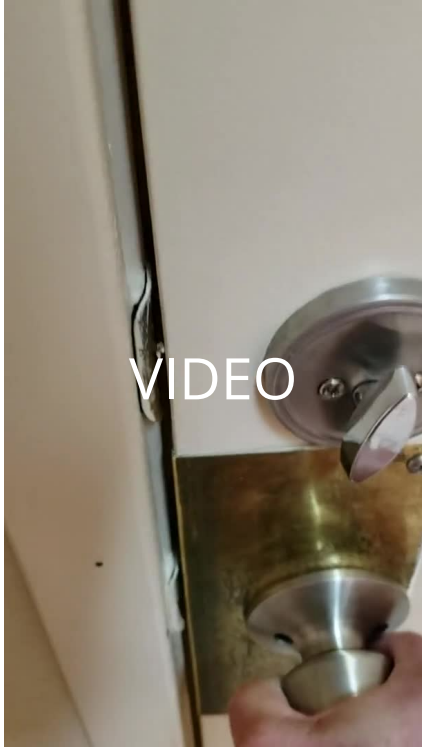
The self-closing device on the door between the garage and the house didn't close and latch the door. The deadbolt does not lock. These devices are installed to keep the door closed to prevent possible fire and fumes from the garage from spreading to the house. Recommend that a qualified person repair or replace as necessary.

Contact a qualified professional.

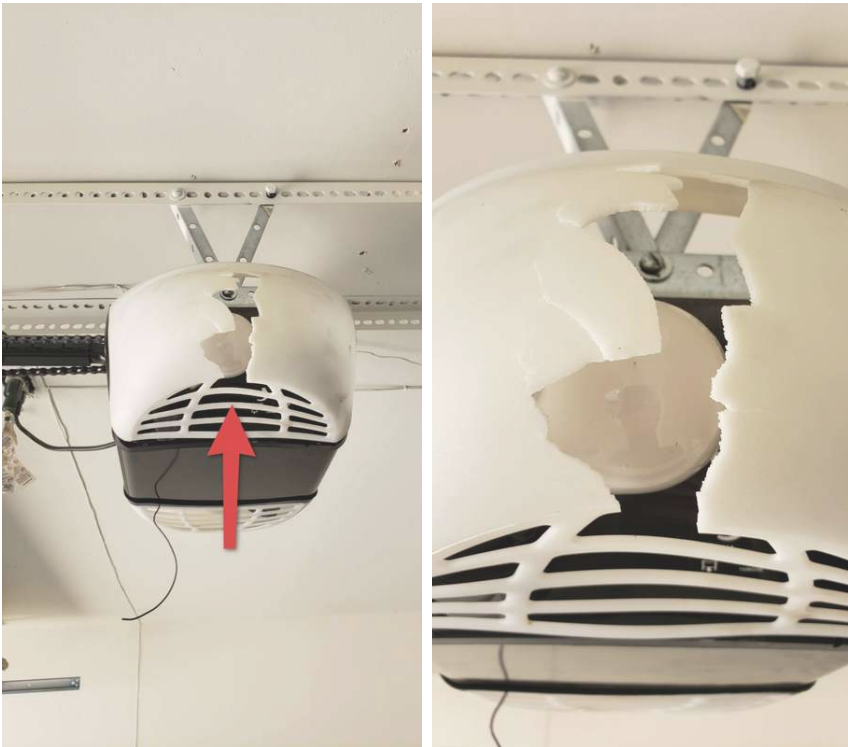
4.4.2 Automatic Opener

LIGHT COVER DAMAGED

The garage opener light cover was damaged. Recommend that a qualified professional replace as necessary.

Contact a qualified electrical contractor.

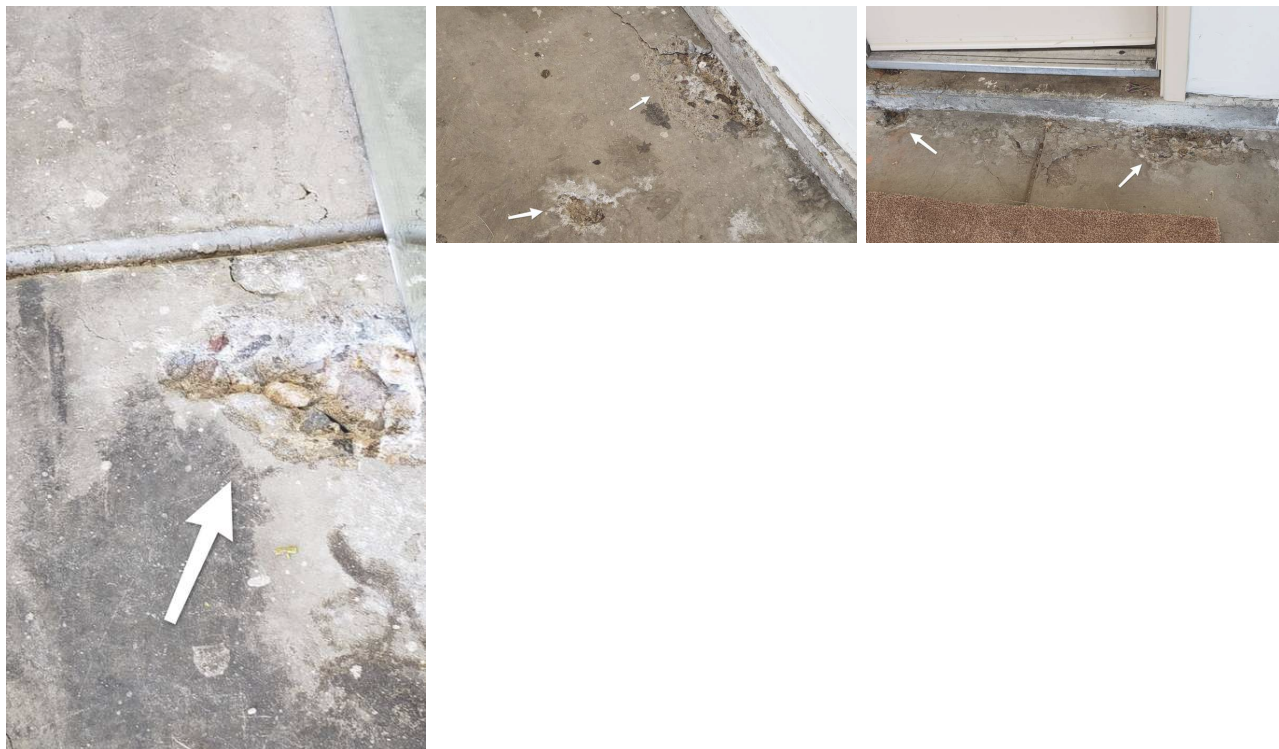
4.5.1 Floor, Walls, Ceiling

**CRACKS / SETTLEMENT / HEAVING**

Significant cracks, heaving or settlement were found in one or more sections of the garage concrete slab. Uneven surfaces can also pose a trip hazard. Recommend that a qualified contractor repair concrete slab floors where necessary.

Contact a qualified professional.

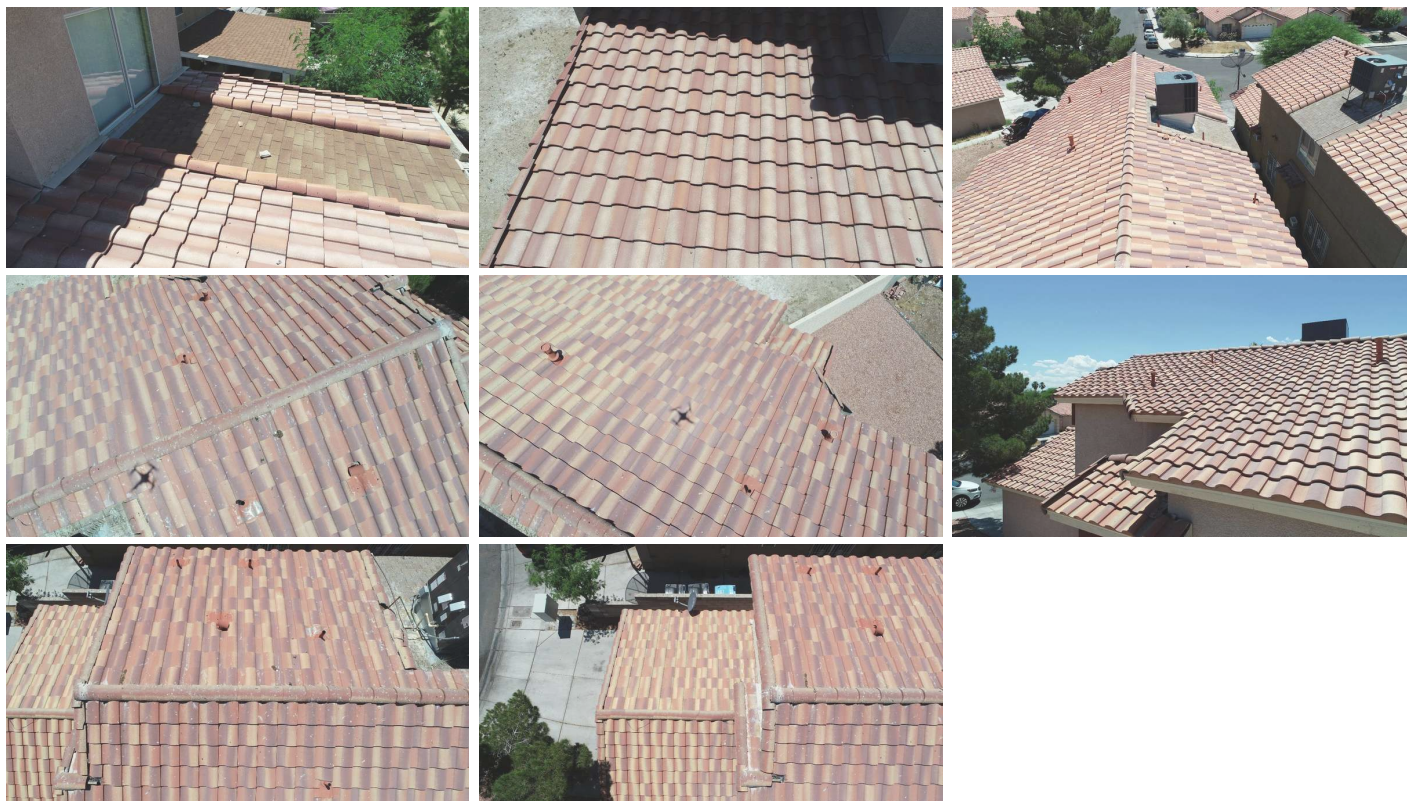
Roof Coverings / Drainage: Drone Photos

Drone photos were used to inspect this roof. I recommend having a qualified roofer evaluate all concerns or questions from the photos provided.

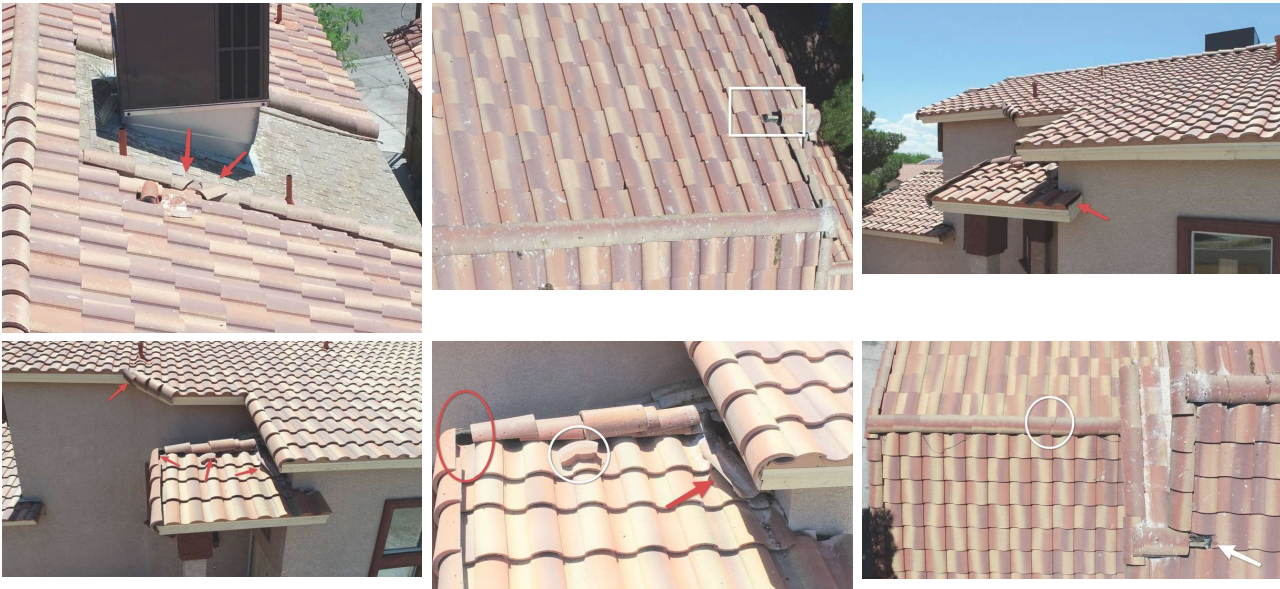
ROOF TILES CRACKED, BROKEN, LOOSE OR MISSING

Contact a qualified roofing professional.

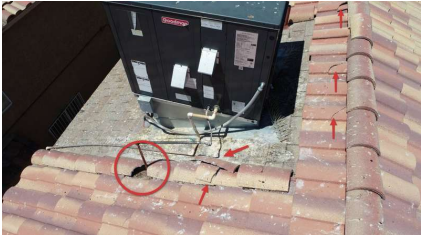
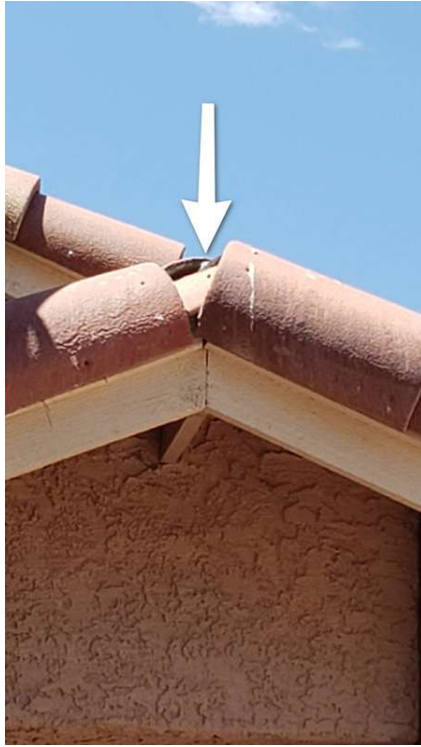
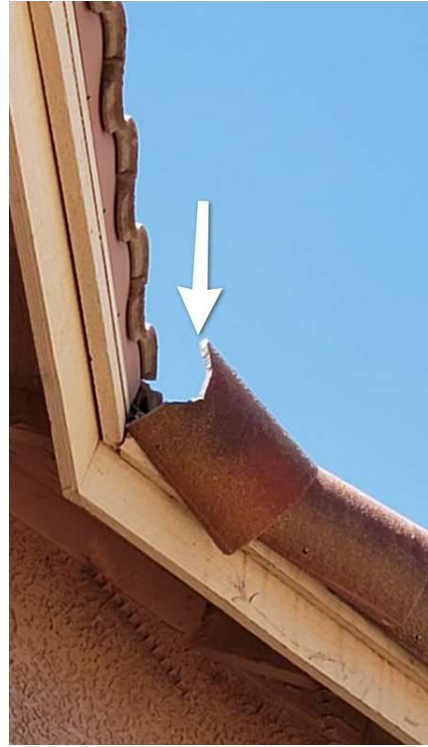
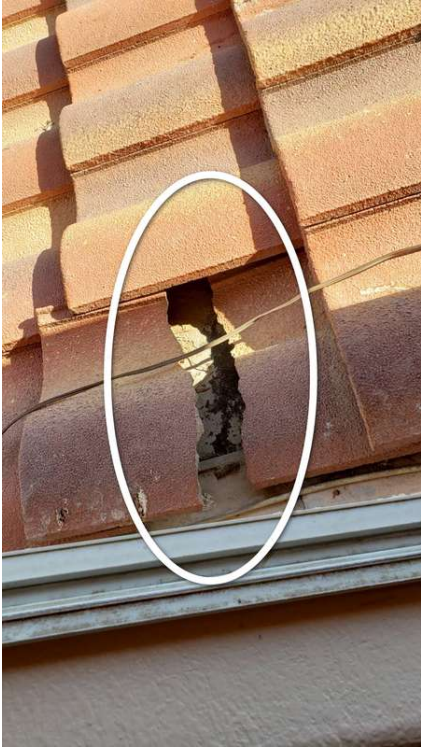
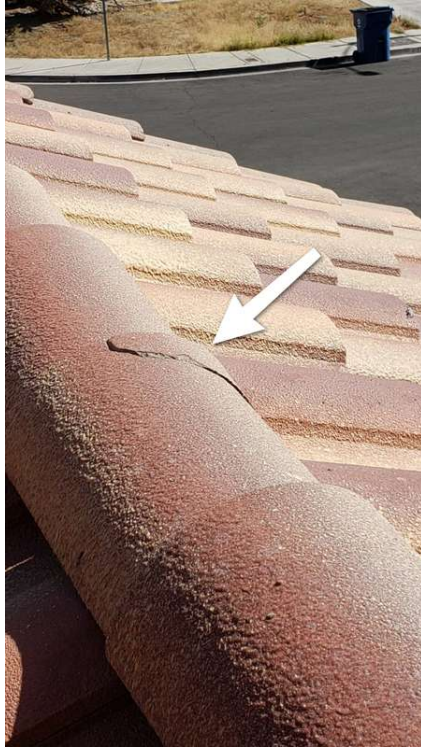
5.2.1 Roofing - Roof Coverings / Drainage: Roof Tiles Cracked, Broken, Loose or Missing
-

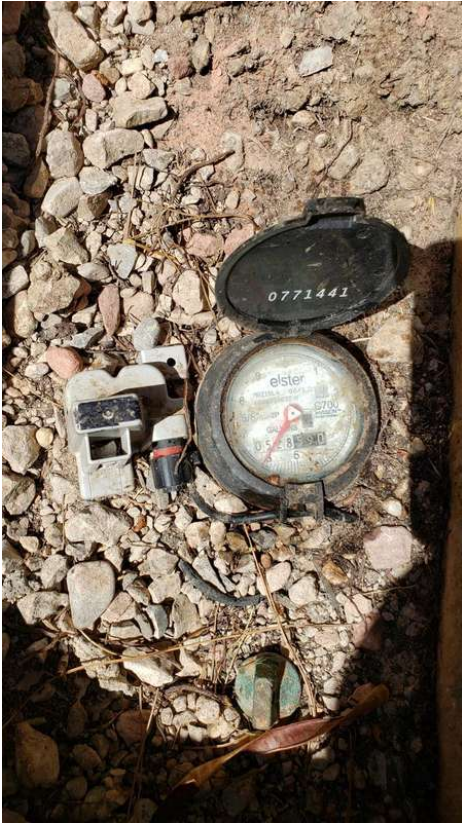
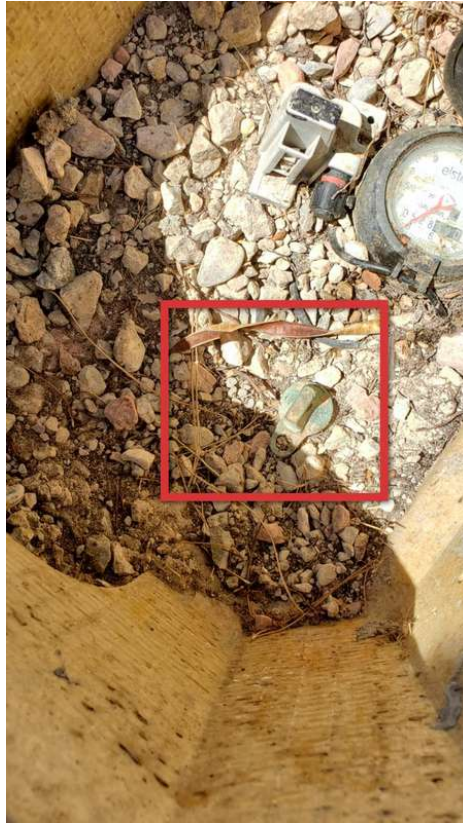
Service: Water Meter Photos

By street

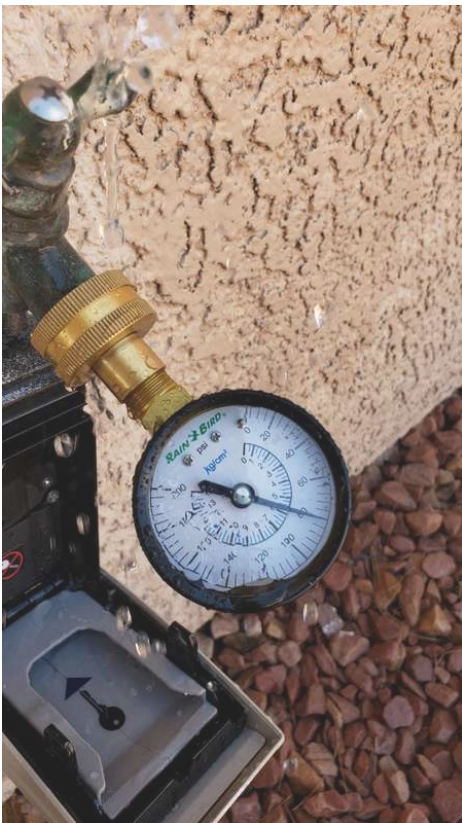
Service: Water Pressure

70-80 PSI

View of water pressure at the time of the inspection. 50 to 80 PSI is acceptable 60 to 75 PSI is ideal.

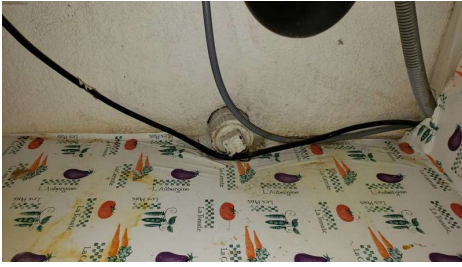
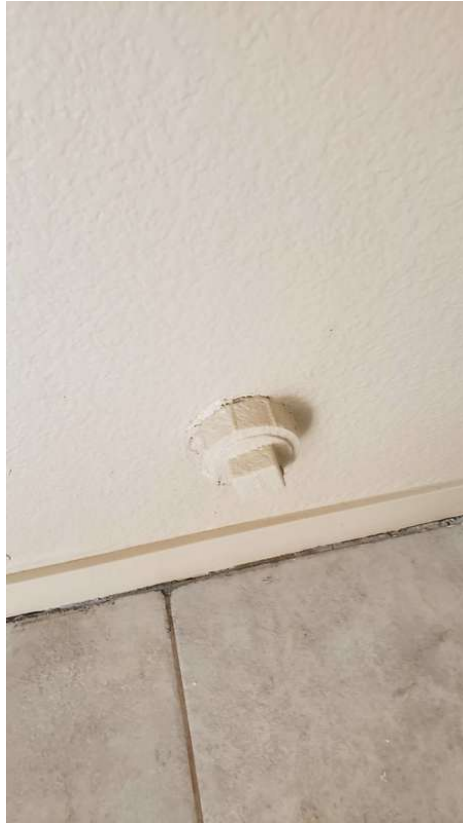
Drain, Waste, & Vent Systems: Clean-out Location(s)

Exterior, Laundry, Kitchen

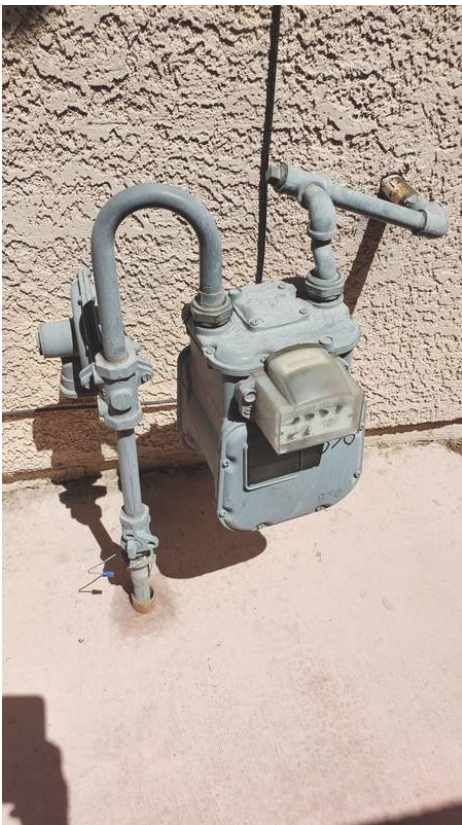
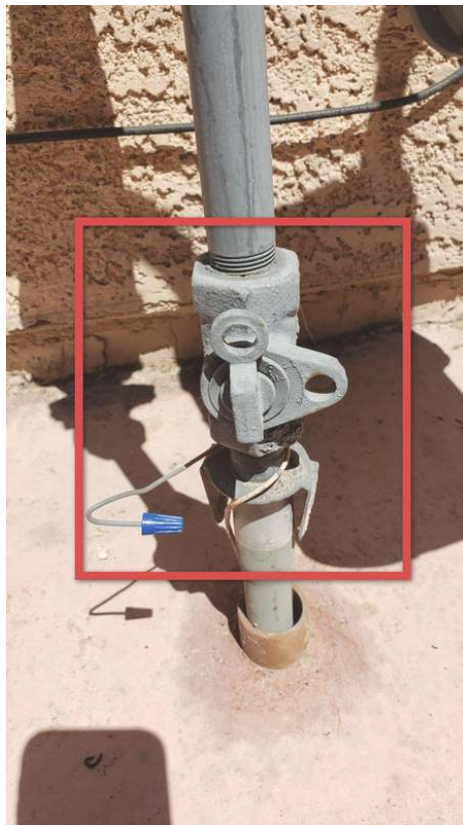
Gas Meter

Exterior - Left Side
