INSPEX HOME INSPECTIONS
Office: 725-605-5888 | Mobile: 725-222-1001
inspex@cox.net
<https://www.inspexgroup.com>

INSPECTION REPORT

1234 Main St.
Denver CO 80210

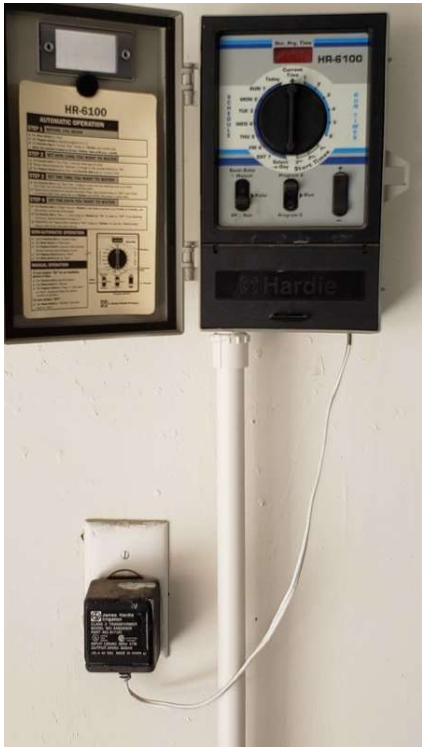
Garage

When this system is operated, recommend verifying that water is not directed at building exteriors, or directed so water accumulates around building foundations. Sprinkler heads may need to be adjusted, replaced or disabled.

Consider having a qualified plumber verify that a backflow prevention device is installed per standard building practices to prevent cross-contamination of potable water.

Recommend that a qualified specialist evaluate the irrigation system for other defects (e.g. leaks, damaged or malfunctioning sprinkler heads) and repair if necessary.

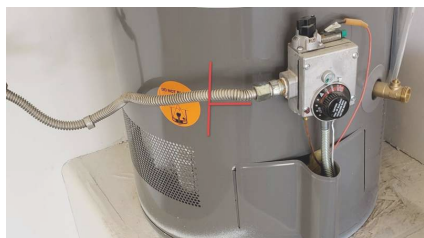
MISSING SEDIMENT TRAP

No sediment trap was present for one or more appliances gas lines. Sediment traps are a T and are placed to prevent moisture and tiny debris in the gas system from entering the combustion chamber prolonging the life of the appliance. Recommend a plumber add a sediment trap per standard building practices.

Contact a qualified plumbing contractor.

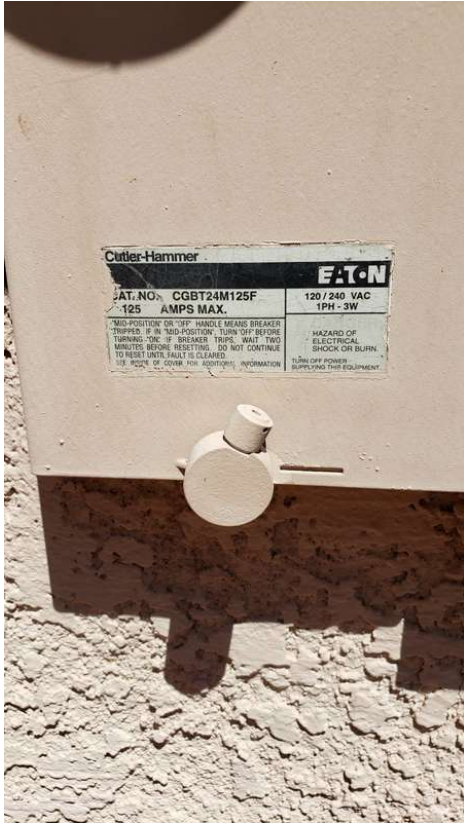
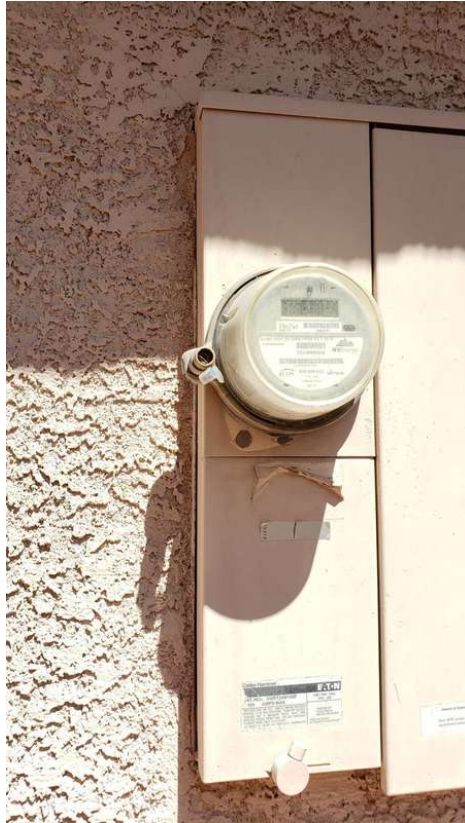
Service Entrance Conductors: Entrance Conductor Material

Unknown / Not Visible, Locked

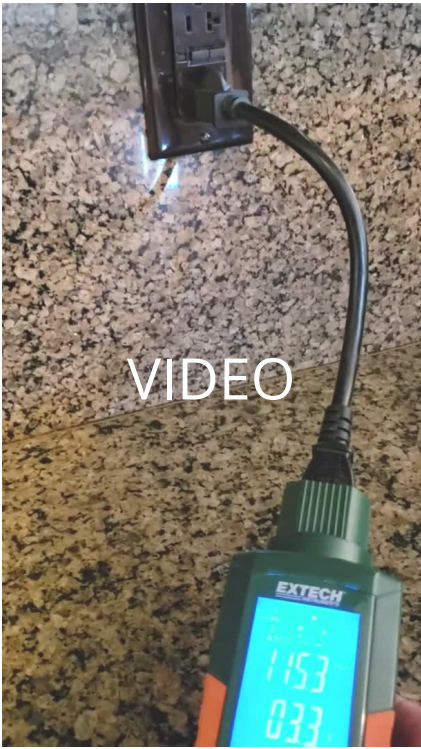
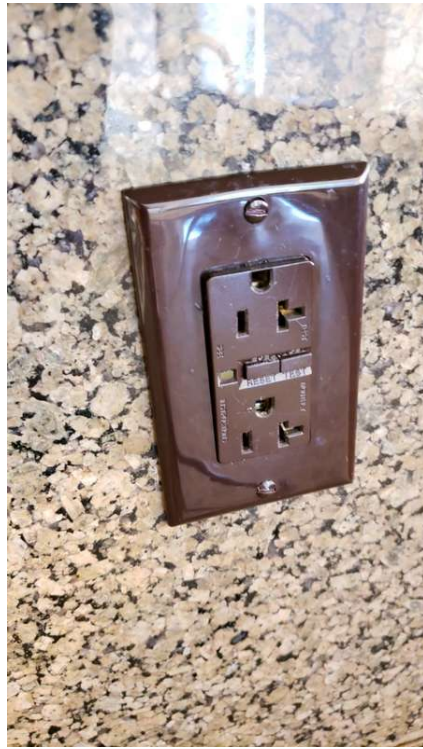
Kitchen

One or more ground fault circuit interrupter (GFCI) receptacles (outlets) were not functioning properly (would not trip). Recommend replacement by a qualified licensed electrical contractor.

Contact a qualified electrical contractor.

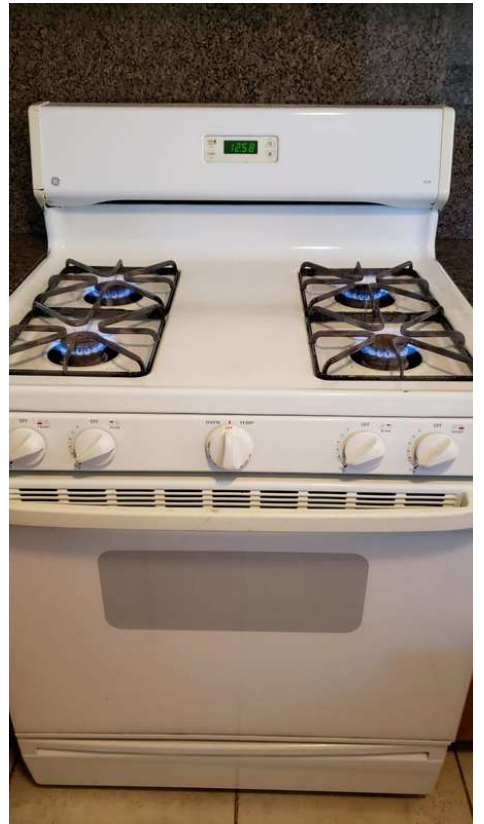
Range/Oven/Cooktop: Range/Oven OK

Range/oven or cooktop functional.

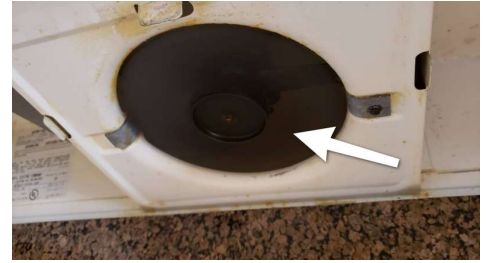
GREASE FILTER MISSING

The hood grease filter was missing. Recommend replace filter as necessary.

Recommended DIY Project

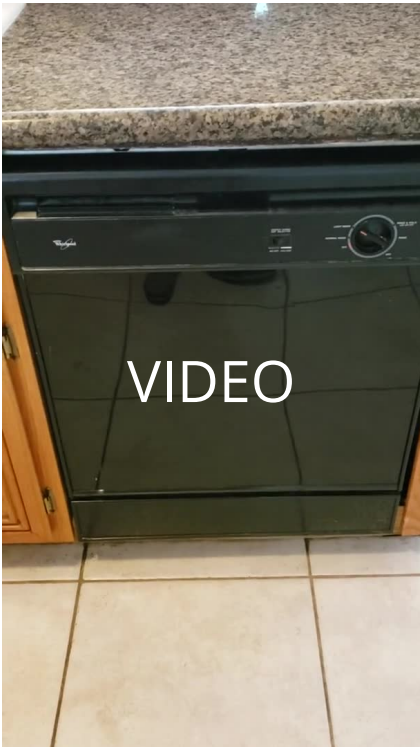
LEAKS AT COUNTER - AIR GAP

The dishwasher was tested and it was found to be leaking at the countertop air gap connection. The test was terminated as soon as the leaks were discovered to prevent additional water leaks or damage. Recommend that a qualified professional evaluate and make repairs as necessary.

Contact a qualified professional.

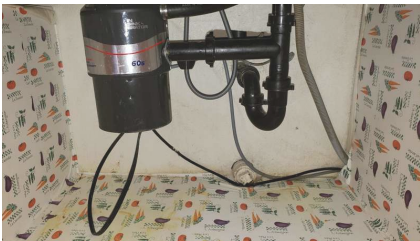
WALL DAMAGE UNDER SINK

The wall under the sink is damaged. Recent repairs may have been performed. Recommend asking the owner about this. Services of a licensed professional are also recommended to patch the wall.

Contact a qualified professional.

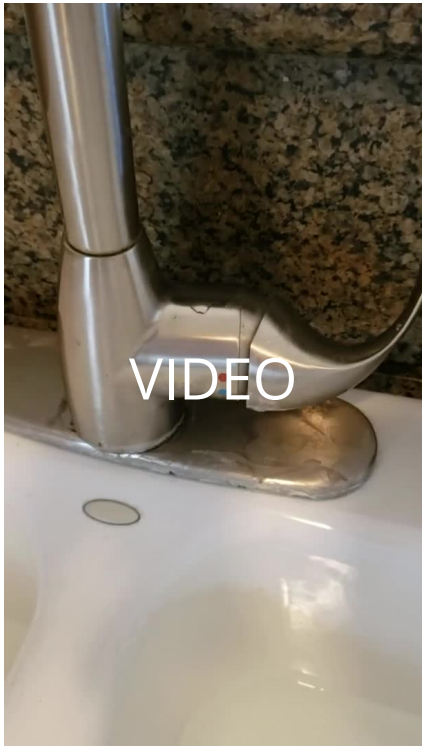
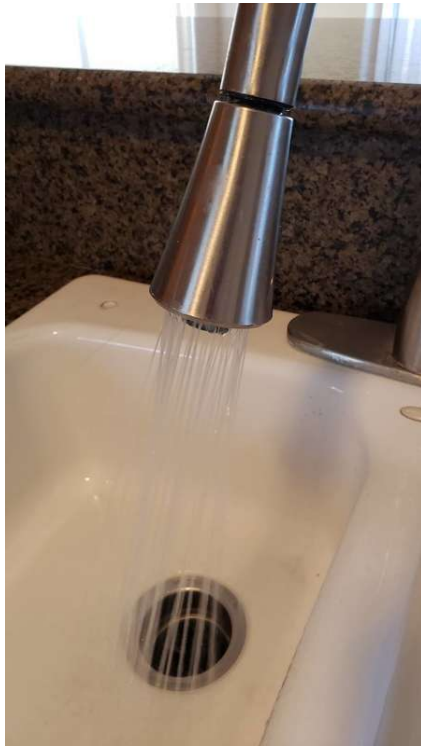
FAUCET LOOSE AT THE BASE

The sink faucet is loose at the base. Hard water/mineral build up is preventing the spout from turning. Recommend that a qualified person repair or replace as necessary.

Contact a qualified plumbing contractor.

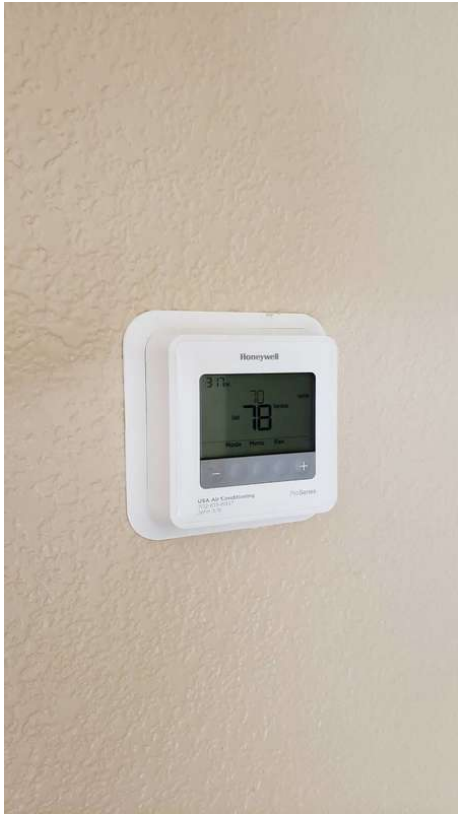
Air Conditioning: Appears Functional

The temperature split differential between the return air and supply registers was within the 14-22 degree (F) range at the time of inspection.

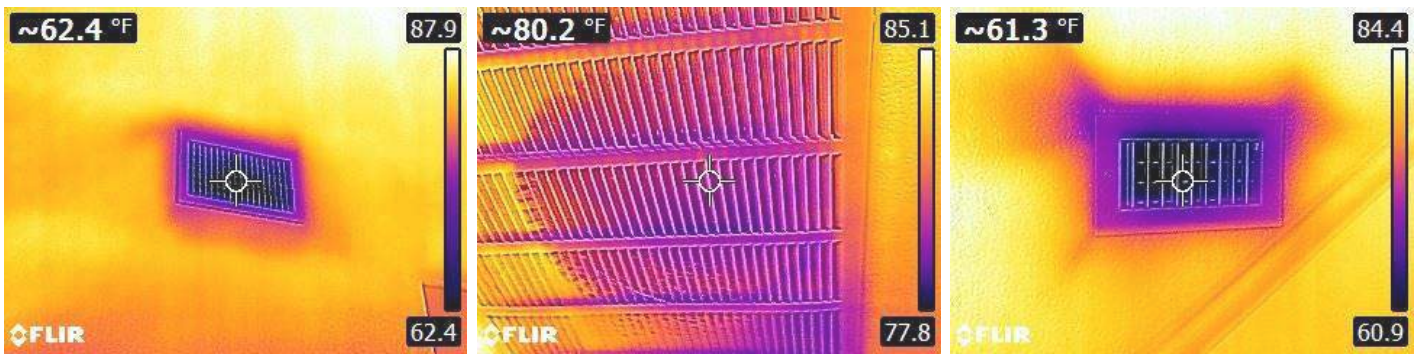
The photos below are a thermal images of the air temperature at supply and return air registers at the time of this inspection.

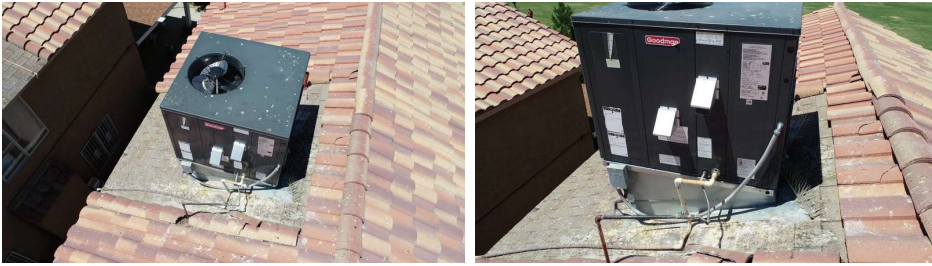
Air Conditioning: Equipment Photos

The estimated useful life for most heat pumps and air conditioning condensing units is 15-20 years. This unit appeared to be near, at or beyond this age and/or its useful lifespan and may need replacing or significant repairs at any time. Recommend budgeting for a replacement in the near future.

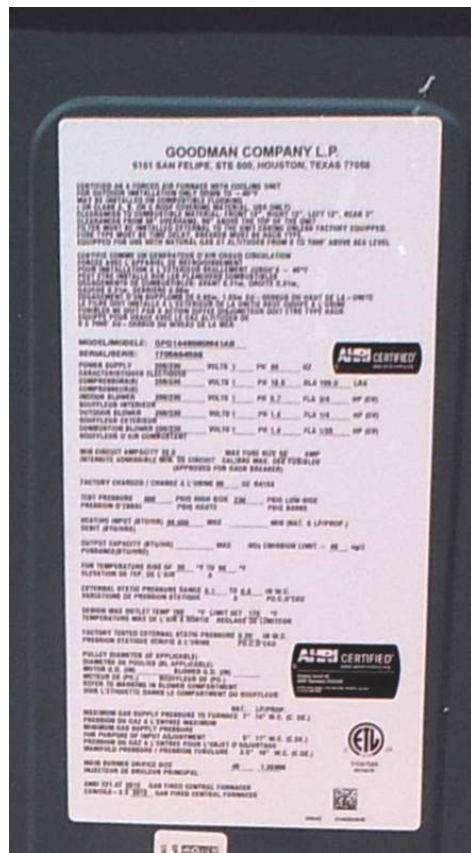
LABEL NOT CLEAR

The inspector was not able to determine the size of one type of refrigerant used as the unit was installed on the roof and the inspector relied only on drone photos. Recommend asking the owner of any documentation about this unit.

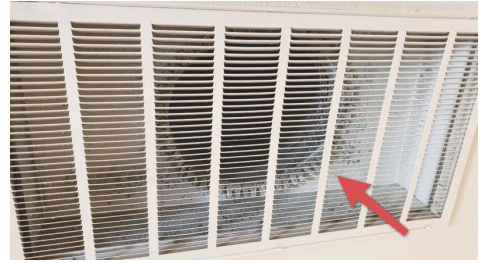
FILTERS MISSING

Air filters for the heating and/or cooling system were missing where they should have been installed. The indoor air quality will be reduced as a result. Recommend installing good quality filters at intended locations. Filters should be sized correctly to minimize air gaps. Many types of filters are available. Recommend installing pleated filters or better rather than the cheapest disposable kind.

Recommendation

Recommended DIY Project

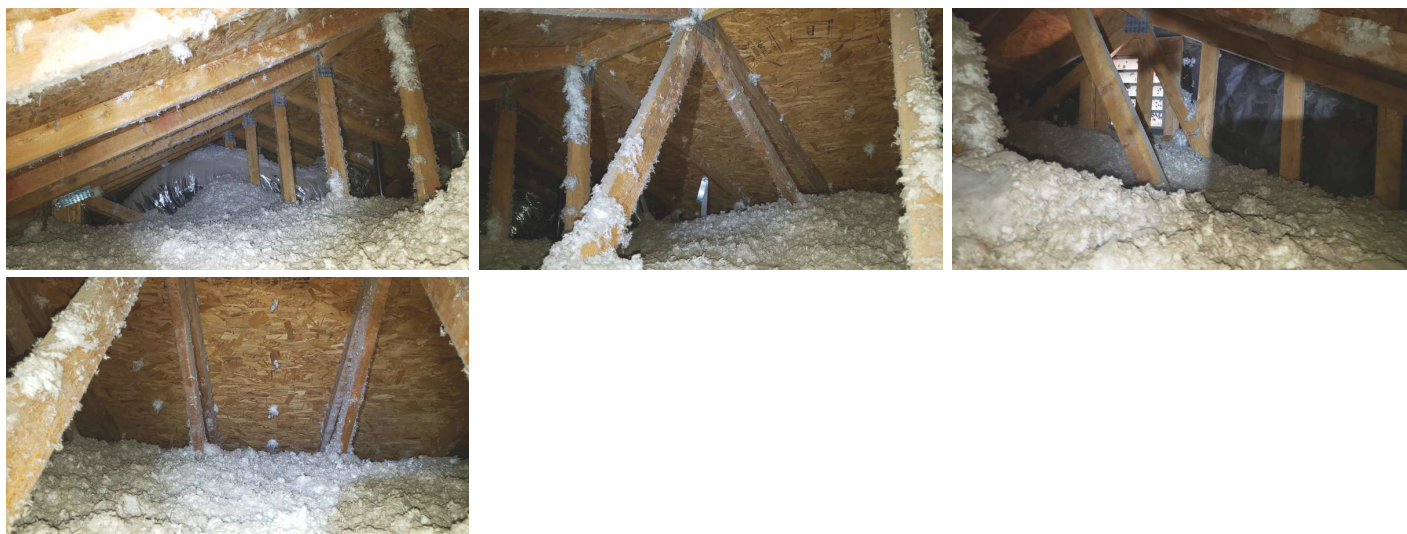
Attic Access: Attic Photos

Only areas in the attic that were accessible to the inspector were inspected, these areas showed no signs of structural deficiencies on the day of the inspection.

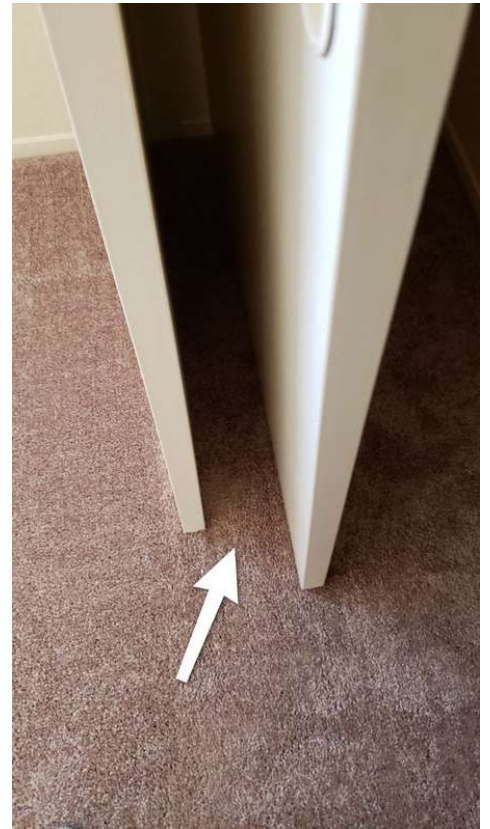
CLOSET DOOR GUIDES MISSING

Floor guides were missing at one or more sliding closet doors.
Recommend replacement by a qualified person.

Recommendation

Contact a handyman or DIY project

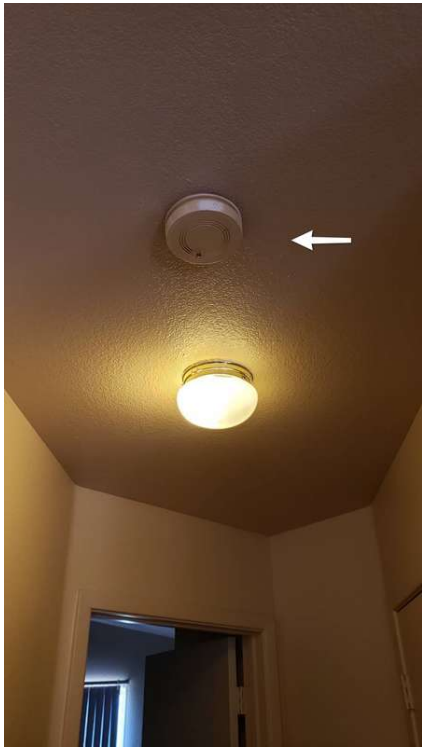
Hallway - 2nd Floor

Carbon Monoxide Detectors were not a requirement when this property was built. However, for safety reasons, recommend being installed in the vicinity of each sleeping area, on each level of the structure and in accordance with the manufacturer's recommendations.

Recommendation

Contact a handyman or DIY project

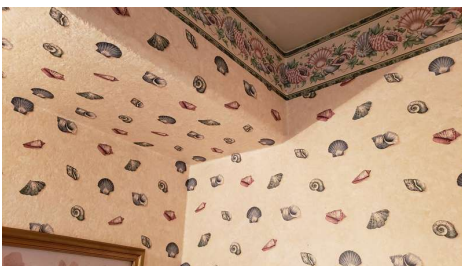
Bathroom - 1st Floor

There is wallpaper in one or more bathrooms. The walls behind the wallpaper can not be evaluated. Moisture can get behind the wallpaper if the bathroom is not properly vented, (an exhaust fan, window etc.) and create mold or wall damage that is not visible.

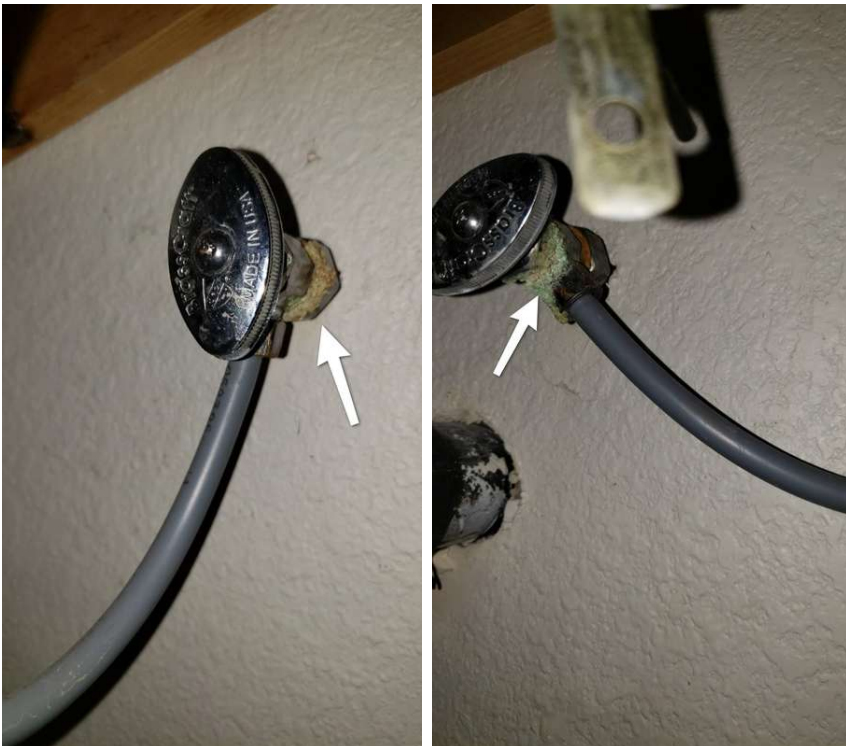
13.7.1 Sinks / Fixtures

CORROSION ON FITTINGS/LINES
