WRIGHT CHOICE HOME INSPECTION

RESIDENTIAL REPORT

1234 Main St.
New Albany Indiana 47150

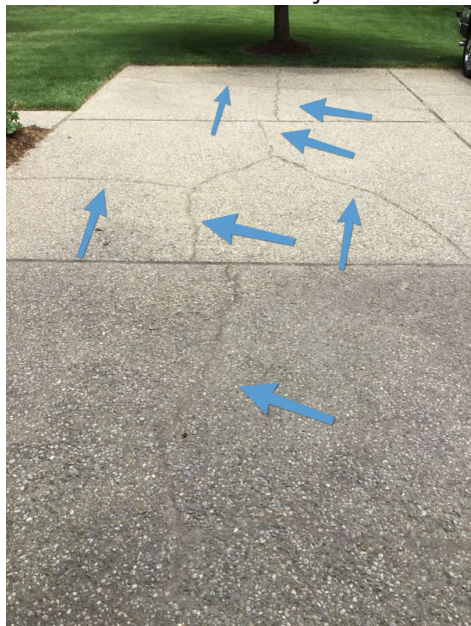
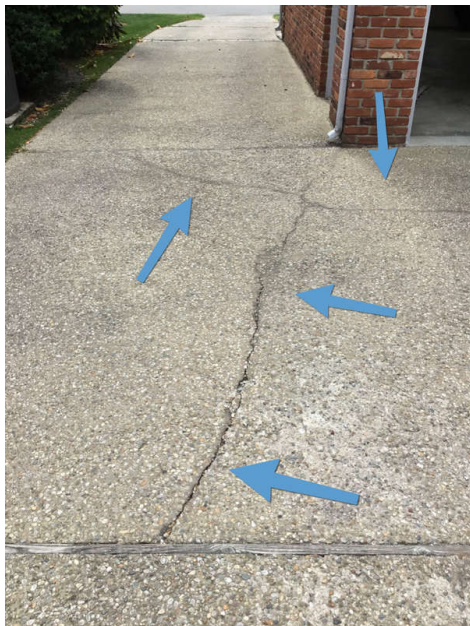
DRIVEWAY CRACKING - MINOR

Minor cosmetic cracks observed, which may indicate movement in the soil. Recommend monitor and/or patch/seal cracks.

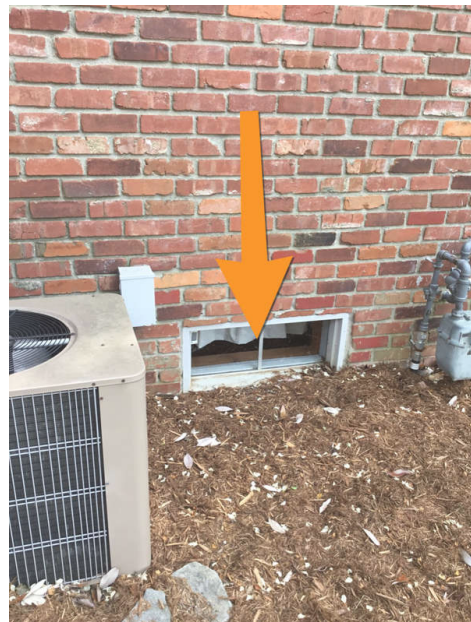
North

RECOMMEND INSTALLING WINDOW WELLS

Recommend installing window wells.

Contact a qualified professional.

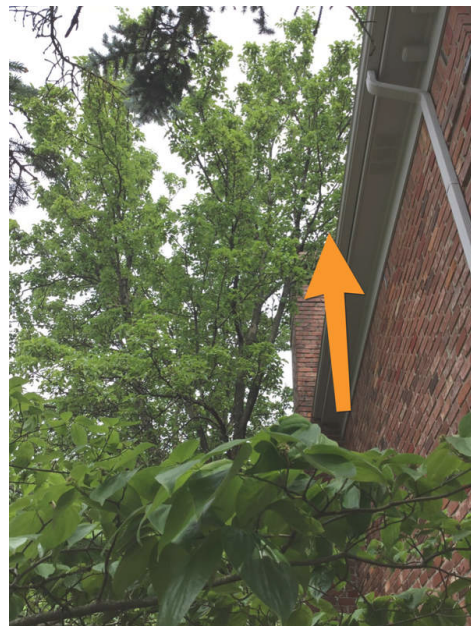
North

Trees observed overhanging the roof. This can cause damage to the roof and prevent proper drainage. Recommend a qualified tree service trim to allow for proper drainage.

Contact a qualified tree service company.

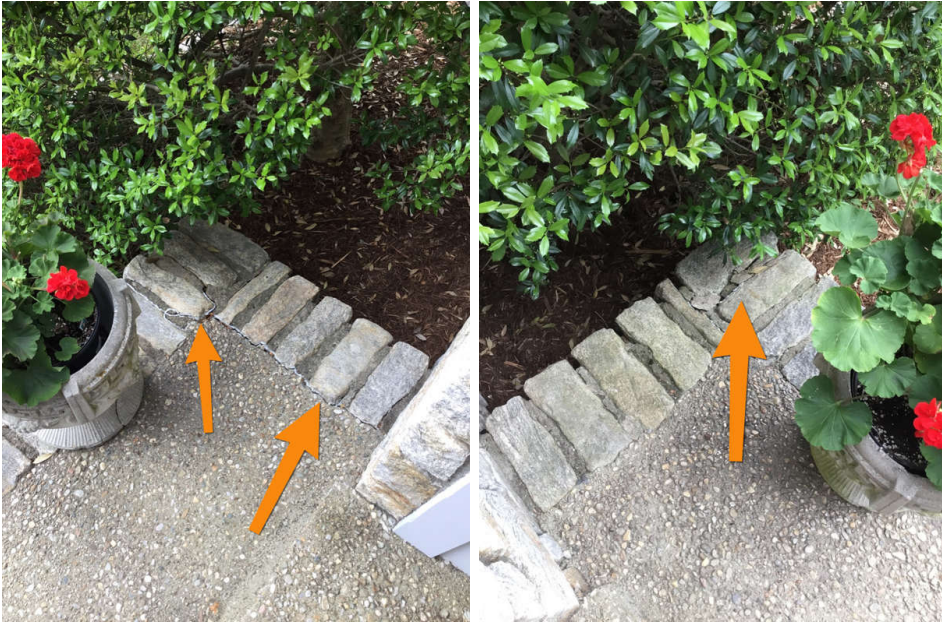
STEP/STOOP- CRACKED/DAMAGED

Step/Stoop is cracked/damaged. Recommend repair and monitoring.

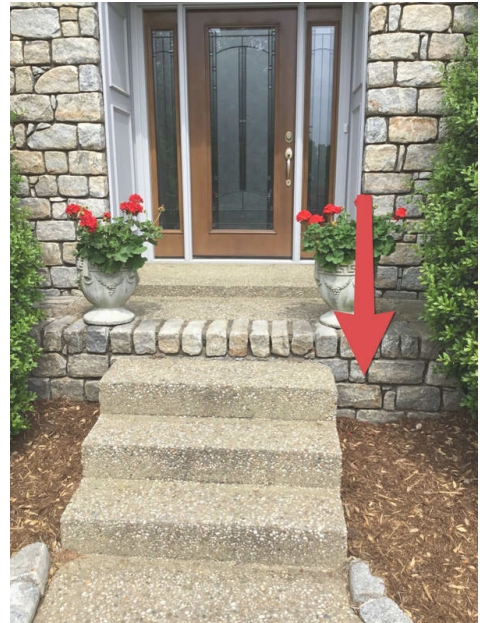
HANDRAIL MISSING

Recommend installing handrails on stairs with more than 4 steps to platform. This is a potential safety hazard

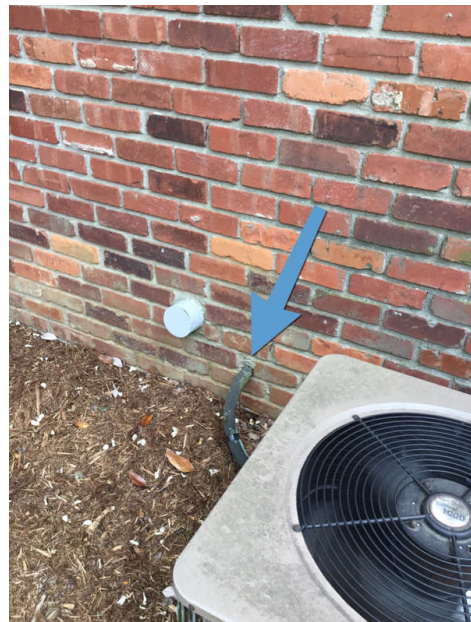
North

CAULK UTILITY PENETRATIONS

Recommend caulking at utility penetrations in siding.

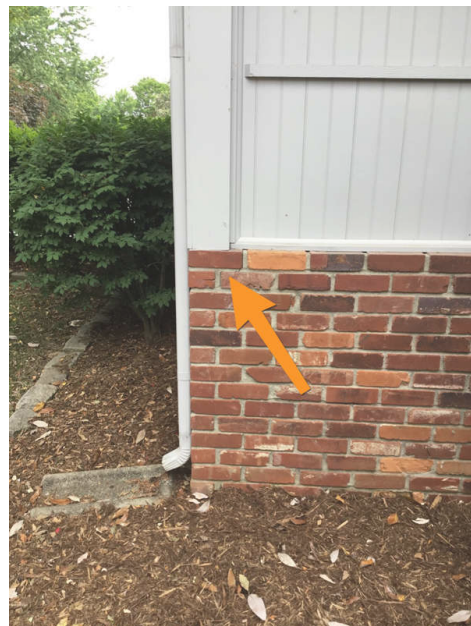
North

CRACKING - MINOR

Siding showed cracking in one or more places. Recommend repair and tuck pointing maintenance of mortar.

Contact a qualified masonry professional.

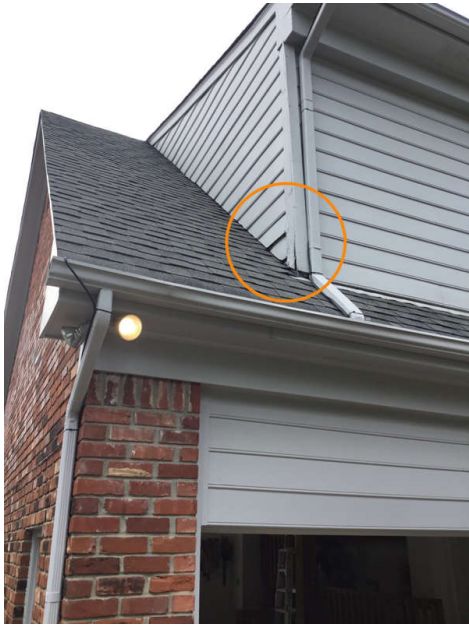
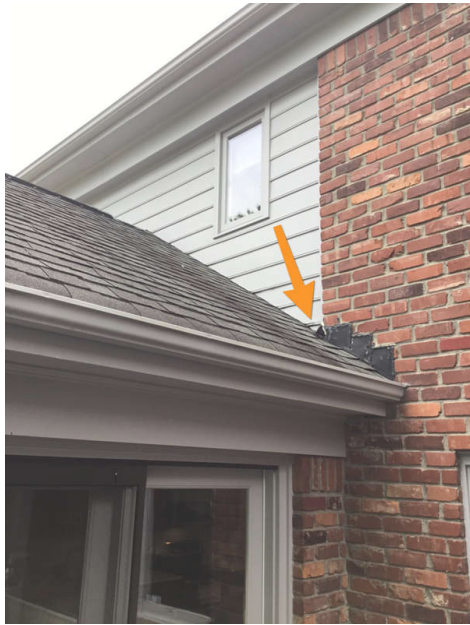
East

SIDING DAMAGE - MINOR

Siding showed signs of minor damage. Recommend repairing/monitoring any damaged areas that may allow moisture intrusion.

Contact a qualified siding specialist.

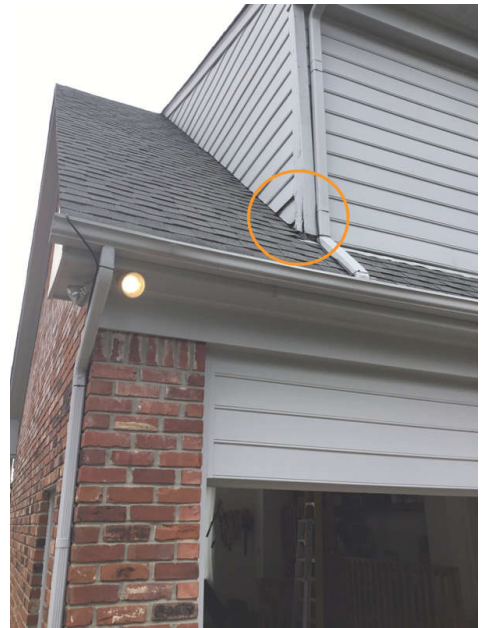
East

TRIM DAMAGED

Exterior trim is visibly damaged. Recommend repair/replacement of damaged sections

Contact a qualified carpenter.

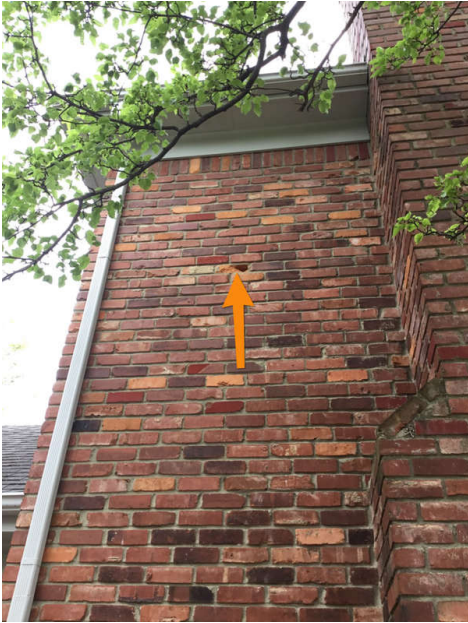
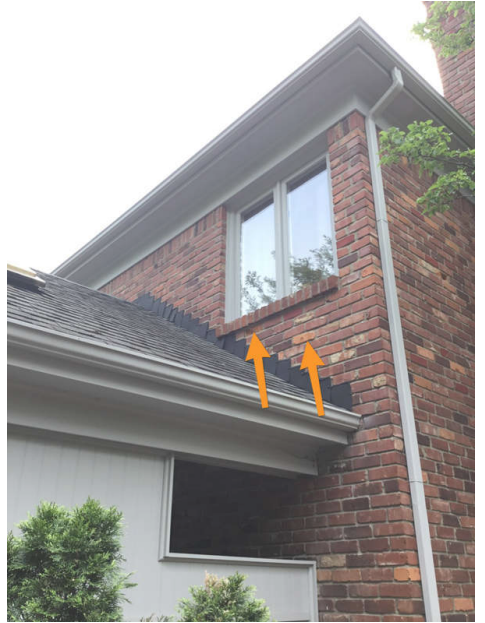
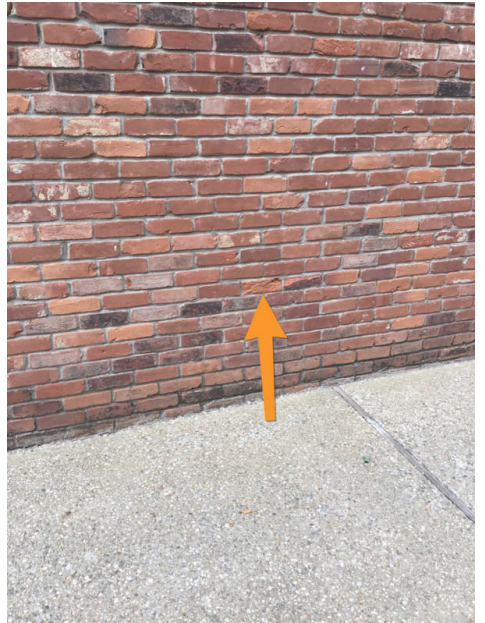
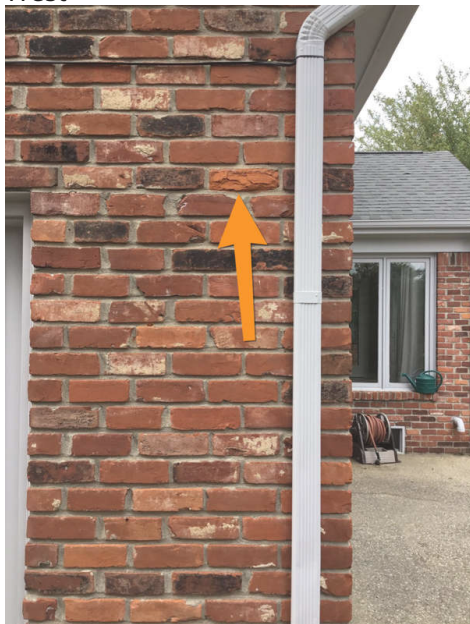
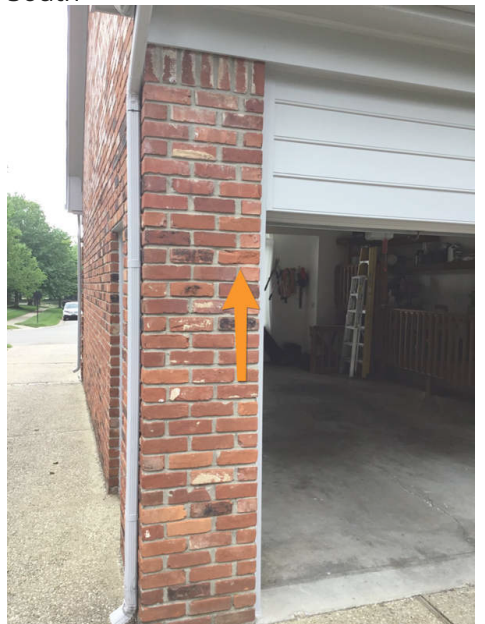
Pumpkin brick was noted on exterior siding. This is old brick of bad quality and is known to deteriorate. Recommend masonry contractor evaluate and repair/replace damaged bricks

Contact a qualified masonry professional.

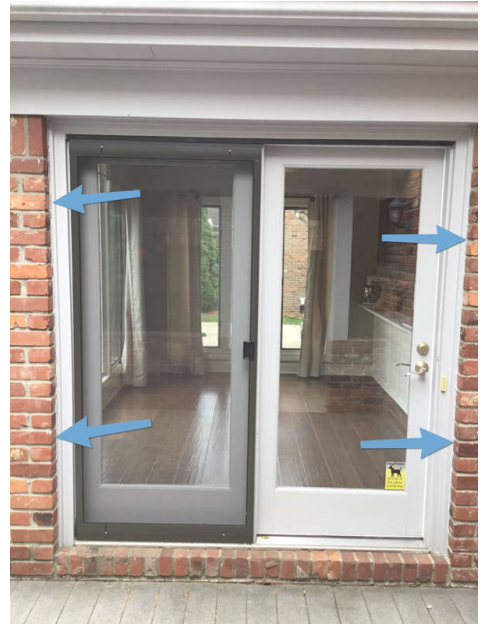
East

Recommend caulking around exterior door(s) where caulking is cracked/separated/missing.

Contact a qualified painter.

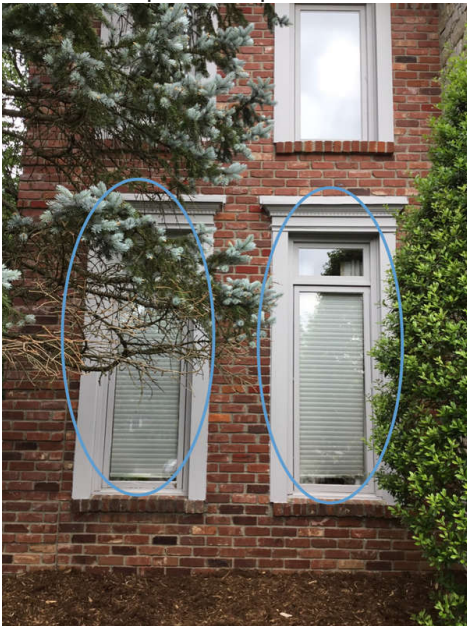
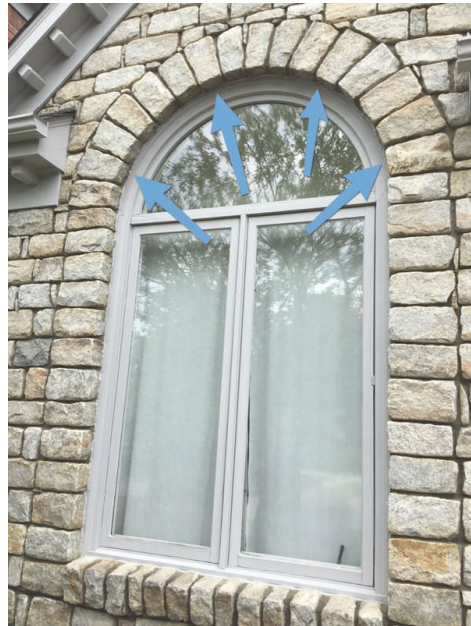
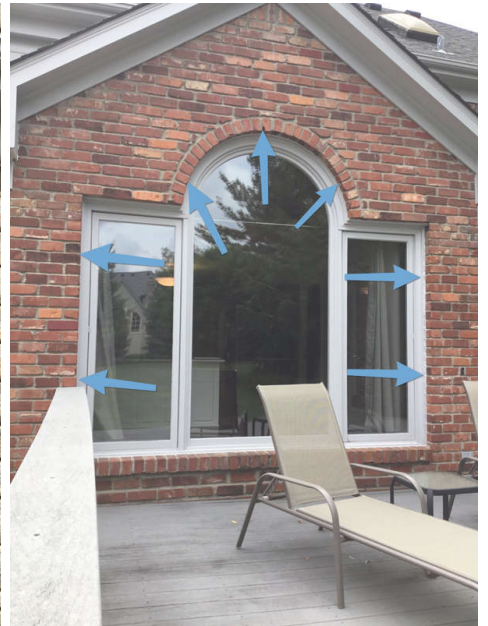
Exterior window caulking is cracked/separated/missing. Recommend caulking maintenance around windows/window trim

Contact a qualified painter.

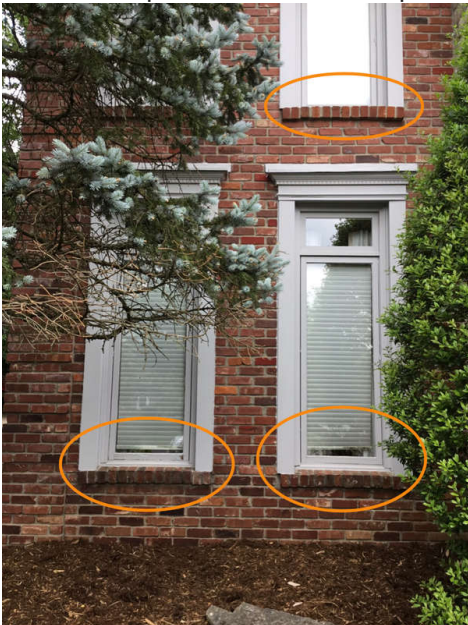
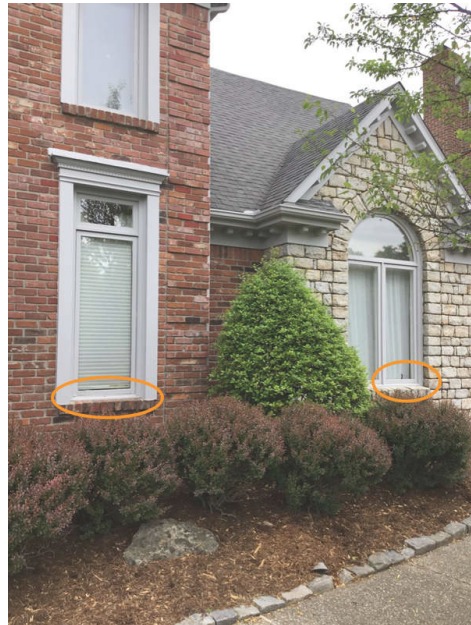
WINDOW FRAME DAMAGED

Window frame is damaged. Recommend repair/replacement of damaged frame(s).

Contact a qualified window repair/installation contractor.

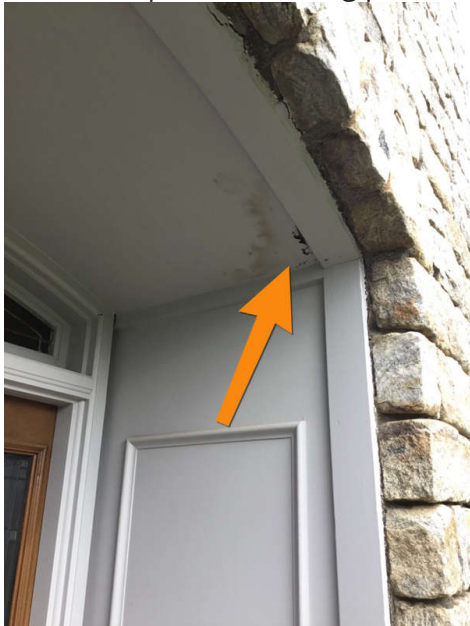
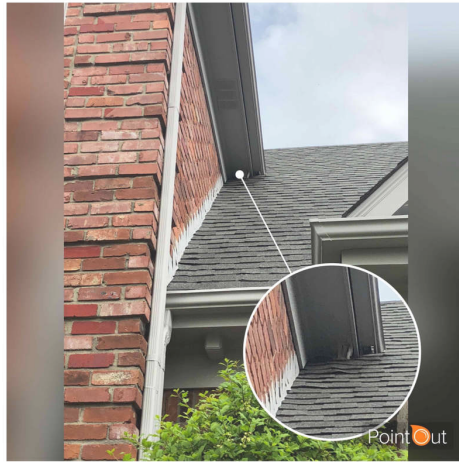
West

SOFFIT/EAVES - DAMAGED

One or more sections of the spffit/eaves are damaged. Recommend qualified roofer evaluate & repair.

Contact a qualified roofing professional.

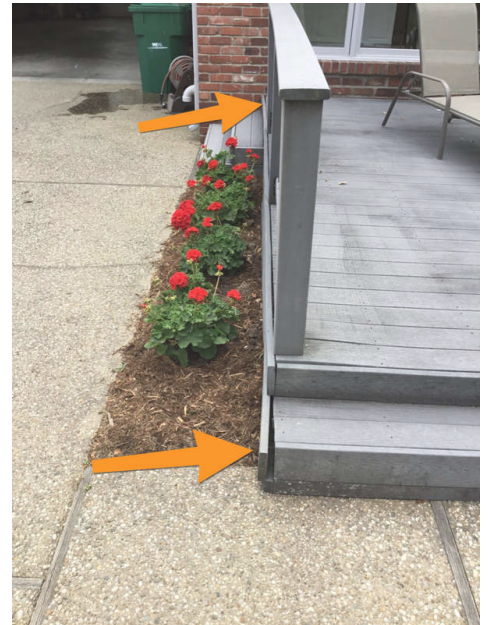
DECK - LOOSE BOARDS

One or more deck boards were observed to be loose. Recommend they be refastened.

Contact a qualified deck contractor.

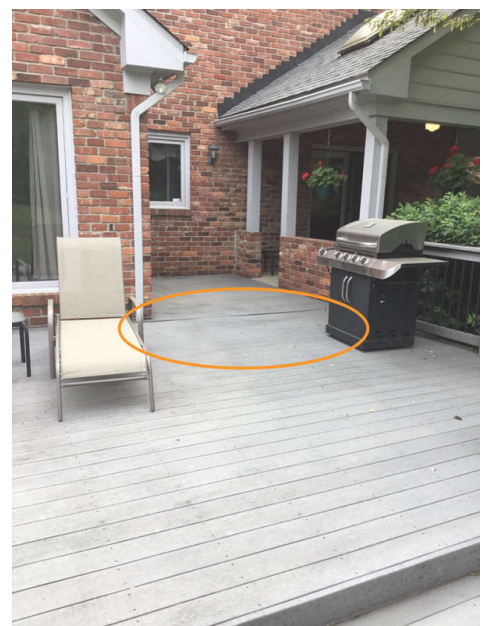
One of more areas of the deck support appears unstable. This could cause a safety hazard and further deterioration of the deck. Recommend qualified deck contractor evaluate and repair.

Contact a qualified roofing professional.

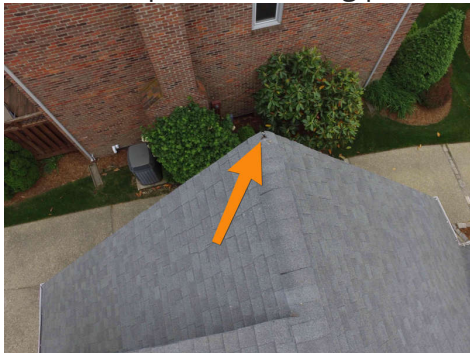
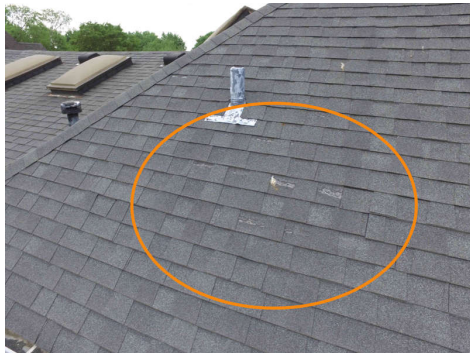
DAMAGED COVERINGS

Roof coverings exhibited general damage that could affect performance. Recommend a qualified roofer evaluate and repair.

Contact a qualified roofing professional.

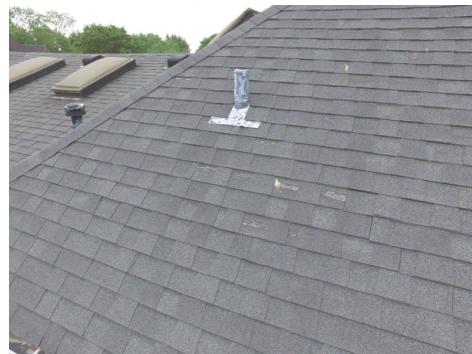
GRANULES MISSING/EXPOSED FELT

Asphalt shingles have missing granules/exposed felt. Recommend a roofing professional evaluate and repair as needed.

Contact a qualified roofing professional.

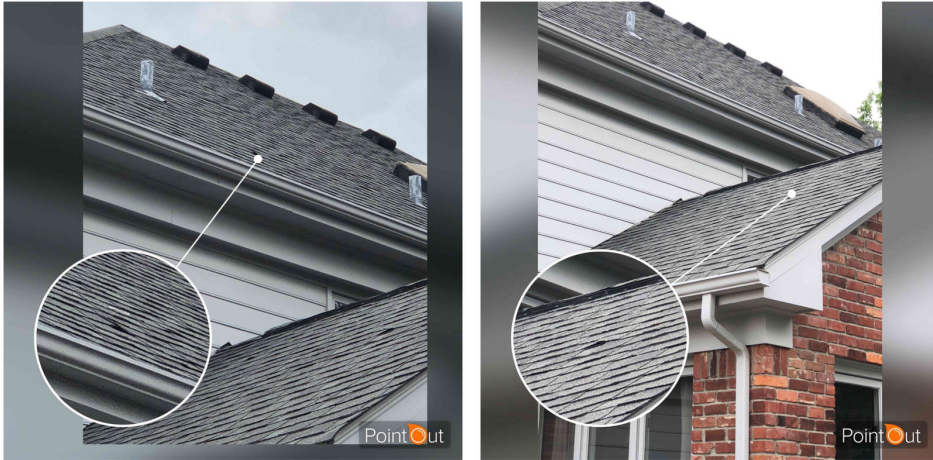
Visible nail pops in roof coverings. Recommend roofing professional evaluate and repair.

Contact a qualified roofing professional.

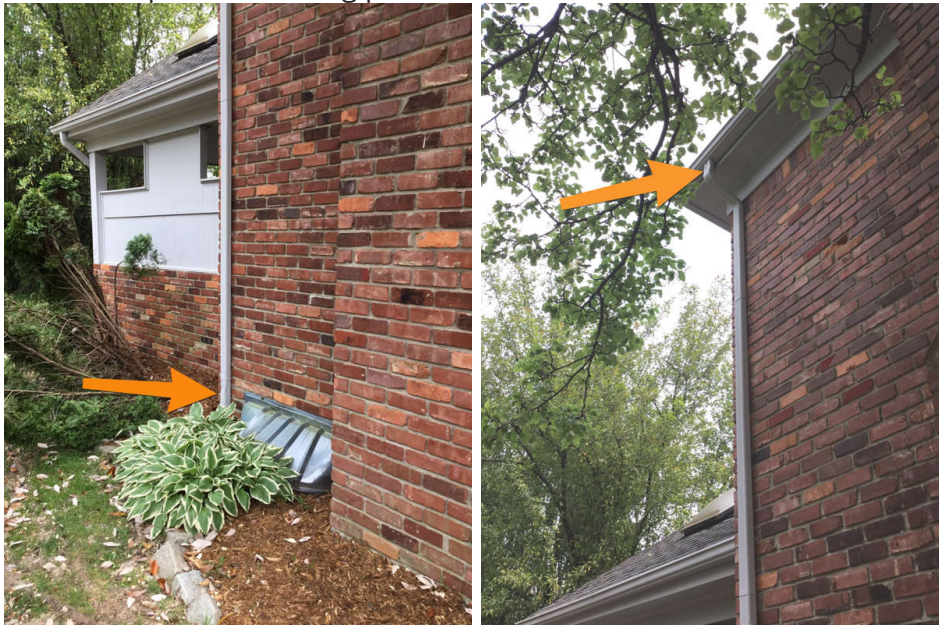
North

DOWNSPOUT DAMAGED

Downspouts were damaged. This can result in excessive moisture in the soil at the foundation, which can lead to foundation/structural movement. Recommend a qualified contractor evaluate and repair.

Contact a qualified roofing professional.

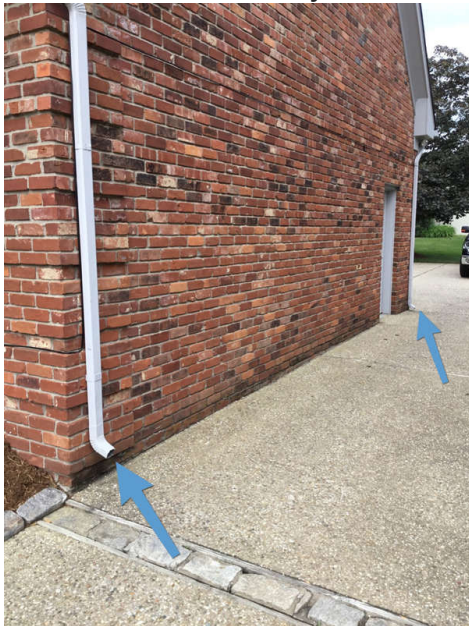
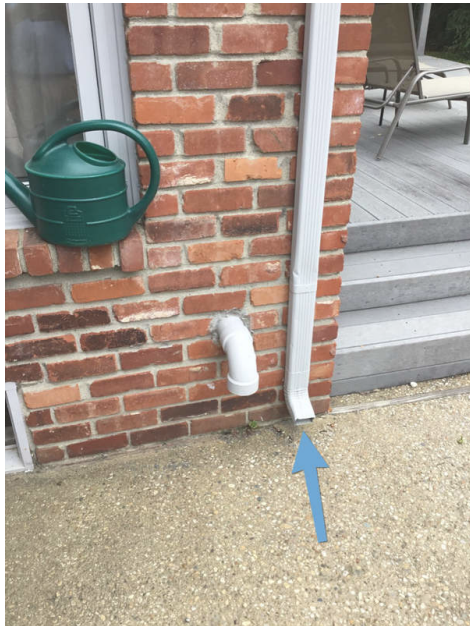
One or more downspouts drain too close to the home's foundation. This can result in excessive moisture in the soil at the foundation, which can lead to foundation/structural movement. Recommend a qualified contractor adjust downspout extensions to drain at least 6 feet from the foundation.

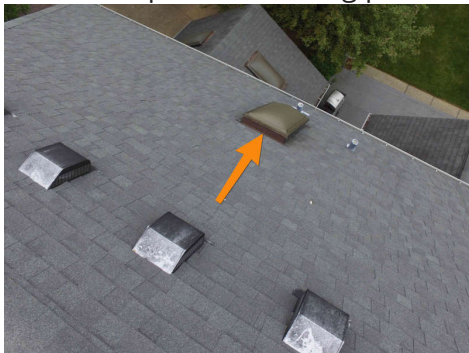
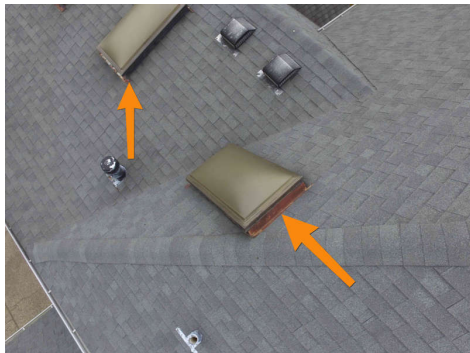
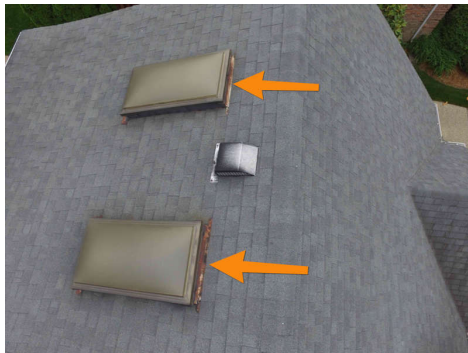
CORRODED - MINOR

Roof flashing showed signs of corrosion, but are still in working condition. Flashing should be evaluated and monitored to prevent severe corrosion leading to moisture intrusion.

Contact a qualified roofing professional.

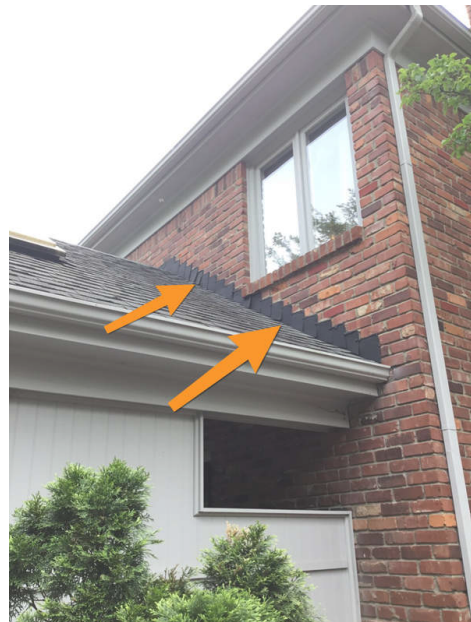
East

LOOSE/SEPARATED

Flashings observed to be loose or separated, which can lead to water intrusion and/or mold. Recommend a qualified roofing contractor repair.

Contact a qualified roofing professional.

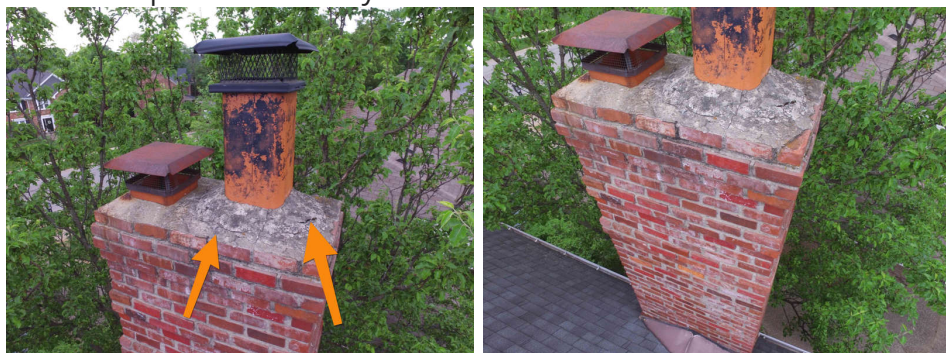
CHIMNEY CAP CRACKED

Chimney cap was visibly cracked. Recommend repair

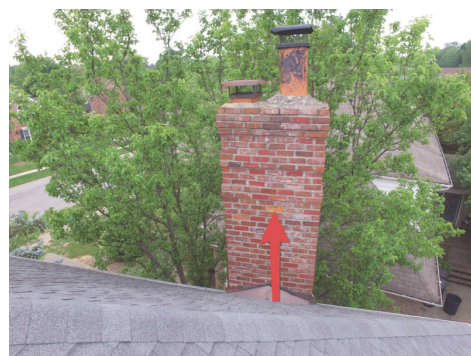
FLAKING/SPALLING BRICK

Chimney has visible flaking/spalling brick. Damaged/loose bricks present a potential safety hazard. Recommend repair.

Contact a qualified masonry professional.

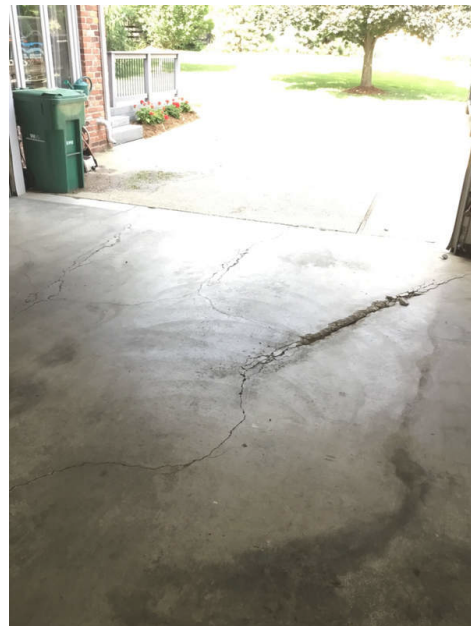
LARGE CRACKS/DAMAGE

Garage floor has large cracks and damage. Recommend concrete contractor evaluate and repair to preserve concrete slab

Contact a qualified concrete contractor.

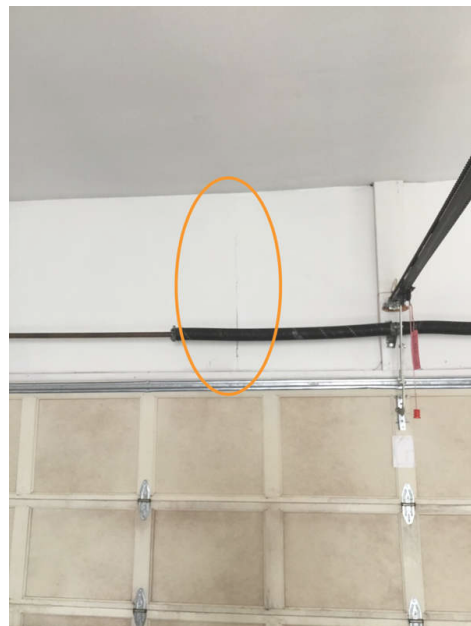
TYPICAL CRACKS/DAMAGE

Garage walls were noted as having typical cracks/damage. Recommend repair of cracked/damaged drywall

Contact a qualified drywall contractor.

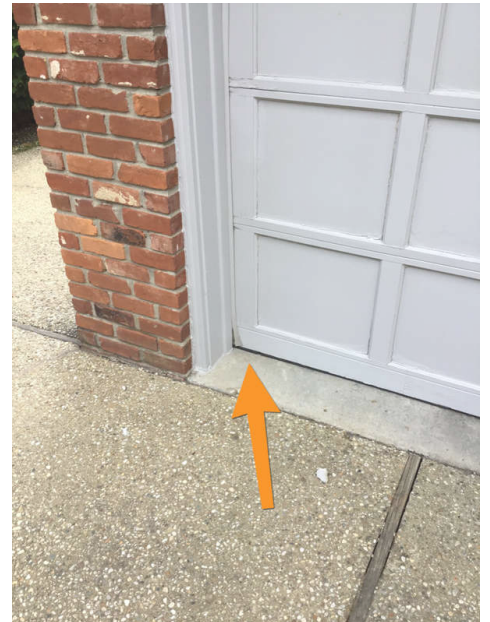
WEATHER STRIPPING DAMAGED

Overhead garage door weather stripping was noted as damaged.
Recommend repair/replacement of damaged sections

Contact a qualified garage door contractor.

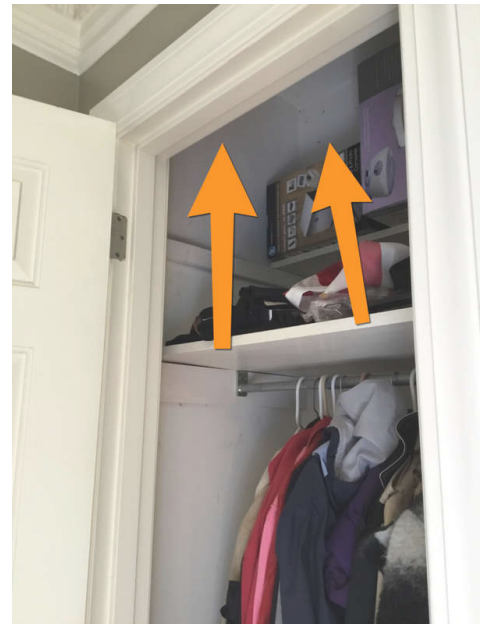
Foyer

WOOD DESTROYING INSECT DAMAGE

Wood Destroying Insect Damage apparent. Recommend further evaluation for damages and repair as needed

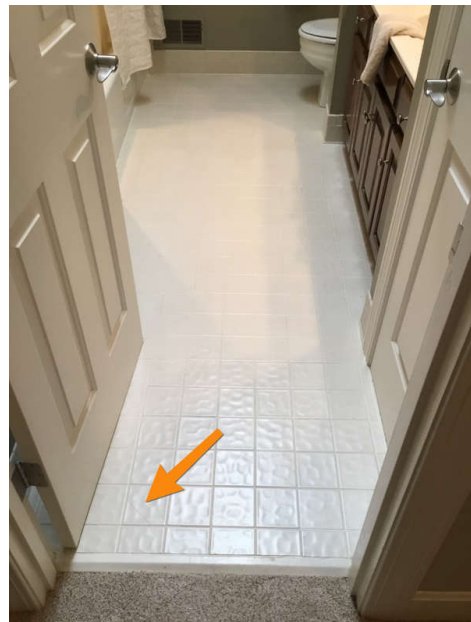
2nd Floor Bathroom

TILES CRACKED/DAMAGED

Floor tiles are visibly cracked/damaged. Recommend tile contractor repair/replace damaged tiles.

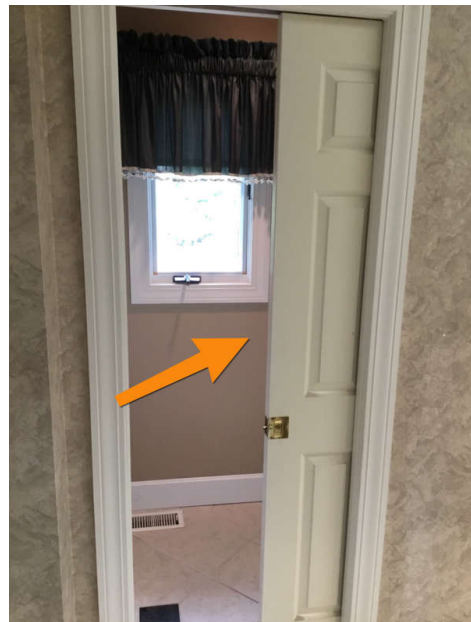
Master Bathroom

Door doesn't latch properly. Recommend handyman repair to ensure proper operation

Contact a qualified handyman.

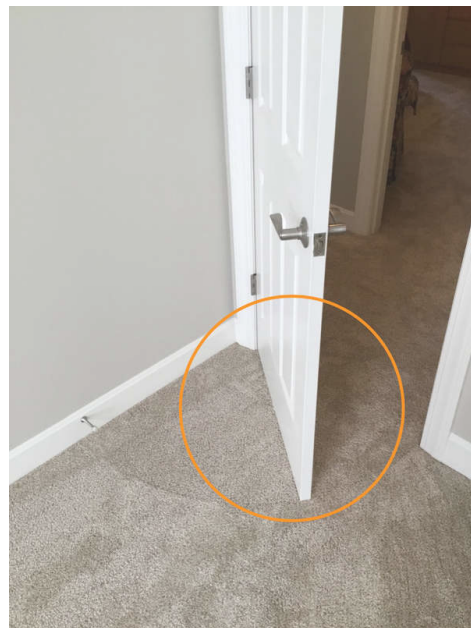
Left Bedroom

Door(s) is dragging carpet when operated. Recommend adjusting to ensure proper operation.

Contact a qualified door repair/installation contractor.

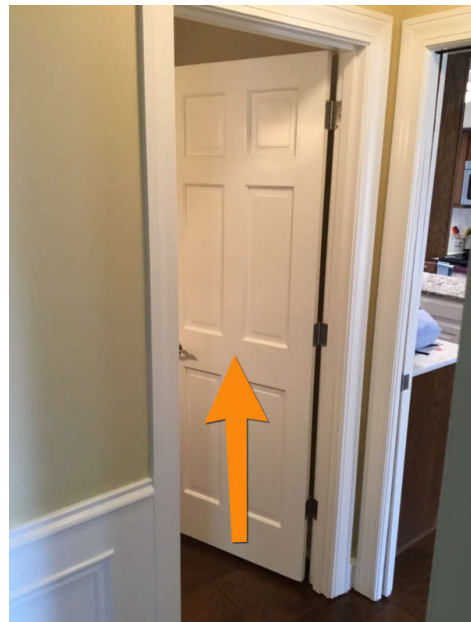
Door is noticeably Warped/Twisted. Recommend repair/replacement as needed

Contact a qualified door repair/installation contractor.

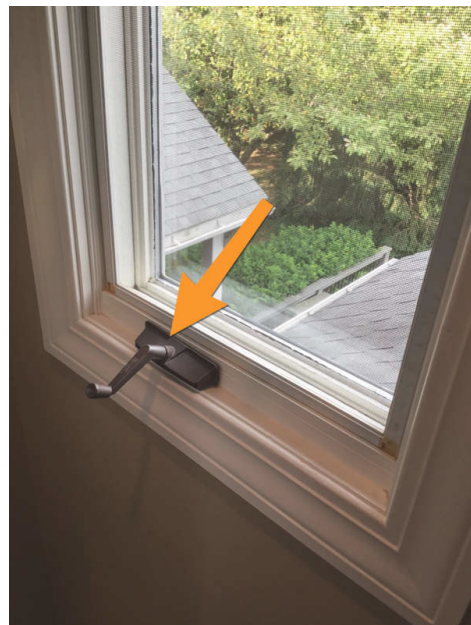
DAMAGED/MISSING HARDWARE

Some windows have damaged/missing hardware. Recommend repairing to ensure proper operation.

Contact a qualified window repair/installation contractor.

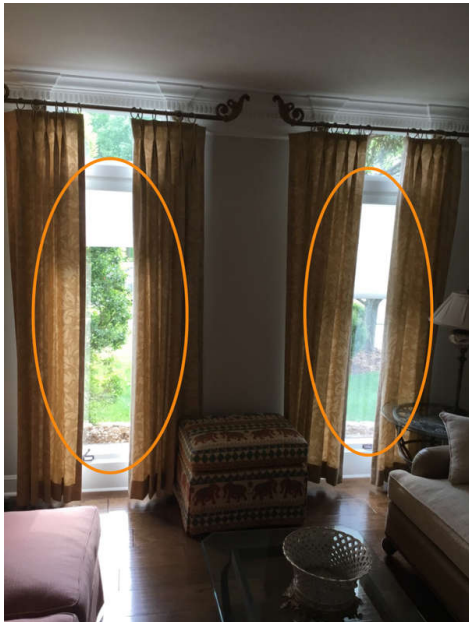
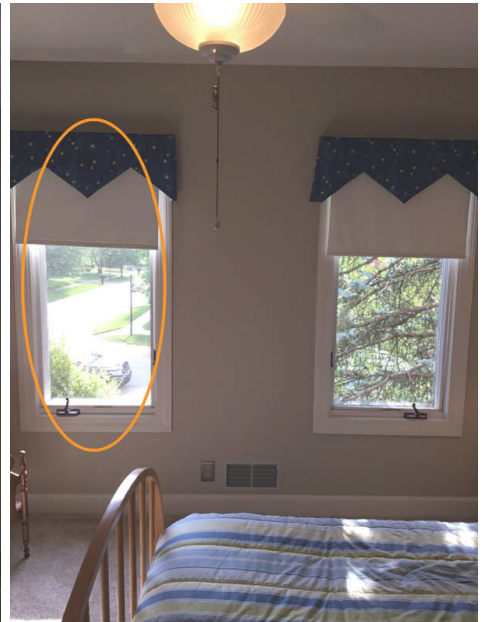
Window will not open under normal operating procedures. Recommemd repair.

Contact a qualified window repair/installation contractor.

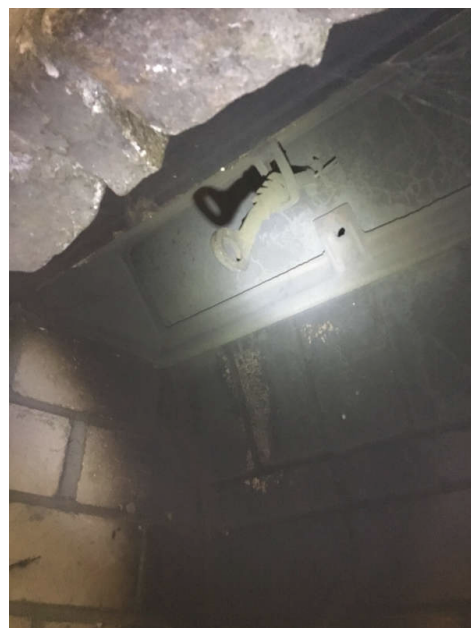
Chimney liner had layer of creosote dust, so underlying structure couldn't be inspected for cracks. Recommend qualified chimney sweep company inspect and/or clean.

Contact a qualified chimney contractor.

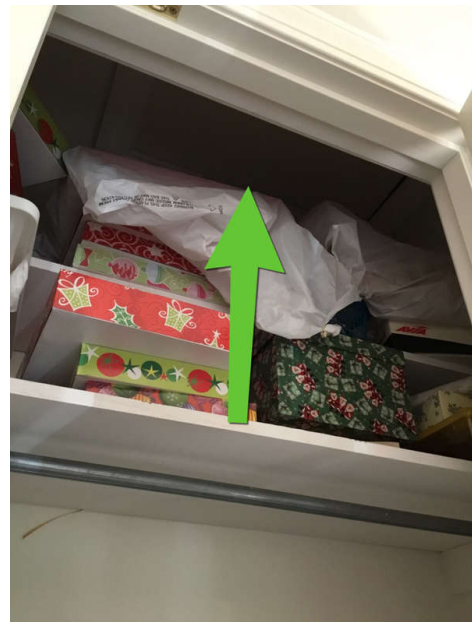
ACCESS LIMITED DUE TO OBSTRUCTIONS

Attic access was limited to inspecting from access due to obstructions. Recommend further inspection of attic and repair as necessary

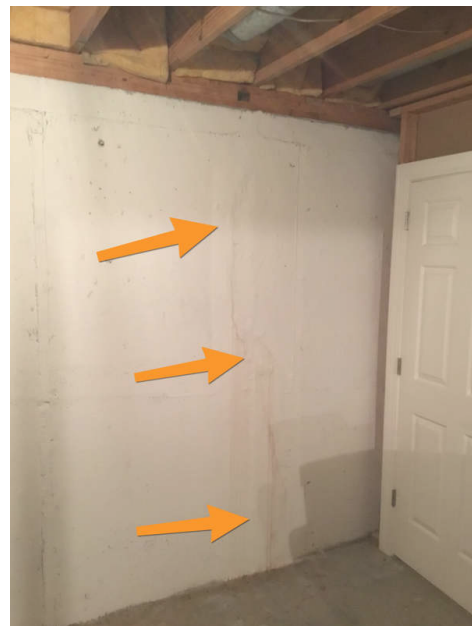
INTERIOR FOUNDATION CRACKS - MINOR

Minor cracking was noted at the foundation. This is common as concrete ages and shrinkage surface cracks are normal. Recommend repairing/sealing cracks and monitoring for more serious shifting/displacement.

Contact a foundation contractor.

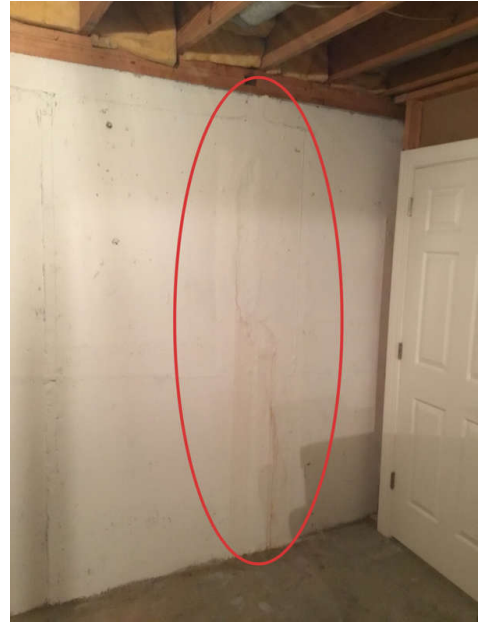
Water intrusion was evident in the basement/crawlspace. This can compromise the basement/crawlspace and could cause damage. Recommend a qualified contractor identify the source of moisture and remedy.

Contact a foundation contractor.

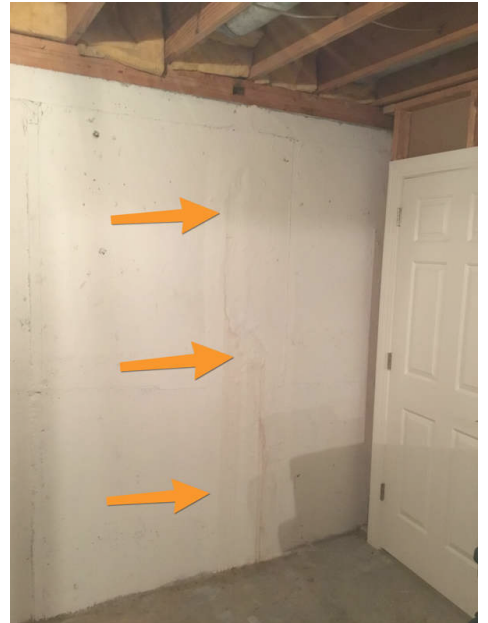
REPAIRED/WATERPROOFED FOUNDATION CRACKS

Visible Repaired/Waterproofed Foundation Cracks were noted at time of inspection. Recommend obtaining any warranty information from owner and monitoring

Contact a qualified professional.

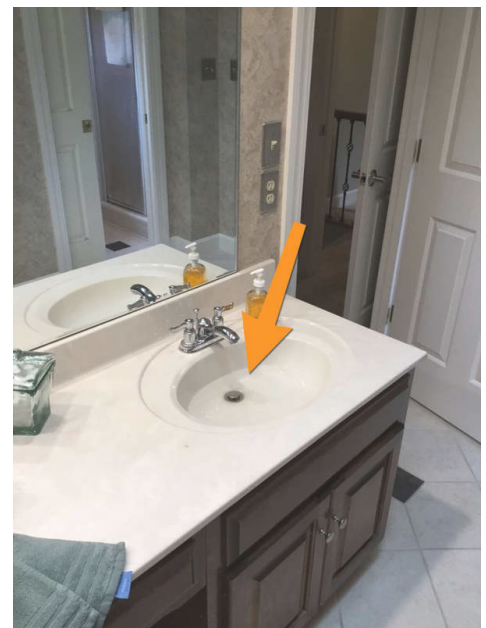
Master Bathroom

Poor/slow drainage was observed at time of inspection. Recommend a qualified plumber evaluate and repair.

Contact a qualified plumbing contractor.

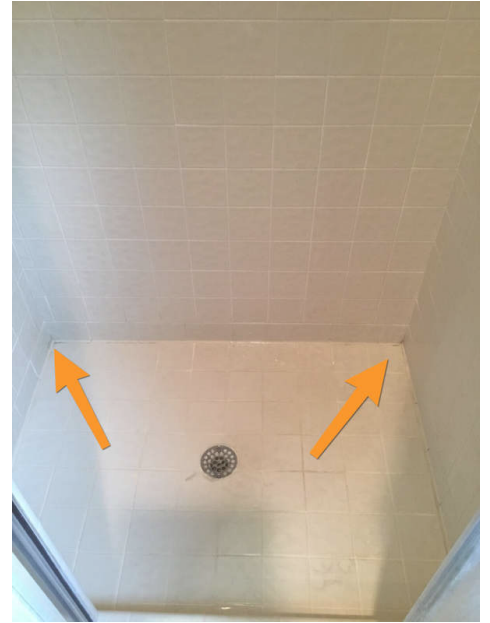
Master Bathroom

Recommend caulking/grouting shower surround where caulk/grout is cracked/separated/missing. This will help prevent moisture damages from occurring.

Contact a qualified professional.

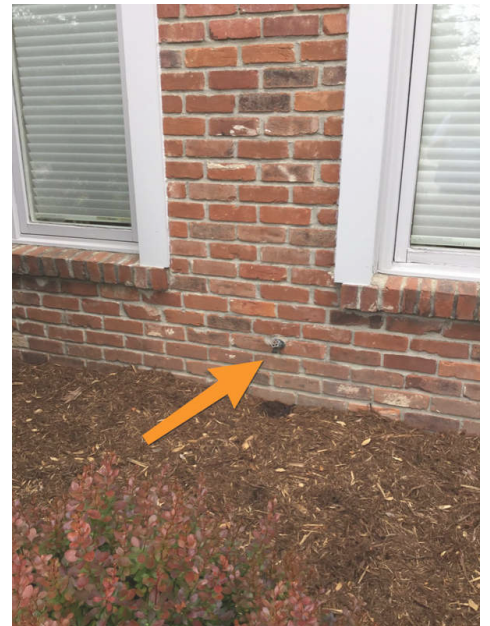
West

**HOSE BIB LEAKING/DRIPPING**

Hose bib is leaking/dripping. Recommend plumber evaluate and repair

Contact a qualified plumbing contractor.

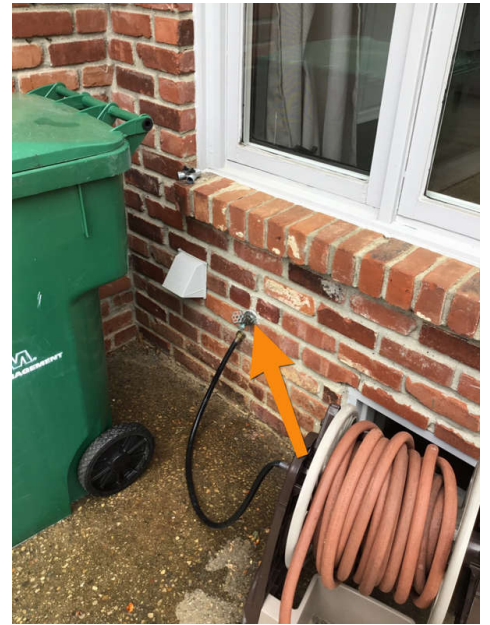
East

Hose bib is not properly secured to exterior of home. Recommend anchoring hose bib to home.

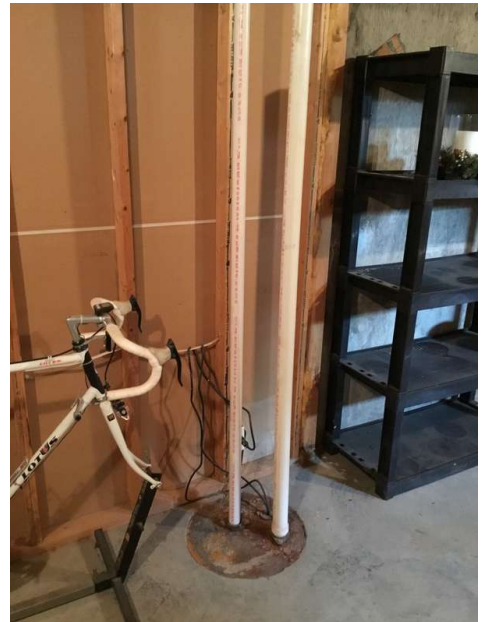
Recommend installing check valve on sump pump discharge line

Contact a qualified plumbing contractor.

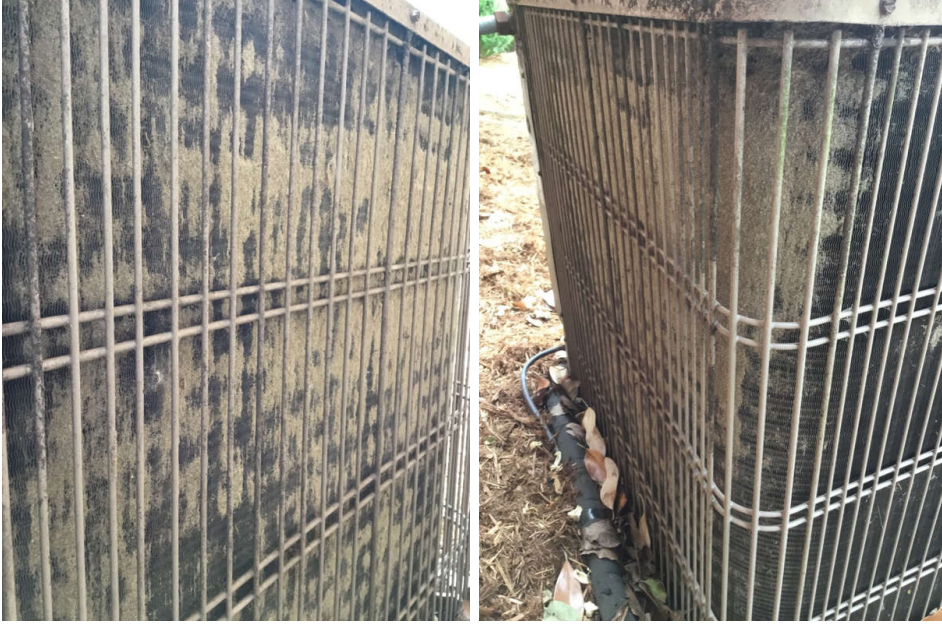
Air flow to the air conditioner condenser was restricted. This may result in inefficient operation. Recommend cleaning dirt and/or debris from unit.

Contact a qualified HVAC professional.

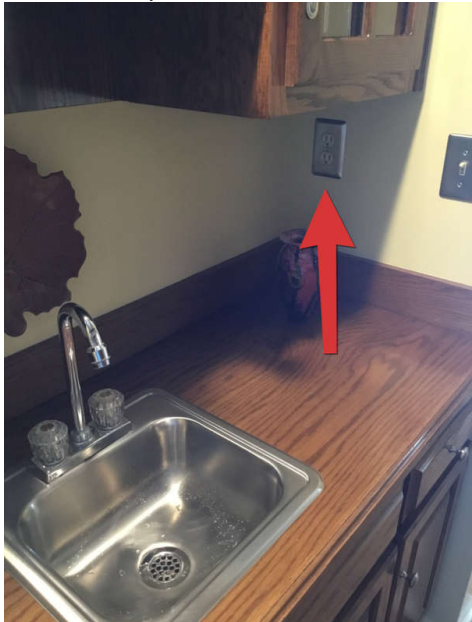
Living Room

No GFCI protection present in noted locations. Recommend licensed electrician upgrade by installing ground fault receptacles in all noted locations.

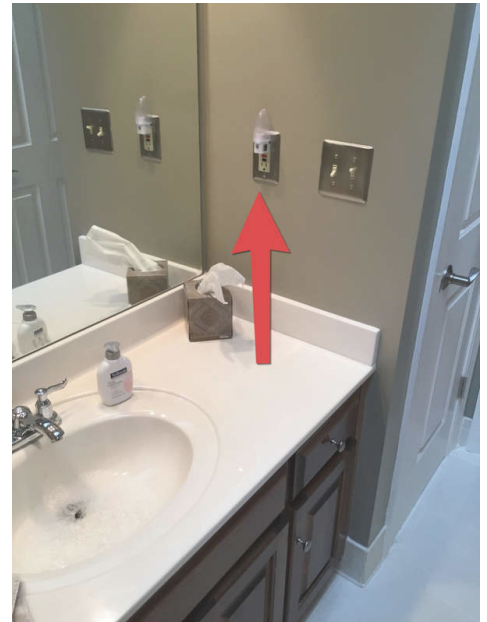
2nd Floor Bathroom

One or more outlets won't "trip" when tested. Recommend a qualified electrician evaluate and repair.

Contact a qualified electrical contractor.
