C & H FULL HOME INSPECTION REPORT

1234 Main St.
Ormond Beach Fl 32174

08/07/2018 9:00AM

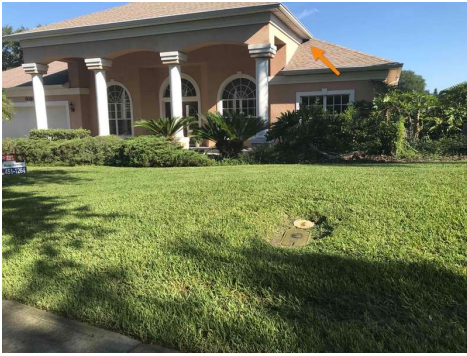
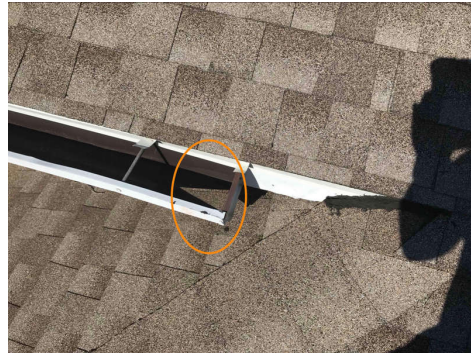
2.3.1 Gutters/drains

GUTTER DRAINS ON ROOF

One or more downspouts terminated above a roof surface, and rainwater from the downspouts washes over the roof surface below. This is a common configuration, but in some cases large quantities of rainwater can damage shingles by removing granules and reduce the life of the roof surface. Consider installing extensions to route the rainwater directly to the closest gutter below to prevent such damage.

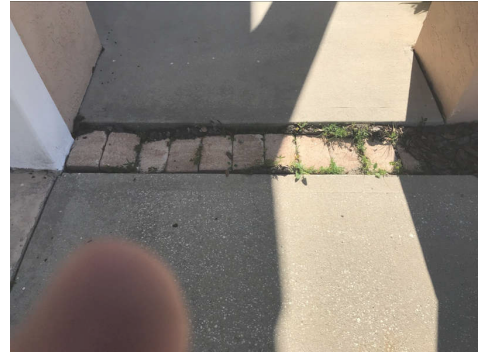
3.1.1 Driveway & Walkway

PAVERS-UNEVEN

The pavers in the driveway and rear patio are uneven in several locations. This can cause premature settlement in several areas leaving lips where the pavers meet. The pavers should be evaluated and reset as necessary.

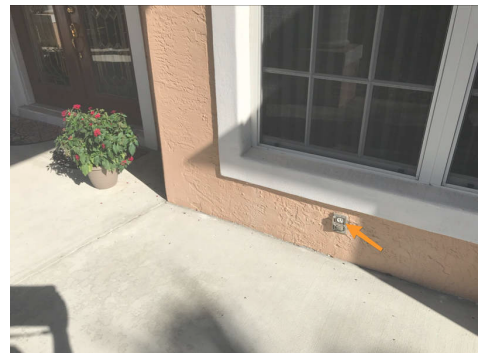
3.3.1 Electrical

WATERPROOF COVER DAMAGED

Waterproof cover(s) over one or more electric receptacles are damaged or broken. This is a safety hazard due to the risk of shock and fire. Damaged covers should be replaced where necessary.

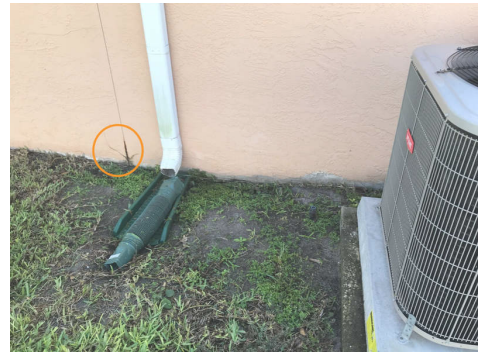
3.8.1 Wall Structure & Coverings

STUCCO-CORNER RUST

Metal corner bead used for stucco was corroded at one or more locations.

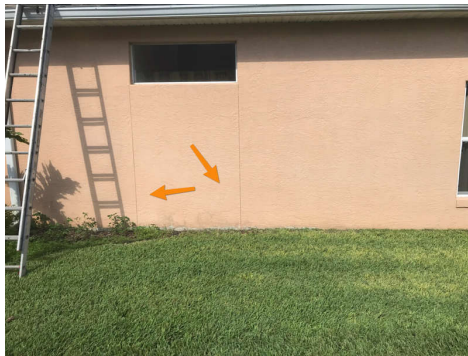
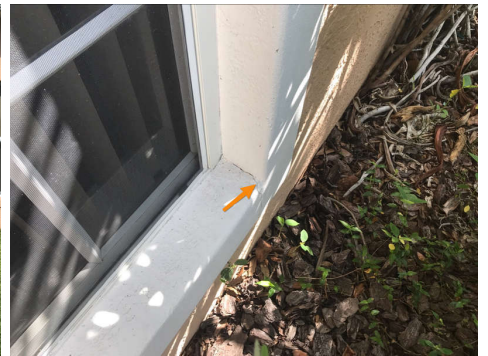
3.8.2 Wall Structure & Coverings

CRACKING-MINOR

One or more minor cracks were found in the wall areas. It is unknown the age of these cracks. At the time of inspection nothing out of the ordinary of normalized cracking was noticed. Recommend caulking and painting these areas, along with monitoring for future movement/widening. Cracks over framing can allow moisture penetration behind wall areas and can potentially damage sheathing/framing. Note that areas concealed behind walls are not able to be evaluated without invasive testing and cannot be evaluated.

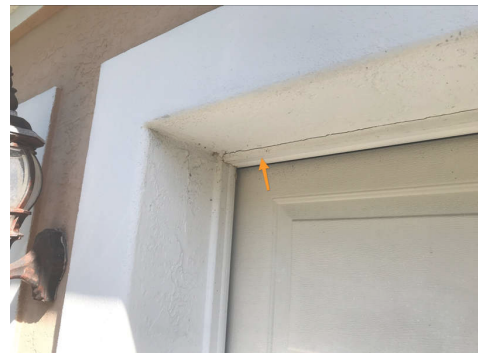
3.8.3 Wall Structure & Coverings

SIDING/TRIM ISSUES

Sections of siding and/or trim were *deteriorated / loose / split / warped / missing / damaged / substandard / rotten*. Recommend that a qualified person repair, replace or install siding or trim as necessary.

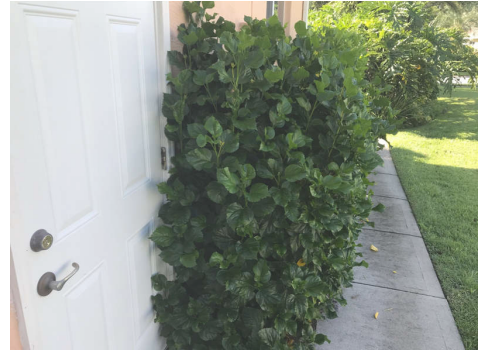
3.9.1 Vegetation and Grading

VEGETATION

Vegetation such as trees, shrubs and/or vines was in contact with or close to the building exterior. Vegetation can serve as a pathway for wood-destroying insects and can retain moisture against the exterior after it rains. This is a conducive condition for wood-destroying organisms. Recommend pruning, moving or removing vegetation as necessary to maintain at least 6 inches of space between it and the building exterior. A 1-foot clearance is better.

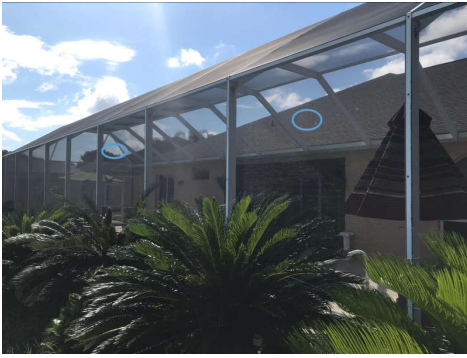
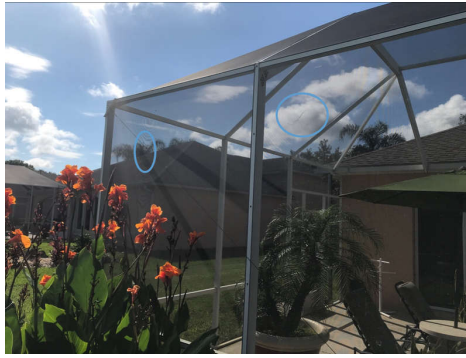
3.12.1 Screen Enclosure

SCREEN ENCLOSURE SCREEN TORN/PATCHED

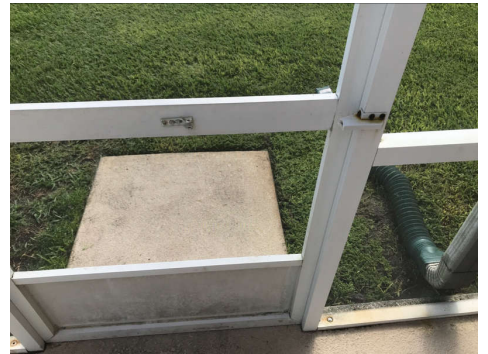
3.12.2 Screen Enclosure

SCREEN DOOR CLOSURE

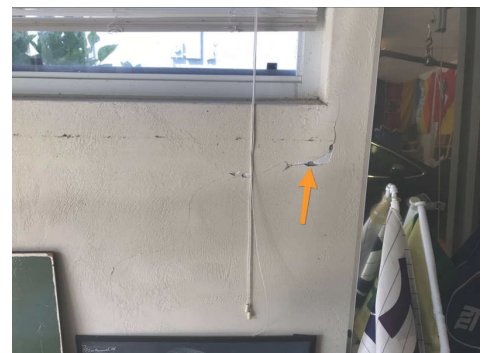
4.1.1 Floors, walls, Ceiling

CEILING/WALL DAMAGE

There is damage to the ceiling/wall. This can allow gases and fumes to enter the homes living spaces. These areas should be properly finished.

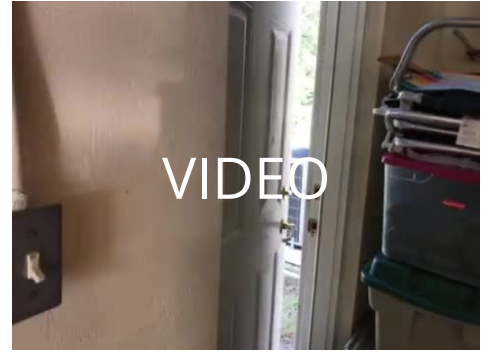
4.2.1 Doors/Windows

EXTERIOR DOOR DIFFICULT

One or more exterior doors were difficult or sticking. Recommend that a qualified person repair as necessary.

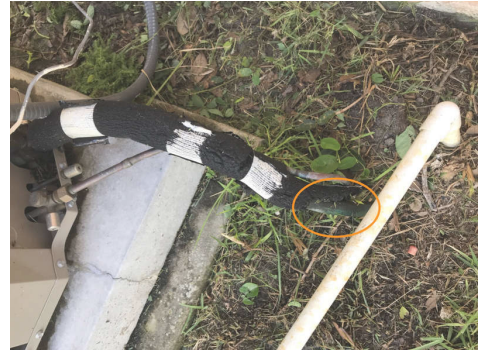
5.2.1 Condensing Unit

Observations/Monitor**LINE INSULATION**

Insulation for the outside condensing unit's refrigerant lines is damaged, deteriorated and/or missing in one or more areas. This may result in reduced efficiency and increased energy costs. A qualified heating and cooling contractor should replace insulation as necessary.

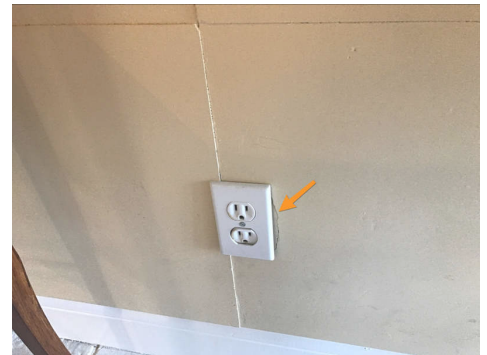
8.3.1 Branch Circuit

RECEPTACLE DAMAGE

One or more receptacles were broken or damaged. This is a potential shock or fire hazard. Recommend that a qualified electrician replace such receptacles as necessary.

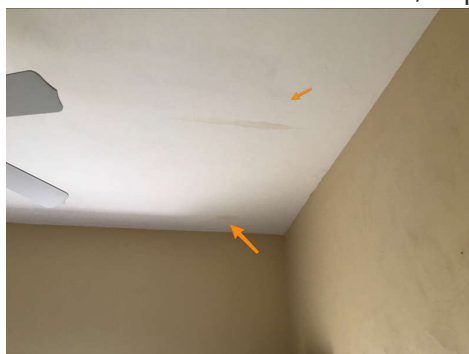
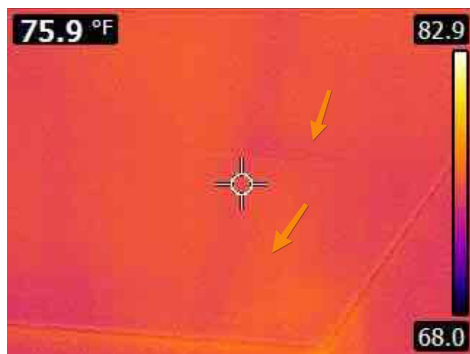
10.2.1 Floors, Walls, Ceilings

CEILING-DRY STAINS

Stains were found in one or more ceiling areas. However, no elevated levels of moisture were found. The stain(s) may be due to past roof and/or plumbing leaks. Recommend asking the property owner(s) about this, and monitoring the stained area(s) in the future, especially after heavy or prolonged rain. If elevated moisture is found in the future, a qualified contractor should evaluate and repair as necessary.

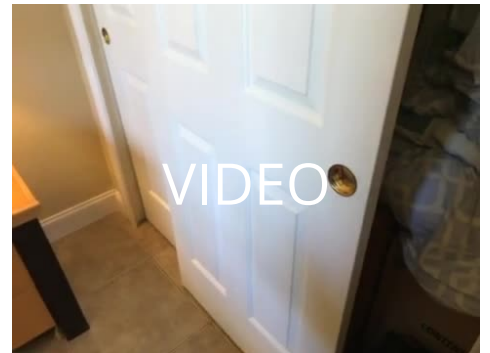
12.3.1 Windows and Door

CLOSET DOORS

One or more closet doors are missing, damaged or need repairs. It is recommended to have the necessary repairs or replacement of the closet door (s).

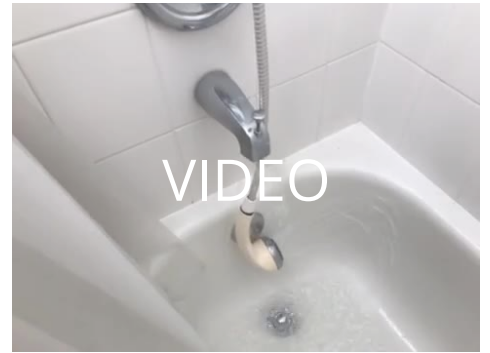
15.8.1 Bathub

MIXING VALVE

The mixing valve in one or bathrooms is not properly operating. The mixing valve allows the hot and cold water to mix so the temperature can be controlled by any person. The mixing valve is not properly mixing hot and cold water at the valve. There is only hot or cold water coming out of the mixing valve. It is recommended to have a Certified Plumbing Contractor make the necessary repairs.

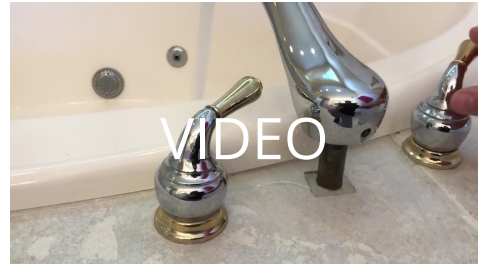
17.8.1 Bathub

FAUCET LEAKS ON

One or more faucets leak by handle(s) or at their base when turned on. A qualified plumber should evaluate and repair as necessary.

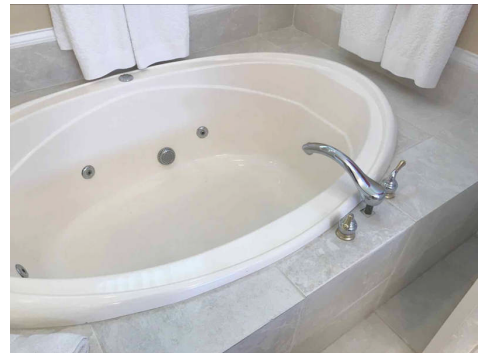
17.8.2 Bathub

JETTED TUB INOPERABLE

The jetted tub was inoperable. The tub should be evaluated and repaired as needed.

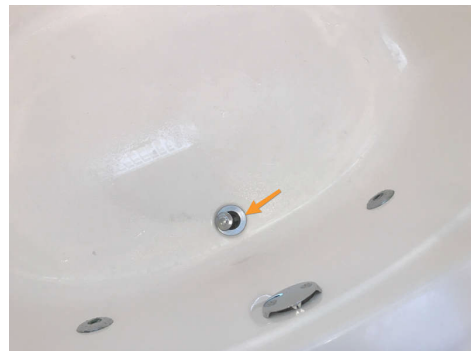
17.8.3 Bathub

STOPPER ISSUE

The bath tub stopper mechanisms are missing, or need adjustment or repair. Stopper mechanisms should be installed where missing and/or repairs should be made so sink stoppers open and close easily.

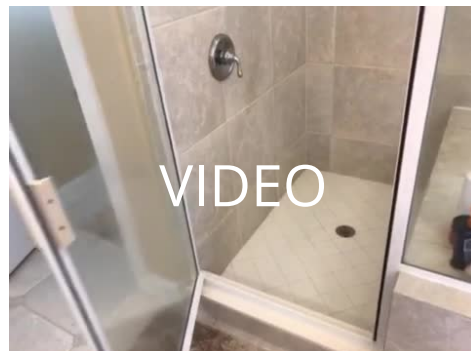
17.9.1 Shower

SHOWER DOOR

The shower door does not properly close on the rail. The shower door should be repaired or replaced to prevent damage to the door.

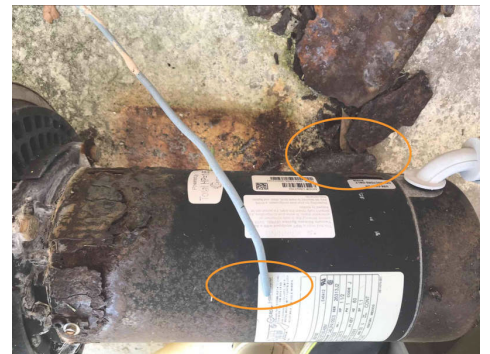
21.1.1 Pool Equipment

BONDING

The bonding wire is missing or not properly connected to the pool circulation pump and or other pool equipment. It is highly recommended to have the wire properly installed for safety.

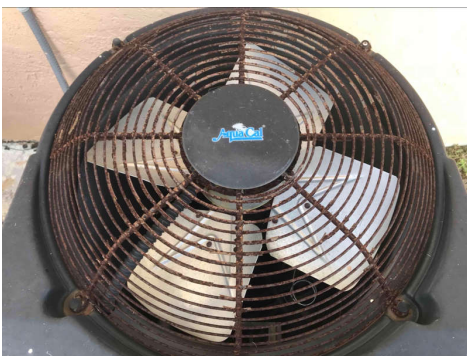
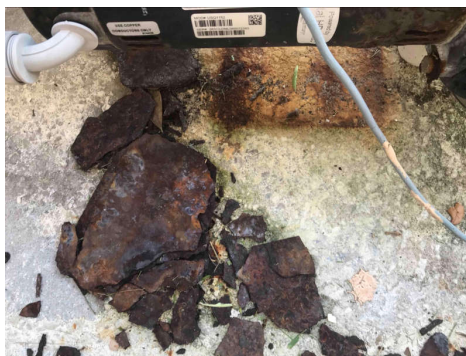
21.1.2 Pool Equipment

EQUIPMENT EVALUATION

Because of the age and condition of the equipment, It is recommended that the pool pump and filter system be evaluated. It's also advised to seek guidance for the proper operation and maintance of the pool equipment as many systems differ.

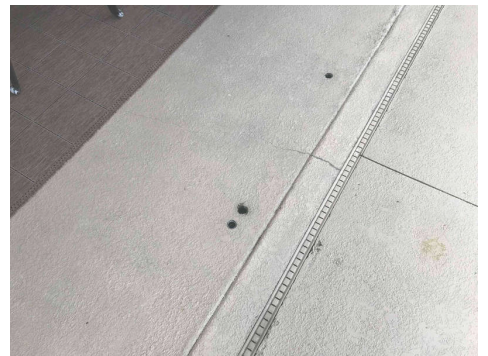
21.4.1 Pool and decking

DECK CRACKING MINOR

The pool deck has some minor deck cracking. It does not appear to be structural at this time, but it is recommended to monitor the area(s) in concern in the future.
