SLAB TO SLATE HOME INSPECTIONS, LLC

HOME INSPECTION REPORT

1234 Main St.
Newport KY 41071

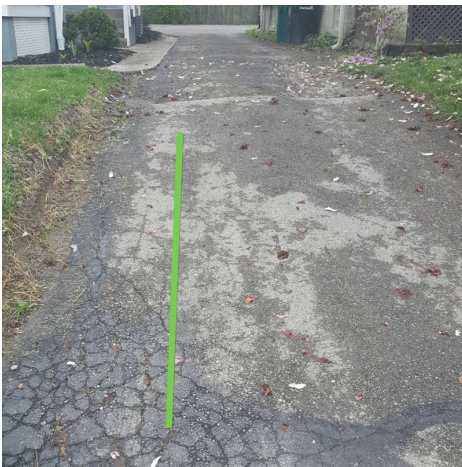
Walkways, Patios & Driveways: Shared Driveway

The driveway appears to be shared with a neighboring property. It is recommend that you fully understand the property division and maintenance division prior to purchasing the home.

Property line

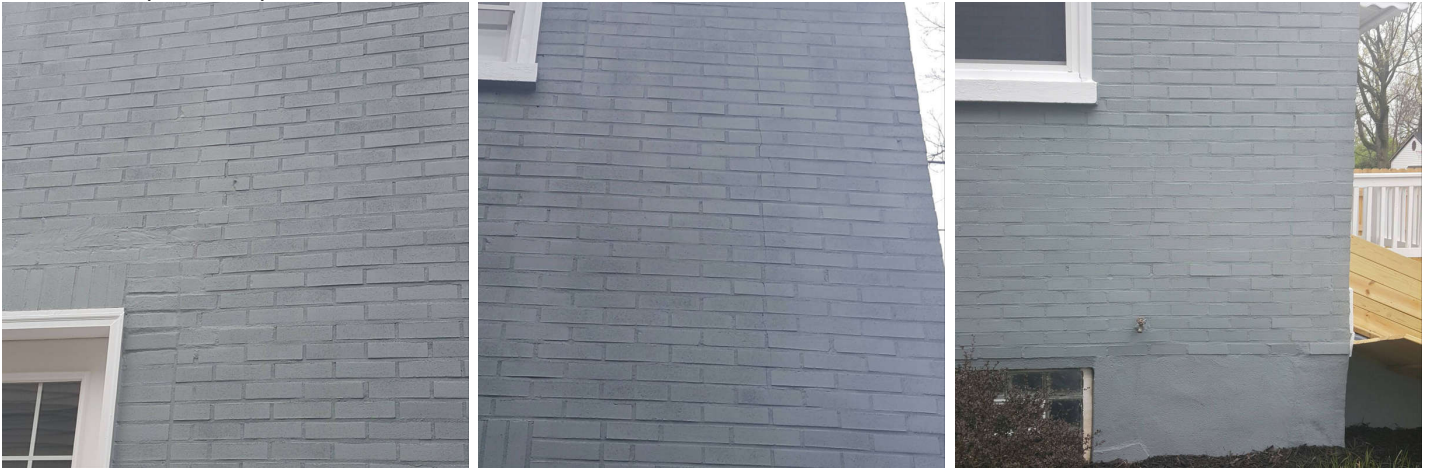
3.2.1 Siding, Flashing & Trim

Moderate Concern
CRACKING / CRUSHING OF FAUX BRICK

This home is constructed with a faux brick siding. The siding showed cracking and / or recent repairs in one or more areas. This is likely representative of damage to the internal wood frame structure. Cracking can be from structural movement, rusting lintels above windows, water intrusion, etc. Enough damage was visible at the interior that it should be assumed that there is also hidden damage because many areas where the siding is crushed or cracked was not visible from the exterior. Invasive inspection is recommended.

Contact a qualified professional.

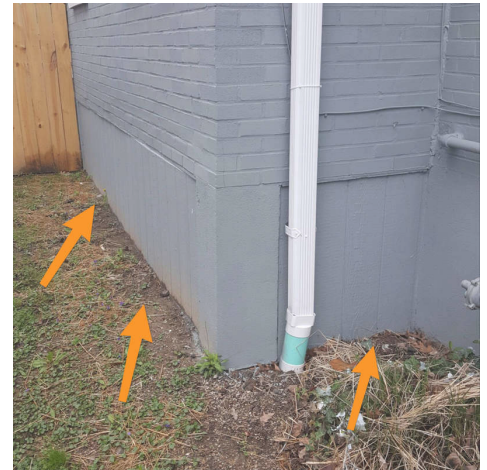
3.2.2 Siding, Flashing & Trim

Without proper air space the trim can rot. Materials behind the trim may also rot. This is also conducive conditions for wood destroying insects. Termite activity and damage was visible at the interior of this area. Recommend installing material appropriate for ground contact.

Contact a qualified professional.

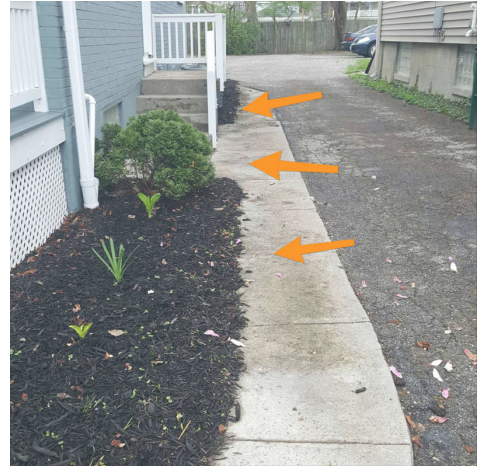
3.4.1 Walkways, Patios & Driveways

When a hard surface such as a driveway, sidewalk, or patio slopes toward the house it can direct a very large amount of water towards the foundation. Over time this water can cause foundation damage. Foundation repairs were noted in the adjacent area.

The concrete appears to be at the end of its life and removal/replacement is recommended.

Contact a qualified concrete contractor.

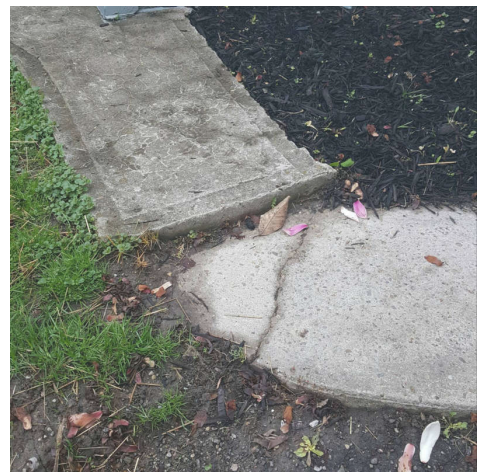
3.4.2 Walkways, Patios & Driveways

TRIP HAZARD

Trip hazards observed. Patch or repair recommended.

Contact a qualified concrete contractor.

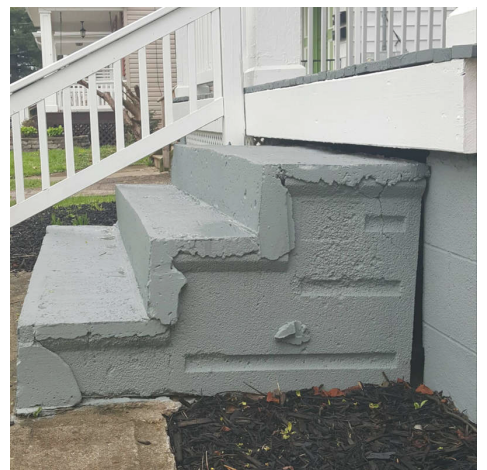
3.5.1 Stairs, Steps, & Stoops

RISERS ARE UNSAFE

Riser heights that are more than 7 3/4 inches and vary by more than 3/8 inch can be a safety hazard. Repair is recommended.

Contact a qualified professional.

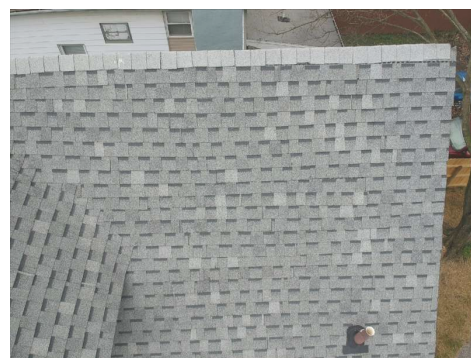
IMPROPER/INCOMPLETE NAILING

Roof coverings showed signs of improper installation and fastening. The shingles are not properly aligned and the seal strip is visible in multiple locations. Recommend a qualified roofing contractor evaluate and repair.

Contact a qualified roofing professional.

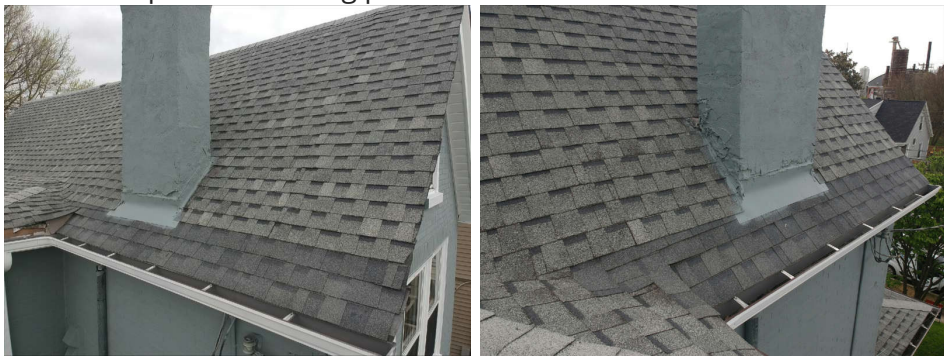
4.2.2 Coverings

REPAIRED

A portion of the roof has recently been repaired. Inquire with the seller as to the history of these repairs. This is typically a sign that the roof is nearing the end of its life and replacement should be budgeted for.

Contact a qualified roofing professional.

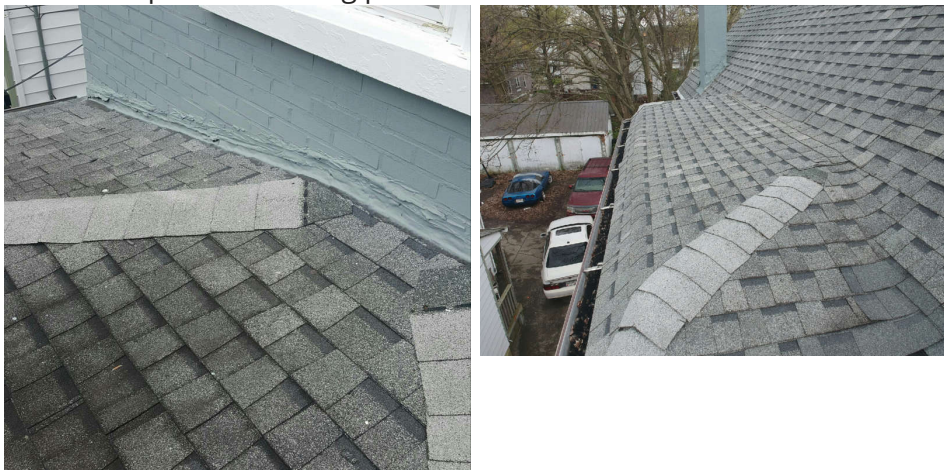
4.2.3 Coverings

TOO FLAT FOR SHINGLES

The roof is less than 2/12 pitch. Shingle manufacturers do not have provisions for installations below 2/12 pitch. Recommend removing the shingles and installing an appropriate roof covering.

Contact a qualified roofing professional.

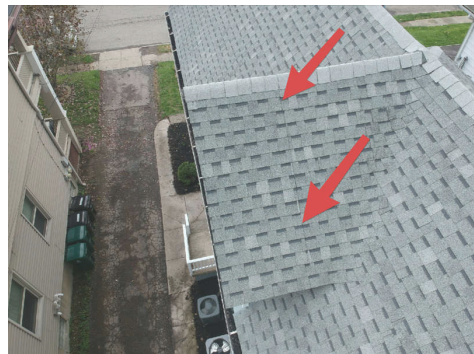
4.2.4 Coverings

IMPROPER INSTALLATION

It appears the shingles line up in more than one area or have been lapped incorrectly. Recommend a full evaluation of the roof installation by a qualified roofing professional.

Contact a qualified roofing professional.

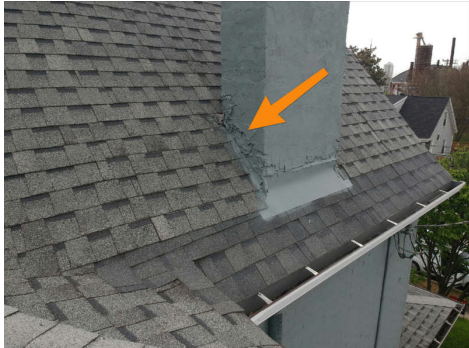
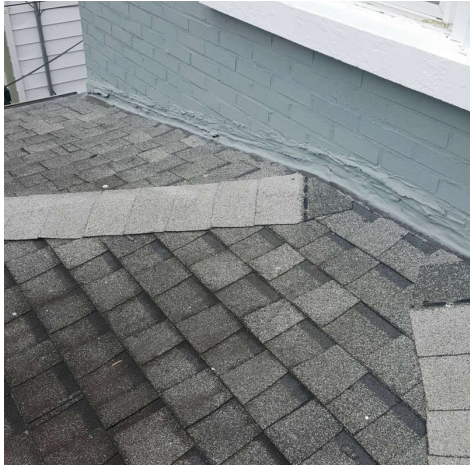
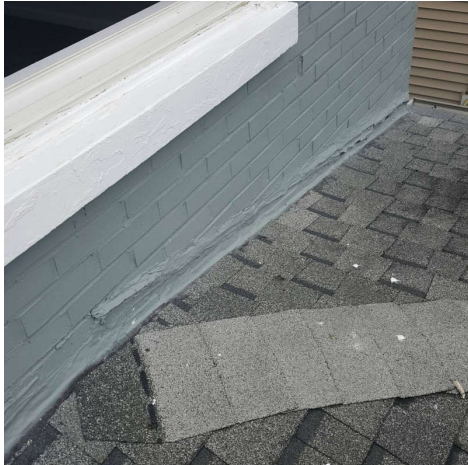
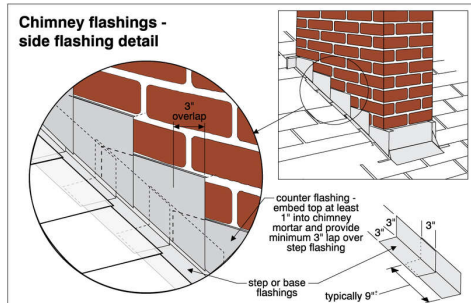
4.3.1 Flashings

COUNTER FLASHING IS MISSING OR DAMAGED - BRICK

Contact a qualified roofing professional.

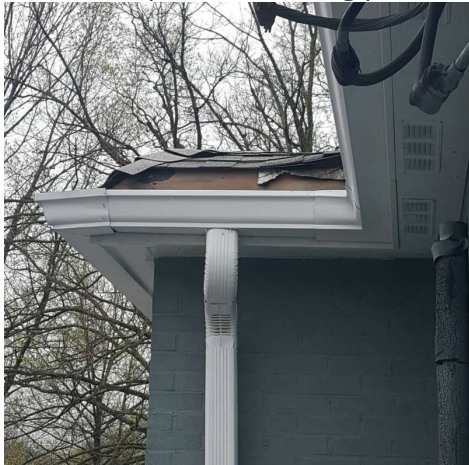
4.3.2 Flashings

DRIP EDGE FLASHING IS MISSING

Contact a qualified roofing professional.

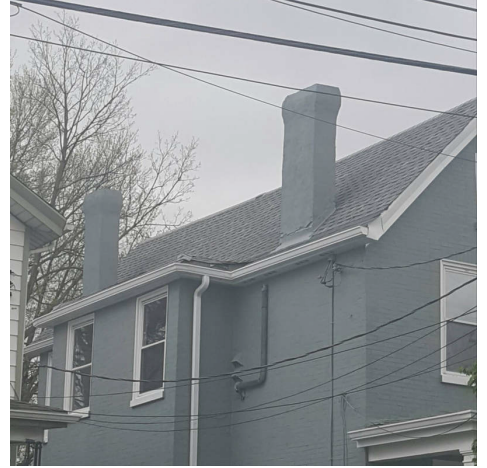
4.4.1 Chimneys

CHIMNEY SPARK ARRESTOR / WEATHER CAP MISSING

A spark arrestor / weather cap can keep rain and animals out of the flue and can greatly prolong the life of the chimney. Recommend adding a spark arrestor / weather cap.

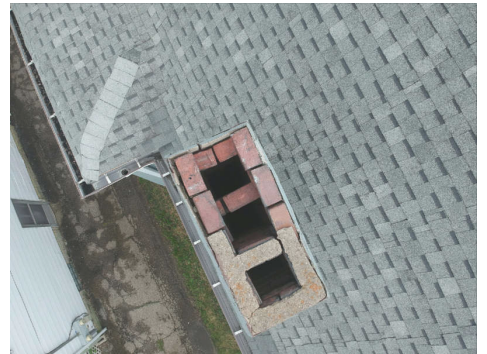
4.4.2 Chimneys

UNLINED CHIMNEY

Chimney was unlined, which can deteriorate the chimney structure and allow harmful gasses to enter home. Recommend a qualified masonry or chimney contractor install a liner.

NOTE: This condition can simulate a persistent roof leak at the interior of the home. The condensation of the gases and water entering from the top can make its way into the home. If a persistent leak is noted in the area adjacent to the chimney this condition should be remedied first, and then further evaluation made to determine if the leak continues.

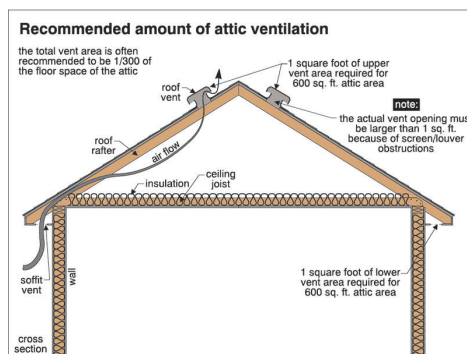
ATTIC VENTILATION MAY BE INADEQUATE

There is no visible attic ventilation. Inadequate ventilation can lead to reduced roof covering life. Without proper venting, moisture can build up in the attic, potentially causing mold growth. The excessive heat may also damage roof decking and roof shingles as well as cause cooling equipment to work harder.

Generally one square foot of free vent is required for every 300 square feet of floor area. This is typically accomplished through a balanced combination of soffit and ridge / roof vents. Cooler air enters through soffit vents and warmer air exits through ridge or roof vents. In situations where soffit vents are not possible, a power vent with a humidistat may also be used.

Recommend a qualified professional evaluate and modify / add ventilation as necessary

Contact a qualified roofing professional.

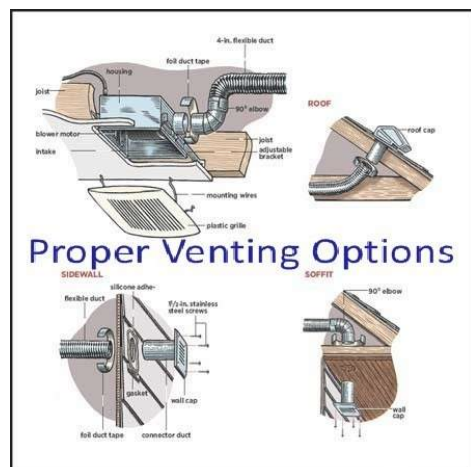
5.8.1 Exhaust Systems

Humidity buildup can be very inefficient on your cooling system and can lead to mold or other damage over time. All bathrooms are recommended to have exhaust fans to expel humidity to the exterior of the home.

Recommend a qualified contractor install a bath fan that exhausts to the exterior of the home.

Contact a qualified professional.

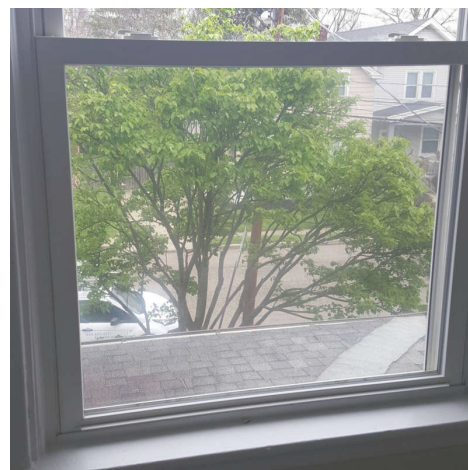
FAILED SEAL

Observed condensation between the window panes, which indicates a failed seal. Replacement or repair will depend greatly on the window type/brand/style.

Contact a qualified window repair/installation contractor.

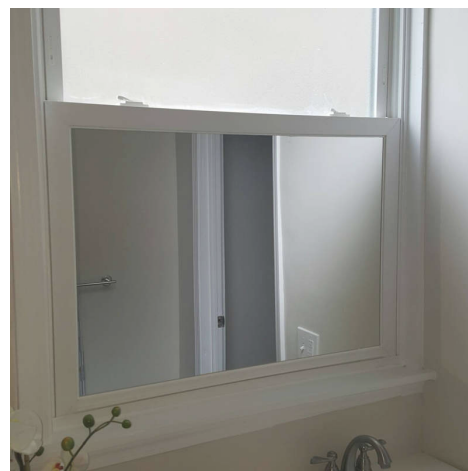
6.2.2 Windows

UNSAFE MODIFICATION

A mirror has been installed / attached to the window pane. This is not a safe installation as the mirror will likely come loose and fall out after some time. The window would have to be used since there is no exhaust fan installed in the room. Recommend removing this mirror.

Contact a handyman or DIY project

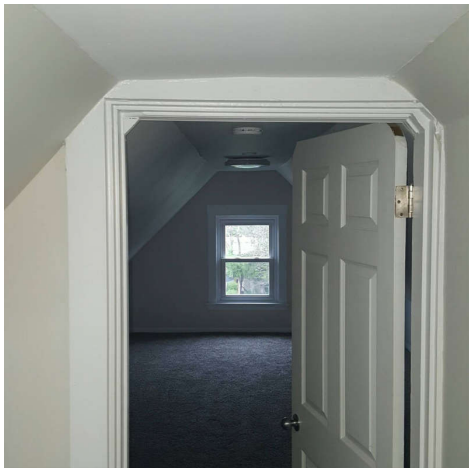
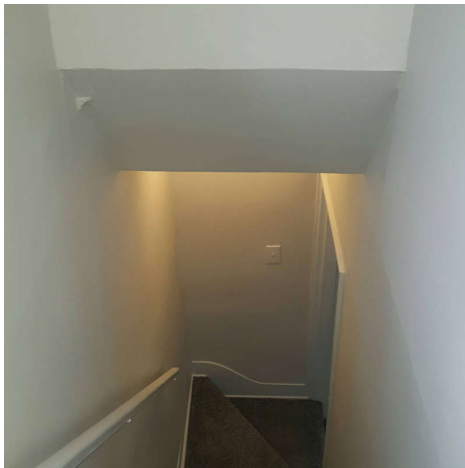
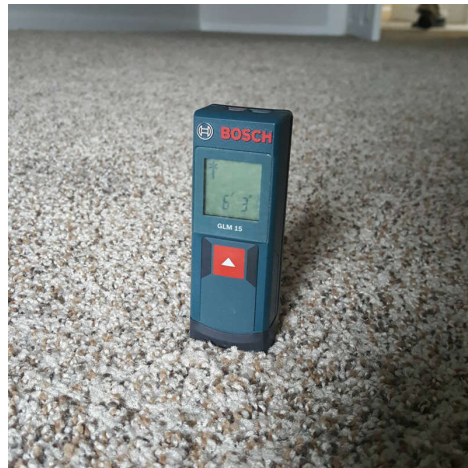
6.6.1 Ceilings

Typically at least 50 percent of the floor area of the room is recommended to have a ceiling height of at least 7 feet.

The room may not be considered living space and may not be attributable to the square footage of the property or safely used for regular habitation. **The MLS listing shows this as a bedroom. For safety reasons the area should not be used as a bedroom or sleeping room. A life safety hazard exists should a fire start and a person is occupying this room. Recommend not using the area as sleeping space.** Inquire with the local building department and county auditor to determine the exact requirements for space attributable to living space square footage.

6'3

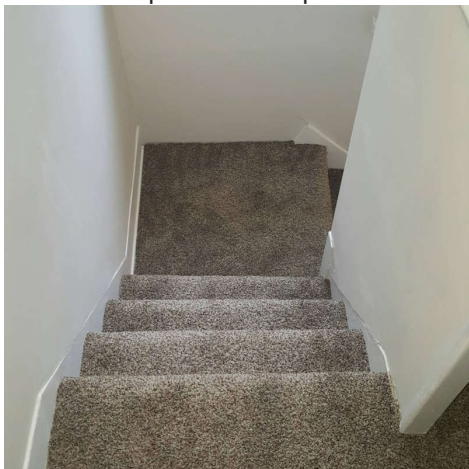
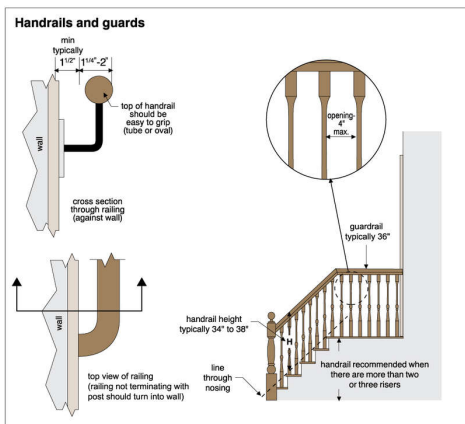
6.7.1 Steps, Stairways & Railings

Staircase is missing a complete handrail. This is a safety hazard. Recommend a qualified contractor install a handrail.

Contact a qualified carpenter.

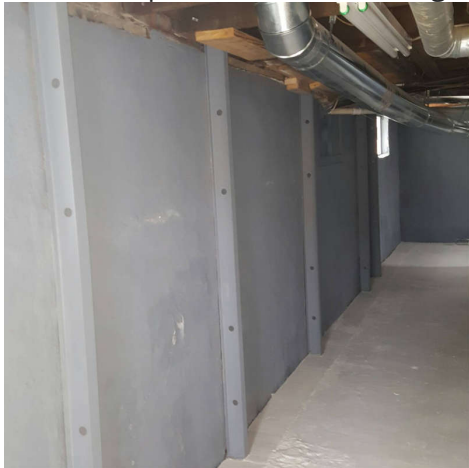
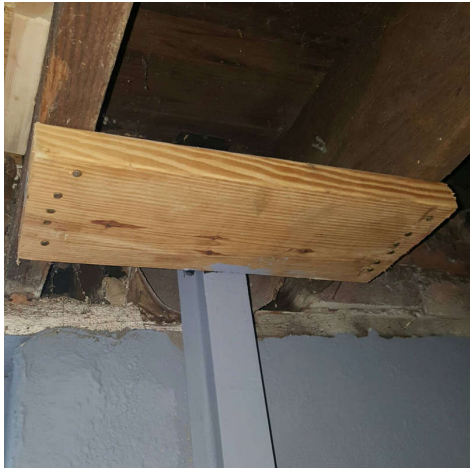
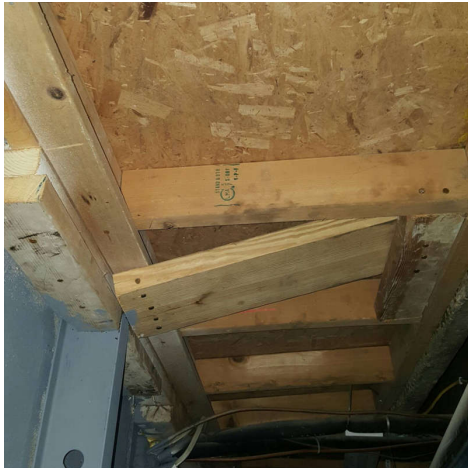
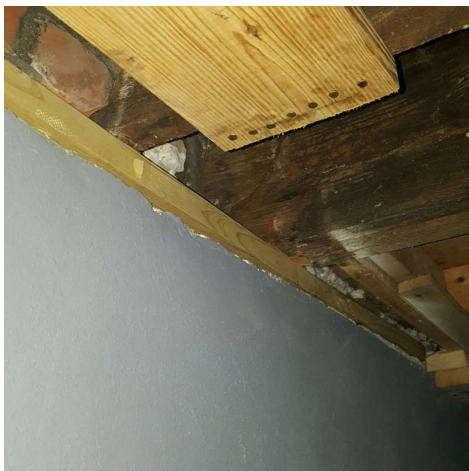
7.2.1 Foundation

FOUNDATION CRACKS - PREVIOUS REPAIRS

The foundation has been repaired in one or more areas. Typically bolts are installed at the wood attached to the joist, the wood spans several floor joists, the gap between the beam and the foundation is filled with non-shrink grout, the beams are typically spaced no more than 5 feet apart.

Recommend obtaining documentation regarding the repair from the seller. Most foundation repairs come with some type of transferable warranty. If there is no transferable warranty you may wish to have the foundation evaluated by a structural engineer.

Contact a qualified structural engineer.

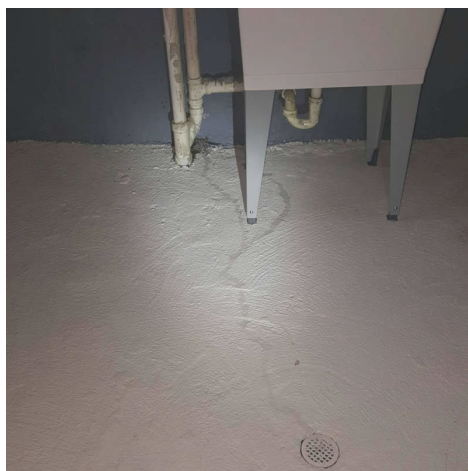
7.2.2 Foundation

WATER INTRUSION

Water intrusion was evident on the surface of the floor slab and running down the wall in the basement. This can compromise the foundations ability to stabilize the structure and could cause damage. The source of the moisture should be identified and corrected. Make all necessary grading, drainage, and gutter repairs. Recommend further evaluation by a basement waterproofing contractor to repair as necessary.

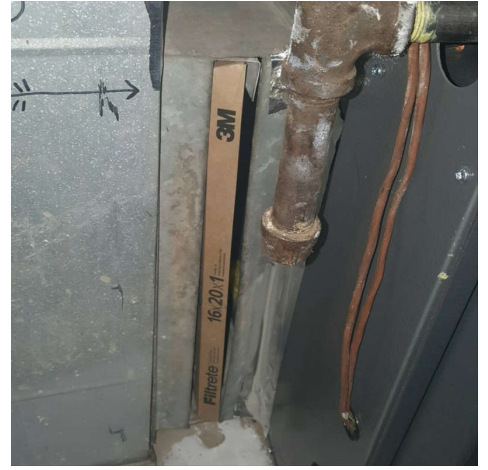
8.2.1 Heating Equipment

Without a secure filter door dirt can be drawn into the system. This can also create inefficient return flow. We recommend Allergy Zone covers that can be purchased [BY CLICKING HERE](#).

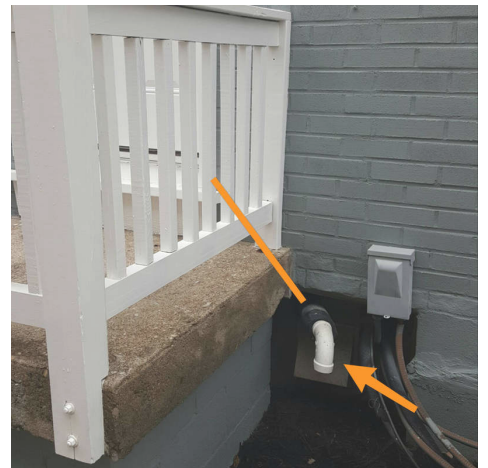
8.5.1 Vents, Flues & Chimneys

Recommendation

Contact a qualified HVAC professional.

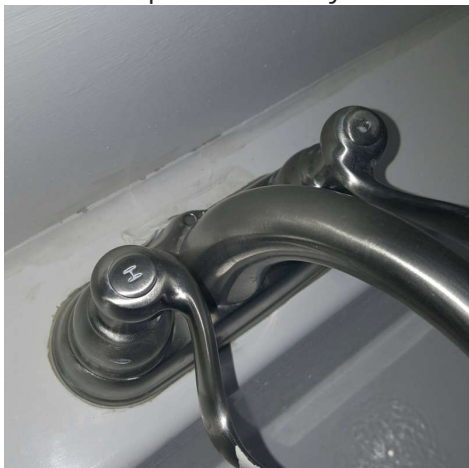
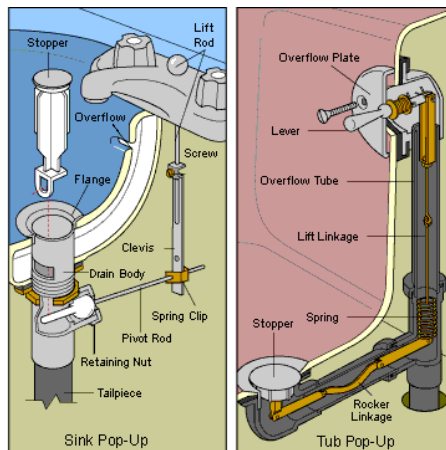
12.9.1 Sinks

DRAIN STOPPER IS NOT WORKING

Contact a qualified handyman.

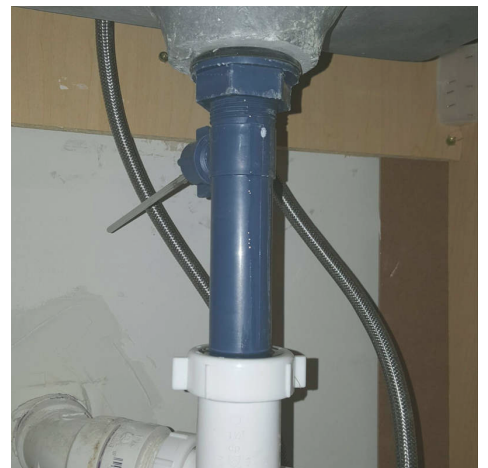
12.9.2 Sinks

LEAKING DRAIN

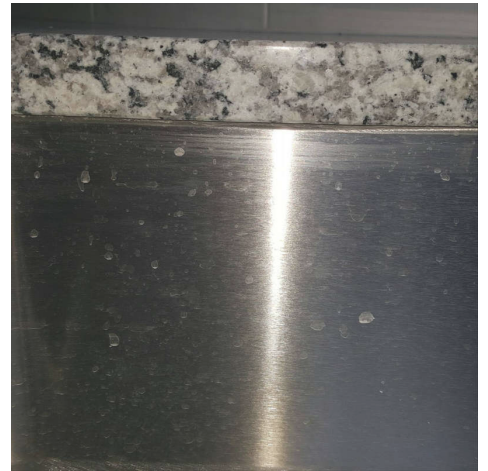
12.9.3 Sinks

SEAL IS MISSING BETWEEN SINK AND COUNTER

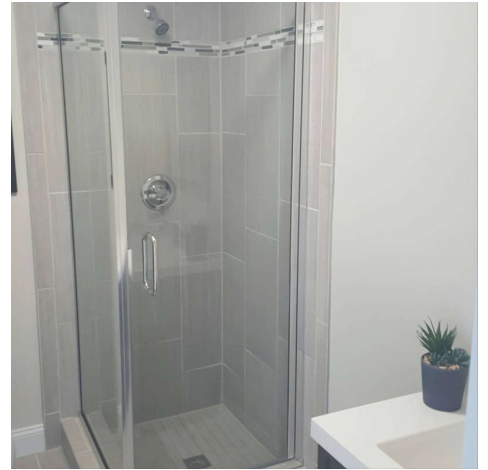
12.10.1 Shower/Tub

SHOWER SPRAY CAN NOT BE CONTAINED

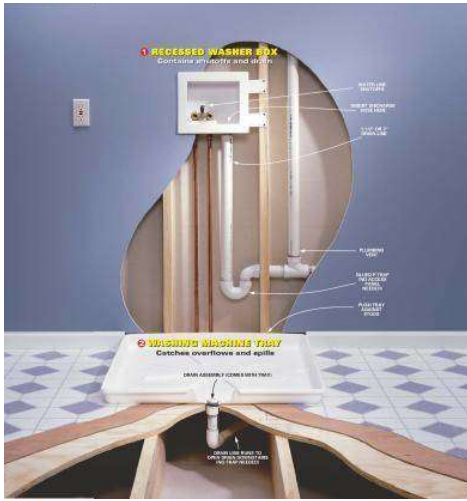
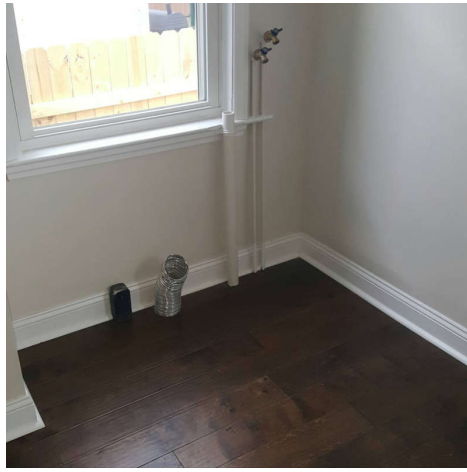
12.11.1 Drain, Waste, & Vent Systems

DRAIN PAN MISSING

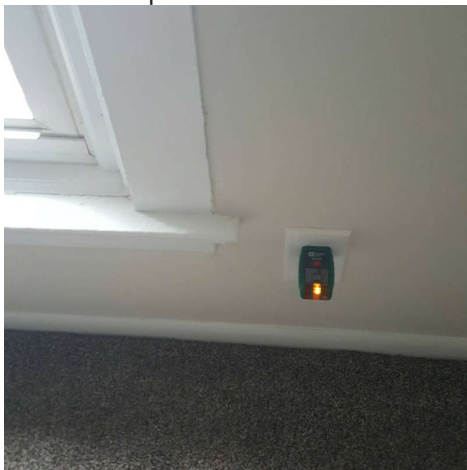
13.5.1 Lighting Fixtures, Switches & Receptacles

Moderate Concern

Recommendation

Contact a qualified electrical contractor.
