DOCTOR J'S HOME INSPECTIONS

DOCTOR J'S HOME INSPECTIONS COPY

1234 Main St.
Sherwood Oregon 97140

Buyer Name
09/30/2018 9:00AM

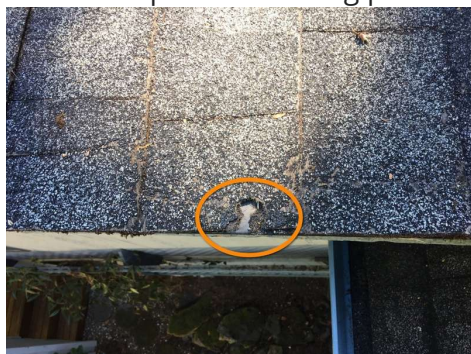
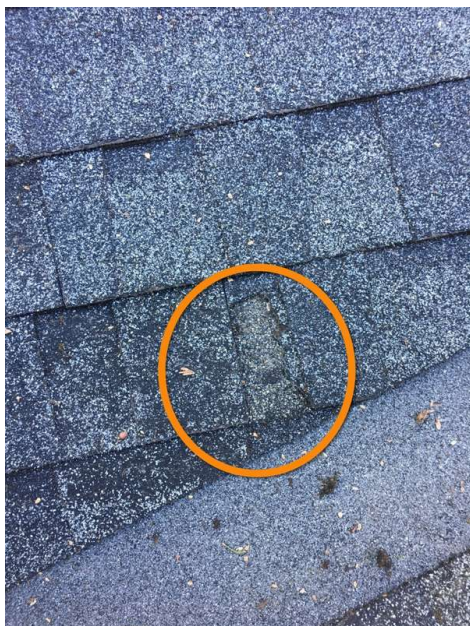
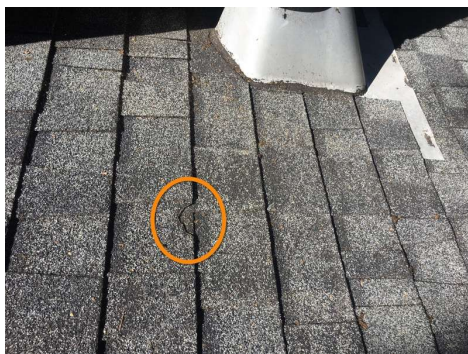
2.1.1 Coverings

DAMAGED COVERINGS

MIDDLE AND EAST SIDE OF ROOF

A few of the roof shingles exhibited general damage that could affect performance. Recommend a qualified roofer evaluate and repair.

Contact a qualified roofing professional.

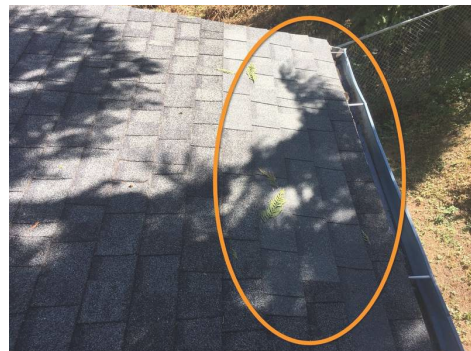
2.1.2 Coverings

ROOF PATCH

SE CORNER

The roof had a patch of several new shingles installed. The rain gutter was also damaged. The home owner said it was a repair from a fallen tree limb.

Contact a qualified roofing professional.

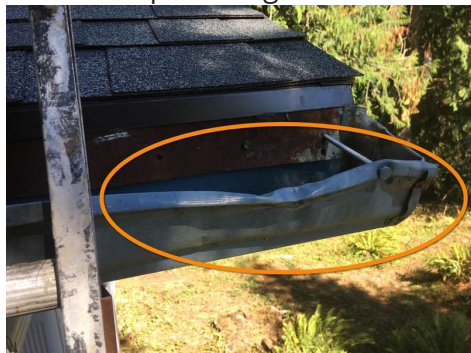
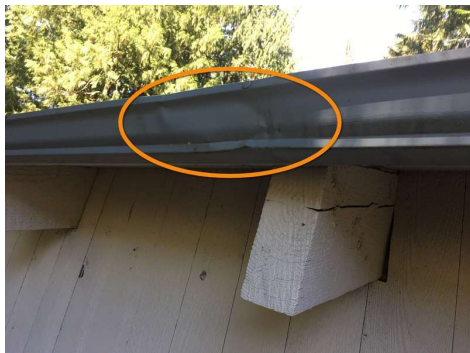
2.2.1 Roof Drainage Systems

GUTTER DAMAGED

SE CORNER

The gutter on the SE corner was damaged from a previous fallen tree limb. This gutter should be replaced.

Contact a qualified gutter contractor

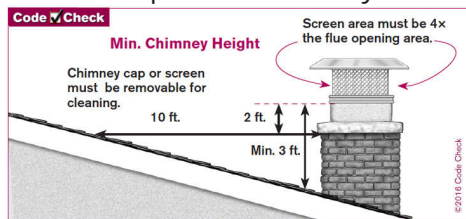
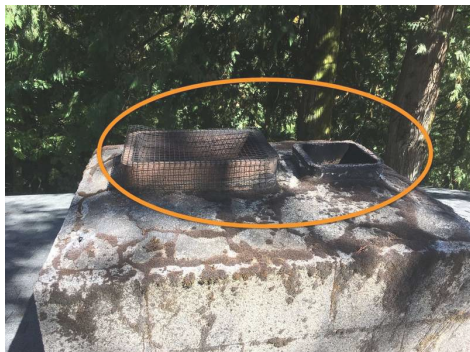
2.4.1 Skylights, Chimneys & Roof Penetrations

CHIMNEY CAP MISSING

No chimney cap was observed. This is important to protect from moisture intrusion and protect the chimney. Recommend a qualified roofer or chimney expert install.

Contact a qualified chimney contractor.

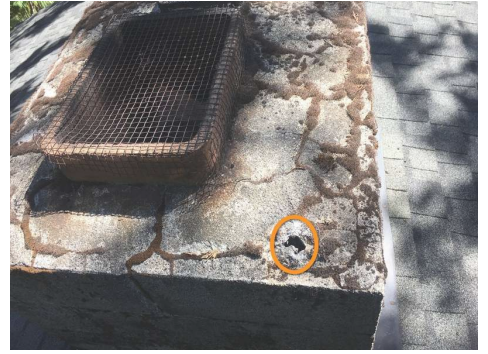
2.4.2 Skylights, Chimneys & Roof Penetrations

**CHIMNEY CAP**

The chimney cap had a hole in the mortar that allows water to run underneath the surface. This will cause damage to the inside structure. I recommend a chimney contractor seal this hole with the appropriate sealant, and remove the moss build up from the top and sides of the chimney. Evaluate the condition of the chimney and chimney liner for its condition and serviceability. Without knowing the last time the chimney was cleaned it is likely that this evaluation may recommend the chimney be cleaned.

Contact a qualified professional.

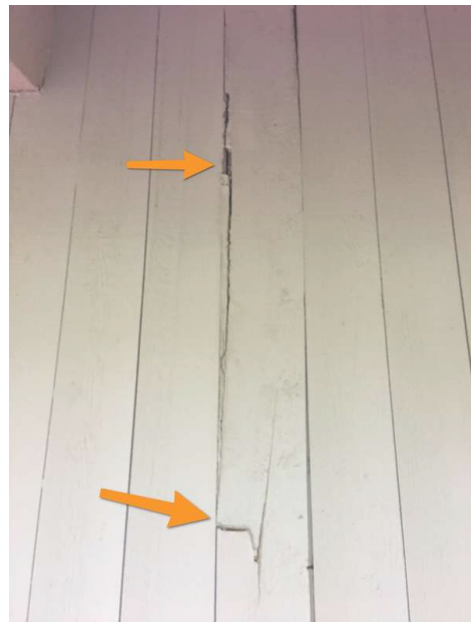
3.1.1 Siding, Flashing & Trim

CRACKING - MINOR

EXTERIOR MASTER BEDROOM

Siding showed cracking in one or more places. Recommend contractor evaluate and repair.

Contact a qualified siding specialist.

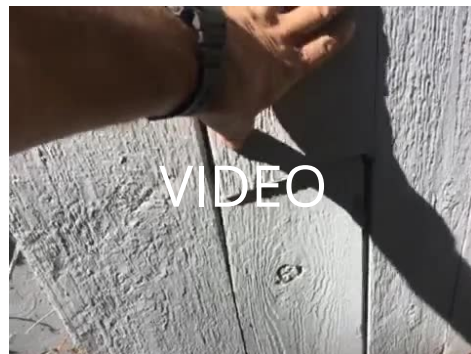
3.1.2 Siding, Flashing & Trim

LOOSE BOARDS

SE SIDE OF HOME

Siding pieces on the SE side of the home were cracked and needs a be secured and sealed if necessary.

Contact a qualified handyman.

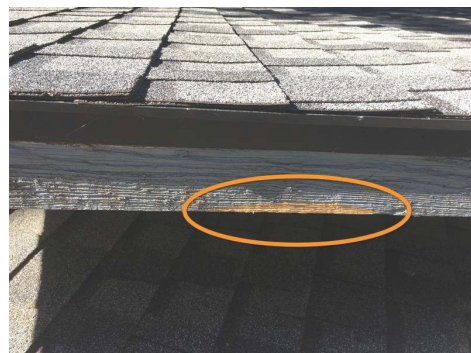
3.1.3 Siding, Flashing & Trim

PAINT NEEDED

MIDDLE SECTION OF ROOF TRIM

A 6" bare spot on the roof trim needs to be painted for protection from rain.

Contact a qualified handyman.

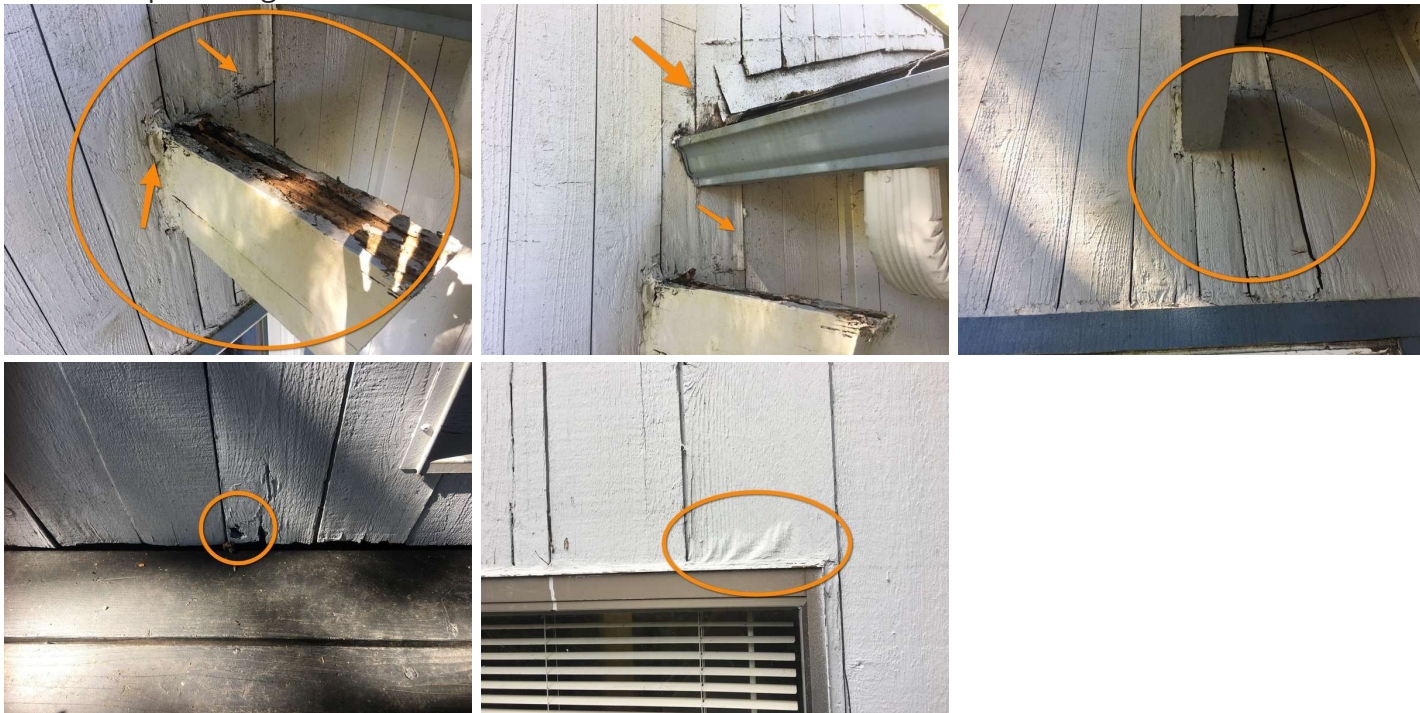
3.1.4 Siding, Flashing & Trim

WATER DAMAGE

SE SIDE OF HOME

The siding and beam above the sliding glass door on the east side of the home has significant water damage. There is a drainage issue that allows the water to run onto the siding and top of the exposed portion of the wood beam. This water should drain into the rain gutter. I recommend a building contractor evaluate, recommend, and repair damaged area.

The paint is bubbled on the East side above the window. The wood is in good condition, but the paint has bubbled. This area needs to be sanded, prepped, and painted.

Contact a qualified general contractor.

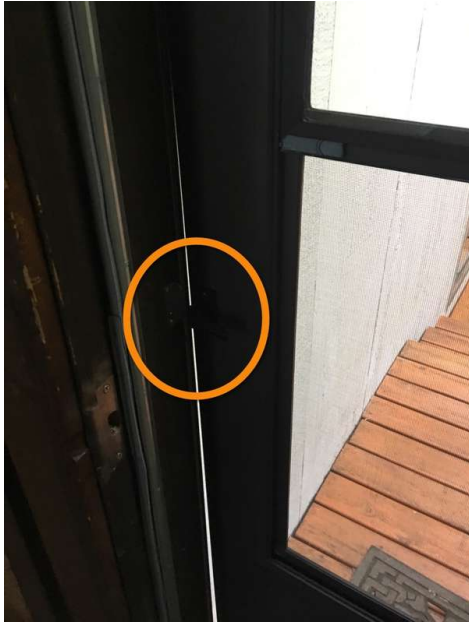
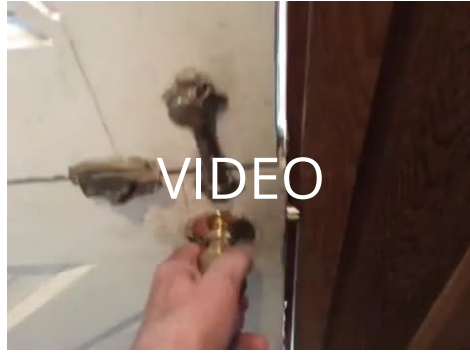
3.2.1 Exterior Doors

DOOR DOESN'T LATCH

FRONT ENTRY STORM DOOR AND LOWER LEVEL STAIRS ENTRY

Storm door doesn't latch properly, Entry door to stairs needs to be pulled up before it will latch
Recommend handyman repair latch and/or strike plate.

Contact a qualified handyman.

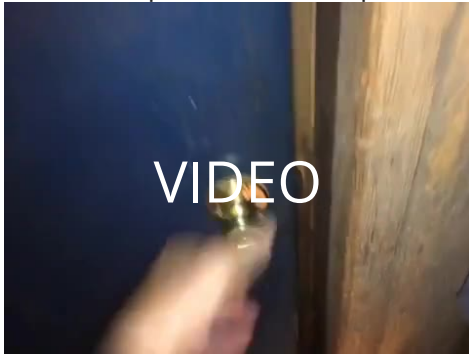
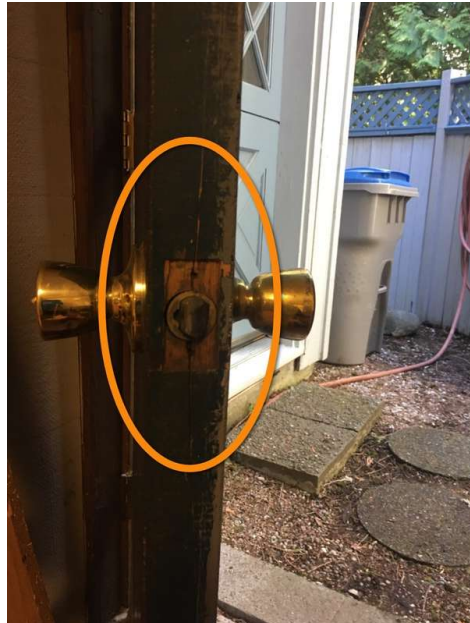
3.2.2 Exterior Doors

DOOR IS DAMAGED

LOWER LEVEL ENTRY BONUS/LAUNDRY ROOM

The door to the lower entry has 3 issues. The door does not latch properly when closed. The metal strike plate is missing, and the door is cracked in the middle. Recommend qualified handyman install a new door with proper hardware.

Contact a qualified door repair/installation contractor.

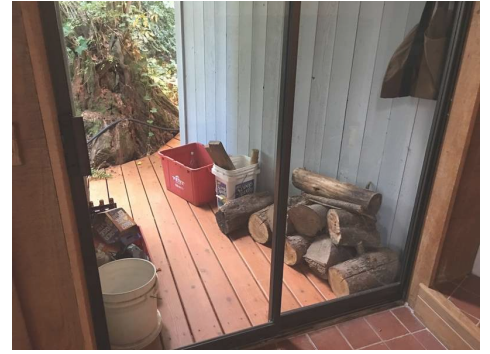
3.2.3 Exterior Doors

MISSING SREEN

The sliding glass door in the sun room is missing the screen.

Contact a qualified professional.

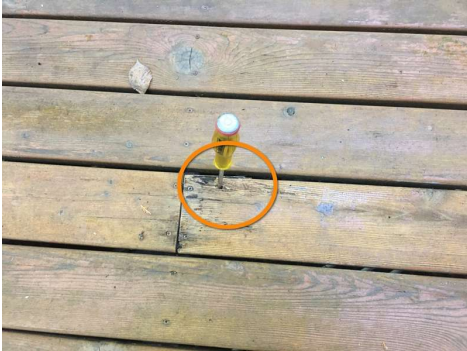
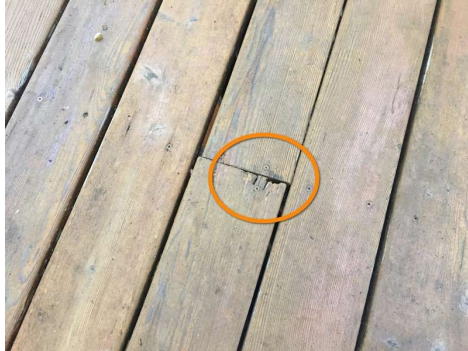
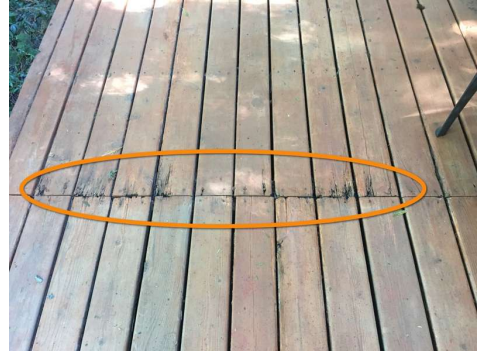
3.3.1 Decks, Balconies, Porches & Steps

DECK - SOFT BOARDS

FRONT, REAR, SE (SUN-ROOM)

Deck boards are showing signs of decay. Recommend a qualified deck contractor evaluate, advise and quote cost of repairs if needed.

Contact a qualified deck contractor.

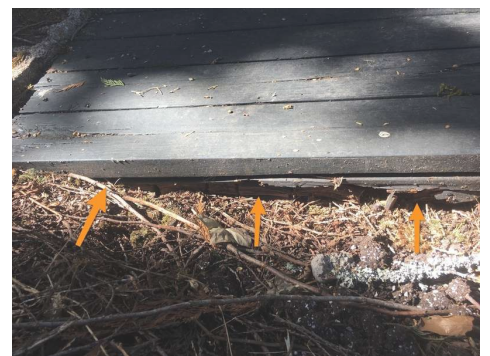
3.3.2 Decks, Balconies, Porches & Steps

EARTH CONTACT

DECK OFF OF SUN ROOM

The outside board for the deck off the sun room was rotted and needs to be replaced.

Contact a qualified professional.

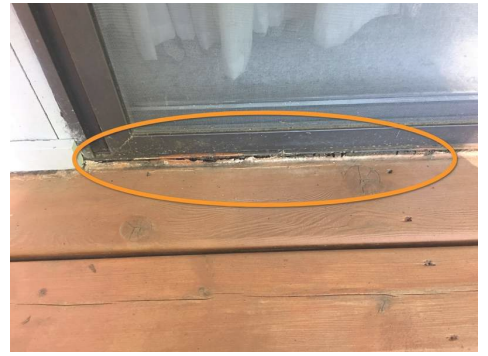
3.3.3 Decks, Balconies, Porches & Steps

CHAULKING NEEDED

UPPER MASTER BEDROOM DECK

Contact a qualified professional.

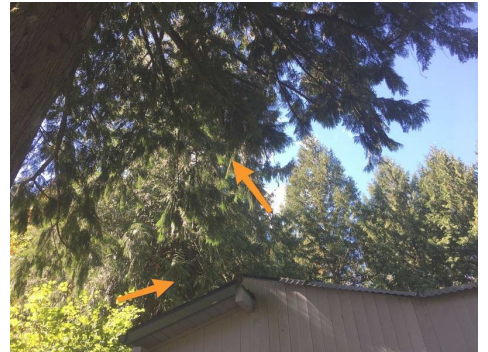
3.5.1 Vegetation, Grading, Drainage & Retaining Walls

Trees observed overhanging the roof. This can cause damage to the roof and prevent proper drainage. Recommend a qualified tree service company evaluate and recommend the safety of the current trees.

Contact a qualified tree service company.

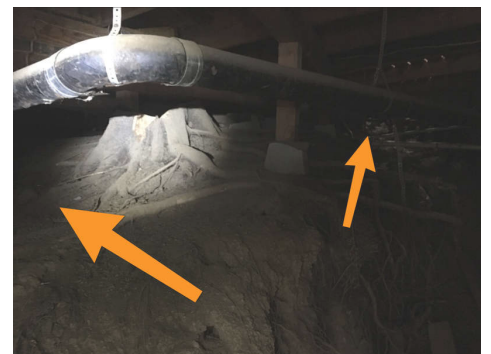
4.1.1 Foundation, Basement & Crawlspaces

MISSING VAPOR BARRIER

A section of the vapor barrier was missing in the crawlspace. The vapor barrier helps prevent moisture from the ground to enter into the crawlspace. Recommend a qualified person install plastic vapor barrier to cover bare dirt.

Contact a qualified handyman.

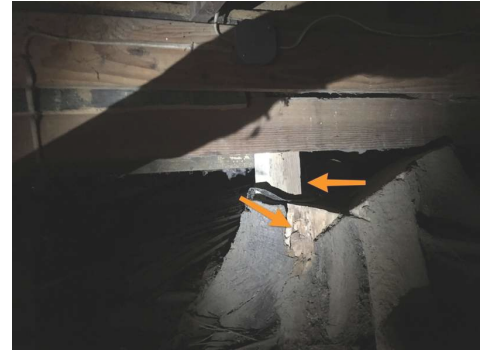
4.1.2 Foundation, Basement & Crawlspaces

IMPROPER SUPPORT

A tree stump and 4x4 post was used as one of the main floor supports. Recommend a qualified person install the proper support for flooring.

Contact a qualified professional.

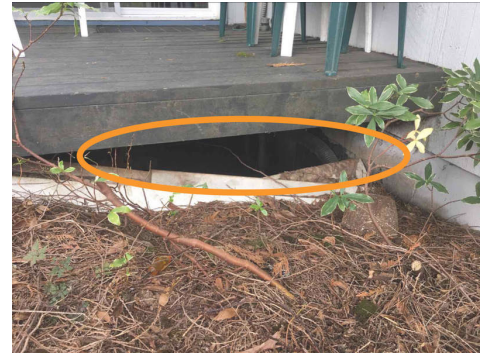
4.1.3 Foundation, Basement & Crawlspaces

The opening under the SE deck allows small animals to gain access nest and breed in the crawlspace under the home. Multiple problems can be created by this. My recommendation is to seal the open area.

Contact a qualified professional.

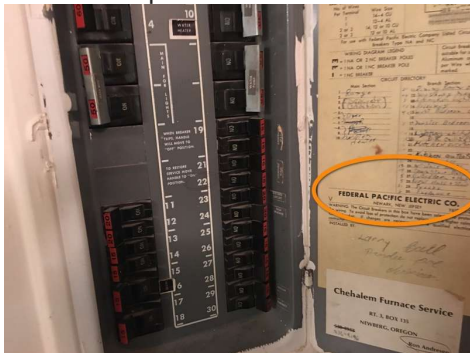
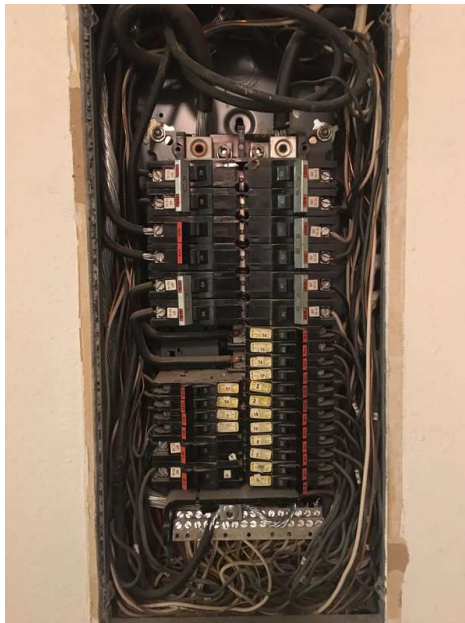
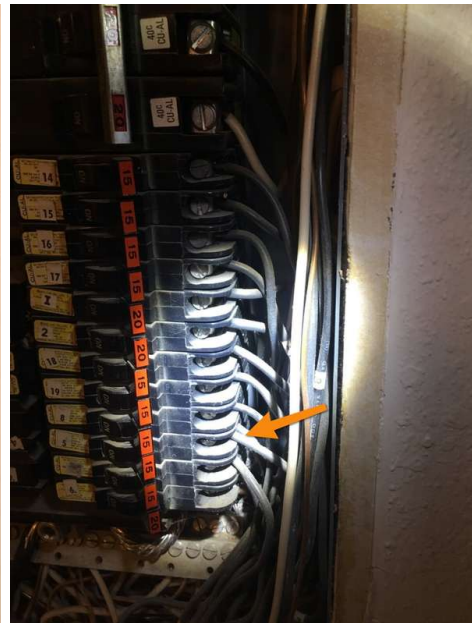
Federal Panels have had class action lawsuits that state this panels are a safety hazard. It is my recommendation that you consult with a licensed electrician to evaluate and recommend. My recommendation is to have the electrical panel replaced with a new panel. Research Federal Pacific Panels safety on-line, then make your decision.

There were 2 wires on circuit 31. Unless the breaker is designed to have 2 wires terminated on this breaker it is a improper installation. Excess heat can make this a safety hazard. Read more information at: <http://www.ismypanelsafe.com/fpe.php>

Contact a qualified electrical contractor.

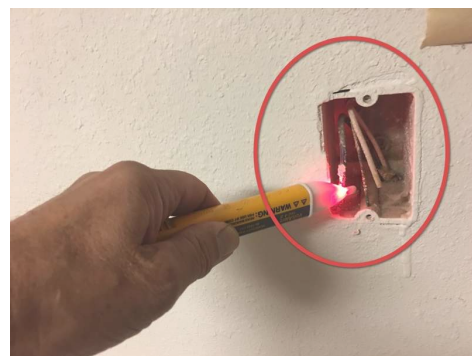
6.3.1 Branch Circuit Conductors, Overcurrent Devices and Compatibility of Their Amperage & Voltage

The wires in the box are energize. All wire connections & charged wires with exposed ends and splices should be covered in junction boxes for safety. Recommend a qualified electrician correct.

Contact a qualified electrical contractor.

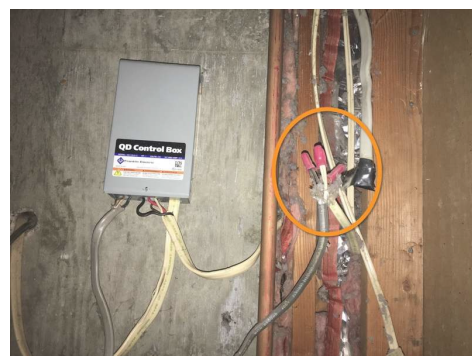
6.3.2 Branch Circuit Conductors, Overcurrent Devices and Compatibility of Their Amperage & Voltage

IMPROPER WIRING

Improper wiring was observed at the time of inspection. Recommend a licensed electrician evaluate and repair.

Contact a qualified electrical contractor.

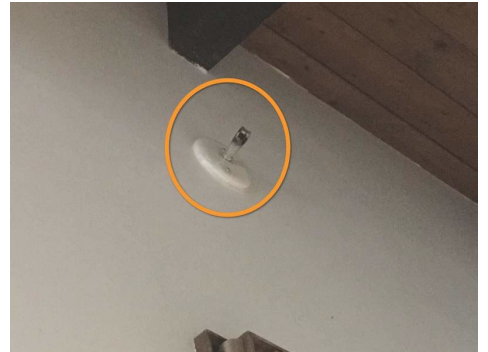
6.4.1 Connected Devices and Fixtures

The light fixture in the hallway on the upper level was missing. Recommend a qualified person install new light fixture.

Contact a qualified electrical contractor.

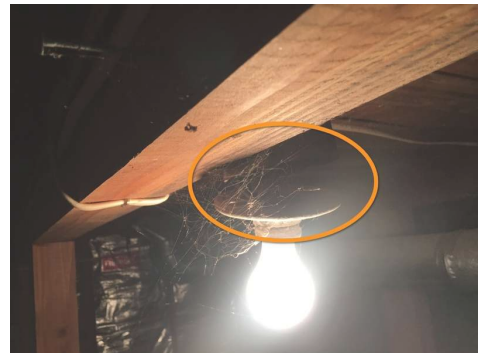
6.4.2 Connected Devices and Fixtures

LOOSE LIGHT

The light for the crawlspace needs to be secured to the box. recommend a qualified person repair.

Contact a qualified professional.

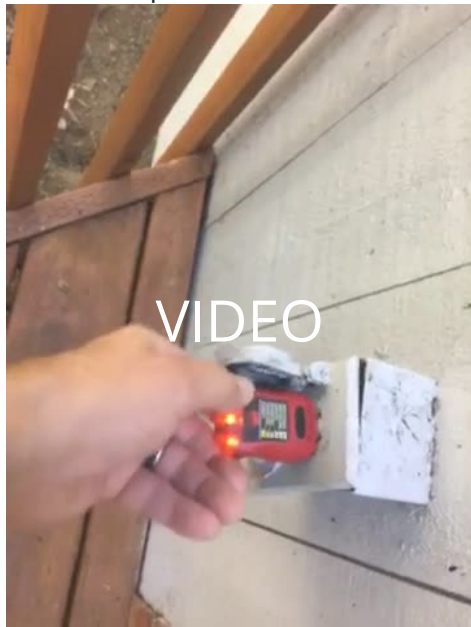
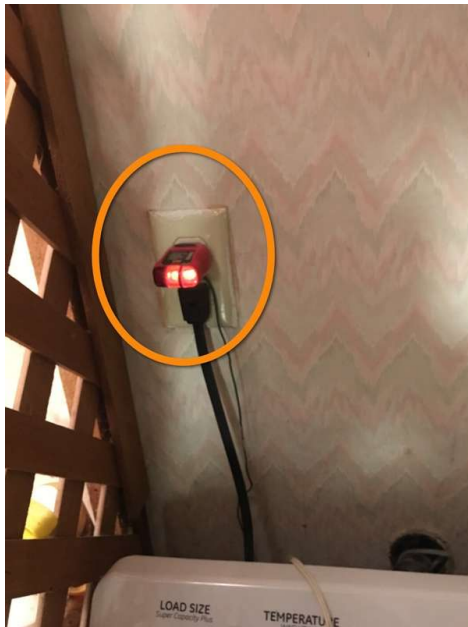
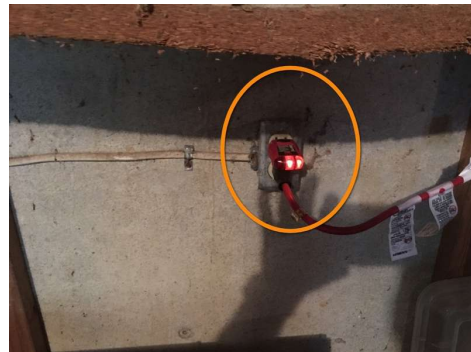
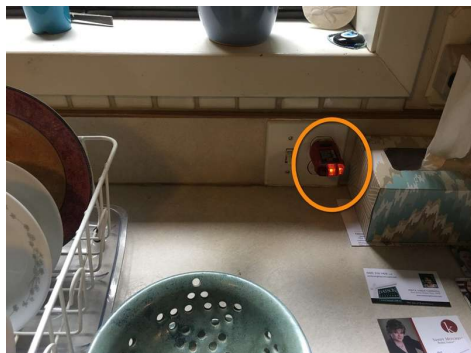
The bathroom on the lower level, The two outlets in the upper bathroom, the three in the kitchen, the garage outlets. Recommend licensed electrician upgrade all of these outlets to GFCI type.

Contact a qualified electrical contractor.

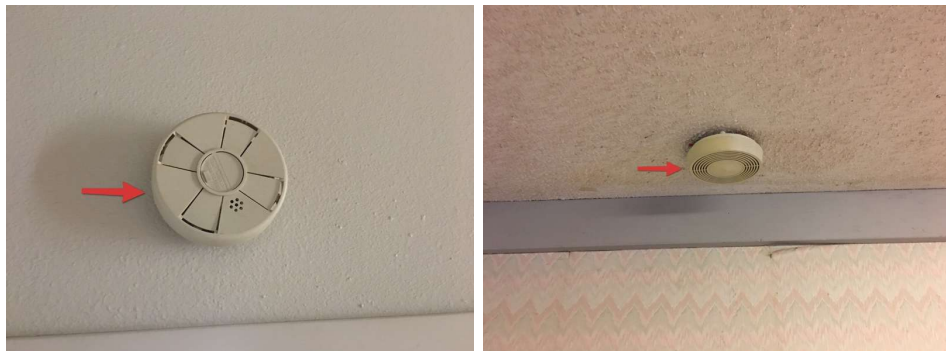
6.7.1 Smoke Detectors

SMOKE ALARMS 10 YEARS OR OLDER THROUGHOUT HOME

Based on the age of this structure and the appearance of existing smoke alarms, the alarms have been installed 10 or more years ago. According to [National Fire Protection Association](#), aging smoke alarms don't operate as efficiently and often are the source for nuisance alarms. Older smoke alarms need to be replaced when they reach 10 years or older. It is important to know that 120 volt smoke alarms can not be replaced with battery type smoke alarms. Test all smoke alarms when moving into a new residence for proper working order. for more information, visit: [SMKALRMLS](#)

Contact a handyman or DIY project

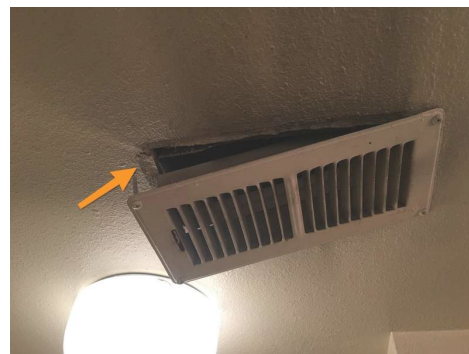
LOOSE FROM CEILING

Downstairs bathroom heat register is loose from the ceiling.

Contact a qualified professional.

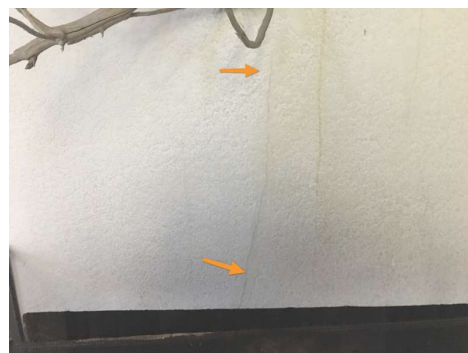
9.1.1 Walls

MINOR CORNER CRACKS

Minor cracks at the corners of doors and windows in walls. Appeared to be the result of long-term settling. Some settling is not unusual in a home of this age and these cracks are not a structural concern.

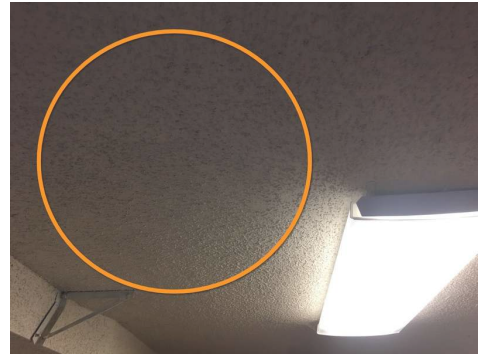
9.2.1 Ceilings

Recommendation**POPCORN CEILING**

Contact a qualified professional.

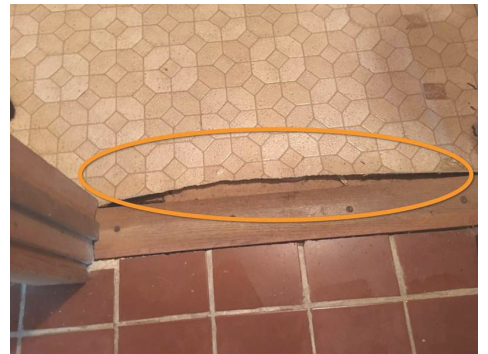
9.3.1 Floors

Recommendation**DAMAGED (GENERAL)**

The home flooring had general moderate damage visible at the time of the inspection. Recommend evaluation by a qualified flooring contractor.

Contact a qualified flooring contractor

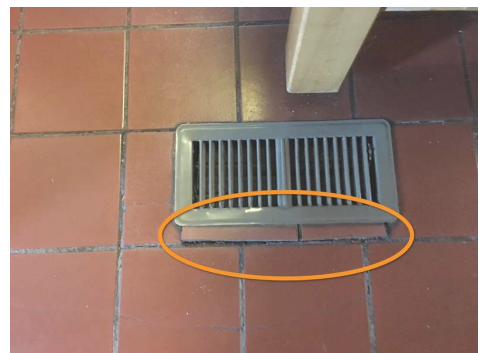
9.3.2 Floors

Recommendation**TILES LOOSE**

Loose tiles around the heat register. Recommend re-attach and secure with new grout.

Contact a qualified flooring contractor

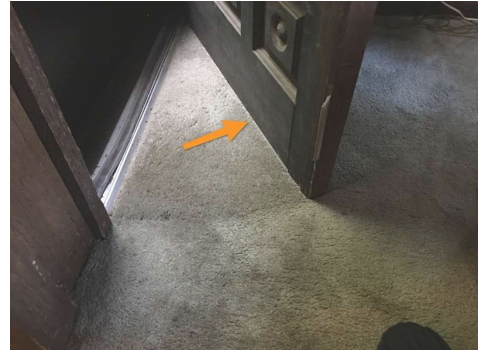
9.6.1 Doors

Recommendation**DOOR DRAGS**

Front door drags on carpet when opening. Recommend trimming the bottom of the door.

Contact a qualified carpenter.

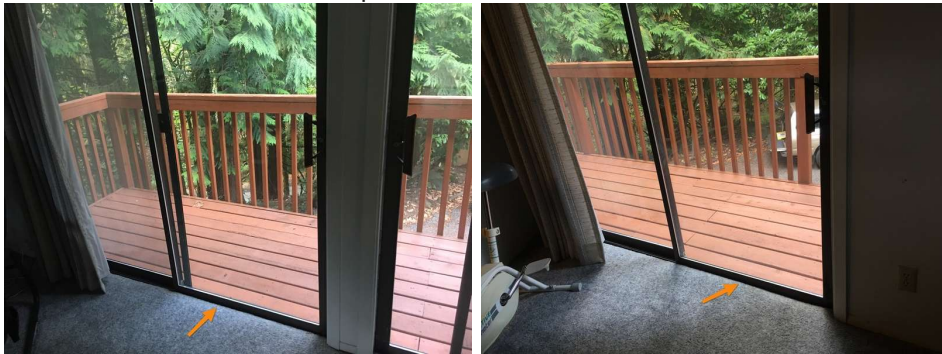
9.6.2 Doors

DOORS DO NOT OPEN PROPERLY

2 of the 3 sliding glass doors in the master bedroom are hard to open. The bottom rollers need adjustment or replaced. Recommend a qualified person evaluate and repair.

Contact a qualified door repair/installation contractor.

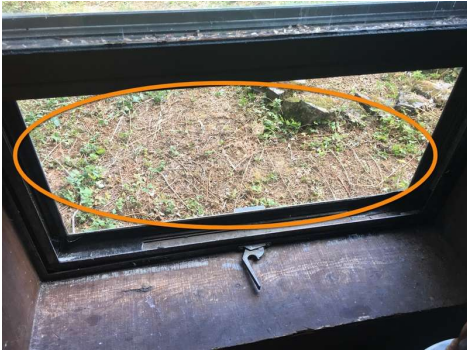
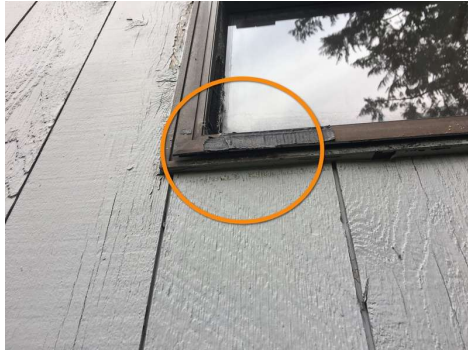
9.7.1 Windows

DAMAGED

The windows were installed at the time the home was built in 1972, so they are 46 years old. One or more windows appears to have general damage, but are operational. Several windows and sliding glass doors had bad thermo-seals that clouds or discolors the window from the inside of the window panes. These thermo-seals will need to be replace. One window in the living room was missing. Two large windows in the living room had long strips of tape on the sides of the windows. Recommend a window professional evaluate and repair necessary defects.

Contact a qualified window repair/installation contractor.

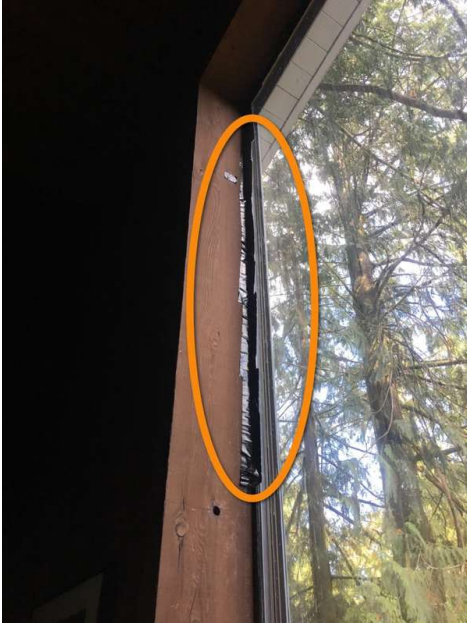
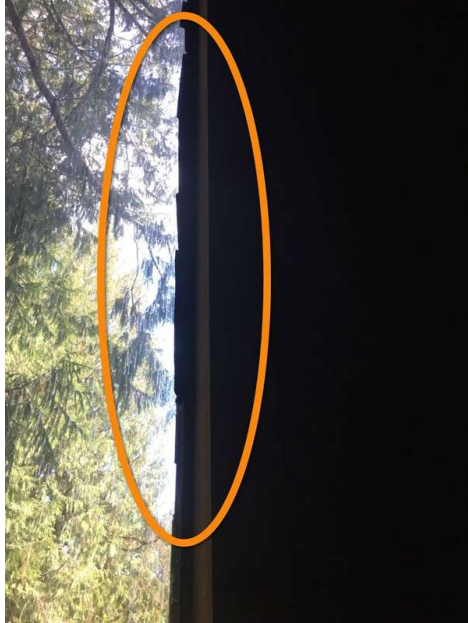
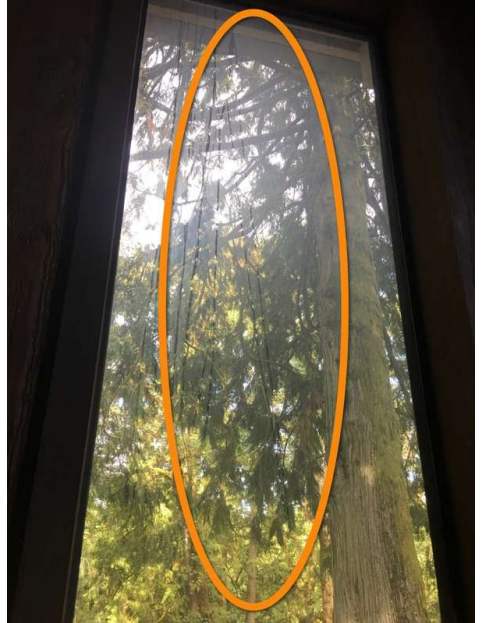
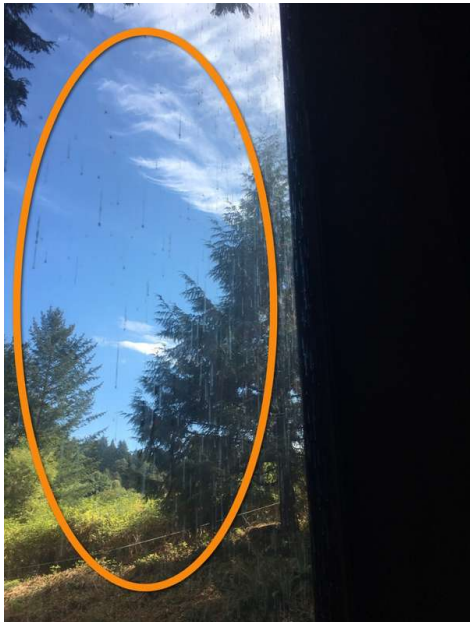
9.7.2 Windows

FAILED SEAL

Observed condensation between the window panes, which indicates a failed seal. Recommend qualified window contractor evaluate & replace.

Contact a qualified window repair/installation contractor.

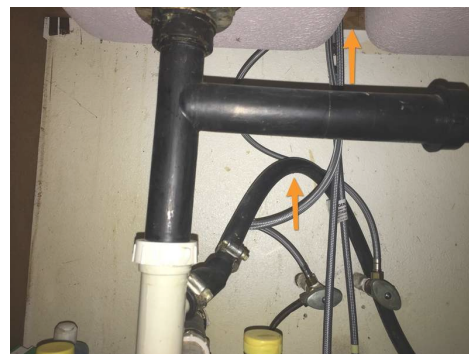
The drain hose from the dishwasher to the garbage disposal needs to have a high loop somewhere in the line that makes this hose as high as the sink at some point. Recommend a Handyman install a bracket that creates a high loop in the hose to reach sink height in the middle section of the drain hose.

Contact a qualified handyman.

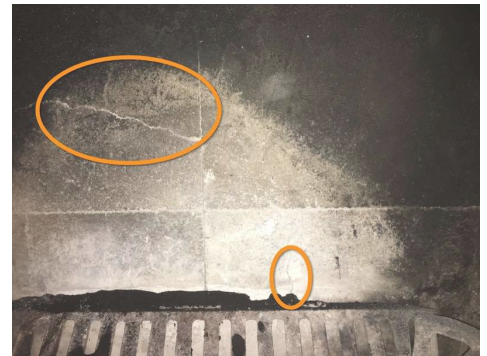
FIREWALL CRACKED

The brick lining of the fireplace was cracked in one or more places, which could lead to chimney damage or toxic fumes entering the home. Recommend a qualified fireplace contractor evaluate and repair.

Contact a qualified fireplace contractor.

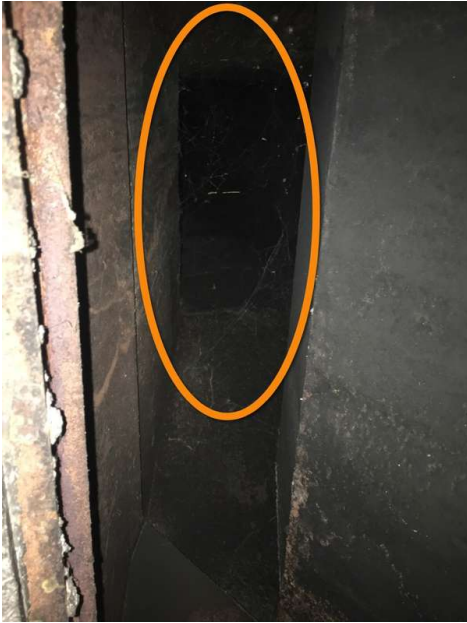
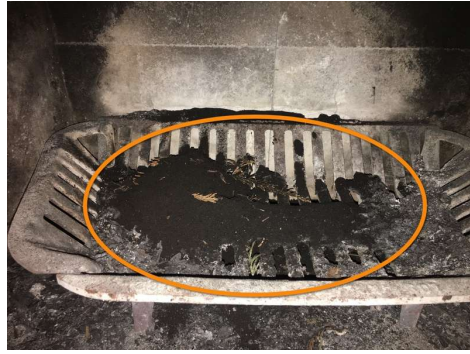
11.1.2 Fireplaces, Stoves & Inserts

The photo of the flue is the fireplace in the living room. The photo of the fire grate is in the Upper master bedroom. The black substance in the photo is what fell out of the chimney when I opened the damper. Recommend a chimney sweep contractor clean both chimneys before use.

Contact a qualified chimney sweep.

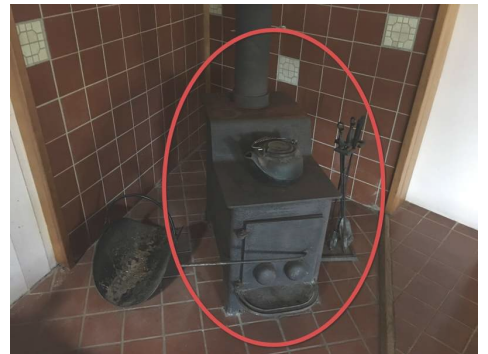
11.1.3 Fireplaces, Stoves & Inserts

NO EPA CERTIFICATION

The wood stove in the sun room was manufactured before the DEQ set the standards for air pollution. All wood burning stove needs to have a DEQ Certification to be used in Oregon. It is hard to find Insurance companies that will insure a home with a stove that is out side of the air quality standards. This room has no other heating source, so the cost of stove removal and a new stove will need to be figured into the budget.

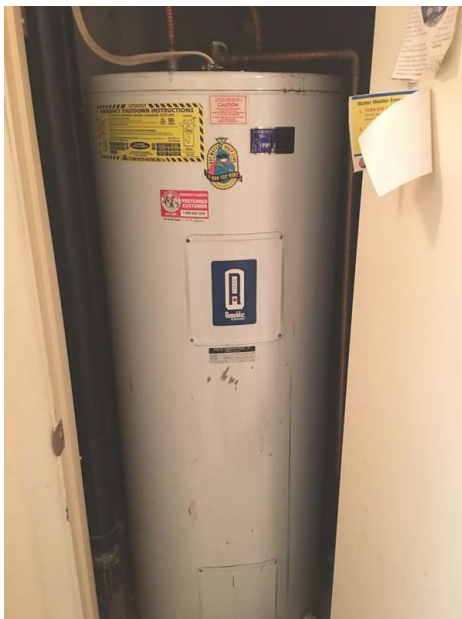
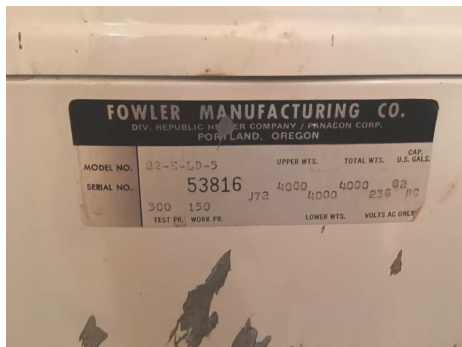
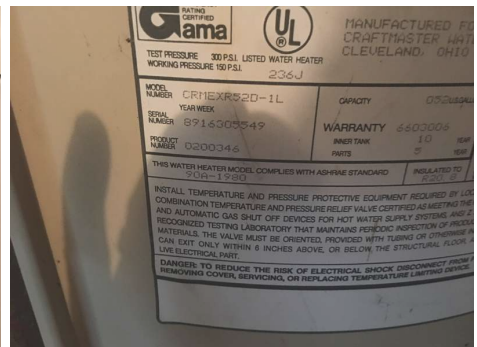
Garage, Lower Level

Menu facture republic serial number 5381 682 gallons electric needs seismic straps

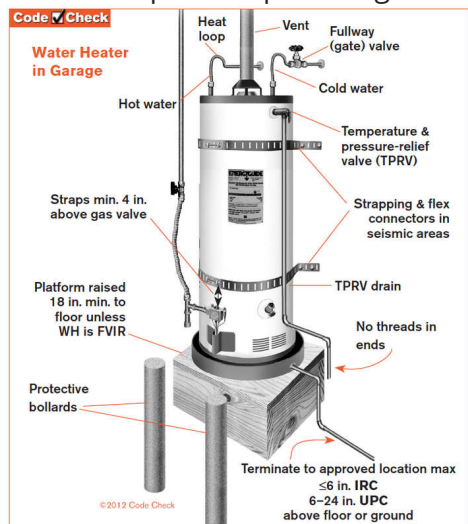
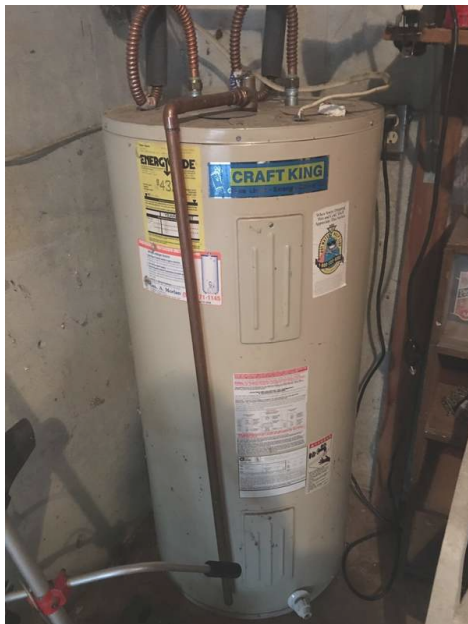
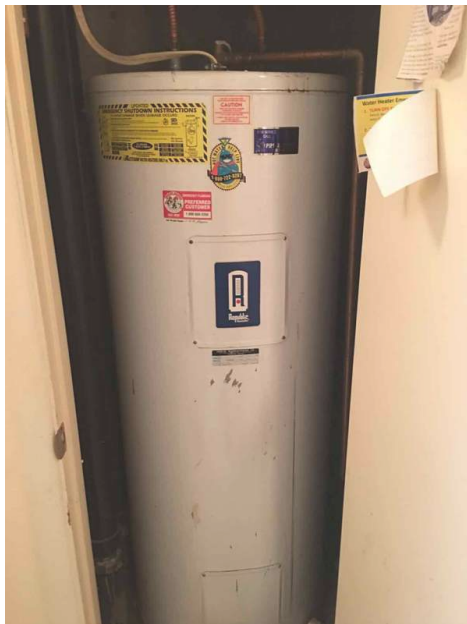
12.3.1 Water Heater

There are 2 water heaters for the home. One is located in the lower level and one is in the garage. Both water heaters need 2 seismic straps to be installed to the top and bottom of the water heaters. These straps help secure the water heater from movement in the event of an earthquake. Recommend a handyman install seismic straps.

Contact a qualified plumbing contractor.
