ON TARGET HOME INSPECTIONS, LLC

ROOM-BY-ROOM RESIDENTIAL

1234 Main St.
Dover TN 37058

Buyer Name
12/10/2018 9:00AM

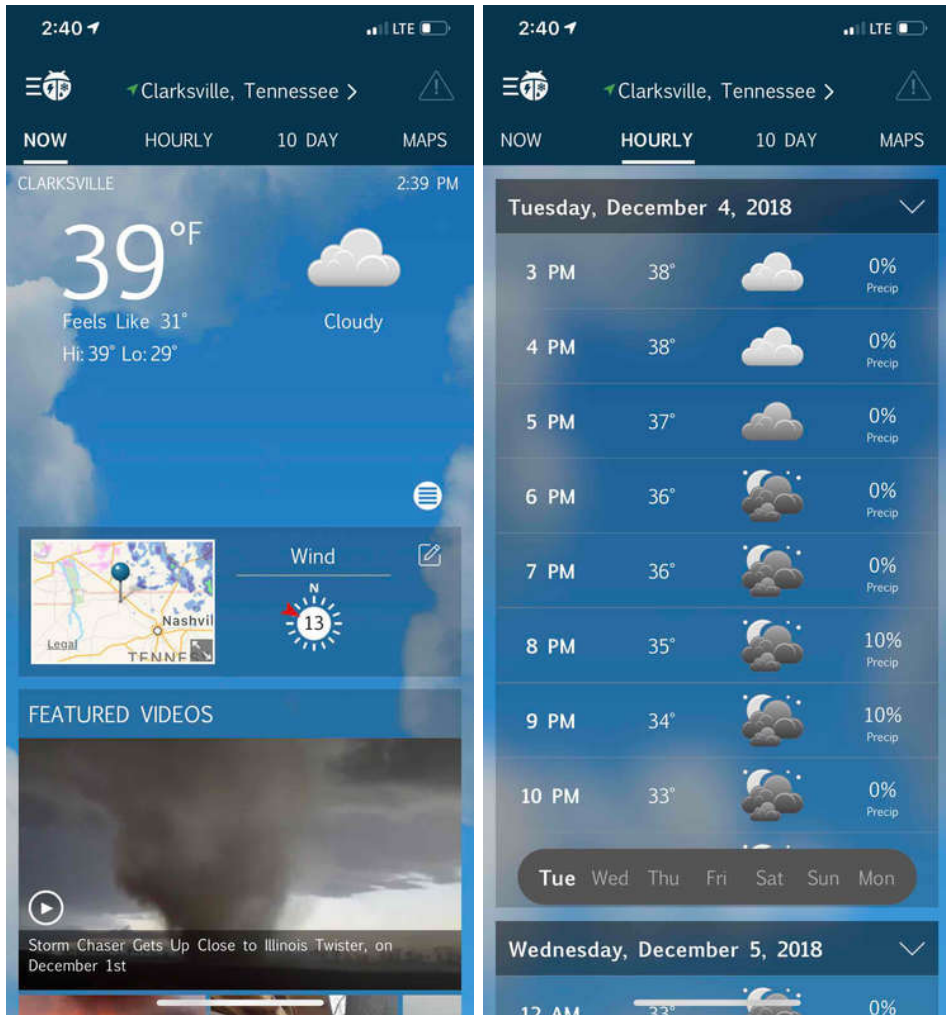
Cooling Equipment

LOW TEMPERATURE

The A/C unit was not tested due to low outdoor temperature. This may cause damage the unit.

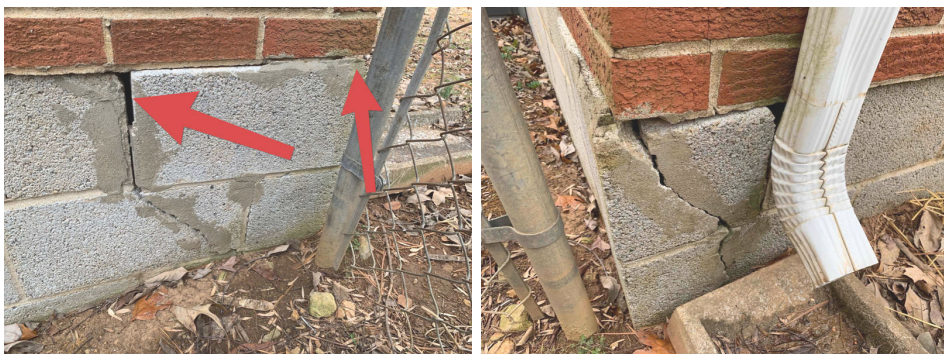
3.3.1 Foundation

FOUNDATION CRACKS - MAJOR

Severe cracking noted at the foundation. This is typically consistent with soil movement and could lead to serious damage to structural components, foundation and/or slabs. Recommend a structural engineer evaluate and provide a report on course of action and remedy.

Contact a qualified structural engineer.

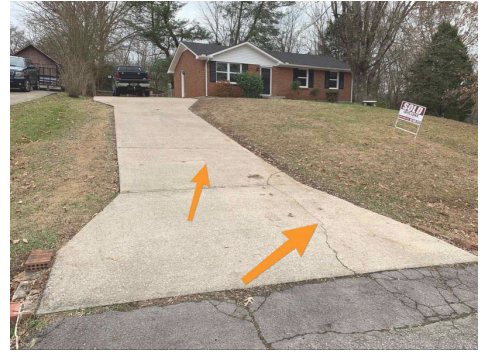
3.6.1 Walkways, Patios & Driveways

DRIVEWAY CRACKING - MINOR

Minor cosmetic cracks observed, which may indicate movement in the soil. Recommend monitor and/or have concrete contractor patch/seal.

Contact a qualified concrete contractor.

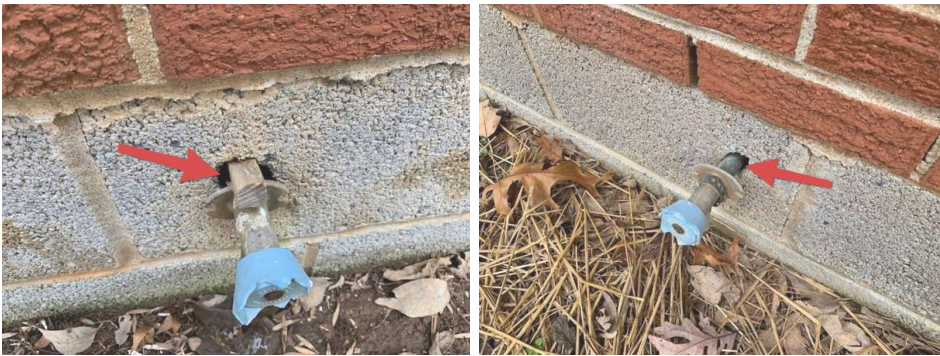
3.9.1 Hose Bibs

POOR OR INSUFFICIENT CAULKING

WEST AND EAST EXTERIOR WALLS

Hose bibs in both the front and backyard did not have any weather sealant caulking around the fixtures. This can allow for moisture penetration into the foundation wall that can cause deterioration the structure. Recommend sealing around the fixture to prevent moisture intrusion. Also recommend inspection of the interior foundation wall by a qualified contractor.

Contact a foundation contractor.

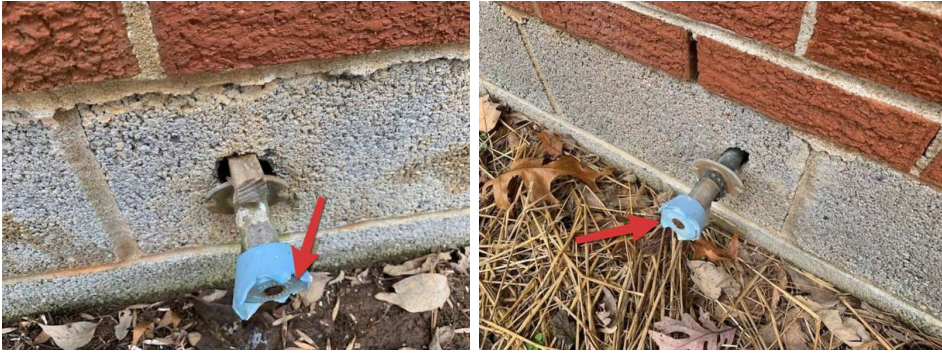
3.9.2 Hose Bibs

BROKEN OR DAMAGED HOSE BIB HANDLES

WEST AND EAST WALLS

The hose bib handles on both the front and backyard hose bibs are broken. This can become a safety issue to the user when turning broken handles. Recommend replacement of broken hose bib handles by a qualified contractor.

Contact a qualified plumbing contractor.

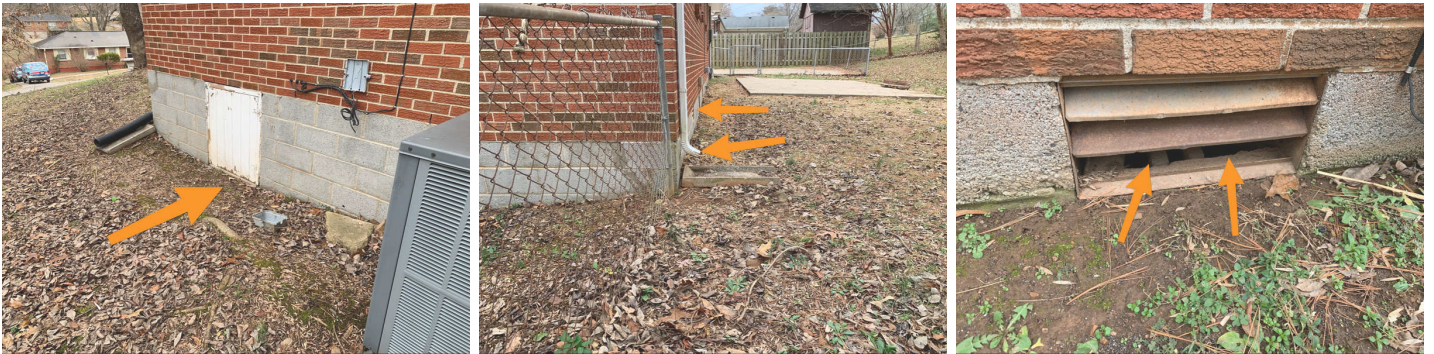
3.11.1 Vegetation, Grading, Drainage & Retaining Walls

NEGATIVE GRADING

NORTHWEST AND NORTH SIDE OF HOUSE

Grading is sloping towards the home in some areas. This could lead to water intrusion and foundation issues. Recommend qualified landscaper or foundation contractor regrade so water flows away from home.

Contact a qualified grading contractor.

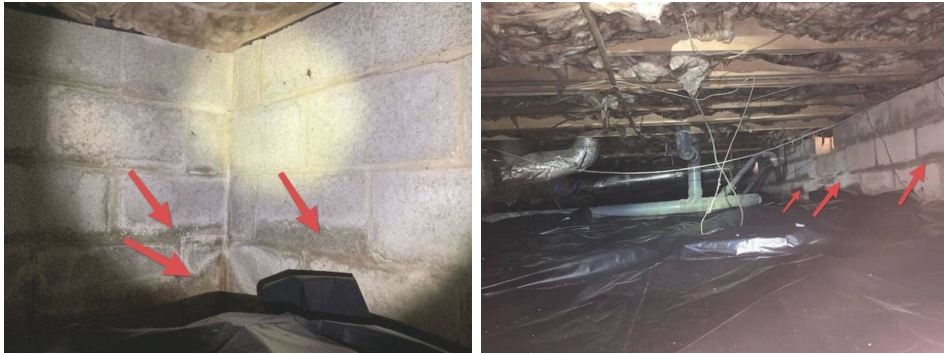
4.6.1 Wall Structure

EVIDENCE OF WATER INTRUSION

CRAWLSPACE

Wall structure showed signs of water intrusion, which could lead to more serious structural damage. Recommend a qualified contractor identify source or moisture and remedy.

Contact a qualified structural engineer.

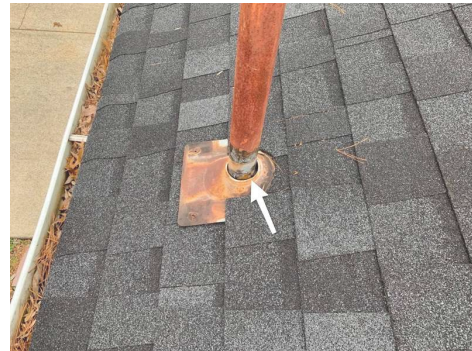
5.1.1 Service Entrance Conductors
MAST WEATHER BOOT MISSING

The weather head mast on the roof is missing the weather boot at the base of the mast where it penetrates the roof. This should be corrected to prevent water infiltration into the roof decking.

Contact a qualified professional.

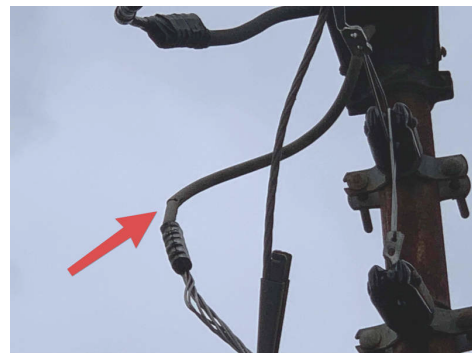
5.1.2 Service Entrance Conductors

FRAYED SHEATHING

Wires on service entrance are damaged or frayed. Recommend contacting your electric utility company or a qualified electrician to evaluate and repair.

Contact a qualified electrical contractor.

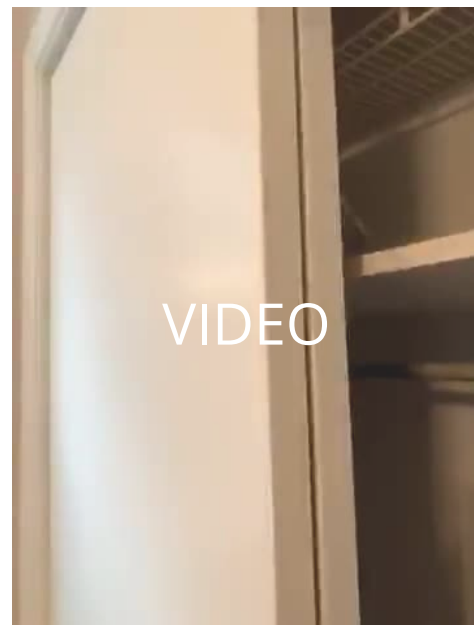
7.2.1 Doors

CLOSET DOOR STICKS

MASTER BEDROOM CLOSET DOOR MASTER

Door sticks and is tough to open. Wheel frame at the top of the door is bent causing the door to stick when opening. Recommend repairing or replacing the door track wheels.

Contact a qualified handyman.

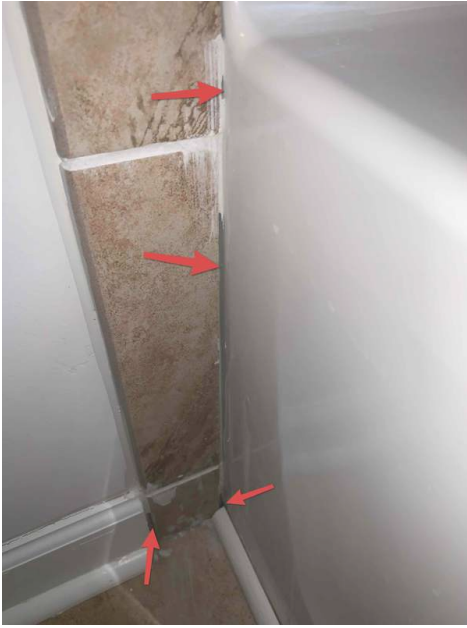
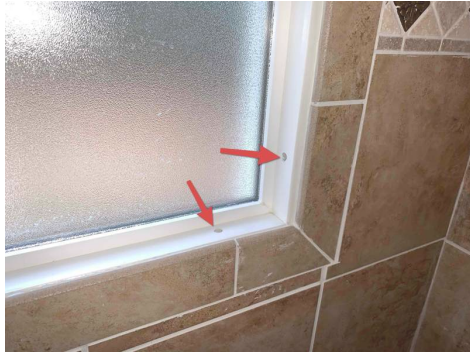
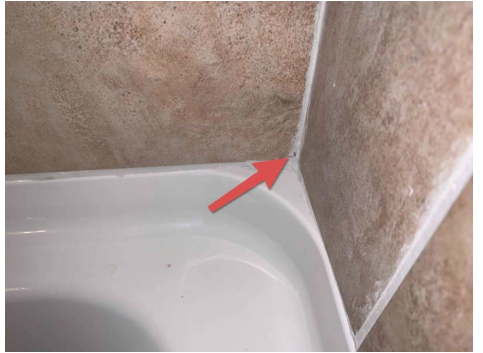
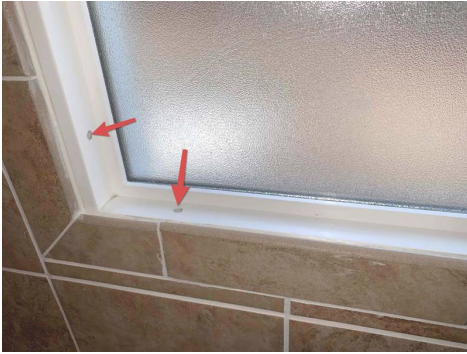
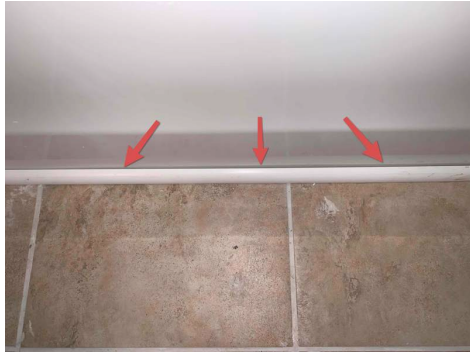
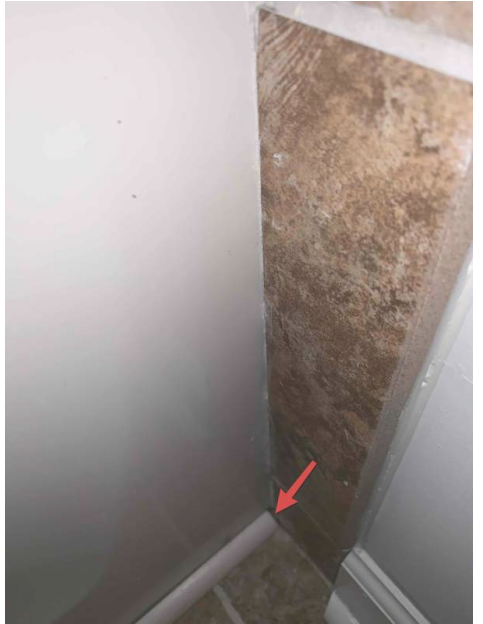
There is insufficient caulking at the tub fixture and the outer edges of the tub down the the floor. Moisture can penetrate these areas with insufficient caulking causing damage to the underlying areas.

Contact a handyman or DIY project

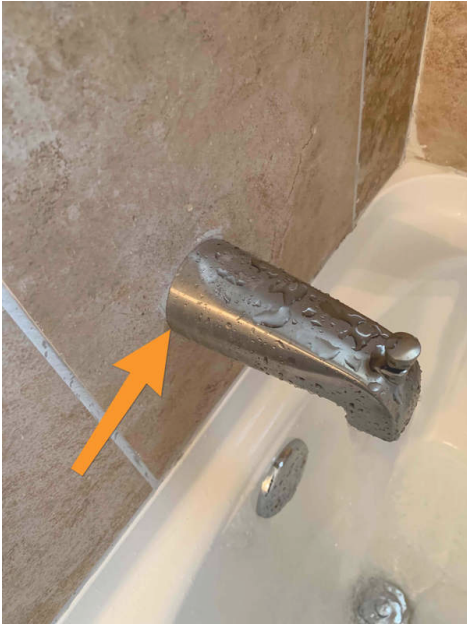
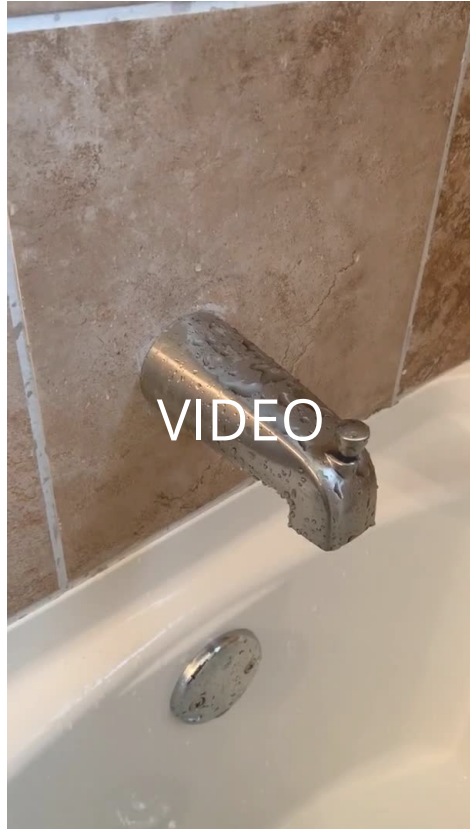
10.2.2 Shower

TUB FIXTURE

Tub fixture is loose and should have a caulked seal around it to prevent moisture intrusion into the wall.

Recommended DIY Project

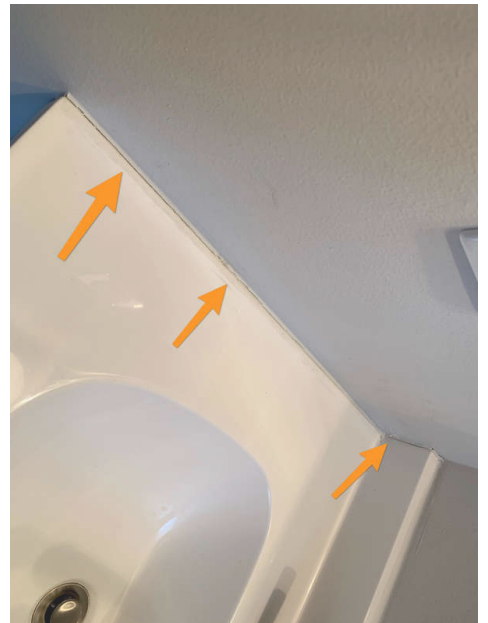
10.7.1 Bathroom Sink

POOR/MISSING CAULK

Bathroom countertop was missing sufficient caulk/sealant at the wall. This can lead to water damage. Recommend adding sealant at sides and corners where counters touch walls.

Recommended DIY Project

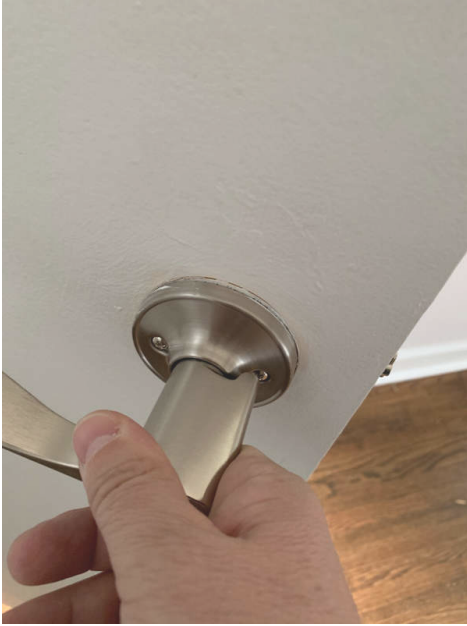
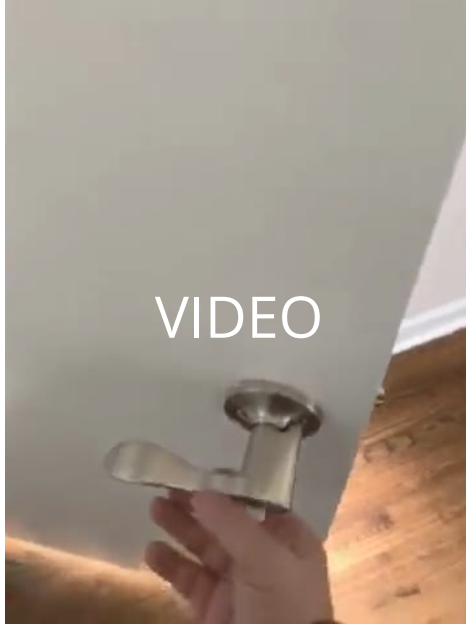
LOOSE DOORKNOB/HANDLE

The front door knob/handle is loose. This should be corrected to prevent premature wear of the doorknob parts and prevent the door knob from not working properly.

Contact a handyman or DIY project

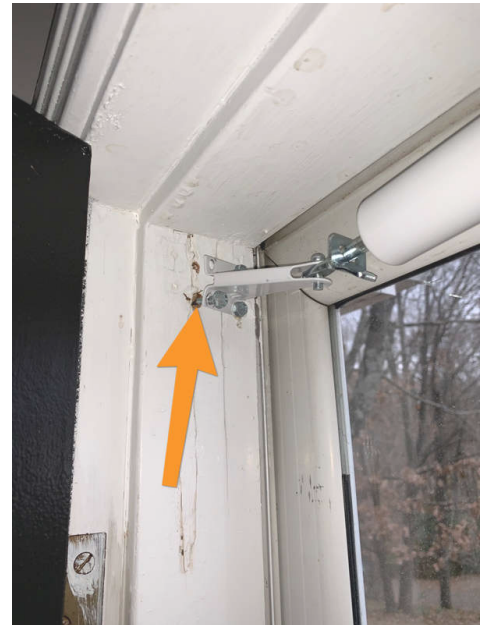
11.1.2 Doors

LOOSE STORM DOOR CLOSER

Storm door closer is loose and does not allow the door to close completely. The anchor has pulled loose and is bent. It should be repaired.

Contact a handyman or DIY project

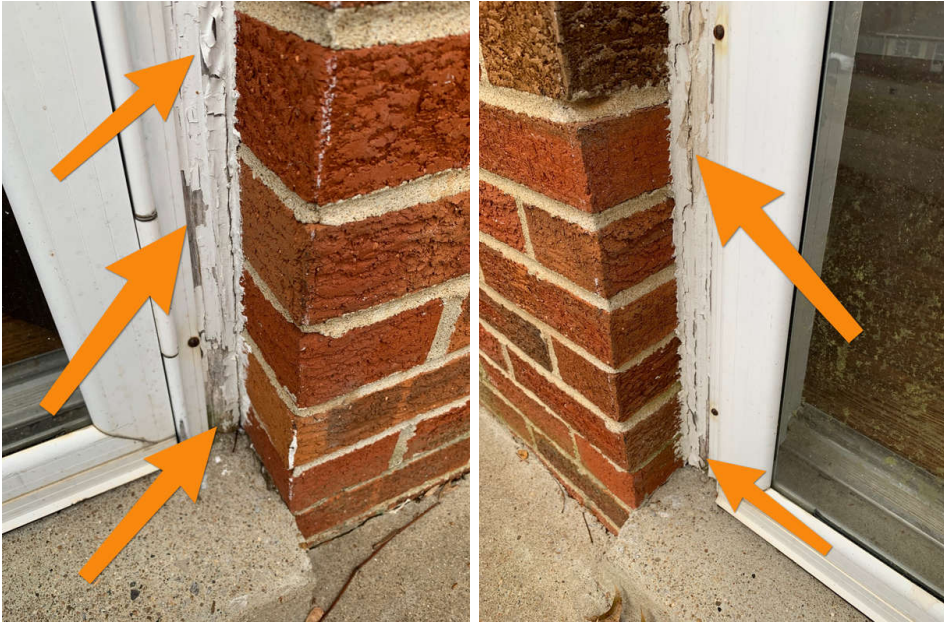
11.1.3 Doors

PAINT CHIPPING AT EXTERIOR DOOR FRAME

Chipped paint at the exterior door frame allows moisture penetration into the frame that cause cause further damage to the frame. This should be corrected to prevent water damage to the frame.

Contact a handyman or DIY project

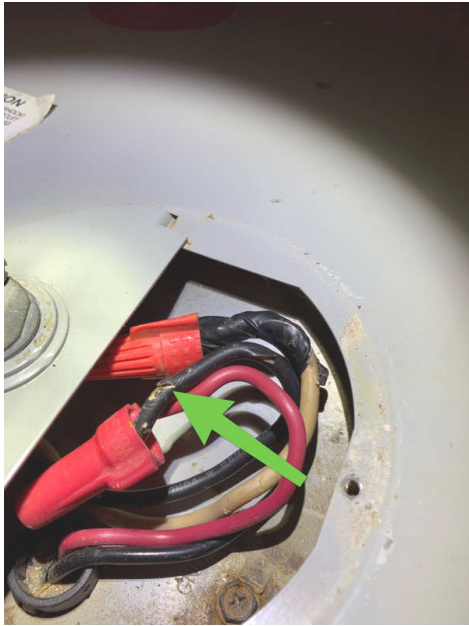
12.2.1 Hot Water Systems, Controls, Flues & Vents

DAMAGE TO WIRE SHEATHING

Damage to the electrical feed wire insulation can cause an arc within the electrical connection box on the water heater. This can cause electrical shock or a fire. This should be repaired immediately by a qualified contractor.

Contact a qualified electrical contractor.
