A PRECISE HOME INSPECTION, INC.

HOME INSPECTION REPORT

1234 Main St.
Colorado Springs CO 80920

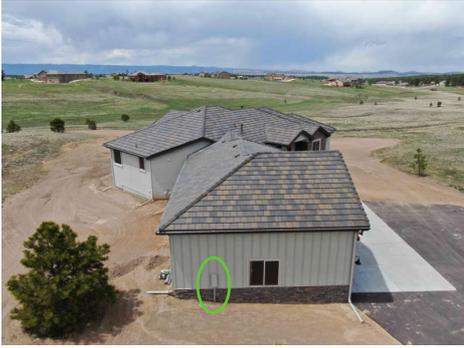
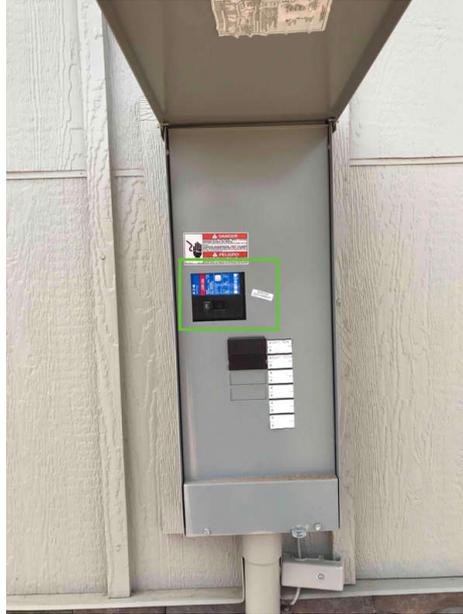
Electrical - Main Disconnect: Location

On the South Exterior

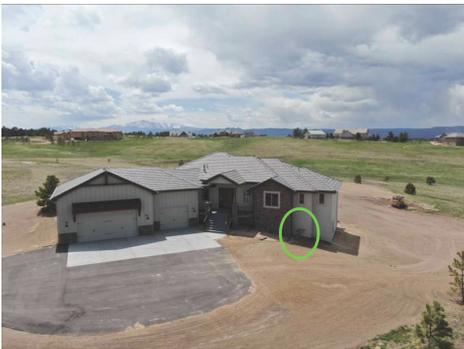
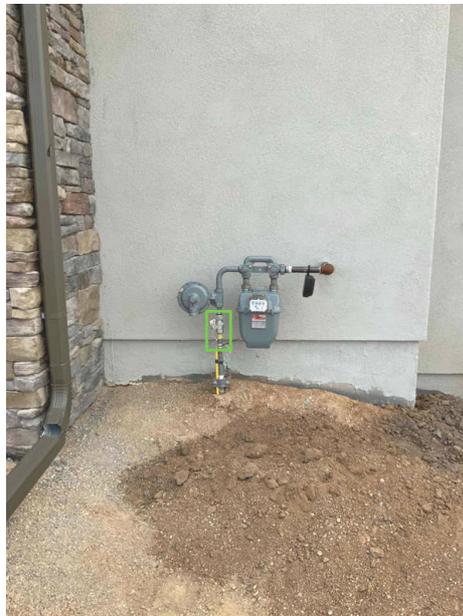
**Gas - Main Shut Off Valve: Location**

At The Regulator, Against the East Exterior Wall

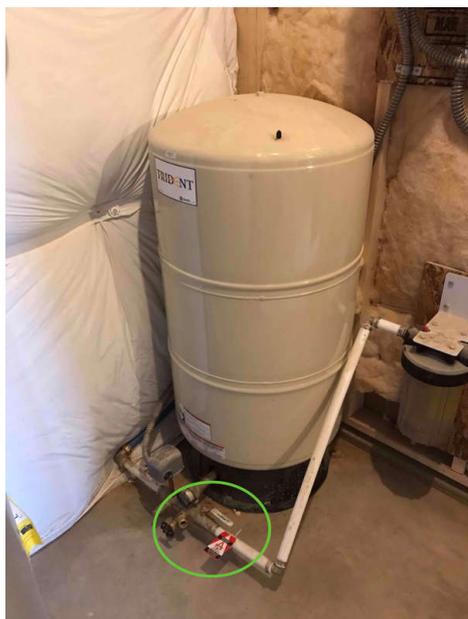
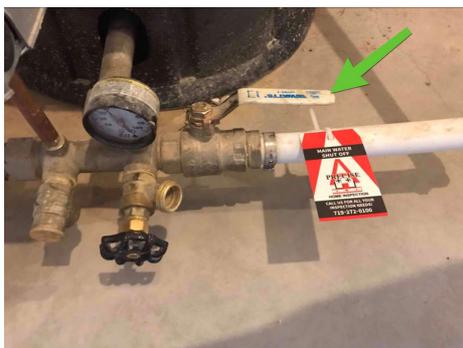
Water - Main Shut Off Valve: Location

Basement, Utility Room

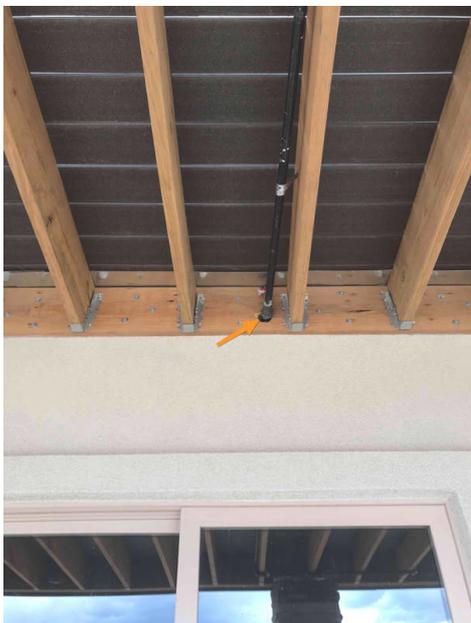
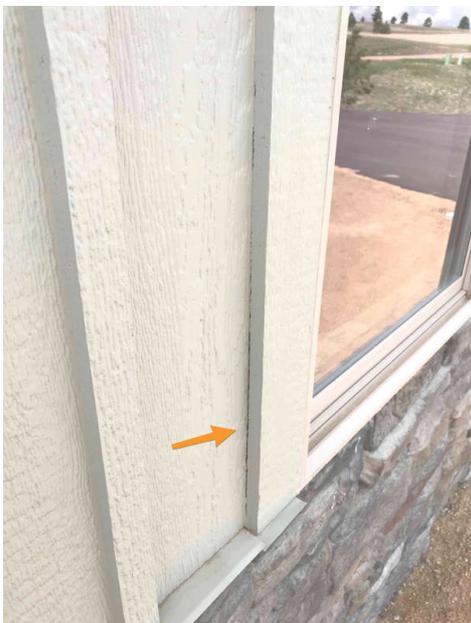
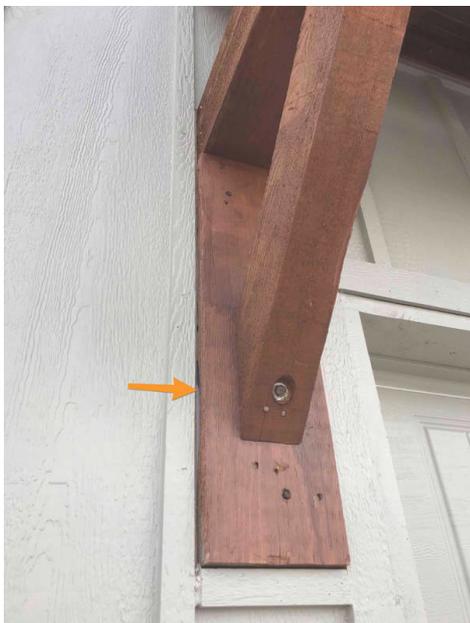
Areas of the exterior paint and caulking are in need of maintenance/repairs. In order to prevent moisture intrusion and to extend the life of the siding and trim, the gaps, pipes, conduit, etc. should be properly sealed. I recommend having the caulking and exterior paint evaluated and repaired as necessary by a qualified painting contractor prior to closing.

Contact a qualified painting contractor.

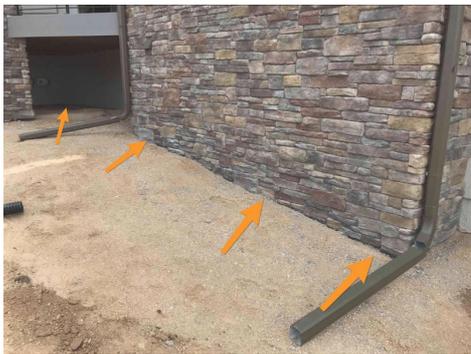
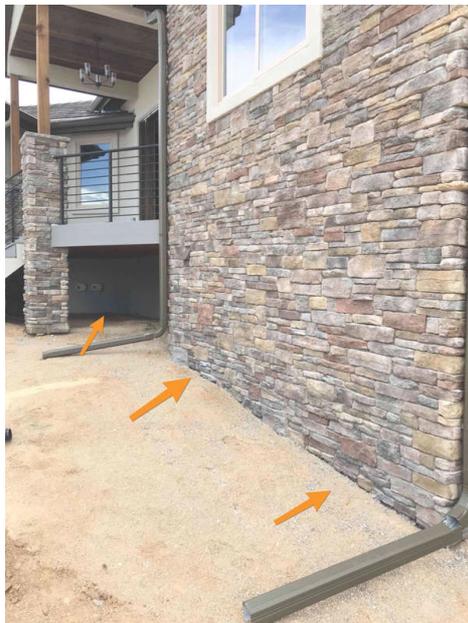
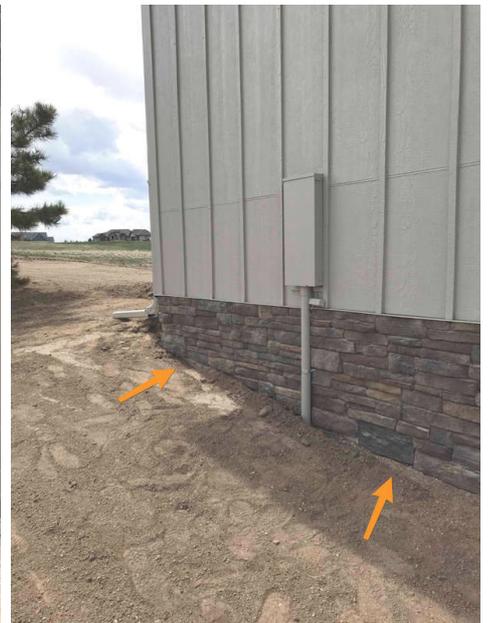
3.1.2 Siding, Flashing & Trim

Areas of the siding are in close contact with the ground. In order to prevent damage to the siding from rain/snow, as well as wood destroying organisms, I recommend having the siding and landscaping evaluated and addressed as necessary by a licensed contractor.

Contact a qualified siding specialist.

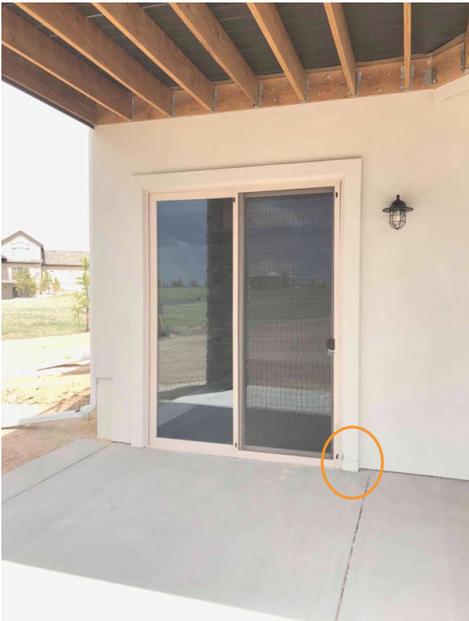
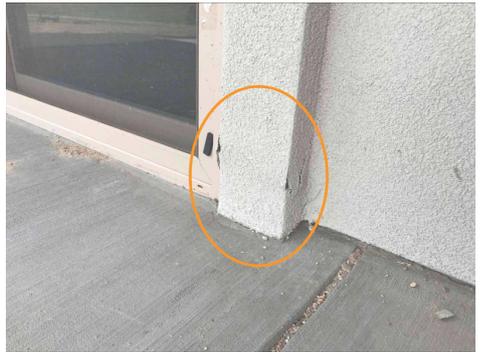
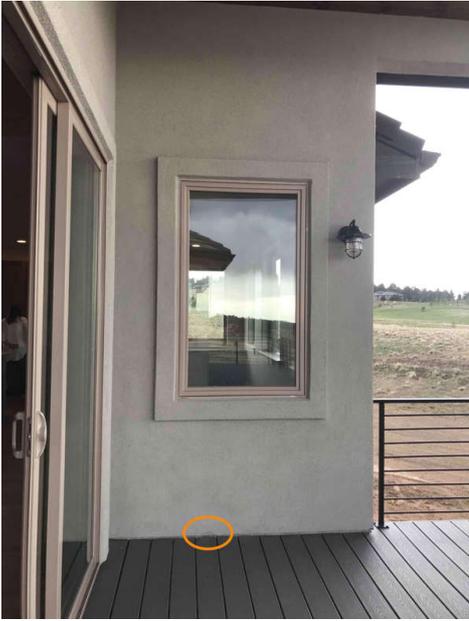
3.1.3 Siding, Flashing & Trim

STUCCO - REPAIRS NEEDED

Areas of the stucco appears to have cracking/damage. In order to prevent moisture intrusion, I recommend having the stucco evaluated and repaired as necessary by a qualified stucco contractor prior to closing.

Contact a stucco repair contractor

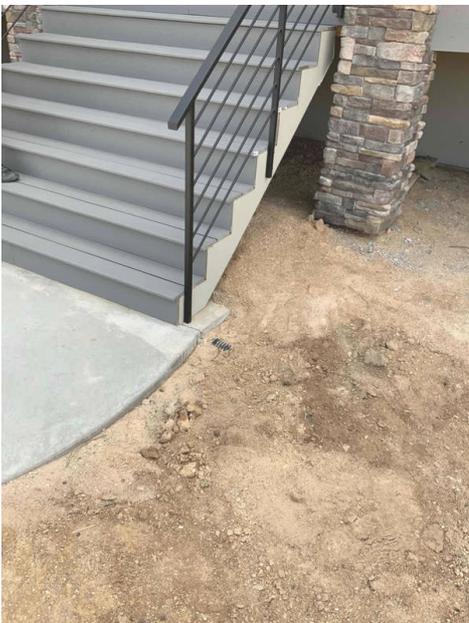
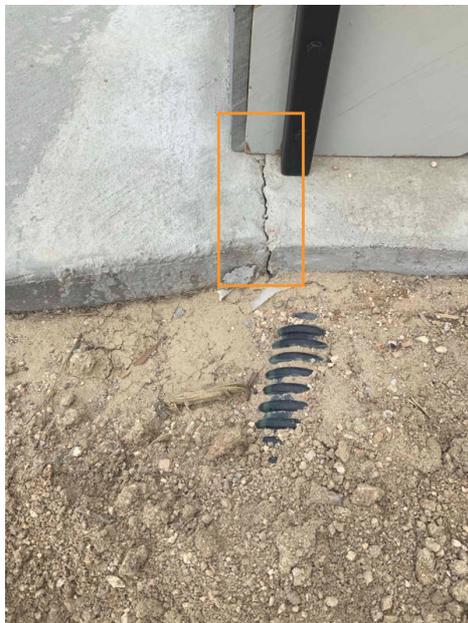
3.3.1 Sidewalks, Patios, Porches, & Driveways

CONCRETE - CRACKING

Cracking was observed in one or more areas of the concrete. I recommend having the cracks sealed in order to prevent moisture intrusion and further cracking.

Contact a qualified concrete contractor.

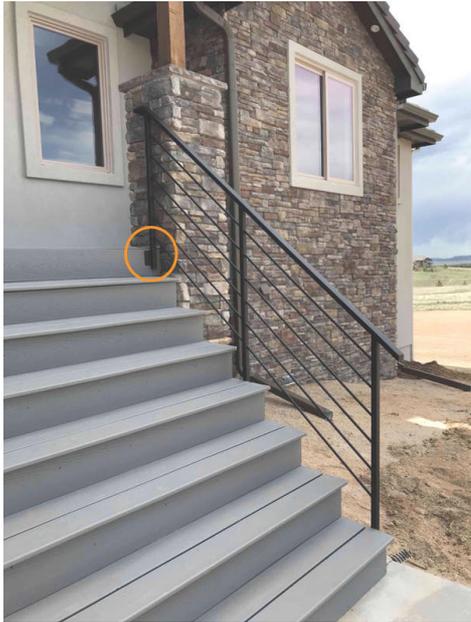
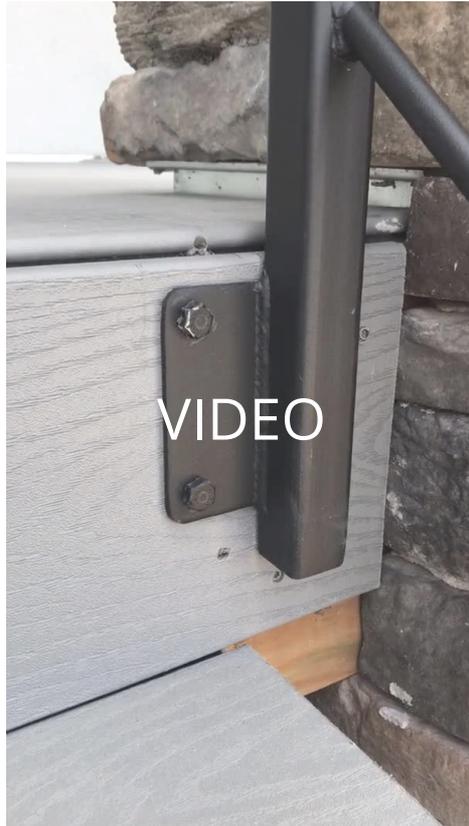
3.4.1 Deck

RAILINGS/HANDRAILS - LOOSE

One or more areas of the railings/handrails appeared to be loose. I recommend having this evaluated and repaired/addressed as necessary by a licensed deck contractor prior to closing.

Contact a qualified deck contractor.

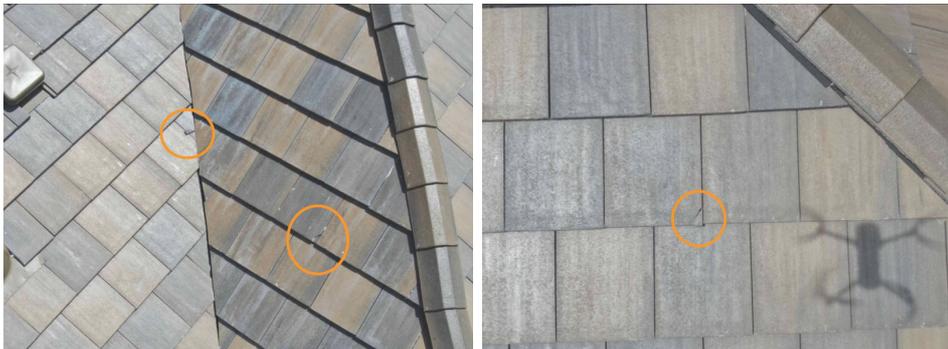
ROOF - DAMAGED TILE

Damaged tiles were observed during the inspection. In order to prevent any moisture intrusion, I recommend having the roof evaluated and repaired/replaced as necessary.

Contact a qualified roofing professional.

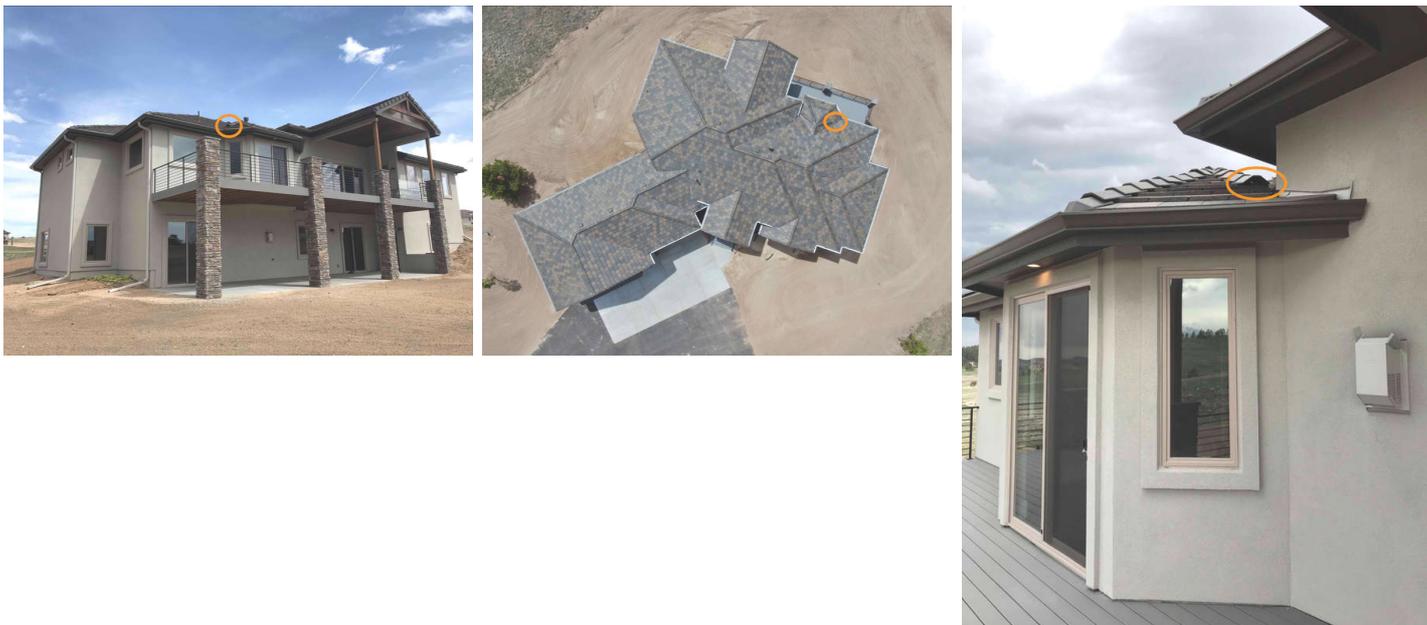
4.2.2 Coverings

TILE - MISSING RIDGE CAP

One or more ridges appeared to be in need of a cap type of tile at the bottom of the ridge. In order to prevent moisture and/or pest intrusion, I recommend having the roof evaluated and repaired as necessary by a qualified and licensed roofing contractor prior to closing.

Contact a qualified roofing professional.

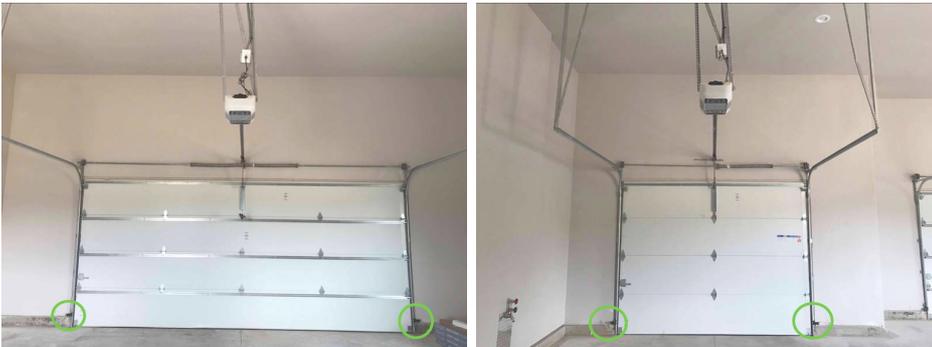
Garage Door Opener and Safety: Photo Eye Safety Feature

The garage door opener(s) were equipped with photo eyes. This is a safety feature that prevents the door from closing if the beam in between the photo eyes is broken. This feature was tested and any defects are noted below.

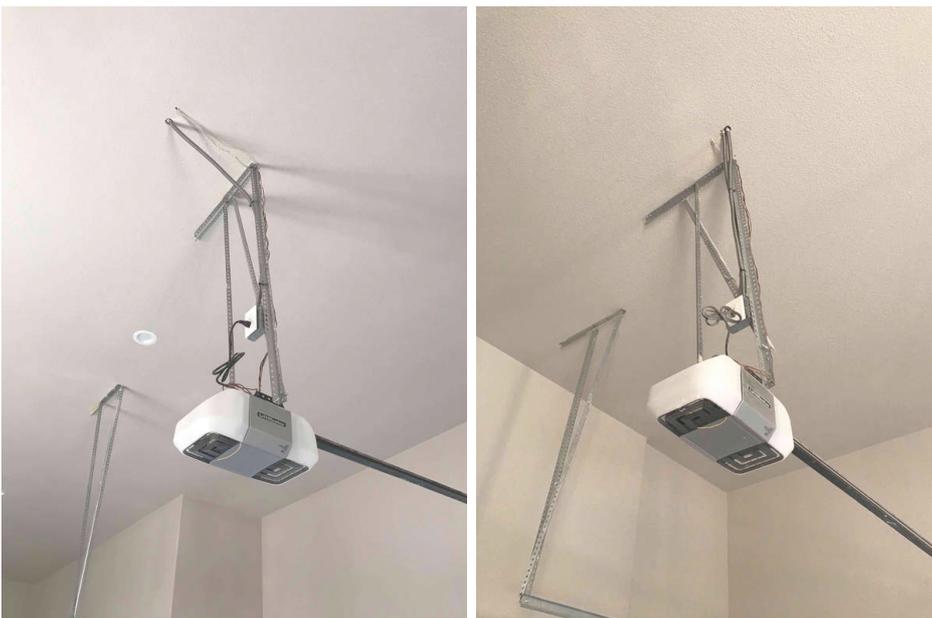
Garage Door Opener and Safety: Auto Reverse Safety Feature

The garage door opener(s) are equipped with a safety feature known as Auto Reverse. If resistance is placed on the bottom of the garage door while coming down, the door automatically reverses and goes back up. This feature was tested, any defects are noted below.

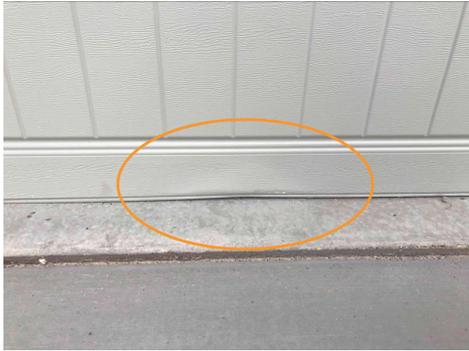
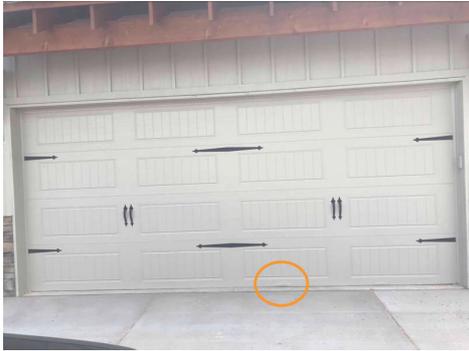
GARAGE DOOR - COSMETIC DAMAGE

2 CAR GARAGE DOOR

One or more areas of the garage door(s) appeared to have cosmetic damage but did not effect the function. This is not a major concern but something you should be aware of.

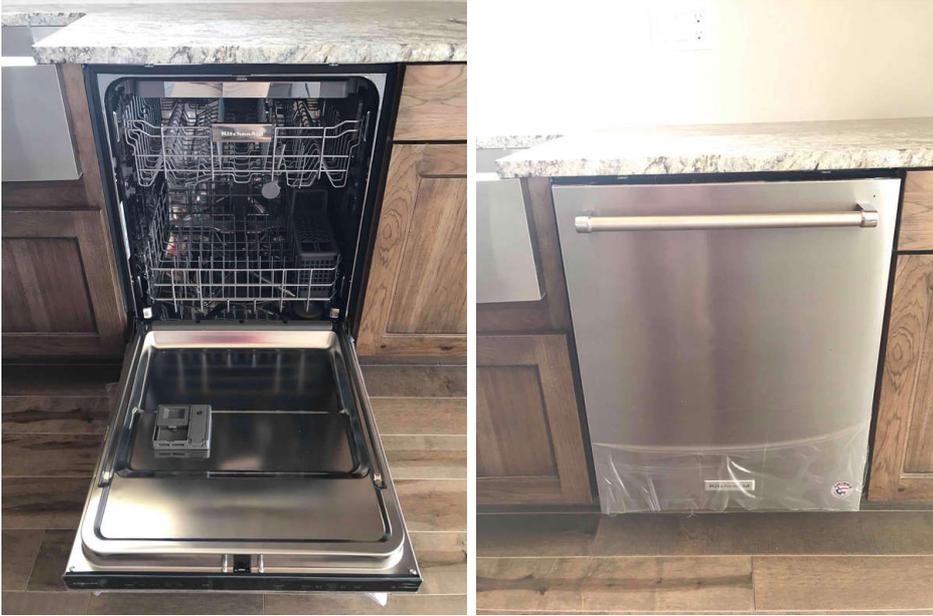
Dishwasher: Dishwasher

The dishwasher was visually inspected and was tested by running it through a brief cycle. The area around the dishwasher and under the kitchen sink were then checked for leaks. Any defects are noted below.

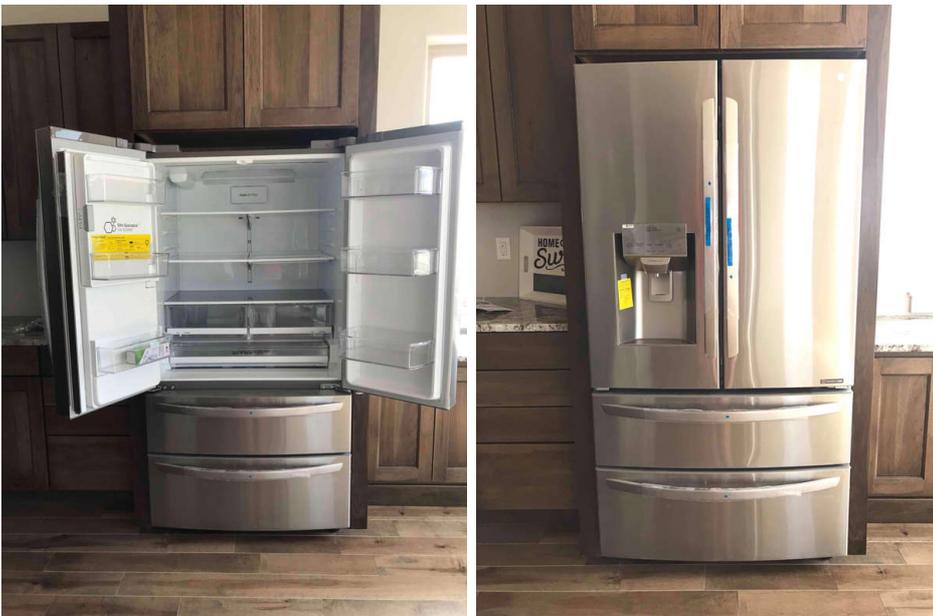
Refrigerator: Refrigerator

The refrigerator was visually inspected and a temperature was taken inside the refrigerator and freezer to ensure that they were cooling properly. Any ice/water dispensers present were tested. Any defects are noted below.

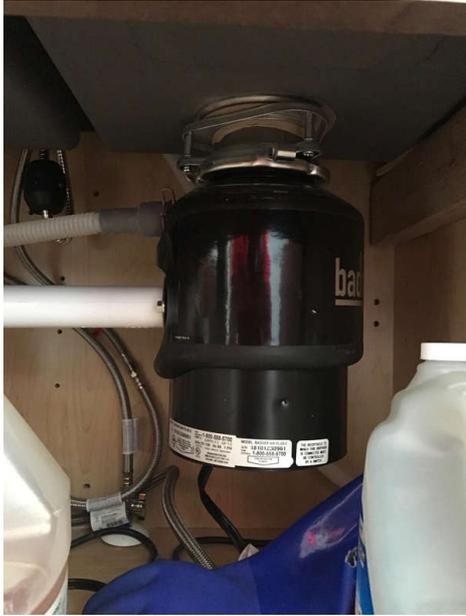
Garbage Disposal: Garbage Disposal

The garbage disposal was visually inspected and tested, then inspected for leaks. Any defects are noted below.

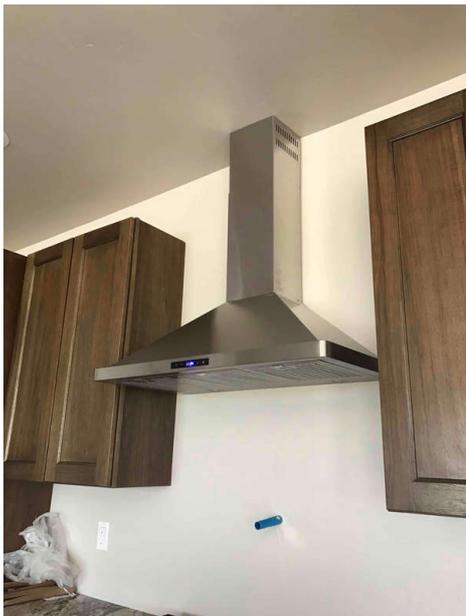
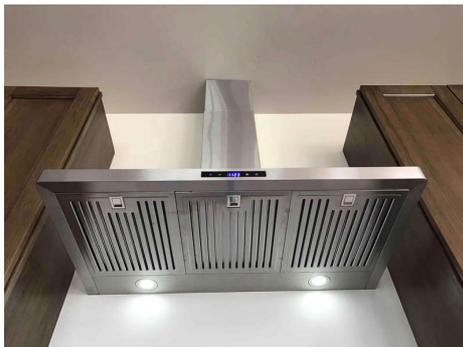
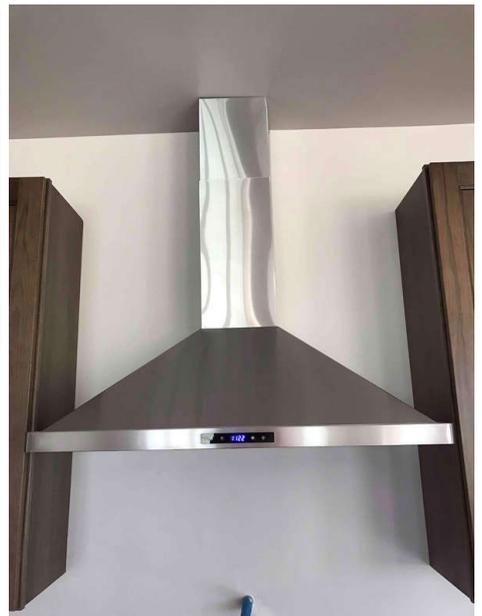
Range Hood: Range Hood

The range hood was visually inspected and the exhaust fan and light were tested. Any defects are noted below.

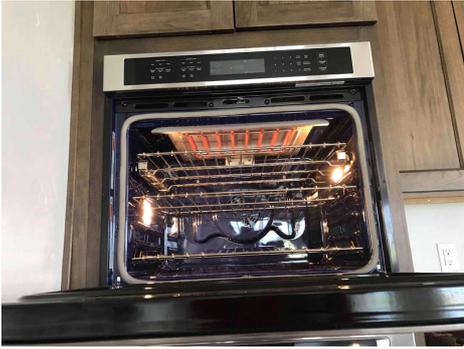
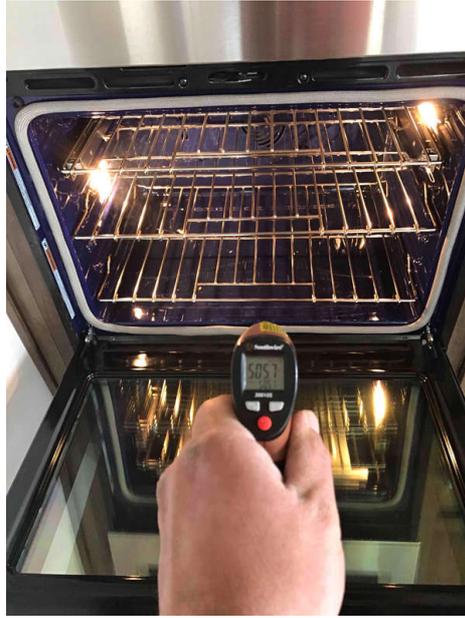
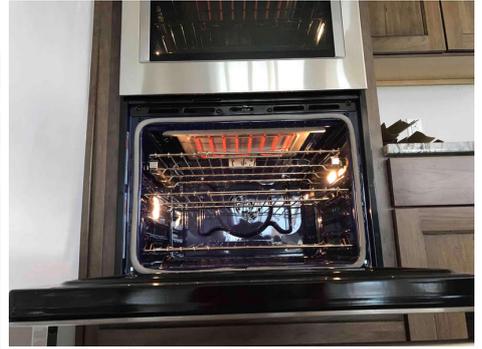
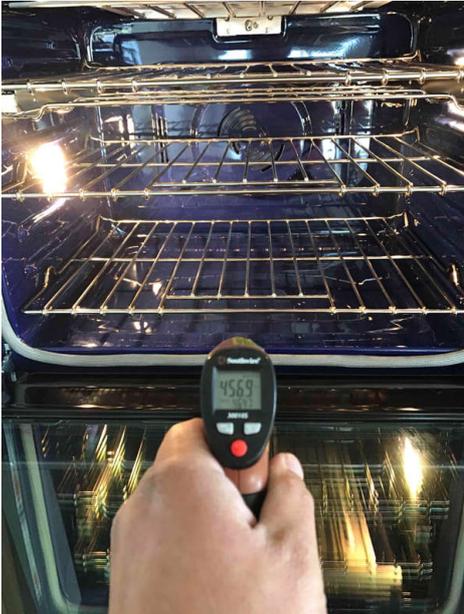
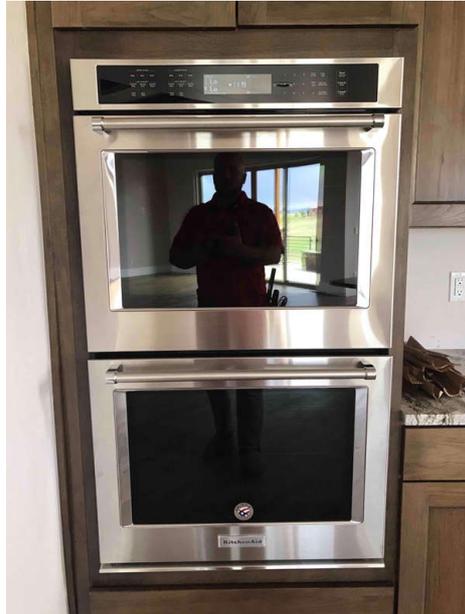
Wall Oven: Wall Oven

The wall oven(s) were visually inspected and all burners/elements were tested to ensure they were functioning properly. Any defects are noted below.

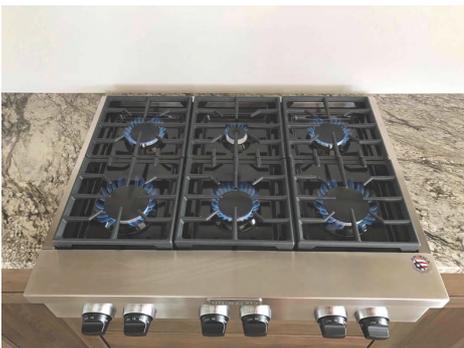
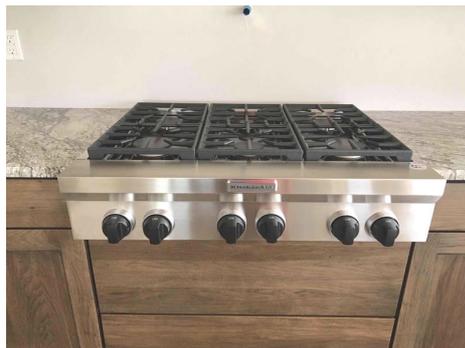
Cooktop: Cooktop

The cooktop was visually inspected and each burner was tested to ensure that they functioned properly. Any built-in exhaust systems present were tested. Any defects are noted below.

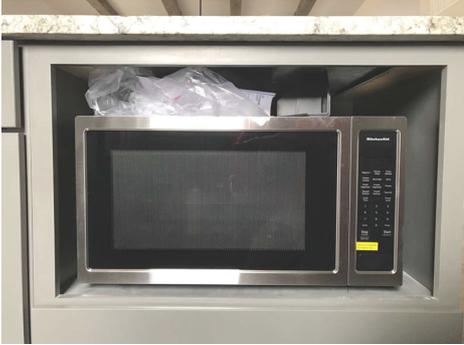
Microwave: Microwave

The microwave was visually inspected and tested to ensure that microwaves were actually being emitted inside. Any defects are noted below.

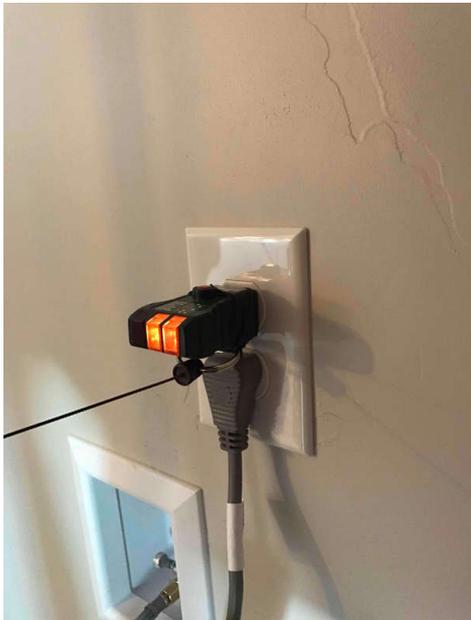
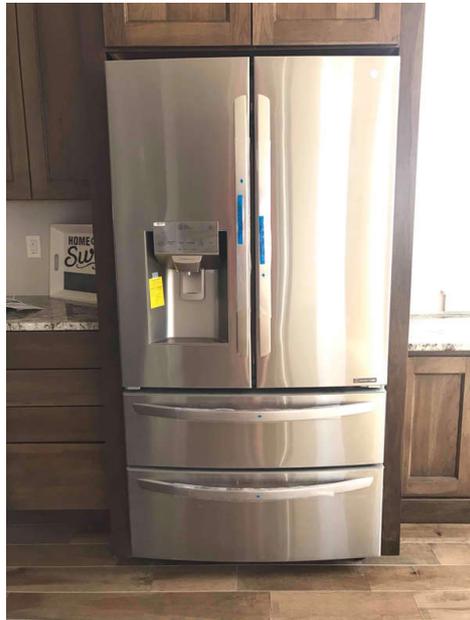
Refrigerator was inoperable at time of inspection. It was plugged in and the receptacle did have power. I recommend having it evaluated and repaired/replaced as necessary by a qualified appliance repair technician prior to closing.

Contact a qualified appliance repair professional.

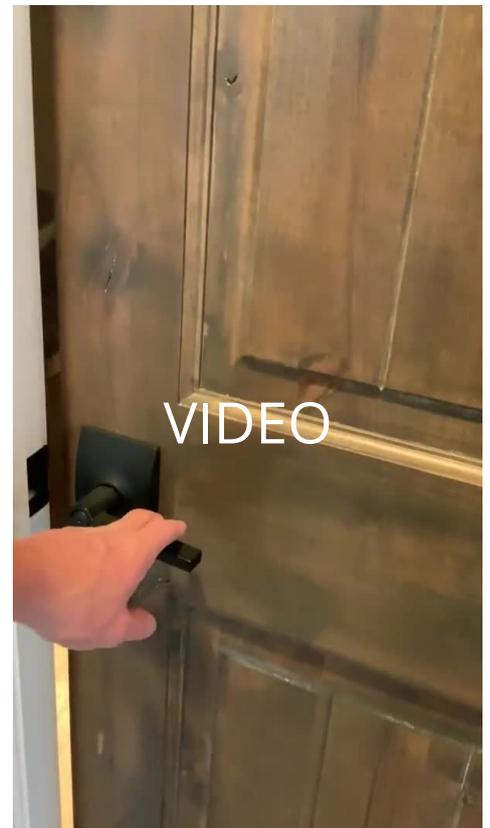
One or more interior doors did not latch/lock properly. I recommend having the doors evaluated and repaired/replaced as necessary.

Contact a qualified handyman.

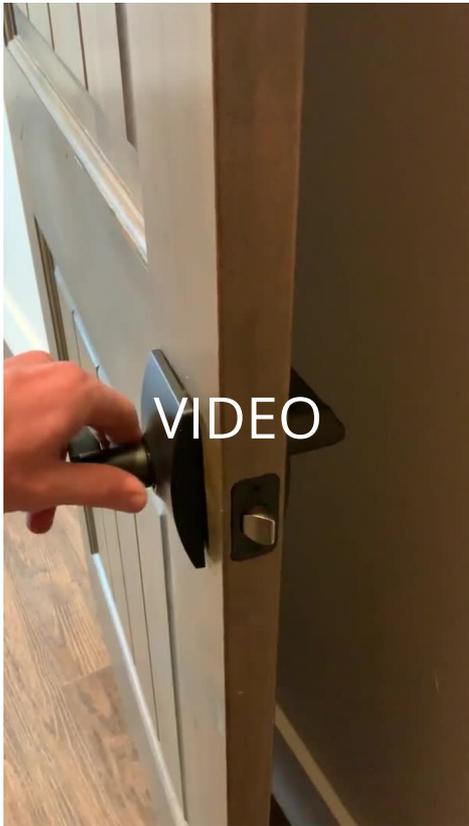
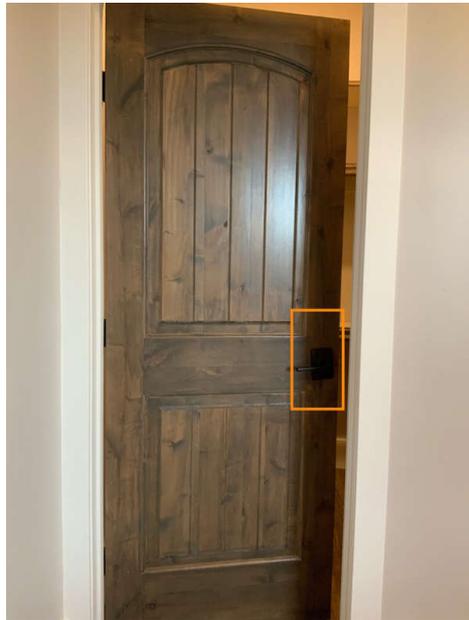
7.1.2 Doors

INTERIOR DOORS - LOOSE HARDWARE

One or more doors appeared to have loose hardware. I recommend having the loose hardware properly tightened.

Contact a qualified handyman.

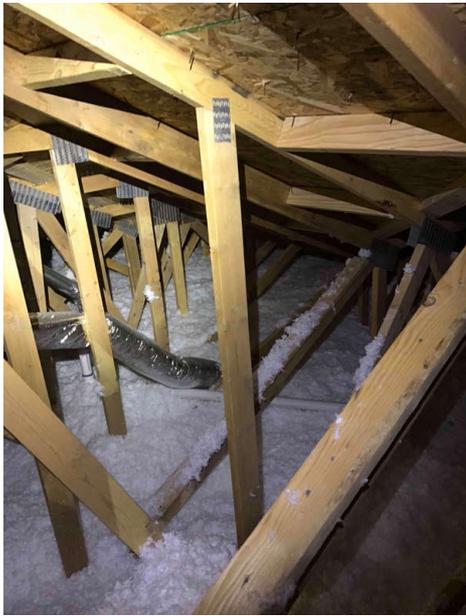
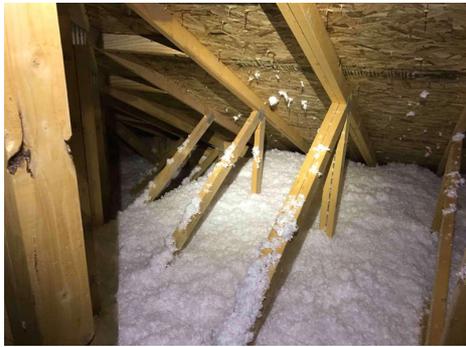
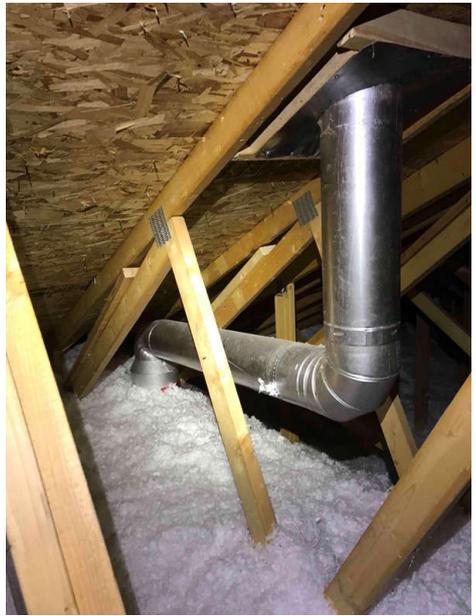
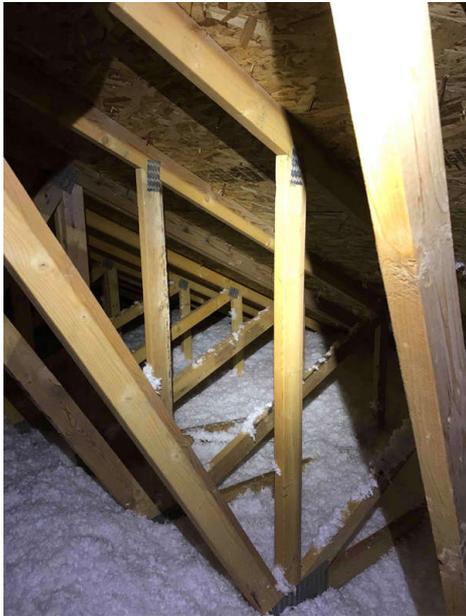
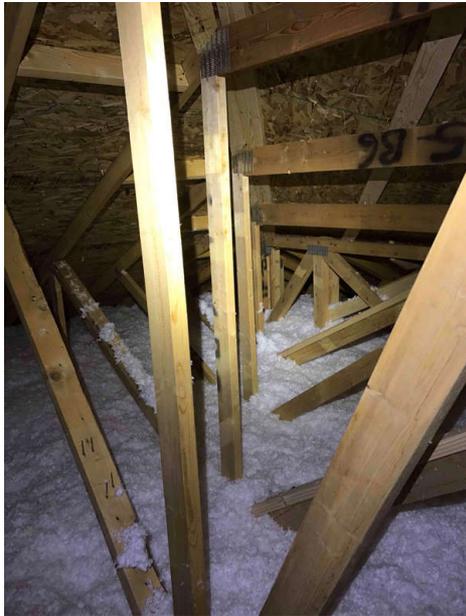
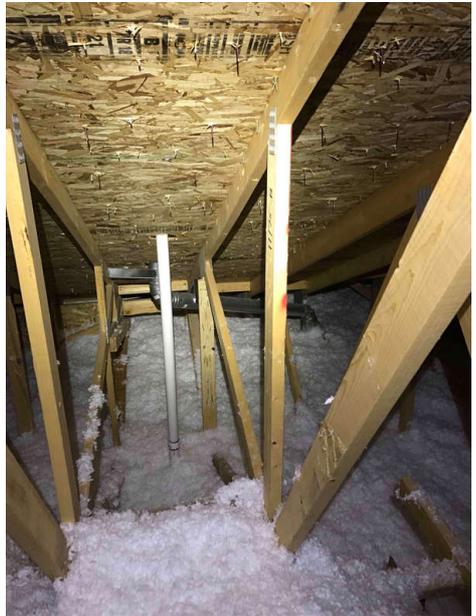
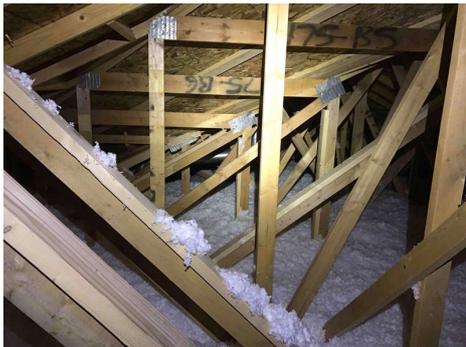
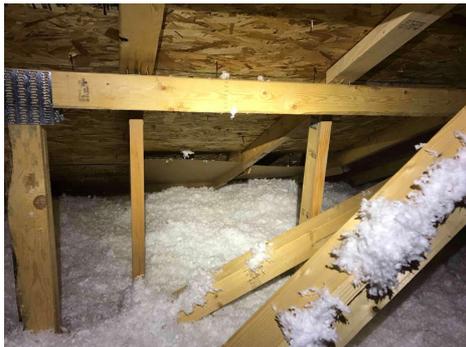
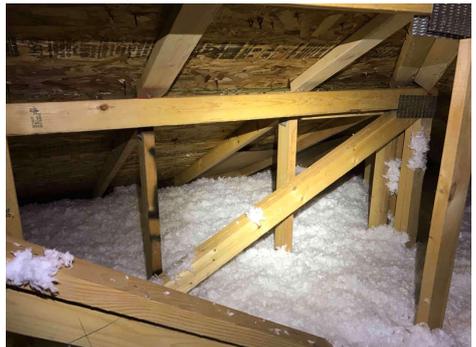
Roof Structure & Attic: Pictures of Attic

Roof Structure & Attic: Decking Material
OSB

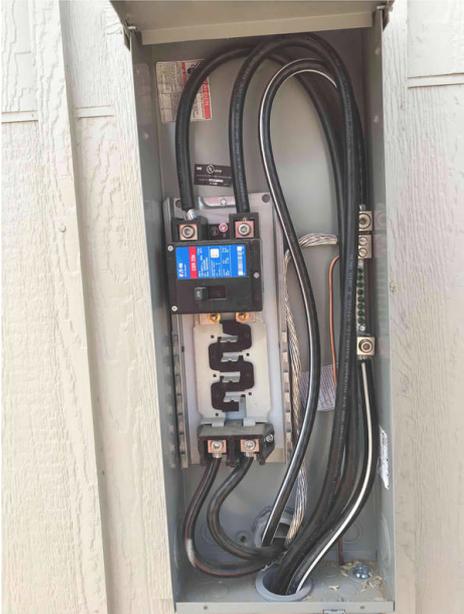
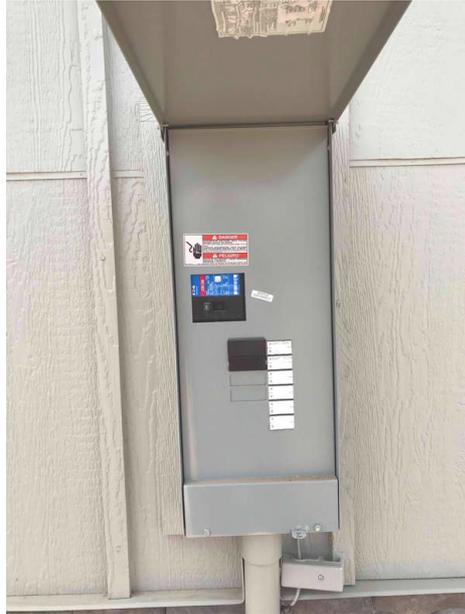
Service Panel: Picture of Inside Service Panel

Service Panel: Main Panel Location
On the South Exterior Wall

Service Panel: Panel Amperage
200 AMP

Service Panel: Equipment in Panel
Circuit Breaker

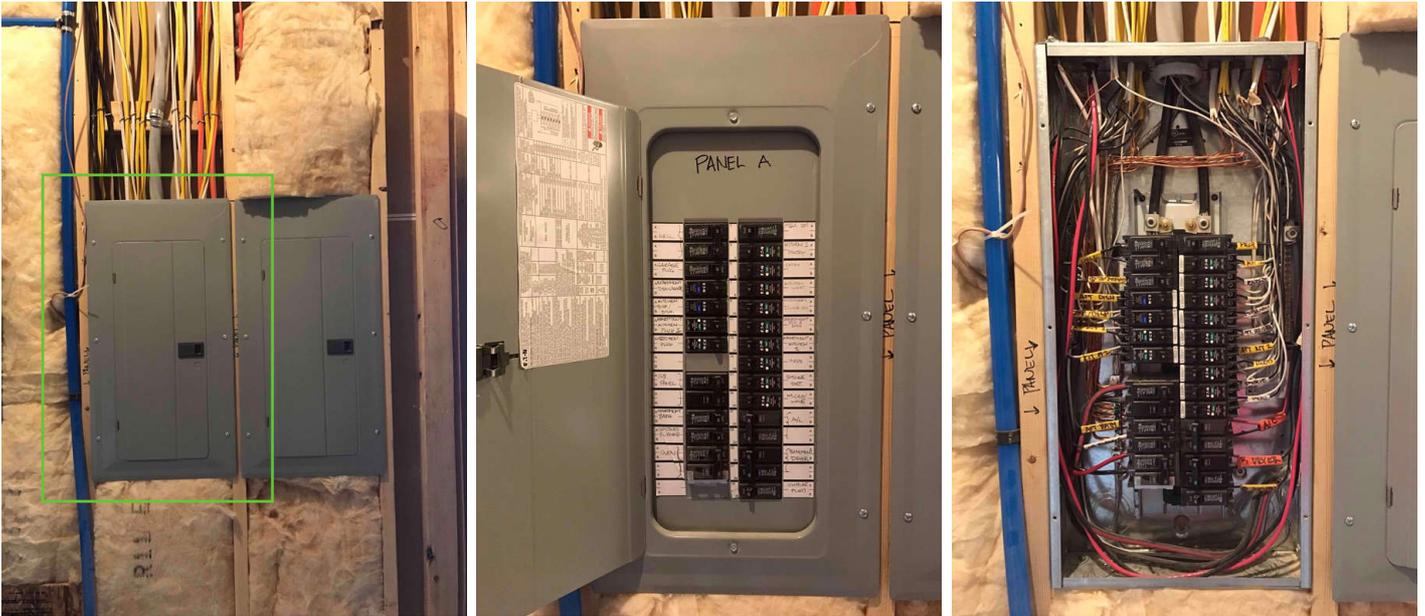
Sub Panel A: Pictures Inside Sub Panel

Sub Panel A: Sub Panel Location Utility Room, Basement
Sub Panel A: Equipment in Panel Circuit Breakers, GFCI Breakers, AFCI Breakers

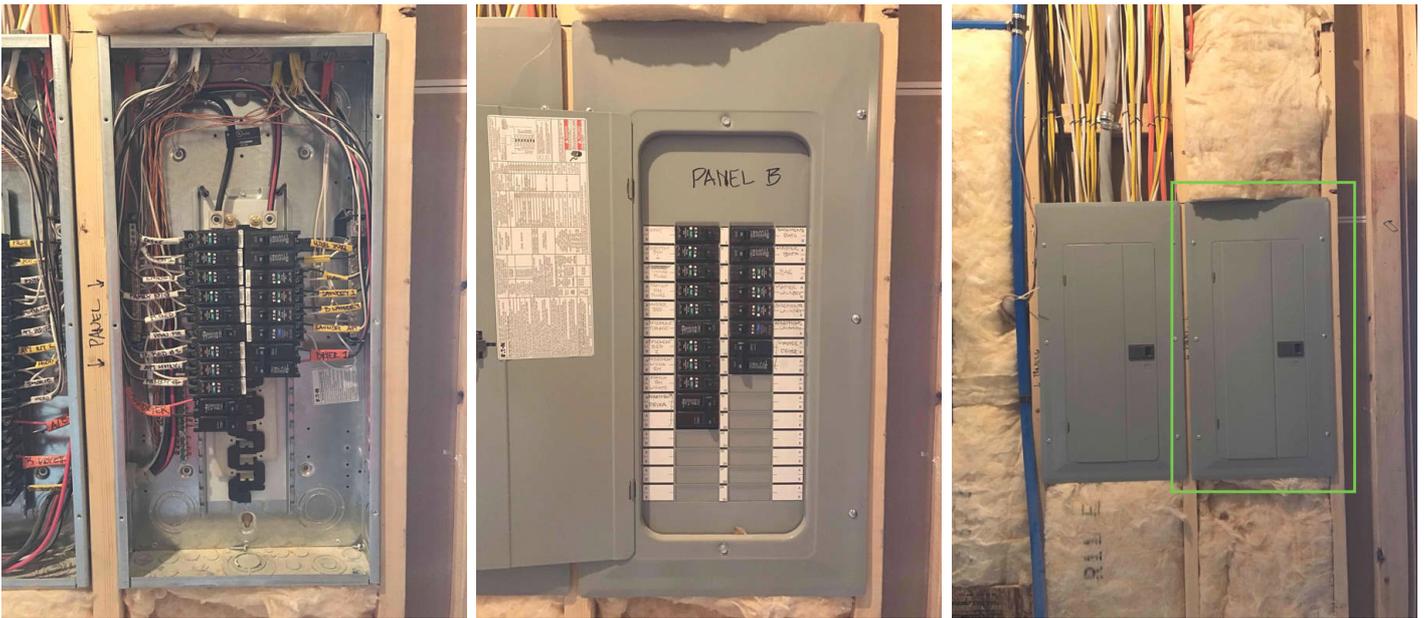
Sub Panel 2: Pictures Inside Sub Panel

Sub Panel 2: Sub Panel Location Basement, Utility Room
Sub Panel 2: Equipment in Panel Circuit Breakers, GFCI Breakers, AFCI Breakers
Branch Wiring Circuits, Breakers & Fuses: Branch Wiring Copper

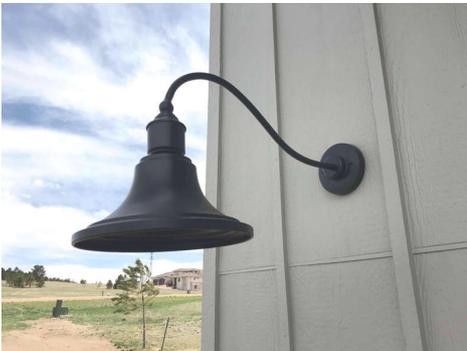
Exterior light fixture(s) were not properly secured to the box. In order to prevent moisture intrusion, I recommend having the light properly sealed and secured by a licensed electrician.

Contact a qualified electrical contractor.

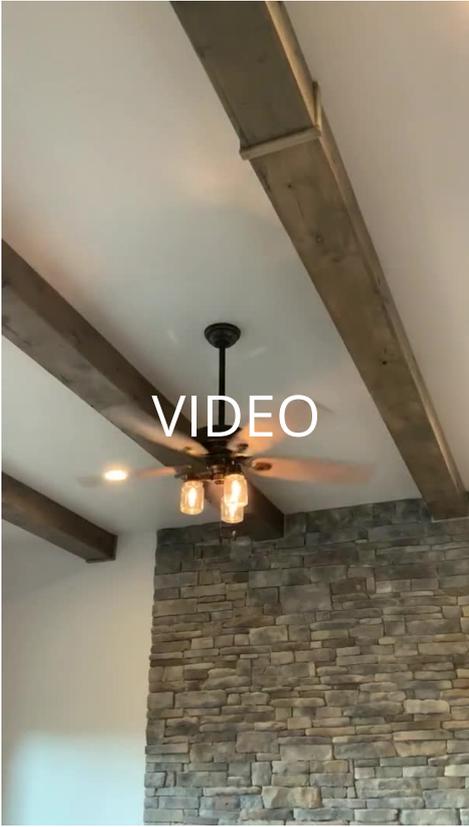
ELECTRICAL - CEILING FAN WOBBLE

One or more ceiling fans had an excessive amount of wobble. I recommend having the ceiling fan(s) evaluated and repaired as necessary by a licensed electrician prior to closing.

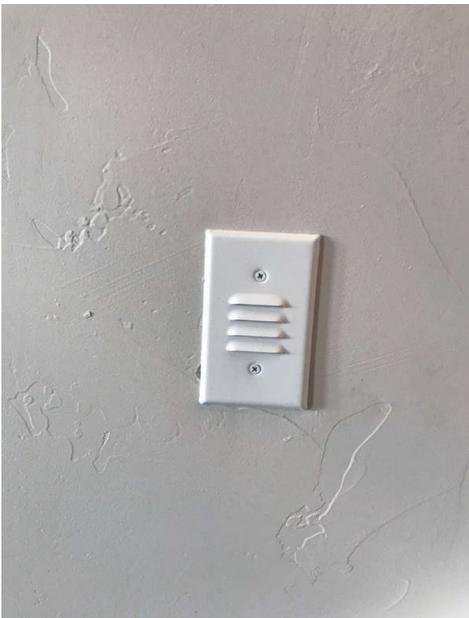
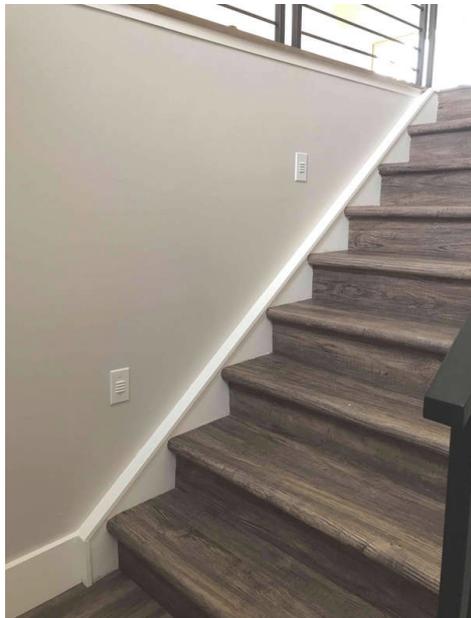
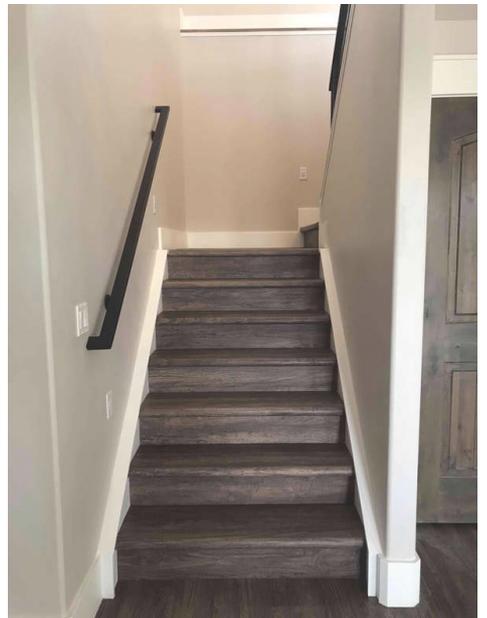
LIGHTING - RECOMMEND EVALUATION

The lighting in the stairwell does not appear to be correctly wired and functioning properly. The chandelier does not appear to be controlled from the bottom of the stairs and the lighting to illuminate the steps does not function at all. There are switches at the top and bottom of the steps that don't appear to control anything. I recommend having this evaluated and repaired/replaced as necessary by a licensed and qualified electrician prior to closing.

Contact a qualified electrical contractor.

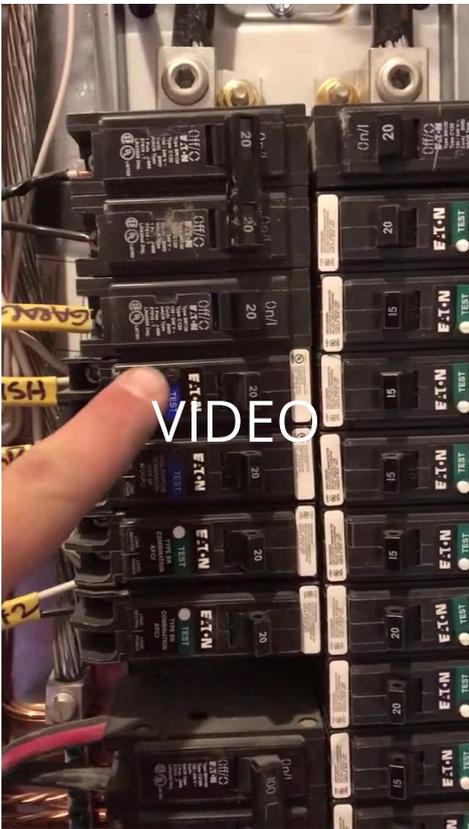
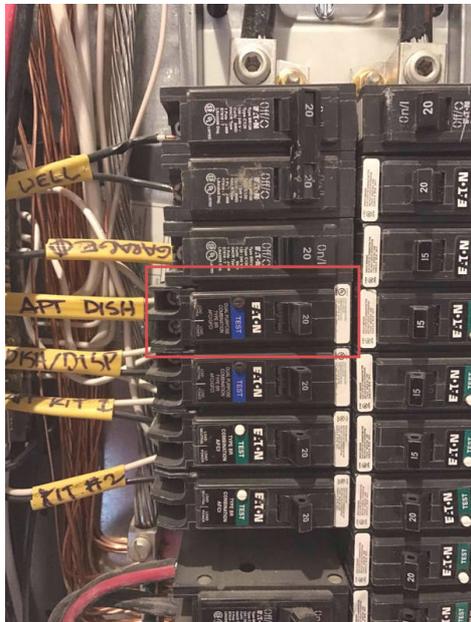
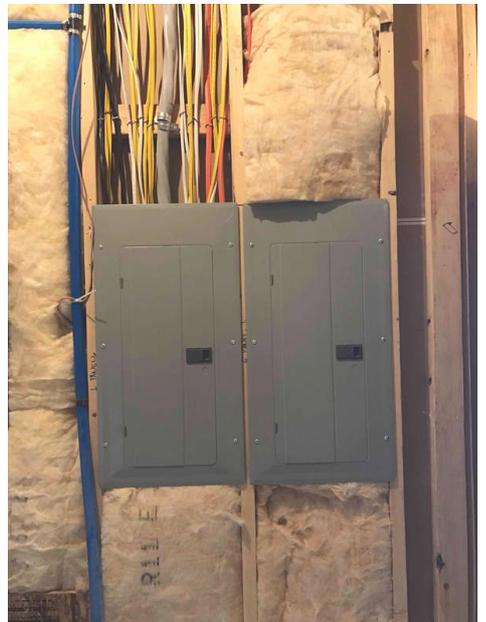
9.7.1 GFCI & AFCI

GFCI/AFCI COMBINATION BREAKER - FAILED TEST

One or more GFCI/AFCI combination breakers in the service panel did not function properly when tested. I recommend having the breaker evaluated and replaced as necessary by a licensed electrician prior to closing.

Contact a qualified electrical contractor.

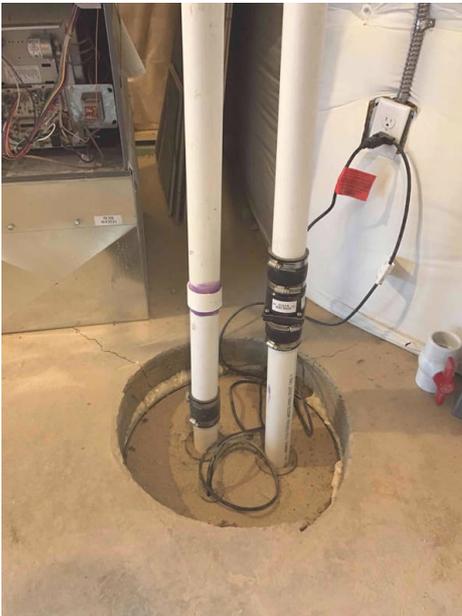
Drain, Waste, & Vent Systems: Sewage Grinder / Lift Station

The home is equipped with a sewage grinder, also known as a lift station. This equipment is commonly installed in homes when there are drains in the home that are below the lateral sewer line, preventing a downward slope. The system was checked to ensure the pump was functioning, the inlet and vent pipes were properly sealed where they enter the pit, a check valve was installed, and that the system was properly vented. Any defects are noted below.

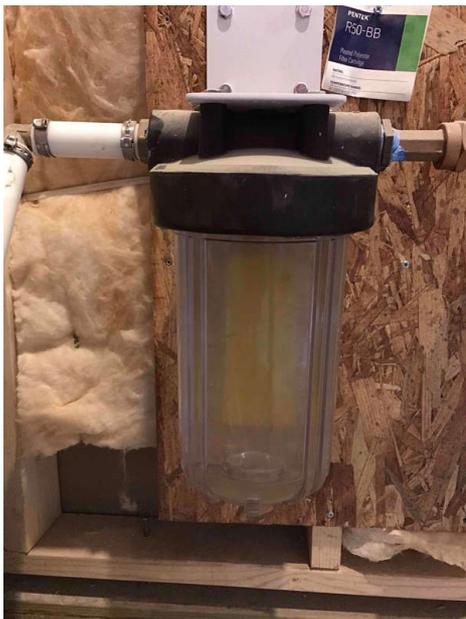
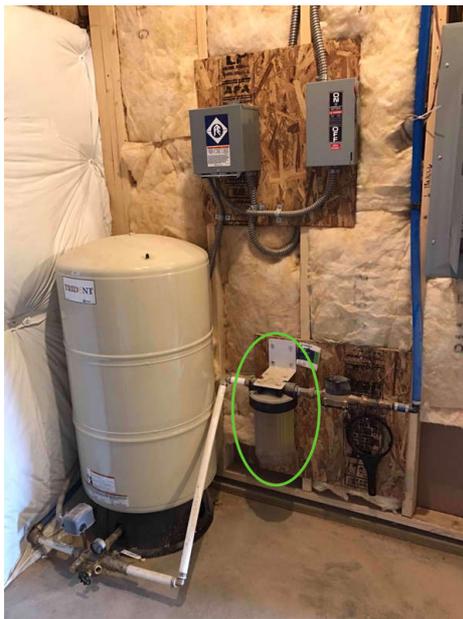
Water Supply: Whole House Sediment Filter

The water supply is equipped with a whole house sediment filter. I recommend acquiring the maintenance manual for your particular type of filter. Generally, the filters should be replaced every 3-6 months. Here is a helpful link about replacing your whole house filter!

The whole house filter housing was missing the actual filter. I recommend having one installed.
