A PRECISE HOME INSPECTION, INC.

HOME INSPECTION REPORT

1234 Main St.
Colorado Springs CO 80920

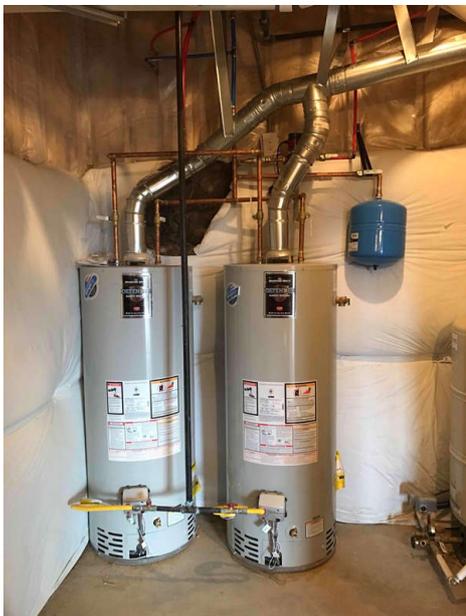
Water Heater: Water Heater

The water heater(s) was visually inspected in order to ensure proper installation and that no leaks, rust, or corrosion were present. The temperature of the water was also checked to ensure the water heater was functioning properly. The recommended temperature for a water heater is at least 120 degrees F to kill microbes and no higher than 130 degrees F to prevent scalding. Any defects are noted below.

Water Heater: Manufacturer
Bradford & White

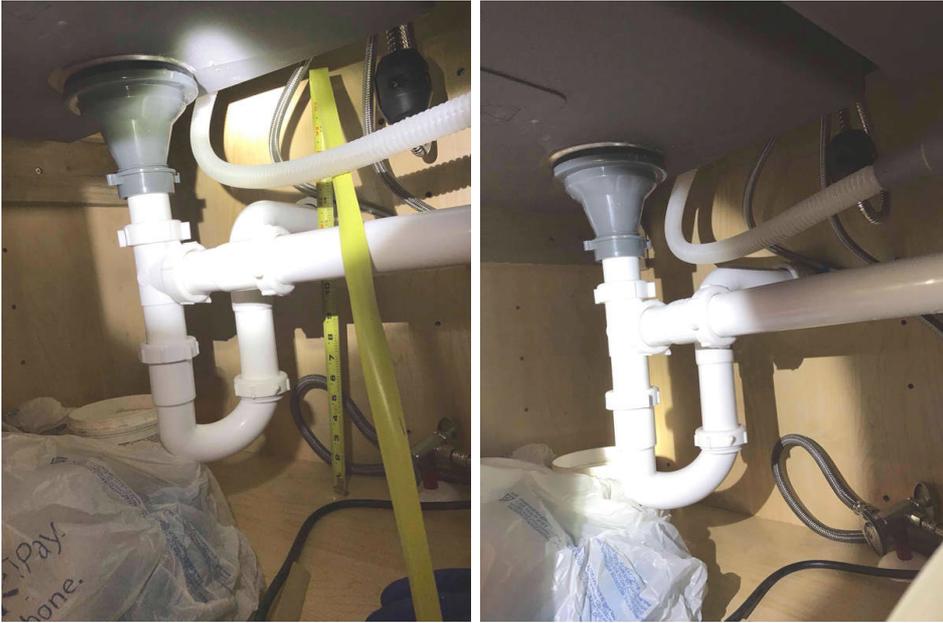
DRAIN - RECOMMEND EVALUATION

The drain rough-in for the kitchen sink is approximately 19" off the floor, which is higher than industry standard. In order to ensure the sinks and disposal all drain properly, I recommend having this evaluated and repaired/replaced as necessary by a licensed and qualified plumber prior to closing.

Contact a qualified plumbing contractor.

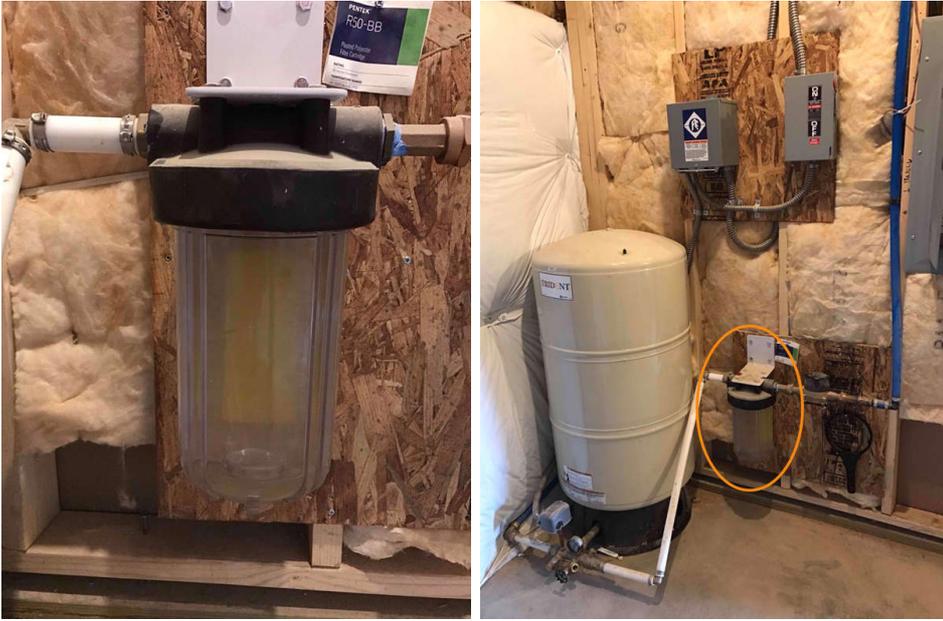
10.2.1 Water Supply

WHOLE HOUSE FILTER - MISSING FILTER

The whole house filter housing was missing the actual filter. I recommend having one installed.

Contact a qualified professional.

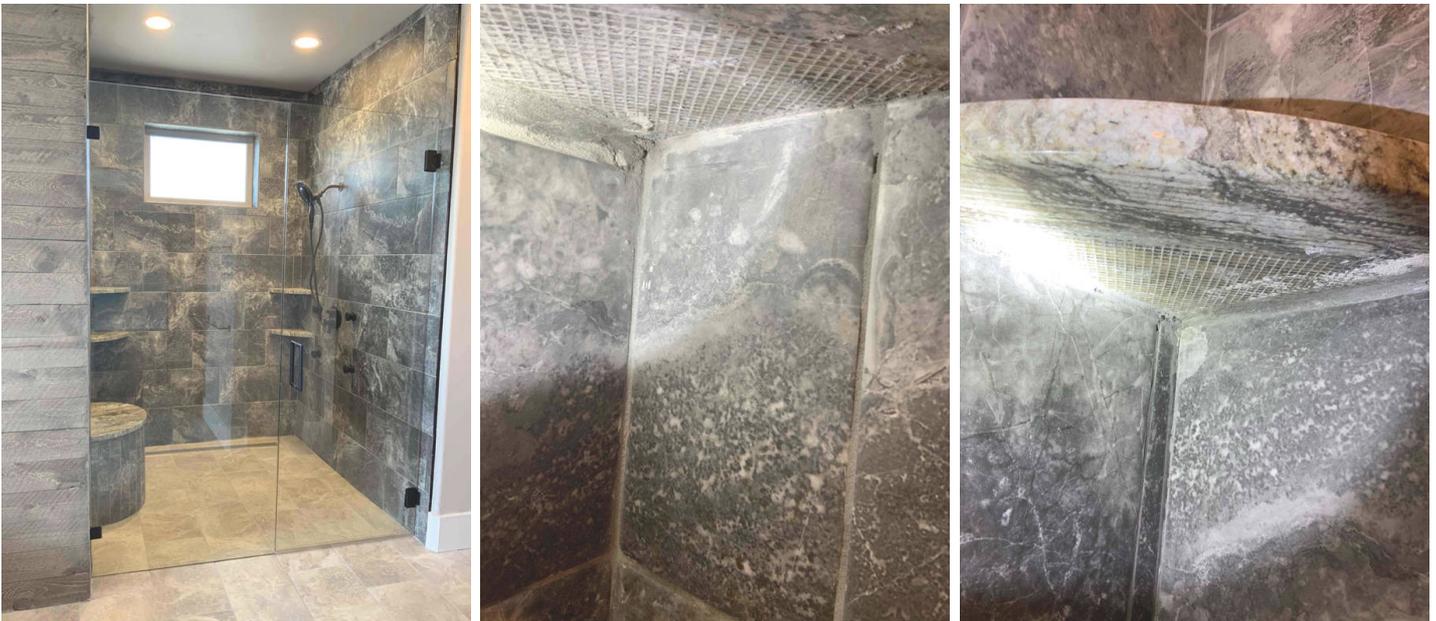
10.5.1 Fixtures

TUB/SHOWER HAS FAILING CAULKING/GROUT

Areas of the caulking/grout in the tub/shower appeared to be failing and is in need of repair. In order to prevent water intrusion, I recommend having this evaluated and repaired as necessary by a qualified contractor prior to closing.

Contact a qualified professional.

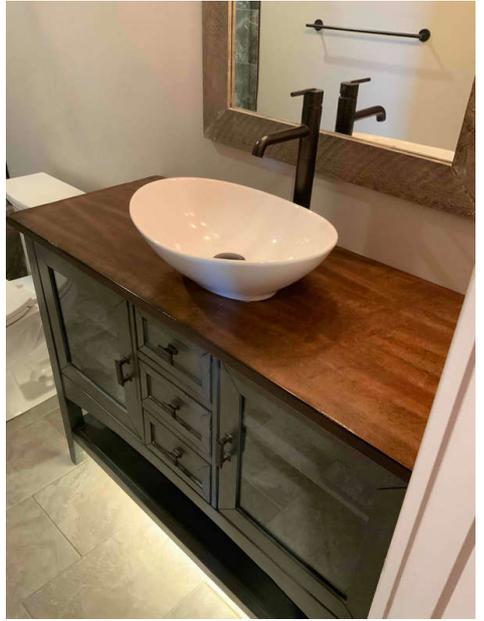
SINK - ACTIVE LEAK

Active leaks were observed under one or more sinks. I recommend having the leak evaluated and repaired as necessary by a qualified plumbing contractor prior to closing.

Contact a qualified plumbing contractor.

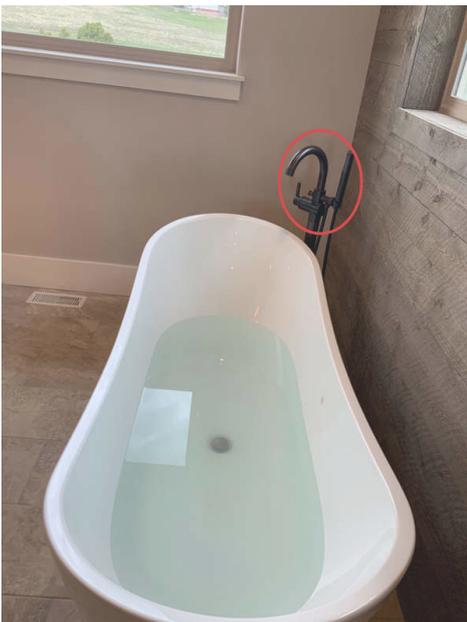
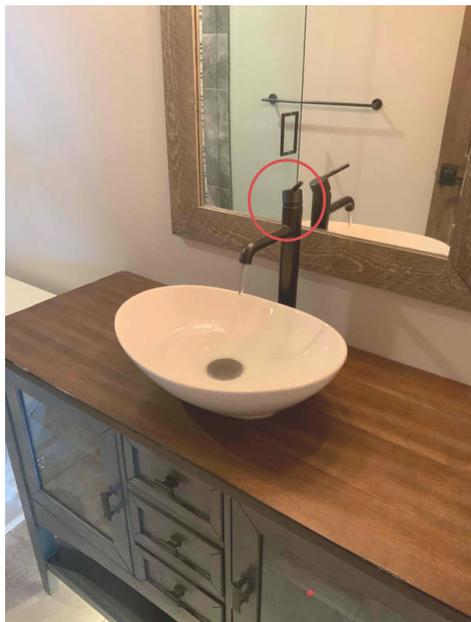
One or more faucets appeared to have the hot and cold water supply installed backwards. In order to prevent any injuries from accidental scalding, I recommend having the faucet evaluated and corrected as necessary by a qualified plumbing contractor prior to closing.

Contact a qualified plumbing contractor.

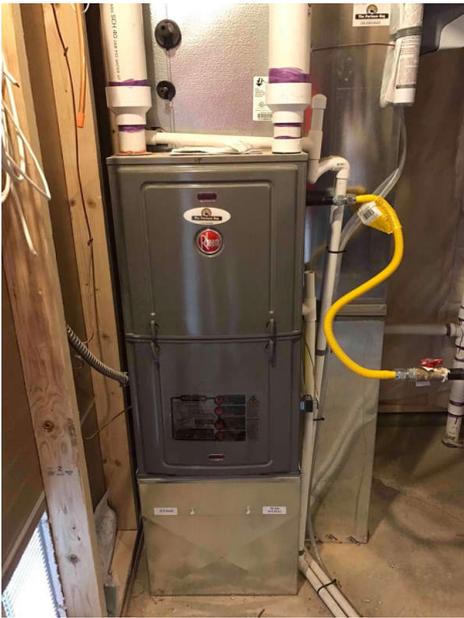
The heating system for the home was visually inspected and tested including the following:

The furnace appeared to be in good overall condition, however I recommend having it cleaned and serviced prior to closing by a licensed HVAC contractor, followed by annually.

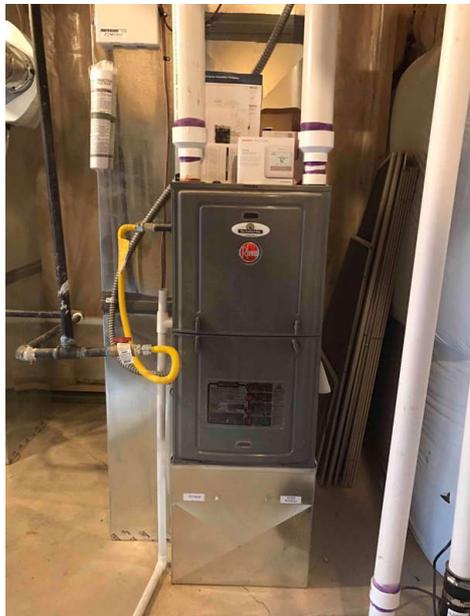
- o Turning on the system at the operating control and ensuring the system operated and heat was delivered from the system.*
- o Opening readily accessible panels to visually inspect the system.*
- o Inspecting the venting system, flues and chimneys, where present.*
- o Temperatures were taken at the registers to ensure that the ducts were providing sufficient airflow.*

The furnace appeared to be in good overall condition, however I recommend having it cleaned and serviced prior to closing by a licensed HVAC contractor, followed by annually.

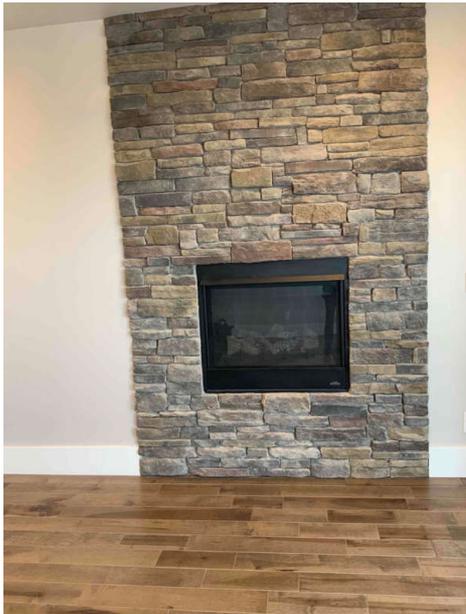
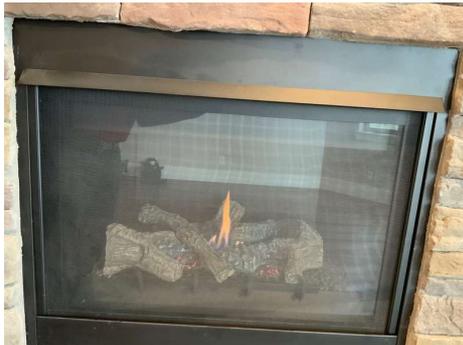
Fireplace & Chimney Master Bedroom: Type of Fireplace

Direct Vent

Pre-fabricated

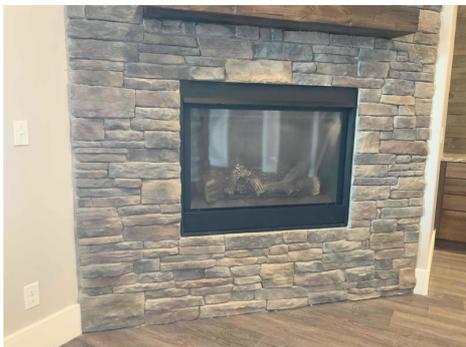
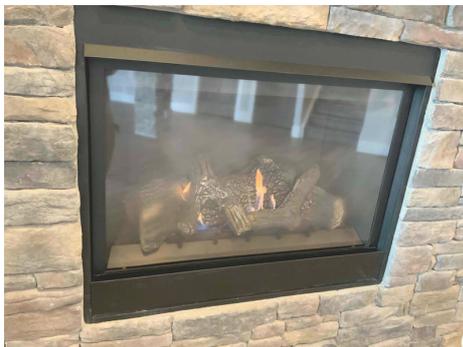
Fireplace & Chimney Basement : Type of Fireplace

Direct Vent

Pre-fabricated

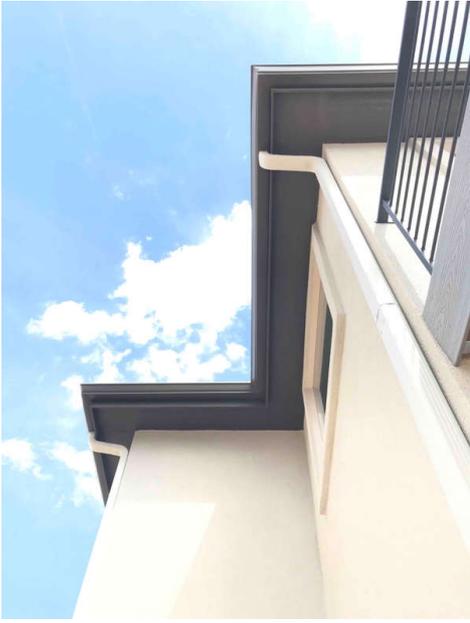
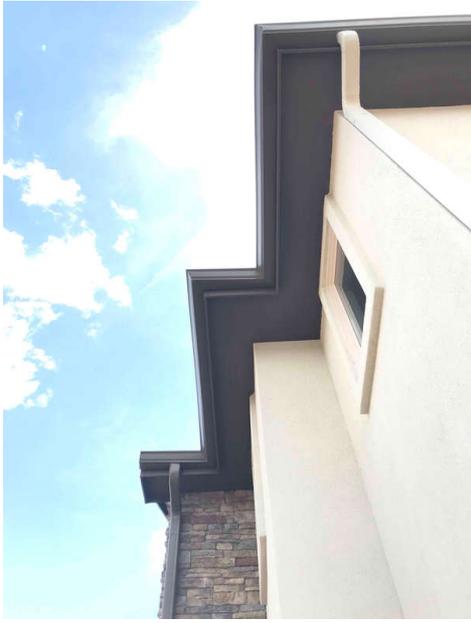
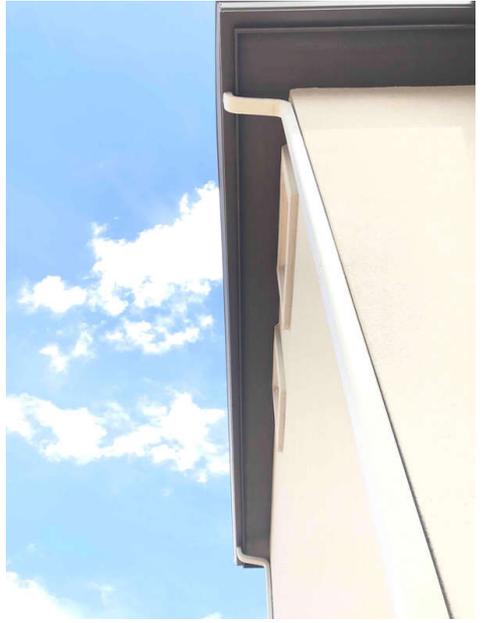
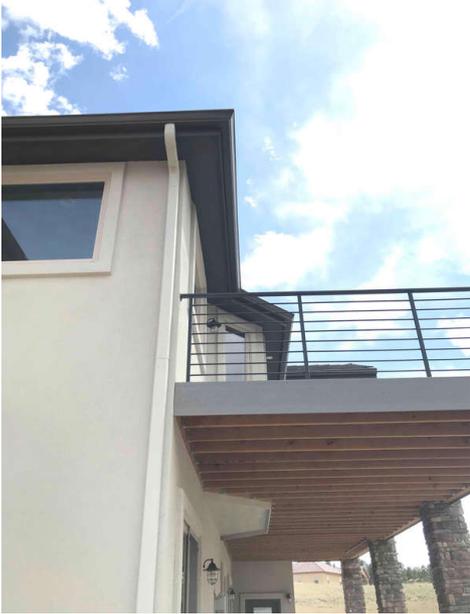
13.5.1 Ventilation & Exhaust

Attic venting appeared to be insufficient at time of inspection. There are no soffit vents installed, which would allow cross ventilation. I recommend having the ventilation evaluated and added as necessary by a licensed contractor.

Contact a qualified professional.

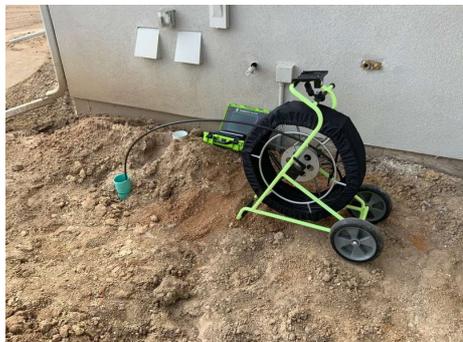
General: Access Point

Southwest Corner of Exterior
Single Outside Cleanout (SOC)

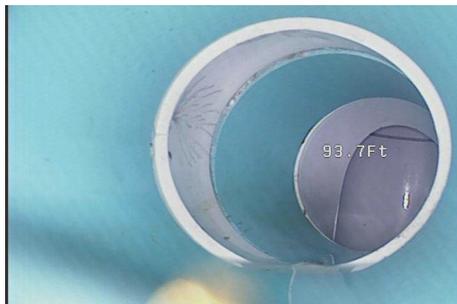
General: Approximate Distance to Septic Tank Entry From The Access Point

94 Feet (Approximate)
