WACHUSETT HOME INSPECTION, LLC

RESIDENTIAL REPORT

1234 Main St.
Leominster Ma 01453

10/02/2018 9:00AM

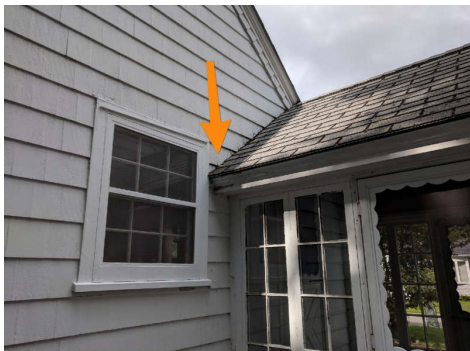
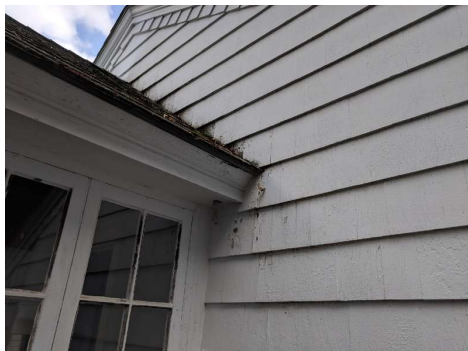
FLASHING - NO KICK-OUT FLASHING VISIBLE
BREEZEWAY
Kick-out flashings divert water from entering behind the siding where roofs terminate at sidewalls (see attached infographic for a visual description/example). A lack of flashing where a roof terminates into a sidewall can lead to moisture intrusion and damage to the wall cavity, which often goes unnoticed for quite some time.

Recommendation
Contact a qualified professional.

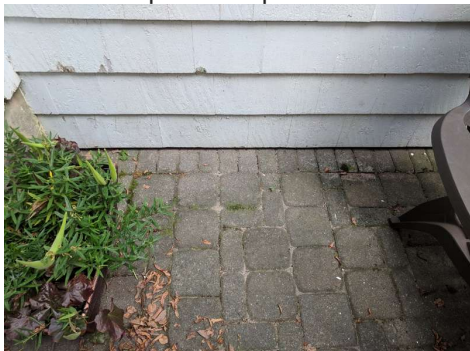
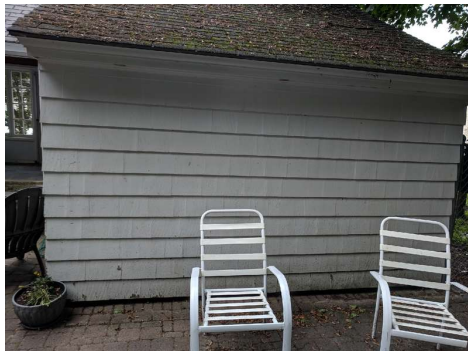
2.1.2 Siding, Flashing & Trim

SIDING - IMPROPER GROUND CLEARANCE

Siding installed near (or in contact) with the ground can lead to moisture intrusion behind the siding material, and subsequent damage to the wall/structure. In many cases the siding material is more rot resistant than the material it is protecting, so damage may go unnoticed. This is particularly true with vinyl siding, which does not rot (but the material behind it can).

Recommend consulting with a qualified professional to determine the most sensible approach to correcting this configuration, or reducing the potential for damage to the structure.

Contact a qualified professional.

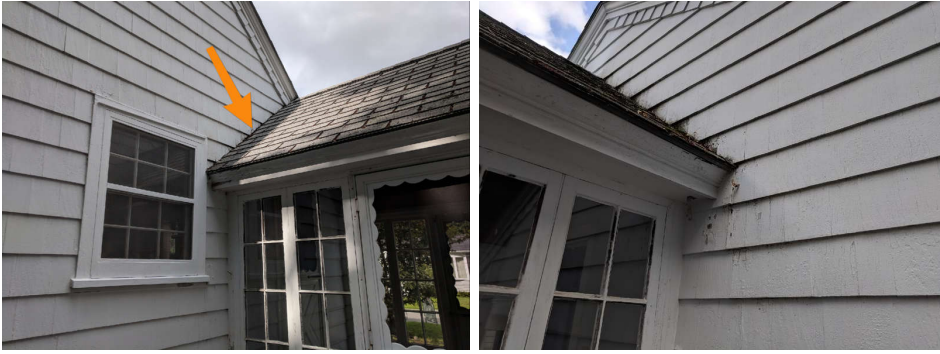
2.1.3 Siding, Flashing & Trim

SIDING - ROOF - LACK OF CLEARANCE

The observed configuration (siding in contact with roof material, or very close to it) can lead to premature siding failure in these areas, and should be corrected.

Contact a qualified professional.

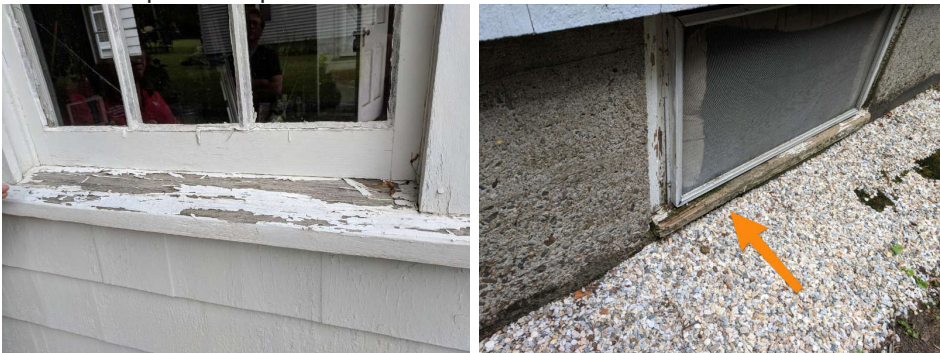
Overall the windows sills were in good condition at the time of inspection, with the exception of one sill on the left side of the garage, and basement window sills in contact with the ground.

Contact a qualified professional.

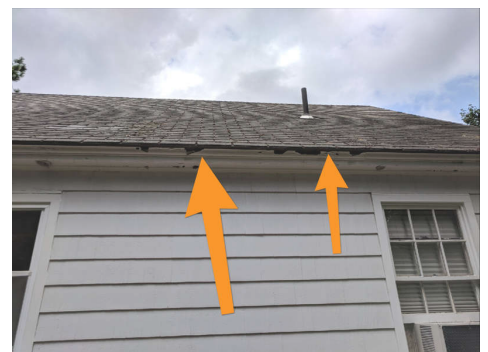
2.1.6 Siding, Flashing & Trim

TRIM

The rear fascia board had peeling paint, and appeared to have some wood rot. Repair as needed.

Contact a qualified professional.

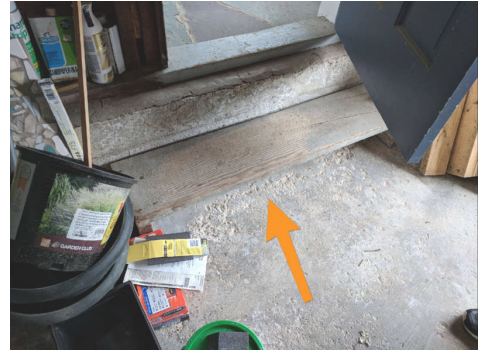
2.3.1 Decks, Balconies, Porches & Steps**WOOD STEP**

The wood step leading from the garage into the breezeway was not properly secured and is a trip hazard, and should be repaired.

Contact a qualified professional.

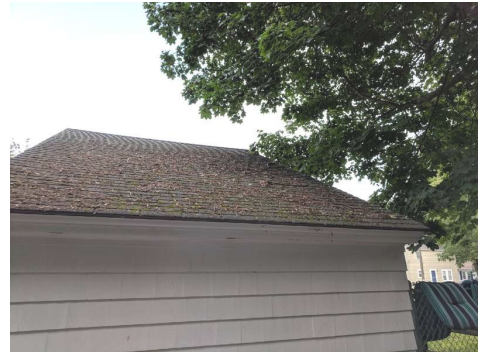
2.4.1 Vegetation, Grading, Drainage & Retaining Walls**TREE OVERHANG**

Trees observed overhanging the roof. This can cause damage to the roof and should be corrected.

Contact a qualified professional.

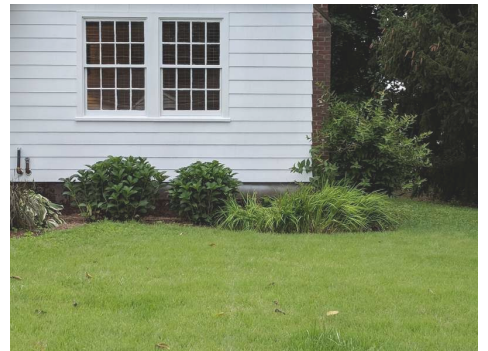
2.4.2 Vegetation, Grading, Drainage & Retaining Walls**VEGETATION TOUCHING HOME**

Trees and vegetation should not be in contact with the home, and ideally not in close enough proximity to hold moisture against the building materials.

Contact a qualified professional.

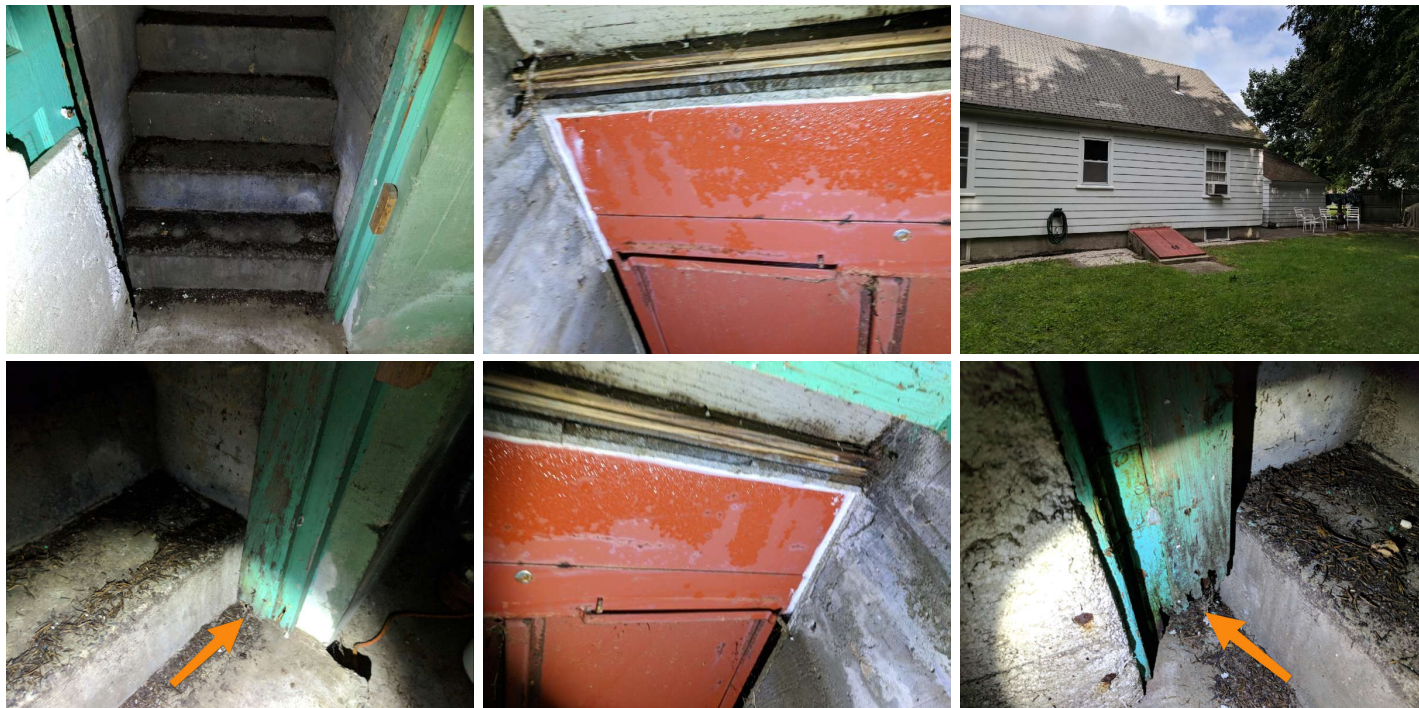
2.6.1 Window Wells and Areaways**BULKHEAD**

The bulkhead was not properly flashed to shed water from the siding material down and away. Active moisture intrusion was observed at the inside of the bulkhead in this area.

Wood rot and active moisture was also noted at the base of the wood entry door frame.

Wood rot

Contact a qualified professional.

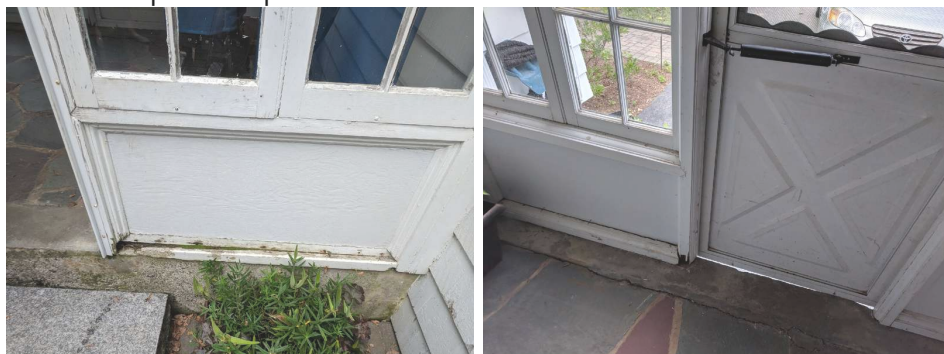
2.7.1 Breezeway

Significant wood rot was noted at the base of the walls in the breezeway, front and back. A qualified Carpenter should determine the scope of repair required.

Contact a qualified professional.

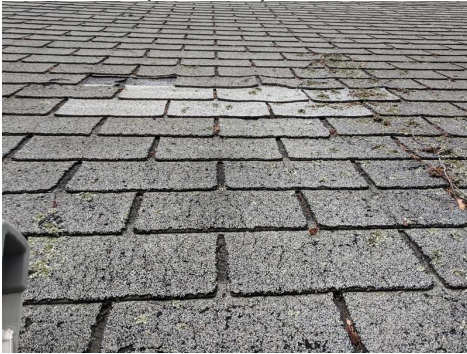
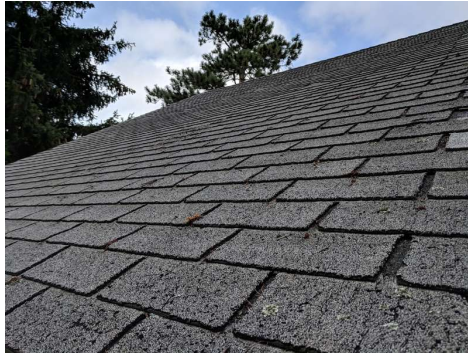
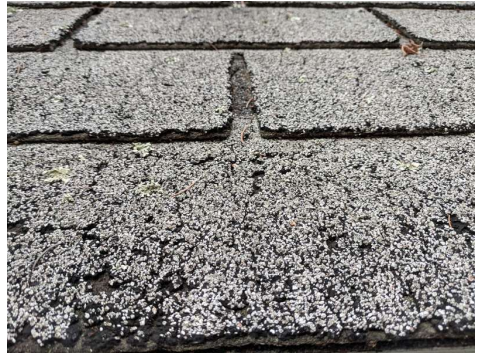
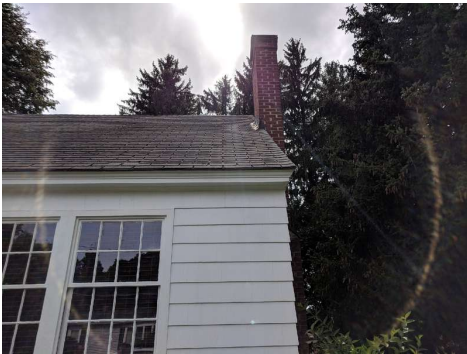
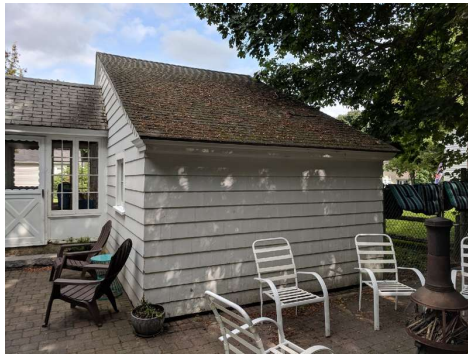
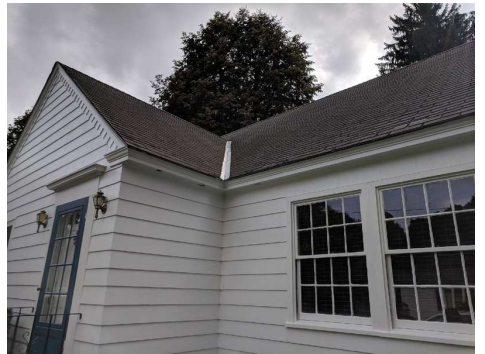
The roof covering material has reached the end of its useful life, and will need to be replaced. When obtaining bids be sure the bid includes completely stripping the roof material and replacing all flashing materials.

Contact a qualified professional.

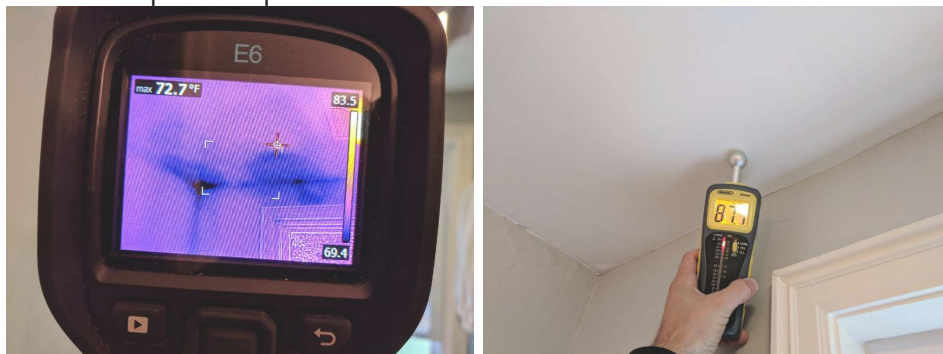
3.5.1 Active Leaks

ACTIVE LEAK

What appeared to be active moisture, likely due to a roof leak, was observed at the rear side of the house in the bathroom. Further investigation is recommended to determine the source of the leak and make necessary corrections. Understand that if this is a long-term leak concealed damage may exist.

Contact a qualified professional.

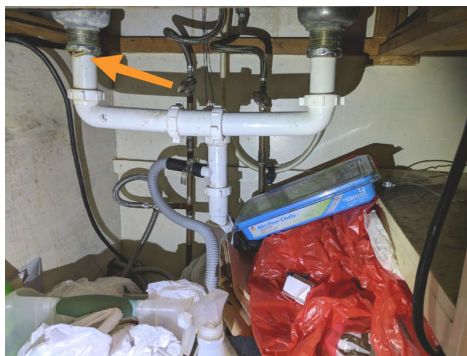
Minor repairs needed on the drain side to prevent leakage.

Contact a qualified professional.

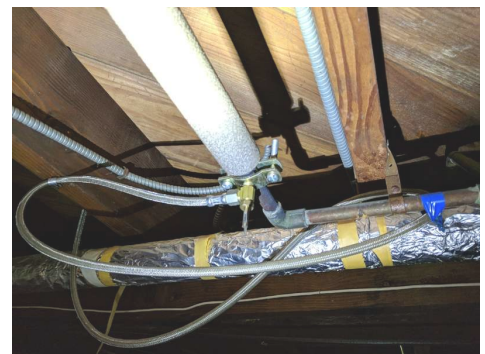
5.8.1 Miscellaneous

SADDLE VALVE

The use of a saddle valve was noted. These are typically installed as a quick solution when a water line is needed at an appliance, such as a refrigerator. Saddle valves are not recommended as they are common leak points.

Contact a qualified professional.

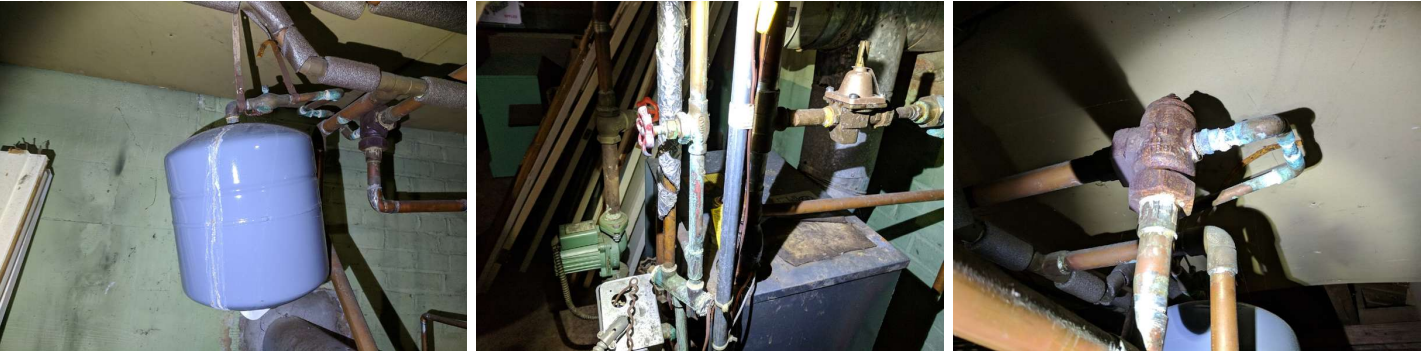
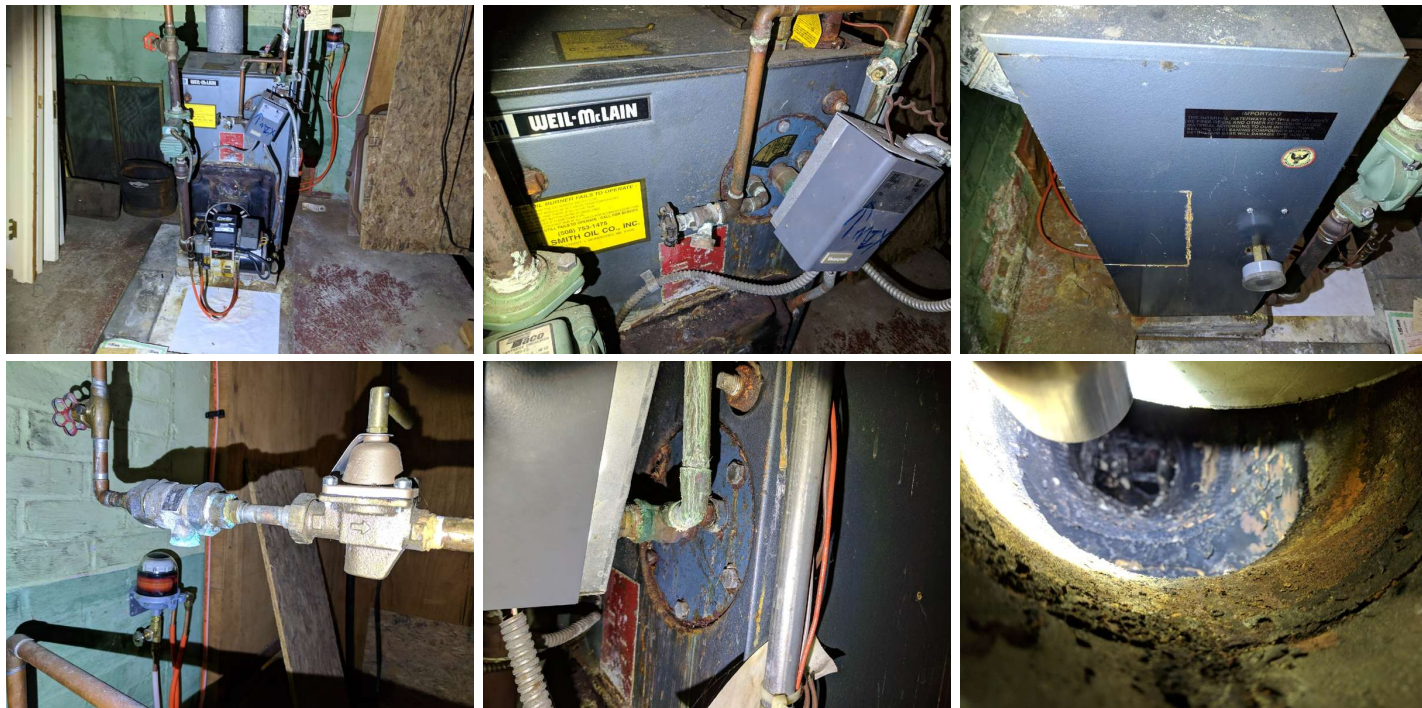
The boiler appeared to be quite old, and has likely exceeded its expected service life. Corrosion and leakage was noted at several fittings. Many leaks appeared to be long-term in nature (suggesting a general lack of maintenance) and have caused damage to adjacent materials. further investigation by a qualified professional is recommended to determine if repair is appropriate, or if replacement is the most efficient route.

Contact a qualified professional.

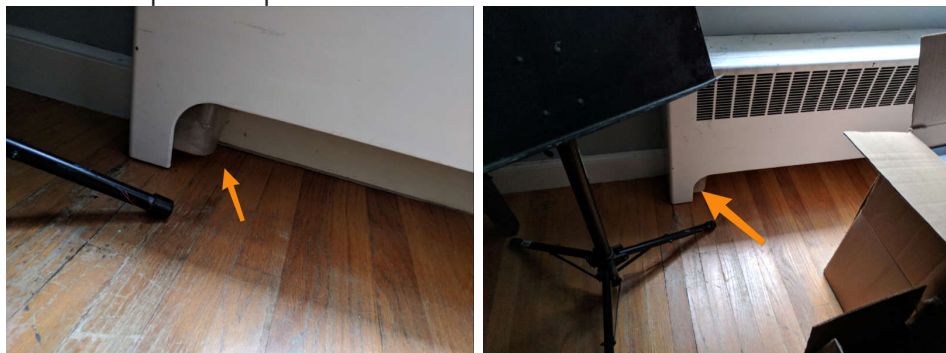
7.2.1 Distribution Systems

LEAK

One of the tenants living in the house disclosed the presence of a leak at a second floor Radiator on the left side of home. Evidence of historic leakage was apparent, and a small vessel meant to catch water was observed in this location. Repair as needed.

Contact a qualified professional.

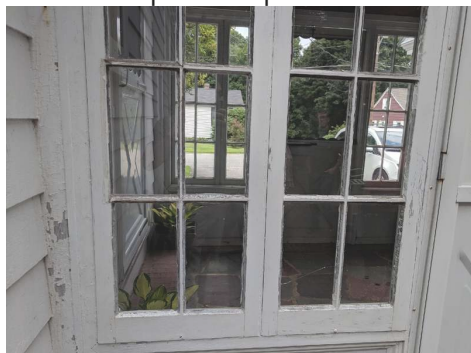
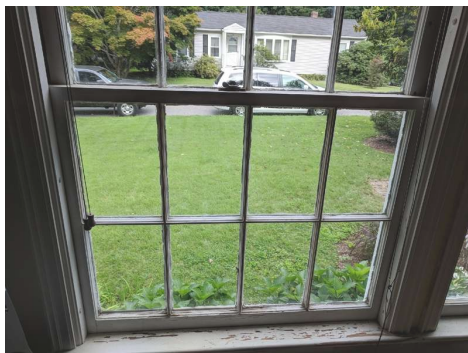
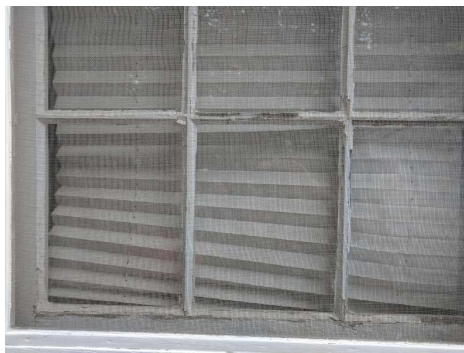
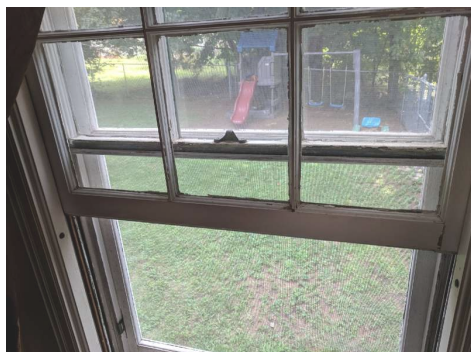
8.6.1 Windows

WOOD WINDOWS

The original wood windows remaining in the home were in overall poor condition and in need of restoration work including glazing, scraping and painting, and replacing cracked panes. The majority of the windows in the home appeared to be original.

Contact a qualified professional.

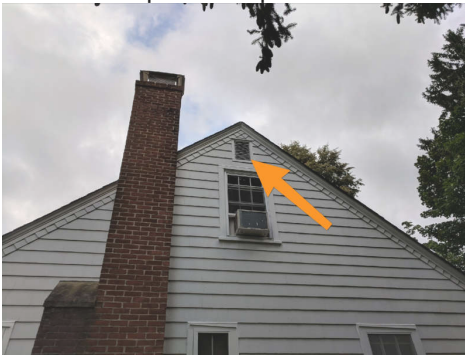
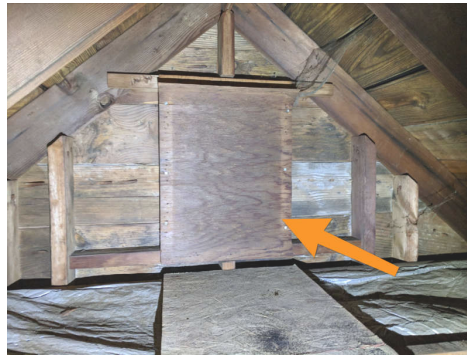
10.2.1 Ventilation

BLOCKED VENT

The gable end vent on the right side of the home was blocked off with plywood. Inspector did not observe an apparent reason for this, nor was an adverse effect noted, however in order for Gable end vents to work properly (cross ventilation) both need to be open.

Contact a qualified professional.

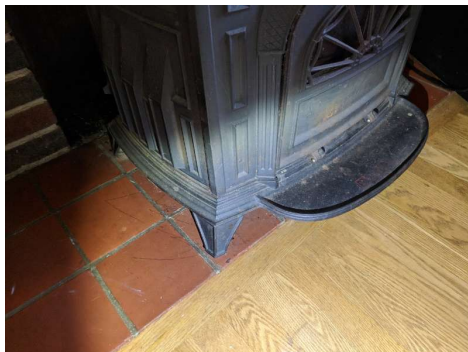
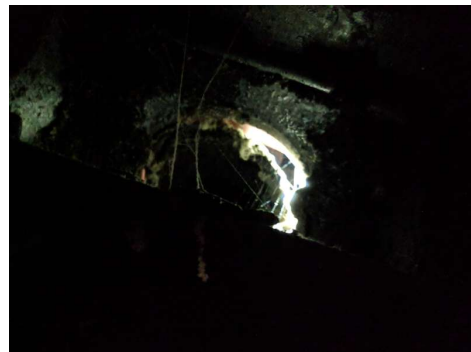
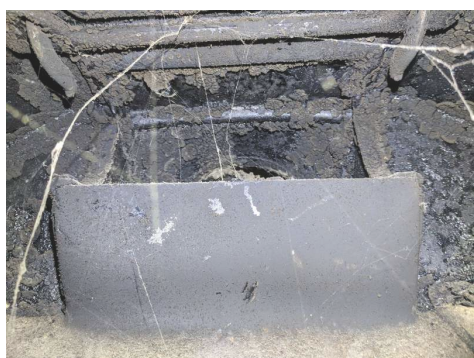
The wood stove should not be used until further evaluation and repairs are completed. The inspector noted significant creosote buildup inside the wood stove. The flue pipe was not properly connected to the back of the wood stove. And the Hearth did not appear to be sufficient to provide proper clearance to combustibles.

Open Gap at flue

Contact a qualified professional.

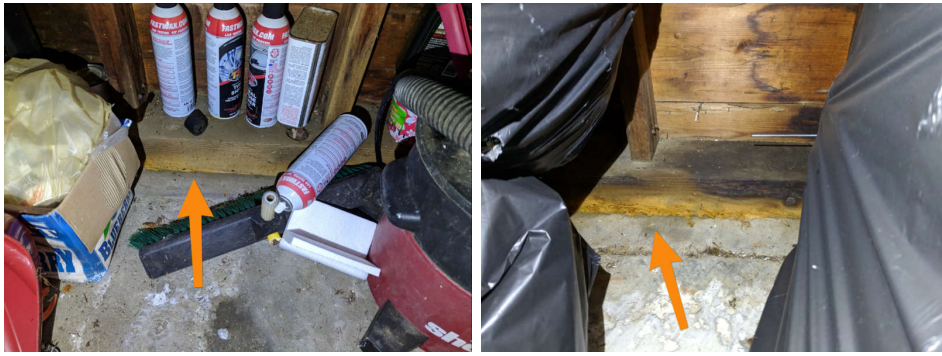
APPARENT MOISTURE DAMAGE
What appeared to be minor damage was noted at the sill plates.

Recommendation
Contact a qualified professional.

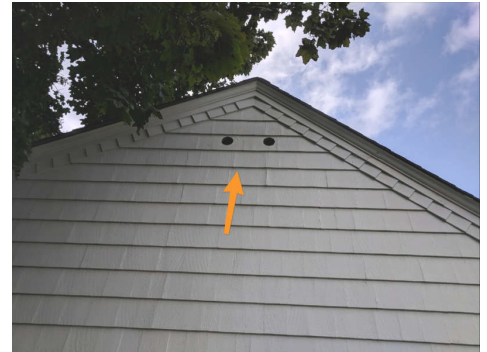
12.6.1 Miscellaneous

VENTS

What appeared to be holes cut for ventilation were noted at the left side. These holes should be covered in some sort of screening material to prevent pest entry.

Contact a qualified professional.
