HOME INSPECTION REPORT

1234 Main St.
Naches WA 98937

11/12/2018 9:00AM

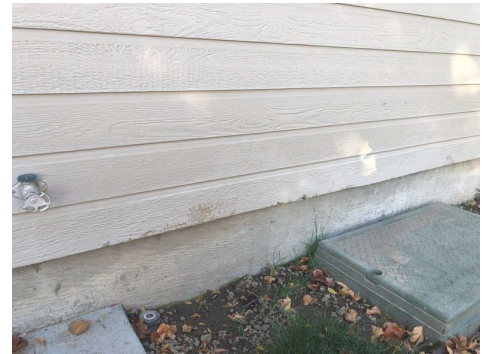
3.1.1 Siding, Flashing & Trim

MINOR DAMAGE

BACK EXTERIOR

Some minor damage/deterioration noted at exterior siding and/or trim. Probable past moisture from garden spigot. Recommend maintaining paint/seal to prevent further compromise due to moisture.

Contact a handyman or DIY project

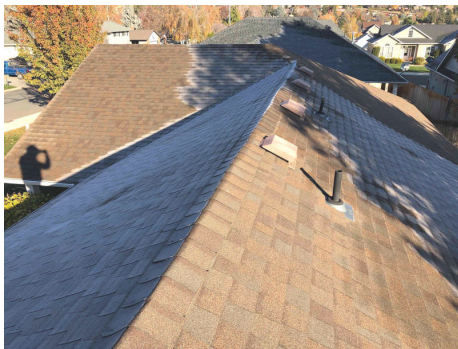
Coverings: Servicable

Roof covering appears to be in good serviceable condition.

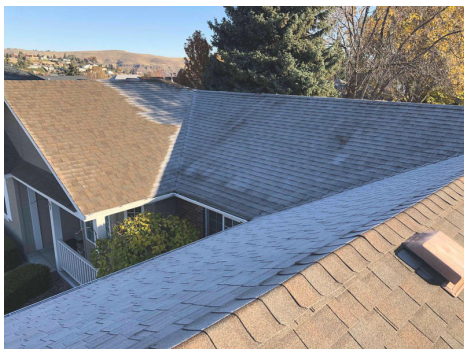
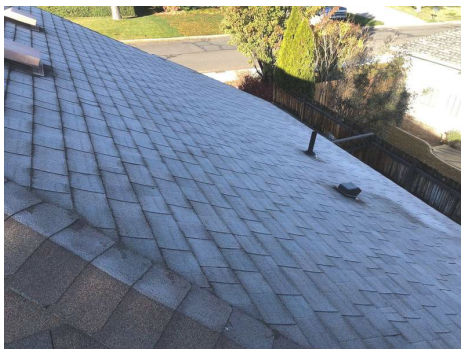
Coverings: Inspection Limited

Inspector did not attempt to walk on some portions of roof due to frost/ice on roof at time of inspection.

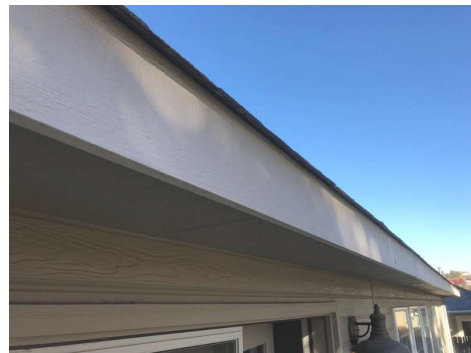
4.4.1 Flashings

DRIP-EDGE FLASHING NOT INSTALLED

Drip-edge flashing protects roof eaves, soffits and fascia from possible moisture penetration and potential damage resulting from moisture. Some areas of home did not have a proper drip-edge flashing installed. Home may benefit from a proper drip-edge flashing installed at roof eaves. Recommend a qualified professional further evaluate and repair.

Contact a qualified roofing professional.

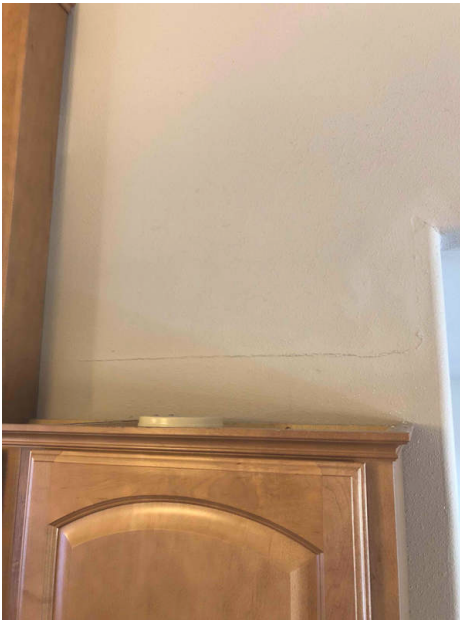
Walls: Interior Cracking

Interior cracks and/or nail-pops observed appear to be typical and not evidence of significant structural compromise. Recommend monitor. If any interior crack begin to grow or become irregular then further evaluation would be required.

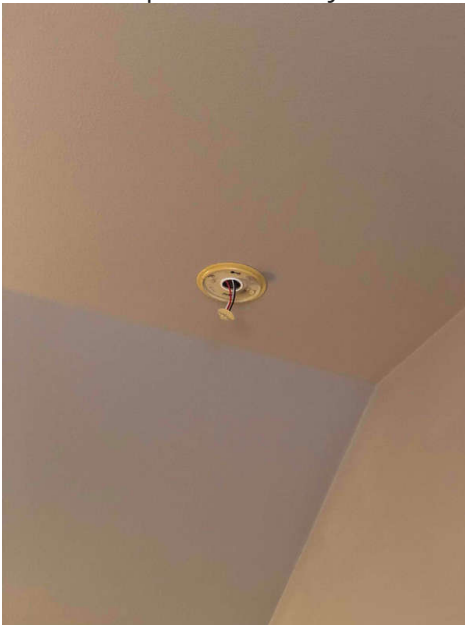
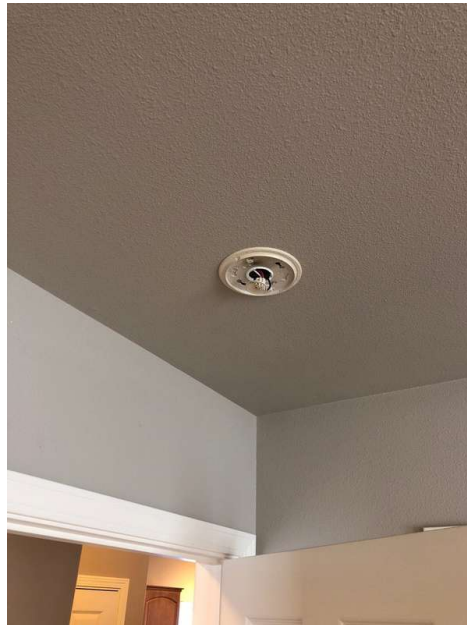
5.1.2 Safety Equipment

SMOKE DETECTORS MISSING

KITCHEN, MASTER BEDROOM, HALL

Inspector was unable to confirm installed Smoke Detectors in all required/recommended locations. Safety Hazard. Recommend repair or replace as needed.

Contact a qualified handyman.

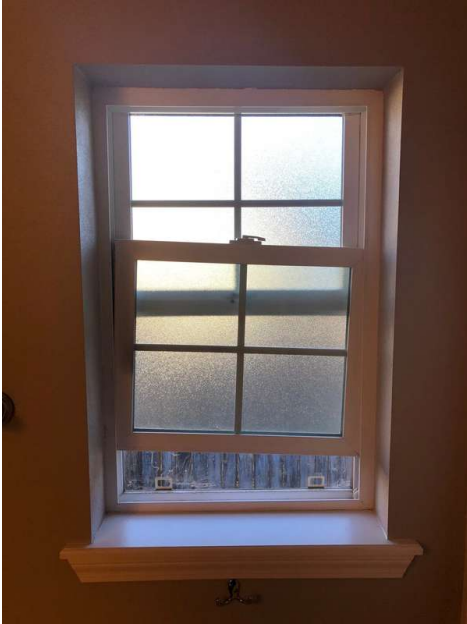
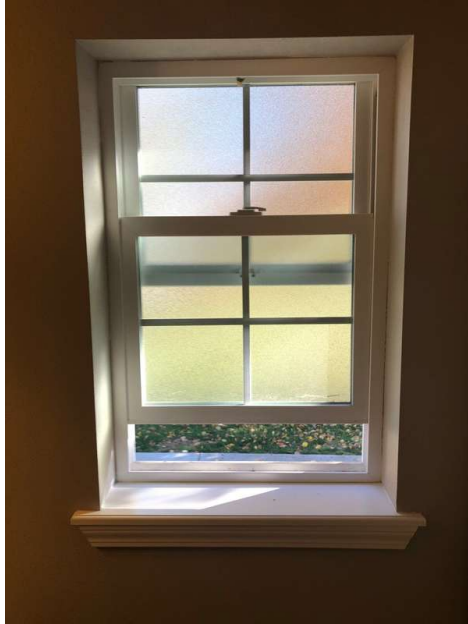
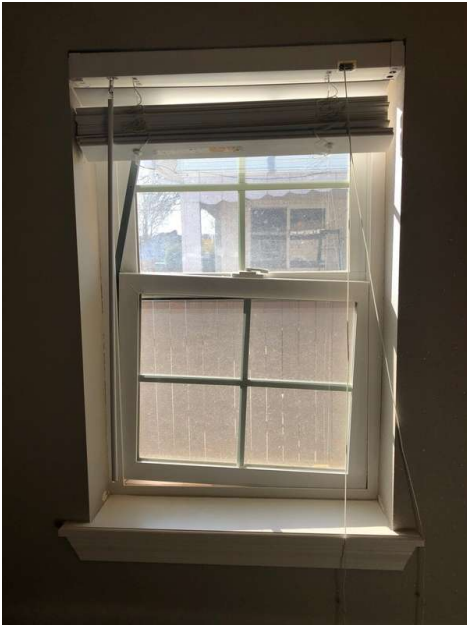
5.5.1 Windows

SINGLE-HUNG WINDOWS

HALL BATHROOM, MASTER BATHROOM, LAUNDRY ROOM

Some single hung windows not operating smoothly/properly and may be in need of adjustment or repair.

Contact a qualified window repair/installation contractor.

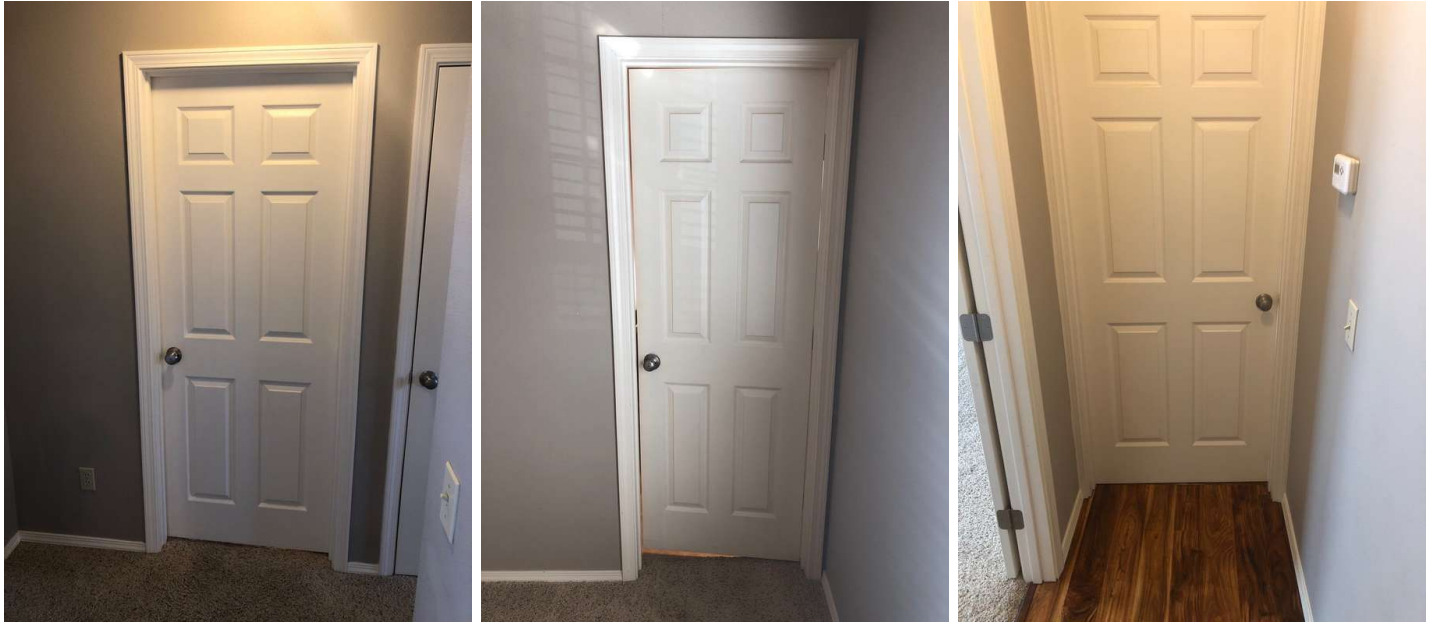
5.6.1 Doors

DOOR IN NEED OF ADJUSTMENT

HALL BATHROOM, MASTER BATHROOM, LAUNDRY ROOM

One or more interior doors stick/rub or do not latch smoothly/properly and may be in need of adjustment or repair.

Contact a qualified door repair/installation contractor.

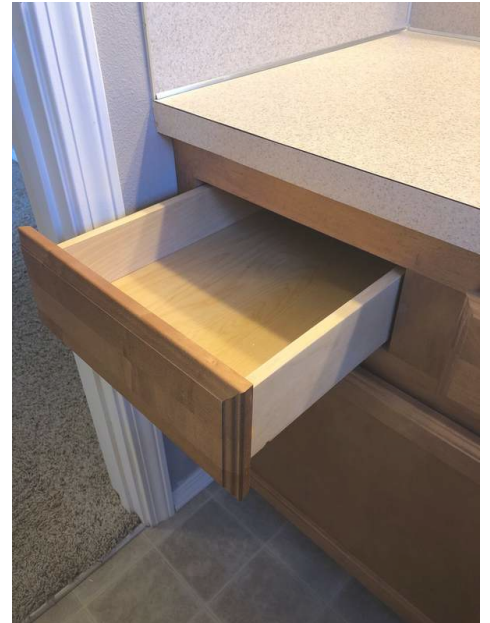
5.10.1 Cabinets & Countertops

ADJUST CABINET HARDWARE

HALL BATHROOM

Some cabinet hardware was not operating smoothly/properly and may be in need of adjustment or repair.

Contact a handyman or DIY project

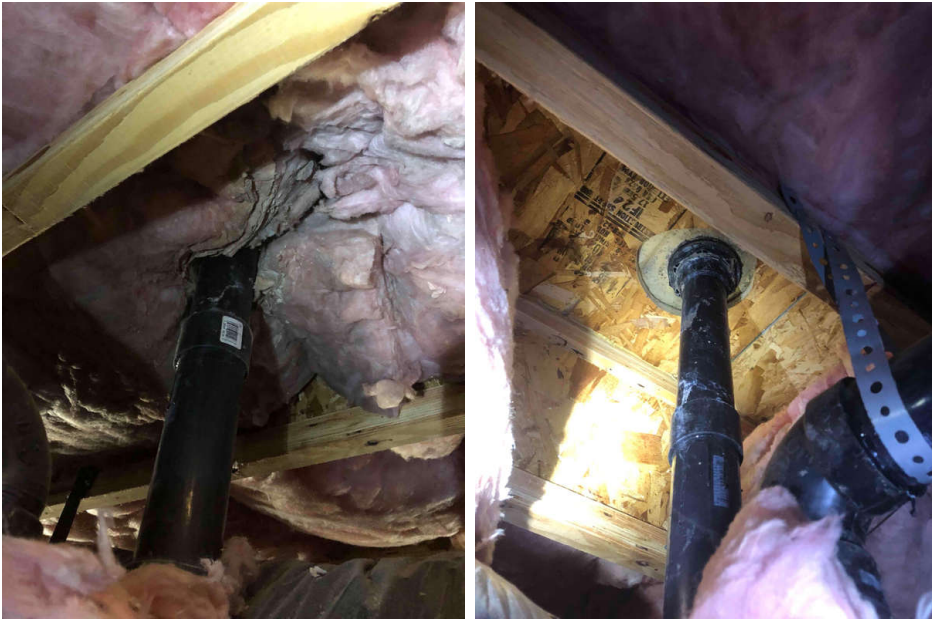
Drain / Waste, & Vent Systems: Past Sink Leak

Master Bathroom Crawlspace

Evidence of past leak noted. No active leak observed at time of inspection. Recommend monitor.

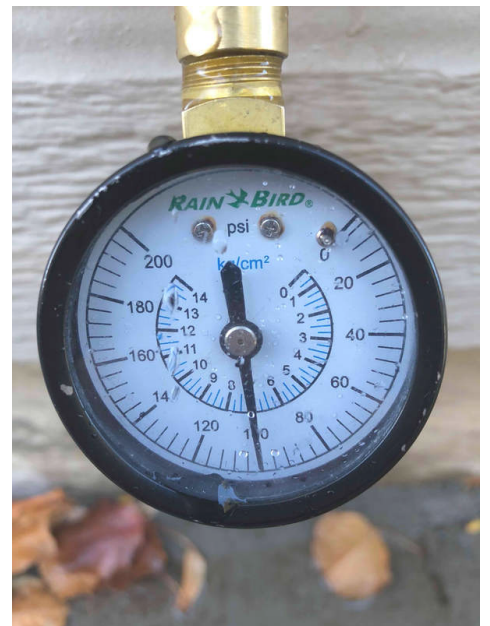
8.1.1 Supply Plumbing

HIGH WATER PRESSURE

High water pressure may put unneeded stress/strain on your plumbing system (pipes and fixtures). The generally recommended safe water pressure for residential application is 60-80 P.S.I. Recommend adjusting water pressure at Pressure Reducing Valve (or install a proper Pressure Reducing Valve if needed). Here is a helpful [article](#) on Water Reducing Valves.

Contact a qualified plumbing contractor.

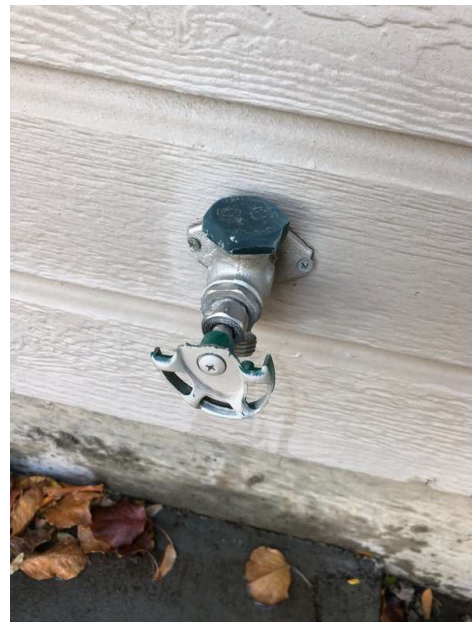
8.2.3 Fixtures & Faucets

SPIGOT HANDLE DAMAGED

BACK EXTERIOR

Garden spigot/hose-bib handle damaged.

Contact a qualified professional.

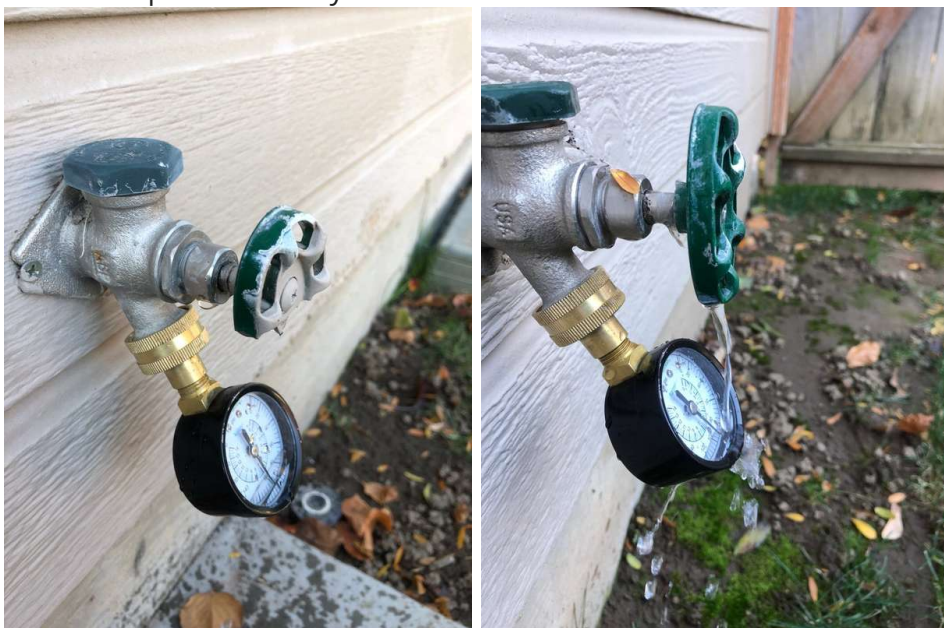
8.2.4 Fixtures & Faucets

SPIGOT LEAKING

Leak noted at exterior garden spigot/s. Recommend repair or replace as needed.

Contact a qualified handyman.

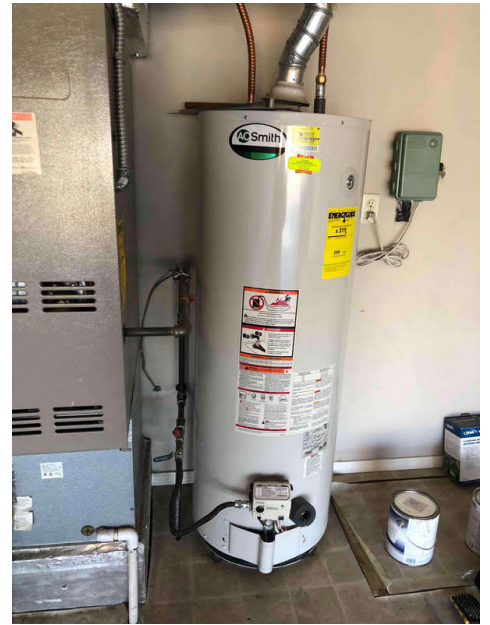
9.3.1 Safety Features

SEISMIC STRAPPING NOT INSTALLED OR IMPROPER

Safety Hazard

Modern safety standards requires seismic strapping at top and bottom thirds of installed Hot Water Tanks. See this helpful [link](#) for approved strapping and anchoring techniques. Recommend repair.

Contact a qualified handyman.

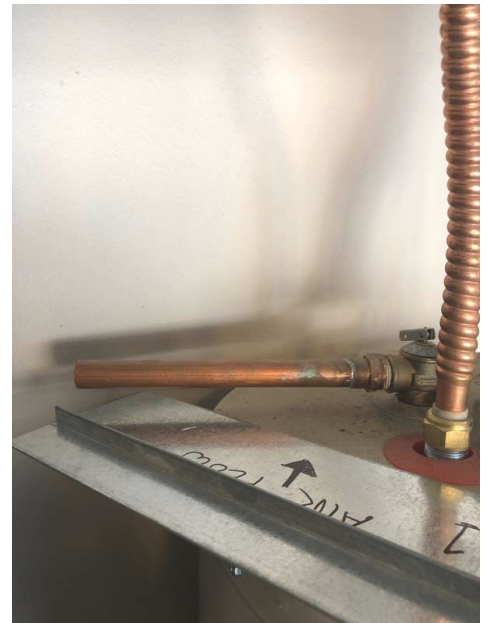
9.3.2 Safety Features

Safety Hazard

TPRV DISCHARGE PIPE MISSING/IMPROPER

Temperature Pressure Relief Valve discharge piping missing or improper. A proper discharge pipe of approved, rigid, high temp material must be installed and terminate within 24" to 8" of floor, or waste drain with a visual air gap to prevent possible back-flow. Discharge pipe must **not reduce in size** or be connected to any other discharge piping. No point of discharge pipe may be tapped, T-ed, threaded or exposed to freezing temperature. Recommend repair or replace as needed.

Contact a qualified appliance repair professional.

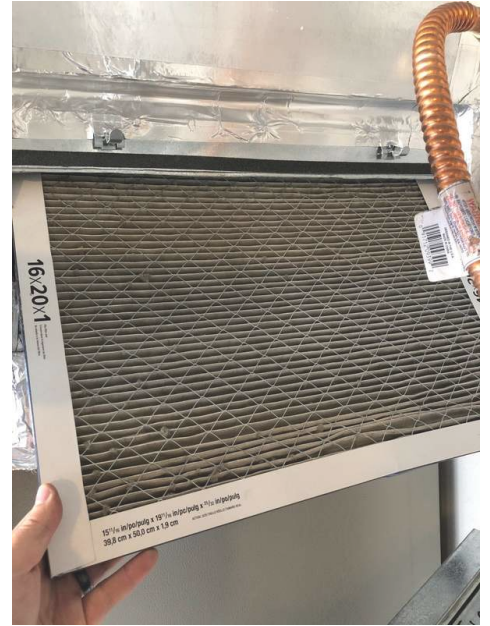
10.1.1 Heating Equipment

FILTER REQUIRES REPLACEMENT

The furnace filter appears to be beyond its expected lifespan. A dirty Furnace Filter may cause excessive wear and undue maintenance to HVAC system. Recommend replacement.

Contact a handyman or DIY project

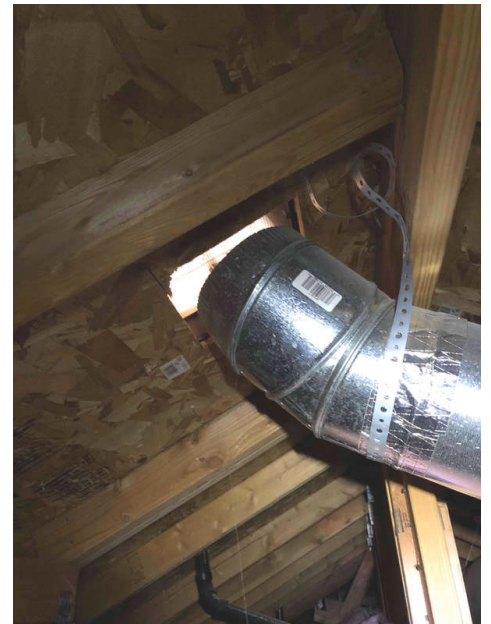
13.1.1 Attic

EXHAUST VENTS NOT TERMINATING TO EXTERIOR

KITCHEN ATTIC

An exhaust vent was not a secured/sealed termination to exterior. Recommend repair or replace as needed.

Contact a qualified handyman.

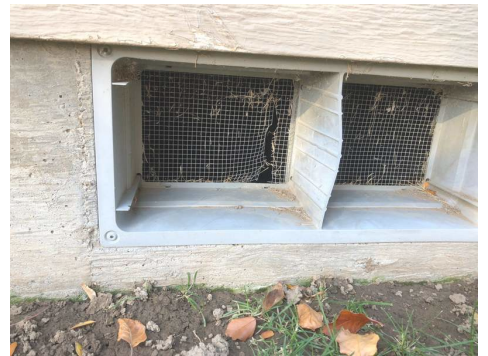
13.3.1 Crawlspace

**FOUNDATION VENT/S
COMPROMISED**

Damaged, loose or missing foundation vent screen/s. Condition conducive to pest intrusion at crawlspace. Recommend repair or replace as needed.

Contact a qualified handyman.

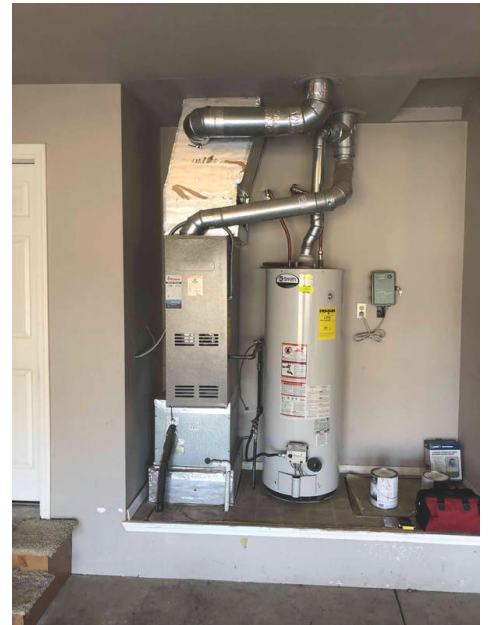
14.5.1 Safety Features

BULKHEAD

A bulkhead/barrier must be present/installed when gas appliances are located inline with the drive-path (back wall) of garage. In case of emergency the bulkhead is designed to protect gas appliances from impact and a potential safety hazard. Recommend qualified professional further evaluate and repair or replace as needed.

Contact a qualified professional.
