## RESIDENTIAL REPORT

1234 Main St.  
Lake Worth FL 33467

11/02/2018 9:00AM

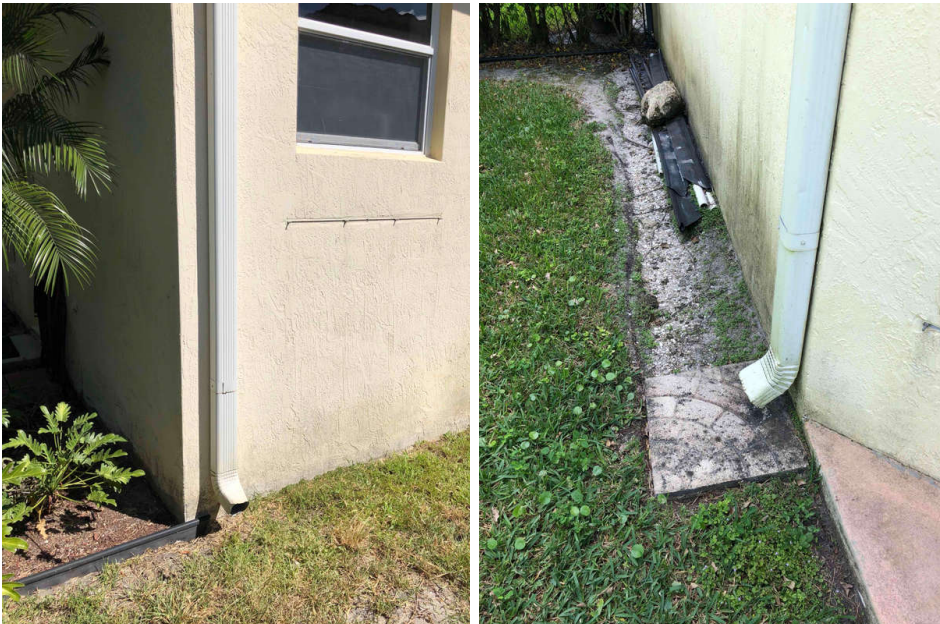
One or more downspouts drain too close to the home's foundation. This can result in excessive moisture in the soil at the foundation, which can lead to foundation/structural movement. Recommend a qualified contractor adjust downspout extensions to drain at least 6 feet from the foundation.

[Here is a helpful DIY link](#) and video on draining water flow away from your house.

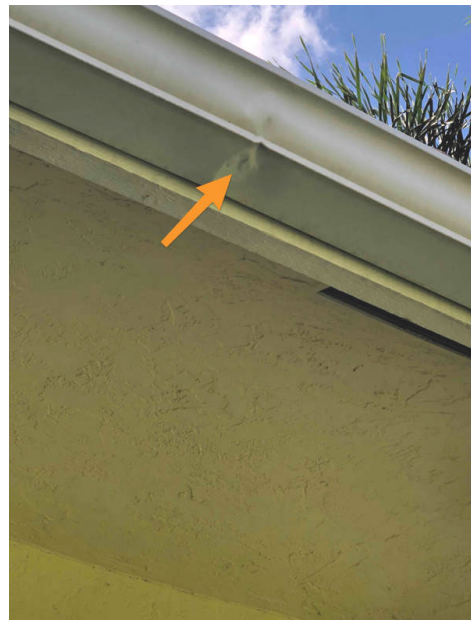
3.4.2 Roof Drainage Systems

**GUTTER DAMAGED**

Gutters were damaged. This can result in excessive moisture in the soil at the foundation, which can lead to foundation/structural movement. Recommend a qualified contractor evaluate and repair.

Contact a qualified professional.

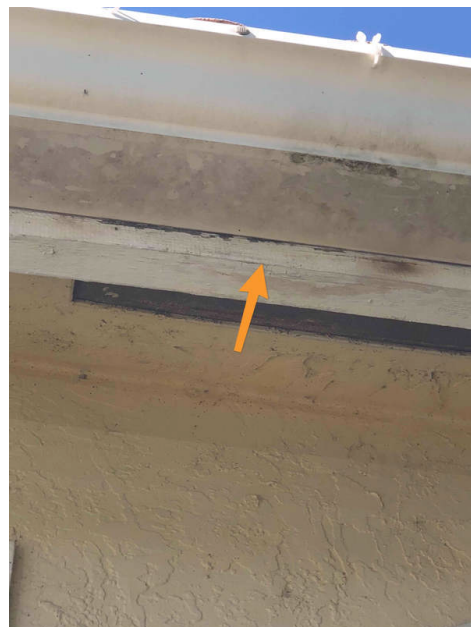
#### FASCIA - WET STAINS

Stains were found at one or more fascia boards. The stains appeared to be from a gutter leak and roof joint due to dripping water, high moisture content, etc. This is a conducive condition for wood-destroying organisms. Recommend that a qualified contractor evaluate and repair as necessary. For example, by repairing the roof surface or flashing or installing drip-edge flashing.

Contact a qualified roofing professional.

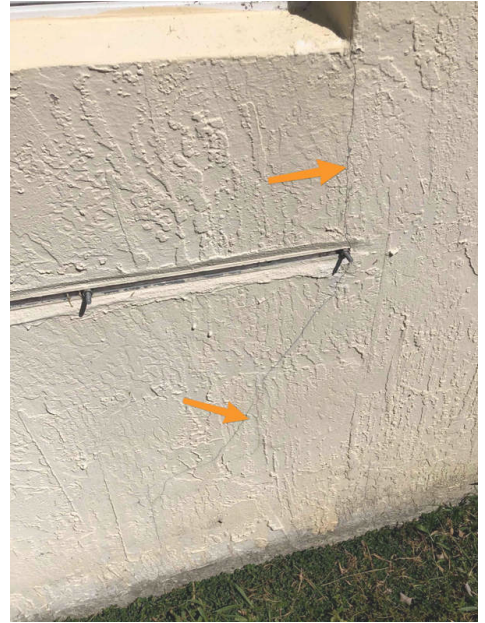
#### 4.2.1 Exterior Walls

#### HAIRLINE STUCCO CRACKING

One or more minor hairline cracks were found in the stucco or wall

areas. It is unknown the age of these cracks. At the time of inspection nothing out of the ordinary of normalized cracking was noticed. Recommend caulking and painting these areas, along with monitoring for future movement/widening. Stucco cracks over framing can allow moisture penetration behind wall areas and can potentially damage sheathing/framing. Note that areas concealed behind walls are not able to be evaluated without invasive testing and cannot be evaluated.

Contact a stucco repair contractor

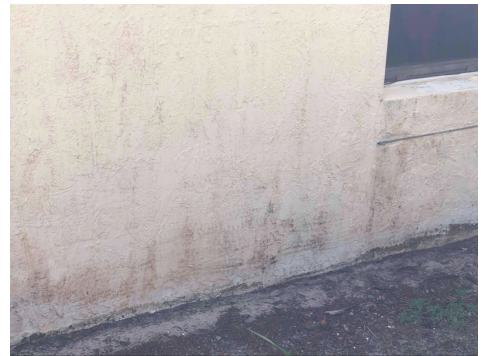
4.2.2 Exterior Walls

**MILDEW/ALGAE**

There are signs of algae and/or mildew on the siding. This is a cosmetic issue and is not uncommon especially on shaded portions of the home. Recommend that said areas be washed or cleaned on a regular basis.

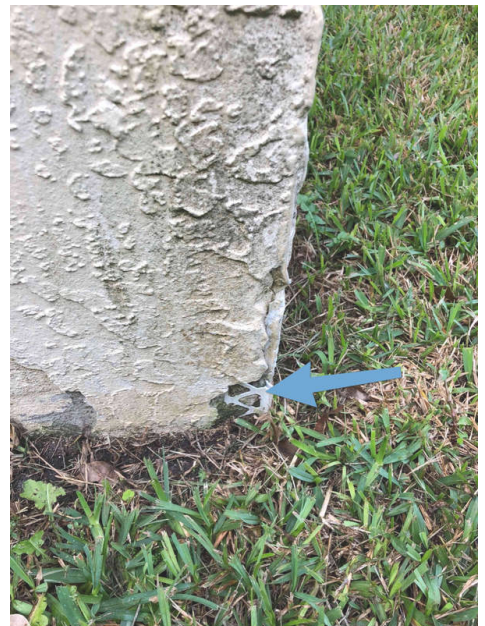
4.2.3 Exterior Walls

**REPAIR STUCCO**

Cracks, deterioration and/or damage were found in one or more areas of the exterior stucco finish. In damp climates, moisture can enter cracks or damaged areas and further deteriorate the stucco. Also the wall behind the stucco can become damaged from moisture. Note that areas behind the stucco are inaccessible and excluded from this inspection. Recommend that a qualified contractor repair or replace stucco as necessary.

Contact a stucco repair contractor

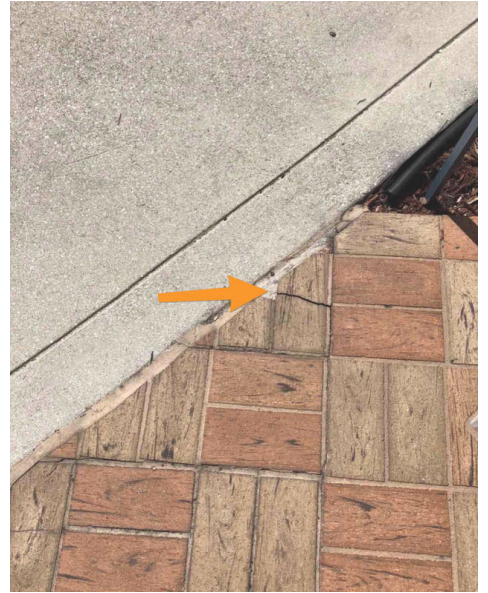
4.5.1 Driveway, Walkway, Patio

**CRACKED TILE-SIDEWALK/PATIO**

One or more of the sidewalk or patio tiles are chipped or cracked. Any paver with a deficiency should be replaced by a certified contractor to help prevent future deterioration.

Contact a qualified professional.

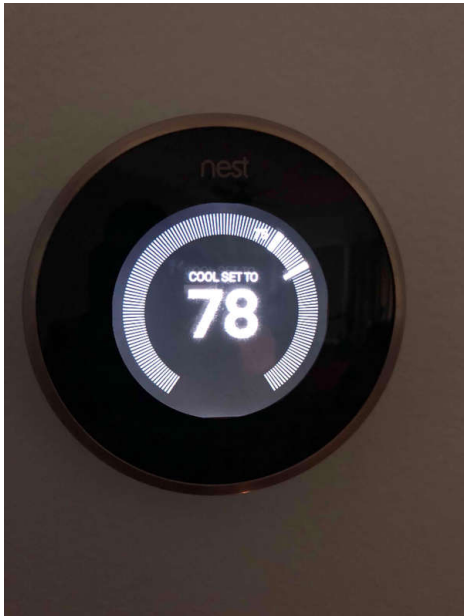
**T-Stat Control: Picture**

The AC or Heat Pump Temperature Split is the comparison of the Return Air (air going into the system) as compared to the Supply Air (air coming out of the system). A healthy AC/Heat Pump should be operating with a 14-21F Temperature Split.

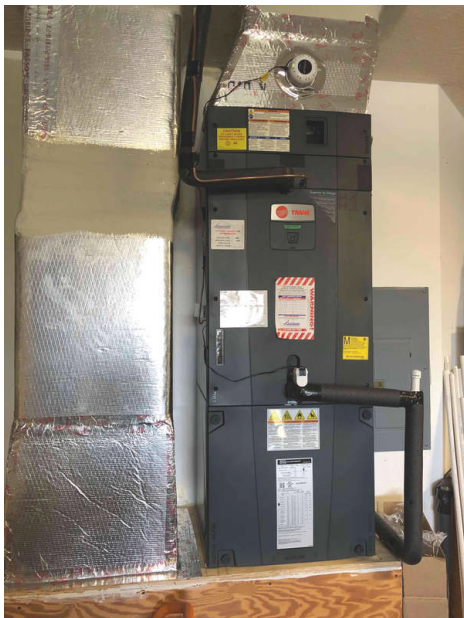
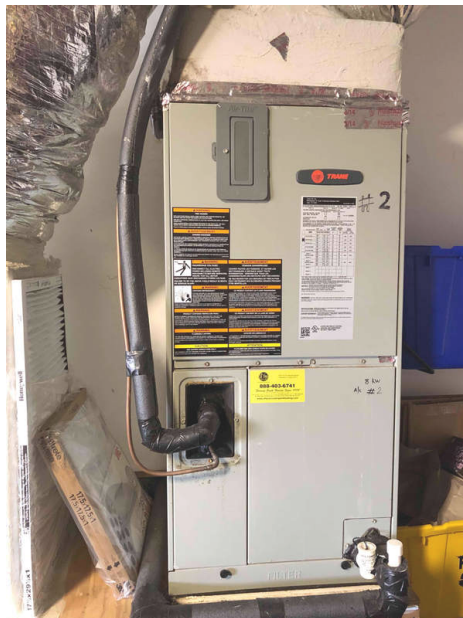
**Air Handler: Pictures of unit**

Trane U.S. Inc. Manufacturer of Trane & American Standard HVAC Tyler, TX 75707 Assembled in USA

4TEC3F36B100AA B364JHXV 1/3 2.20 200-230

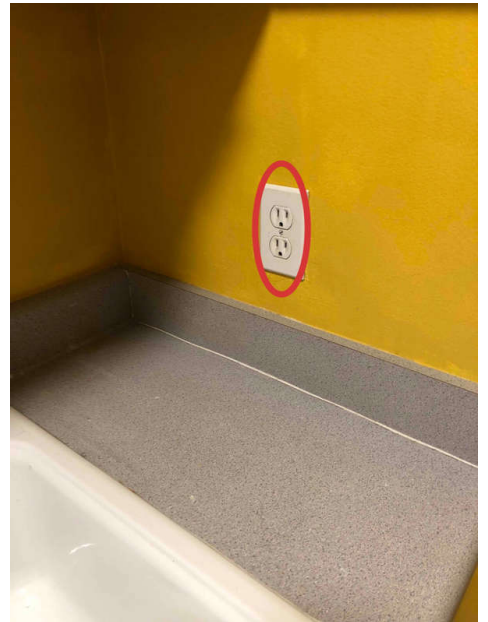
### 13.3.1 Electrical

The receptacle by the laundry sink that is not GFCI protected. It is recommended to have this receptacle switched to a GFCI for protection, to help prevent possibility of electrical shock.

Contact a qualified electrical contractor.

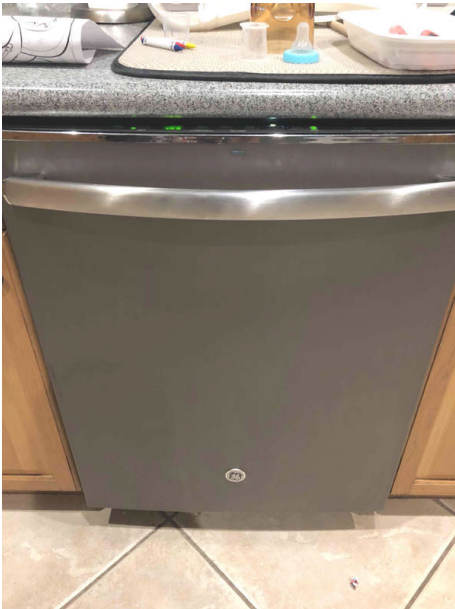
**Appliance Pictures: Dishwasher**

The dishwasher is functional and operated as expected. The unit was operated through a short cycle. No operational discrepancies were noted.
