MADEWELL INSPECTION SERVICES, LLC

HOME INSPECTION REPORT

1234 Main St.
Columbia, MD 21044

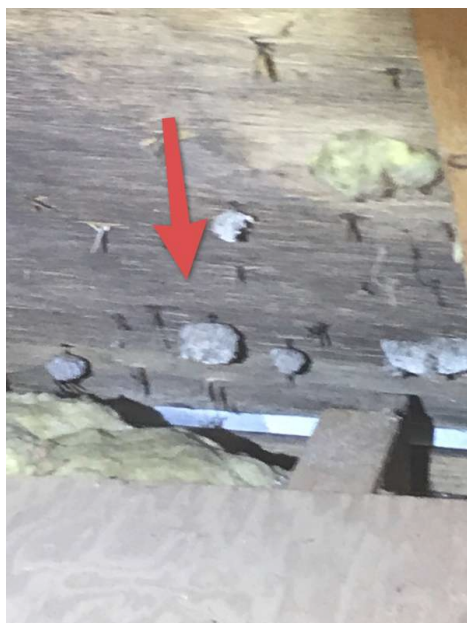
Wasp nests were found in the attic, detached garage, and barn / stable. These can pose a safety hazard. A pest control pro should remove nests or exterminate as necessary.

Active Wasp Nests In Attic

Contact a qualified pest control specialist.

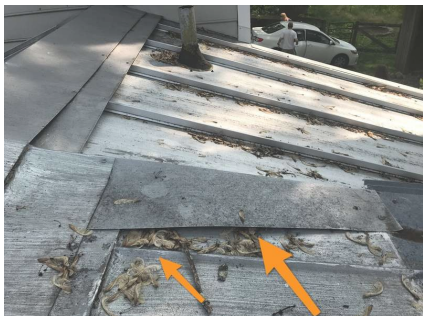
The metal ridge vent covering the first floor roof was made from two sections of metal. The seam along the midline of the ridge vent was not consistently sealed and may allow moisture intrusion. A smaller metal panel over a transition was also unsealed and may collect debris resulting in moisture intrusion or corrosion of the metal roof.

Unsealed Opening

The inspector recommends these openings be evaluated and repaired as needed by a qualified roofing contractor.

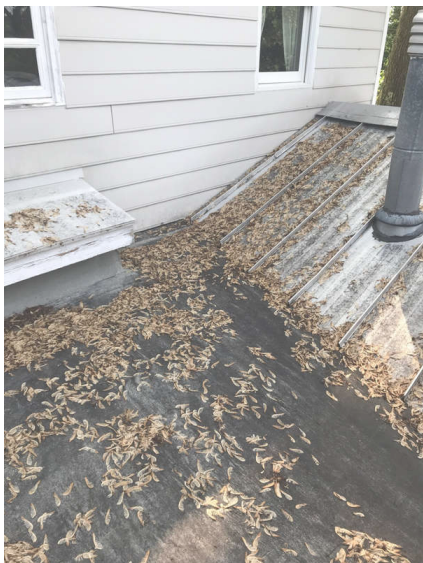
One or more roof surface sections were designed so as to be prone to accumulating debris and/or snow. For example, where two slopes converged, a slope descended to a vertical wall and/or a steeper slope met a shallow slope. Accumulated debris in these areas can result in leaks. At a minimum, monitor such areas for accumulated debris in the future and clean as necessary.

High Maintenance Area

Recommend monitoring.

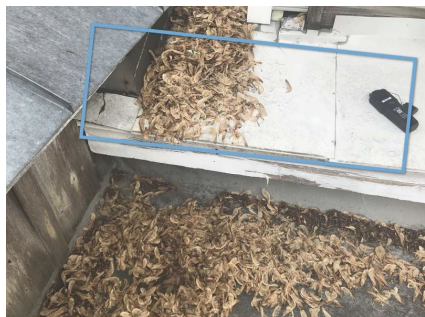
Moisture damage and deterioration of roof sheathing below one section of flashing was visible at the time of the inspection. The moisture meter showed elevated levels of moisture present in these areas indicating recent moisture intrusion.

Moisture Intrusion / Deterioration of Wood Sheathing Beneath Flashing

The inspector recommends a qualified roofing contractor determine the source of the moisture intrusion and repair.

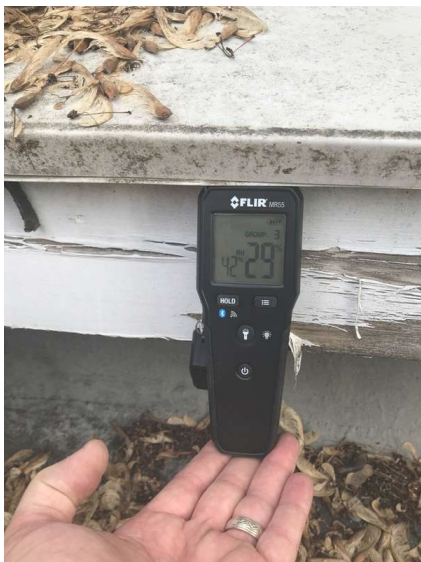
Elevated Moisture Level In Wood Sheathing

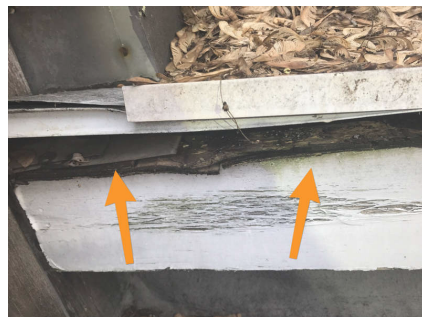
Deteriorated Roof Sheathing

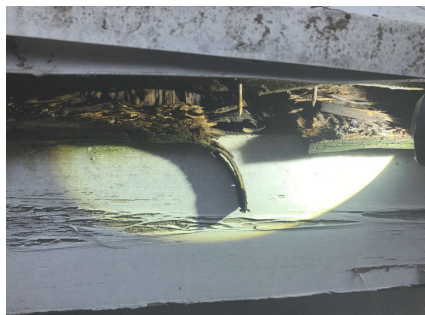
Deteriorated Roof Sheathing

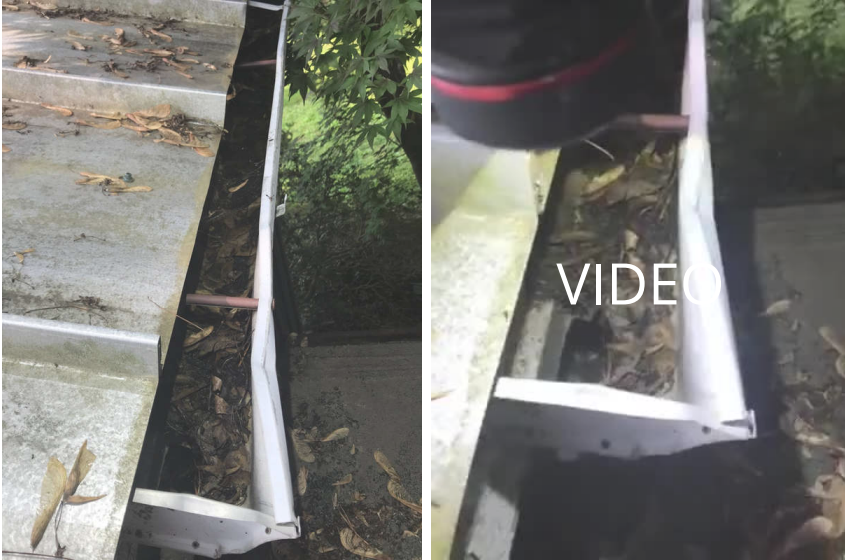
Debris has accumulated in the gutters on the house and barn. Recommend cleaning to facilitate water flow.

Debris In Gutters

Contact a qualified roofing professional.

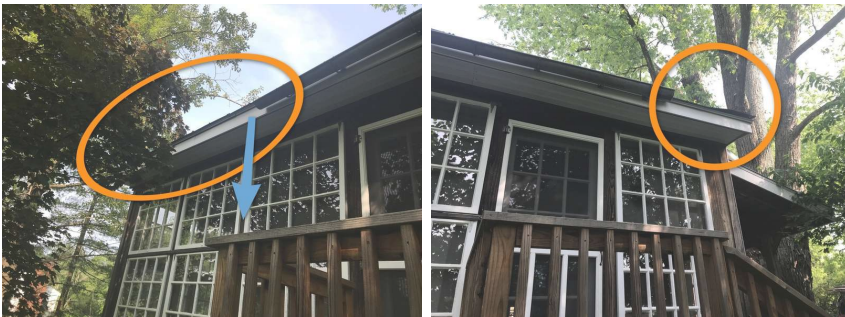
The roof on the rear side of the home had gutters in one portion above the door, with no downspout. Portions of the home without gutters / downspouts may experience excessive moisture levels in soil near the foundation. This condition can result in excessively high moisture levels in soil at the foundation. Excessive moisture levels in soil near the foundation can effect the ability of the soil to support the weight of the structure above. The Inspector recommends repair of the roof drainage system to help protect the home structure and occupants.

Missing Gutter And Downspout

Missing Gutter

Contact a qualified gutter contractor

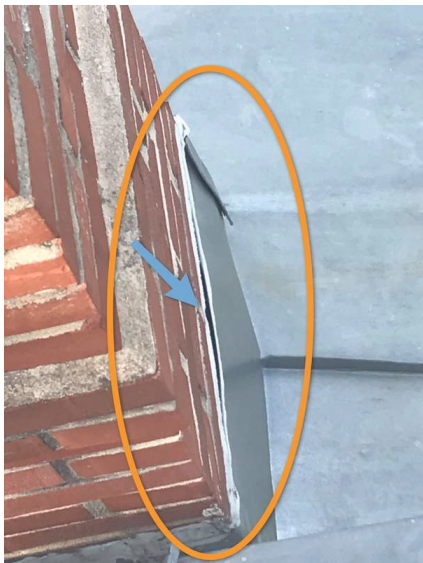
Flashings observed to be loose or separated, which can lead to water intrusion and/or mold. Recommend a qualified roofing contractor repair.

Chimney Flashing Separated From Masonry

Contact a qualified roofing professional.

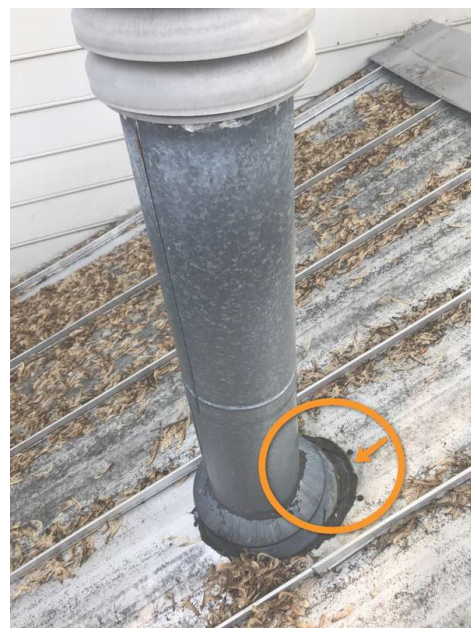
The metal roof penetration for the gas appliance chimney was poorly sealed. The sealant may trap water which can result in leaks or encourage corrosion of the metal roof. Recommend sealing this penetration with flashing or sealant so that water is diverted away from the chimney. Sealant will eventually dry, shrink and crack. These areas should be examined annually and an appropriate sealant re-applied as necessary by a qualified person.

Roof Sealant Traps Water

Contact a qualified roofing professional.

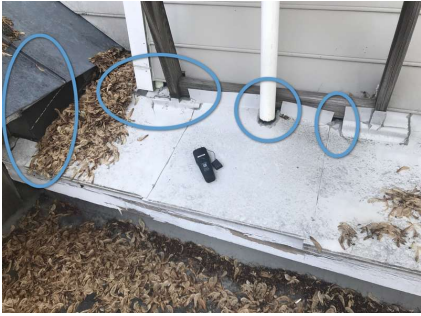
Flashing was installed in a manner that will route runoff beneath the roof-covering material. This condition is improper and may increase the chance of leakage and appears to have caused deterioration of the wood sheathing below the flashing. The Inspector recommends that you consult with a qualified roofing contractor to determine options and costs for correction.

Improper Flashing

Contact a qualified roofing professional.

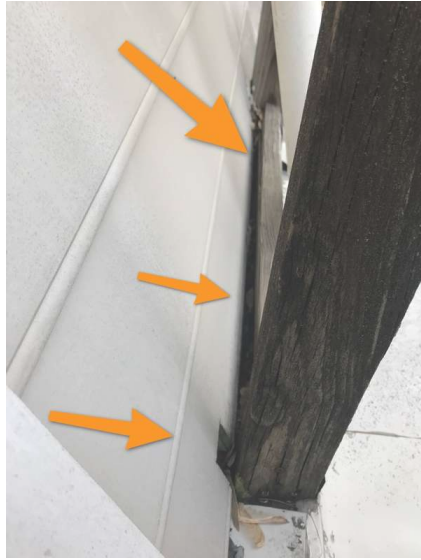
Missing Flashing / Unsealed Penetrations

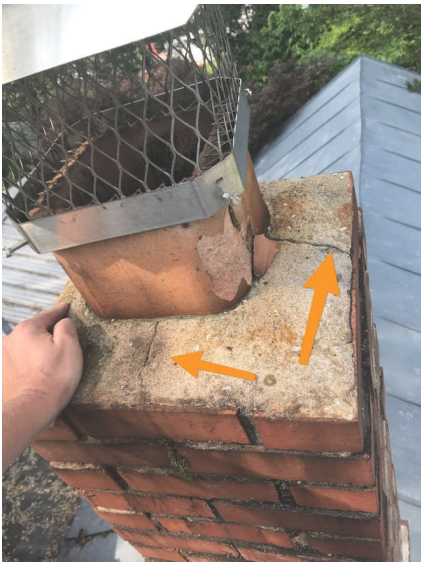
The chimney crown was cracked or damaged at the time of inspection. Cracks or missing mortar can allow moisture intrusion into the chimney and masonry, resulting in further damage to the masonry chimney and liner. Recommend a qualified chimney contractor evaluate and repair the chimney crown.

Cracked Chimney Crown

Contact a qualified chimney contractor.

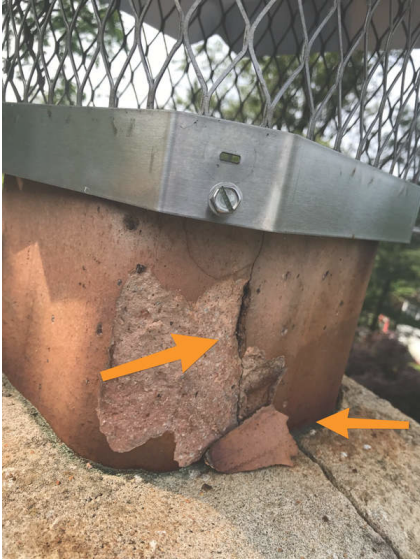
The top chimney flue tile was cracked. Cracked tiles may allow moisture or corrosive gasses to damage the chimney structure. Cracked tiles in the lower sections of the chimney may allow the toxic products of combustion to enter the living space.

Cracked Chimney Flue

The inspector recommends a qualified chimney contractor perform a **Level 2 Chimney Inspection** on the masonry chimney to ensure the chimney is safe for use.

Contact a qualified chimney contractor.

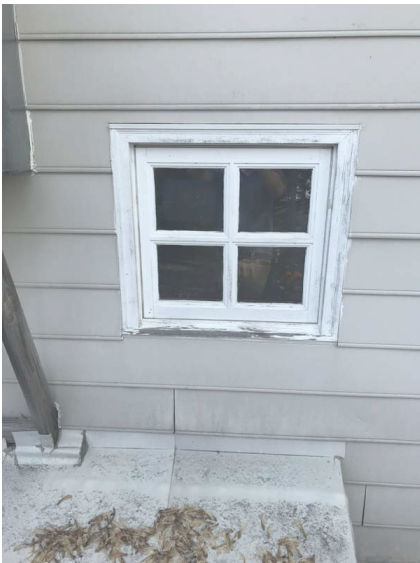
Home Maintenance Tip: Exterior wood trim should be sealed with caulk and painted to prevent water intrusion and deterioration.

Wood Trim Needs Paint

Contact a qualified painting contractor.

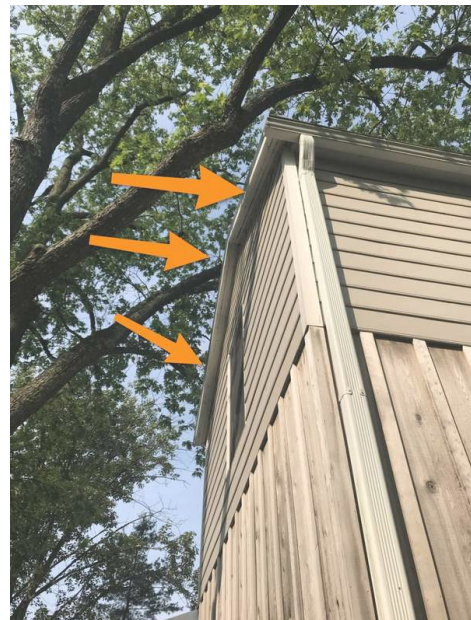
One or more sections of the eaves / fascia may be damaged from what appears to be carpenter bees. Carpenter bee frass was observed on the rear siding below the fascia and eaves. Recommend qualified roofer evaluate & repair.

Contact a qualified roofing professional.

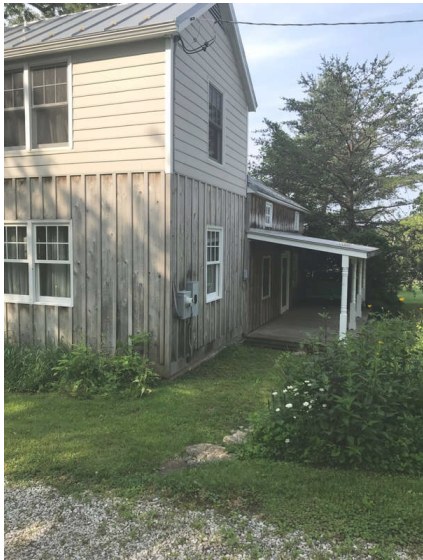
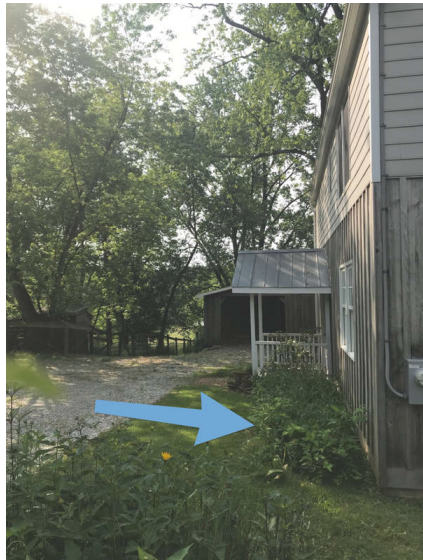
Grading is sloping towards the home in some areas. This could lead to water intrusion and foundation issues. Recommend qualified landscaper or foundation contractor regrade so water flows away from home.

Contact a qualified landscaping contractor

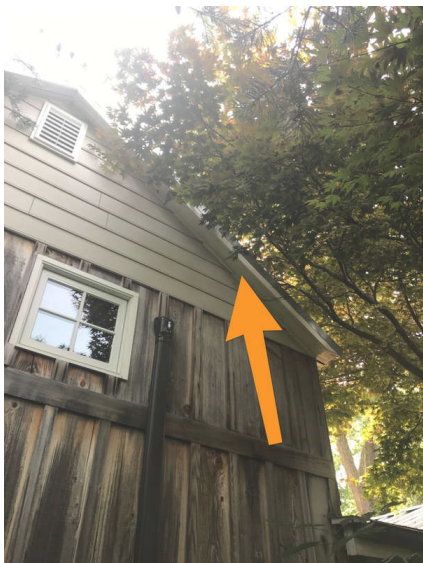
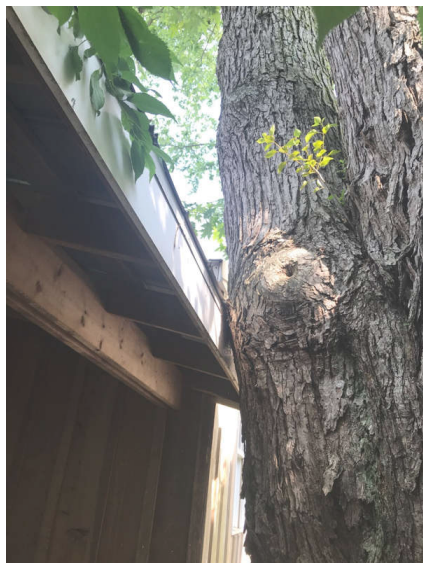
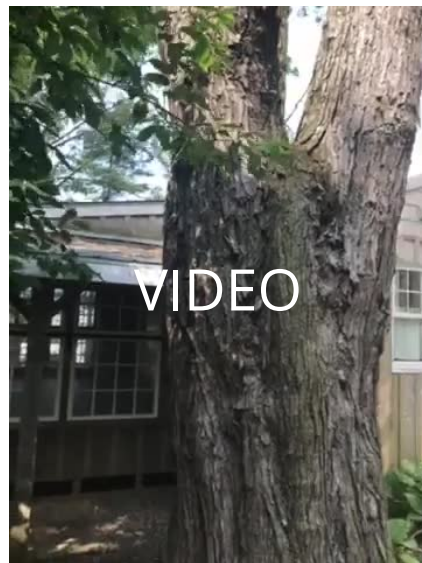
Trees were in contact with or were close to the building at one or more locations. Damage to the building can occur, especially during high winds, or may have already occurred (see other comments in this report if applicable). Recommend that a qualified tree service contractor or certified arborist remove trees as necessary to prevent damage to the building exterior.

Contact a qualified tree service company.

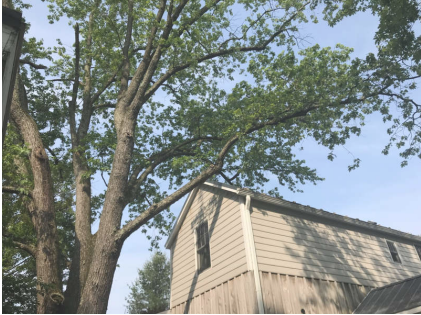
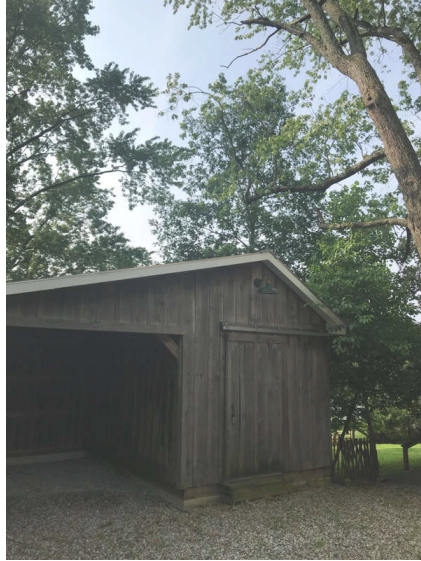
Trees observed overhanging the roof. This can cause damage to the roof and prevent proper drainage. Recommend a qualified tree service trim to allow for proper drainage.

Contact a qualified tree service company.

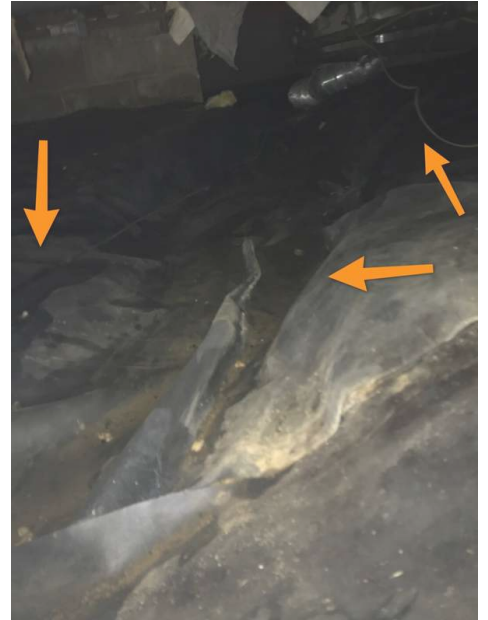
Standing pools (small) of water and condensation were found in multiple areas of the crawl space. Some minor seasonal water accumulation can be normal. However significant amounts of Water may evaporate and enter the structure above causing high levels of moisture in the structure. This can be a conducive condition for wood-destroying organisms. Rain runoff is the most common cause of wet crawl spaces but water can come from other sources such as groundwater or underground springs. Recommend monitoring the crawl space in the future, especially after heavy and/or prolonged periods of rain. Correct any issues related to outside perimeter grading and/or roof drainage (see any other comments about this in this report). Also, review any disclosure statements available and ask the property owner about past accumulation of water in the crawl space.

Standing Water In Crawlspace

If standing water persists or increases in amount, recommend that a qualified contractor who specializes in crawlspace or drainage issues evaluate and repair as necessary. Typically such repairs include:

Contact a qualified professional.

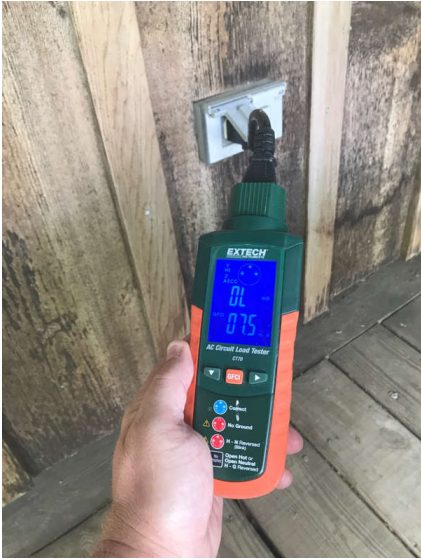
No GFCI On Front Porch

Contact a qualified electrical contractor.

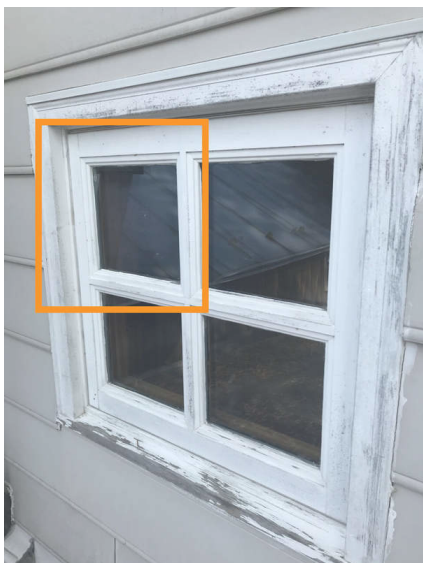
Failed Seal

Contact a qualified window repair/installation contractor.

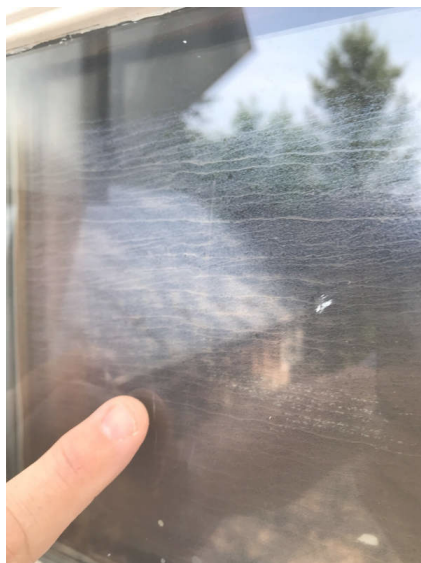
Failed Seal Close View

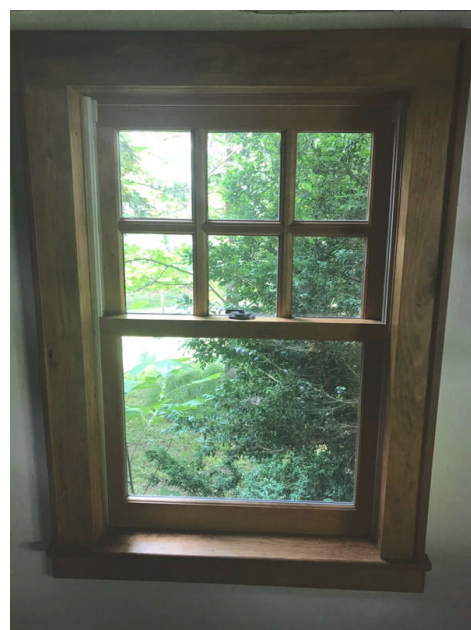
Window Screen Missing

Contact a qualified window repair/installation contractor.
