YOUR HOME INSPECTION

1234 Main St.
Celina TX 75009

PROPERTY INSPECTION REPORT

Concerning: 1234 Main St. Celina TX 75009
(Address or Other Identification of Inspected Property)

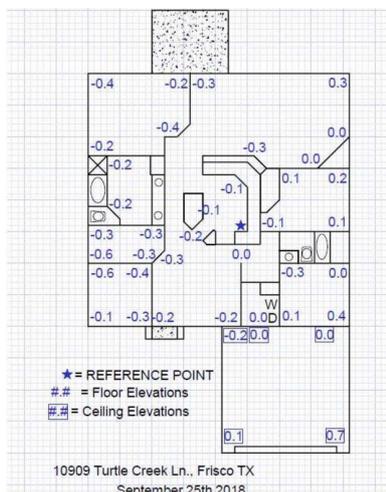
- Interior floor elevations were taken with a Technidea Pro-2000 Zipllevel. Elevations were recorded to the nearest 0.1-inch throughout the home. A benchmark of 0.0 was established and is shown on drawing with a star. An adjustment was made for floor height changes (sunken livingroom - raised platforms etc..) if they were a different elevation than the floor covering at benchmark location. It should be noted that the elevation measurements include effects of elevation variation in the original construction. New homes are normally within 0.6 inches to 1 inch of level, however sometimes they are up to 2.0 inches of level. A sketch of the house with the elevations is shown on the drawing below.

An elevation survey was performed on the foundation on the interior of the home. In addition, the interior and exterior of the home were reviewed for signs of distress due to movement. The elevation measurements along with the exterior and interior signs of distress were used to determine if the foundation is performing within recommended acceptable limits for slopes (movement) in a foundation.

Deflection variations greater than 1 inch of vertical movement in 20 feet horizontally is when this inspector Starts to considers wether slopes should be corrected. This home was measured to be **+0.7 inches** of vertical movement in 23 feet horizontal, as shown on the drawing above. Slopes in a foundation are typically cosmetic in nature and there is no definitive limit.

In **my opinion**, the foundation does not have any slopes in the elevation that are above acceptable tolerance for slopes and the foundation is **performing as designed**. Interior and exterior cosmetic damage is minimal. The foundation appears to be performing within acceptable limits of deflection and No foundation repairs are recommended.

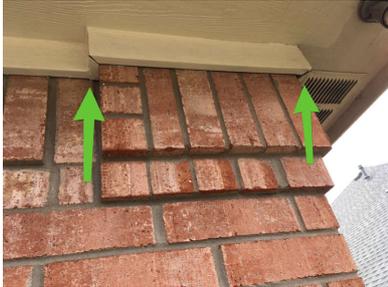
Front

Frieze Board Separation:

- Frieze board separations were observed.

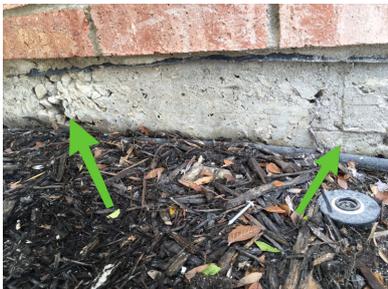
Foundation nails need removed:

- Exposed foundation nails need to be removed

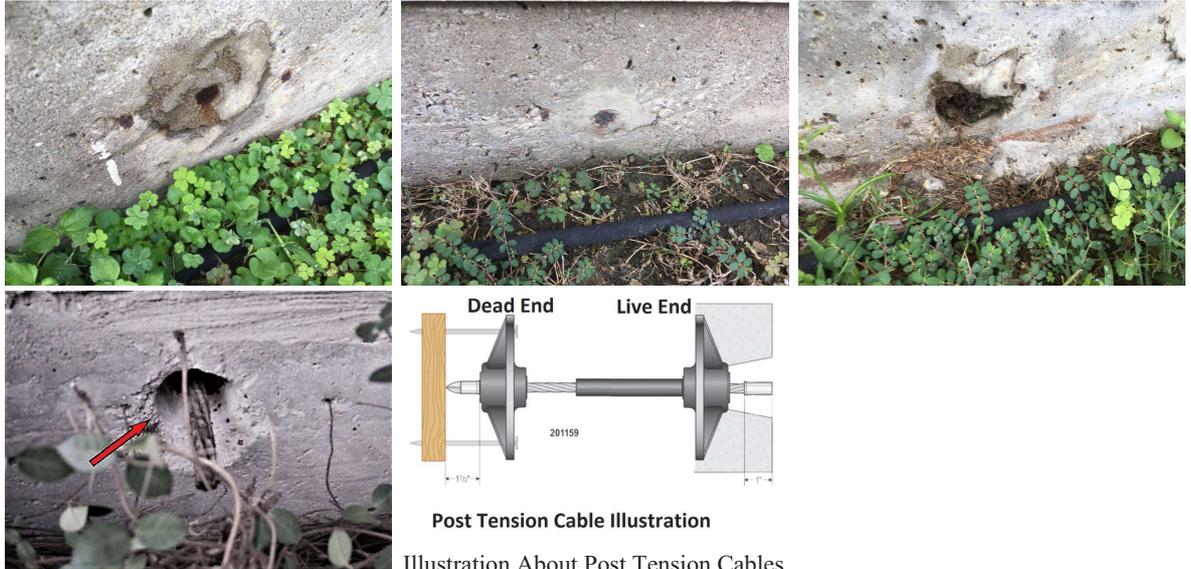
Example Picture of an Exposed Post Tension Cable (Live End)

- **Exposed** post tension **cable ends** were observed at the exterior of the home. It is recommended that the metal cables be painted (rust inhibiting paint) and then the slab should be patched. The slab patch / mortar should be used in conjunction with a bonding agent that helps it bond to the old concrete.

Illustration About Post Tension Cables

Recommendation: Contact a handyman or DIY project

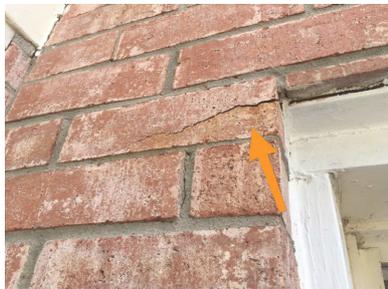
2: Brick / Mortar crack

- Brick/ mortar cracks were observed at the home. These cracks could be a sign of foundation movement and should be further evaluated.
- The crack should be repaired by a qualified brick mason.

Recommendation: Contact a handyman or DIY project

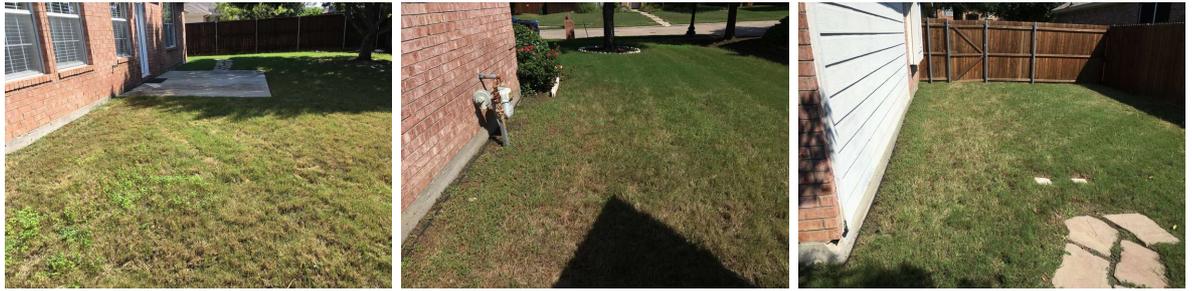
Drainage OK:

- This property appears to have adequate drainage. No corrective action is recommended at the time of this inspection.

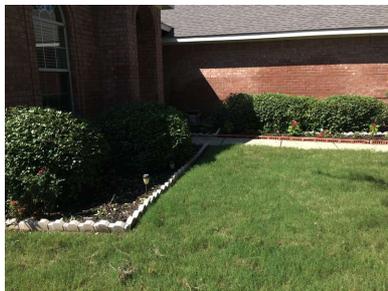
Marginal Site Drainage:

- Marginal site drainage was observed. Proper drainage is needed to help prevent water from standing and/or ponding next to the foundation beam. Corrective measures may be needed if the water stands within 10-feet of the foundation perimeter beam for more than 24-hours.

Fill dirt is needed. The low spots in the finished grade (ground) adjacent to the foundation perimeter wall need to be filled in to help prevent water from standing and/or ponding next to the foundation area.

Recommendation: Contact a qualified landscaping contractor

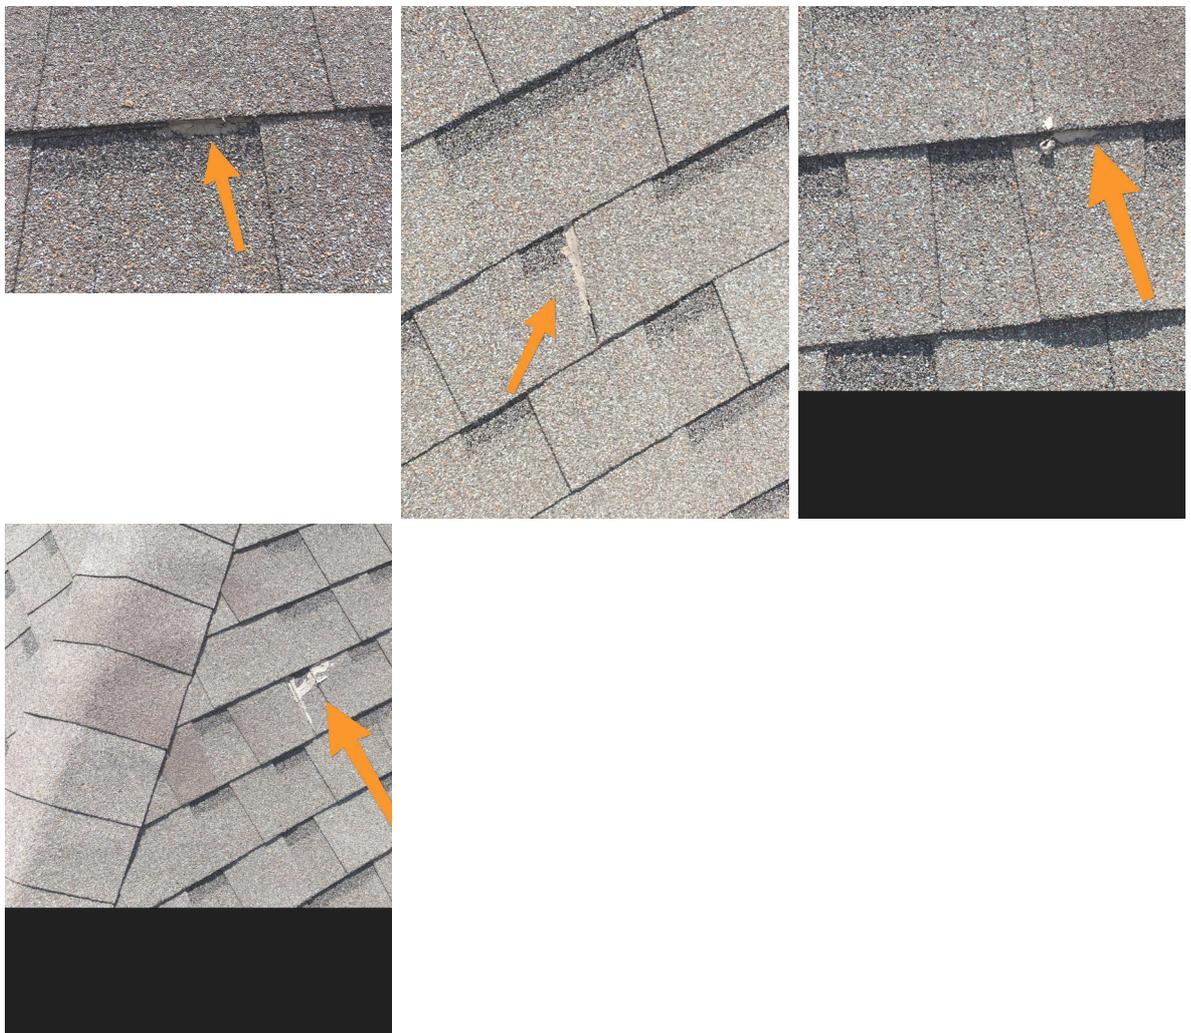
- Damaged shingles were observed to have been temporarily fixed with caulking. It is recommended that the damaged shingles be replaced.

Recommendation: Contact a qualified roofing professional.

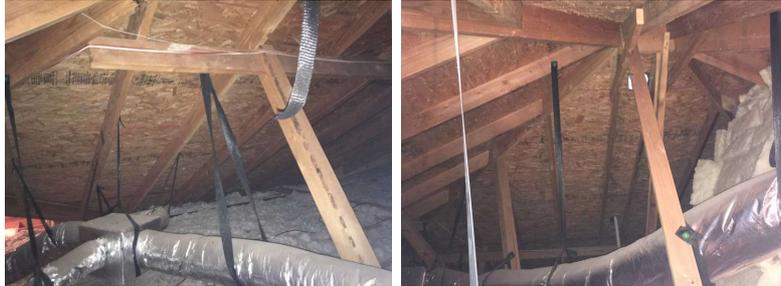
Roof structure good.:

- The roof structural components appeared to be in satisfactory condition at the time of this inspection. No corrective actions are recommended at this time.

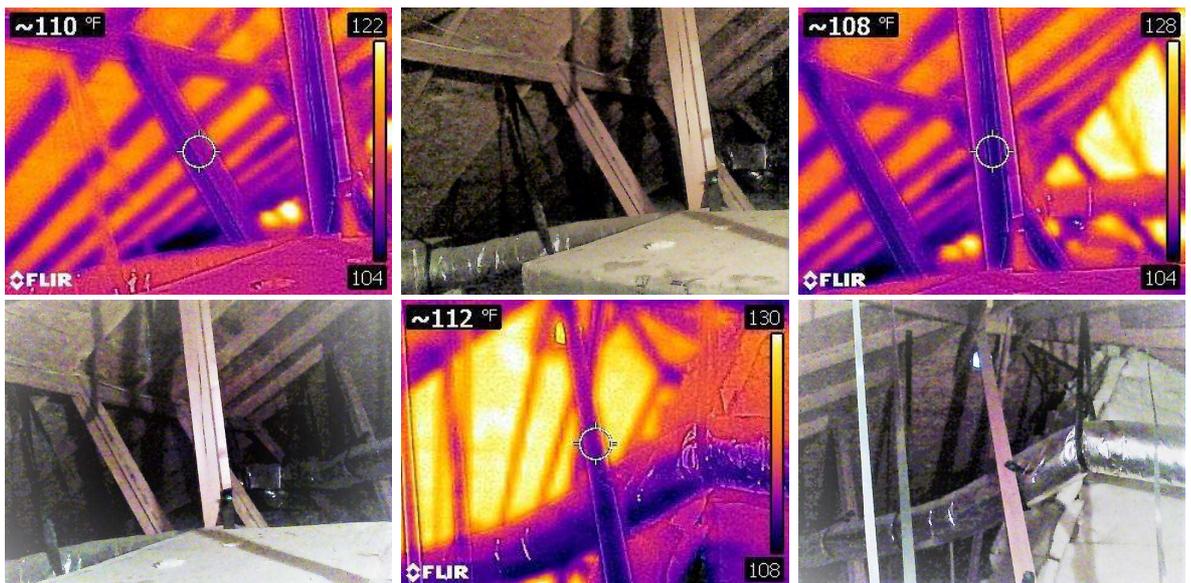
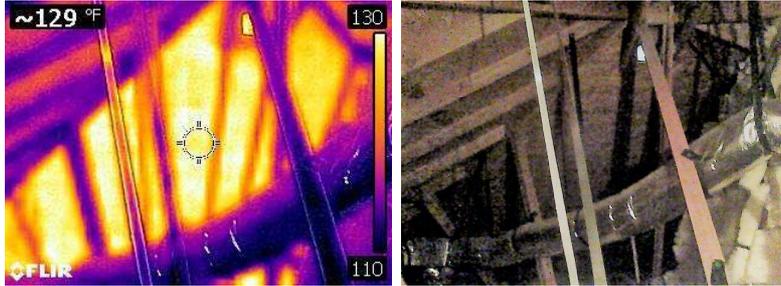
The roof structure attic space does not appear to be adequately ventilated. It is recommended to increase the amount of lower and or upper ventilation to help prevent heat buildup in the attic space area. This condition should be further evaluated and corrected as necessary.

Recommendation: Contact a qualified roofing professional.

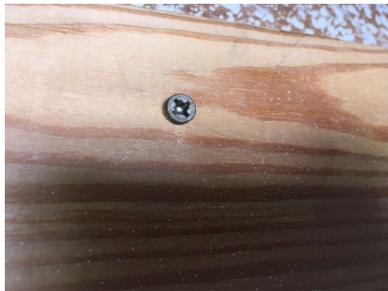
2: Attic Ladder Improper Fasteners

The attic ladder was observed to be installed with improper fasteners. The attic ladder should be secured in place with 16d nails or 3-inch lag bolts. This condition should be further evaluated and corrected as necessary.

Recommendation: Contact a qualified handyman.

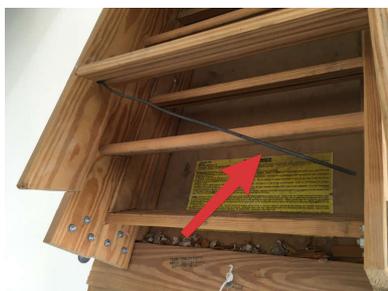
3: Attic Ladder Damaged

One or more of the attic ladder components were observed to be damaged. This condition should be corrected for reasons of safety.

Recommendation: Contact a qualified handyman.

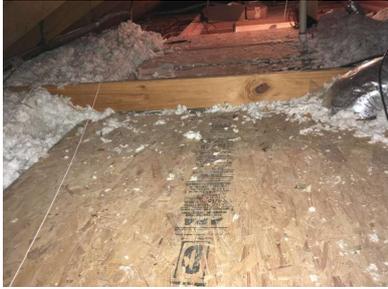
4: Needs Safe Access

The walking path to the 2nd floor HVAC equipment was not safe. The decking for the walking path should be smooth and **at least 3/4 thick**. Some areas were thinner and felt weak when walked on. Improvements for safety are recommended.

Recommendation: Contact a qualified professional.

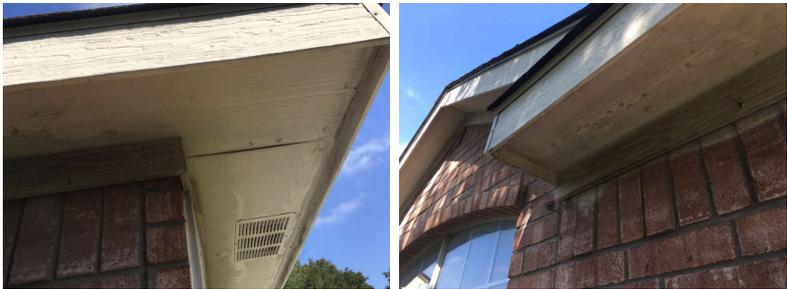
5: Sound Coat Paint

- The soffit and fascia boards are due for a paint job. It is recommended that all joints be caulked as necessary and all soffit and fascia boards should be painted as necessary with a sound coat of paint. Any wood rot or deteriorated soffit or fascia components should be replaced, resealed and properly painted.

Recommendation: Contact a qualified professional.

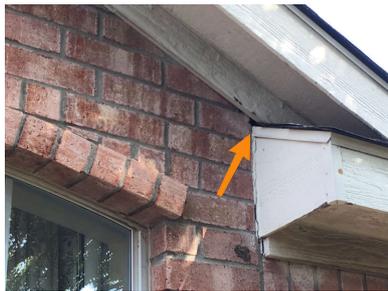
Mortar improvements are recommended for the exterior masonry veneer

Recommendation: Contact a qualified masonry professional.

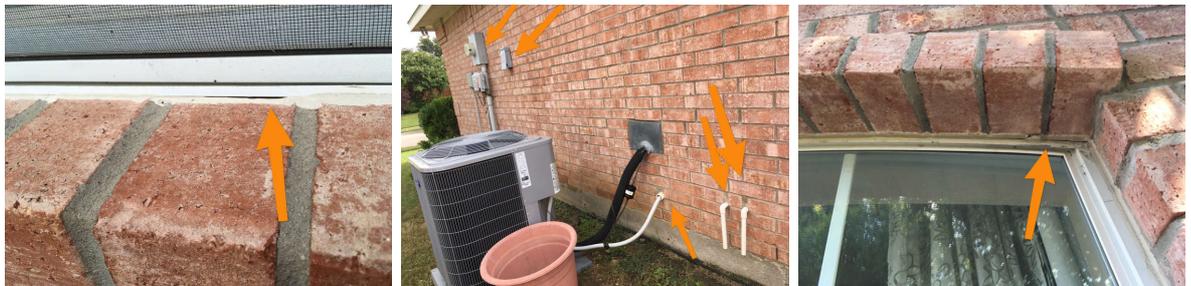
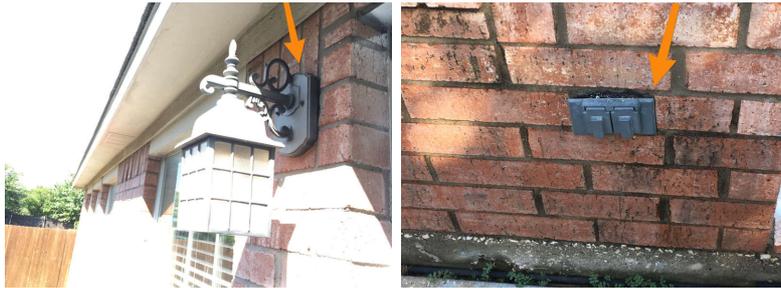
2: Seal Penetrations

It is recommended to use elastomeric caulking.

Recommendation: Contact a handyman or DIY project

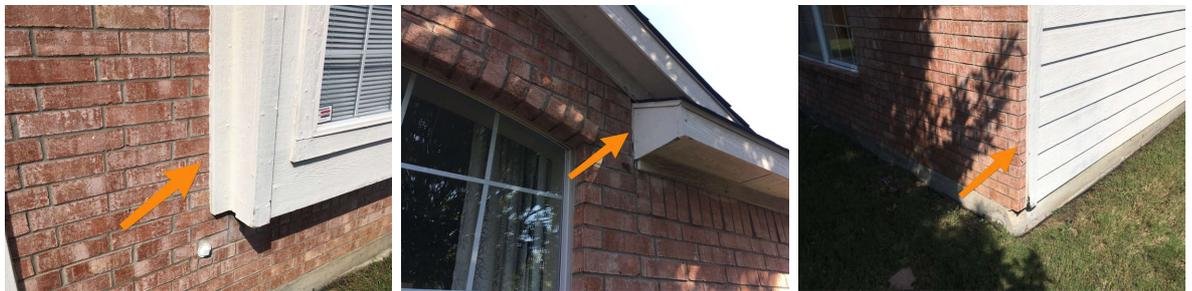
The transition from wood veneer to brick veneer needs to be better sealed.

Recommendation: Contact a handyman or DIY project

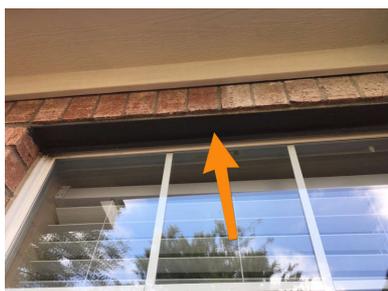
4: Rusted Lintel

Lintels above one or more exterior doors or windows were visibly rusted at the time of the inspection. Rust damage to the exterior wall covering will continue unless loose rust is removed, existing rust chemically neutralized and exposed steel protected from weather.

Recommendation: Contact a qualified painter.

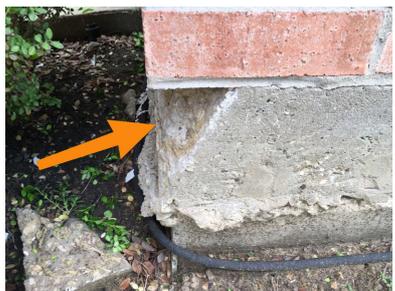
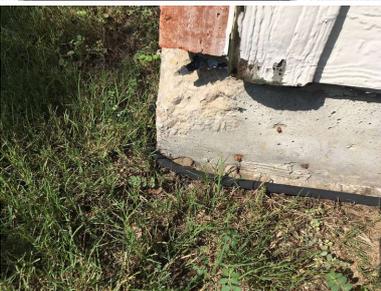
Corner pops were observed at the corner of the foundation. Concrete and brick expand and contract differently and can cause the corners of the slab to pop off if there is not a plastic bond breaker between the brick and the concrete and the brick veneer. This is a cosmetic deficiency and should be repaired as necessary or as desired. The mortar patch should be mixed with or used in conjunction with a bonding agent so the new patch bonds to the older concrete.

Recommendation: Contact a qualified concrete contractor.

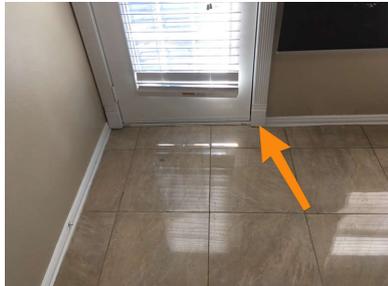
Light was observed to be visible between the door jamb and the exterior door. The weatherstripping should be adjusted or replaced.

Recommendation: Contact a qualified professional.

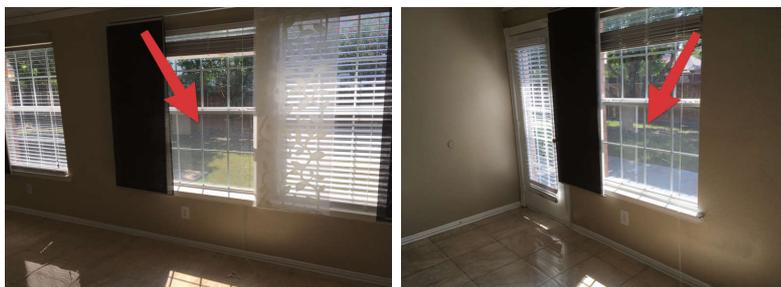
One or more of the window balancers are bad and the window will not stay up. The window needs to be adjusted for safety reasons.

Recommendation: Contact a qualified professional.

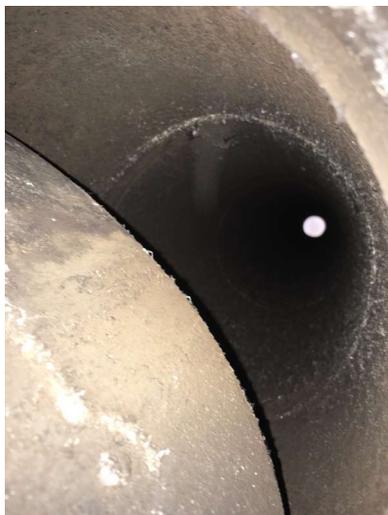
Picture of the fireplace during operation. The fireplace appeared to be performing properly at the time of this inspection.

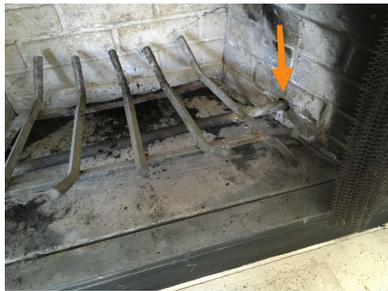
Fire caulk or high heat caulking is needed to seal around the gas line where it enters the firebox

Recommendation: Contact a handyman or DIY project

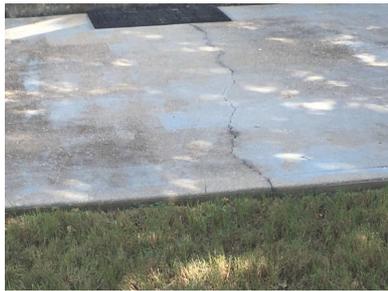
Some cracking of the Patio, Driveway & Sidewalks was observed at the time of this inspection. These appear to be normal cracks and are not a structural concern at this time.

Recommendation: Contact a qualified concrete contractor.

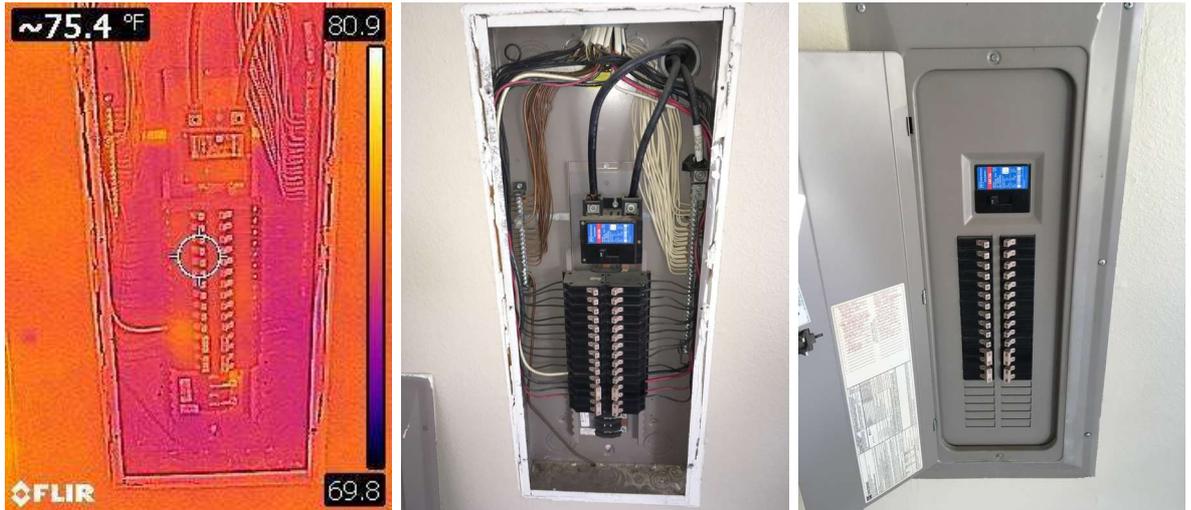
3 Pics for Reference::

- Picture of the panel with the cover on for reference.
- Picture of the electrical service panel with the cover removed for reference.
- I checked the electrical service panel with an IR (InfraRed) camera looking for any overheating components in the panel.

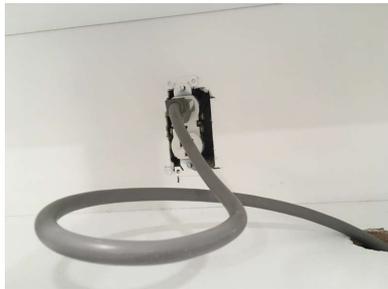
One or more of the receptacles was noted to have missing or damaged cover plate.

Recommendation: Contact a qualified electrical contractor.

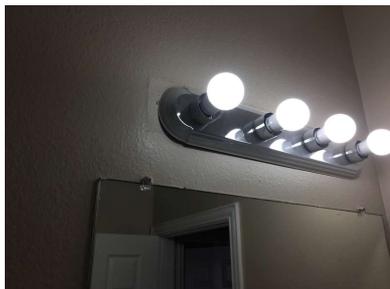
One or more of the light fixtures are loose at the ceiling mount

Recommendation: Contact a qualified electrical contractor.

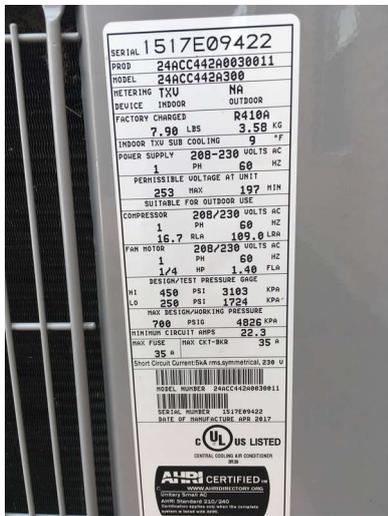
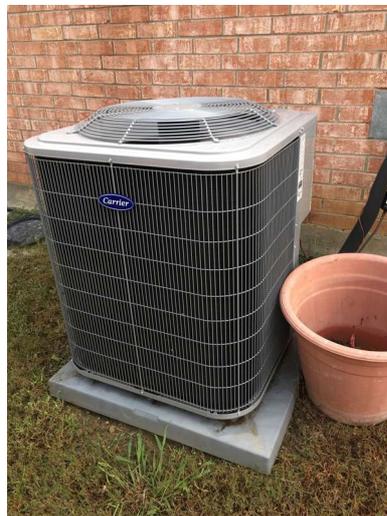
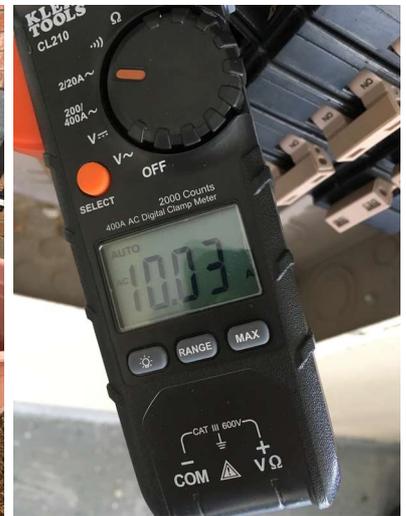
RLA draw -> Inside & Outside units : Central Cooling, Carrier, Manufacturers Year, 2017, Refrigerant Type, R410, System Size, 3.5 TON, Temperature Differentials, Temp Drop 21 degrees, Recommended Breaker Size, 35 AMP -

- The RLA (Running Load Amps) rating for the condensing unit is . **amps** (Total for fan and compressor). The unit drew . **amps** . This rough check is within the normal operating range.
- Picture of the cooling equipment in the atticHVAC closet for your reference.
- Picture of the outside condensing unit for reference.

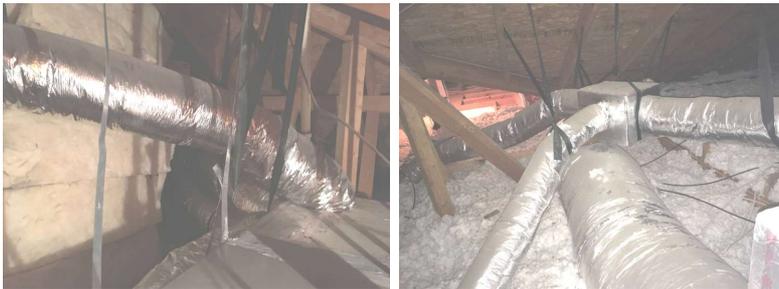
Ductwork ok:

- All visible ducts appeared to be in satisfactory condition at the time of this inspection.

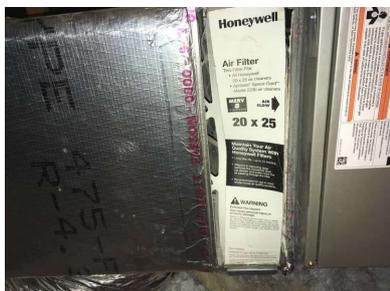
2: Dirty Filters

- The filters were dirty at the time of inspection and should be replaced as necessary. **1 in filters** should be replaced **monthly** and **4 in filters** should be replaced **every 3 months**.

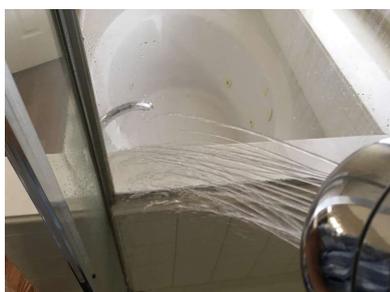
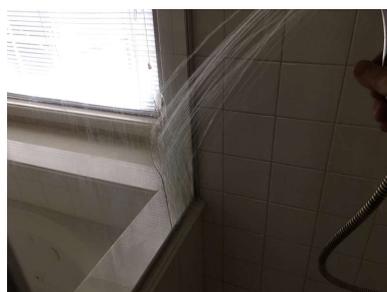
I aimed water at the corners of the shower enclosure checking for leaks. No leaks were found at the time of inspection

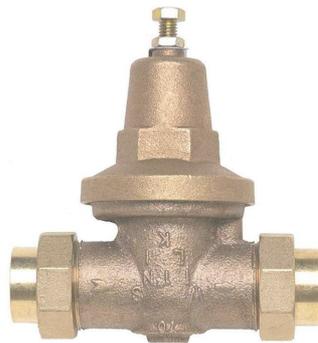
Example Pressure Reducing Valve

Cut away of Pressure reducing valve

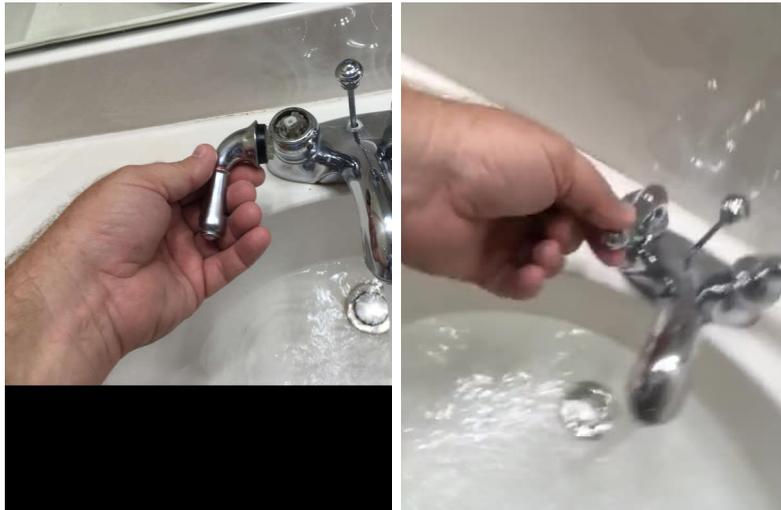
- The faucet assembly is loose and should be resecured by a licensed plumber.

Recommendation: Contact a qualified plumbing contractor.

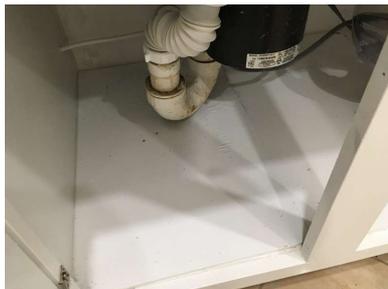
- Signs of a previous leak were observed under the sink. **No leaks were found at the time of inspection** but the cabinet should be repaired as necessary.

Recommendation: Contact a handyman or DIY project

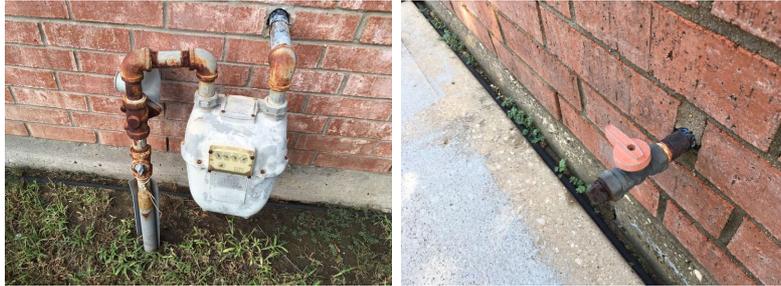
- The surface rust should be cleaned off the gas lines and the gas lines painted with a good exterior paint rust resistant paint.

Recommendation: Contact a qualified handyman.

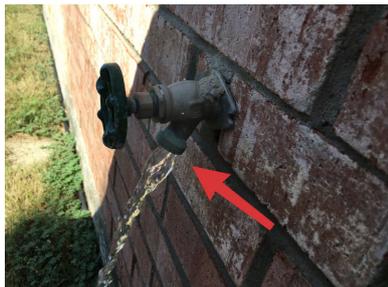
One or more of the hosebibs / exterior faucets was absent a pressure relief collar. A pressure relief collar should be installed.

Recommendation: Contact a qualified plumbing contractor.

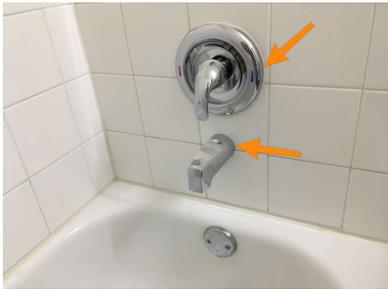
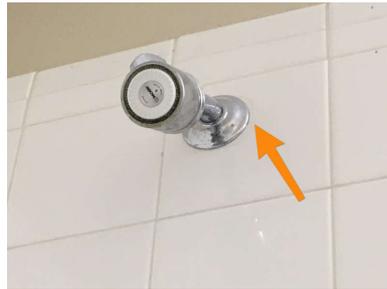
The tub controls, spout and shower head need to be sealed to the wall.

Recommendation: Contact a qualified professional.

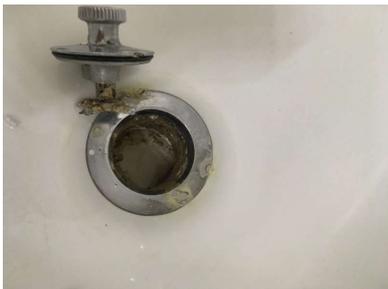
- The tub drain assembly is damaged and needs to be replaced by a licensed plumber.

Recommendation: Contact a qualified plumbing contractor.

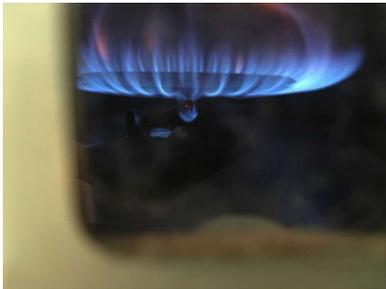
Picture Combustion Chamber:
Picture of the combustion Chamber for reference.

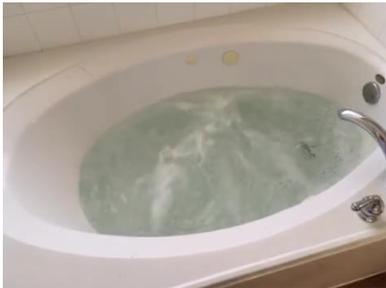
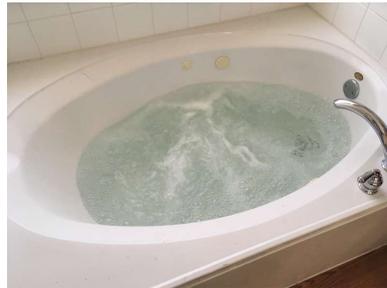
Picture of the hydrotherapy tub during operation.

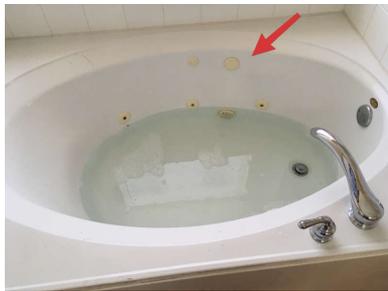
The air valve was observed to be stuck and would not turn. This condition should be corrected.

Recommendation: Contact a qualified plumbing contractor.

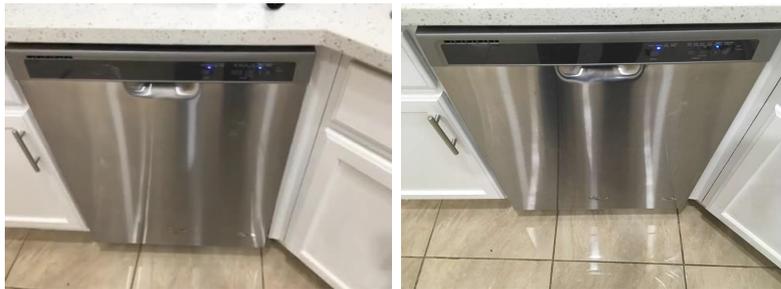
Dishwasher ok:

Picture of the dishwasher for reference. The dishwasher appeared to be working properly at the time of inspection.

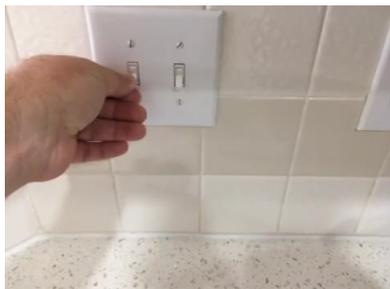
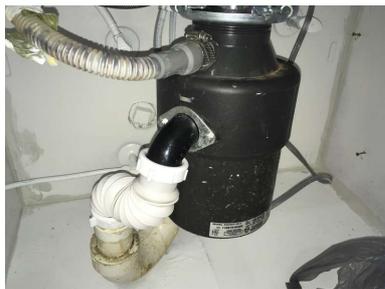
The disposal was tested and appeared to be working properly at the time of this inspection.

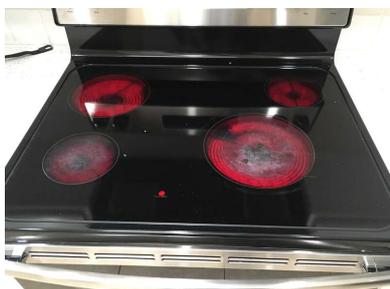
Cooktop OK:

The cooktop burners appeared to be performing properly at the time of this inspection.

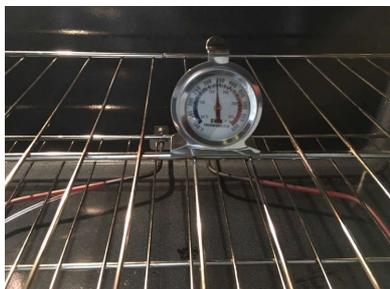
Oven temperatures:

The oven or ovens were tested at 350 degrees.

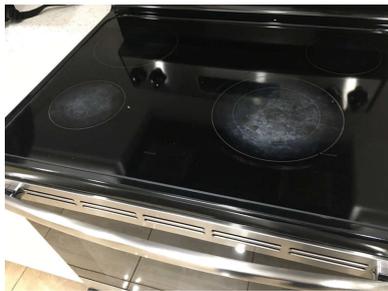
Cosmetic scratches were observed on the range/cooktop. This condition should be corrected as desired.

Recommendation: Contact a qualified appliance repair professional.

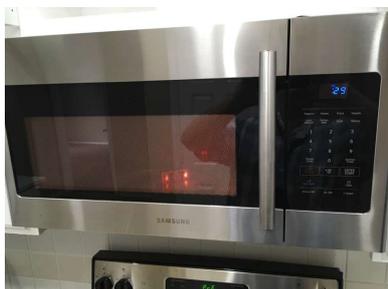
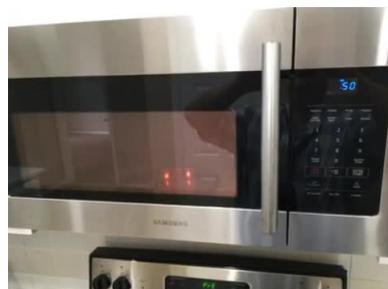
Microwave OK:

The microwave was observed to be working properly at the time of this inspection.

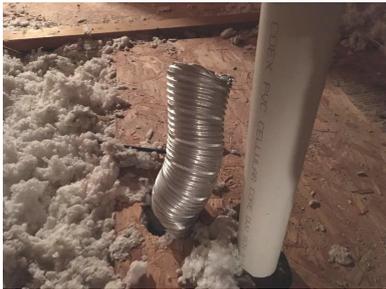
The exhaust vent terminates in the attic. This was not a requirement at the time that the home was built but TREC requires that i mark this item as deficient.

Recommendation: Contact a handyman or DIY project

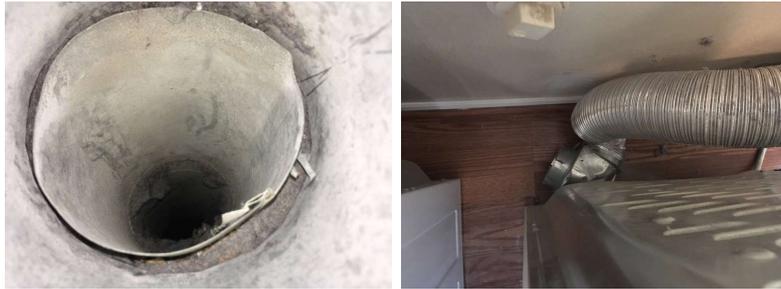
Vent duct not connected to dryer:

- The dryer vent duct is not connected to the dryer.

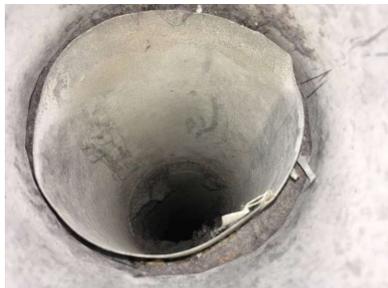
1: Dryer Vent Dirty

- The dryer vent termination appears to be clogged and should be cleared for safety reasons.

Recommendation: Contact a qualified professional.

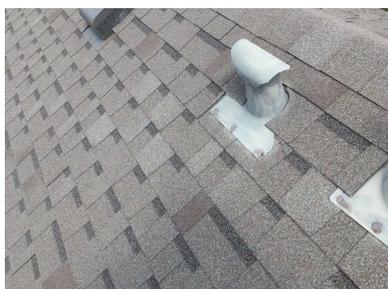
2: Wrong type of termination

- This type of roof level dryer vent termination is not approved for use with dryer vents. There should be a flapper that keeps birds or rodents from entering the ductwork. It is also important that no screens be installed. Screens can trap lint and create a fire hazard. It is recommended that the dryer vent termination be replaced with one approved for use on dryer vent ducts.

Recommendation: Contact a qualified professional.

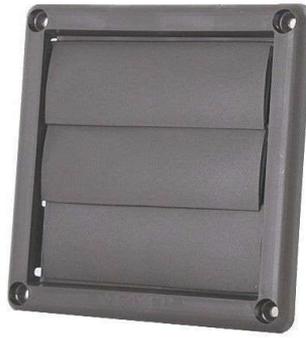
Example wall termination

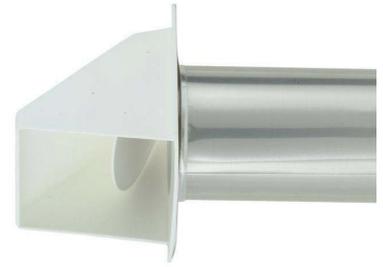
Example dryer vent wall termination

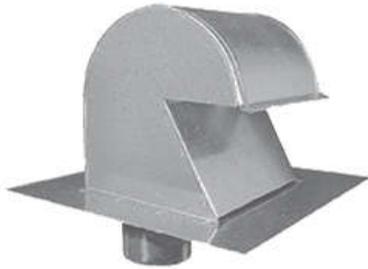
Example Dryer vent Roof cap

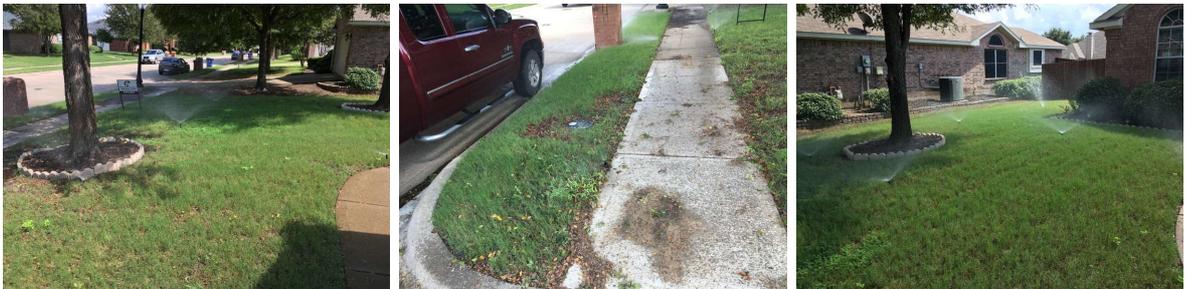
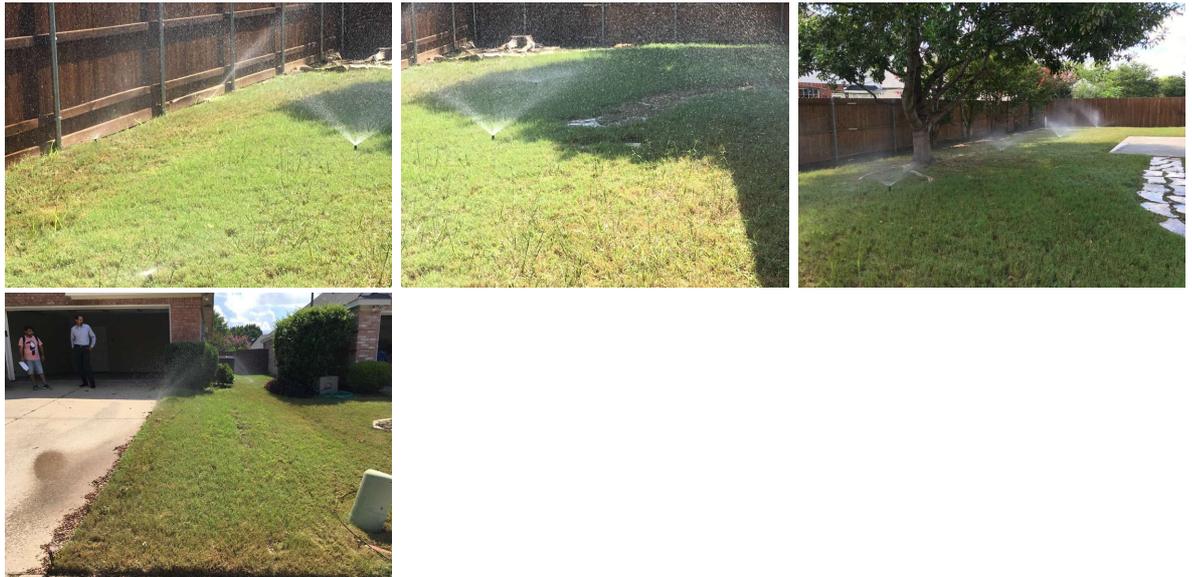
Pics during operation:

Pictures of the sprinklers during operation.

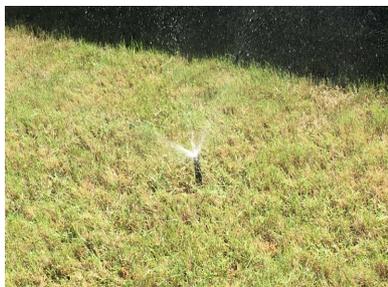
2: Damaged sprinkler head

- One or more of the sprinkler heads was damaged and should be replaced as necessary.

Recommendation: Contact a qualified professional.

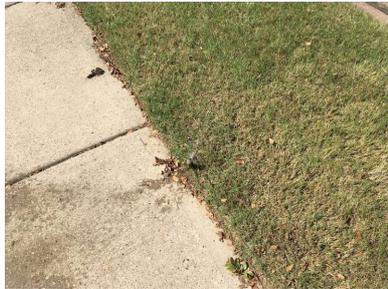
3: Sprinkler head Aimed wrong

- One of the sprinkler heads was observed to have a narrow angle of spray and should be adjusted or replaced.

Recommendation: Contact a qualified professional.
