TPI HOME INSPECTION REPORT COPY

1234 Main St.  
College Station TX 77845

# PROPERTY INSPECTION REPORT

**Concerning:** 1234 Main St. College Station TX 77845  
(Address or Other Identification of Inspected Property)

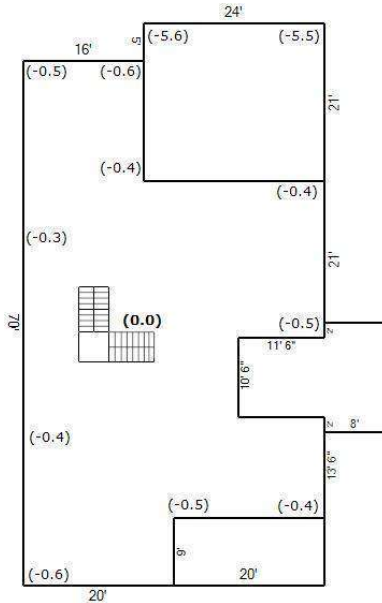
*Elevation Survey:*

Elevation measurements can be useful, but should not be relied on as a definitive statement of foundation condition. Elevation is measured against a benchmark "0" set in the middle of the structure and indicated at lower (-) or higher (+) than the benchmark. Measurements are in inches.

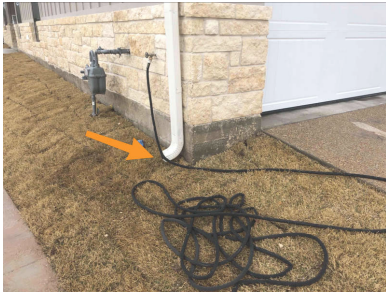
**1: Erosion At Downspouts**

Splash blocks or extensions should be installed to the gutter system downspouts where needed to prevent erosion adjacent to the foundation.

Recommendation: Contact a qualified lawn care professional.

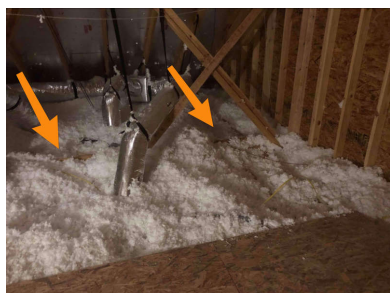
### **1: Missing Attic Insulation**

Gaps in the insulation can cause condensation and heat loss. Add / replace insulation as necessary for adequate thermal protection

Recommendation: Contact a qualified insulation contractor.

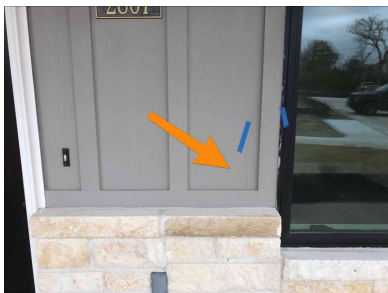
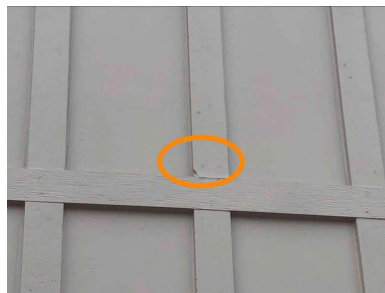
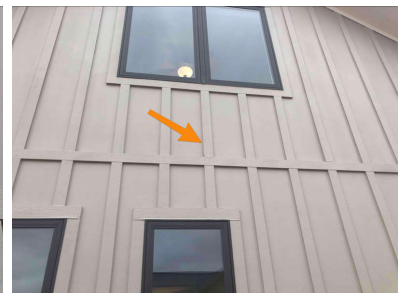
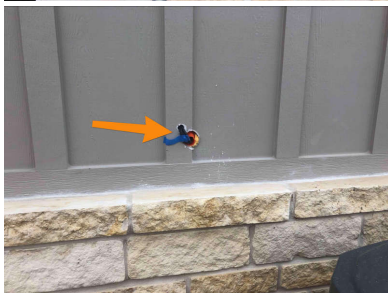
**1: Broken /Cracked Siding**

All damaged / cracked siding should be repaired or replaced and any cracks sealed to keep the integrity of the weather envelope provided by exterior wall coverings.

Recommendation: Contact a qualified siding specialist.

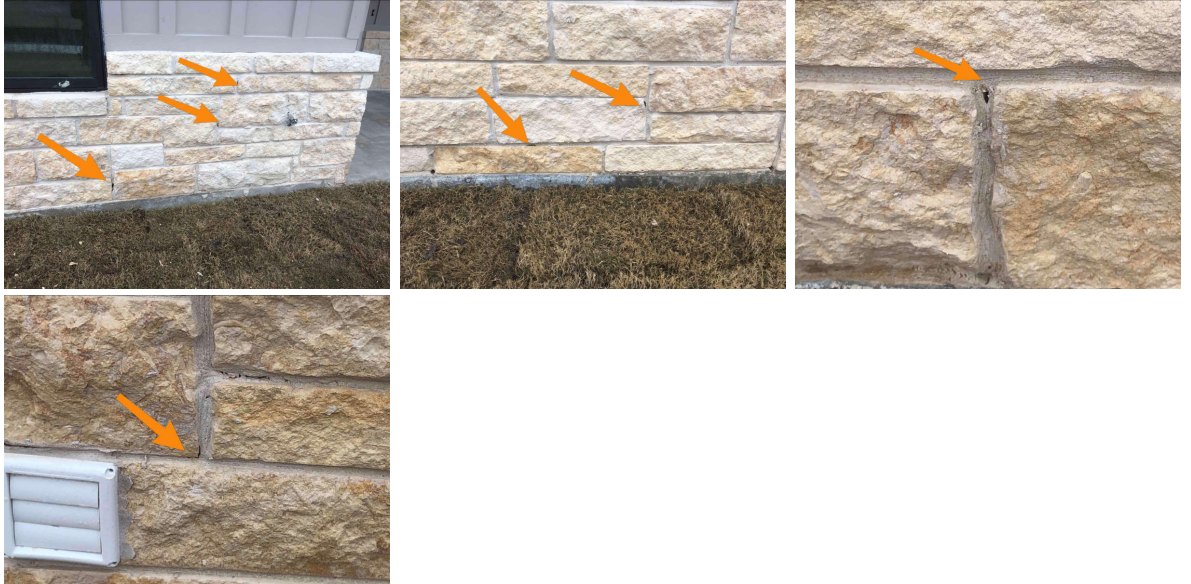
**4: Voids In Masonry Mortar Joints**

Mortar is less durable than brick, and can be maintained by "repointing." To repoint, chip the old mortar out to a depth of 1/2-inch to 3/4-inch. Then dampen the joints with water, and repack with new mortar.

Recommendation: Contact a qualified masonry professional.

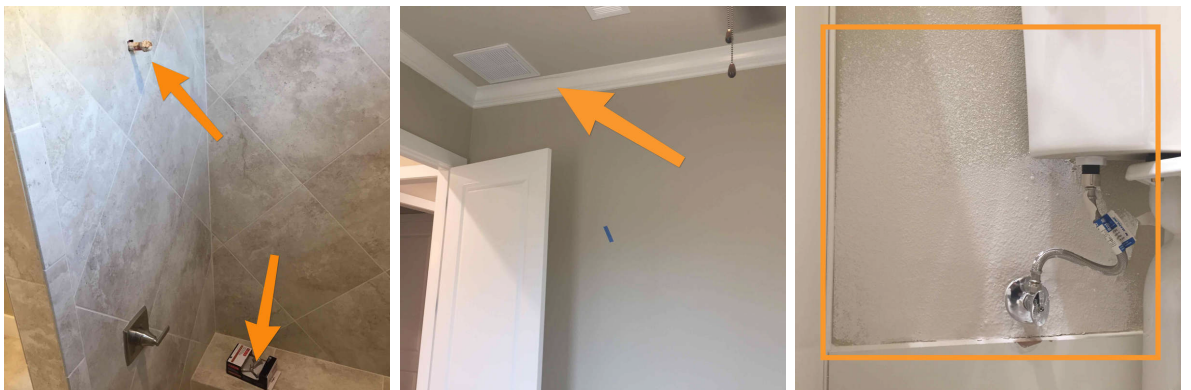
**5: Interior Unfinished Work /Cosmetic Repairs**

Unfinished work, painting and cosmetic repairs or touch ups are needed.

Master Shower

Cracked crown molding

Recommendation: Contact a qualified professional.

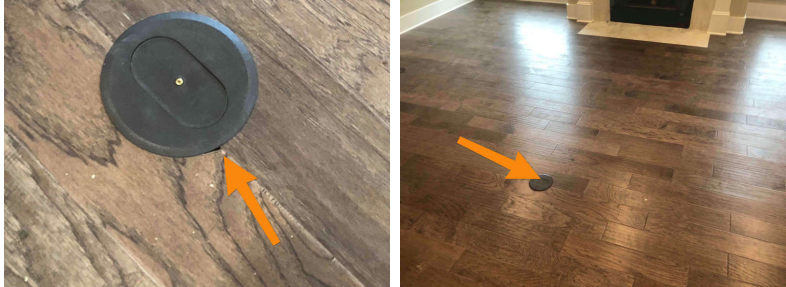
**1: Cosmetic repair needed at floor covering.**

Flooring has been over cut at floor receptacle.

Recommendation: Contact a qualified professional.

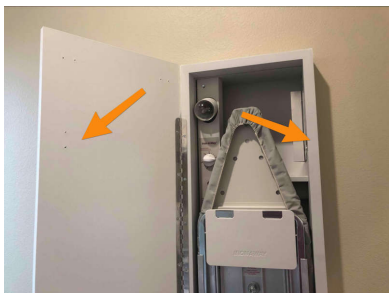
**2: Door Doesn't Latch**

Latch is missing.

Recommendation: Contact a qualified handyman.

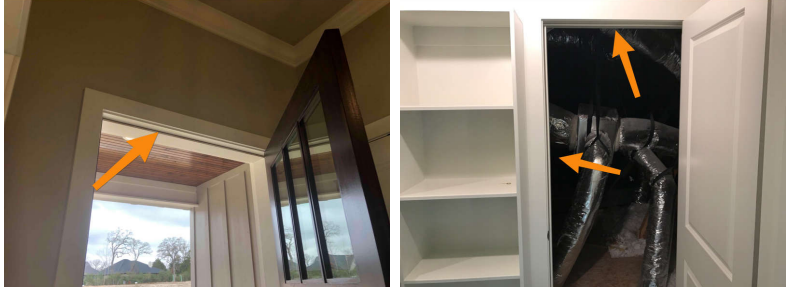
**3: Weatherstripping Missing**

No weatherstripping is installed at the door frame.

Recommendation: Recommended DIY Project

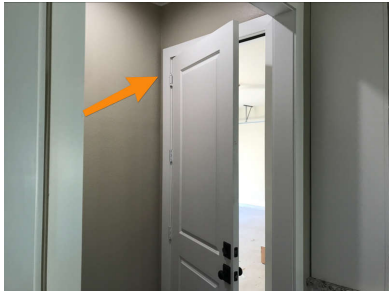
**4: Self Closing Hinges Need Adjustment**

Self closing hinges do not provide enough tension to fully close the door.

Recommendation: Contact a qualified professional.

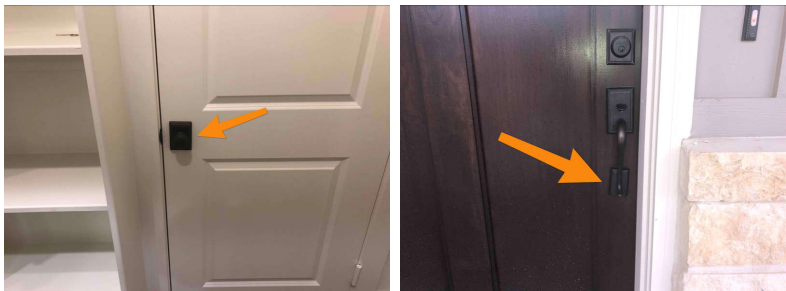
**5: Door handle trim installed out of square.**

Front Entry, Attic Access Door

Recommendation: Contact a qualified professional.

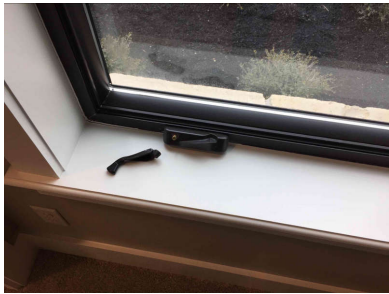
**1: Latch Not Properly Installed**

Window latches needed to prevent unwanted entry and proper function.

Recommendation: Contact a qualified professional.

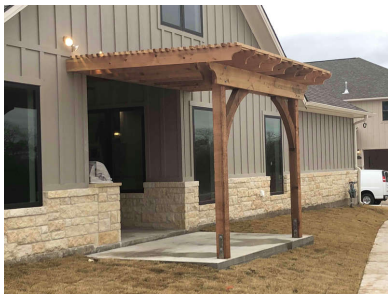
*Discrepancy noted::*

Stain has not been applied to exposed patio structure.

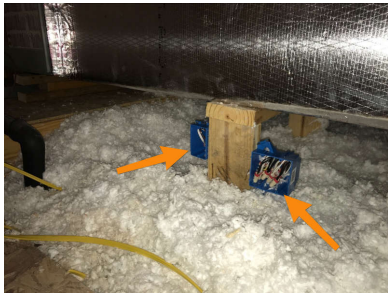
All wire connections & charged wires with exposed ends and splices should be covered in junction boxes for safety. Recommend a qualified electrician correct.

Recommendation: Contact a qualified electrical contractor.

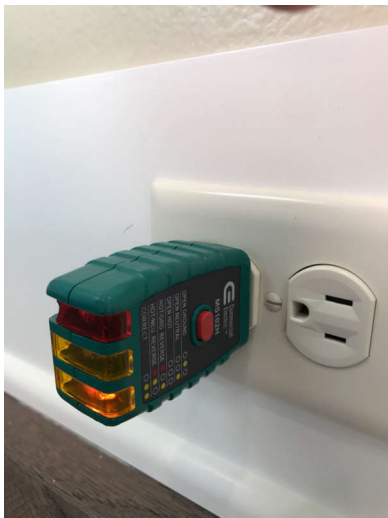
Check for proper wiring of the electrical receptacle.

Recommendation: Contact a qualified electrical contractor.

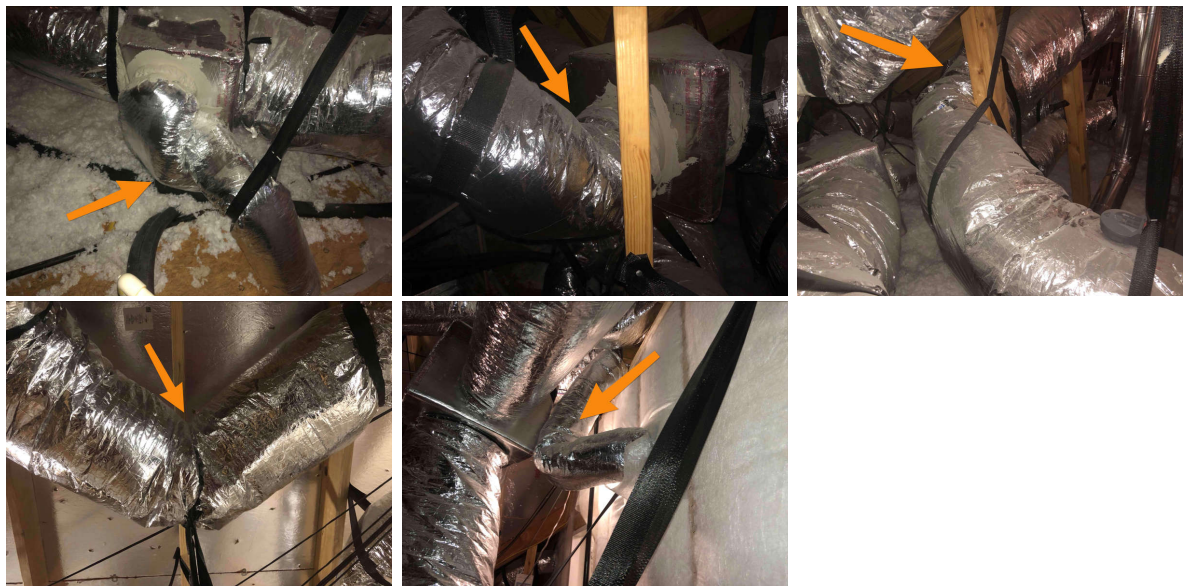
Flexible air ducts should have no sharp bends and be supported every 4 feet.

Recommendation: Contact your builder.

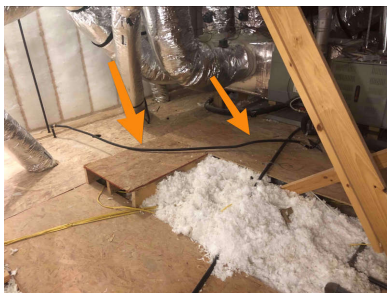
Gas piping should be installed in a manor to prevent damage to pipe and tripping hazard.

Recommendation: Contact a qualified professional.
