RESIDENTIAL REPORT

1234 Main St.
Edmonton AB T5T3E9

Buyer Name
01/18/2018 9:00AM

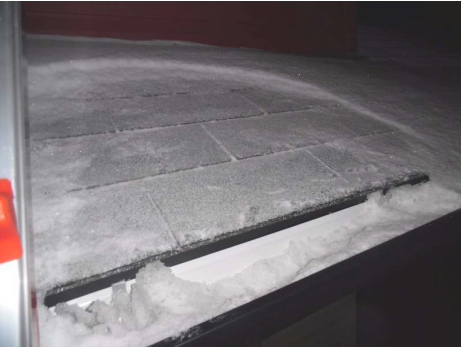
Limitation: Snow covered.

Asphalt Shingles observed functional at the time inspection. 15 years shelf life remaining, par manufacture.

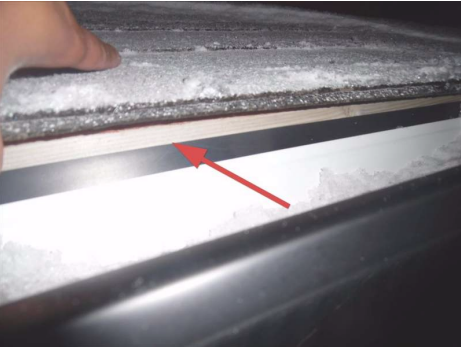
Drip edge flashing missing, recommend installing to protect the roof board, Contact Condo board for all exterior maintenance and repair.

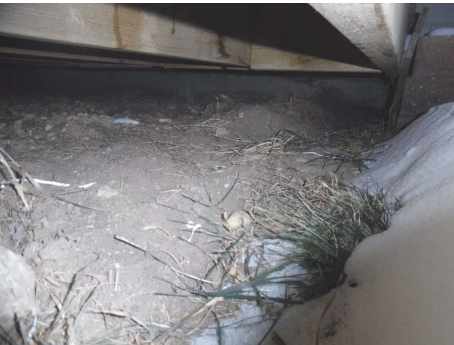
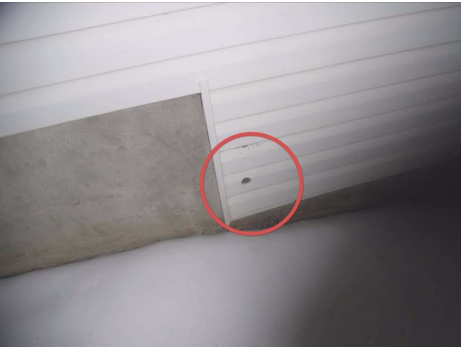
Siding, Flashing & Trim: Siding Material
Asphalt
Observed Openings on back and side of the house. Recommend correction by professional. Contact Condo Management for all exterior repair and maintaiance.

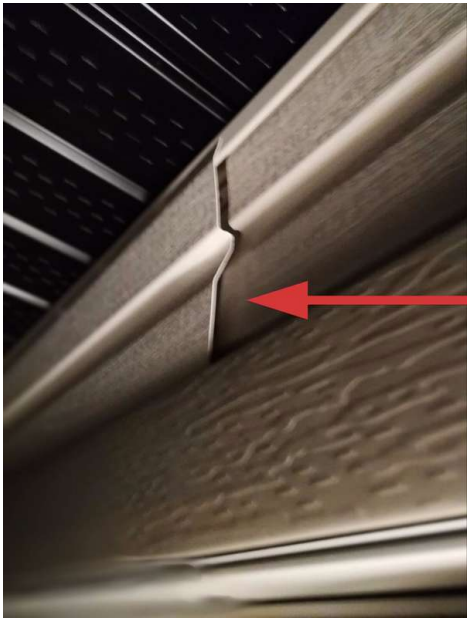
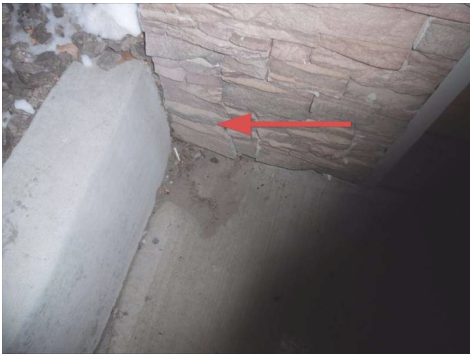
3.1.1 Siding, Flashing & Trim

CRACKING - MINOR

OUTSIDE GARAGE CORNER WALL

Loose sliding observed. This is a result of temperature changes, and typical as homes with stucco age. Recommend monitoring.

Recommended DIY Project

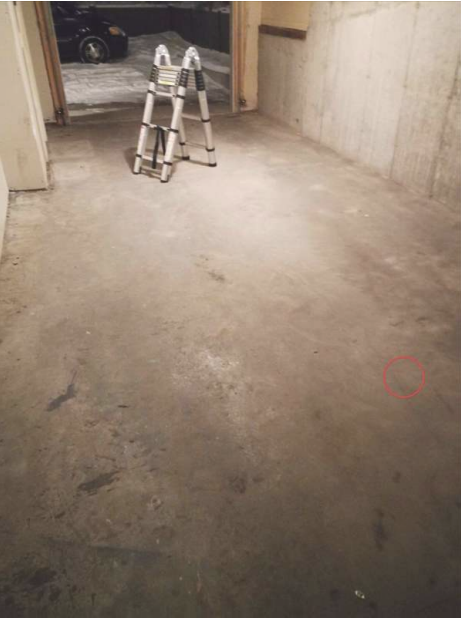
Floor Structure: Minor Crack
Observed minor crack in Basement/ Garage floor.
These Cracks are normal but Recommend monitoring.

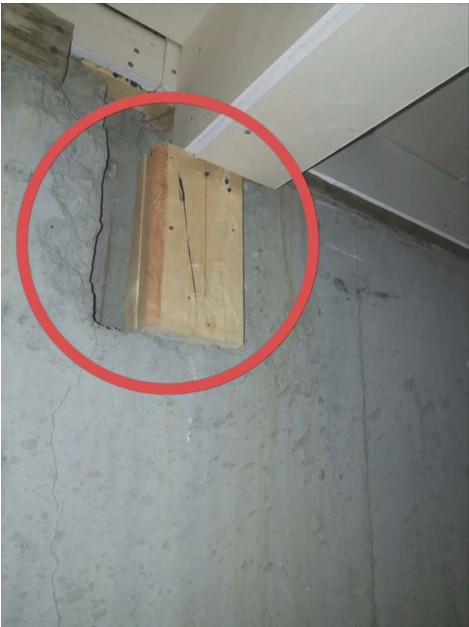
4.5.1 Ceiling Structure

EVIDENCE OF STRUCTURAL DAMAGE

Evidence of structural repair was found in the ceiling structure. Recommend a structural engineer evaluate repair.

Recommendation
Contact a qualified structural engineer.

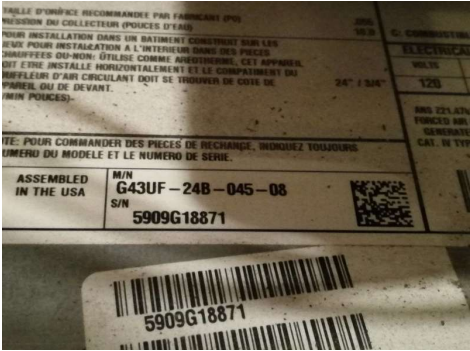
5.1.1 Equipment

NEEDS SERVICING/CLEANING

Furnace should be cleaned and serviced annually. Recommend a qualified HVAC contractor clean, service and certify furnace.

Contact a qualified HVAC professional.

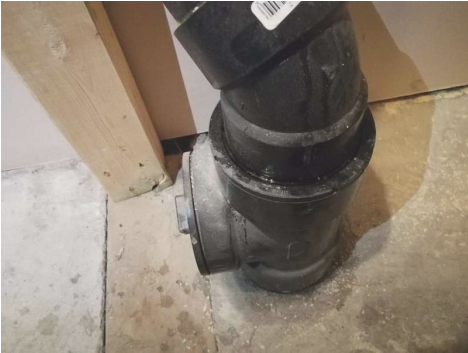
6.2.1 Drain, Waste, & Vent Systems

IMPROPER CONNECTION

BASEMENT

loose connection and leak observed at a drain, waste pipe. Recommend a qualified plumber evaluate and repair.

Contact a qualified plumbing contractor.

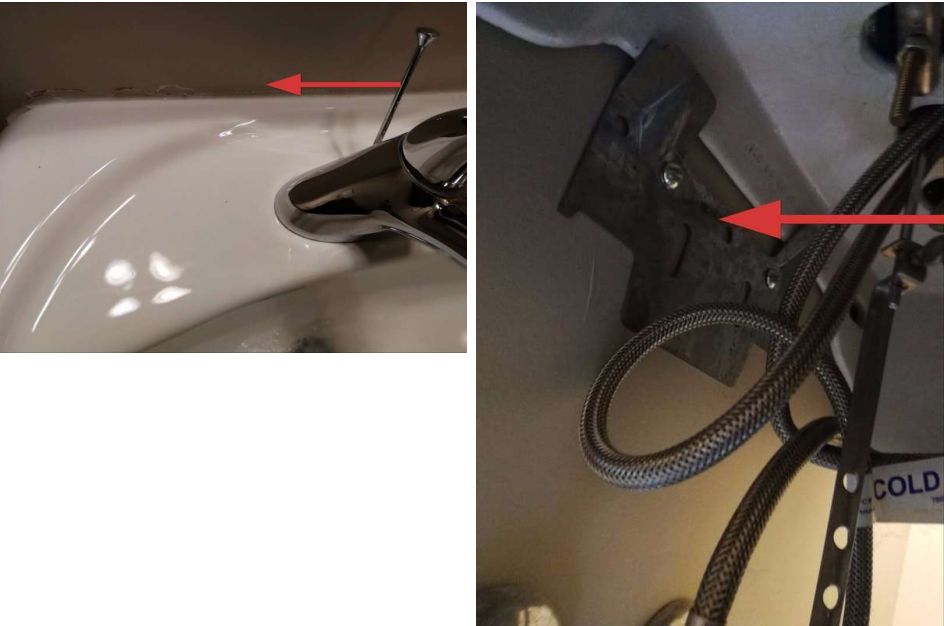
6.6.1 Bathroom Fixture

SINK

MAIN FLOOR HALF BATHROOM

Loose fitting observed at Mainfloor Haf bathroom, Recommend Repair by qualified Professional.

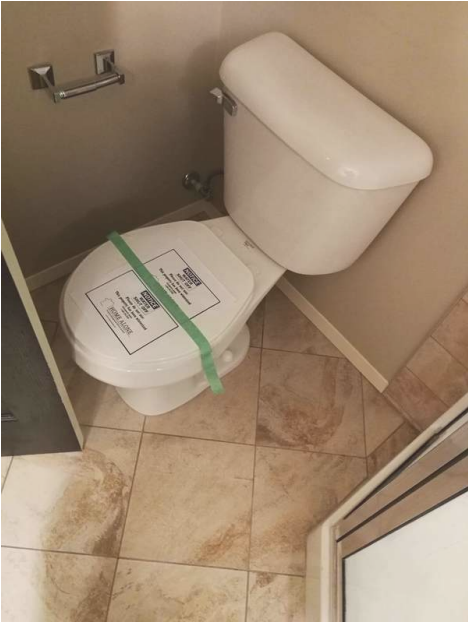
6.6.2 Bathroom Fixture

TOILET

2ND FLOOR ENSUITE BATHROOM

Loose fitting observed, Recommend Repair by qualified Professional.

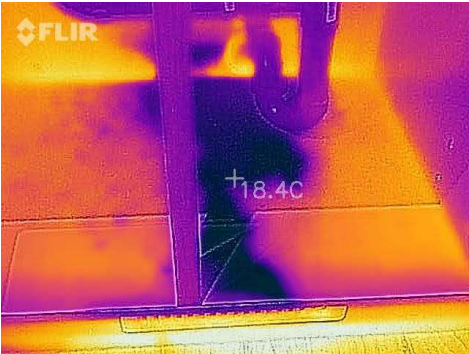
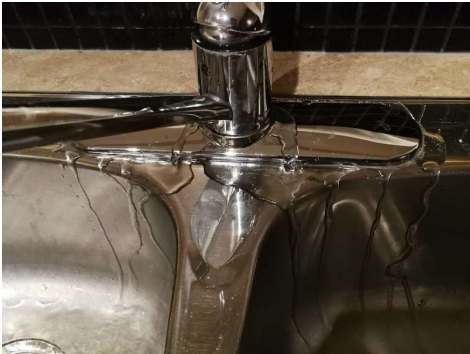
6.7.1 Kitchen Fixture

SINK

MAIN FLOOR KITCHEN

Observed leak while operating kitchen Faucet, Recommend Repair by qualified professional.

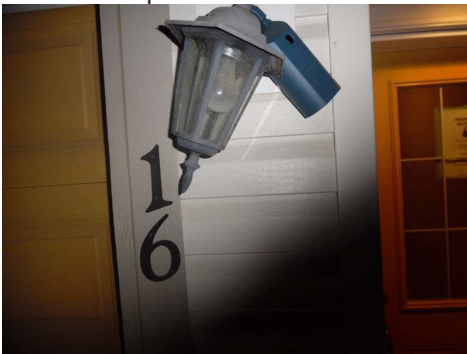
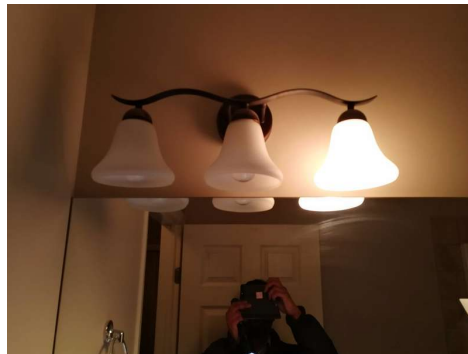
7.4.1 Lighting Fixtures, Switches & Receptacles

LIGHT INOPERABLE

EXTERIOR, LIVING ROOM, 2ND FLOOR

One or more lights are not operating. New light bulb possibly needed.

Contact a qualified electrical contractor.

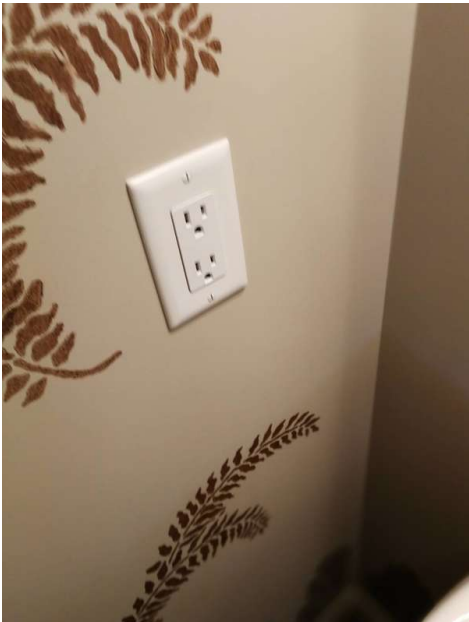
7.5.1 GFCI & AFCI

NO GFCI PROTECTION INSTALLED

MAIN FLOOR HALF BATHROOM

No GFCI protection present in all locations. Recommend licensed electrician upgrade by installing ground fault receptacles in all locations.

Contact a qualified electrical contractor.

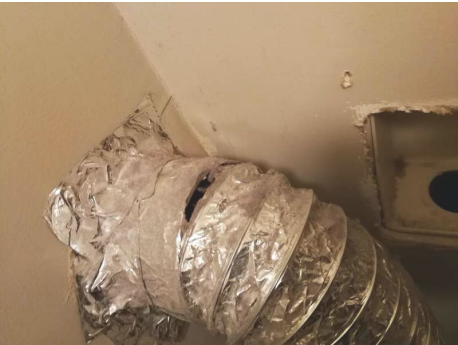
Metal Flex Dryer vent

Observed Damaged,
Recommend replacing by
qualified professional.

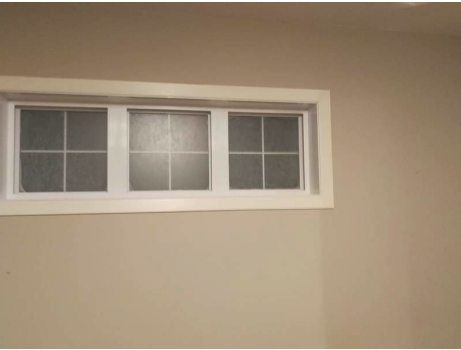
Observed Operational at the time of inspection.
minor insulation missing in the 2nd-floor master bedroom

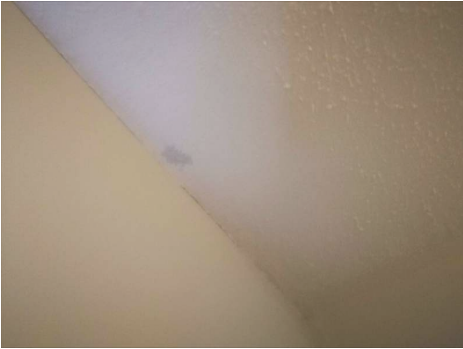
Poor Paint Finishing observed 2nd Floor

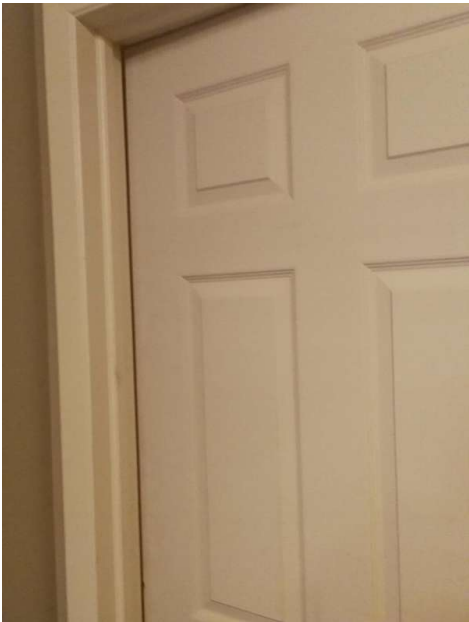
9.1.1 Doors

DOOR DOESN'T LATCH

2ND FLOOR BEDROOM

Door doesn't latch properly. Recommend handyman repair latch and/or strike plate.

Contact a qualified handyman.

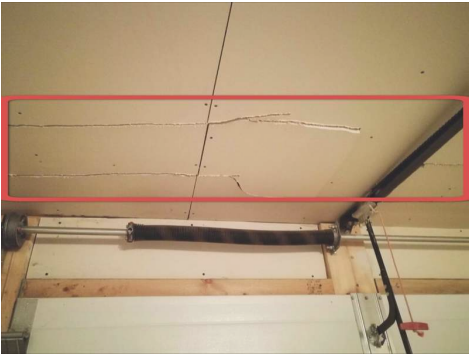
11.1.1 Ceiling

DAMAGED

Garage ceiling was damaged. Recommend qualified contractor evaluate and repair.

Contact a qualified professional.

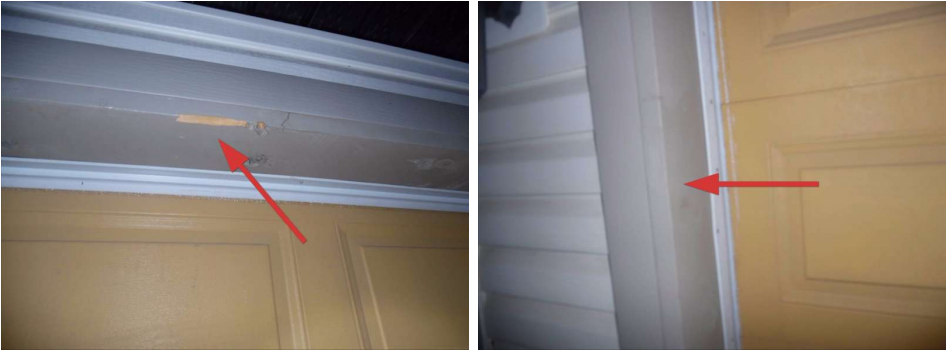
11.3.1 Walls & Firewalls

DAMAGE GARAGE TRIM

GARAGE

Observed Garage door' trim damage and missing cover plate to protect from deterioration.

Contact a qualified garage door contractor.
