HOME INSPECTION REPORT

1234 Main St.
Severn 21144

07/18/2018 9:00AM

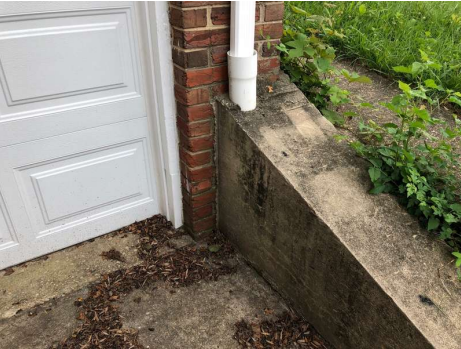
Drainage System: Roof Discharges Underground

The roof drainage system, or a portion of it, discharges underground. There is no way for your inspector to know where the water will go or if it is done properly as it is underground and cannot be visually inspected. Observation during a downpour is recommended.

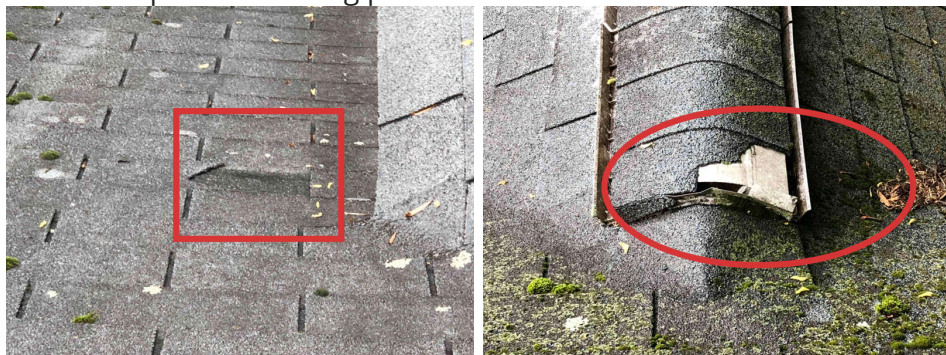
2.1.2 Roof Covering

LOOSE BLOWN-OFF SHINGLES

There are loose or blown-off shingles that should be repaired to prevent leakage.

Contact a qualified roofing professional.

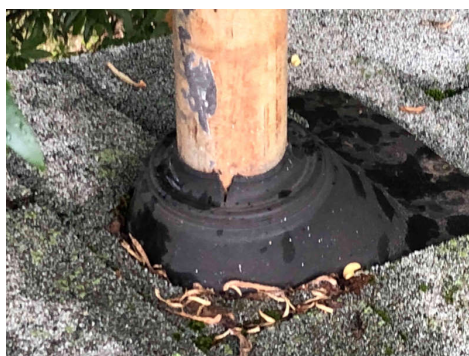
2.2.1 Flashing / Penetrations

DETERIORATED BOOTS

There are one or more old boots at the plumbing vents that are deteriorated and should be replaced as part of regular maintenance to prevent leakage.

Contact a qualified roofing professional.

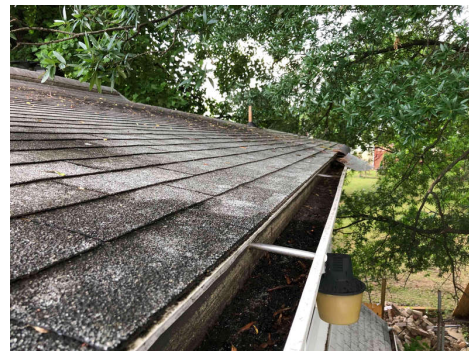
2.3.1 Drainage System

DEBRIS IN RAIN GUTTERS

Rain gutters need to be cleaned out to prevent overflowing and possible leakage into the home or basement.

Contact a qualified professional.

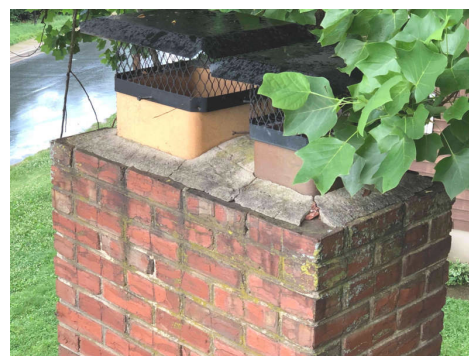
2.4.1 Chimney and Flue Condition

SEVERELY DETERIORATED CROWN

The chimney crown should be replaced to prevent water damage to the chimney chase.

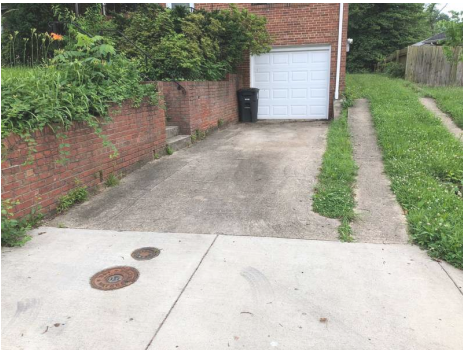
Driveway / Sidewalk / Patio: About Concrete

Concrete driveways and sidewalks can last 25-50 years depending on how well they were built and maintained. Sealing cracks and gaps in concrete will help to prevent premature deterioration caused by the freeze-thaw cycle. Tree roots and underground water leaks are common causes of premature deterioration.

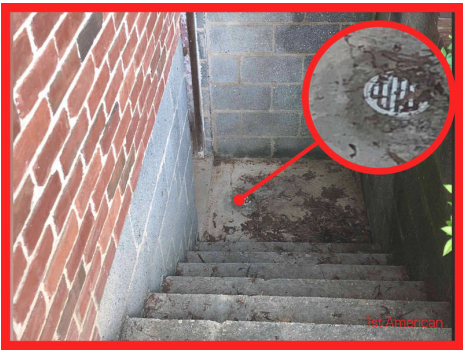
Steps / Porch / Deck: Drain In Stairway

There is a drain at the bottom of the exterior stairs to the basement. This drain must be kept clear at all times. Your inspector cannot be certain this drain is functioning properly absent a rain storm.

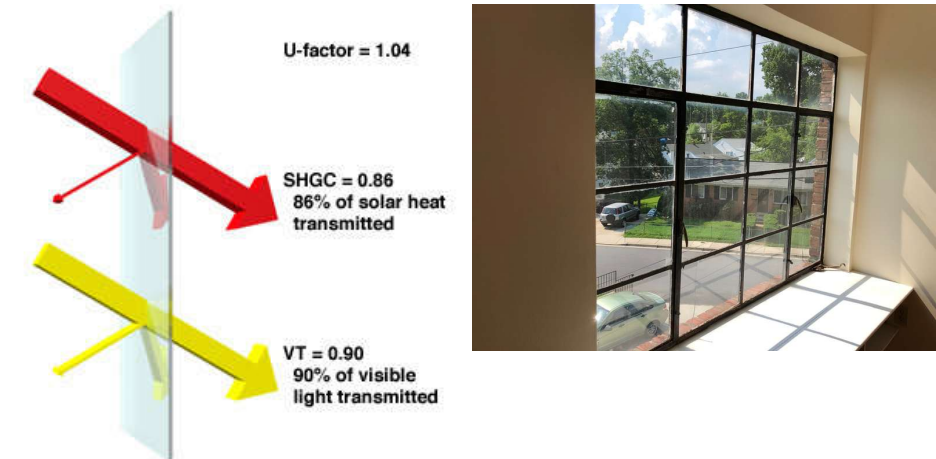
Relative to all other glazing options, single-glazed with clear glass allows the highest transfer of energy (i.e. heat loss or heat gain depending on local climate conditions) while permitting the highest daylight transmission. Remember that single pane windows will sweat due to condensation and require regular cleaning to prevent mold and mildew.

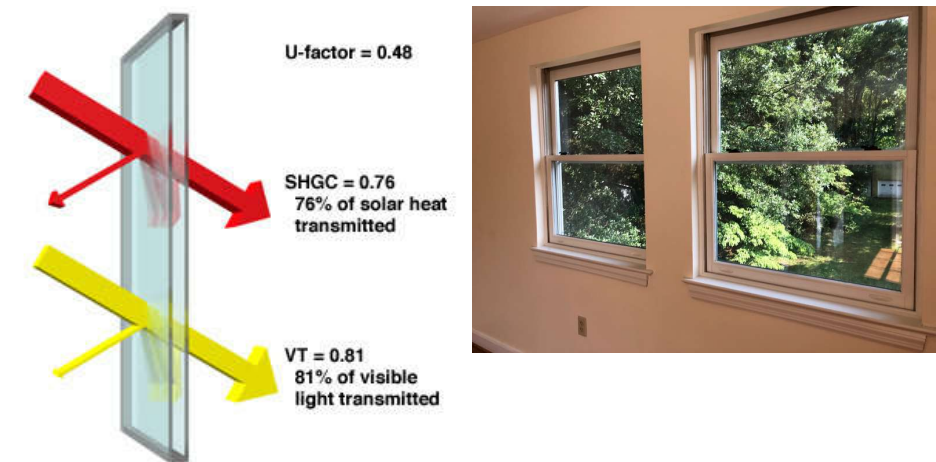
Doors / Windows: Double-Glazed

A typical clear, double-glazed unit has two lites of glass with the inner and outer layers of glass both being clear and separated by an air gap. Double glazing, compared to single glazing, cuts heat loss in half due to the insulating air space between the glass layers. In addition to reducing the heat flow, a double-glazed unit with clear glass will allow the transmission of high visible light and high solar heat gain.

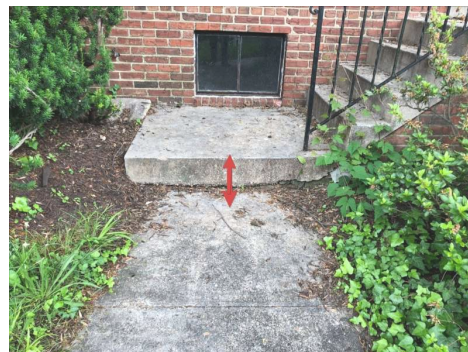
3.1.2 Driveway / Sidewalk / Patio

The walkway has settled leaving a step too high. This may be a trip/fall hazard and should be corrected.

Contact a qualified concrete contractor.

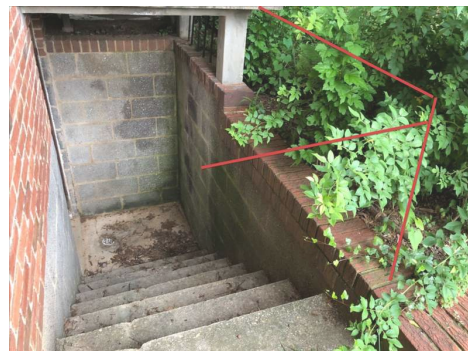
3.2.1 Steps / Porch / Deck

HANDRAIL MISSING

This stairway is missing a graspable handrail. Falls are more likely to happen on stairways and a handrail is needed for safe use.

Contact a qualified carpenter.

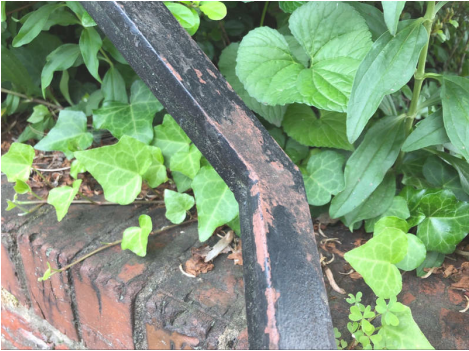
3.2.2 Steps / Porch / Deck

RAILING NEEDS PAINT

Handrails and guardrails need to be painted to prevent water damage or corrosion and more expensive repairs.

Recommendation
Contact a qualified painter.

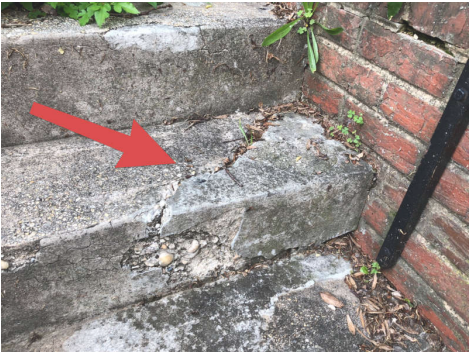
3.2.3 Steps / Porch / Deck

SEVERELY DETERIORATED
CONCRETE STAIRWAY

Portions of the concrete stairway are severely deteriorated. This condition may worsen and become unsafe if not corrected.

The cracked section of concrete is starting to come loose

Recommendation
Contact a qualified concrete contractor.

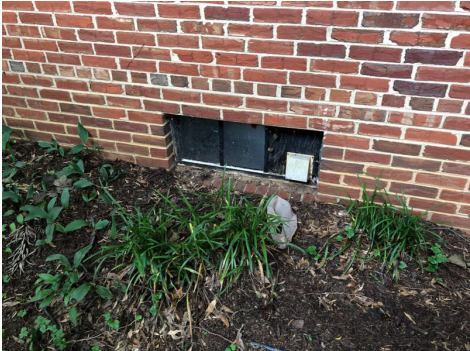
3.3.1 Doors / Windows

BROKEN GLASS IN WINDOW

There is broken glass in the window. This condition may worsen and cause personal injury if not corrected.

Recommendation
Contact a qualified window repair/installation contractor.

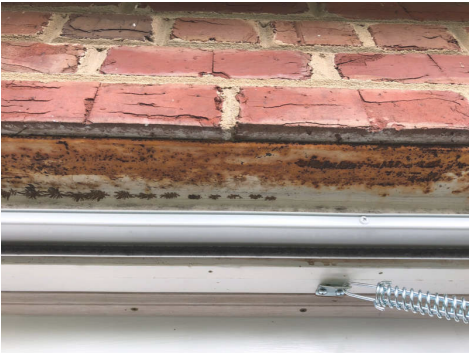
3.4.1 Siding / Trim / Flashing

GAPS AT PENETRATIONS

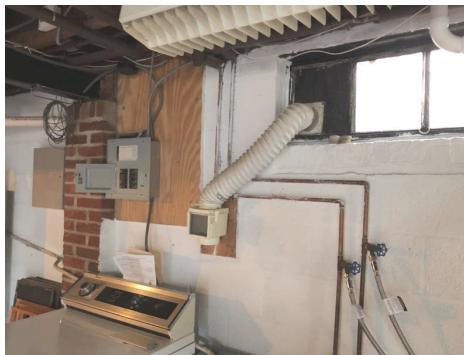
4.3.2 Ventilation / Exhaust Fans

KITCHEN VENTED BY WINDOWS ONLY

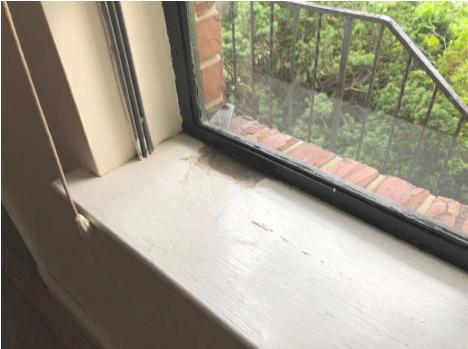
6.2.4 Windows / Doors / Closets

WINDOW PAINTED STUCK

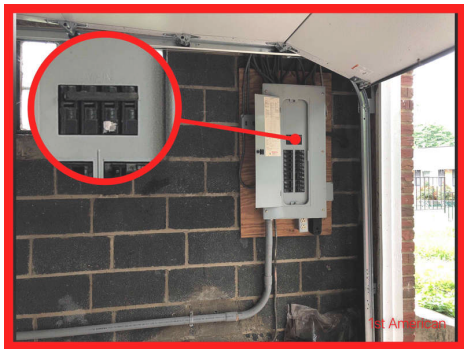
Service Panel / Main Disconnect: Main Disconnect / Panel in Garage

The main electrical shutoff (disconnect) is located in the garage. It is important to maintain easy access to the main service panel so that power can be turned off or back on in the event of an emergency. This is a very good place to keep a flashlight.

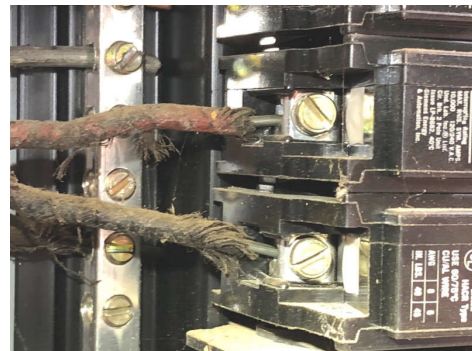
8.3.1 Service Panel / Main Disconnect

Single-strand aluminum wiring was observed in the main panel. Between approximately 1965 and 1973 aluminum wiring was sometimes substituted for copper branch circuit wiring in residential electrical systems. Neglected connections in outlets, switches and light fixtures containing aluminum wiring become increasingly dangerous as time passes. Poor connections cause wiring to overheat, creating a potential fire hazard. In addition to creating a potential fire hazard, the presence of aluminum wiring may have an effect on your insurance policy. You should ask your insurance agent whether the presence of aluminum wiring is a problem that requires changes to your policy language in order to ensure that your house is covered. Here are the reasons aluminum wiring connections deteriorate: Thermal expansion and contraction: Even more than copper, aluminum expands and contracts with changes in temperature. Over time, this will cause connections to loosen. When wires are poorly connected they overheat, which creates a potential fire hazard. Vibration: Electrical current vibrates as it passes through wiring. This vibration is more extreme in aluminum than it is in copper and as time passes, it can cause connections to loosen. Again, when wires are poorly connected they overheat, which creates a potential fire hazard. Oxidation: Exposure to oxygen in the air causes deterioration to the outer surface of wire. This process is called oxidation. Aluminum wire is more easily oxidized than copper wire and as time passes, this process can cause problems with connections. Again, when wires are poorly connected they overheat, which creates a potential fire hazard. Galvanic corrosion: When two different kinds of metal are connected to each other a very low-voltage electrical current is created which causes corrosion. Corrosion causes poor connections. More information is available at this comprehensive website. <http://www.inspect-ni.com/aluminum/aluminum.htm> Options for Correction The wiring should be evaluated by a qualified electrician. This means an electrician experienced in evaluating and correcting aluminum wiring problems. Not all electrical contractors qualify.

1. At a minimum, all connections should be checked and an anti-oxidant paste applied as needed.
2. Aluminum wire can be spliced to copper wire at the connections using approved wire nuts (called "pigtail", not recommended by the US Consumer Product Safety Commission.)
3. Copalum crimps can be installed. Although this is the safest option, Copalum Crimps are expensive.
4. AlumiConn Connector.
5. Complete home re-wire. Costs will vary. Consult with a qualified electrical contractor.

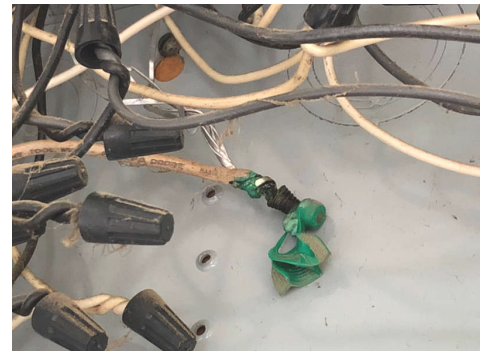
8.4.1 Wiring / Grounding / Junction Boxes

OPEN JUNCTION BOXES

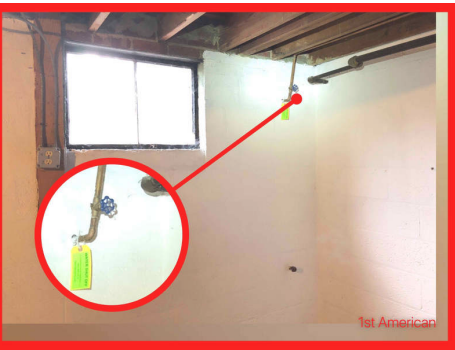
Water Supply Piping / Shutoff: Water service in garage

The main water service enters the garage. The garage is typically an unheated, unconditioned space. If the pipes are allowed to freeze they will burst and flood the area.
