RESIDENTIAL REPORT

1234 Main St.
Mountain Grove MO 65711

Buyer Name
01/06/2019 9:00AM

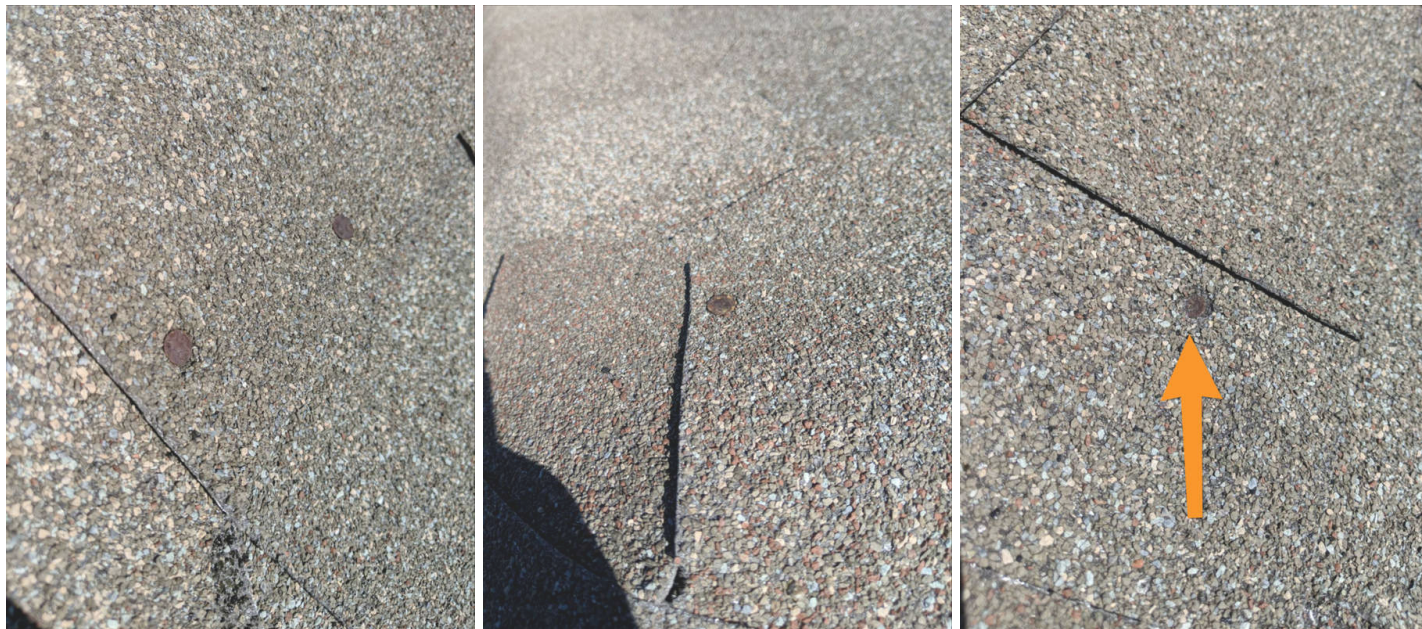
2.1.1 Coverings

EXPOSED NAILS

Under-driven or exposed nails were found in one or more roof coverings. Recommend a qualified roofer evaluate and correct.

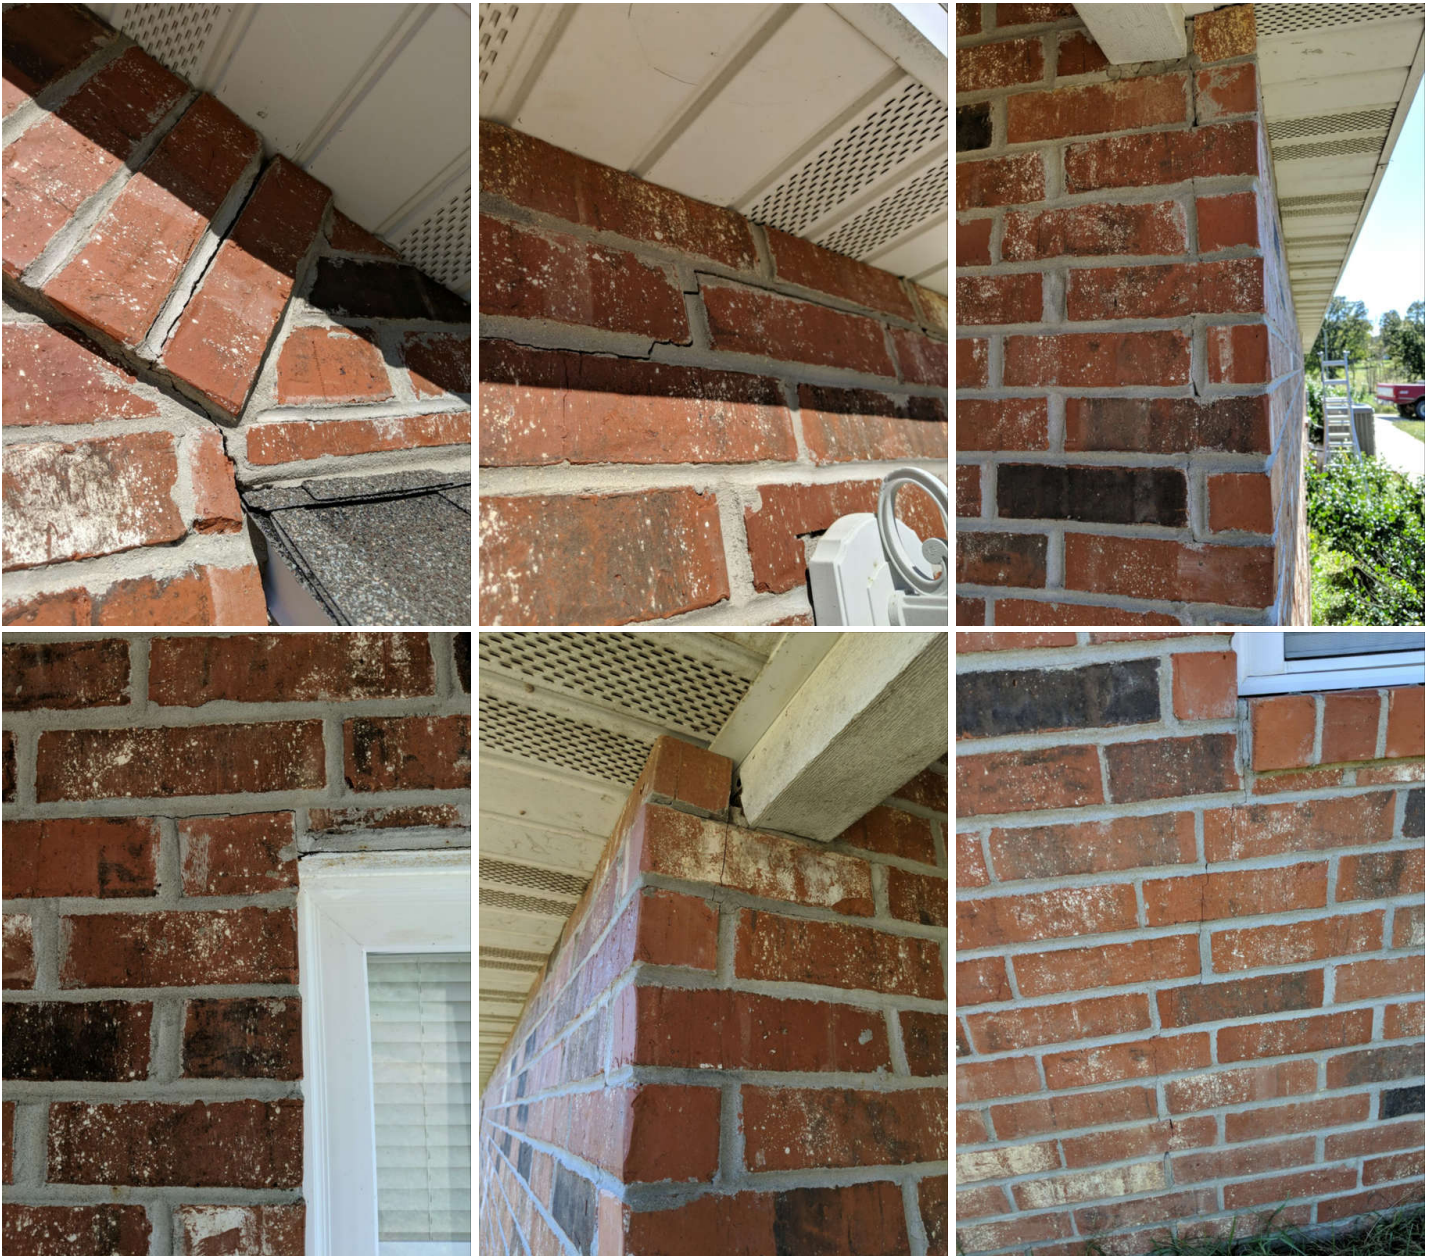
3.1.1 Siding, Flashing & Trim

CRACKING - MINOR

Siding showed cracking in one or more places. This is a result of temperature changes, and typical as homes with brick age. Recommend sealing to prevent water intrusion and further monitoring.

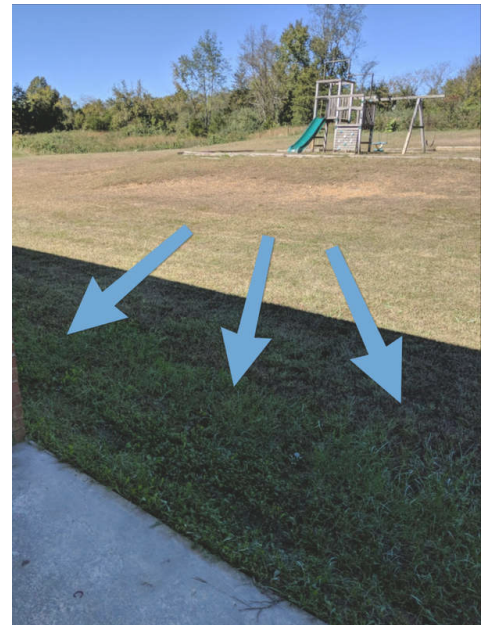
3.5.1 Vegetation, Grading, Drainage & Retaining Walls

NEGATIVE GRADING

Grading is sloping towards the home in some areas. This could lead to water intrusion and foundation issues. Recommend qualified landscaper or foundation contractor regrade so water flows away from home.

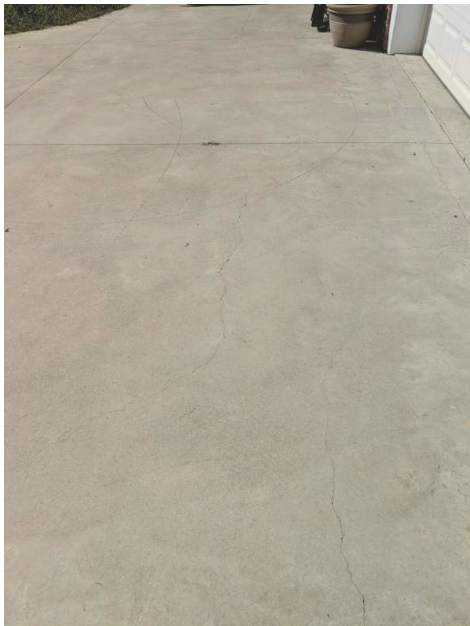
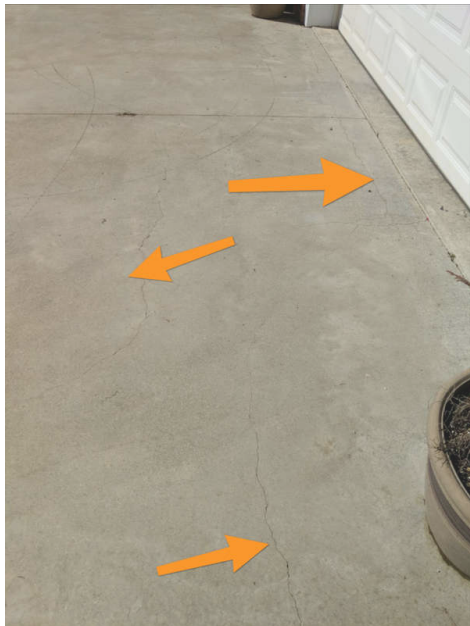
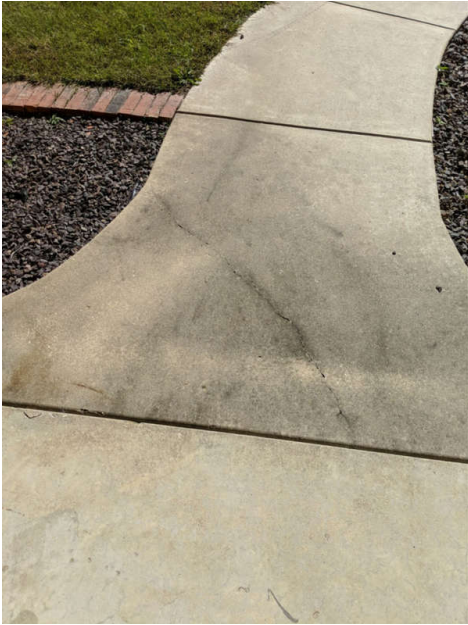
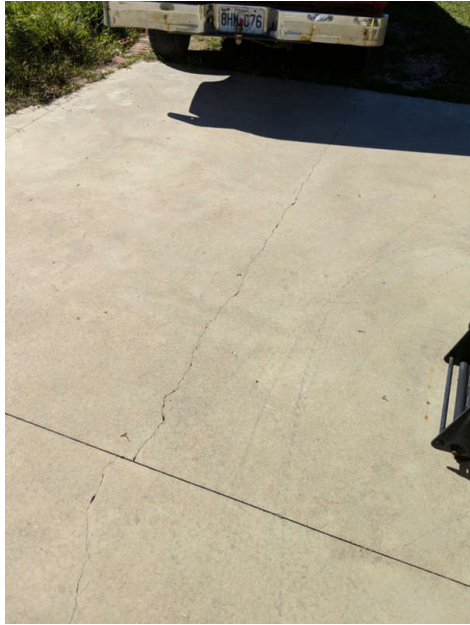
3.6.1 Walkways, Patios & Driveways

DRIVEWAY CRACKING - MINOR

Minor cosmetic cracks observed, which may indicate movement in the soil. Recommend monitor and/or have driveway contractor patch/seal.

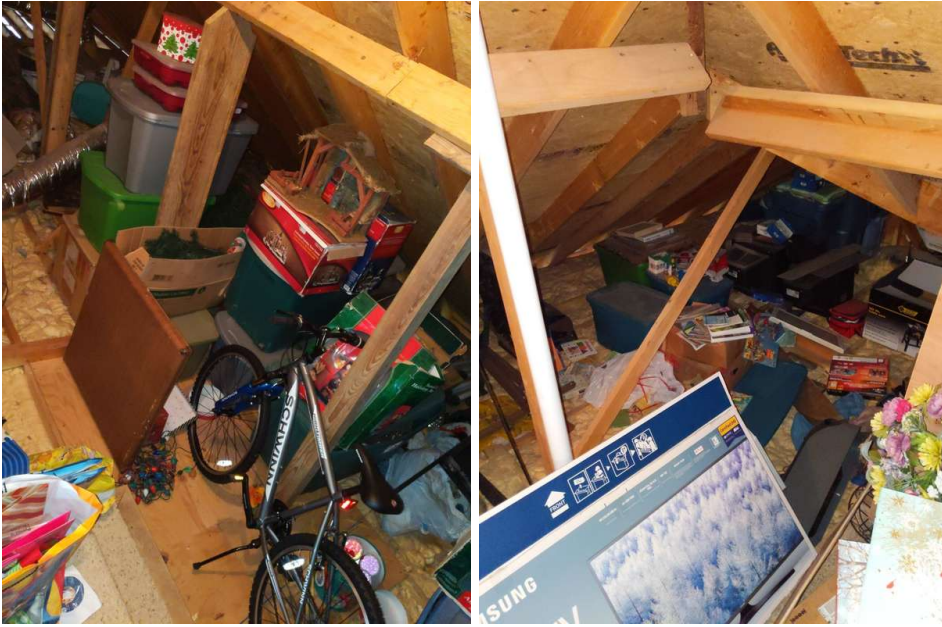
Attic Insulation

PARTIALLY OBSCURED VIEW

Some areas of the Attic were partially obscured from viewing/observation.

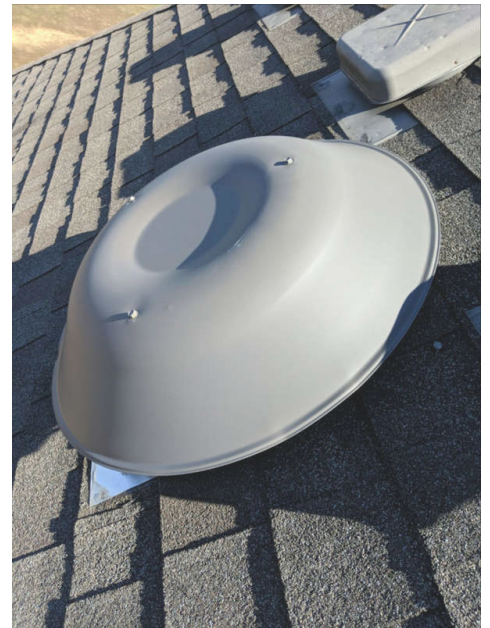
5.3.1 Ventilation

ATTIC FAN INOPERABLE

Attic fan was observed on the roof but interior portion and controls were in a part of the Attic that appears inaccessible. Recommend consulting current owner for further information

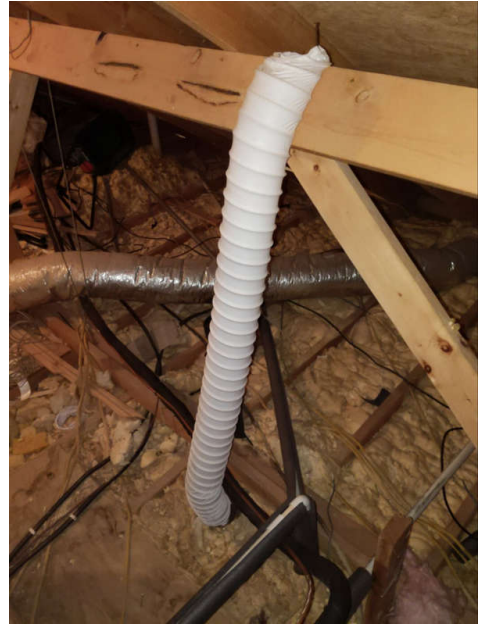
5.4.1 Exhaust Systems

BATHROOM VENTS INTO ATTIC

Bathroom fan vents into the attic, which can cause moisture and mold. Recommend a qualified attic contractor properly install exhaust fan to terminate to the exterior.

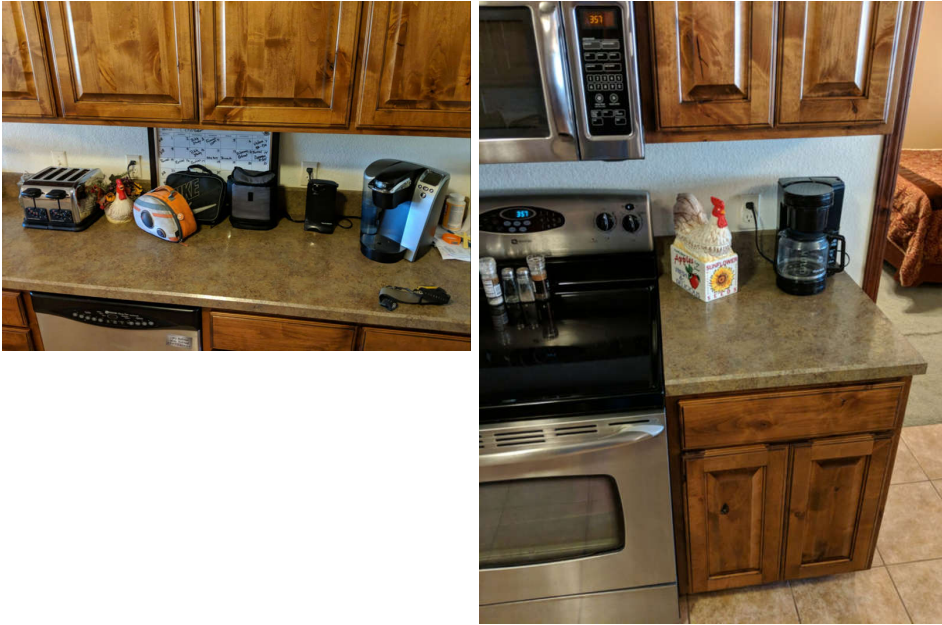
6.6.1 GFCI & AFCI

NO GFCI PROTECTION INSTALLED

KITCHEN

No GFCI protection present in one or more locations. Recommend licensed electrician upgrade by installing ground fault receptacles in all locations.

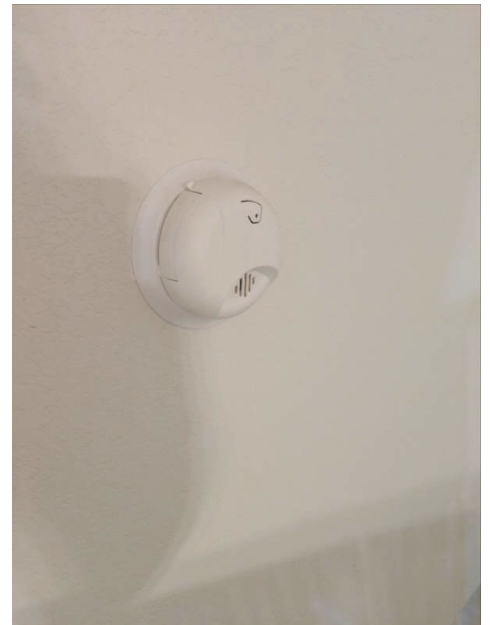
6.7.1 Smoke Detectors

DEFECTIVE

2ND FLOOR NORTHEAST

Smoke detector is connected, but not functioning properly. Recommend replacement.

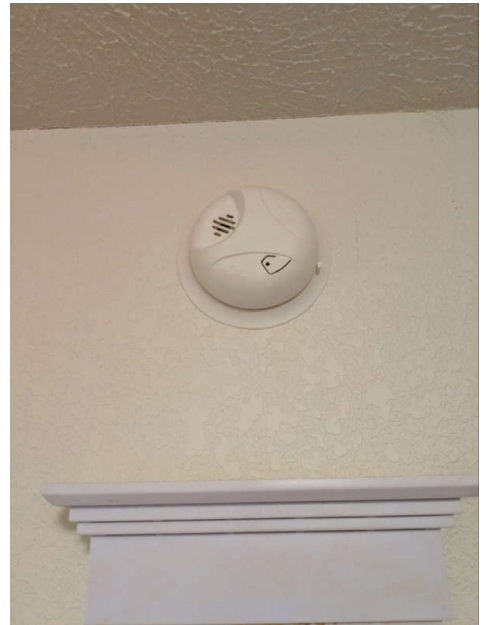
6.7.2 Smoke Detectors

LOW BATTERY

1ST FLOOR EAST

Smoke detector failed to respond when tested. Recommend battery be replaced.

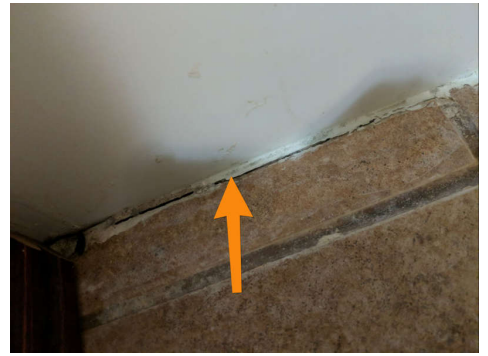
8.1.1 Fixtures / Faucets

FAILED CAULKING AROUND TUB/SHOWER

1ST FLOOR BATHROOM

One or more sections of failed caulking observed around tub/shower. Recommend repairing to keep any water intrusion from happening.

Contact a qualified professional.

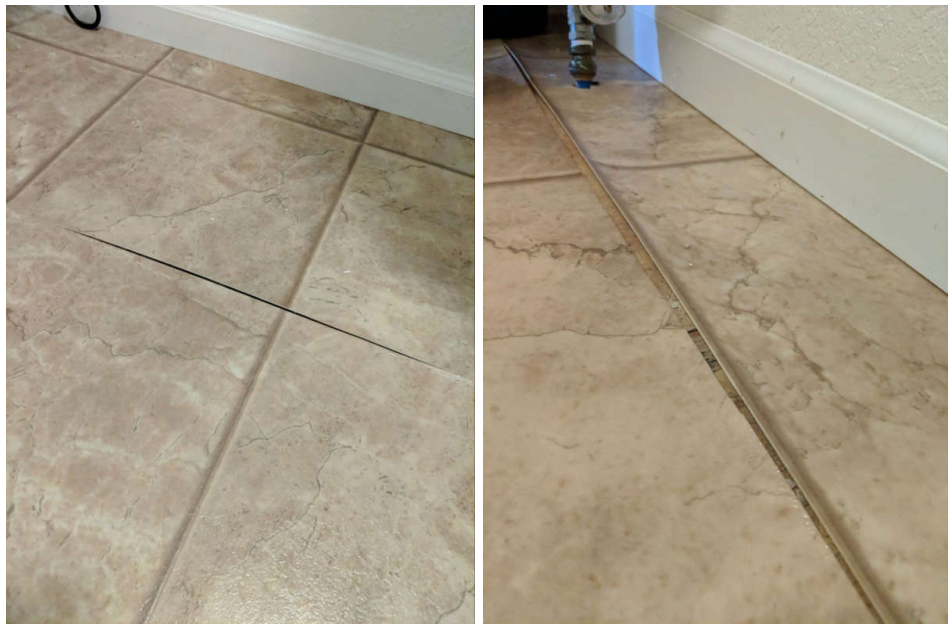
10.3.1 Floors

LINOLEUM LOOSE/PEELING

2ND FLOOR BATHROOM

One or more sections of linoleum coming loose from floor

Contact a qualified professional.

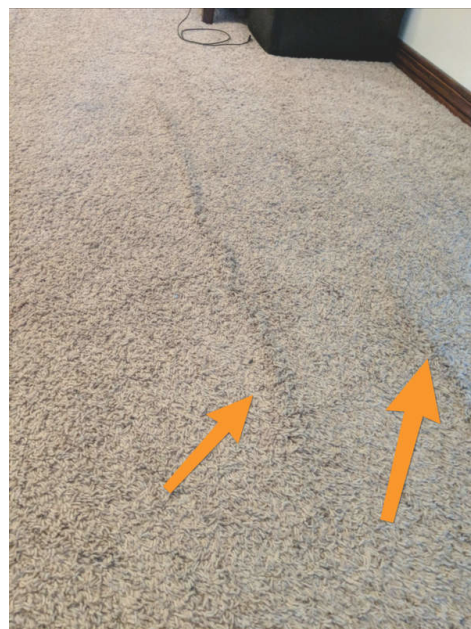
10.3.2 Floors

LOOSE CARPET

Carpet showed signs wear. Recommend flooring professional evaluate for possible restretching or replacing

Contact a qualified professional.

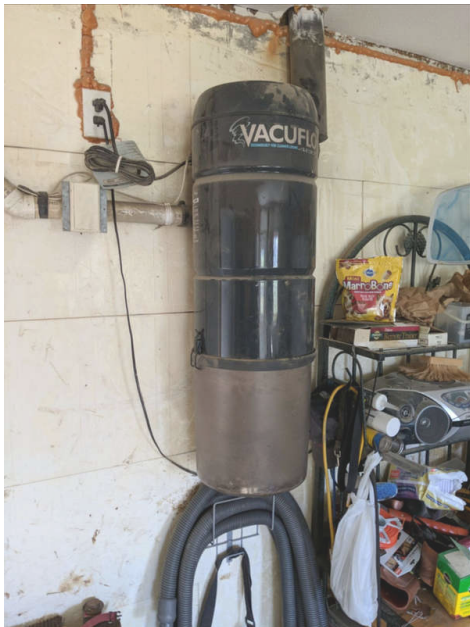
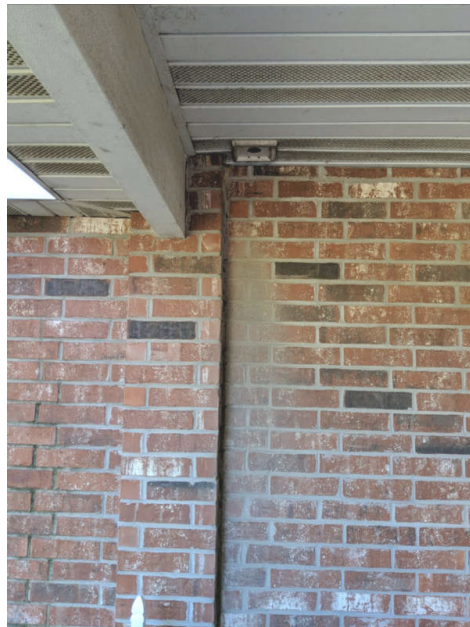
10.10.1 Whole House Vacuum

VACUUM INOPERABLE

Whole house vacuum did not operate at time of inspection. Recommend further evaluation by a qualified professional.

Contact a qualified professional.
