PROPERTY INSPECTION REPORT

1234 Main St.
Windham, NH 03087

06/13/2019 9:00AM

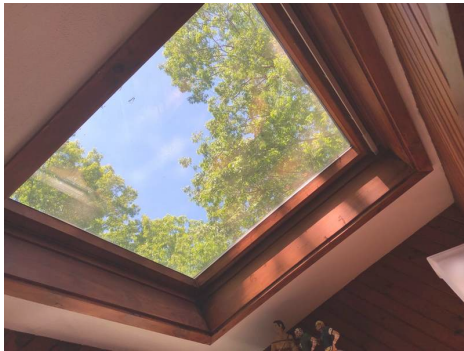
Skylights Present

This roof has skylights. Skylights are notoriously problematic and a common point for water leaks. These skylights appear to be in satisfactory condition, however leaking may occur under certain circumstances not present at time of inspection. It will be important to keep the area around the skylights free from debris and to monitor them for evidence of leaks during heavy rains and winter snow melts.

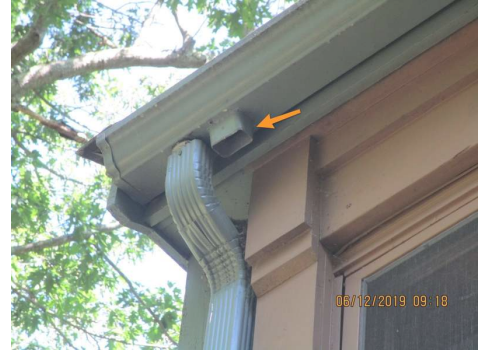
Gutter to downspout connection

CONNECTION DEFECTIVE

Unable to determine if connection from gutter to downspout has been relocated intentionally or shifted out of place. Recommend evaluating the system for proper water drainage. Repair as necessary.

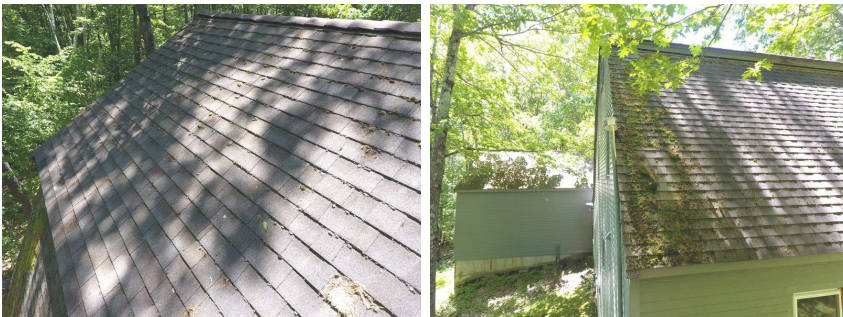
ROOF-MOSS OBSERVED

Moss observed on roof covering. This can lead to premature failure of the roof covering and subsequent leaks. Recommend treating moss during its growing season (wet months) with a moss killer.

Contact a qualified professional.

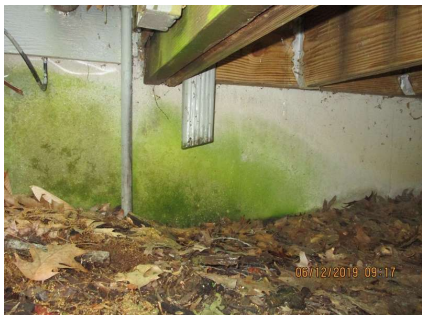
One or more downspouts drain too close to the home's foundation. This can result in excessive moisture in the soil at the foundation, which can lead to foundation/structural movement. Recommend a qualified contractor adjust downspout extensions to drain at least 6 feet from the foundation.

Downspout extension needed

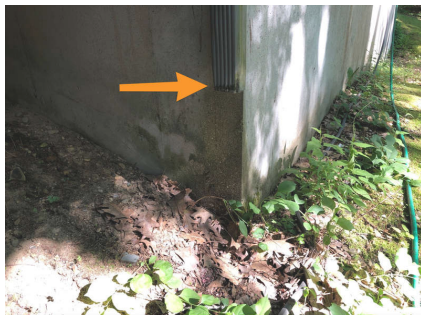
Downspout extension needed

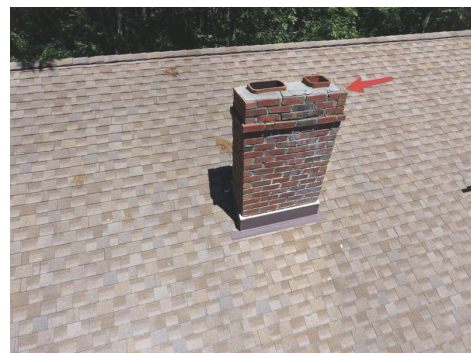
Chimney crown. Cracked mortar

CHIMNEY-MISSING RAIN CAP/SPARK ARRESTOR

Spark arrestor and rain cap missing from masonry chimney. Mortar cracked on chimney crown.

Contact a qualified roofing professional.

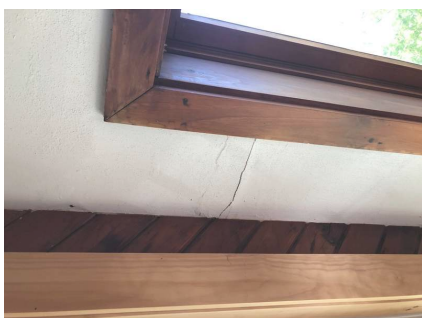
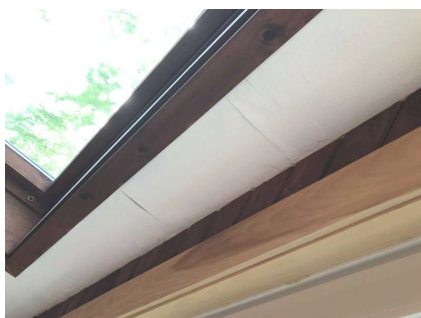
2.5.2 Roof Penetrations

There are signs of prior water intrusion at or near the skylight. Skylights, if not properly installed, are prone to leaking. Monitor the condition and if there is sign of leak then have the skylight repaired or replaced.

Proper flashing around the skylight is critical.

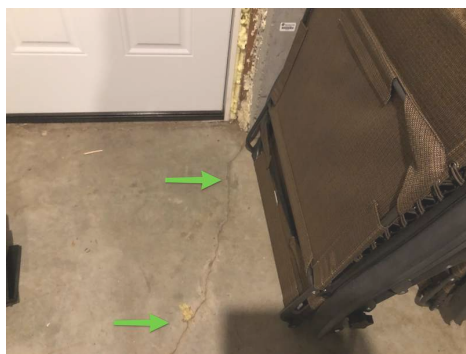
Concrete, Shrinkage Cracks

Shrinkage cracks

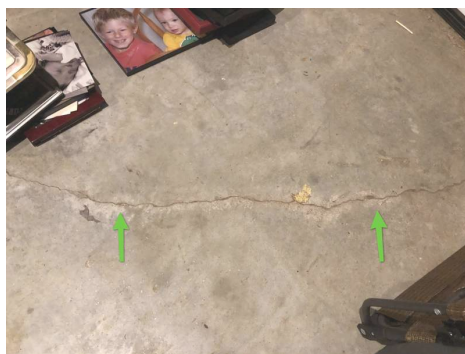
Cracks. Shrinkage

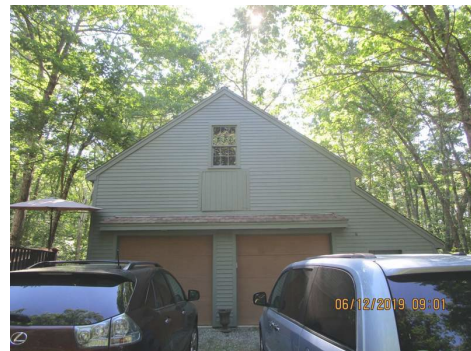
EXTERIOR BUILDING NOT INSPECTED

Exterior detached garage and workshop/barn observed on property. Detached buildings, excluding those agreed upon by client and inspector, are not included in a general home inspection.

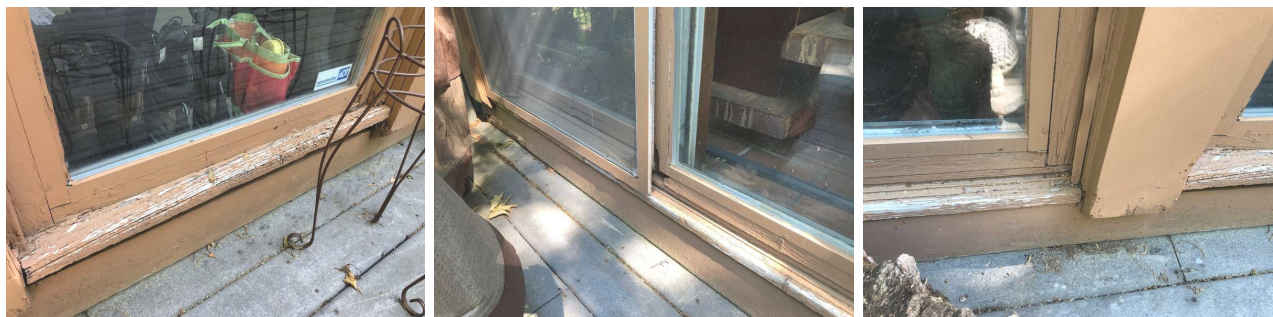
One or more areas of worn paint were observed around doors and windows along the exterior. Recommend sealing and protecting wood by painting, as necessary. This will prolong the life of the trim and maintain a seal to prevent moisture intrusion and dry rot.

Contact a handyman or DIY project

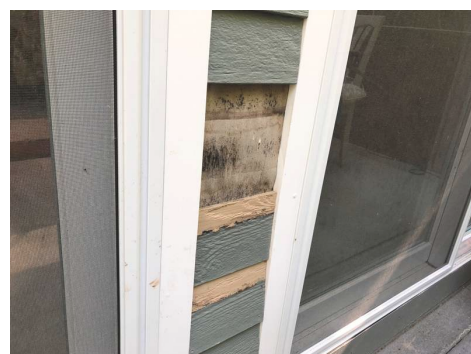
4.1.2 Siding, Flashing & Trim

SIDING MISSING

One or more areas were observed missing pieces of siding. This can lead to insect or pest infestations if not repaired and/or sealed. Recommend siding contractor installing siding/trim to keep pests and insects out of home.

Contact a qualified professional.

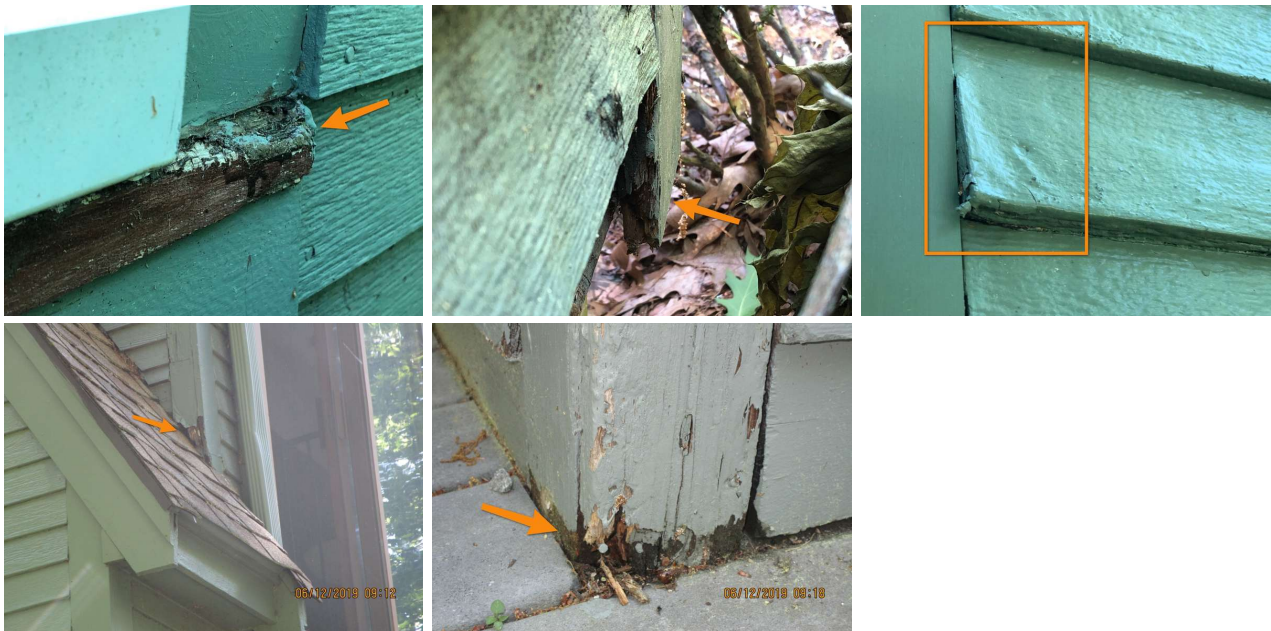
4.1.3 Siding, Flashing & Trim

SIDING AND TRIM-WOOD ROT

Wood rot observed on several areas of trim and siding. Some areas may require replacement due to excessive water damage.

Contact a qualified professional.

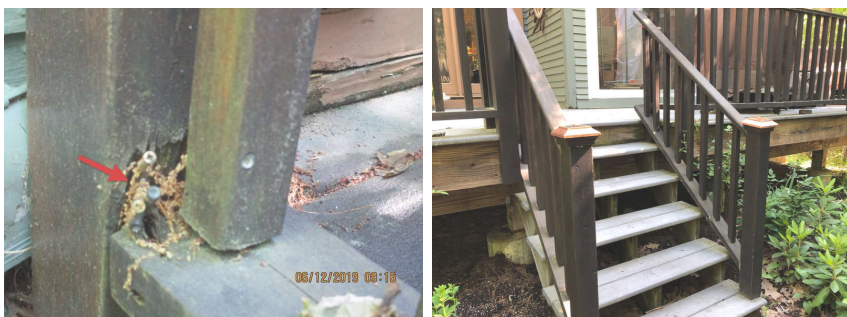
4.4.1 Decks & Porches

RAILING-LOOSE

Railing and handrail observed to be loose. Recommend replacing or tightening to withstand at least 200 lb of force.

Railing damaged and loose.

Handrail loose.

Contact a handyman or DIY project

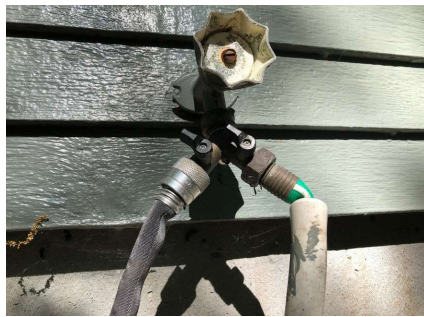
East hose bib

Maintenance Tip: Due to the inclement weather in our region, exterior hose bibs may freeze during winter months. This may cause the pipes to crack or split due to the extreme cold. Recommend upgrading existing bibs to frost-free hose bibs with anti-siphon valves.

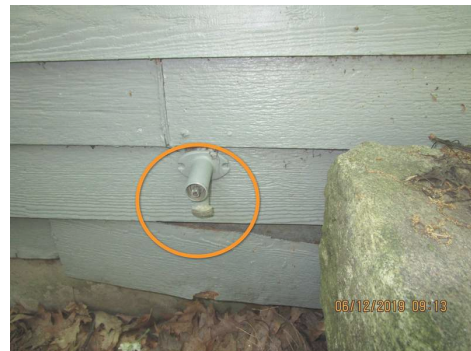
HOSE BIB-HANDLE MISSING

Handle/valve missing on hose bib. Recommend replacement.

Missing handle/valve

Contact a qualified plumbing contractor.

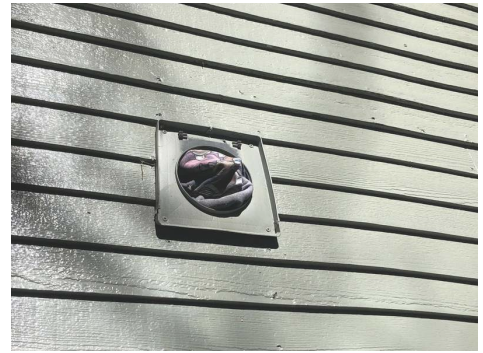
Dryer vent no longer in use and stuffed with a rag. This is not an acceptable method of sealing the opening. Recommend properly removing exhaust vent and closing the opening to prevent unwanted pests and insects from entering the home.

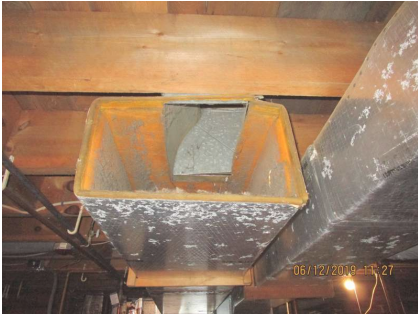
DUCT DAMAGED

Air supply duct was damaged. Recommend a qualified HVAC contractor repair.

Missing end cap. Return air entering system from unconditioned basement

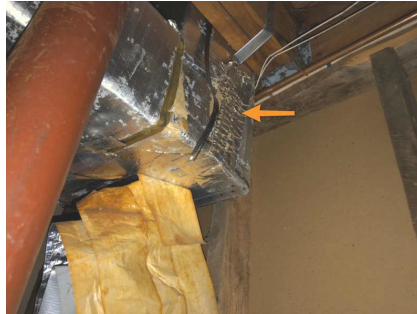
Insulation loose and falling off distribution ducts.

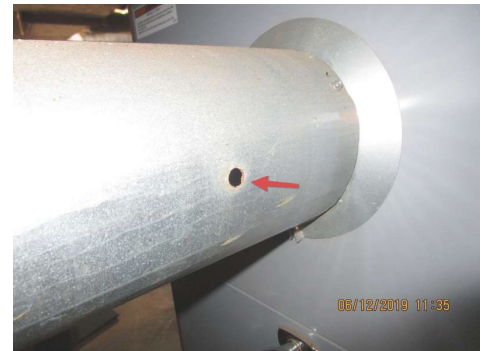
6.4.1 Vents, Flues & Chimneys

FLUE VENT DAMAGED-HOLE

Flue vent damaged. Observed a hole in vent pipe. Recommend HVAC specialist replace the vent pipe to ensure no gases are being released into the home. Safety hazard.

hole in flue vent pipe

Contact a qualified professional.

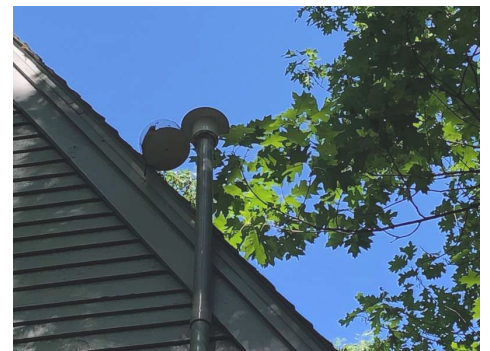
6.4.2 Vents, Flues & Chimneys

VENT CAP DAMAGED

Vent cap damaged. Vent pipe (possibly radon water system) discharges above the roof system. Cap is partially disconnected and hanging from pipe.

Contact a qualified professional.

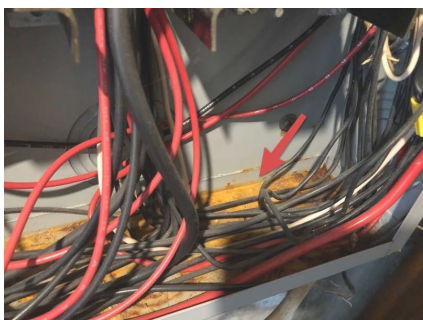
CORROSION/RUST OBSERVED

Rust and/or corrosion observed inside electrical panel. This indicates high moisture levels. Recommend licensed electrician evaluate further and replace, if necessary.

Rust inside distribution panel

Contact a qualified electrical contractor.

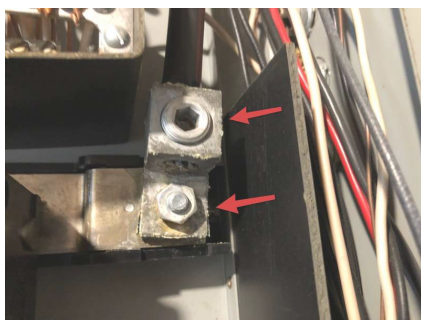
Corrosion on service entrance lug/bolt

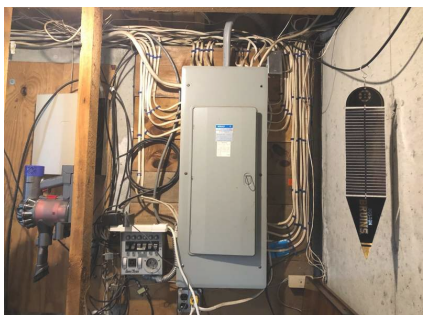
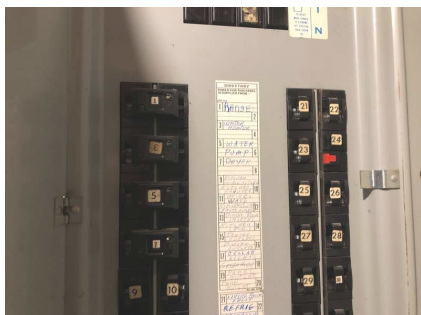
7.2.2 Main & Subpanels, Service & Grounding, Main Overcurrent Device

Observed ITE (Seimens) Push-Matic Electri-Center Panel in home. Push-matic electrical panels have had issues with failing to "trip" or failing to indicate proper status. Although this system has not been recalled, it is no longer used in homes and obtaining replacement parts may be difficult. Recommend consulting with in electrician for full evaluation of system and possible upgrade. This is only a recommendation and not to be confused with a safety issue or hazardous panel.

Contact a qualified electrical contractor.

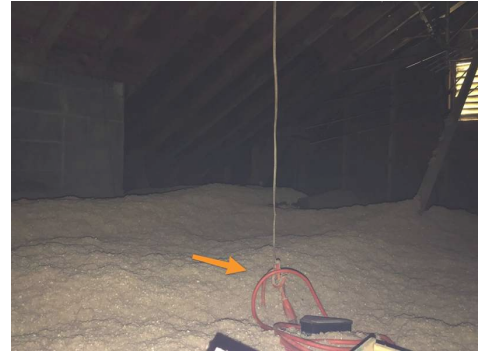
7.4.1 Lighting Fixtures, Switches & Receptacles

Observed extension cord observed in attic. Extension cords and other temporary wiring should never be used for permanent installation. Recommend licensed electrician remove temporary wiring. Safety and fire hazard.

Extension cord connecting clip on lamp

Contact a qualified professional.

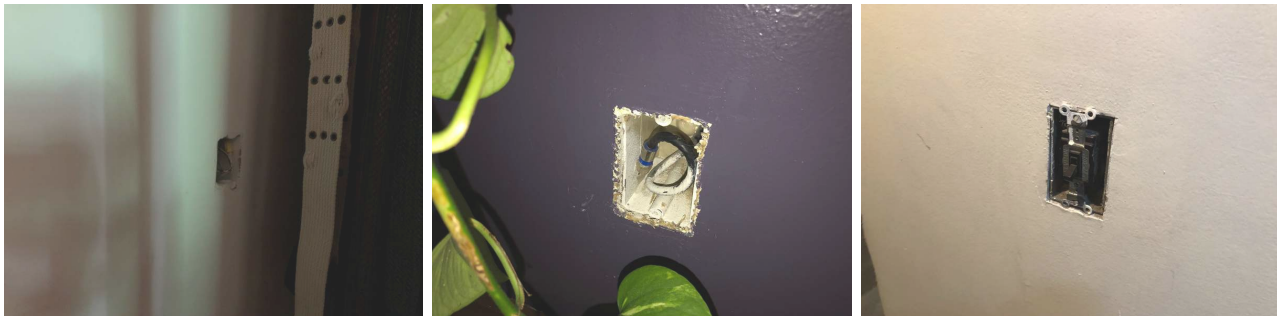
7.4.2 Lighting Fixtures, Switches & Receptacles

COVER PLATES MISSING

One or more receptacles are missing a cover plate.

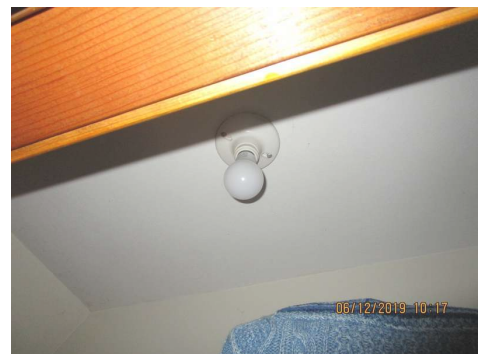
7.4.3 Lighting Fixtures, Switches & Receptacles

IMPROPER FIXTURE IN CLOSET

One or more improper lighting fixtures were observed inside closets. Incandescent light bulbs should be fully encased if located inside closets. Recommend upgrading light fixtures to surface mounted or recessed lighting.

Improper and no switch located during inspection to activate fixture

Contact a qualified electrical contractor.

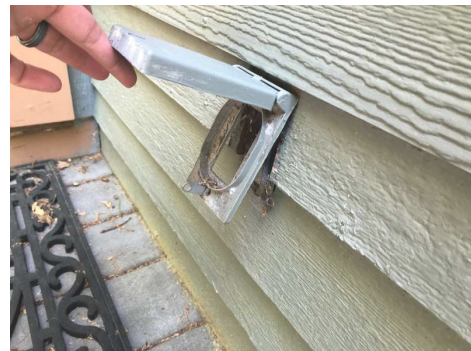
7.4.4 Lighting Fixtures, Switches & Receptacles

LOOSE RECEPTACLE-EXTERIOR

Exterior receptacle loose and pulling away from siding. This receptacle was not tested.

Contact a qualified electrical contractor.

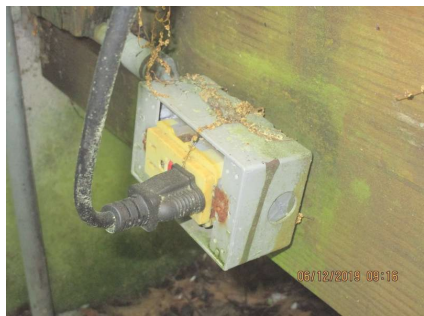
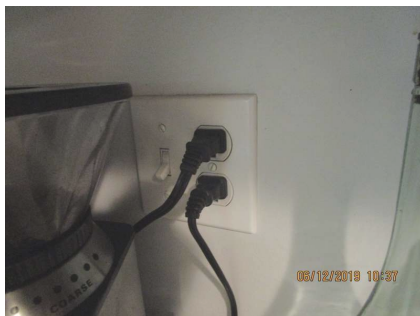
7.5.1 GFCI & AFCI

GFCI UPGRADE RECOMMENDED

GFCI receptacles are now standard in all wet/damp locations, including kitchen, laundry, bathrooms, garage, exterior, basements, pool/spa areas, and any other locations prone water or high moisture levels. This home was built prior to many of these requirements and therefore, should be updated to bring it up to today's standards.

GFCI not protected with weather-proof cover. Not tested.

I strongly recommend installing/upgrading all required receptacles to GFCI for safety.

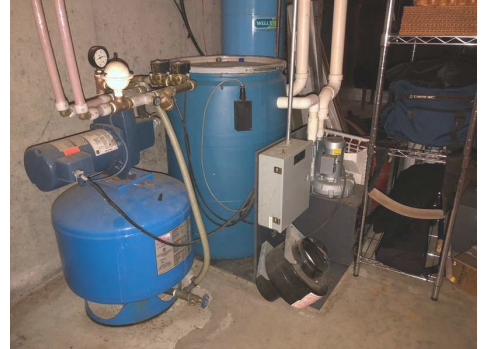
This home is equipped with a radon water filtration system called AeroSparge 2000. [Here is a link to the product](#) for further information.

Radon water filtration system-
AeroSparge 2000

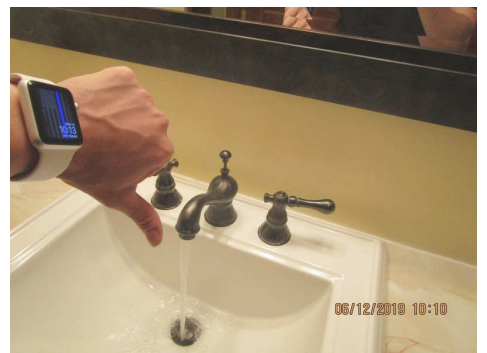
One or more sink drain stops were inoperable. Recommend repair/replacement of stoppers.

Drain stop inoperable

Contact a handyman or DIY project

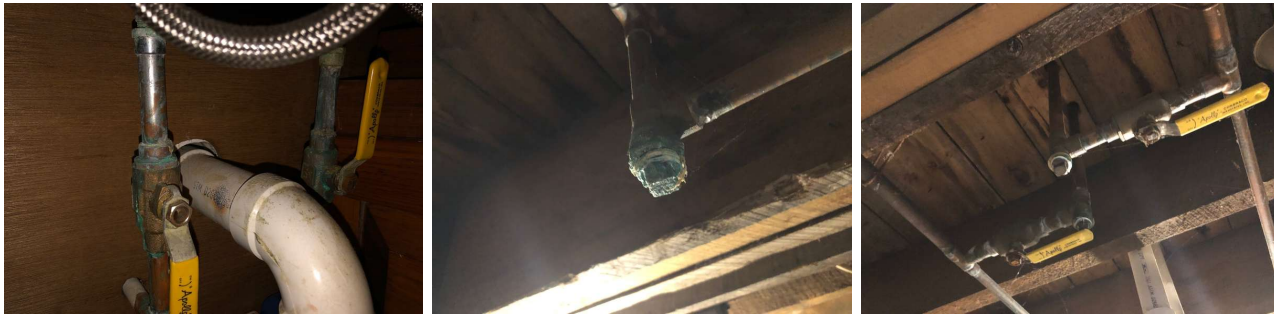
8.3.2 Water Supply, Distribution Systems & Fixtures

PIPES-CORROSION

Corrosion observed on one or more pipes in the plumbing system.

Contact a qualified professional.

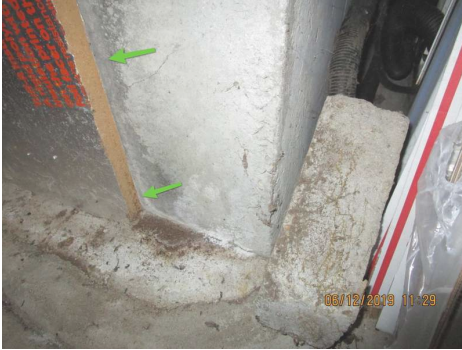
Evidence of pest infestation observed in attic and basement. Mouse traps/bait stations were observed, along with nesting material, droppings and pathway debris. Recommend pest control technician evaluate and exterminate

Rodents using insulated panels as a pathway to floor system above. Debris left behind.

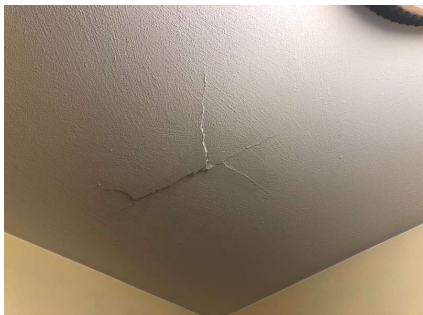
Observed one or more areas in the ceiling structure that had visible damage.

Crack in hallway. 2nd Floor

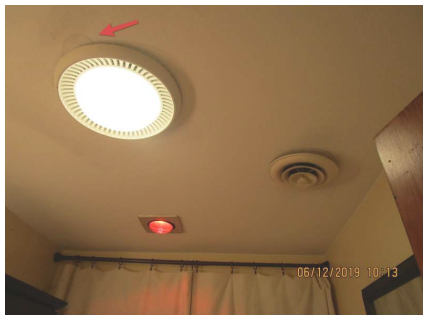
Stain observed in bathroom. 2nd Floor

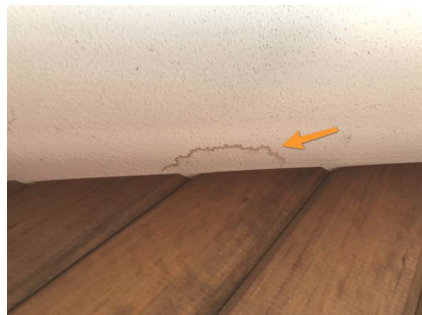
Stain. Sunroom

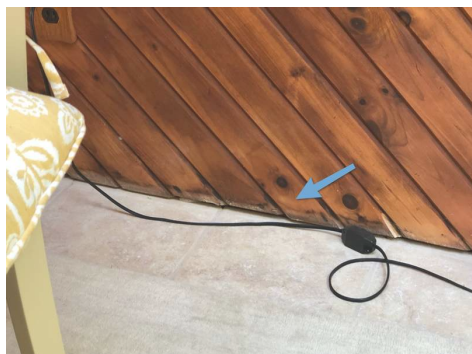
9.2.1 Walls

Stains on the walls visible at the time of the inspection appeared to be the result of moisture intrusion. The source of moisture may have been corrected. Recommend further examination by a qualified contractor to provide confirmation.

Floor to wall connection. Sunroom

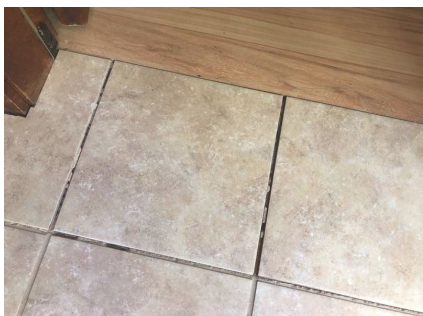
Laminate floor showed signs of water intrusion.
Floor around sliding doors have gaps from basement to 1st floor.
Grout missing around several tiles. Tiles loose.

Grout missing. Tile loose

Recommendation
Contact a qualified professional.

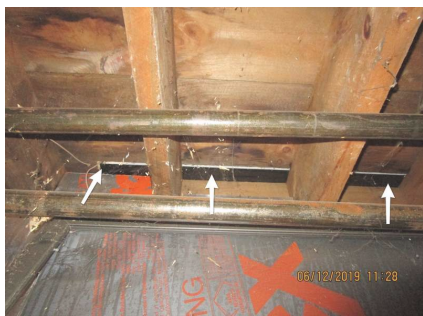
Sliding door. Basement view

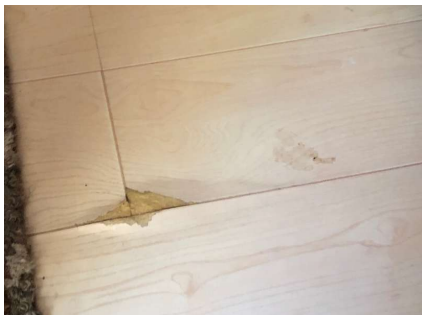
Dining Room. Floor damaged.

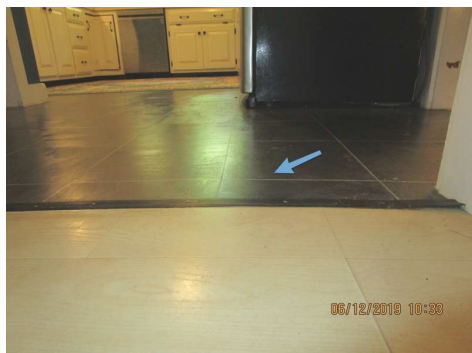
9.3.2 Floors

FLOORS UNEVEN

Observed slight bow to floors in kitchen and living room. This is directly above the main support beam connections located in the basement.

Floor uneven.

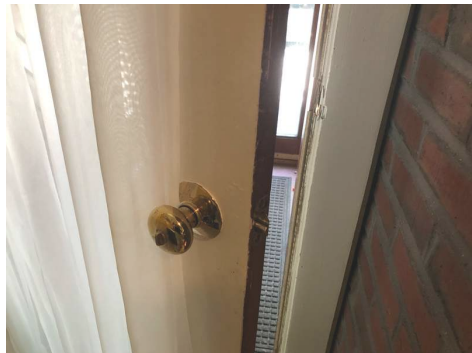
9.5.1 Doors

DOOR DOESN'T LATCH

One or more interior doors do not latch properly. Recommend handyman repair latch and/or strike plate.

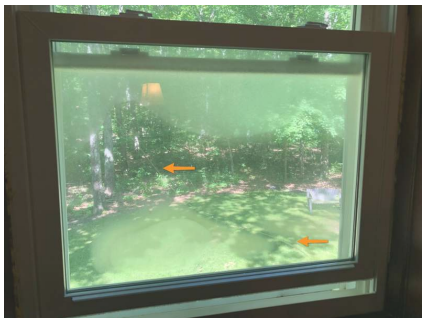
Observed condensation between the window panes, which indicates a failed seal. Recommend qualified window contractor evaluate & replace.

Window cracked through bottom inside pane.

Crack in window. Failed seal

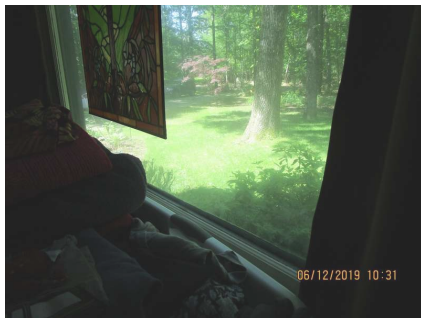
Failed Seal. Living Room

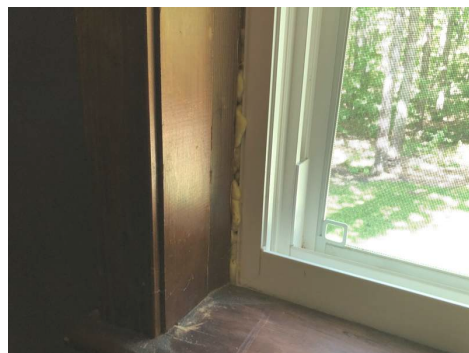
9.6.2 Windows

WINDOW-FOAM INSULATION

Foam insulation observed around windows. Possibly due to gaps (energy loss) between original frame work and new window installation. Monitor these areas during heavy rains to ensure a proper seal around trim.

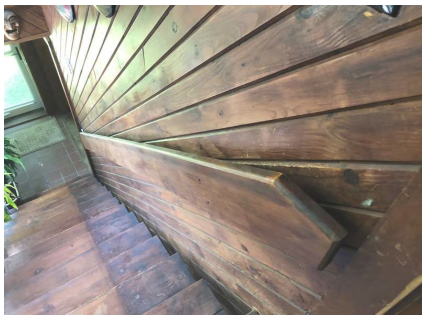
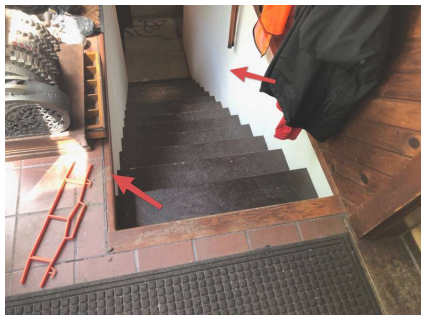
9.7.1 Steps, Stairways & Railings

Missing railings and graspable handrails.

Contact a handyman or DIY project

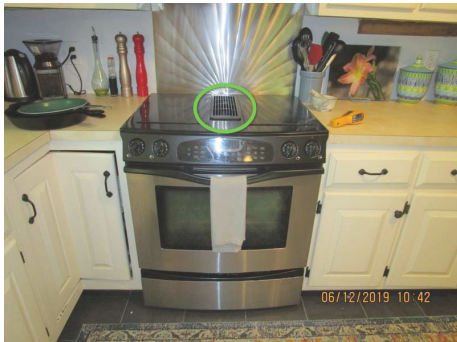
Downdraft ventilation is built-in to the electric range.

Downdraft Range

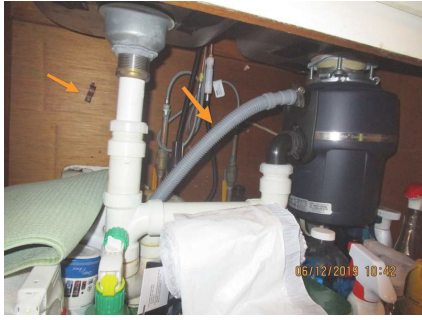
10.1.1 Dishwasher

High-loop not observed

Contact a qualified plumbing contractor.
