HICKORY PROPERTY SERVICES LLC INSPECTION REPORT

1234 Main St.
Steamboat Springs CO 80487

Buyer Name
01/10/2019 9:00AM

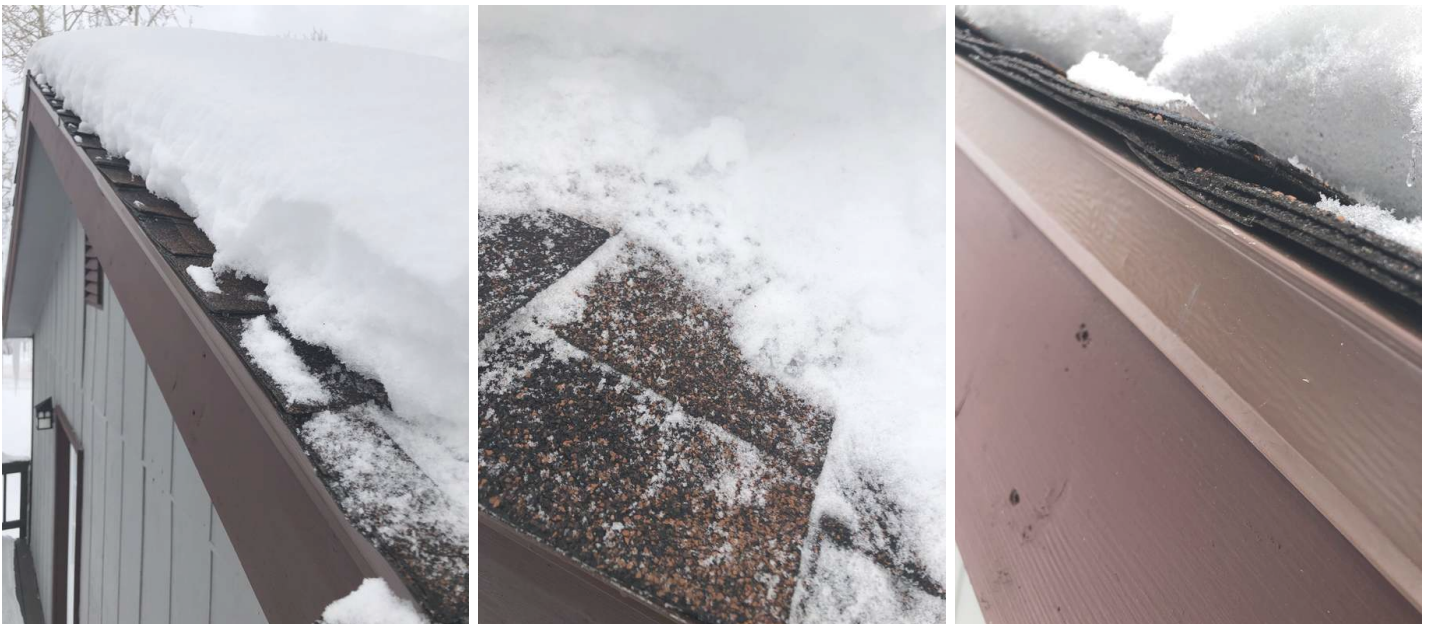
LIMITED ACCESS TO TO SNOW

The roof is covered with about a foot of snow at the time of the inspection. I was able to push away some of the snow on the edges to get a look at the roof. It appears the roof had this been recently installed and is in good condition.

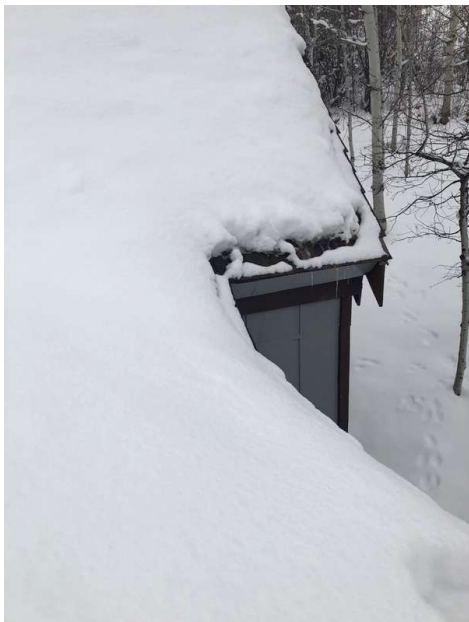
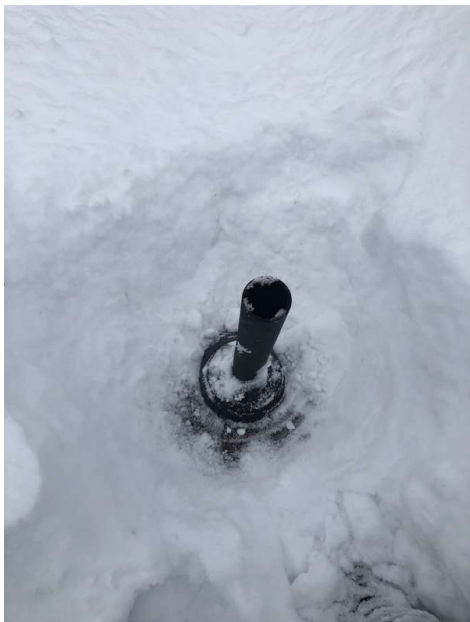
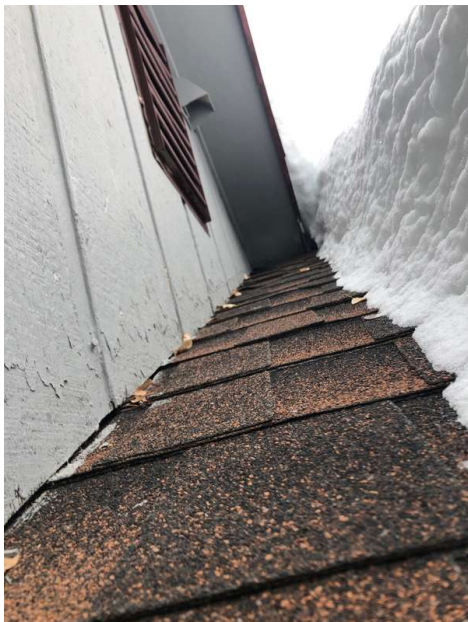
2.1.1 Coverings

Ice dams have formed on the West and East side of the roof. An ice dam is a ridge of ice that forms at the edge of a roof and prevents melting snow from draining. As water backs up behind the dam, it can leak through the roof and cause damage to walls, ceilings, insulation and other areas. Ice dams are formed by an interaction between snow cover, outside temperatures, and heat lost through the roof. Specifically, there must be snow on the roof, warm portions of the upper roof (warmer than 32 F), and cold portions of the lower roof (at freezing or below). Melted snow from the warmer areas will refreeze when it flows down to the colder portions, forming an ice dam. To prevent the ice dams from forming, there are various approaches to take such as adding insulation in the attic, seal air leaks at plumbing pipes & electrical penetrations in attic and adding vents. Recommend a qualified roofing contractor evaluate to determine the best approach to take to prevent this from occurring each winter.

Contact a qualified roofing professional.

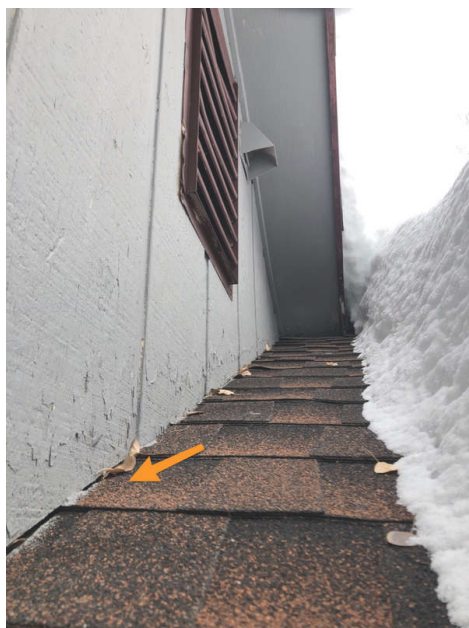
2.3.1 Flashings

STEP FLASHING MISSING

Step flashing is not installed at the sidewalls and chimney chase; instead just the underlayment is installed. Anywhere roof sections adjoin wall sections, step flashing should be used to keep water from entering the walls. The step flashing should be extended at least 4 inches up the wall from the roof deck and at least 4 inches out along the roof deck (2015 International Residential Code [IRC]) with the house siding installed over the step flashing, ending at least 1 inch above the roof surface. Recommend a qualified roofing contractor install step flashing to prevent water damage to the structure.

Contact a qualified roofing professional.

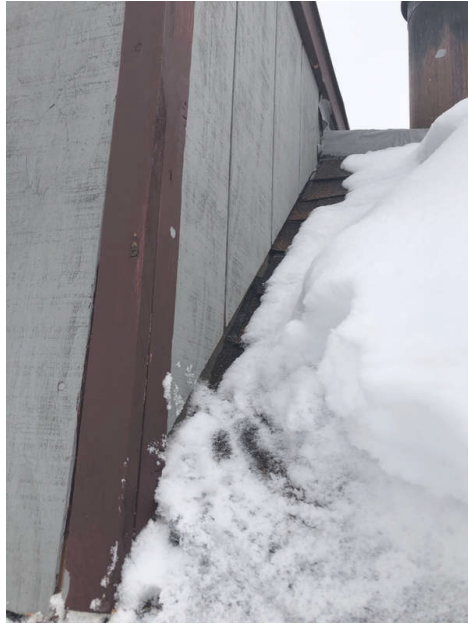
2.4.1 Skylights, Chimneys & Other Roof Penetrations

There is no counter flashing installed at the chimney roof penetration. The point at which the chimney penetrates the roof should be sealed with flashing to prevent leaks and moisture damage. Recommend a roofing contractor install counter flashing.

Contact a qualified roofing professional.

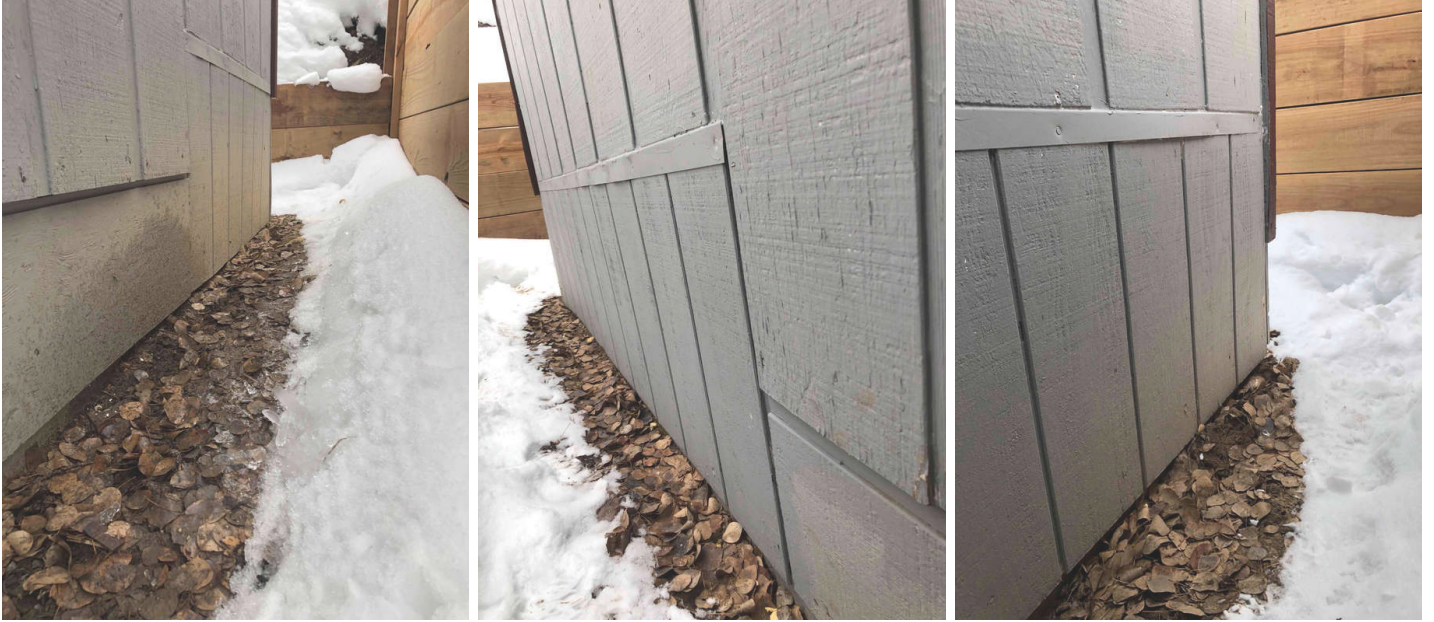
NORTHEAST

Inadequate clearance between siding and ground on the NE corner of the house. Recommend a minimum ground clearance between bottom of siding and ground of 4". Siding in contact with the ground or soil is a serious concern because that condition can provide direct access for wood destroying insects.

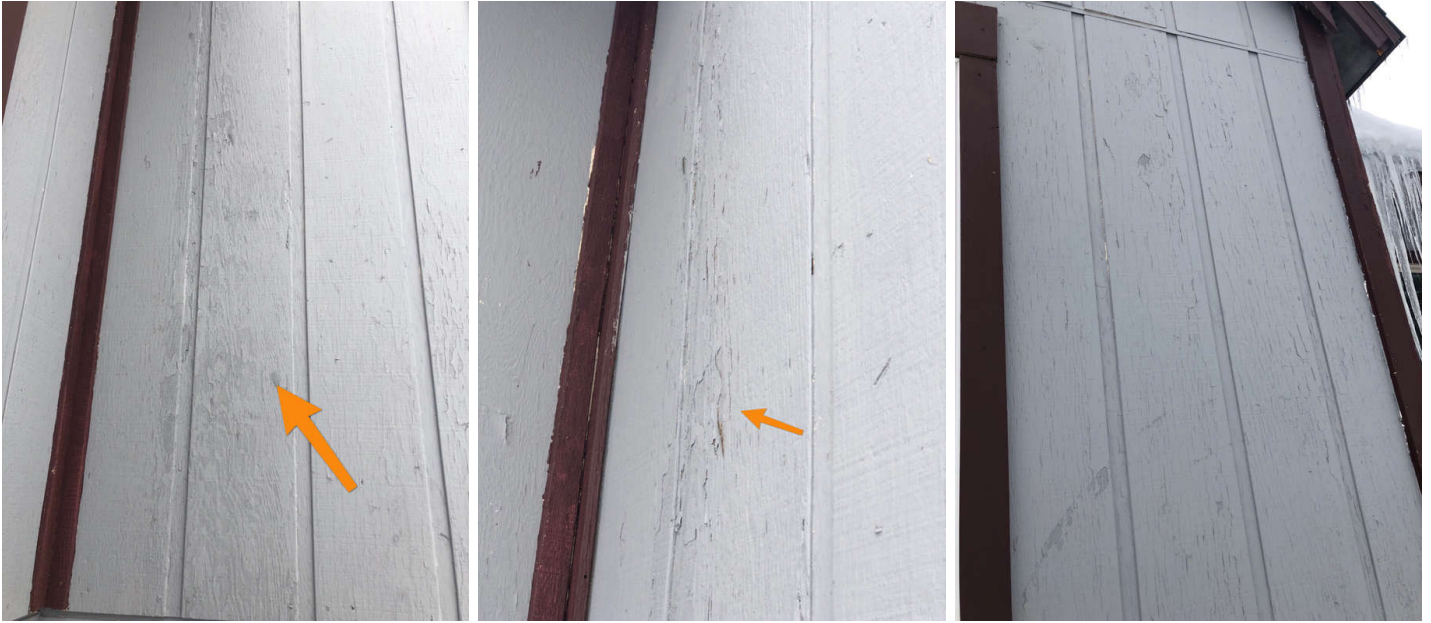
**SIDING PAINT/ FINISH FAILING**

The paint or finish is failing on the siding at places, primarily on the East side of the home. This can lead to deterioration and rot of the material. Recommend that the areas be properly prepared and painted / finished.

Contact a qualified painter.

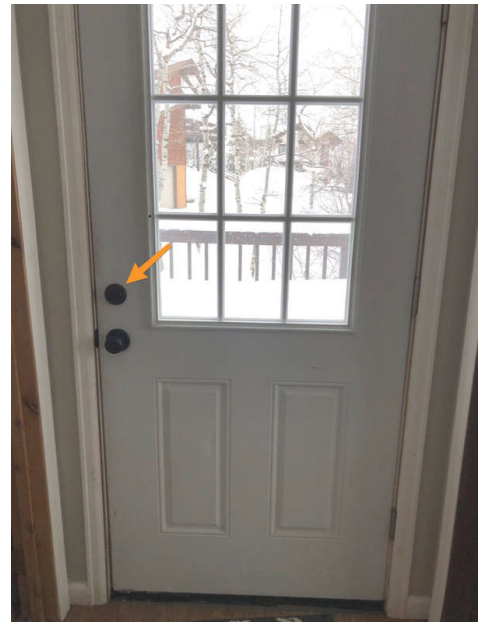
3.2.1 Exterior Doors

Door deadbolt does not latch properly. Recommend qualified handyman adjust strike plate and/or lock.

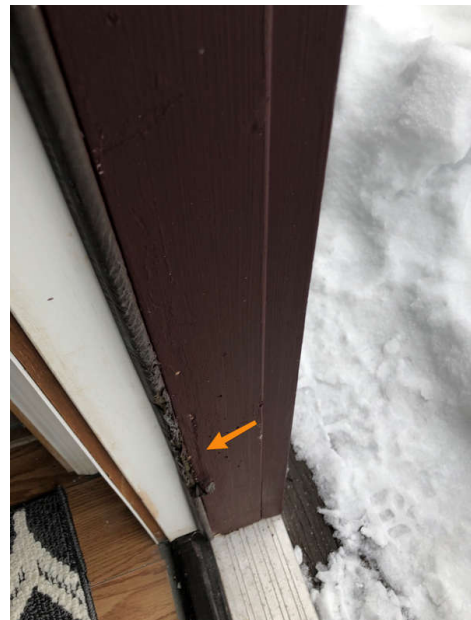
3.2.2 Exterior Doors

WEATHERSTRIPPING DAMAGED

Door weatherstripping is damaged. This can result in energy loss and moisture intrusion. Recommend installation of standard weatherstripping.

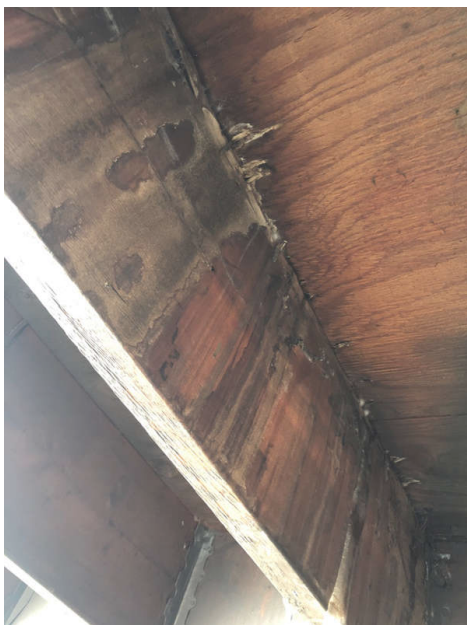
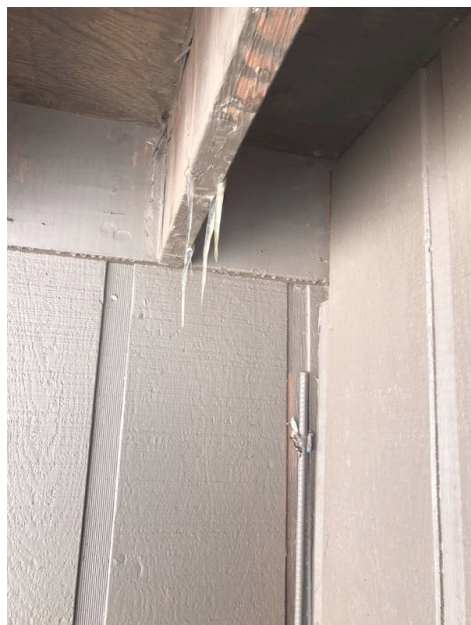
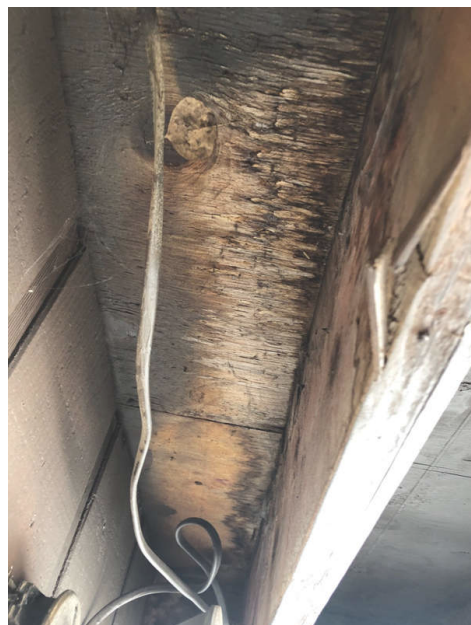
3.4.1 Decks, Balconies, Porches & Steps

The subflooring on the deck is weathered and showing signs of moisture damage on the East side of the deck. The deck had a membrane installed to keep the underside of the deck waterproof, but these moisture stains indicate the membrane may be compromised and a repair of the membrane could be needed to keep the underside of the deck fully waterproof. I would recommend having a deck contractor evaluate the deck to determine if the membrane needs to be repaired and what the cost would be.

Contact a qualified professional.

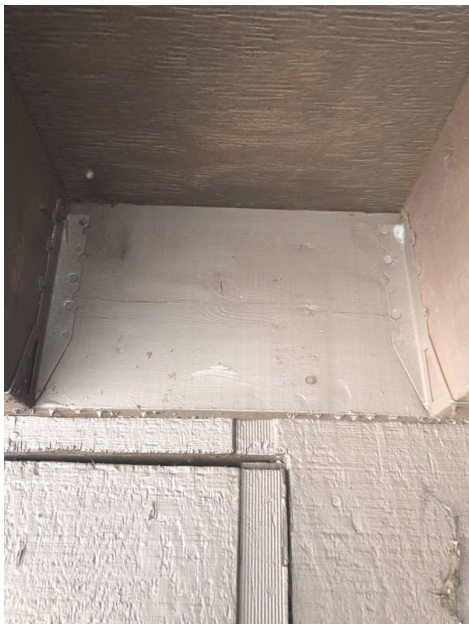
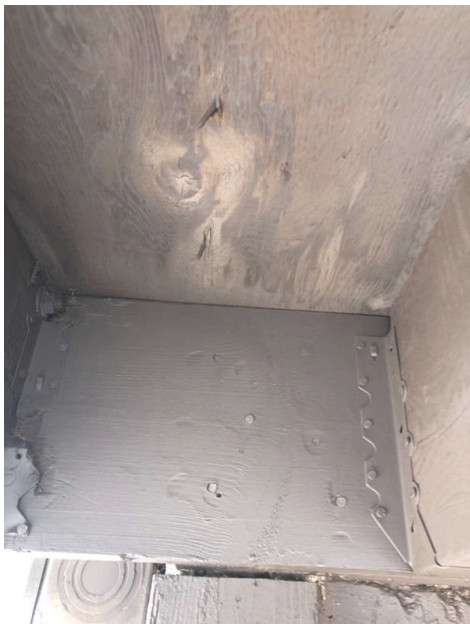
3.4.2 Decks, Balconies, Porches & Steps

LEDGER BOARD IMPROPERLY INSTALLED

Ledger boards for one or more decks, balconies or porches appeared to be attached with nails only. This method of attachment is substandard and may result in such structures separating from the main building. This is a potential safety hazard. Modern standards call for ledger boards to be installed with 1/2 inch lag screws or bolts into solid backing, and brackets such as [Simpson Strong Tie DTT2 brackets and threaded rod](#), connecting interior and exterior joists. Recommend that a qualified contractor repair per standard building practices. For more information, visit:

Contact a qualified deck contractor.

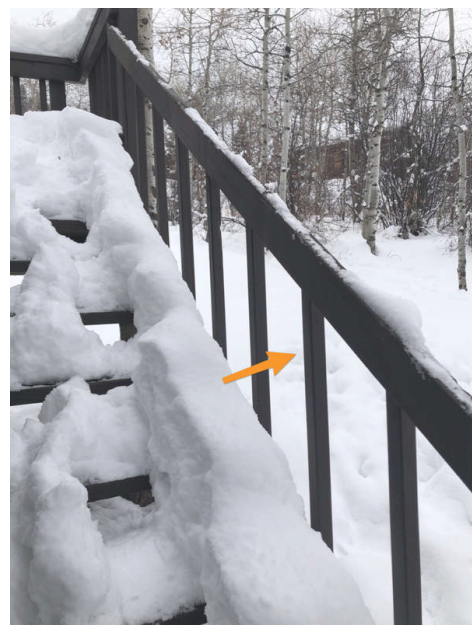
3.4.3 Decks, Balconies, Porches & Steps

RAILING UNSAFE

There is an unsafe opening in the railing. The spacing on the rail should not exceed 4". An opening greater than 4" is a serious safety hazard especially for children as their head or other body part can become trapped.

Contact a qualified deck contractor.

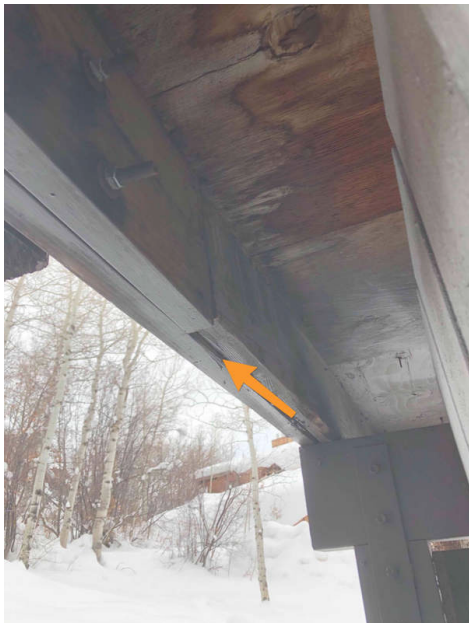
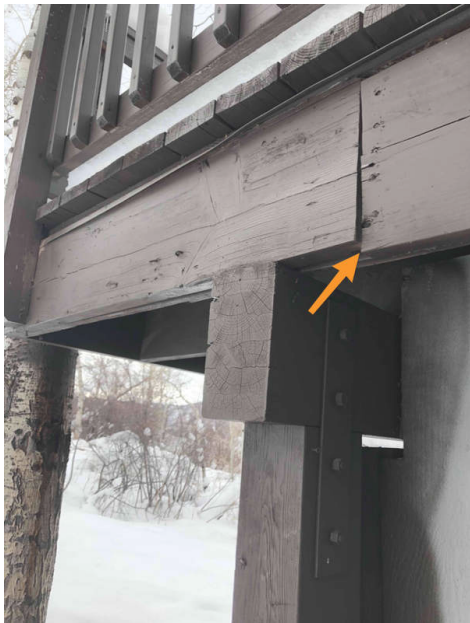
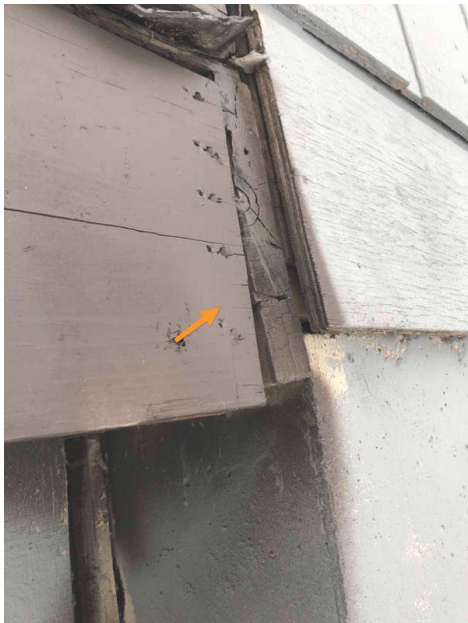
3.4.4 Decks, Balconies, Porches & Steps

MISSING POST BEAM TIES

On the a east side of the deck, the rim joist was not positively secured with hangers or supported with a post. Deck beams are commonly connected to support posts by "toenailing," which is inadequate. Decks are subject to movement under live loads and require a positive connection between their support posts and beams. Recommend that a qualified contractor repair per standard building practices. For example, by installing metal plates, plywood gussets or dimensional lumber to connect posts and beams.

Contact a qualified professional.

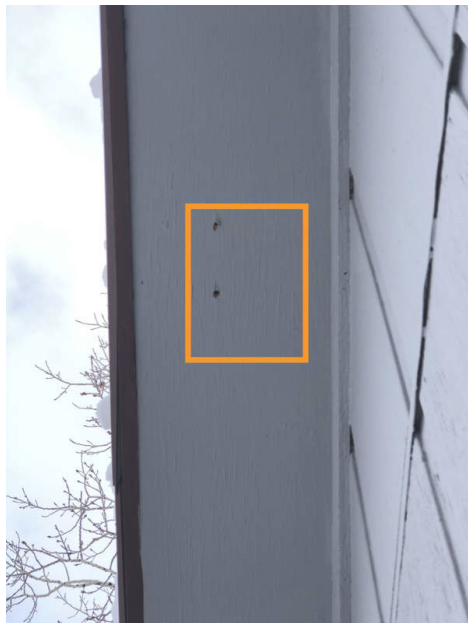
3.5.1 Eaves, Soffits & Fascia

HOLES IN SOFFIT

There were a couple of holes in the soffit on the South side of the house which should caulked. This can allow water intrusion and rodent infestation as well as deterioration of the surrounding material.

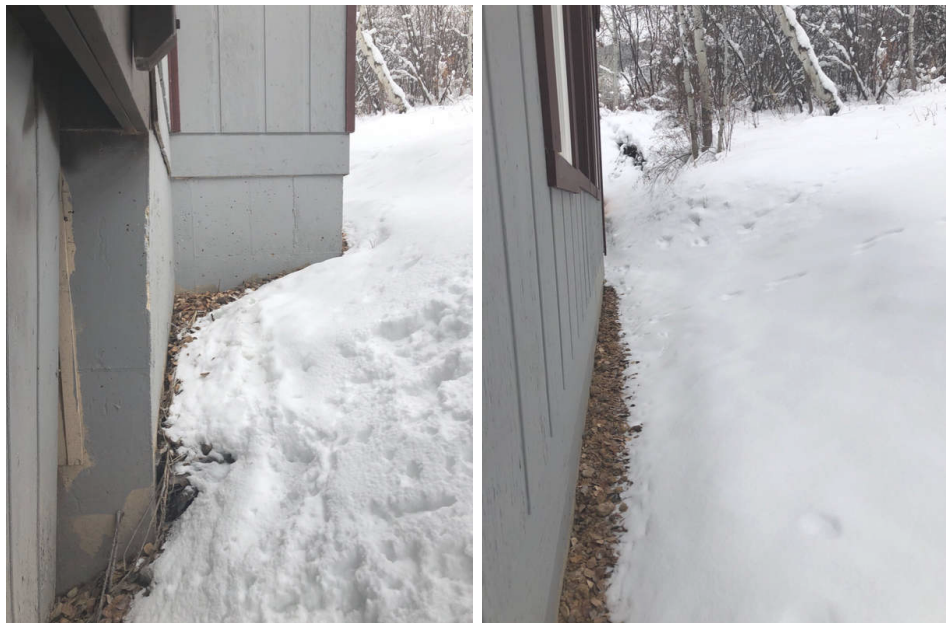
3.6.1 Vegetation, Grading, Drainage & Retaining Walls

Grading is sloping towards the home in some areas. This can result in water accumulating around building foundations or underneath buildings. At a minimum, monitor these areas, and areas under the structure in the future for accumulated water. If water does accumulate, recommend grading soil so it slopes down and away from buildings with a slope of at least 1 inch per horizontal foot for at least 6 feet out from buildings.

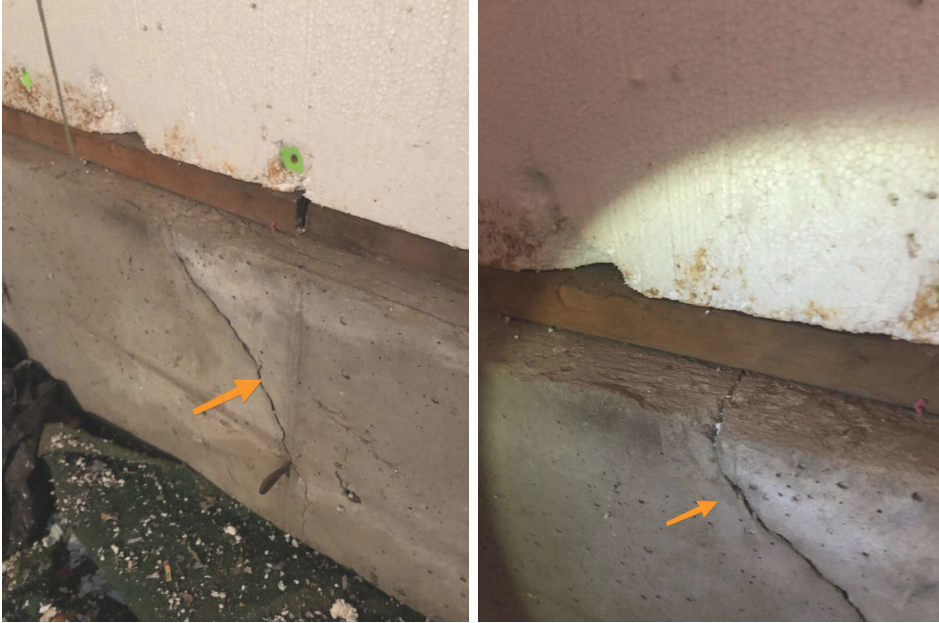
4.1.1 Foundation

FOUNDATION CRACKS - MINOR

A minor diagonal crack was noted at the foundation wall on the South side. The crack is larger on top and reduces to a hairline crack as it continues down the wall of the foundation. This type of crack indicates there is some slight settling or it is a shrinkage crack when the concrete was curing and has grown over time. This part of the foundation wall is the only section that is not backfilled which may be why it has settled. The rest of the concrete foundation did not have any cracks and appears to be in great shape. Recommend monitoring this one diagonal crack for more serious shifting/displacement overtime.

Recommend monitoring.

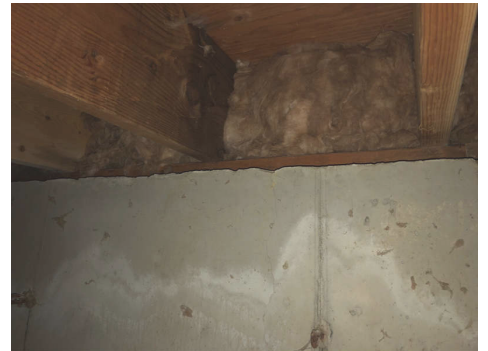
WATER INTRUSION

Discoloration was noted on the East foundation wall. This appears to be due to the inconsistencies of concrete mixing when the foundation was poured rather than water intrusion. The foundation does not show signs of cracking or structural issues, but wanted to note this for awareness.

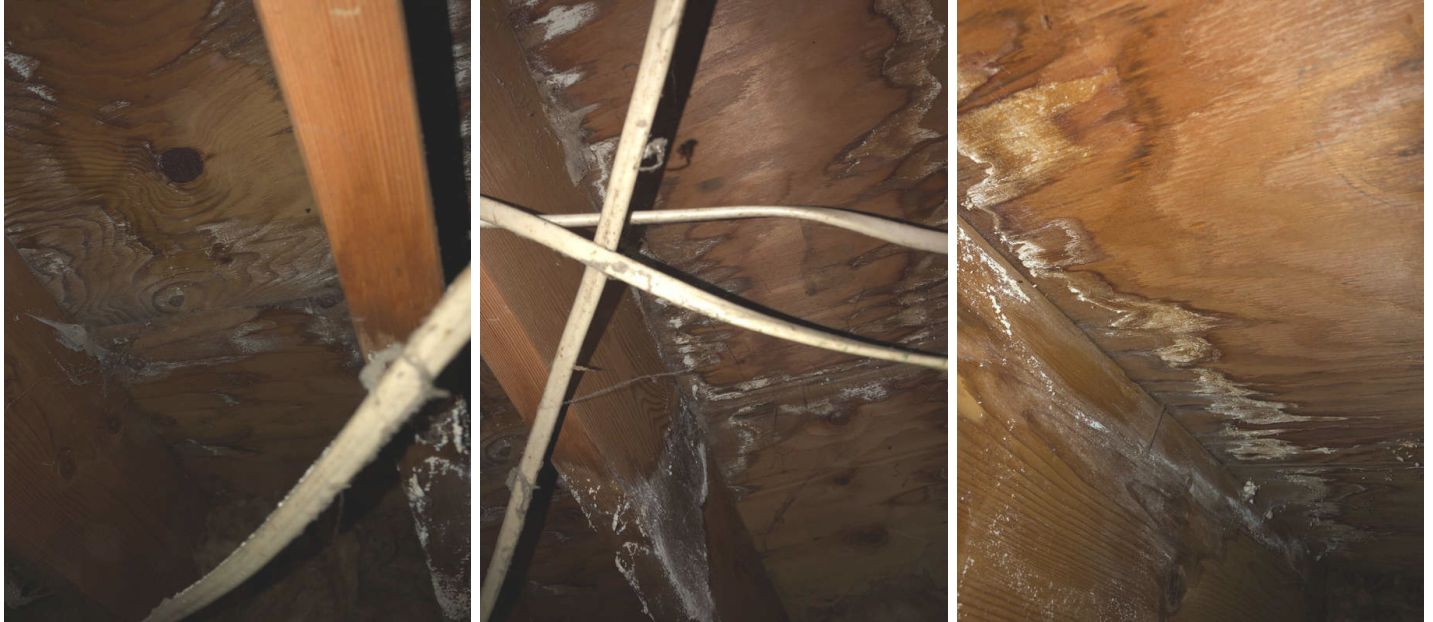
Observed signs of a white powder on the floor joist and subflooring on the west side of the crawl space. The white powder is most likely a mold or fungus growth due to high humidity or condensation in the crawl space. The moisture meter did not indicate any water was present in the joists or subflooring, but overtime the mold/fungus could cause damage to the wood. A vapor barrier has been installed in places in the crawl space, though it does not cover the whole area and is torn in places. A structural engineer could provide repair requirements along with preventive solutions for this problem.

Contact a qualified structural engineer.

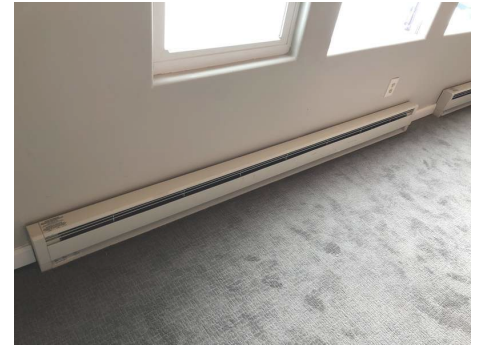
Normal Operating Controls: Electric Baseboard Heaters

Temperature was taken from noted source using an IR thermometer; both source and ambient temps are measured. Temps are within norms.

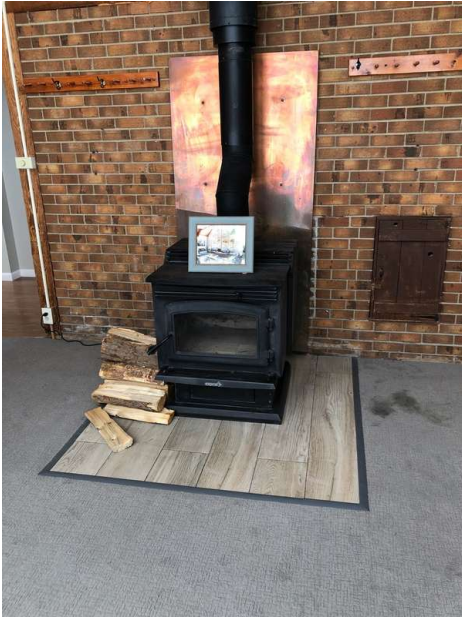
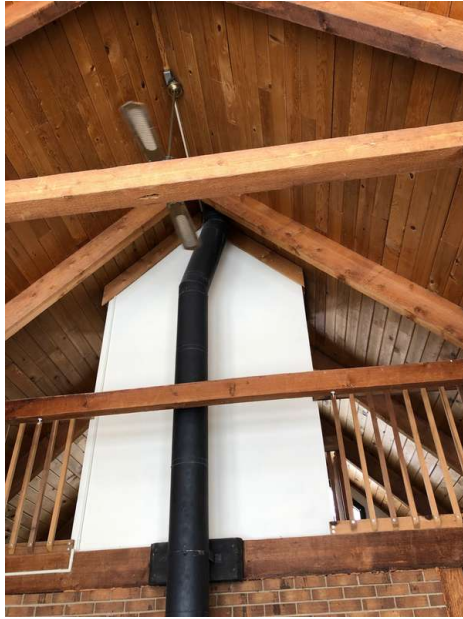
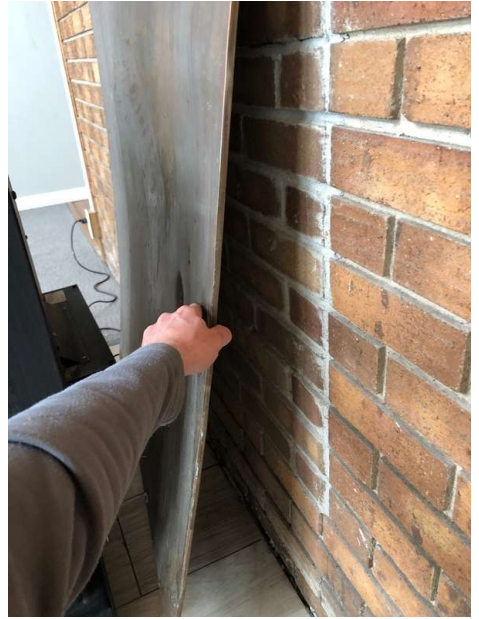
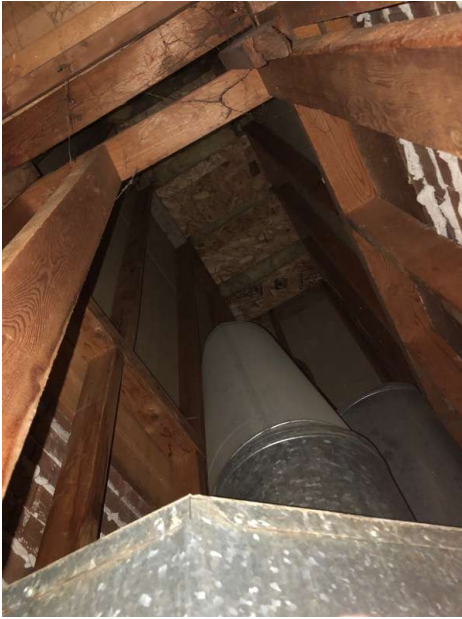
Fireplace: Type

There is currently a wood fireplace that is operational and there is a chimney that has been abandoned for a recessed fireplace that is no longer in use. Since there may be a desire to use the chimney and remove the existing wood fireplace, I would recommend having a fireplace contractor evaluate the chimney to determine if it is usable and what code updates would be required to use it again.

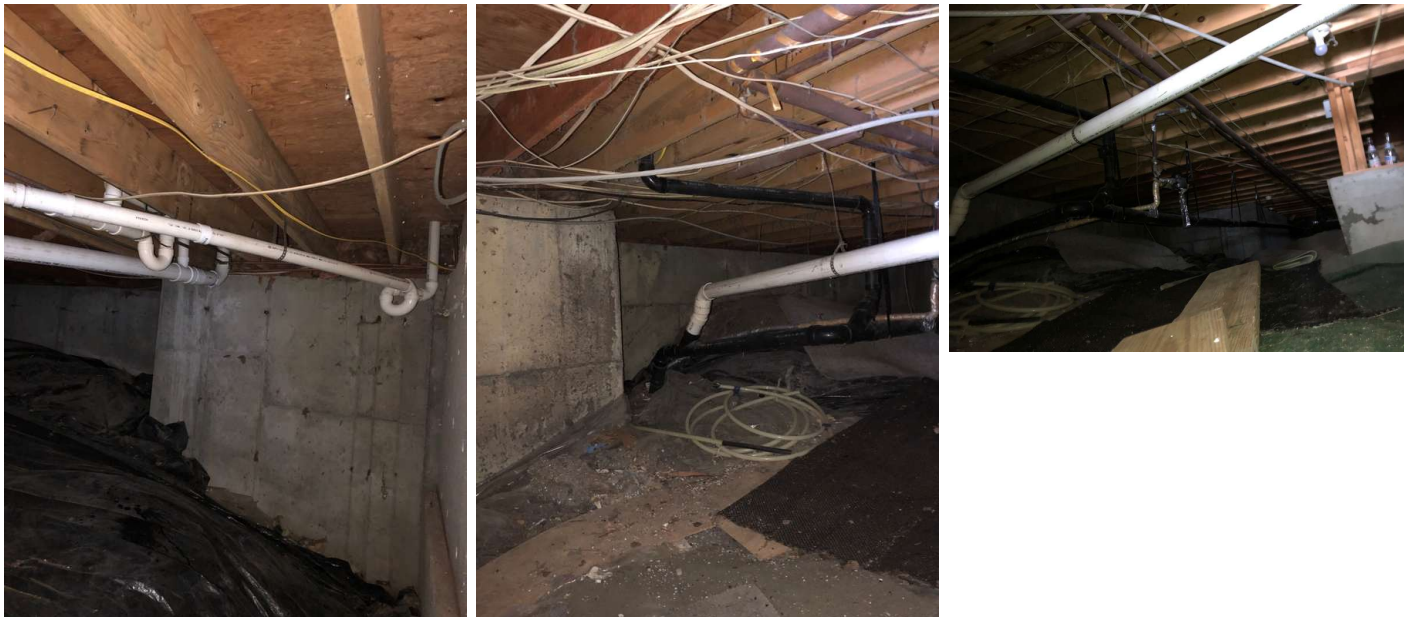
Drain, Waste, & Vent Systems: Material

In general, the sanitary waste system appears to have been installed by a non-professional plumber since there are a number of improper practices followed that are against plumbing code. I would recommend a professional plumber evaluate and make necessary repairs to bring the sanitary waste system up to code regulations.

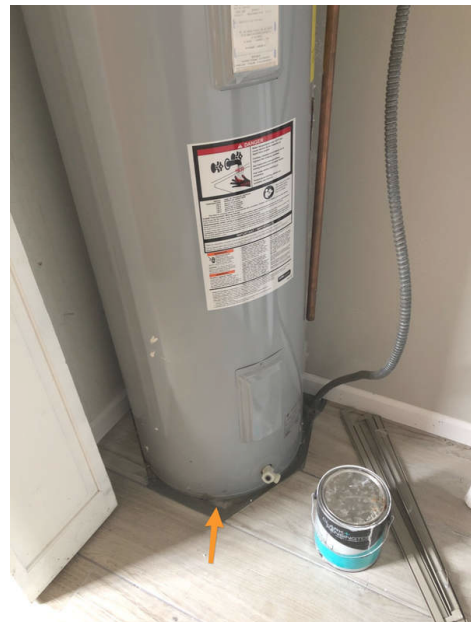
NO DRIP PAN

No drip pan was present. Recommend installation by a qualified plumber.

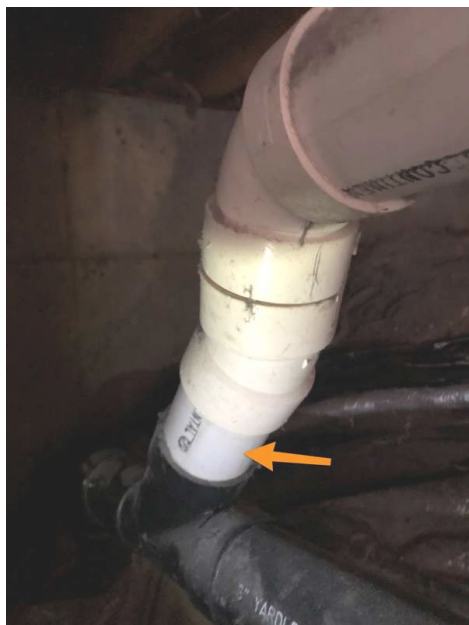
IMPROPER JOINT CONNECTION

The waste drainage system consists of PVC and ABS pipe. Where the PVC connects to the ABS is considered against plumbing code and is an improper connection. Colorado State Plumbing code section 707.1. states that solvent-cement joints between different types of plastic pipe is prohibited. Its possible to join ABS to PVC, but its only supposed to be done with an approved listed adapter or transition fittings. Though this technically should not be installed this way, it is commonly done.

Incorrect way to connect PVC to ABS pipe. Can't be glued.

Contact a qualified plumbing contractor.

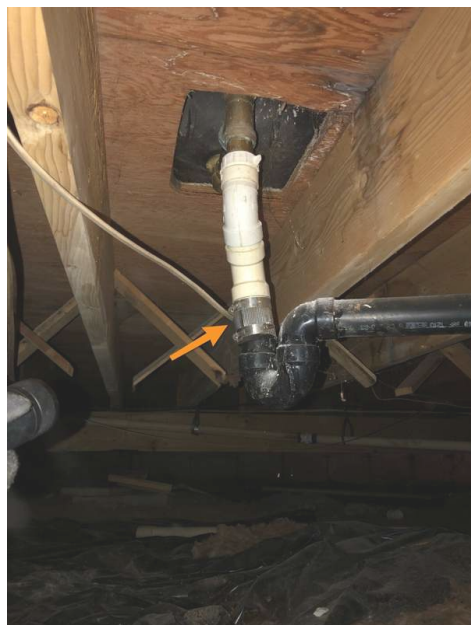
Correct way to connect ABS to PVC pipe

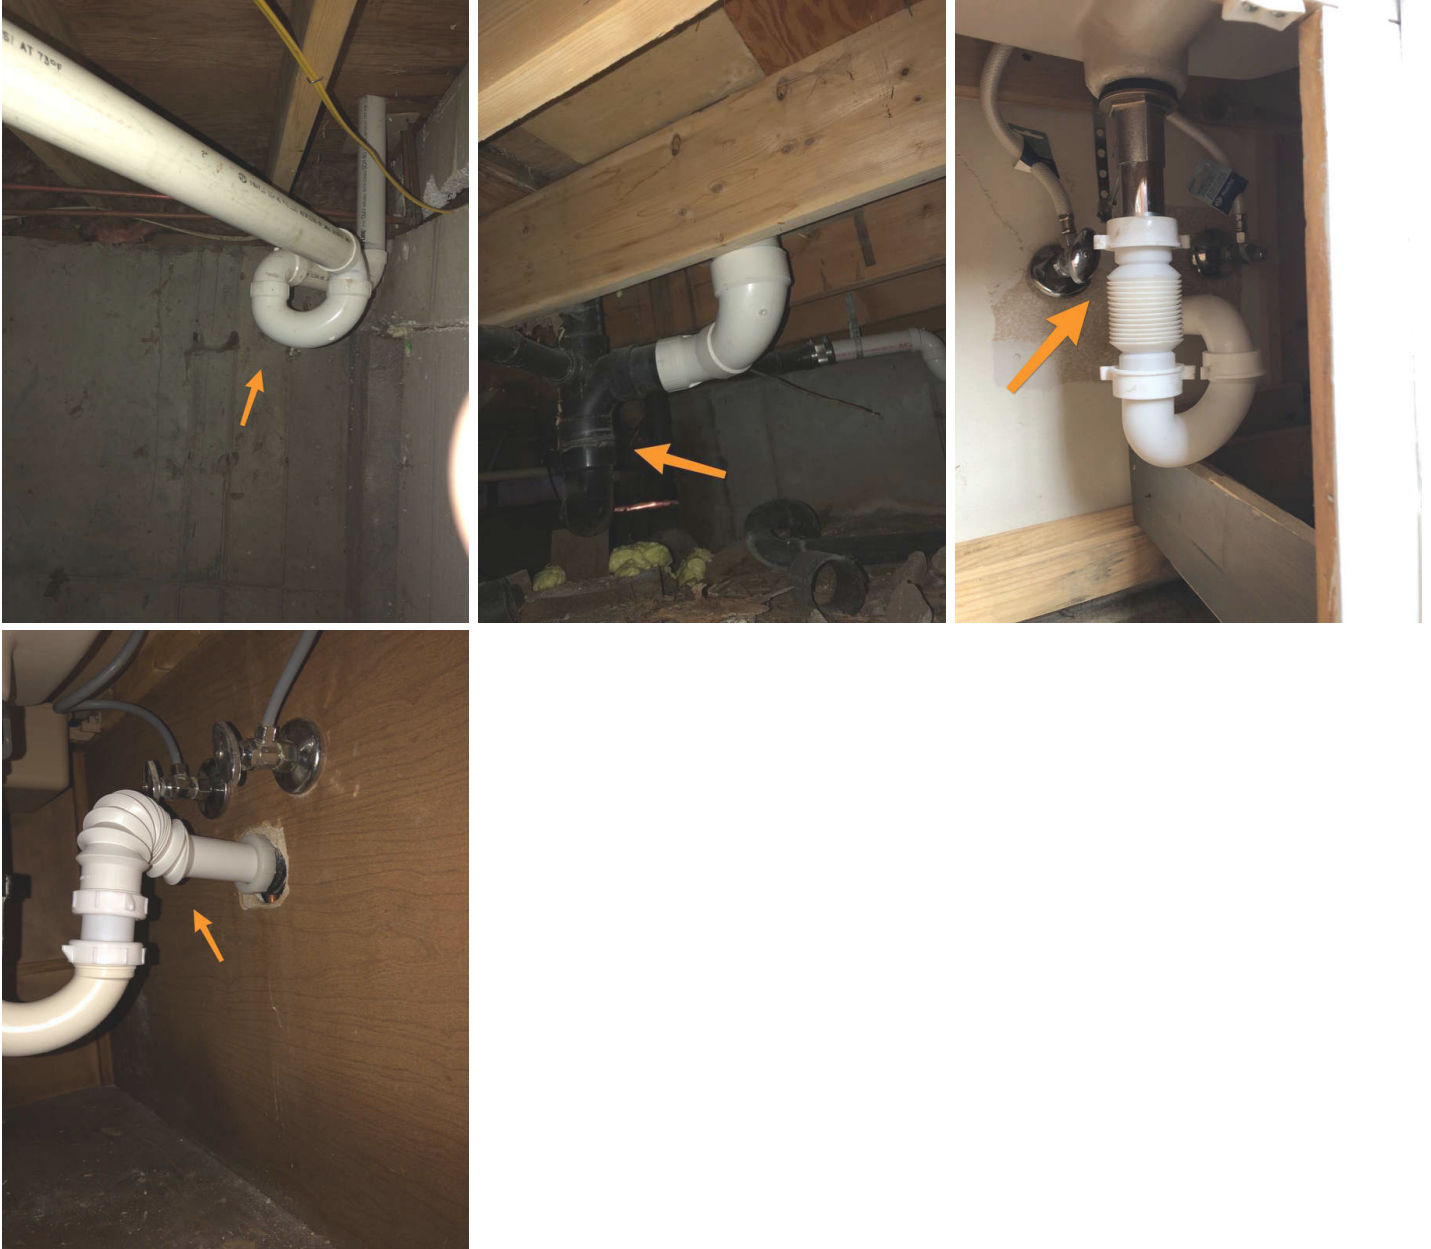
IMPROPER P-TRAP INSTALLATION

In the crawl space, a "running trap" has been installed which is considered an improper p-trap. A running trap is when a drain line from a fixture runs horizontal then makes a u-shape trap and continues horizontal. It lowers the velocity and turbulence needed to wash (clean/scour) the trap, and causes slow running drains, among other things. The p-trap should be installed at the vertical tailpiece of the fixture.

In the bathrooms, a flexible drain transition pipe is installed. This is not approved by plumbing code because the inside walls are not smooth and will hold gunk. This kind of pipe is thinner and prone to leakage.

Contact a qualified plumbing contractor.

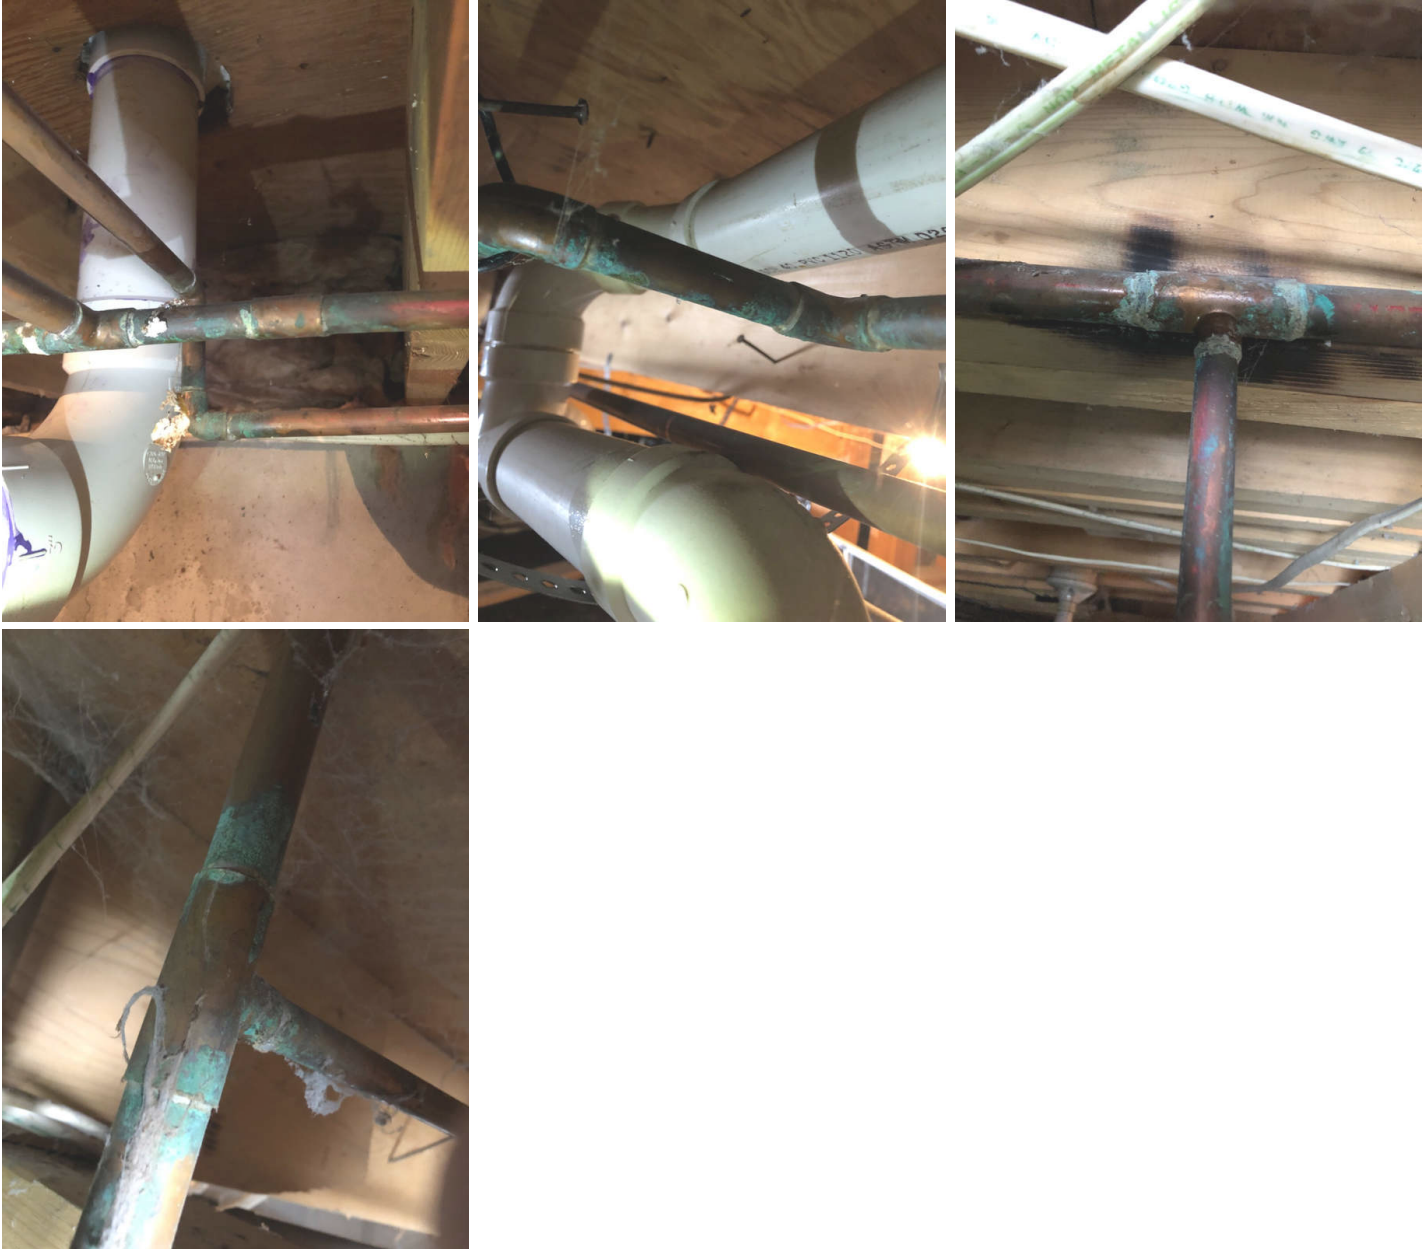
7.5.1 Water Supply & Distribution Systems

MAIN WATER SUPPLY PIPE CORRODED

Sections of the water supply pipe are showing signs of minor corrosion at some fittings. Even the highest quality metal piping system will corrode over time due to oxidation. Severe corrosion can lead to burst pipes, resulting in major property damage that costs thousands in repairs. The longer corrosion is left unchecked, the more costly it will be to repair. I recommend monitoring the piping for these warning signs and catch pipe corrosion early.

Recommendation
Recommend monitoring.

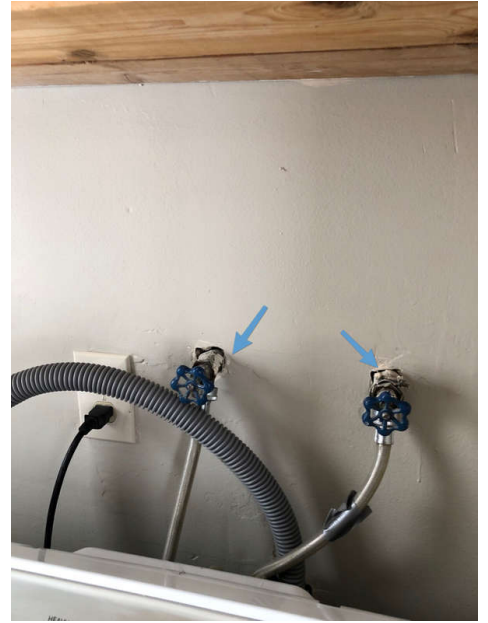
7.5.2 Water Supply & Distribution Systems

The hot and cold water supply piping stubouts for the washing machine is not secured behind the wall and is loose. The piping should be clamped to a stud to prevent bending or further damage in the future that would cause a leak.

Recommendation
Contact a qualified plumbing contractor.

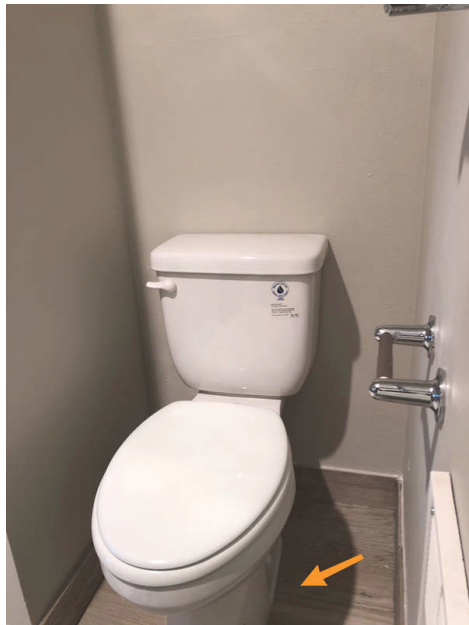
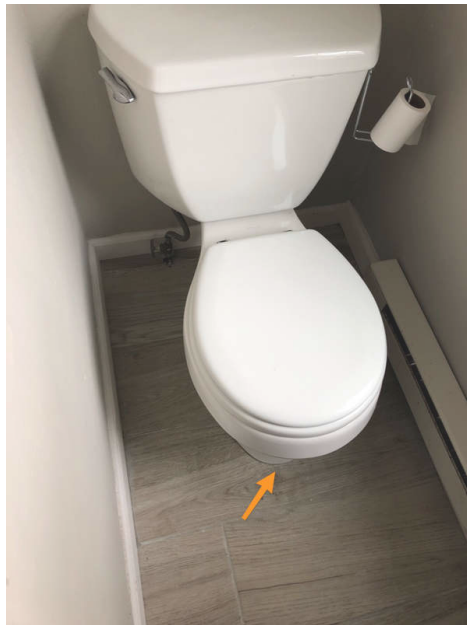
7.6.1 Fixtures

TOILET LOOSE

The toilet is not well secured to the floor. Recommend repair to help prevent (further) leaks around the wax ring.

Loose toilet

Contact a qualified professional.

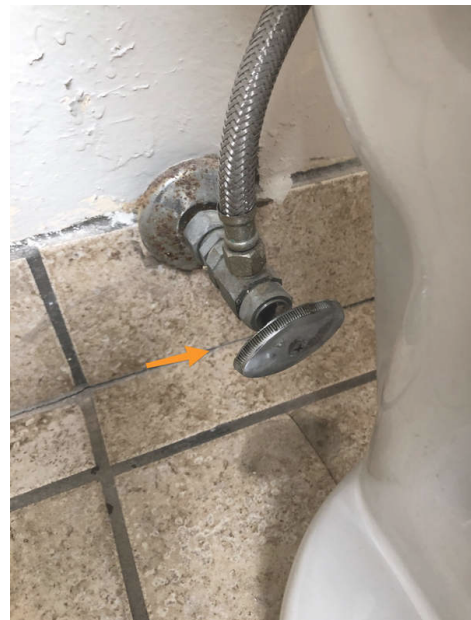
LEAKING SUPPLY LINES

The water shut-off valve at the toilet leaks. It has to be turned a quarter of the way open for it to not leak. Otherwise it leaks fully opened or any one it is turned. A qualified plumber should repair as necessary.

Contact a qualified plumbing contractor.

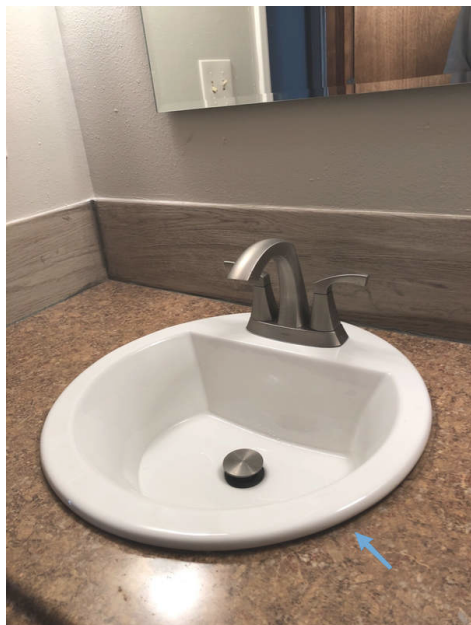
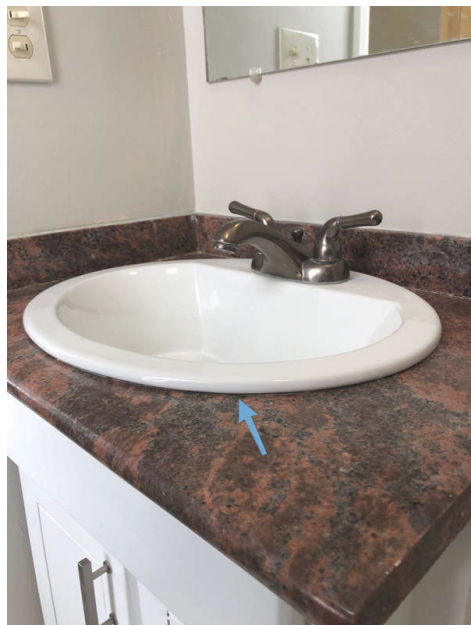
7.6.3 Fixtures

CAULKING MISSING OR DETERIATED

Caulking in the bathroom sink is not adequately applied. Recommend applying a bead of caulk around the rim of the bowl to prevent moisture damage to the countertop.

Contact a handyman or DIY project

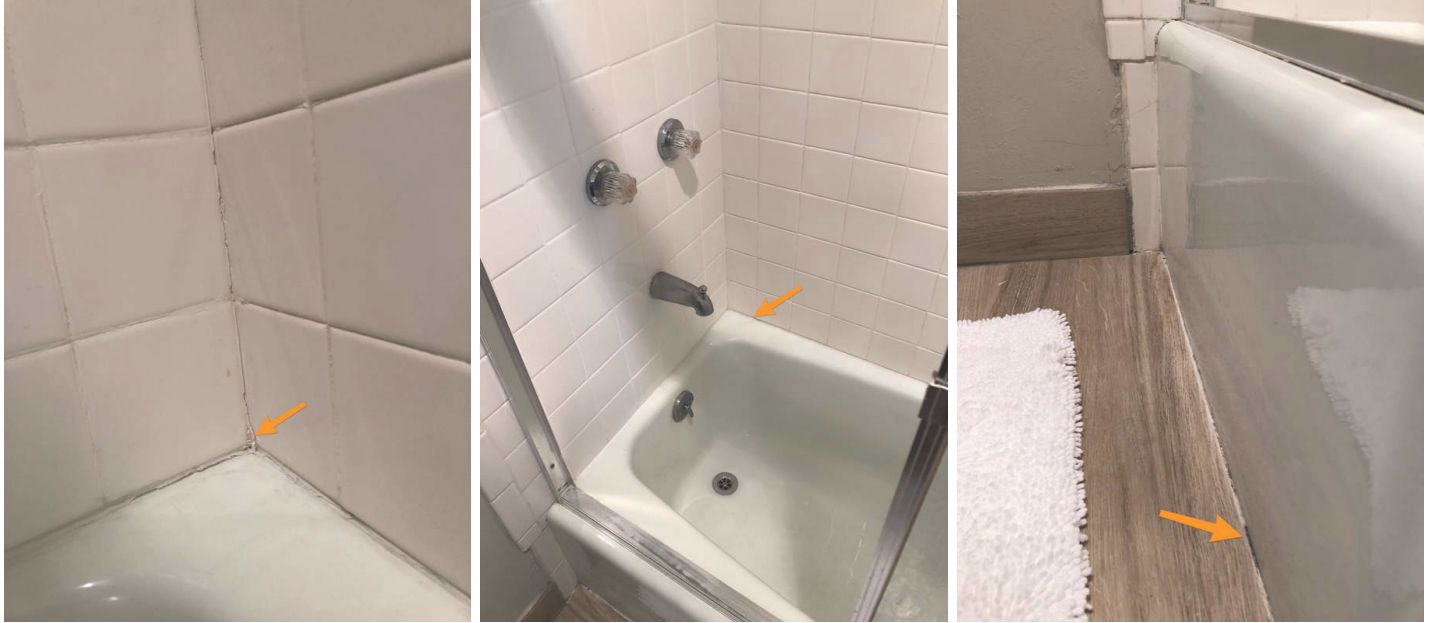
7.7.1 Tubs, Shower and Tile

CAULKING DETERIORATED/ MISSING

The caulking around the tub is missing or worn. Water can penetrate these areas and cause damage. Recommend repair to help protect from moisture damage.

Contact a handyman or DIY project
