HICKORY PROPERTY SERVICES LLC INSPECTION REPORT

1234 Main St.
Steamboat Springs CO 80487

Buyer Name
01/10/2019 9:00AM

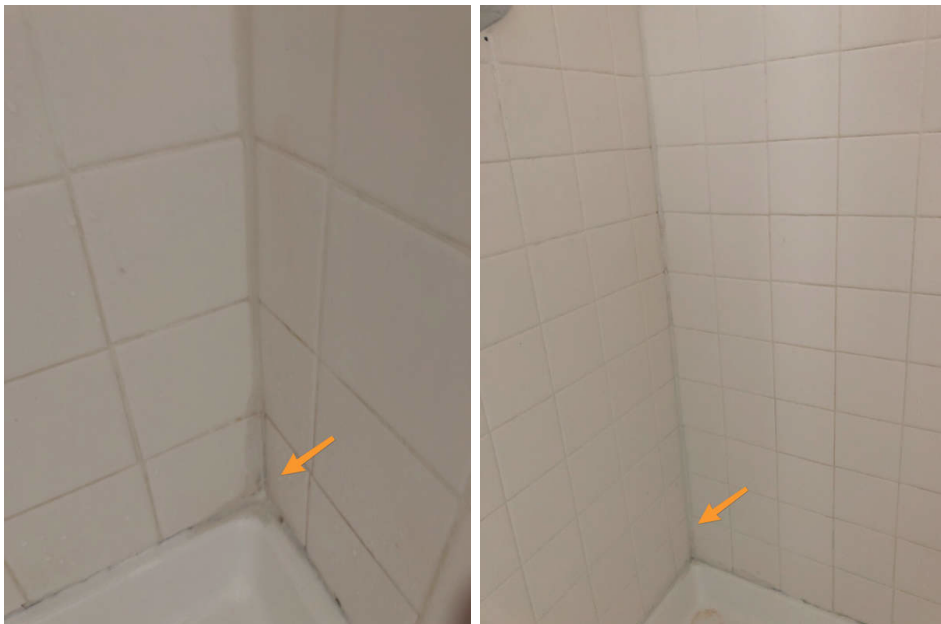
7.7.2 Tubs, Shower and Tile

HEAVY CAULKING IN CORNERS

There is heavy caulking in the corners of the tiles shower base. Recommend monitoring for moisture leaks and repairing as necessary.

Contact a handyman or DIY project

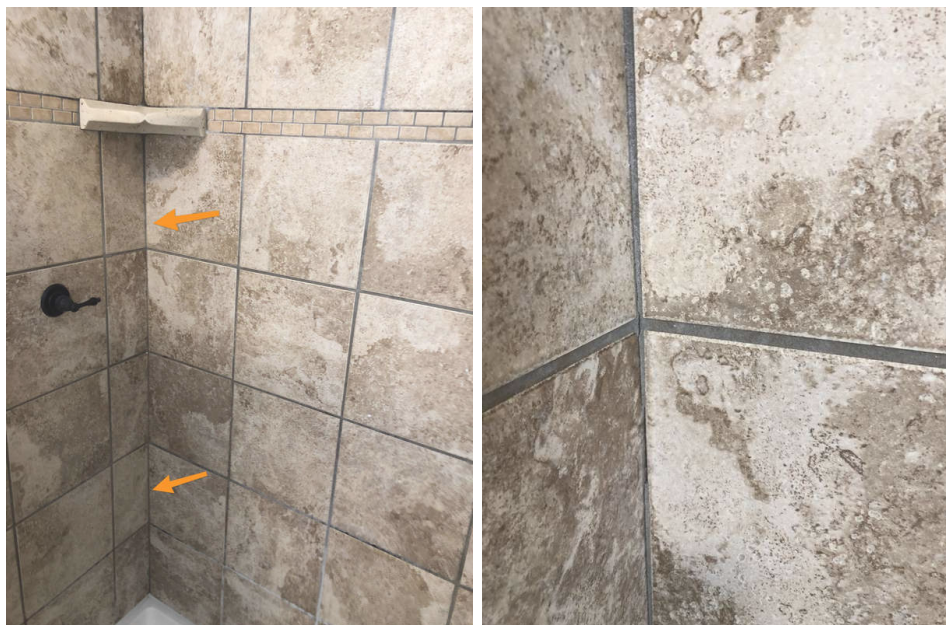
7.7.3 Tubs, Shower and Tile

GROUT - GAPS AND CRACKS

There are cracks and gaps in the grout. Recommend repair to help prevent water damage.

Contact a qualified tile contractor

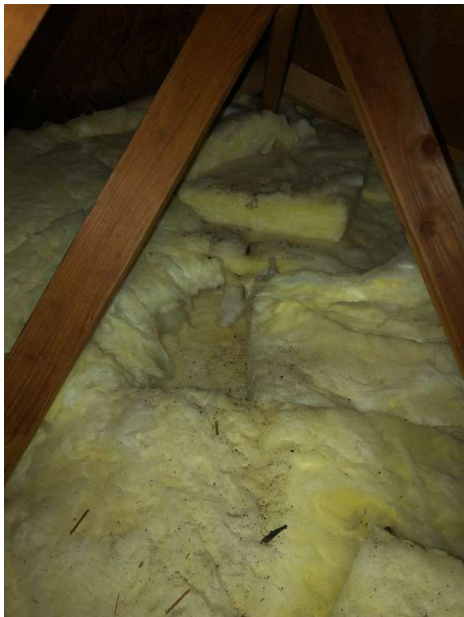
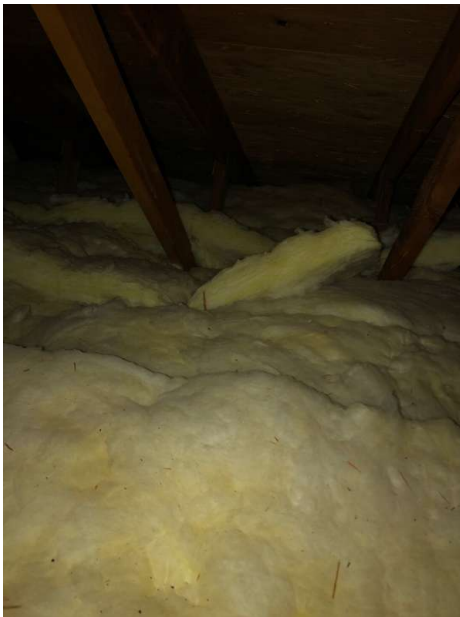
Attic Insulation: R-value

The amount of insulation in the attic meets the minimum recommendations for the climate zone in Steamboat Springs. With the amount of ice dams that are forming on the roof, adding more insulation in the attic may help, however the problem could be that the insulation is not placed properly and is not allowing proper ventilation to keep the roof cold. An insulation or roofing contractor can evaluate the insulation in the attic and determine the best way to fix this issue.

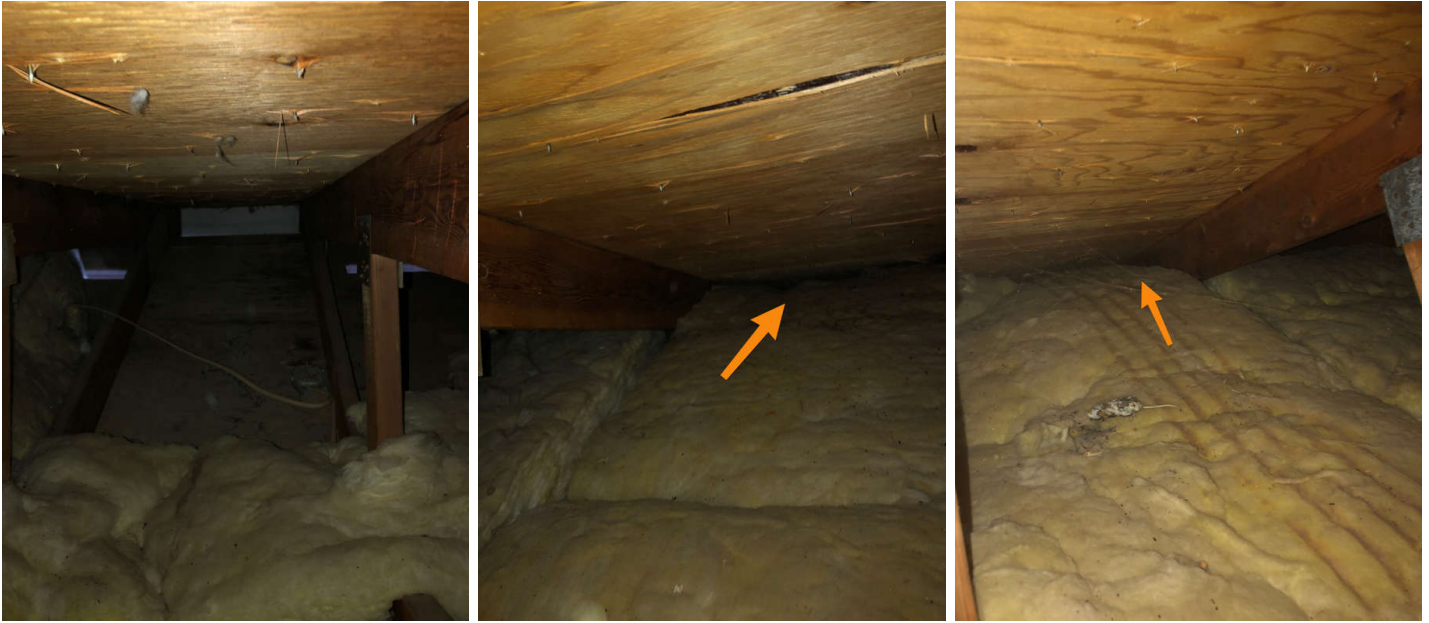
IMPROPER INSTALLATION

Attic insulation was too close to the roof sheathing in places along the perimeter of the roof. There should be a minimum of a 1 - 2" gap between the insulation and roof sheathing to allow for proper ventilation. This could be one of the causes for the ice dam build up on the roof. Recommend a qualified insulation contractor evaluate and correct.

Contact a qualified insulation contractor.

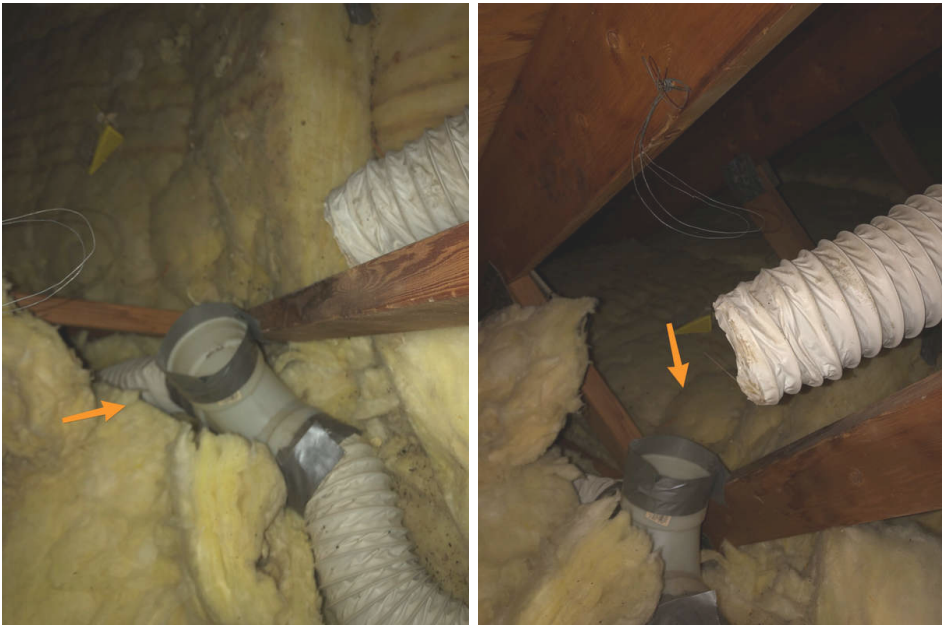
8.3.1 Exhaust Systems

The flex duct for the vent from the bathroom is disconnected in the attic and vents into the attic, which can cause moisture and mold. Recommend the vent be repaired so it can properly exhaust to the exterior.

Contact a qualified HVAC professional.

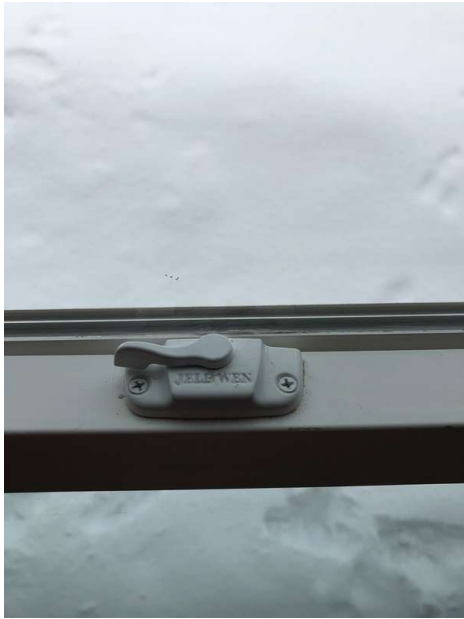
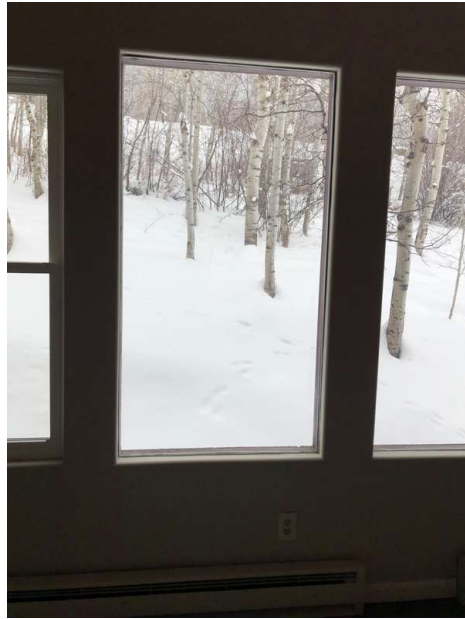
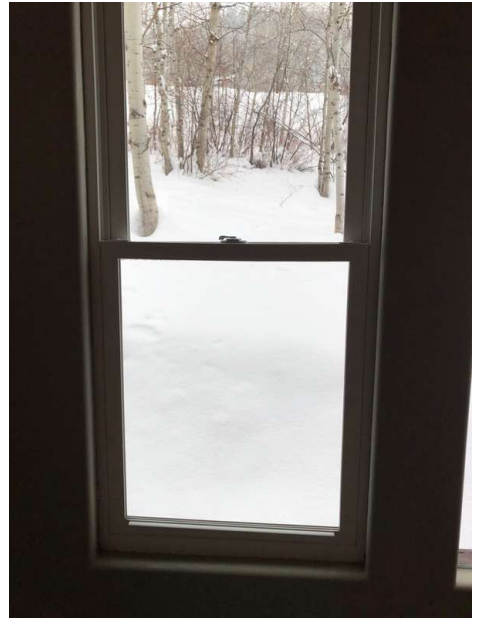
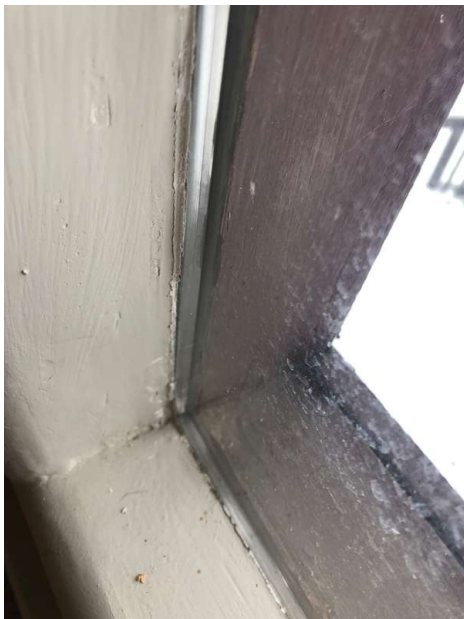
Windows: Window Manufacturer

The windows are a mix of different manufactures. It appears they have been replaced overtime and are in good condition.

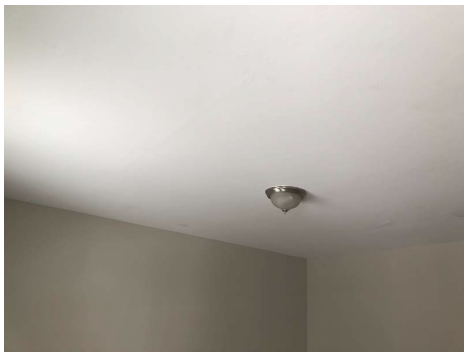
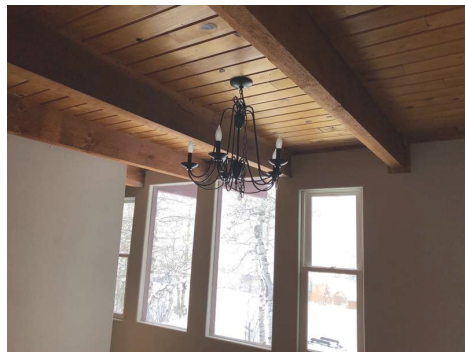
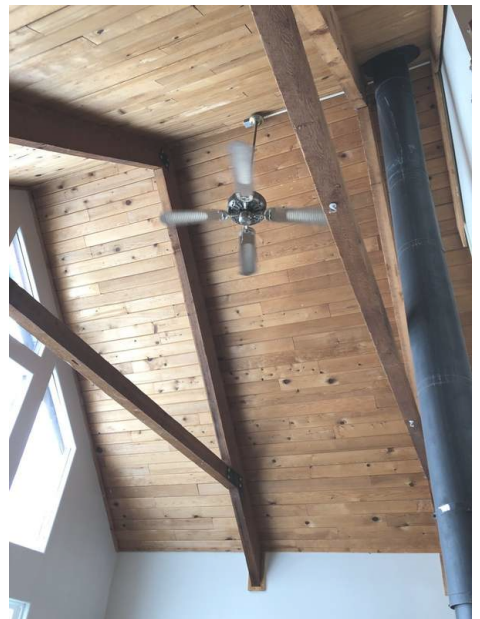
Ceilings: Thermal Efficiency

Bedroom, Master Bathroom, Hallway

There were some locations where the insulation is missing or does not cover the ceiling evenly as indicated by the cold spots in purple. Cold spots are common along wall and ceiling joints because the wood studs are cold. When you seen large square or round cold spots, this is an indication that not enough insulation is placed in the ceiling in those areas.

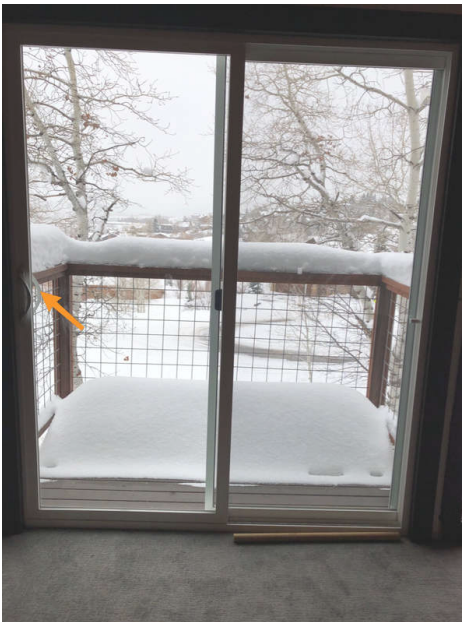
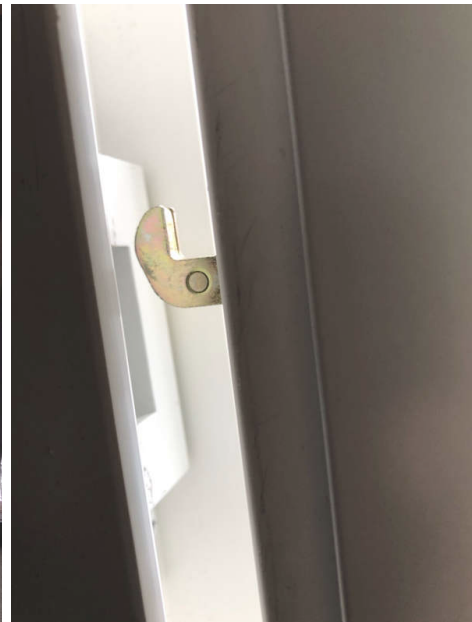
LOFT

Door doesn't latch properly. Recommend handyman repair latch and/or strike plate.

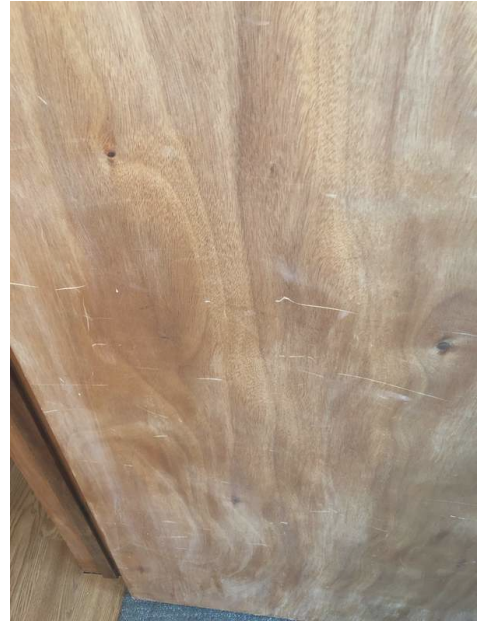
MINOR DAMAGE

The doors have scratches and dents from general wear and tear over time. Recommend replacing or painting to restore.

Recommendation

Contact a qualified door repair/installation contractor.

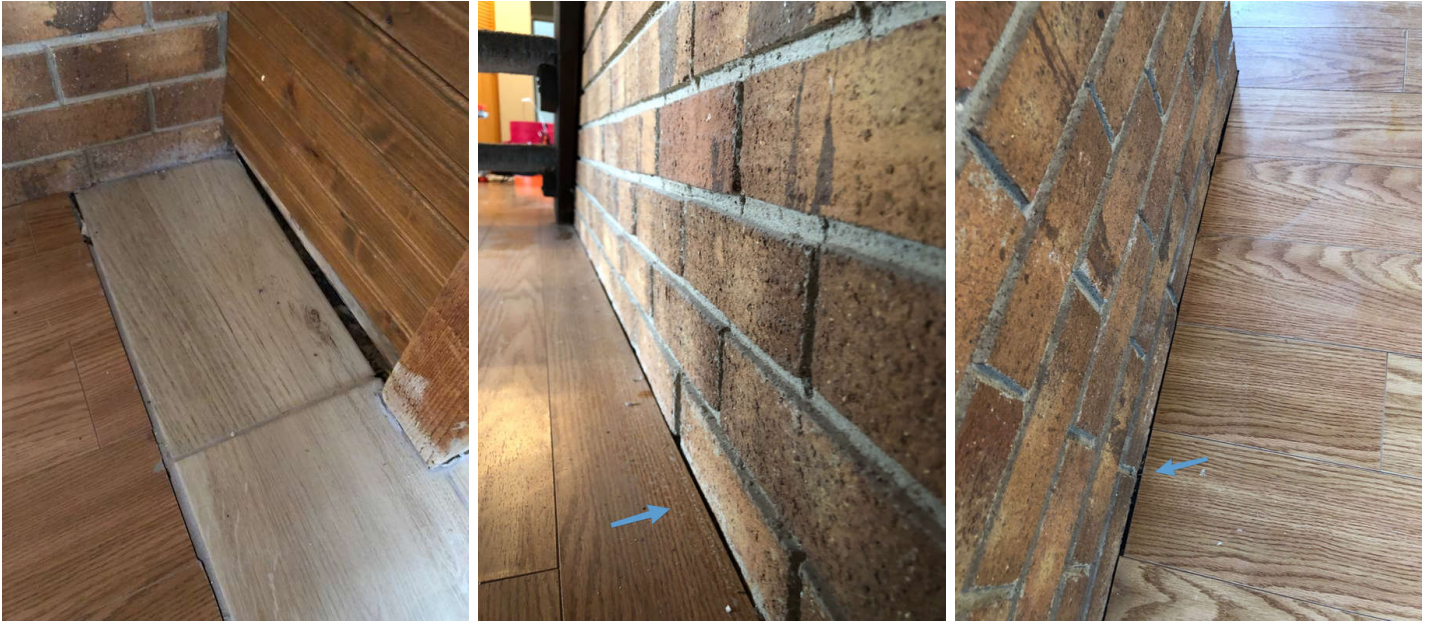
BASEBOARDS AND TRIM MISSING

The trim pieces or baseboards are missing various locations. Recommend installing for a clean and finished look.

Recommendation

Contact a qualified flooring contractor

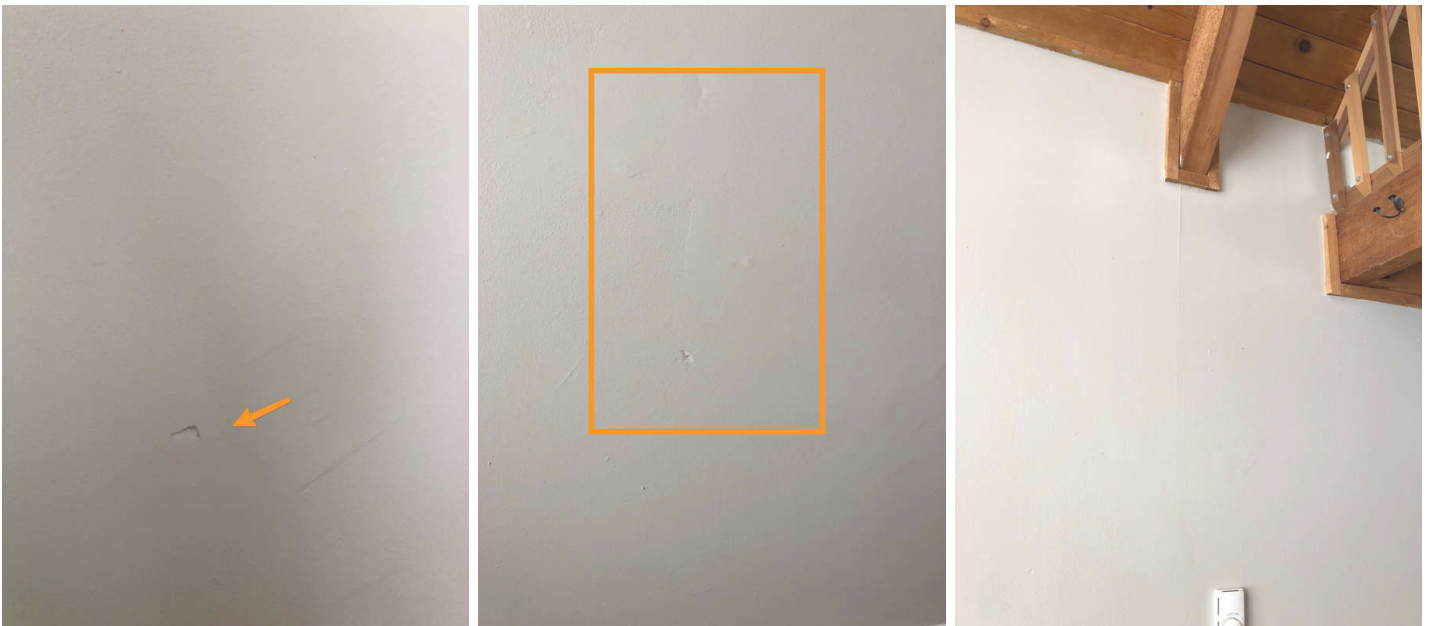
9.4.1 Walls

POOR PATCHING

Sub-standard drywall patching observed at time of inspection. Recommend re-patching.

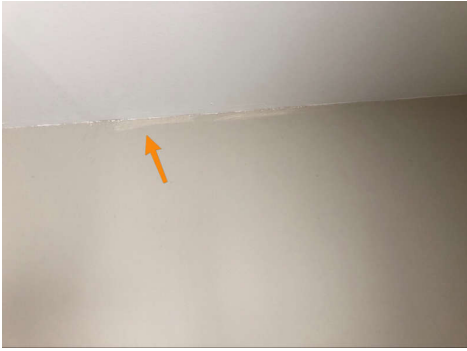
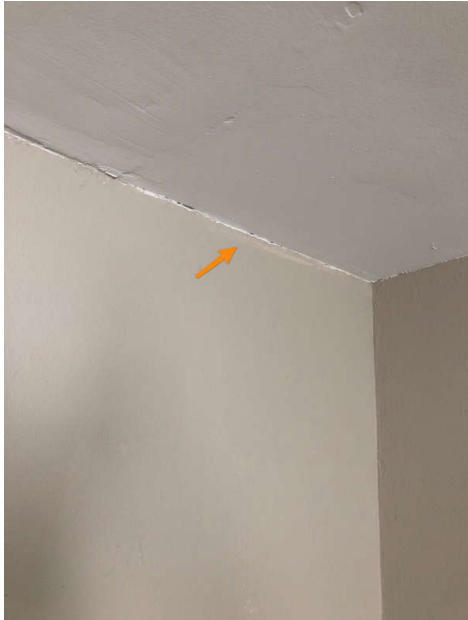
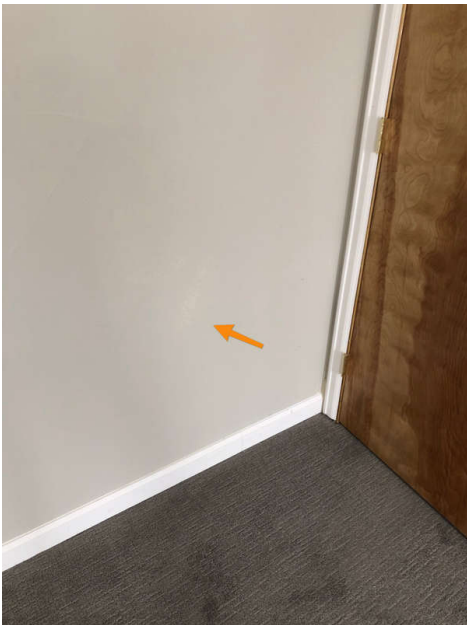
The wall does not have an even coat of paint in their spots where the paint is thin or was not applied properly. Recommend repainting the wall.

Recommendation

Contact a qualified painter.

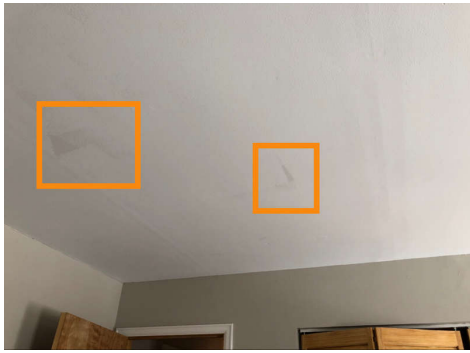
9.5.1 Ceilings

POOR PAINT APPLICATION

The ceiling does not have an even coat of paint in their spots where the paint is then or was not applied. Recommend repainting ceiling.

Recommendation

Contact a qualified painter.

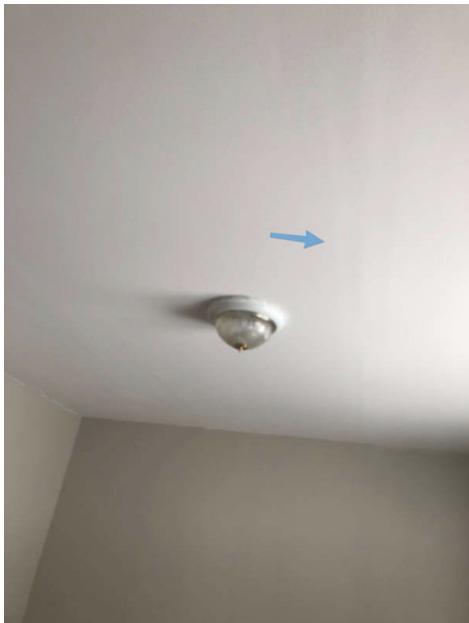
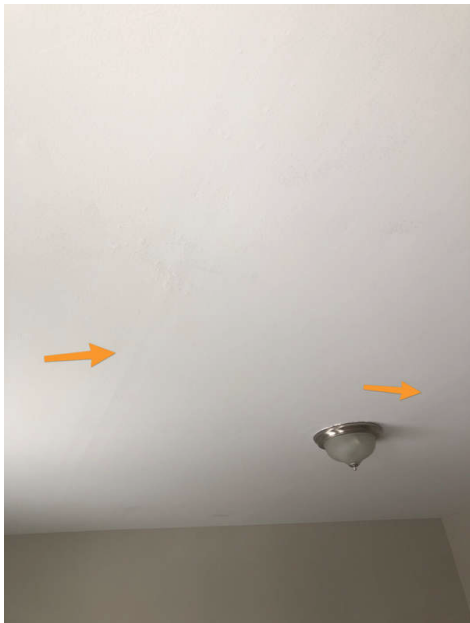
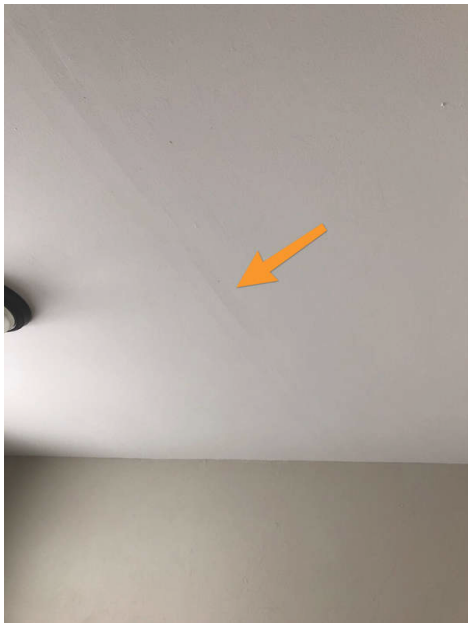
9.5.2 Ceilings

The drywall joints on the ceiling were not taped properly and can be seen. If desired to repair recommend a drywall contractor to re-tape and finish.

Recommendation

Contact a qualified drywall contractor.

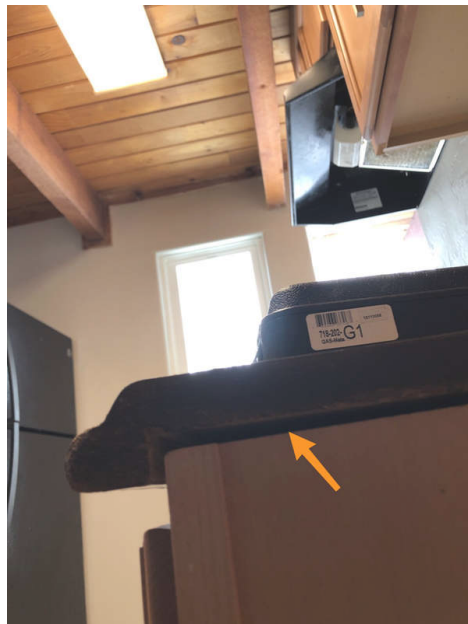
Kitchen countertop was not secured to the wall or cabinet. Recommend qualified countertop contractor secure countertop properly.

Recommendation

Contact a qualified countertop contractor.

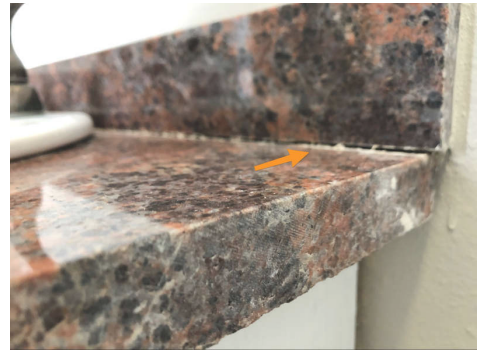
9.7.3 Countertops & Cabinets

GROUT DETERIORATING

Grout lines were cracked or severely deteriorated. Recommend a qualified contractor repair or replace grout.

Recommendation

Contact a qualified countertop contractor.

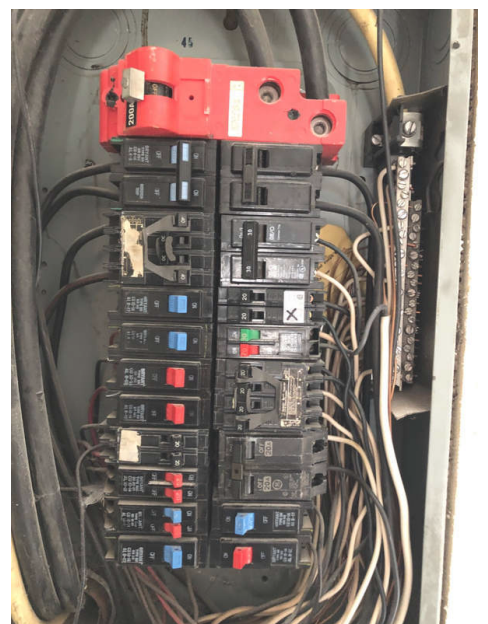
There are no Arc Fault Circuit Interrupter (AFCI) breakers installed in the electric panel. These are safety devices that are installed to protect an outlet that has poor plug retention or an outlet that creates a spark as a plug is removed from an outlet. Any construction after January 2002 should have this protection installed for any outlets located in bedrooms. This structure predates the requirement for newer construction of Arc Fault protected outlets in certain areas, but is recommended to update the electrical panel for safety purposes.

Recommendation

Contact a qualified electrical contractor.

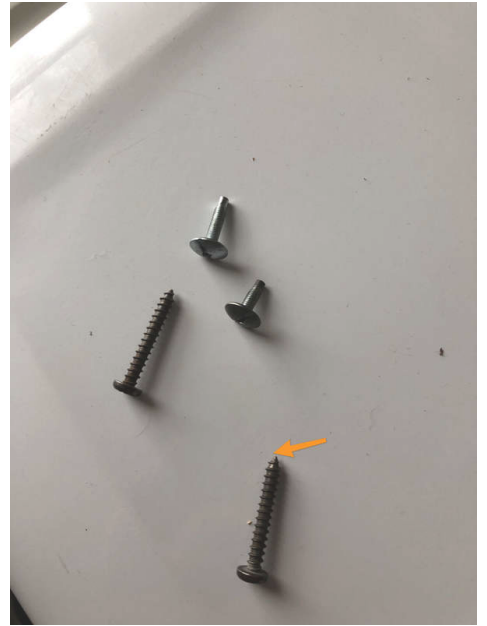
12.2.2 Main & Subpanels, Service & Grounding,
Main Overcurrent Device

The panel cover was removed in order to inspect and test the internal components. Two pointed screws were removed from the panel cover. This is a potentially dangerous condition. If one of the screws penetrates the insulation of a wire, a direct short will occur at a minimum popping a breaker or possibly electrocuting someone. Recommend replacing with a flat head tip screw rated for electrical panels.

Recommendation

Contact a qualified electrical contractor.

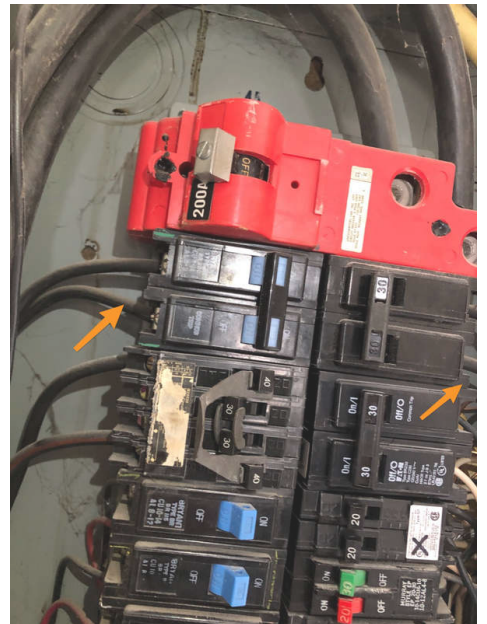
ALUMINUM BRANCH CIRCUITS

Aluminum wire appears to be installed on a couple of the branch electrical circuits. These single strand, branch circuit aluminum wires were used widely in houses during the mid 1960s and 1970s. According to the U.S. Consumer Product Safety Commission, problems due to expansion can cause overheating at connections between the wire and devices (switches and outlets) or at splices, which has resulted in fires. For further information on aluminum wiring contact the U.S. Consumer Product Safety Commission via the Internet at <http://www.cpsc.gov/> . It is recommended that the electrical system be evaluated by a licensed electrician.

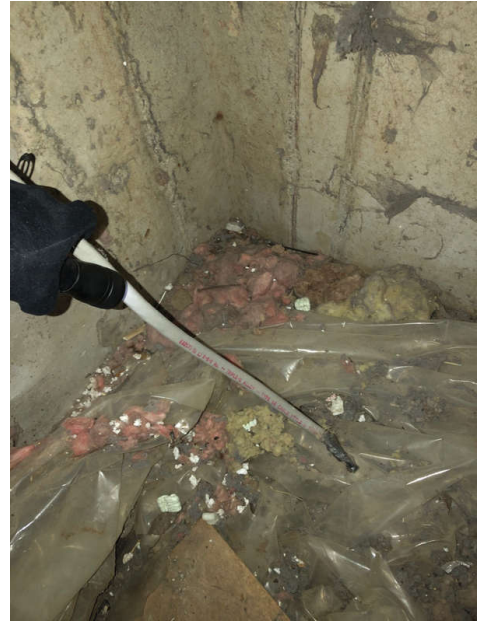
Bare wire ends, or wires with a substandard termination, were found at one or more locations. This is a potential shock hazard. Recommend that a qualified electrician repair as necessary. For example, by cutting wires to length and terminating with wire nuts in a permanently mounted, covered junction box.

Recommendation

Contact a qualified professional.

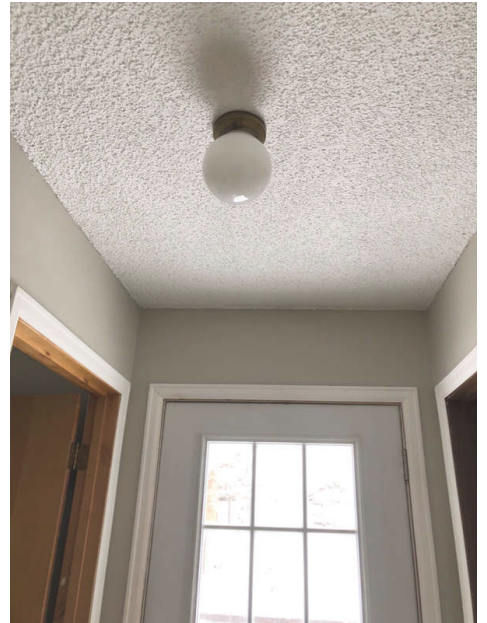
12.4.1 Lighting Fixtures, Switches & Receptacles

BACK DECK ENTRY

One or more lights are not operating. New light bulb possibly needed.

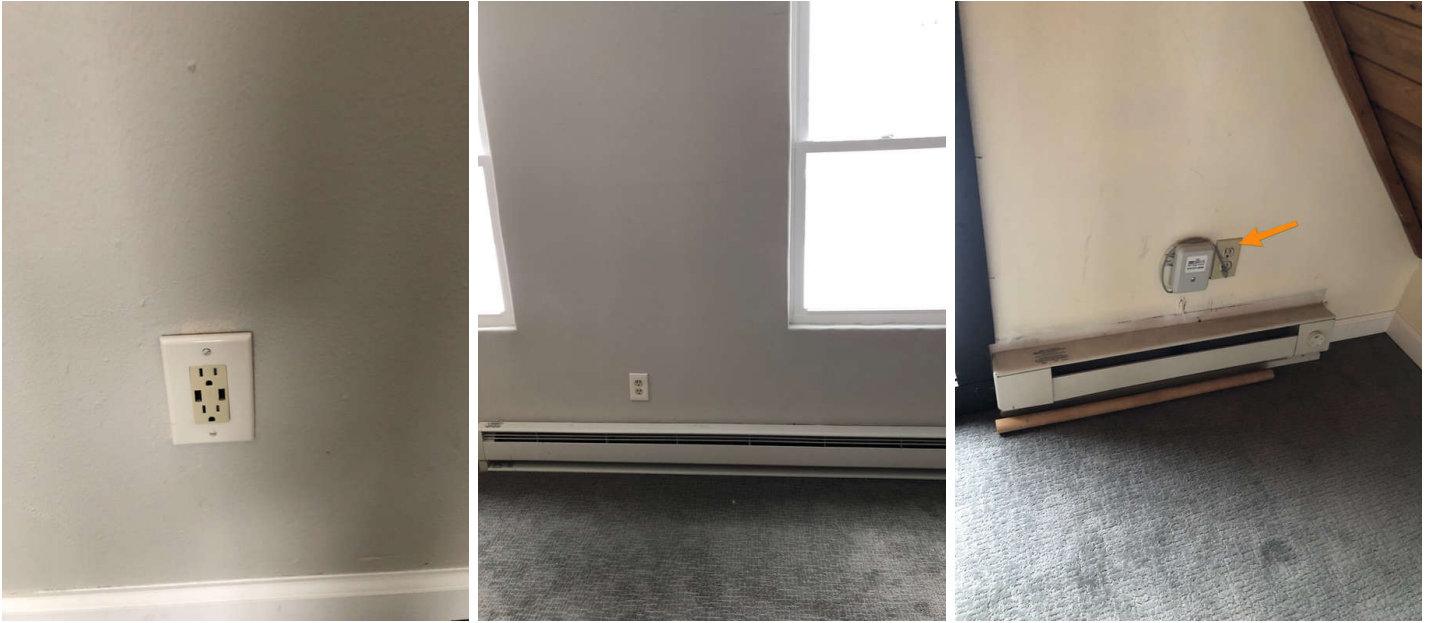
MASTER BEDROOM, NORTHEAST BEDROOM, LOFT

One or more receptacles are loose and not well secured. Recommend licensed electrician repair or replace.
