CREPPS HOME INSPECTION LLC

## RESIDENTIAL REPORT

1234 Main St.  
Coxs Creek KY 40013

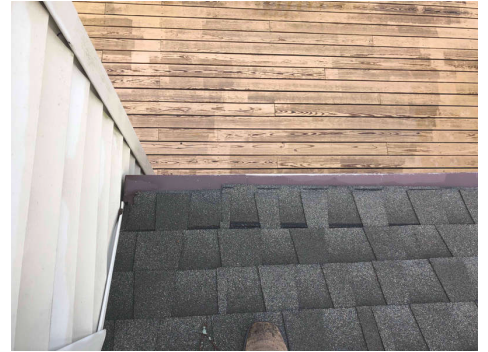
One or more of the shingles were loose or missing. This will allow for moisture intrusion. This will also increase the likelihood of additional wind damage. The cause may or may not be related to poorly bonded shingles, age, or improperly nailed shingles. Further review of the entire roof is recommend for this reason. Repairs, depending on location and other factors, are not typically hard to accomplish.

Contact a qualified roofing professional.

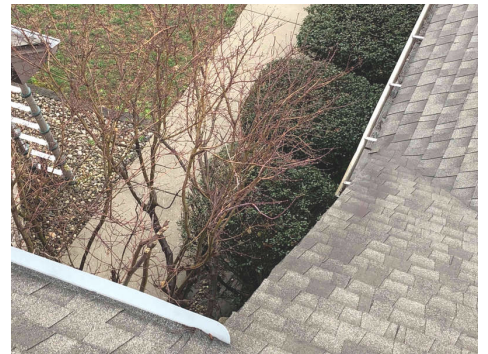
2.1.3 Coverings

**TREE BRANCHES - NO DAMAGE**

Be sure to keep the tree branches trimmed back to prevent damage to the roof.

Contact a handyman or DIY project

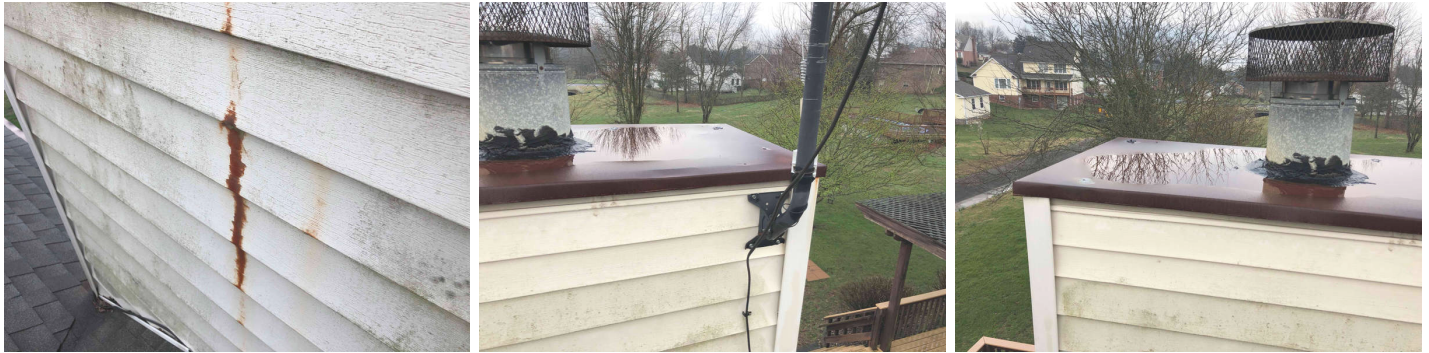
2.6.1 Chimney

The cap was damaged or in need of maintenance. Recommend further review and repair to mitigate the risk of pest intrusion.

Contact a qualified chimney contractor.

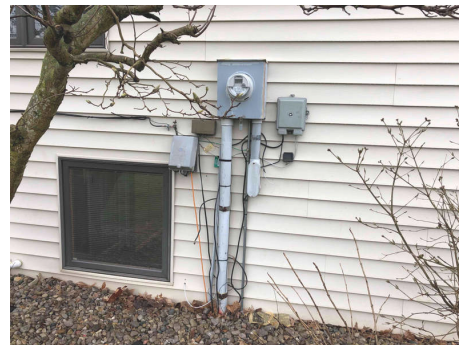
##### Gas, Water, & Electric: Electrical Service

Below Ground

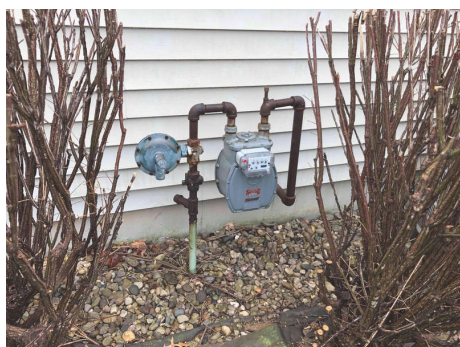
##### Gas, Water, & Electric: Main Gas Shut-off Location

Gas Meter

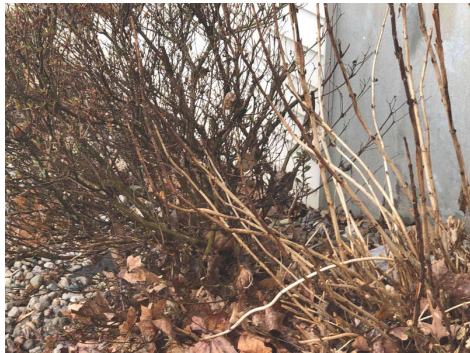
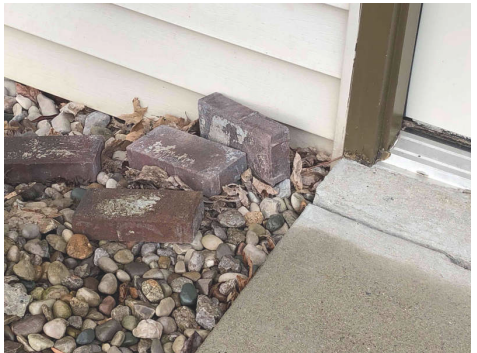
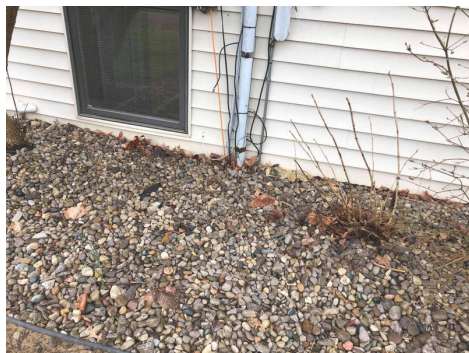
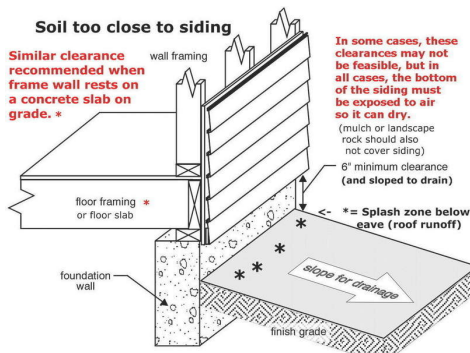
There should be a gap between the siding and the soil/ground. There is a risk of moisture wicking as well as a pathway for wood destroying insects.

Contact a qualified professional.

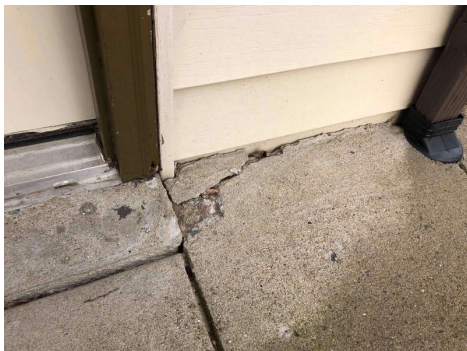
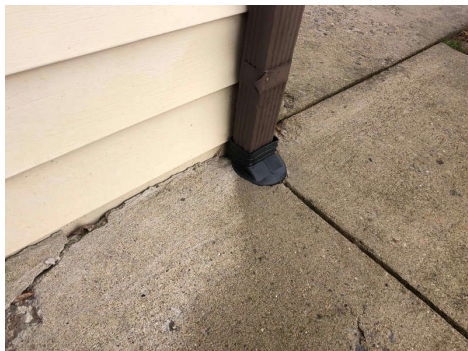
### 3.1.2 Siding, Flashing & Trim

### CONCRETE CLEARANCE

There should be a gap between the siding and the concrete and flashing. No major concerns observed but moisture could get trapped between or behind.

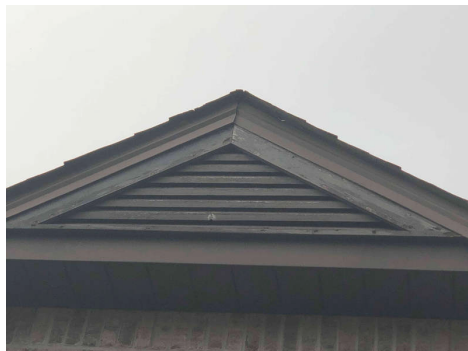
3.1.3 Siding, Flashing & Trim

**FAILING PAINT**

The paint was damaged or failing and preventative measures are needed to mitigate further damage to the siding. Recommend further by a paint or siding contractor for repair costs and options.

Contact a qualified professional.

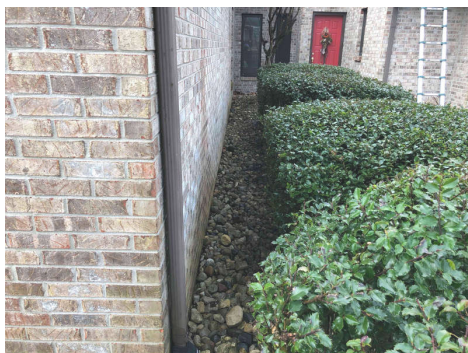
3.3.1 Vegetation, Grading, & Drainage

Grading is sloping towards the home in some areas. This could lead to water intrusion and foundation issues. Recommend qualified landscaper or foundation contractor regrade so water flows away from home.

Contact a qualified landscaping contractor

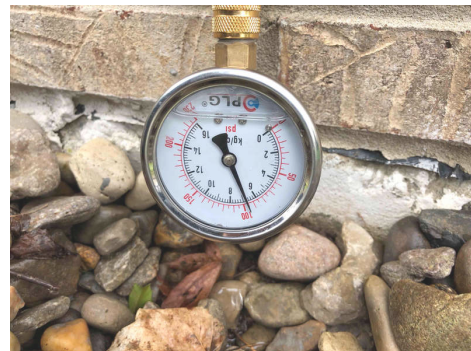
The water pressure inside the residence is exceeds 80 psi and the regulator should be adjusted so that the static pressure is between 60 and 75 psi. However, it may be that the regulator has failed, or is failing, or not present and the pressure cannot be reduced, in which case the regulator should be replaced or installed by a qualified plumber.

Contact a qualified plumbing contractor.

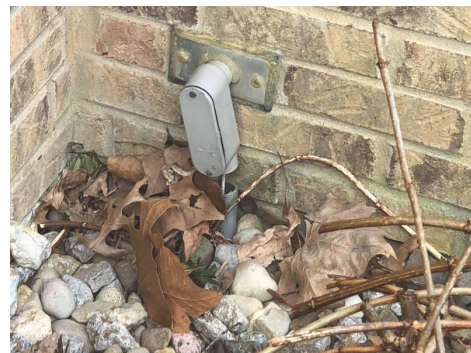
3.4.3 Gas, Water, & Electric

Exposed wires are subject to damage and should be protected and or bury/exterior rated material.

Contact a qualified electrical contractor.

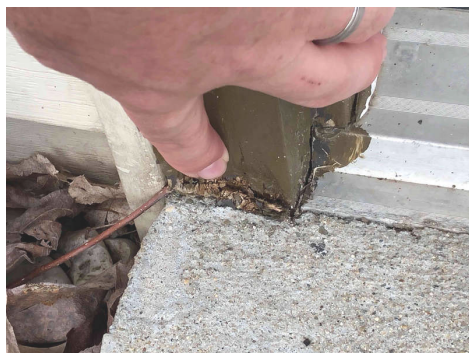
3.5.1 Exterior Doors

**JAMB - MOISTURE DAMAGE**

Some moisture induced degradation was noted at one or more exterior jambs and door. Though this is typical, attempts to prevent furthering and repair damage should be considered. [Here is some more information that may be useful.](#)

Contact a qualified handyman.

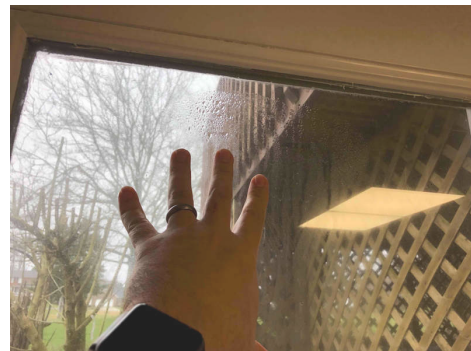
3.5.2 Exterior Doors

**DOOR GLASS HAZING - FAILED SEAL**

The sliding glass door had double-pane glazing in which condensation was visible. This indicates a loss of thermal integrity. The door should be repaired or replaced as necessary by a qualified contractor. Replacement is more typical.

Contact a qualified door repair/installation contractor.

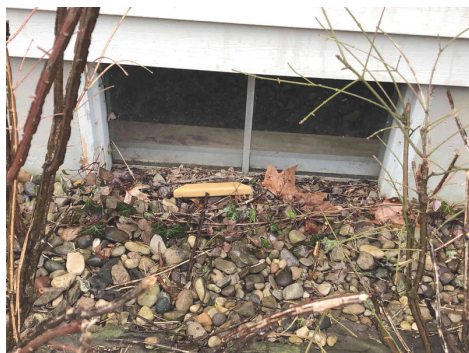
A window well should be installed and the grading should be improved so that water is going away from the foundation.

Contact a handyman or DIY project

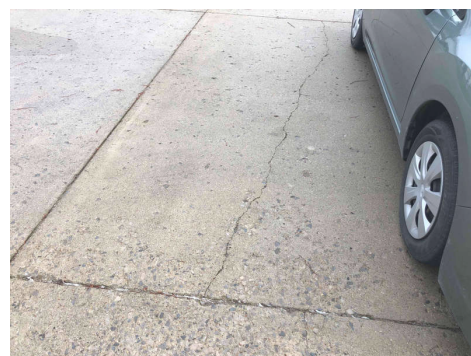
3.7.2 Driveways & Walkways

**TYPICAL CRACKING**

Some typical cracking observed. No significant deficiencies were observed.

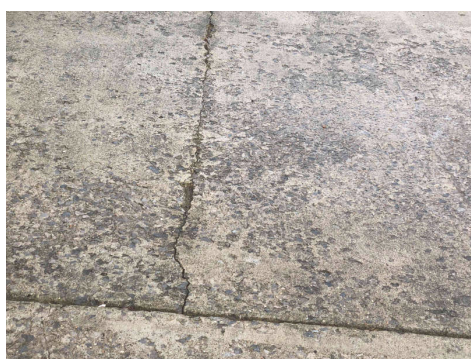
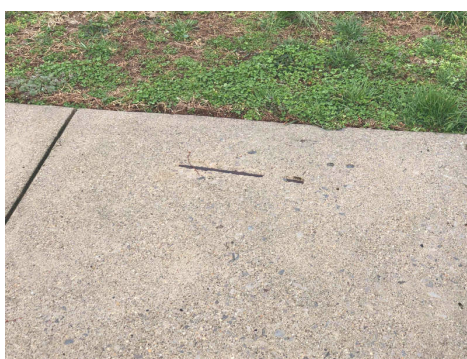
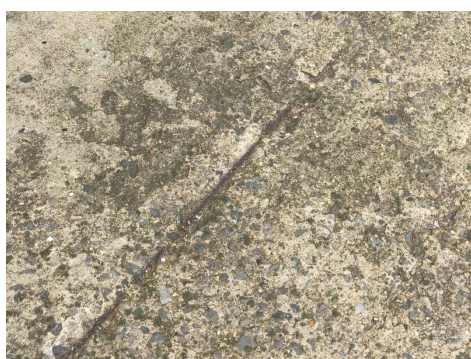
3.7.3 Driveways & Walkways

**DAMAGE**

There was some damage noted at the drive/sidewalk. Some continuation is probable. This appeared to be rebar too close to the surface.

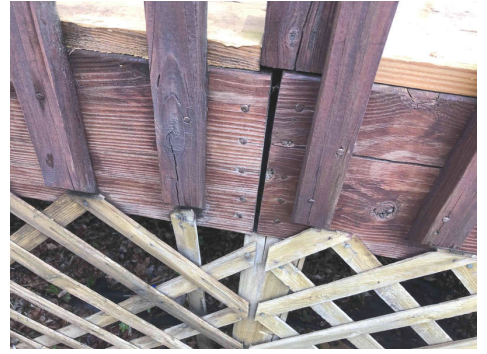
3.8.1 Decks & Balconies

**RIM JOIST MISSING LAG BOLTS**

**\*SAFETY\*** The rim joist on the deck should be bolted to the post. Or the post should be notched. Failure is possible and the deck could collapse. Repair is needed.

Contact a qualified deck contractor.

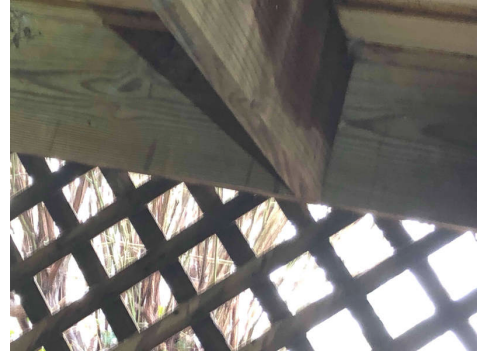
## 3.8.2 Decks &amp; Balconies

**JOIST HANGERS - MISSING**

Joist hanger(s) are missing or improperly installed. This could cause the deck structure to fail. Recommend that joist hangers be properly installed by qualified contractor.

Contact a qualified deck contractor.

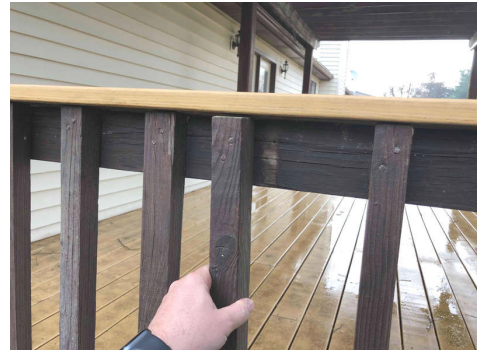
## 3.8.3 Decks &amp; Balconies

**SPINDLES MISSING/DAMAGE**

**\*SAFETY\*** Spindles were damaged, missing, or loose in one or more locations. Fall hazards exist as well as other concerns. Recommend further review and repair.

Contact a qualified deck contractor.

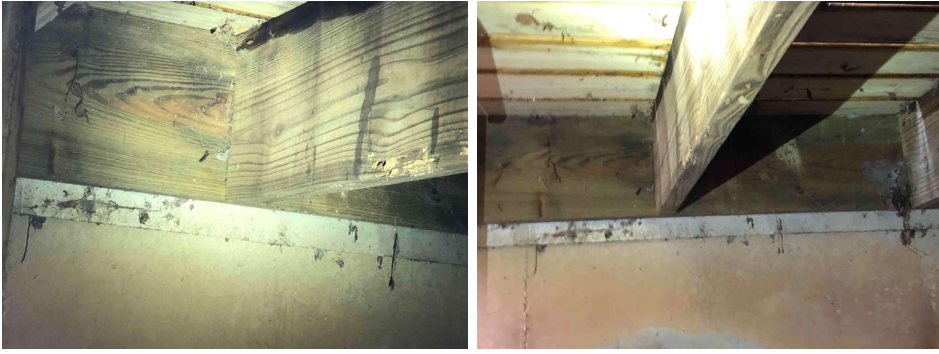
## 3.8.4 Decks &amp; Balconies

**LEDGER BOARD IMPROPERLY INSTALLED**

**\*SAFETY\*** The ledger board did not appear to be adequately attached to the building. This can cause the deck to pull away from the building and possibly collapse. Recommend that the deck and/or ledger board be properly attached by qualified contractor. [Here is an article explaining how a ledger board should be installed.](#)

Contact a qualified deck contractor.

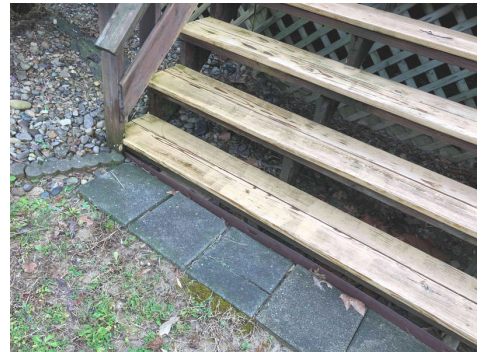
3.10.1 Stairs

**STAIRS - GROUND CONTACT**

Stringers should not be resting on the ground. They are not rated for ground contact. Monitor. Repair as needed.

Contact a qualified deck contractor.

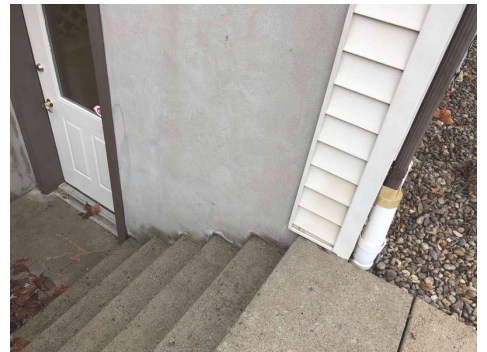
3.10.2 Stairs

**STAIRS - HANDRAIL MISSING**

**\*SAFETY\*** There should be a handrail installed that allows for one handed grasping. This helps minimize the fall hazard. This handrail is too low.

Contact a handyman or DIY project

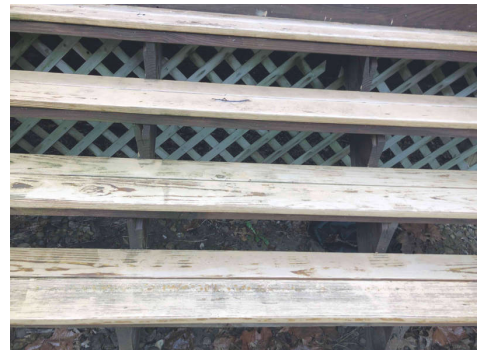
3.10.3 Stairs

**STAIRS - RISERS**

**\*SAFETY\*** There were no risers installed. Risers are recommend because of the potential fall hazard.

Contact a handyman or DIY project

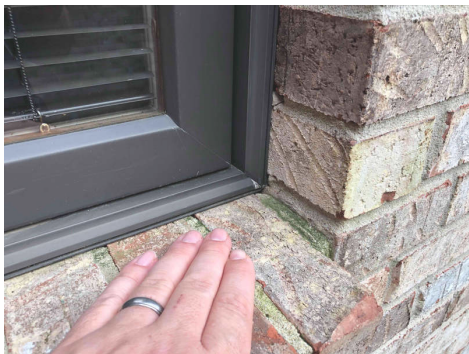
3.11.1 Masonry

**GAPS - WINDOWS/DOORS**

Any gaps around windows or doors should be sealed to mitigate moisture intrusion. Moisture intrusion between the masonry and framing could cause damage to the framing that would be difficult to observed. Recommend making corrections as needed.

Contact a handyman or DIY project

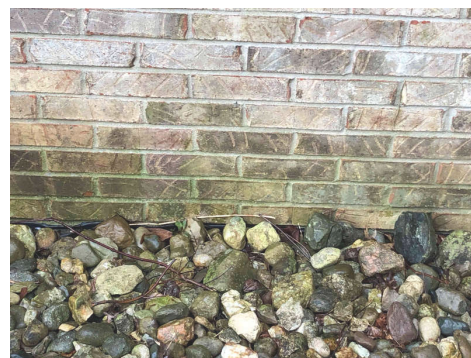
3.11.2 Masonry

**WEEP HOLES**

No means was provided for ventilating the air space behind the brick (weep holes). Good building practice requires ventilating the air space behind the brick to help prevent moisture problems.

Under certain circumstances, this condition can create moisture problems resulting from condensation and excessive moisture levels in wall assembly materials. This condition may also trap any moisture which finds its way into this space from roof or plumbing leaks. Excessive moisture levels in wall materials can also encourage the growth of microbes such as mold fungi.

There is not typically a way to correct this condition because it requires flashing that can not be installed after the fact. Recommend monitoring the area.

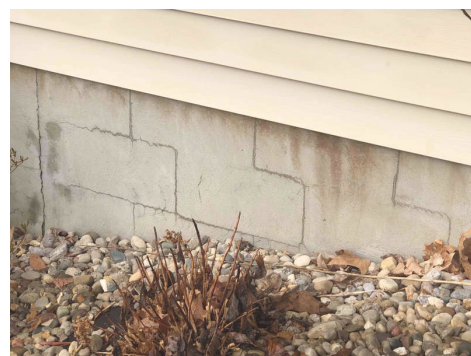
3.12.1 Foundation Perimeter

**CMU CRACKING - MINOR**

Concrete Masonry Unit (CMU) foundation walls had minor stepped cracking visible in mortar joints. Cracking was normal and there were no major concerns. Consider sealing gaps to prevent further damage. Monitor horizontal cracking for any widening and take additional measures if the gap increases.

Contact a handyman or DIY project

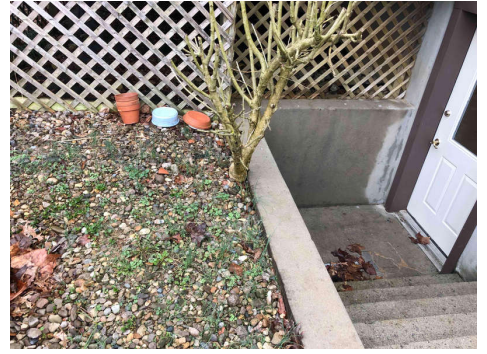
3.13.1 Fence / Retaining Wall

**FALL HAZARD**

**\*SAFETY\*** There were fall hazards noted. Use caution and consider measures to mitigate the risk.

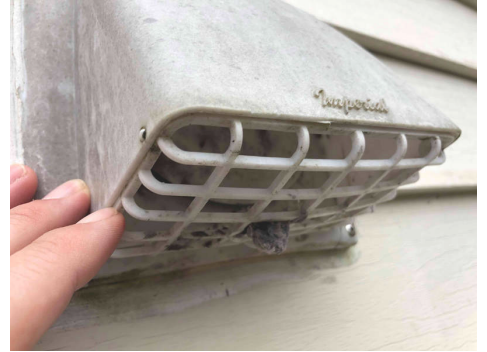
3.14.1 Vents

**SCREEN**

There should not be a screen installed on the dryer vent.  
Recommend making corrections.

Contact a handyman or DIY project

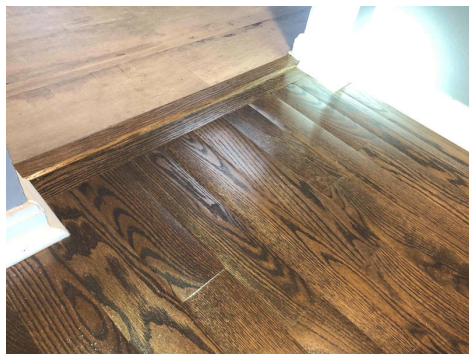
**MOISTURE DAMAGE**

Floors had areas of visible moisture damage. It appeared to be dry and from a previous event.

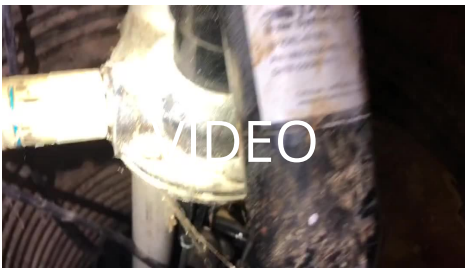
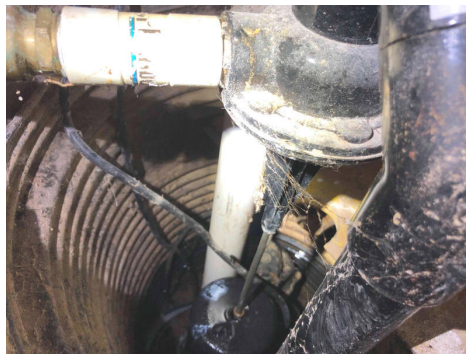
The back up pump was leaking and causing the system to operate more frequently.

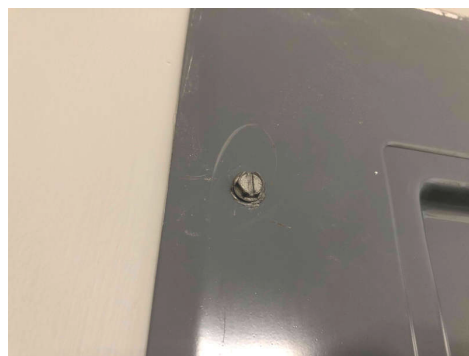
### SCREWS MISSING OR WRONG TYPE

**\*SAFETY\*** Sharp pointed screws were noted or screws were missing. Sharp pointed screws can potentially penetrate a wire. This is a safety hazard. Recommend replacing with the proper machine screw.

Contact a qualified electrical contractor.

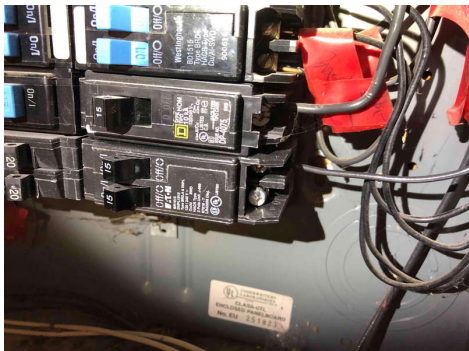
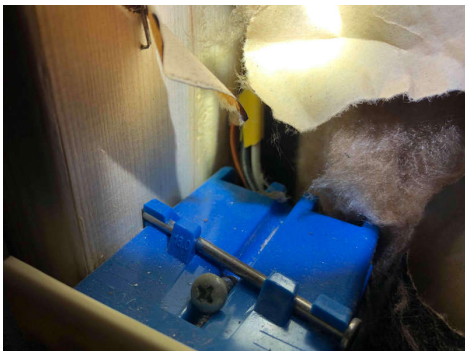
There were a few circuits added but no additional inspection stickers noted. Consider further review.

Contact a qualified electrical contractor.

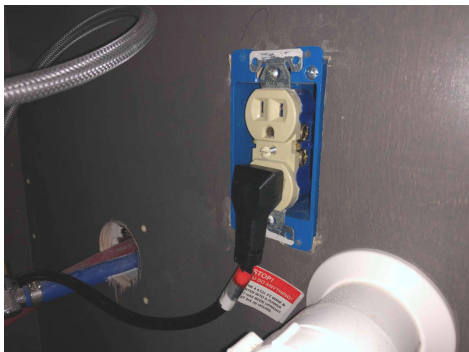
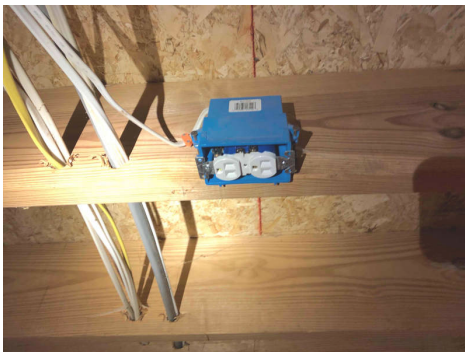
**COVER PLATES MISSING**

**\*SAFETY\*** One or more receptacles are missing a cover plate or the cover was damaged/loose. This causes short and shock risk. Recommend installing plates where needed.

Contact a handyman or DIY project

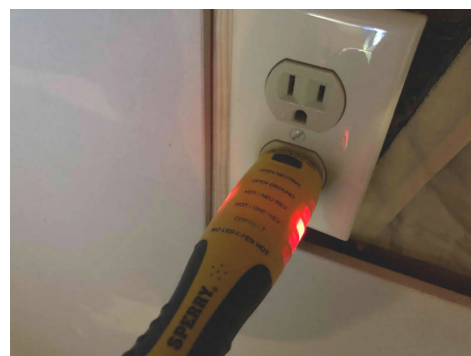
Southwest Basement

One or more receptacles have been wired with reverse polarity. This can create a shock hazard. Recommend licensed electrician evaluate & repair.

Contact a qualified electrical contractor.

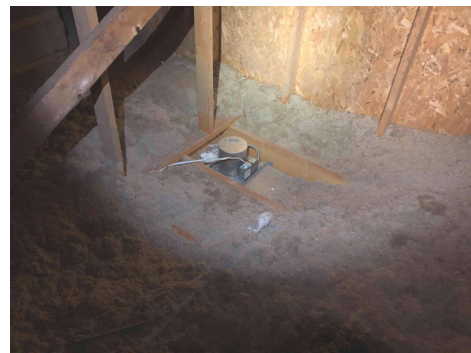
There were gaps noted in the insulation. This can enable energy loss and make some areas more difficult to regulate.

Contact a qualified insulation contractor.

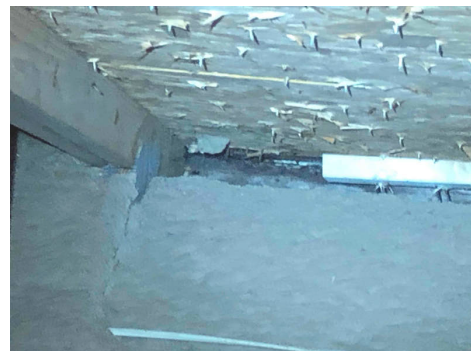
Front

**FACIA DAMAGE/STAINS NOTED**

There was some staining/damage noted at the fascia. Cause not determined. Further review recommended.

Contact a qualified professional.

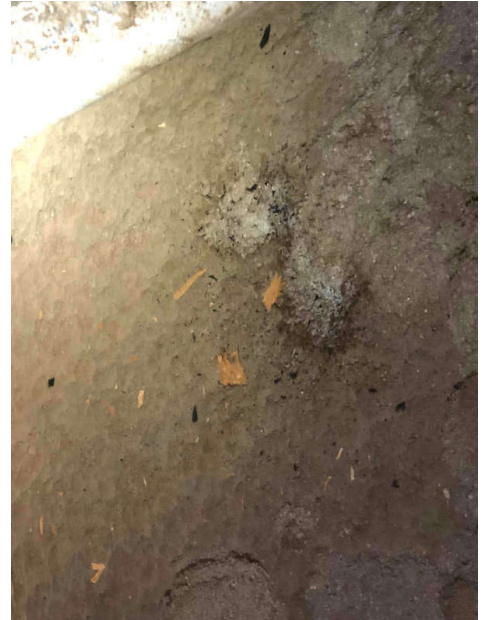
**PREVIOUS LEAKS**

There was some water staining indicating previous water leaks. Previous leaks around plumbing boots.

Recommend monitoring.

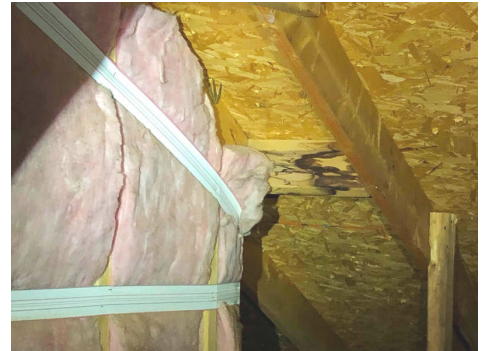
**PREVIOUS LEAKS**

There was some water staining indicating previous water leaks. This could have been the source for the moisture damage at the kitchen floor. No active leaks observed.

Recommend monitoring.

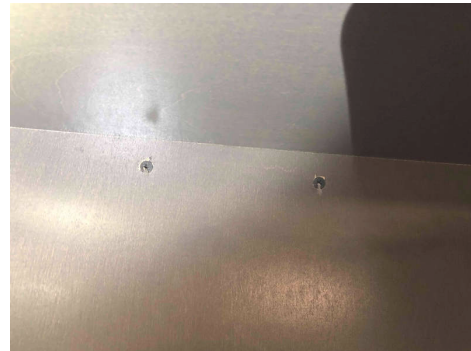
One or more cabinet screws are missing or the wrong type of screws were used. Recommend further review and installing as needed. Drywall screws are tapered and can pull thru the cabinet. Truss head screws should be used.

Contact a handyman or DIY project
