HOT HOME INSPECTIONS

## RESIDENTIAL INSPECTION

1234 Main St.  
Oklahoma City oklahoma 73170

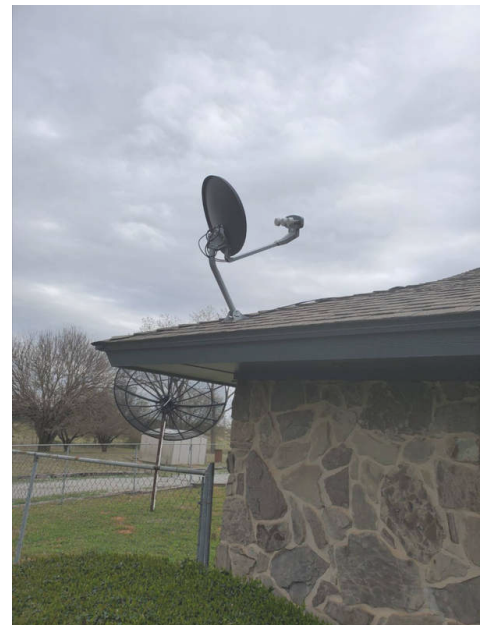
There were one or more areas where a satellite has been secured to the roof surface. Repair/seal these areas as needed.

Contact a qualified professional.

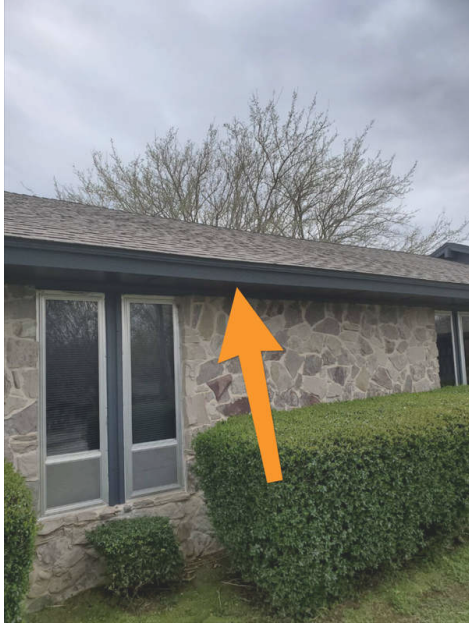
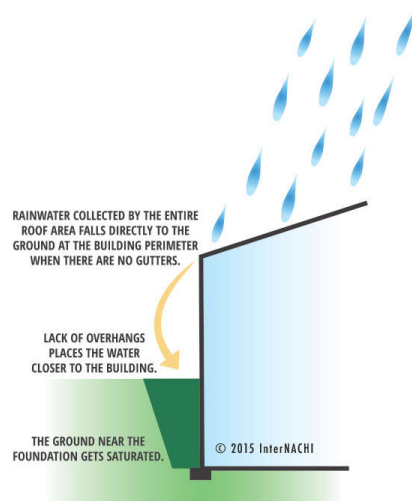
There is no or partial guttering on the structure. We recommend installing guttering to all applicable areas of the structure.

Contact a qualified gutter contractor

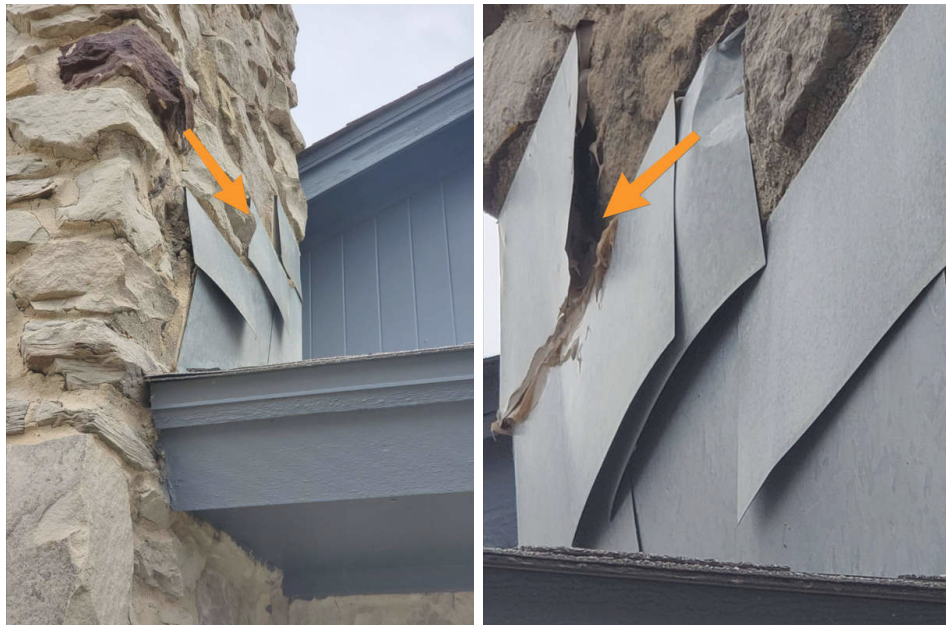
**DAMAGED FLASHING**

One or more flashings are damaged. To prevent possible moisture intrusion into the building structure we recommend having the flashing repaired and/or replaced.

Starting to loosen

Contact a qualified professional.

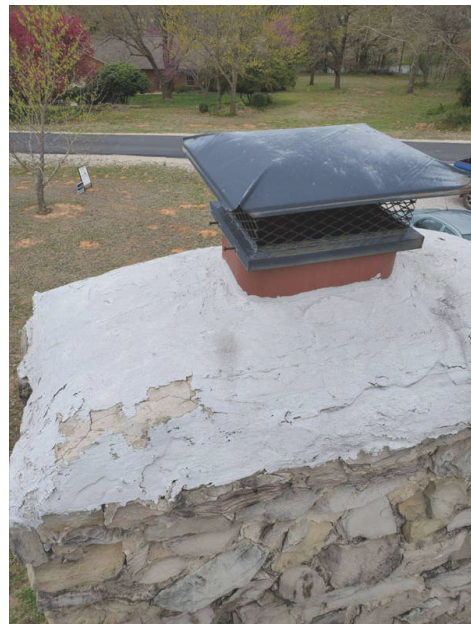
**CHIMNEY CAP- END OF USEFUL LIFE**

The chimney cap had severe deterioration and appeared to be at the end of its useful life. Failure of the cap can allow moisture intrusion of the chimney structure that can damage the structure and create unhealthy conditions.

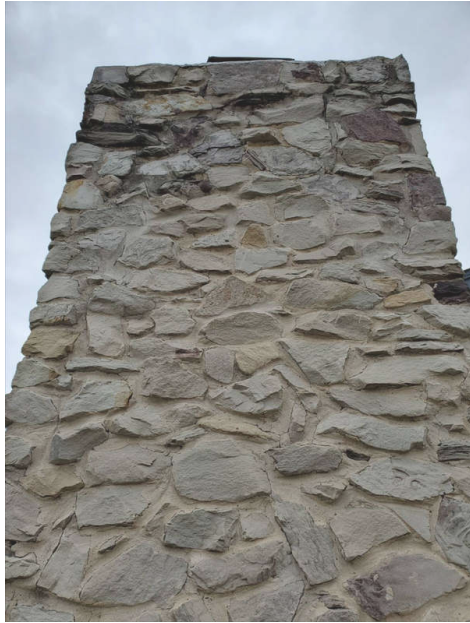
Chimney

### **CRACKED BRICK AND/OR MORTAR**

Seal and monitor brick and/or mortar cracks to prevent moisture intrusion.

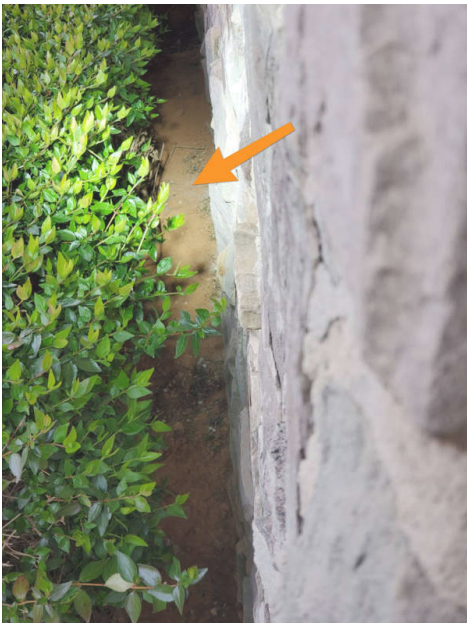
Inadequate clearance between siding and ground. Recommend a minimum ground clearance between bottom of siding and ground of 4". Siding in contact with the ground or soil can provide direct access for wood destroying insects.

Contact a qualified landscaping contractor

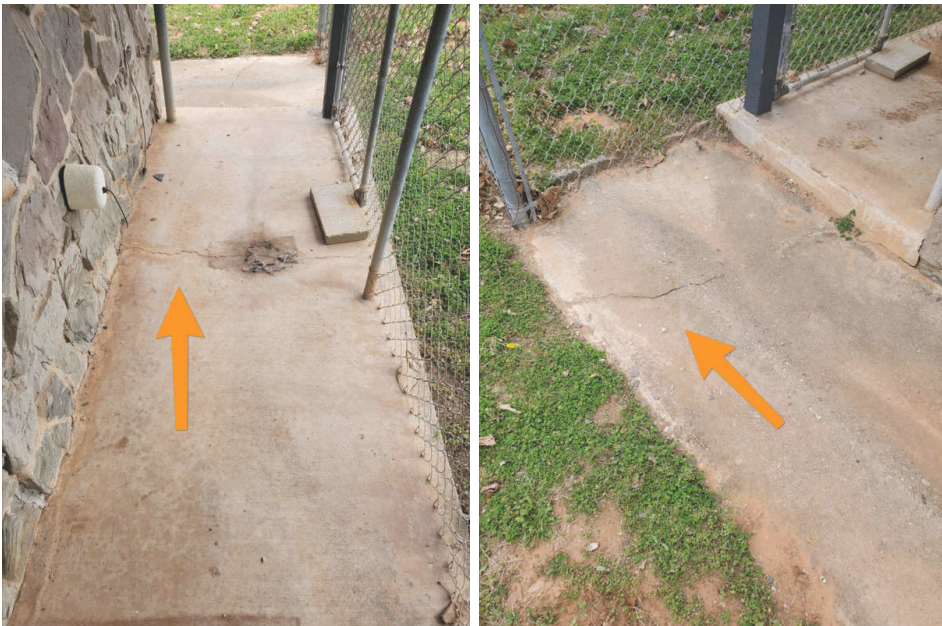
Left side

**WALKWAY CRACKS**

Cracks observed at the walkway. Seal and monitor to prevent further damage. Bigger cracks or settling could cause a tripping hazard.

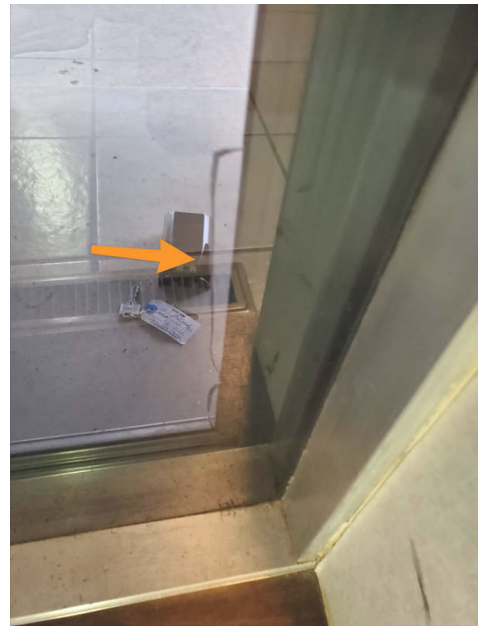
#### **BROKEN GLASS**

One or more windows have broken glass.

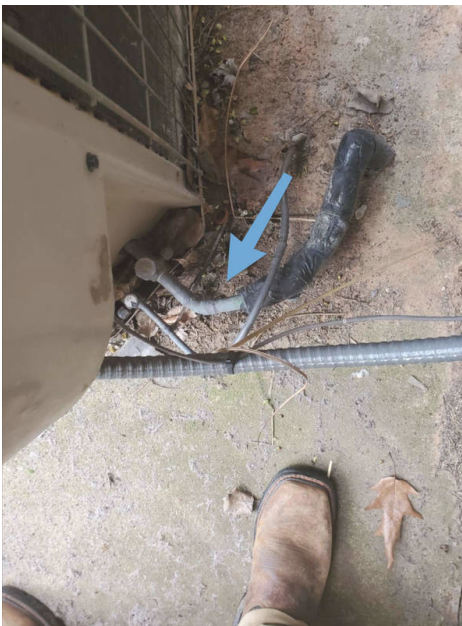
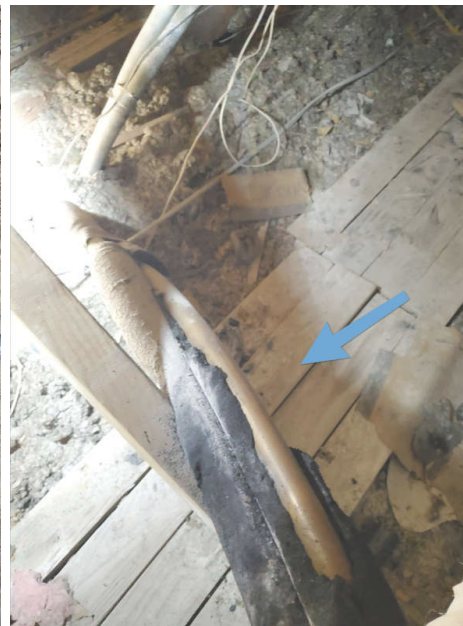
Attic

#### **INSULATION MISSING OR DAMAGED**

Refrigerant line insulation is missing and/or damaged. Missing or damaged insulation on refrigerant lines can cause energy loss and condensation buildup - leading to moisture intrusion. Recommend repair area of concern by owner or hvac contractor.

Contact a qualified HVAC professional.

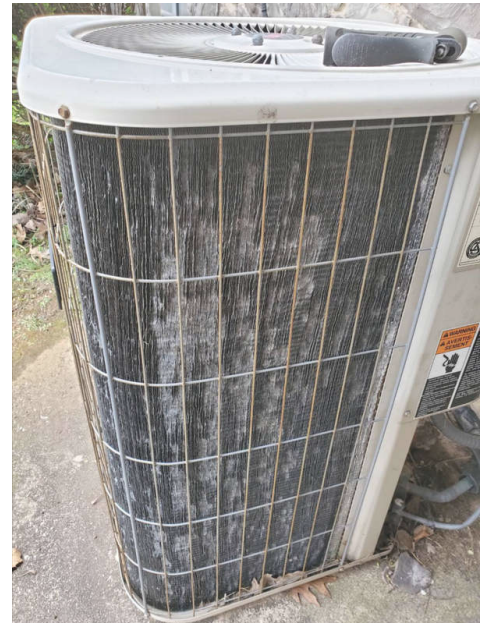
**CONDENSER COIL FINS DAMAGED AND/OR DIRTY**

Condenser coil fins are damaged and/or dirty.

Contact a qualified HVAC professional.

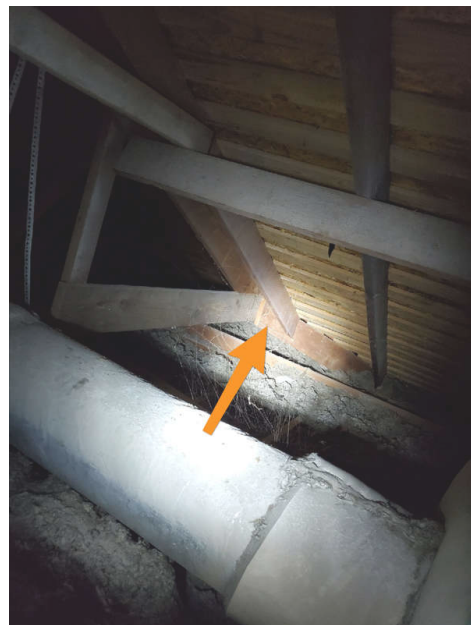
**BROKEN RAFTER**

Very minor

Recommend repairing to protect the integrity of the roof structure.

Contact a qualified professional.

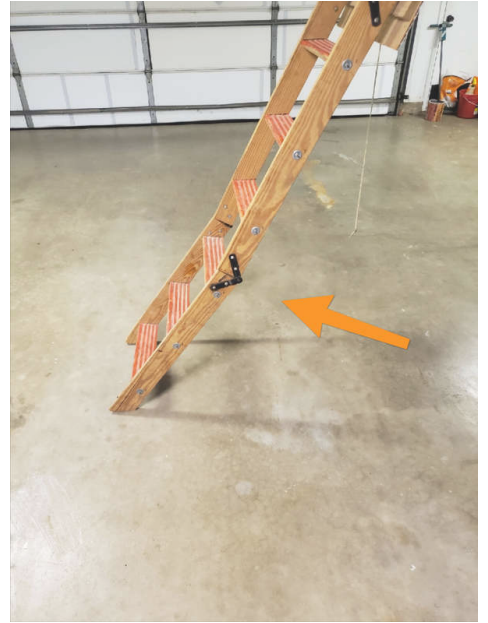
Upgrade/Maintenance Item**ADJUSTMENT NEEDED**

Adjustment is needed at the attic-access pull-down ladder to facilitate personal safety.

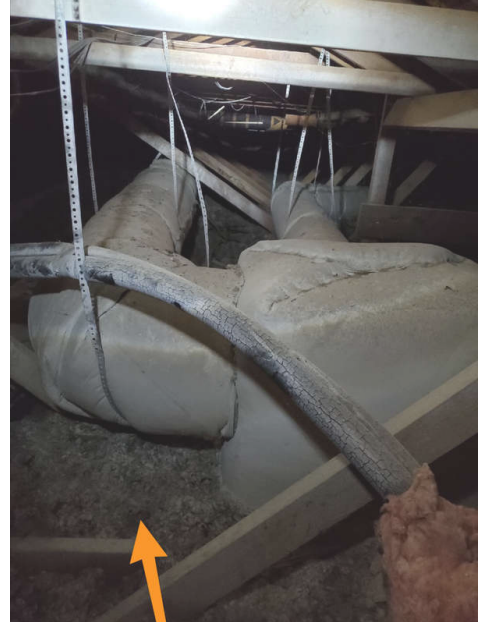
Moderate Item**INSUFFICIENT INSULATION**

Insulation depth was inadequate. To maximize savings on heating and cooling costs, insulation levels should comply with local energy codes. Current standard is R-40. We recommend a qualified attic insulation contractor install additional insulation.

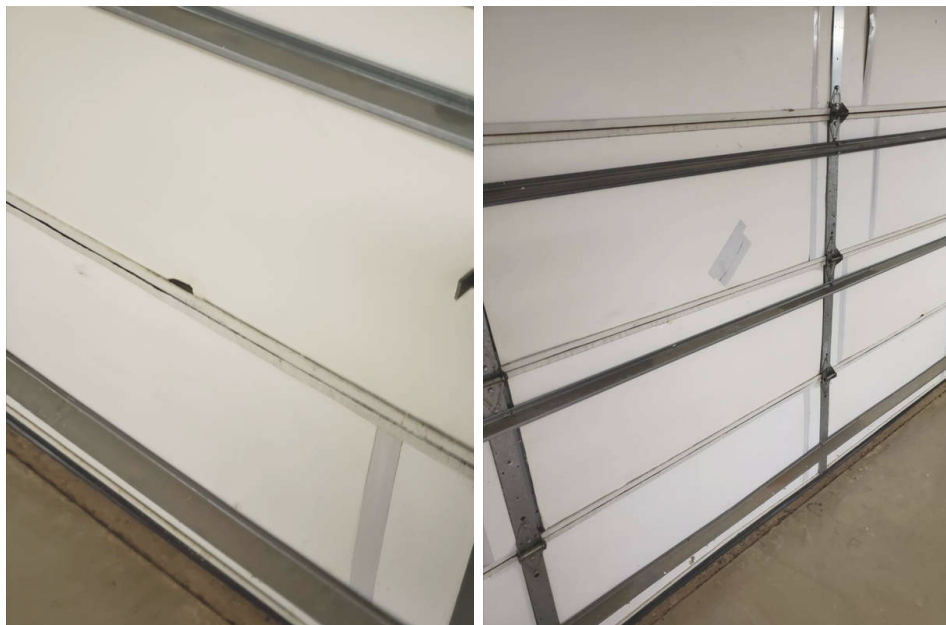
### PANEL DAMAGE

Garage door panel is damaged.

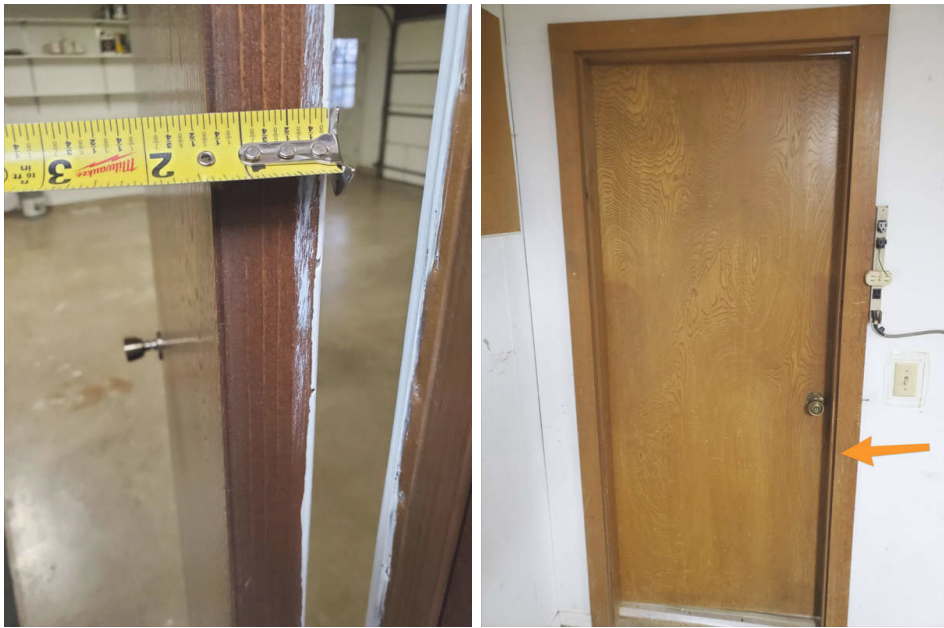
BOTH OCCUPANT DOORS

Door separating garage and home does not meet safety standards. Doors in firewalls must be at least 1 3/8-inch thick, metal/steel, or a 20-minute fire-rated door.

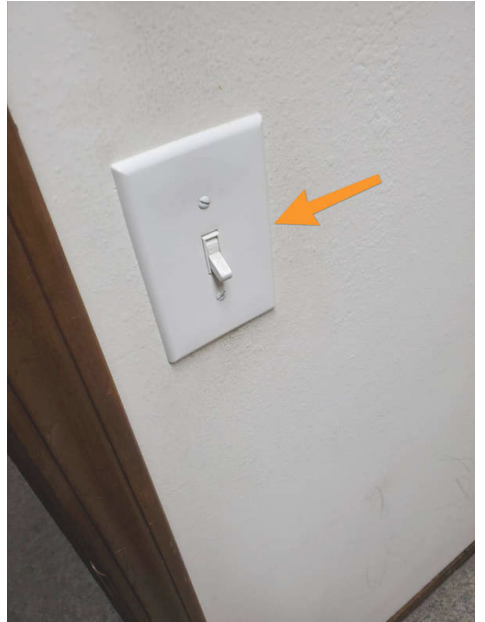
Laundry Room

**UNKNOWN SWITCH**

The inspector was unable to determine what device is controlled by a switch.

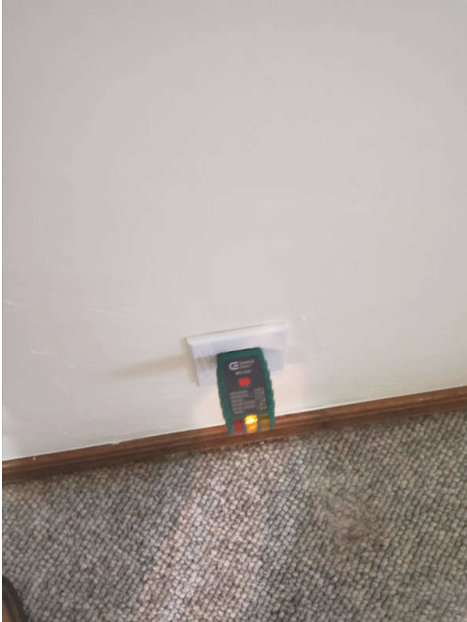
Dining - left of hallway opening

**DAMAGED RECEPTACLE(S)**

An electrical receptacle is damaged.

Contact a qualified electrical contractor.

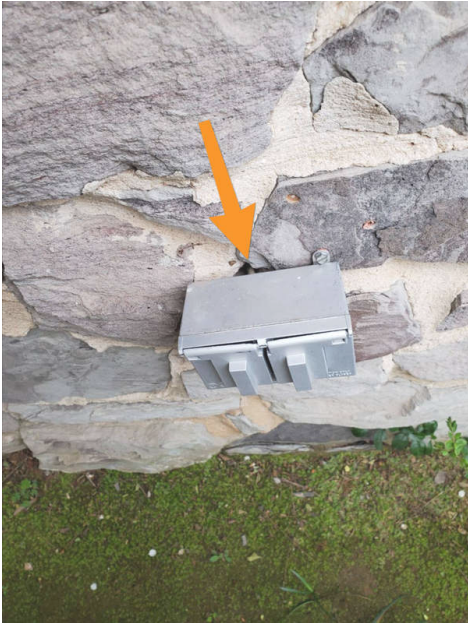
Front right side - loose and needs secured

Contact a qualified electrical contractor.

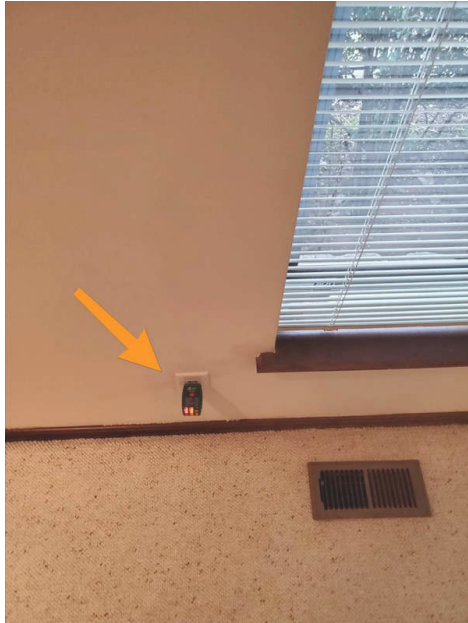
Living between window and fireplace

An electrical receptacle exhibited visible scorching. This condition is a potential fire hazard and should be investigated and any repairs made by a licensed electrician.

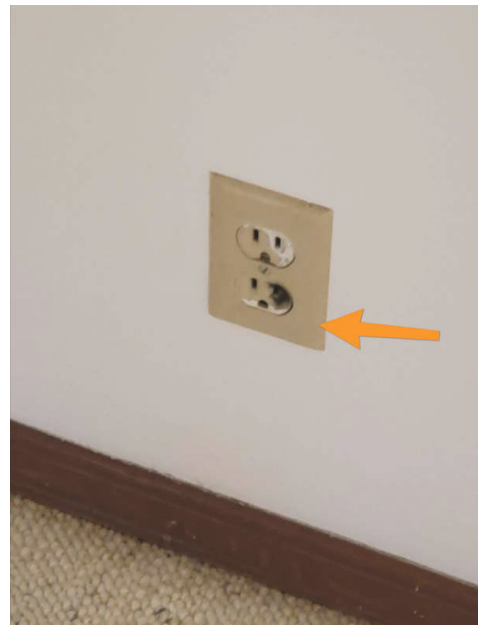
Living room on left

**SCORCHING- RECEPTACLE**

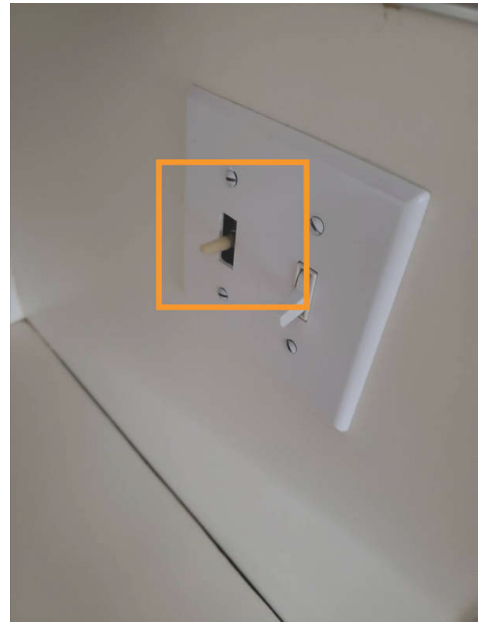
Control kitchen ceiling fan speed

**DAMAGED SWITCH**

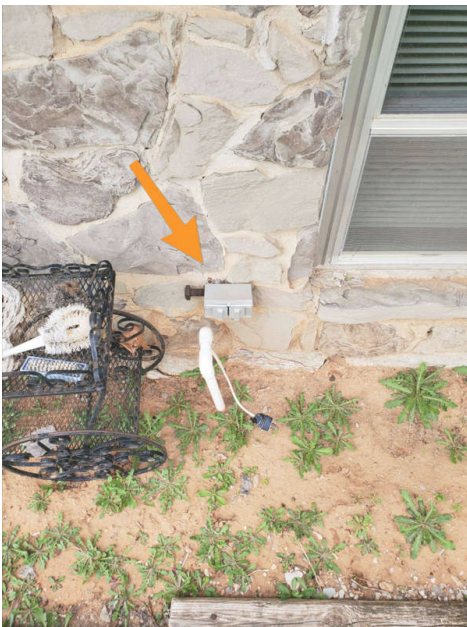
No ground fault circuit interrupter (GFCI) protection of home electrical receptacles was provided at one or more locations in the home at the time of inspection. Although GFCI protection may not have been required at the time the home was built, for safety reasons, the Inspector recommends that electrical receptacles located in basements, crawlspaces, garages, the home exterior, and interior receptacles located within 6 feet of a plumbing fixture be provided with ground fault circuit interrupter (GFCI) protection in good working order to avoid potential electric shock or electrocution hazards. This can be achieved relatively inexpensively by:

Contact a qualified electrical contractor.

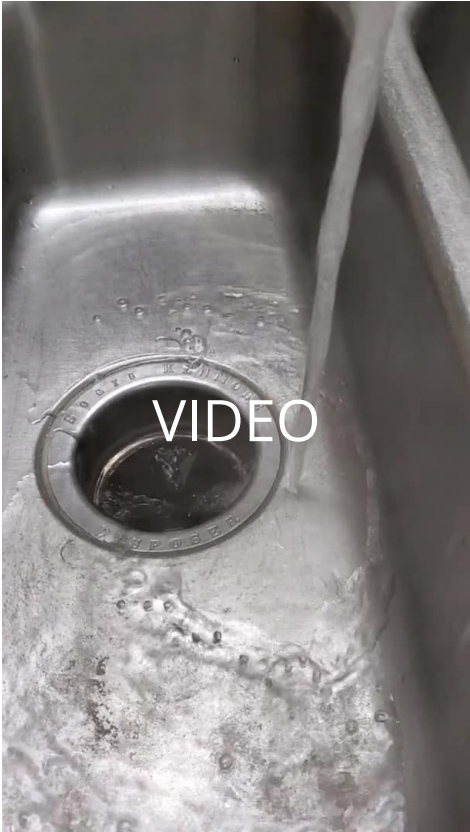
#### NO AIR GAP/ANTI-SIPHON/HIGH-LOOP DEVICE PRESENT

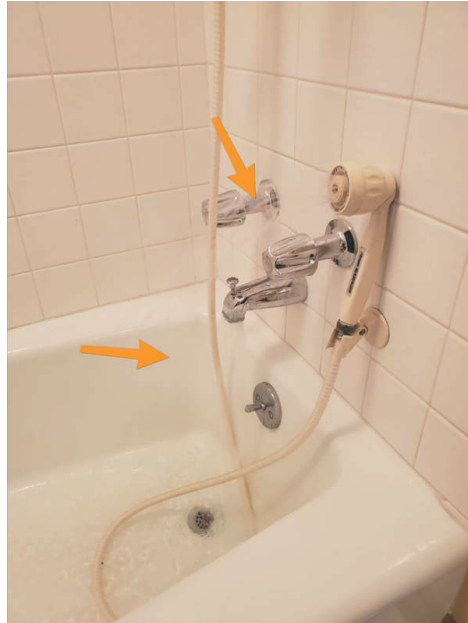
Guest room

One or more plumbing fixtures were damaged. Please see individual pictures and comments for further details.

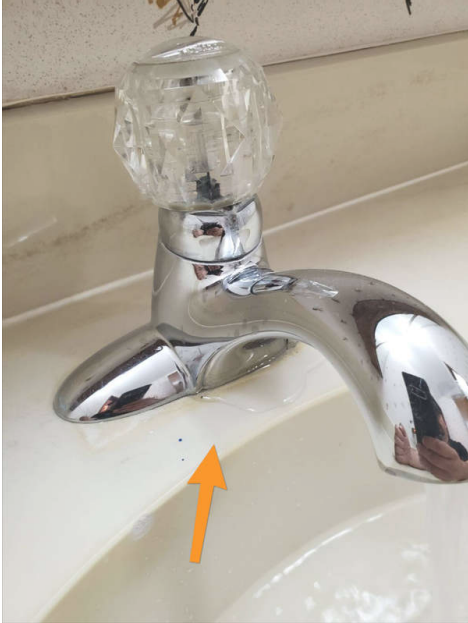
Hallway sink

**PLUMBING FIXTURE LEAKS**

Contact a qualified professional.

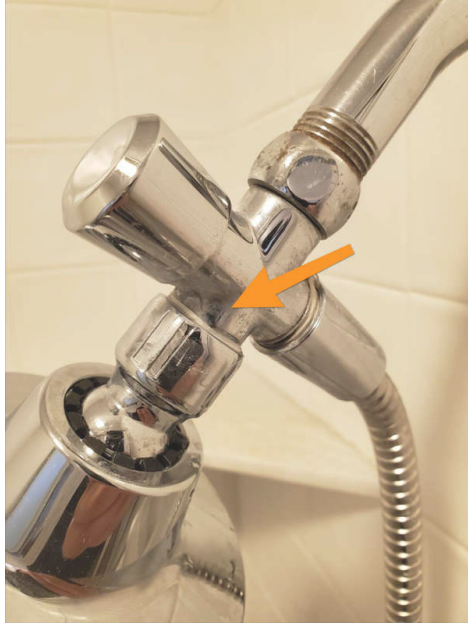
Leak at fitting - master

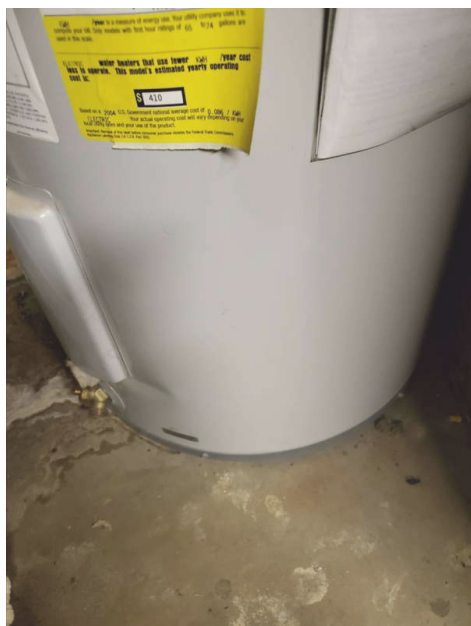
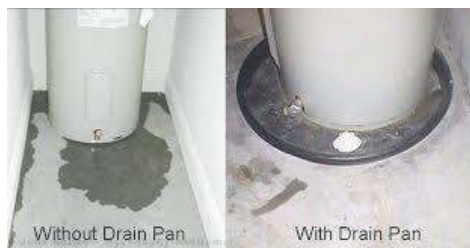
The water heater drain pan had no overflow. To reduce the potential for damage from a leaking tank or pipe fittings, the drip pan should have an overflow pipe installed that discharges to the home exterior or to a floor drain. The Inspector recommends correction by a qualified plumbing contractor.

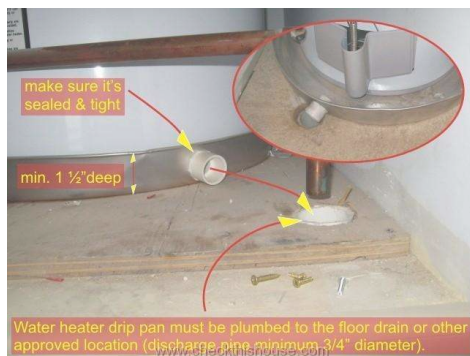
**OVERFLOW PAN NOT PLUMBED TO DRAIN**
