RESIDENTIAL HOME INSPECTION REPORT

1234 Main St.
Raleigh NC 27615

Buyer Name
03/31/2019 9:00AM

Inspector
Travis Stephens

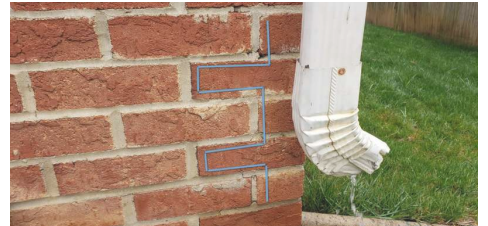
2.1.1 Foundation (Structure)

BRICK STEP CRACKS

There are stair-step cracks in the brick veneer. This may indicate differential settlement of the home, differential brick expansion or be in response to steel lenth expansion or sag. Brick veneer is a protective exterior siding (weather barrier) and does not provide structural support to the home. Repair is recommended to prevent further cracking and allow water penetration behind the brick leading to potential damage of the exterior wall assembly. Please consult a general contractor for further evaluation and direction for repair as necessary.

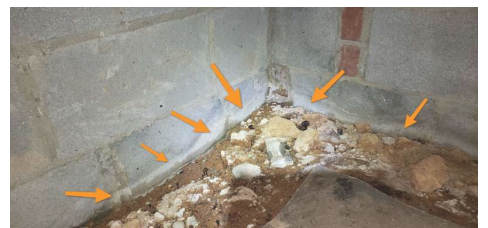
2.1.2 Foundation (Structure)

Efflorescence (salt stains) was noted on the foundation wall. The stains indicate that the foundation has been cyclically wet and dry. While efflorescence is a common cosmetic issue that does not pose a problem itself, it can be an indication of moisture intrusion possibly due to an absent or damaged waterproofing and/or foundation drain system. Please consult a water proofing contractor for further evaluation and direction for repairs as necessary.

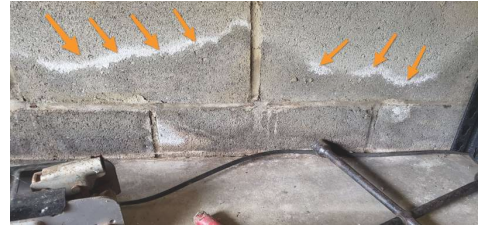
2.1.3 Foundation (Structure)

Efflorescence (salt stains) was noted on the foundation wall in the garage. The stains indicate that the foundation has been cyclically wet and dry. Garage slabs typically have more shallow depth foundations and are more subject to movements in the soil, based upon seasonal changes in temperature, humidity and ground water conditions. Efflorescence is a common cosmetic issue and should not pose a problem unless the capillary (water wicking) actions comes into contact with the framing. The current visible evidence suggests that it does not come into contact with the framing. Please monitor this condition over time and if the efflorescence starts to contact wood framing, please consult a waterproofing contractor for further evaluation.

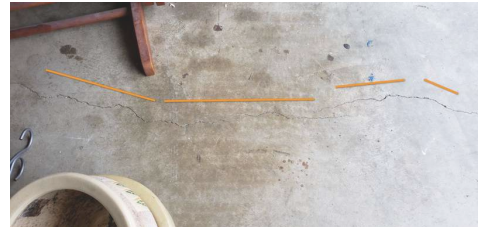
2.1.4 Foundation (Structure)

**MINOR CRACKING,
GARAGE**

When concrete cures (dries and hardens) it shrinks and wants to crack, which is a reason why control joints are used (i.e. provide a weak spot where the concrete can crack without affecting aesthetics, strength, or safety). Cracks may form with or without control joints. Garage slabs typically have more shallow depth foundations and are more subject to movements in the soil, based upon seasonal changes in temperature, humidity and ground water conditions. These cracks should be sealed to prevent potential water penetration into the slab, which can lead to further cracking. Please monitor these cracks over time and if they become larger than 1/8 inch in width, vertical/horizontal displacement is evident on either sides of the crack further evaluation by a general or concrete contractor is recommended.

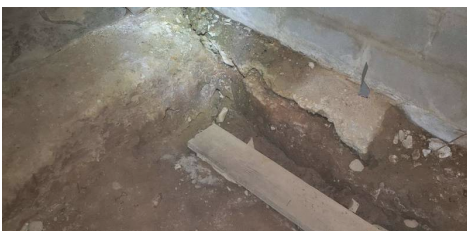
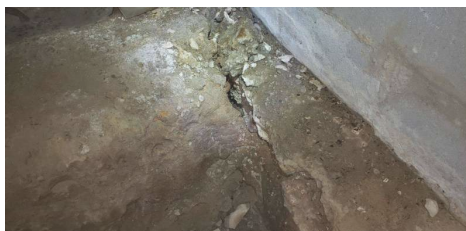
2.1.5 Foundation (Structure)

There is moderate soil erosion in the back of the crawlspace along the footing that is a result of excessive water intrusion at some point in time. Recommend a qualified contractor evaluate and repair as needed.

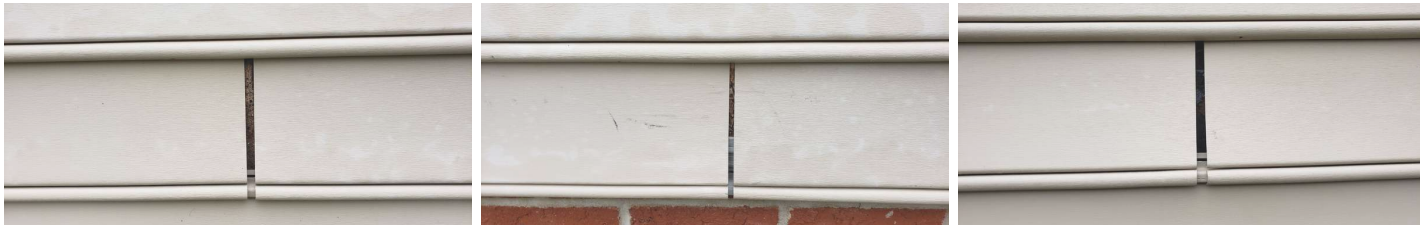
There are gaps in the siding planks, which can allow water penetration behind the siding causing damage to the exterior wall assembly and possibly entering the interior of the home. Please consult a siding or general contractor for further evaluation and repair.

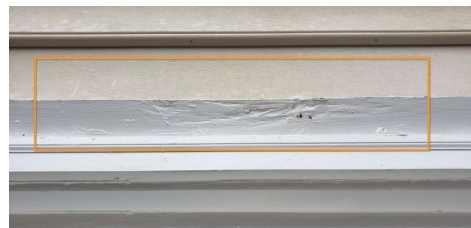
3.1.2 Siding, Flashing & Trim

The trim above the back door is soft to the touch and decayed/damaged, which can allow additional water penetration behind the siding causing damage to the exterior structure or interior of the home. Recommend a qualified contractor repair or replacement as needed.

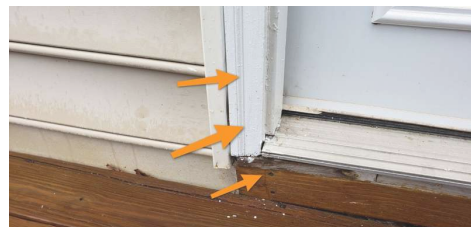
3.1.3 Siding, Flashing & Trim

TRIM LOOSE

The trim on the left side of the back door is loose, which can allow water penetration behind the siding causing damage to the exterior structure or interior of the home. Recommend a qualified contractor repair or replacement as needed.

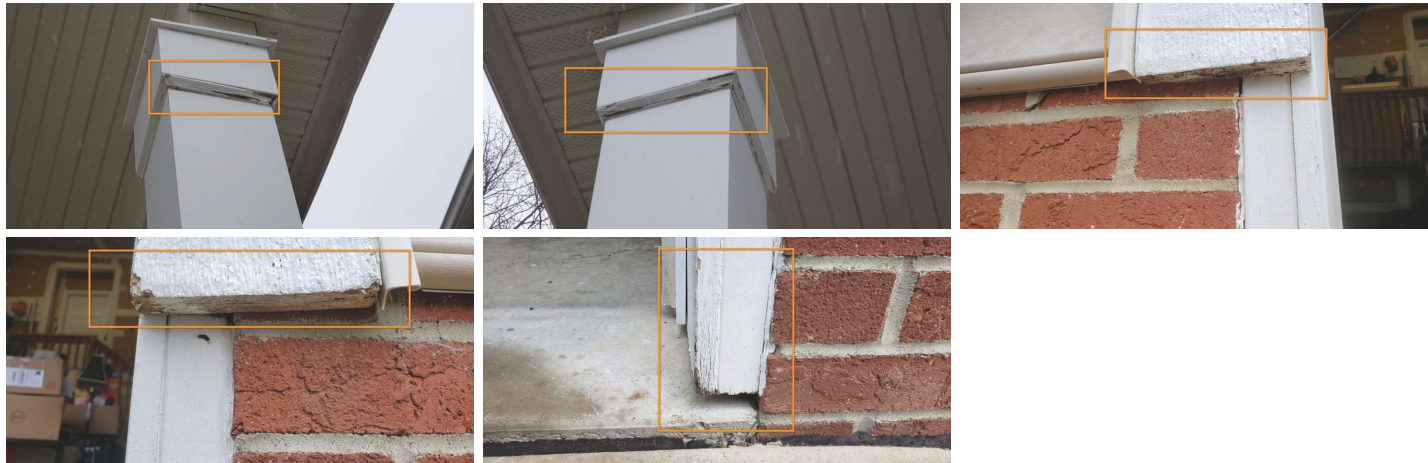
3.1.4 Siding, Flashing & Trim

TRIM DAMAGE

The wood trim above the front porch and around the garage overhead door appears to show visible signs of mild decay/rot. If unrepaired, this can allow water penetration behind the trim causing damage to the structure behind it. Recommend consulting a general contractor for repair or replacement of the damaged materials.

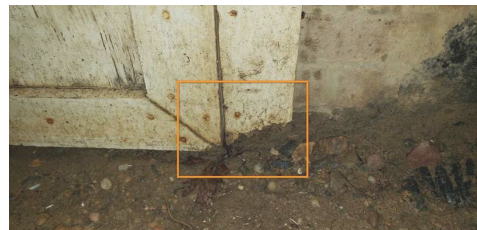
3.2.1 Exterior Doors

CRAWSPACE DOOR DAMAGE

The crawl space door has minor damage, which currently does not prevent it from functioning as intended. Please monitor the condition of the door over the life of the home and consult a general contractor for repair when necessary.

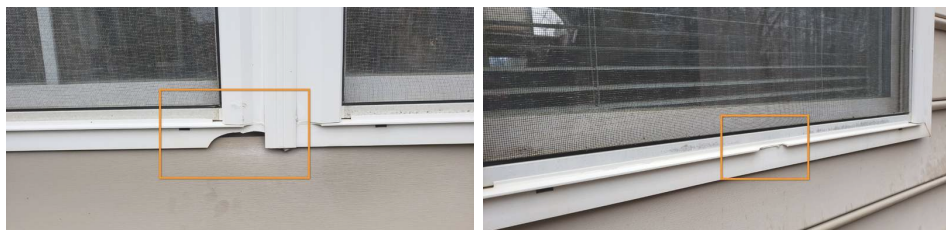
3.3.1 Windows

WINDOW - VINYL - DAMAGED

The vinyl window casing has some minor damage, which may allow water penetration behind the siding. Please consult a general contractor for repair to prevent potential water penetration.

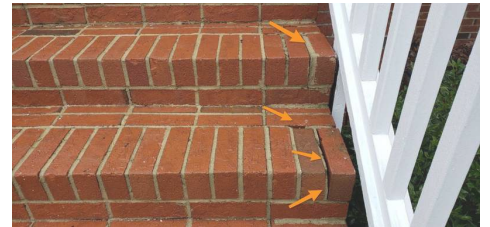
3.5.1 Decks, Balconies, Porches & Steps

The bricks on the steps are missing mortar between the bricks, which can allow the bricks to become loose over time and allow water penetration into the steps. Please have any missing mortar repointed by a general contractor.

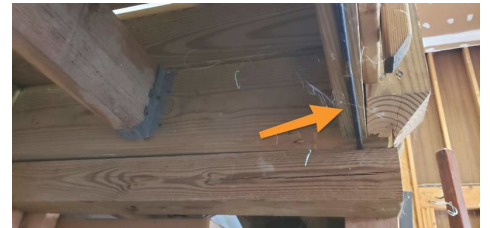
3.5.2 Decks, Balconies, Porches & Steps

A joist on the garage deck is missing a joist hanger. This could cause the deck structure to fail. Recommend that joist hanger be properly repaired by qualified contractor.

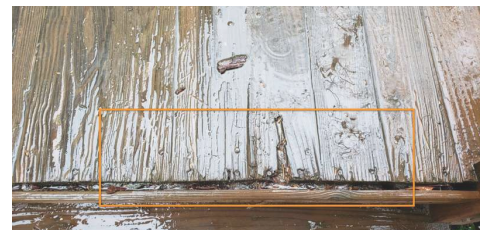
3.5.3 Decks, Balconies, Porches & Steps

DECK - DAMAGED

Some of the deck flooring boards are damaged/decayed, which means they are not offering the appropriate support. Please have any damaged flooring boards replaced. Please consult a general contractor for further evaluation and repair.

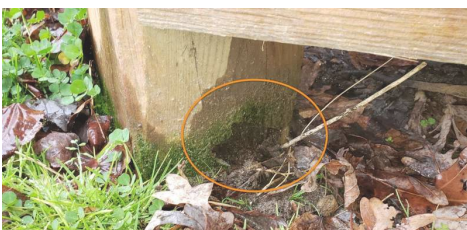
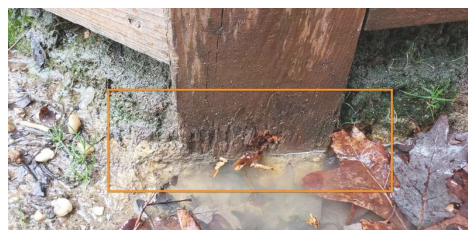
3.5.4 Decks, Balconies, Porches & Steps

DECK SUPPORT DECAY

The deck support posts are deteriorated where they contact the ground and can be easily probed through the post. The affected posts may no longer bear the appropriate weight from the remainder of the deck, which is a safety concern. Please consult a general contractor for further evaluation and repair or replacement of the damaged support posts.

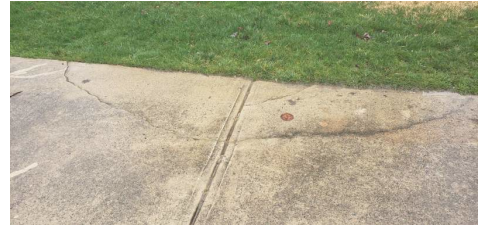
3.7.1 Walkways, Patios & Driveways

DRIVEWAY CRACKING - MINOR

The concrete has minor cracking, which is a common occurrence and does not affect the functionality of the concrete. This cracking may fluctuate based upon seasonal variations in temperature and humidity. The cracks should be repaired using concrete patching or sealant.

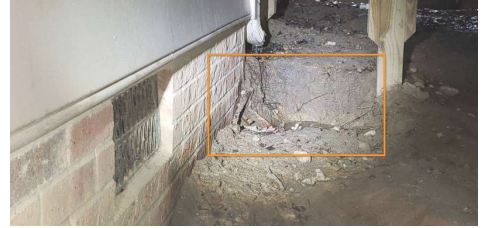
3.8.1 Vegetation, Grading, Drainage & Retaining Walls

There is major erosion under the deck due to the gutter draining directly below the deck. Erosion can lead to structural defects if enough soil is displaced. Please consider installing gutter extensions and/or yard drainage systems to prevent excessive erosion.

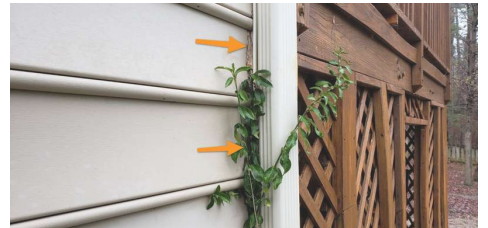
3.8.2 Vegetation, Grading, Drainage & Retaining Walls

Vegetation was noted growing into and/or against the vinyl siding. Vegetation can separate the siding from the home and possibly allow moisture intrusion behind the siding. Recommend removal and monitoring.

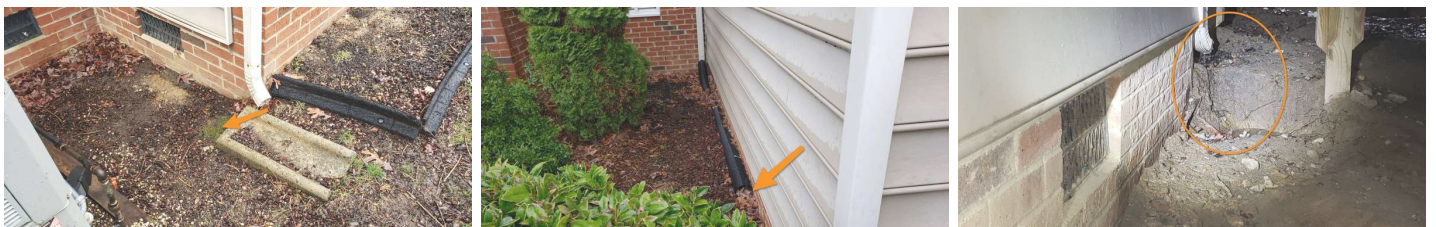
DOWNSPOUTS DRAIN NEAR FOUNDATION

One or more downspouts drain too close to the foundation which may cause water to enter into the home. Recommend a general contractor add/adjust downspout extensions to drain at least 6 feet from the foundation.

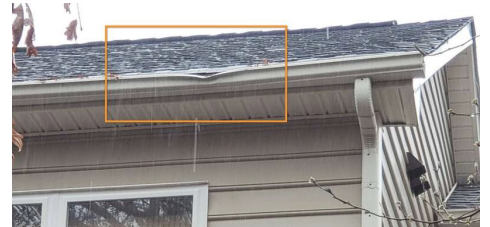
4.2.2 Roof Drainage Systems

GUTTER DAMAGED

The gutter is damaged, which may allow water to spill over the front of the gutter, which prevents the intended drainage of rain water. Please consult a general contractor for repair.

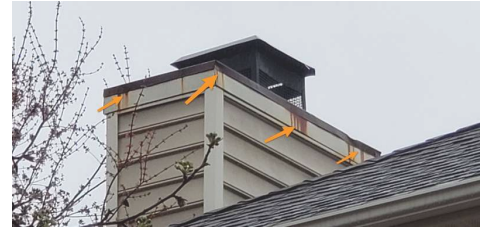
4.4.1 Skylights, Chimneys & Other Roof Penetrations

CHIMNEY CROWN RUST

The chimney crown top plate shows visible moderate/substantial rusting, which can lead to leaking at the chimney. Please consult a general contractor for repair/replacement of the top plate.

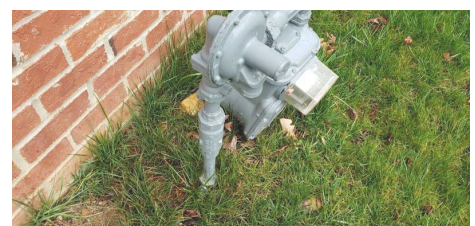
Gas Meter

Location

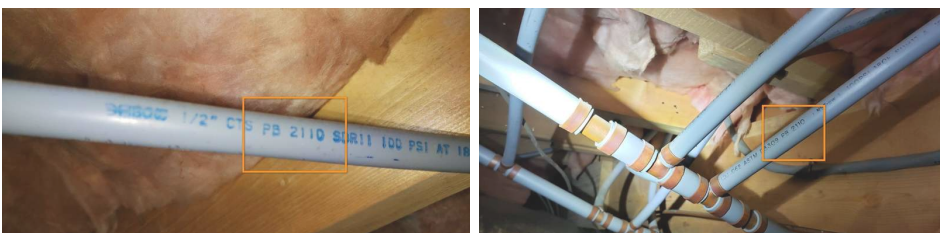
The following is recommended language provided by the NCHILB: Polybutylene plumbing supply lines (PB) are installed in this house. PB was used as water distribution piping in many homes built from the mid 1980s until the mid 1990s. The piping and associated fittings have had a failure rate and subsequent leakage sufficient to have been the subject of several nationwide class action lawsuits. Copper and brass fittings used in later years seem to have reduced the failure rate, but the piping may still fail due to problems with poor installation, improper handling, or chemical reaction with the water supply. The piping in this house has copper fittings. You may wish to have the plumbing system evaluated by a licensed plumbing contractor.

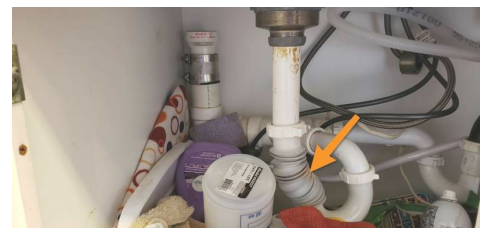
5.2.1 Drain, Waste, & Vent Systems

The sink drain uses an accordion style drain pipe, which is not approved for drain or waste applications since it can harbor debris and bacterial growth. The drain pipe should be replaced with a smooth wall PVC type material. Please consult a plumbing contractor for repair.

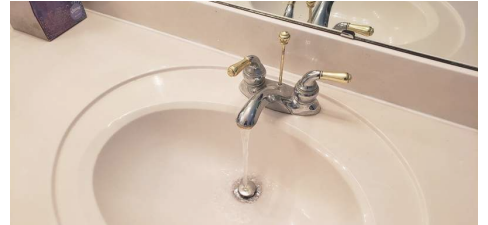
5.3.1 Fixtures & Faucets

When the faucet lift arm is raised the stopper for the sink will not close. Please have the stopper assembly and lift arm repaired so that the stopper can be raised and properly seal the sink as intended.

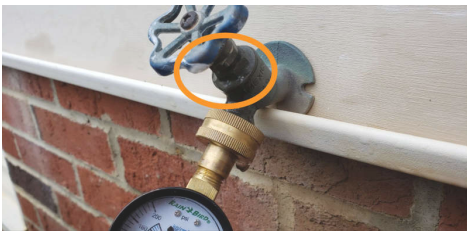
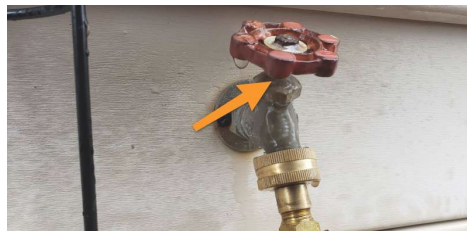
5.3.2 Fixtures & Faucets

HOSE BIBB LEAKING

Multiple hose bibb valves were noted as leaking when turned on. Recommend a qualified contractor repair or replace as necessary.

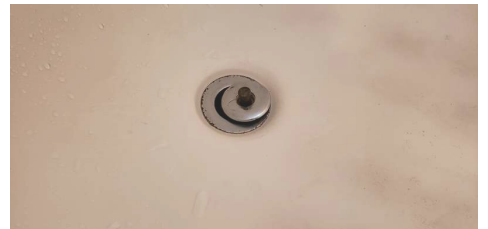
5.4.1 Shower, Tubs & Sinks

TUP STOP BROKEN

The tub stop in the 2nd floor hallway bathroom was damaged/ not connected. Recommend qualified contractor repair or replace and ensure it is functioning properly.

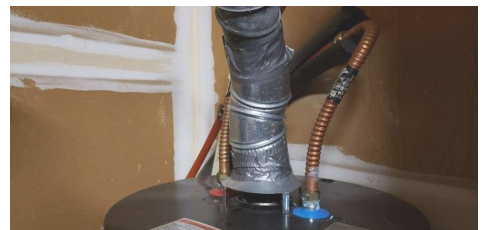
5.5.1 Hot Water Systems

DRAFT HOOD LOOSE

The draft hood for the hot water heater is loose and appears to be secured with duct tape, which can prevent the proper flow of combustion gases and carbon monoxide from entering the vent and exiting the home. This can potentially allow higher levels of carbon monoxide in the home, which is a safety concern. Please consult a plumbing contractor for repair.

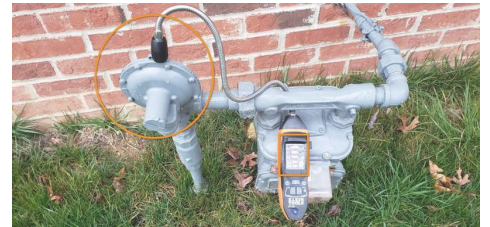
5.6.1 Fuel Storage &
Distribution Systems

A gas leak was noted at the regulator of the gas meter on the right side of the home. Recommend consulting with your local utility company or qualified gas company to repair and evaluate for potential leaks.

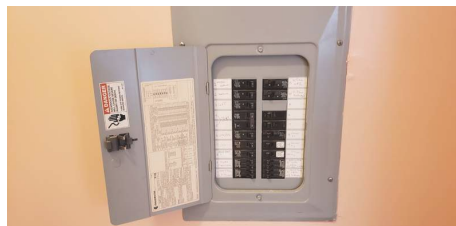
**Branch Wiring Circuits, Breakers
& Fuses: Branch Wiring**

Aluminum, Copper

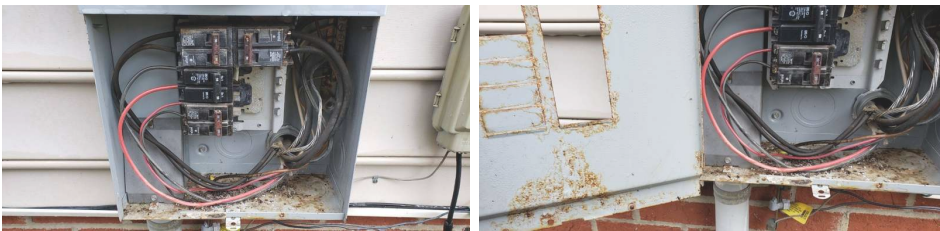
MOISTURE IN ELECTRICAL PANEL

The interior of the electrical panel has dust/debris and rust build up on some of the circuit breaker components. This dust/debris and indications of water penetration (from the rust/moisture) can act as a conductor, which can lead to electric shock, arc flash accidents and potentially cause a fire. Please consult an electrical contractor to clean the interior of the panel and repair/replace components as necessary to prevent these conditions.

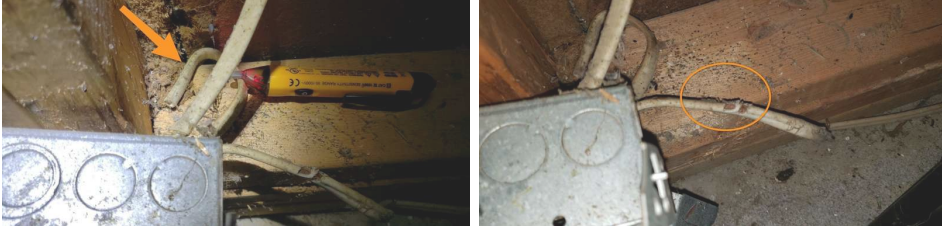
6.3.1 Branch Wiring Circuits, Breakers & Fuses

DAMAGED SHEATHING/ EXPOSED ELECTRICAL

There are loose, uncapped, live electrical wires as well as wire with damaged sheathing, which is a safety hazard. Please consult an electrical contractor to properly terminate the wiring in an approved junction box and repair any damaged wire.

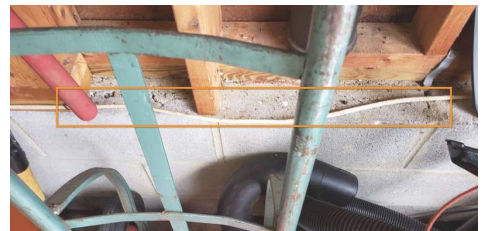
6.3.2 Branch Wiring Circuits, Breakers & Fuses

The electrical wires are not properly secured at the appropriate intervals to the framing or are surface mounted, which can lead to damage of the wiring. Please consult an electrical contractor to review the current configuration and make repairs as necessary.

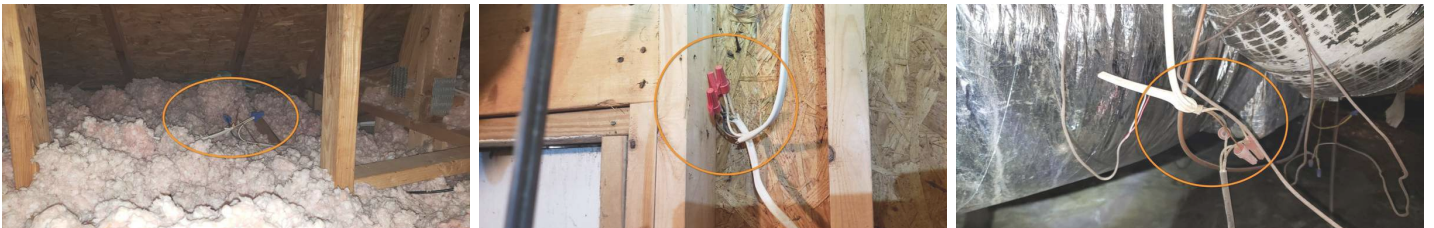
6.3.3 Branch Wiring Circuits, Breakers & Fuses

There is an electrical wire connection made outside of a junction box, which is a shock hazard and safety concern. Please consult an electrical contractor for repair.

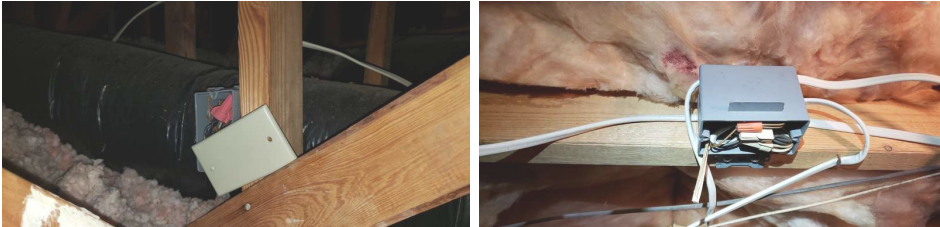
6.4.1 Lighting Fixtures, Switches & Receptacles

COVER PLATES MISSING/LOOSE

Electrical box cover plates are not secured or are missing, which is a potential shock hazard and safety concern. Please have the missing/loose face plate replaced/repaired.

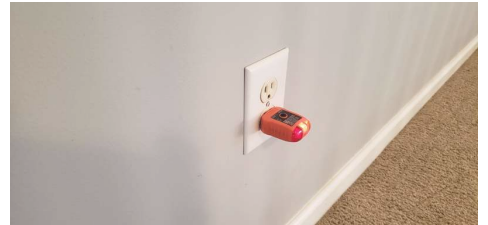
6.4.2 Lighting Fixtures, Switches
& Receptacles

RECEPTACLES - LOOSE INTERIOR

The receptacle box is loose, which can cause damage to the wiring and is a safety concern. Please consult a general contractor for repair.

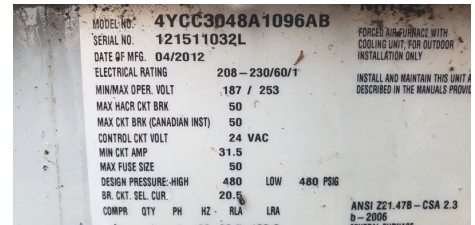
Equipment: Heat Unit 1

Trane

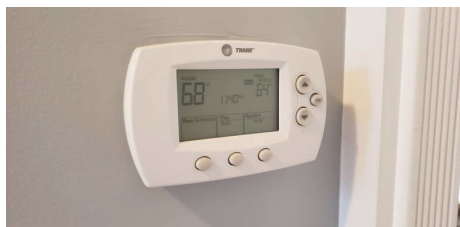
Thermostat Location

Hallway

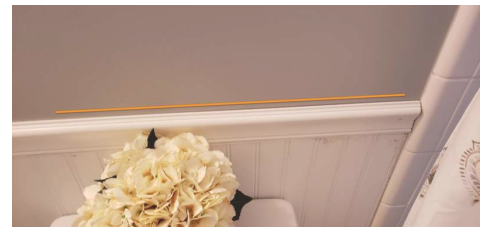
The trim in the 2nd floor hallway bathroom behind the toilet is loose. Recommend repair by a qualified contractor.

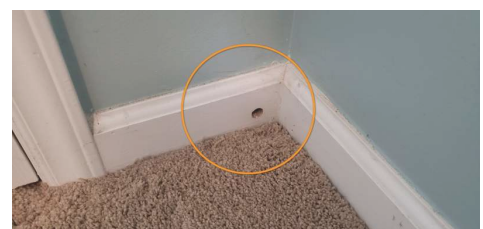
9.1.2 Walls

There is a hole in the baseboard in the 2nd floor right bedroom. Recommend repair by a qualified contractor.

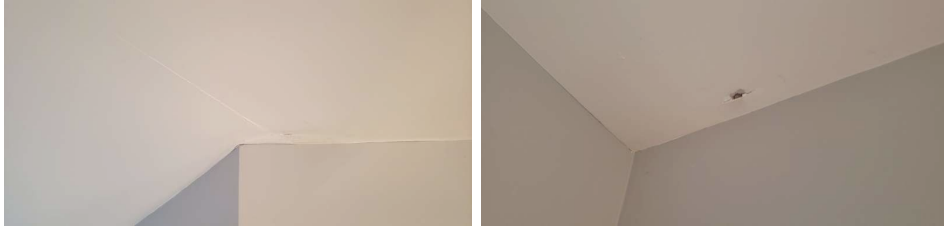
9.2.1 Ceilings

Minor damage or deterioration to the ceiling was visible in the 2nd floor loft and 2nd floor hallway at the time of the inspection. Recommend repair by a qualified contractor.

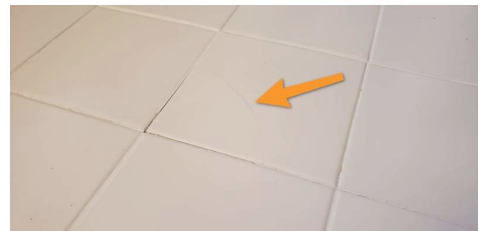
9.3.1 Floors

The master bathroom had a cracked floor tile visible at the time of the inspection. Recommend repair by a qualified contractor to reduce further damage and possible moisture intrusion in the floor.

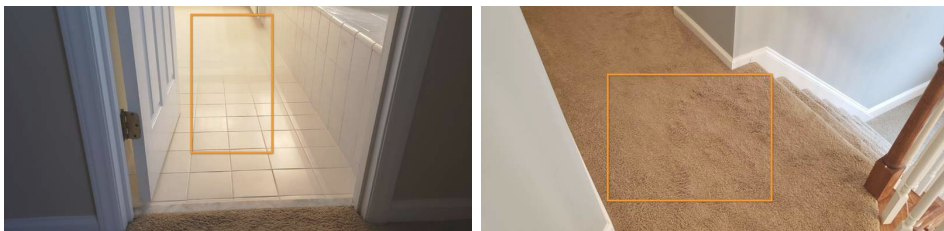
9.3.2 Floors

The floor makes a creaking and popping sound when being walked on. This is not usually a structural concern and may be due too loose subfloor materials or subfloor attachment to the floor joists. Please consult a general contractor for further evaluation to determine the cause for the concern and repair as necessary.

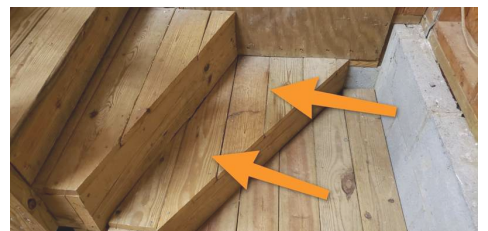
9.4.1 Steps, Stairways & Railings

One of the steps in the garage stairwell is loose and could pose a trip hazard. Recommend a qualified contractor repair as needed to secure.

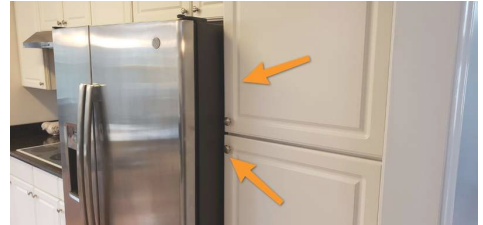
9.5.1 Countertops & Cabinets

Cabinet doors are not closing all the way on 1 or more of the cabinets. This may be due to poor hinges or normal usage wear and tear. Recommend qualified contractor repair as needed.

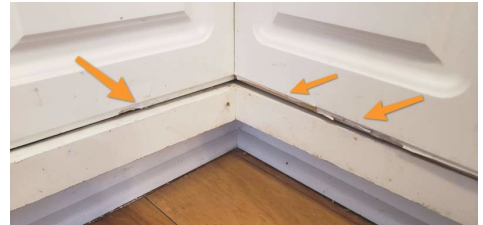
9.5.2 Countertops & Cabinets

The rotating corner cabinet in the kitchen has minor damage along the bottom of the door. Recommend repair by a qualified contractor as necessary.

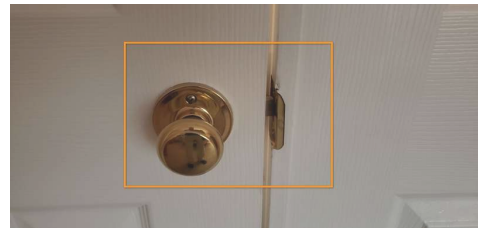
9.6.1 Doors

The double doors leading into the master bedroom would not close and latch as intended (i.e. the latch mechanism is not aligned with the strike plate on the door frame). Please consult a general contractor to adjust the alignment of the strike plate.

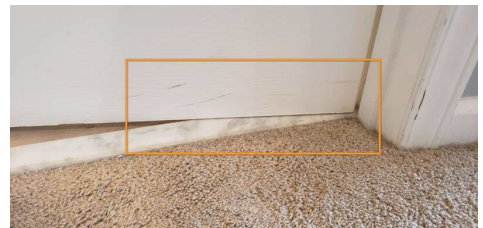
9.6.2 Doors

The 2nd floor bathroom door rubs on the threshold during operation, which can damage the flooring and/or the door. Please consult a general contractor for repair.

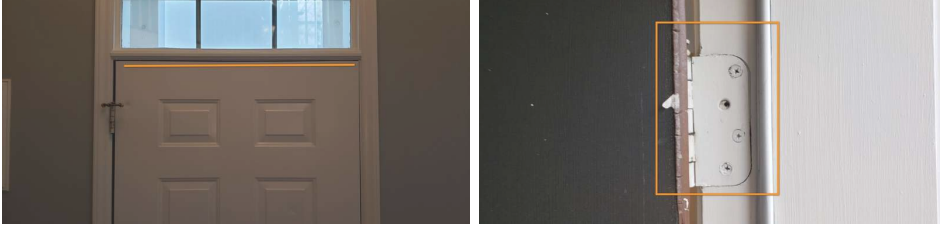
9.6.3 Doors

The front door is visibly out of square/ not aligned properly possibly due to the top hinge not being properly secured to the frame. Recommend a qualified contractor repair as necessary to prevent future damage to the door or frame.

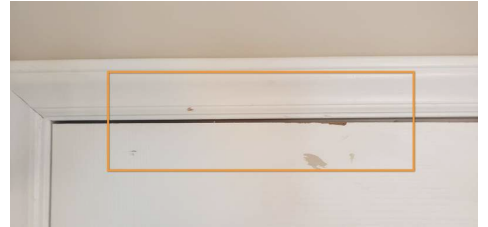
9.6.4 Doors

There is minor damage to the closet door in the 2nd floor left bedroom. Please consult a general contractor for repair.

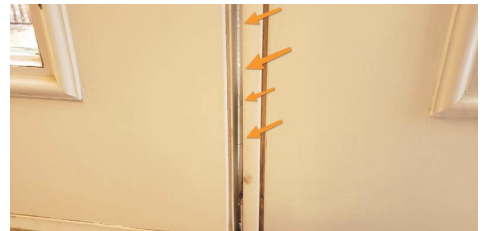
9.6.5 Doors

The exterior door in the family room is not sealing completely at the bottom when closed as daylight can be seen through the crack. Recommend a qualified contractor repair as needed to reduce possible moisture intrusion and conditioned air leakage.

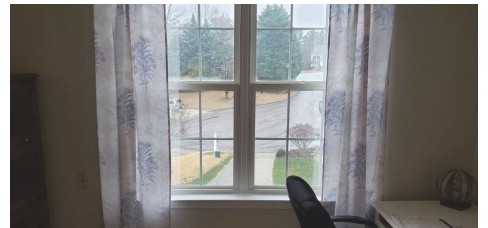
2ND FLOOR FRONT LEFT BEDROOM

Windows were difficult to open/close during inspection which may cause damage to the window during opening if not repaired. Recommend a qualified contractor repair the window so that it may easily open.

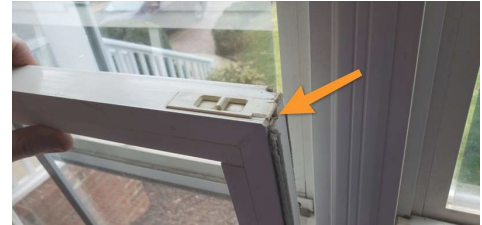
LIVING ROOM MIDDLE FRONT

Multiple windows had hardware was damaged and the window would not "click" or lock in. Please consult a window or general contractor for further evaluation and repair.

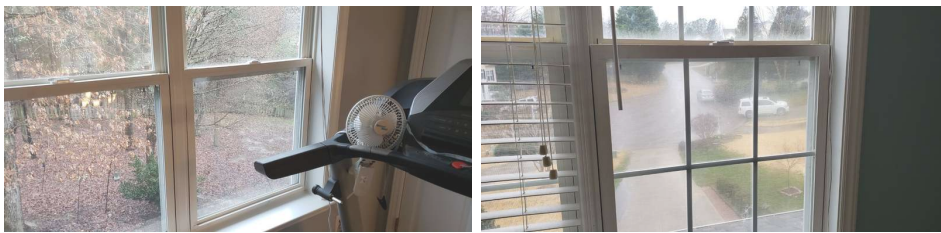
2ND FLOOR LOFT RIGHT WINDOW, 2ND FLOOR FRONT RIGHT BEDROOM

The window will not stay open when raised, which can cause damage when the window falls back down. Please consult a window or general contractor for further evaluation and repair.

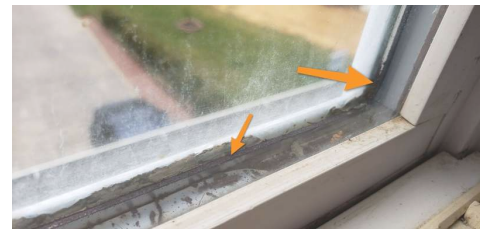
2ND FLOOR FRONT RIGHT BEDROOM

The window has visible condensation, fogging and/or rust between the panes of glass, which indicates a broken seal. A broken seal can reduce the insulation capabilities of the window and in severe cases lead to leaking. Also, please note that other windows in the home may also have broken seals, but were not readily visible at the time of the inspection. Please consult a window specialist or general contractor for review of the windows and repair or replace any windows with broken seals.

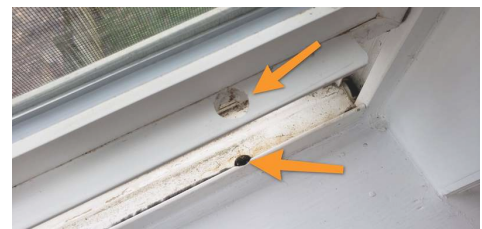
FAMILY ROOM LEFT OF FIREPLACE

The window frame and sash of the window to the left of the fireplace have holes drilled in them which could allow moisture intrusion into the wall below the window. Recommend a qualified contractor repair as needed.

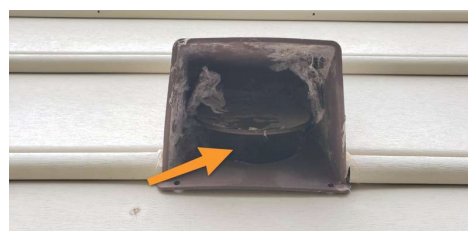
The dryer exhaust vent appears to be clogged, which is preventing the damper from closing when it is not exhausting. This can cause pest intrusion into the ducts. The vent exhaust should be cleaned and then check to ensure the damper can properly close the duct.

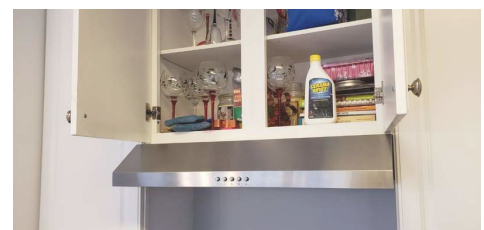
VENT FAN IS NOT VENTED KITCHEN

The vent fan above the cook top is not vented to the exterior and there is no duct work. This will allow smoke and fumes from the stove top to be released into the kitchen. This vent hood should be replaced with a recirculating vent hood or vented to the exterior of the home. Recommended qualified contractor repair/install vent work as needed.
