Carolina Premier Inspections
Guaranteed Home Inspections

RESIDENTIAL INSPECTION

1234 Main St.
Moncks Corner SC 29461

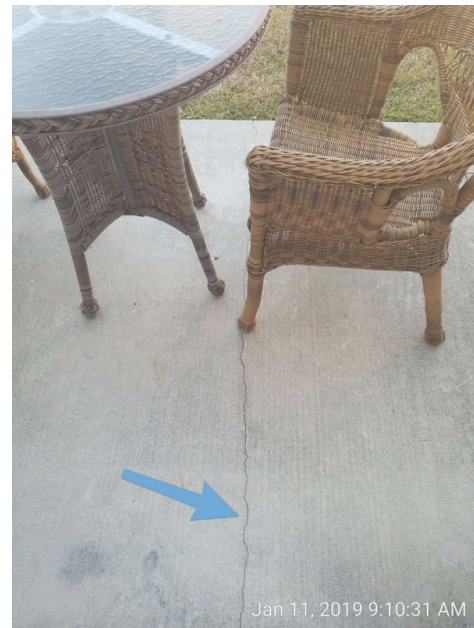
2.7.1 Porch Observations (Exposed)

COMMON CRACKS

REAR - EXTERIOR

Cracks in poured concrete may be an indication of shrinkage, material defects, lack of maintenance, movement or settlement. Cracks and other defects in poured concrete should be repaired or sealed with an appropriate sealant and monitored over time for movement, deflection and deterioration.

Recommend monitoring.

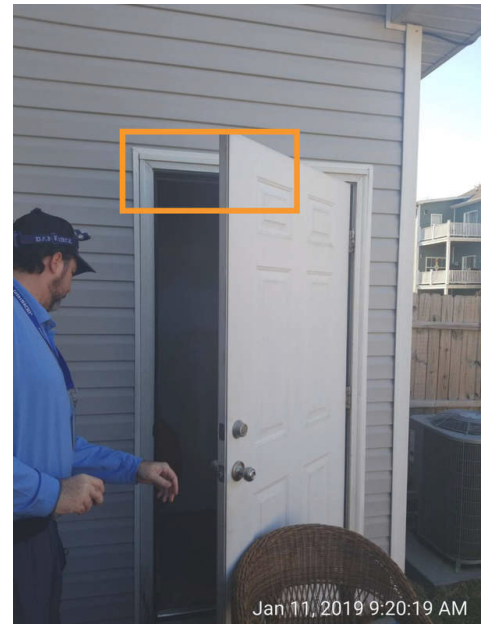
3.4.1 Doors(Exterior)

BINDING DOOR - EXTERIOR

REAR - EXTERIOR

A exterior door that rubs the frame jamb was observed. Exterior doors that stick, rub, hit the door frame or do not perform as intended are indications of movement, settlement or other installation defects. The cause of exterior doors that rub, stick or hit door frames should be determined and repaired as needed.

Contact a qualified door repair/installation contractor.

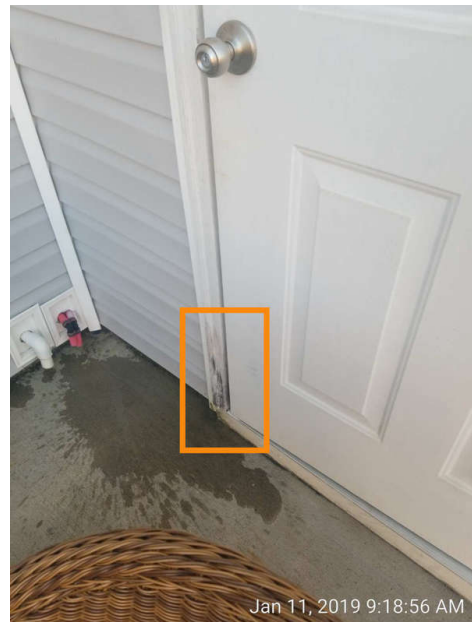
3.4.2 Doors(Exterior)

ROT - DOOR TRIM/JAMB (CL-100 RELEVANT)

REAR - EXTERIOR

Exterior door framing had decayed sections from excessive moisture at the time of inspection. I recommend repair by a qualified contractor. **This is a condition disclosed in a CL-100 report.**

Contact a qualified professional.

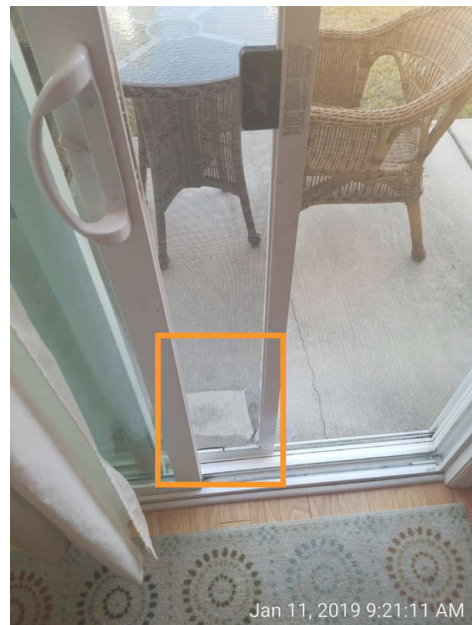
3.5.1 Screen/Storm Door(s)

DAMAGE - SCREEN DOOR

REAR ENTRY

The screen on the rear sliding door was damaged. Recommend replacement of the screen.

Contact a qualified professional.

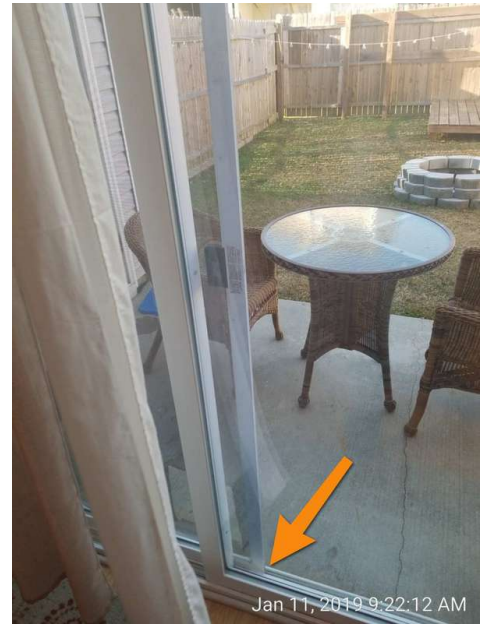
3.5.2 Screen/Storm Door(s)

SLIDING SCREEN CONCERNS

REAR ENTRY

The sliding screen door revealed poor sliding function at the time of inspection. I recommend maintenance service to the track by a qualified professional to improve function and prevent damage to the unit.

Contact a qualified professional.

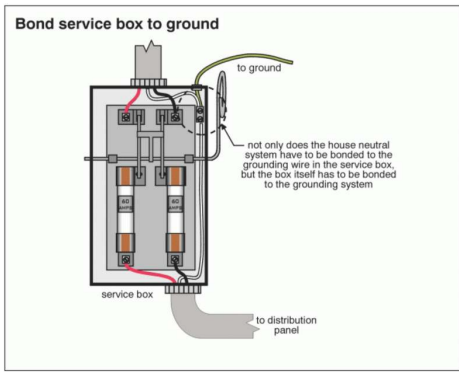
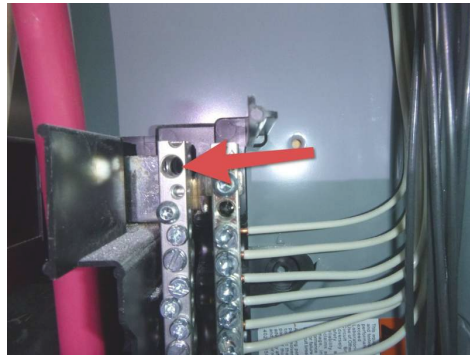
MISSING BONDING SCREW

The bonding screw was missing at the neutral bus bar of the service panel. Without a bonding screw (or other bonding device), the neutral bus bar, metal cabinet, and grounding system are not bonded (electrically connected). This condition is a safety concern and can present an electrical shock/electrocution hazard. The inspector recommends correction by a licensed electrical contractor.

Contact a qualified electrical contractor.

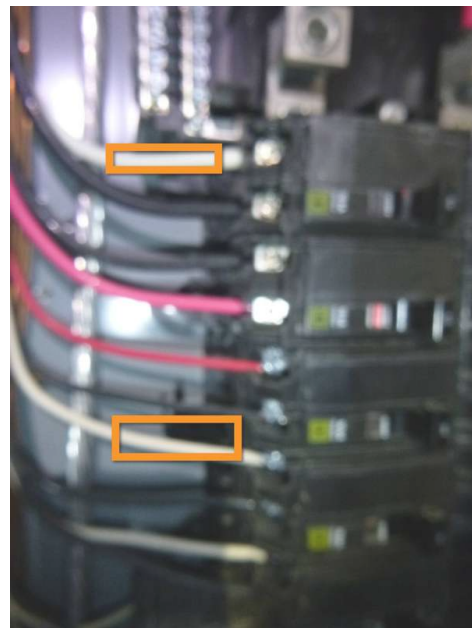
5.4.2 Electric Panel

One or more energized conductors in panel had white, gray or green insulation. Insulation on energized conductors (hot wires) should be black or red in color to identify them as energized wires. Recommend that a qualified electrician re-identify wires per standard building practices. For example, by wrapping in black vinyl tape or marking with a black permanent marker.

Contact a qualified electrical contractor.

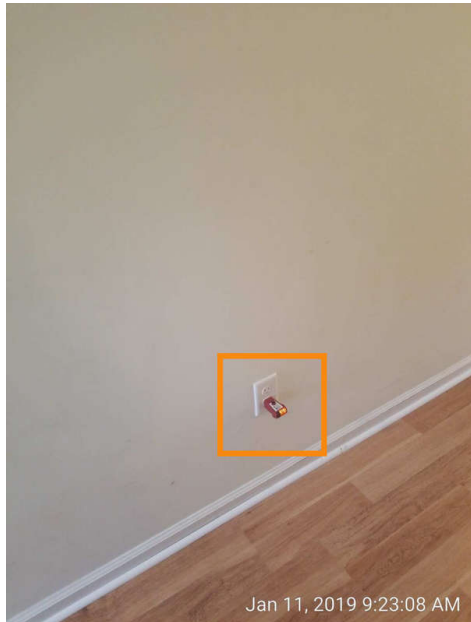
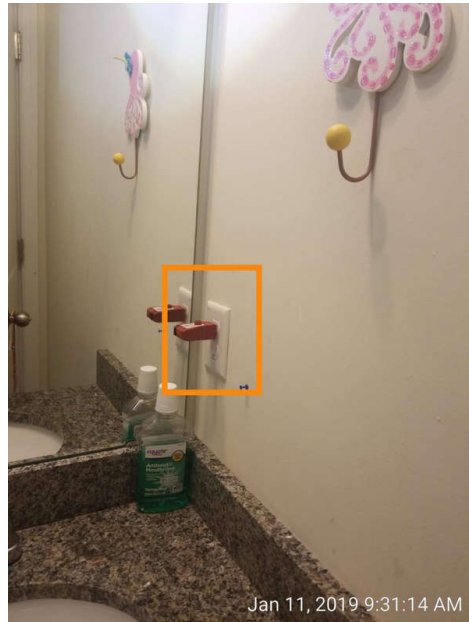
5.7.1 Outlet Observations

LOOSE RECEPTACLE (POOR CONDITION)

One or more electric receptacles were observed to be loose or in poor condition. Noted electrical receptacles should be repaired by a certified, licensed electrical specialist.

Contact a qualified electrical contractor.

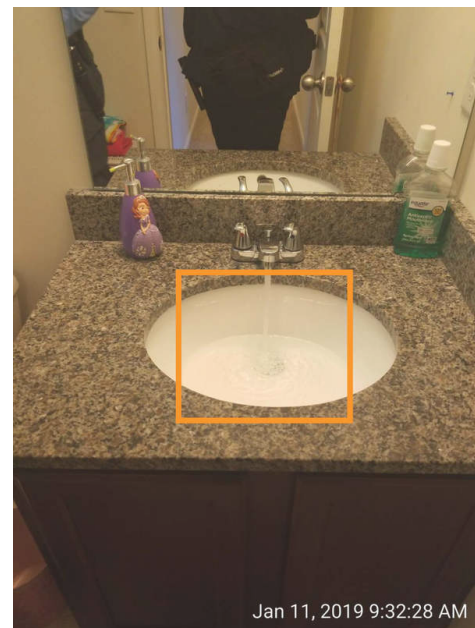
Inspection of the plumbing system revealed only a minor issue with a slower draining sink. The household had functional flow, pressure and drainage. Fixtures were in good working condition functioning as intended. Approved piping materials have been installed. No issues were observed with regard to the plumbing system venting.

Contact a qualified plumbing contractor.

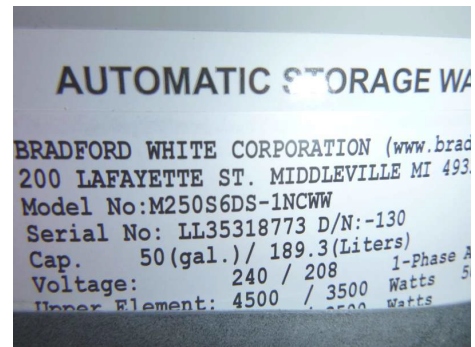
Bradford White

The water heater located in the attic was found to be in good overall condition. The unit is 4 years old and will remain under a manufacturer warranty for 2 more years.

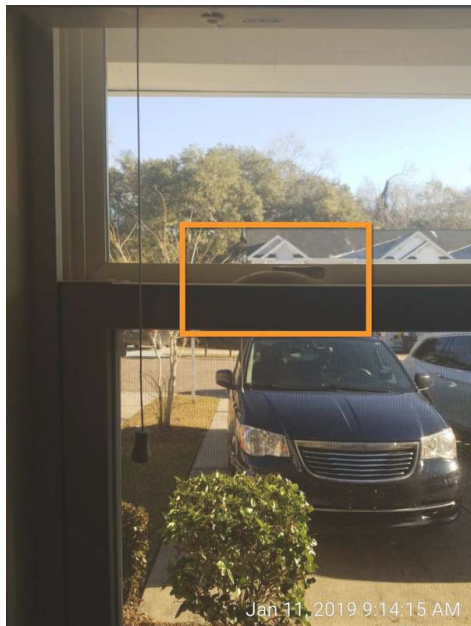
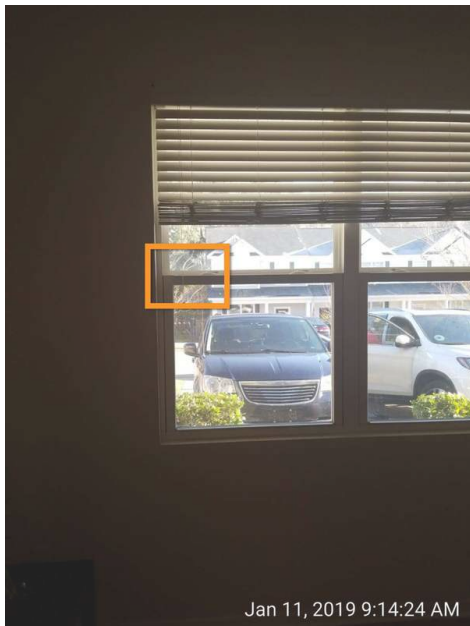
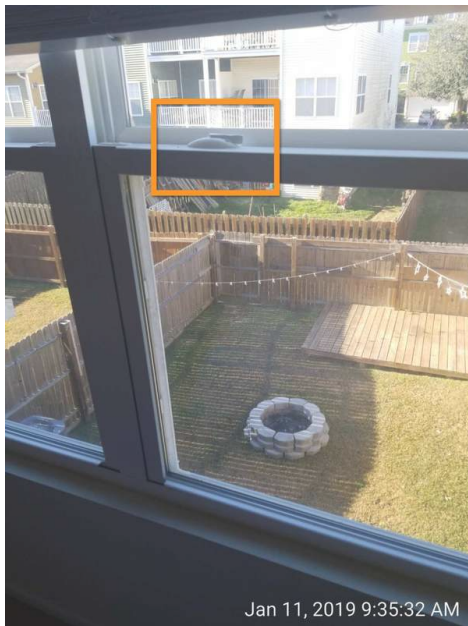
Some window lock(s) were difficult to latch. I recommend repair by a qualified professional to restore proper function. Windows that do not latch can be a security issue and contribute to heat loss or gain.

Contact a qualified window repair/installation contractor.

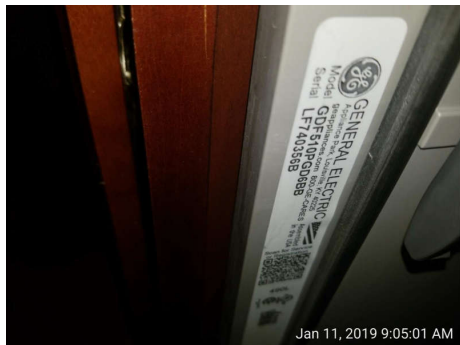
GE

A recall check will be run on all built in appliances and delivered to you in a separate report. Appliances were in good overall condition. A high loop should be added to the dishwasher drain hose (This is an easy fix). An anti-tip device is recommended for the range oven unit especially if young children will be in the home (This is an easy fix).

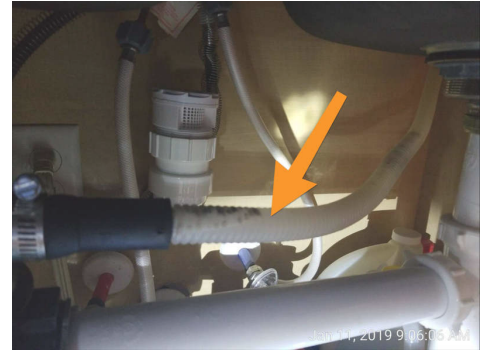
The high loop or air gap must be used to prevent potential back-flow contamination of the dishwasher. This also keeps the drain hose dried out and keeps any odors from backing up into the dishwasher. Some newer dishwashers may have built in anti-siphon devices that are not visible. The buyer is encouraged to consult the owners manual or contact the manufacturer if an anti-siphon device is not visible. Although new dishwashers come from the manufacturer with the drain looped up at the side of the dishwasher, every installation manual still requires this high loop underneath the sink. We recommend correction by a qualified professional.

Contact a qualified professional.

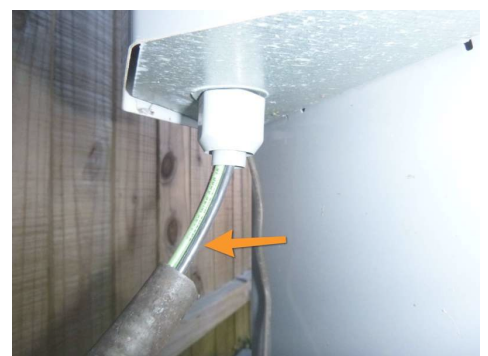
13.3.1 Exterior Equipment

DAMAGED CONDUIT

The flex conduit for the electrical wiring of the condenser unit is damaged. I recommend a qualified licensed electrical contractor repair or replace the conduit to protect exterior HVAC wiring.

Contact a qualified professional.

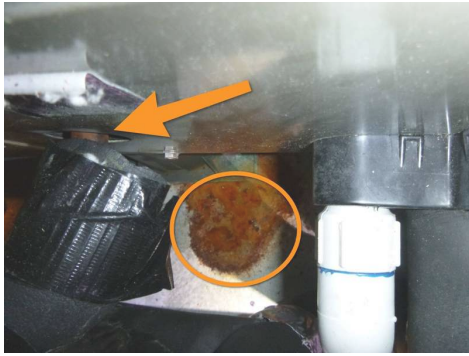
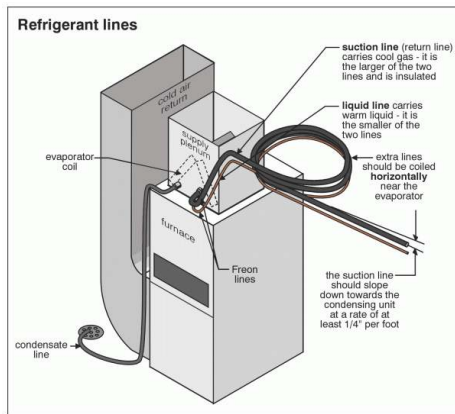
13.4.1 Refrigerant Line Set

INADEQUATE INSULATION - SUCTION LINE

The HVAC refrigerant lines was not properly insulated at the interior equipment. Inadequate cooling line insulation at the interior HVAC equipment has caused localized rusting to the safety pan. The pan does not need replacement at this time however failure to improve insulation at the air handler will create condensation and further corrosion. Repair by a licensed HVAC tech is recommended.

Contact a qualified HVAC professional.

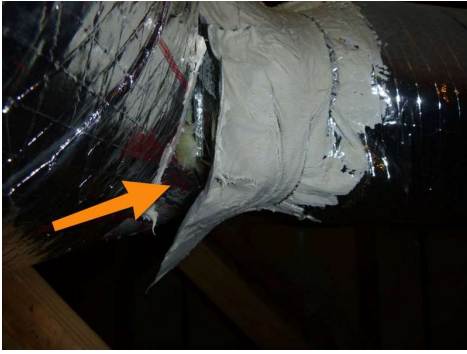
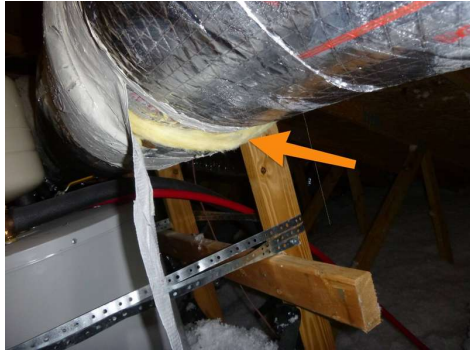
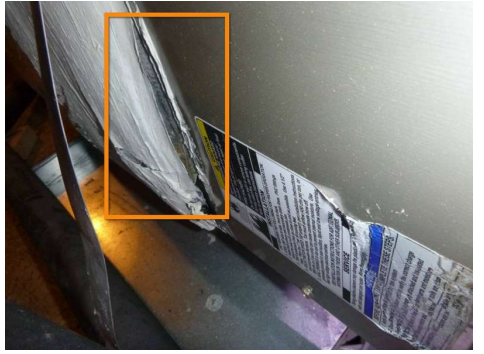
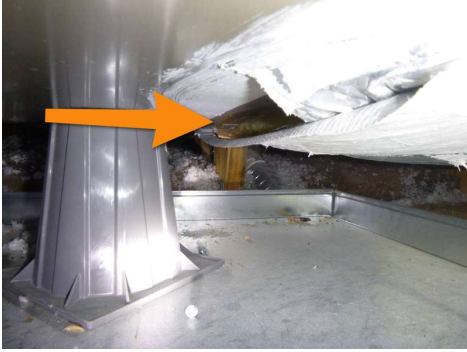
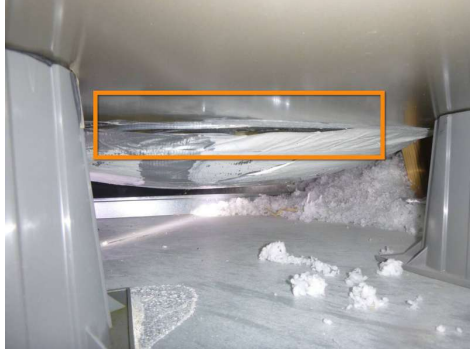
The heating/cooling distribution ducts were not properly sealed. Inadequate air plenum and duct connections may allow unwanted air, vapors or debris to be pulled into the cooling equipment. Inadequate air handler plenum seals can create excessive condensation that causes water damage and microbial amplification. Loss of conditioned air also results in energy efficiency reduction. Improperly sealed cooling equipment air handler plenum and ducts should be repaired by a qualified HVAC tech.

Contact a qualified HVAC professional.
