## RESIDENTIAL INSPECTION

1234 Main St.  
Charleston SC 29412

02/07/2019 9:00AM

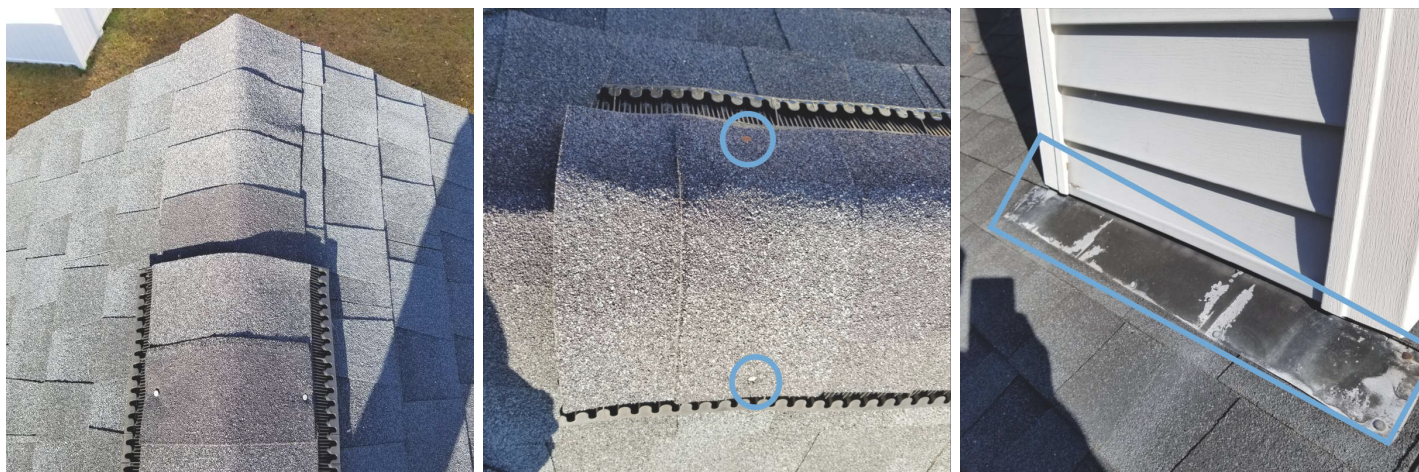
2.2.1 Shingles

**EXPOSED NAIL HEADS**

Nail heads were exposed at one or more shingles. Recommend applying an approved sealant over exposed nail heads now and as necessary in the future to prevent leaks.

Contact a qualified roofing professional.

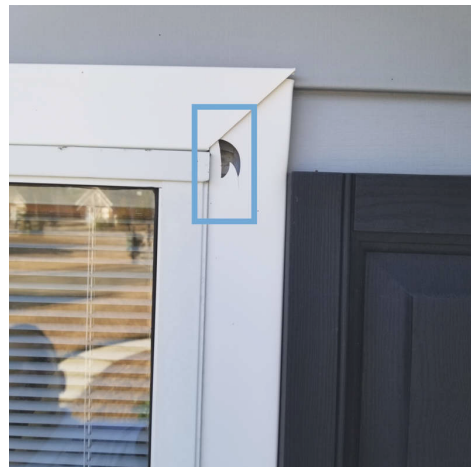
Northeast

Holes in different areas should be repaired or sealed by a qualified professional to minimize water intrusion. Recommend a qualified professional to repair or seal as necessary.

Contact a qualified professional.

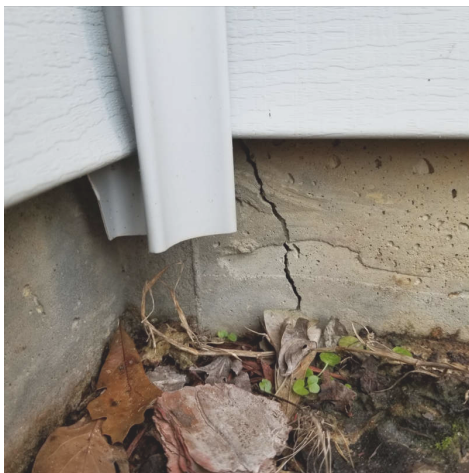
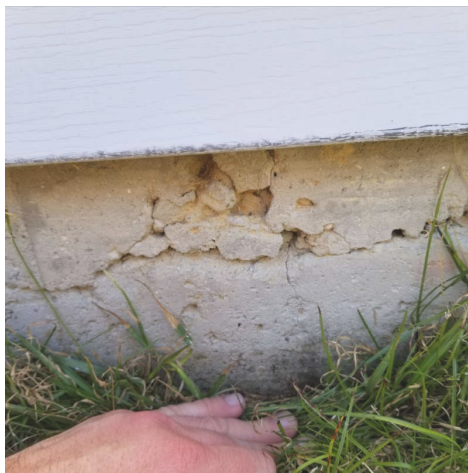
4.2.2 Exterior issues

**CRACKS-MINOR**

One or more minor cracks were found in the foundation. These didn't appear to be a structural concern but recommend sealing them to prevent water infiltration and monitor them in the future. Numerous products exist to seal such cracks including hydraulic cement, non shrinking grout, resilient caulks and epoxy sealants.

Recommend monitoring.

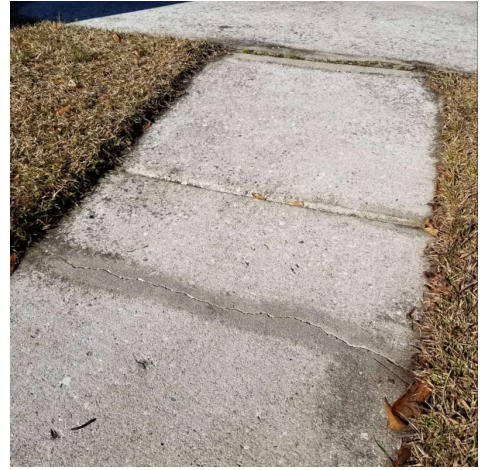
4.3.1 Driveway, Walkway, Patio

**CRACKED -SIDEWALK**

One or more of the sidewalk slabs is cracked. Any sidewalk with a deficiency should be monitored or replaced by a certified contractor to help prevent future deterioration.

Contact a qualified professional.

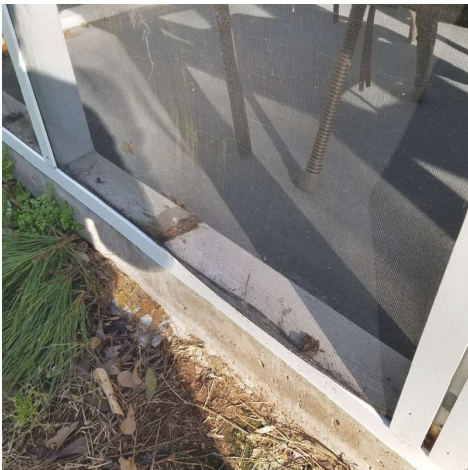
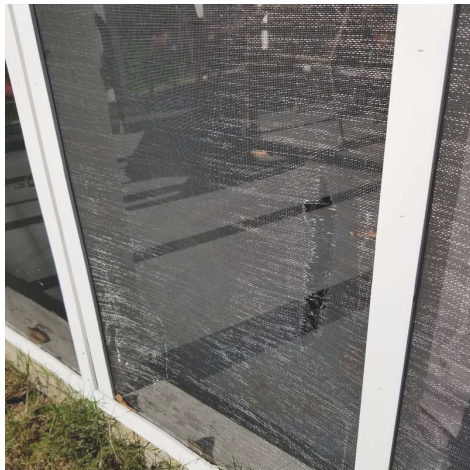
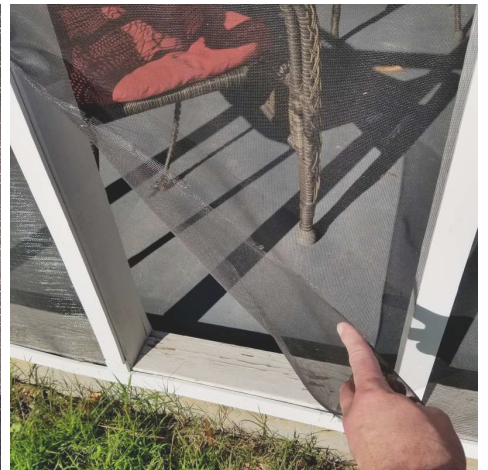
4.3.2 Driveway, Walkway, Patio

**SCREEN ENCLOSURE-SCREENS TORN**

One or more screens are torn or missing in the frame(s) of the screen patio. A certified contractor should make the necessary repairs.

Contact a qualified handyman.

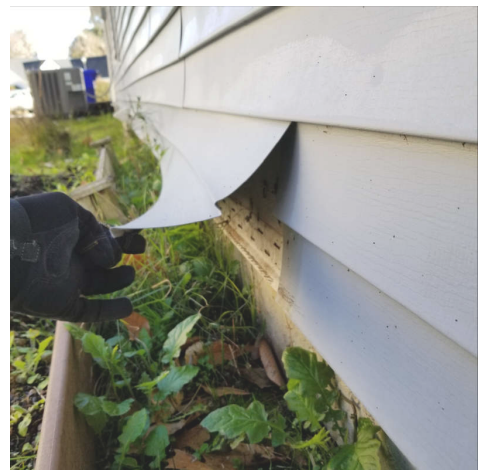
4.6.1 Siding And Trim

**SIDING ISSUES**

Sections of siding were *loose or damaged*. Recommend that a qualified person repair, replace or install siding as necessary.

Contact a qualified professional.

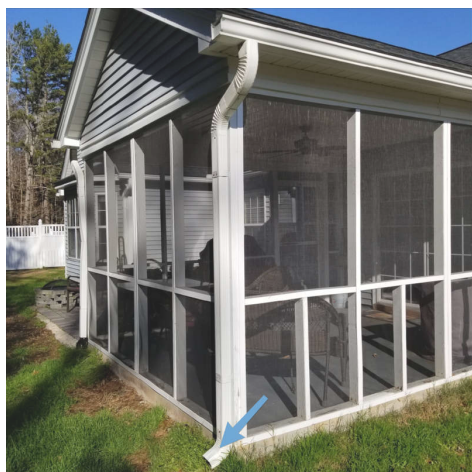
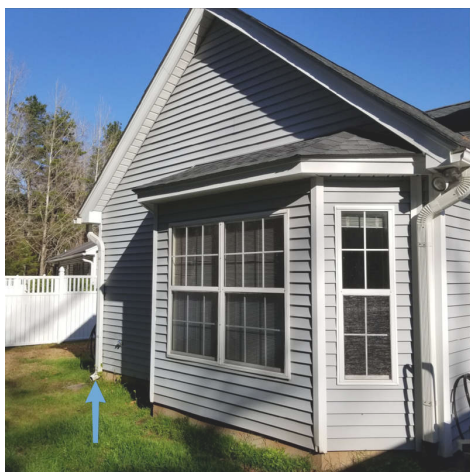
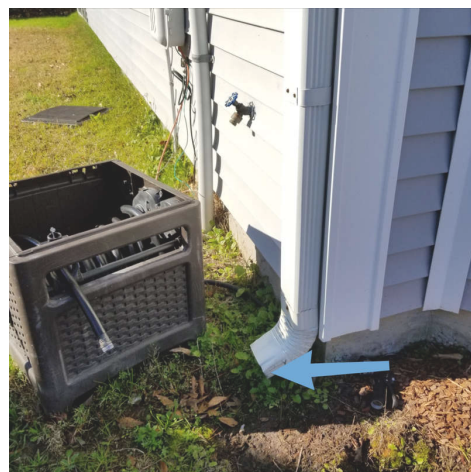
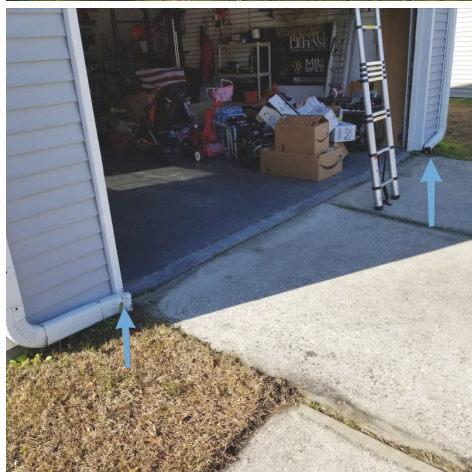
4.7.2 Gutters and Flashing

Extensions such as splash blocks or drain pipes for one or more downspouts were missing / misaligned / substandard. Water can accumulate around the building foundation as a result. Recommend that a qualified person install, replace or repair extensions as necessary so rainwater drains far away from the structure.

Contact a handyman or DIY project

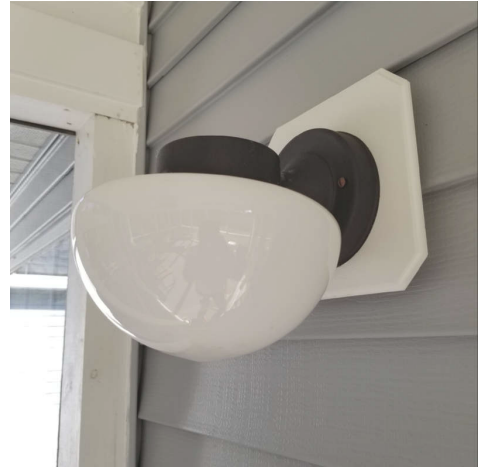
4.9.1 Electrical

One or more light fixtures appear to be inoperable. Recommend further evaluation by replacing bulb(s) and/or consulting with the property owner(s). Repairs or replacement of the light fixture(s) by a qualified electrician may be necessary.

Recommended DIY Project

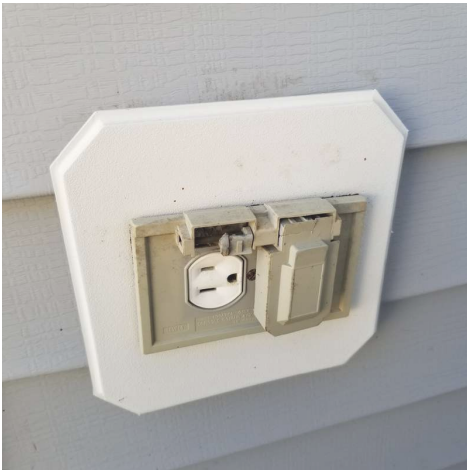
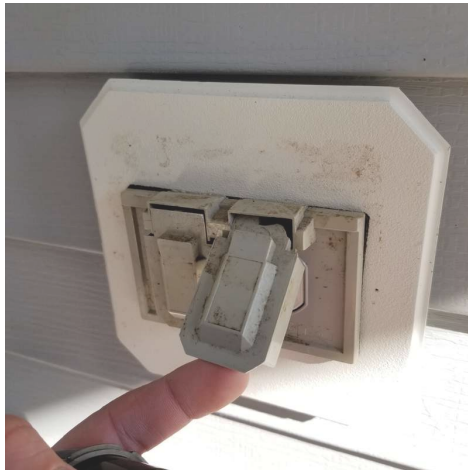
4.9.2 Electrical

**RECEPTACLE COVER BROKEN**

One or more exterior receptacle covers were broken. This is a potential shock hazard. Recommend that a qualified person replace covers where necessary.

Contact a qualified handyman.

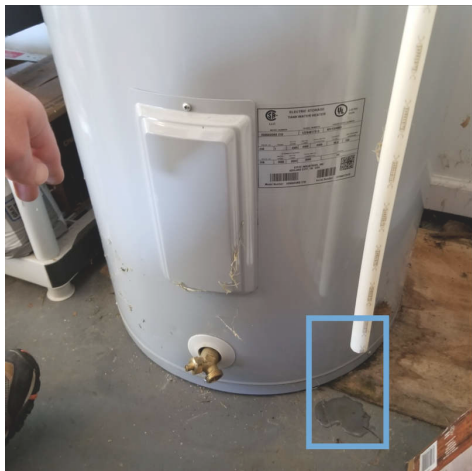
5.1.1 Water Heater

**TPR LEAKING**

The TPR (temperature-pressure relief) valve showed signs of leaking. Recommend that a qualified plumber repair as necessary. For example, by replacing the valve or seeing if a thermal expansion tank is needed.

Recommendation  
Recommend monitoring.

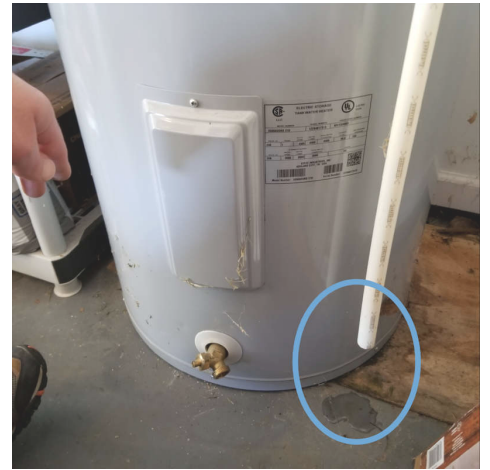
5.1.2 Water Heater

So as to not ruin any of your stored items in the garage, it's recommend to have the TPR drain either draining to the outside of the home or a Pan underneath the TPR valve.

Contact a qualified professional.

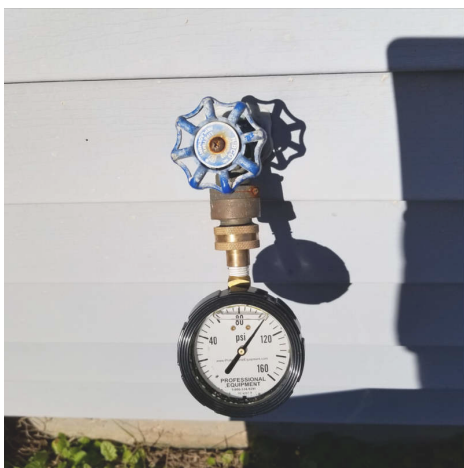
**General: Water Pressure**

100 PSI

The water supply pressure is greater than 80 psi. Pressures above 80 psi may void warranties for some appliances such as water heaters or washing machines. Flexible supply lines to washing machines are more likely to burst with higher pressures. Typically the pressure cannot be regulated at the water meter. Recommend having a qualified plumber evaluate and make modifications to reduce the pressure below 80 psi. Installing a pressure reducing valve on the main service pipe is a common solution to this problem. If one exists, then it should be adjusted for lower pressures.

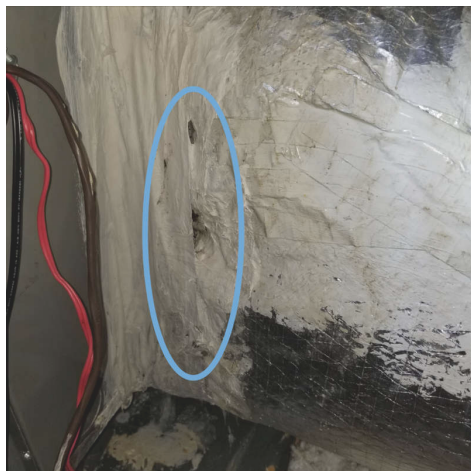
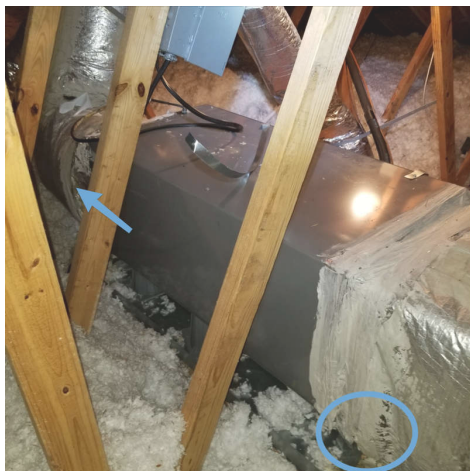
One or more sections of duct are leaking and need to be re-sealed or repaired. When the cooler air escapes from the duct in the attic and creates condensation which will cause mold and or dirt from the attic to collect at the area of the air leak. It is recommended to have a qualified professional make the necessary repairs.

Right side of air Handler

Contact a qualified professional.

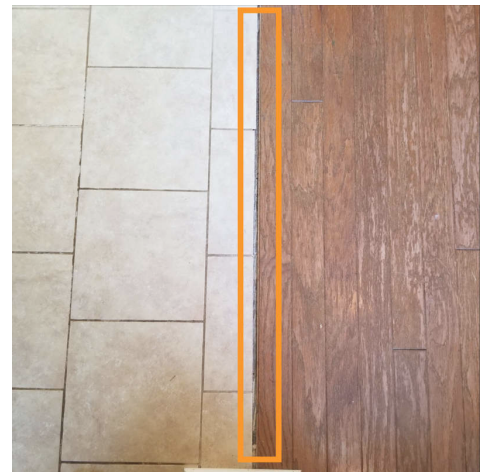
Foyer

### MISSING TRANSITION STRIP

There is no transition strip between the hardwood and tile in the foyer. A transition strip or grout should be installed to help prevent deterioration to the hardwood or tile.

Contact a qualified flooring contractor

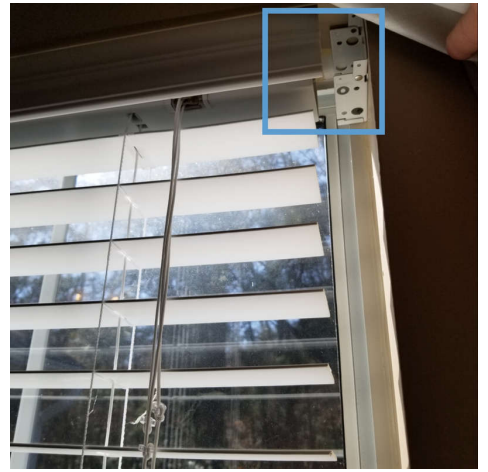
Southwest

Blinds were damaged or not working properly. The blind shows incomplete workmanship. Recommend repair by a qualified professional.

Contact a qualified professional.

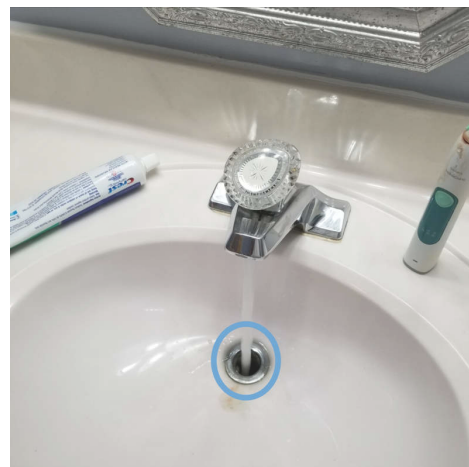
Master Bathroom

One or more sink stopper(s) mechanisms are missing, or need adjustment or repair. Stopper mechanisms should be installed where missing and/or repairs should be made so sink stoppers open and close easily.

Contact a qualified plumbing contractor.

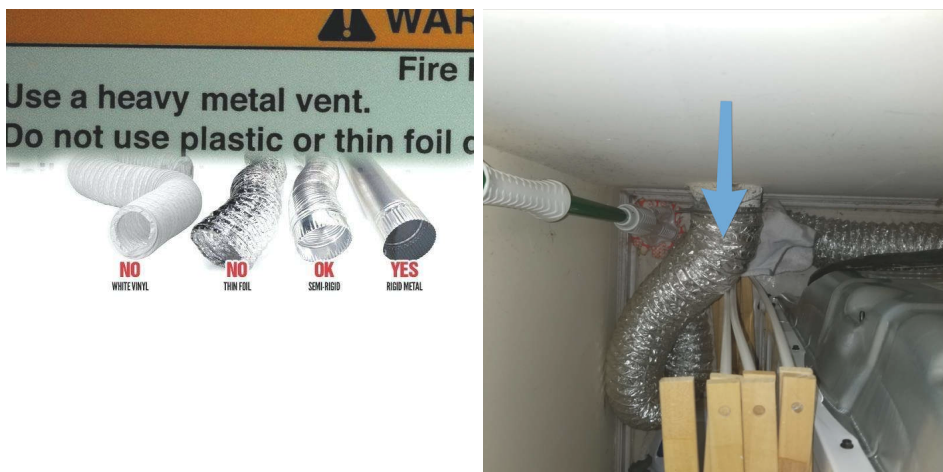
Laundry

The clothes dryer is equipped with a vinyl or foil, accordion-type, flexible exhaust duct. The U.S. Consumer Product Safety Commission considers these types of ducts to be unsafe, and a fire hazard. These types of ducts can trap lint and are susceptible to kinks or crushing, which can greatly reduce the air flow. This duct should be replaced with a rigid or corrugated semi-rigid metal duct, and by a qualified contractor if necessary. Most clothes dryer manufacturers specify the use of a rigid or corrugated semi-rigid metal duct.

Contact a qualified appliance repair professional.

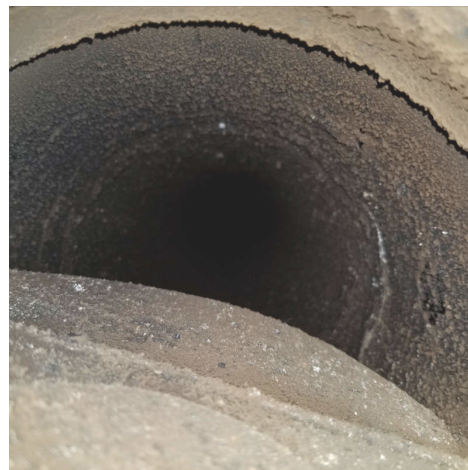
A significant amount of creosote (1/8 inch or more) is visible in the flue. A qualified chimney service contractor should inspect, clean, and repair if necessary now and annually in the future.

Contact a qualified fireplace contractor.
