CREPPS HOME INSPECTION LLC

RESIDENTIAL REPORT

1234 Main St.
Coxs Creek KY 40013

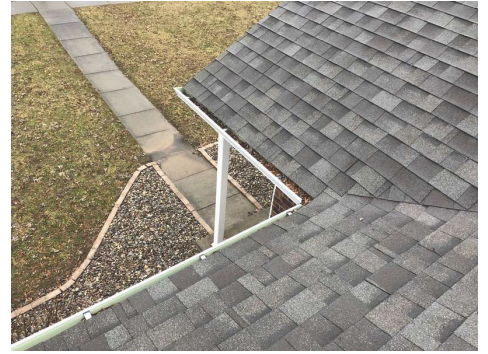
Debris has accumulated in the gutters. Recommend cleaning to facilitate water flow.

Contact a handyman or DIY project

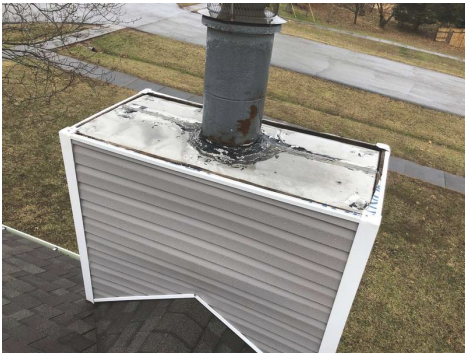
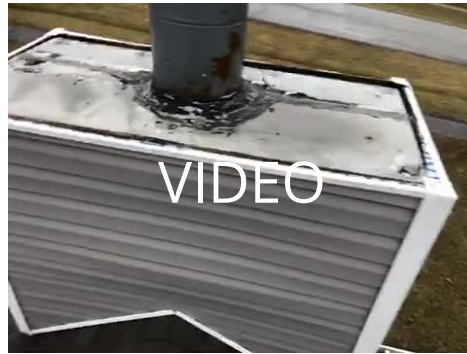
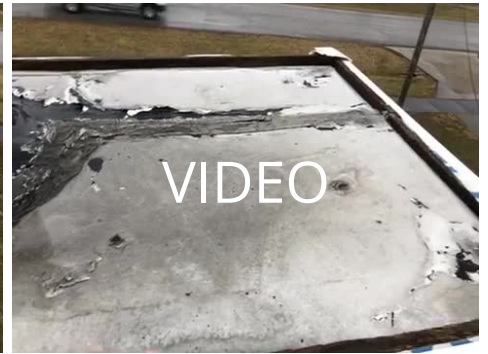
2.6.1 Chimney

The cap was damaged or in need of maintenance. Recommend further review and repair to mitigate the risk of pest intrusion.

Contact a qualified chimney contractor.

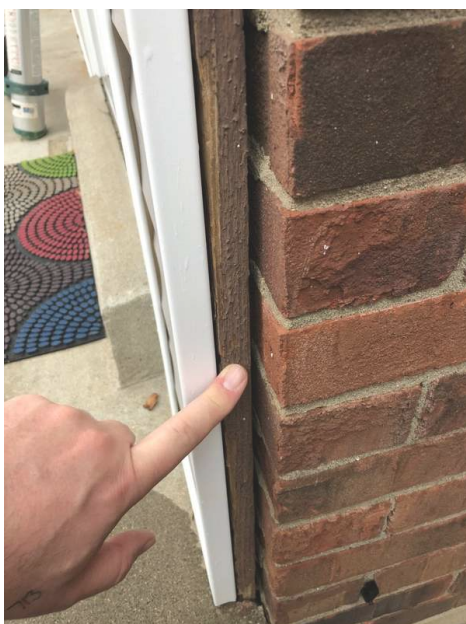
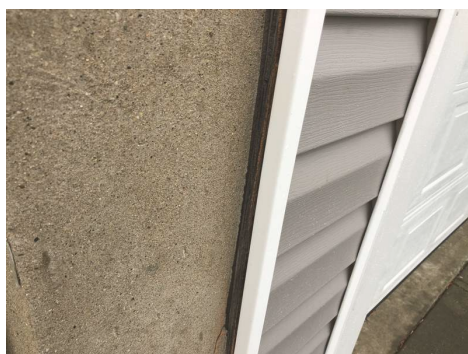
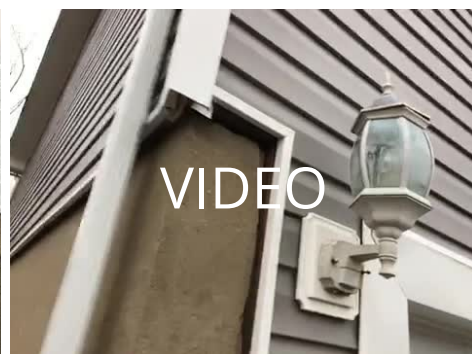
There were one or more locations where gaps might allow for moisture intrusion. Recommend [sealing](#) any such gaps or installing flashing as needed.

Contact a handyman or DIY project

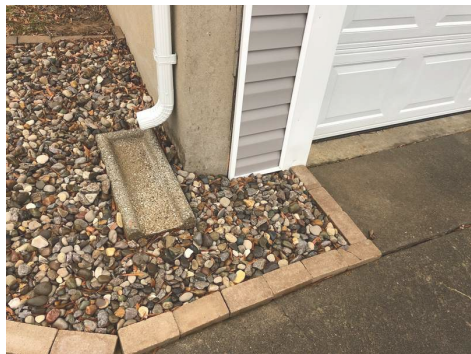
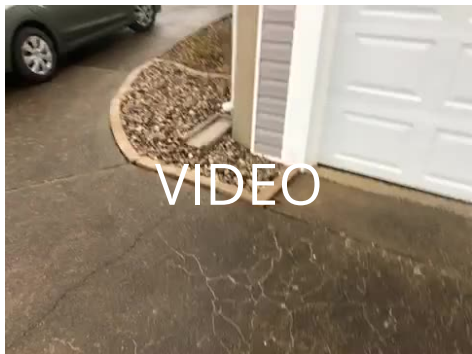
3.1.2 Siding, Flashing & Trim

SIDING - CLOSE TO GROUND

There should be a gap between the siding and the soil/ground. There is a risk of moisture wicking as well as a pathway for wood destroying insects. Repair.

Contact a qualified professional.

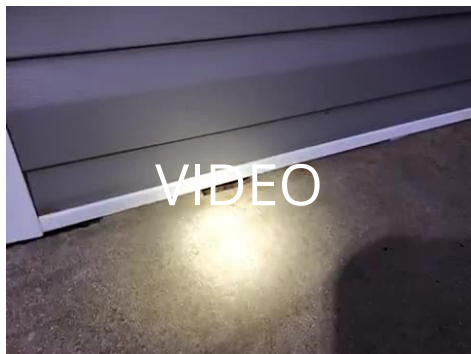
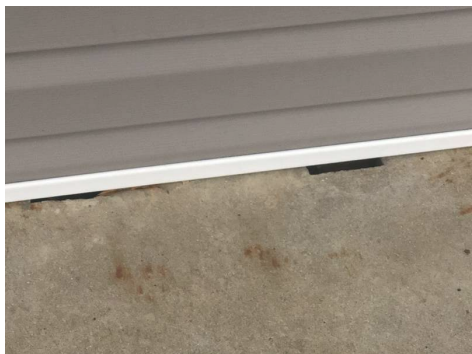
3.1.3 Siding, Flashing & Trim

CONCRETE CLEARANCE

There should be a gap between the siding and the concrete and flashing. No major concerns observed but moisture could get trapped between or behind. Heavier rains may impact this area. This is also a potential spot for termite intrusion.

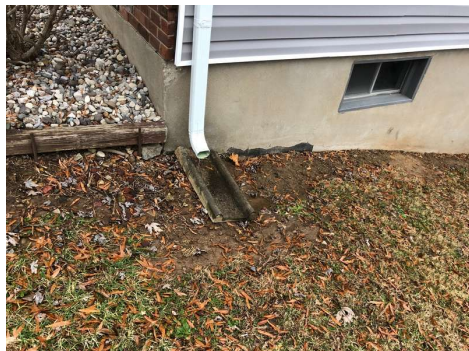
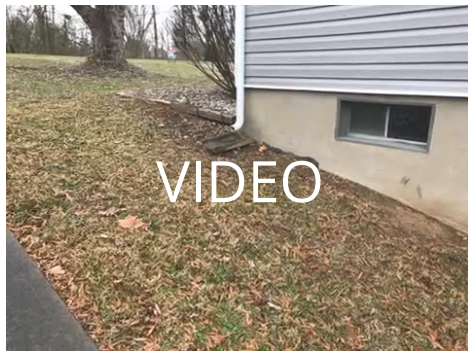
3.3.1 Vegetation, Grading, & Drainage

DOWNSPOUTS - DRAIN NEAR HOUSE

One or more downspouts drain too close to the home's foundation. This can result in excessive moisture in the soil at the foundation, which can lead to foundation/structural movement. Recommend a qualified contractor adjust downspout extensions to drain at least 6 feet from the foundation.

Contact a handyman or DIY project

Recommend extending the downspouts further away from the foundation.

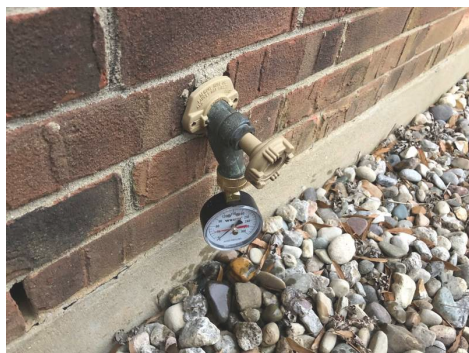
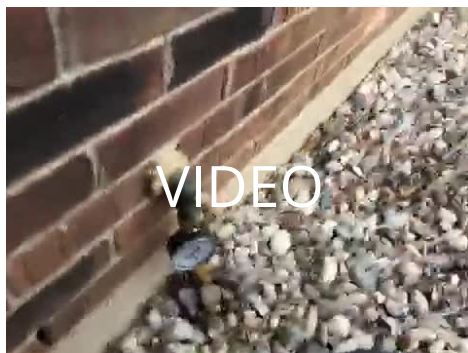
3.4.1 Gas, Water, & Electric

DAMAGED - IN WALL

The hydrant appeared to be damaged inside the wall this is typically caused by freezing. When operating water is dumping inside the wall and there will be no pressure. Replacement is needed. Recommend a frost proof wall hydrant like the one [found here](#). (This is rated major mainly because of the potential for damage. It most likely will not be terribly expensive to fix but it needs to be and may be somewhat difficult to access.)

Contact a qualified plumbing contractor.

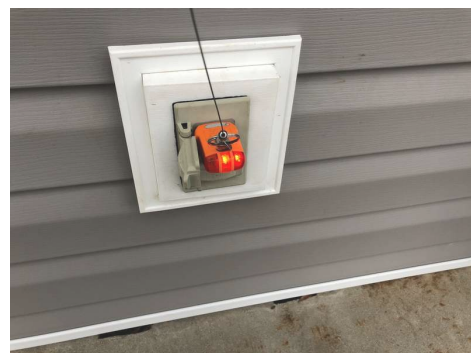
3.4.2 Gas, Water, & Electric

SAFETY All exterior/garage receptacles should be GFCI protected. Have an electrician update or repair.

Contact a qualified electrical contractor.

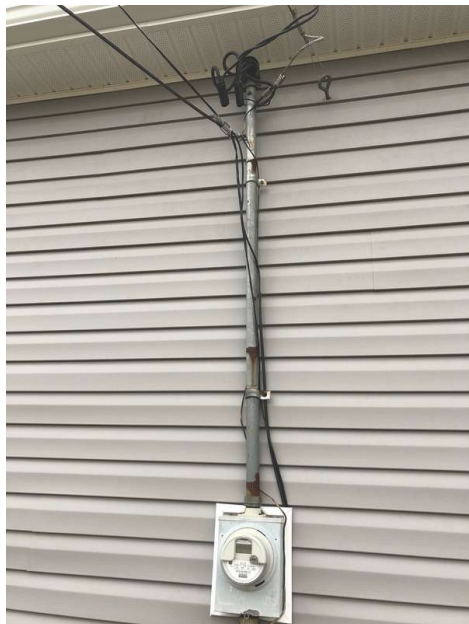
3.4.3 Gas, Water, & Electric

MAST OR METER NOT SECURED OR LOOSE

The service mast or meter appeared loose or inadequately secured. Further review and correction is needed to prevent failure.

Contact a qualified electrical contractor.

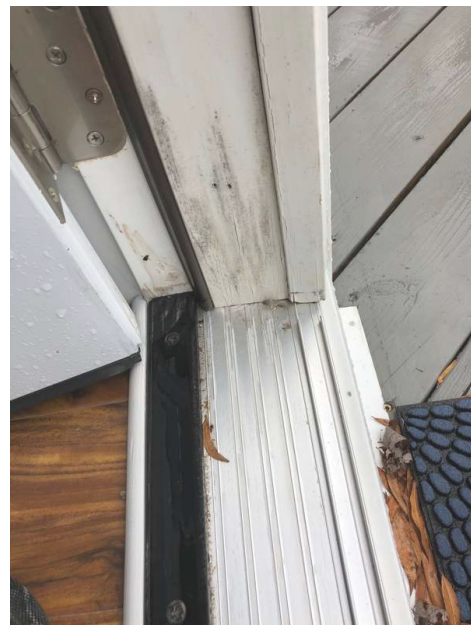
3.5.1 Exterior Doors

JAMB - MOISTURE DAMAGE

Some moisture induced degradation was noted at one or more exterior jambs and door. Though this is typical, attempts to prevent furthering should be considered. [Here is some more information that may be useful.](#)

Contact a qualified handyman.

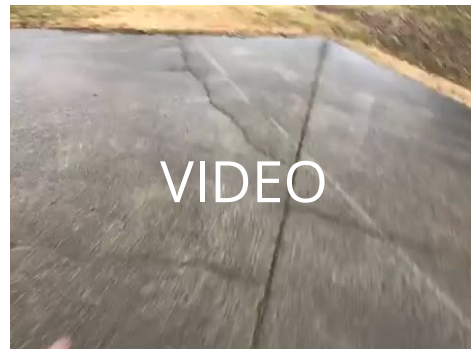
3.7.1 Driveways & Walkways

CRACKING/SETTLING

Major cracks and/or settling observed. This may indicate inadequate soil prep or erosion. It may be a lack of reinforcing bar. Some trip hazards may exist.

Contact a qualified concrete contractor.

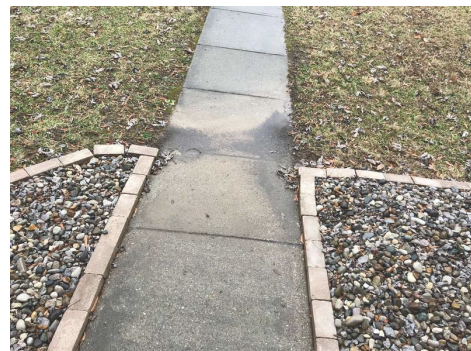
3.7.2 Driveways & Walkways

Standing water, or the potential for, was noted.

Contact a qualified landscaping contractor

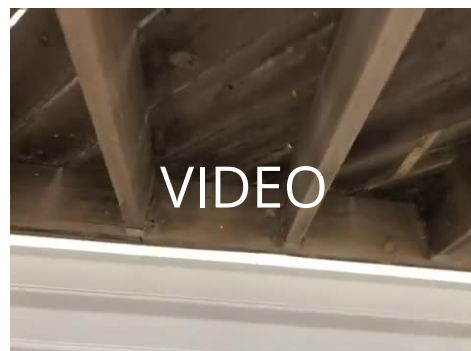
3.8.1 Decks & Balconies

FLASHING IMPROPER

Where the deck abuts the home should be flashed to keep moisture from penetrating the exterior wall. [Here is an article that explains how a ledger should be installed.](#) Sometimes it is difficult to assess if flashing exists.

Contact a qualified deck contractor.

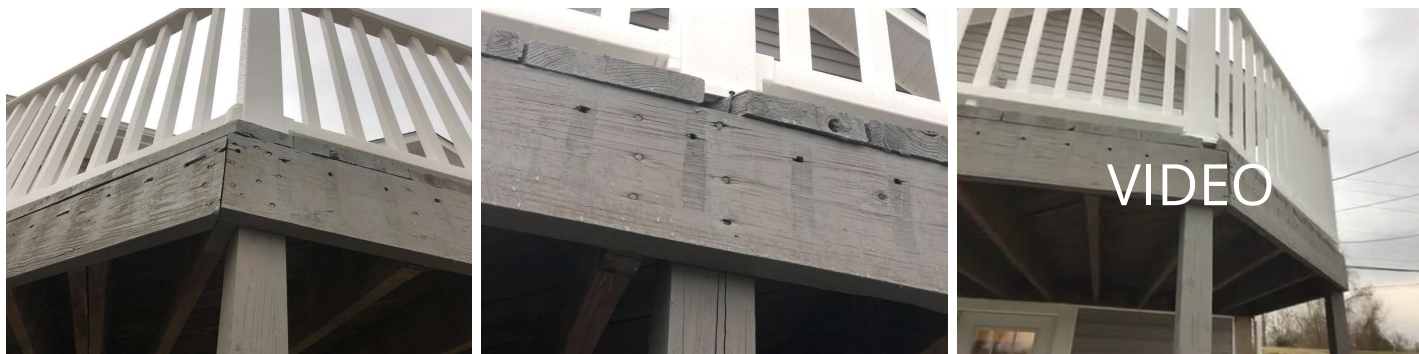
3.8.2 Decks & Balconies

RIM JOIST MISSING LAG BOLTS

SAFETY The rim joist on the deck should be bolted to the post. Or the post should be notched. Failure is possible and the deck could collapse. Repair is needed.

Contact a qualified deck contractor.

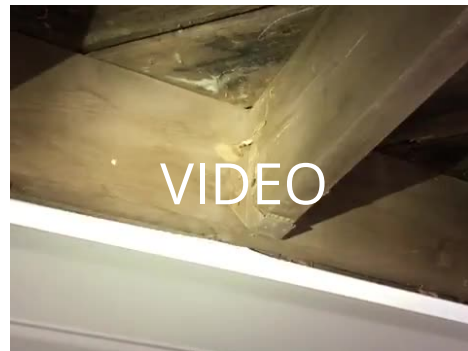
3.8.3 Decks & Balconies

JOIST HANGER - UNDERSIZED

SAFETY Joist hangers are engineered connectors that will not work as intended if they are undersized or modified on site. If a particular span requires a 2x10 joist to carry the load, for example, then you have to use a 2x10 joist hanger; a smaller hanger doesn't have enough capacity. The reason they make larger hangers is that a larger hanger provides for more nails, which can support a larger load. The hanger also keeps the joist from rotating at the end, which helps to stiffen the floor. If the hanger is too short, it won't resist rotation as well as a taller hanger. All the nail holes need to be utilized and they are not.

Contact a qualified deck contractor.

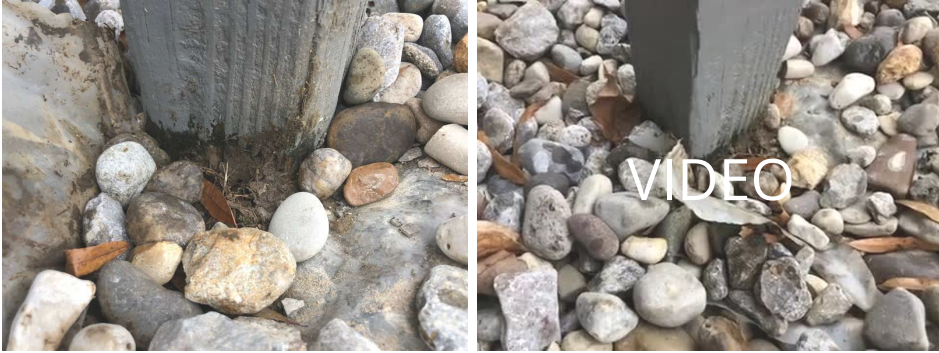
3.8.5 Decks & Balconies

The covered deck was constructed using buried 4x4 posts. These posts are carrying a larger load and should ideally be resting on footers and piers. The posts are subject to degradation being buried. They may also not be rated for the load. Some slight damage was noted.

Contact a qualified deck contractor.

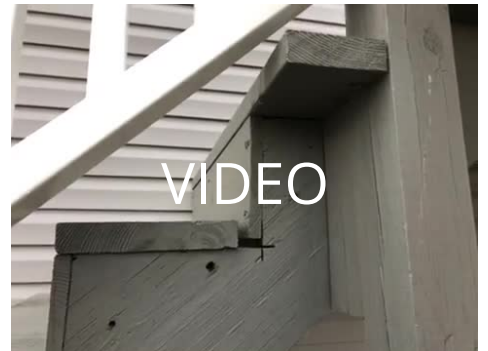
RAILING UNSAFE

SAFETY There is an unsafe opening in the railing. The spacing on the rail should not exceed 4". An opening greater than 4" is a serious safety hazard especially for children as their head or other body part can become trapped.

Contact a qualified deck contractor.

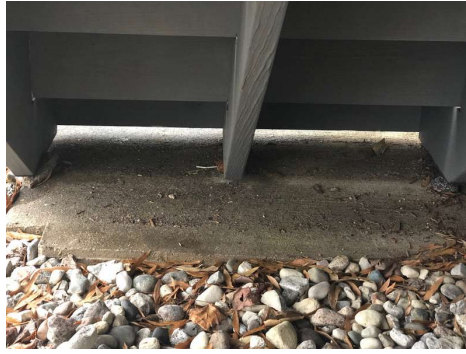
3.10.2 Stairs

IMPROPER BEARING

Contact a qualified handyman.

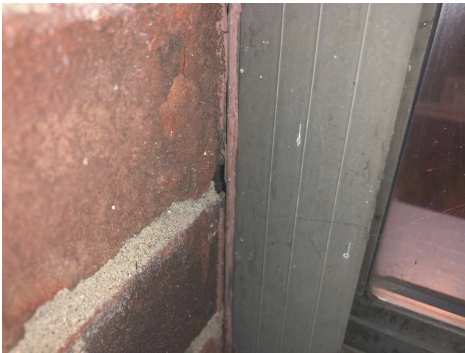
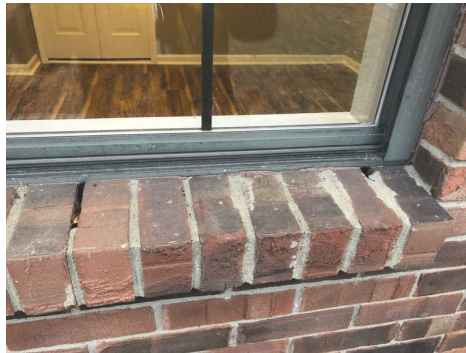
3.11.1 Masonry

GAPS - WINDOWS/DOORS

Any gaps around windows or doors should be sealed to mitigate moisture intrusion. Moisture intrusion between the masonry and framing could cause damage to the framing that would be difficult to observed. Recommend making corrections as needed.

Contact a handyman or DIY project

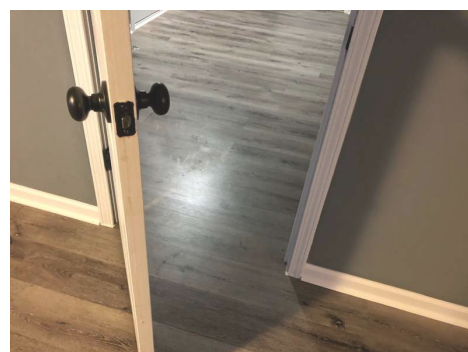
4.1.2 Doors

Door drags slightly, or worse. Recommend sanding down offending sides.

Contact a handyman or DIY project

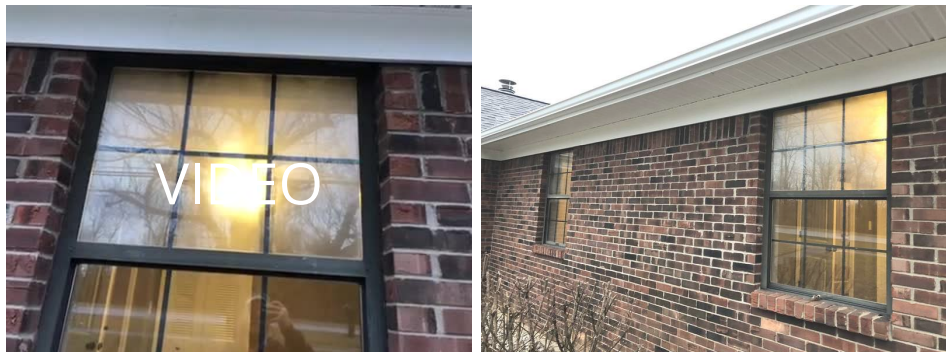
4.2.1 Windows

One more of the windows had a damaged seal and condensation was noted in between the panes of glass. Recommend further review and correction.

Contact a qualified window repair/installation contractor.

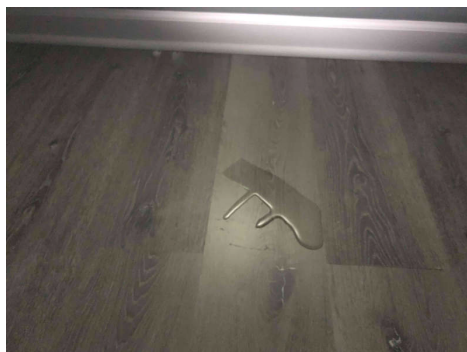
4.3.1 Floors

There was water on the floor in the basement. It appeared to most likely be related to the damaged wall hydrant on the front wall. Further review and correction is needed.

Contact a qualified professional.

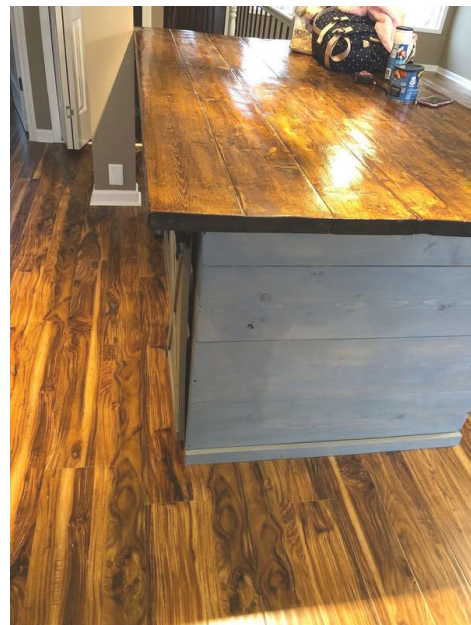
4.7.1 Countertops & Cabinets

ISLAND - NOT SECURED

SAFETY Island was loose and it presents a tip over hazard. Recommend securing.

Contact a qualified handyman.

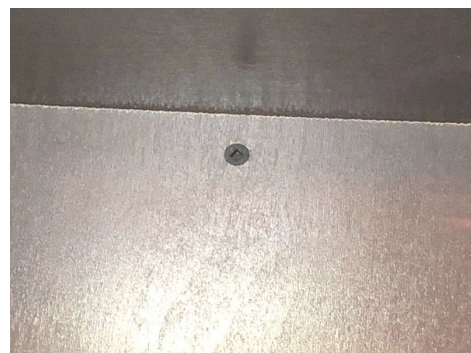
4.7.2 Countertops & Cabinets

CABINET SCREWS

One or more cabinet screws are missing or the wrong type of screws were used. Recommend further review and installing as needed. Drywall screws are tapered and can pull thru the cabinet. Truss head screws should be used.

Contact a handyman or DIY project

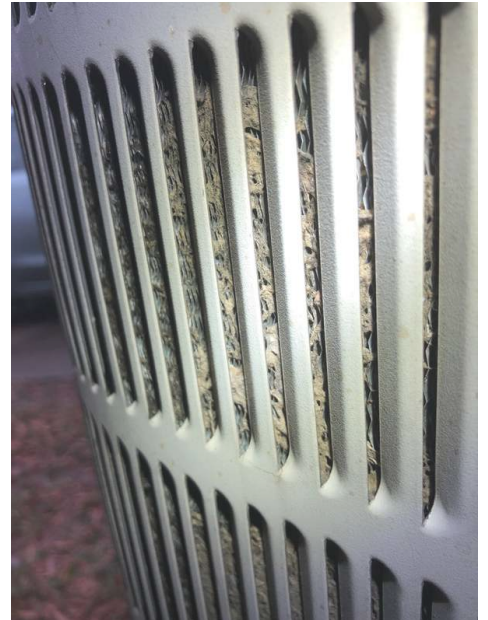
FINS DAMAGED/DIRTY

The fins were dirty or damaged. This may inhibit their ability to dissipate heat. Recommend further review by an HVAC professional.

Contact a qualified HVAC professional.

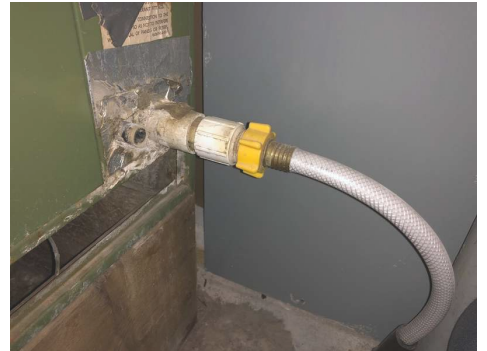
6.2.3 Inside Unit

CONDENSATE TUBE DAMAGED

Condensate tube was improper because no trap was installed. This can allow air moving in and out of the air handler at this location.

Contact a qualified HVAC professional.

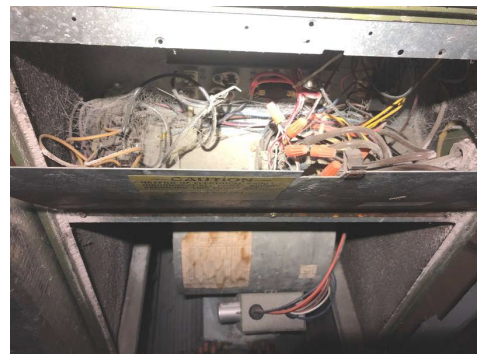
6.2.4 Inside Unit

Furnace should be cleaned and serviced annually. Recommend a qualified HVAC contractor clean, service and certify furnace.

Contact a qualified HVAC professional.

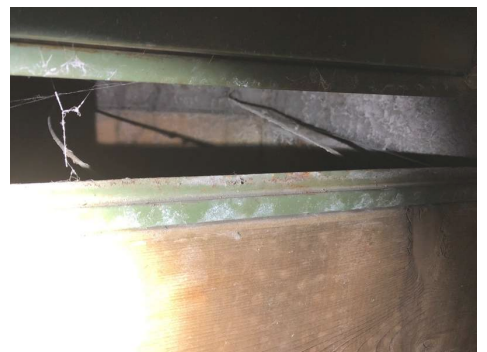
6.3.1 Filters

FILTER MISSING

There was no filter observed. This can cause several different issues as follows.

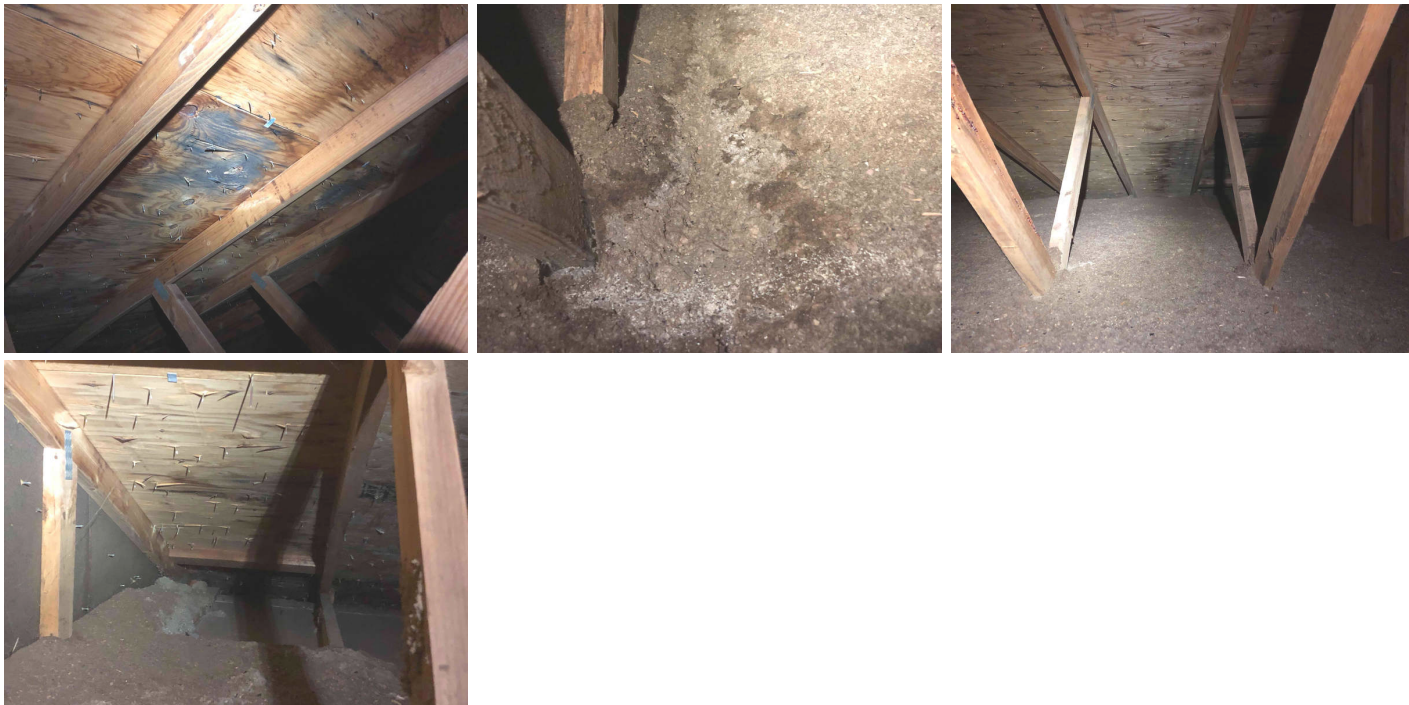
Leaks: Previous Leaks

Previous leaks noted. No active leaks detected. Recommend monitoring.

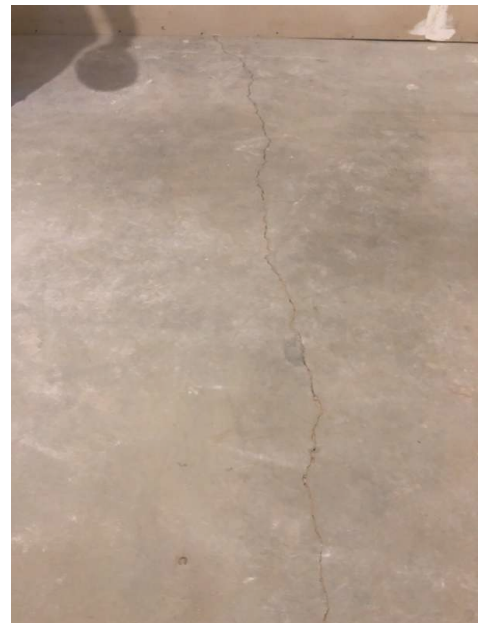
CRACKING - NORMAL

Cracking of the floor was noted. This is caused by a lack of control joints and/or insufficient reinforcement. No major concerns observed at this time.
